REVIEW OF SELECTED LANDSLIDES INVOLVING SOIL-NAILED SLOPES

GEO REPORT No. 222

F.H. Ng, M.F. Lau, K.W. Shum & W.M. Cheung

**GEOTECHNICAL ENGINEERING OFFICE
CIVIL ENGINEERING AND DEVELOPMENT DEPARTMENT
THE GOVERNMENT OF THE HONG KONG
SPECIAL ADMINISTRATIVE REGION**

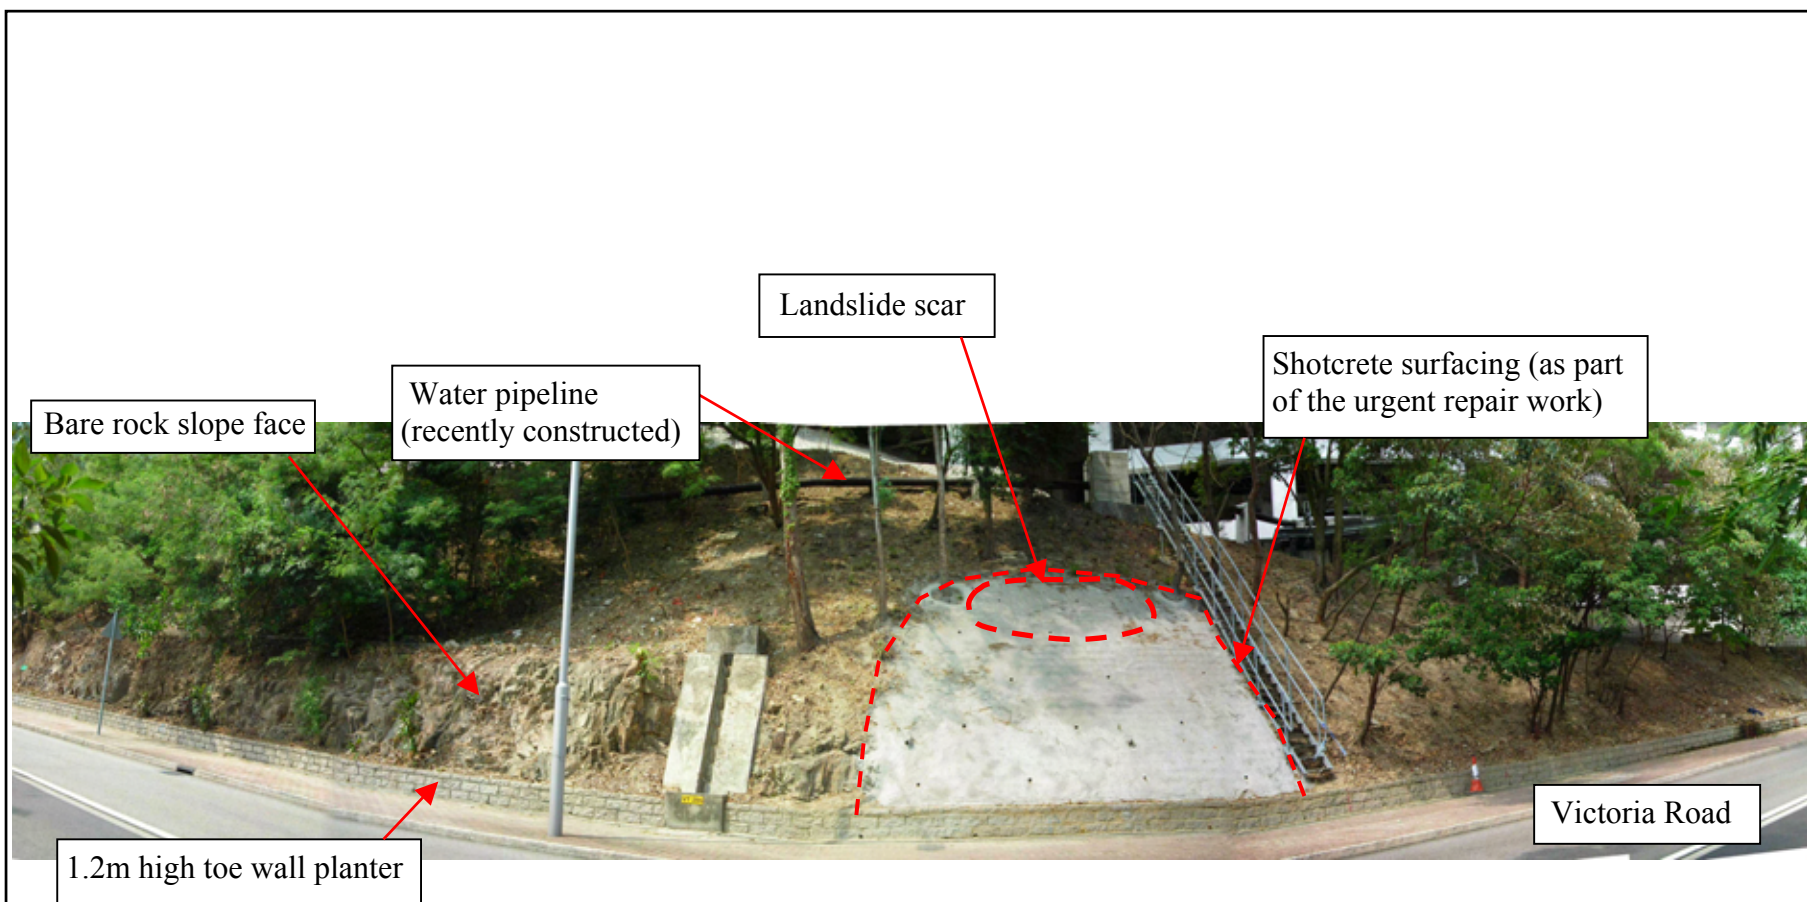
A subsequent site inspection on 13 October 2006 revealed that shotcrete with weepholes had been applied to the landslide scar, extending down to the toe planter (Figure 3 and Plate 2). No seepage was observed from either the weepholes or the raking drains during the inspection. However, continuous water seepage was observed at two locations from the toe planter near the north-eastern end of the slope (Figure 3), one of which was in line with the location observed by the GEO in January 2005.

Plate 2 - General View of Slope No. 11SW-C/C383 (Photograph taken on 13 October 2006)

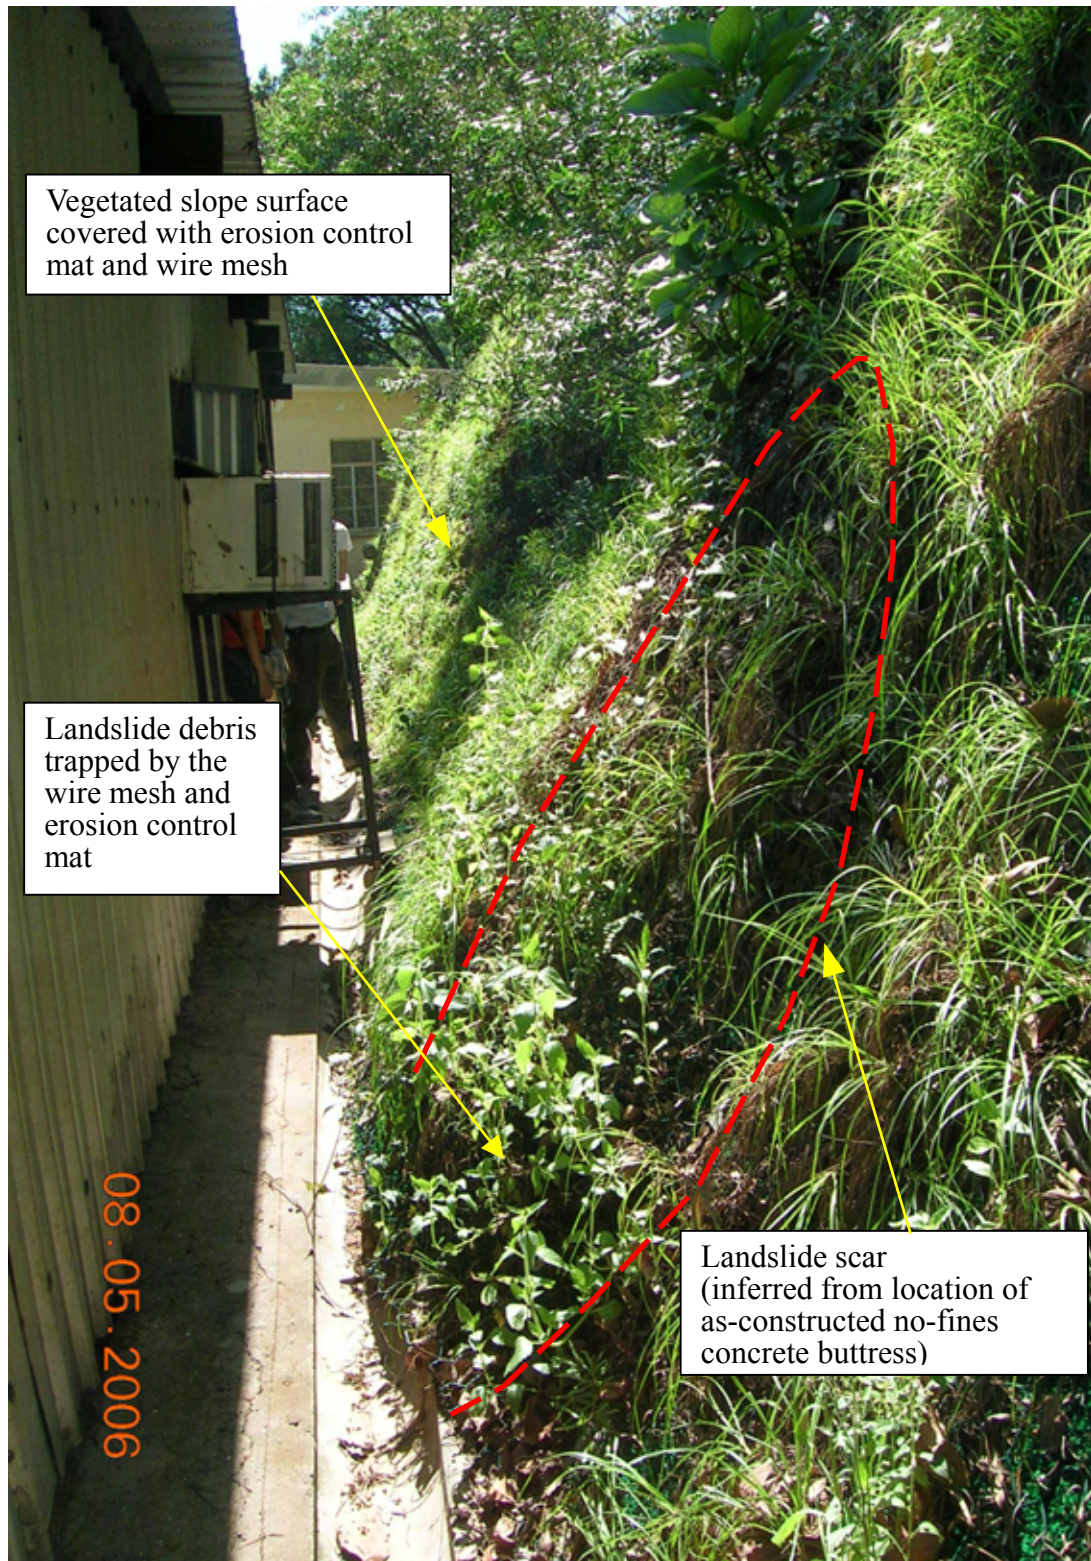
According to the ArchSD's Incident Report, a landslide involving an estimated volume of 4 m³ occurred on 26 April 2006. The landslide debris was trapped behind the steel wire mesh (Plate 3). No casualties or damage to property were reported as a result of the landslide.

Plate 3 - View of Landslide Scar and Landslide Debris on Slope No. 3SE-D/C61
(Photograph taken by ArchSD on 8 May 2006)

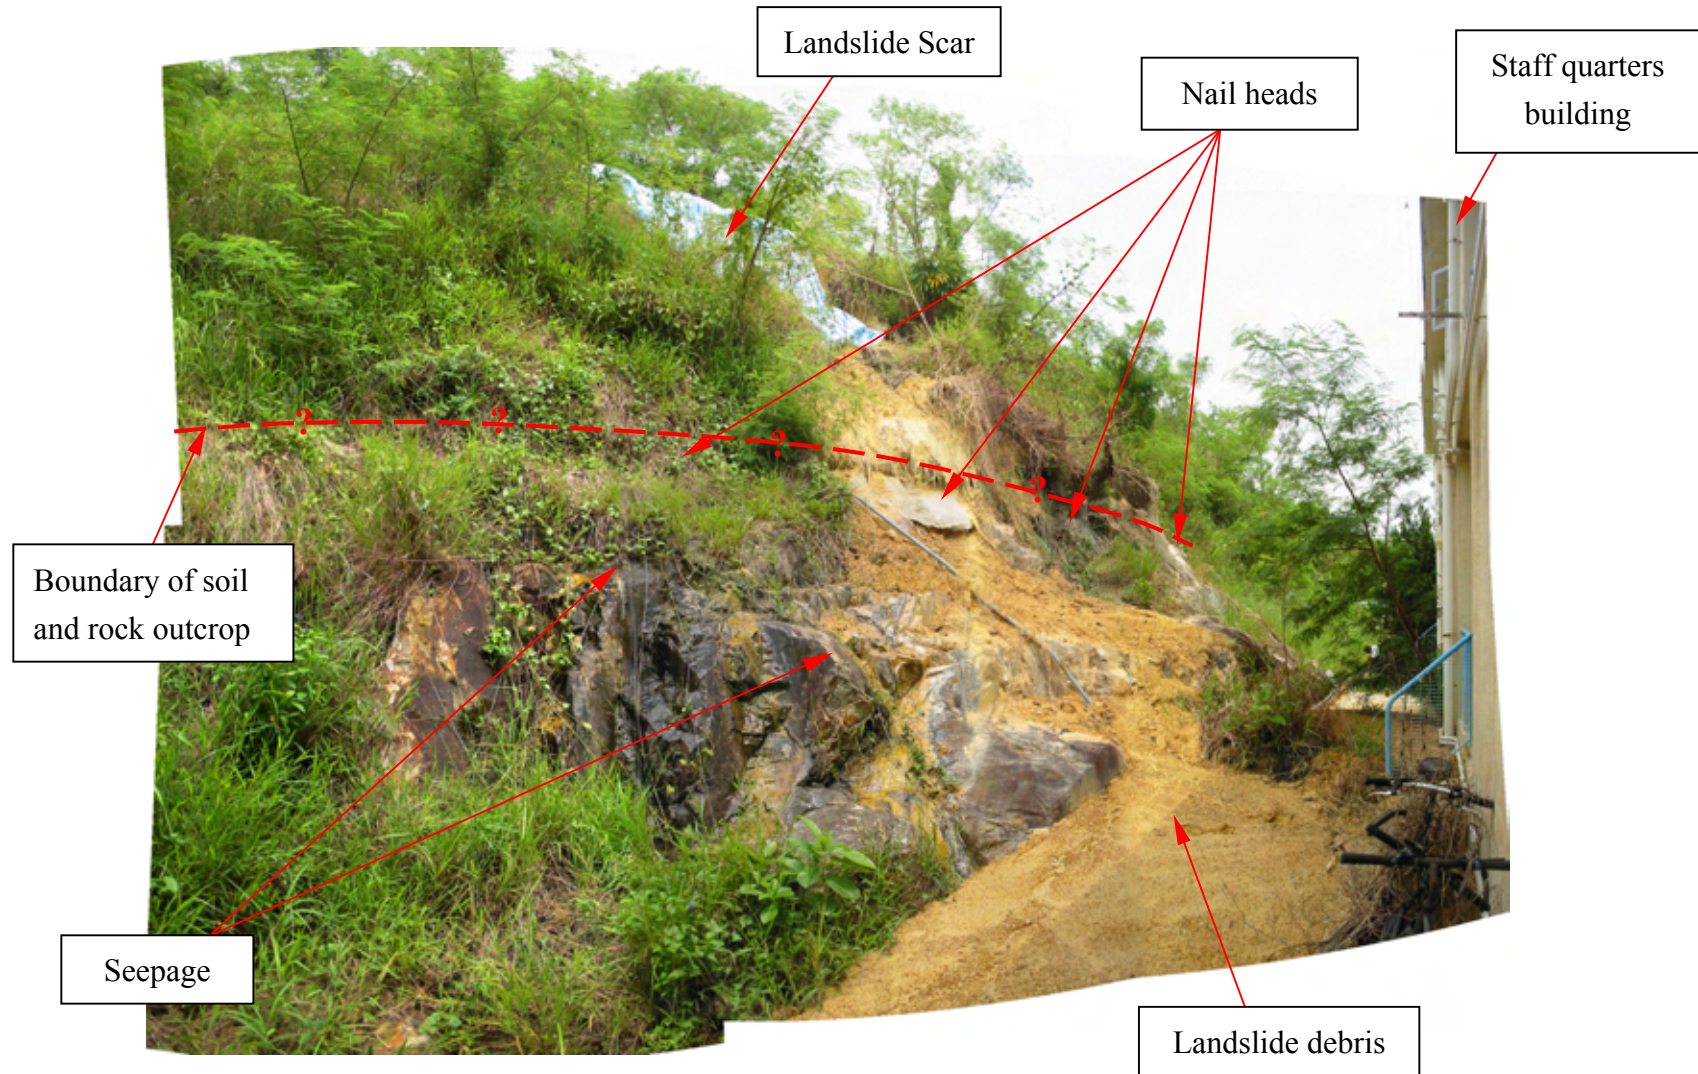
The landslide scar was located in the central portion of the slope immediately below the berm slab and above the rock outcrop. The main scarp (maximum 1 m high) undermined the berm slab generally by about 700 mm. The scar, with dimensions of about 6 m (width) by 7 m (length) by 1.5 m (depth) maximum, extended downslope to the top of the rock outcrop. No seepage was observed at the main scarp and the exposed material was dry at the time of inspections on 30 August and 2 September 2005, at which time the weather was fine. However, seepage was noted at the soil/rock interface immediately adjacent to both sides of the scar, indicating that a perched water table is liable to build up above the interface during heavy rainfall.

Plate 4 – View from Toe of Slope No. 15NE-A/C152 Looking North East (Photograph taken on 2 September 2005)

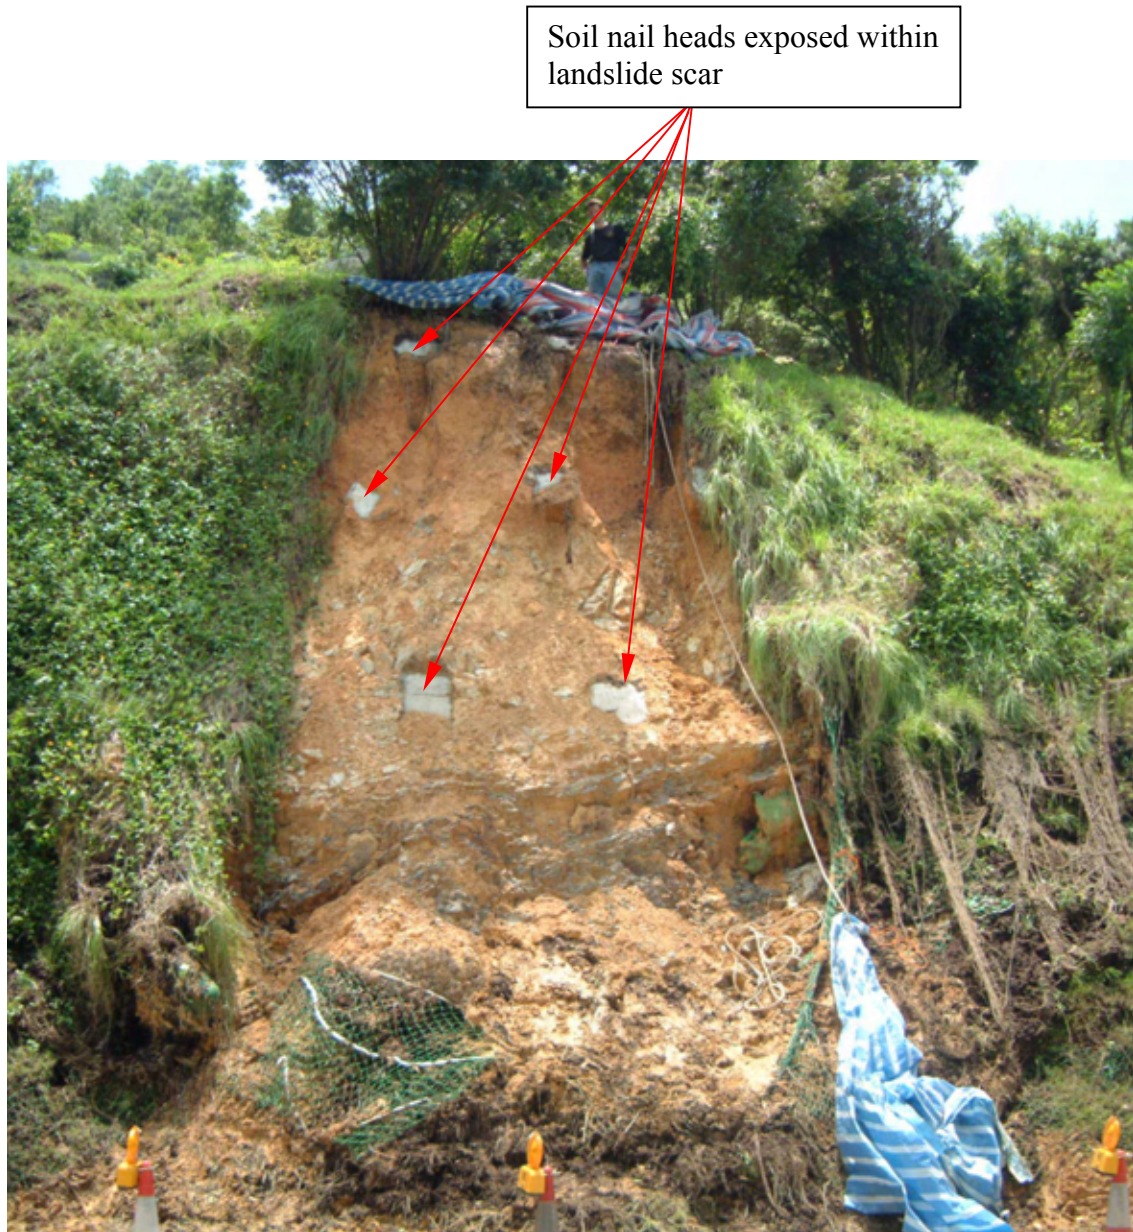
The top surfaces of the recessed concrete soil nail heads of dimensions of 400 mm by 400 mm were exposed in the landslide scar, and they did not appear to have been significantly affected by the failure. Rock was exposed along the surface of rupture near the toe of the landslide scar and over the lower portion of the slope. Debris from the landslide was deposited on the slope below the scar and along a portion of the west bound lane of South Lantau Road, which had been cleared away by the time of inspection. The landslide debris on the slope below the scar was very wet and comprised mainly brown sandy, gravelly SILT with many cobbles (C/HDT).

The area above the slope did not appear to have been affected by the landslide and no evidence of overland flow or subsurface seepage was observed during the site inspection on 23 August 2005.

Plate 6 – General View of Scar at Feature No. 13NE-A/C100
(Photographs Taken on 23 August 2005)

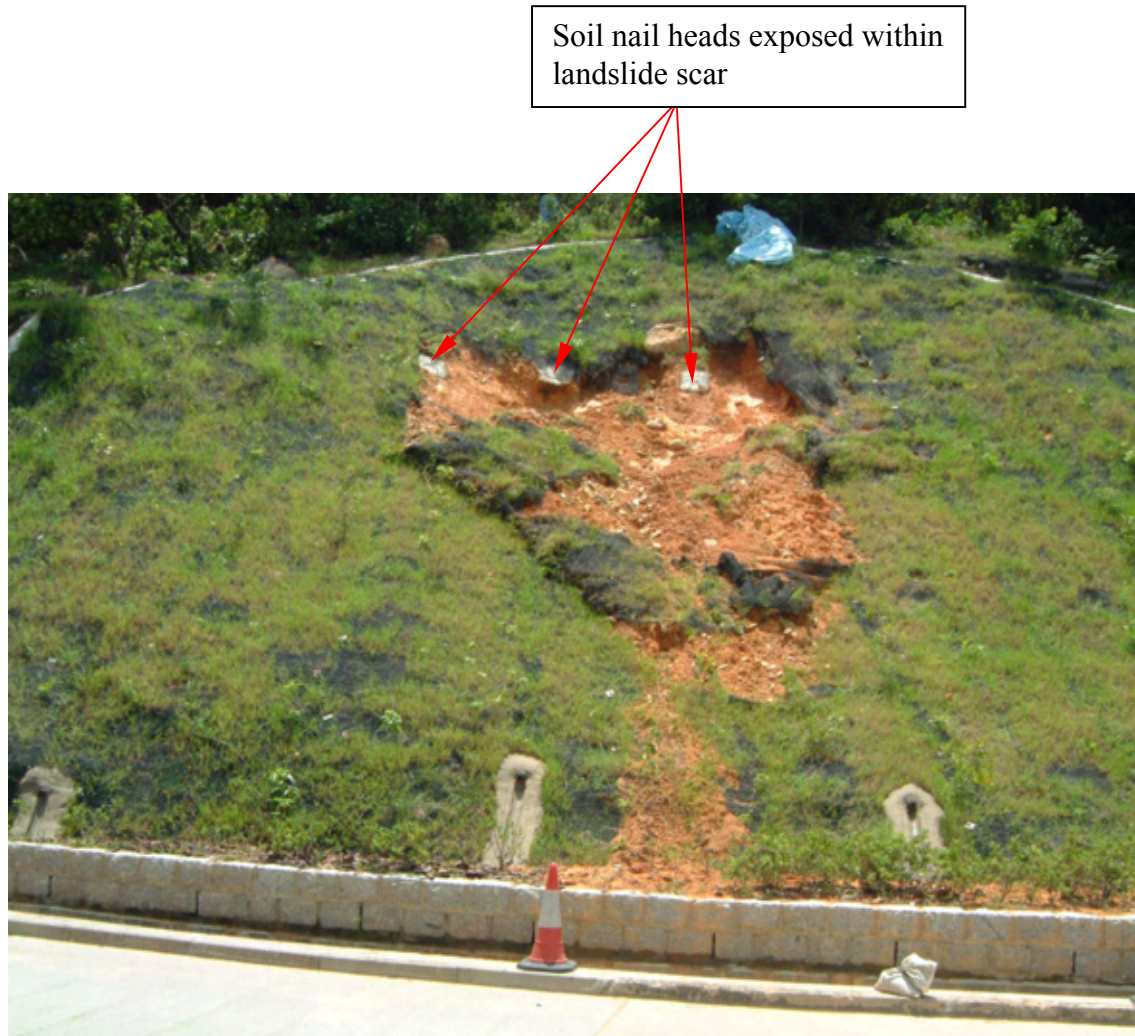
A minor failure occurred near the crest of the eastern end of slope No. 13NE-A/C102 on 20 August 2005 (Incident No. 2005/08/0313b). The slope angle at the failure location was between 25° and 35°. The source area of the landslide was estimated to be about 6 m wide by 3.5 m high and up to 0.5 m deep, with an estimated debris volume of about 5 m³ (Figure 11 and Plate 7).

The top surfaces of the recessed 400 mm square nail heads were exposed in the landslide scar. The nail heads did not appear to have been significantly affected by the failure. Debris from the landslide, together with erosion control mat and vegetation, was deposited on the slope below the source area. The landslide debris was very wet and comprised mainly yellowish brown sandy SILT with many gravels and cobbles (colluvium/CDT).

Plate 7 – General View of Scar at Feature No. 13NE-A/C102
(Photograph Taken on 23 August 2005)

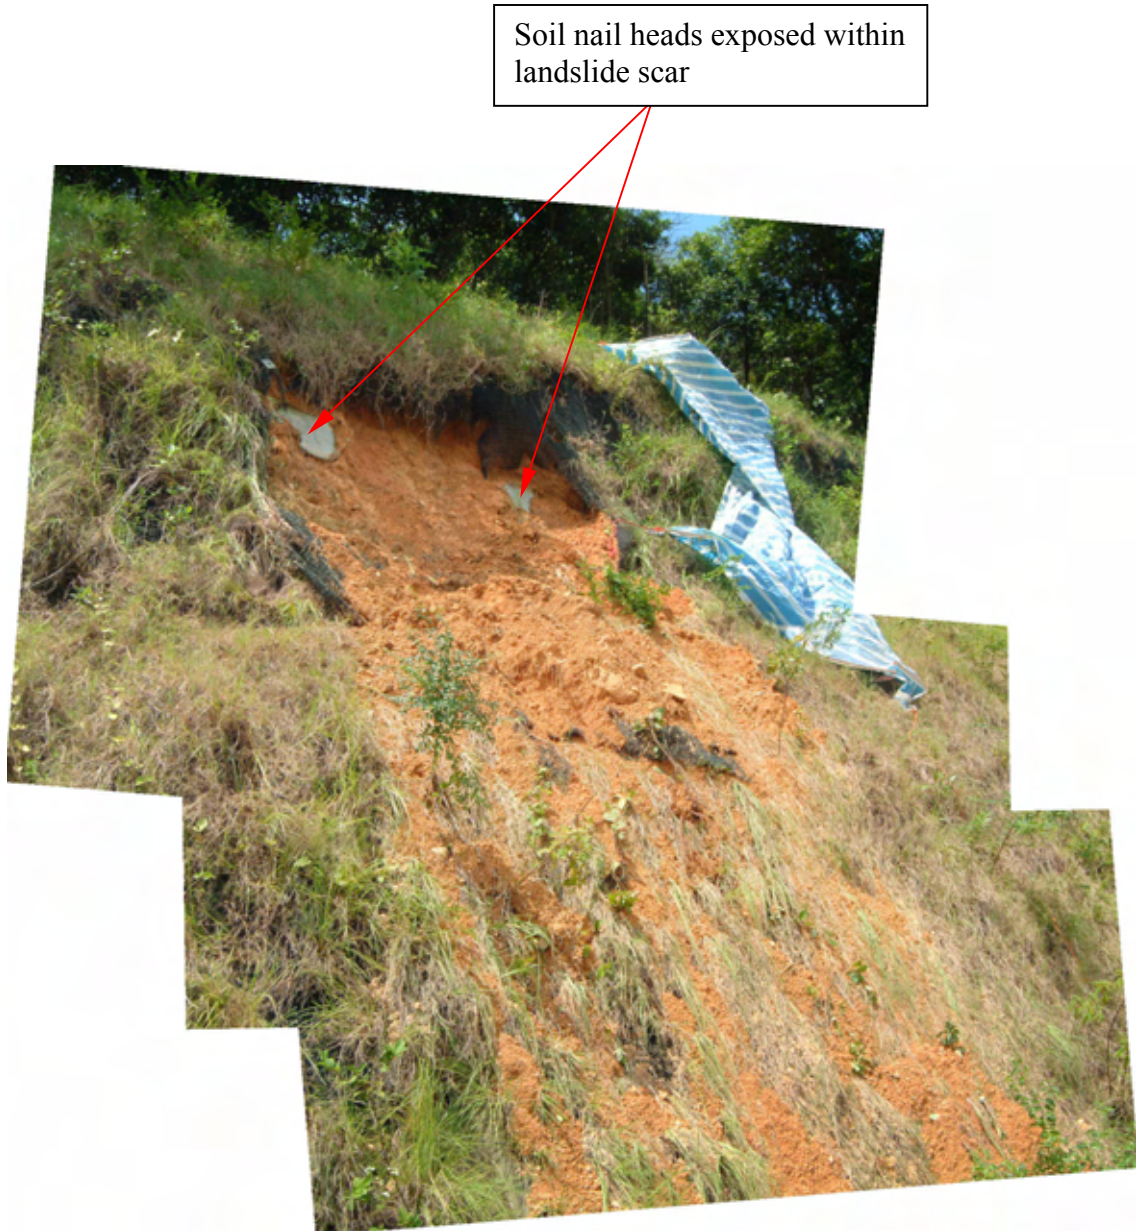
The source area of the larger landslide (Scar A) was about 2.5 m wide by 2.5 m high and up to 0.4 m deep (Figure 12 and Plate 8), with a debris volume of about 1 m³. The source area of the smaller failure (Scar B) was about 1.5 m wide by 2 m high and up to 0.4 m deep, with a debris volume of about 0.5 m³ (Figure 13 and Plate 9).

Plate 8 – General View of Scar A at Feature No. 13NE-A/C108
(Photographs Taken on 23 August 2005)

Soil nail head exposed within
landslide scar

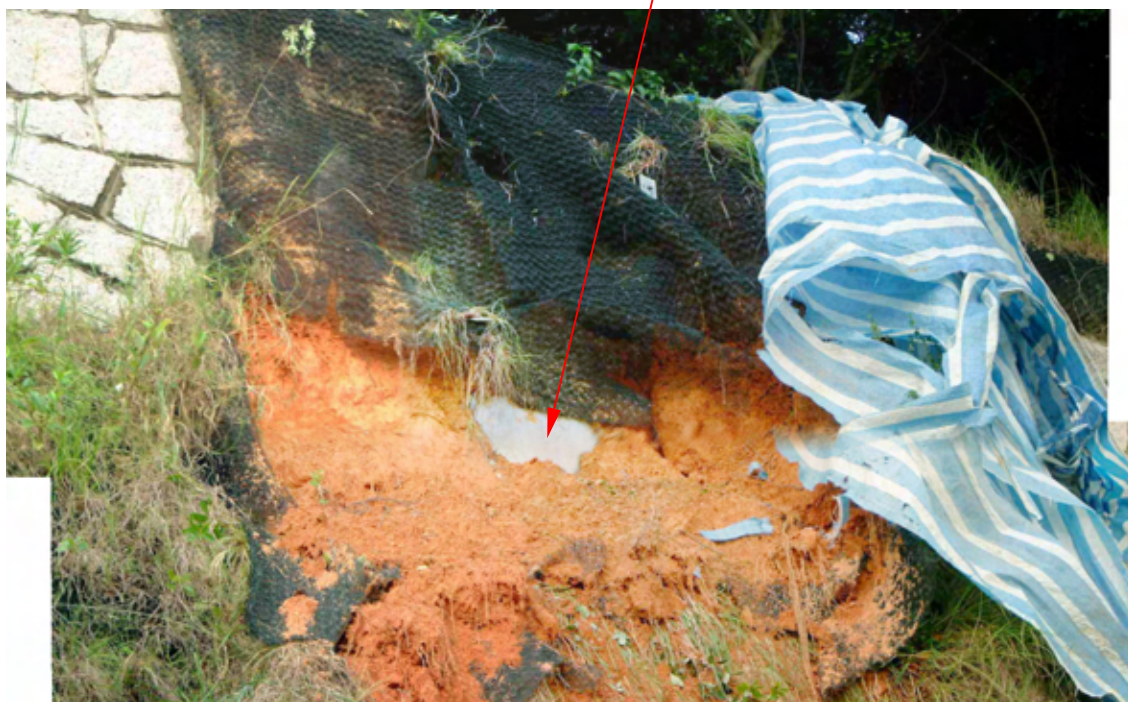
Plate 9 – General View of Scar B at Feature No. 13NE-A/C108
(Photographs Taken on 23 August 2005)

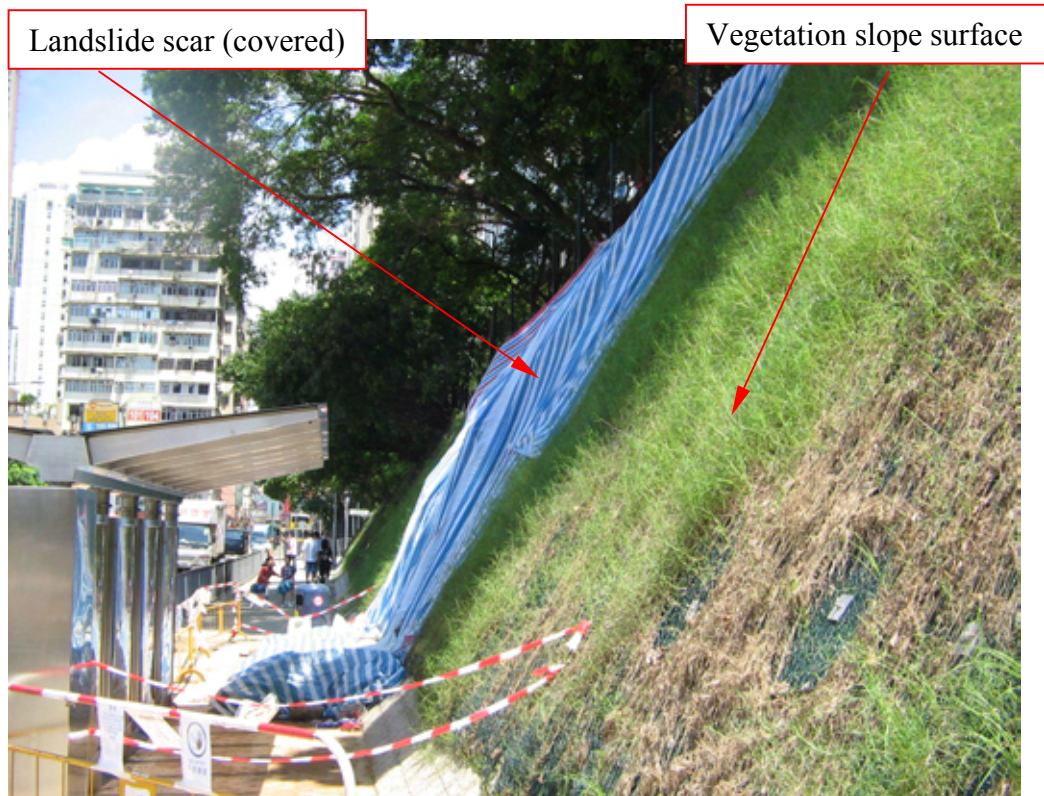
The failure occurred in the central portion of the slope and affected the full slope height. The scar was about 8 m wide by 4 m high and about 0.5 m deep (maximum). The estimated failure volume was about 3 m³. The main scarp exposed yellowish brown mottled white, sandy clayey silt with boulders (colluvium). Ten nail heads were exposed within the landslide scar and they did not appear to have been affected by the landslide. The erosion control mat and the steel wire mesh at the upper portion of the landslide scar were torn, but the connecting nuts, washers and plates were still connected to the soil nail heads. Steel wire mesh was noted on the slope surface at both sides of the scar (Plate 11).

The correlation between the rainfall on 19 and 20 August 2005 and the timing of the incident suggests that the landslide was probably rain-induced. The landslide was probably caused by the wetting up of the near-surface slope-forming material below the hydroseeded surface through direct infiltration. The concrete upstand at the slope crest probably prevented significant surface erosion on the slope face. The relatively steep cut slope (60°) comprising near-surface colluvium predisposes the slope to shallow instability. Given the shallow geometry of the landslide scar, leakage from the buried water-carrying services behind the slope crest as a contributory factor to the landslide is considered unlikely.

Plate 10 - General View of the August 2005 Landslide (Slope No. 11SW-A/C102)
(Photograph taken on 22 August 2005)

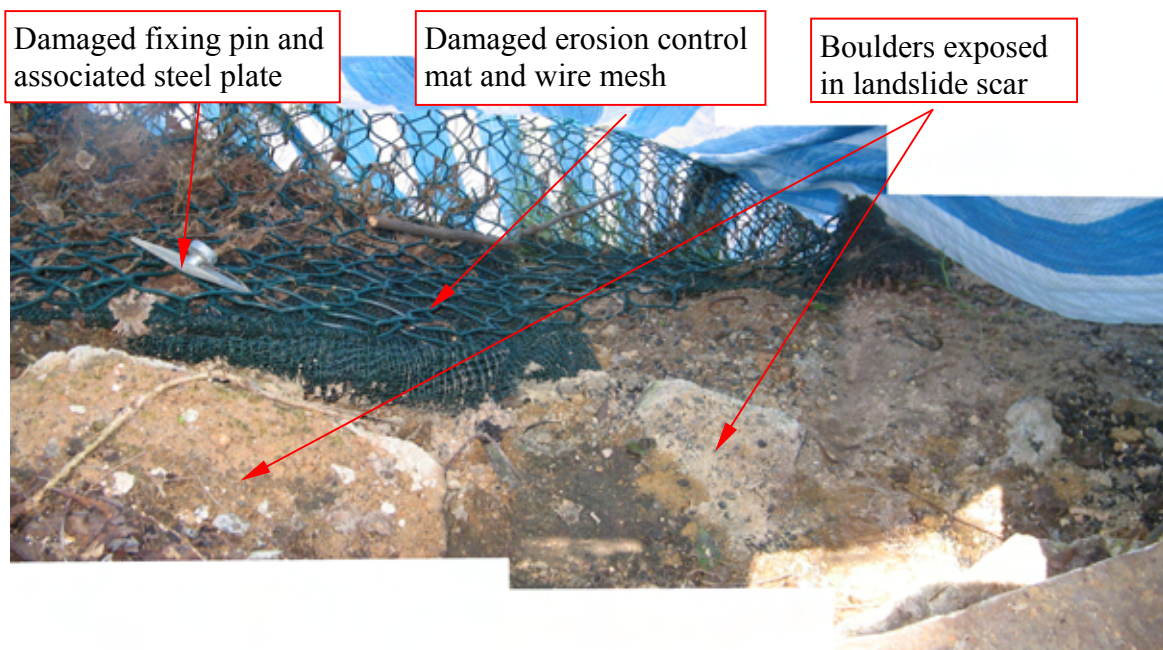
Plate 11 - View of Landslide Scar at Slope Crest (Slope No. 11SW-A/C102)
(Photograph taken on 22 August 2005)

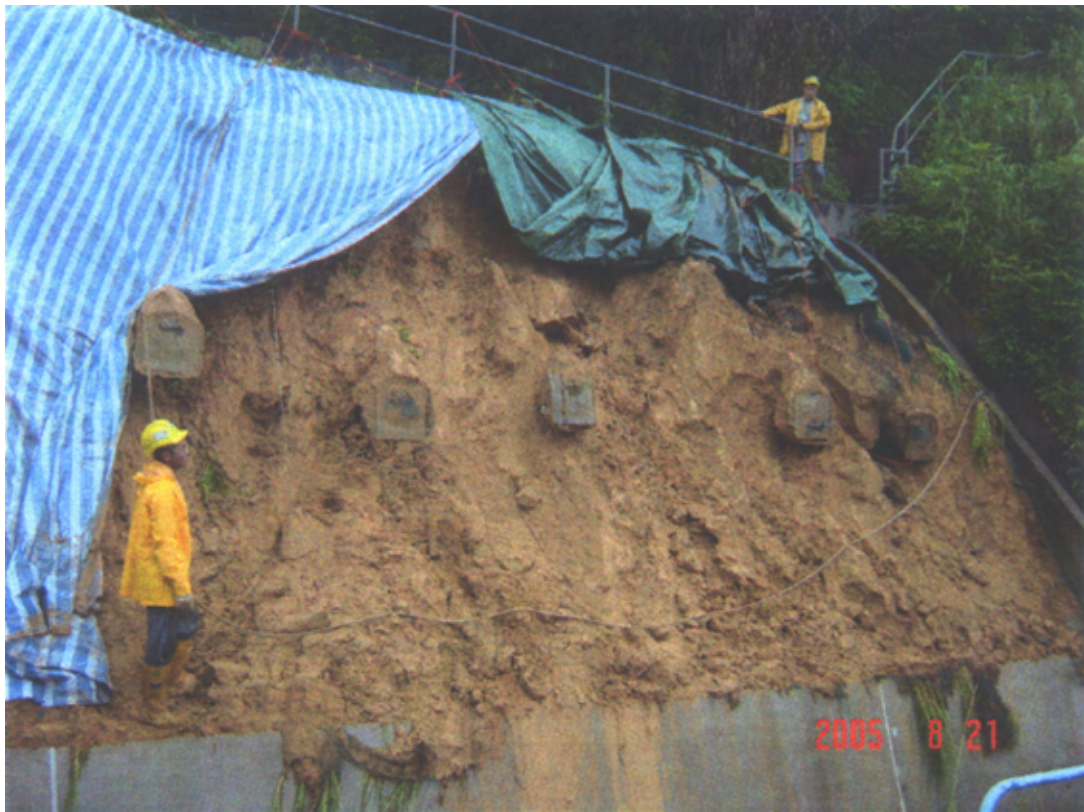
A total of 14 nail heads (400 mm to 500 mm square in size) at about 1.5 m to 1.9 m centres horizontal spacing, together with the heads of two raking drains, were exposed within the landslide scar (Plate 12). Due to the on-going landslide repair works at the time of the inspections, the exposed concrete nail heads, steel reinforcement and the grout cores of the lower two rows of soil nails could not be closely examined. Based on the record photographs and inspection of the exposed uppermost row of soil nails, the soil beneath the nail heads was eroded and the grouting beneath was slightly exposed. There appeared to be no noticeable damage to, or deformation of, the soil nail bars.

Plate 12 - General View of the Landslide at Tai Lam Chung Catchwater

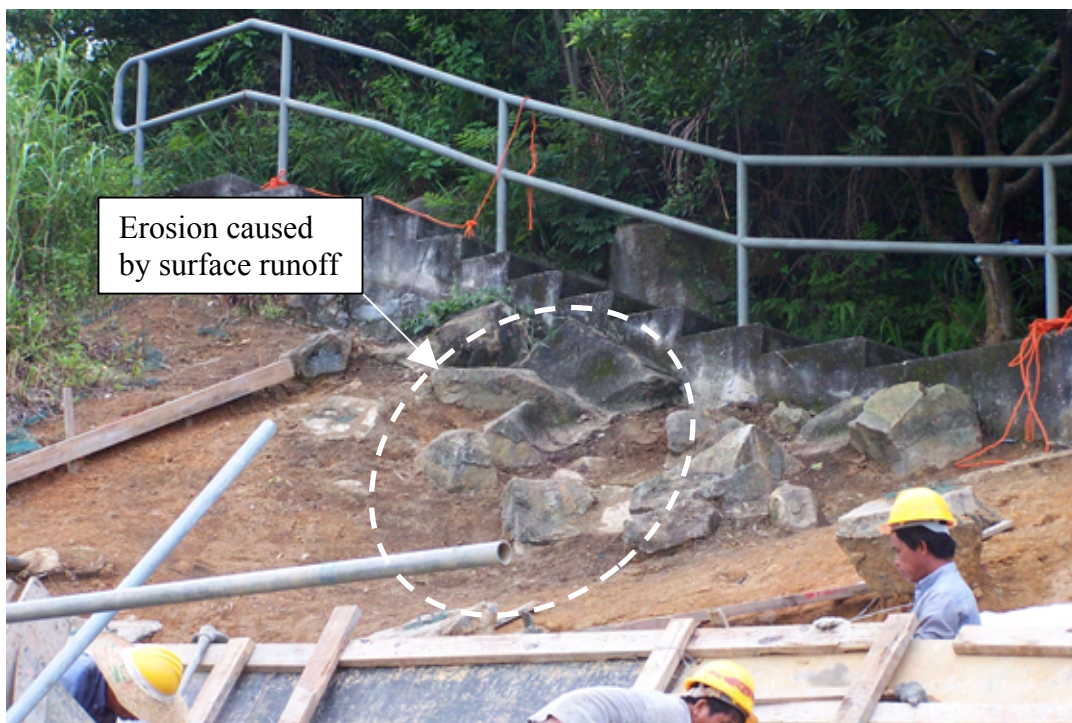
Plate 13 - View of the Upper Portion of the Landslide Scar

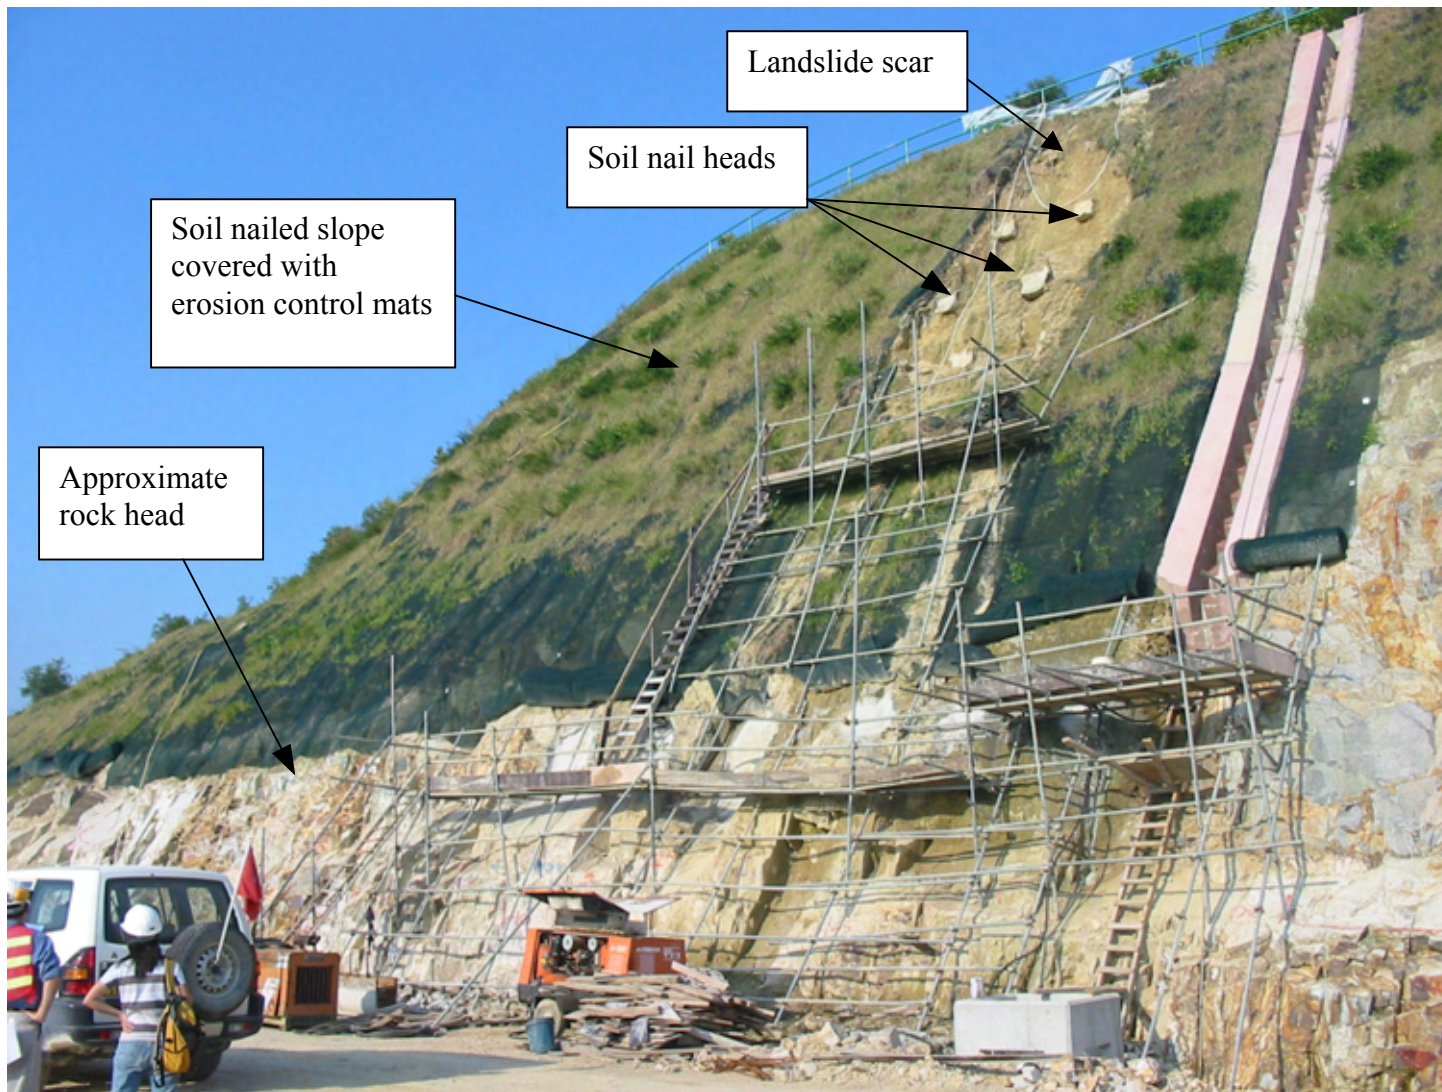
Plate 14 – General View of the August 2004 Landslide at Anderson Road (Photograph taken on 5 October 2004)

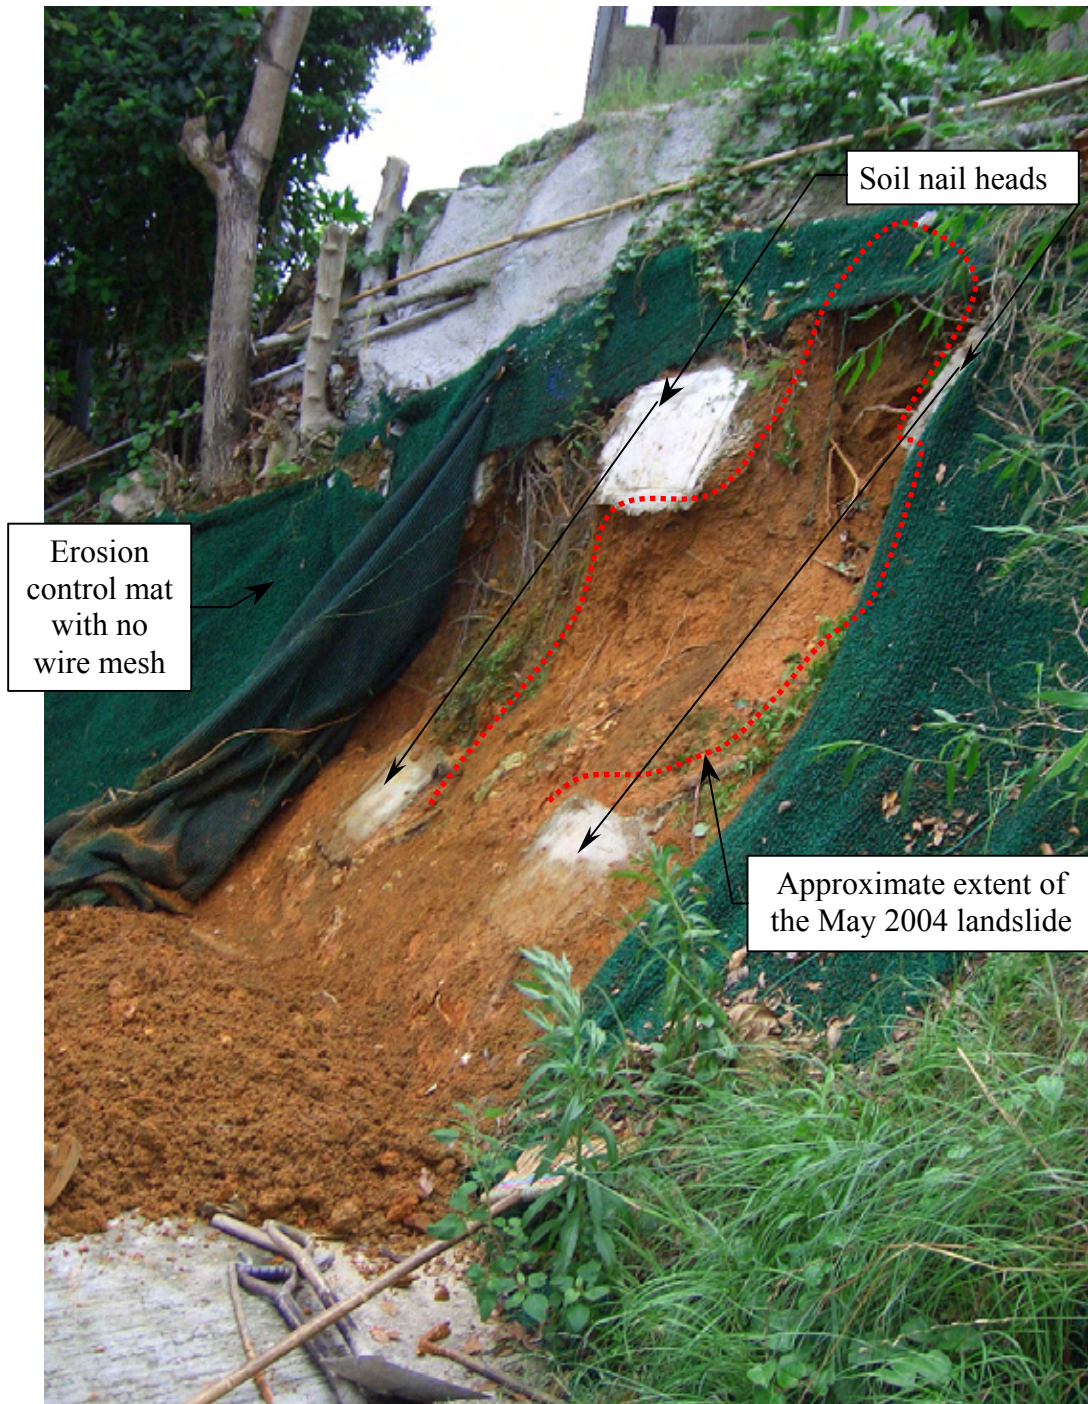
Plate 15 -The May 2004 Landslide on the Northeastern End of Slope No. 11NE-B/C542
(Photograph taken by Lands D on 20 May 2004)

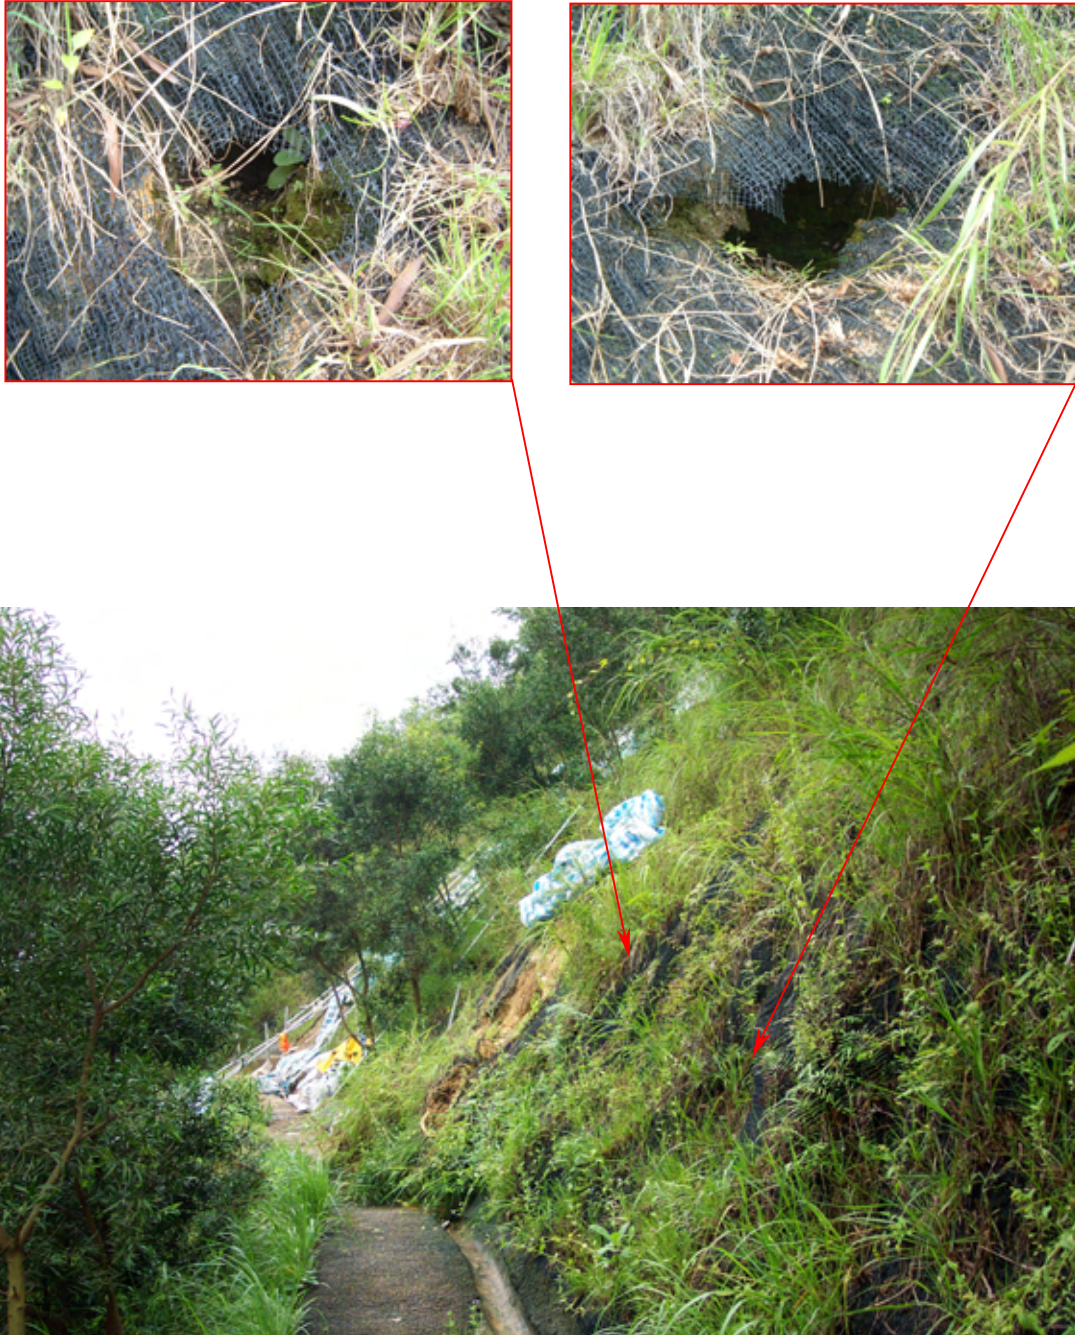
Plate 16 - View of the Erosion Scars on Slope No. 6NE-B/C8 above the Berm
(Photograph taken on 14 June 2003)

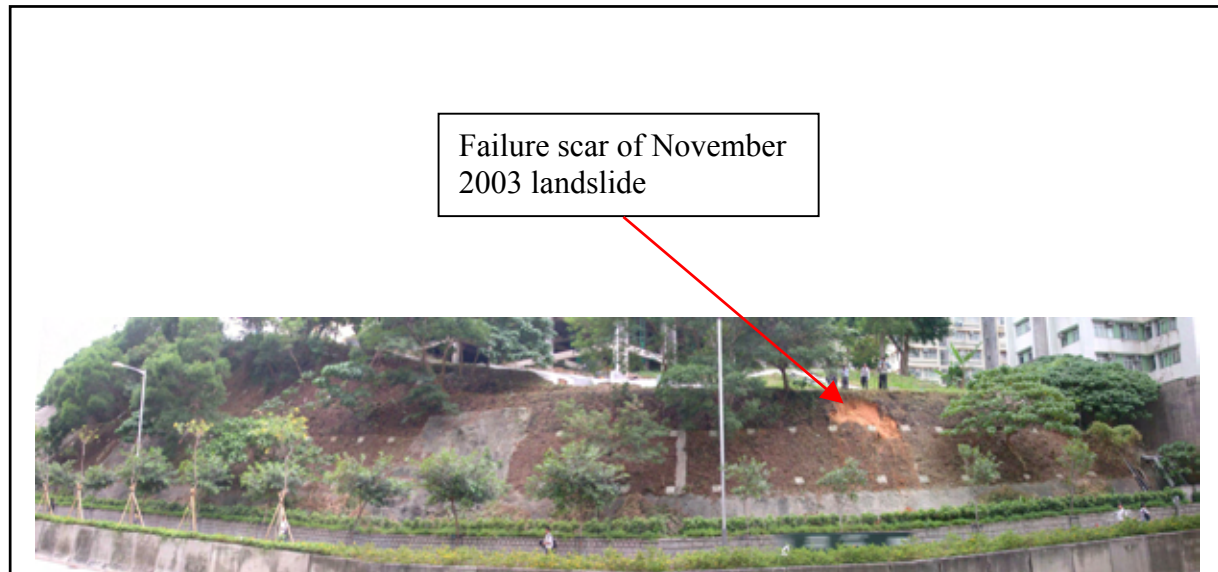
Plate 17 - General View of the Landslide (Slope No. 11SE-D/C22)
(Photograph taken on 10 November 2003)

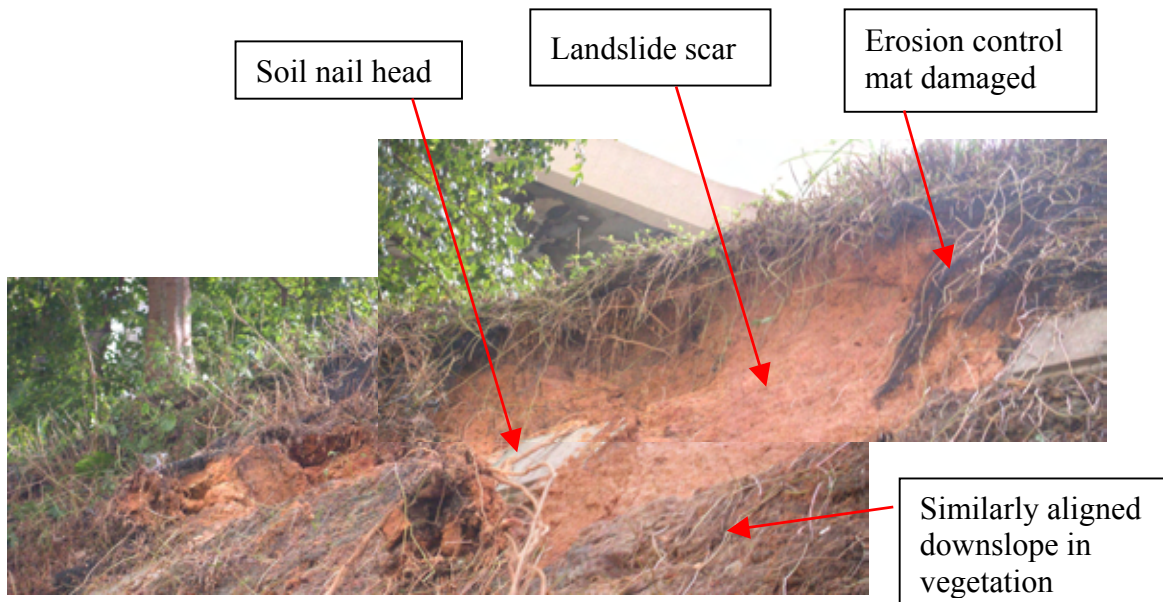
Plate 18 - General View of the Landslide Scar on Slope No. 11SE-D/C22
(Photograph taken on 10 November 2003)

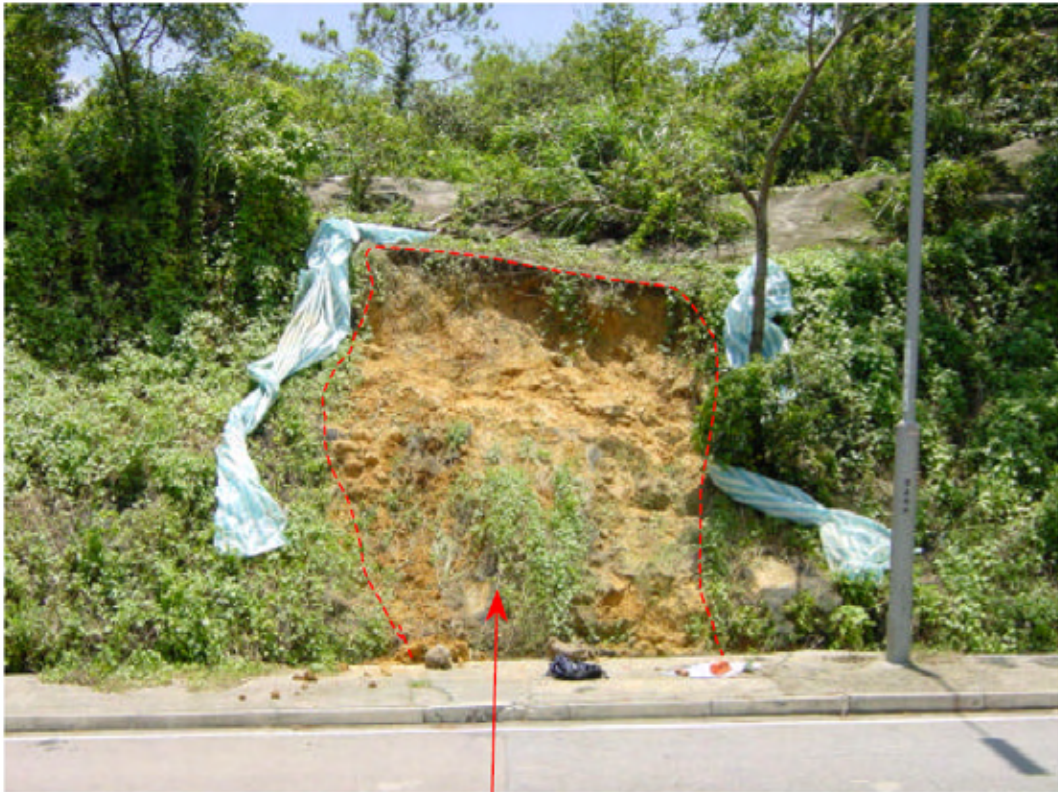
Plate 20 - Elevation View of Landslide A on Slope No. 6SE-B/C4
(Photograph taken on 10 July 2001)
