REVIEW OF SELECTED LANDSLIDES INVOLVING SOIL-NAILED SLOPES

GEO REPORT No. 222

F.H. Ng, M.F. Lau, K.W. Shum & W.M. Cheung

**GEOTECHNICAL ENGINEERING OFFICE
CIVIL ENGINEERING AND DEVELOPMENT DEPARTMENT
THE GOVERNMENT OF THE HONG KONG
SPECIAL ADMINISTRATIVE REGION**

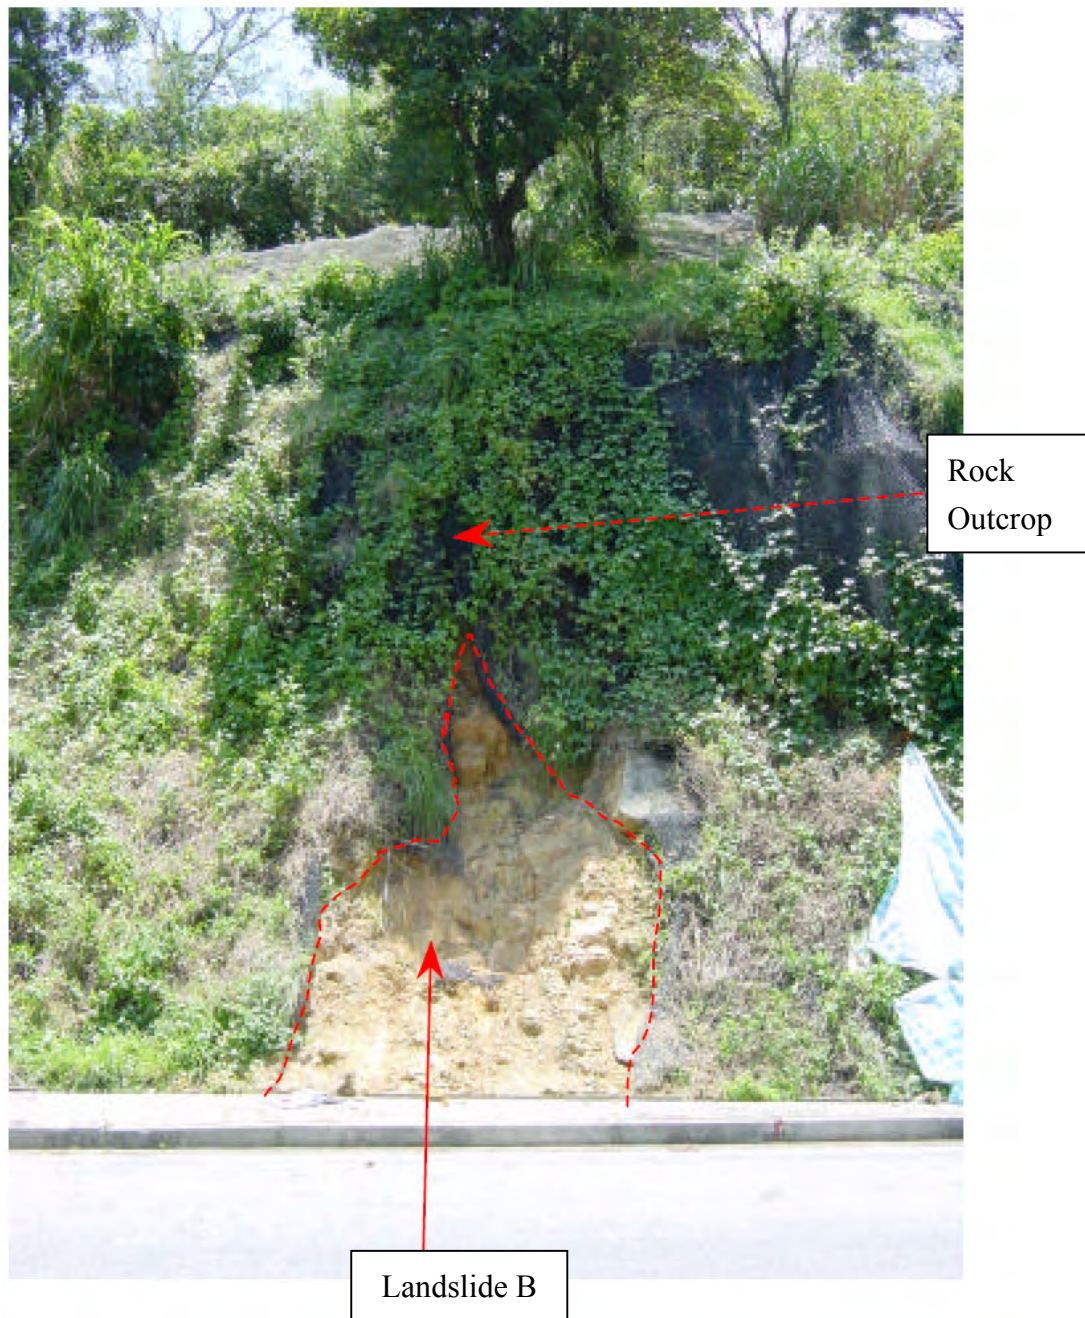
Plate 21 - Elevation View of Landslide B on Slope No. 6SE-B/C4
(Photograph taken on 10 July 2001)

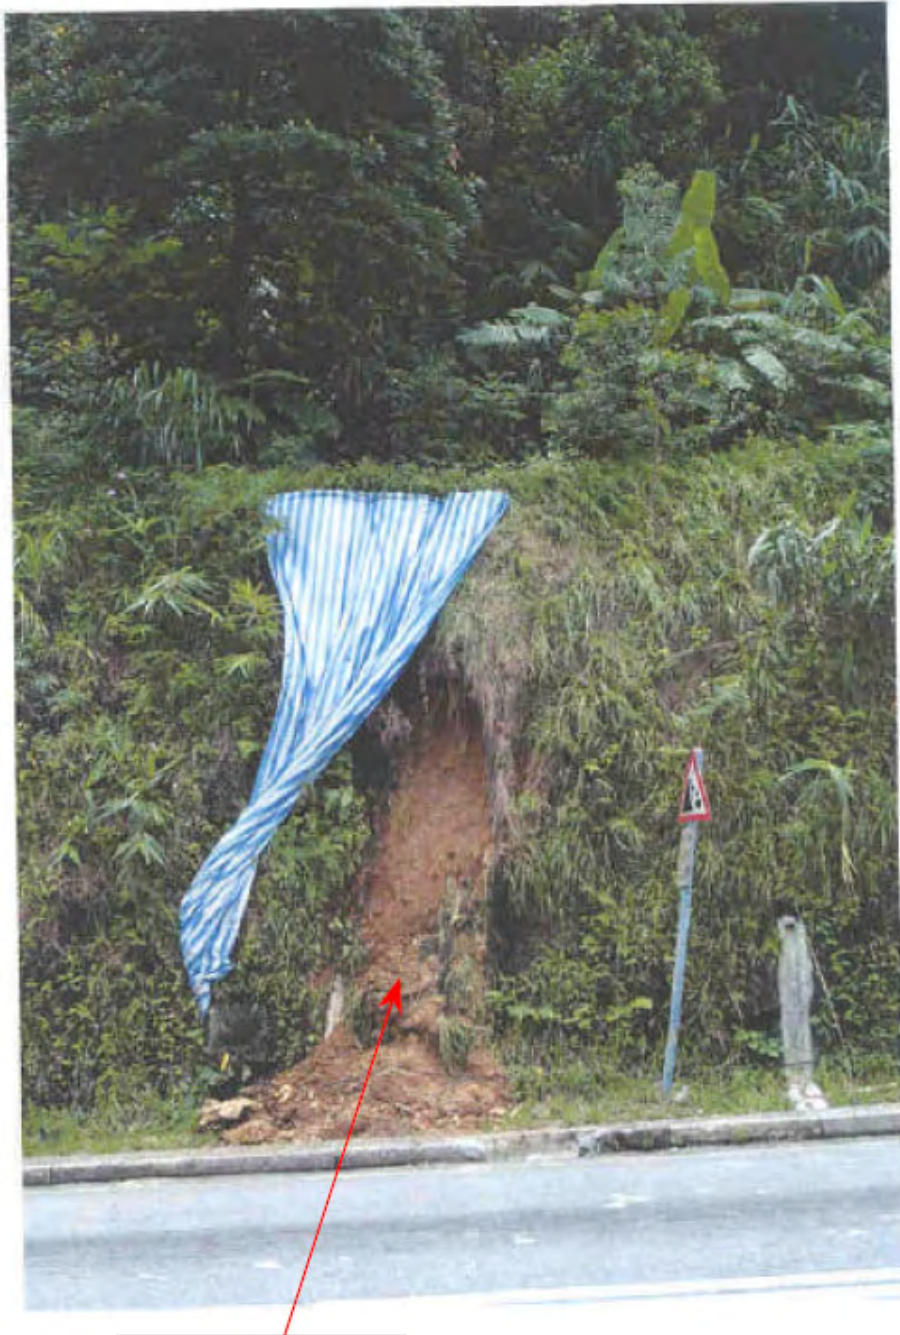
The 2001 landslide

Plate 22 - Elevation View of the 2001 Landslide on Slope No. 6NE-D/C6
(Photograph taken on 10 July 2001)
