FINAL REPORT OF THE COMMISSION OF INQUIRY INTO THE RAINSTORM DISASTERS 1972

GEO REPORT No. 229

T.L. Yang, S. Mackey & E. Cumine

**This report is largely based on the Final Report of the Commission
of Inquiry into the Rainstorm Disasters 1972 produced in November 1972**

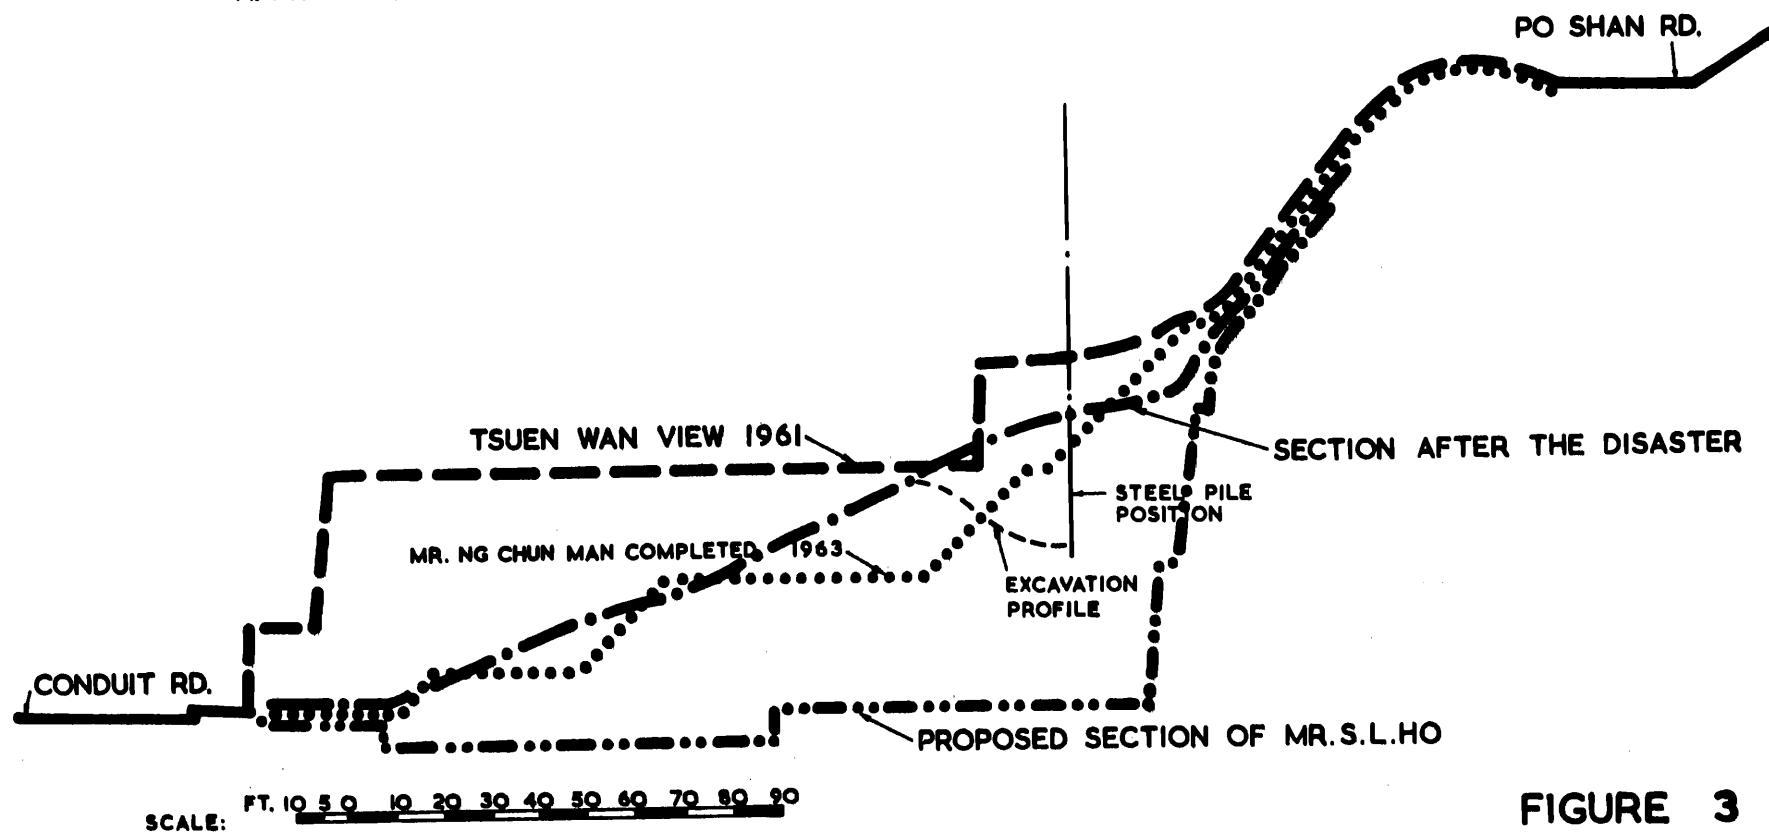
FIGURE 3

DIAGRAM OF CROSS SECTIONS TAKEN THROUGH THE MIDDLE OF I.L.2260 (51C & 51D CONDUIT ROAD) TO ILLUSTRATE THE EXTENT OF THE CUTTINGS AT THE VARIOUS STAGES OF THE DEVELOPMENT AND FORMATION OF THIS SITE. ALL SECTIONS ARE APPROXIMATE.

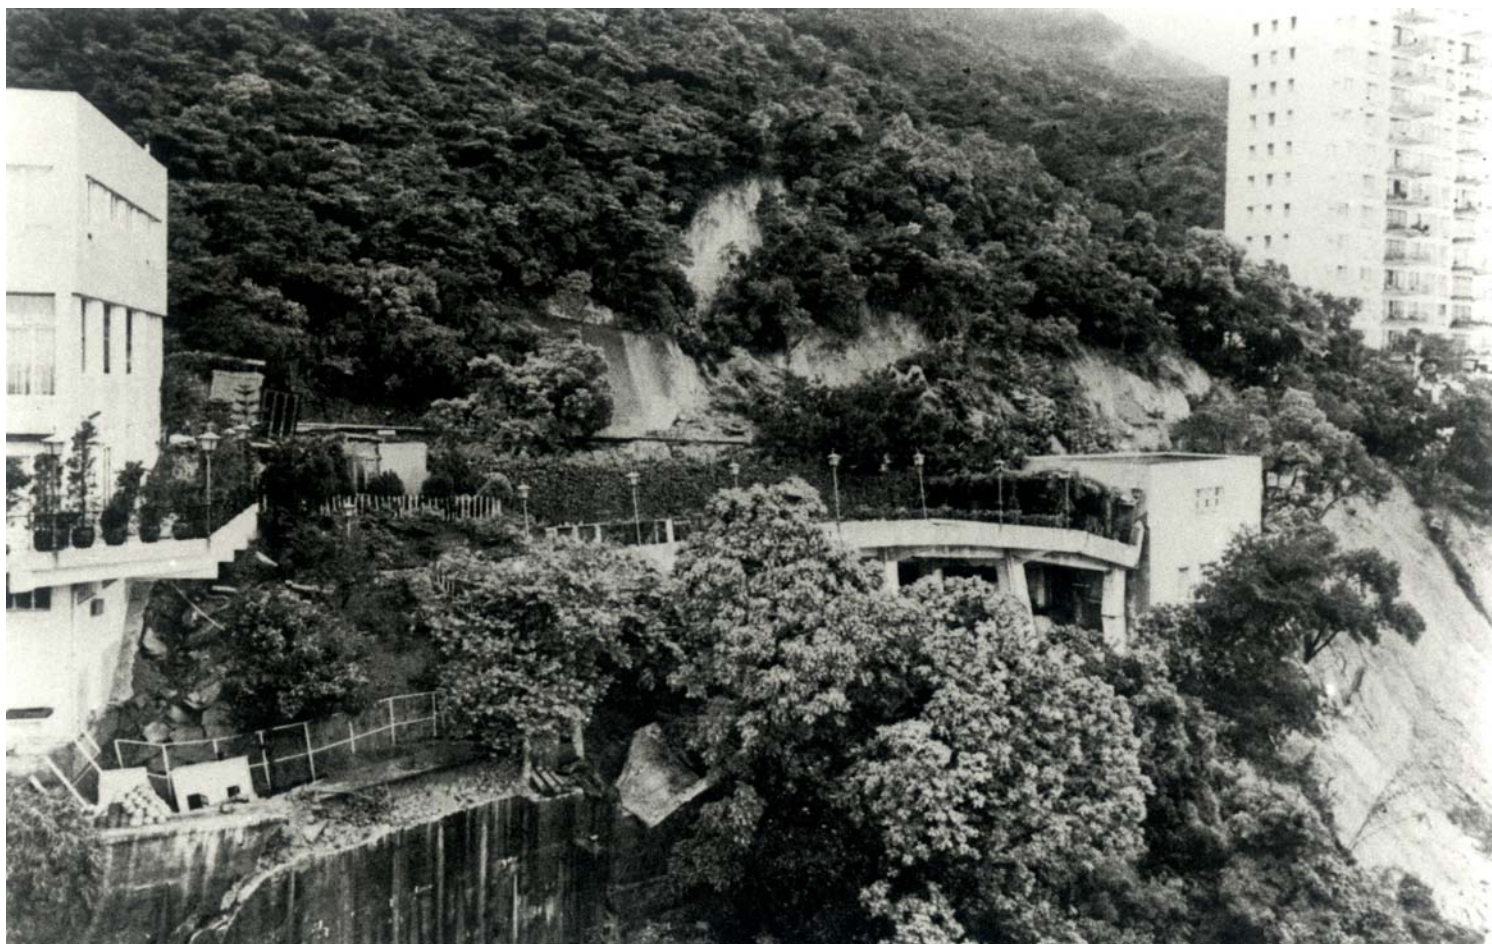
Plate 8

110. By early afternoon the retaining wall below 21, Po Shan Road had moved and fractured. The filling behind the retaining wall and the paving had settled fairly extensively. Nevertheless, apart from minor cracks the house itself appeared to be intact. The slope above Mirror Marina was also showing signs of strain. The main slip face continued to give indications of movement. Settlement continued until at one stage the half-width of Po Shan Road was some 20 feet below normal level. The condition of the garage and terrace deteriorated steadily throughout the afternoon. The garage still appeared intact but settling, tilting towards the garden terrace. The terrace was distorted and bowed from end to end, and the supporting beams and columns were fractured. One of the eye-witnesses also noticed a large hole in the garden terrace. The two structures were apparently on the point of imminent collapse and were expected to slip towards the direction of Skyline Mansion (see Plate 8).

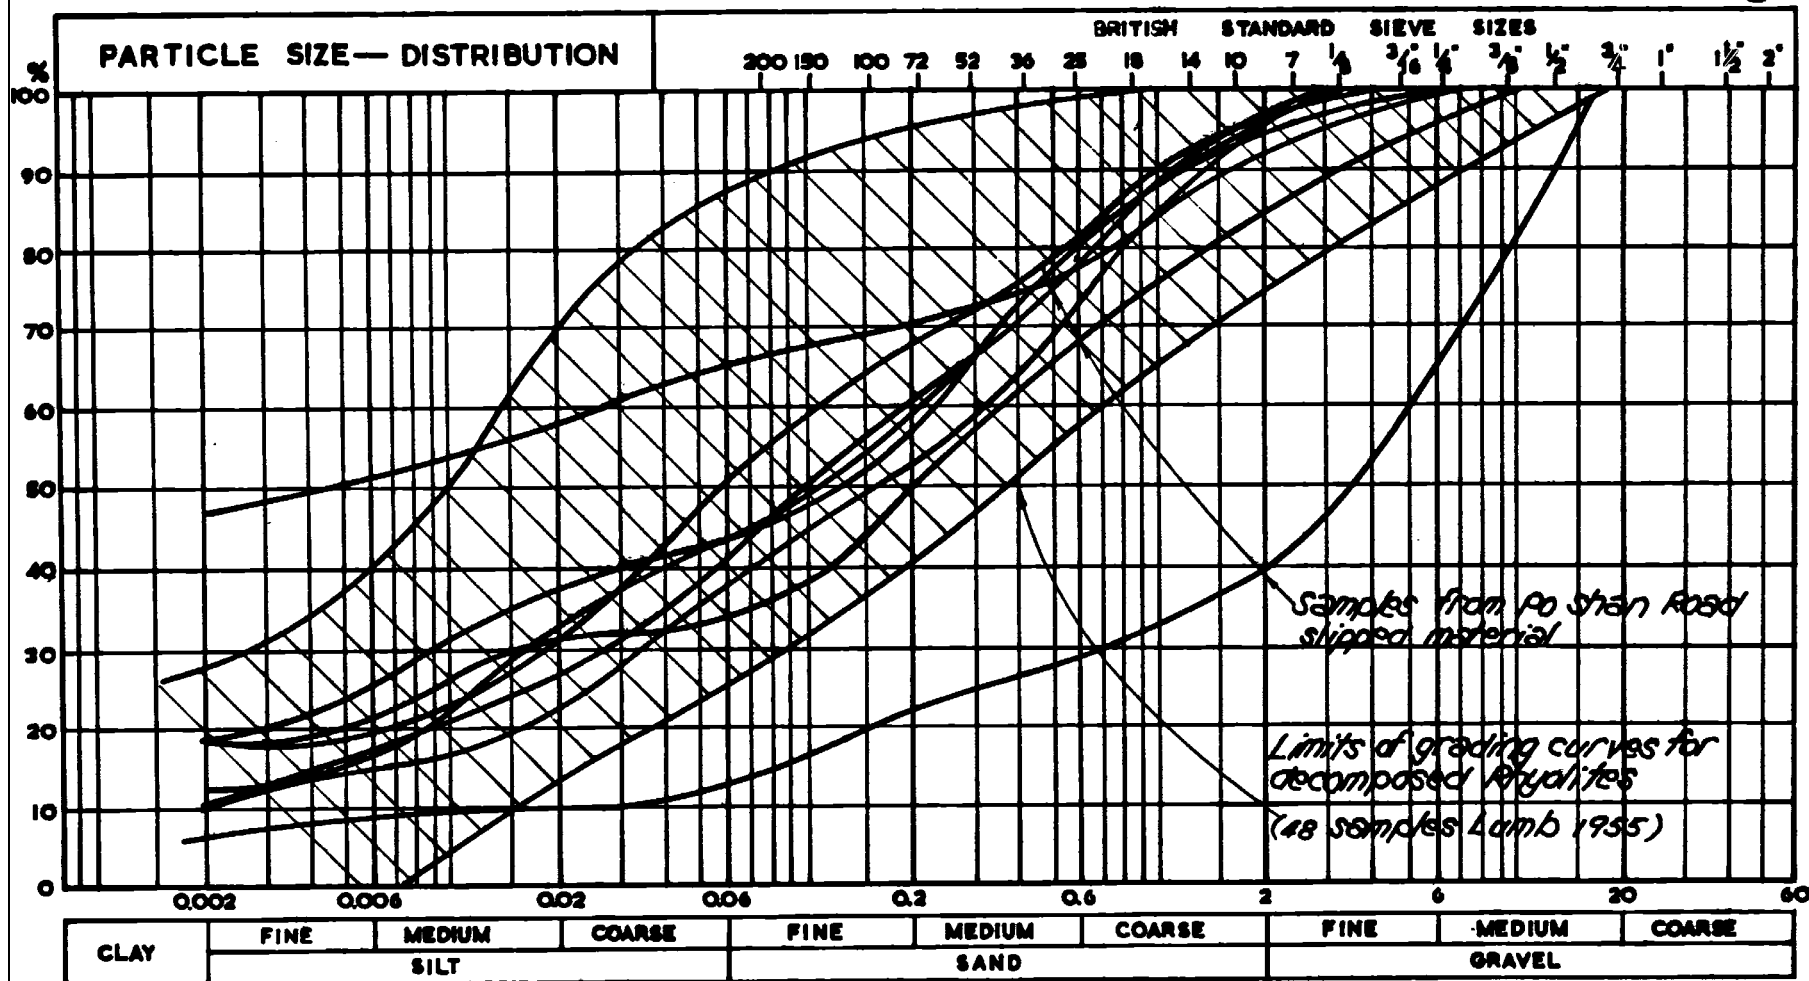
FIG. 5

GRADING CURVES OF DECOMPOSED VOLCANIC ROCK

(TAKEN FROM P. W. D. TEST RESULTS FROM THE PO SHAN ROAD AREA)

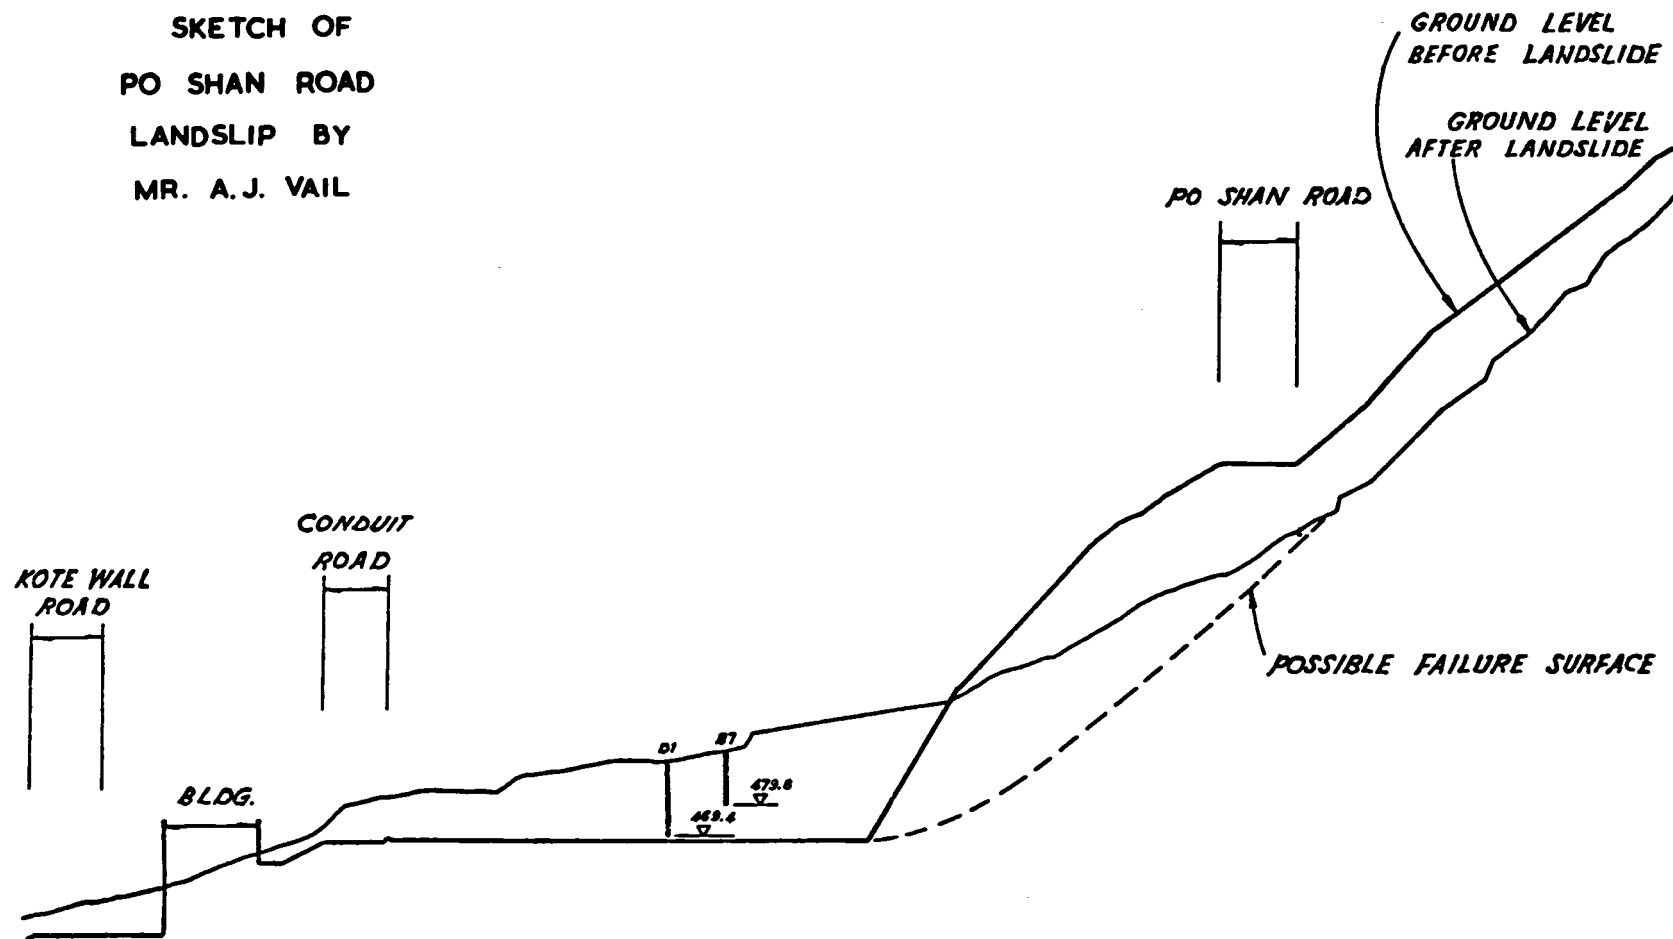
APPENDIX XIX

SKETCH OF
PO SHAN ROAD
LANDSLIP BY
MR. A.J. VAIL
