**DETAILED STUDY OF THE
21 AUGUST 2005 DEBRIS FLOW
ON THE NATURAL HILLSIDE
NEAR FEI NGO SHAN
SERVICE RESERVOIR**

GEO REPORT No. 233

Maunsell Geotechnical Services Limited

**GEOTECHNICAL ENGINEERING OFFICE
CIVIL ENGINEERING AND DEVELOPMENT DEPARTMENT
THE GOVERNMENT OF THE HONG KONG
SPECIAL ADMINISTRATIVE REGION**

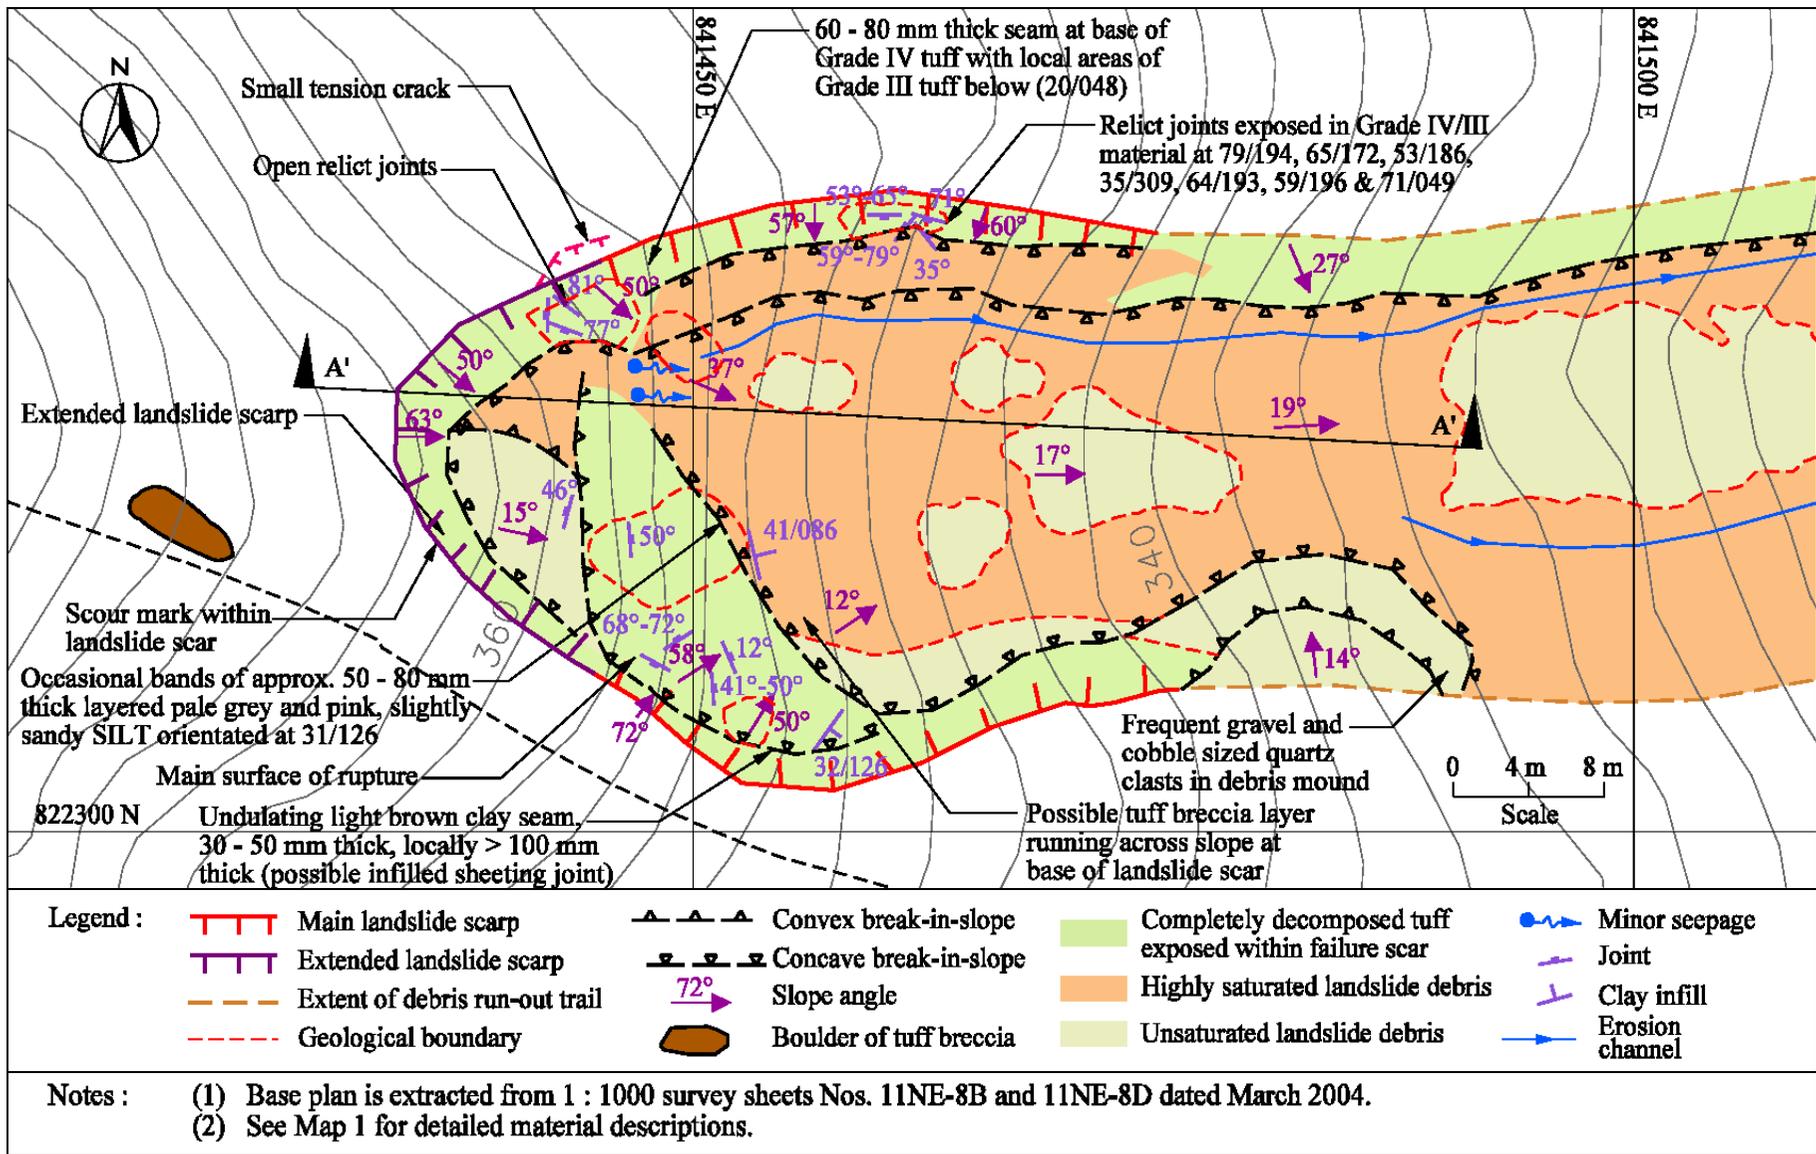
Figure 6 - Field Mapping of Landslide No. 1 Source Area

There was a small extension immediately above the main landslide scar (Figure 6). The extension comprised an approximately 12 m long by 12 m wide and between 2 m and 3 m deep detachment of soil (Plate 7), with a failure volume of about 250 m³. The total failure volume was therefore estimated to be about 3,350 m³. No substantial tension cracks in the vicinity of or above the extended landslide scar were observed.

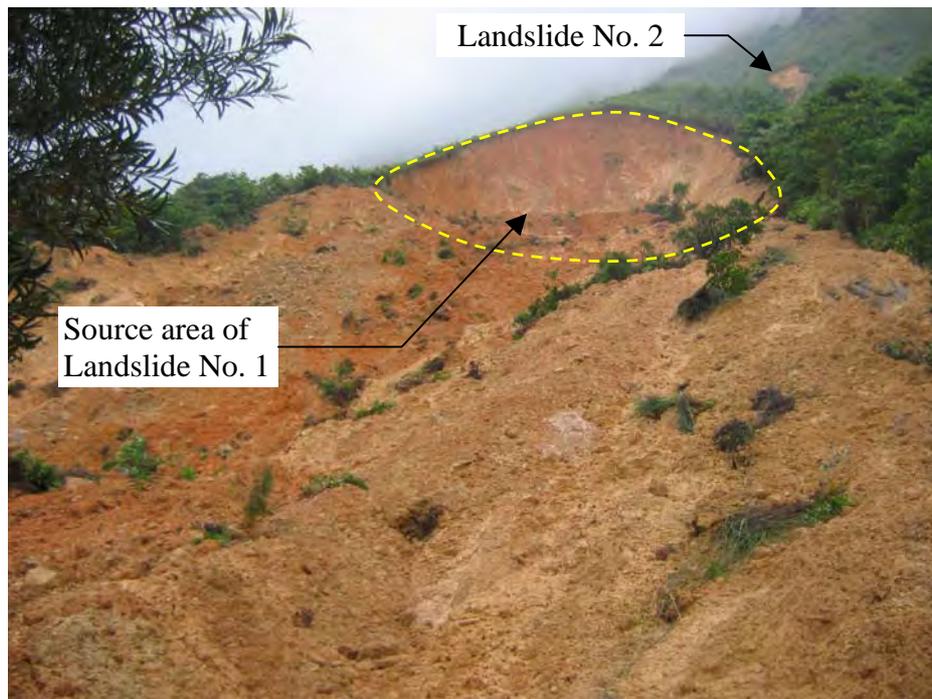
The source area of Landslide No.1 is located mainly within a rounded, scoop-shaped depression which is inferred to be the site of a degraded relict landslide (Figure 2, Plates 2 and A4). Aerial photographs taken in 2004 indicate that the source area had a moderately dense vegetation cover of grasses and shrubs (Plate A9). The crown of the landslide was at an elevation of 365 mPD in a natural hillside with varying inclination. Within the source area, the original natural hillside had an average angle of about 30°, with a maximum local gradient of 38°. The landslide scar was up to 42 m long, 25 m to 32 m wide and 3.5 m to 5 m deep, with a volume of about 3,100 m³.

Plate 2 - General View of the Source Area of Landslide No. 1
(Photograph taken on 21 August 2005)

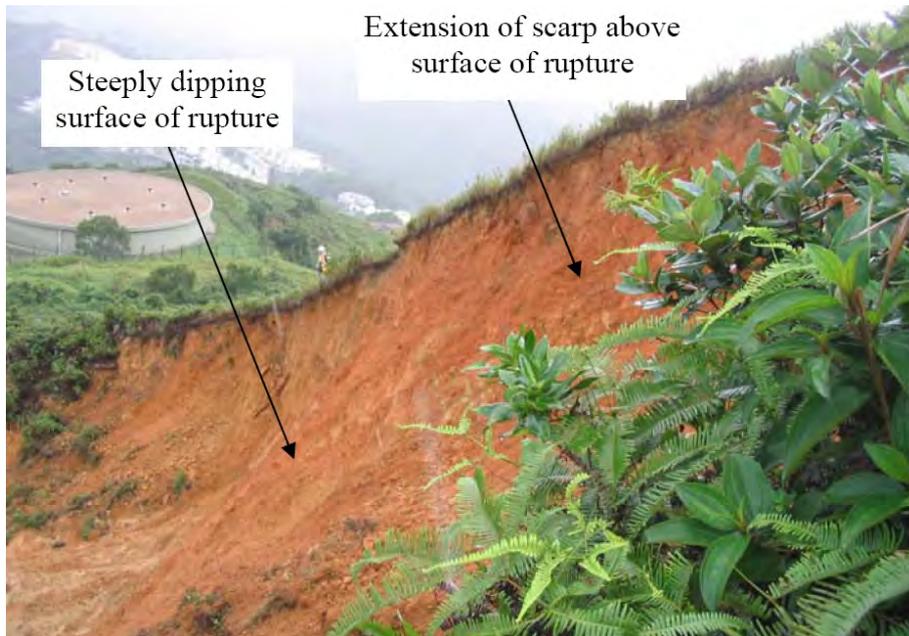
Plate 7 - Extension of Scarp at the Crown of Landslide No. 1
(Photograph taken on 29 August 2005)

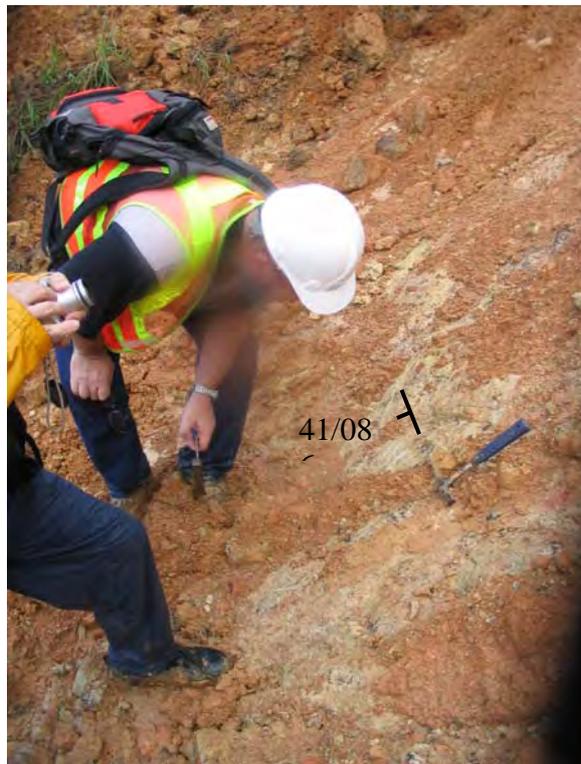
Plate 8 - Clay Seam at Basal Release Surface of Landslide No. 1
(Photograph taken on 29 August 2005)

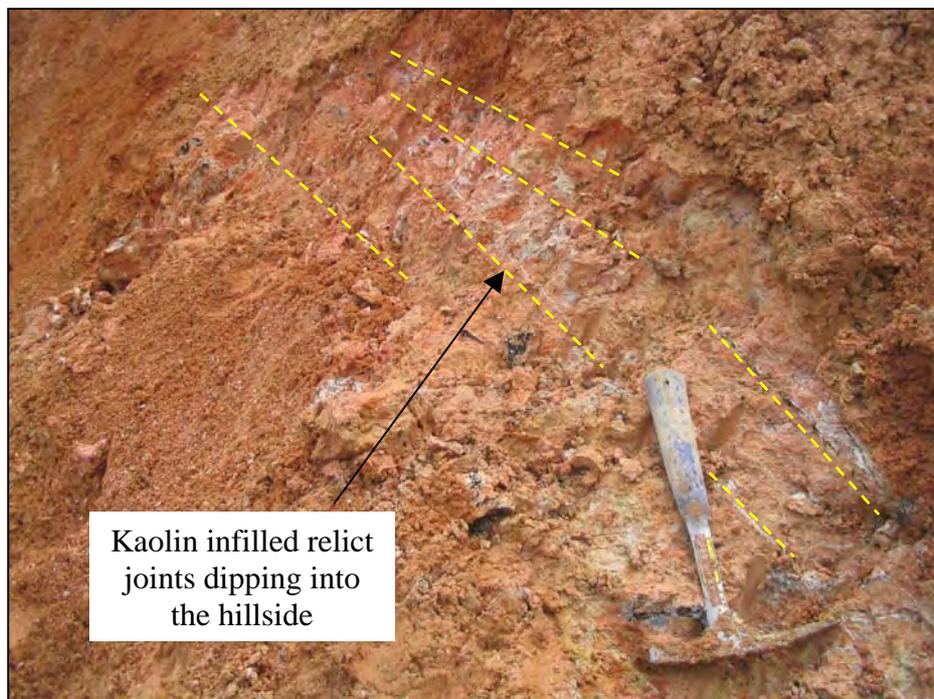
Several relict joints were also identified below the surface of rupture. The locations and orientations of these relict joints are shown in Drawing No. 1. Most of these joints, which dipped steeply into the slope, were found to be stained with manganese and have thin layers of kaolin infill (Plate 10). No indications of movement such as slickensides were apparent on these relict joint surfaces.

Kaolin infilled relict
joints dipping into
the hillside

Plate 10 - Kaolin Infilled Relict Joints in the Basal Release Surface
(Photograph taken on 29 August 2005)

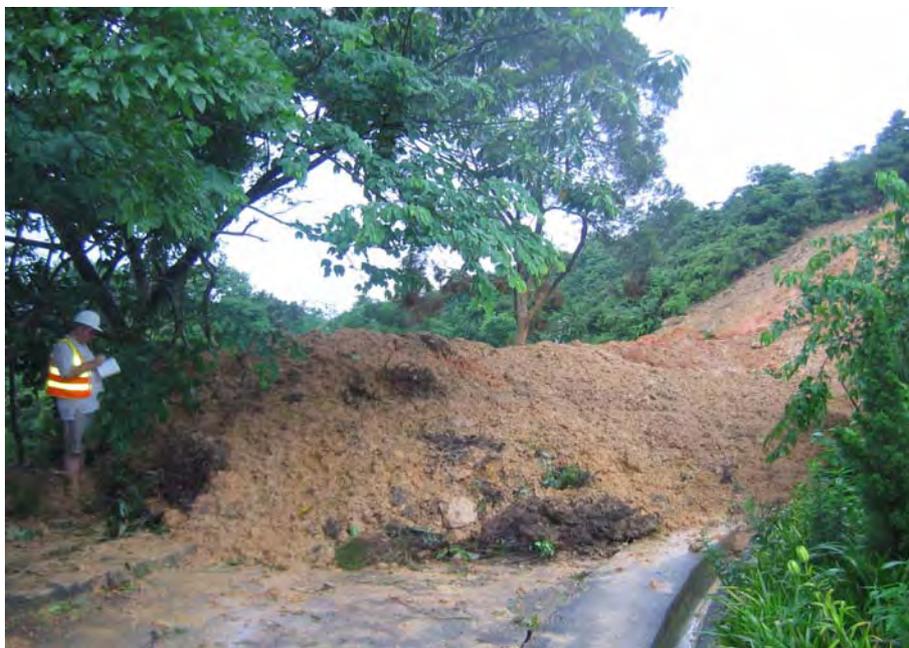
25 m). When the debris flow intersected the access road, the debris fanned out to a width of about 30 m and deposited up to 2 m of debris (Plate 12). Parts of the man-made slopes Nos. 11NE-C655 and 11NE-B/F231, which are situated above and below the access road respectively, were also affected and covered by the debris. The insitu materials of these two slopes were not exposed and field mapping of their failure scars was not possible.

Plate 12 - Landslide Debris Deposited at the Access
Road to Fei Ngo Shan Service Reservoir
(Photograph taken on 21 August 2005)

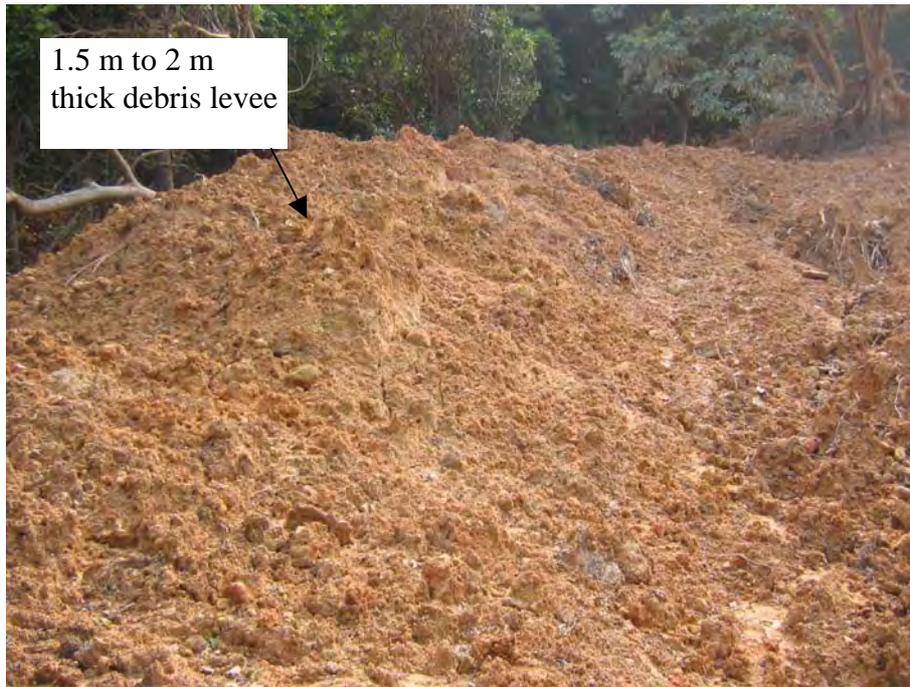
Plate 13 - Debris Levee on Southern Side of the Mid-portion of the Debris Trail
(Photograph taken on 7 September 2005)

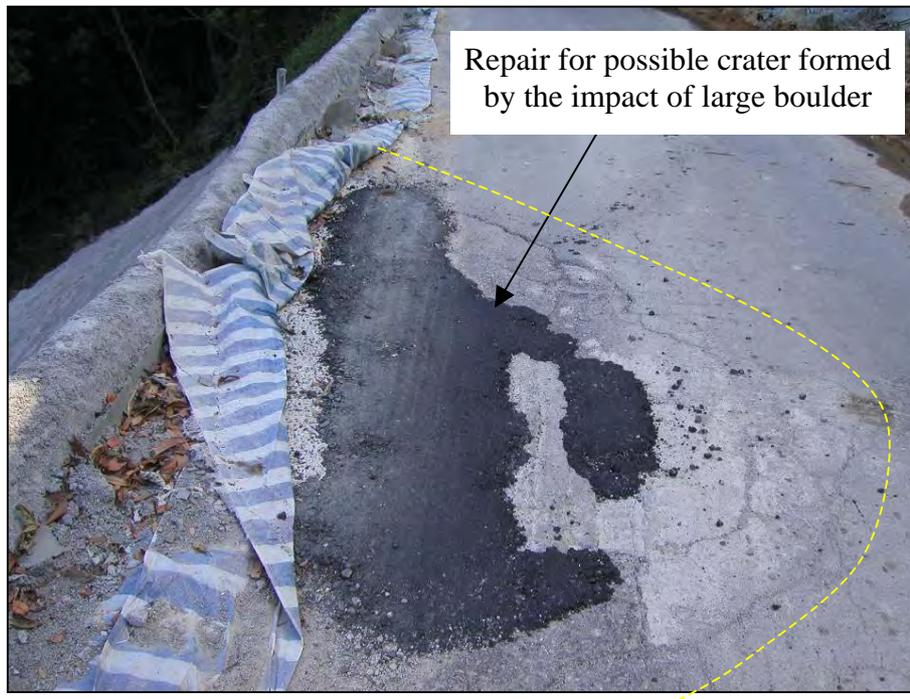
Plate 20 - Repair Works to the Pavement of Fei Ngo Shan Road after the Incident
(Photograph taken on 27 October 2005)

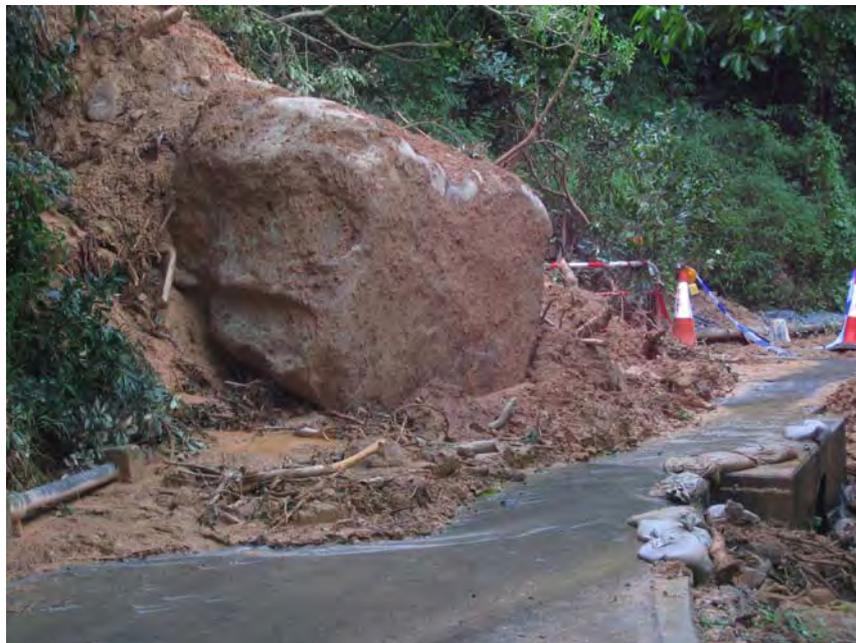
Plate 22 - Large Boulder Deposited at the Distal End of the Landslide Debris on Pak Fa Lam Road (Photograph taken on 22 August 2005)

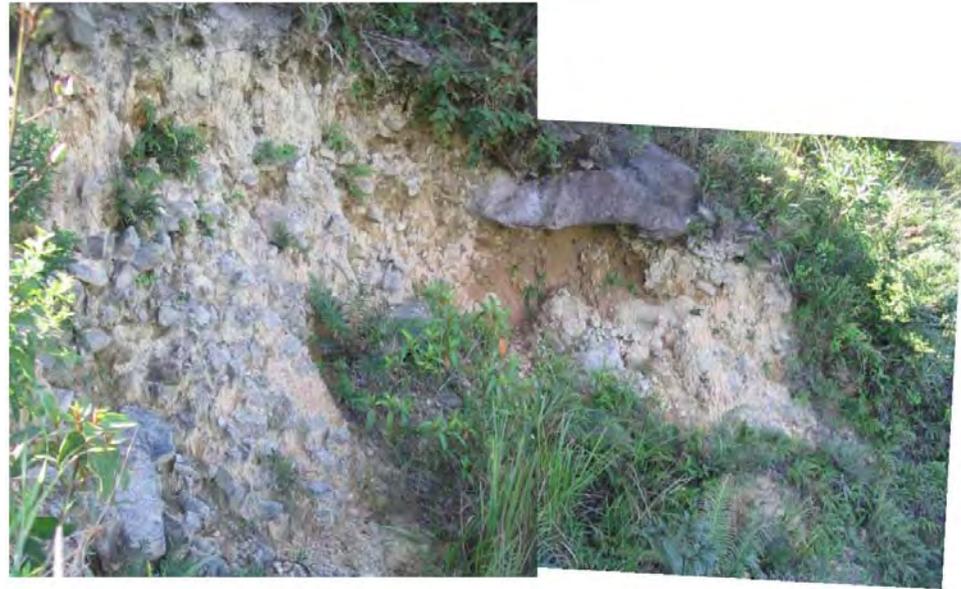
Plate 24 - Close-up View of the Scarp of Landslide No. 2
(Photograph taken on 16 September 2005)

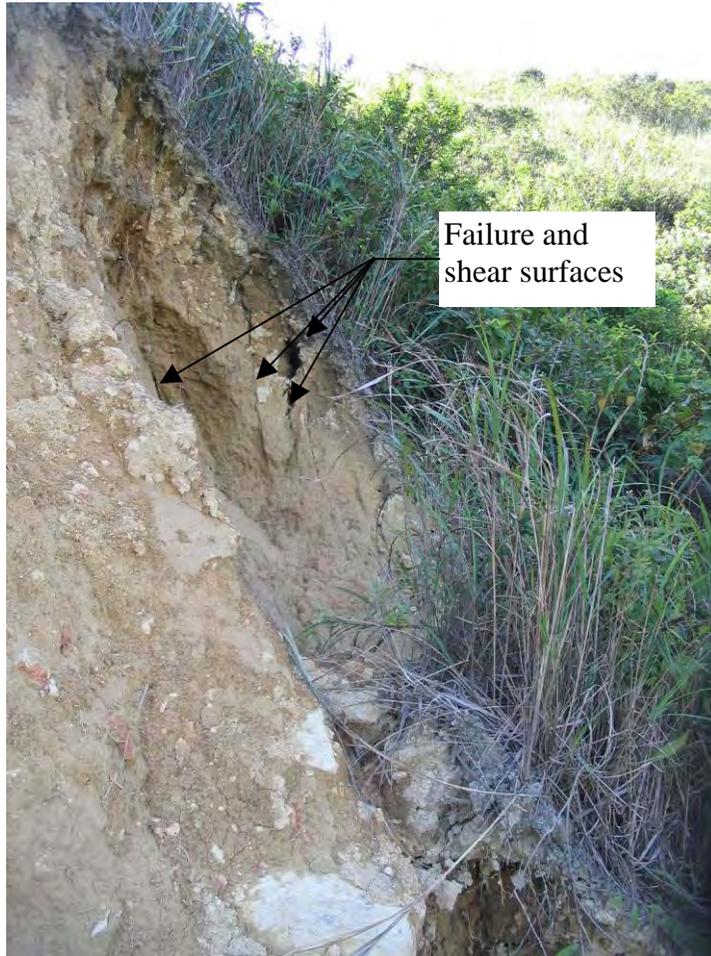
Plate 25 - Failure and Shear Surfaces on the Scarp of Landslide No. 2
(Photograph taken on 16 September 2005)

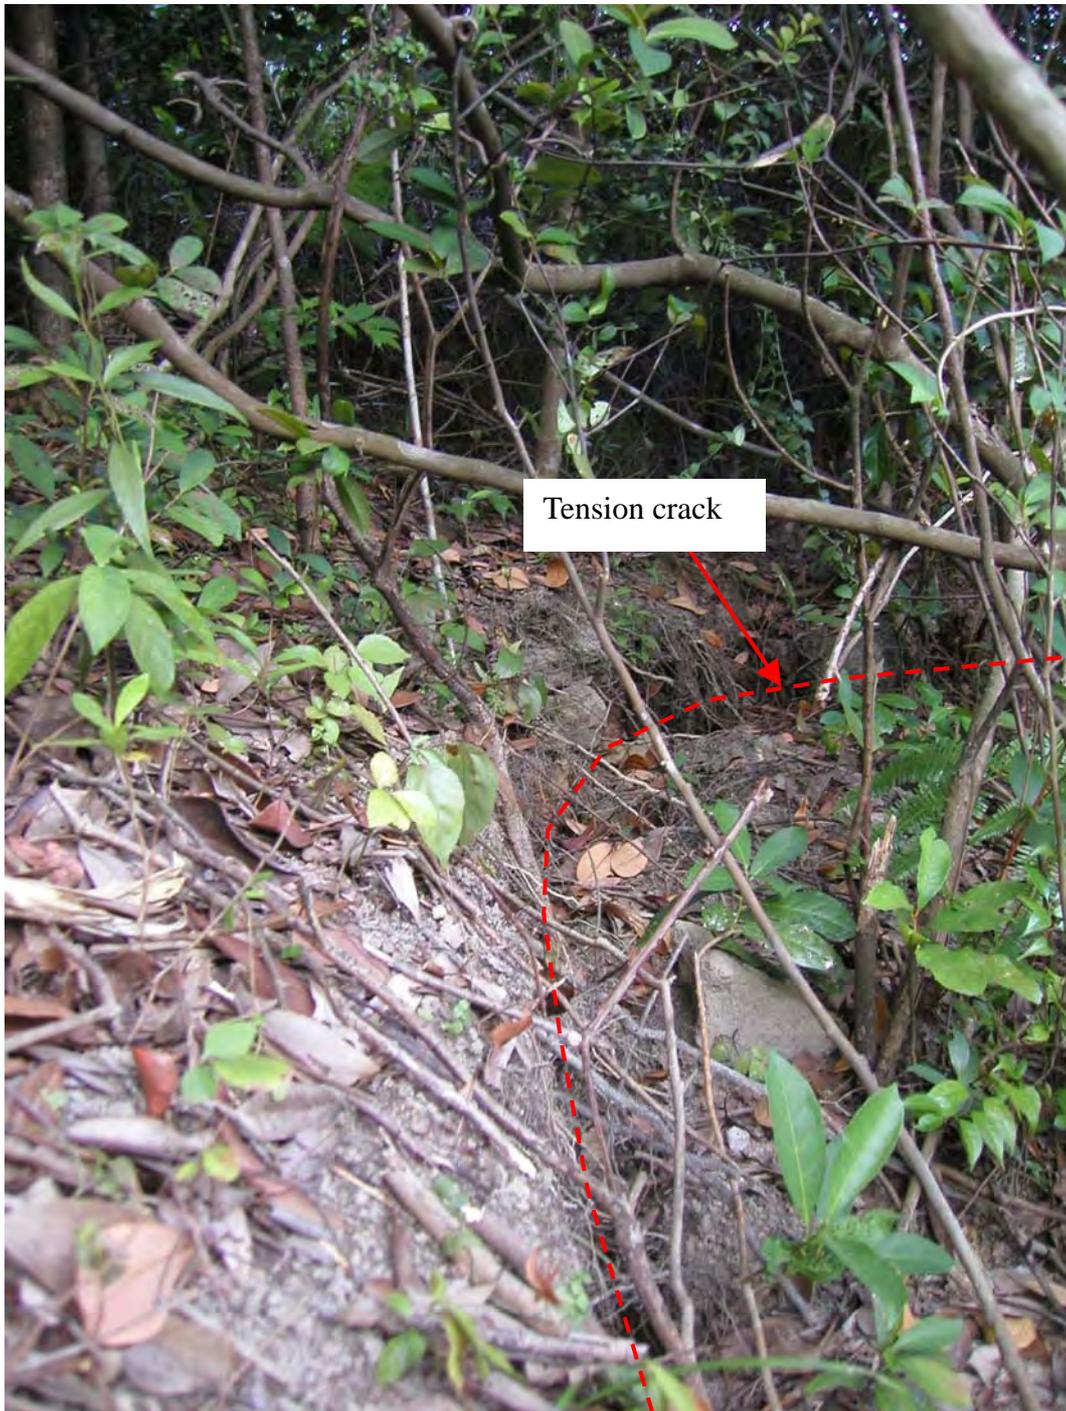
Plate 27 - Tension Crack near Crown of Landslide No. 3
(Photograph taken on 27 October 2005)

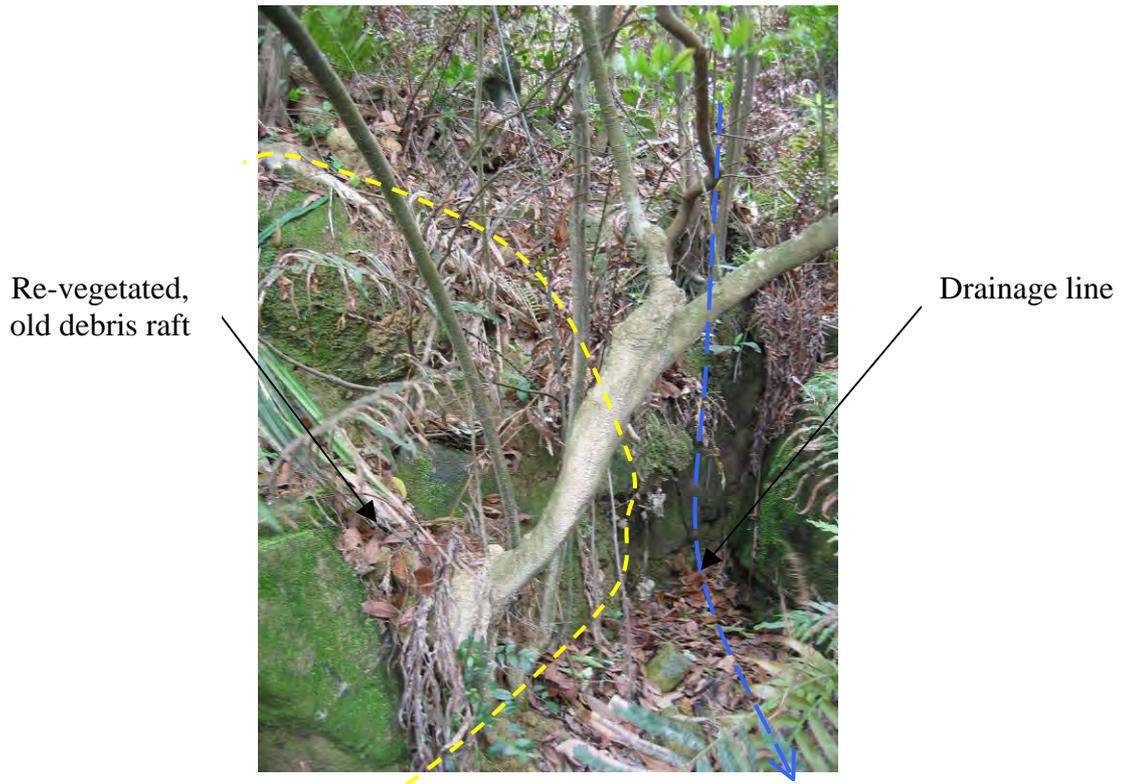
Plate 28 - Old Debris Rafts Deposited along the Drainage Line Downhill of Landslide No. 2 (Photograph taken on 11 April 2006)

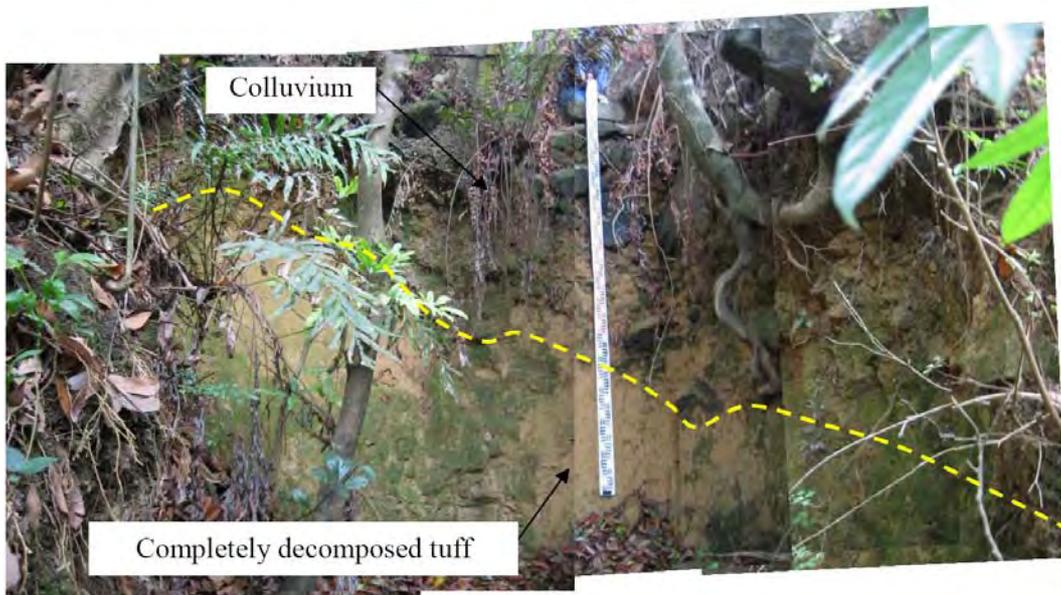
Plate 29 - Deeply Incised Gully along the Drainage Line Downhill of Landslide No. 2 (Photograph taken on 11 April 2006)

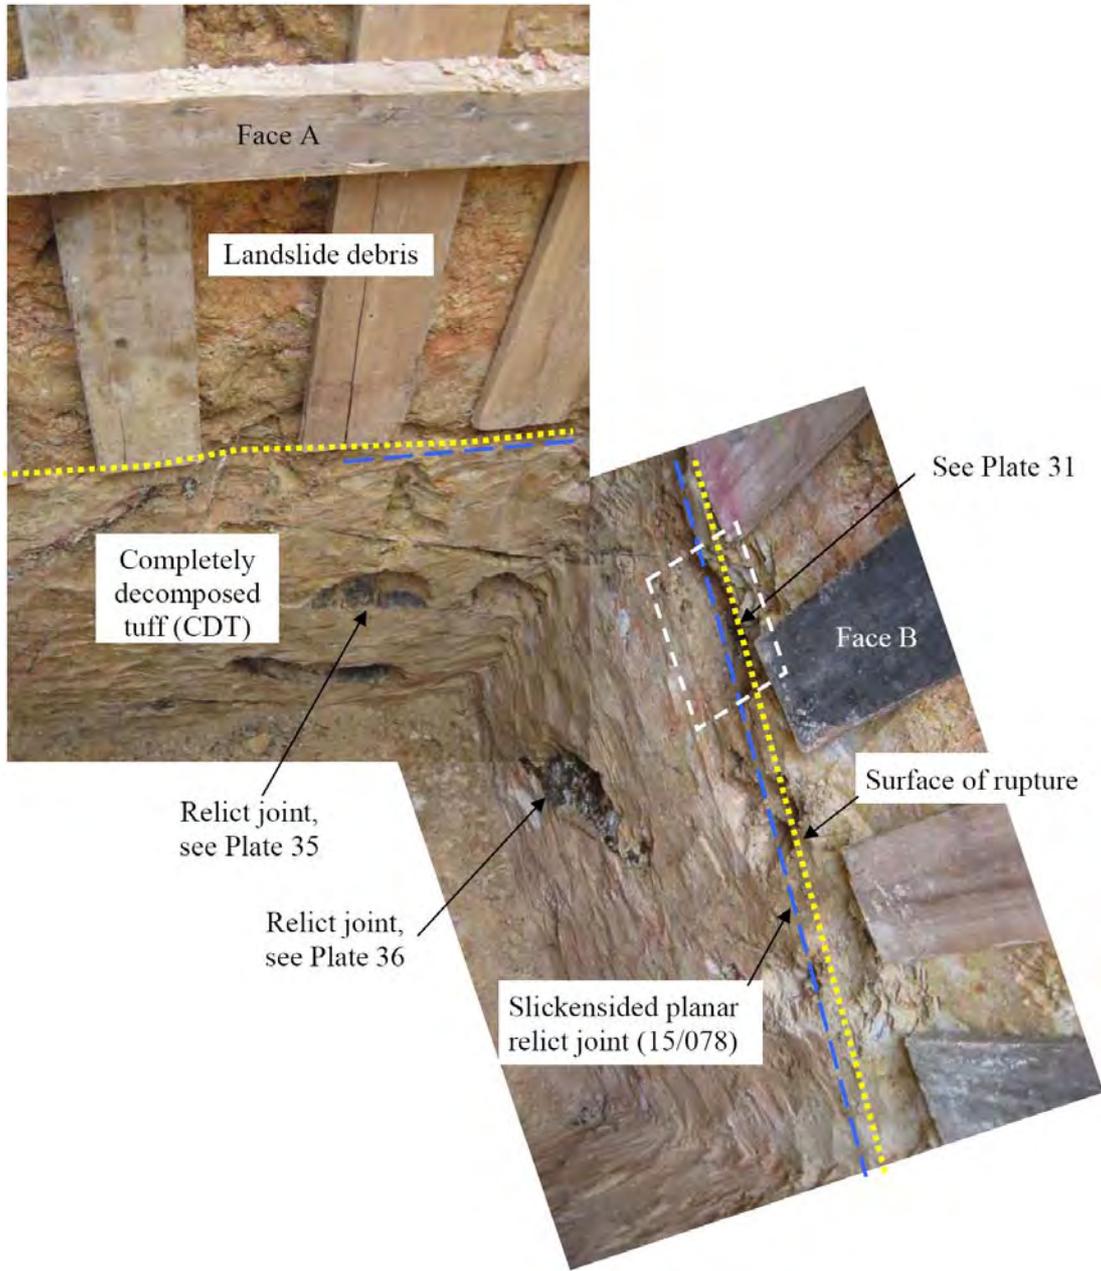
Plate 30 - Surface of Rupture between Landslide Debris and CDT at Faces A and B of Trial Pit No. TP7 (Photograph taken on 19 April 2006)

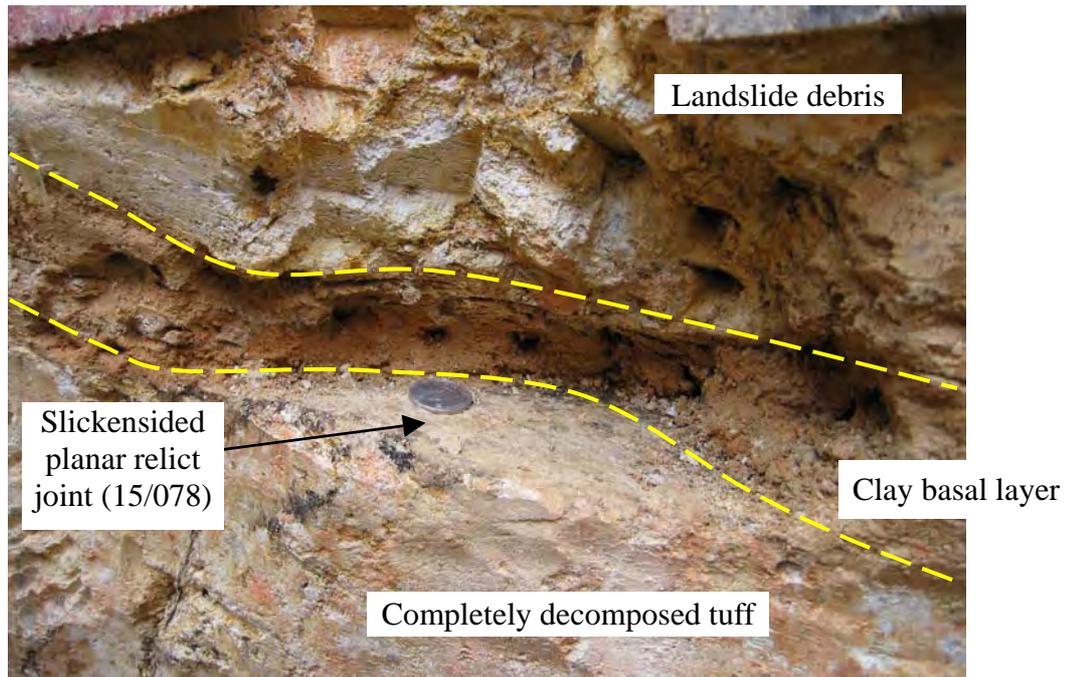
Plate 31 - Surface of Rupture with a Slickensided Planar Relict Joint at the Base of the Clay Layer at Face B of Trial Pit No. TP7 (Photograph taken on 19 April 2006)

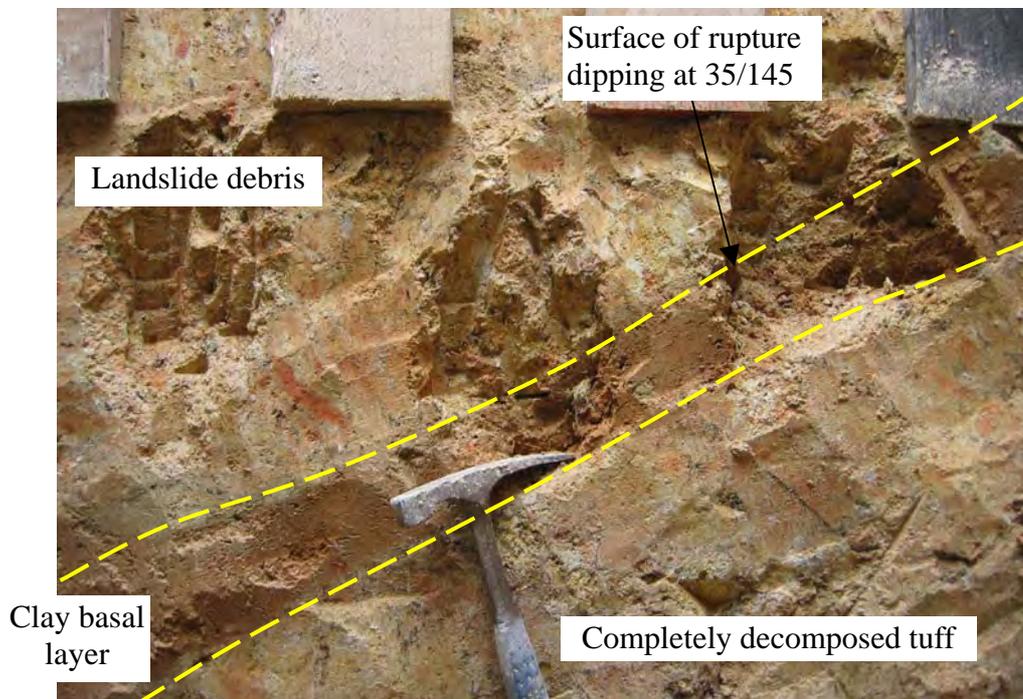
Plate 32 - Surface of Rupture at Face D of Trial Pit No. TP7 (Photograph taken on 19 April 2006)

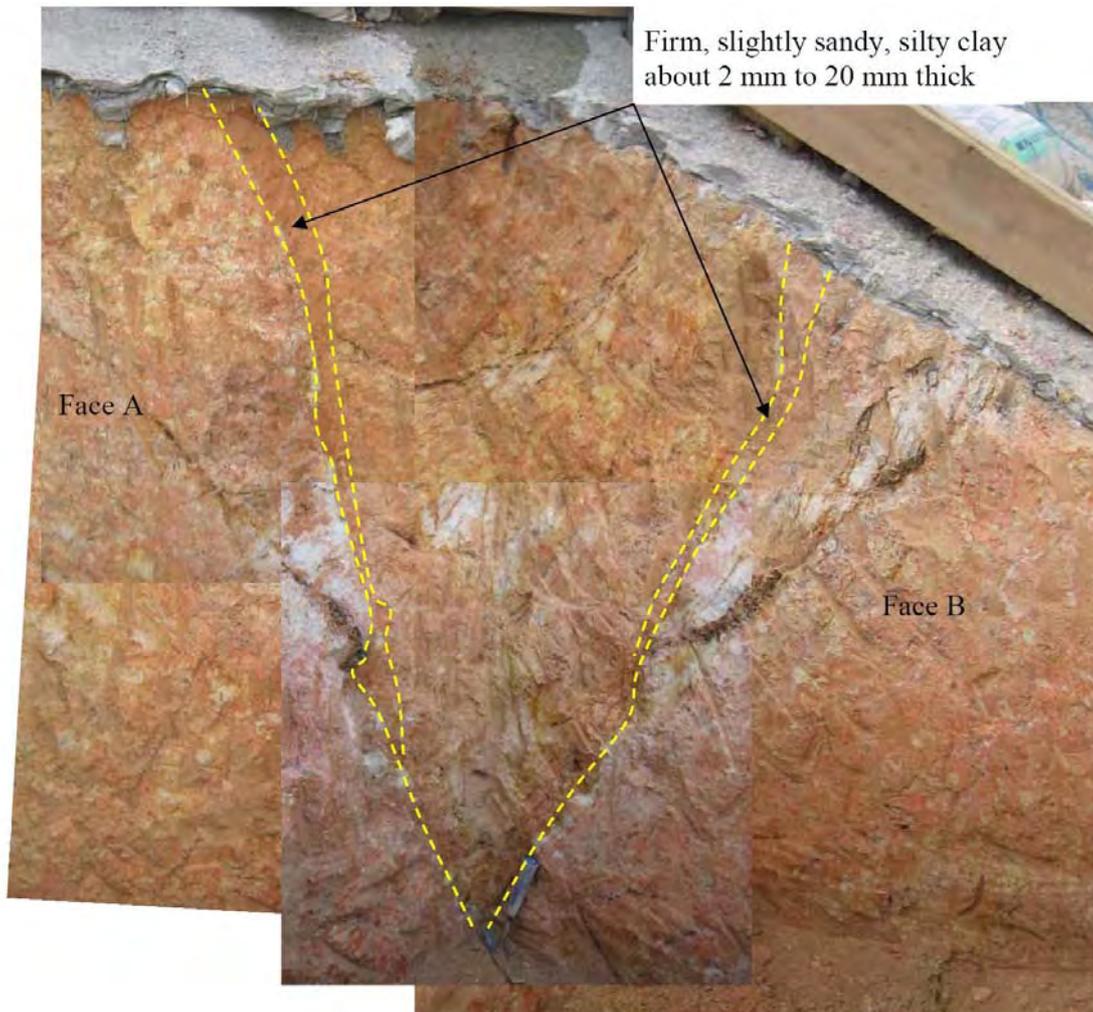
Plate 33 - Clay Infill within Completely Decomposed Tuff at Faces A and B of Trial Pit No. TP2 (Photograph taken on 10 April 2006)

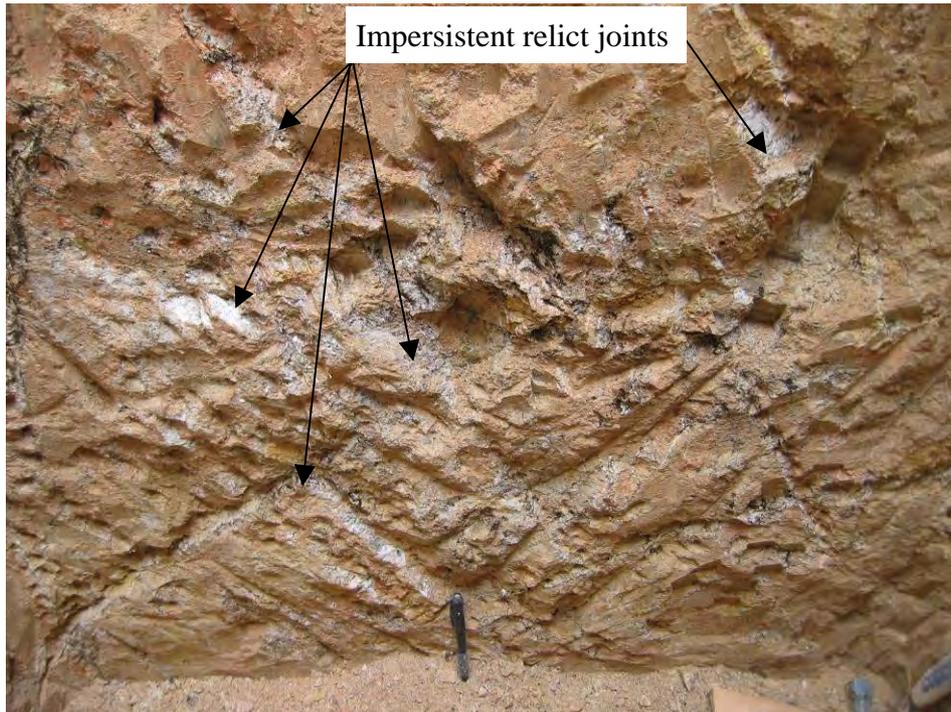
Plate 34 - Impersistent, Commonly Manganese Coated and Kaolin Infilled Relict Joints in CDT at Face C of Trial Pit No. TP2 (Photograph taken on 20 April 2006)

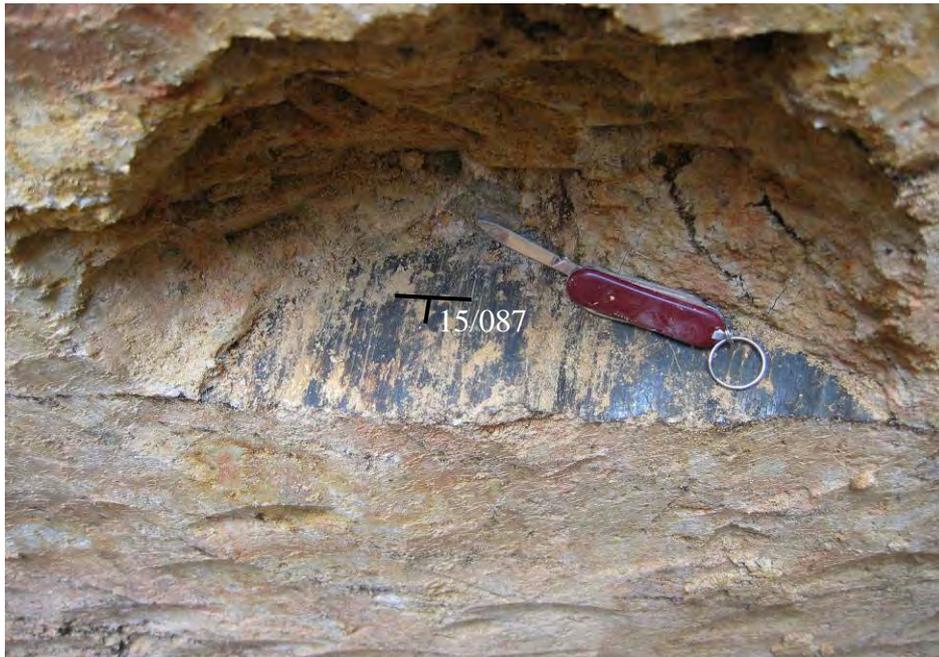
Plate 35 - Slickensided Undulating, Manganese Coated and Kaolin Infilled Sub-horizontal Relict Joints at Face A of Trial Pit No. TP 7 (Photograph taken on 19 April 2006)

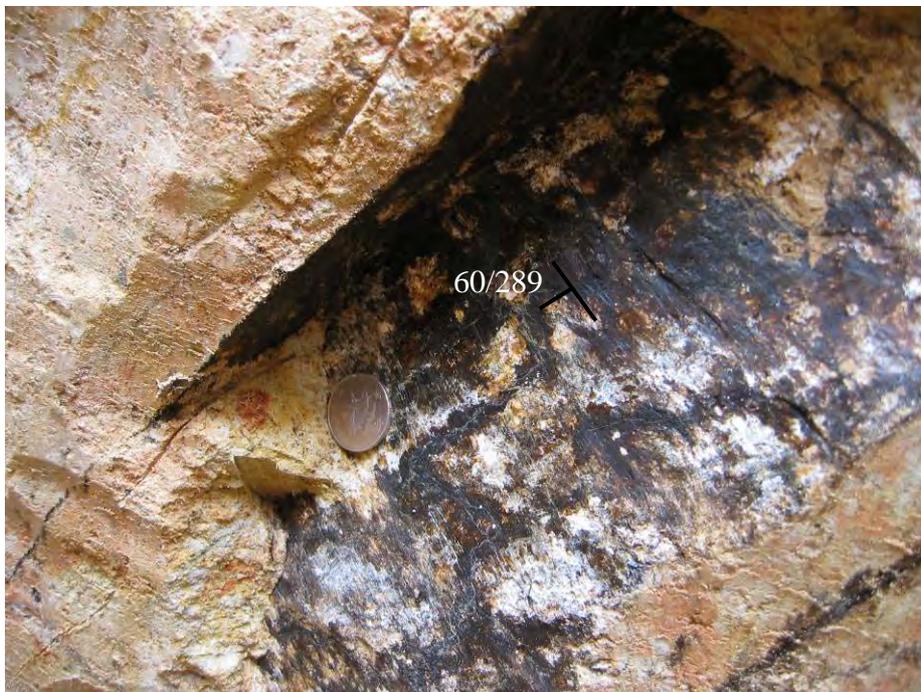
Plate 36 - Slickensided Planar, Manganese Coated and Kaolin Infilled Relict Joints at Face B of Trial Pit No. TP 7 (Photograph taken on 19 April 2006)
