**REVIEW OF  
THE 16 JULY 2006 LANDSLIDE  
ON SLOPE NO. 14NE-B/CR180  
NO. 49 PO WAH YUEN  
YUNG SHUE WAN  
LAMMA ISLAND**

**GEO REPORT No. 234**

**Fugro Scott Wilson Joint Venture**

This report presents the findings of a review of a landslide (Incident No. 2006/07/0672) that occurred on 16 July 2006 on slope No. 14NE-B/CR180, above a village house at No. 49 Po Wah Yuen, Yung Shue Wan on Lamma Island. The failure involved a shallow landslide in the soil cut slope with an estimated debris volume of about 15 m<sup>3</sup>, which was deposited on the level ground at the slope toe. Muddy water associated with the debris mound was reported to have entered the dwelling through the gap at the base of the rear door. No casualties were reported as a result of the incident.

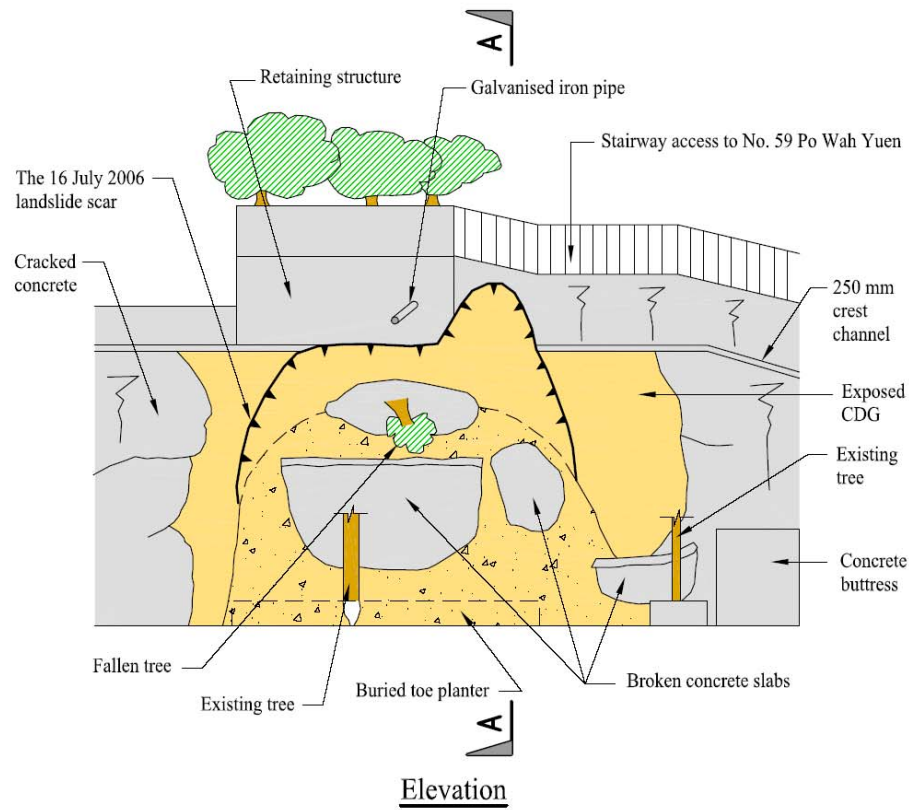
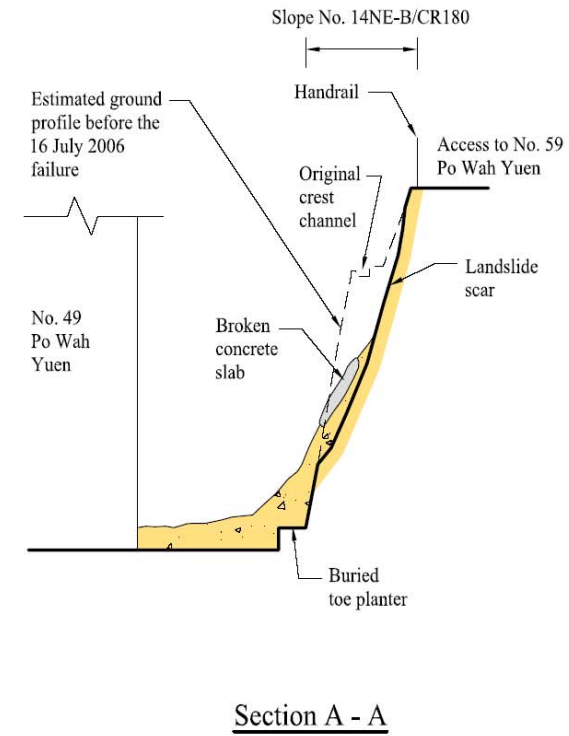
Figure 5 - Elevation View and Cross-section A-A through the 16 July 2006 Landslide Scar

The source area of the landslide (Plate 1) extended over the majority of the slope face above No. 49 Po Wah Yuen from the slope crest to the toe planter wall, with dimensions of about 5.5 m wide by 4 m long. The landslide scar was relatively shallow, having a maximum depth of about 0.3 m, and concave, with a steep scarp inclined at 70° or more. CDG was exposed in landslide scar. The slope profile prior to the failure was inferred to be inclined at around 60° to the horizontal.

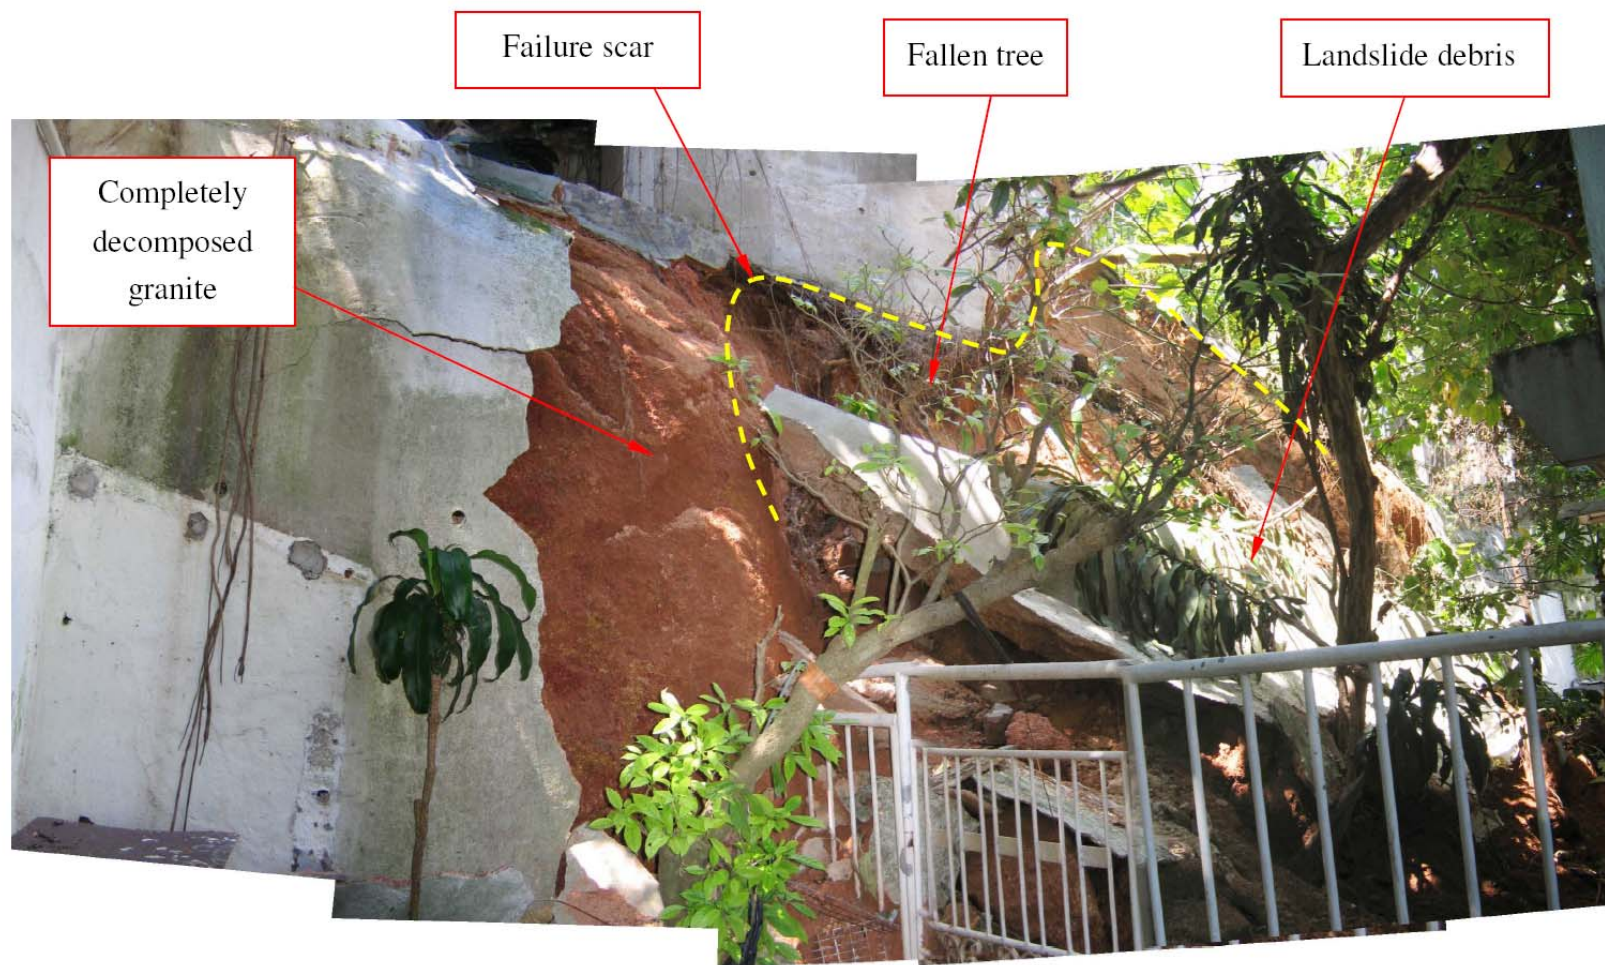
Plate 1 - View Northeast across Slope No. 14NE-B/CR180 above No. 49 Po Wah Yuen Showing Landslide Scar  
(Photograph taken by GEO on 20 July 2006)

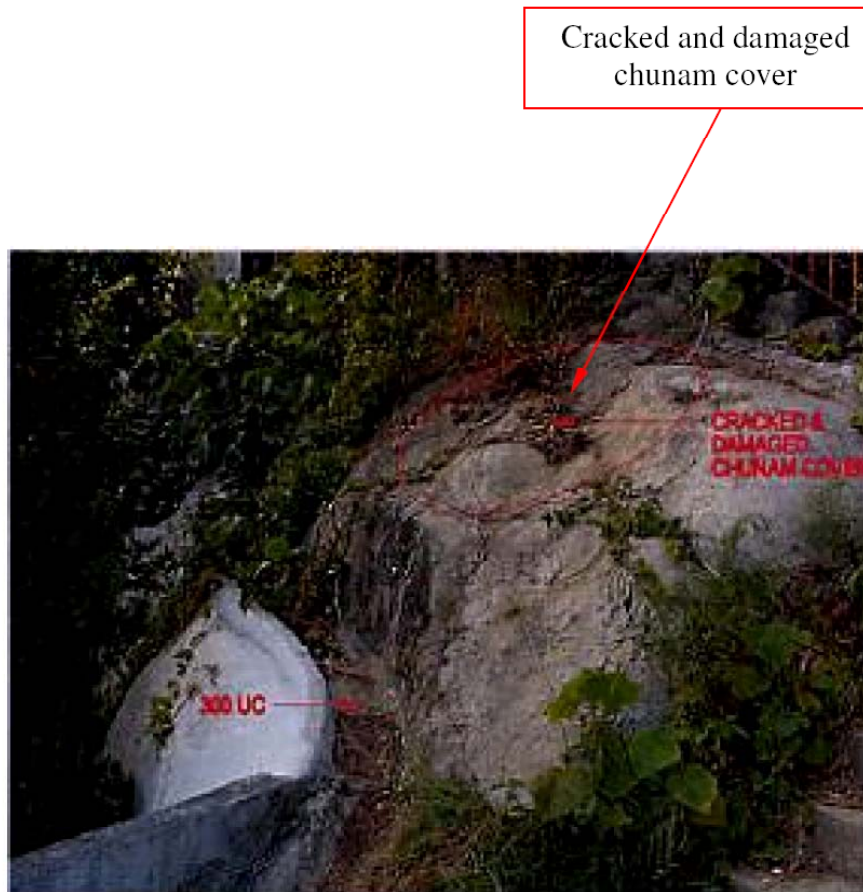
Inspection of the feature by CMWAL in March 2003 for the LPM Stage 2 Study identified that the chunam surface cover over the western portion of slope No. 14NE-B/CR180 behind No. 49 Po Wah Yuen was cracked and damaged (Plate 2), and that “slight” vegetation was growing on the upper portion of the slope face. The majority of the randomly spaced, 40 mm diameter weepholes in the chunam surfacing were found to be partially blocked at the time of inspection, as was the 300 mm wide crest U-channel.

Plate 2 - View of Upper Portion of Slope No. 14NE-B/CR180 above No. 49 Po Wah Yuen Showing Poor Condition of Chunam Surface Cover (Photograph taken by C M Wong & Associates in April 2003)

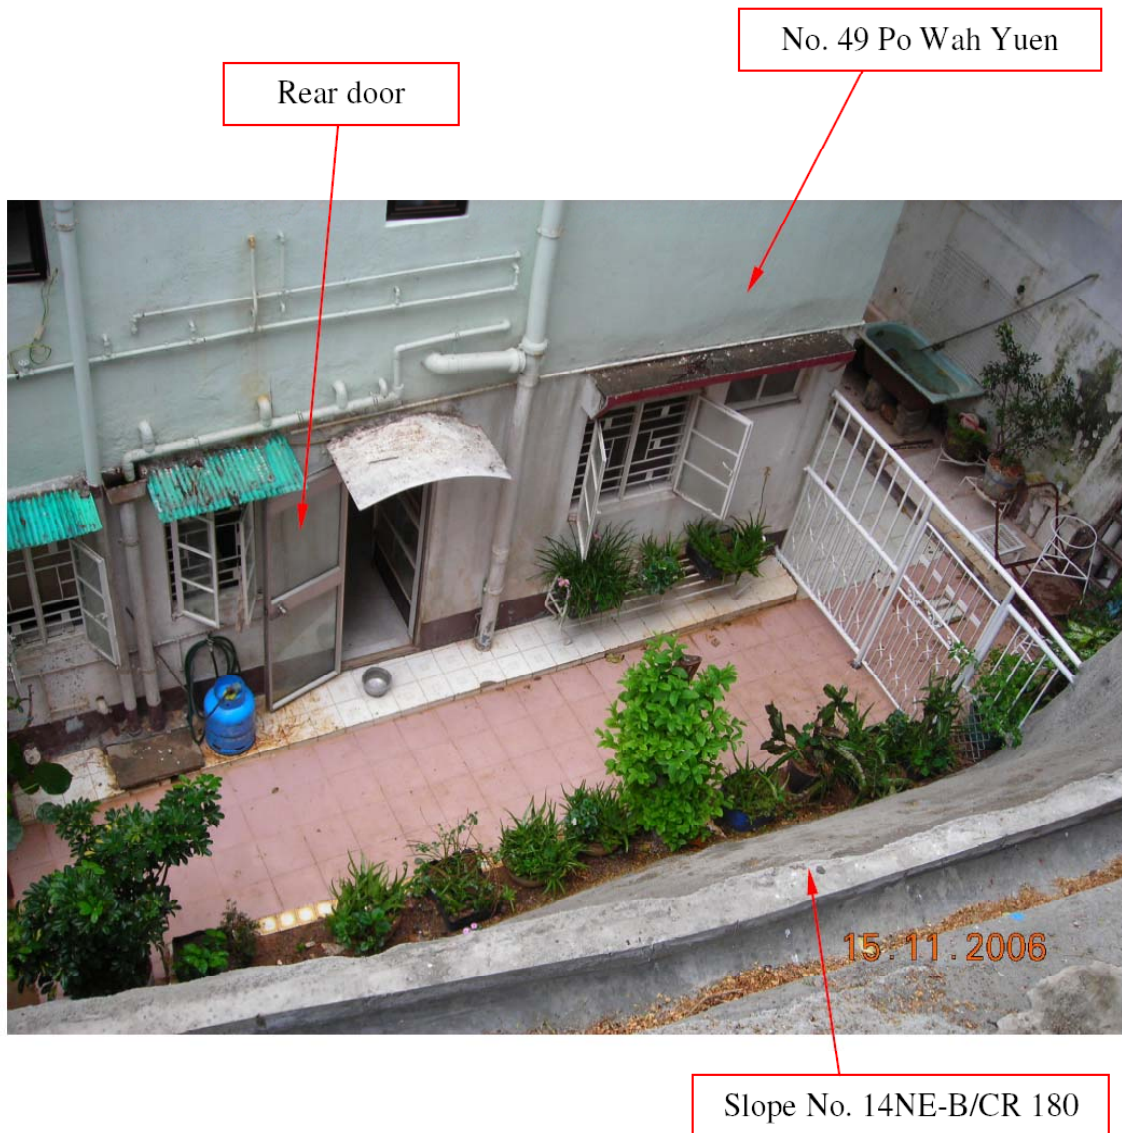
Plate 3 - View Showing Arrangement at Rear of No. 49 Po Wah Yuen  
(Photograph taken on 15 November 2006)

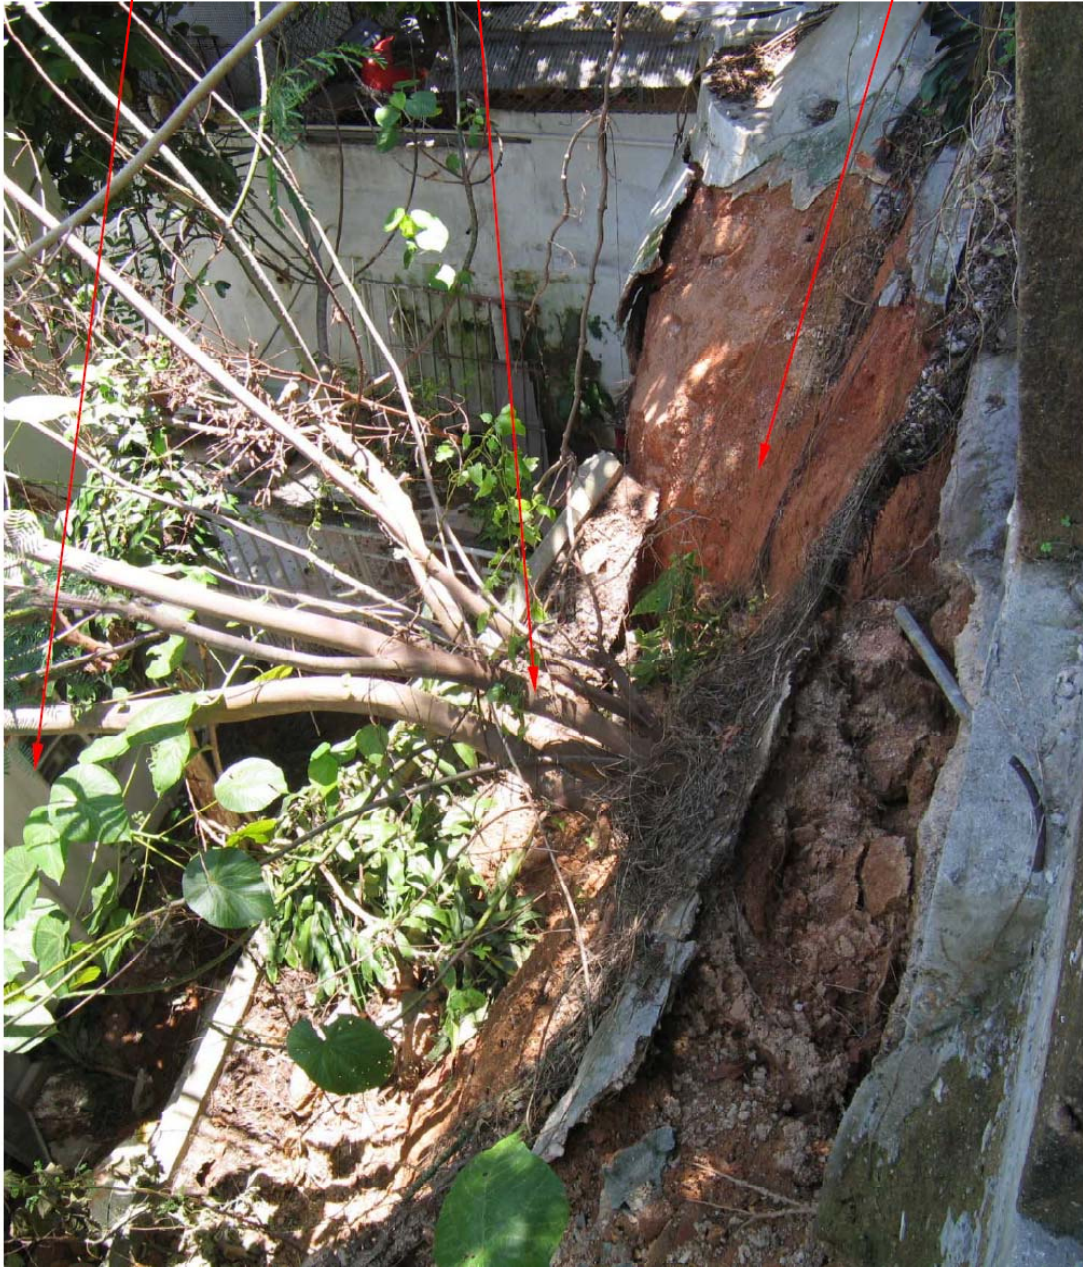
The GEO inspected the landslide site on 20 July 2006, and reported that there was no field evidence of past instability at or adjoining the failure location, and that blocked/broken drains had been identified at the slope crest. The GEO also reported that a tree growing from the slope face had been blown about during the stormy weather conditions on 16 July 2006, leading to damage to the chunam surface cover, based on advice received from one of the residents of No. 49 Po Wah Yuen, and considered this to be a possible contributory cause of the failure. A photograph taken by the GEO on 20 July 2006 (Plate 4) shows the mature tree with chunam surrounding the root mass remaining within the landslide scar.

Fallen  
mature tree

16 July 2006  
landslide scar

Plate 4 - View West across Slope No. 14NE-B/CR180 above No. 49 Po Wah Yuen Showing 16 July 2006 Landslide Scar and Mature Tree with Chunam Surround to Root Mass Remaining within Scar (Photograph taken by GEO on 20 July 2006)

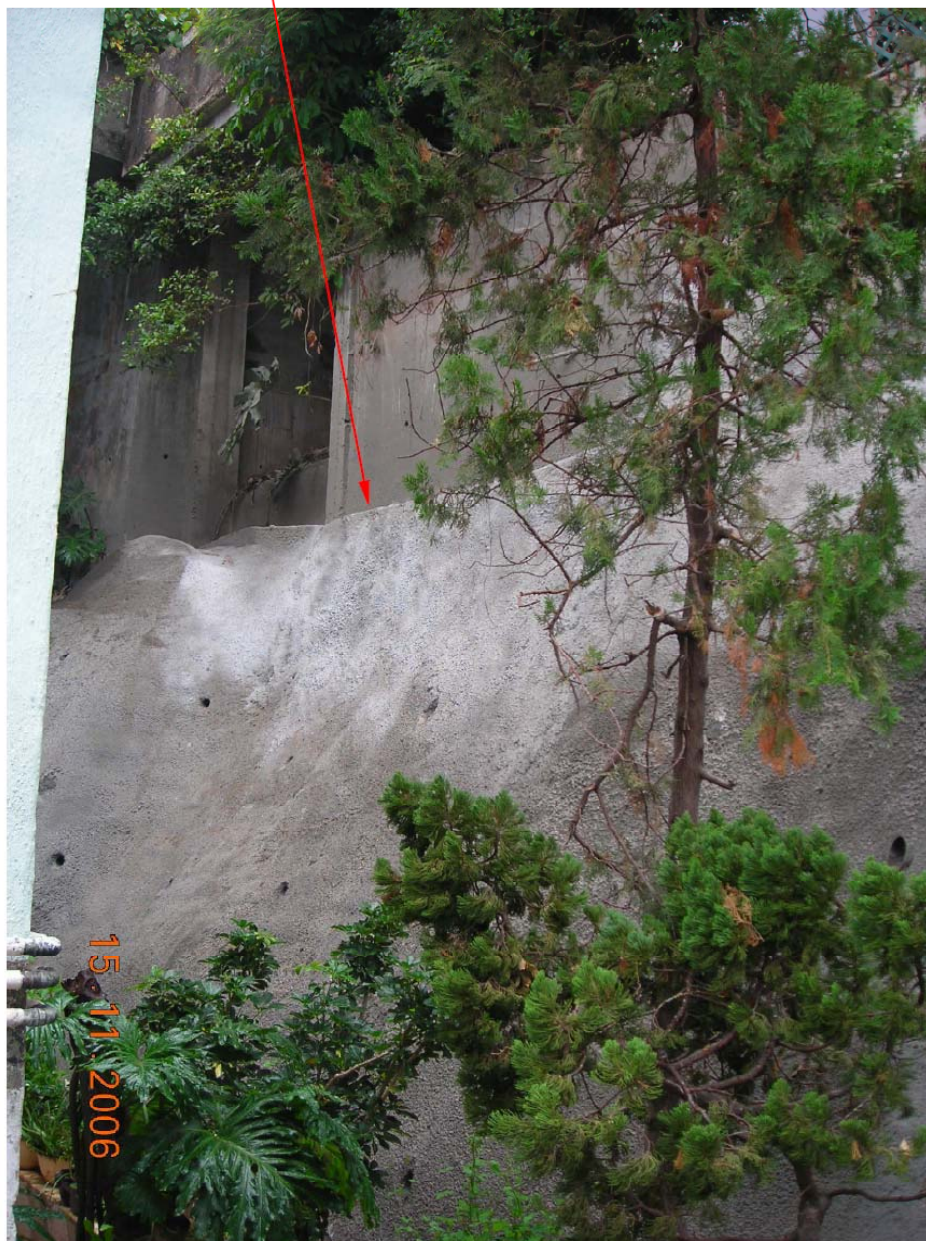
Reconstructed crest  
drainage channel

Plate 5 - View West across Slope No. 14NE-B/CR180 above No. 49 Po Wah Yuen  
Following Urgent Repair Works (Photograph taken on 15 November 2006)

FSW inspected the landslide site on 15 November 2006, by which time urgent repair works (comprising the application of shotcrete to the landslide scar and surrounding slope face and reconstruction of the crest drainage channel) had been completed (Plate 5). Bulging and associated cracking were observed in the toe planter wall (Plate 6), which was assessed as pre-dating the July 2006 landslide based on the placement of ceramic tiles around the bulge on the adjacent open space at the slope toe.

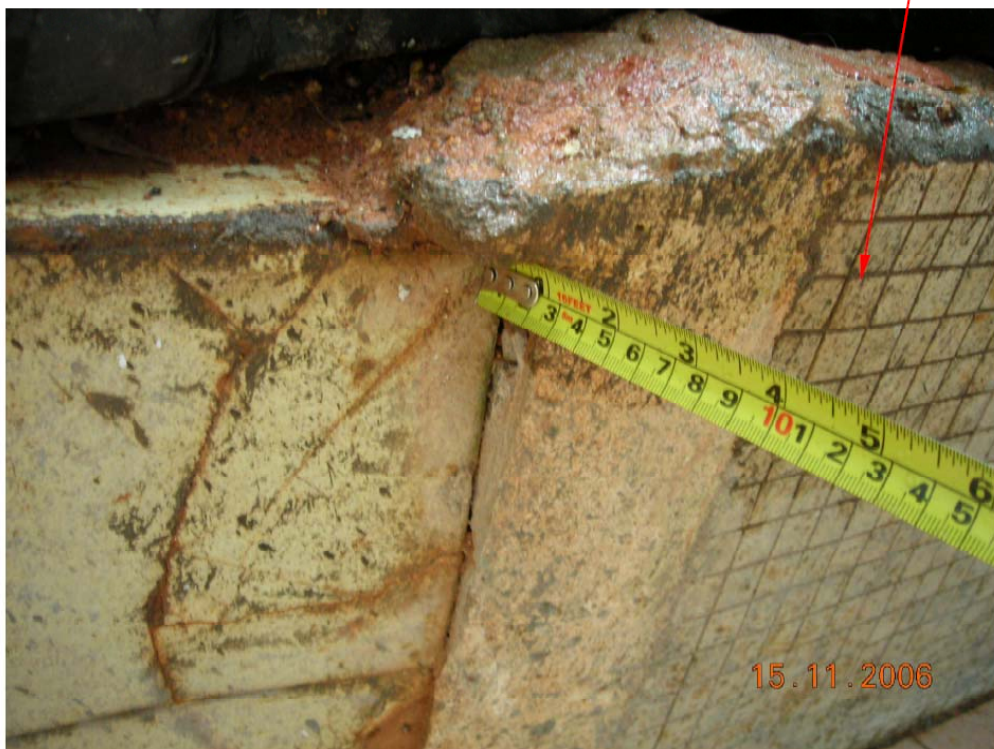
Toe planter  
wall

Plate 6 - Close View of Toe Planter Wall Showing Bulging and Cracking  
(Photograph taken on 15 November 2006)

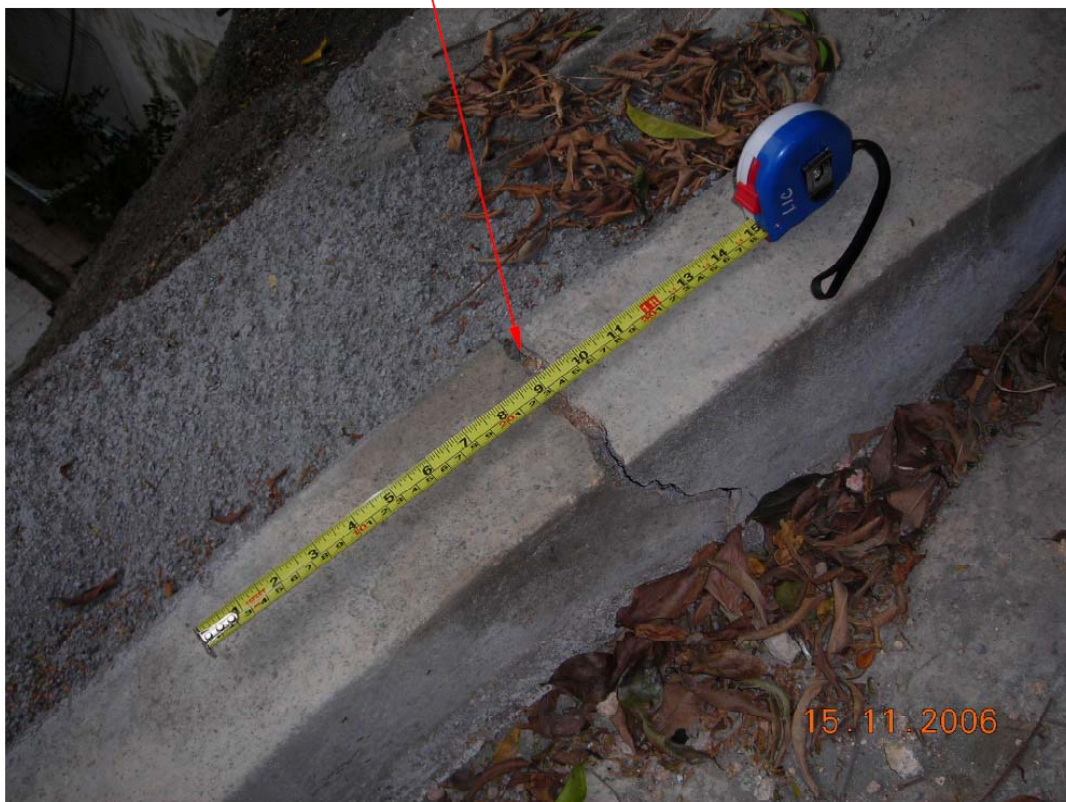
Cracks up to 20 mm in width were identified in original sections of the crest drainage channel remaining in place on the western side of the reconstructed portion (Plates 7 and 8).

Crack on crest drainage channel

Plate 7 - Close View of Example of Cracking in Crest U-channel  
(Photograph taken on 15 November 2006)

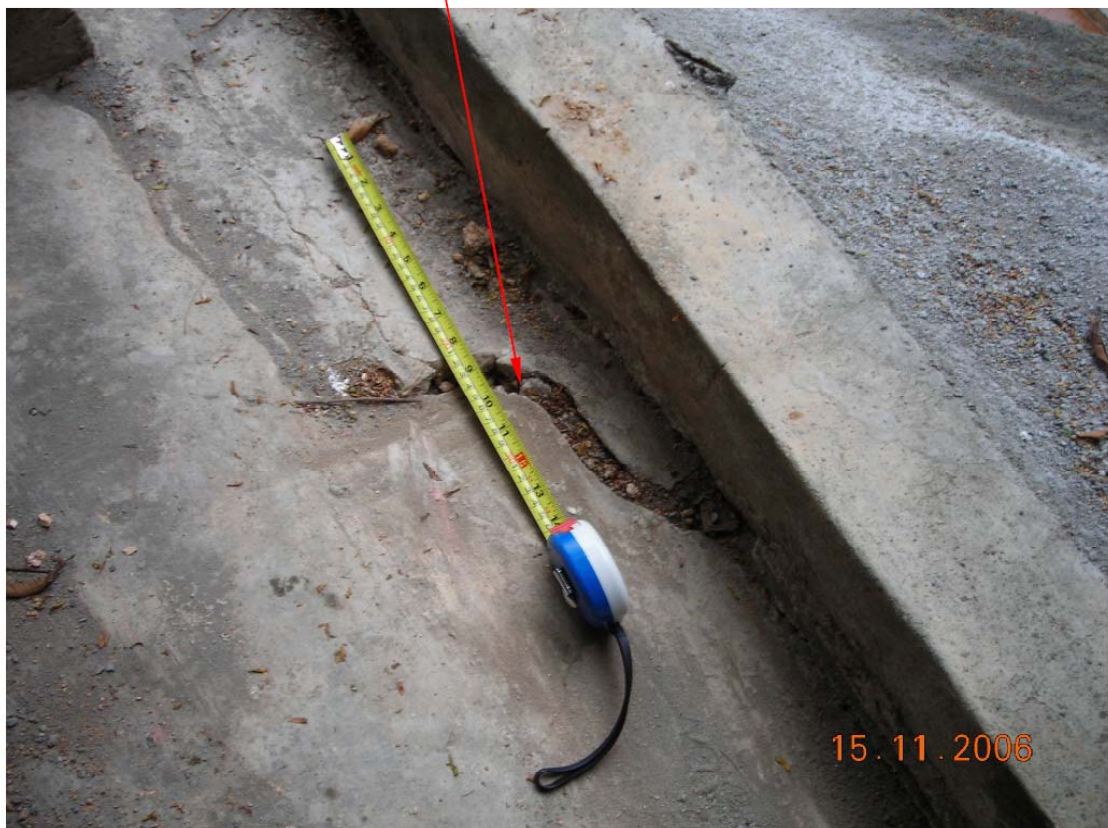
Up to 20 mm wide crack on  
crest drainage channel

Plate 8 - Close View of Example of Cracking in Crest U-channel  
(Photograph taken on 15 November 2006)

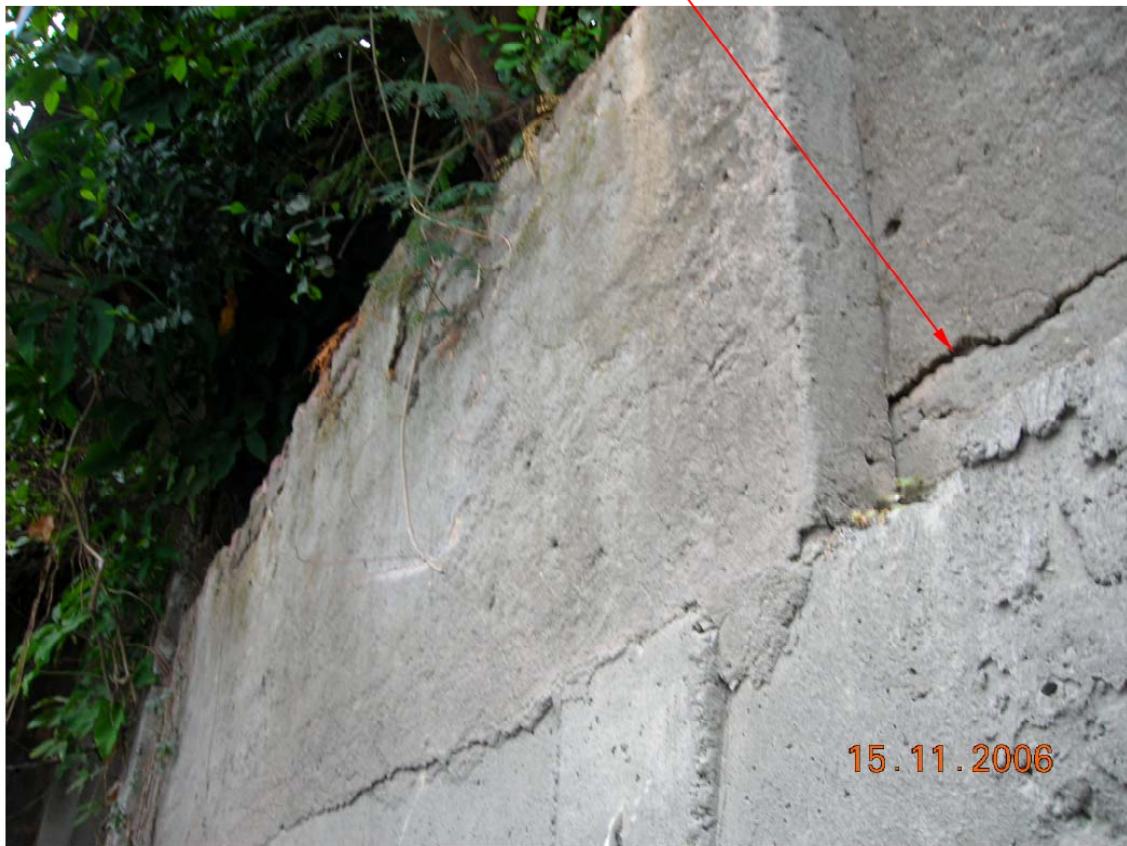
The retaining structure above the slope crest was observed to contain cracks (Plate 9) and gaps (Plate 10), suggesting the previous occurrence of movement. A 19 mm diameter galvanized iron pipe protruded from the mass concrete portion of the wall above the crest channel (Plate 11), the purpose and function of which were not clear; however, no signs of discharge from the pipe were observed.

Cracks on retaining wall

Plate 9 - Close View of Retaining Wall at Crest of Slope No. 14NE-B/CR180  
above No. 49 Po Wah Yuen Showing Existing Cracks  
(Photograph taken on 15 November 2006)

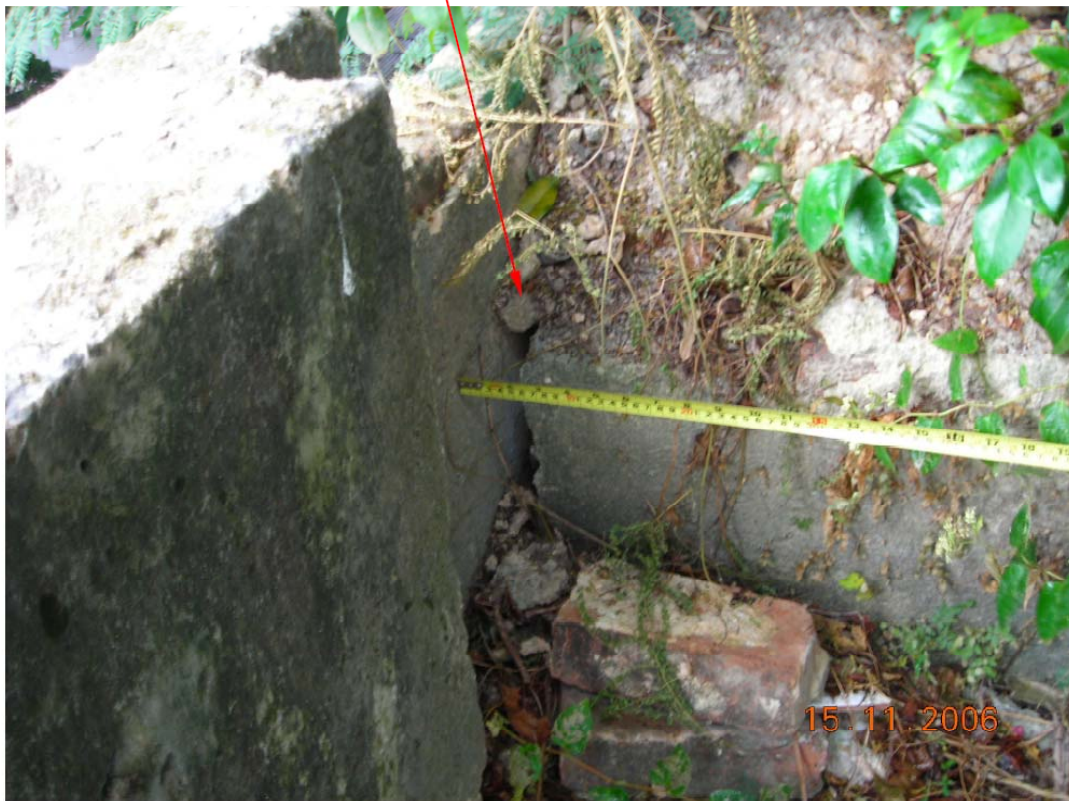
Gap behind retaining wall

Plate 10 - Close View of Crest Area of the Retaining Wall at Crest of Slope No. 14NE-B/CR180 above No. 49 Po Wah Yuen Showing Gaps between Concrete Elements (Photograph taken on 15 November 2006)

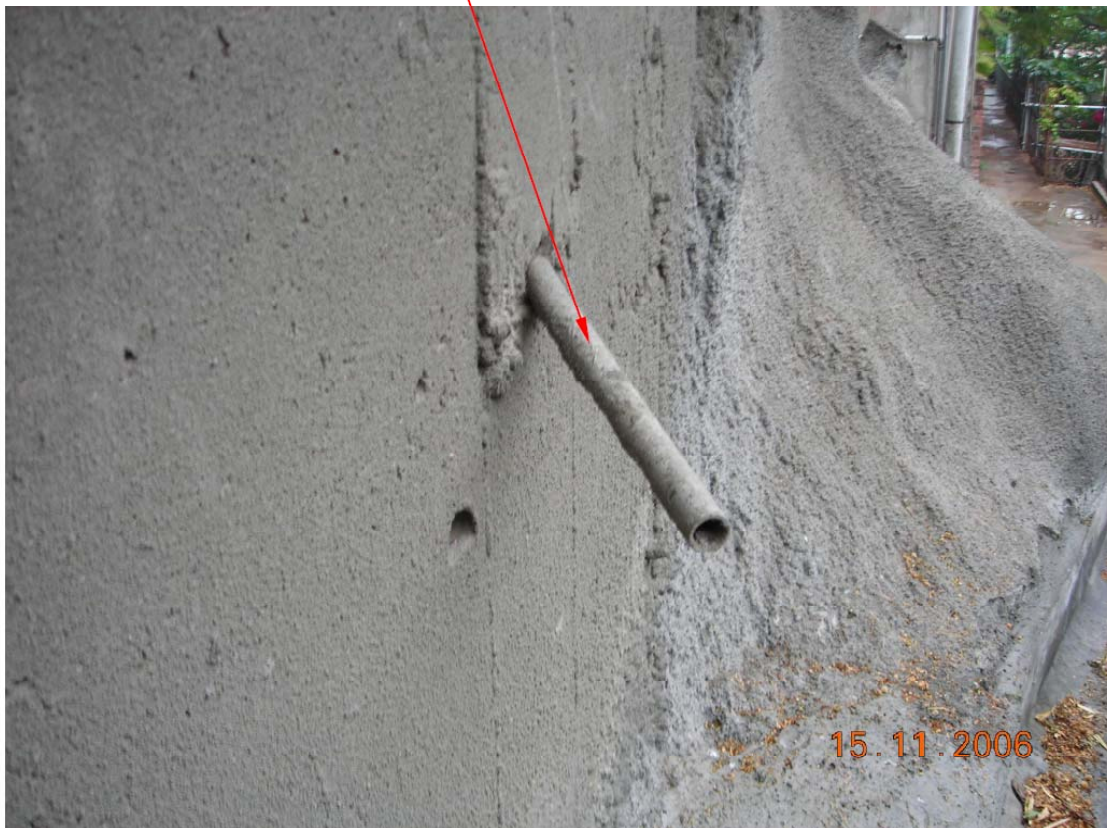
19 mm diameter galvanized iron pipe

Plate 11 - Close View of 19 mm Diameter Galvanised Iron Pipe Protruding from Retaining Wall at Crest of Slope No. 14NE-B/CR180 above No. 49 Po Wah Yuen (Photograph taken on 15 November 2006)

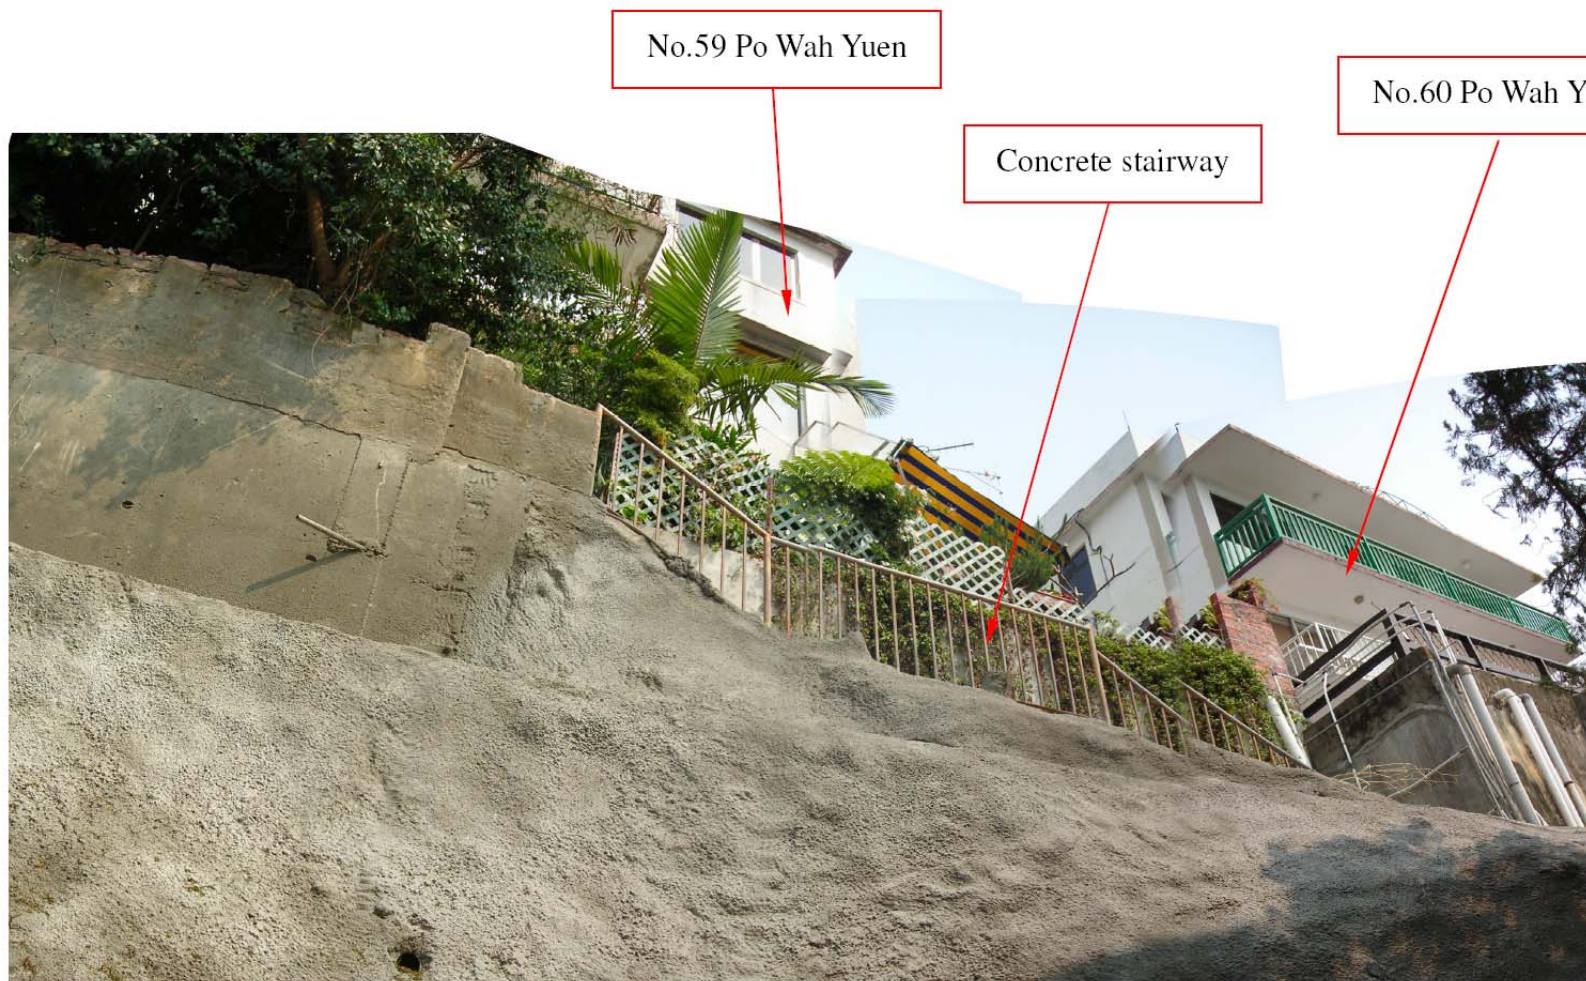
Plate 12 - View of Arrangement at Building Platform of No. 59 Po Wah Yuen (Photograph taken on 5 March 2007)

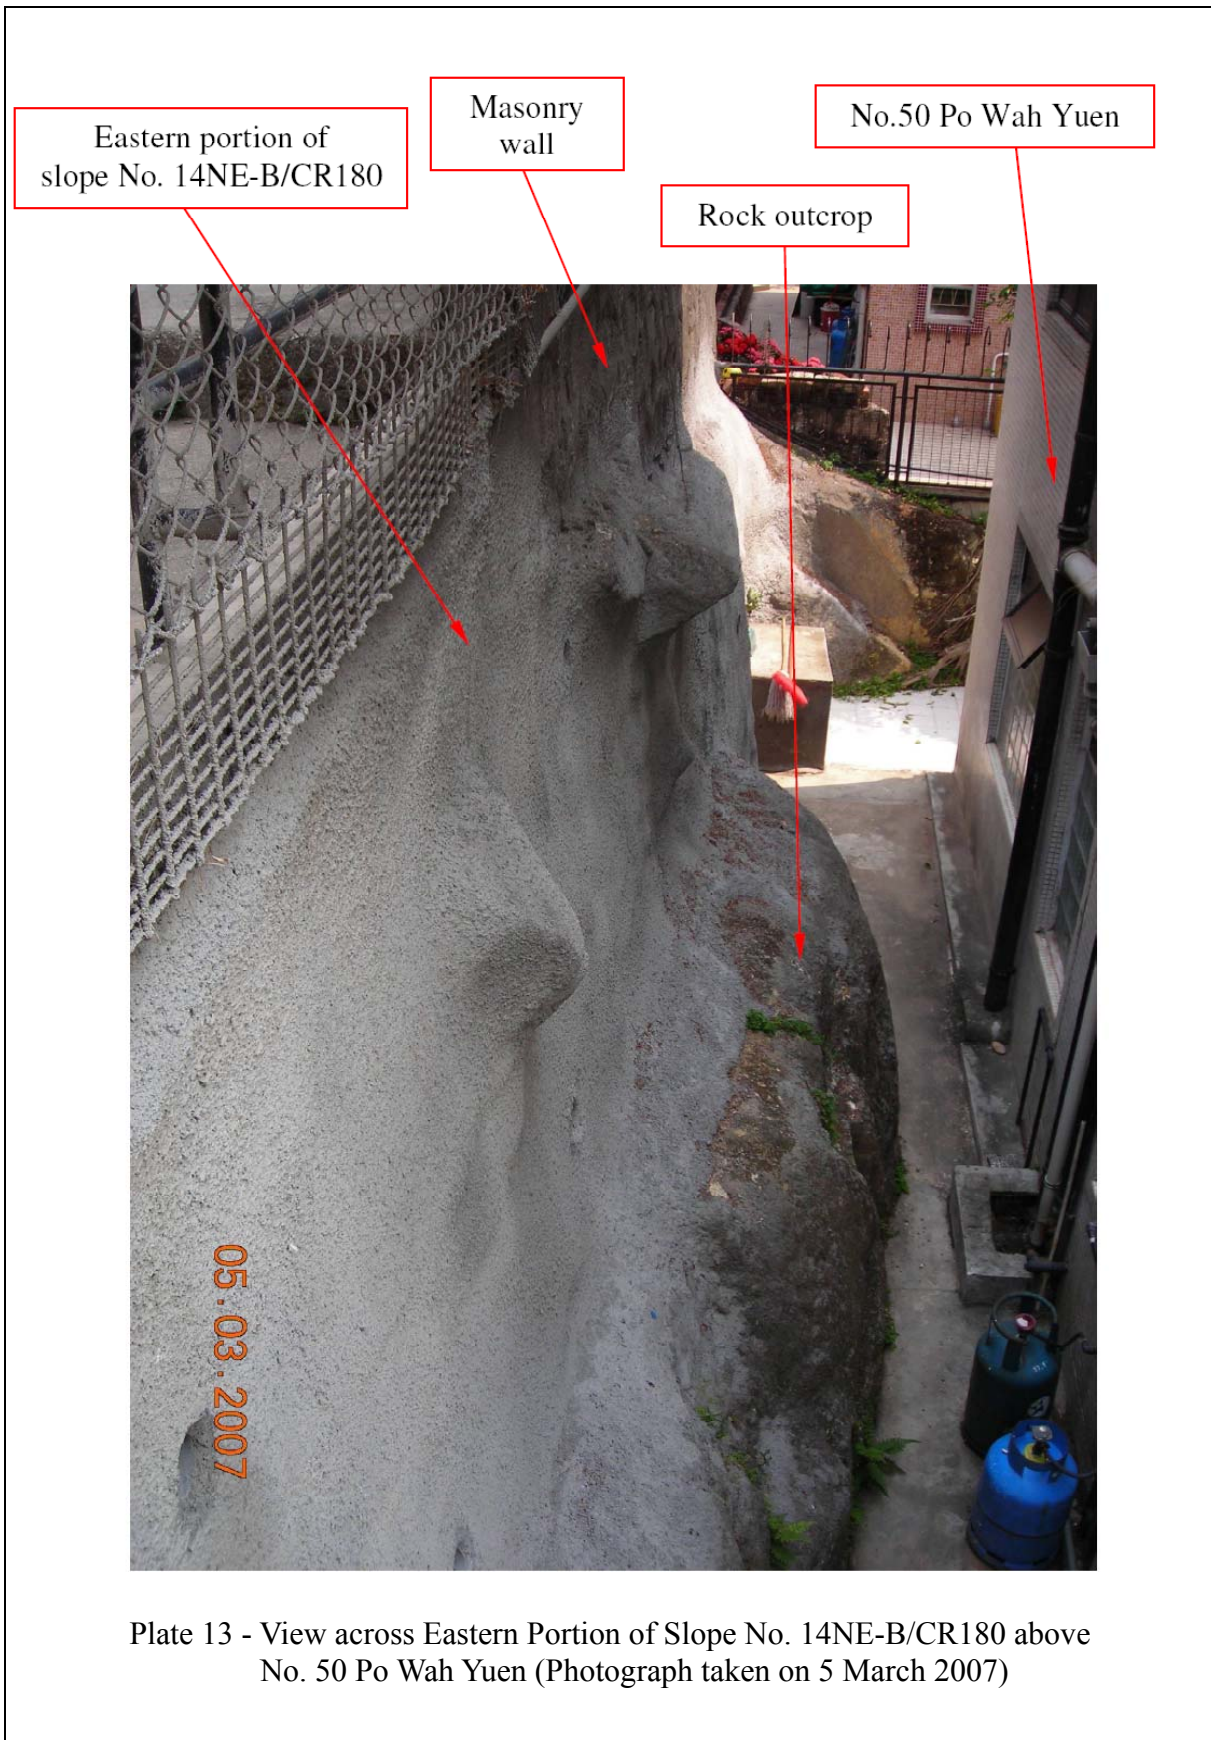
The portion of slope No. 14NE-B/CR180 located above No. 50 Po Wah Yuen was found to be in good condition, with a shotcrete surface cover recently applied to the slope portion of the feature (Plate 13).
