**REVIEW OF THE
22 AUGUST 2005 LANDSLIDE
ON THE NATURAL HILLSIDE
ABOVE BEACON HEIGHTS,
LUNG PING ROAD, KOWLOON**

GEO REPORT No. 235

Maunsell Geotechnical Services Limited

**This report is largely based on GEO Landslide Study Report
No. LSR 13/2007 produced in December 2007**

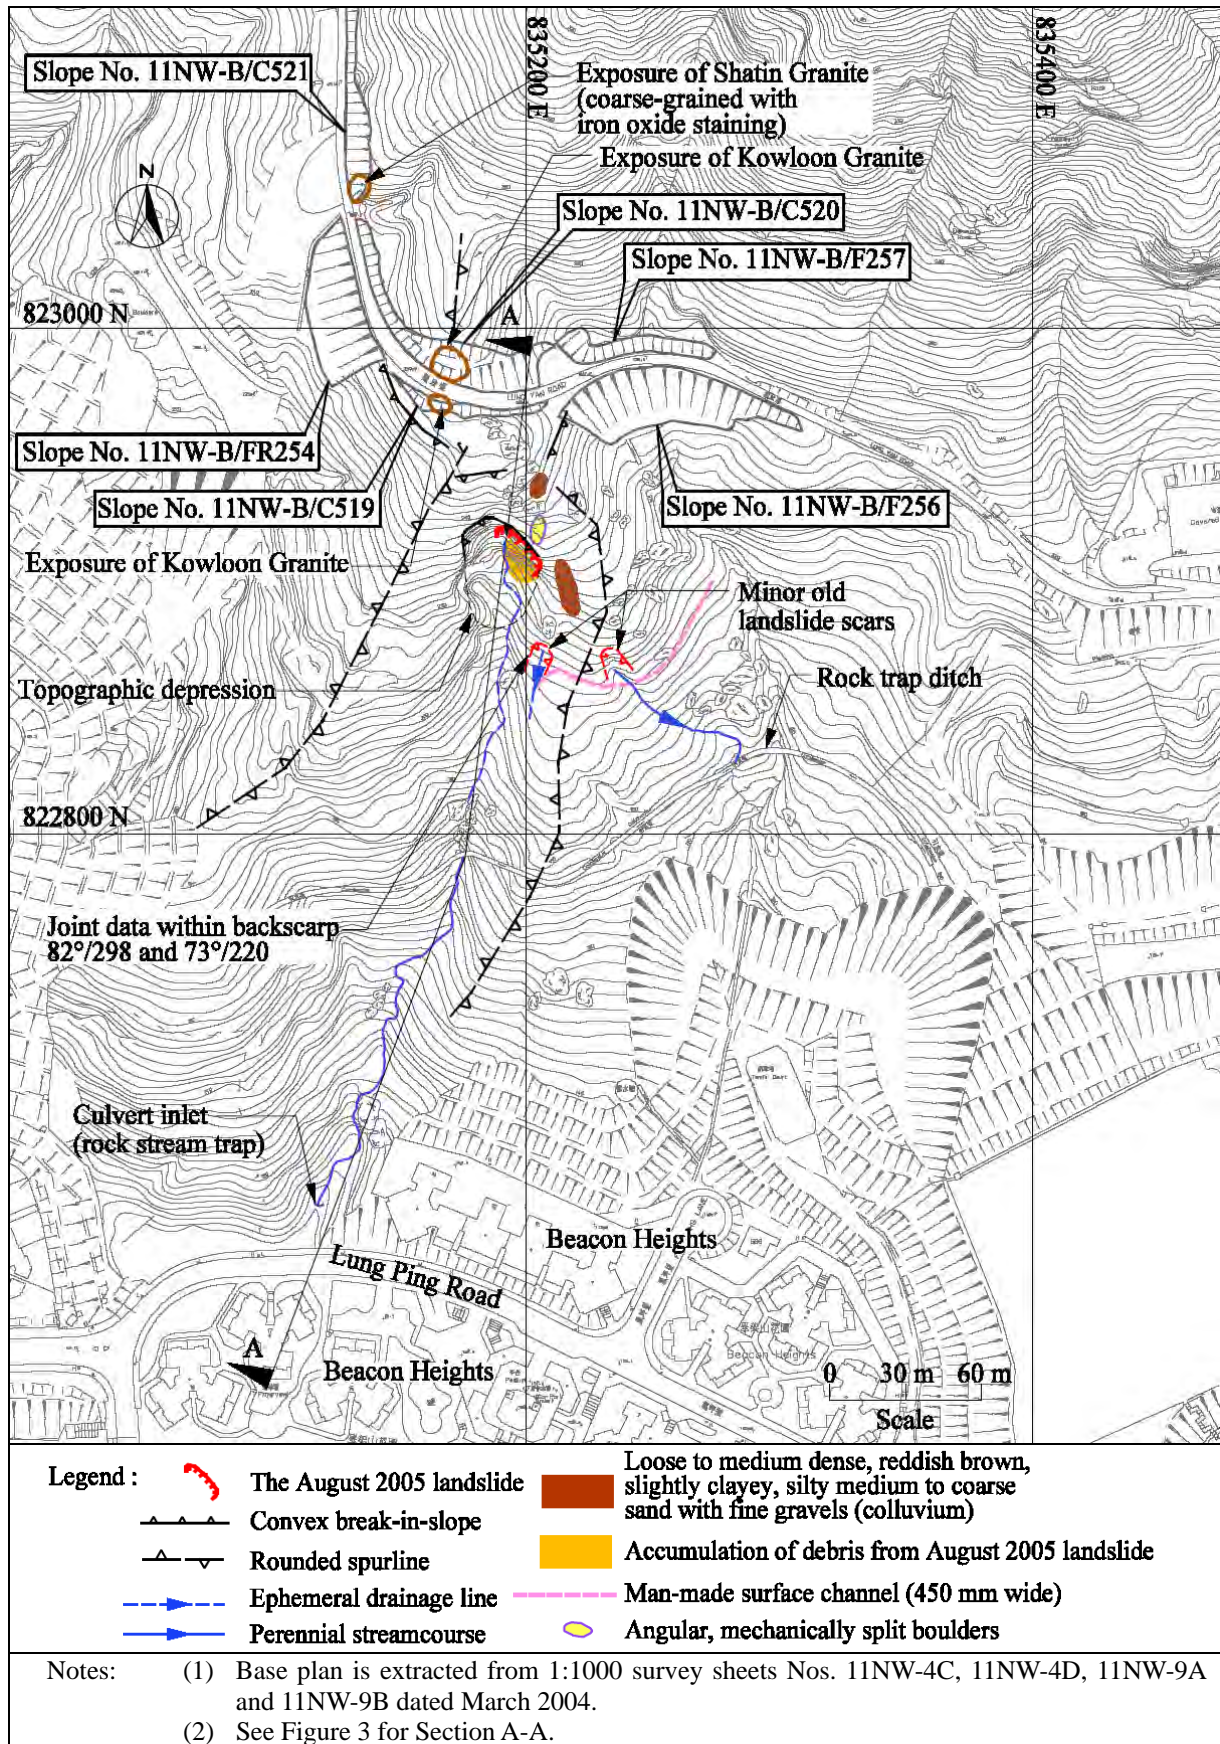
Figure 2 - Site Layout Plan and Field Observations

Two minor old failure scars (generally with a failure volume less than 30 m^3) within highly decomposed medium-grained granite were identified on the downhill side and to the southeast of the August 2005 landslide (Figure 2). Subvertical steeply dipping and southwest-facing joint surfaces, with the orientations of $82^{\circ}/298^{\circ}$ and $73^{\circ}/220^{\circ}$, were identified at the back scarps of the older landslide scars (Plate 11).

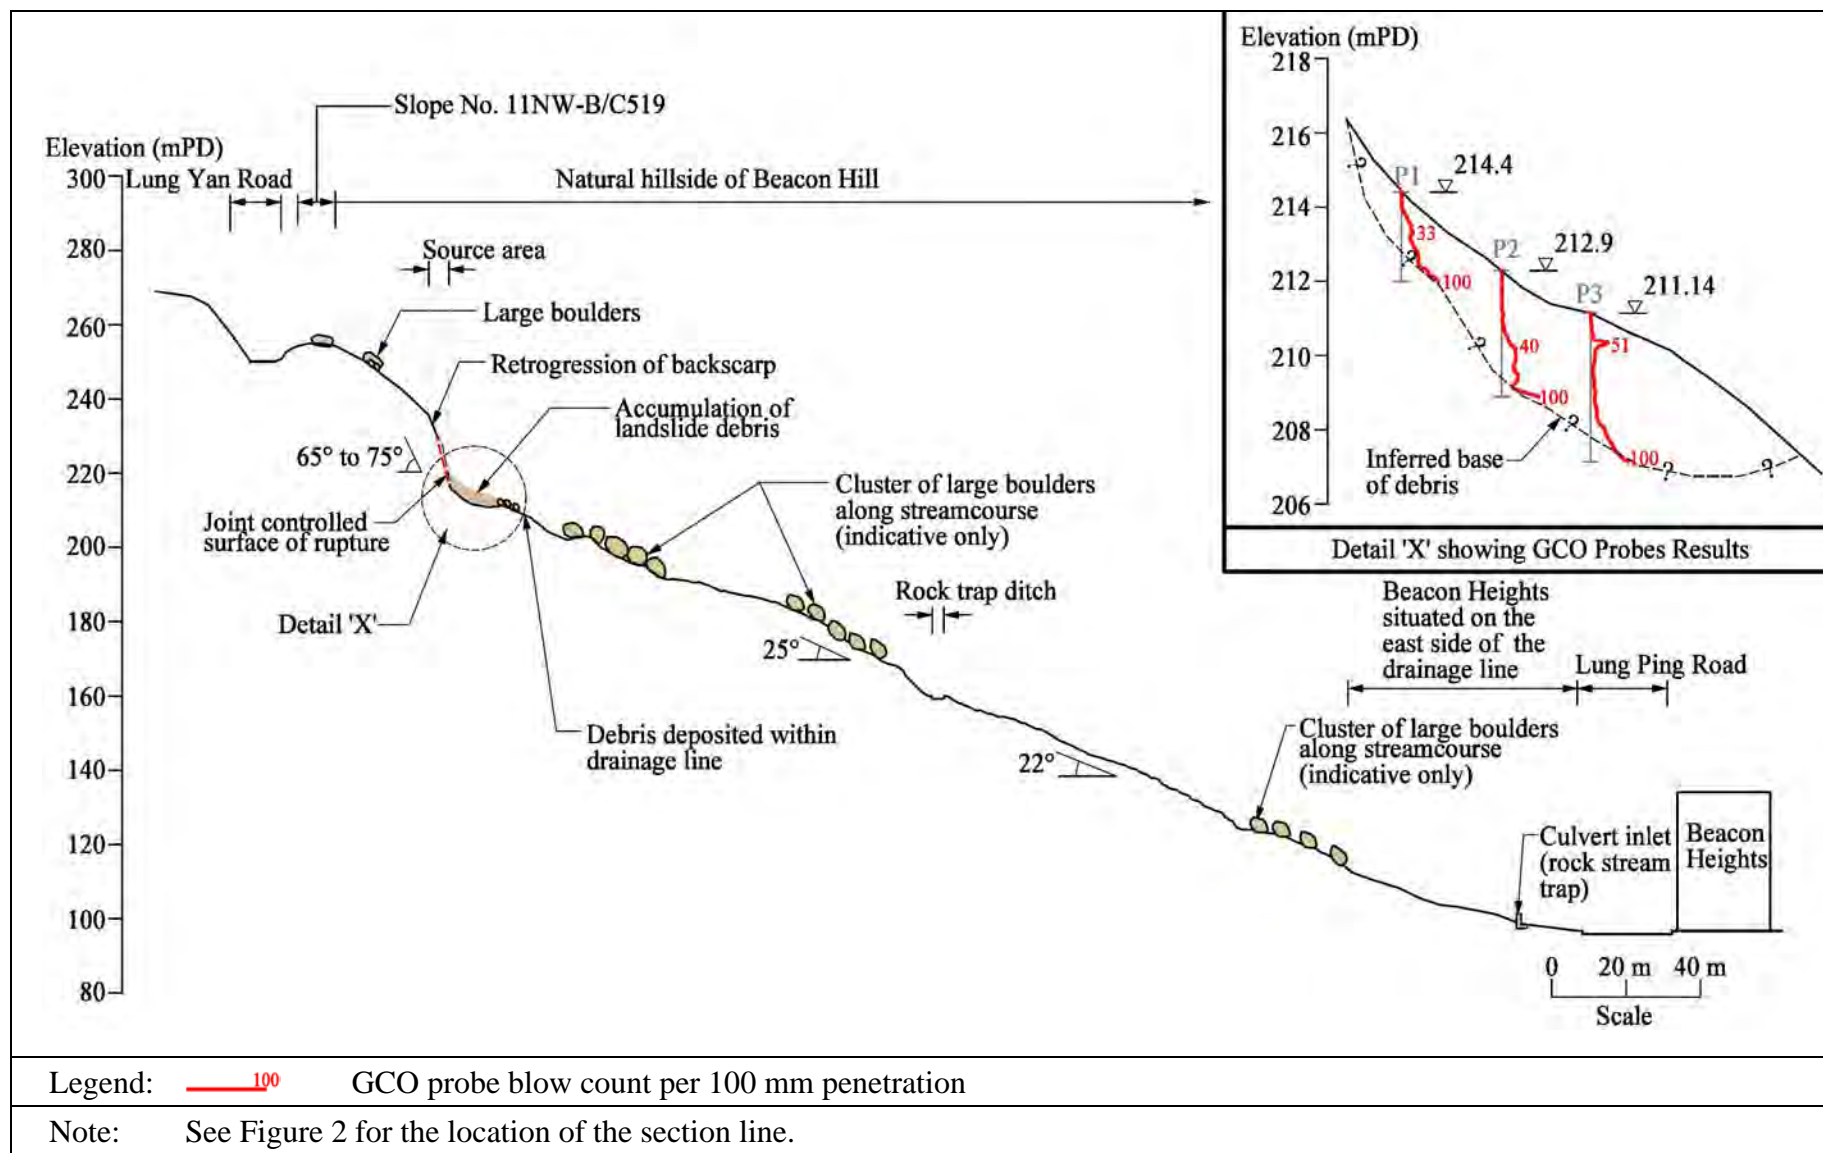
Figure 3 - Section A-A through the August 2005 Landslide

The landslide affected the southwest-facing side of the steep-sided topographical depression, with the surface of rupture extending from the base of the depression retrogressively cutting through the sharp convex break-in-slope at the crest of the depression and at the head of the drainage line. The surface of rupture appeared to be entirely within highly decomposed granite and was planar, possibly a joint surface, suggesting a structure-controlled failure. The rupture surface was inclined at between about 65° and 70°,

Much of the debris, that varied from a very sandy silt to a silty/clayey medium to coarse sand, was deposited at the toe of the surface of rupture and there was little evidence that much of the landslide debris had travelled into the drainage line below (Plate 4). The accumulated debris occupied an area about 15 m wide by 20 m long, which had been covered by shotcrete during the repair works carried out in 2006 (Figure 3 and Plate 5).

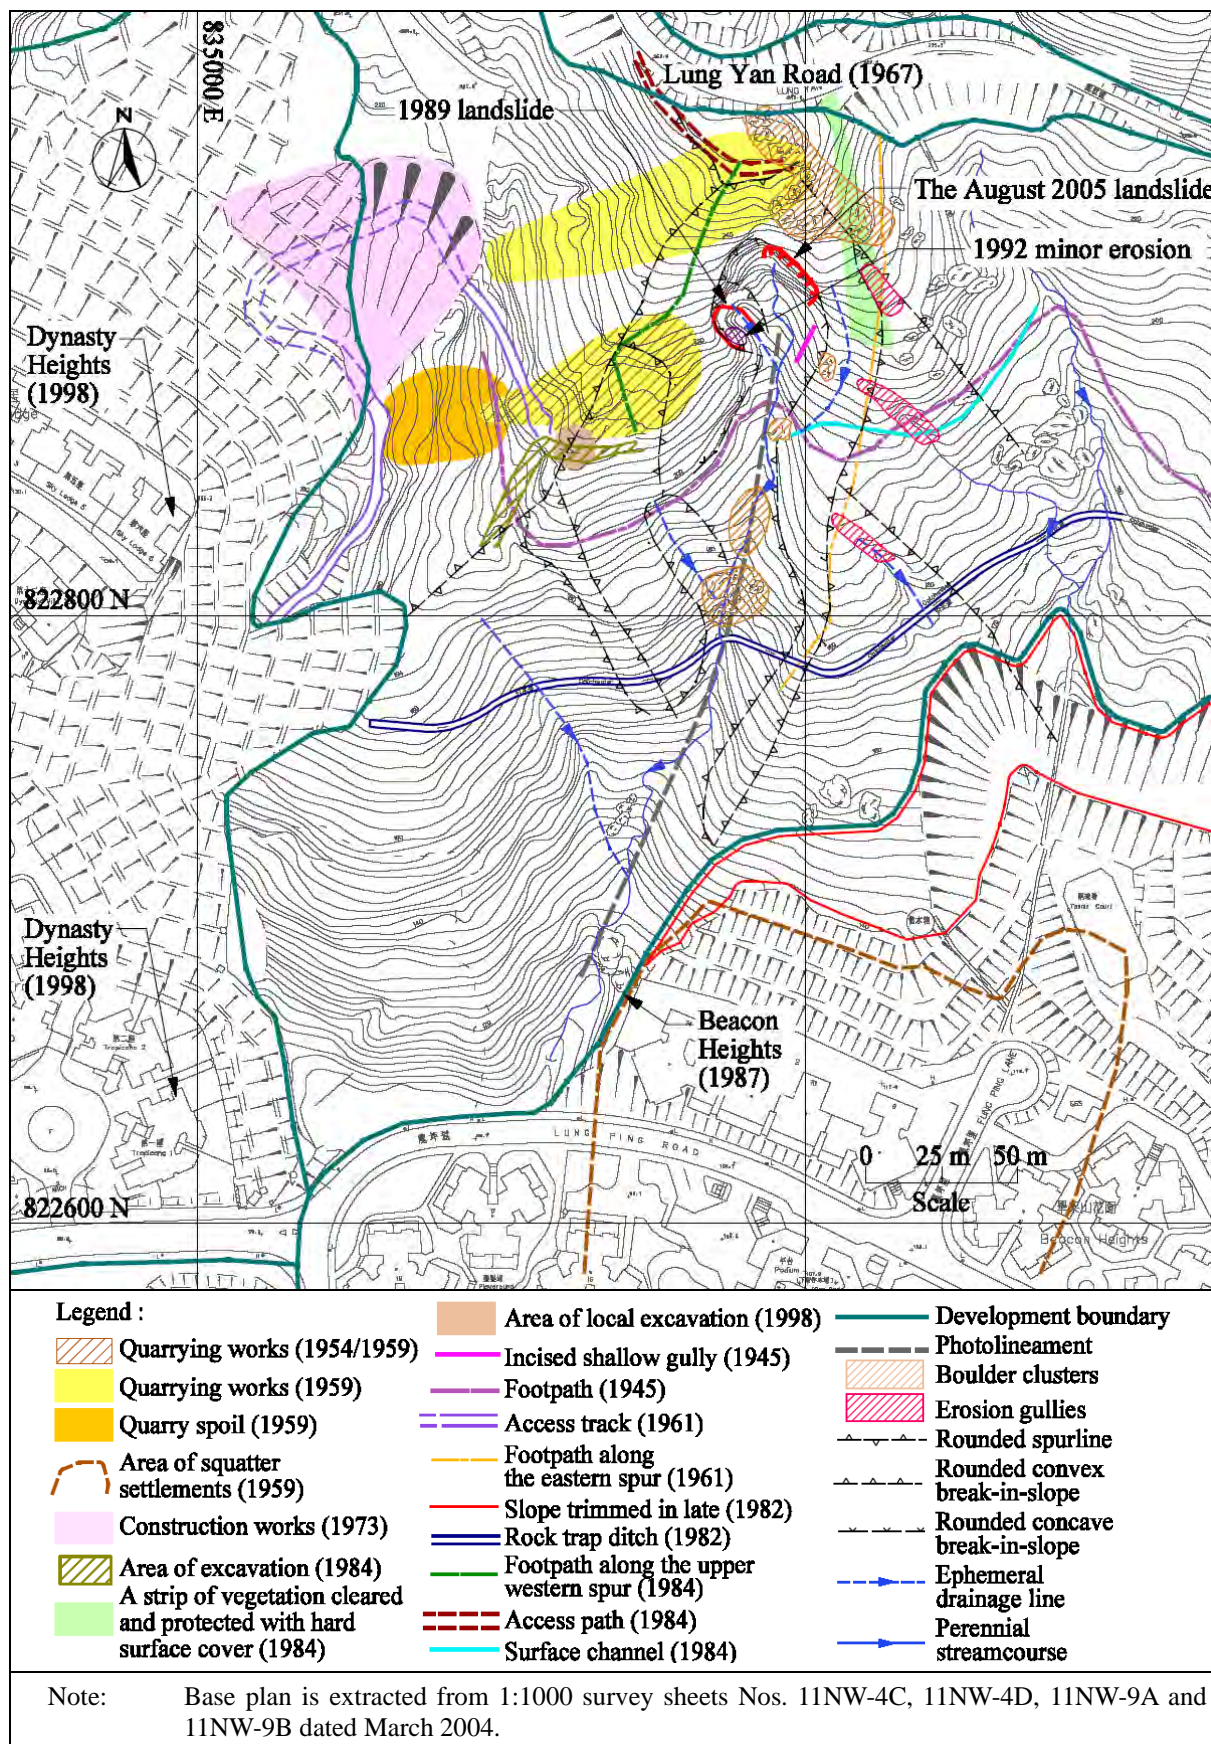
Figure 5 - Site History and Geomorphology

The overall orientation of the rupture surface, striking approximately north-northwest to south-southeast, was sub-parallel to the orientation of the erosion gullies on the hillside close to the August 2005 landslide site (Figure 5). The similarity in orientation supports the inference that the instability was structurally controlled.

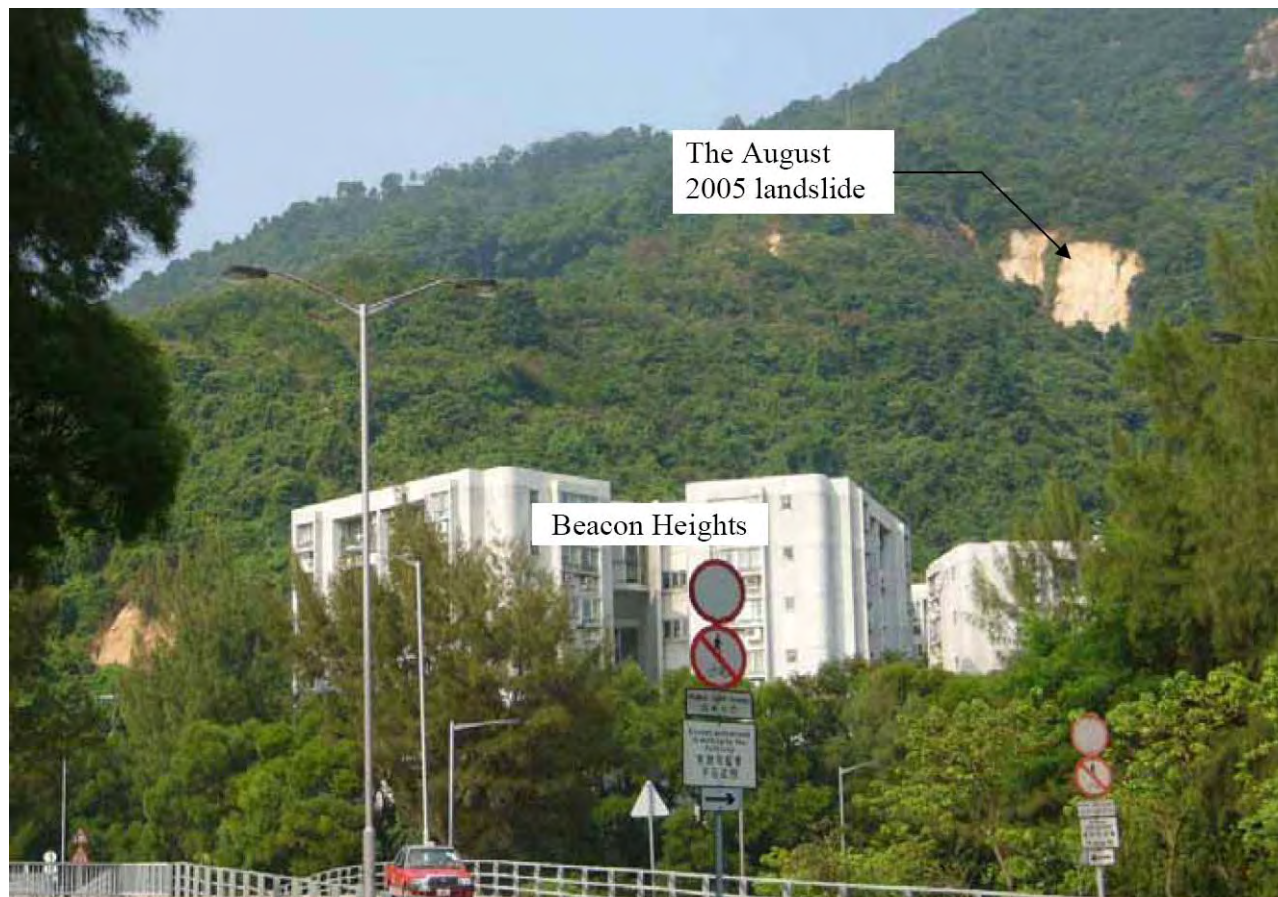
Plate 1 - General View of the August 2005 Landslide and the Hillside of Beacon Hill (Photograph taken on 24 October 2005)

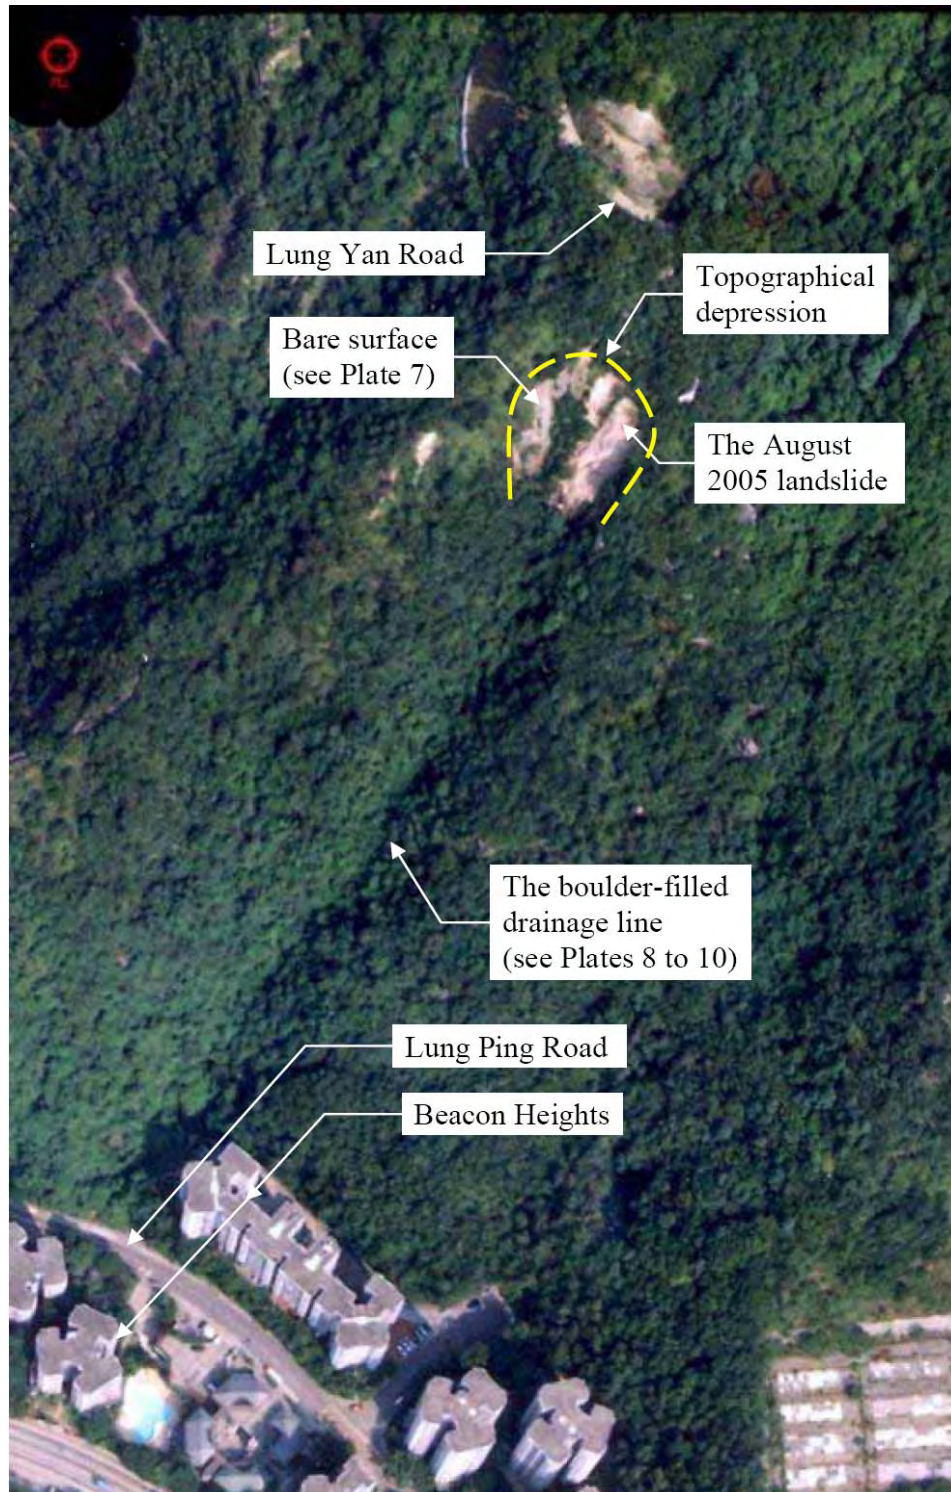
The August 2005 landslide is clearly visible in the October 2005 aerial photographs (Plate 2) and can be seen to comprise two scars separated by a narrow strip (about 1 m to 2 m wide) of vegetation. Landslide repair works, comprising the construction of a reinforced shotcrete cover on the landslide scar, were carried out by Highways Department in May 2006.

Plate 2 - Aerial View of the August 2005 Landslide
(Aerial Photograph No. CW65668 taken on
24 October 2005)

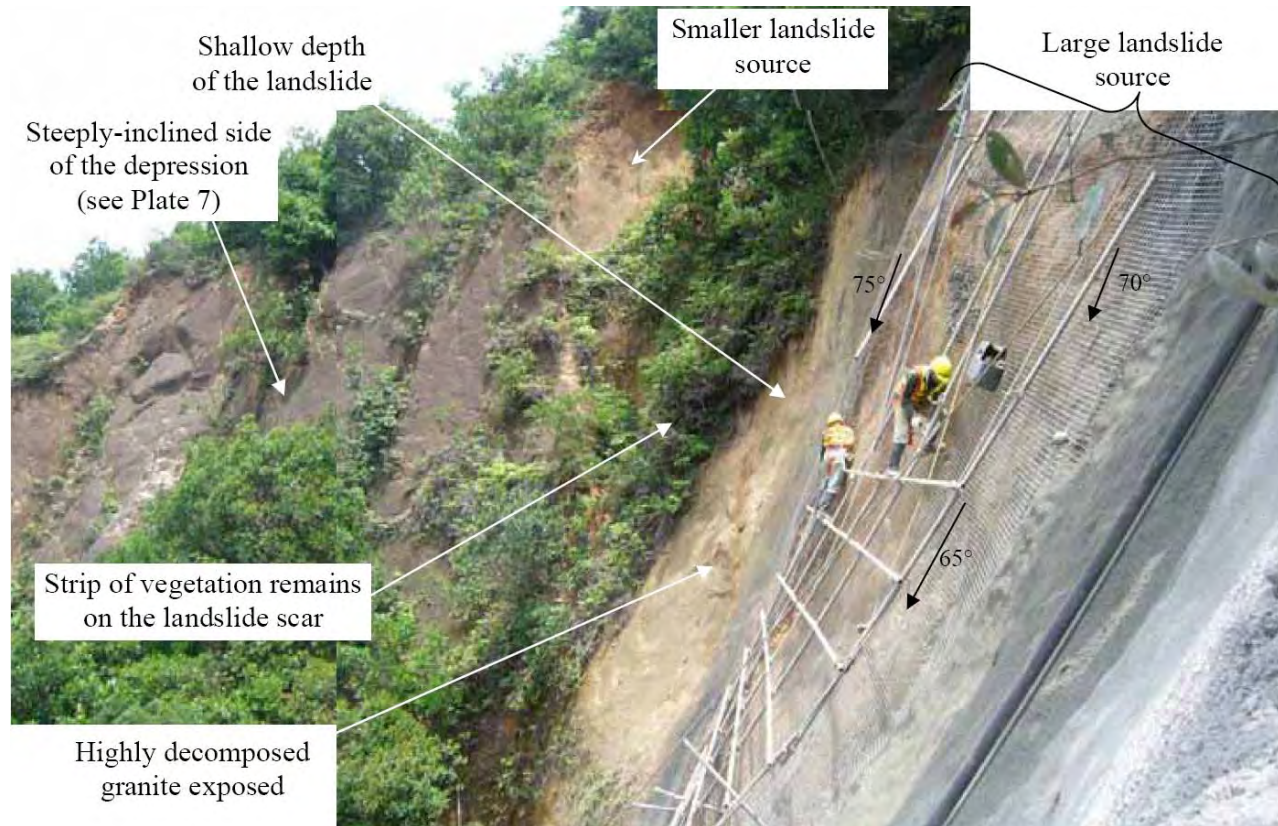
During the course of the site inspection carried out on 25 May 2006, two landslide source areas separated by a narrow strip of vegetation, were identified within a steep-sided topographical depression at the head of the drainage line (Plate 3). The larger landslide source area was approximately 15 m high by 20 m wide and about 0.5 m deep. The smaller landslide source area was about one-third of the size of the main source. The total estimated volume of failure from both sources was about 200 m³.

Plate 3 - View of the Landslide Source Area and the Urgent Repair Works (Photograph taken on 25 May 2006)

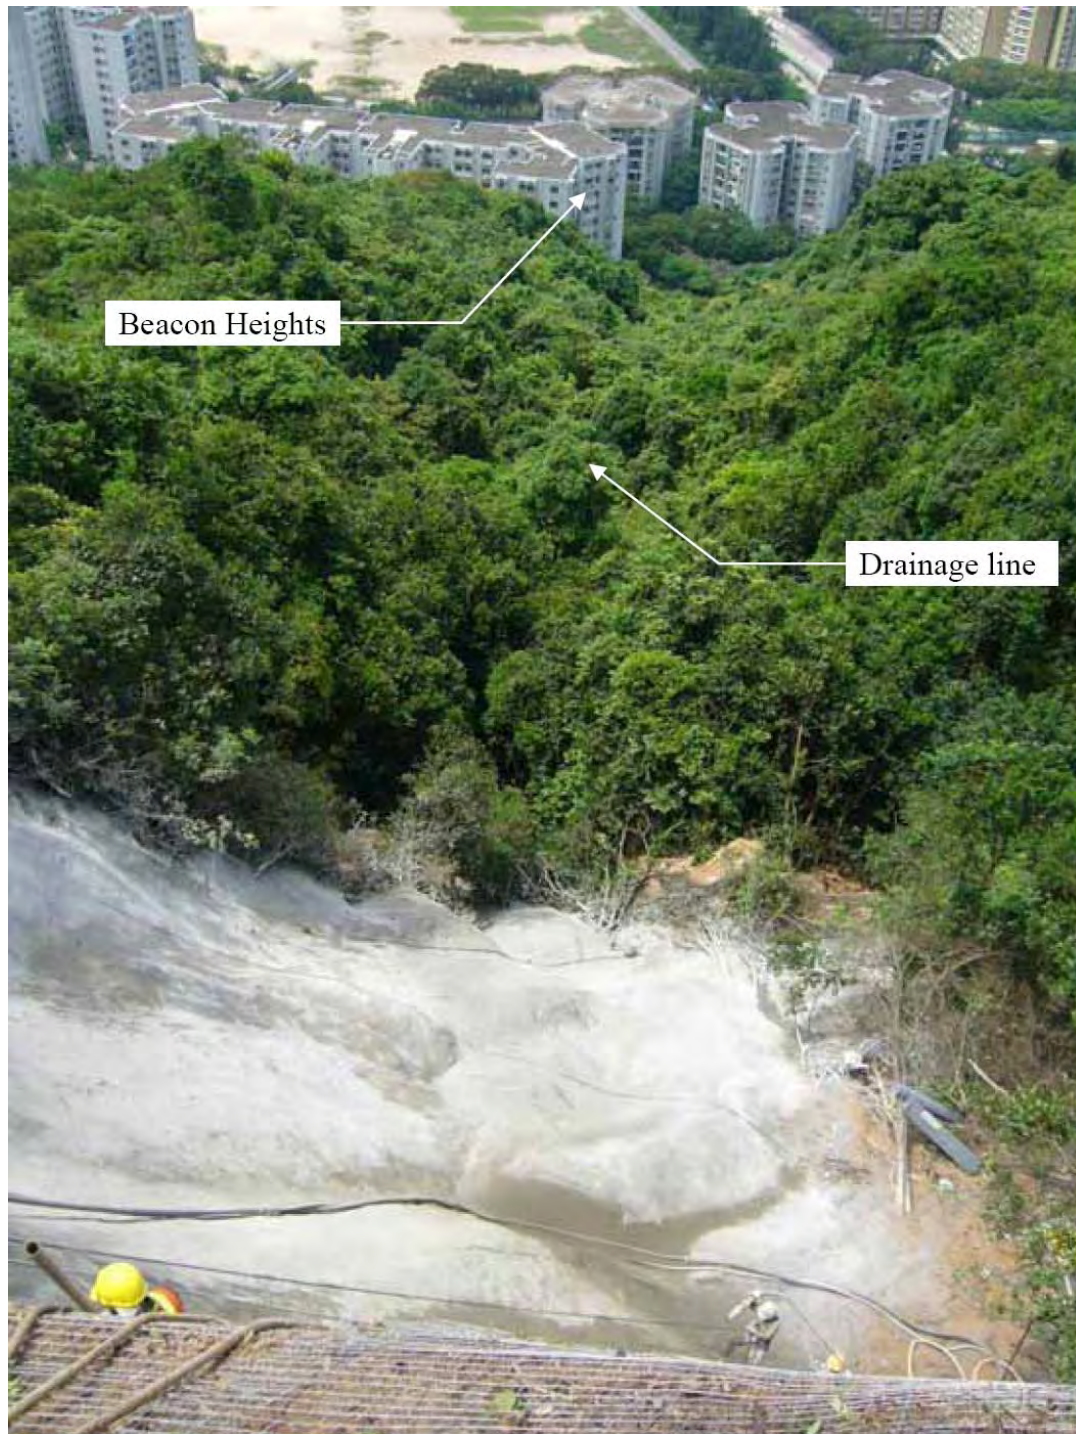
Plate 4 - View of the Drainage Line and Beacon Heights from the Crest of the August 2005 Landslide (Photograph taken on 25 May 2006)

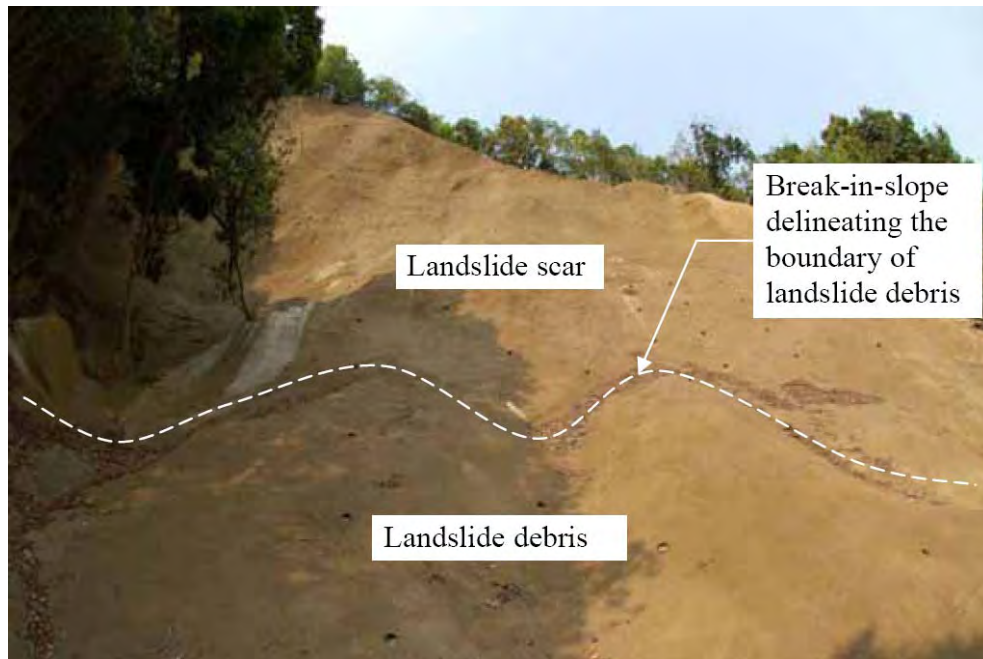
Plate 5 - Landslide Debris Covered by Shotcrete (Photograph taken on 13 April 2007)

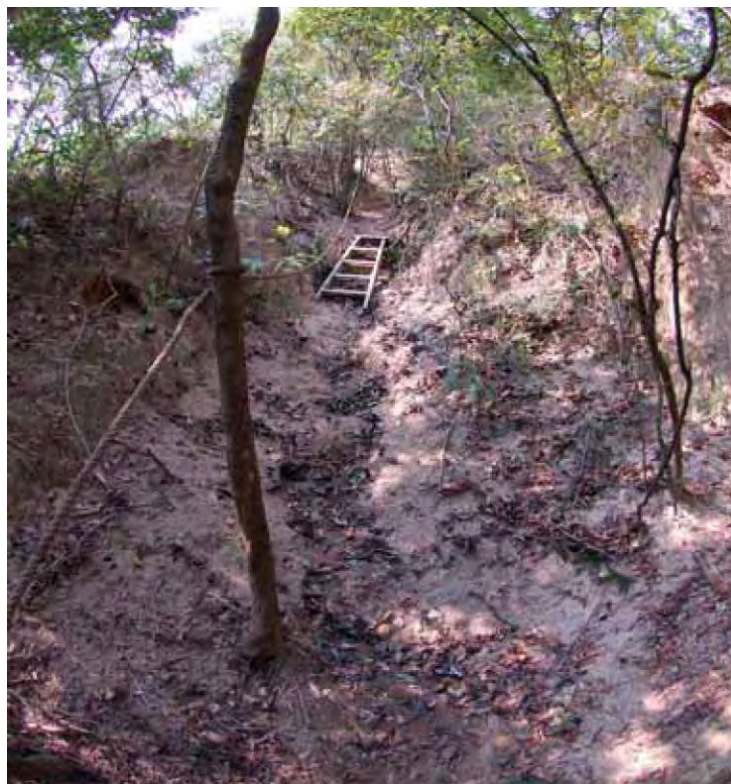
A minor ephemeral drainage line was observed to run from north to south on the hillside above the crest of the landslide (Figures 2 and 5; Plate 6).

Plate 6 - A Minor Ephemeral Drainage Line behind the Crest of the August 2005 Landslide (Photograph taken on 13 April 2007)

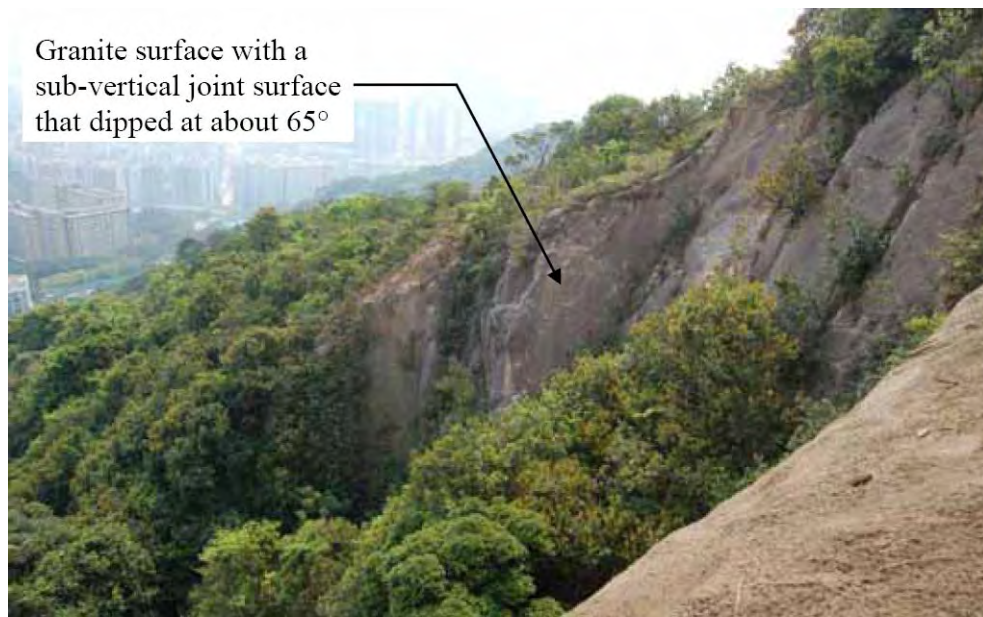
Plate 7 - Highly Decomposed Granite Surface on the Western Side of the Topographical Depression (Photograph taken on 13 April 2007)

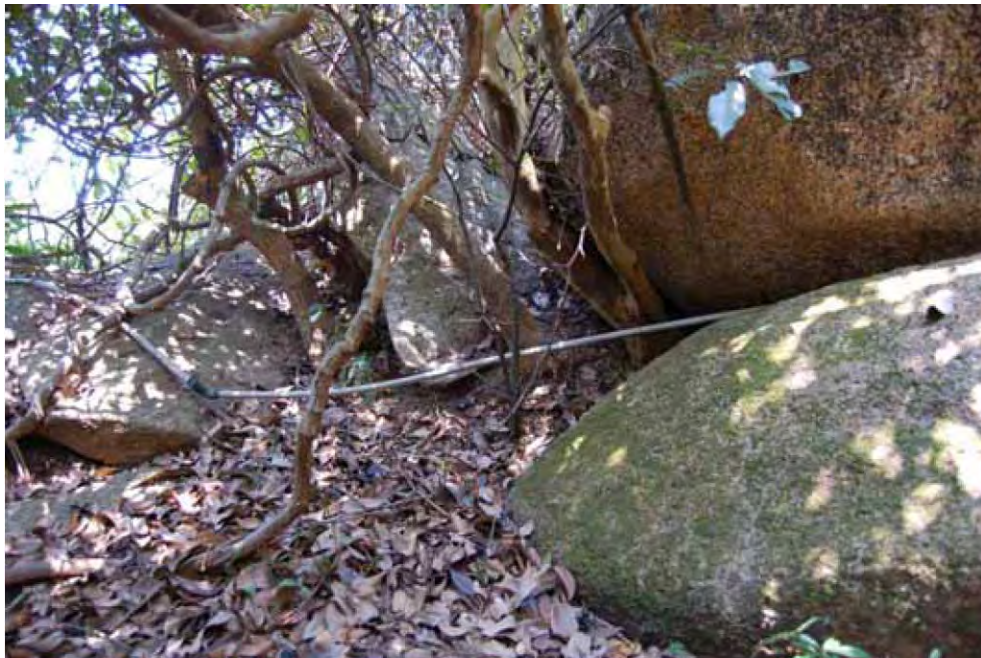
Large (up to 3 m diameter) rounded to sub-rounded boulders were observed on the adjacent spur to the east of the topographical depression (Plate 8) and along which the temporary inspection access has been formed. Substantial clusters of sizeable boulders (some up to 8 m in diameter) were observed within the drainage line below the August 2005 landslide (Plate 9). An accumulation of possible debris from a previous minor failure was observed within the drainage line further downstream of the debris from the August 2005 landslide (Plate 10).

Plate 8 - Large Rounded to Sub-rounded Boulders on Adjacent Spur (Photograph taken on 13 April 2007)

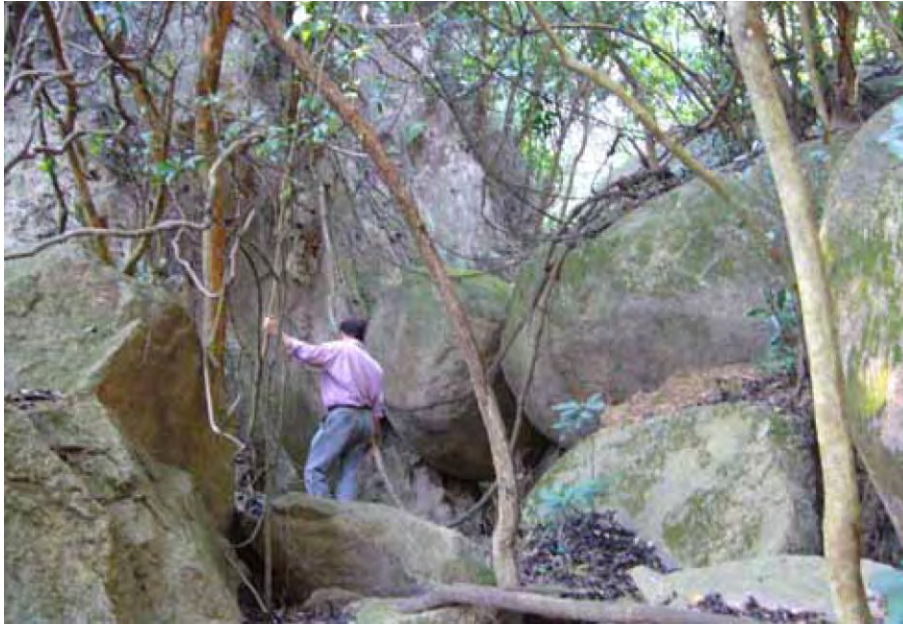
Plate 9 - Cluster of Sizeable Boulders within Drainage Line below the August 2005 Landslide (Photograph taken on 13 April 2007)

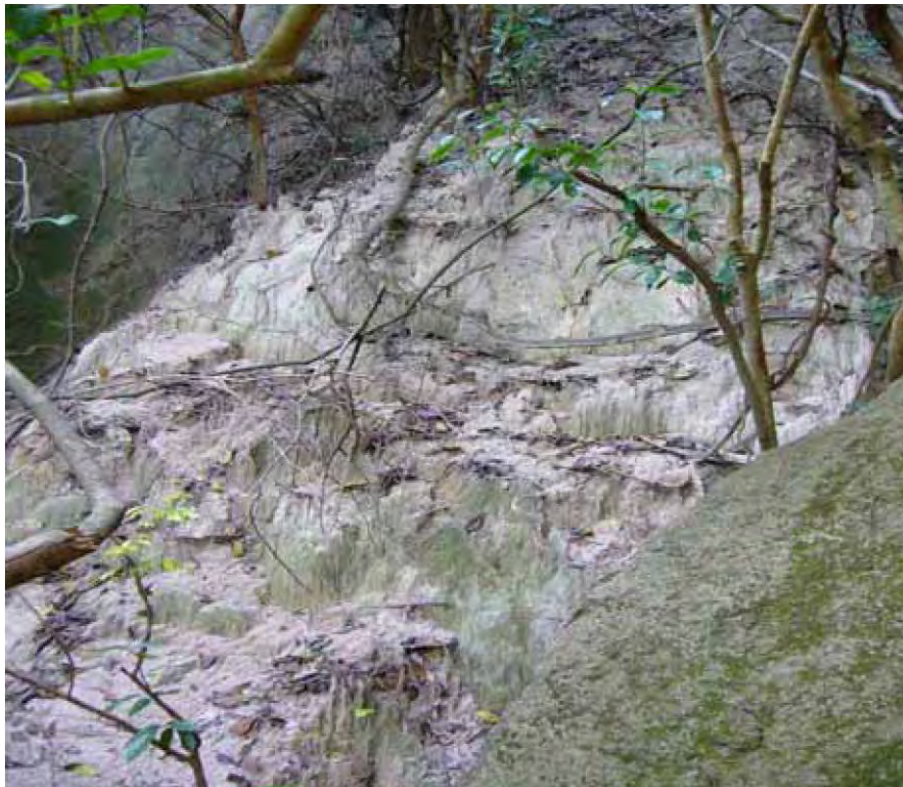
Plate 10 - Accumulation of Possible Debris from Previous Failures (Photograph taken on 13 April 2007)

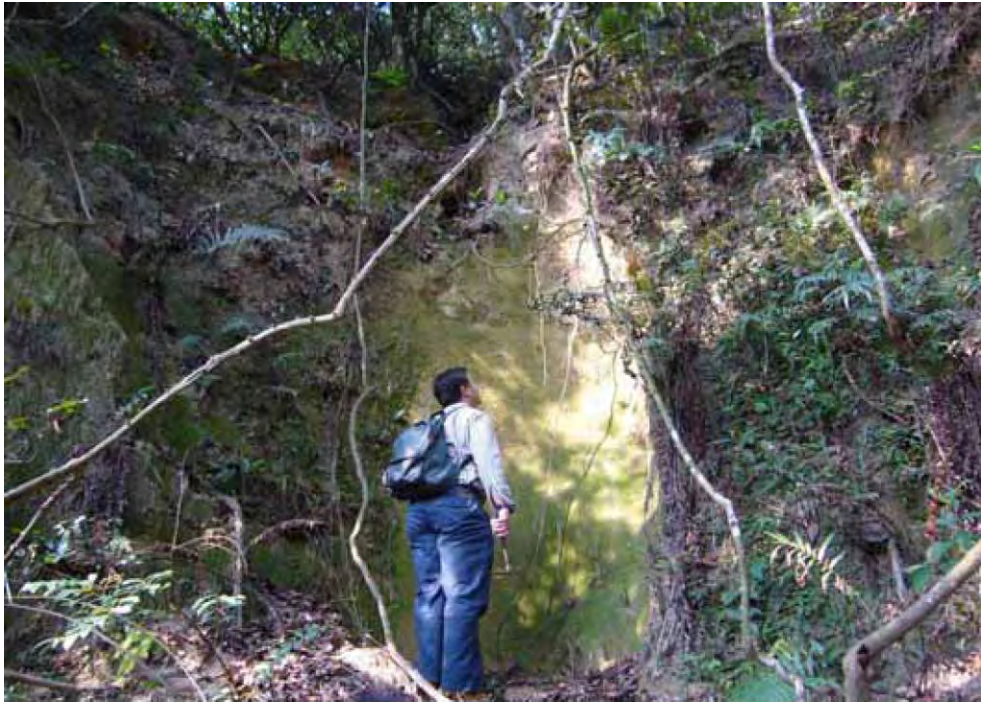
Plate 11 - Sub-vertical Steeply Dipping, Southwest-facing Joint Surfaces at Backscarp of Older Landslide Scar (Photograph taken on 13 April 2007)

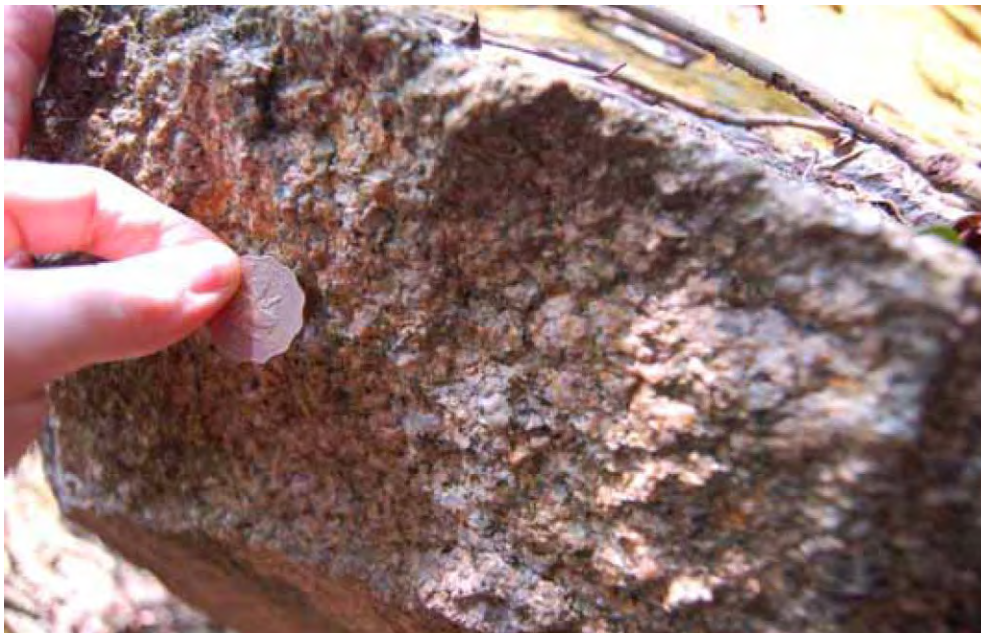
Plate 12 - Exposure of Pale Pink Kowloon Granite at Cut Slopes Nos. 11NW-B/C519 and 11NW-B/C250 (Photograph taken on 27 April 2007)

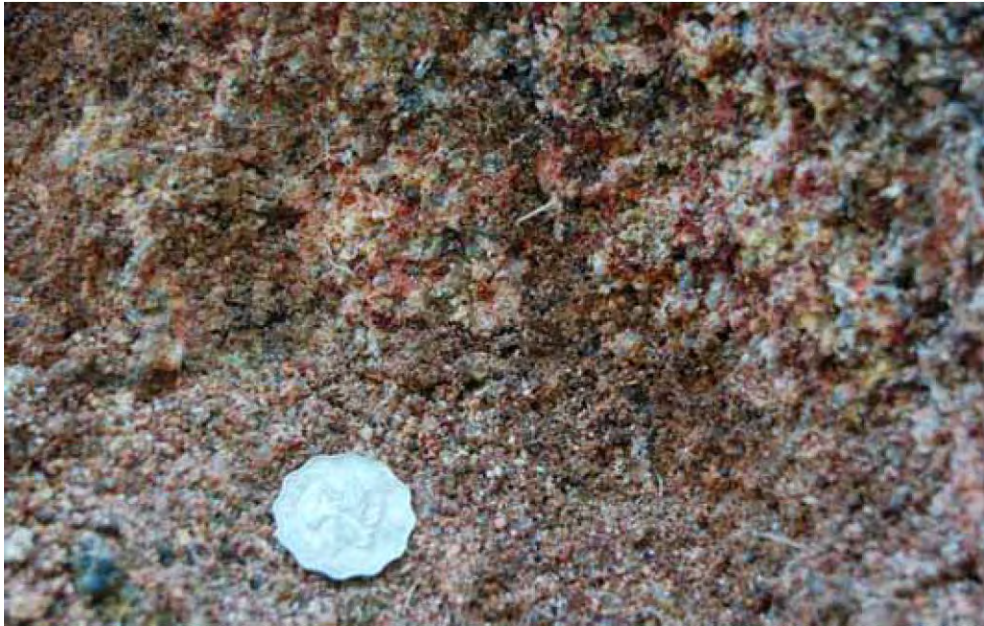
Plate 13 - Exposure of Completely Decomposed Coarse-grained Shatin Granite at Slope No. 11NW-B/C521 (Photograph taken on 27 April 2007)

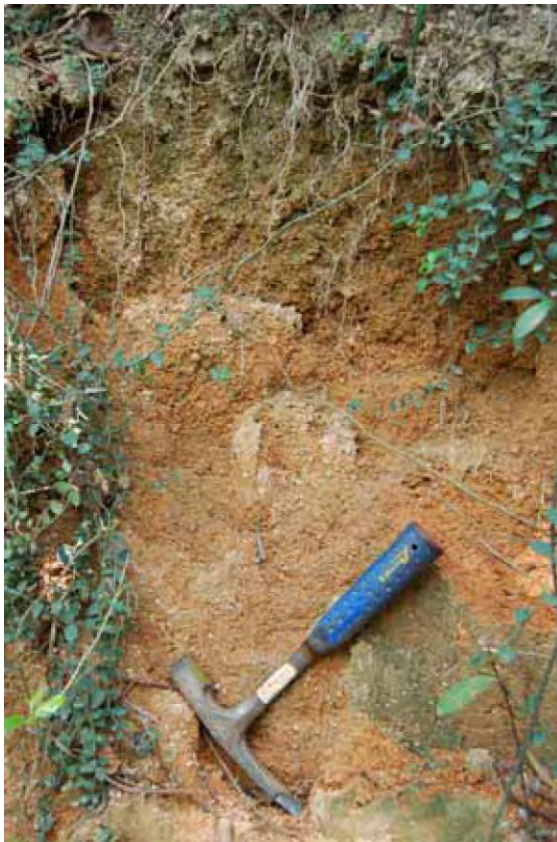
The solid geology in the vicinity of the August 2005 landslide comprises completely to moderately decomposed medium-grained and coarse-grained granite. A possible layer of residual soil was also observed at the site (Plate 14). Based on the results from the previous GI and site inspection, the granite appears to be deeply weathered with pervasive iron oxide staining.

Plate 14 - Colluvium Overlying Residual Soil
(Photograph taken on 27 April 2007)
