**REVIEW OF THE 2 JUNE 2006  
LANDSLIDE ON SLOPE  
NO. 7NE-D/FR58 ALONG  
MA ON SHAN TSUEN ROAD**

**GEO REPORT No. 236**

**Maunsell Geotechnical Services Limited**

**This report is largely based on GEO Landslide Study Report No. LSR 9/2007  
produced in October 2007**

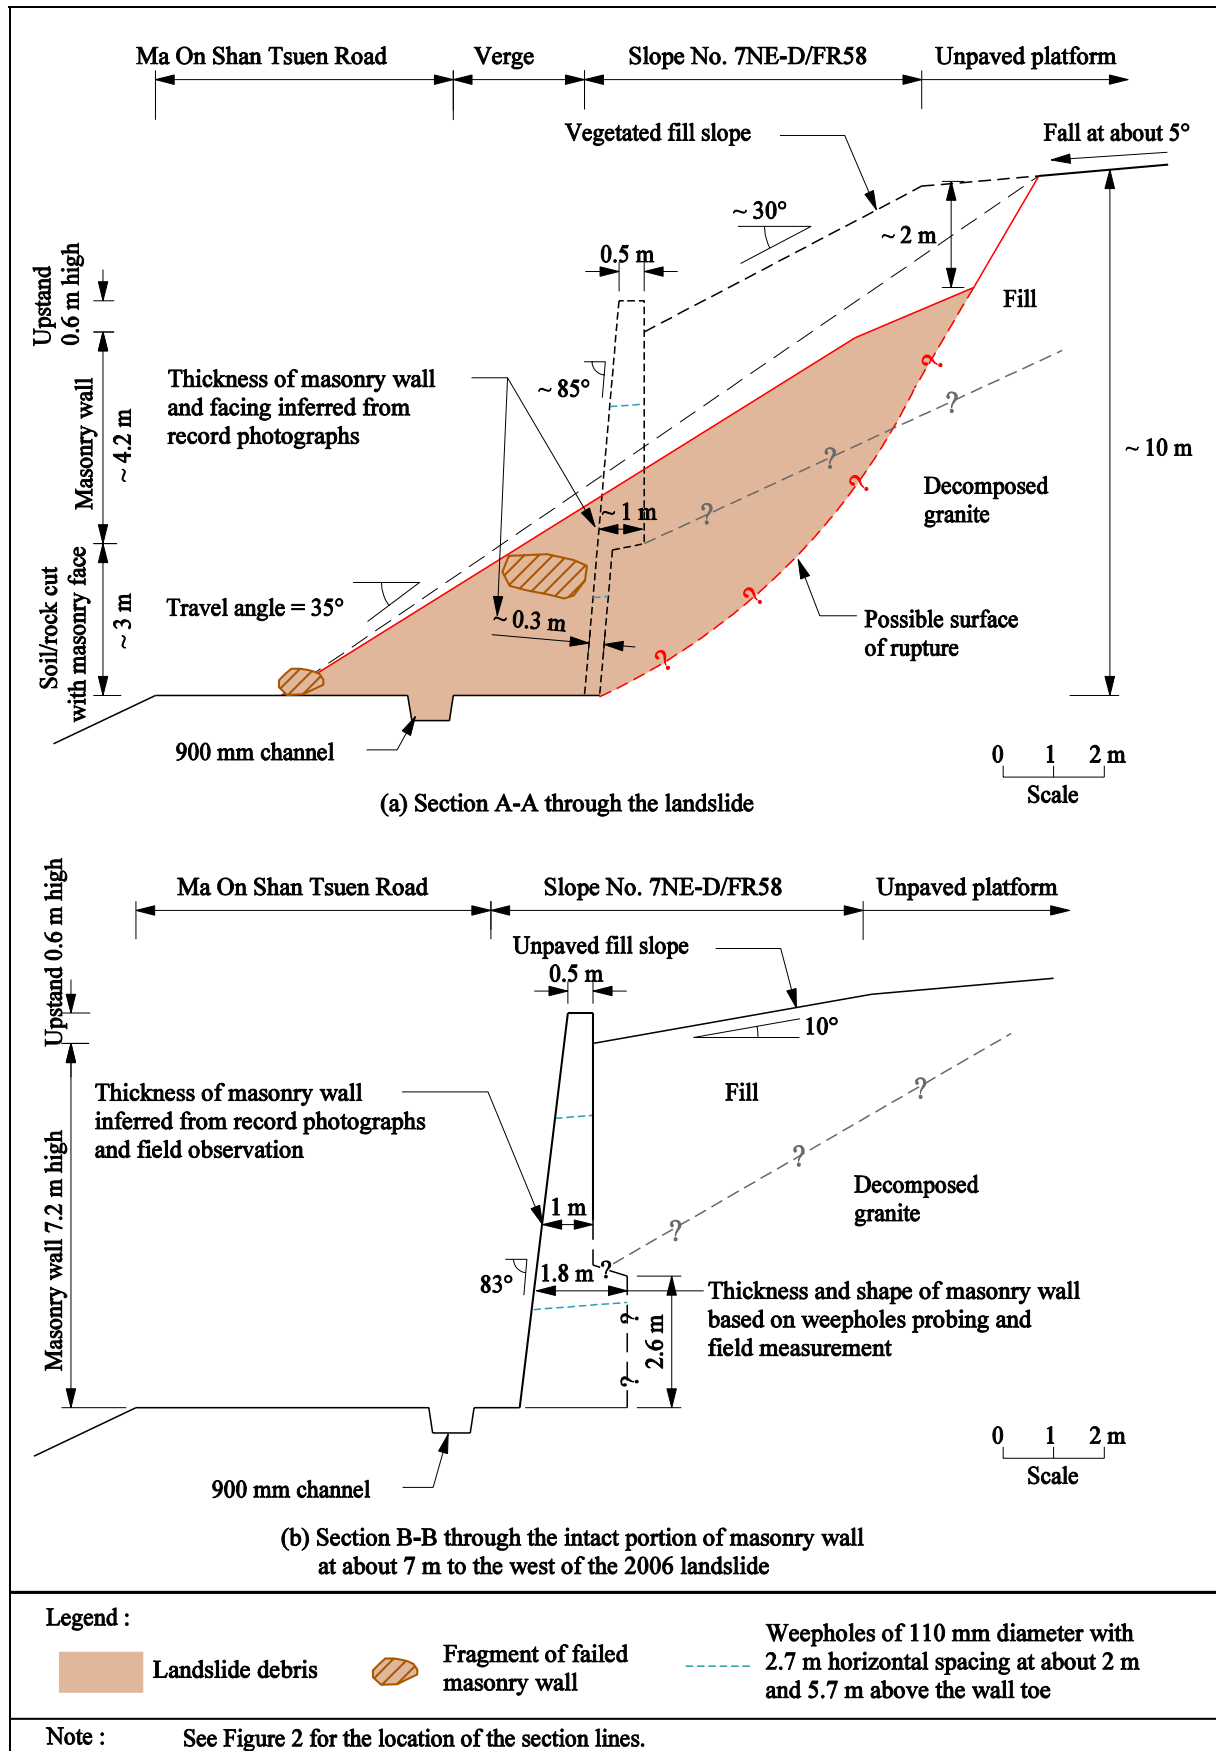
Figure 5 - Cross Sections

The failure surface might have passed through a significant portion of the insitu ground (i.e. decomposed granite as shown in Figure 5), in which case the potentially brittle failure through the decomposed granite could have rendered the wall behave in an apparently different manner from other non-slender masonry walls retaining fill materials, viz. this wall together with the overall slope could have failed in a brittle manner without prolonged signs of significant deformation because of the above.

It should be noted that the geometry shown in Section A-A (Figure 5) could give rise to a very special circumstance that the wall failure was in effect very slender if the masonry facing over the bottom 3 m behaved as if it was part of the retaining structure. Under this scenario, the base width at the toe (where the failure surface daylighted) is very small, with a slenderness ratio of about 24. The wall may be considered to be effectively standing on a small toe and it could behave as for a very slender wall.

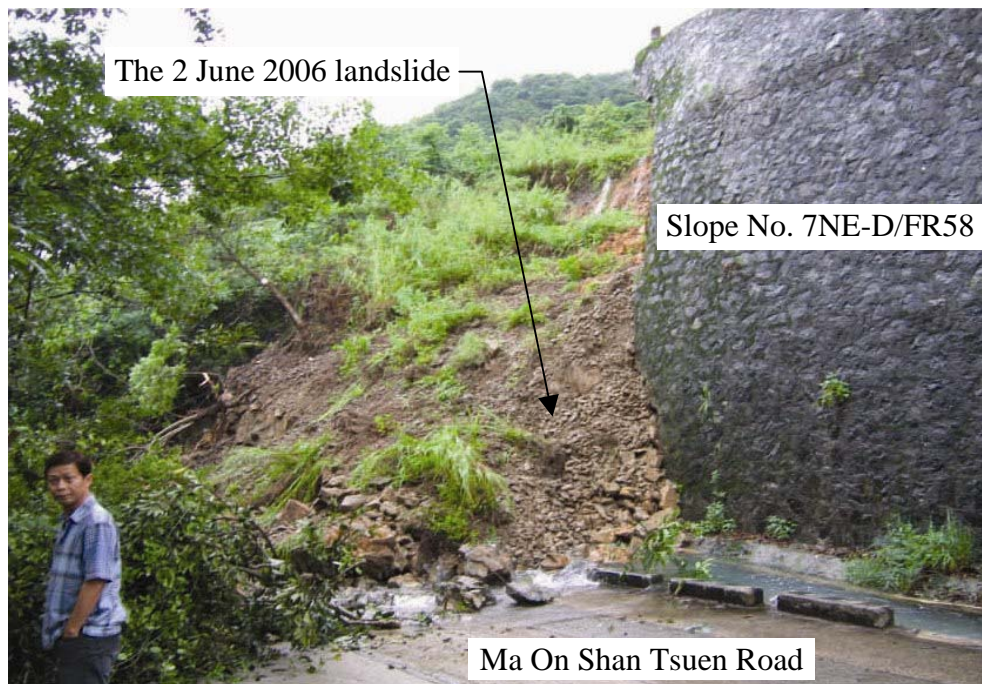
The landslide scar was about 30 m wide by 10 m high (Figure 5 and Plate 1) with an estimated failure volume of about 350 m<sup>3</sup>. The main scarp of the landslide was about 2 m high and inclined at an angle of about 65°, with fill material exposed (Plate 8). No signs of seepage or soil pipes were observed in the main scarp. A 19 m long portion of the masonry wall (including the location where a crack was identified by BAJV in 2001, see Section 4.3), and the fill slope above had collapsed. The landslide debris, which comprised a mixture of fill material, masonry blocks and vegetation, travelled a distance of about 6 m with a travel angle (Wong & Ho, 1996) of about 35° (Figure 5 and Plate 1). In addition, an 11 m long portion of masonry wall at the western end of slope No. 7NE-D/F66 was displaced by about 0.5 m and the fill slope above had collapsed (Plates 4 and 8). Some masonry blocks came to rest at the toe of the landslide debris (Plate 1) and a large detached wall fragment was exposed in the middle of the debris during its removal, with the original wall front facing downward (Plate 9).

Plate 1 - General View of the 2 June 2006 Landslide on Slope No. 7NE-D/FR58  
(Photograph taken by GEO on 2 June 2006)

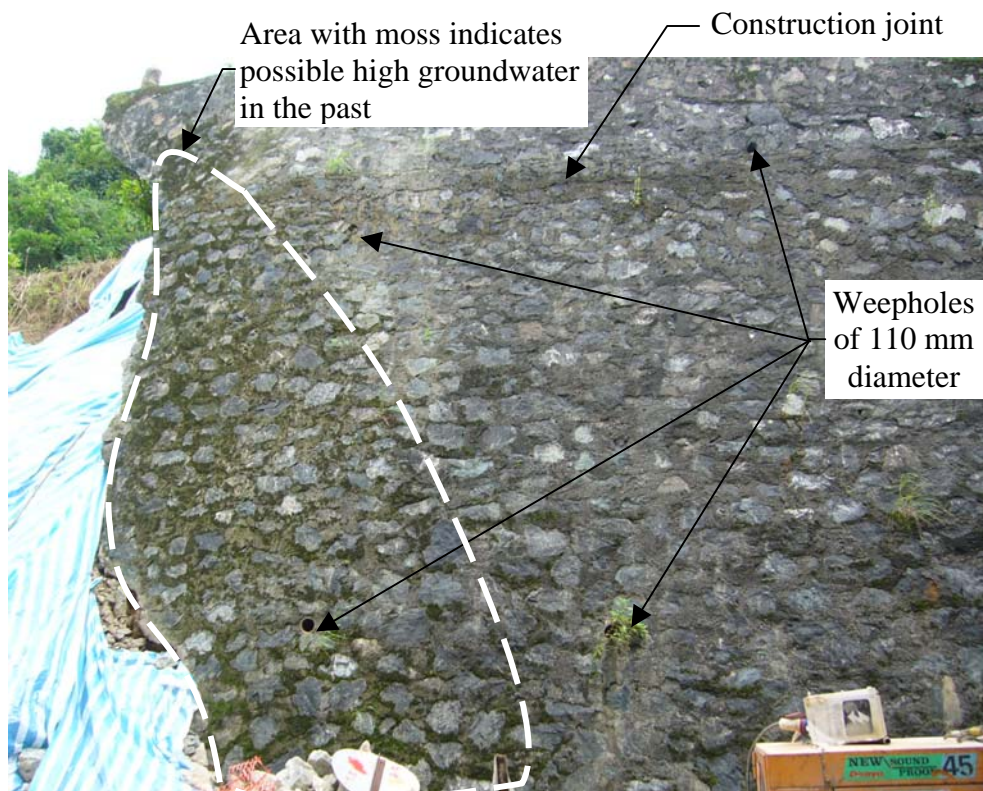
Slope No. 7NE-D/FR58 is about 55 m long with a maximum height of about 10 m. The masonry wall portion at the toe, with a face inclination of about 80° to 85°, was formed using pointed random rubble blocks (Plate 3). The height of the masonry wall increases from 0.5 m at the junction of the unpaved access and Ma On Shan Tsuen Road to a maximum of about 7.2 m near the middle portion. The masonry wall extended into the northwest corner of slope No. 7NE-D/F66 where the height of the wall was about 2.5 m and it was founded on exposed rock (Figure 2 and Plate 4). At slope No. 7NE-D/FR58, a 20 m long and maximum 3 m high vegetated fill slope was situated above the northeast portion of the wall and inclined at a maximum angle of about 35°. A 10 m wide unpaved platform is located at the crest of slopes Nos. 7NE-D/FR58 and 7NE-D/F66 (Figure 2). The platform generally has a fall towards the retaining wall. This platform leads to an abandoned mining portal which is located about 100 m to the east of slope No. 7NE-D/FR58.

Plate 3 - Front View of the Masonry Wall Portion of Slope No. 7NE-D/FR58  
(Photograph taken on 7 June 2006)

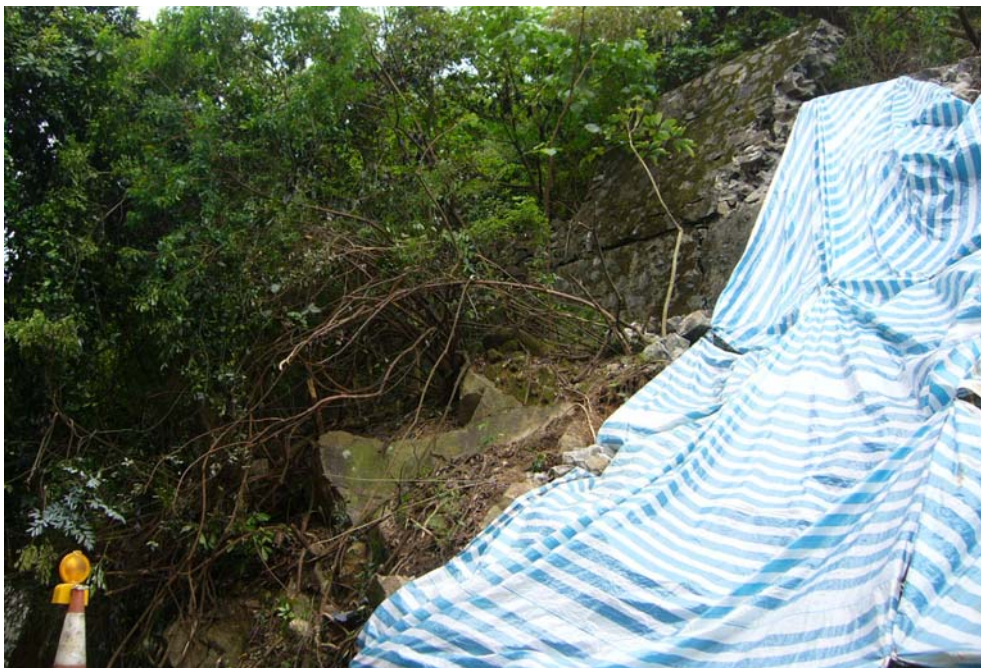
Lands D, the base of the masonry wall was examined by MGSL. Very few masonry blocks were observed in the central portion of the June 2006 landslide although a distinct boundary of soil/masonry block was identified near the western flank of landslide (Plate 12). Weephole probing of the portion of the unfailed masonry wall, located at about 7 m to the west of the 2006 landslide, showed that the thickness of the base of the wall in this portion was about 1.7 m to 1.9 m. The slenderness ratio of the masonry wall at this location was about 4 (Figure 5). Another 3 m high masonry wall, which rested on exposed rock mass, is located to the east of the June 2006 landslide within slope No. 7NE-D/F66 (Figure 2 and Plate 4). No signs of distress were observed on this wall.

Plate 4 - Masonry Wall Extended to Slope No. 7NE-D/F66  
(Photograph taken on 7 June 2006)

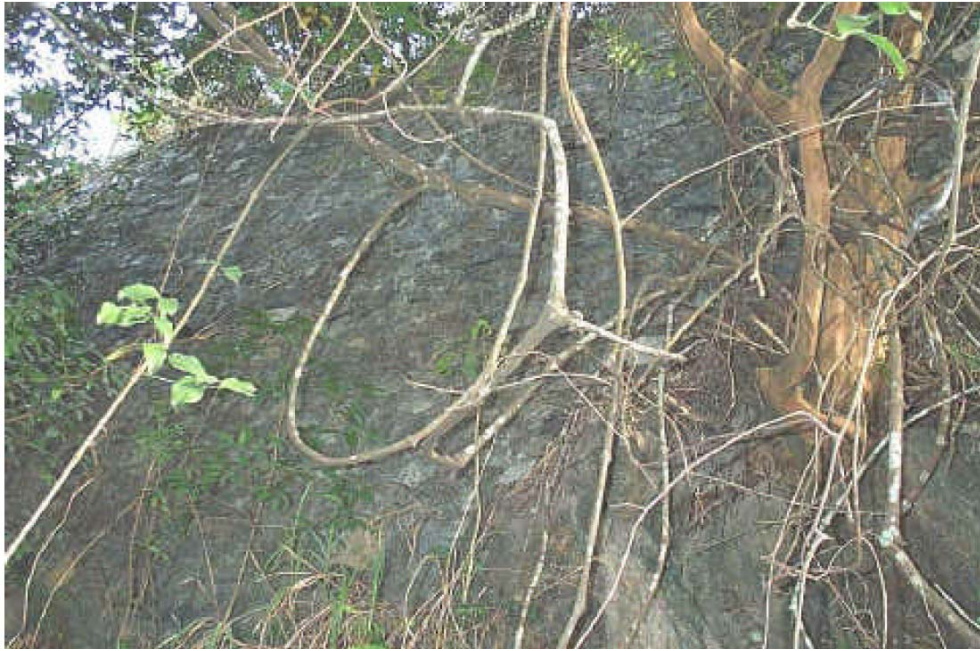
Plate 7 - Crack Observed on the Masonry Wall at the June 2006 Landslide Location  
(Photograph taken by BAJV on 9 November 2001)

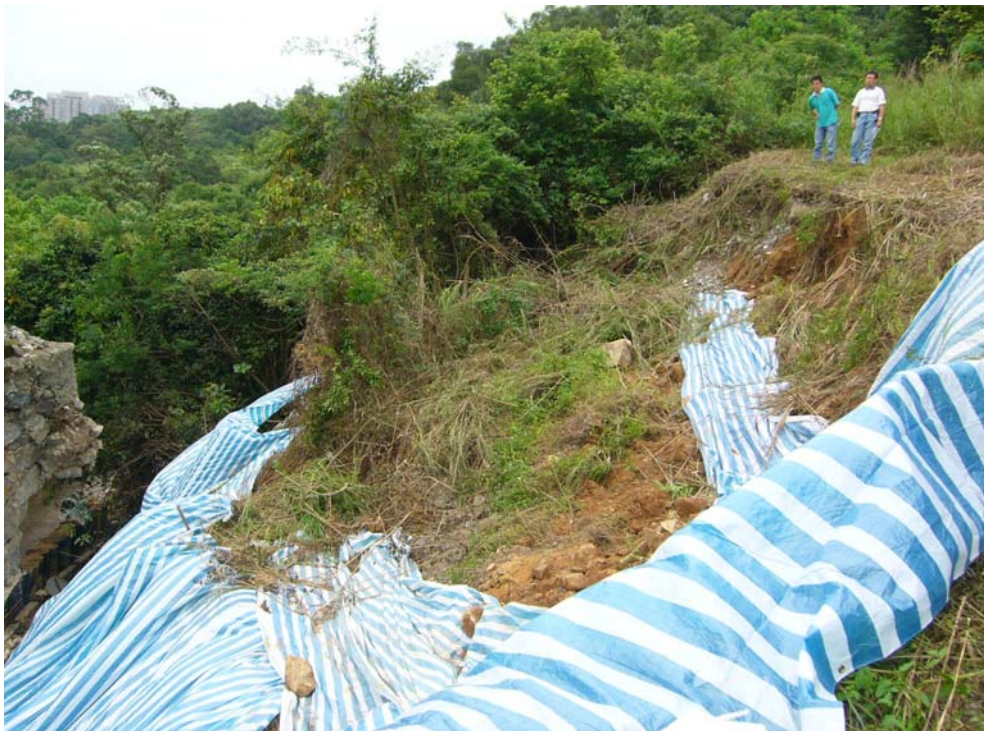
Plate 8 - View of the Main Scarp of the 2 June 2006 Landslide  
(Photograph taken on 7 June 2006)

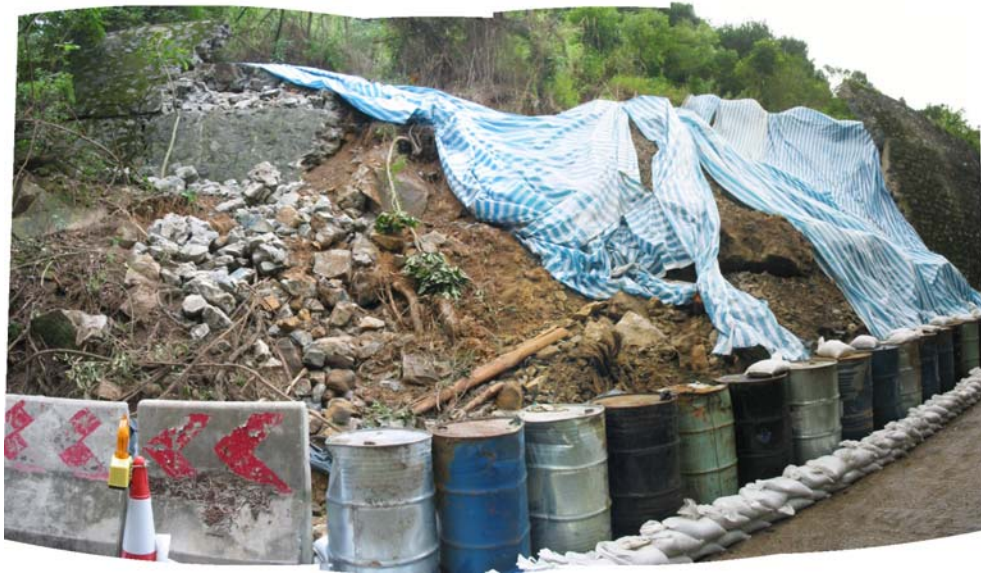
Large masonry wall fragments were found within the mid-height of the landslide debris with its original wall front facing downward (Plate 9). The slip surface was exposed at the toe of the 7.2 m high section, which suggests that the failure surface did not daylight at the point where the interface between fill and decomposed granite meets the wall back. However, without a detailed investigation, the sequence of failure, the failure mode and the precise profile of the failure surface are uncertain. The pattern of the landslide debris and relative position of the large wall fragment indicate that the landslide was neither an overall rotational failure nor an overall toppling failure of the masonry wall.

Plate 9 - View of the Landslide Debris and Masonry Wall Fragment  
(Photograph taken by Lands D on 5 June 2006)

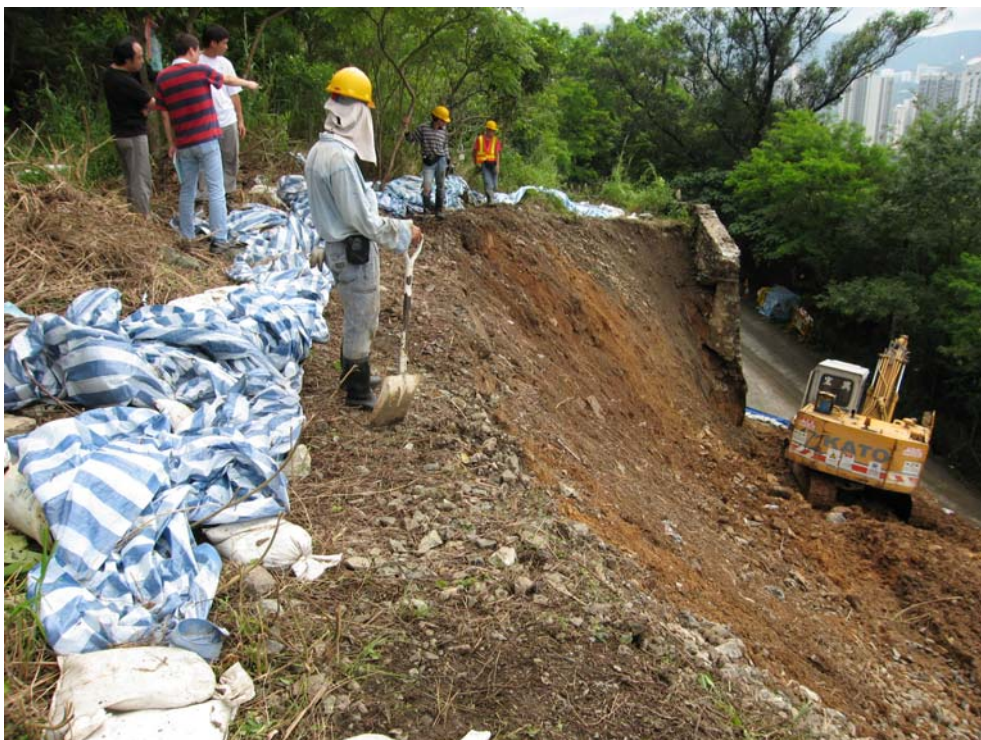
Plate 10 - View of the Exposed Wall Stem during the Urgent Repair Works  
(Photograph taken by Lands D on 13 June 2006)

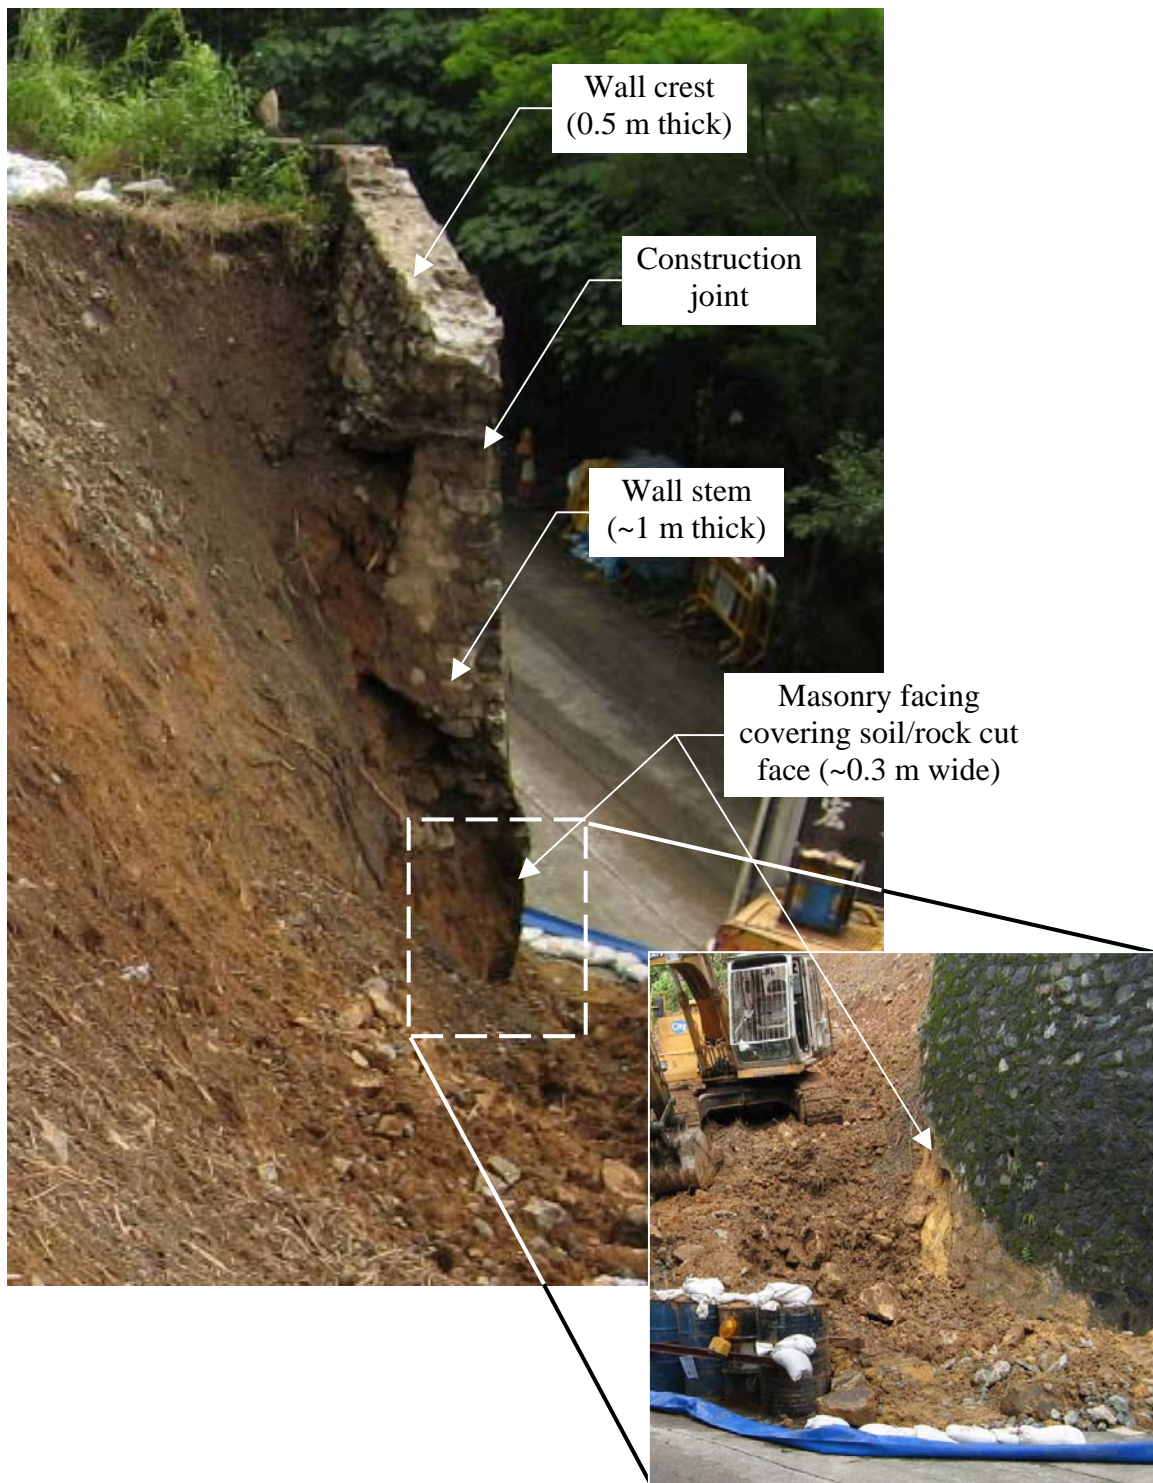
Plate 11 - Close-up View of the Exposed Wall Stem and Masonry Facing at Wall Toe  
(Photograph taken by Lands D on 13 June 2006)

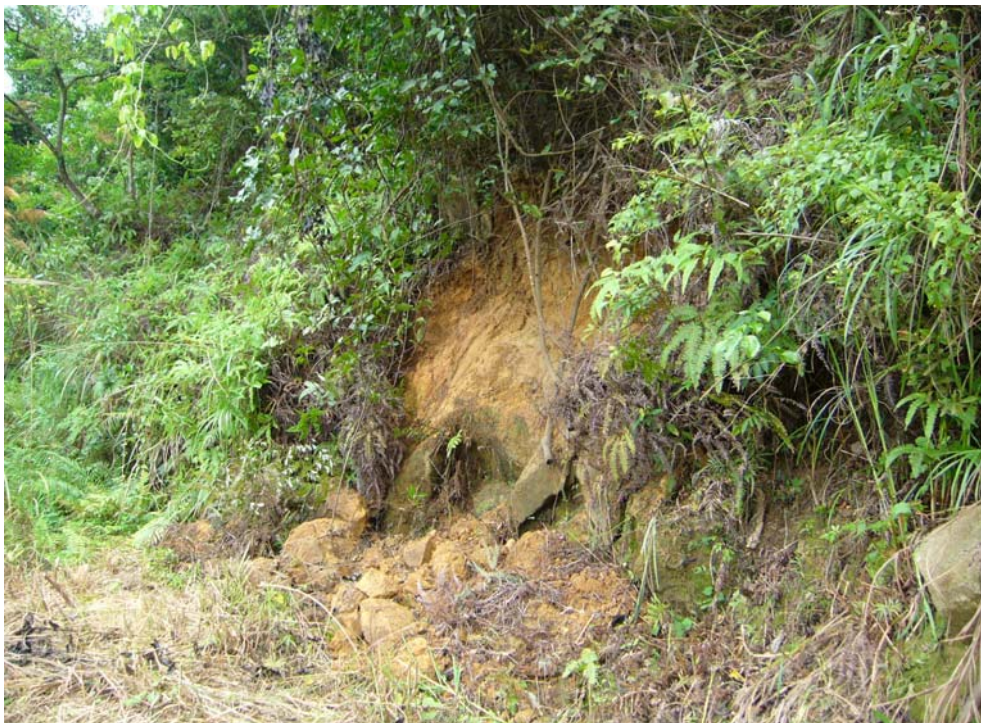
There were no obvious signs of distress on the unpaved platform above the June 2006 landslide. A minor landslide/erosion scar (about 1 m<sup>3</sup> in volume) was observed at the east end of slope No. 7NE-D/C178 (Plate 13) and another landslide scar (about 22 m wide, 10 m high with a maximum depth of 1 m and colluvium exposed in the main scarp) was exposed at the west end of the slope (Plate 14), following the vegetation clearance in September 2006. The larger landslide does not appear to be recent. It seems to be located at approximately the same location as the 1982 landslide identified by API (Figures 2 and 4). An approximately 8 m long, 1.4 m high counterfort wall is present at the middle portion of slope No. 7NE-D/C178 (Plate 15). The counterfort wall coincides with the location of the 1973 landslide identified by API, and was probably part of the remedial works that were carried out following that incident. Seepage was observed at the counterfort wall (Plate 15) on the afternoon of 13 June 2006, some 10 hours after a Red Rainstorm Warning. A 300 mm wide U channel is located at the toe of slope No. 7NE-D/C178 in front of the counterfort wall. The excavation on slope No. 7NE-D/C179 that was identified on the 1977 aerial photographs was clearly visible after vegetation clearance (Plate 5).

Plate 13 - Minor Landslide on Slope No. 7NE-D/C178  
(Photograph taken on 7 June 2006)

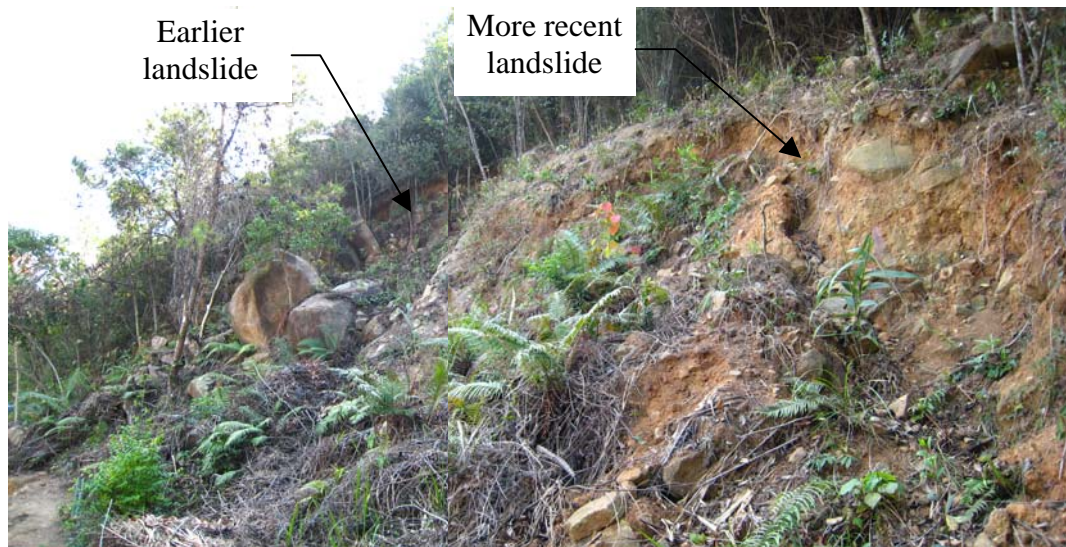
Plate 14 - Major Landslide on Slope No. 7NE-D/C178  
(Photograph taken on 7 February 2007)

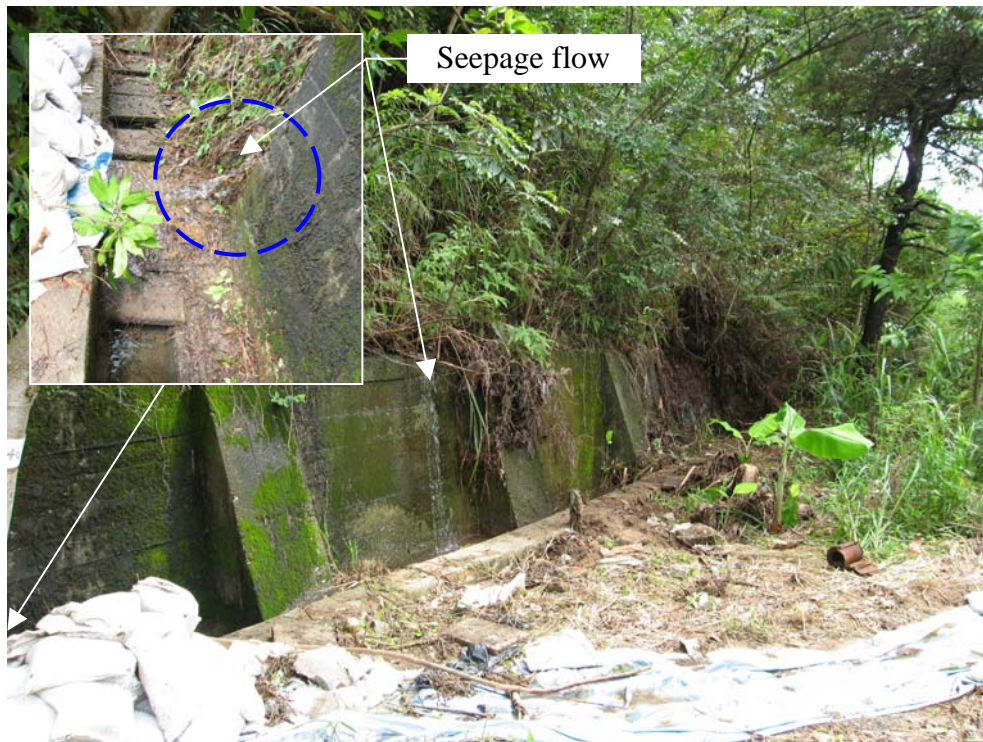
Plate 15 - Counterfort Wall on Slope No. 7NE-D/C178 with Active Seepage  
(Photograph taken by Lands D on 13 June 2006)

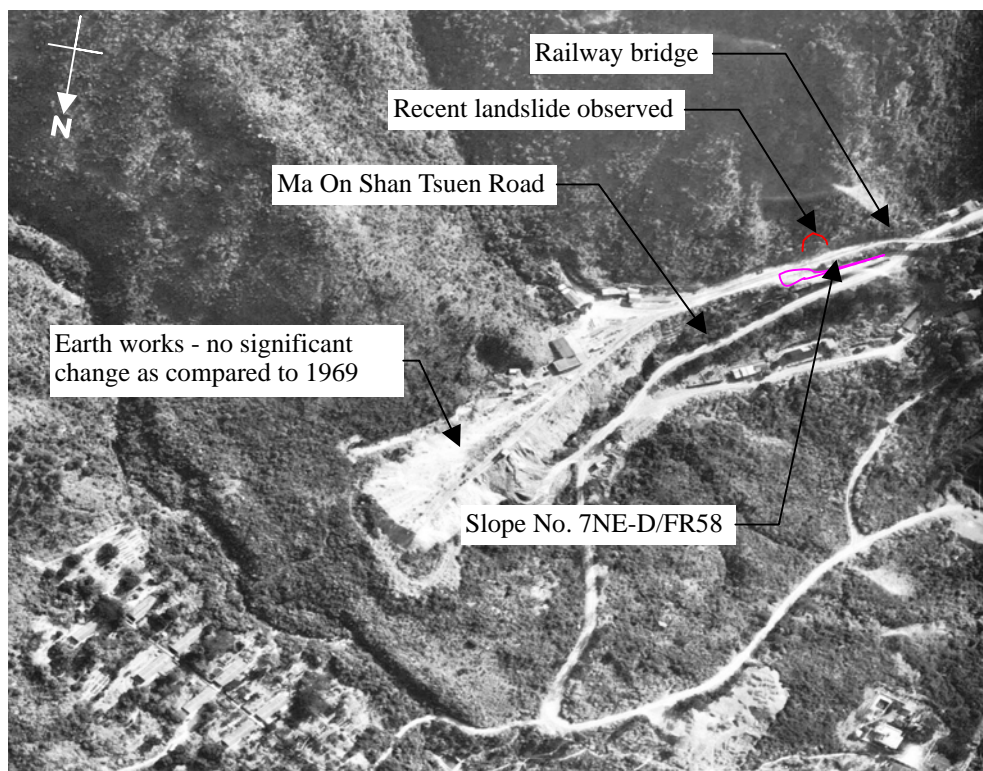
1973	A minor failure is observed on slope No. 7NE-D/C178. The debris is still visible and did not affect the railway track (Plate A5).
------	---

Plate A5 - Interpretation of 1973 Aerial Photograph No. 07275

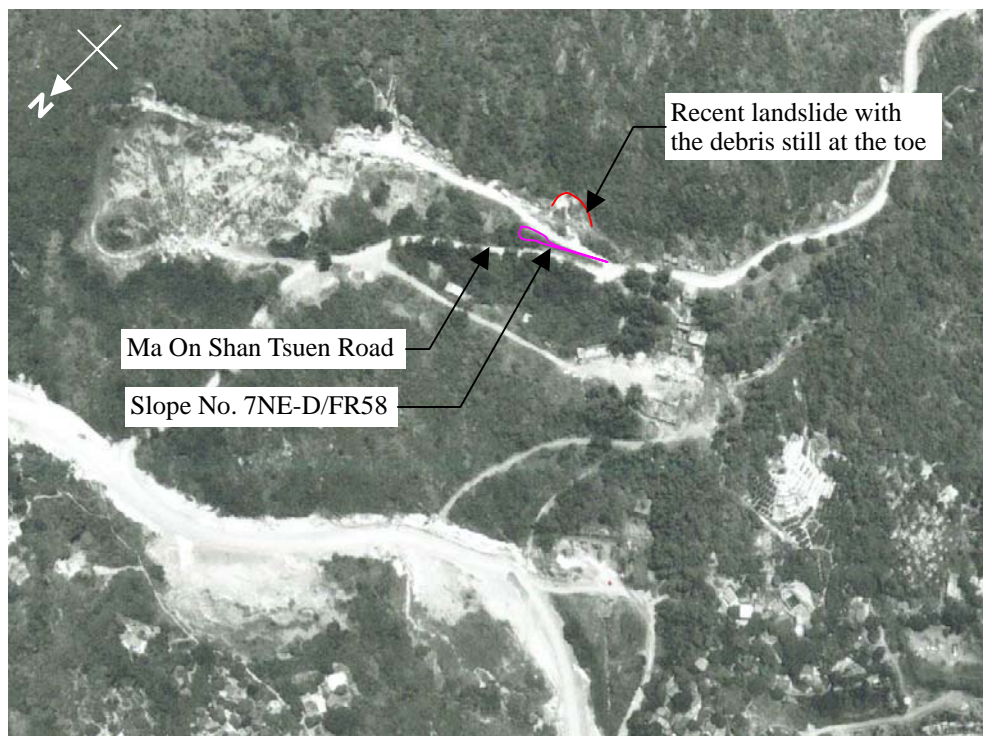
A recent landslide can be seen to have affected slope No. 7NE-D/C178. The position of the landslide and the extent of the associated failure debris can be clearly identified (Plate A8). The excavation at slope No. 7NE-D/C179 identified in 1977 is now generally covered by vegetation.

Plate A8 - Interpretation of 1982 Aerial Photograph No. 43229
