**REVIEW OF THE
9 JUNE 2006 AND
16 JULY 2006
WASHOUTS ON SLOPE
NO. 11NW-B/FR60 BEHIND
PHOENIX HOUSE,
LUNG CHEUNG ROAD**

GEO REPORT No. 238

Maunsell Geotechnical Services Limited

**GEOTECHNICAL ENGINEERING OFFICE
CIVIL ENGINEERING AND DEVELOPMENT DEPARTMENT
THE GOVERNMENT OF THE HONG KONG
SPECIAL ADMINISTRATIVE REGION**

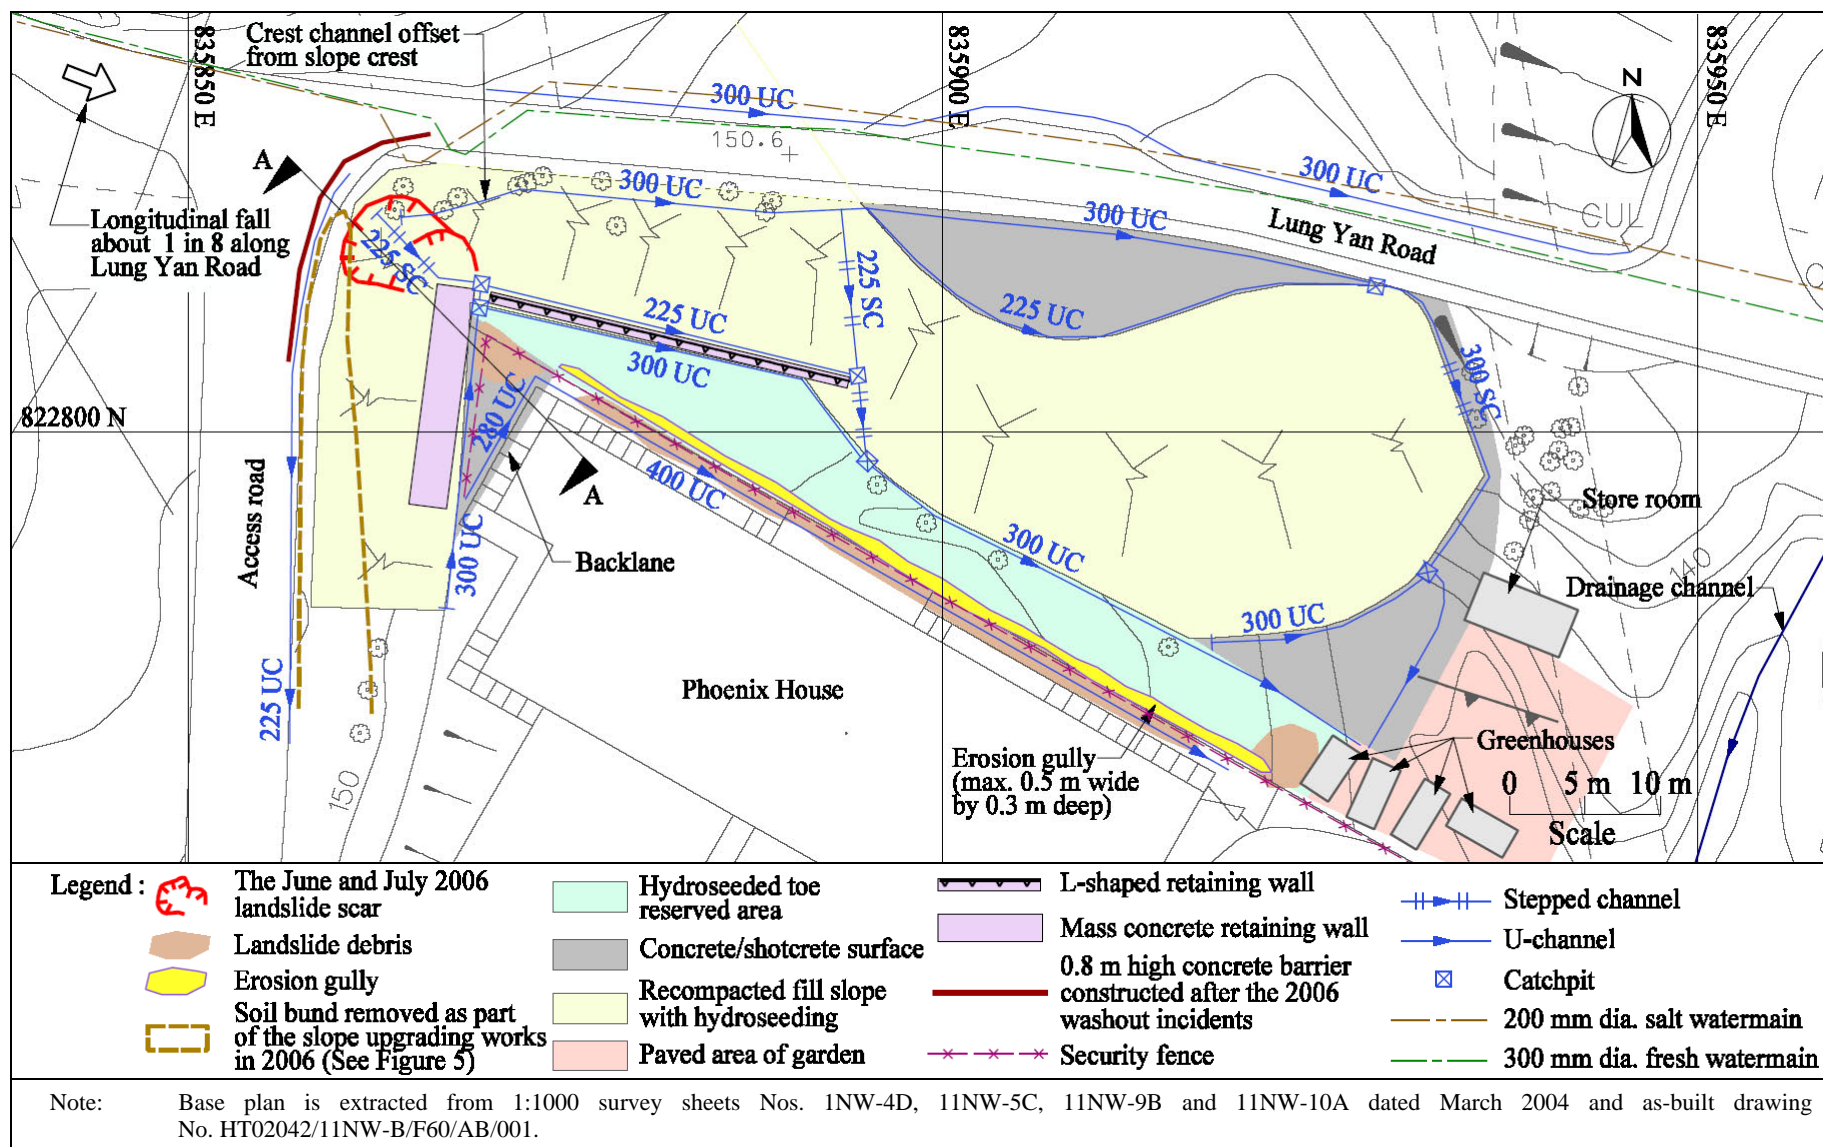
Figure 2 - Site Layout Plan and Field Observations

According to the records of the Arch SD and witnesses from CSD, both incidents were observed following the issue of Black Rainstorm Warnings on 9 June 2006 and 16 July 2006 respectively (Plates 1 and 2). The June and July 2006 incidents were reported by Arch SD to LPM Division 1 of the GEO on 24 July 2006 and 23 October 2006 respectively, as part of the quarterly updating of incidents attended to by the slope maintenance departments without the need for input from GEO's District Divisions. The landslide debris from both incidents was deposited on the shotcrete slope cover below the mass concrete wall (Plates 1 and 2) and along the toe channels to the north of the main building of Phoenix House (Plate 11). Debris from the July 2006 washout was also washed down to the garden area east of slope No. 11NW-B/FR60 (Figure 2 and Plate 12).

Based on record photographs from Arch SD and field observations by MGSL, the July 2006 washout has a similar extent as the June 2006 washout (Plates 1 and 2). A 50 m long erosion gully (maximum 0.5 m wide by 0.3 m deep) was noted along the toe of the fence (Figure 2, Plates 6 and 14). According to Arch SD's records, remedial works to the July 2006 washout comprised the removal of debris, backfilling the erosion scars with no-fines concrete (Plate 13) and the construction of an approximately 20 m long and 0.8 m high concrete dwarf wall above the erosion scar (Plate 4). The concrete dwarf wall was constructed between 22 and 24 July 2006. The erosion gully and the landslide scar were backfilled between 24 July 2006 and 8 August 2006.

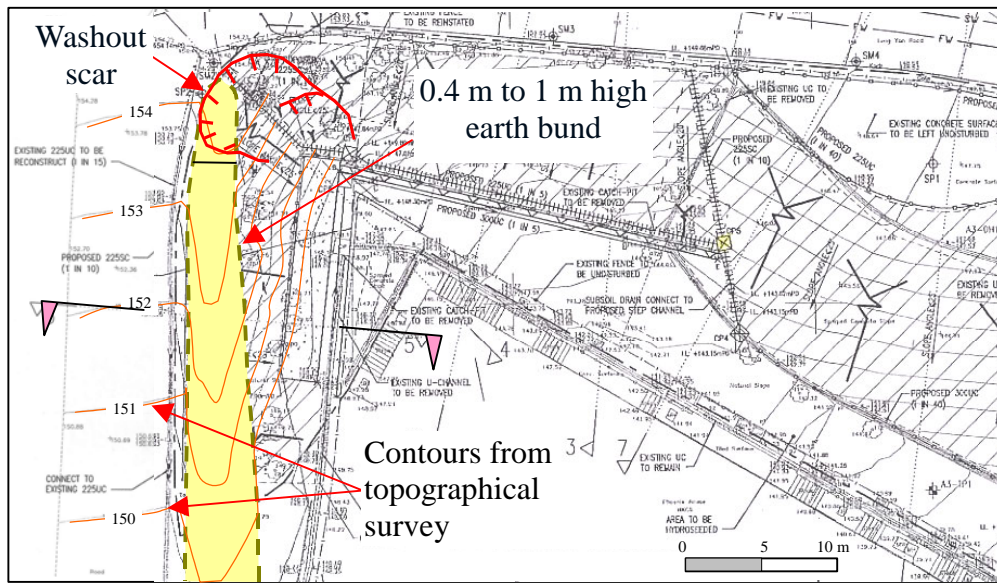
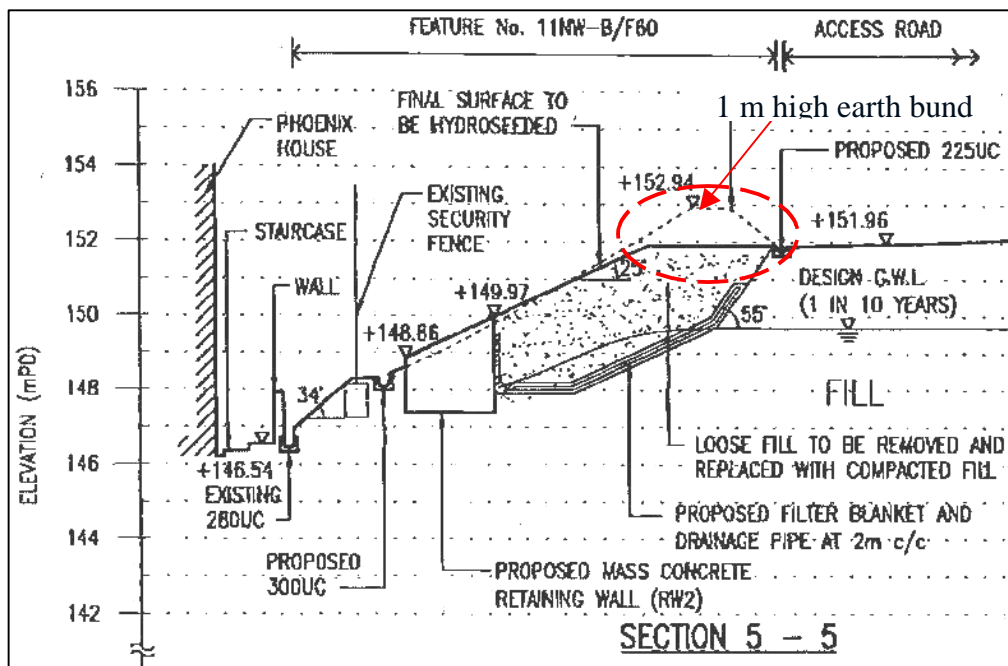
Figure 5 - Extent of the Earth Bund Prior to the Slope Upgrading Works in 2005

The drainage design only considered the catchment within the registered slope boundary and no drainage calculations for the design of the crest channel were provided. It was proposed that an earth bund (about 0.4 m to 1 m high) located along the crest of the western limb of the slope (above the washout location, see Figure 5) should be removed to allow for fill recompaction and that an existing 225 mm wide U-channel along the toe of the earth bund should be re-constructed. The potential impact on the surface drainage provisions as a result of removing this earth bund was not assessed in the design report.

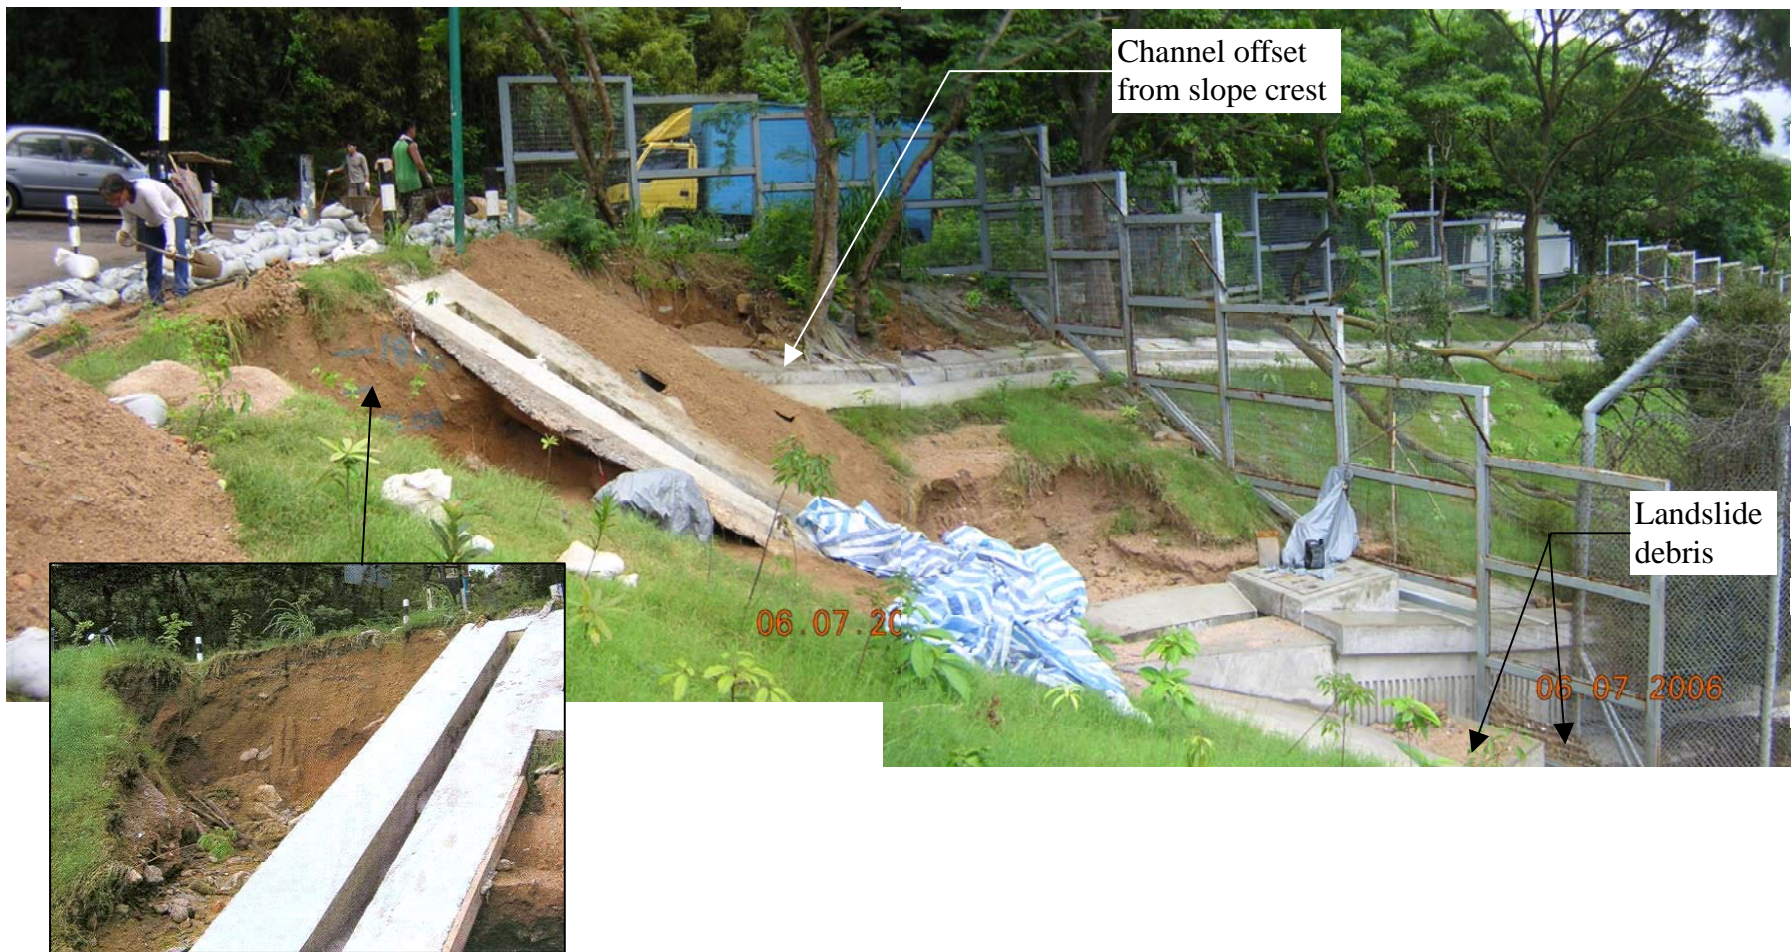
The first incident involved the washout of the fill material above a mass concrete wall near the northwest corner of slope No. 11NW-B/FR60 (Figure 2 and Plate 1). The landslide debris, with a volume of about 4 m³, was deposited on a shotcreted slope below the mass concrete wall. The second incident involved the washout of the recompacted fill which was placed in early July 2006 as remedial works to the June 2006 washout, together with erosion at the slope toe along the northern boundary of Phoenix House (Figure 2 and Plate 2). The landslide debris, with a volume of about 8 m³, was deposited on the shotcreted slope below the mass concrete wall and partly washed down onto a garden to the east of the slope.

The landslide debris had been removed at the time of inspection and the landslide scar was backfilled with no-fines concrete in early August 2006 (Plate 13). Based on record photographs from Arch SD, the June 2006 washout scar was about 10 m long by 6 m wide. The depth of scar is estimated to be about 1 m to 1.5 m to the southwest of the stepped channel which was undermined, and less than 0.5 m to the northeast of the stepped channel (Figure 6 and Plate 1).

Plate 1 - General View of the 9 June 2006 Washout Incident on Slope No. 11NW-B/FR60
(Photograph taken by Arch SD on 6 July 2006)

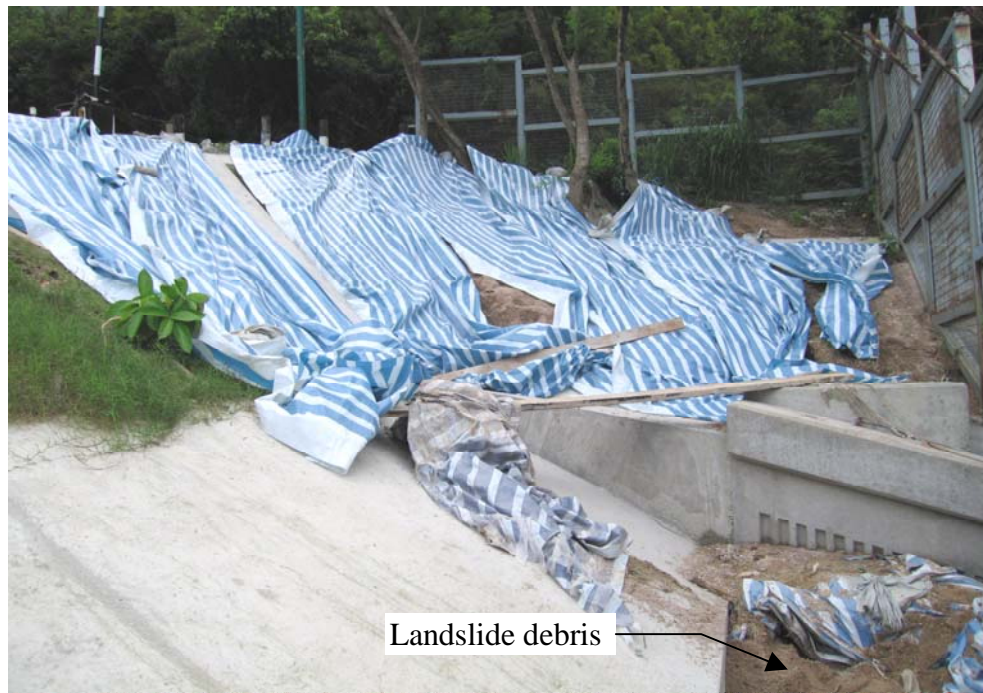
Plate 2 - General View of the 16 July 2006 Washout Incident on Slope No. 11NW-B/FR60
(Photograph taken by Arch SD on 19 July 2006)

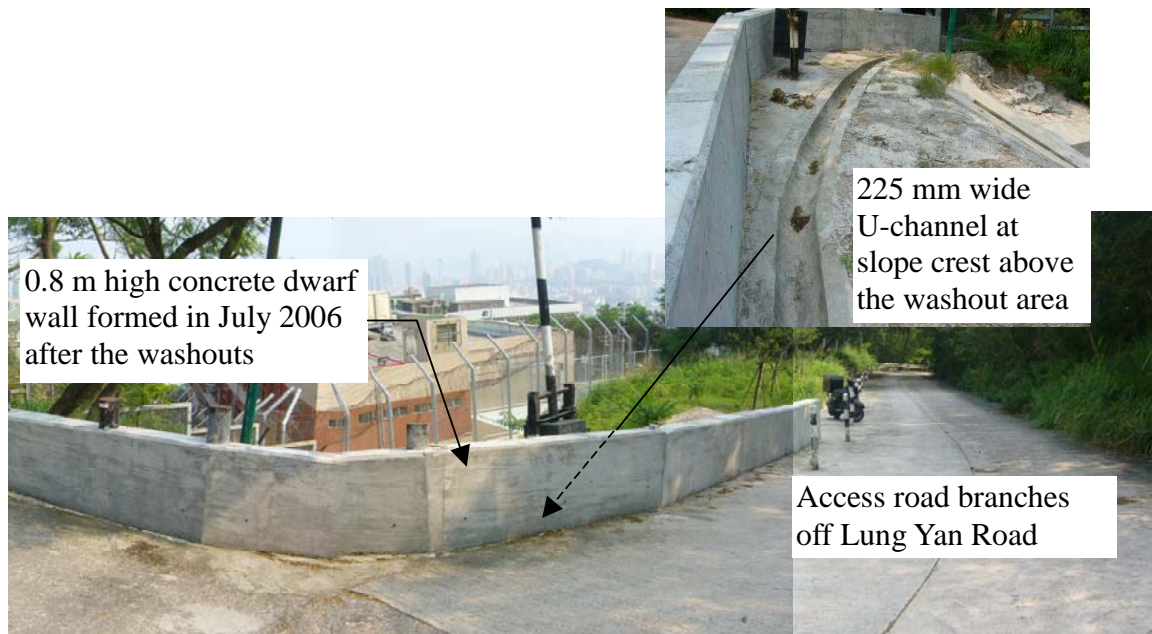
Plate 4 - View of Access Road to the West of Slope No. 11NW-B/FR60 and Concrete Dwarf Wall Constructed after the July 2006 Washout Incident (Photograph taken on 20 September 2006)

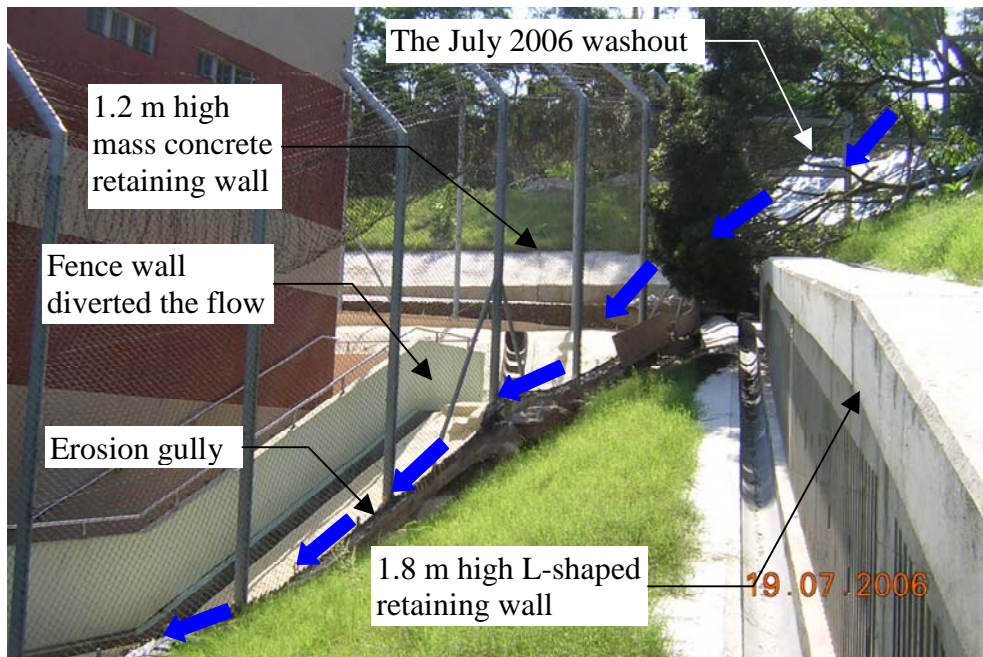
During heavy rainfall, significant surface runoff from the streamcourse on the hillsides above (with a fairly substantial catchment area of about 15,000 m²) drains to the culvert inlet at the east end of slope No. 11NW-B/C506 and overtopping from the culvert inlet is likely to occur due to significant blockage of the outlet of the cross-road culvert by the water pipes. The overflow from the culvert inlet probably runs along Lung Yan Road where there is no surface drainage system to intercept the overland flow. As a result, the uncontrolled and concentrated flow of surface water down the road overtopping the crest of slope No. 11NW-B/FR60 probably caused the washout failures.

Plate 6 - View of the L-shaped and the Mass Concrete Retaining Walls and Inferred Flow Path of Surface Water during the Washout Incidents (Photograph taken by Arch SD on 19 July 2006)

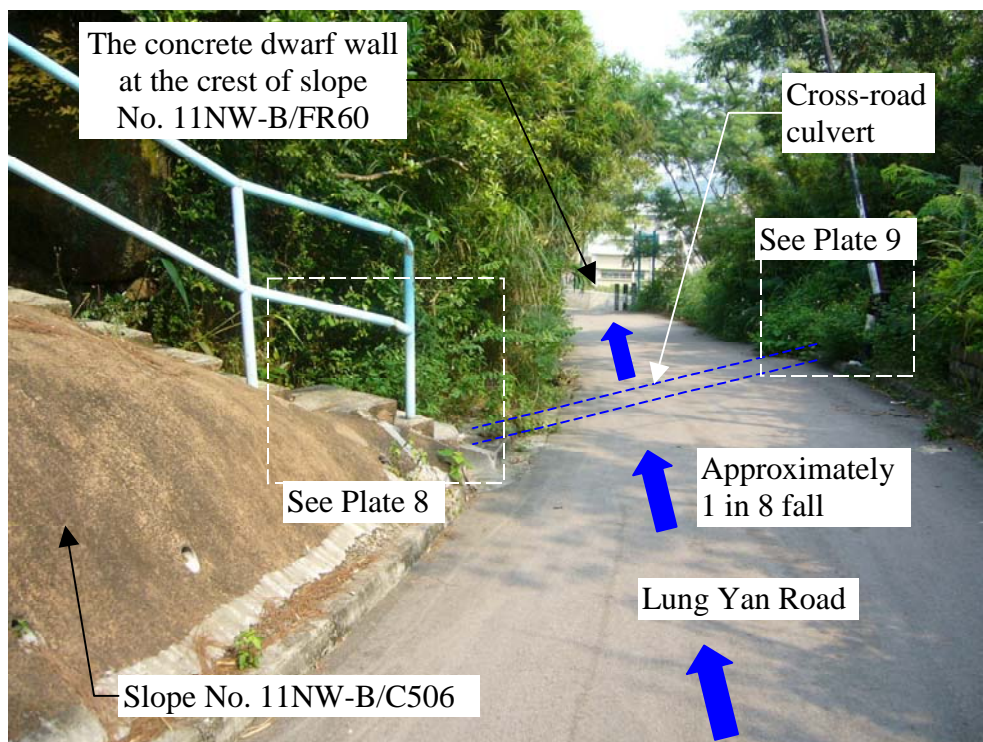
The section of Lung Yan Road uphill of slope No. 11NW-B/FR60 has a longitudinal fall of about 1 in 8 towards the northwest corner of the slope (Plate 7). An ephemeral streamcourse (with a catchment area of about 15,000 m²) is intercepted by Lung Yan Road near the east end of slope No. 11NW-B/C506 (Figure 1). The stormwater discharges through a cross-road culvert with an inlet of about 0.7 m deep by 0.6 m wide (Plate 8). Three water pipes (about 200 mm to 300 mm in diameter) traverse the outlet of the culvert, which reduced the effective opening of the outlet to about 0.2 m deep by 0.4 m wide (Plate 9). Downstream of the culvert, the stormwater flows along a short section of 600 mm wide surface channel to the south of Lung Yan Road (Figure 1) and discharges onto an unlined shallow channel, which disperses on the hillside to the west of the access road.

Plate 7 - View of Lung Yan Road Running towards Erosion Scar at the Northwest Corner of Slope No. 11NW-B/FR60 (Photograph taken on 20 September 2006)

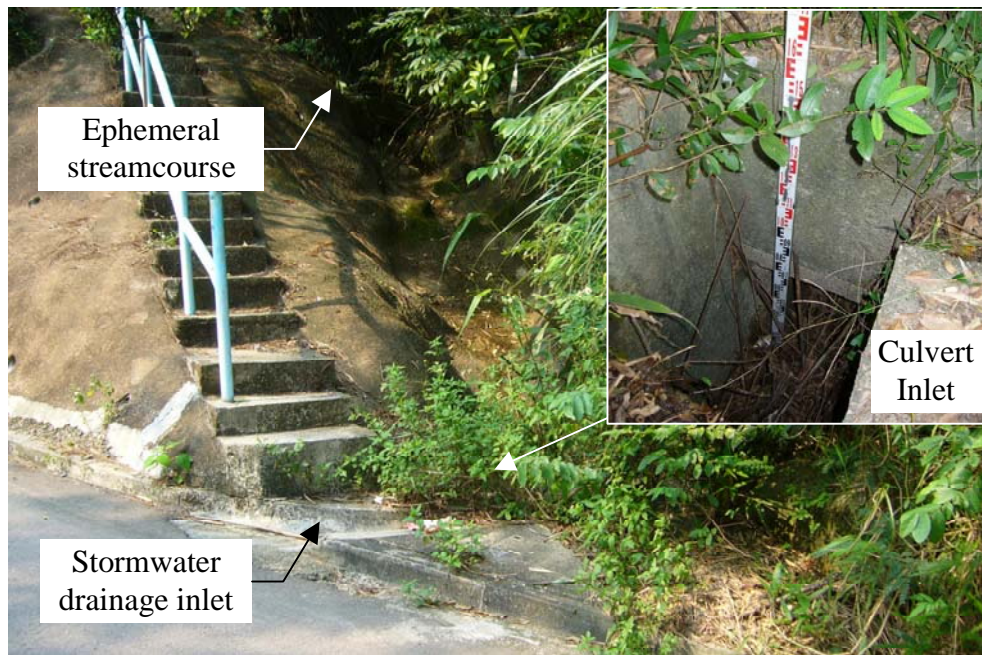
Apart from a stormwater drainage inlet to the cross-road culvert at the east end of slope No. 11NW-B/C506 (Plate 8), there is no road drainage system along a 200 m long stretch of Lung Yan Road to the west of slope No. 11NE-B/FR60. The road has a longitudinal fall of about 1 in 8 towards the crest of the washout area (Figure 1 and Plate 7). No blockage of the culvert inlet was observed at the time of inspection in August 2006. However, the outlet of the cross-road culvert is substantially blocked by the water pipes and silting was observed at the invert of the outlet (see Section 2 and Plate 9).

Plate 8 - View of the Ephemeral Streamcourse at East End of Slope No. 11NW-B/C506 and the Drainage Inlet of the Cross-road Culvert (Photograph taken on 20 September 2006)

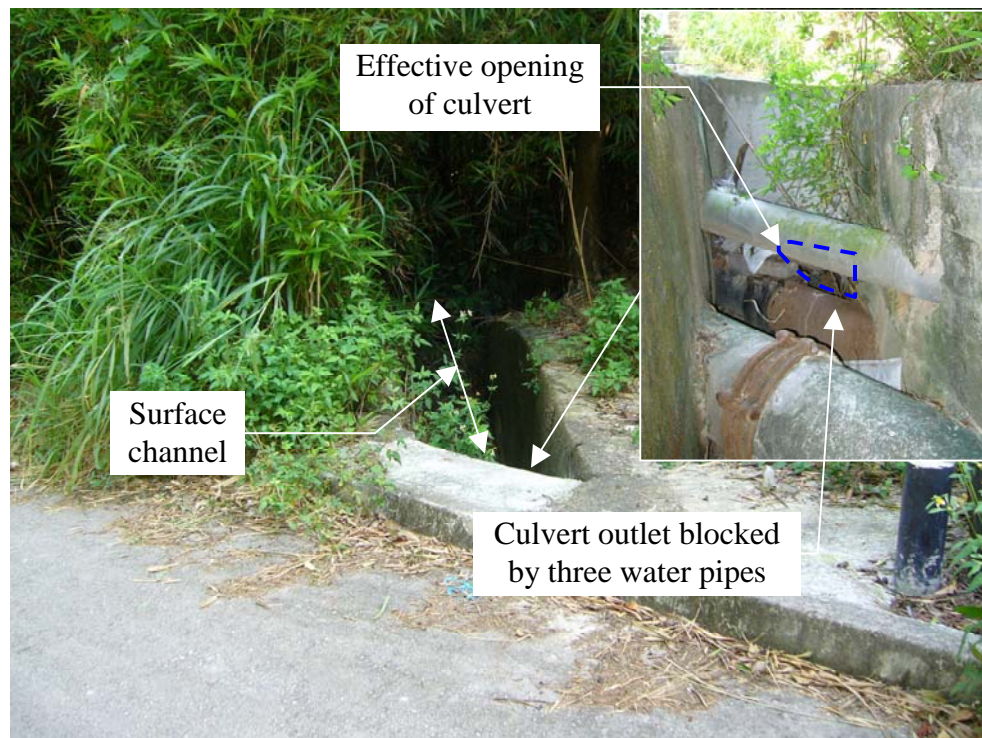
Plate 9 - View of the Surface Channel and the Outlet of the Cross-road Culvert (Photograph taken on 9 October 2007)

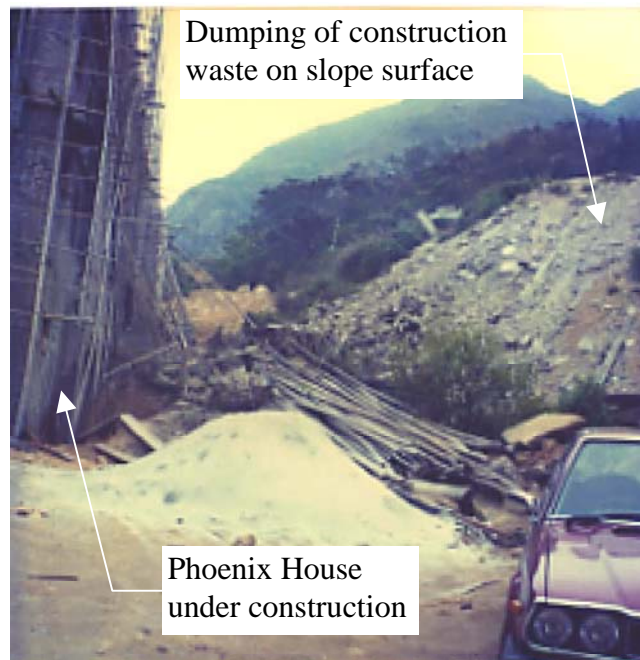
In a memorandum to GCO dated 25 March 1982, AO requested GCO to consider the removal of "illegal dumping" on "Crown Land immediately adjacent to the above site boundary" that would "endanger" the Phoenix House development. On 7 April 1982, Chief Geotechnical Engineer/Public Buildings of the Building Development Department replied that it was unlikely that GCO would be able to carry out any works to slope No. 11NW-B/FR60 before the due date for completion of Phoenix House development in April 1983 and recommended AO to study the slope and carry out any preventive works to the slope if found necessary for the development. On 28 September 1982, SWKP visited the site and noted that additional construction waste was dumped on the slope since their last inspection in October 1980. The distance between the slope toe and the building was reduced to 6 m (Plate 10). In April 1984, AO requested a jurisdiction from Landslips and Rainstorm Damage Committee of the Lands D on the responsibility to remove the construction waste. On 28 May 1984, the Mainland East (ME) Division of GCO, in response to the request by the Director of Lands, reviewed the threat posed by the dumped materials and suggested that partial removal of the illegally dumped materials to an angle of no more than 30°, provision of drains and paving, and installation of a chain-link fence at the slope crest could minimise the threat to Phoenix House. In a memorandum to Lands D dated 28 February 1985, ME Division confirmed that "no further geotechnical assessment is required" as the works are "only partial removal of fill to minimise the threat to existing buildings." A 3 m wide planting area at the slope toe as a buffer zone to further minimise the risk was also recommended by the ME Division of GEO.

Plate 10 - View of the Illegal Dumping of Construction Waste on Slope No. 11NW-B/FR60 in 1982
(Photograph taken by GCO in 1982)

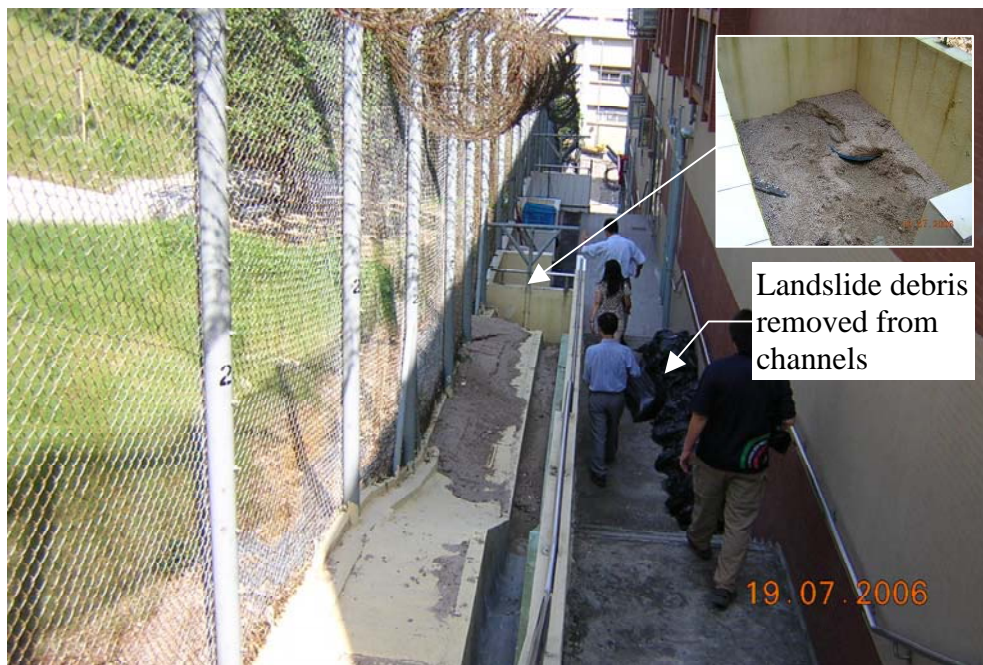
Plate 11 - Landslide Debris Deposited along the Toe Channels of Slope No. 11NW-B/FR60
(Photograph taken by Arch SD on 19 July 2006)

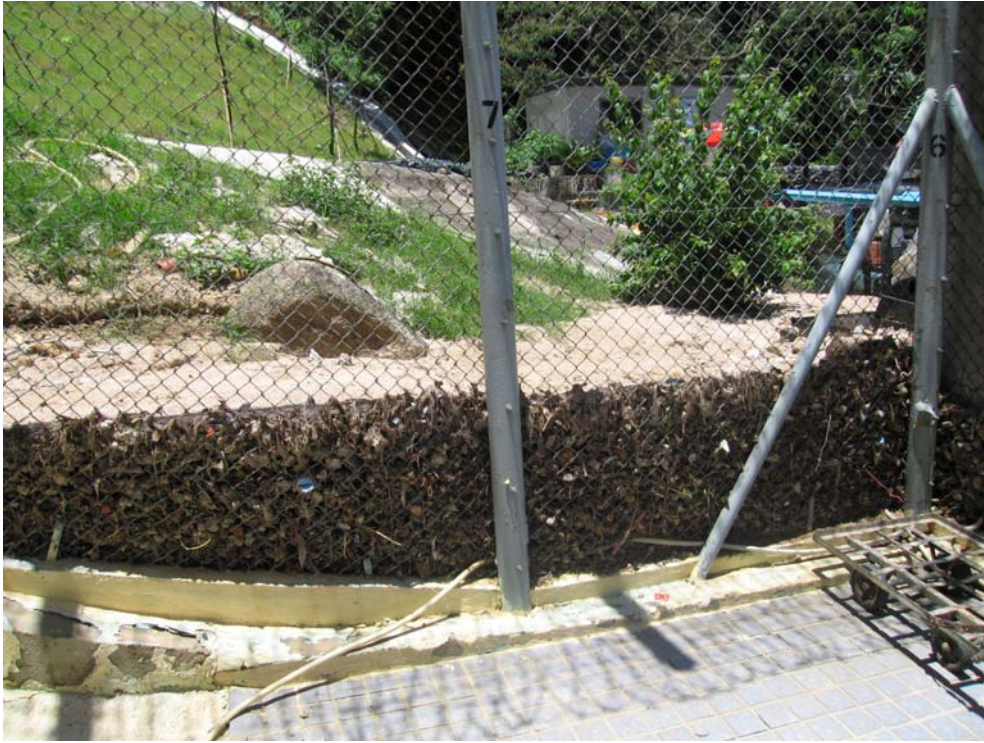
Plate 12 - Landslide Debris Deposited near the Garden to the East of Slope No. 11NW-B/FR60
(Photograph taken by Arch SD on 20 July 2006)

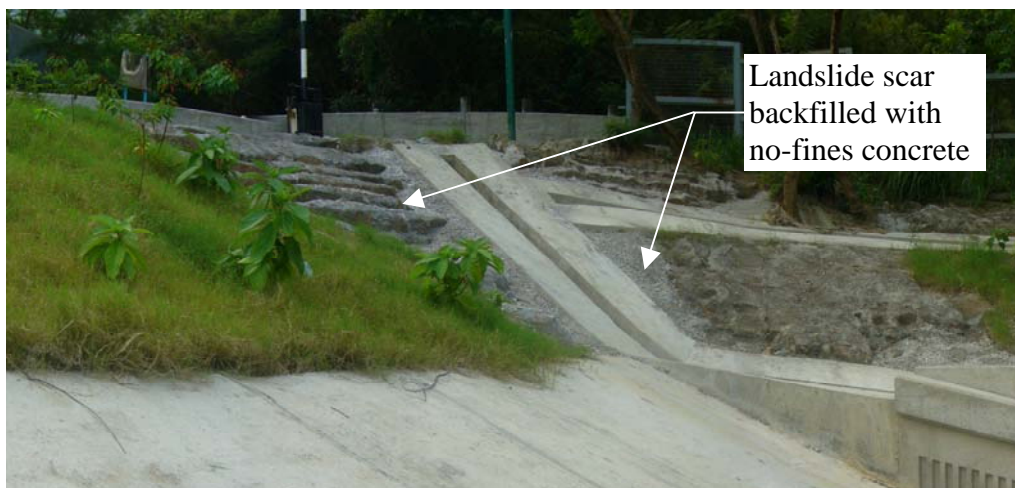
Plate 13 - Urgent Repair Works for the July 2006 Washout
(Photograph taken on 18 August 2006)

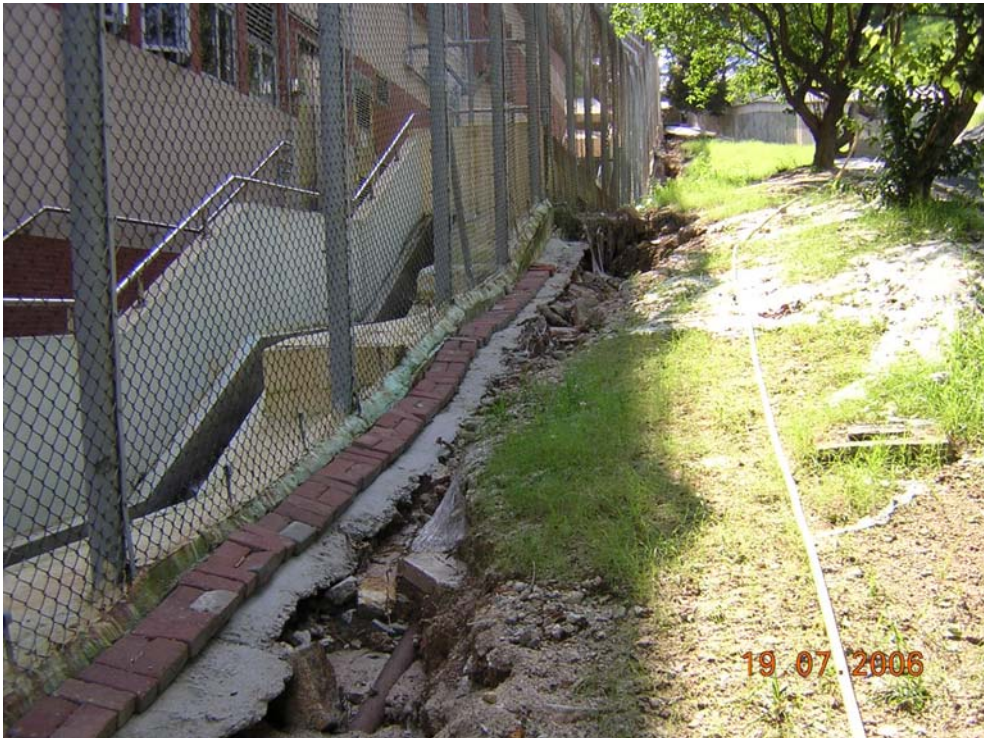
Plate 14 - Erosion Gully along the Toe of Slope No. 11NW-B/FR60
(Photograph taken by Arch SD on 19 July 2006)
