**DETAILED STUDY OF
THE 22 AUGUST 2005
LANDSLIDE AND
DISTRESS ON THE
NATURAL HILLSIDE
AT KWUN YAM SHAN,
BELOW TATE'S RIDGE**

GEO REPORT No. 239

Maunsell Geotechnical Services Limited

**GEOTECHNICAL ENGINEERING OFFICE
CIVIL ENGINEERING AND DEVELOPMENT DEPARTMENT
THE GOVERNMENT OF THE HONG KONG
SPECIAL ADMINISTRATIVE REGION**

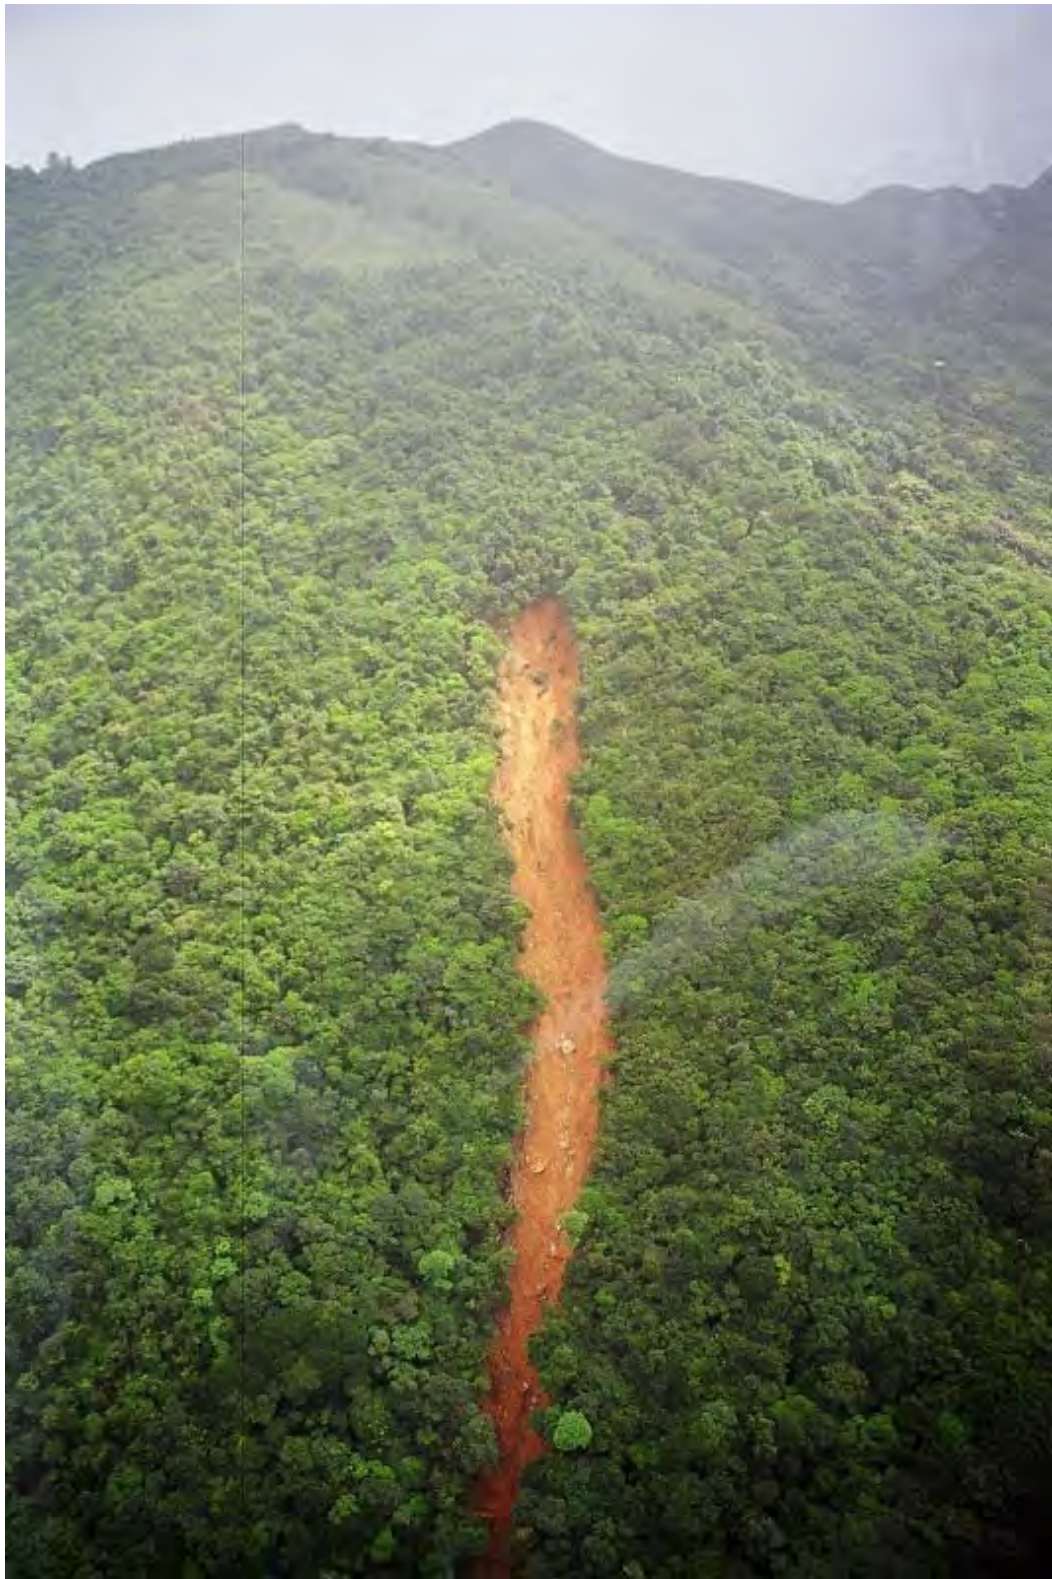
Plate 1 - Oblique Aerial View of the August 2005 Landslide
(Photograph taken on 28 August 2005)

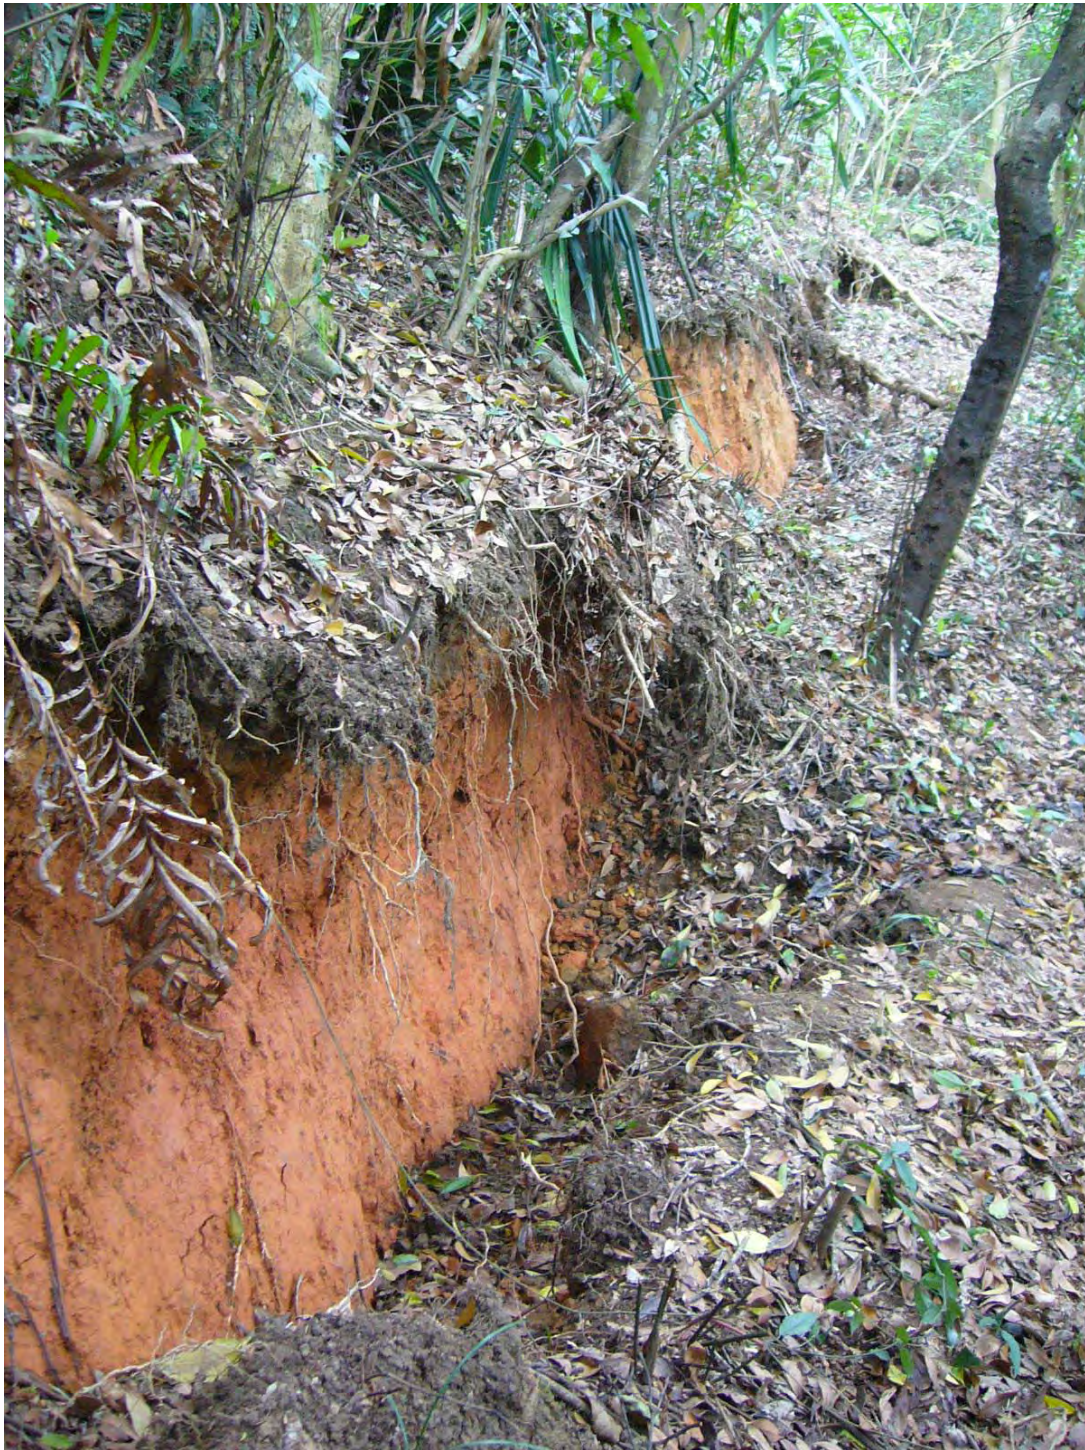
Plate 3 - Central Part of the Eastern Flank of the Main Scarp within the Distressed Hillside (Photograph taken on 8 March 2006)

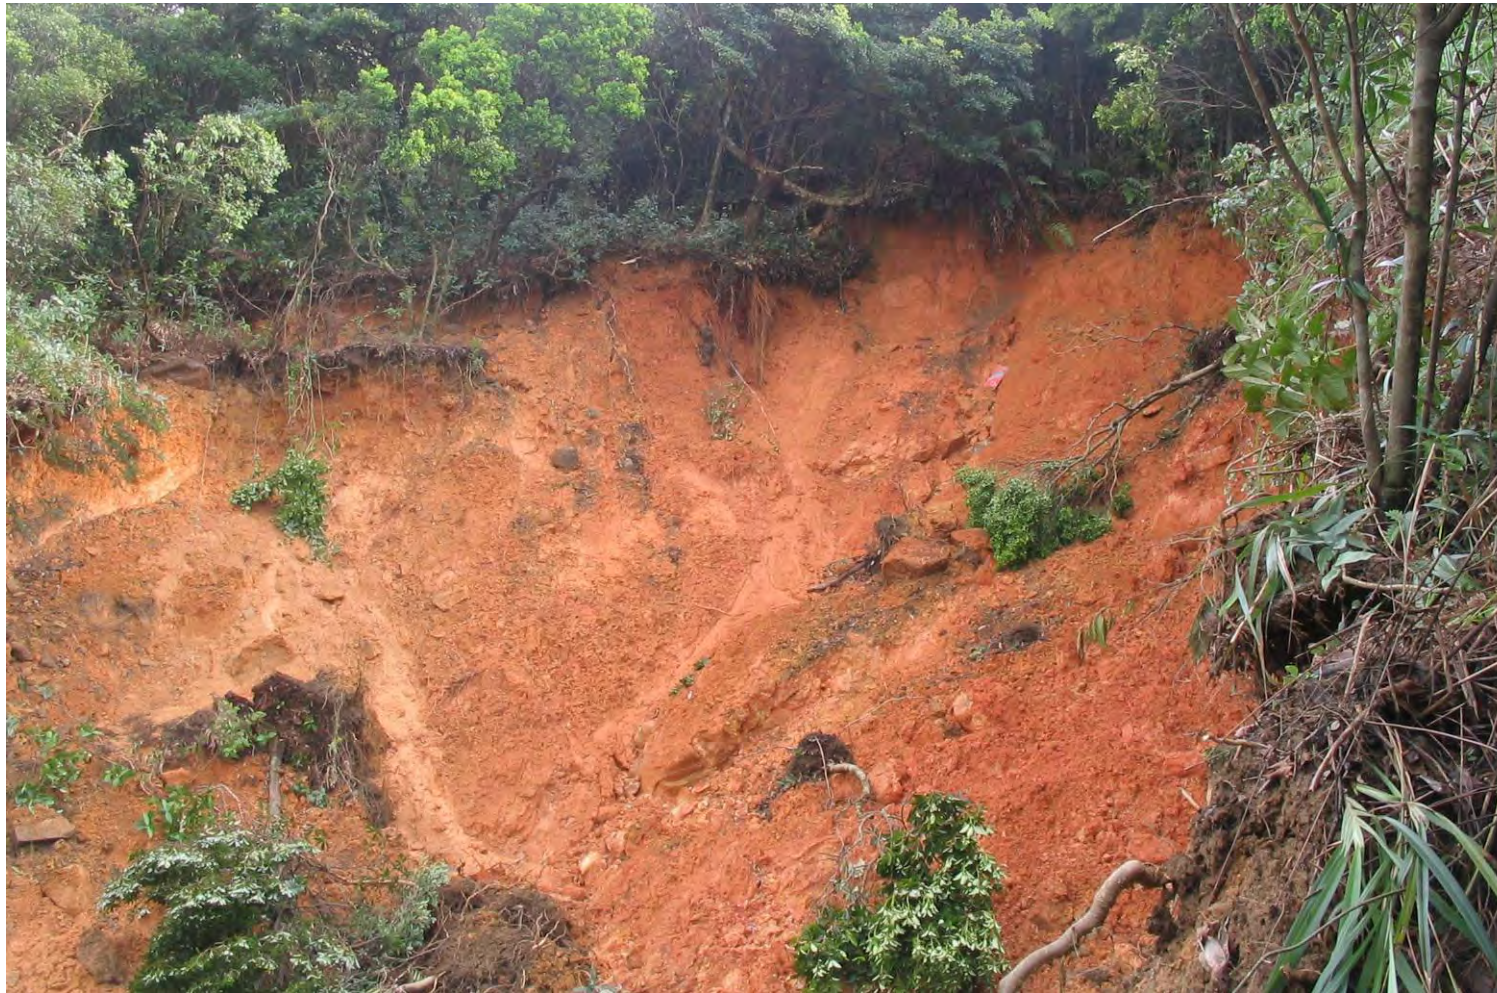
Plate 6 - General View of Main Scarp of the August 2005 Landslide
(Photograph taken on 24 August 2005)

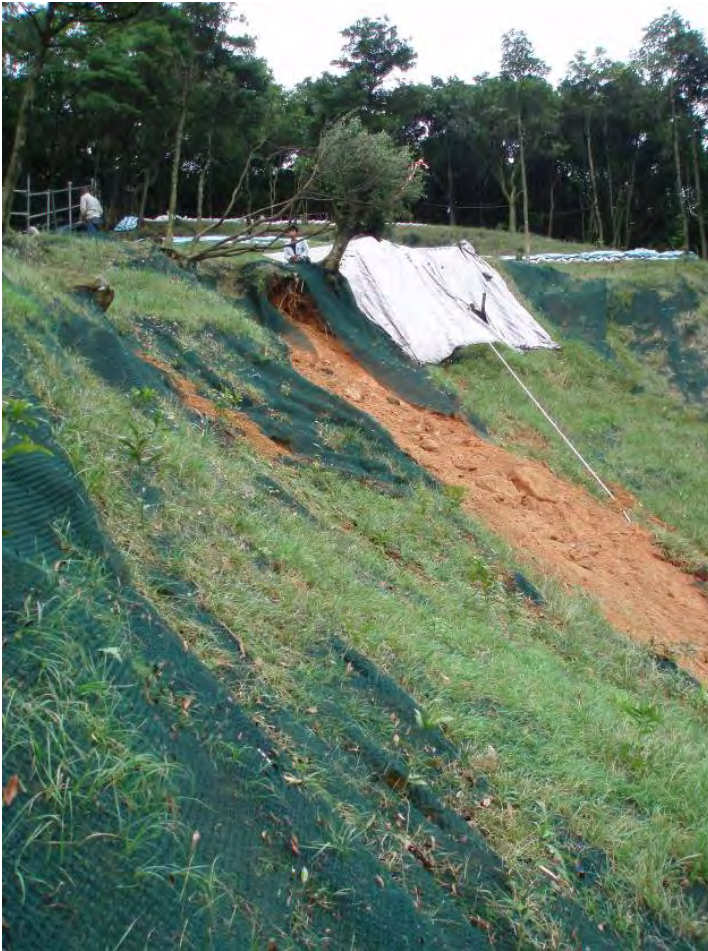
Plate 7 - Displaced Mass below Stepped Tension Cracks on Eastern Flank of the August 2005 Landslide Source (Photograph taken on 5 June 2006)

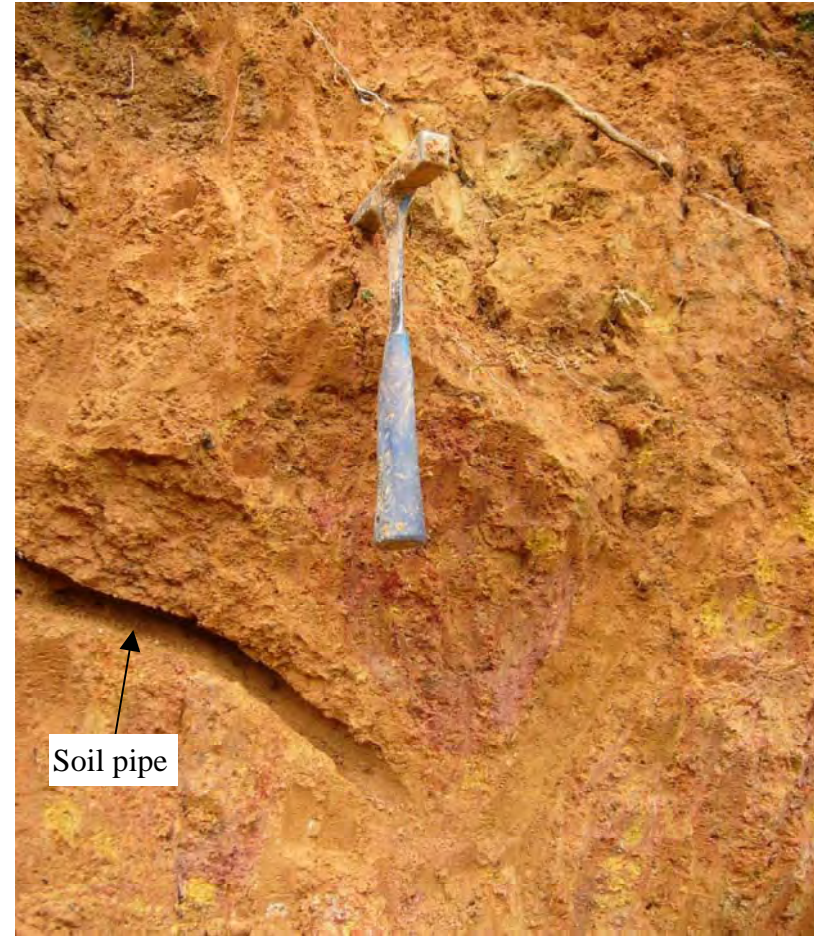
Plate 8 - Old Colluvium Exposed in the Western Flank of the August 2005 Landslide (Photograph taken on 14 March 2006)

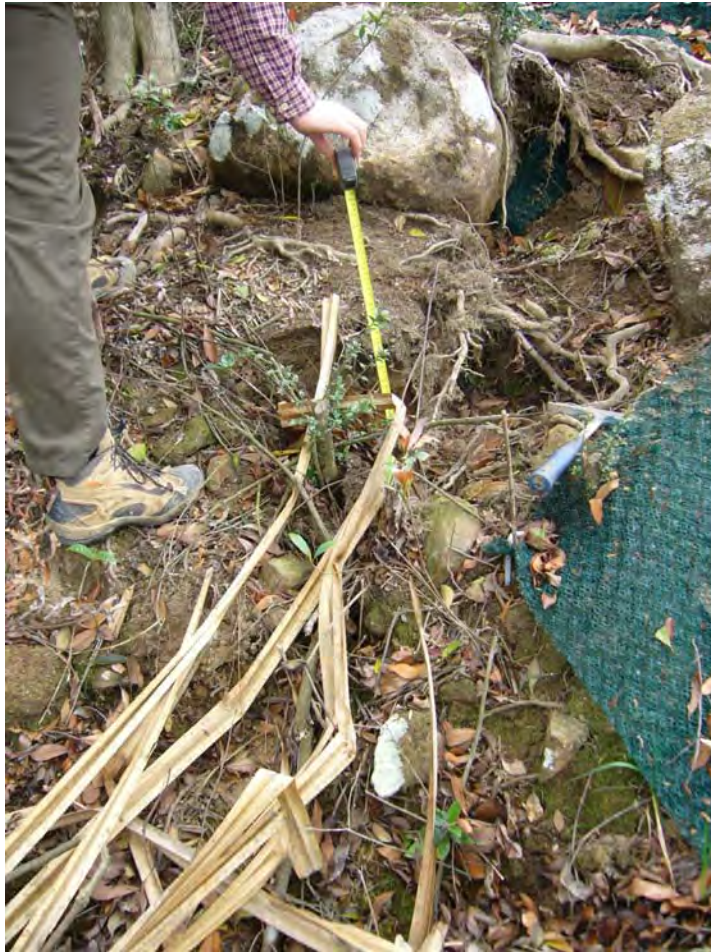
The eastern flank of the landslide scar exhibits lateral tension cracks (Plates 9 and 10) that extend towards the westernmost of the two large erosion gully features.

Plate 9 - Lateral Tension Crack Immediately West of
the August 2005 Landslide
(Photograph taken on 10 March 2006)

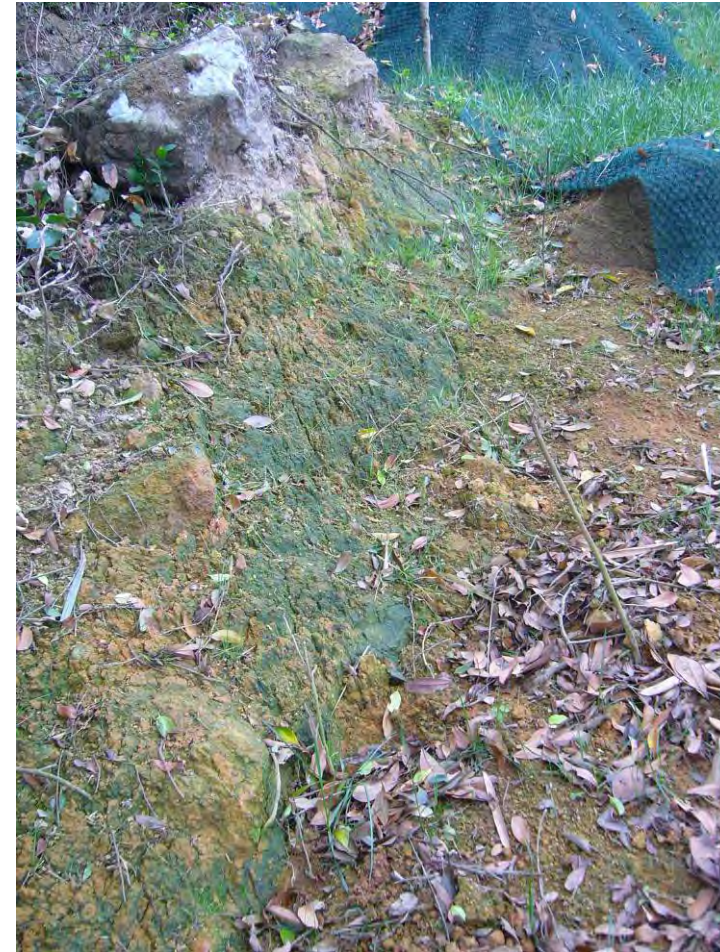
Plate 10 - Upslope Extension of the Lateral Tension Crack Immediately
West of the August 2005 Landslide above the Main Scarp
(Photograph taken on 10 March 2006)

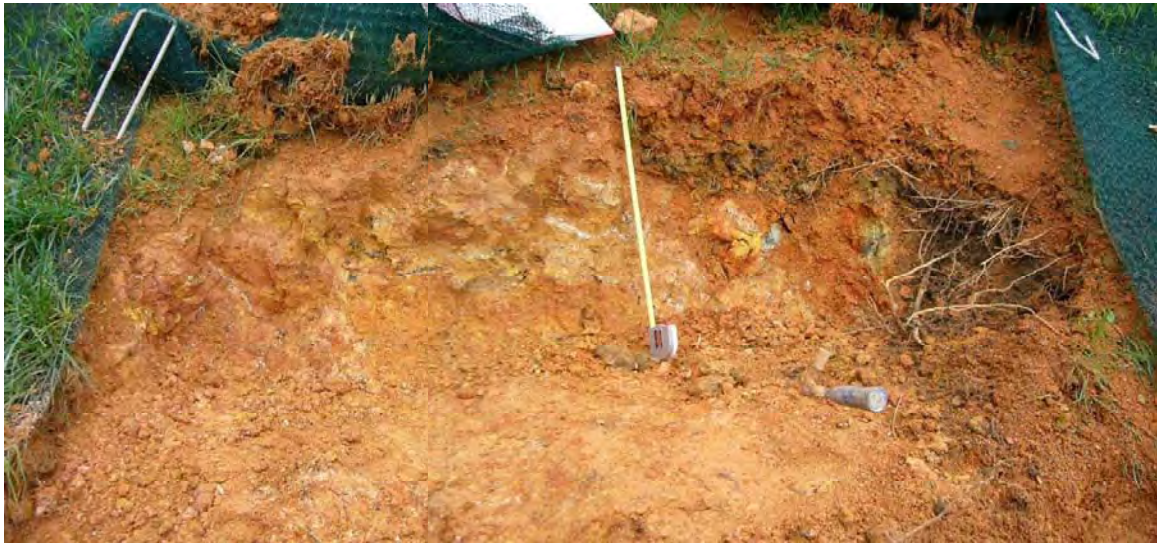
The surface of rupture appears to have been primarily along the colluvium/saprolite interface with the deepest part of the landslide passing through the upper CDT that contains several thin kaolin veins (Drawing No. 1 and Plate 11).

Plate 11 - Completely Decomposed Tuff with Kaolin Veins
Exposed in the Base of the August 2005 Landslide
(Photograph taken on 14 March 2006)

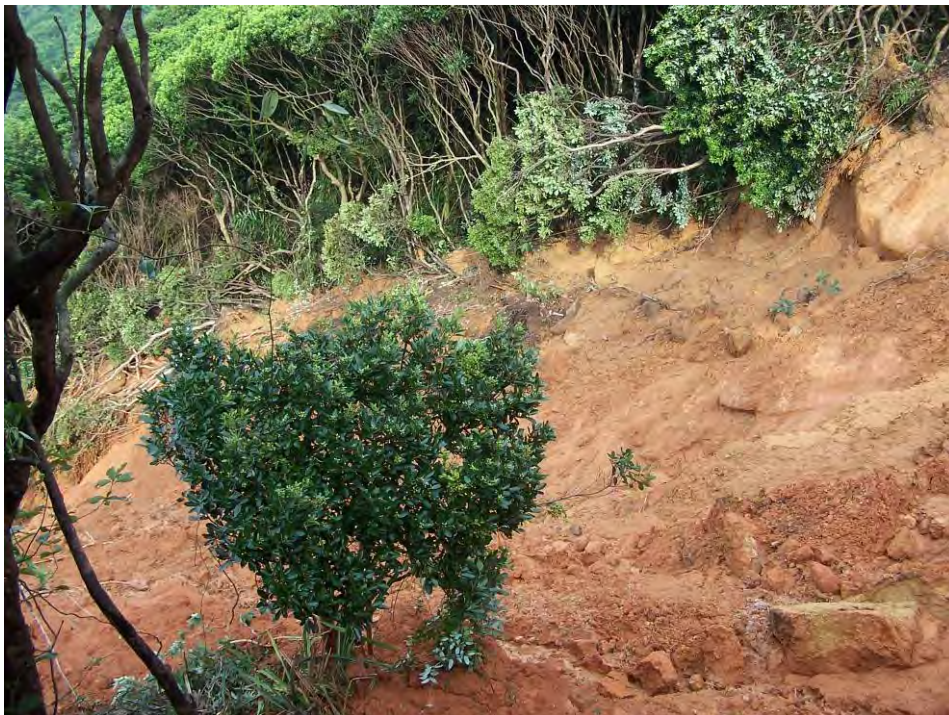
Several trees alongside the trail were observed to have been toppled by the debris with several noted to have been displaced and many were likely to have been entrained together with the debris (Plates 12 and 14).

Plate 14 - Debris Trail below the Toe of Rupture of the August 2005 Landslide
(Photograph taken on 24 August 2005)

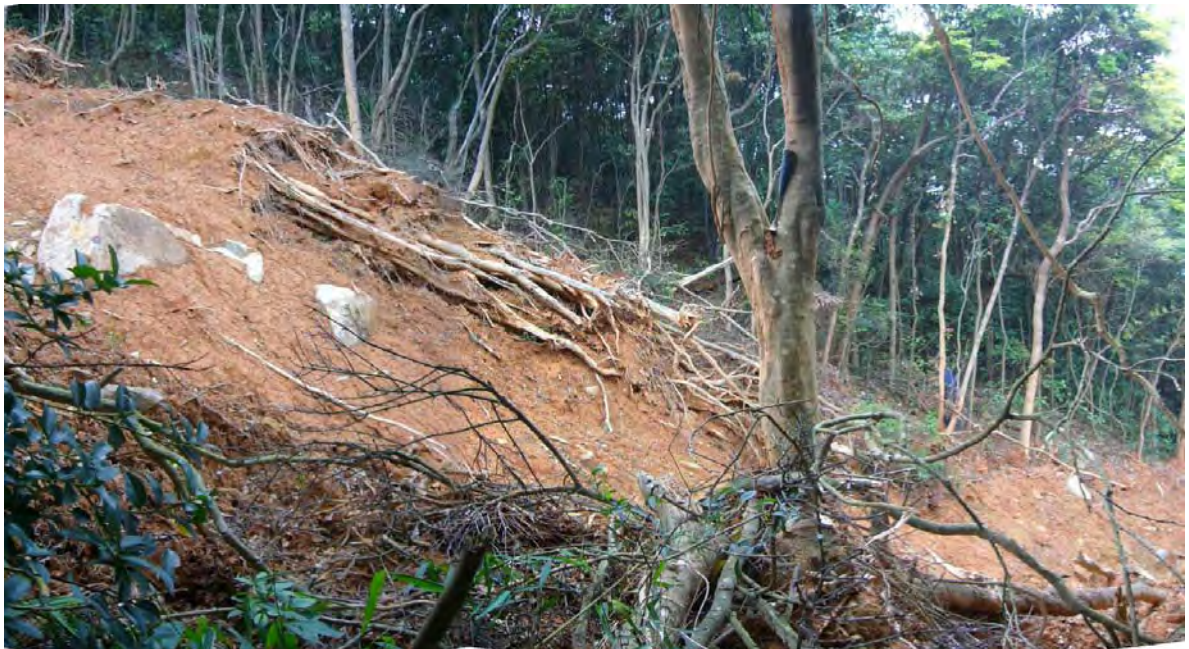
There was much deposition of remoulded debris (Material type MT8) with a large proportion of small tree trunks along the flanks of the upper debris trail despite the steepness (30° to 40°) of the terrain (Plate 16). Generally, debris was deposited in lobes and pressed up against trees on the original ground surface, on either side of the deeper central portion of the drainage line. Debris splatter was observed on the trees alongside the debris trail, with some debris splatter reaching several metres up the tree trunks and on branches. The extent of the debris splatter suggests wet debris probably travelling in a turbulent manner.

Plate 16 - Upper Debris Trail at Chainage CH136
(Photograph taken on 15 March 2006)

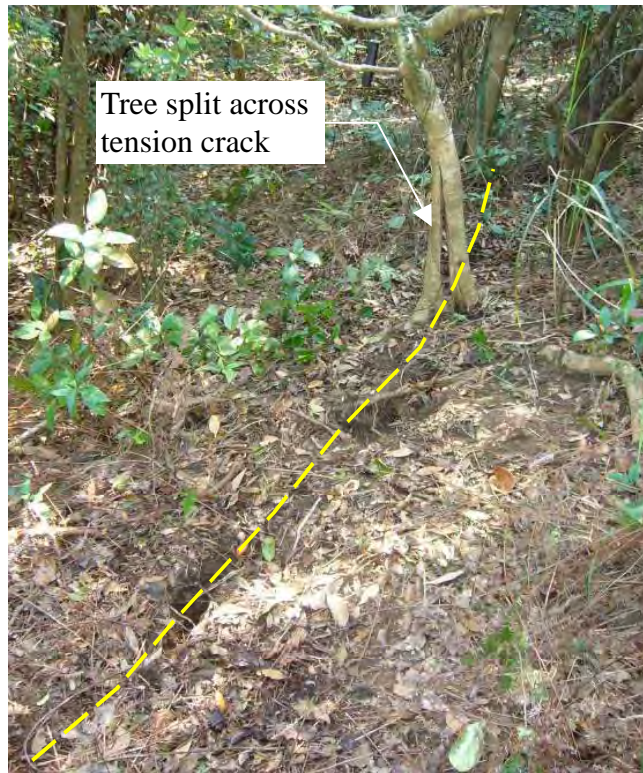
Plate 25 - One of a Series of Stepped Tension Cracks
on the Western Flank of the Distressed Hillside
(Photograph taken on 10 March 2006)

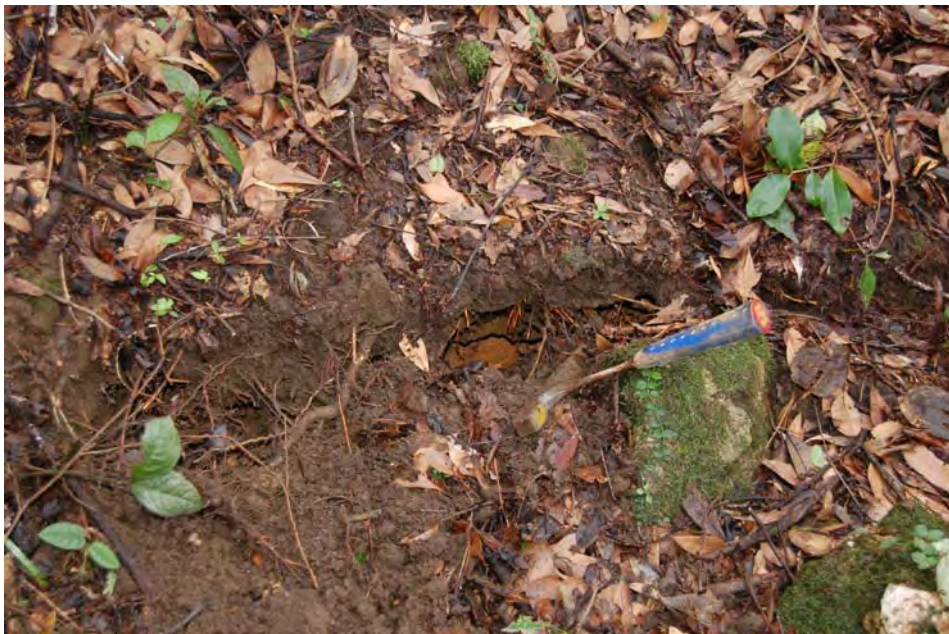
Plate 26 - Discontinuous Tension Crack above Drillhole No. BH4
near the Western Flank of the Distressed Hillside
(Photograph taken on 10 July 2006)

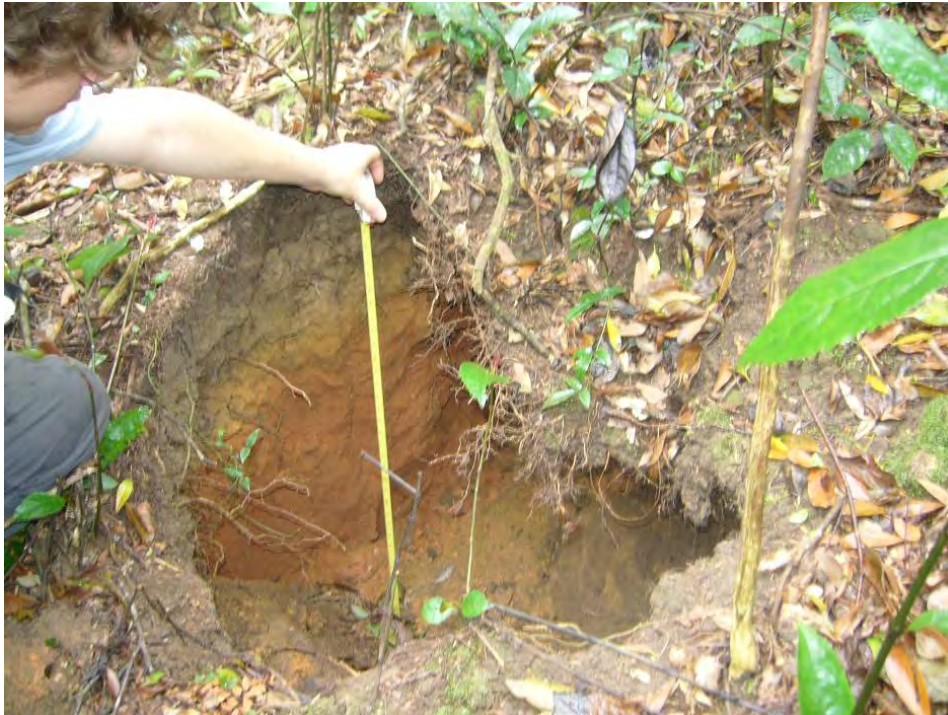
Plate 27 - Collapse Feature Upslope of Main Scarp of the Distressed Hillside
(Photograph taken on 22 March 2006)

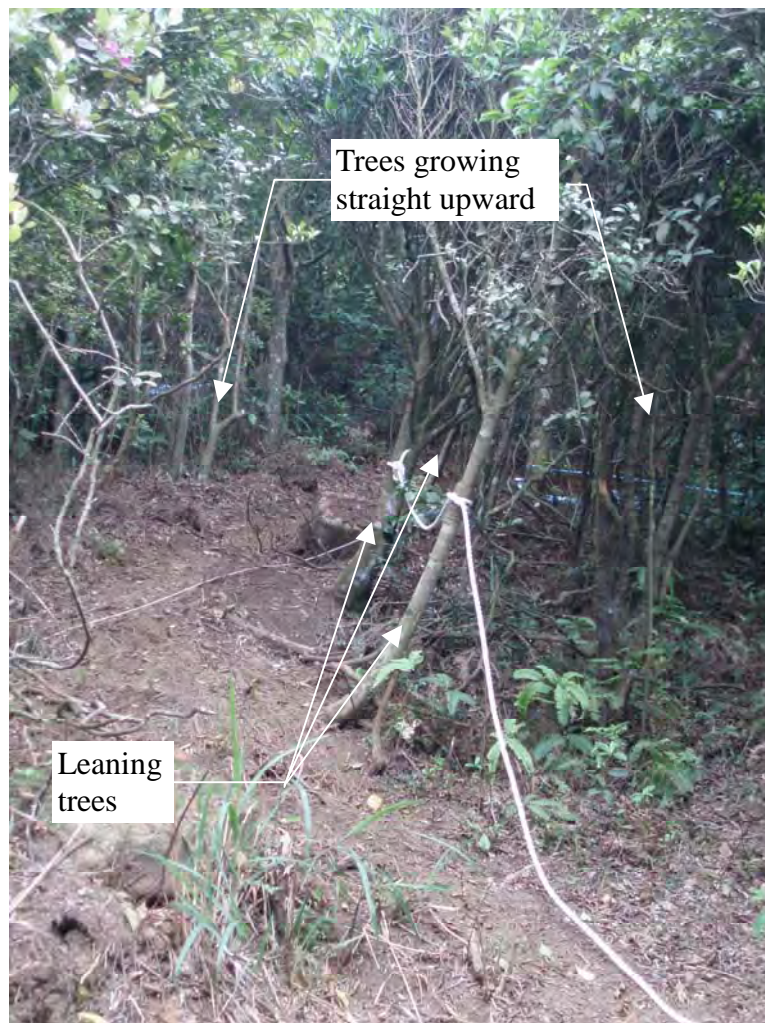
Plate 29 - Leaning Trees near the Eastern Flank
of the Distressed Hillside
(Photograph taken on 28 April 2006)

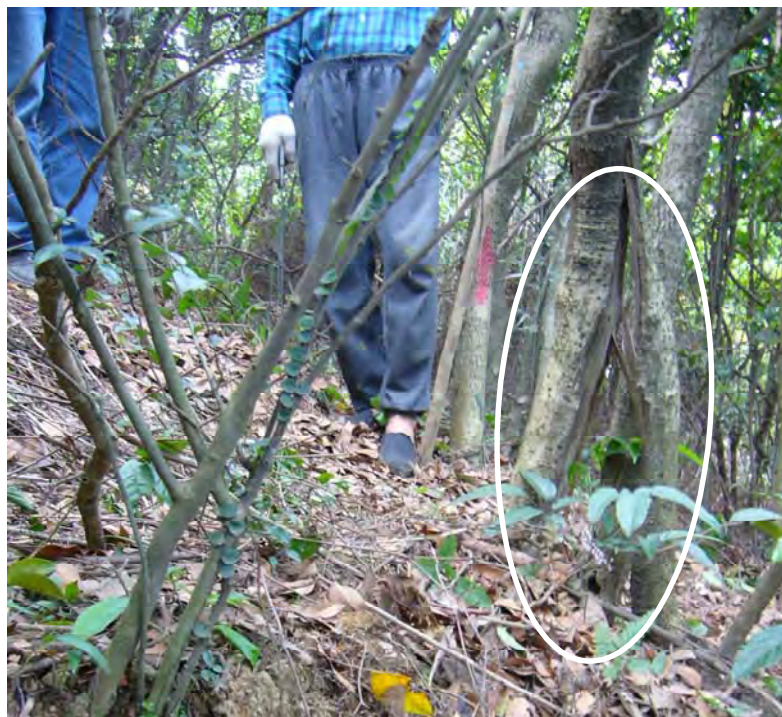
Plate 31 - Tree Split across the Tension Crack on Western Flank of the
Distressed Hillside (Photograph taken on 10 March 2006)

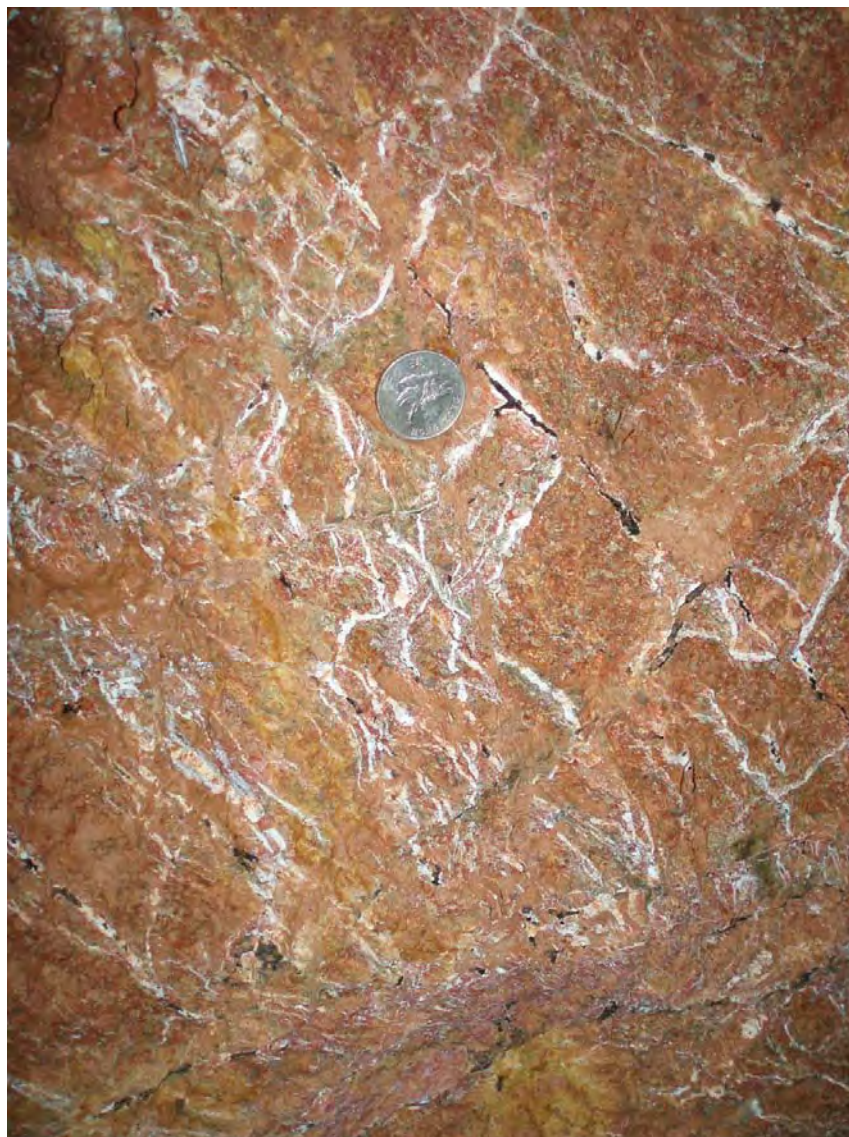
Plate 35 - Boxwork Kaolin Veins in CDT in Trial Pit No. TP8

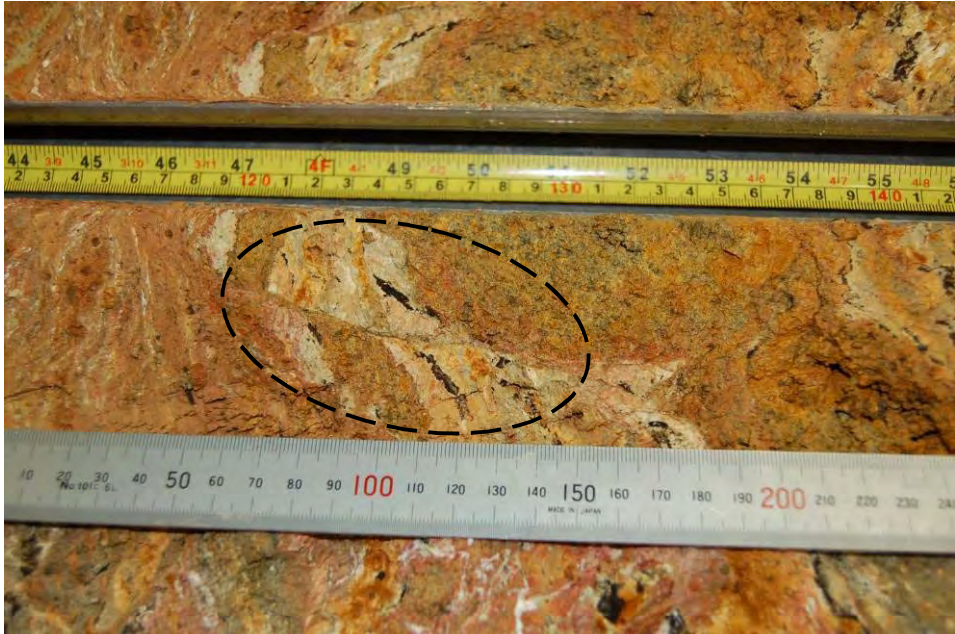
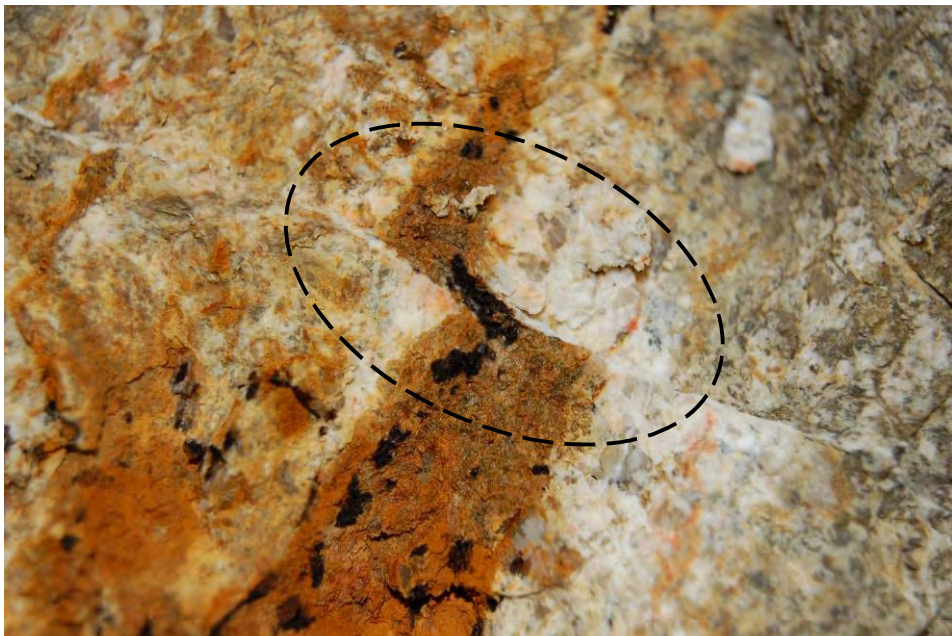
(a) Offset observed at about 9 m Depth in drillhole No. BH4

(b) Offset observed at about 25 m Depth in drillhole No. BH5

Plate 36 - Offset Observed in Split Mazier Samples

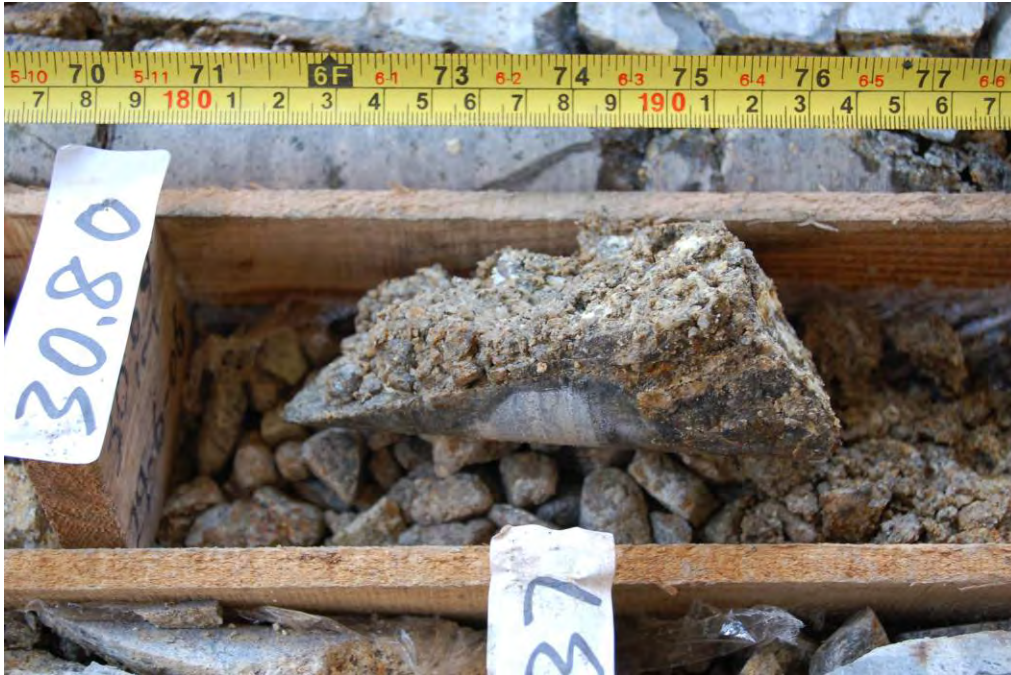
Plate 37 - Fault Gouge along Joint at 30.8 m Depth in Drillhole No. BH2

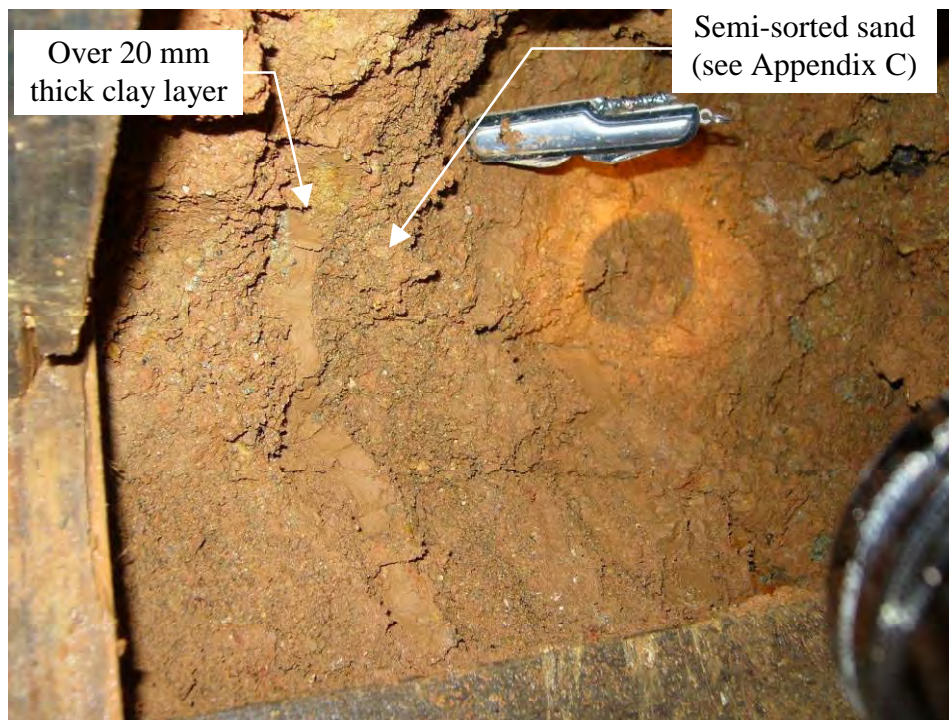
Plate 45 - Layered Deposit in Soil Pipe Observed
in Face B of Trial Pit No. TP2

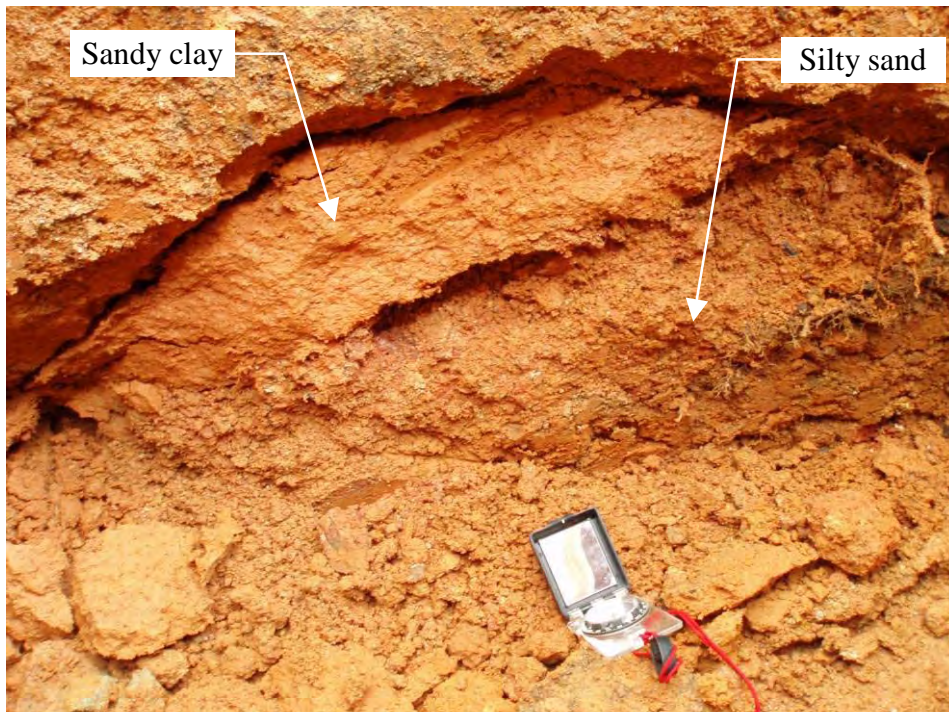
Plate 46 - Accumulation of Clay on Top of Sandy Soil in
Soil Pipe in Face C of Trial Pit No. TP8
