**DETAILED STUDY OF
THE 20 AUGUST 2005
DEBRIS FLOOD AT
ROUTE TWISK, TSUEN WAN**

GEO REPORT No. 240

Maunsell Geotechnical Services Limited

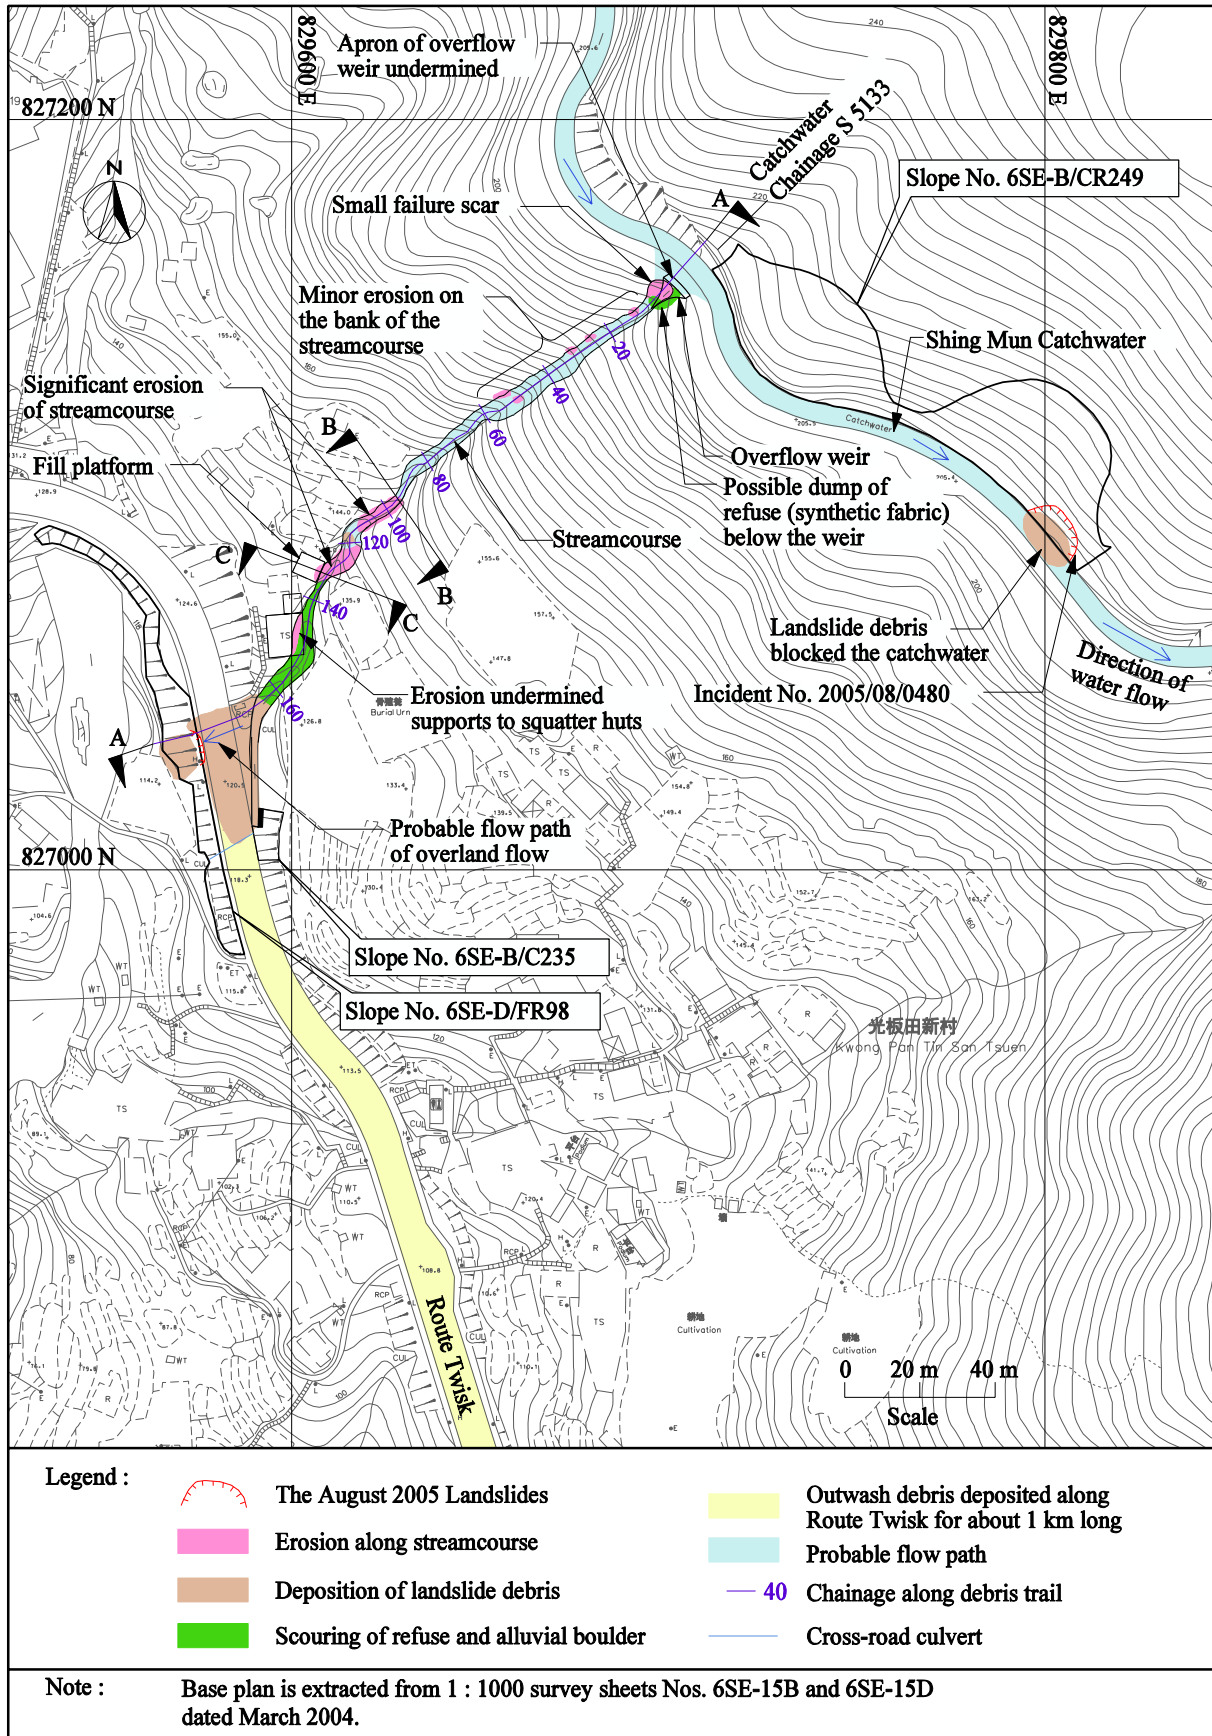
Figure 3 - Debris Flood Trail

Erosion at the sides (about 1 m deep) and base of the streamcourse (about 0.3 m deep) was observed between chainages CH 88 and CH 108. In total, about 20 m³ of materials was eroded (Figures 3 and 9). Colluvium, which comprised brown and reddish brown, sandy clayey silt, was exposed on both sides of the streamcourse (Plate 21). HDT, comprising reddish brown to yellowish brown sandy silt, was also observed just above the eroded bed of the streamcourse. In this section of the streamcourse, deposition of angular rock fragments was observed on the stream bed (Plate 20). However, it was difficult to determine whether or not these rock fragments were deposited as a result of the August 2005 incident.

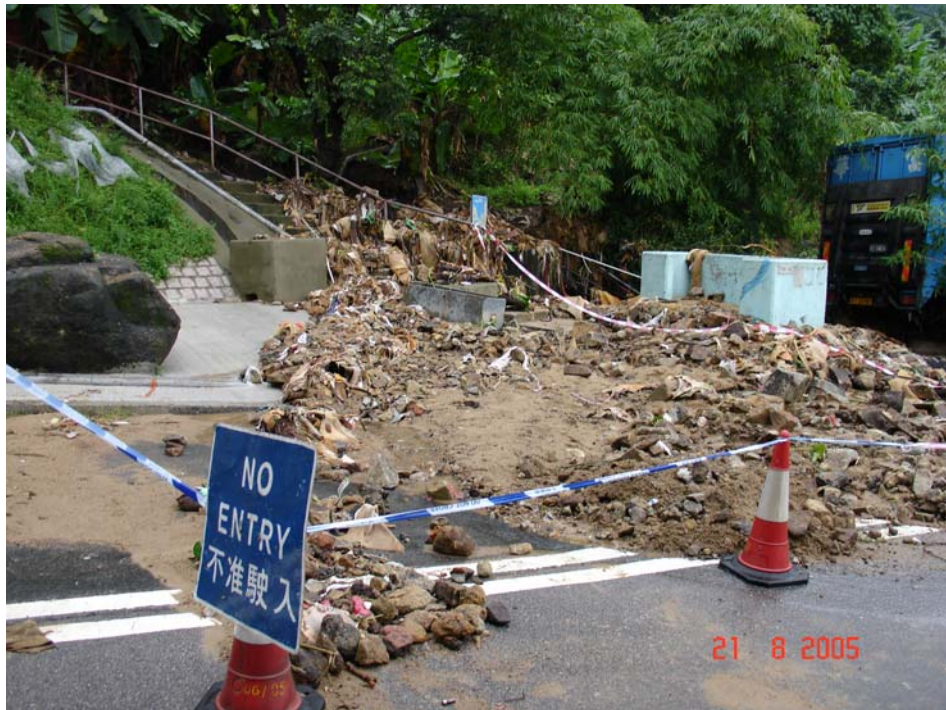
Debris, comprising boulders, tree branches, domestic refuse, fragments of synthetic fabric, silt and detritus, was observed to have accumulated beyond the sharp bend of the streamcourse, extending onto Route Twisk (Plates 1 and 2). The thickness of the debris was at up to 1 m near the sharp bend and diminished across Route Twisk. Some outwash fines and debris were also observed along Route Twisk towards Tsuen Wan (Plate 27). Based on the photograph provided by HyD (Plate 28), debris was also deposited in the vicinity of the inlet of the cross-road culvert. However, it appears that the debris might not have fully blocked the inlet of the cross-road culvert.

Plate 1 - Debris Deposited on Route Twisk Looking East
(Photograph taken by HyD on 21 August 2005)

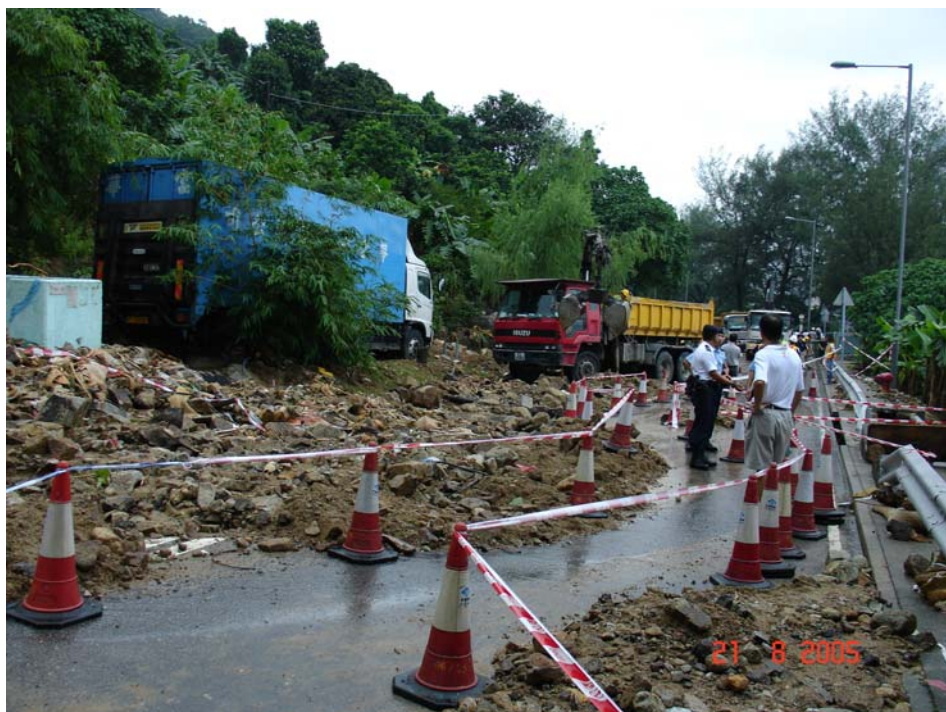
Plate 2 - Debris Deposited on Route Twisk Looking Southeast
(Photograph taken by HyD on 21 August 2005)

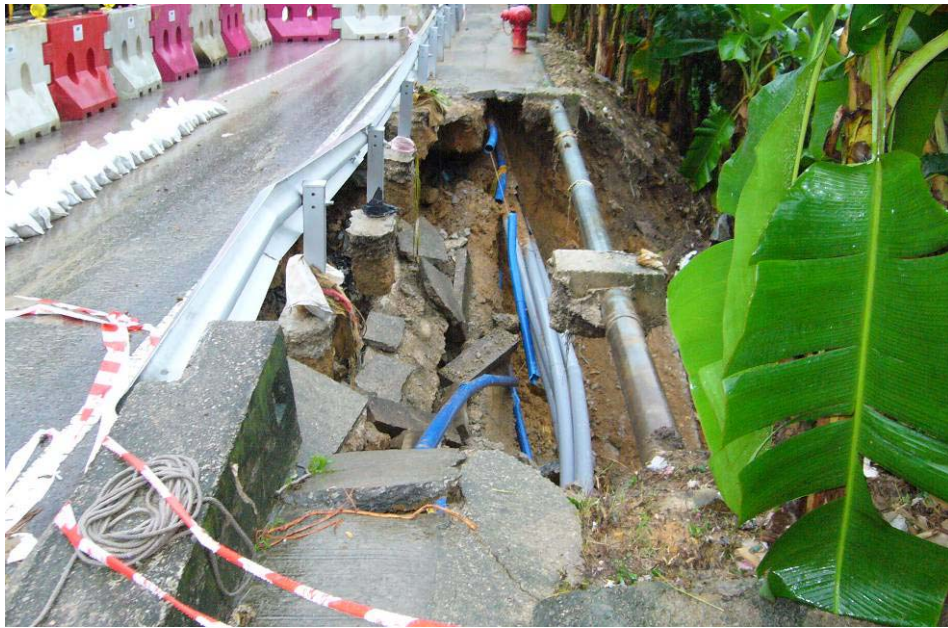
Slope No. 6SE-D/FR98, which is situated on the western side of Route Twisk and opposite the sharp bend of the streamcourse, also failed in this incident (Figure 3). The landslide measured approximately 10 m wide by 7 m high and up to 4 m deep, with a failure volume of about 130 m³. The landslide debris was deposited near the toe of the landslide scar and comprised mainly brown, silty sand with boulders. Utilities in the footpath located at the crest of the slope were also damaged (Plate 3).

Plate 3 - View of Landslide at Slope No. 6SE-D/FR98
(Photograph taken on 21 August 2005)

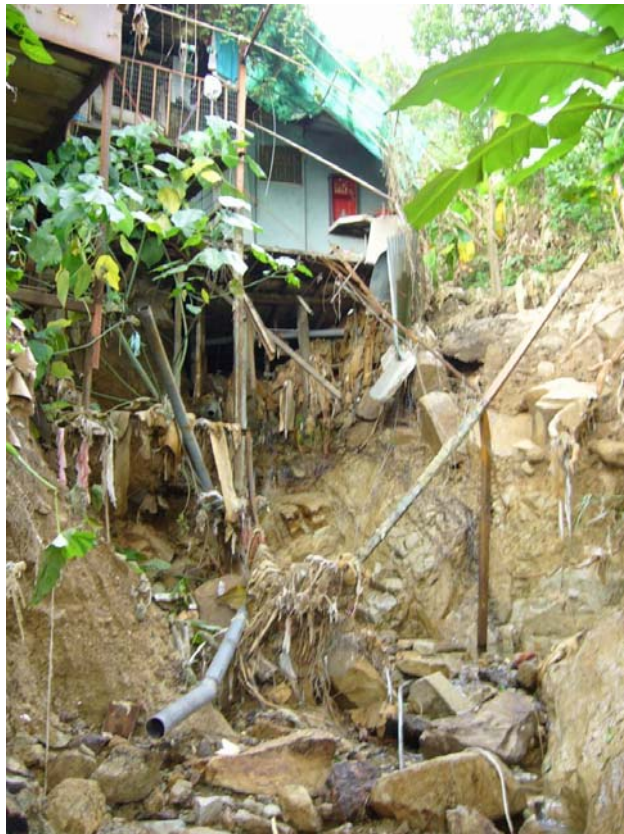
As a result of the incident, one registered squatter structure was undermined (Plate 4) and subsequently recommended for permanent evacuation.

Plate 4 - View of Undermining of Registered Squatter
Structure No. RTW/4D/296 along Streamcourse
(Photograph taken on 26 August 2005)

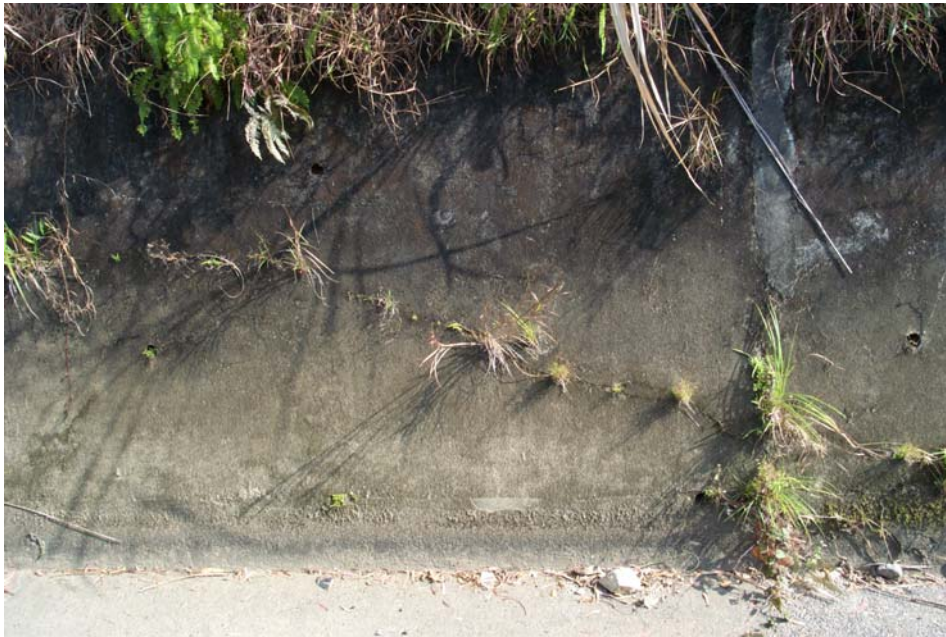
Slope No. 6SE-B/CR249, located directly above the catchwater, comprised an old (pre-1977) cut that was formed without any geotechnical input. This feature had a record of past instability (Incident No. NT82/241). The EI of the slope carried out in 2001 also identified some cracking on the channel wall within the August 2005 landslide source area.

Plate 9 - Cracking of Catchwater Channel before the Landslide
on Slope No. 6SE-B/CR249
(Photograph taken on 7 December 2000)

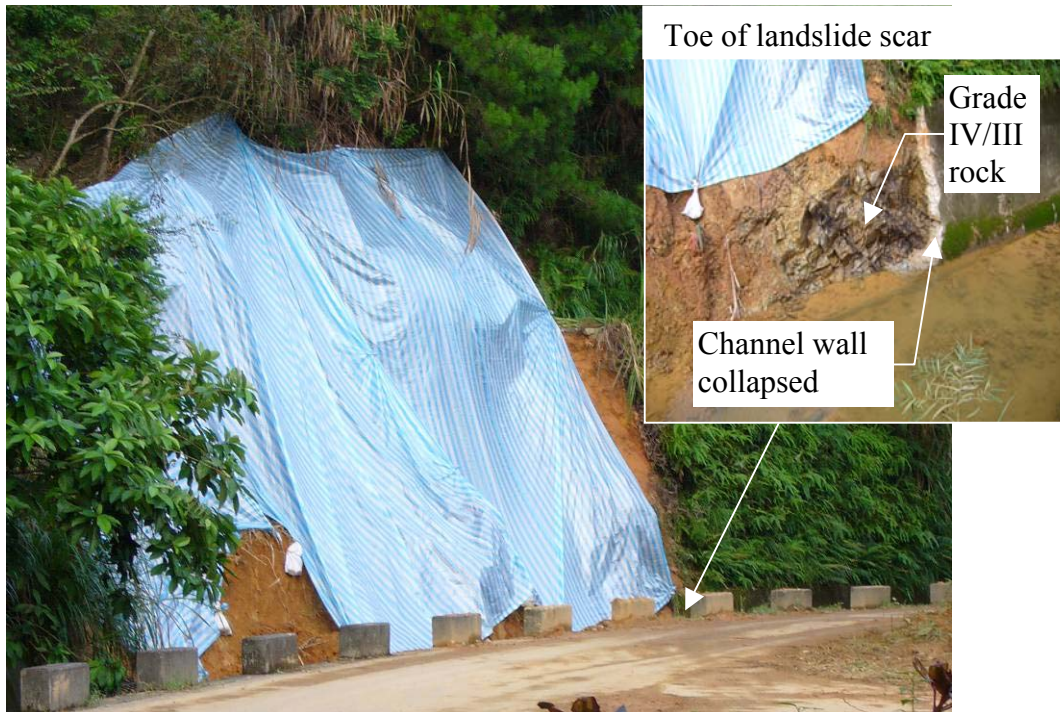
deep with a failure volume of about 50 m³. A surface drainage channel located on mid-slope also collapsed. The toe of the scar was at the base level of the catchwater channel, and the channel wall had collapsed (Plate 10). With limited exposure of the scar, the scar materials appeared to comprise yellowish brown, sandy clayey silt (completely decomposed tuff). A small area of Grade IV/III rock was observed at the toe of the scar (Plate 10). Sealed cracks on the catchwater channel wall immediately adjacent to and northwest of the landslide scar were observed (Plate 11). At the time of inspection, urgent repair works, including the removal of the debris and placement of some gabion cages in the catchwater channel were on-going. Plate 12, provided by WSD, shows the general view of the landslide just before the slope surface was covered with shotcrete.

Plate 10 - General View of the Landslide on Slope No. 6SE-B/CR249
(Photograph taken on 26 August 2005)

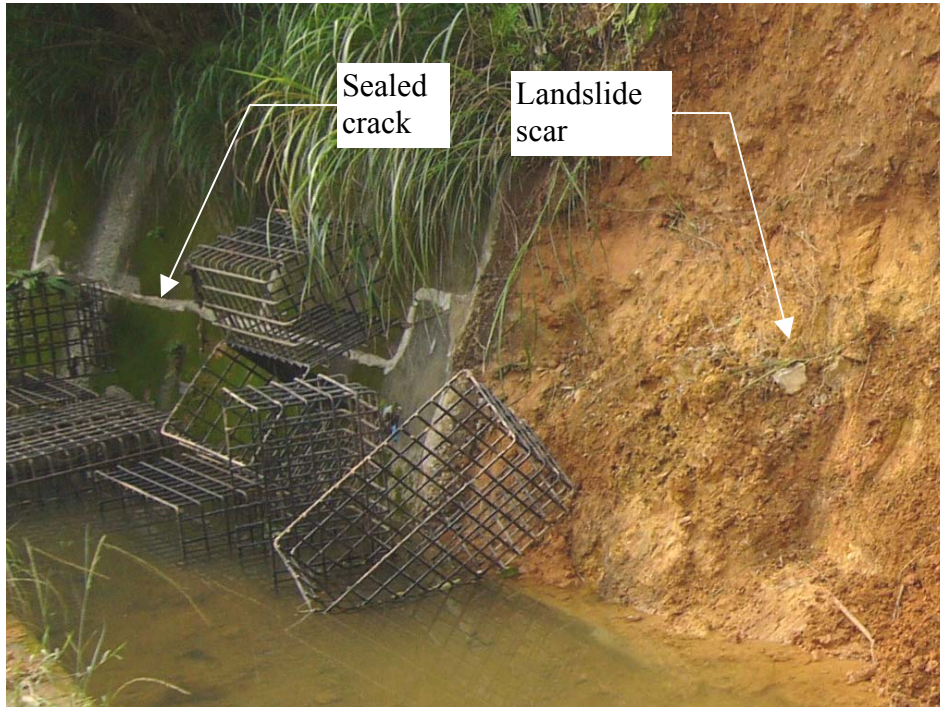
- (a) the severe and prolonged rainfall, with critical return periods of greater than 1 in 100 years for long-duration rainfalls, triggered the landslide at slope No. 6SE-B/CR249, which has a history of instability (Section 3.3.2);
- (b) the landslide at slope No. 6SE-B/CR249 might have occurred with little warning (WSD carried out their inspection between 3:00 p.m. and 4:35 p.m. on 20 August 2005, i.e. 1½ hr to 3 hr before the incident and no landslide or irregularity was reported);
- (c) the EI of slope No. 6SE-B/CR249 carried out in 2001 identified cracking of the channel wall, which might have provided an indication of slope distress. Sealed cracks on the channel wall (adjacent to the landslide scar) were

observed in the post-failure site inspection, suggesting some sealing of cracks might have been carried out following the EI. However, no relevant records could be found;

Plate 11 - Sealed Cracks on Catchwater Channel adjacent to Landslide Scar of Slope No. 6SE-B/CR249
(Photograph taken on 26 August 2005)

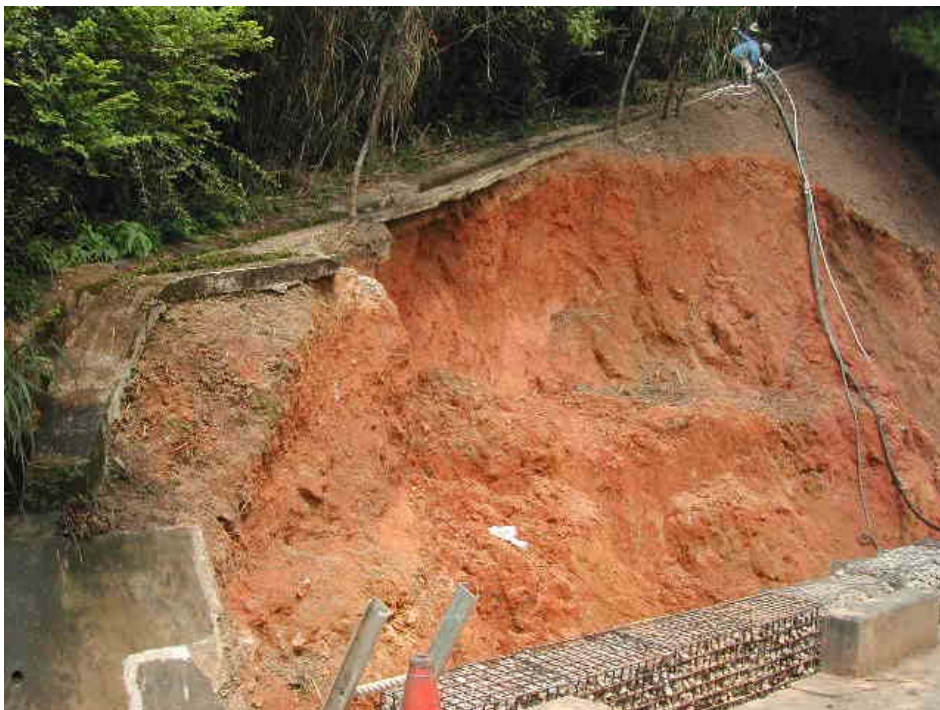
Plate 12 - General View of the Landslide on Slope No. 6SE-B/CR249
(Photograph taken by WSD on 31 August 2005)

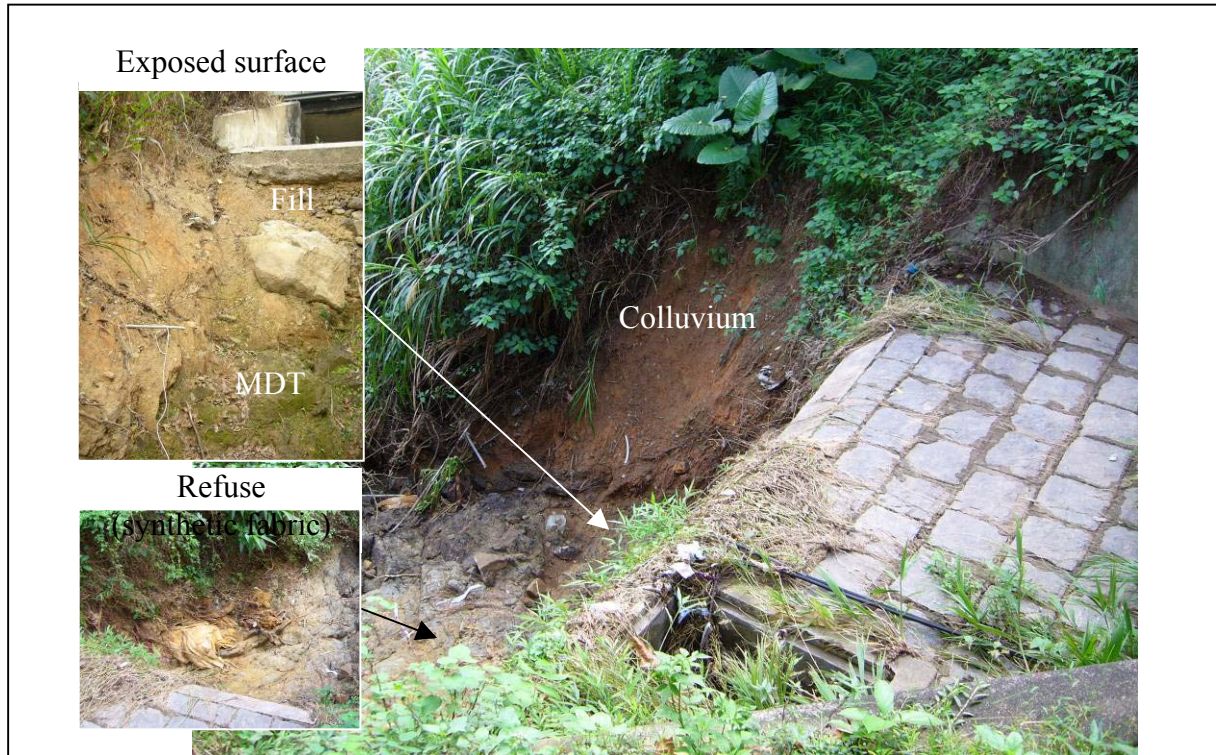
Plate 13 - Erosion below Overflow Weir SMOF-28
(Photograph taken on 26 August 2005)

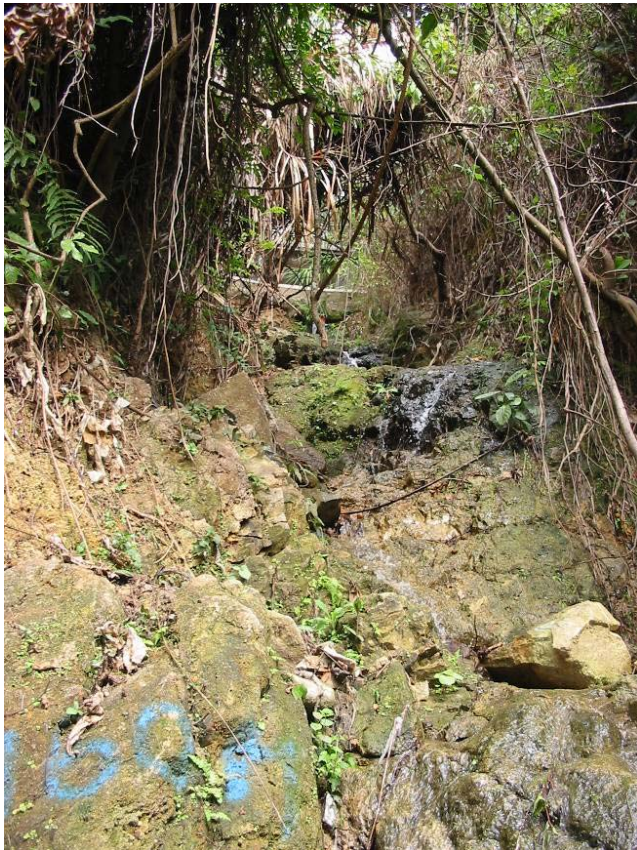
For ease of reference, a chainage line has been established along the debris flood trail with the outlet of the overflow weir being designated as chainage 0 (CH 0, see Figure 3). The hillside alongside the upper section of the trail is covered with dense vegetation. An area of erosion (Figure 3 and Plate 13), about 6 m wide by 5 m long by 0.6 m deep with a volume of about 5 m³, was observed on the northern side of the streamcourse immediately below the overflow weir. Colluvium comprising reddish brown and brown, sandy clayey silt with some fine to coarse gravel, was exposed on the erosion scar. Some refuse comprising synthetic fabric was observed on the southern side, which suggests that fill was probably placed on the downslope side of catchwater (Plate 13). Further downstream (chainage CH 23), rock was exposed at the stream bed, which comprised grey, moderately decomposed coarse ash tuff (Plate 14).

Plate 14 - View of the Upper Portion
of the Debris Flood Trail at
CH 23 (Photograph taken
on 22 February 2006)

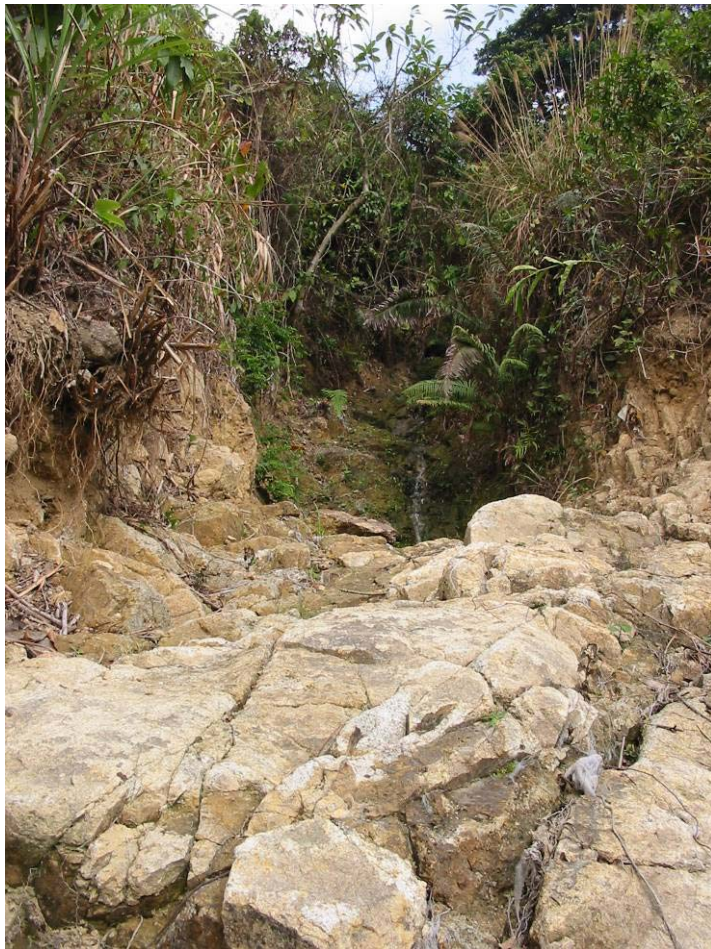
The streamcourse widens to about 5 m to 6 m between CH 32 and CH 57 (Figure 3 and Plate 15). The gradient of the streamcourse increases locally to about 45° between chainages CH 49 and CH 57 (Figure 8 and Plate 16). MDT was exposed in the bed of the streamcourse with moss and vegetation, which suggests little erosion along the bed in this section. Minor erosion (with a depth of about 0.2 m to 0.3 m and a total volume of about 5 m³) was observed on the sides of this steep section of the streamcourse (Figure 3 and Plate 17).

Plate 15 - View of the Upper Portion of the Debris Flood Trail at CH 32
(Photograph taken on 22 February 2006)

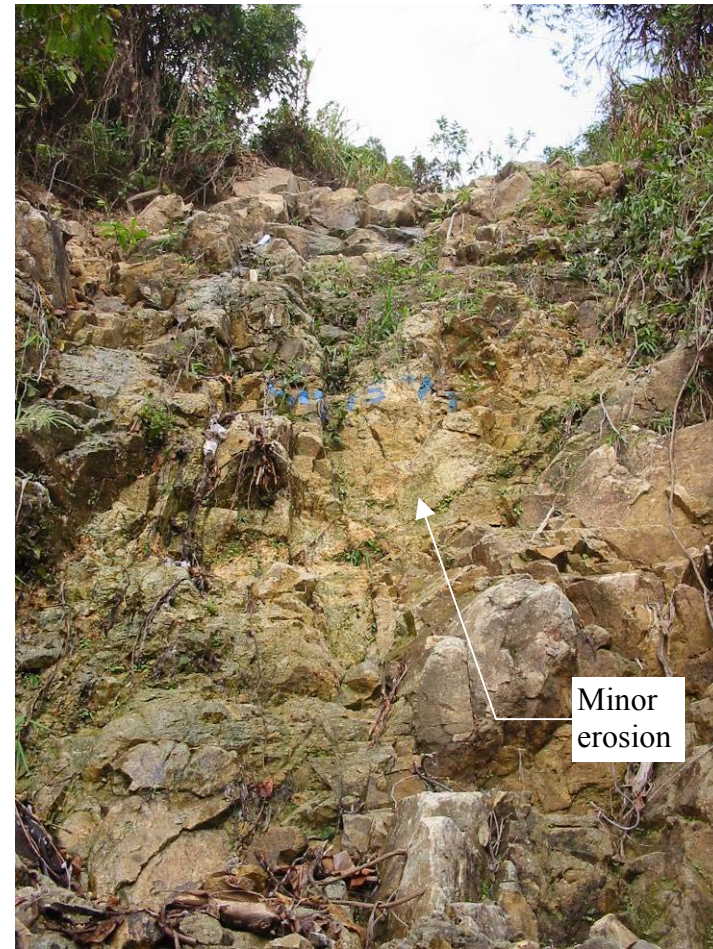
Plate 16 - View of the Steeper Section of the Debris Flood Trail between CH 49 and CH 57
(Photograph taken on 22 February 2006)

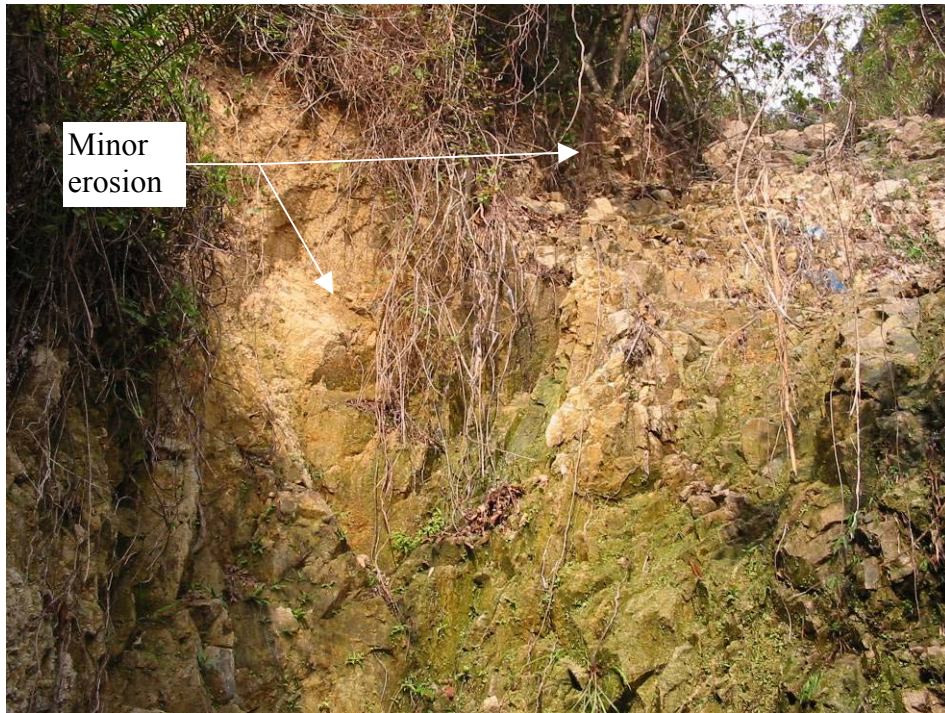
Plate 17 - Erosion along the Northern Bank of the Streamcourse at CH 57
(Photograph taken on 22 February 2006)

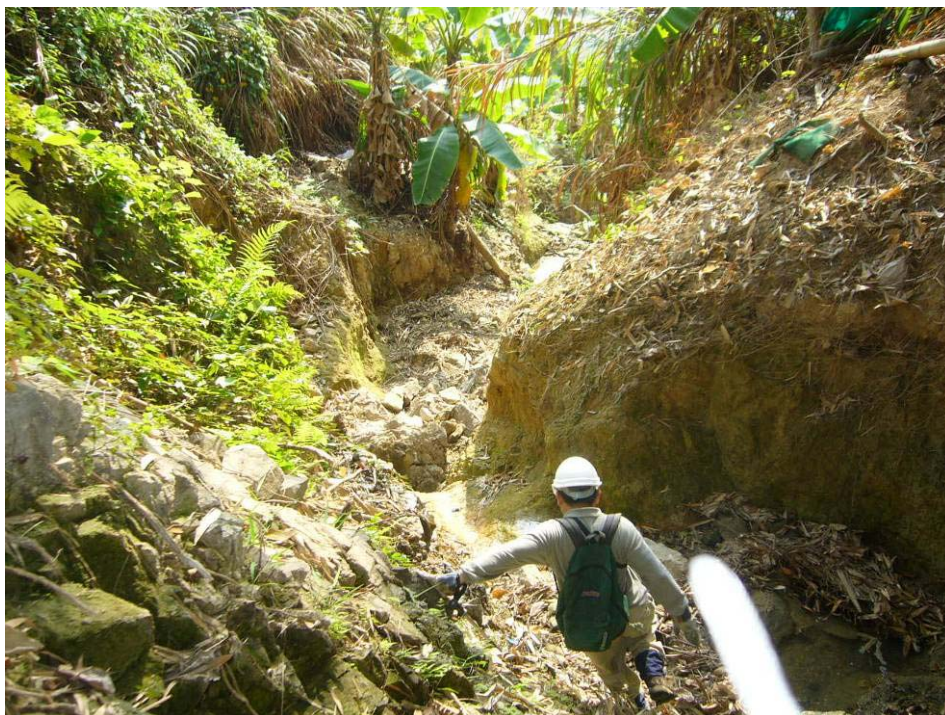
Plate 21 - View of the Erosion between CH 88 and CH 108
(Photograph taken on 22 February 2006)

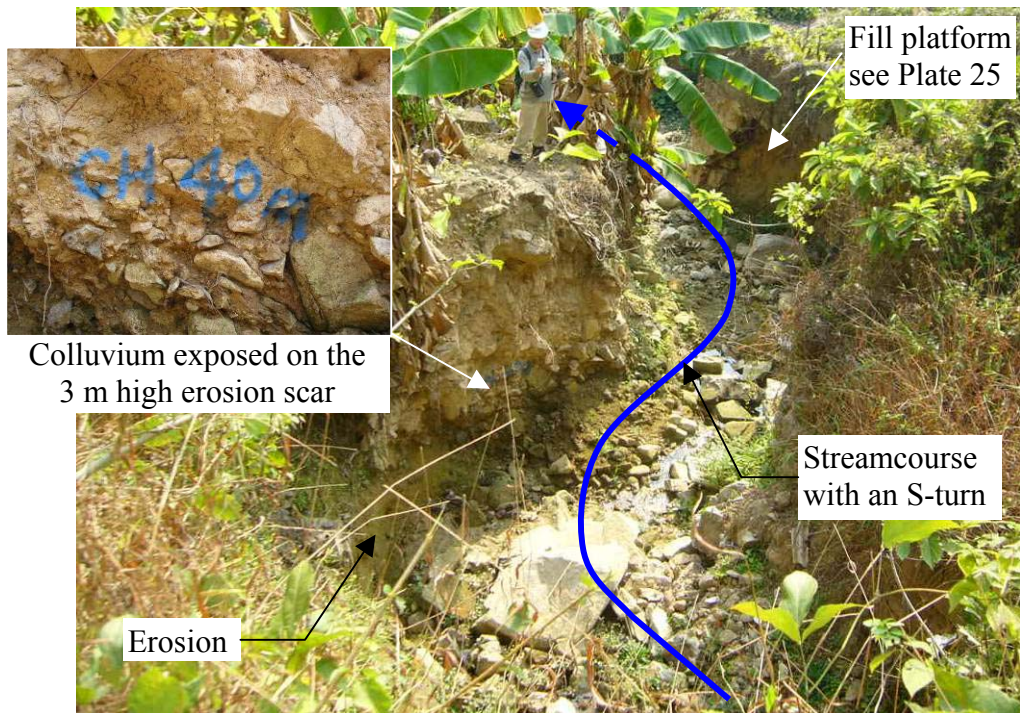
Plate 24 - View of the Significant Erosion at Middle Portion of the Debris Flood Trail at CH 126 (Photograph taken on 22 February 2006)

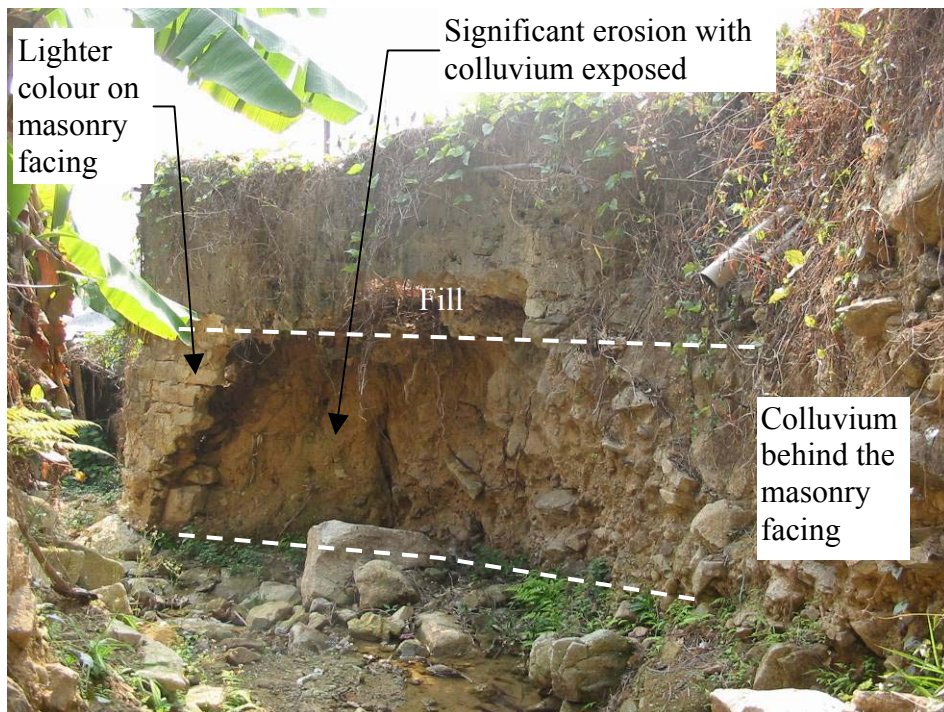
A 2.5 m high fill platform with a masonry facing was observed on the western side of the streamcourse, from CH 130 to CH 136 (Figure 3 and Plate 25). The platform was probably occupied by a squatter structure previously. A registered squatter structure (No. RTW/4D/296) (Plate 26) is located on the west side of the streamcourse, between chainages CH 140 and CH 146 (Figure 3). The streamcourse near the fill platform is about 1 m to 2 m wide and it widens to about 3 m wide near the sharp bend of the streamcourse (Figure 3). The streamcourse in this section has an overall gradient of about 10° to 15° with some small drops of about 1 m high at chainage CH 140 and 2 m high at chainage CH 146, beside registered squatter structure No. RTW/4D/296.

Plate 25 - View of the Masonry Facing and the Fill Platform (Photograph taken on 22 February 2006)

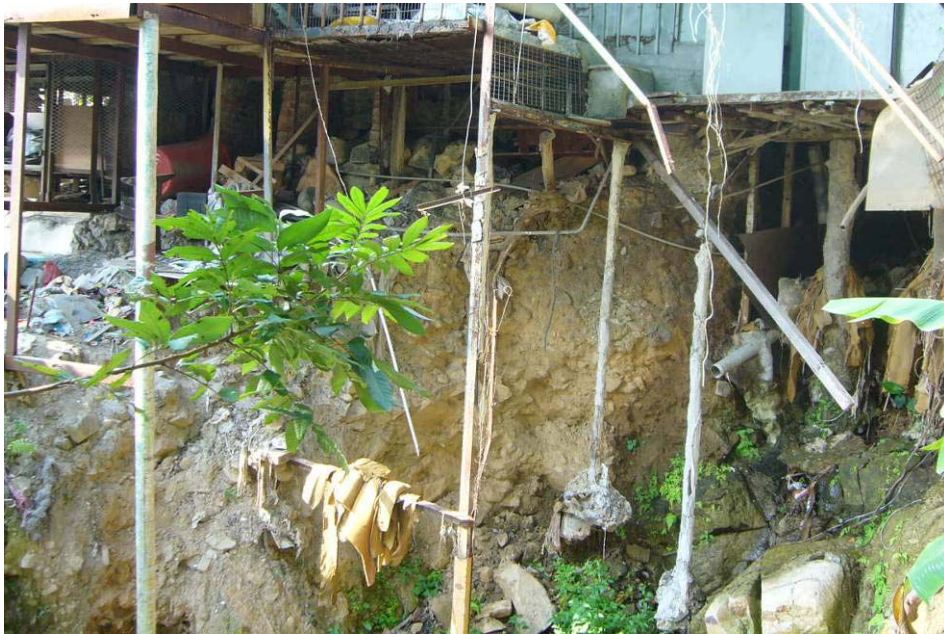
Plate 26 - Erosion underneath Registered Squatter
Structure No. RTW/4D/296
(Photograph taken on 22 February 2006)

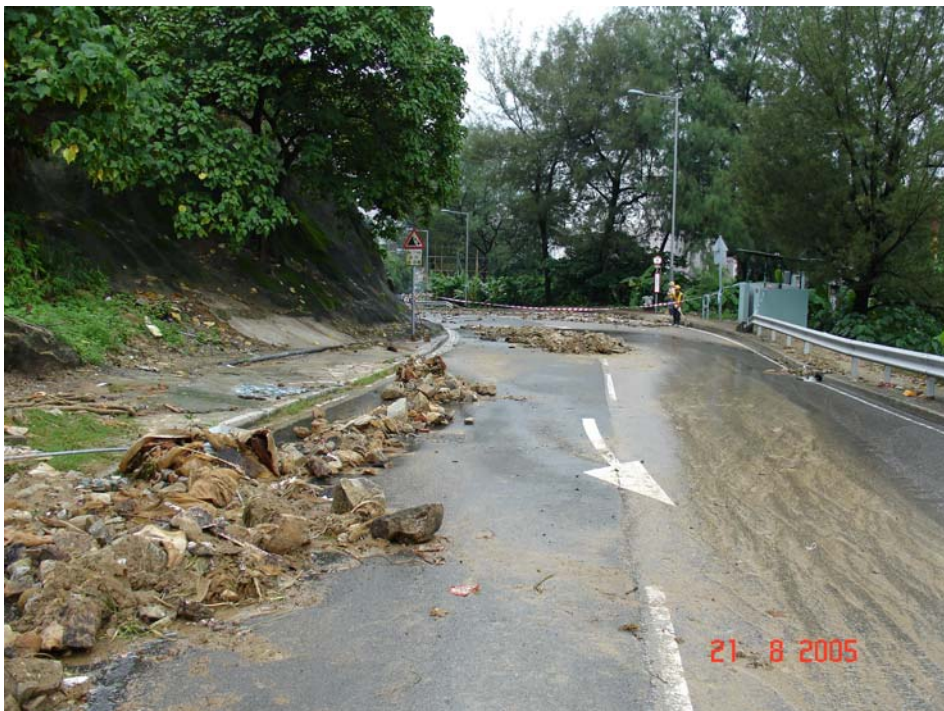
Plate 27 - Washout Debris along Route Twisk
(Photograph taken by HyD on 21 August 2005)
