**REVIEW OF THE 22 AUGUST 2005
LANDSLIDE ON THE NATURAL
HILLSIDE ABOVE SLOPE
NO. 7SW-D/C2 AT LION ROCK
TUNNEL ROAD, SHA TIN**

GEO REPORT No. 241

Maunsell Geotechnical Services Limited

**This report is largely based on GEO Landslide Study Report
No. LSR 7/2007 produced in August 2007**

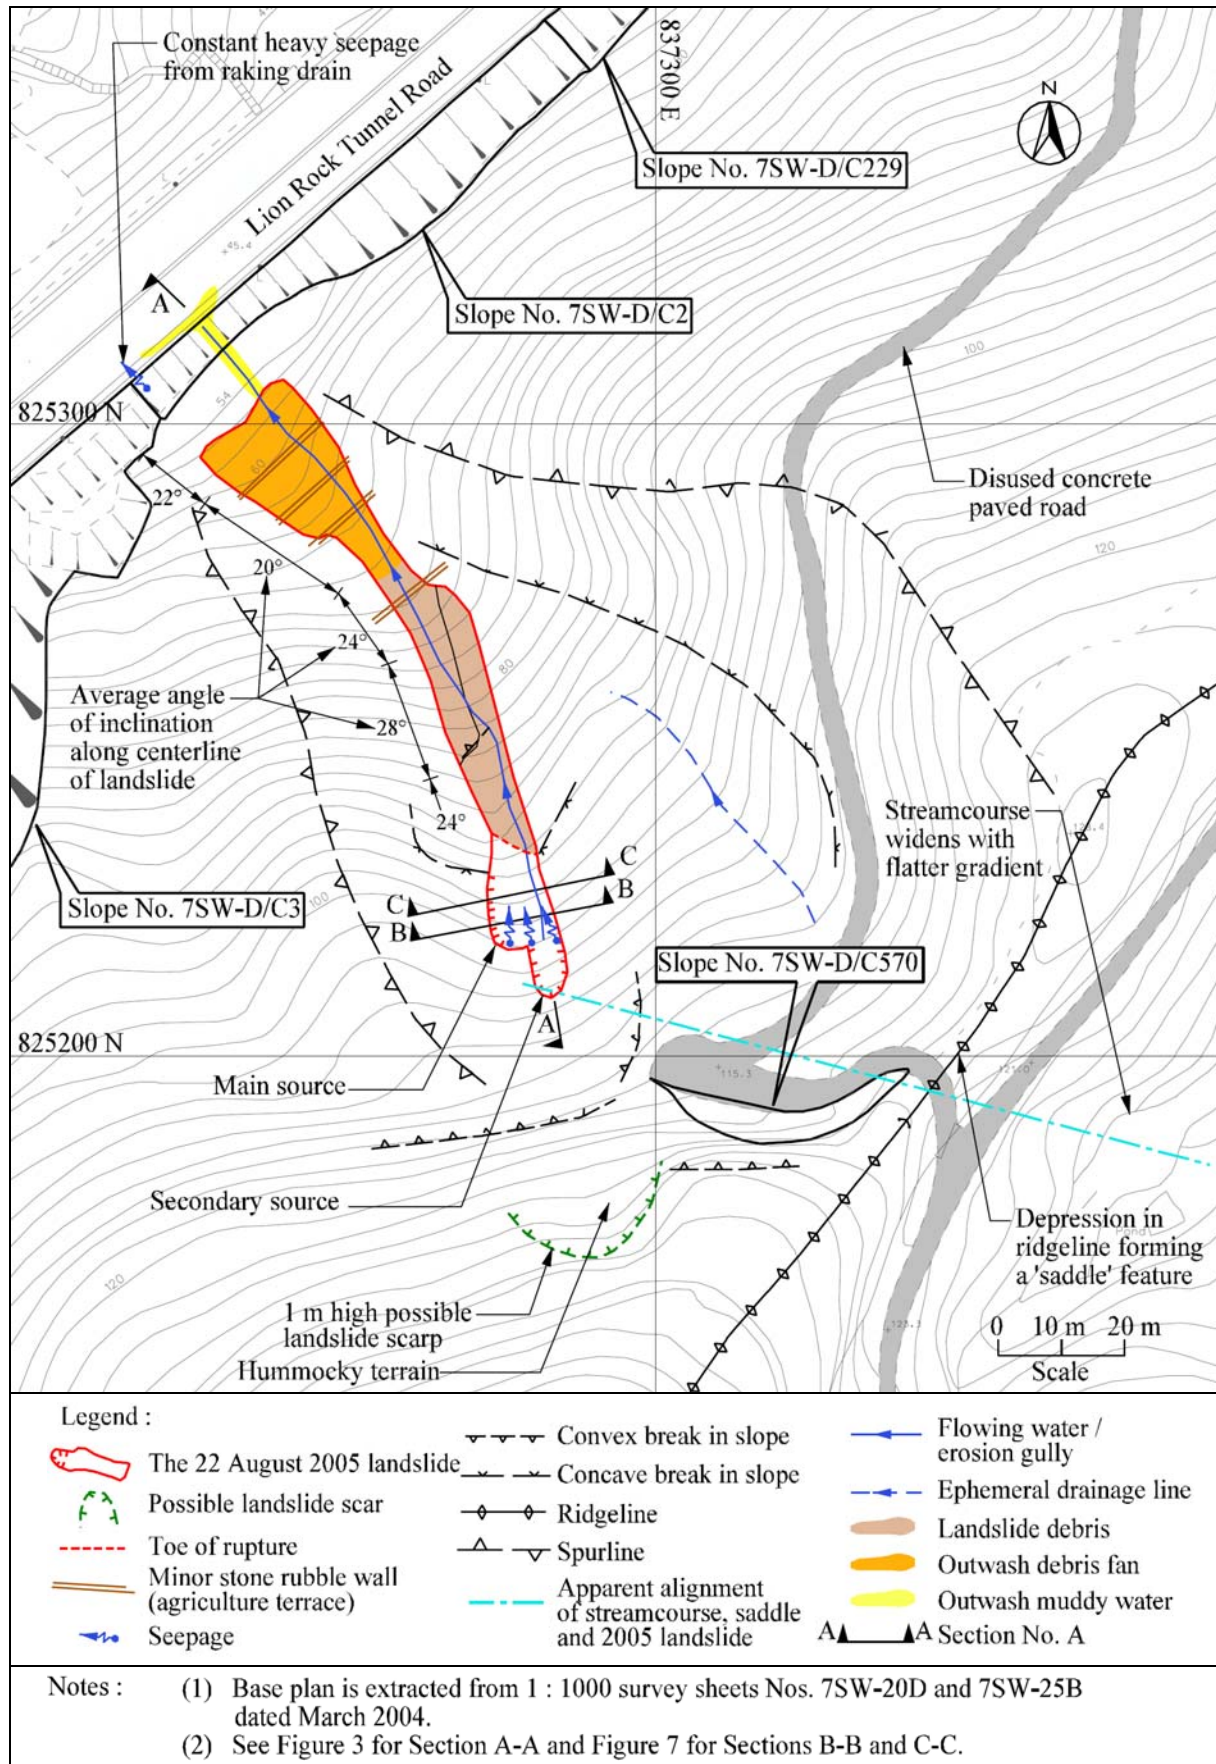
Figure 2 - Site Layout Plan

A number of minor steps in the terrain, generally less than 1 m high, is evident uphill of the August 2005 landslide (Figure 2). The largest step observed, about 1 m high, was located at an elevation of about 114 mPD (i.e. about 20 m below the ridge line). The steps may be highly degraded landslide scarps, and appear to coincide with relict landslides identified under the ENTLI (Section 3.3.1).

An area of hummocky terrain was observed about 20 m to the south of the August 2005 landslide. This area coincides with a depression indicated on the 1:1000 topographical survey sheet No. 7SW-25B and landslide scars identified from API (Figure 5 and Plate A1) and recorded under the ENTLI (tag No. 07SWD0693E on Figure 6). The scarp was about 1 m in height bounding the southern side of the hummocky ground (see Figure 2), and it appears to be an old landslide.

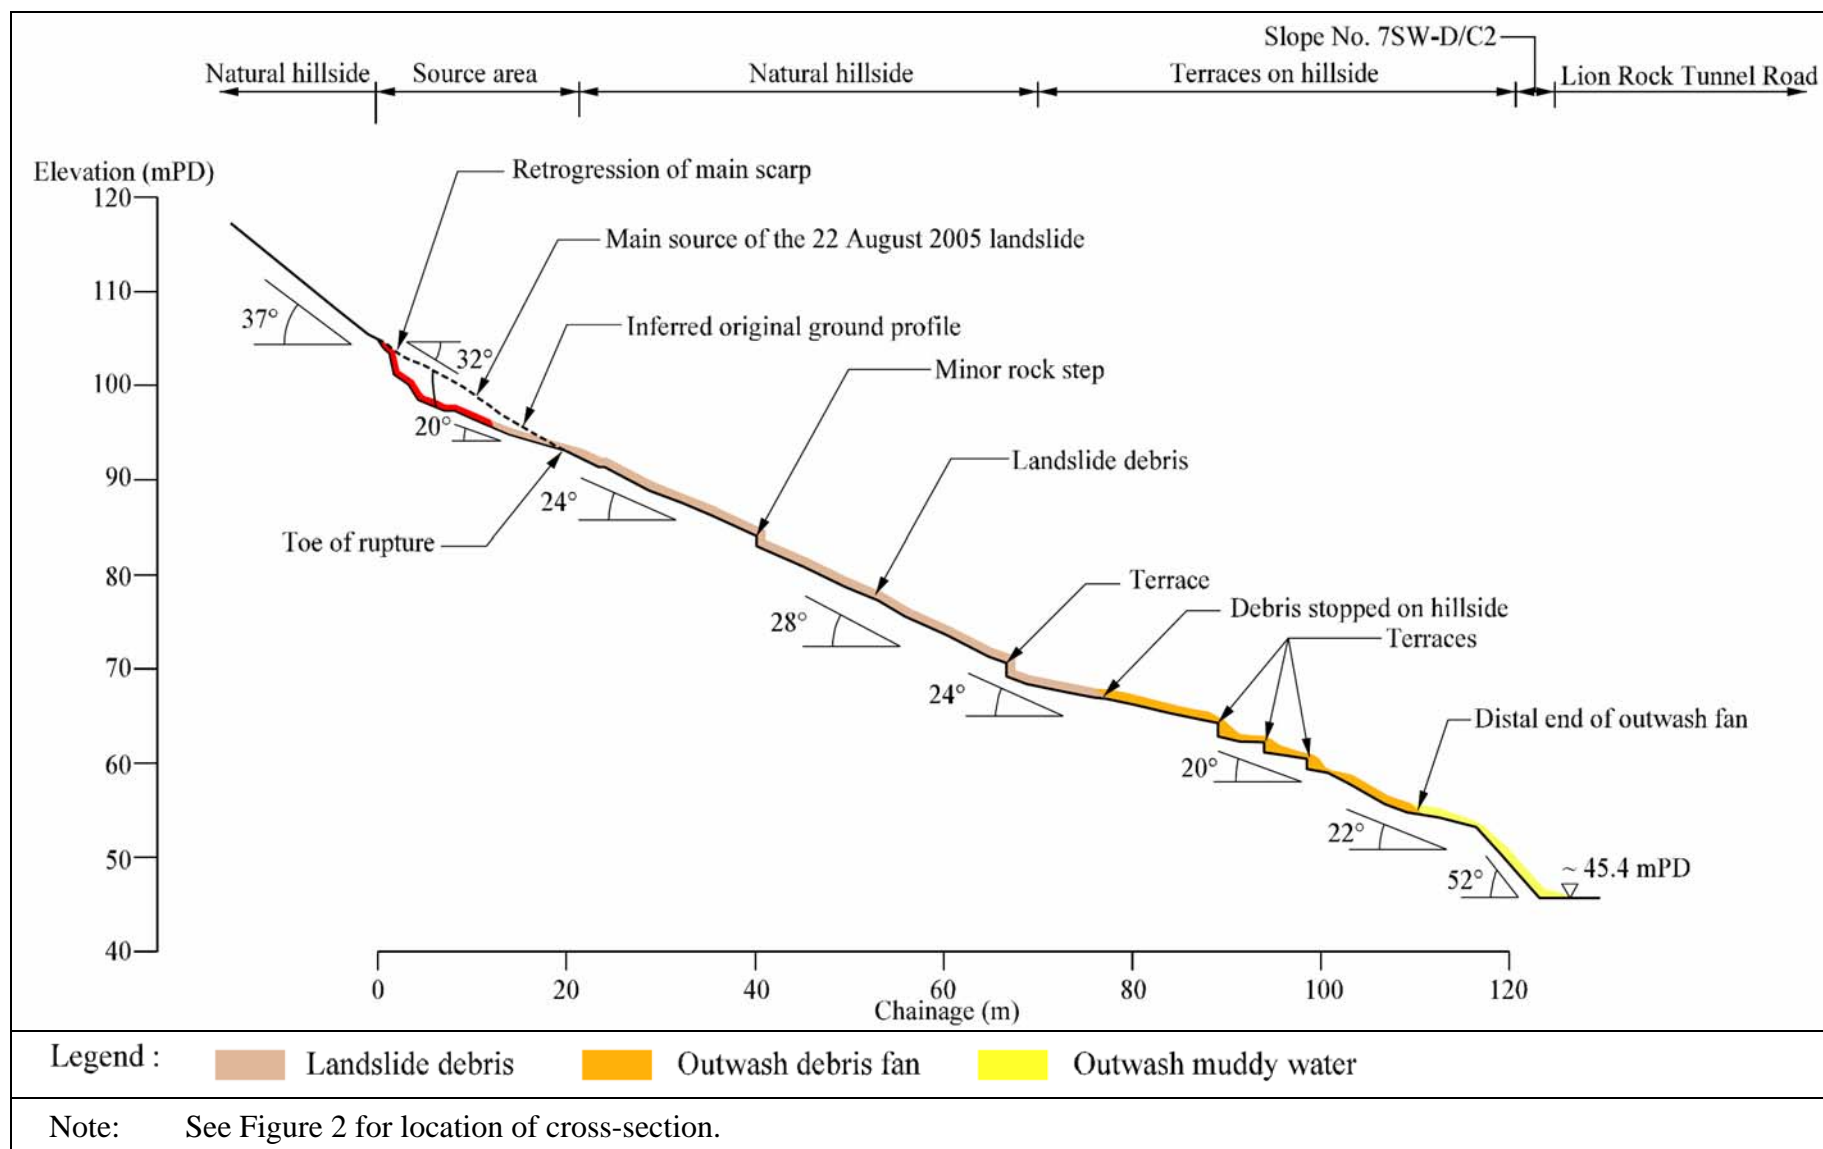
Figure 3 - Section A-A through the 22 August 2005 Landslide

The surface of rupture of the landslide was covered by debris, but based on site inspection it appeared to be inclined at an angle of about 20° (Figure 3). The surface of rupture appeared to be within colluvium at the western side of the landslide source and within completely decomposed granite at the eastern side, and may therefore have been partially structurally controlled.

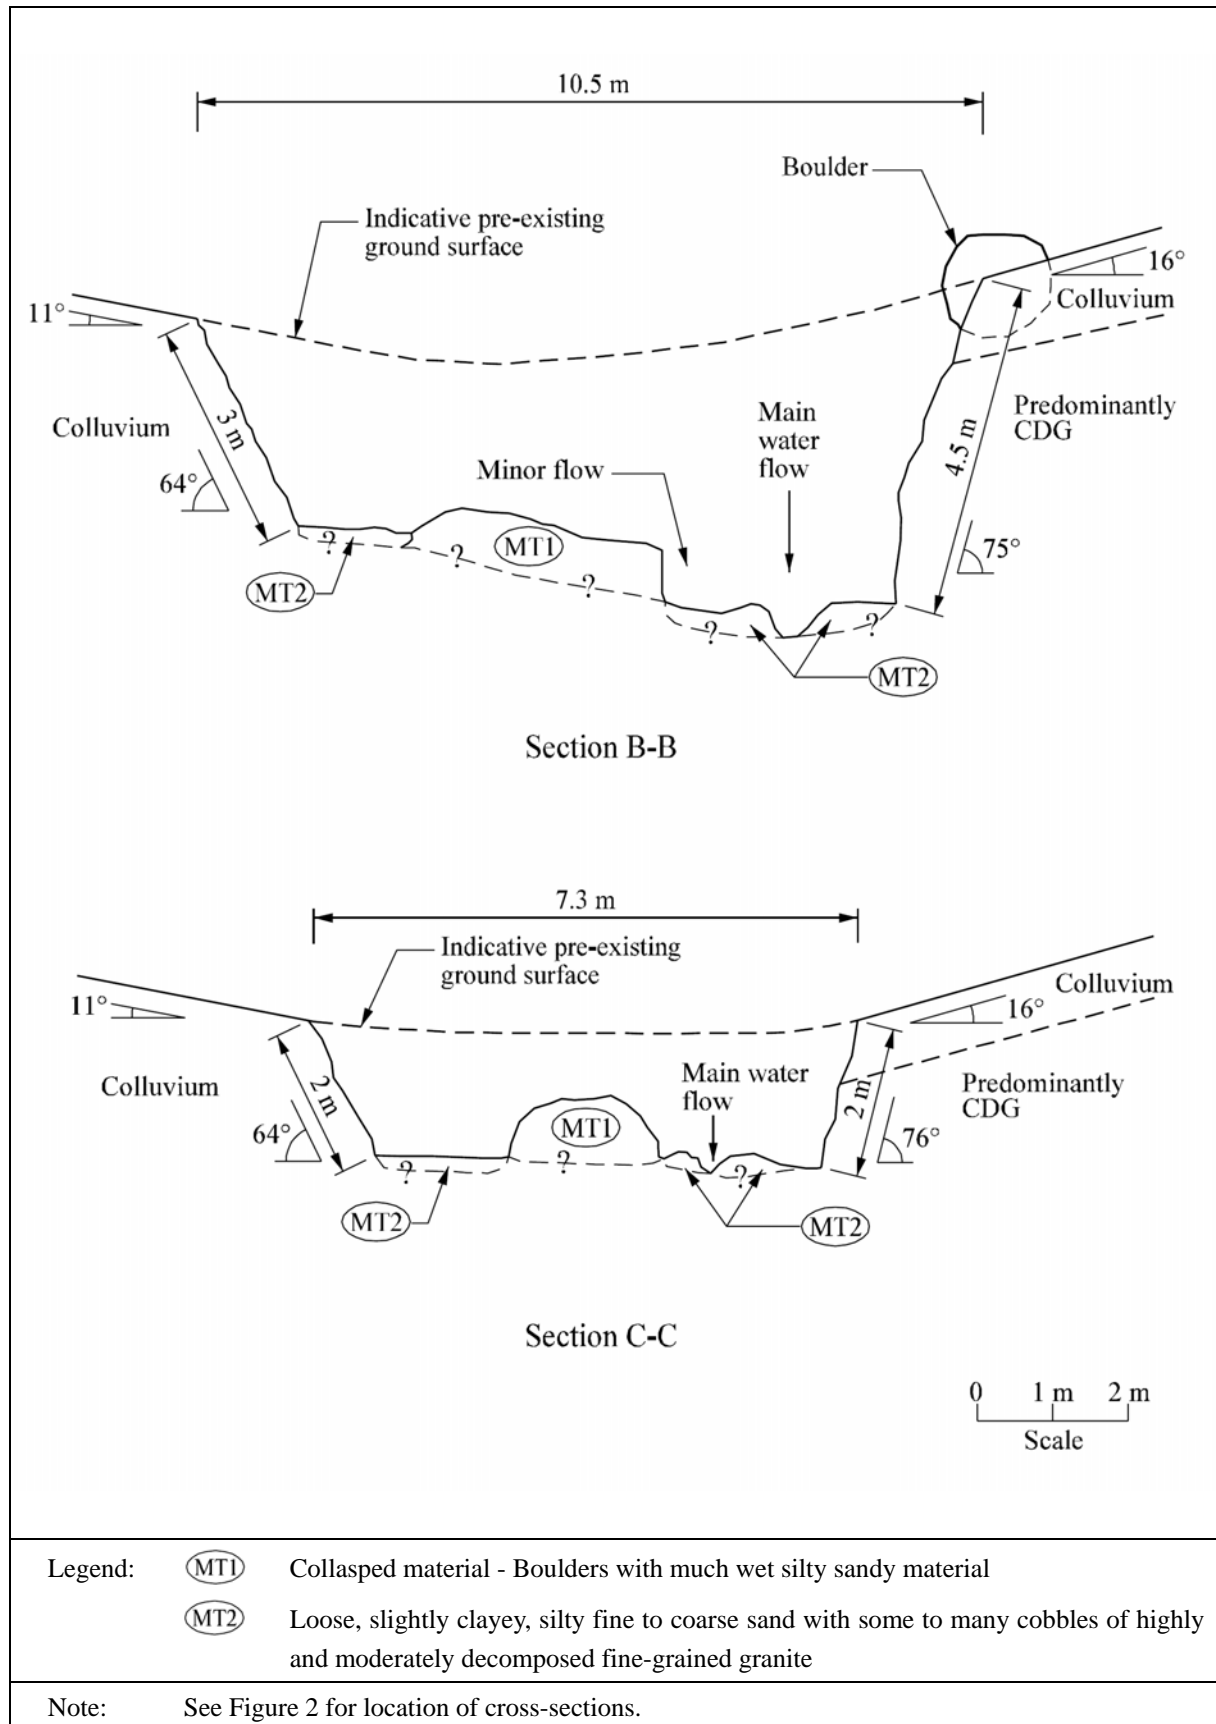
Figure 7 - Sections B-B and C-C through the 22 August 2005 Landslide

The main source of the August 2005 landslide had a maximum length of about 18 m, a maximum width of about 8 m, a maximum depth of 4.5 m and an average depth of about 2.75 m. The crown of the landslide is at an elevation of between 102 mPD and 104 mPD. The source is located immediately above a concave break-in-slope where the terrain gradient, based on the 1:1,000 topographical plan, changes from about 37° above the source to between 30° and 32° at the source, reducing to about 24° below the toe of the surface of rupture (Figure 2). The flanks of the main source (trending 160°-340° and 000°-180° on the eastern and western sides respectively) decreased in height from 4.5 m at the crown of the landslide scarp to existing ground level at the toe of surface of rupture. The eastern flank measured 11 m in length while the western flank was 13 m long. The main source width (at the original ground surface) ranged from about 8.5 m at the main scarp to about 7 m near the toe of rupture. The estimated volume of the main source of the landslide was about 265 m³. Cross sections through the main source are shown on Figure 7.

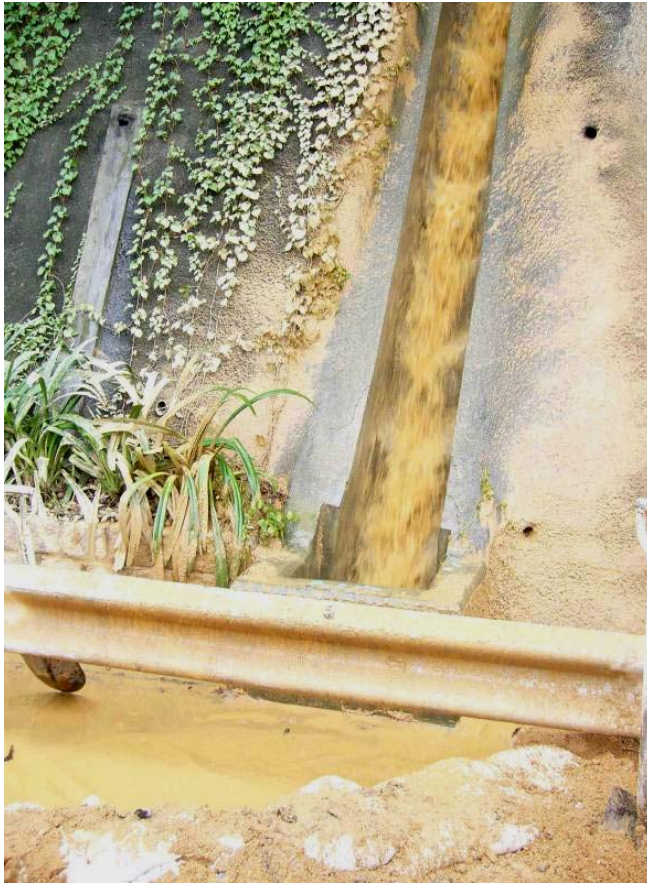
MGSL inspected the landslide site on the morning of 23 August 2005. Muddy water continued to discharge from the natural terrain uphill into the crest channel of slope No. 7SW-D/C2 and a heavy discharge of water from a raking drain on the slope face was observed below the location of the muddy water flow (Plates 3 and 4). Access to the landslide source area was difficult due to dense vegetation and its remote location from the road. The location of the source of the August 2005 landslide was therefore not confirmed until around 12:00 noon on 23 August 2005. Subsequent inspections of the landslide site were carried out on 25 August 2005, 29 August 2005 and 9 February 2006.

Plate 3 - Muddy Water Flow from Stepped Channel of Slope No. 7SW-D/C2 (Photograph taken on 23 August 2005)

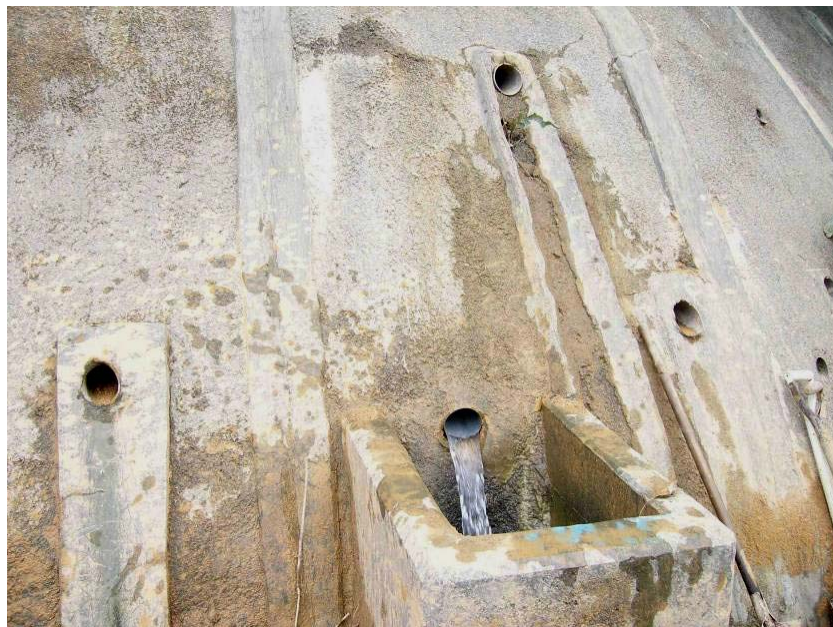
The flow of water from the hillside above slope No. 7SW-D/C2 into the crest channel had ceased by the time of the second MGSL site visit on 25 August 2005, although water continued to discharge from the raking drain installed in slope No. 7SW-D/C2 and was observed during all site visits. The rate of water discharge had diminished by 9 February 2006, but the flow remained moderate.

Plate 4 - Water Flow from Raking Drains of Slope No. 7SW-D/C2 (Photograph taken on 23 August 2005)

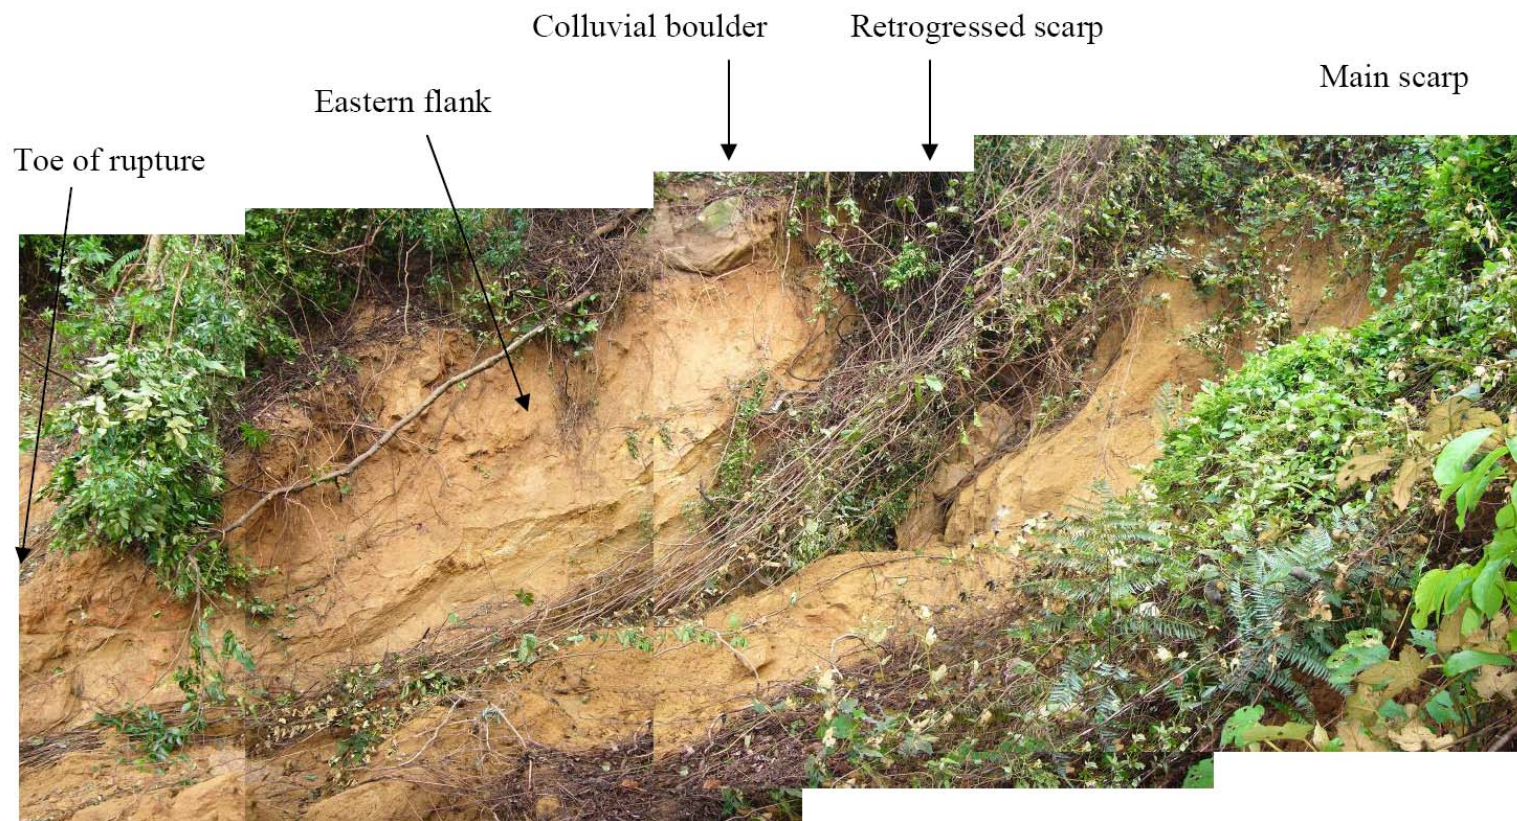
The lower portion of the eastern flank of the landslide is within completely decomposed granite. Distinct areas of kaolinisation, kaolin seams and manganese oxide staining were noted within the CDG (Plates 11 to 13). The main flow of surface water was observed along the base of the landslide scar near the eastern flank. The general planar nature of the upper part of this side-scarp suggested the influence of relict discontinuities. About 1 m of the upper portion of the eastern flank comprised bouldery colluvium with several boulders on the ground surface (Plate 7).

Plate 7 - General View of the Eastern Flank of the Landslide (Photograph taken on 24 August 2005)

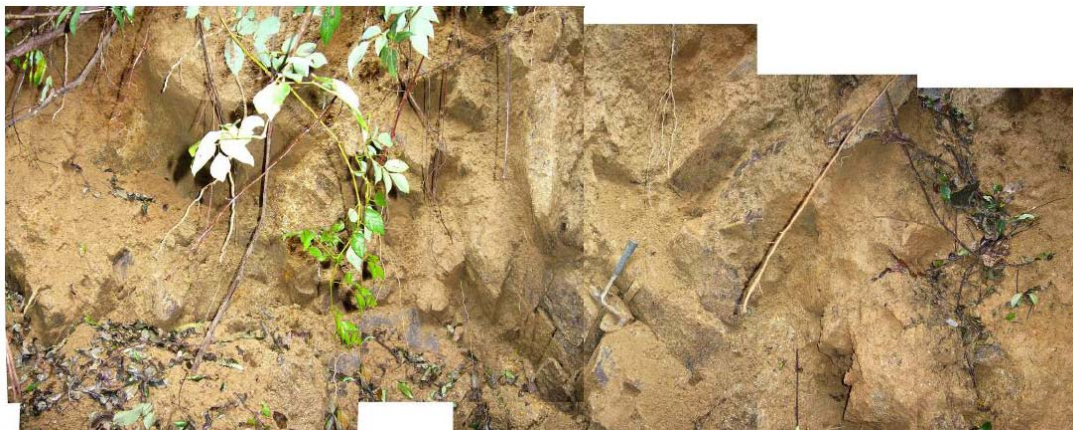
The material observed within the secondary source comprised MDG with considerable displacement and dilation between individual MDG blocks of up to 200 mm, in the lower part of the main scarp (Plates 9 and 10). Surface water flow was observed in the secondary source during the first inspection on 23 August 2005 but it had ceased by the second inspection on 25 August 2005.

Plate 9 - Main Scarp of Retrogressive Area Showing In-situ Material with Distinct Block Displacement and Joint Opening (Photograph taken on 29 August 2005)

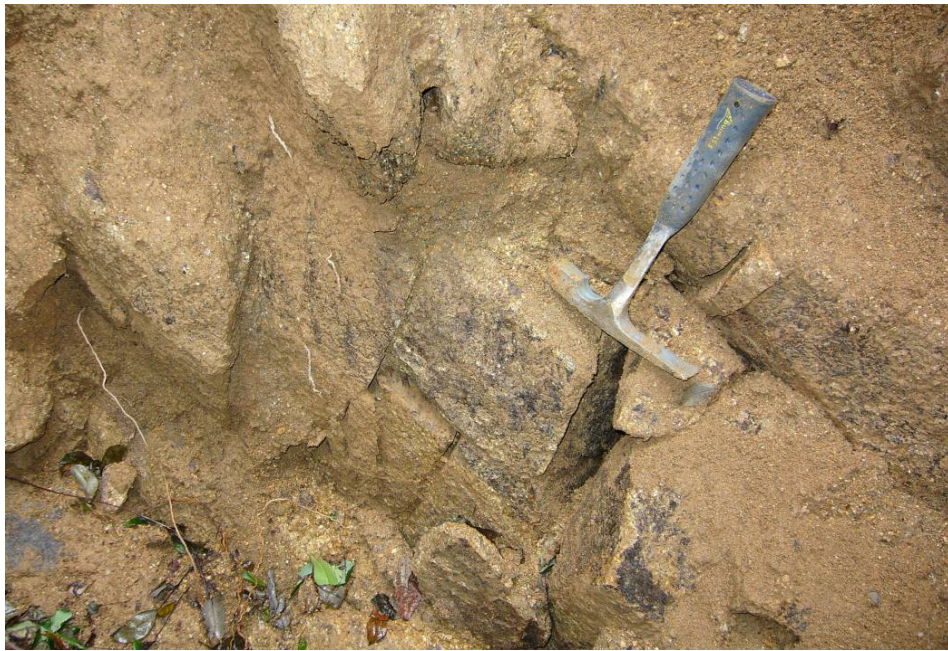
Plate 10 - Close-up View of Main Scarp of Retrogressive Area Showing Distinct Block Displacement and Joint Opening (Photograph taken on 29 August 2005)

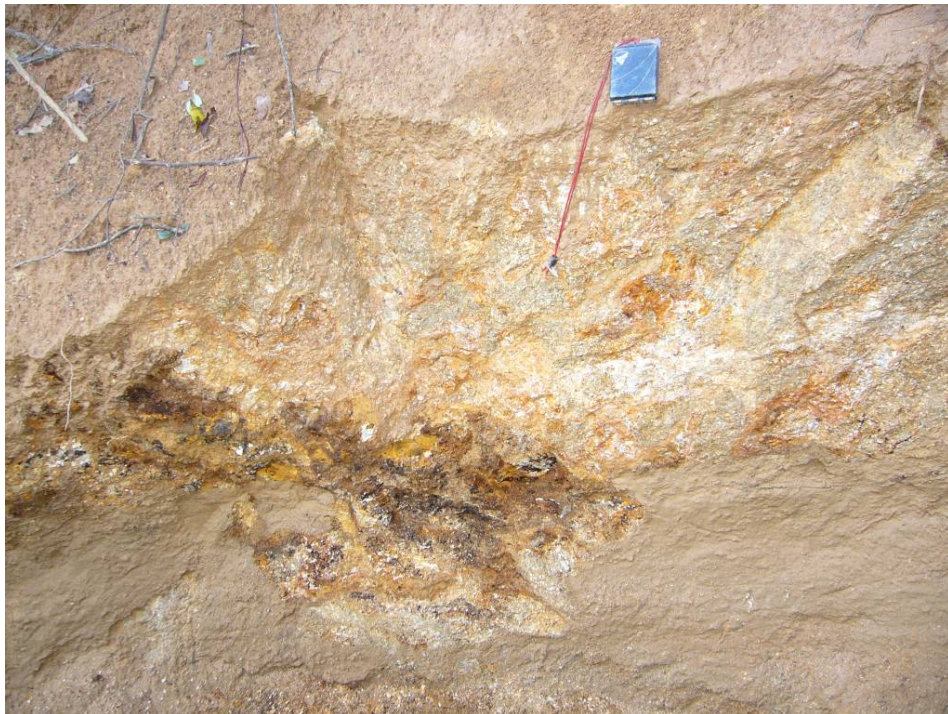
Plate 11 - General View of East Flank: Water Eroded Ditch below the Base of Photograph, Toe of Rupture to Left (Photograph taken on 29 August 2005)

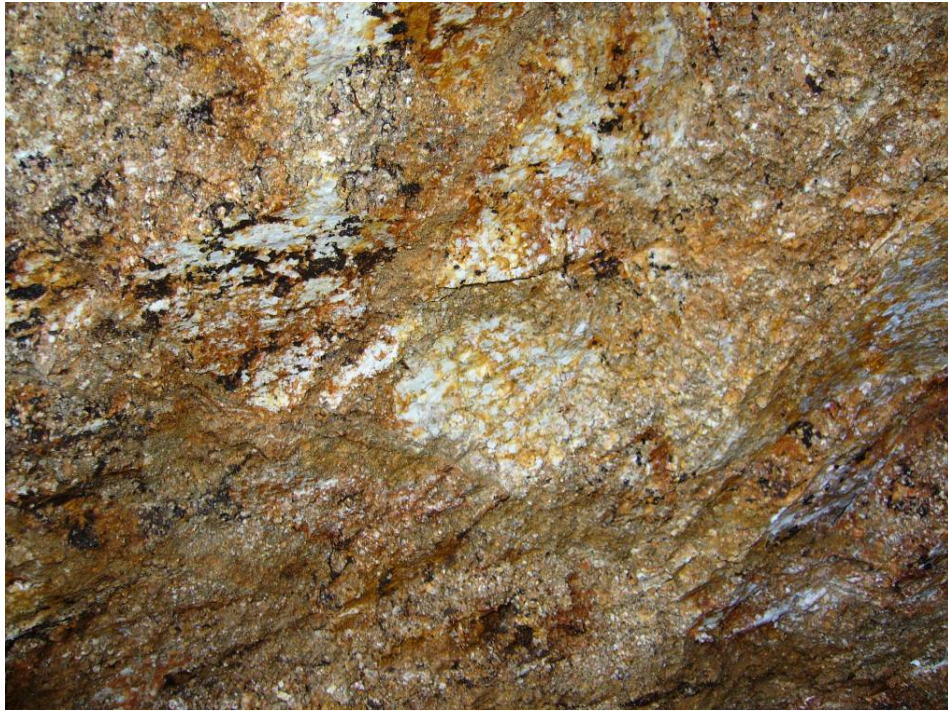
Plate 12 - Kaolinisation of Grade V Granite in the Eastern Flank
(Photograph taken on 29 August 2005)

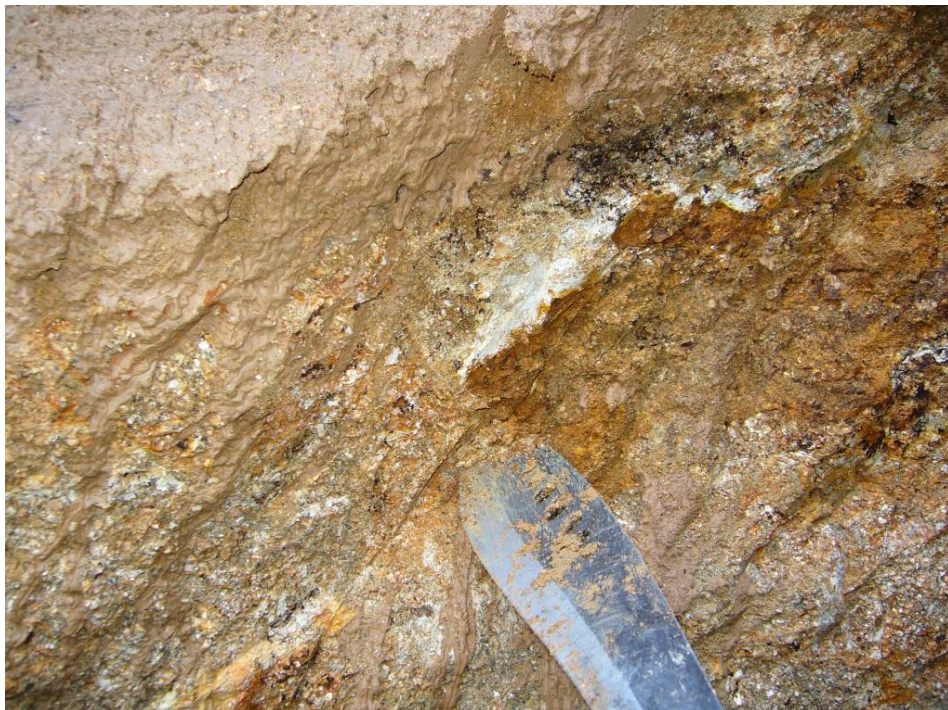
Plate 13 - Close-up View of Pocket of Kaolin Seam in Eastern Flank
(Photograph taken on 29 August 2005)

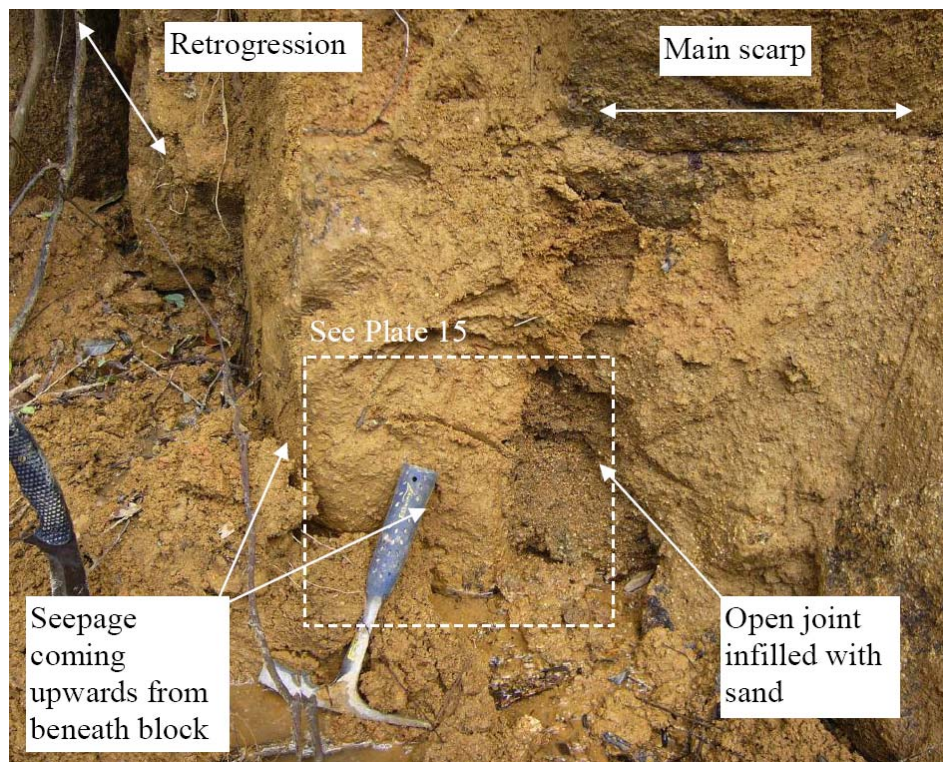
Plate 14 - Active Seepage from Centre of Main Scarp
(Photograph taken on 29 August 2005)

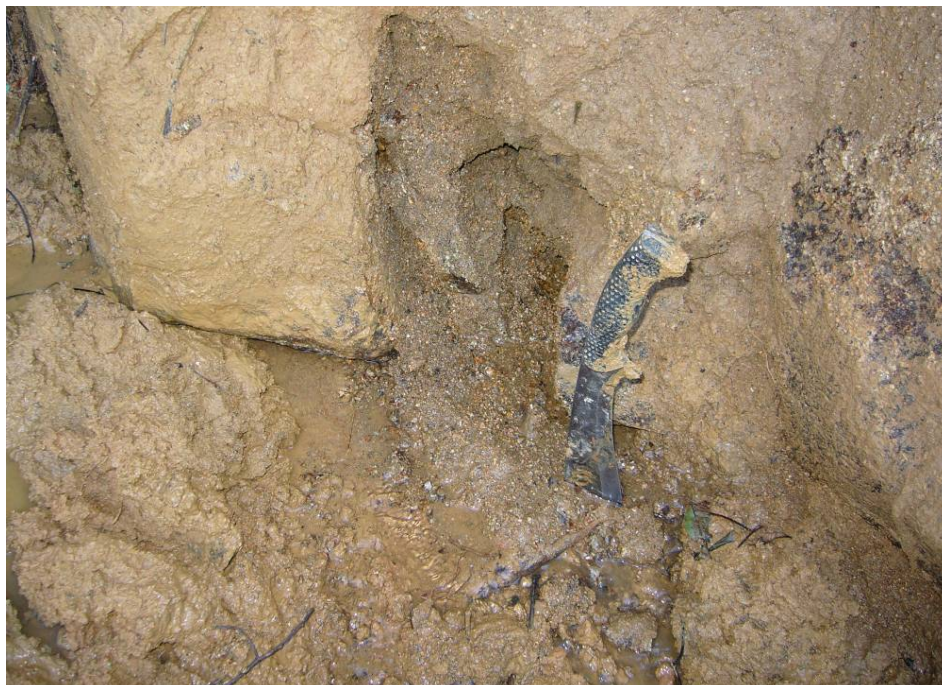
Plate 15 - Close-up View of Seepage at Centre of Main Scarp
(Photograph taken on 29 August 2005)

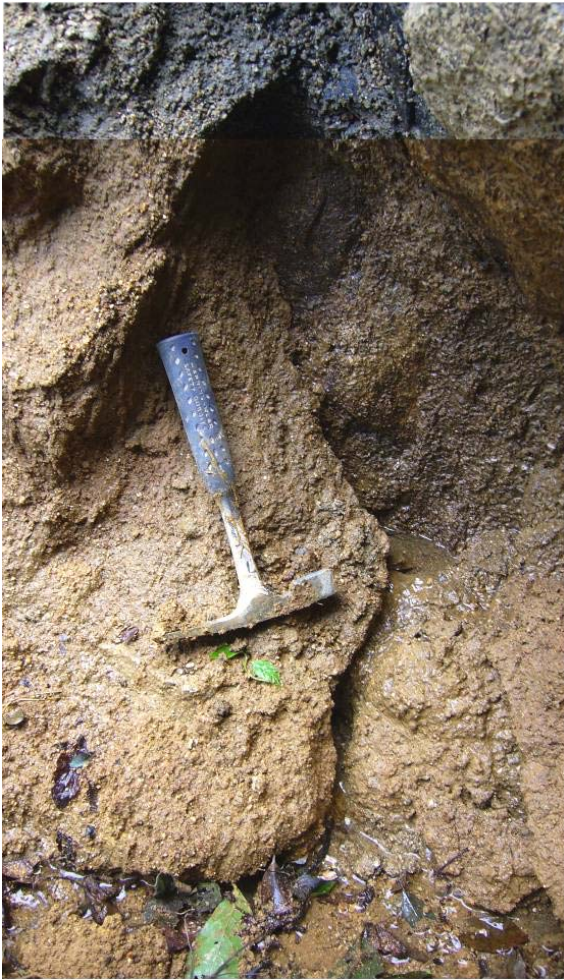
Plate 16 - Active Seepage from Sandy Joint Infill of Main Scarp (Photograph taken on 29 August 2005)

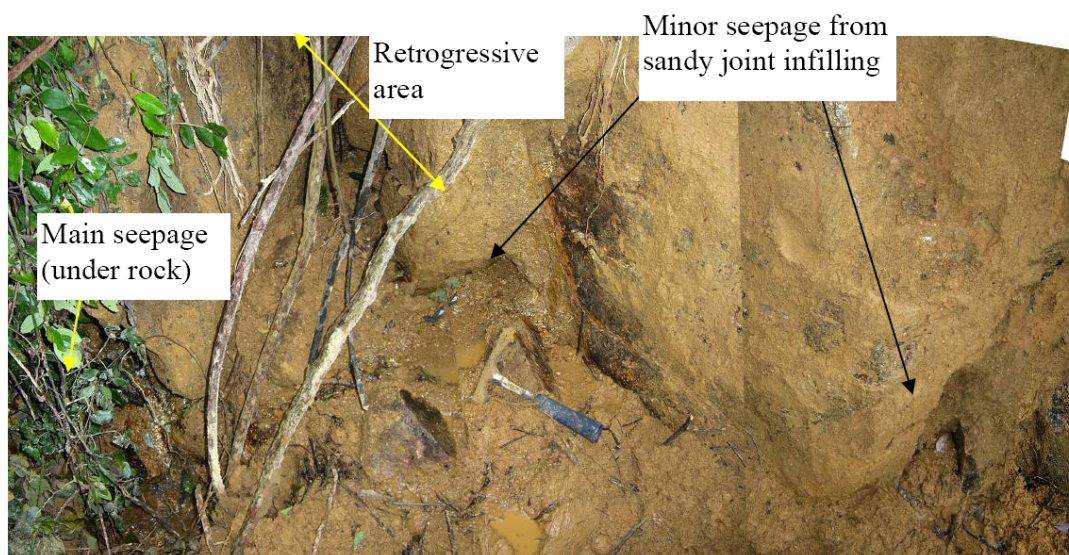
Plate 17 - Active Seepage from Centre of Main Scarp and from Retrogressive Area (Photograph taken on 29 August 2005)

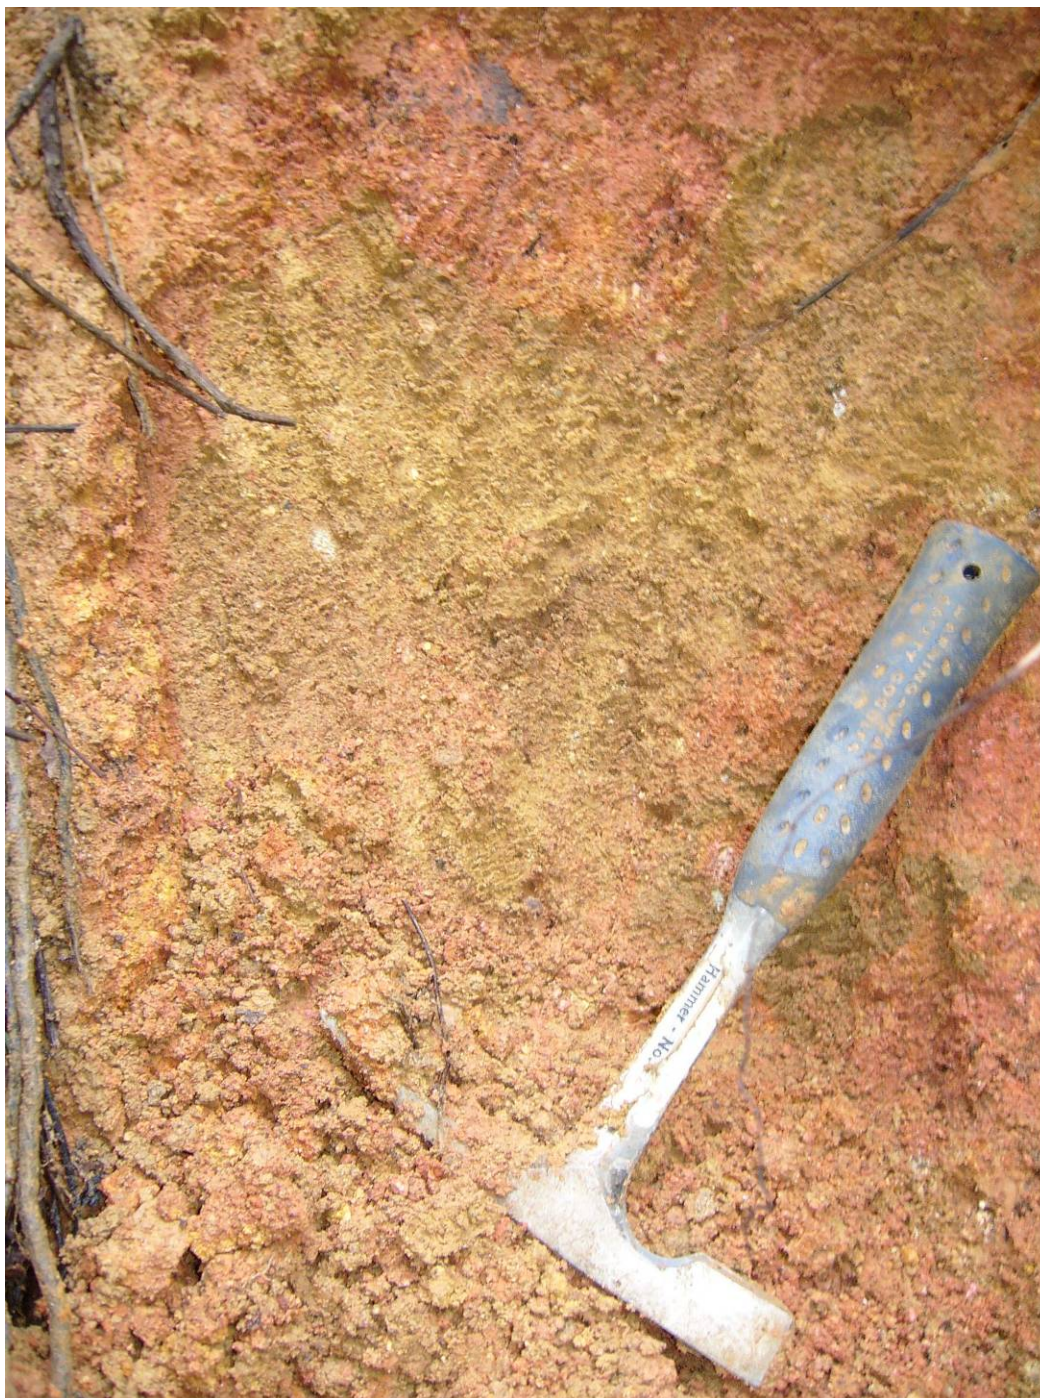
The western flank of the landslide comprised a bouldery colluvium towards the toe of rupture and towards the ground surface. The colluvium comprised cobbles and boulders of MDG to CDG up to 1 m across in a sandy silt matrix. There was no evidence of in-situ structure (Plate 18).

Plate 18 - Exposure of Colluvium in Western Flank
(Photograph taken on 24 August 2005)

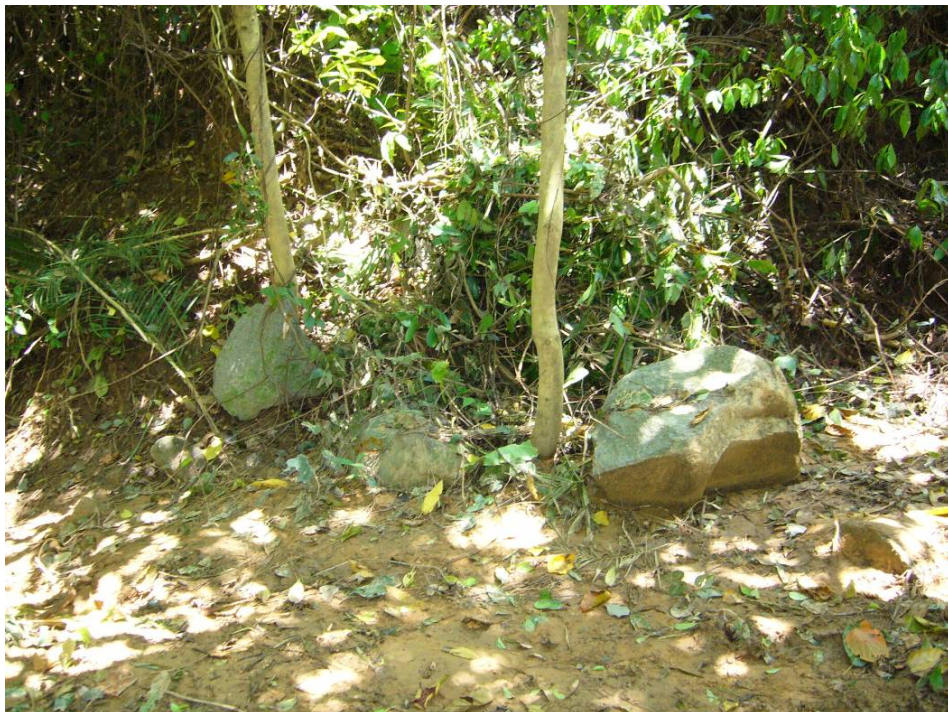
Plate 22 - Displaced Boulders on Northeast Flank of Debris Trail
(Photograph taken on 29 August 2005)

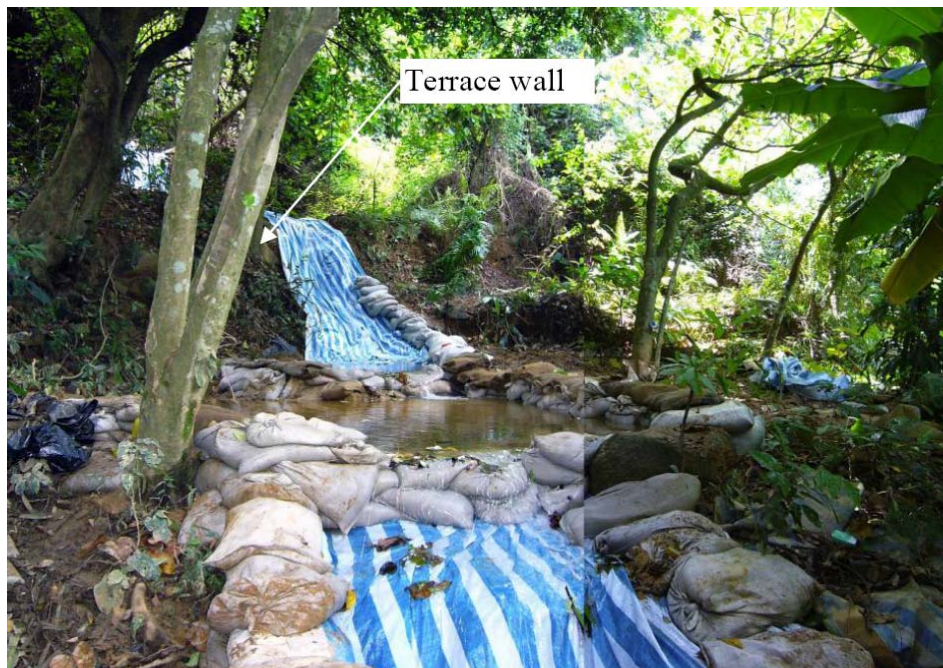
Chainage CH 58 - chainage CH 78: Debris trail width 5 m; hillside inclined at 24°; maximum depth of debris 0.25 m. About 1 m high edge of cultivation terrace at chainage CH 66. The maximum travel distance of the debris noted at about chainage CH 78 (Plates 23 and 24).

Plate 23 - Debris Trail: Looking Upslope to Terrace Wall
(Photograph taken on 29 August 2005)

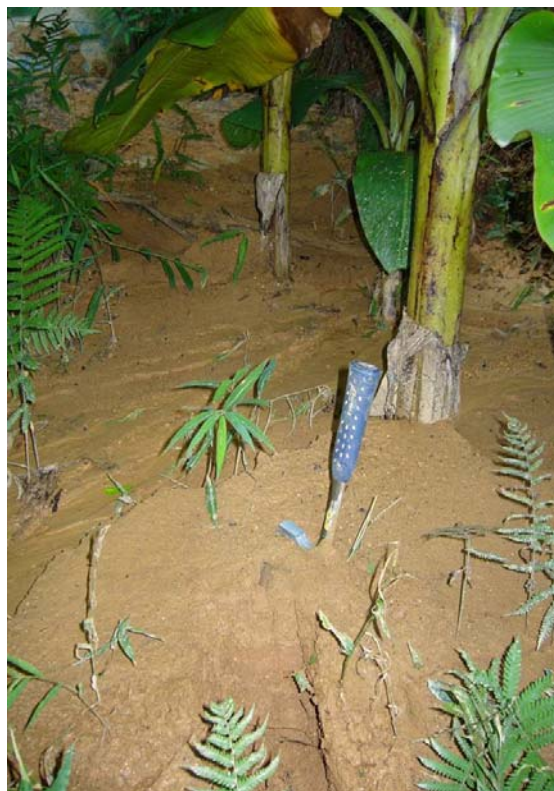
Plate 24 - Sandy Debris on Terrace Surface (Photograph taken on 29 August 2005)

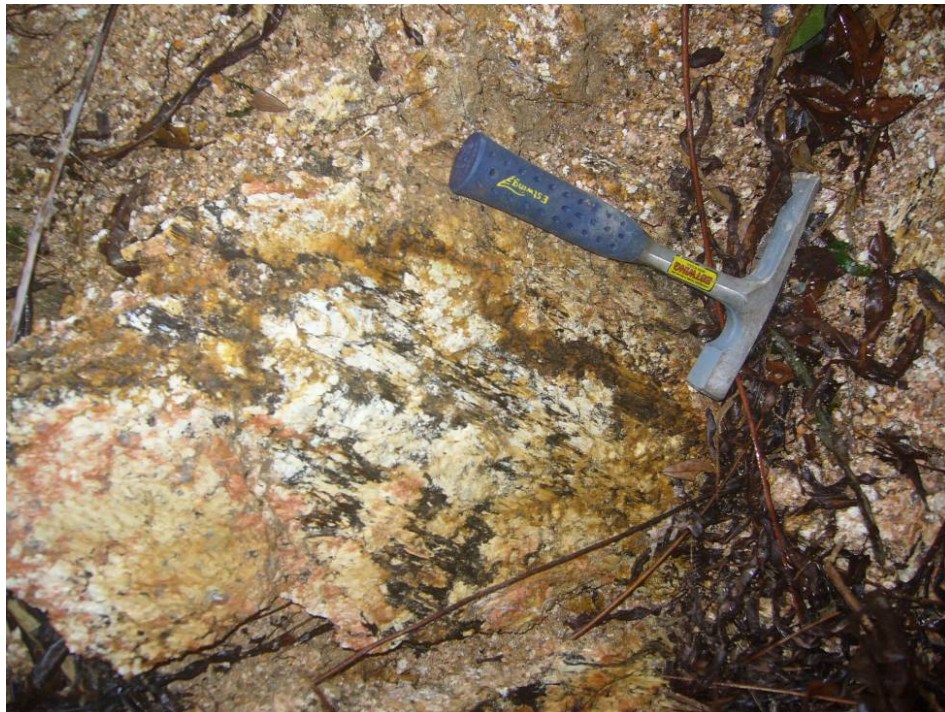
Three minor exposures were identified uphill of the August 2005 failure. Completely decomposed coarse-grained granite with substantial kaolinisation was observed at slope No. 7SW-D/C570 located about 30 m southeast of the August 2005 landslide (Figure 2). A minor failure from the slope face exposed the granite which also exhibited slickensides plunging down dip on a thick manganese-stained relict joint surface dipping $72^{\circ}/170^{\circ}$ (Plate 28).

Plate 28 - Exposure Upslope (Southwest) of Landslide Source, Showing Decomposed Granite, Kaolinisation and Slickensides (Photograph taken on 25 August 2005)

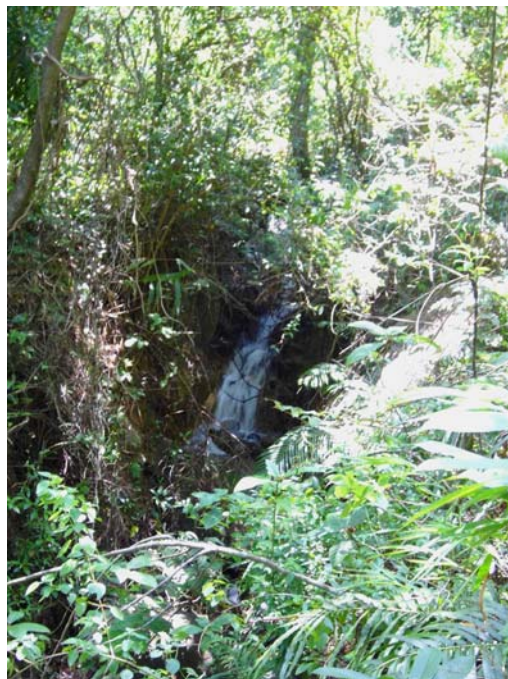
Plate 30 - Active Water Discharge in Stream Upslope (Southeast) of Landslide Scar (Photograph taken on 23 August 2005)
