**GEO Technical Guidance Note No. 49 (TGN 49)
Supplementary Guidelines on Precautionary Measures for Mitigating
the Risks of Excessive Ground Loss and Sinkhole Formation Associated
with Deep Excavations**

Issue No.: 1	Revision: A	Date: 16.11.2023	Page: 1 of 23
--------------	-------------	------------------	---------------

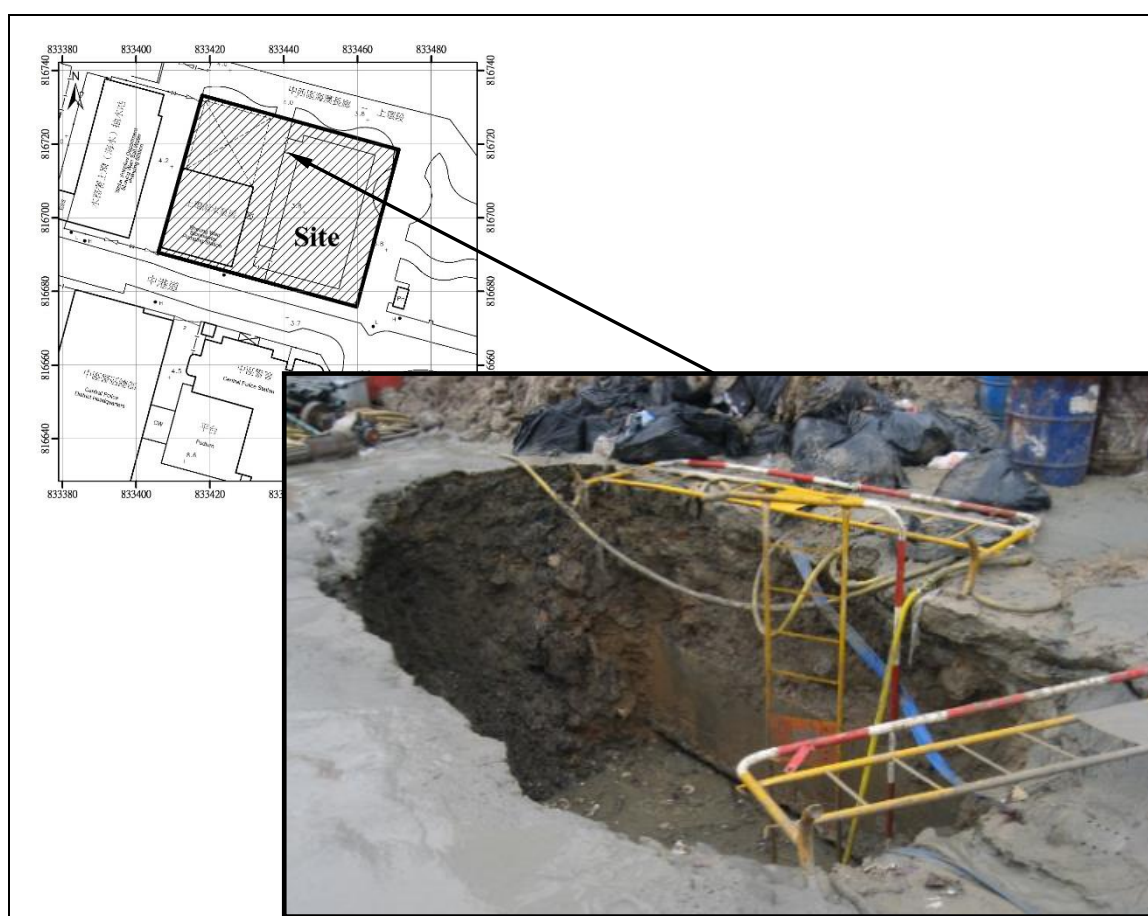
Case No. 1: Sheung Wan Stormwater Pumping Station

Date of incident	2007	Ground Conditions	
Size of sinkhole	3m x 2m x 2m deep	Top soil layers	14-35m FILL, 0-14m MD
Consequences	Site area affected	Depth of rockhead	60m
Major preceding construction activities	Pre-boring of H-pile foundation in progress	Depth of groundwater table	1.5 to 3.5m
Drilling method/ flushing medium	Concentric drilling/ air

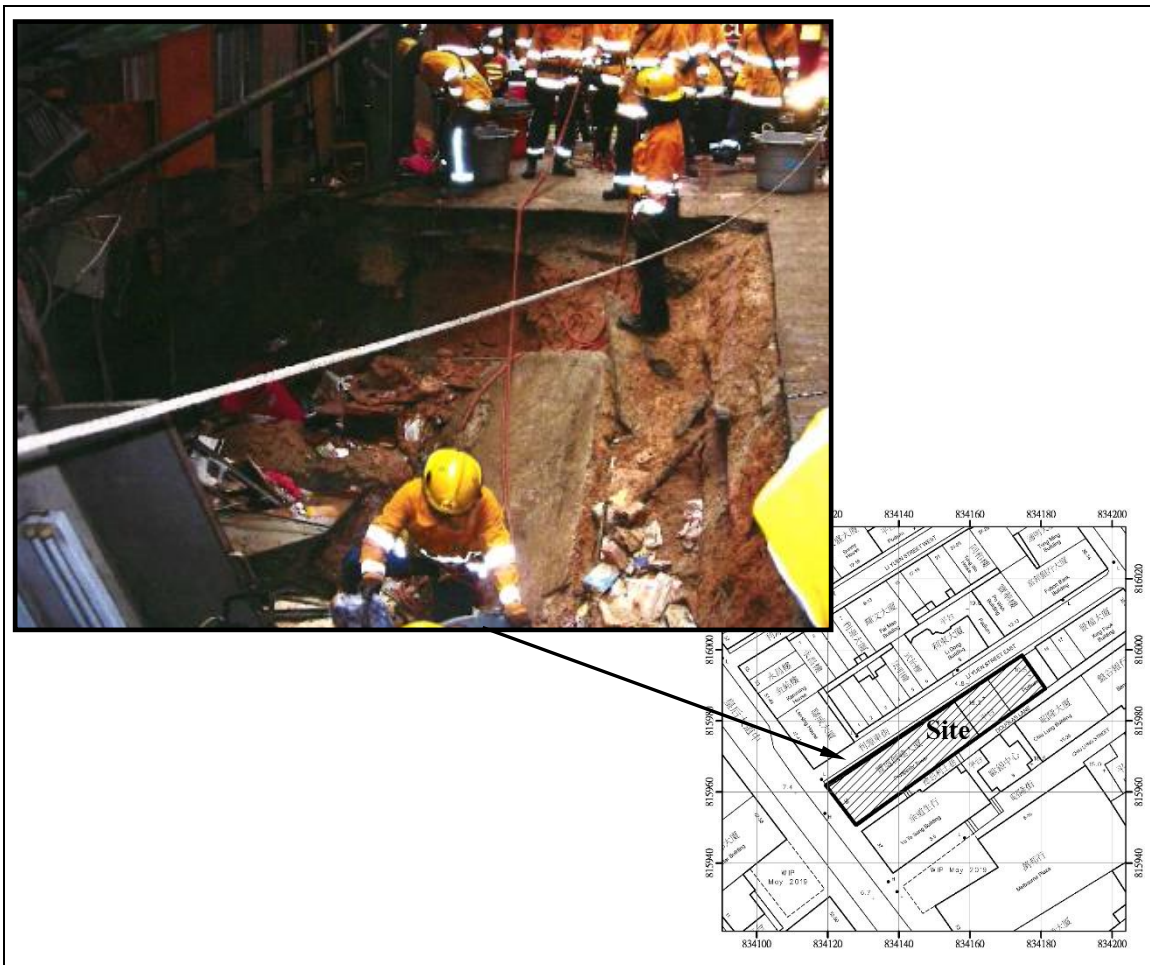
Case No. 2: Li Yuen Street East

Date of incident	<i>24 April 2007</i>	Ground Conditions	
Size of sinkhole	<i>8 m x 3.5 m x 3.5 m deep</i>	Top soil layer	<i>9m ALL</i>
Consequences	<i>Several hawker stalls and 4 hawkers fell into the sinkhole. The hawkers suffered injuries and property loss.</i>	Depth of rockhead	<i>40m</i>
Major preceding construction activities	<i>Pre-boring of H-pile foundation in progress</i>	Depth of groundwater table	<i>1 to 4m</i>
Drilling method/ flushing medium	<i>ODEX drilling/ air</i>

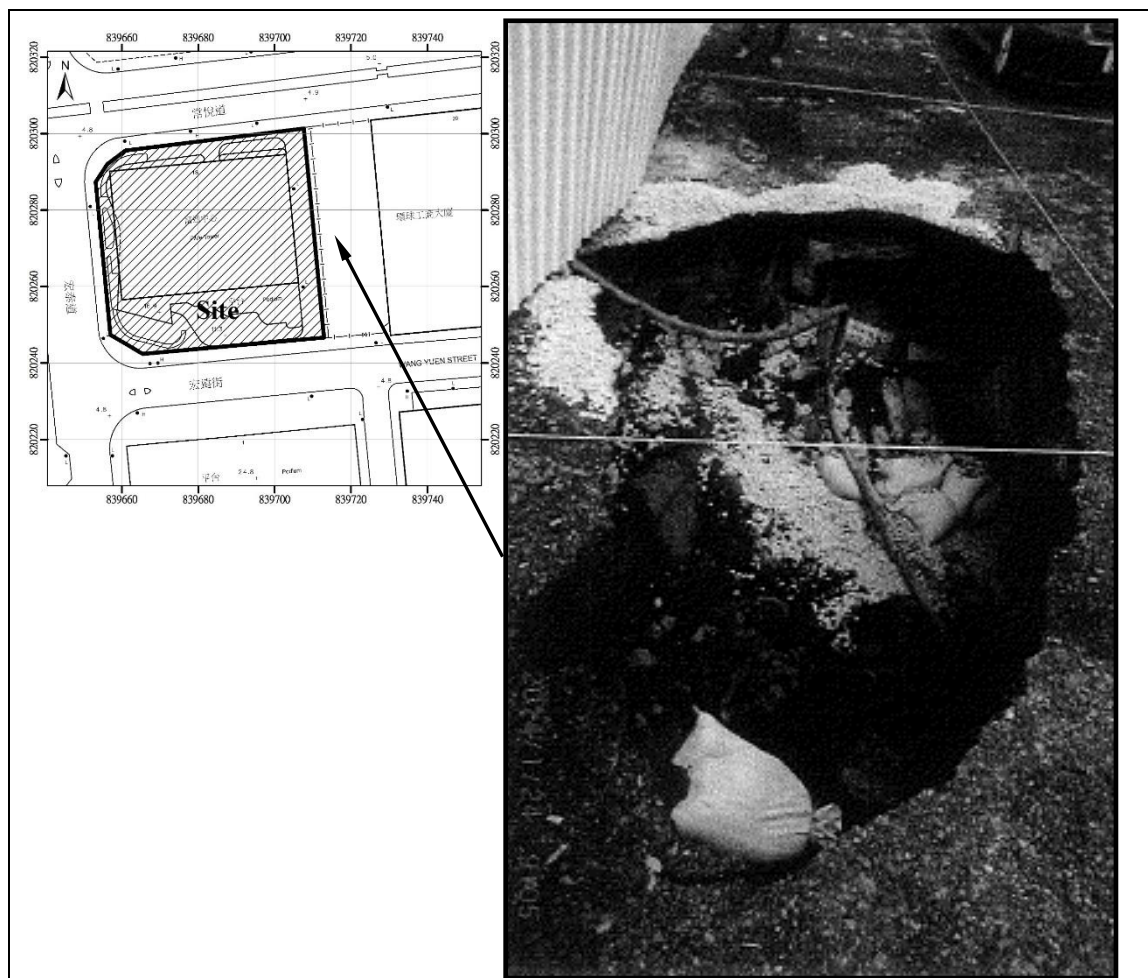
Case No. 3: Sheung Yuet Road

Date of incident	24 January 2014	Ground Conditions	
Size of sinkhole	1m x 0.8m x 1m deep	Top soil layers	15m FILL, 20m ALL
Consequences	Adjacent carpark area affected	Depth of rockhead	60m
Major preceding construction activities	Sheet-piling works with pre-drilling in progress	Depth of groundwater table	Near ground surface
Drilling method/ flushing medium	Concentric drilling/ air

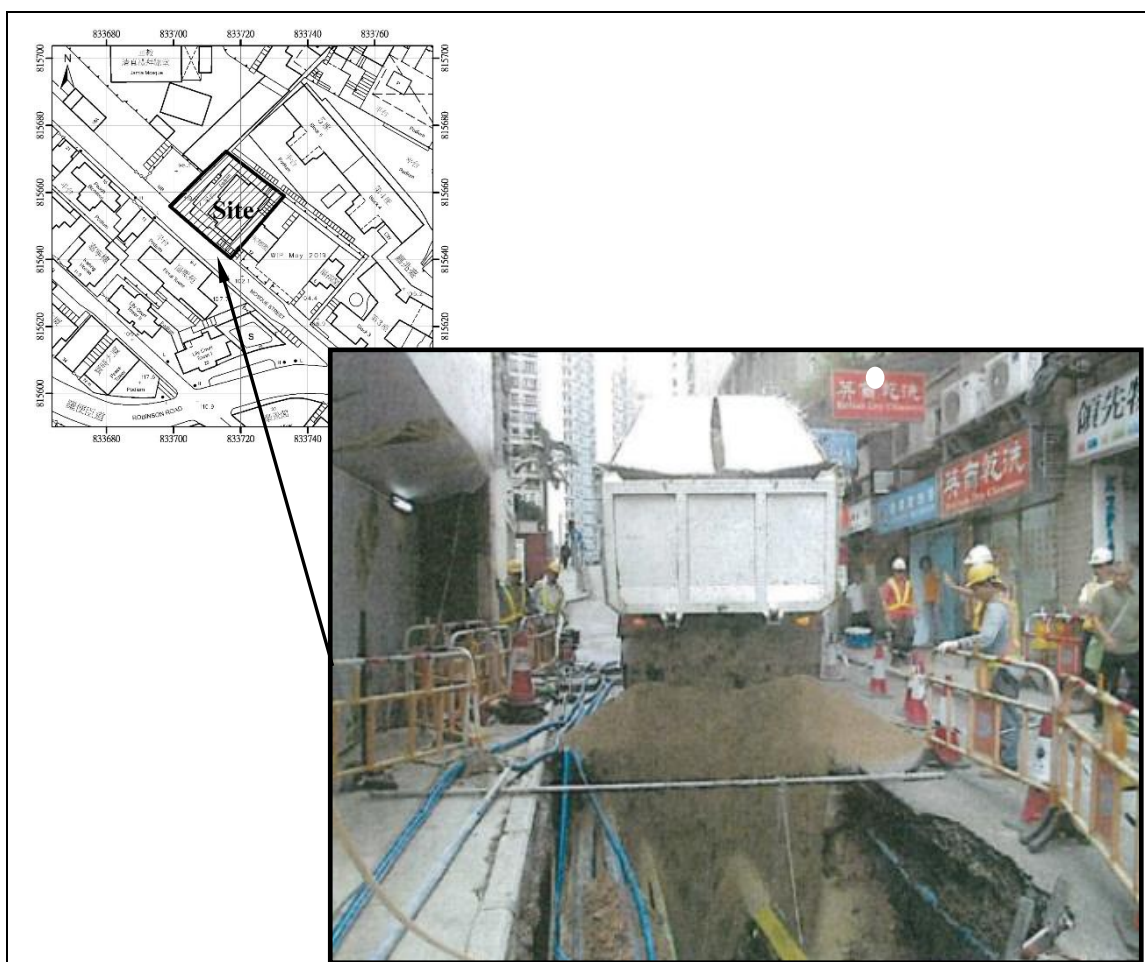
Case No. 4: 14-18 Mosque Street

Date of incident	27 October 2014	Ground Conditions	
Size of sinkhole	2m x 2m x 2.5m deep	Top soil layer	16m COLL
Consequences	Mosque Street partly closed temporarily		
Major preceding construction activities	Drilling works for pipe piles completed recently and that for grout curtain in progress	Depth of rockhead	60m
Drilling method/ flushing medium	Concentric drilling/air for pipe piles	Depth of groundwater table	20m

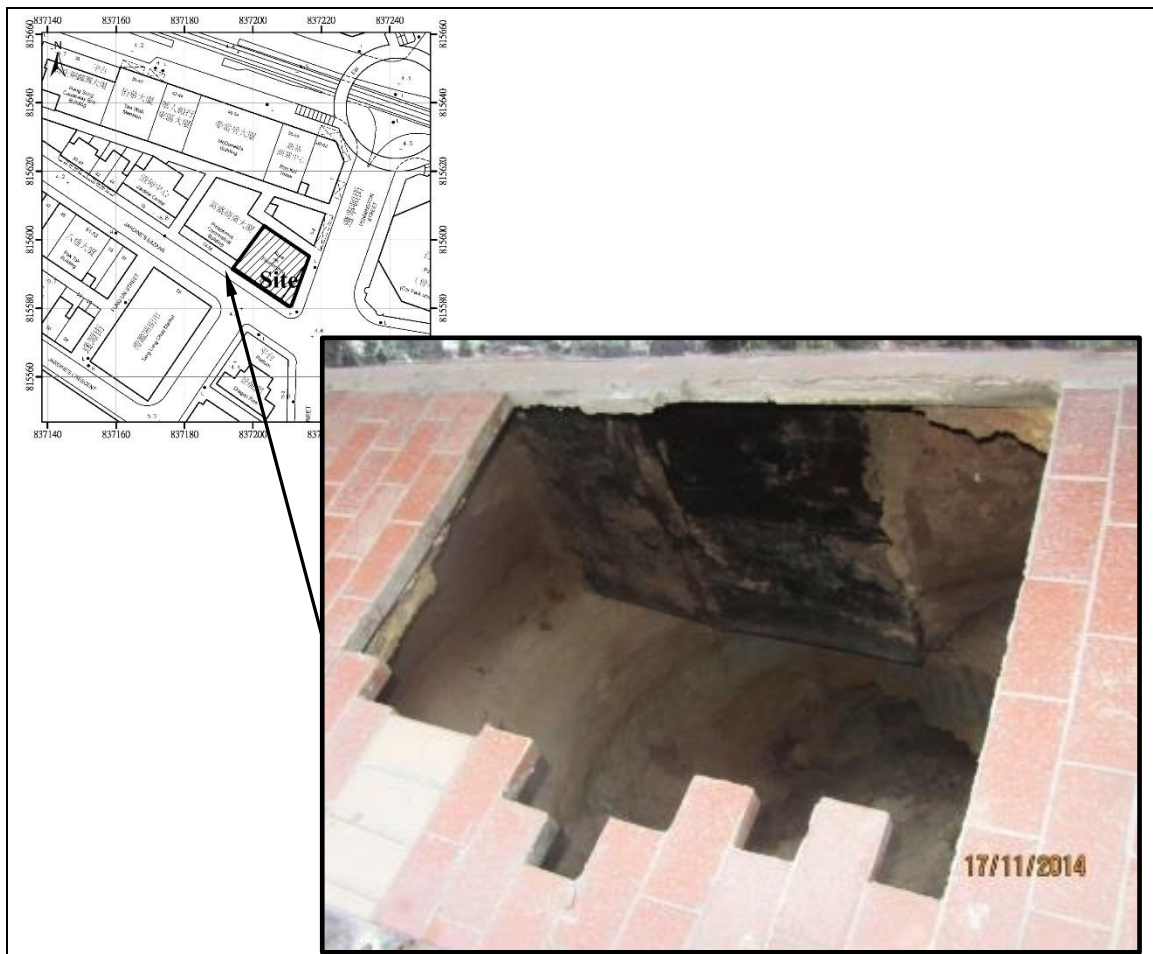
Case No. 5: 60-66 Jardine's Bazaar

Date of incident	<i>17 November 2014</i>	Ground Conditions	
Size of sinkhole	<i>3.5m x 2.5m x 3.7m deep</i>	Top soil layers	<i>25m FILL/ALL</i>
Consequences	<i>A passer-by fell into the sinkhole and suffered injuries</i>		
Major preceding construction activities	<i>Bulk excavation within pipe pile & grout curtain cofferdam in progress</i>	Depth of rockhead	<i>40m</i>
Drilling method/ flushing medium	<i>Concentric drilling/air for pipe piles</i>	Depth of groundwater table	<i>1 to 2.5m</i>

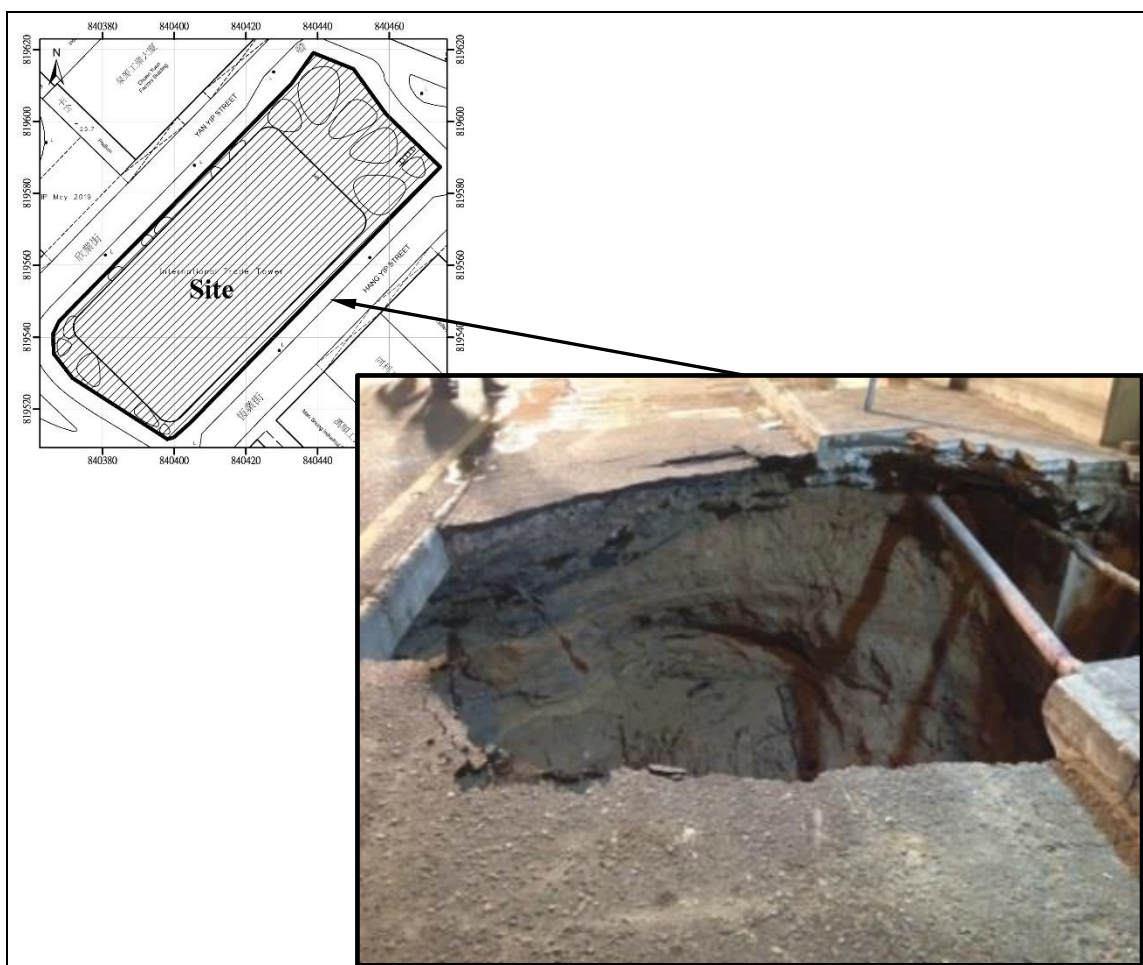
Case No. 6: Hang Yip Street, Ngau Tau Kok

Date of incident	9 September 2015	Ground Conditions	
Size of sinkhole	5m x 5m x 4m deep	Top soil layers	14m FILL/MD
Consequences	A large truck and the driver of a pick-up truck fell into the sinkhole		
Major preceding construction activities	Bored pile foundation works in progress	Depth of rockhead	100m
Drilling method/ flushing medium	Reverse circulation drilling/ water	Depth of groundwater table	2 to 3m

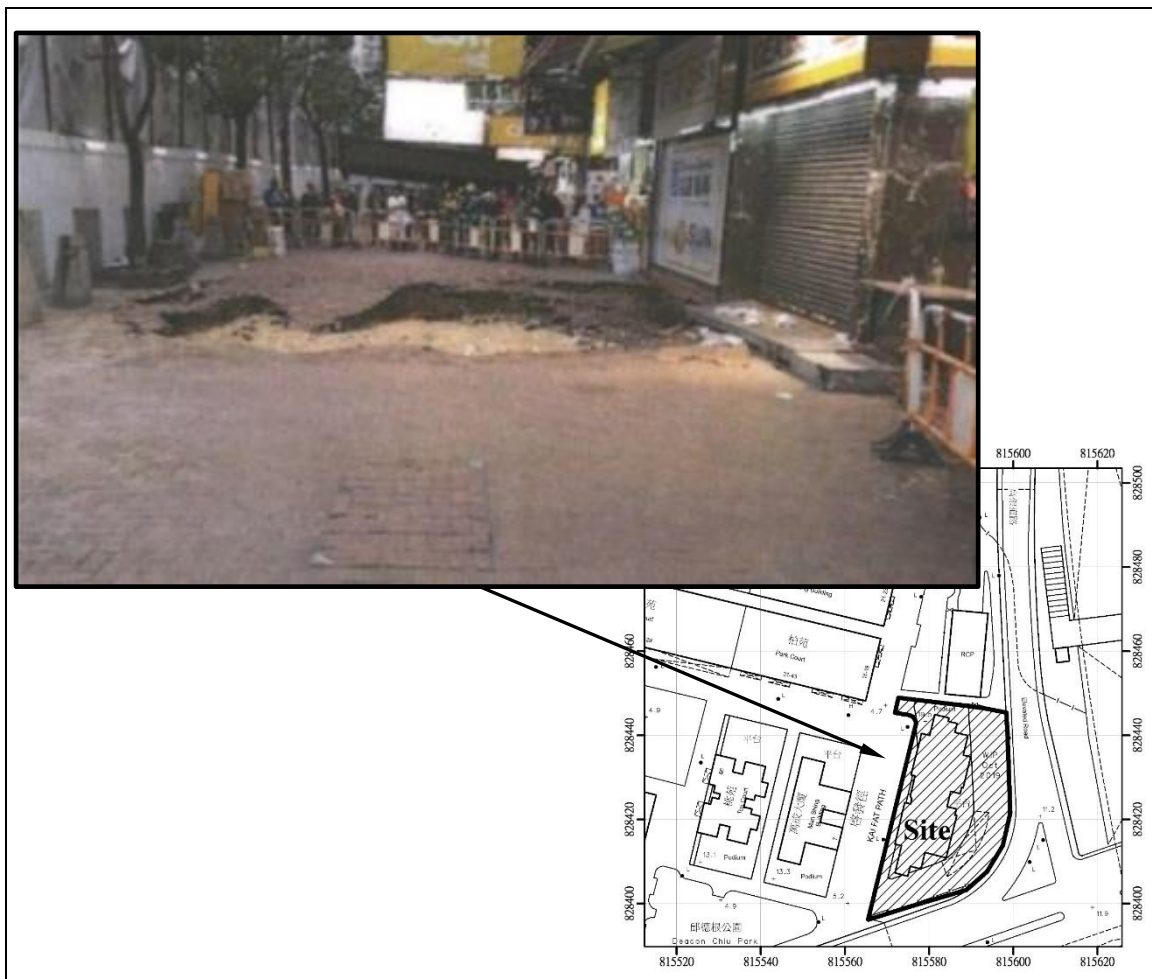
Case No. 7: Yan Ching Street, Tuen Mun

Date of incident	<i>22 March 2016</i>	Ground Conditions	
Size of sinkhole	<i>10m x 5m x 1m deep</i>	Top soil layers	<i>12m FILL/MD/ALL</i>
Consequences	<i>Adjacent footpath temporarily closed</i>		
Major preceding construction activities	<i>Bored pile foundation works in progress</i>	Depth of rockhead	<i>50 to 80m</i>
Drilling method/ flushing medium	<i>Reverse circulation drilling/ water</i>	Depth of groundwater table	<i>Near ground surface</i>

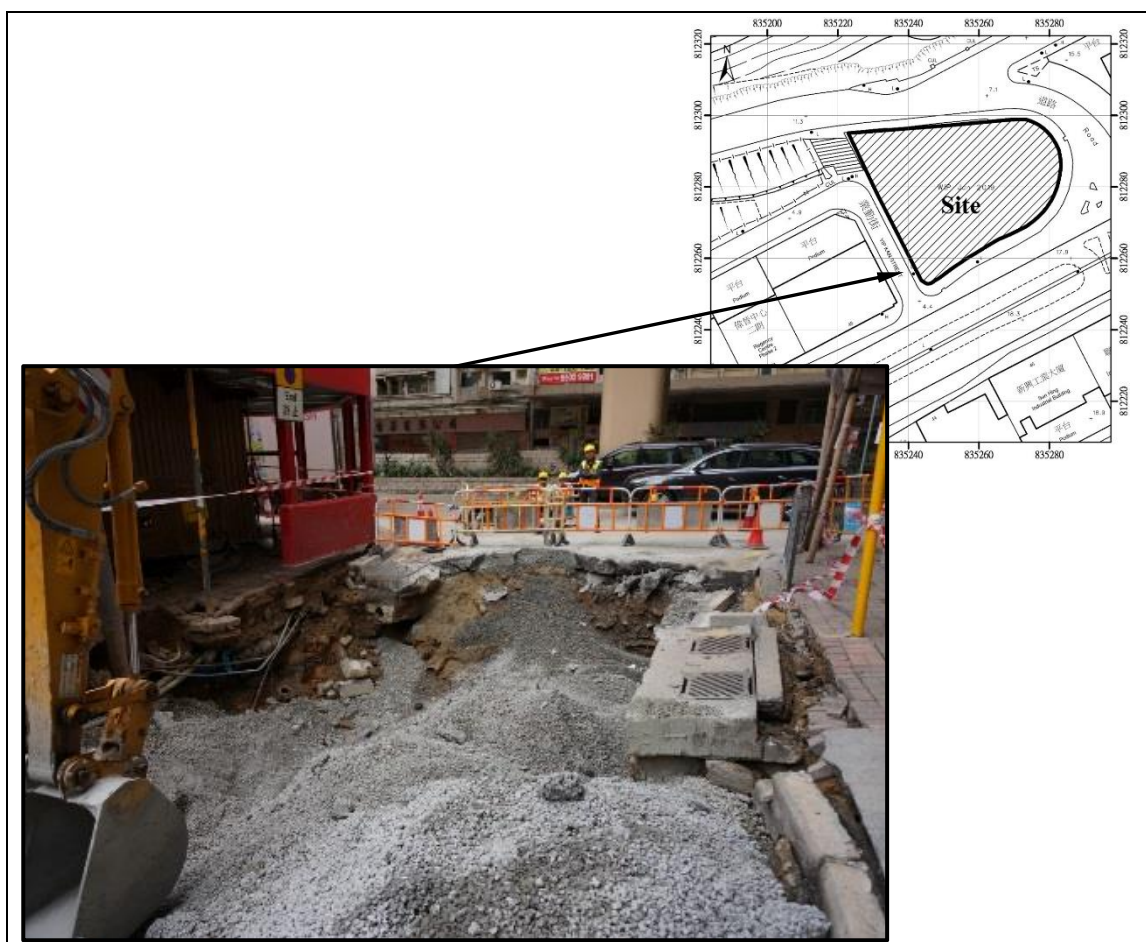
Case No. 8: Yip Kan Street, Aberdeen

Date of incident	<i>23 February 2019</i>	Ground Conditions	
Size of sinkhole	<i>4m x 4m x 6m deep</i>	Top soil layers	<i>9m FILL/MD</i>
Consequences	<i>Yip Kan Street entirely closed temporarily</i>		
Major preceding construction activities	<i>Bulk excavation within pipe pile & grout curtain cofferdam in progress</i>	Depth of rockhead	<i>20m</i>
Drilling method/ flushing medium	<i>Concentric drilling/air for pipe piles</i>	Depth of groundwater table	<i>2 to 3m</i>

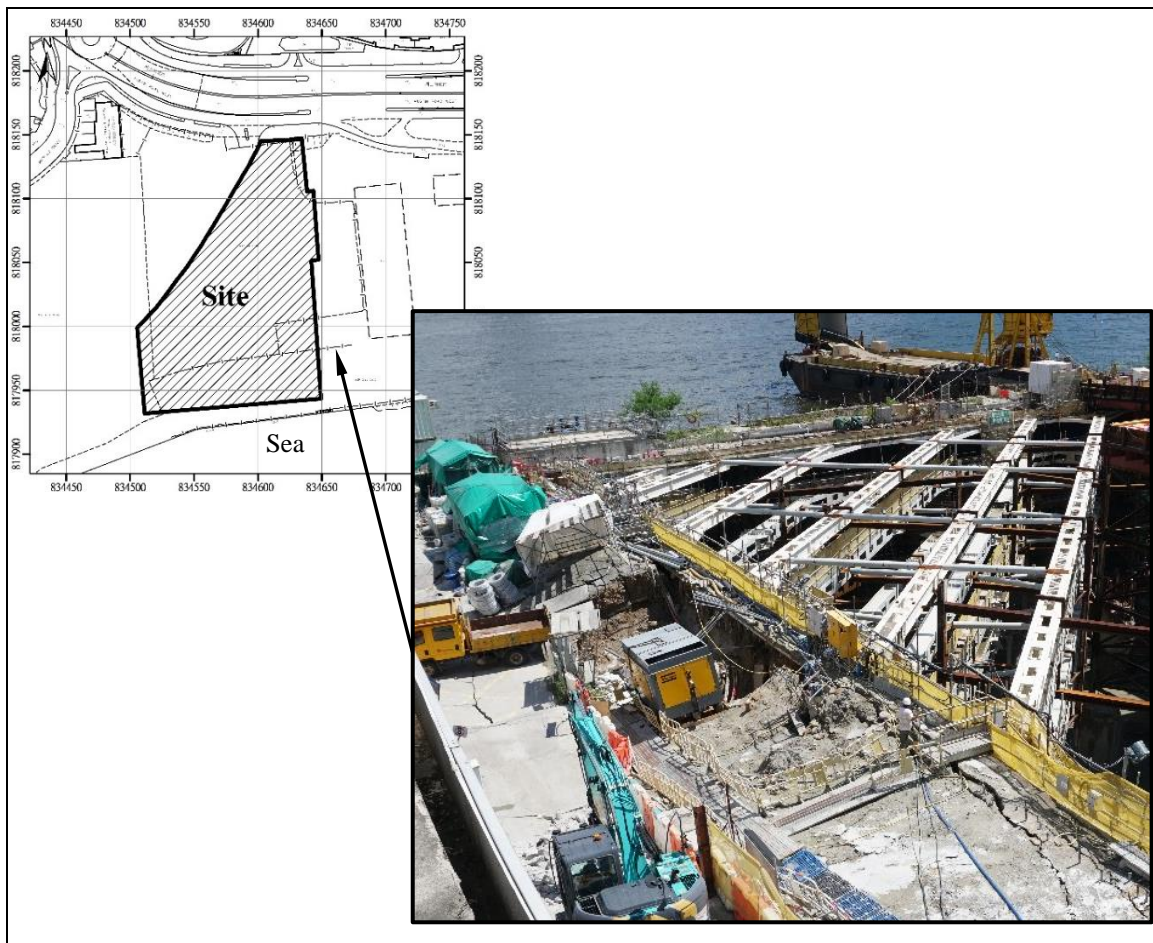
Case No. 9: Lyric Theatre, West Kowloon Cultural District

Date of incident	<i>25 July 2019</i>	Ground Conditions	
Size of sinkhole	<i>10m x 5m x 2m deep</i>	Top soil layers	<i>27m FILL</i>
Consequences	<i>Adjacent site area/site office affected</i>		
Major preceding construction activities	<i>Bulk excavation within pipe pile & grout curtain cofferdam in progress</i>	Depth of rockhead	<i>45m</i>
Drilling method/ flushing medium	<i>Concentric drilling/air for pipe piles</i>	Depth of groundwater table	<i>2m</i>

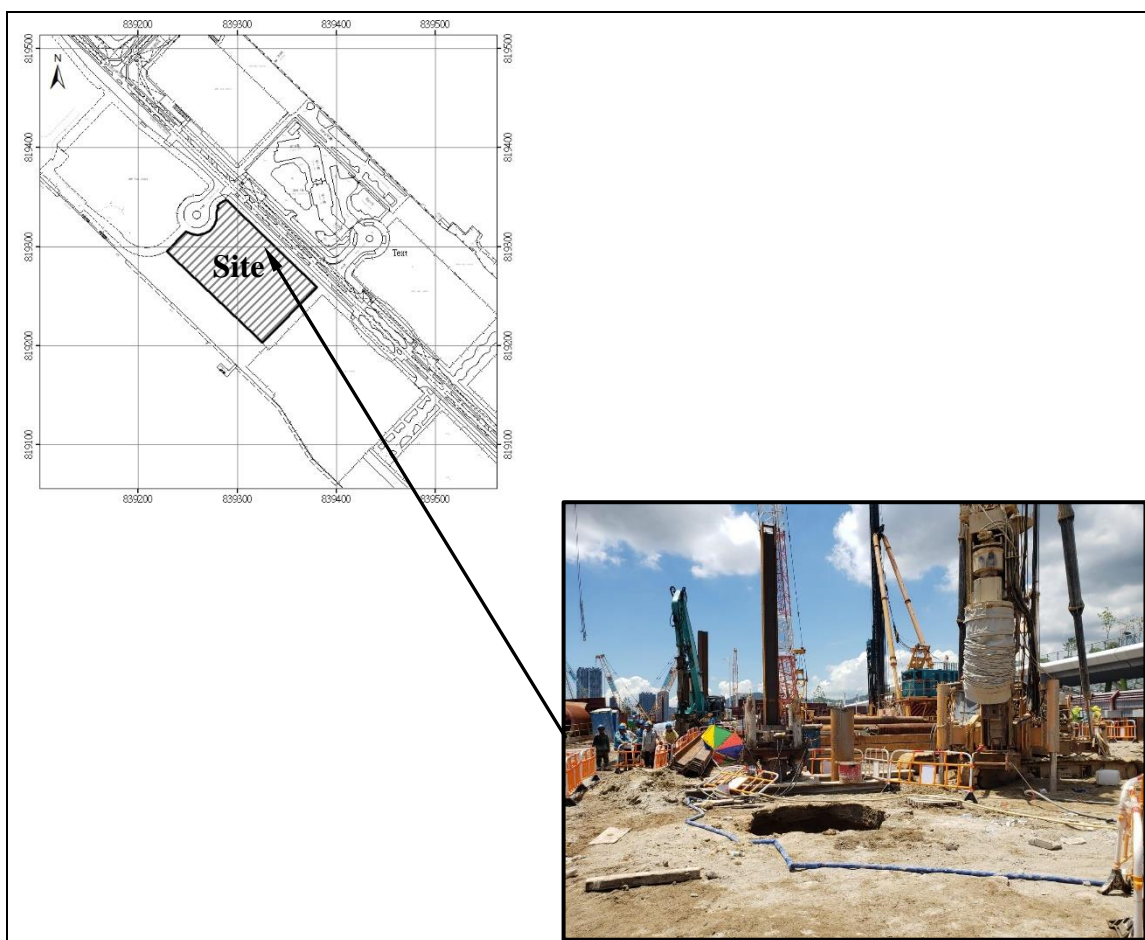
Case No. 10: Shing Fung Road, Kai Tak Former Runway

Date of incident	23 July 2020	Ground Conditions	
Size of sinkhole	2.5m diameter x 2.7m deep	Top soil layers	10m FILL
Consequences	A site personnel fell into the sinkhole and subsequently passed away		3-8m MD
			20-25m ALL
Major preceding construction activities	Pipe pile foundation works in progress	Depth of rockhead	60m
Drilling method/ flushing medium	Concentric drilling/air for pipe piles	Depth of groundwater table	2 to 3m

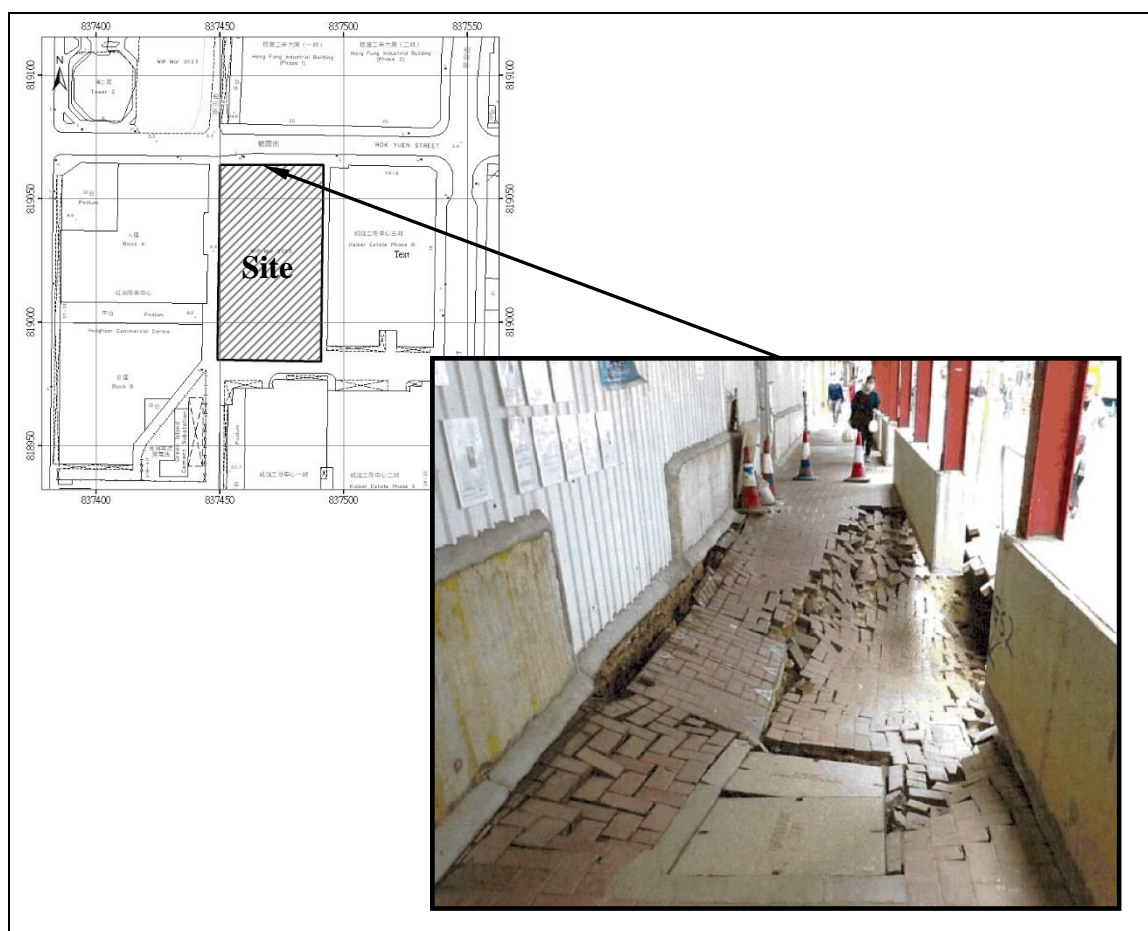
Case No. 11: Hok Yuen Street, Hung Hom

Date of incident	<i>3 April 2023</i>	Ground Conditions	
Size of sinkhole	<i>6m x 3.8m x 1.8m deep</i>	Top soil layers	<i>6-12m FILL</i>
Consequences	<i>Adjacent footpath temporarily closed, carriageway undermined and underground utilities damaged</i>		
Major preceding construction activities	<i>Bulk excavation within pipe pile & grout curtain cofferdam in progress</i>	Depth of rockhead	<i>32m</i>
Drilling method/ flushing medium	<i>Concentric drilling/air for pipe piles</i>	Depth of groundwater table	<i>2 to 2.5m</i>

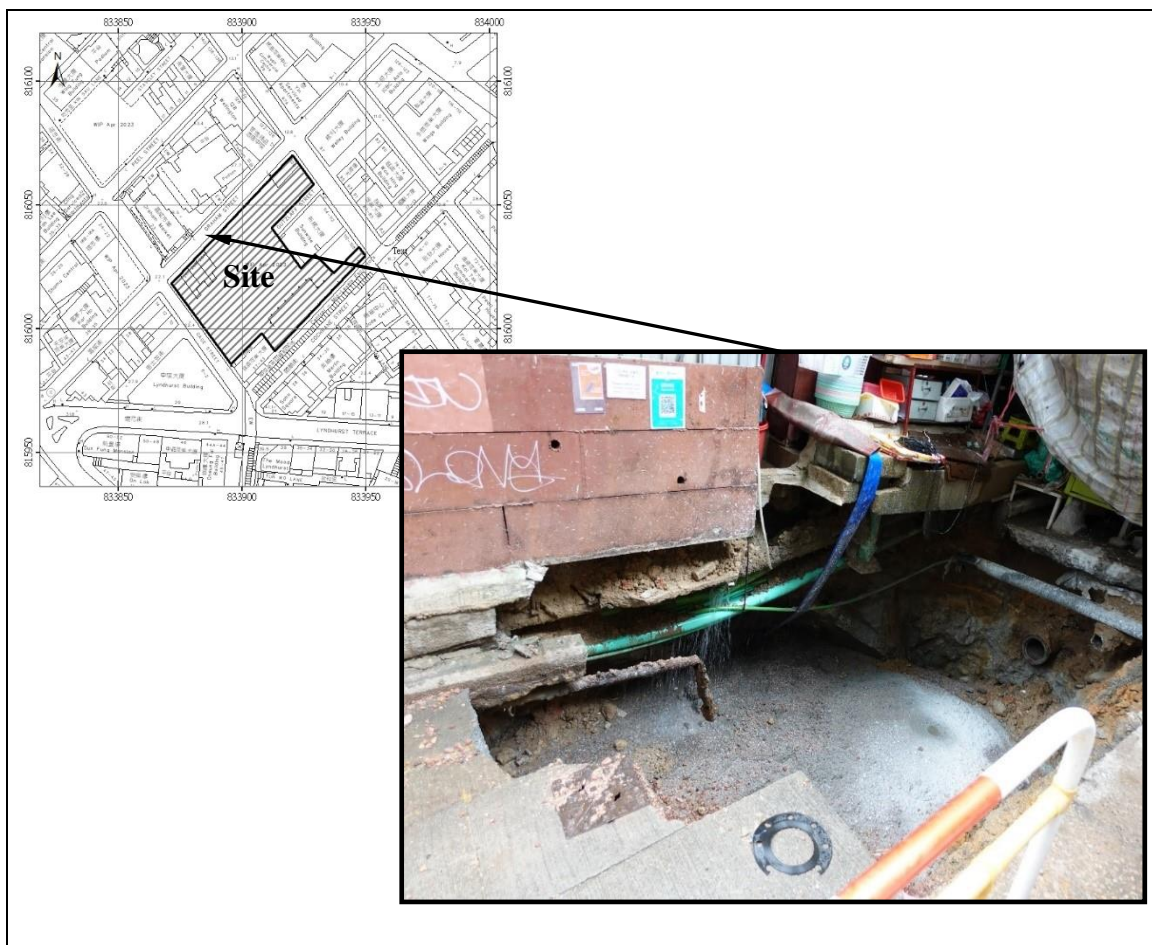
Case No. 12: Graham Street, Central

Date of incident	6 May 2023	Ground Conditions	
Size of sinkhole	5m x 2m x 7m deep	Top soil layers	3m FILL
Consequences	Two workers fell into the sinkhole; three water pipes broken; adjacent footpath and market stalls affected		
Major preceding construction activities	Final excavation level reached; pile cap construction in progress	Depth of rockhead	>100m
Drilling method/ flushing medium	Concentric drilling/air for pipe piles; oscillator and grab for bored piles	Depth of groundwater table	0.5 to 1.5m

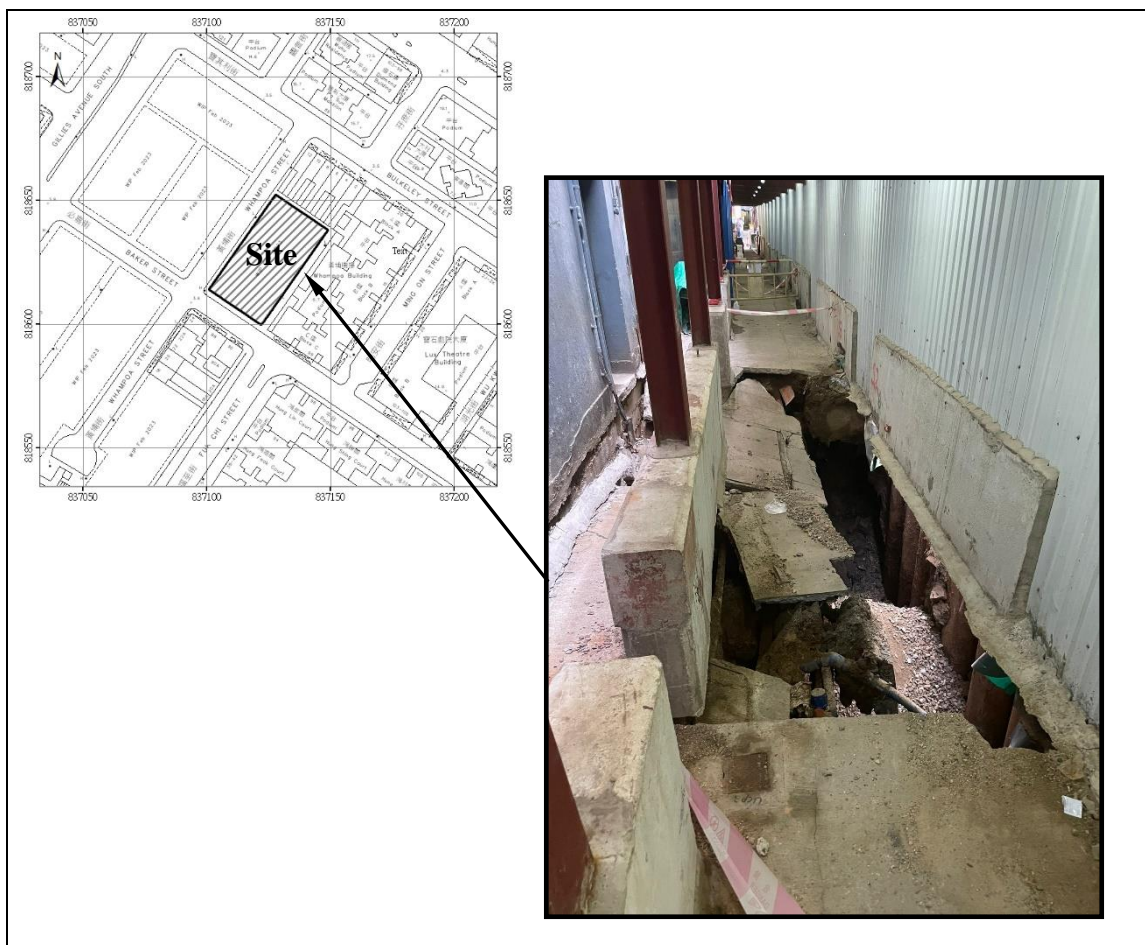
Case No. 13: Whampoa Street, Hung Hom

Date of incident	20 May 2023	Ground Conditions	
Size of sinkhole	5m x 1m x 5m deep	Top soil layers	4-5m FILL
Consequences	Adjacent service lane temporarily closed and underground utilities damaged		3-4m MD
			4m ALL
Major preceding construction activities	Bulk excavation within pipe pile & grout curtain cofferdam in progress	Depth of rockhead	18 to 20m
Drilling method/ flushing medium	Concentric drilling/air for pipe piles	Depth of groundwater table	1.6m

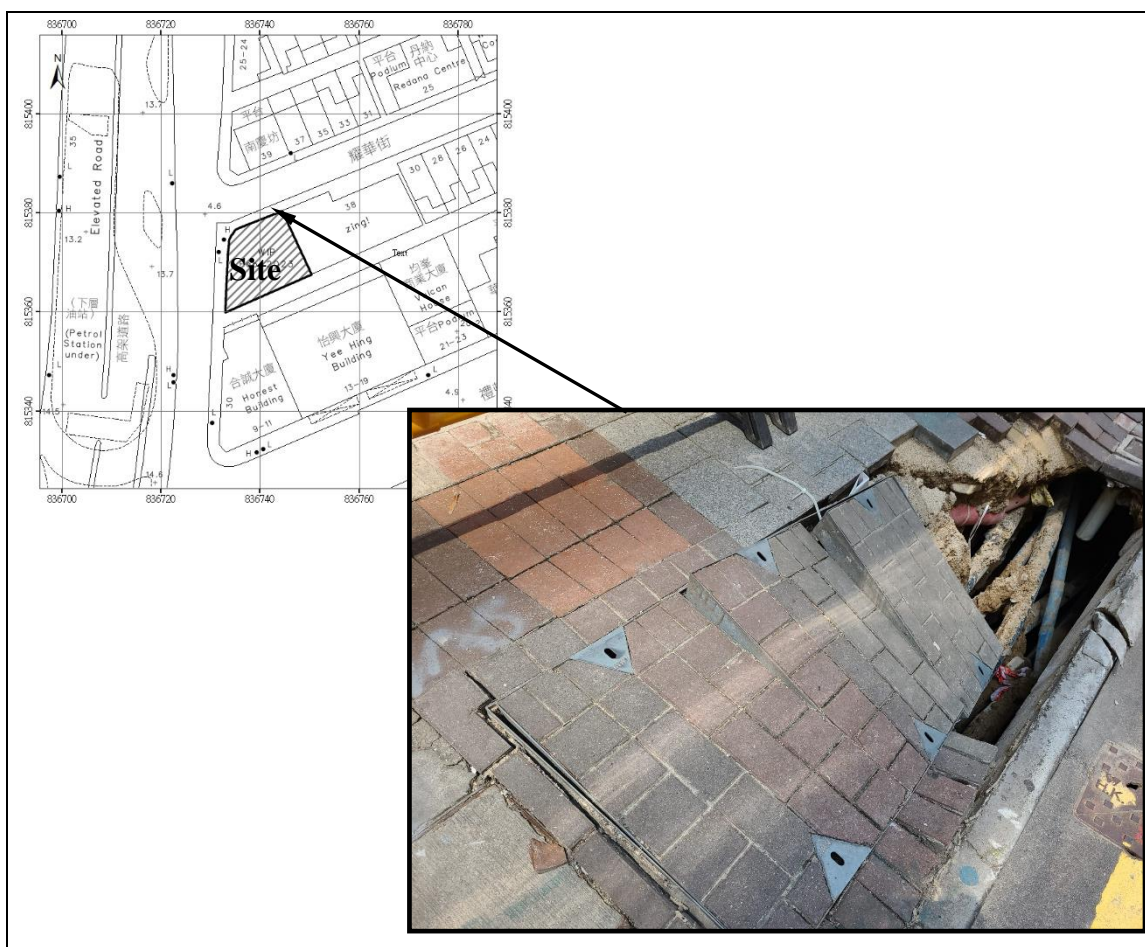
Case No. 14: Yiu Wa Street, Causeway Bay

Date of incident	25 May 2023	Ground Conditions	
Size of sinkhole	4.4m x 2.1m x 2.8m deep	Top soil layers	10m FILL
Consequences	Adjacent walkway and part of the road (Yiu Wa Street) was closed		4-9m MD
			4-6m ALL
Major preceding construction activities	Bulk excavation and final level reached	Depth of rockhead	35 to 45m
Drilling method/ flushing medium	Press-in method for sheet pile and vibrator for channel planking	Depth of groundwater table	0.3m

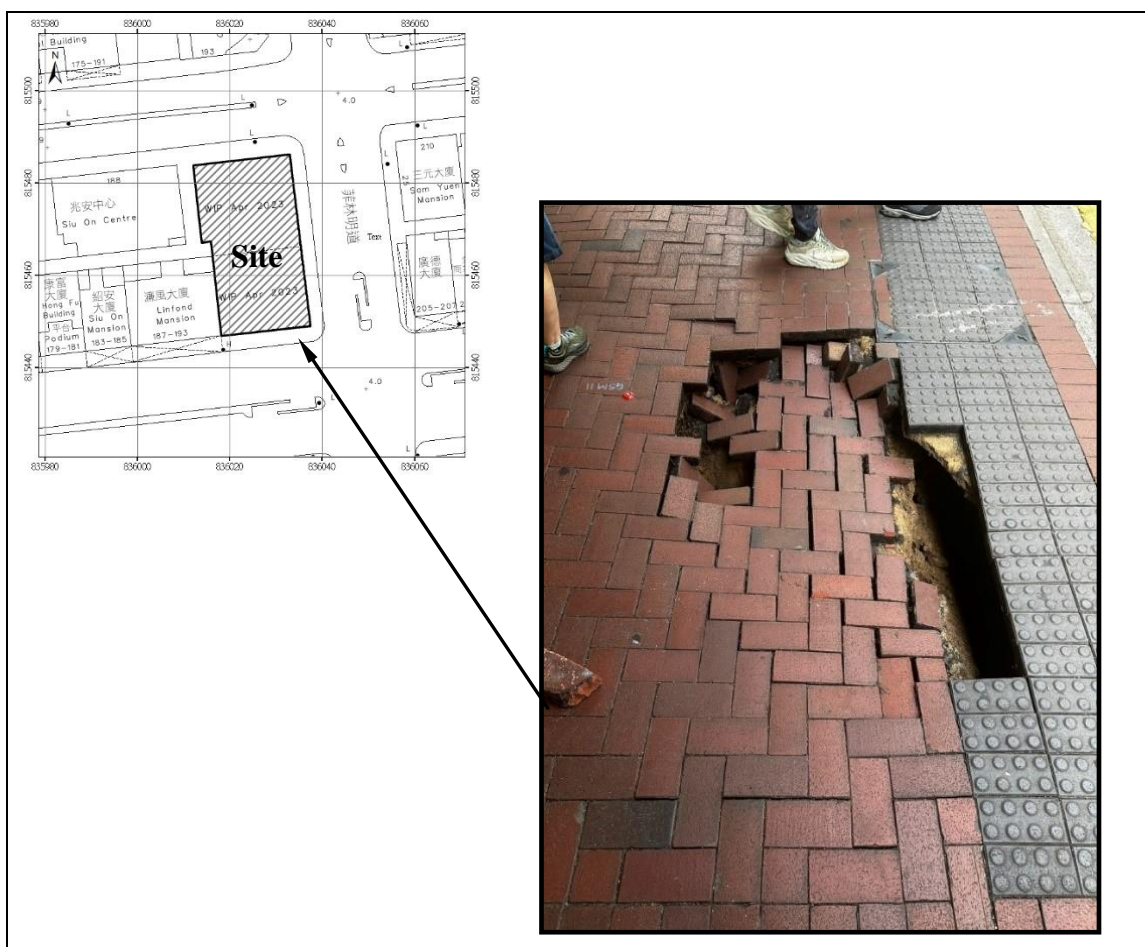
Case No. 15: Hennessey Road, Wan Chai

Date of incident	<i>5 June 2023</i>	Ground Conditions	
Size of sinkhole	<i>1.5m x 1m x 0.7m deep</i>	Top soil layers	<i>6m FILL 3m MD 5m ALL</i>
Consequences	<i>Adjacent walkway was temporarily closed</i>	Depth of rockhead	<i>30m</i>
Major preceding construction activities	<i>Bulk excavation within pipe pile & grout curtain cofferdam in progress</i>	Depth of groundwater table	<i>0.3m</i>
Drilling method/flushing medium	<i>Concentric drilling/air for pipe piles</i>
