**GEO Technical Guidance Note No. 49 (TGN 49)
Supplementary Guidelines on Precautionary Measures for Mitigating
the Risks of Excessive Ground Loss and Sinkhole Formation Associated
with Deep Excavations**

Issue No.: 1	Revision: B	Date: 5.2.2024	Page: 1 of 23
--------------	-------------	----------------	---------------

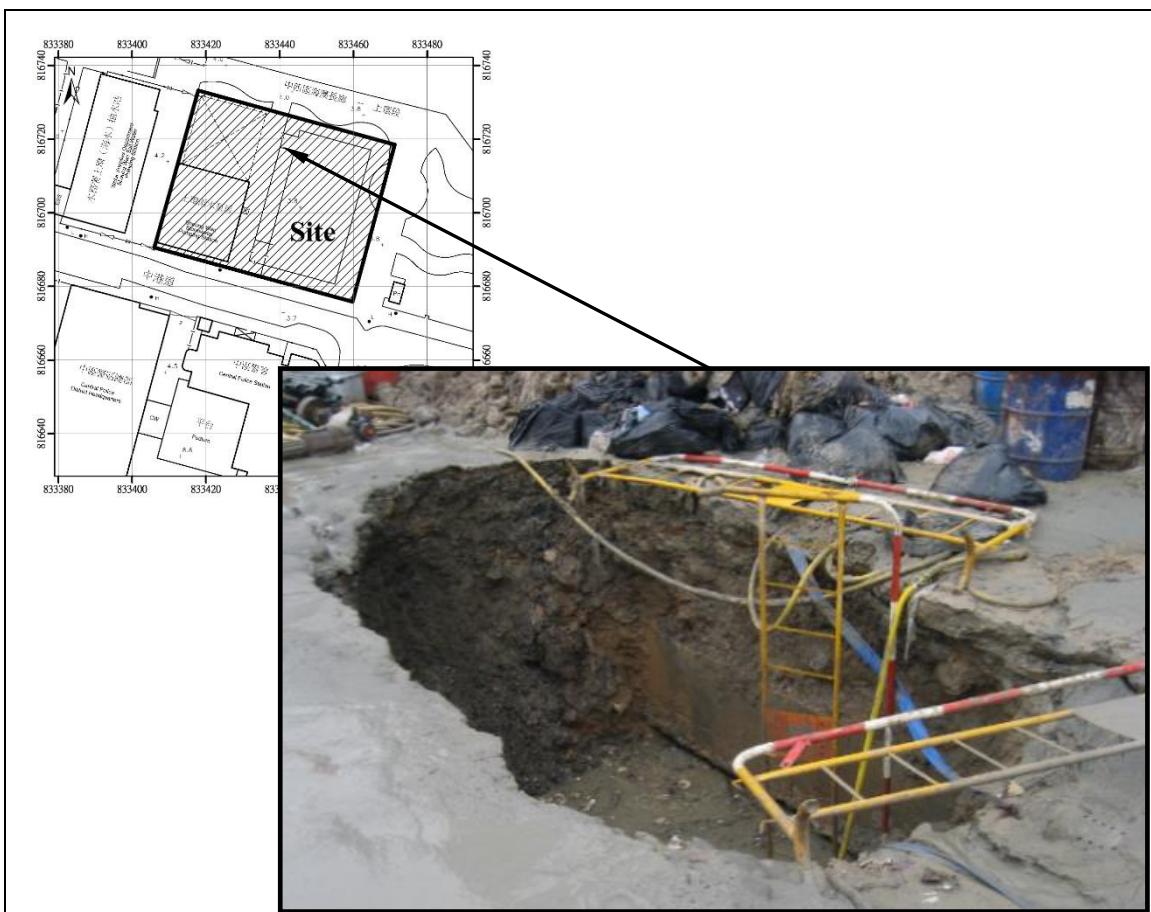
Case No. 1: Sheung Wan Stormwater Pumping Station

Date of incident	2007	Ground Conditions	
Size of sinkhole	<i>3m x 2m x 2m deep</i>	Top soil layers	<i>14-35m FILL, 0-14m MD</i>
Consequences	<i>Site area affected</i>		
Major preceding construction activities	<i>Pre-boring of H-pile foundation in progress</i>	Depth of rockhead	<i>60m</i>
Drilling method/ flushing medium	<i>Concentric drilling/ air</i>	Depth of groundwater table	<i>1.5 to 3.5m</i>

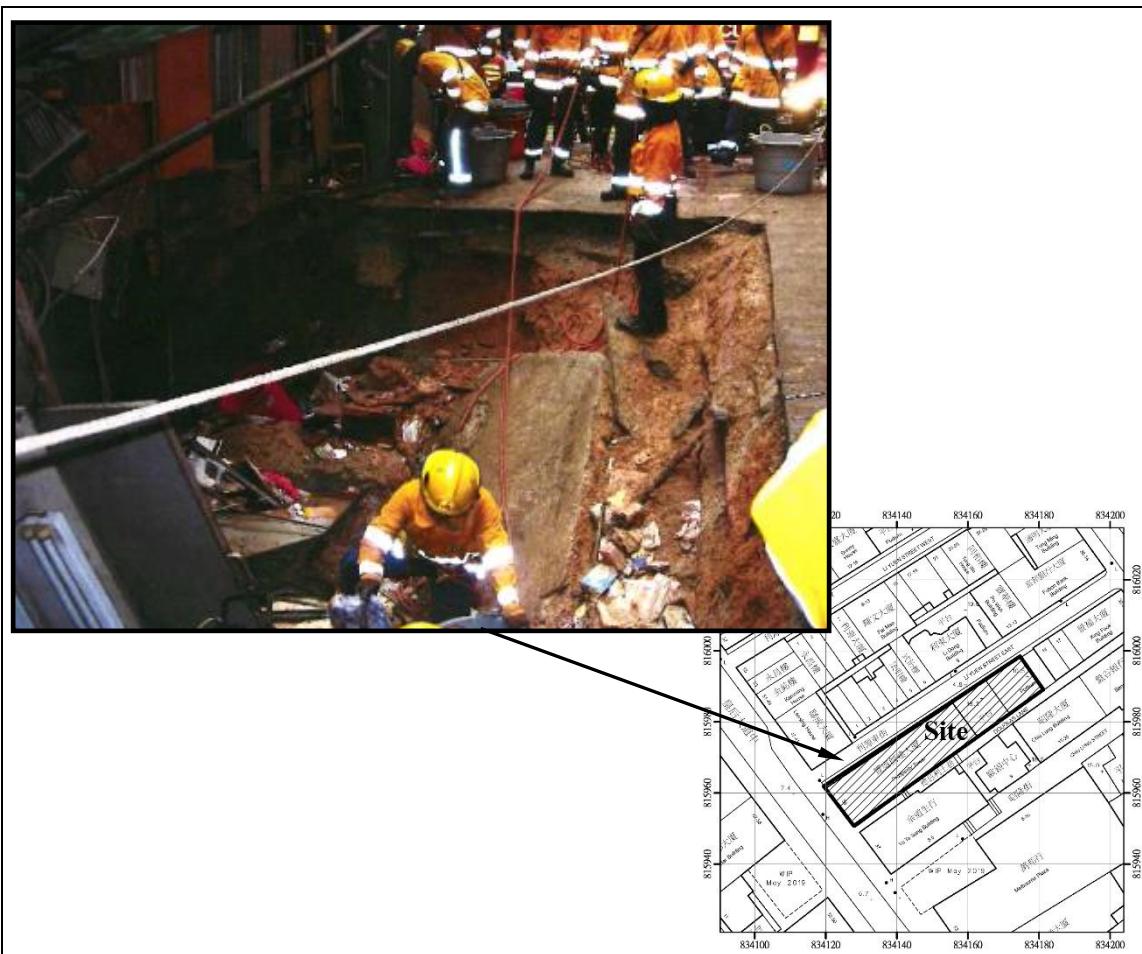
Case No. 2: Li Yuen Street East

Date of incident	24 April 2007	Ground Conditions	
Size of sinkhole	8 m x 3.5 m x 3.5 m deep	Top soil layer	9m ALL
Consequences	Several hawker stalls and 4 hawkers fell into the sinkhole. The hawkers suffered injuries and property loss.		
Major preceding construction activities	Pre-boring of H-pile foundation in progress	Depth of rockhead	40m
Drilling method/ flushing medium	ODEX drilling/ air	Depth of groundwater table	1 to 4m

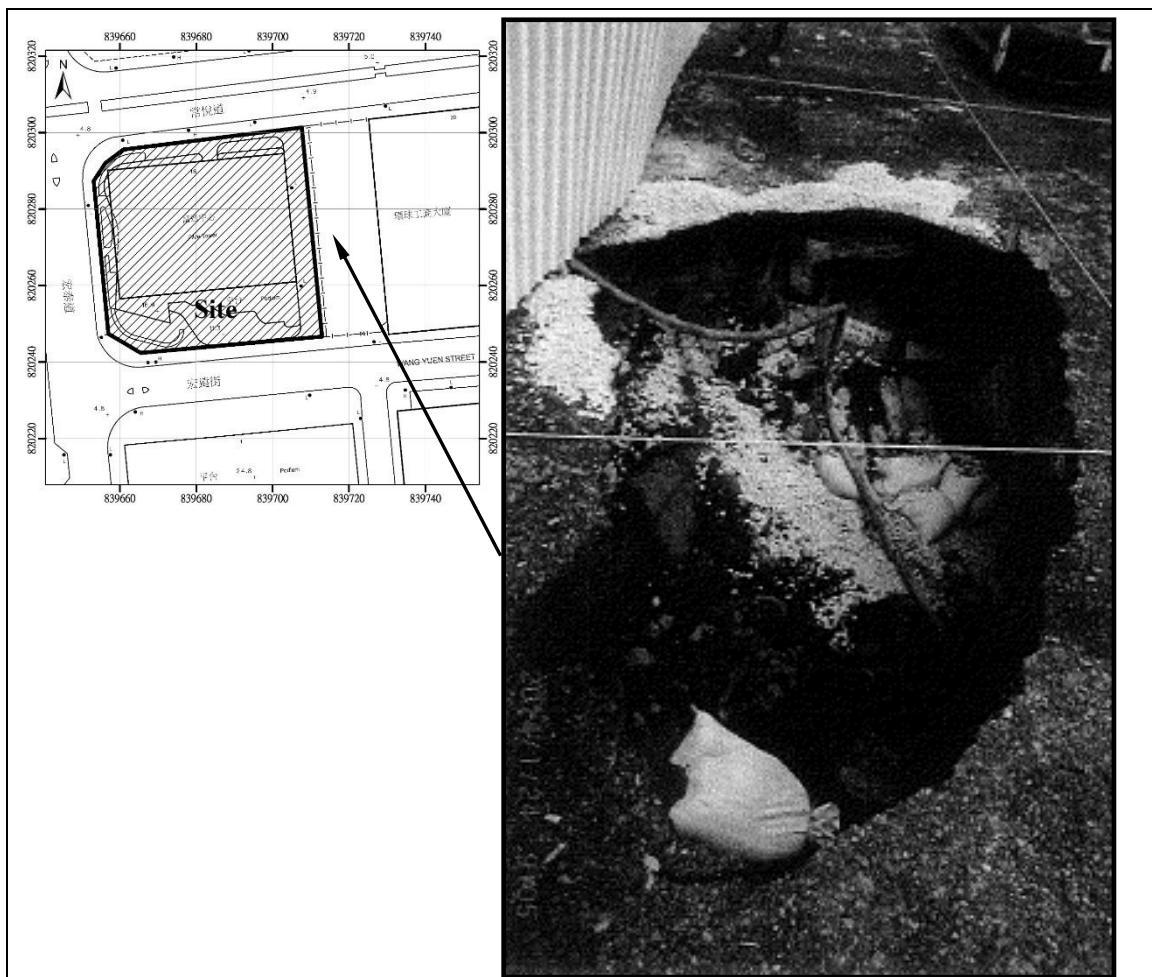
Case No. 3: Sheung Yuet Road

Date of incident	24 January 2014	Ground Conditions	
Size of sinkhole	<i>1m x 0.8m x 1m deep</i>	Top soil layers	<i>15m FILL, 20m ALL</i>
Consequences	<i>Adjacent carpark area affected</i>		
Major preceding construction activities	<i>Sheet-piling works with pre-drilling in progress</i>	Depth of rockhead	<i>60m</i>
Drilling method/ flushing medium	<i>Concentric drilling/ air</i>	Depth of groundwater table	<i>Near ground surface</i>

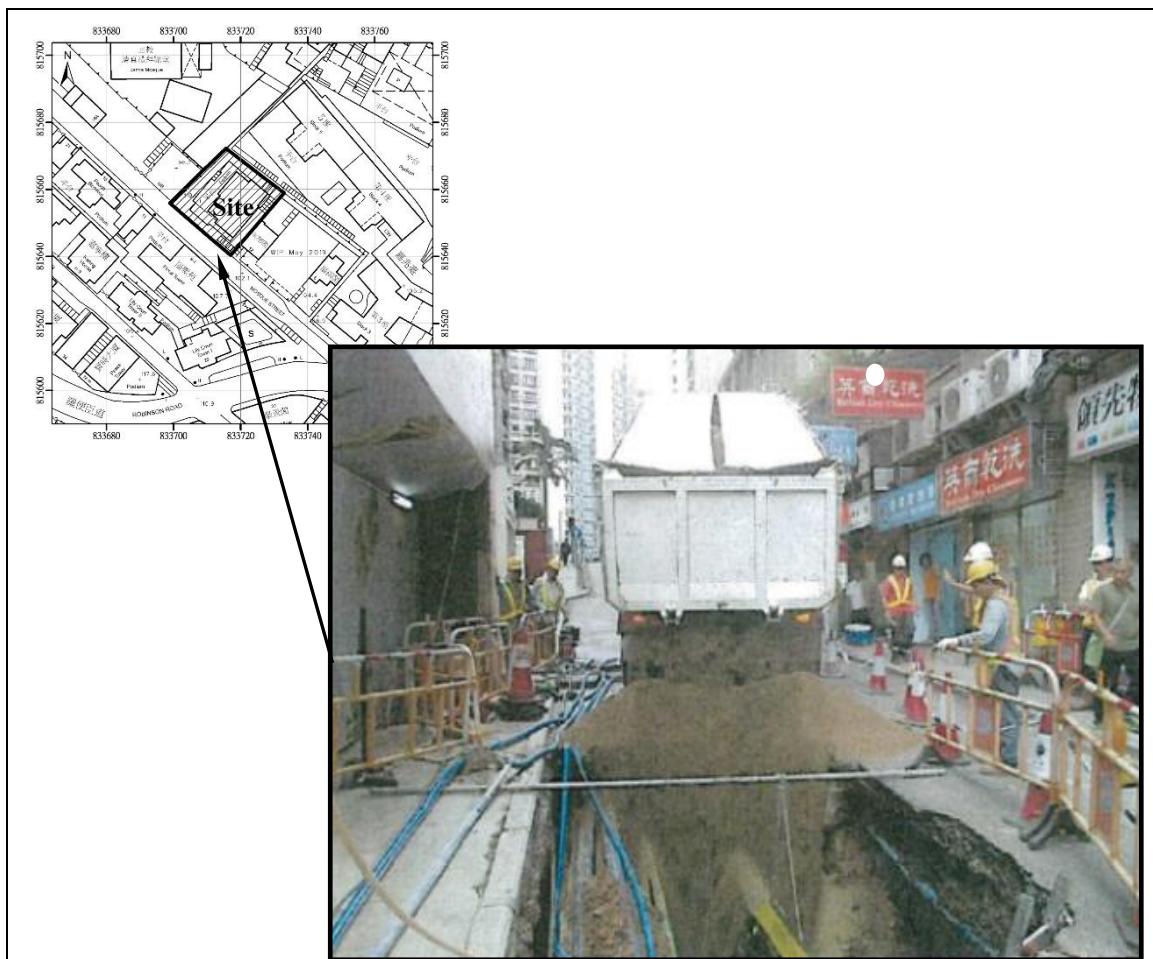
Case No. 4: 14-18 Mosque Street

Date of incident	27 October 2014	Ground Conditions	
Size of sinkhole	2m x 2m x 2.5m deep	Top soil layer	16m COLL
Consequences	Mosque Street partly closed temporarily		
Major preceding construction activities	Drilling works for pipe piles completed recently and that for grout curtain in progress	Depth of rockhead	60m
Drilling method/flushing medium	Concentric drilling/air for pipe piles	Depth of groundwater table	20m

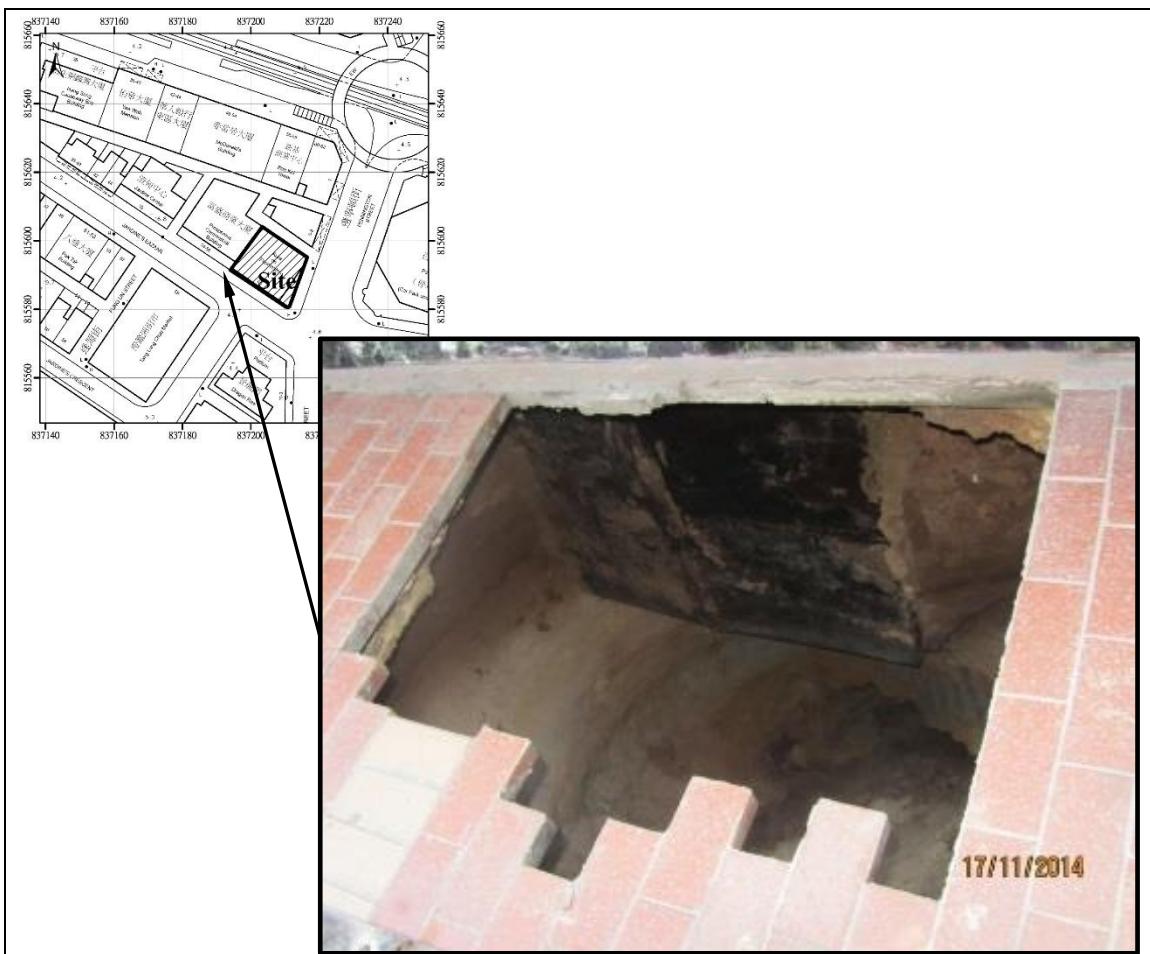
Case No. 5: 60-66 Jardine's Bazaar

Date of incident	17 November 2014	Ground Conditions	
Size of sinkhole	3.5m x 2.5m x 3.7m deep	Top soil layers	25m FILL/ALL
Consequences	A passer-by fell into the sinkhole and suffered injuries		
Major preceding construction activities	Bulk excavation within pipe pile & grout curtain cofferdam in progress	Depth of rockhead	40m
Drilling method/flushing medium	Concentric drilling/air for pipe piles	Depth of groundwater table	1 to 2.5m

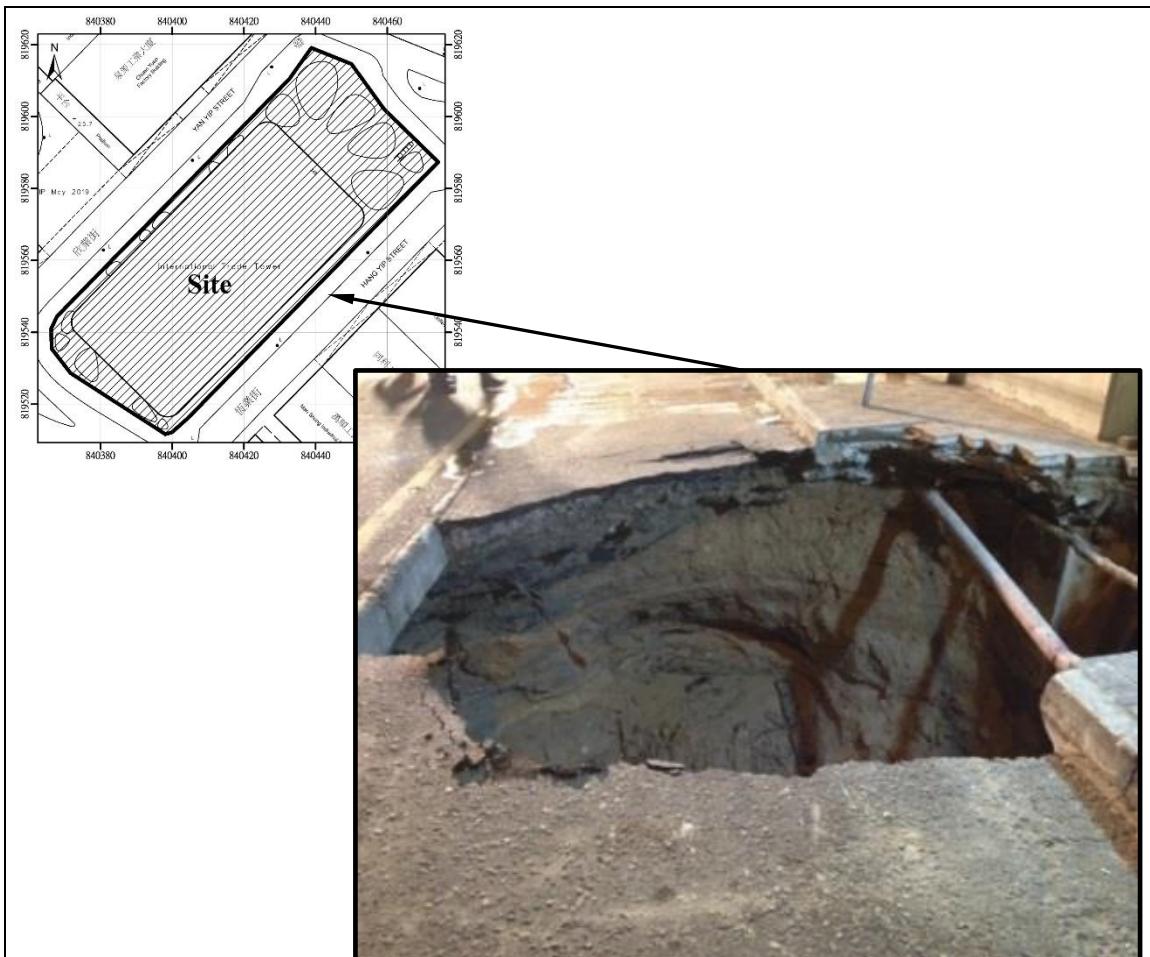
Case No. 6: Hang Yip Street, Ngau Tau Kok

Date of incident	9 September 2015	Ground Conditions	
Size of sinkhole	5m x 5m x 4m deep	Top soil layers	14m FILL/MD
Consequences	A large truck and the driver of a pick-up truck fell into the sinkhole		
Major preceding construction activities	Bored pile foundation works in progress	Depth of rockhead	100m
Drilling method/flushing medium	Reverse circulation drilling/water	Depth of groundwater table	2 to 3m

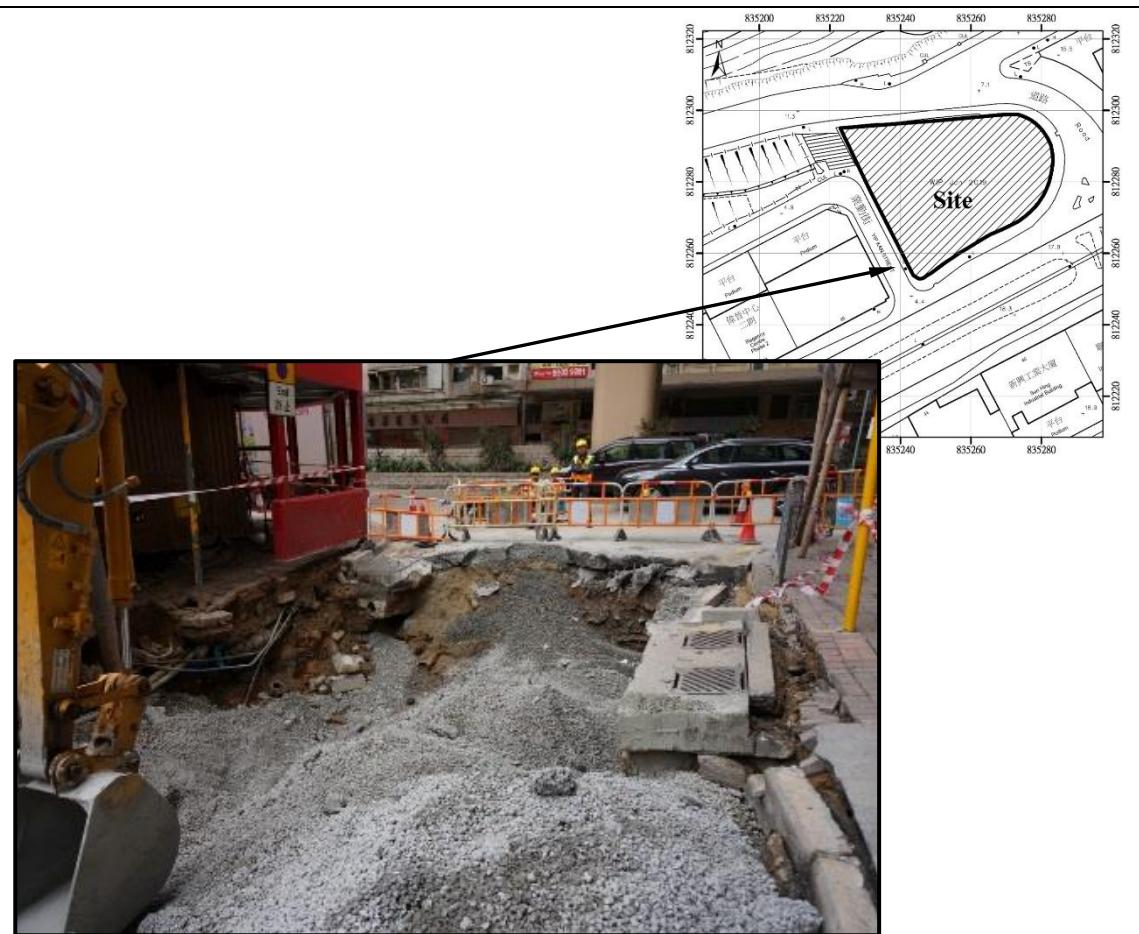
Case No. 8: Yip Kan Street, Aberdeen

Date of incident	23 February 2019	Ground Conditions	
Size of sinkhole	4m x 4m x 6m deep	Top soil layers	9m FILL/MD
Consequences	<i>Yip Kan Street entirely closed temporarily</i>		
Major preceding construction activities	<i>Bulk excavation within pipe pile & grout curtain cofferdam in progress</i>	Depth of rockhead	20m
Drilling method/flushing medium	<i>Concentric drilling/air for pipe piles</i>	Depth of groundwater table	2 to 3m

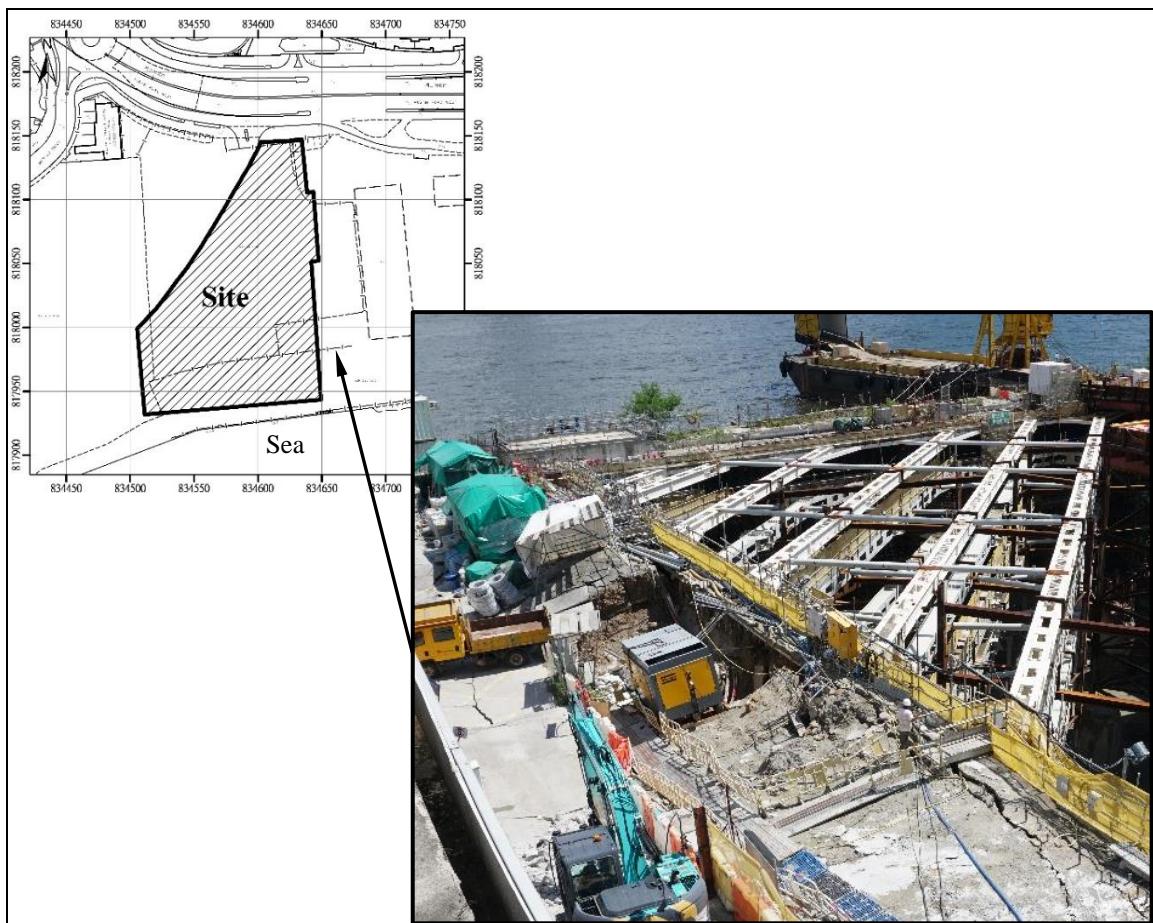
Case No. 9: Lyric Theatre, West Kowloon Cultural District

Date of incident	25 July 2019	Ground Conditions	
Size of sinkhole	10m x 5m x 2m deep	Top soil layers	27m FILL
Consequences	Adjacent site area/site office affected		
Major preceding construction activities	Bulk excavation within pipe pile & grout curtain cofferdam in progress	Depth of rockhead	45m
Drilling method/flushing medium	Concentric drilling/air for pipe piles	Depth of groundwater table	2m

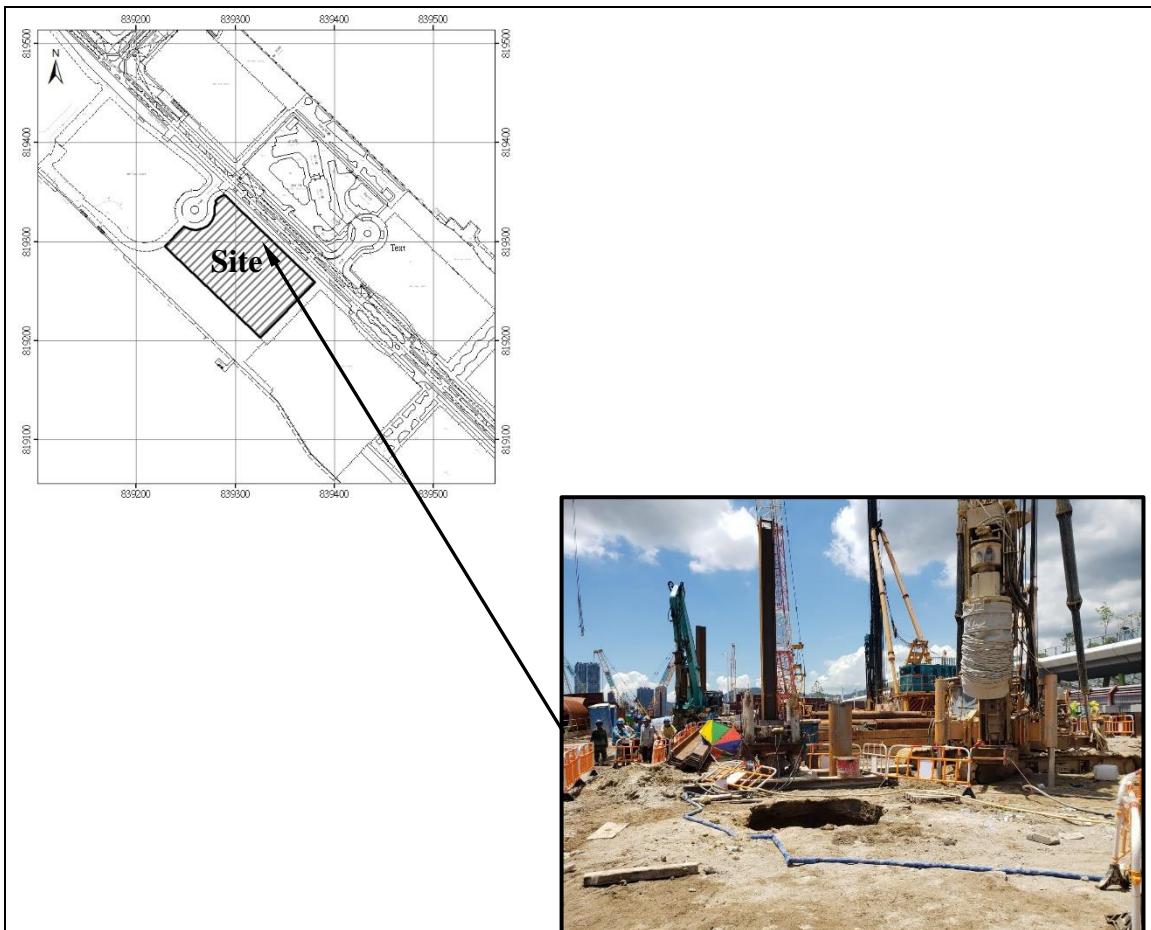
Case No. 10: Shing Fung Road, Kai Tak Former Runway

Date of incident	23 July 2020	Ground Conditions	
Size of sinkhole	2.5m diameter x 2.7m deep	Top soil layers	10m FILL 3-8m MD 20-25m ALL
Consequences	A site personnel fell into the sinkhole and subsequently passed away	Depth of rockhead	60m
Major preceding construction activities	Pipe pile foundation works in progress	Depth of groundwater table	2 to 3m
Drilling method/flushing medium	Concentric drilling/air for pipe piles

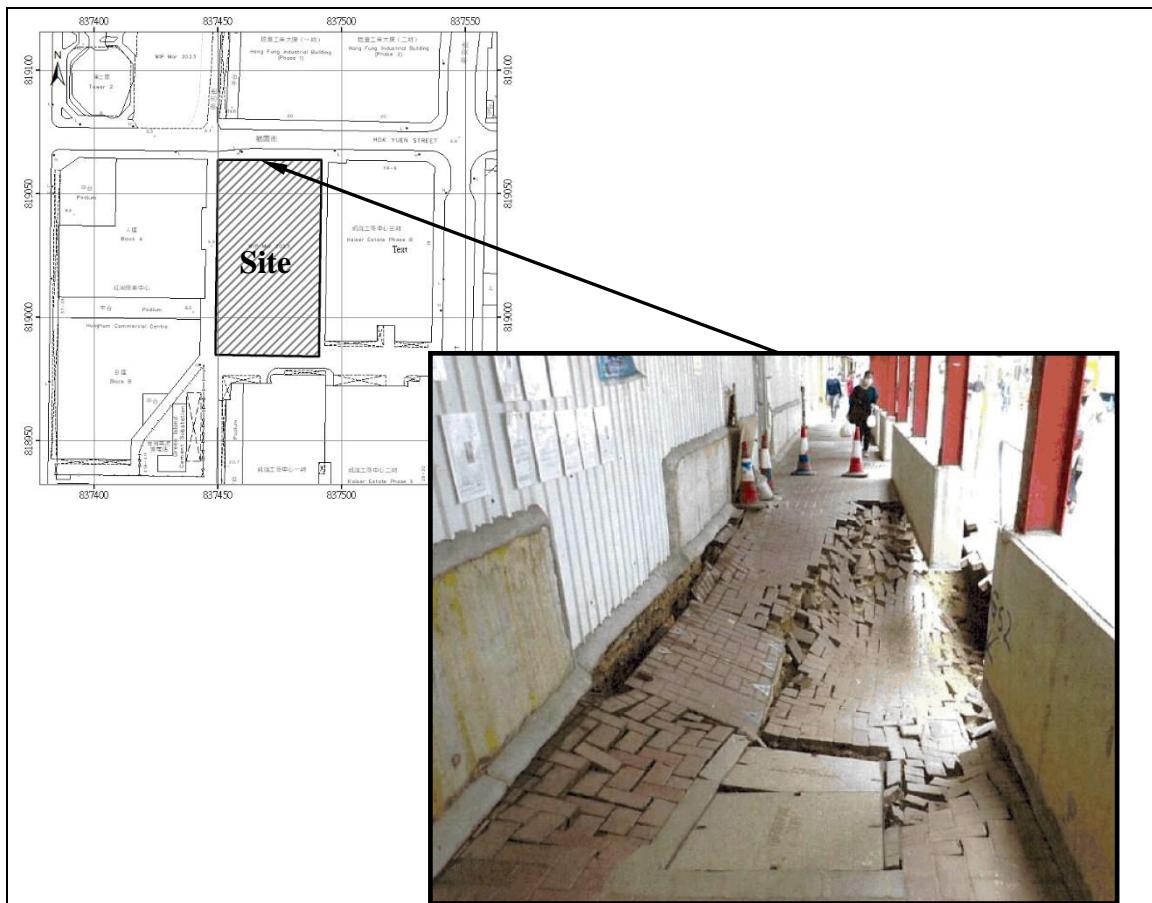
Case No. 11: Hok Yuen Street, Hung Hom

Date of incident	3 April 2023	Ground Conditions	
Size of sinkhole	6m x 3.8m x 1.8m deep	Top soil layers	6-12m FILL
Consequences	Adjacent footpath temporarily closed, carriageway undermined and underground utilities damaged		
Major preceding construction activities	Bulk excavation within pipe pile & grout curtain cofferdam in progress	Depth of rockhead	32m
Drilling method/flushing medium	Concentric drilling/air for pipe piles	Depth of groundwater table	2 to 2.5m

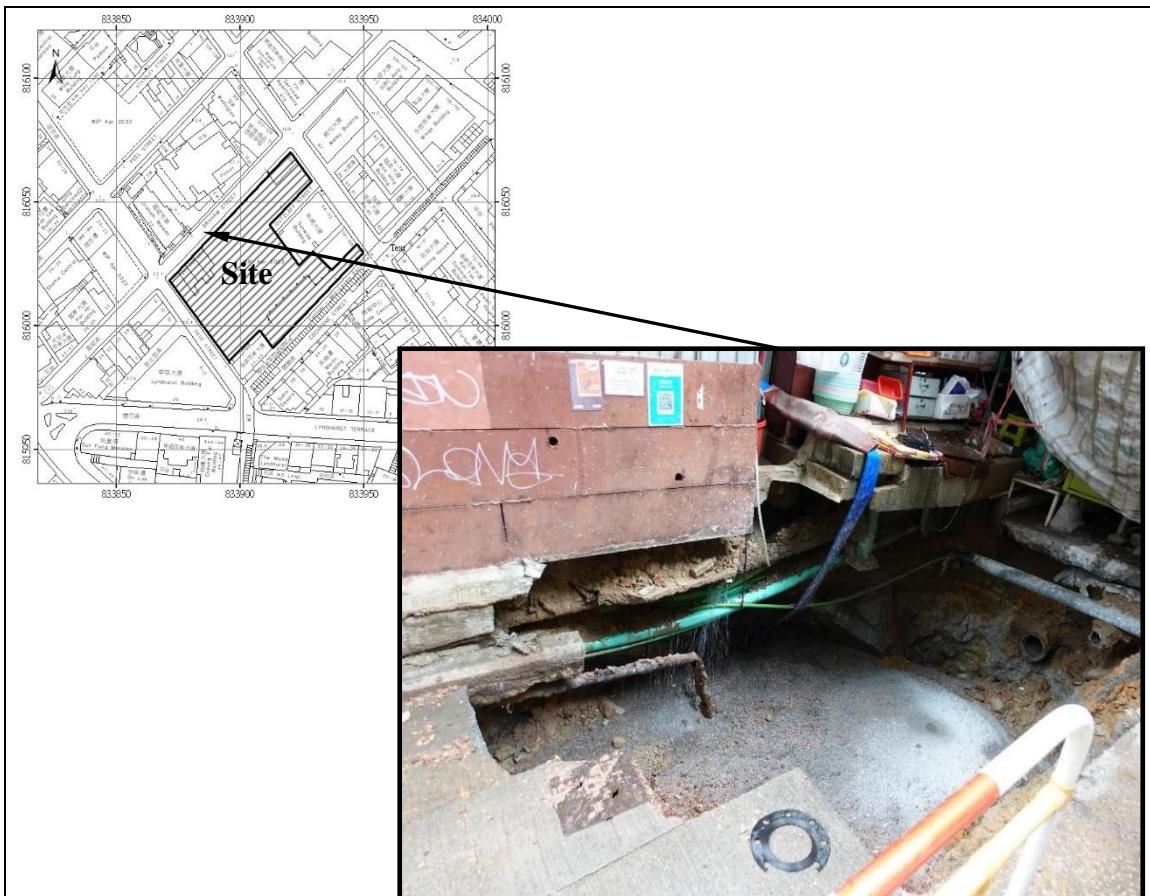
Case No. 12: Graham Street, Central

Date of incident	6 May 2023	Ground Conditions	
Size of sinkhole	5m x 2m x 7m deep	Top soil layers	3m FILL
Consequences	<i>Two workers fell into the sinkhole; three water pipes broken; adjacent footpath and market stalls affected</i>		
Major preceding construction activities	<i>Final excavation level reached; pile cap construction in progress</i>	Depth of rockhead	>100m
Drilling method/flushing medium	<i>Concentric drilling/air for pipe piles; oscillator and grab for bored piles</i>	Depth of groundwater table	0.5 to 1.5m

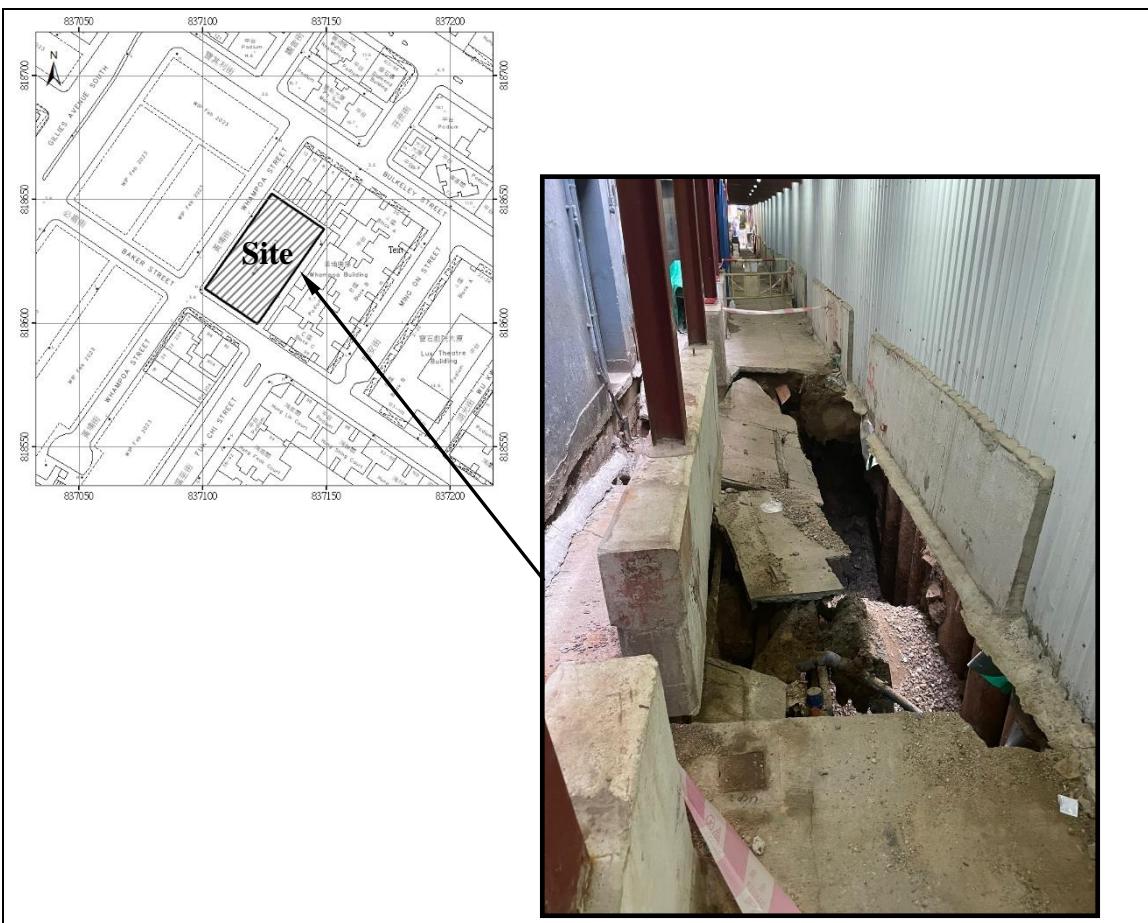
Case No. 13: Whampoa Street, Hung Hom

Date of incident	20 May 2023	Ground Conditions	
Size of sinkhole	5m x 1m x 5m deep	Top soil layers	4-5m FILL 3-4m MD 4m ALL
Consequences	Adjacent service lane temporarily closed and underground utilities damaged		
Major preceding construction activities	Bulk excavation within pipe pile & grout curtain cofferdam in progress	Depth of rockhead	18 to 20m
Drilling method/flushing medium	Concentric drilling/air for pipe piles	Depth of groundwater table	1.6m

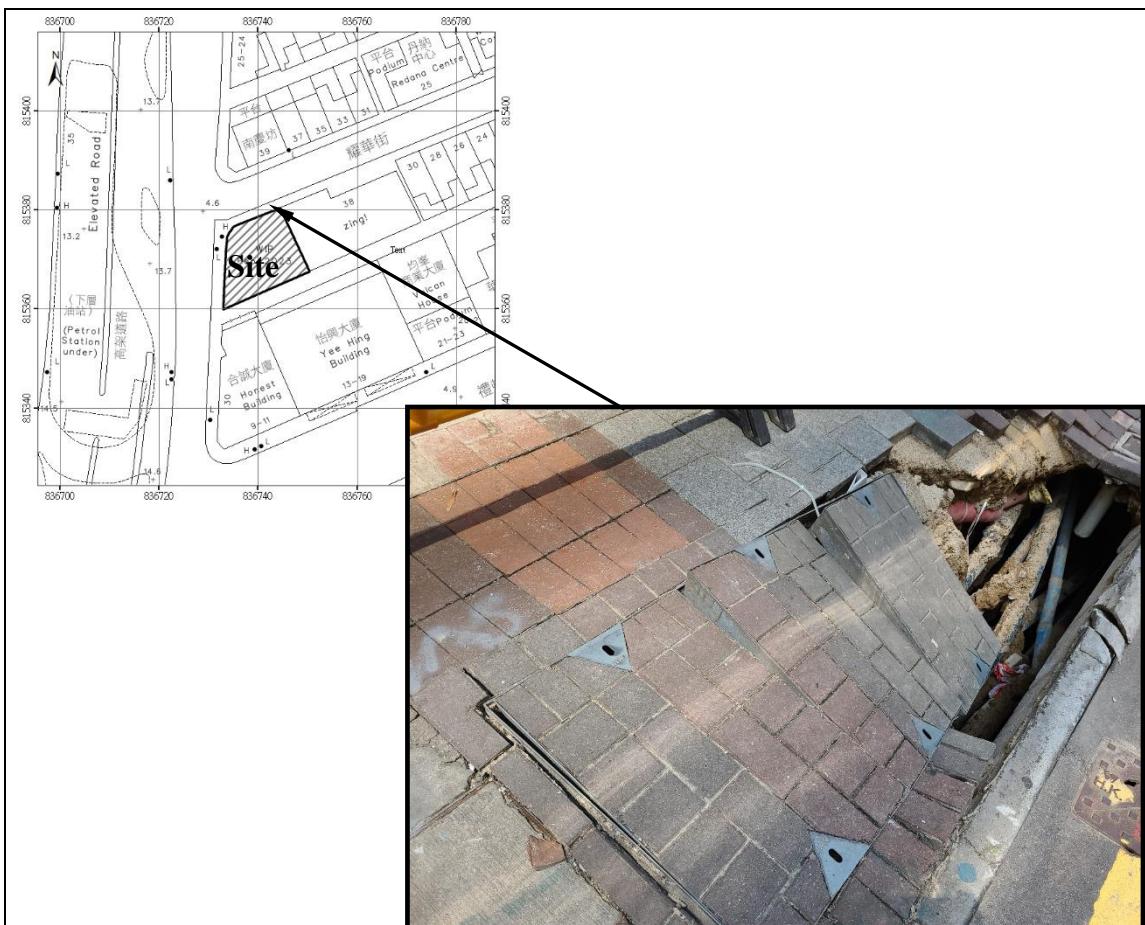
Case No. 14: Yiu Wa Street, Causeway Bay

Date of incident	25 May 2023	Ground Conditions	
Size of sinkhole	4.4m x 2.1m x 2.8m deep	Top soil layers	10m FILL 4-9m MD 4-6m ALL
Consequences	Adjacent walkway and part of the road (Yiu Wa Street) was closed	Depth of rockhead	35 to 45m
Major preceding construction activities	Bulk excavation and final level reached	Depth of groundwater table	0.3m
Drilling method/flushing medium	Press-in method for sheet pile and vibrator for channel planking

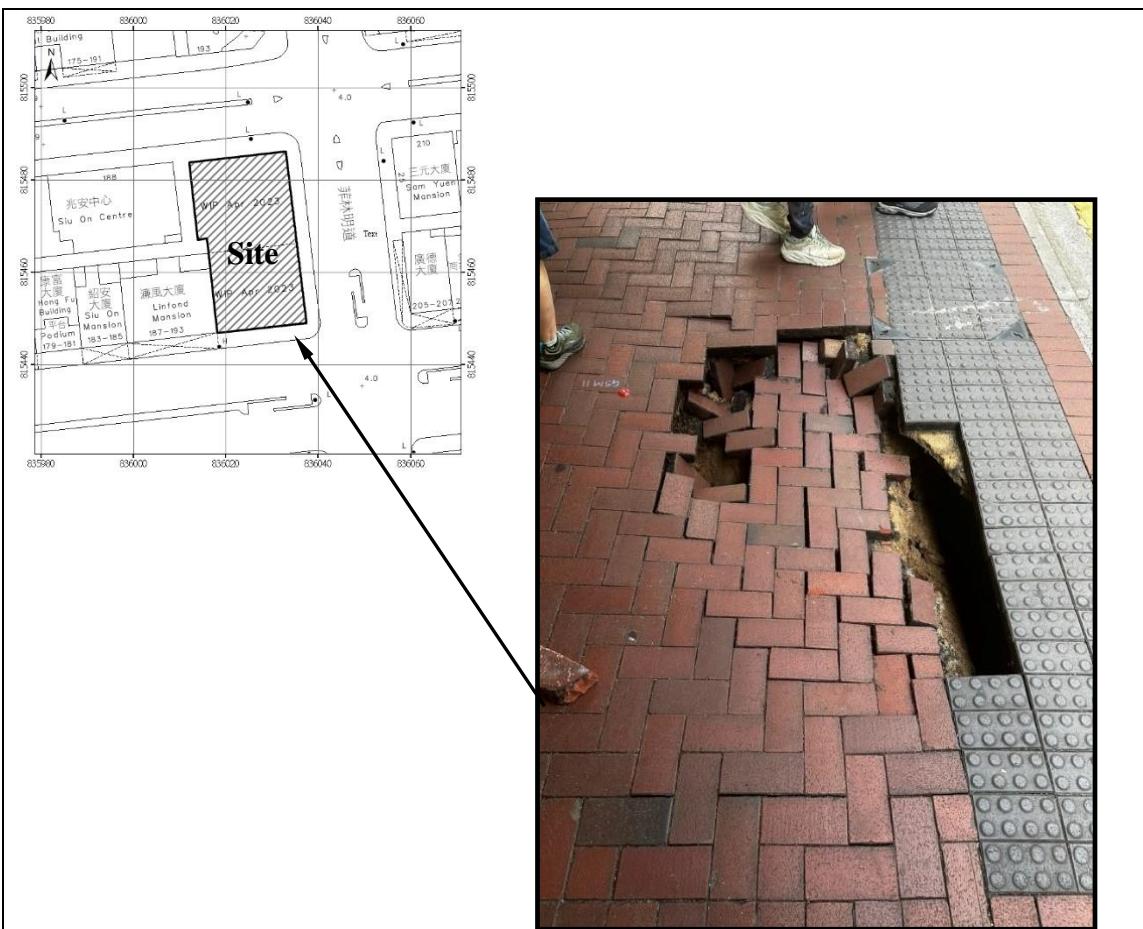
Case No. 15: Hennessey Road, Wan Chai

Date of incident	<i>5 June 2023</i>	Ground Conditions	
Size of sinkhole	<i>1.5m x 1m x 0.7m deep</i>	Top soil layers	<i>6m FILL 3m MD 5m ALL</i>
Consequences	<i>Adjacent walkway was temporarily closed</i>		
Major preceding construction activities	<i>Bulk excavation within pipe pile & grout curtain cofferdam in progress</i>	Depth of rockhead	<i>30m</i>
Drilling method/flushing medium	<i>Concentric drilling/air for pipe piles</i>	Depth of groundwater table	<i>0.3m</i>
