**REPORT ON THE 22 MAY 2013
DISTRESS AT A REINFORCED
FILL WALL AT A
CONSTRUCTION SITE
ABOVE SHUN ON ROAD,
SAU MAU PING**

*Fugro Scott Wilson Joint Venture
for
Geotechnical Engineering Office
Civil Engineering and
Development Department
The Government of The Hong Kong
Special Administrative Region*

December 2013
(minor amendments made in November 2020)

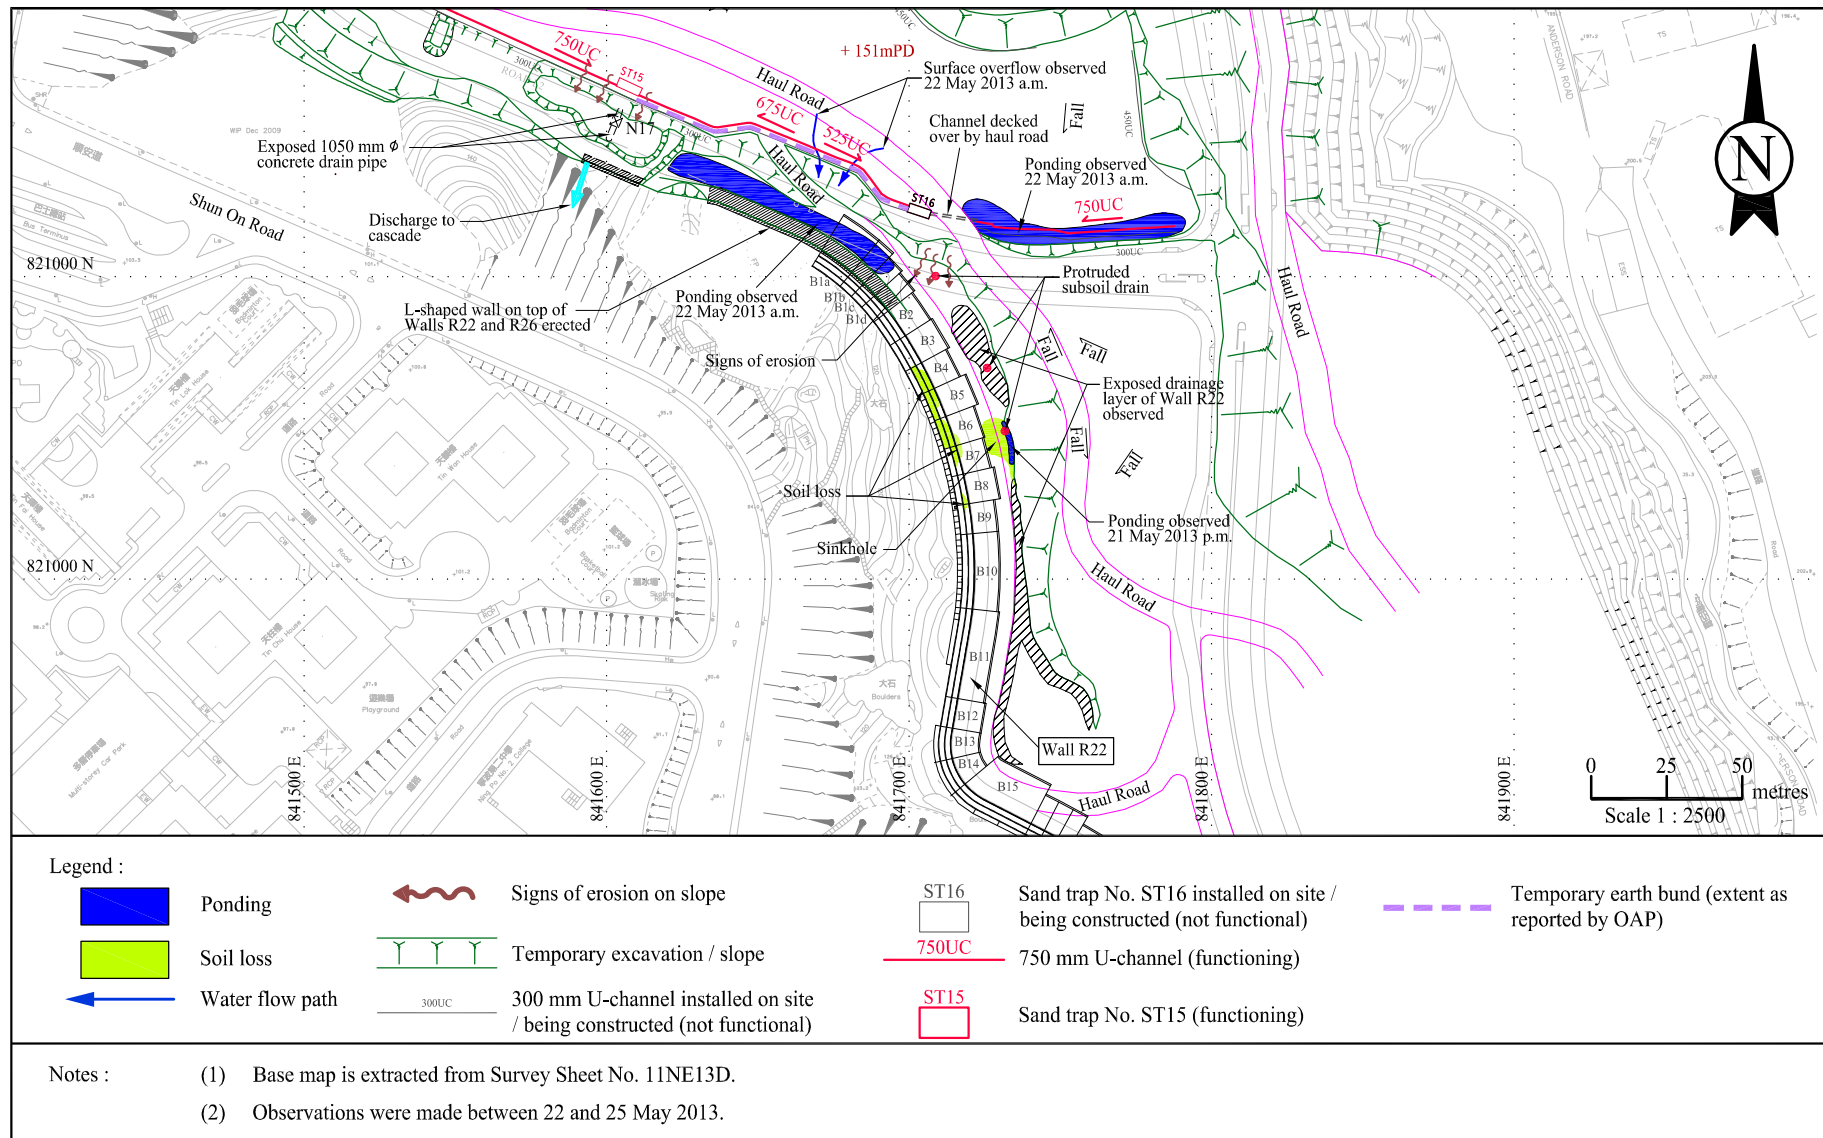
Figure 5.5 Field Observations on Surface Drainage Provisions in the Vicinity of Wall R22

In the morning of 22 May 2013, significant overland flow originating from Platform B over the location of the temporary earth bund was observed (Figure 5.5 and Plate 12) flowing down a haul road towards the back of Wall R22. Based on photographic records, the temporary earth bund between the haul road and sand trap ST16 was estimated to be around 500 mm high. The temporary earth bund was not effective in controlling the surface runoff as evidenced by the overland flow in the morning of 22 May 2013 as well as erosions scars below the reported bund extent observed several days prior to the incident.

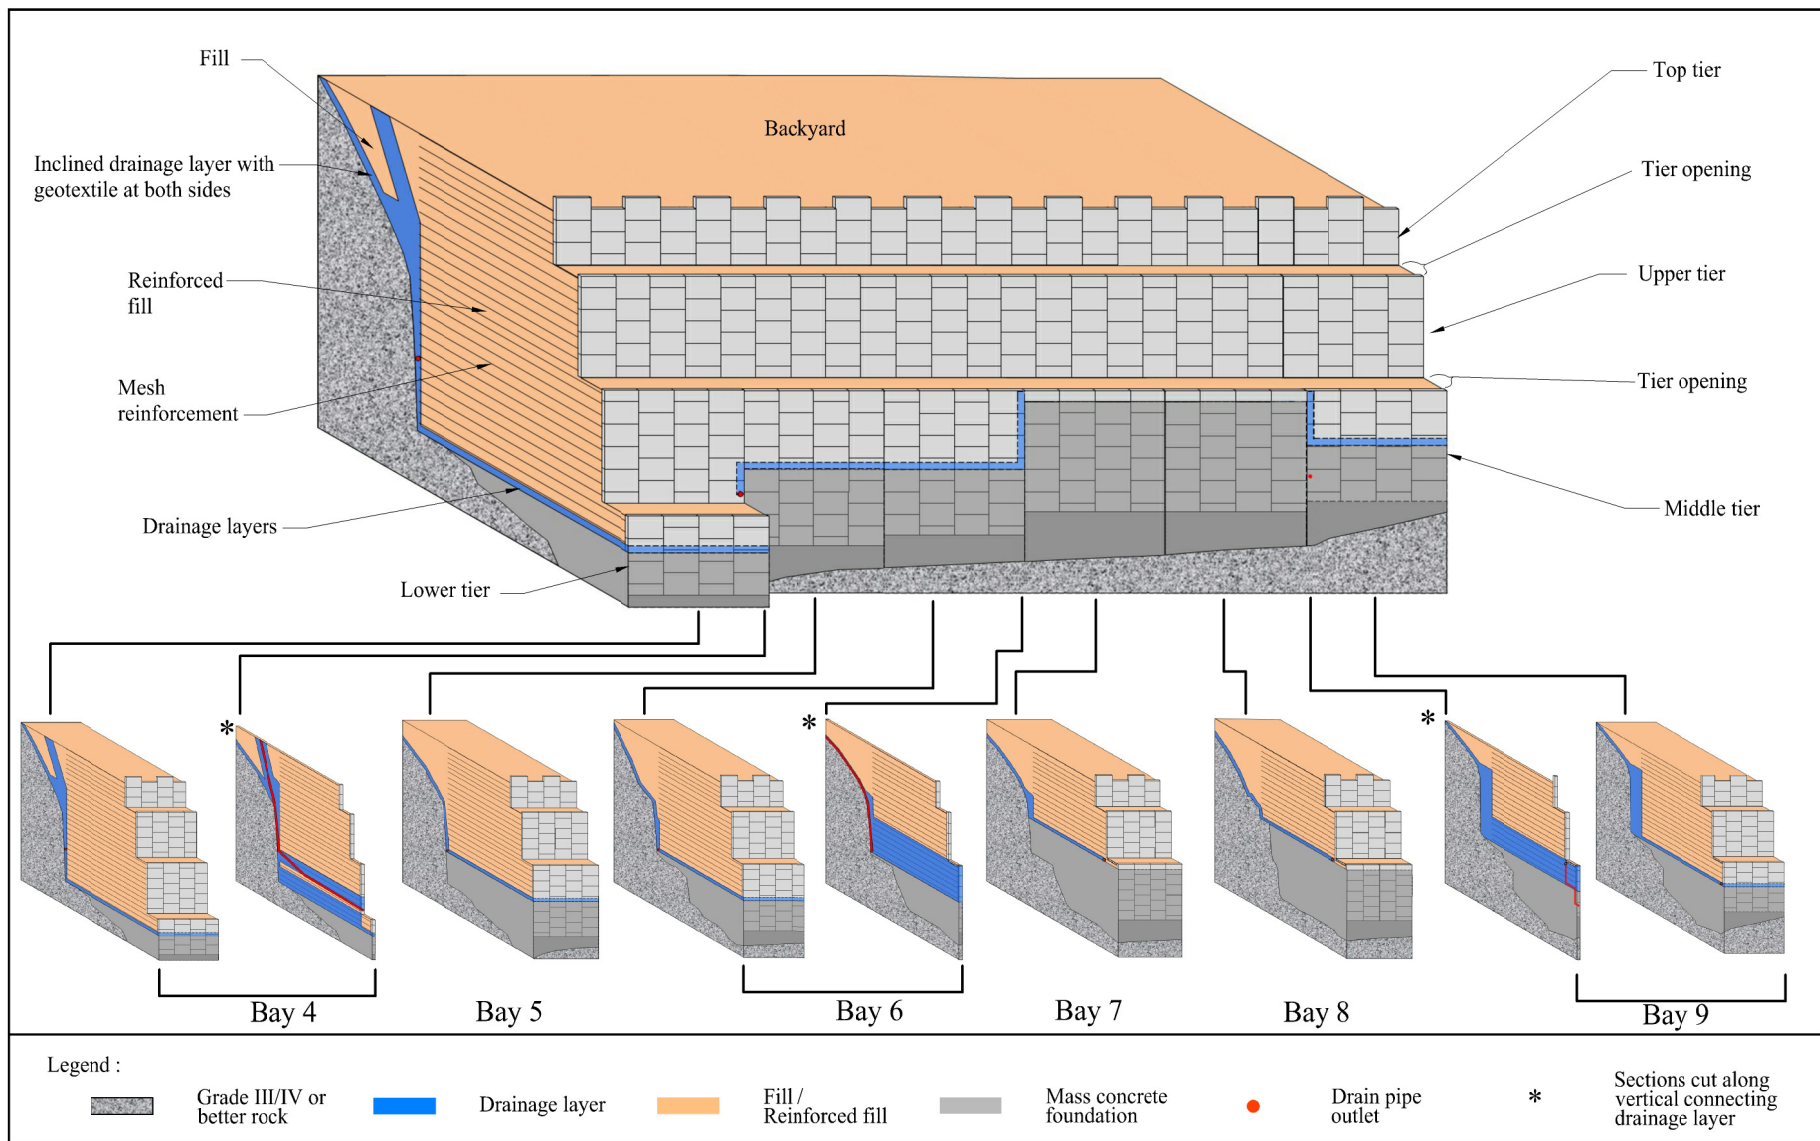
Figure 7.3 3D Spatial Arrangement of the Drainage Layers and Tiers

The drainage design arrangement of the wall results in the '*vertical connecting drainage layers*' at the interfaces between Bays 4 and 5, between Bays 6 and 7, and between Bays 8 and 9 being in close proximity to a tier opening (see Figure 7.3). Over the portion of the reinforced fill wall under construction, such arrangement was unique at these three wall locations, which were observed to be coincident with the location of the three localised distressed zones. The implication of this wall arrangement is further discussed in Section 9.

Figure 7.3 is a three-dimensional depiction of the arrangement of the subsurface drainage layers and tiers between Bays 4 and 9. It can be seen from the various sections shown in Figure 7.3 that the lowest tier openings are all located above the base drainage layers. In particular it should be noted that at the sections coinciding with the vertical steps in the mass concrete foundations (denoted by an asterisk) the tier openings are almost coincident with the '*vertical connecting drainage layers*'. The sections in Figures 3.3, 3.4 and 3.5 show that the thickness of soil cover between the tier openings and the '*vertical connecting drainage layers*' was very thin.

The overburden pressure exerted by the soil layers at the tier openings would have been very small. The build-up of high water pressures at the underlying drainage layer would have exceeded the overburden pressures causing hydraulic uplift of the soil layer and piping at the tier opening. Given the configuration of the wall, it is also possible that the soil in the vicinity of the tier openings was subject to high local stress ratio (shear/effective vertical stress) and is susceptible to local failure should there be a build-up of high water pressure in the vicinity.

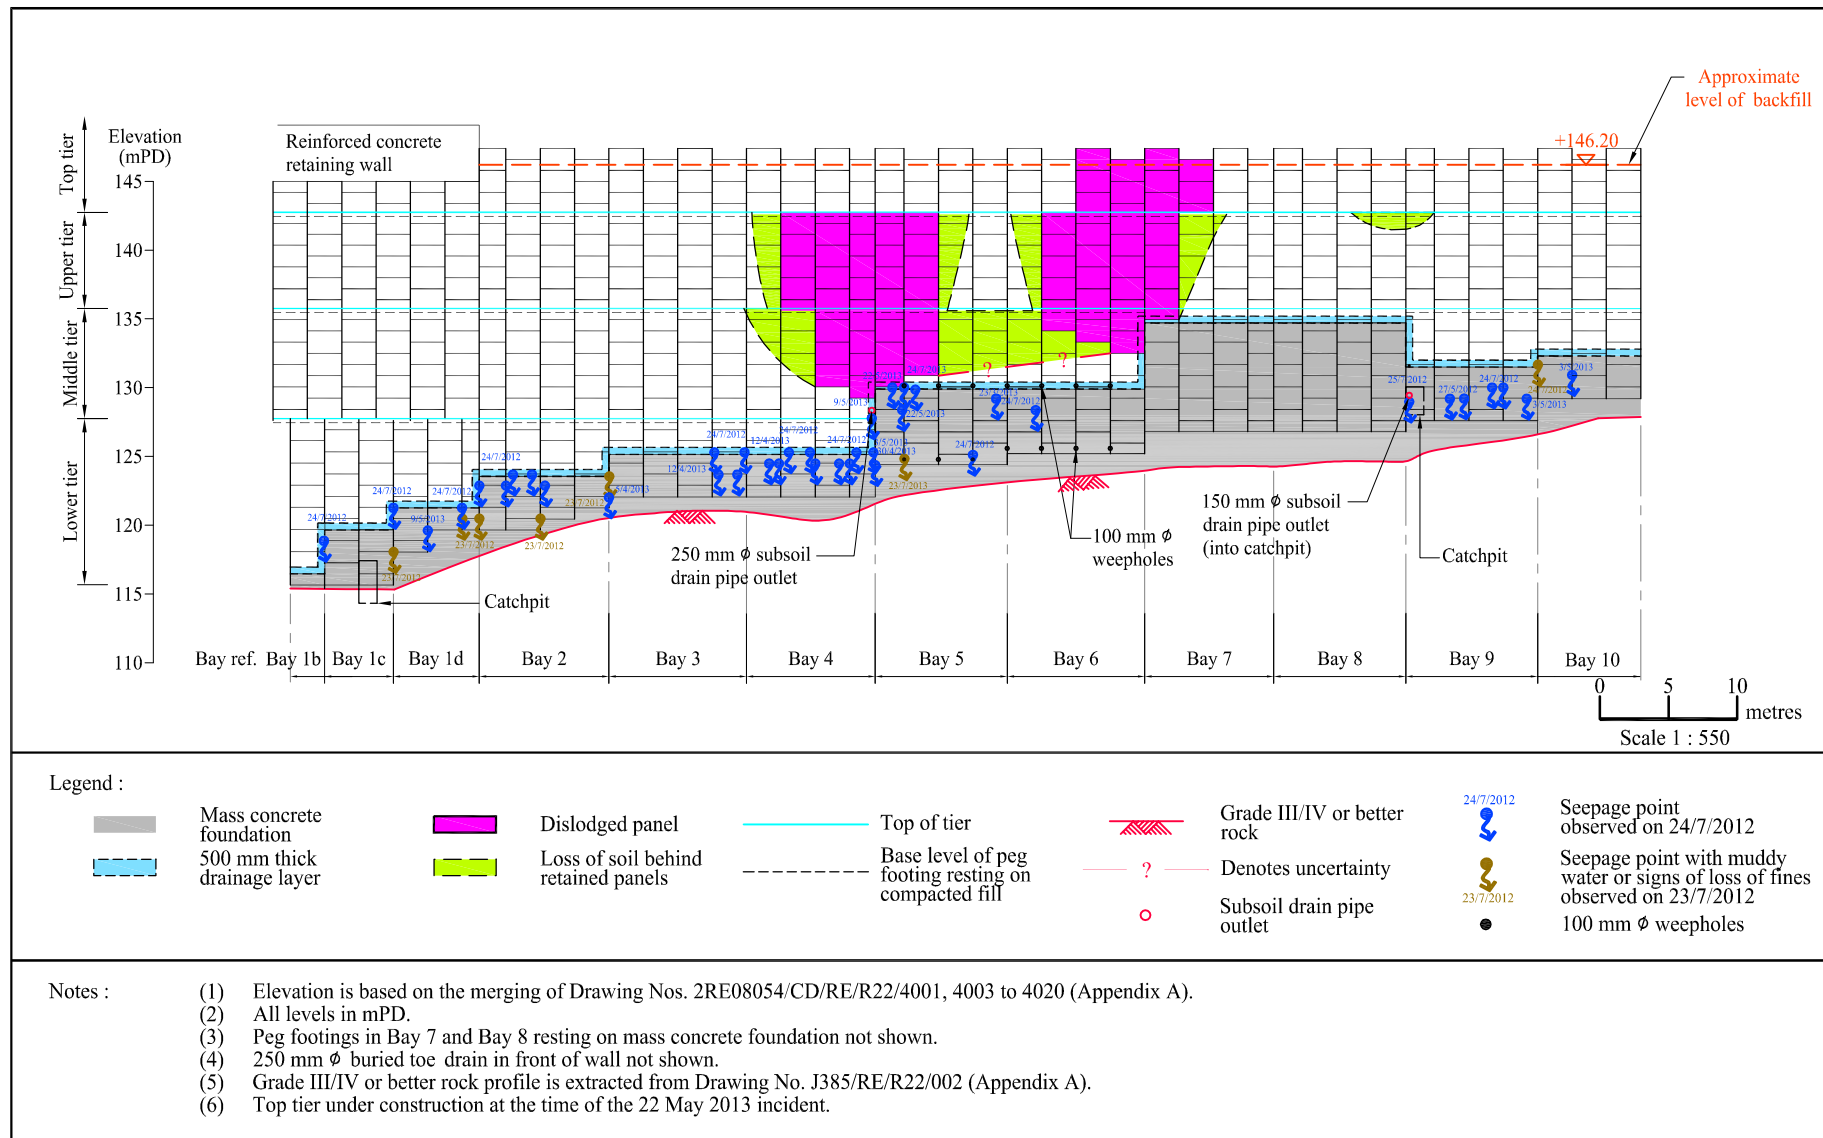
Figure 7.4 Seepage Observations at Wall R22

Based on available site records, seepage flows issuing from the wall face since May 2012 were noted (Figure 7.4 and Plate 17). Seepage was mainly observed between Bays 1 and 5 as well as Bay 9 of the wall. Both clear and muddy seepages have been noted with varying degrees of intensity. Most of the seepage was through the joints of the dummy panels (i.e. at a level at or below the base of the base drainage layer). Limited water seepage points were observed at Bays 6 and 7.

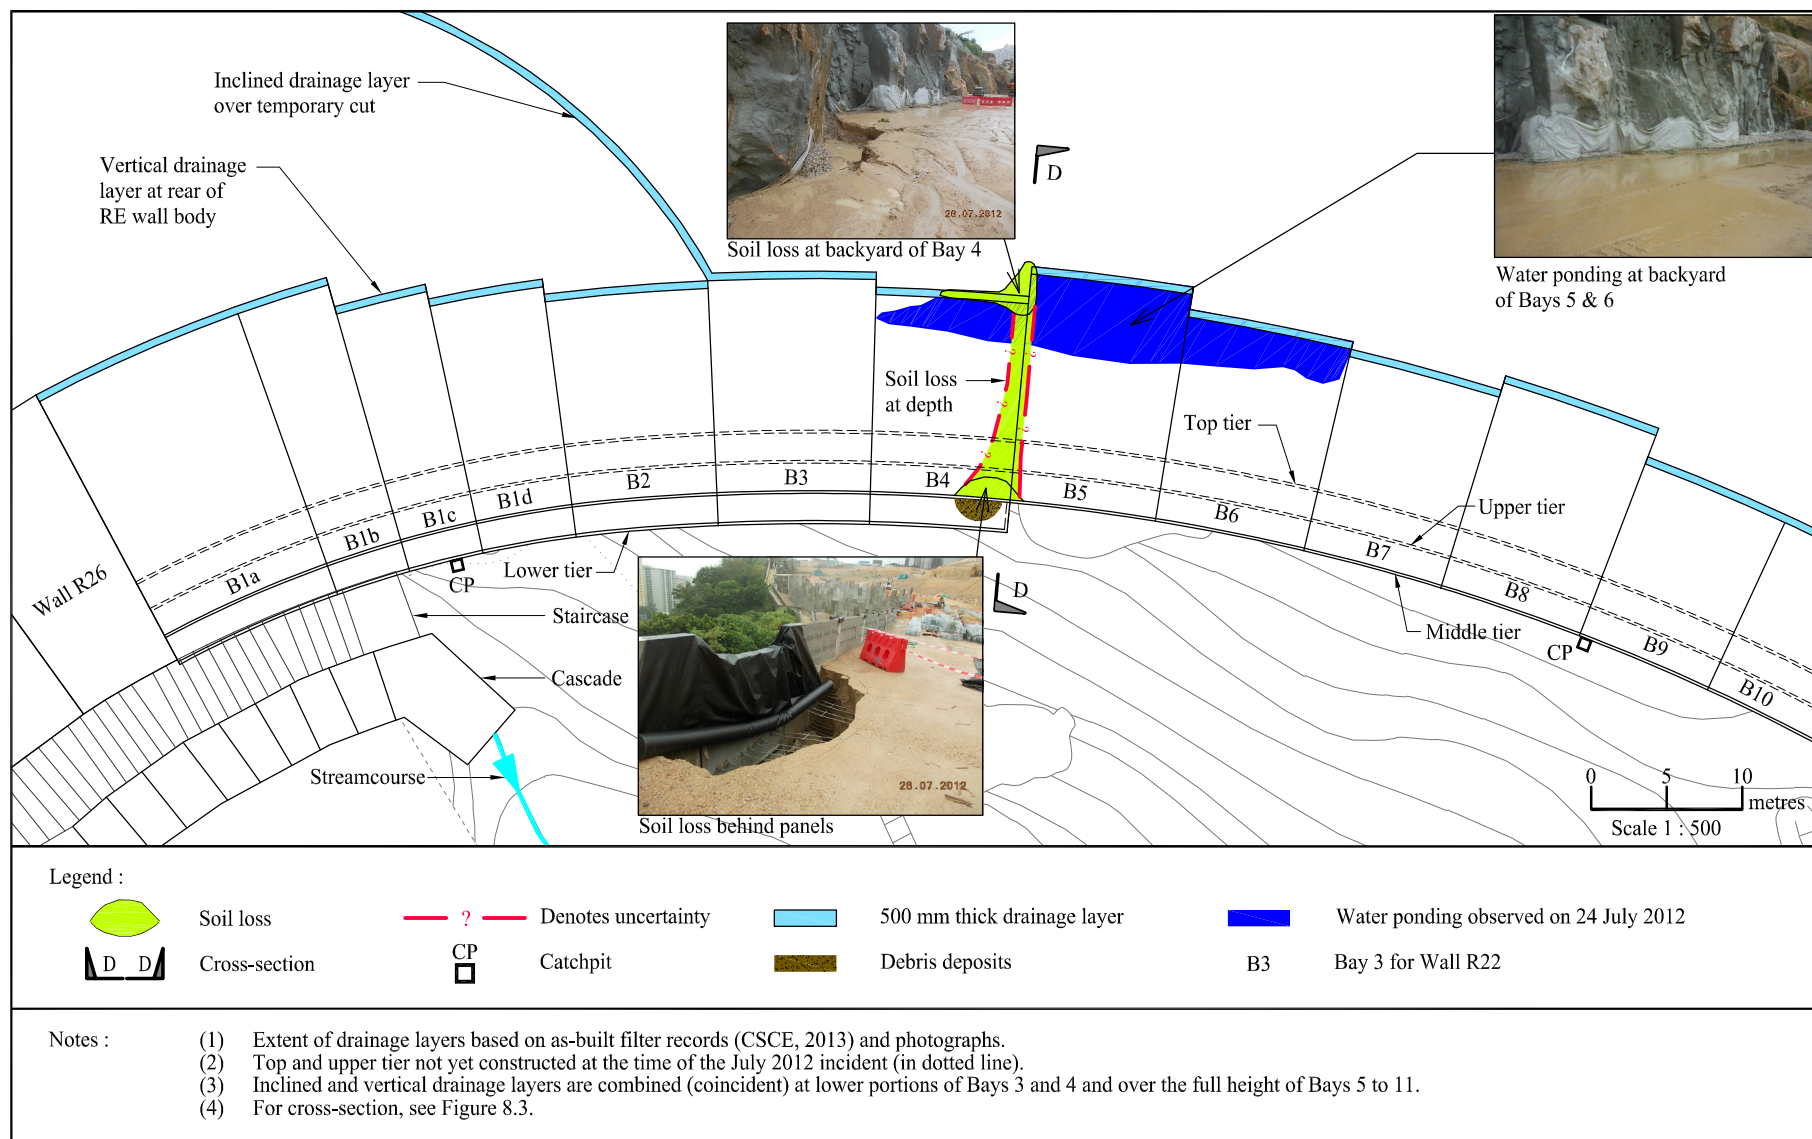
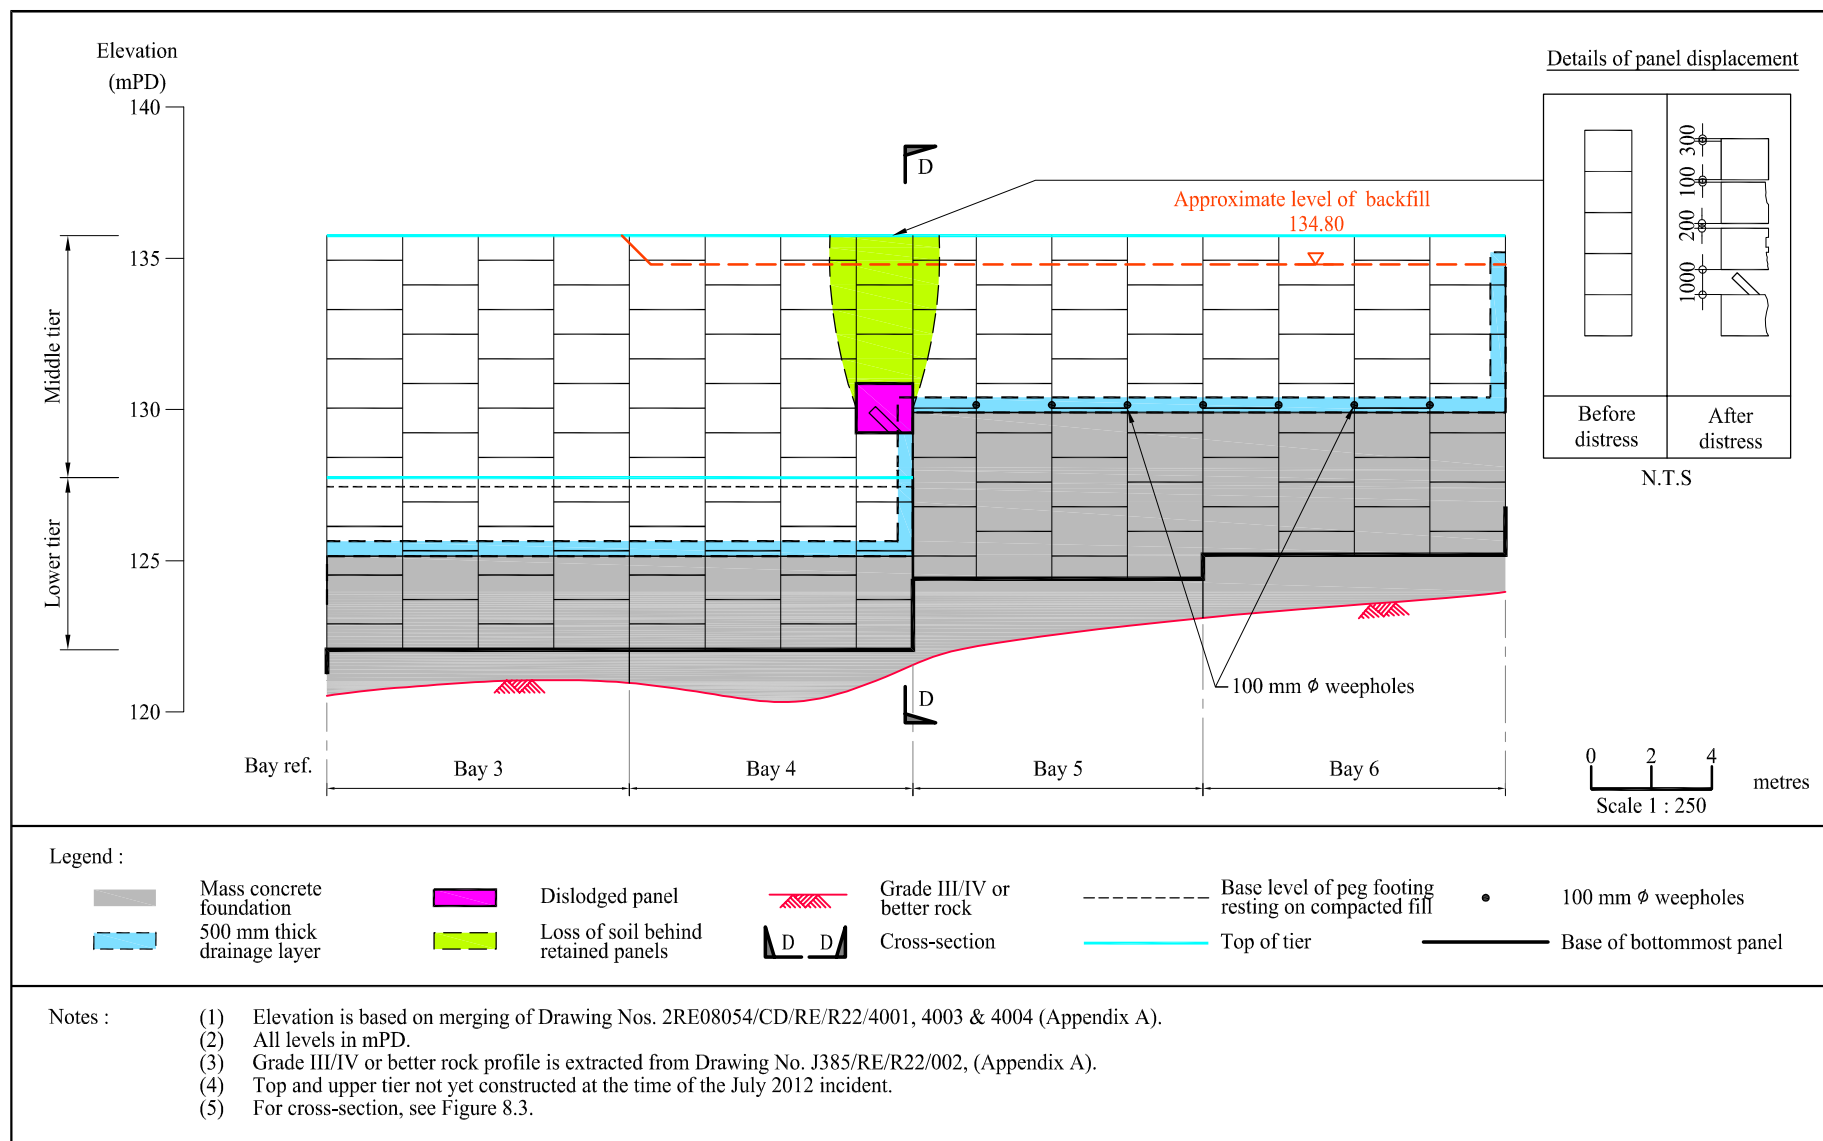
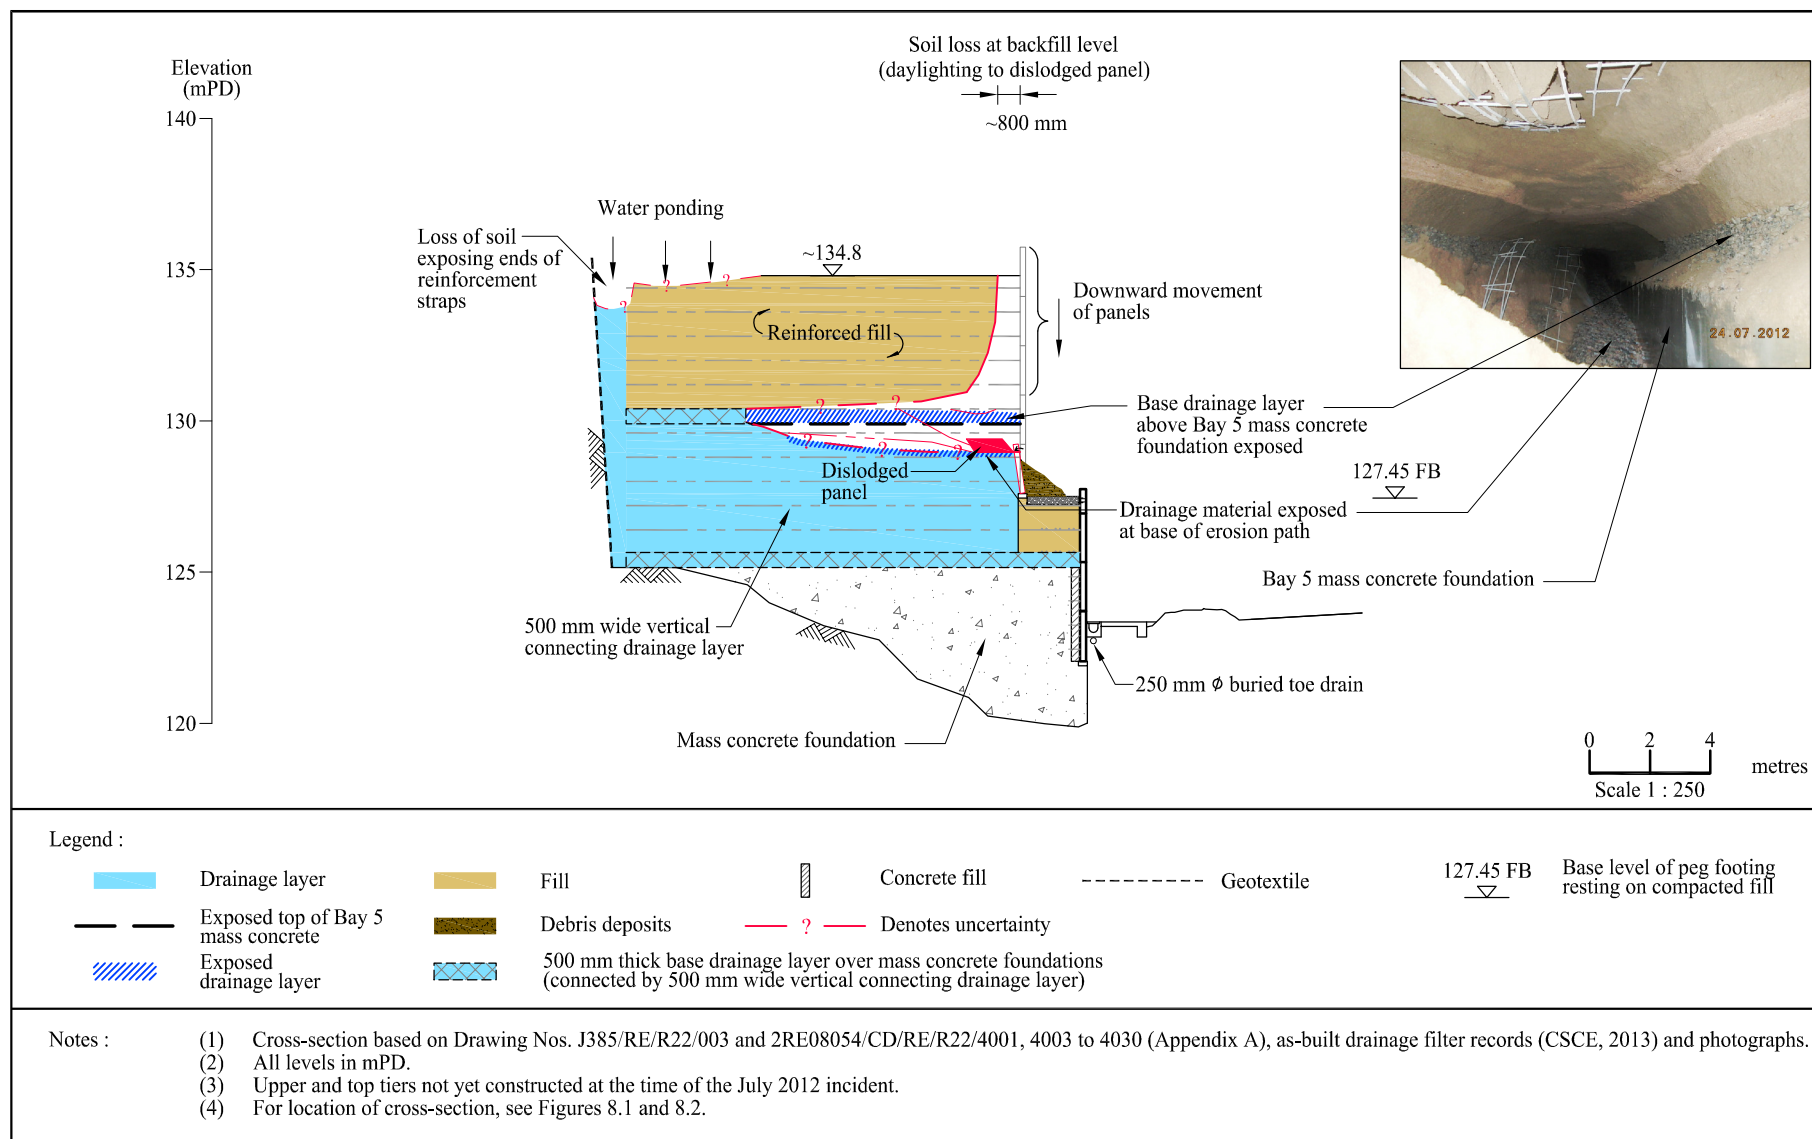
In the morning of 24 July 2012, after Typhoon Vicente had hit Hong Kong, a panel was found dislodged and collapsed into the wall at Bay 4 (Figures 8.1 to 8.3, Plates 18 and 19). The three panels above showed signs of downward and inwards movement. Approximately 40 m³ of soil loss was apparent immediately behind the panels, in the vicinity of the 'vertical connecting drainage layer' at the interface between Bays 4 and 5, as well as in the backyard of the wall. At that time, the wall was formed up to a level of about +135 mPD, with the height of reinforced fill about 10 m.

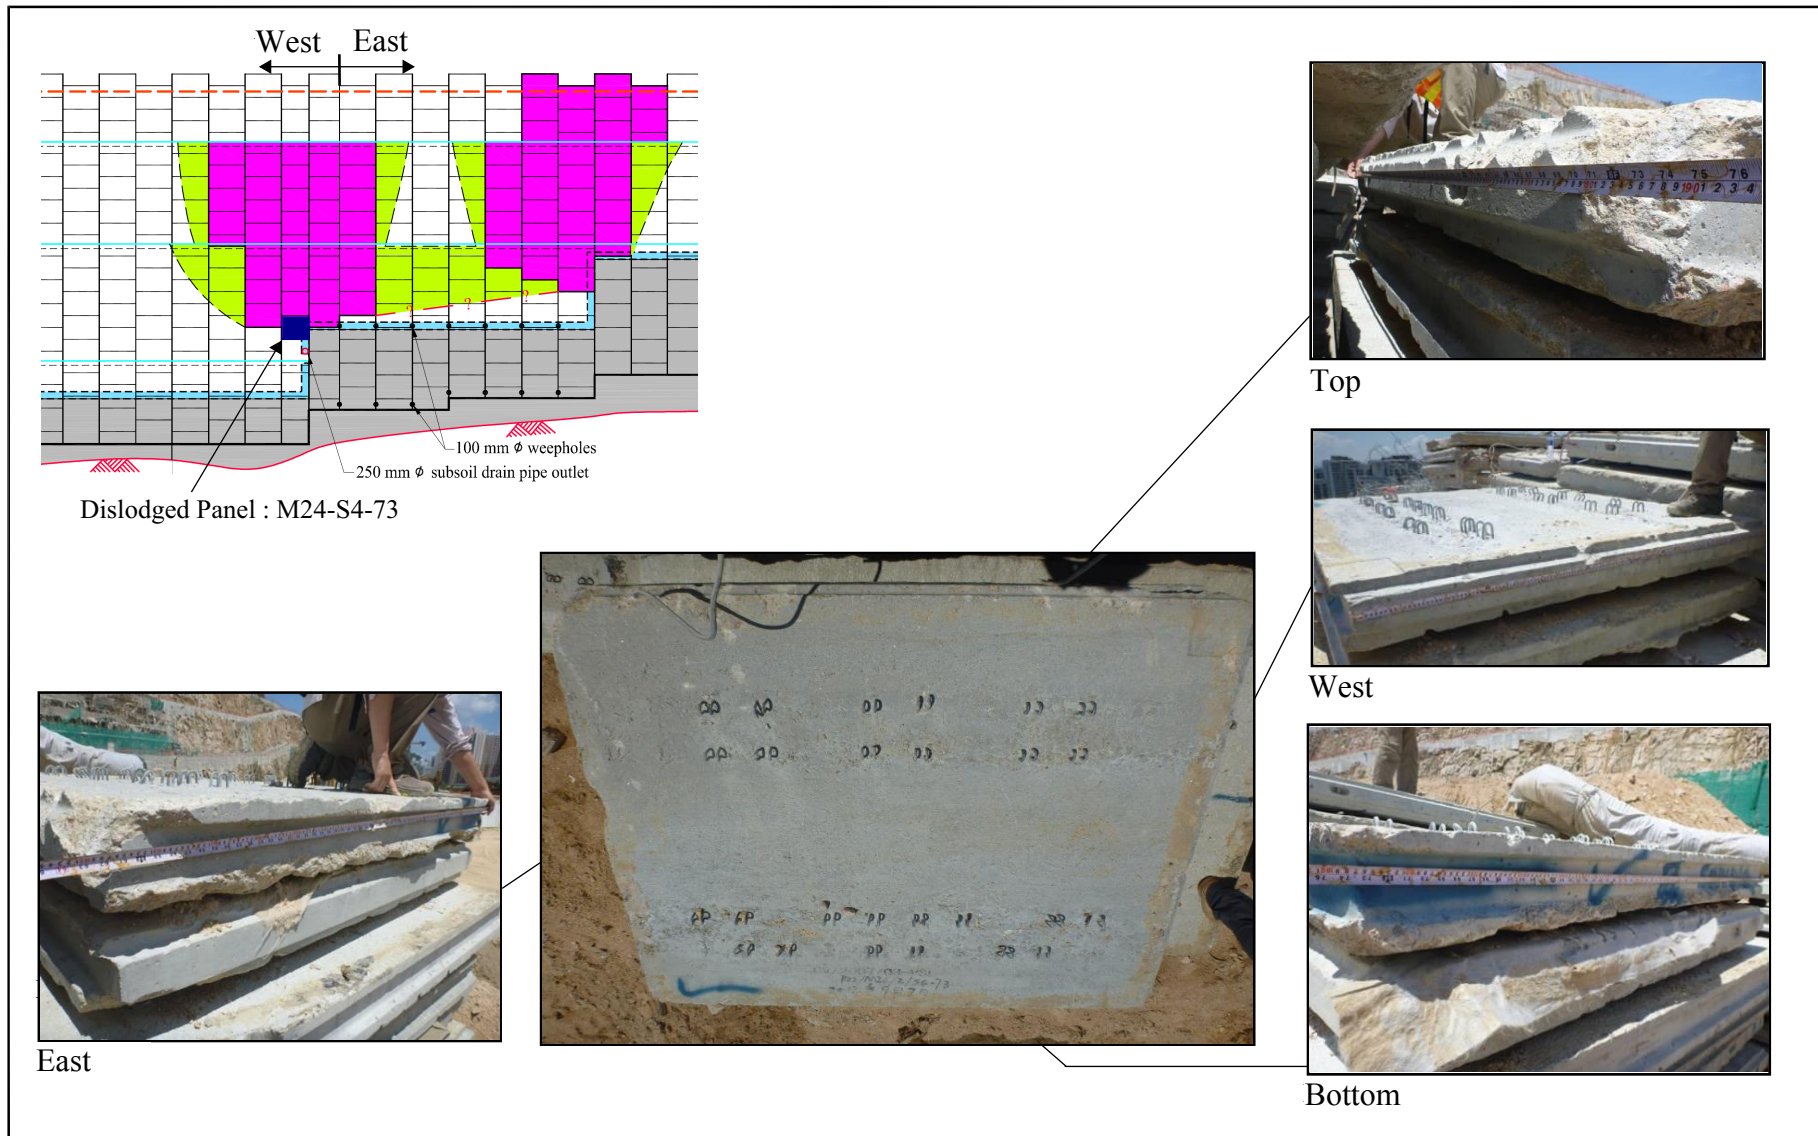
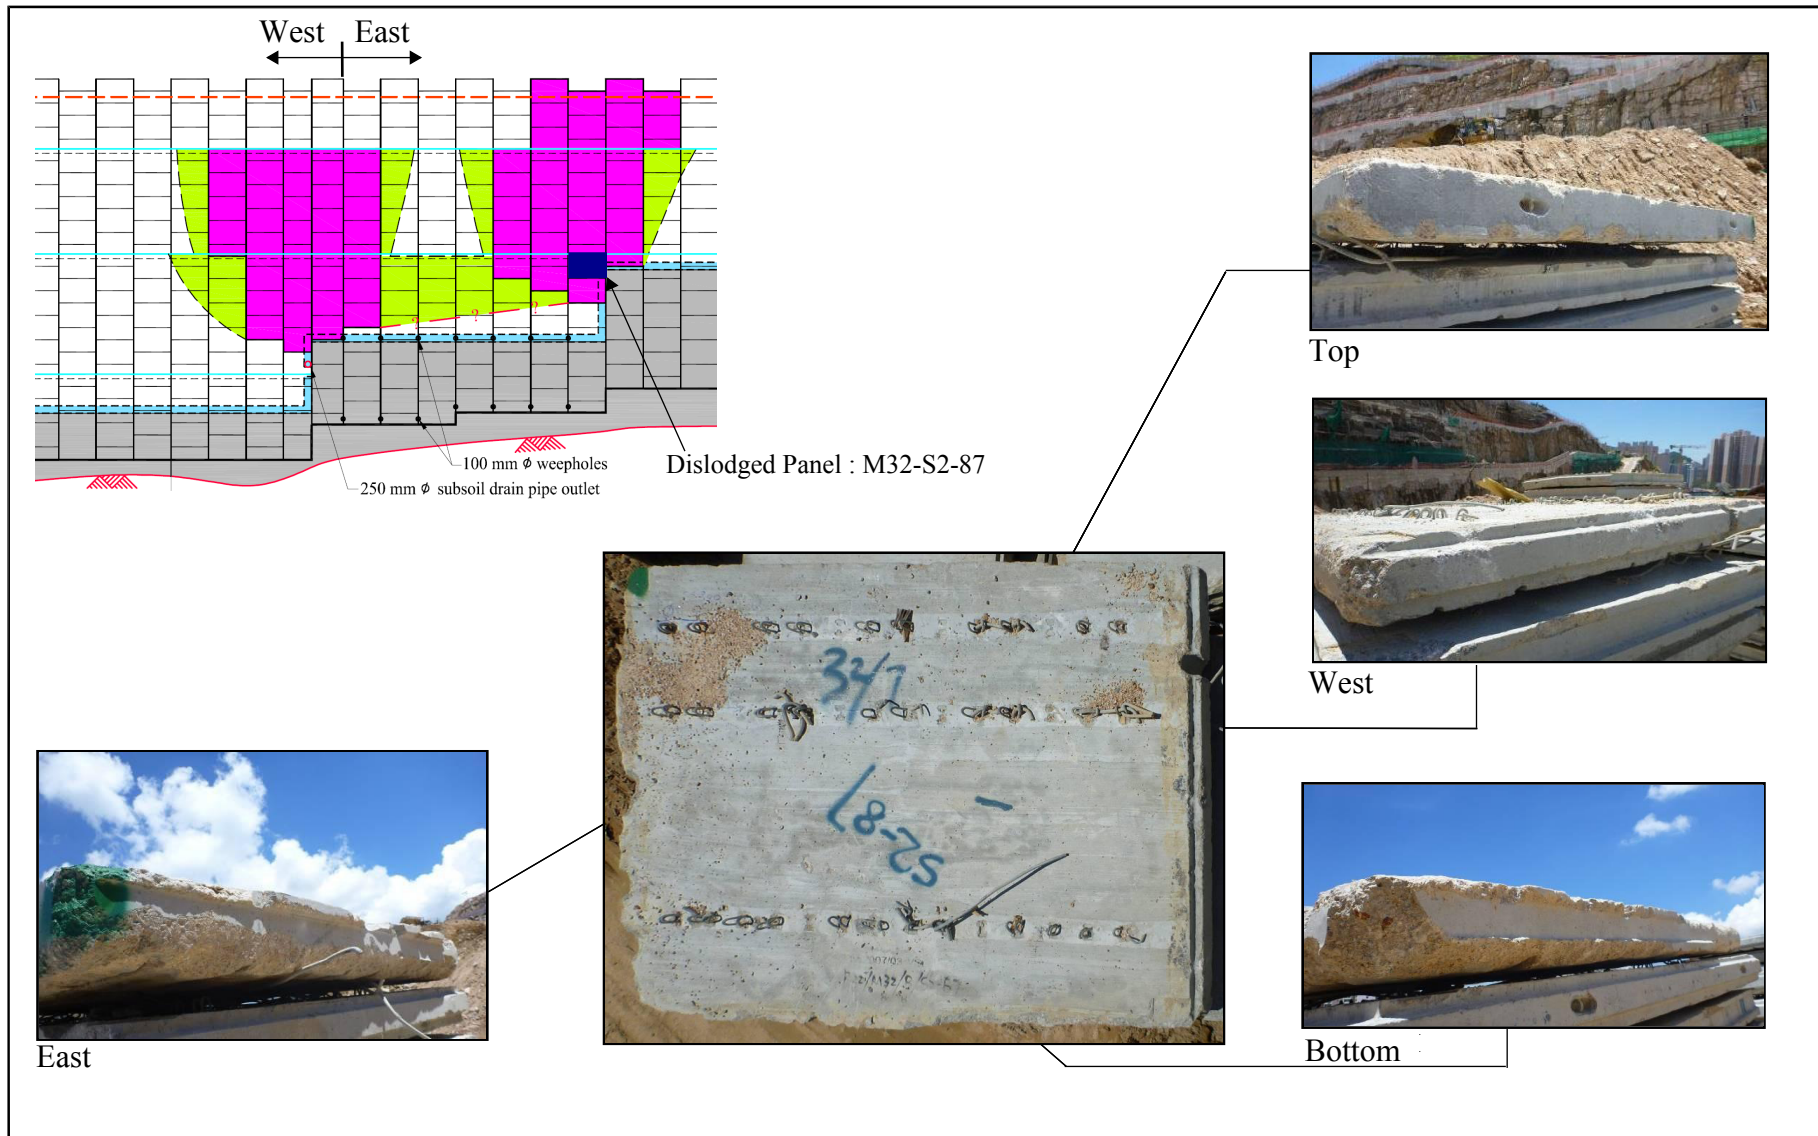
The ravelling process which involved slumping of the fill could induce tensile forces in the reinforcement straps attached to the panels. When the induced tensile forces were large enough to shear off the socket connections at the joints of the panels, as well as to overcome the available earth pressure of the fill behind the panels, panel dislodgement could occur. The observed damage on the panels at Bays 4 and 5, and Bays 6 and 7 where the front part of the panel sockets had been sheared off whilst the rear part of the socket generally remained intact (Figures 9.1 and 9.2) supports this postulated onset mechanism of the panel dislodgement.

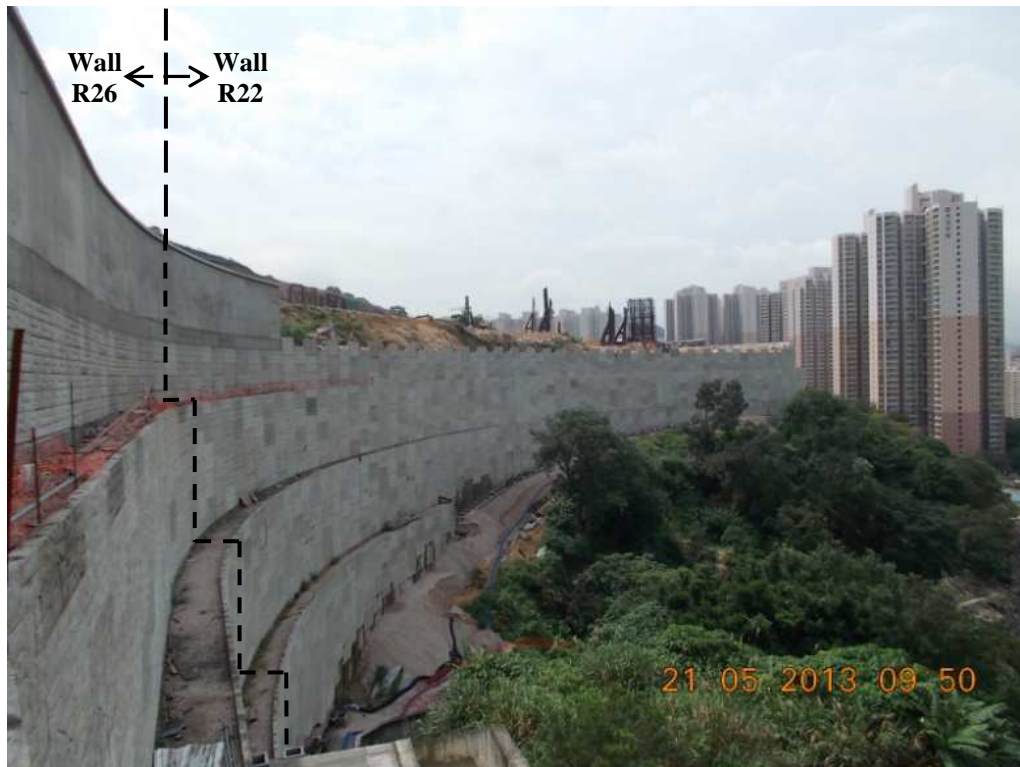
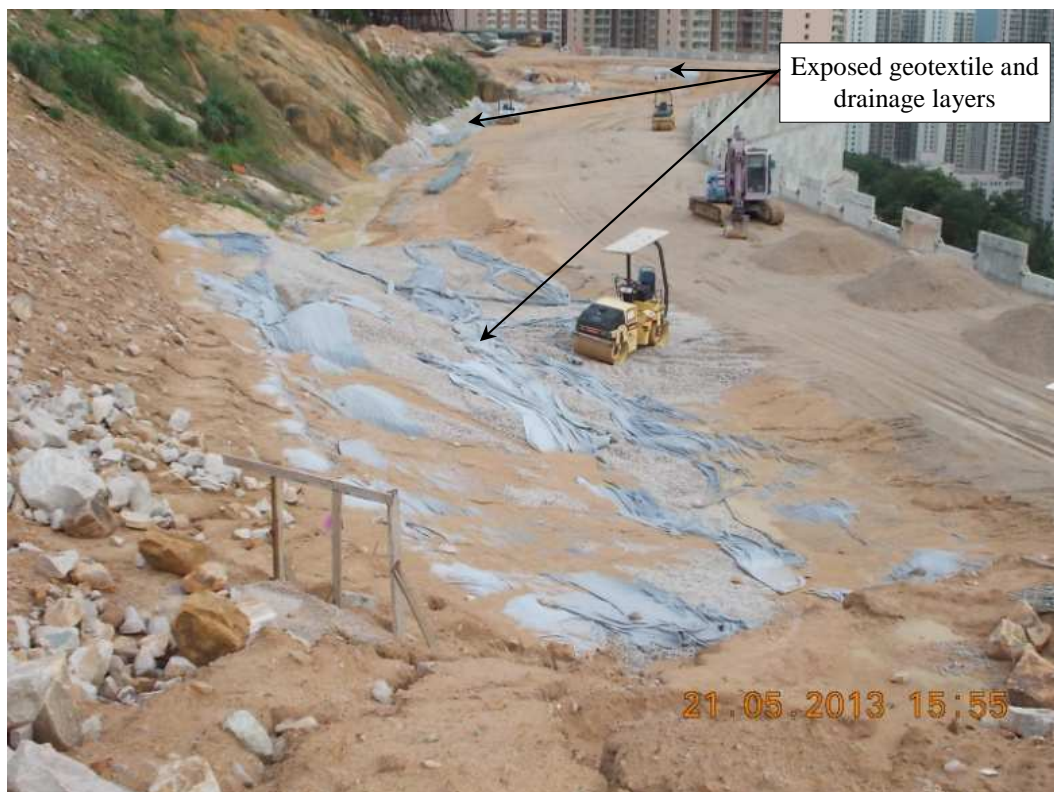
Plate 3 Pre-incident Conditions of Wall R22 (Photographs taken on 21 May 2013)

At the time of the incident, the top surface of the compacted fill (the backyard) was slightly graded away from the wall face (Plate 3). The backyard at Bays 4 to 7 of the wall was a topographical low point in the vicinity, as evidenced by water ponding observed on the day before the incident (Plate 13). No temporary surface drainage was provided at this location (Plate 4). The top end of the drainage layer at the back of Wall R22 was exposed in this area (Plate 13). This allowed any surface water that accumulated at the backyard to get inside Wall R22. Discussion of the drainage arrangement of Wall R22 is given in Section 7.1.2.

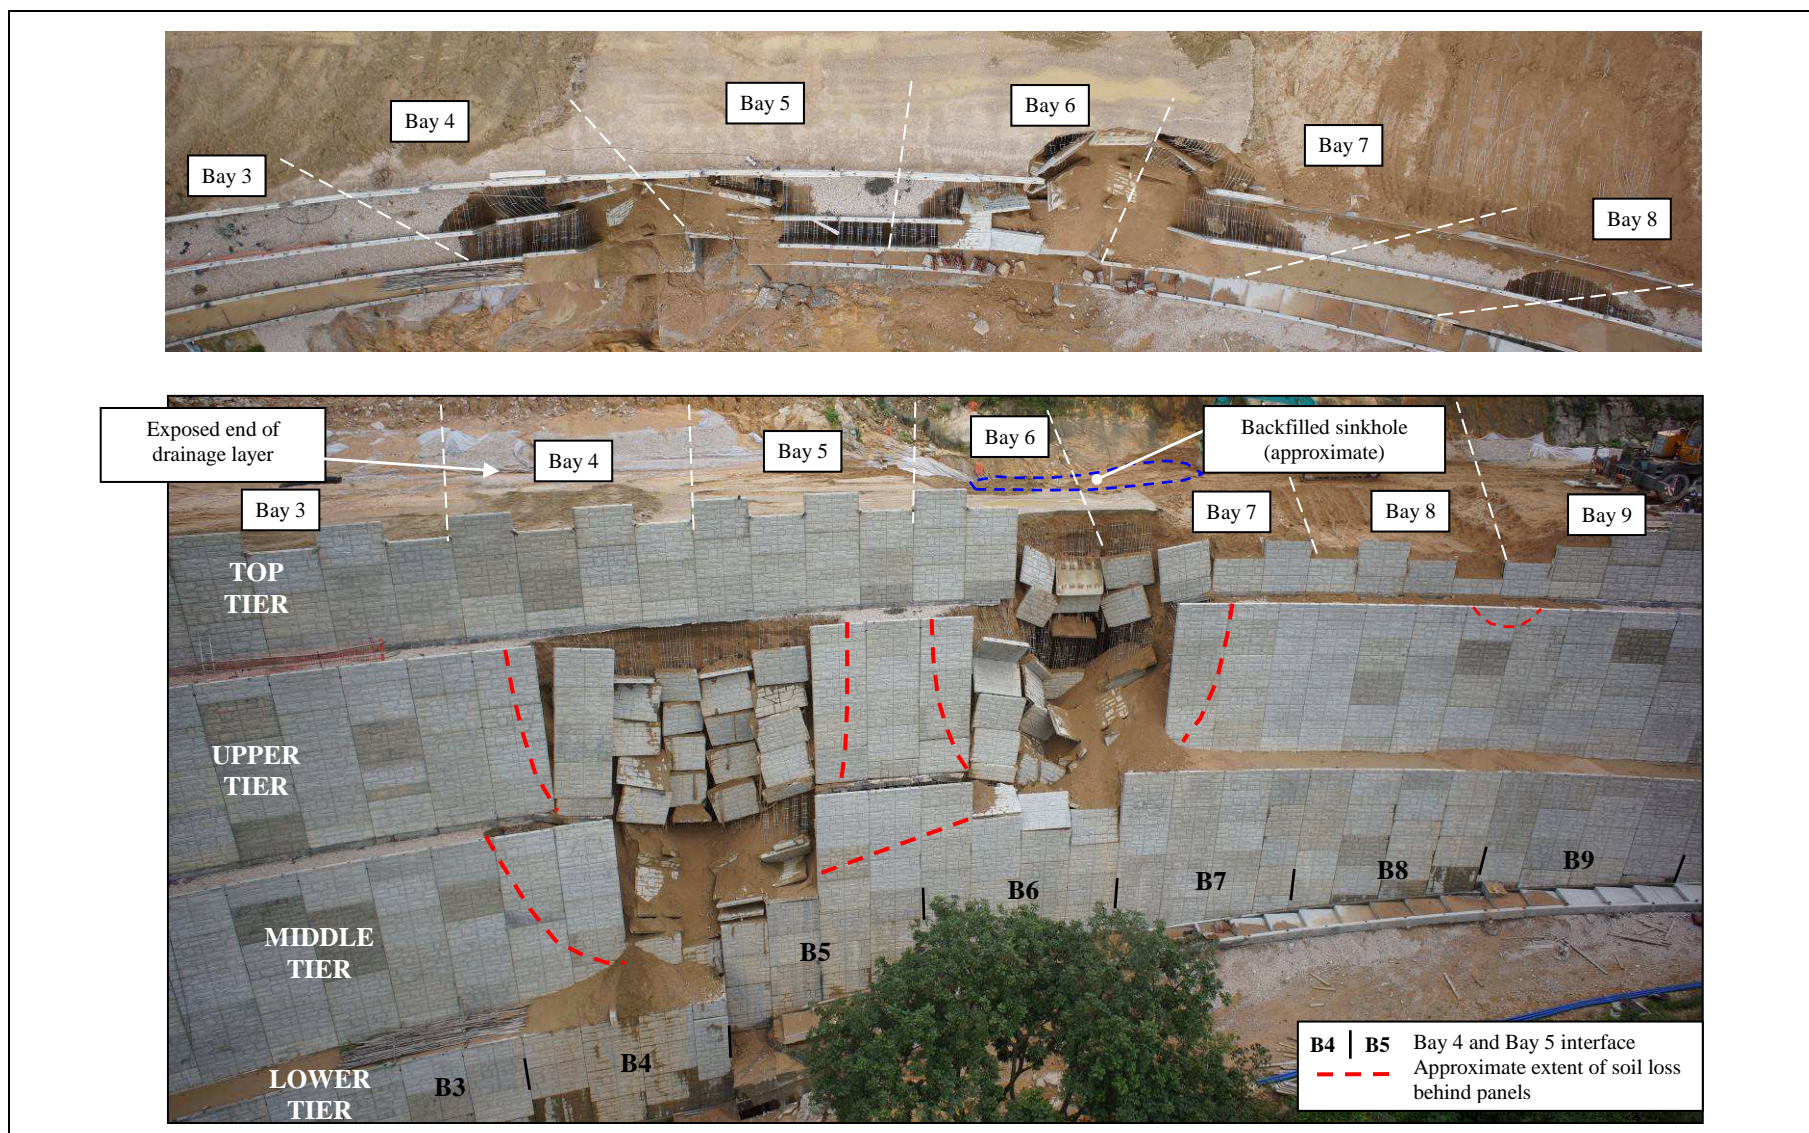
Plate 4 Aerial Views of the 22 May 2013 Incident at Wall R22 (Photographs taken on 23 May 2013)

The localized distress at the interface between Bays 6 and 7 involved the dislodgement of 38 panels from the middle to the top tiers (Plates 4 and 6). Approximately 340 m³ of soil loss was observed immediately behind the dislodged panels and their adjacent panels. Loss of soil was mainly limited to within a distance of 2 m away from the panel. At the backyard of the wall, a sinkhole measuring approximately 8 m wide by 12.5 m long on plan, extending up to 9 m deep and with an approximate volume of 450 m³ was observed (Plate 7). Photographic records indicate that the central part of the soil loss appeared to extend deeper and would have likely connected to the sinkhole (Plates 6 and 7).

The localized distress at the interface between Bays 8 and 9 involved a relatively small scale of soil loss (approximately 5 m³) immediately behind the panels at the top of the upper tier (Plates 4 and 8). Soil debris of around 5 m³ was deposited on the top of the middle tier below the location where loss of soil was noted. No signs of dislodgement or notable movement of panels was observed at the affected facing panels (Plate 8).
