**REPORT ON THE 22 MAY 2013
DISTRESS AT A REINFORCED
FILL WALL AT A
CONSTRUCTION SITE
ABOVE SHUN ON ROAD,
SAU MAU PING**

*Fugro Scott Wilson Joint Venture
for
Geotechnical Engineering Office
Civil Engineering and
Development Department
The Government of The Hong Kong
Special Administrative Region*

December 2013
(minor amendments made in November 2020)

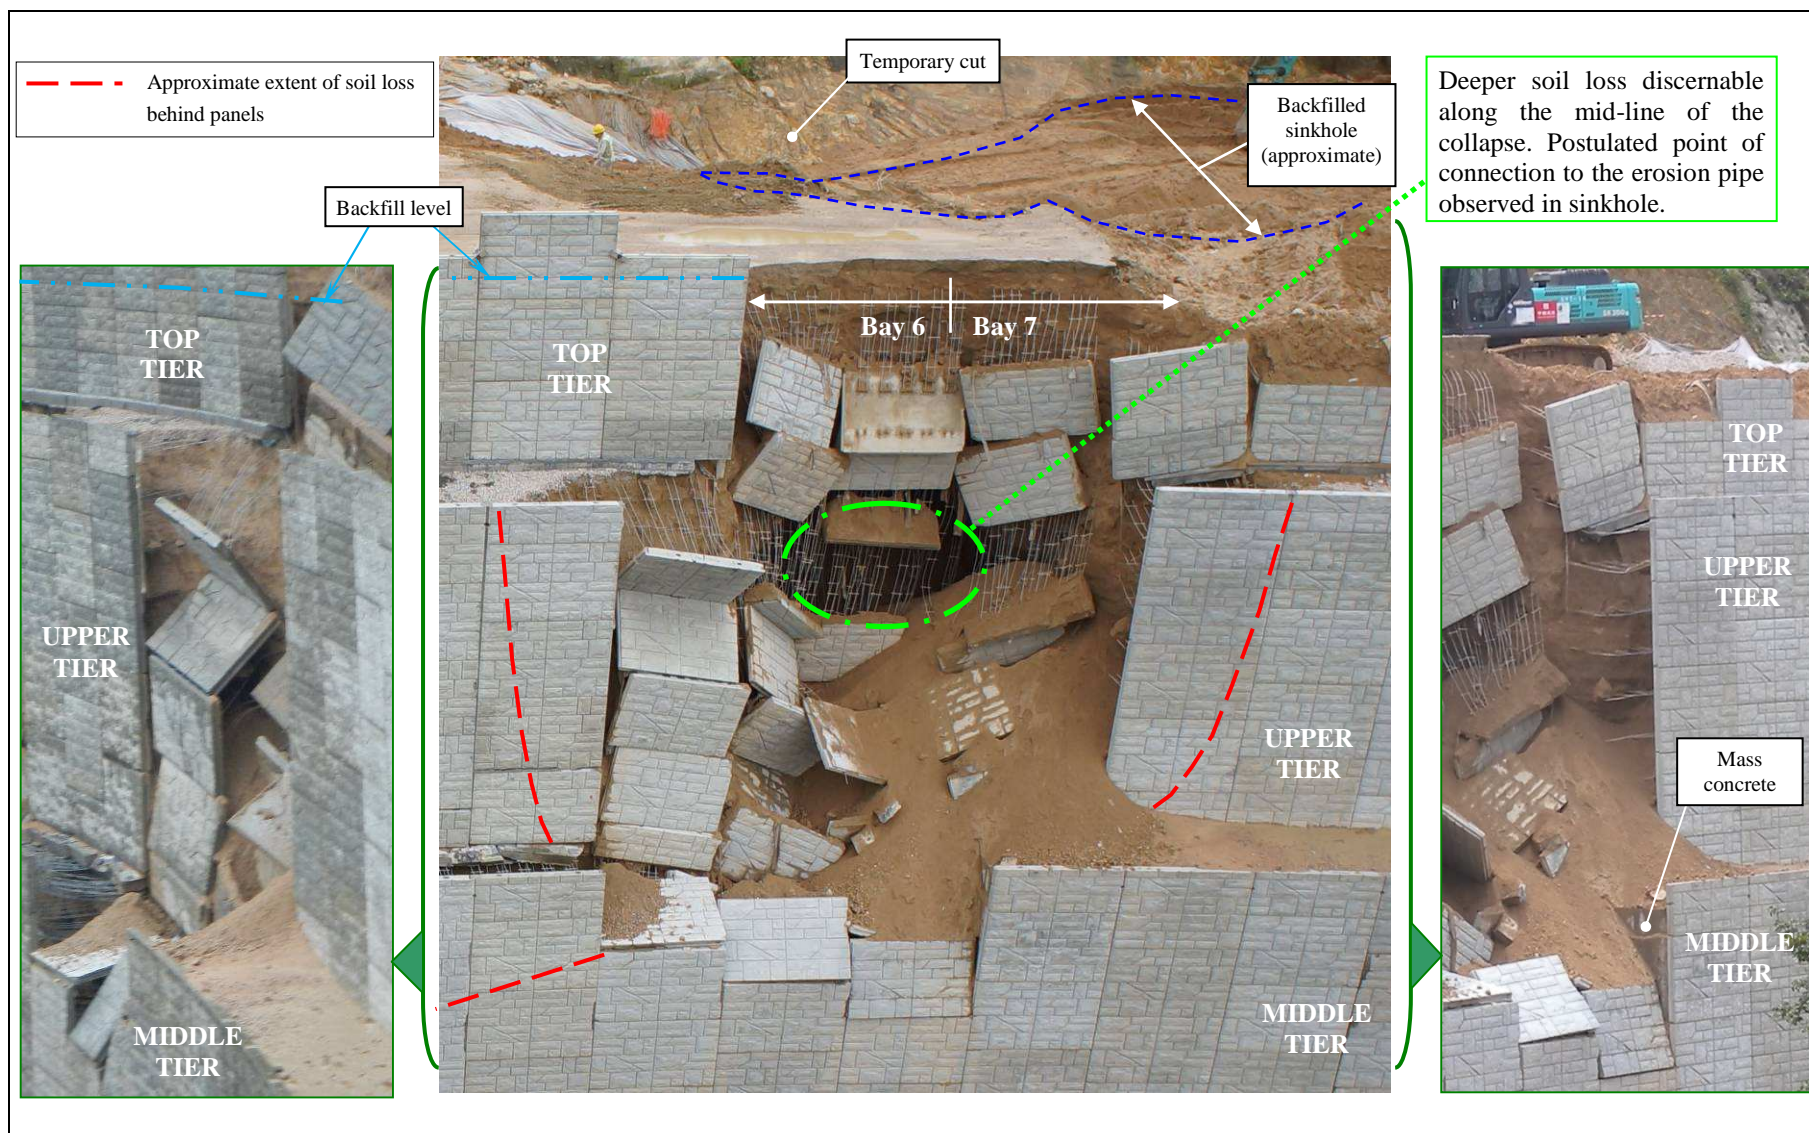
Plate 6 Distressed Zone at Bays 6/7 of Wall R22 (Photographs taken on 22 and 23 May 2013)

The localized distress at the interface between Bays 6 and 7 involved the dislodgement of 38 panels from the middle to the top tiers (Plates 4 and 6). Approximately 340 m³ of soil loss was observed immediately behind the dislodged panels and their adjacent panels. Loss of soil was mainly limited to within a distance of 2 m away from the panel. At the backyard of the wall, a sinkhole measuring approximately 8 m wide by 12.5 m long on plan, extending up to 9 m deep and with an approximate volume of 450 m³ was observed (Plate 7). Photographic records indicate that the central part of the soil loss appeared to extend deeper and would have likely connected to the sinkhole (Plates 6 and 7).

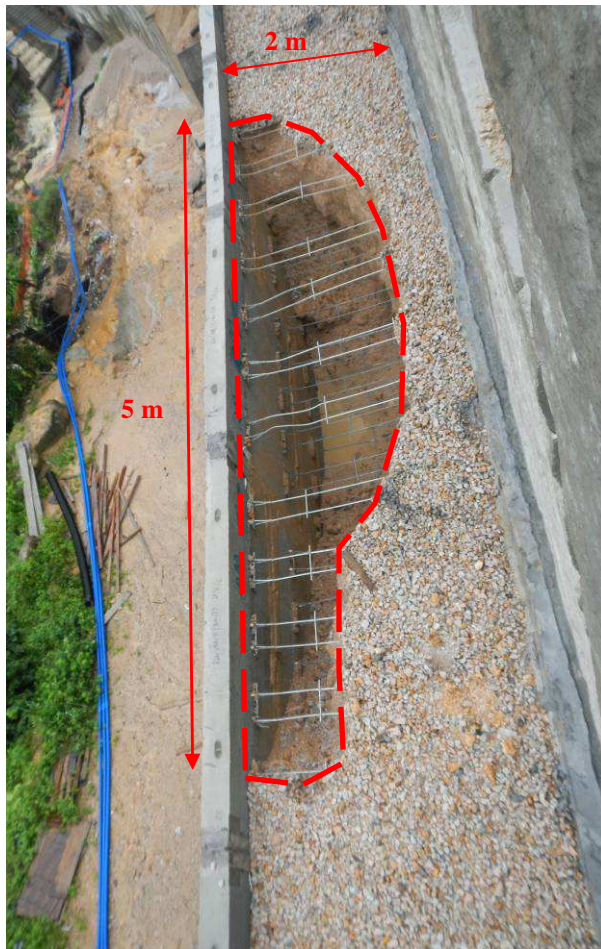
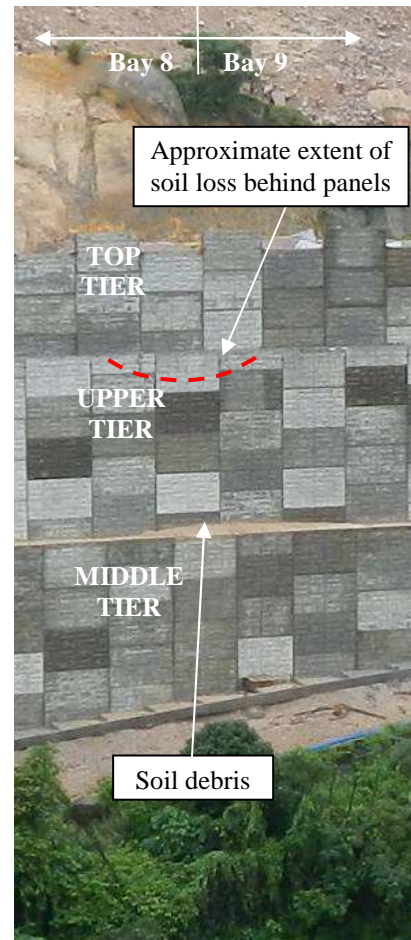
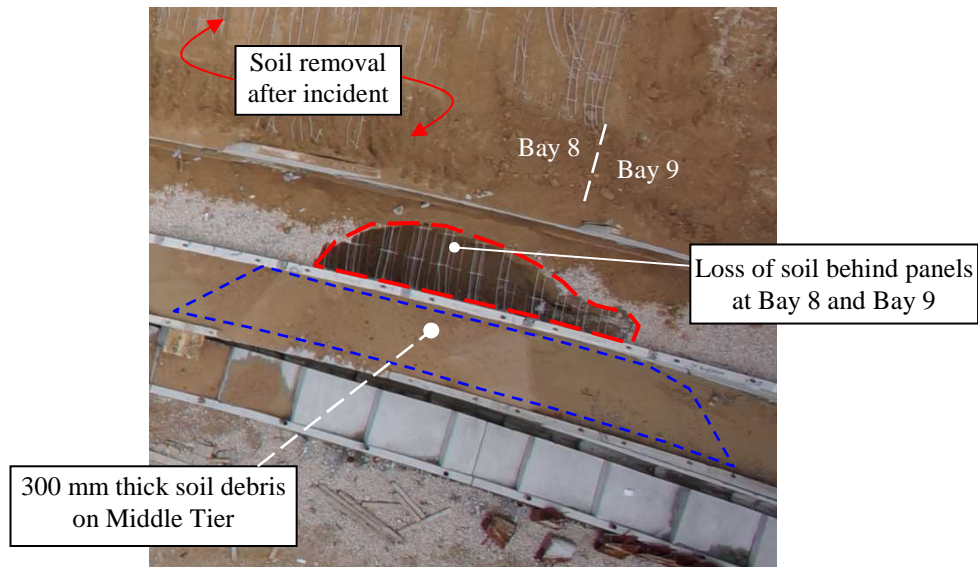
Plate 8 Soil Loss behind the Upper Tier at Bays 8/9 (Photographs taken on 23 May 2013)

The localized distress at the interface between Bays 8 and 9 involved a relatively small scale of soil loss (approximately 5 m³) immediately behind the panels at the top of the upper tier (Plates 4 and 8). Soil debris of around 5 m³ was deposited on the top of the middle tier below the location where loss of soil was noted. No signs of dislodgement or notable movement of panels was observed at the affected facing panels (Plate 8).

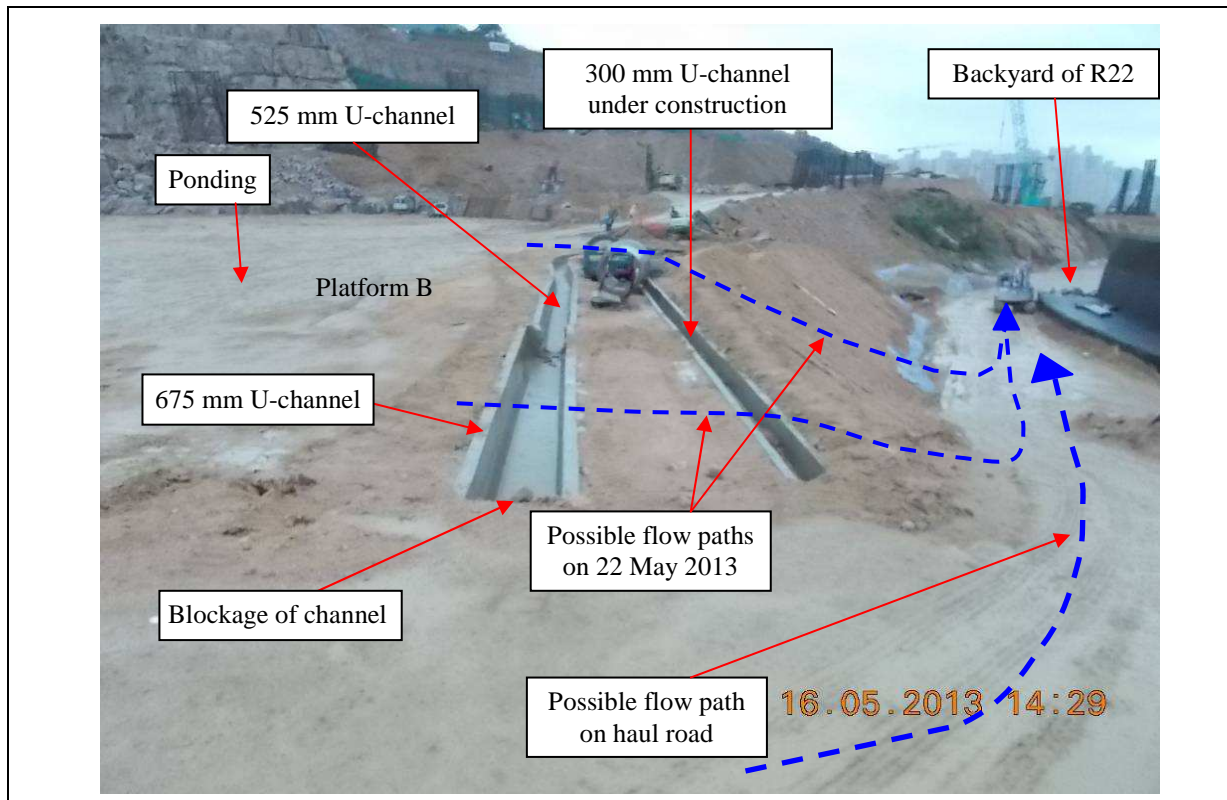
Plate 11 Temporary Haul Road over the 675 mm U-channel between Sand Traps ST15 and ST16 (Photograph taken on 16 May 2013)

Road L2 as part of the permanent drainage system (Figure 5.3). Limited drainage works under Road L2 were constructed at the time of the incident. Only one of the constructed sand traps (ST15 in Figures 5.3 and 5.4, Plate 10) was connected to the cascade in front of Wall R22 and Wall R26 (Figure 5.4). Given the as-built fall direction of these U-channels, surface flow against the invert fall would occur at some sections of U-channels (Figure 5.4), hampering the flow efficiency and capacity of these channels under the temporary drainage condition. Signs of blockage of the drainage system were observed days before the incident (Plate 11).

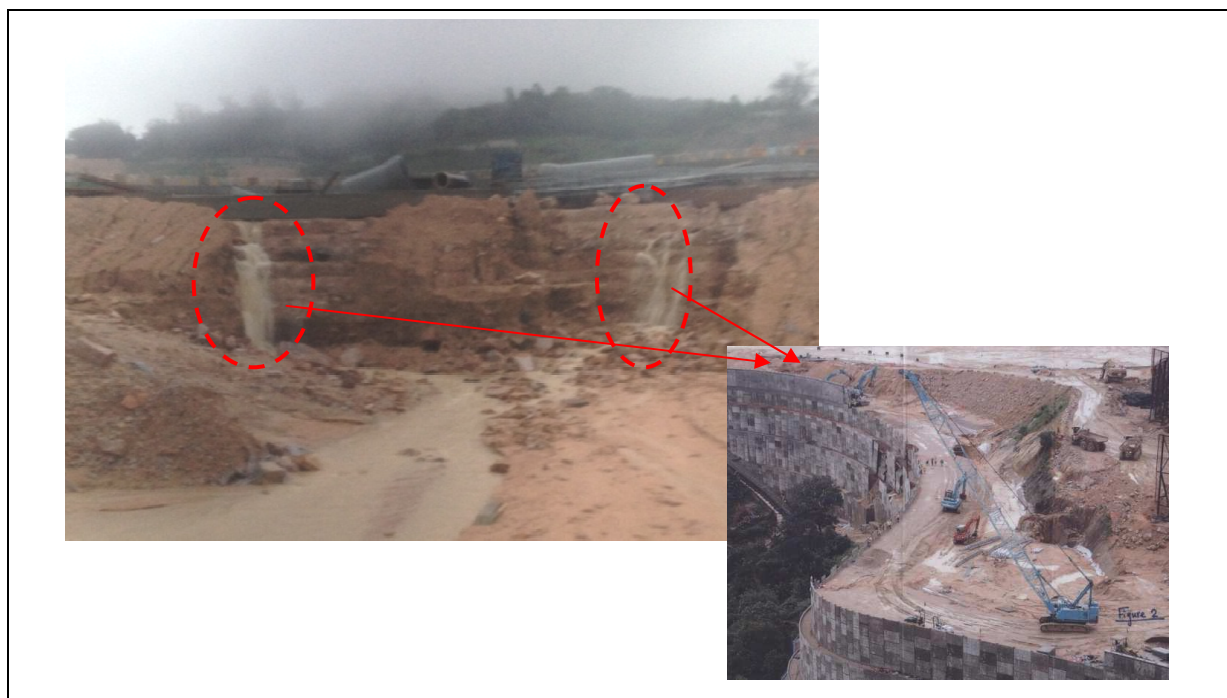
Plate 12 Significant Overland Flow from Platform B between Sand Traps ST15 and ST16 towards the Back of Wall R22 (Photographs taken around 9:00 a.m. on 22 May 2013)

In the morning of 22 May 2013, significant overland flow originating from Platform B over the location of the temporary earth bund was observed (Figure 5.5 and Plate 12) flowing down a haul road towards the back of Wall R22. Based on photographic records, the temporary earth bund between the haul road and sand trap ST16 was estimated to be around 500 mm high. The temporary earth bund was not effective in controlling the surface runoff as evidenced by the overland flow in the morning of 22 May 2013 as well as erosions scars below the reported bund extent observed several days prior to the incident.

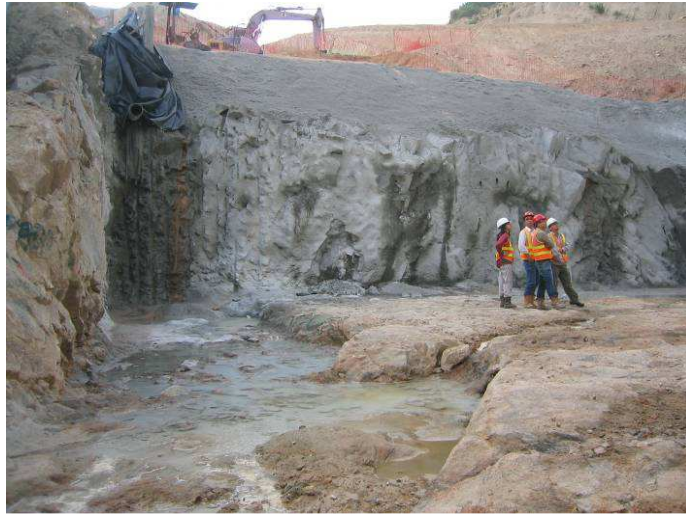
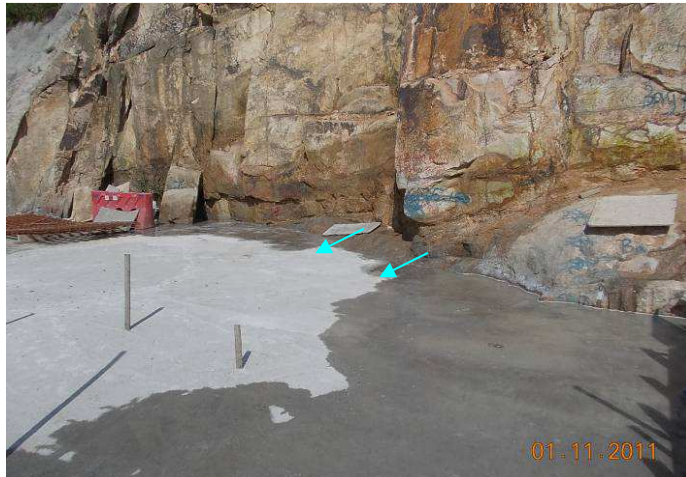
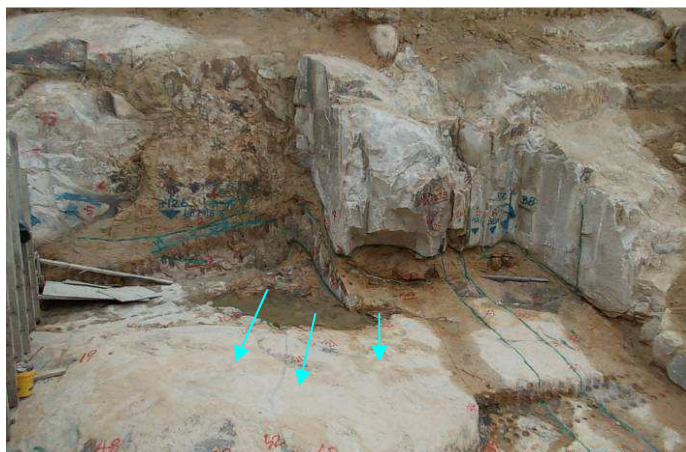
Plate 14 Seepage from Temporary Cuts during the Construction of Wall R22

During the construction of Wall R22, continued seepage (measured as 0.84 litres per second in April 2010) was observed at the temporary cut of Bay 1 (Plate 14), whereas the temporary cut at the back of Bays 3 to 7 showed relatively minor seepage above some weathered weak seams (Plate 14). No flow measurement was taken at these seepage locations. The seepage levels were around or below the base level of the reinforced fill portion of the wall.

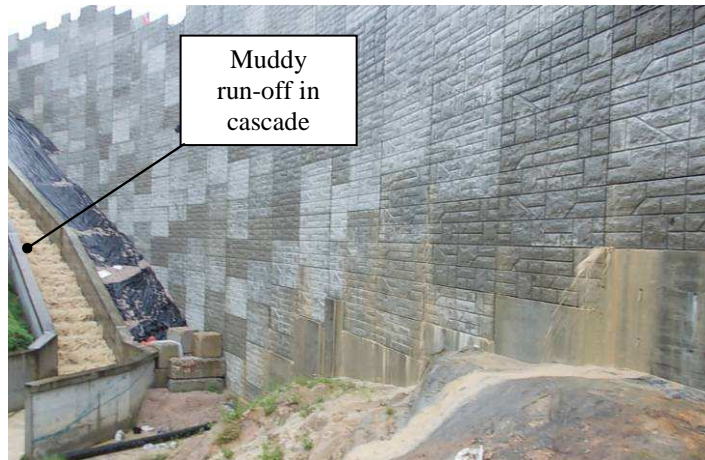
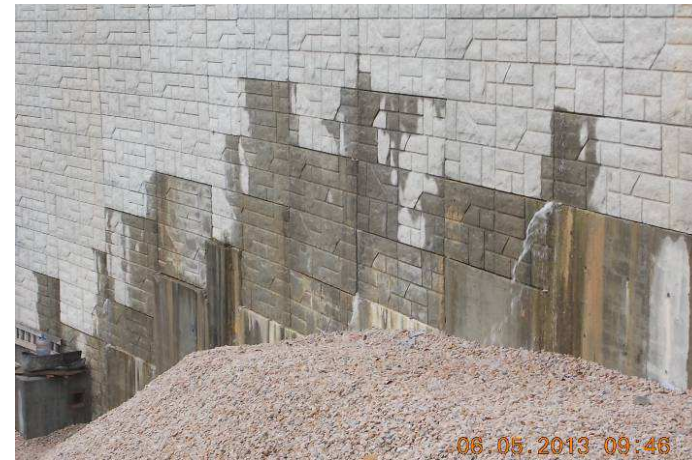
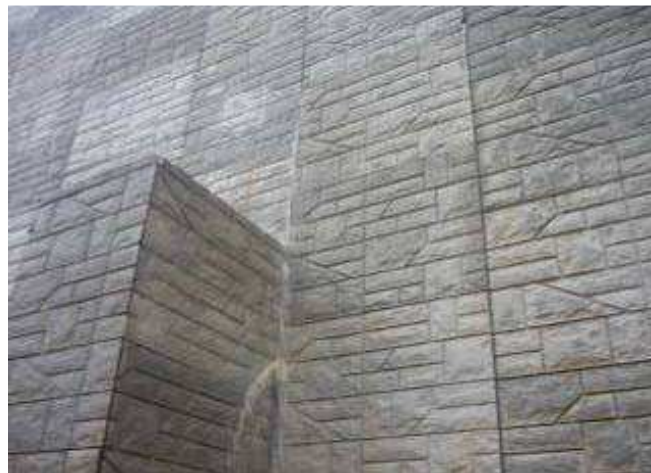
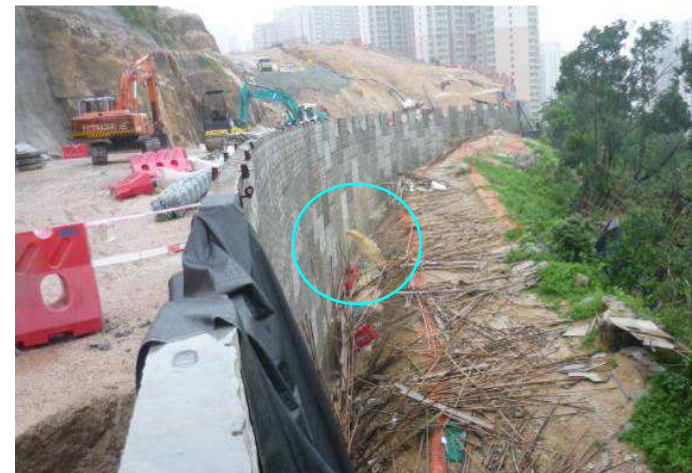
Plate 17 Examples of Observations of Seepage from the Face of Wall R22

Based on available site records, seepage flows issuing from the wall face since May 2012 were noted (Figure 7.4 and Plate 17). Seepage was mainly observed between Bays 1 and 5 as well as Bay 9 of the wall. Both clear and muddy seepages have been noted with varying degrees of intensity. Most of the seepage was through the joints of the dummy panels (i.e. at a level at or below the base of the base drainage layer). Limited water seepage points were observed at Bays 6 and 7.

Before the incident, some seepage flow was noted through the joints of the panels near the interface between Bays 4 and 5 (Plate 17c). Following the 24 July 2012 incident, the wall was partially removed from Bay 2 to Bay 6 in a stepped profile down to the level of the collapsed panel (Figure 8.5). Additional internal drainage measures as mentioned in Section 7.1.2 were provided (Figure 8.6). CSCE and OAP also carried out field inspections to identify any seepage under heavy rainfalls subsequent to the 24 July 2012 incident.

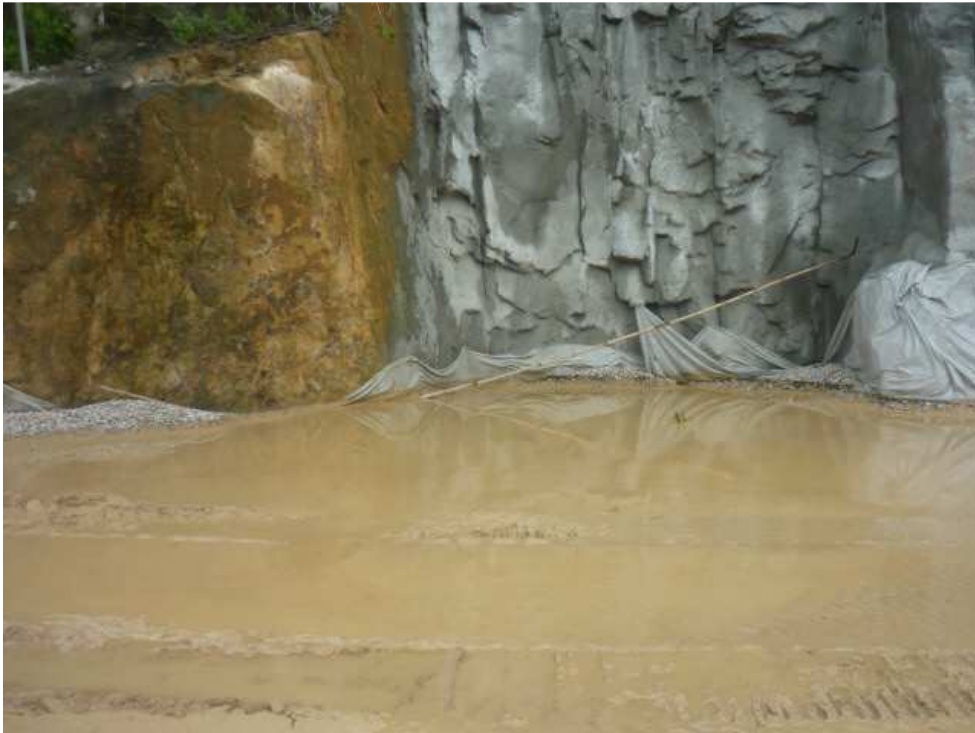
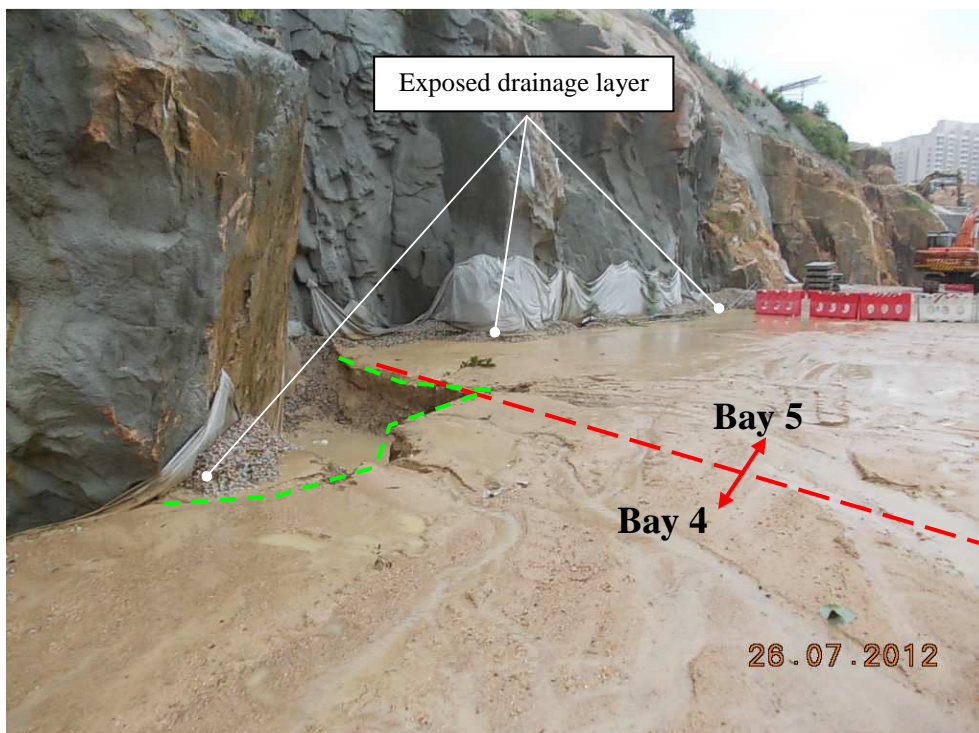
Plate 19 Backyard of Bays 4/5 after the July 2012 Incident

In the morning of 24 July 2012, after Typhoon Vicente had hit Hong Kong, a panel was found dislodged and collapsed into the wall at Bay 4 (Figures 8.1 to 8.3, Plates 18 and 19). The three panels above showed signs of downward and inwards movement. Approximately 40 m³ of soil loss was apparent immediately behind the panels, in the vicinity of the 'vertical connecting drainage layer' at the interface between Bays 4 and 5, as well as in the backyard of the wall. At that time, the wall was formed up to a level of about +135 mPD, with the height of reinforced fill about 10 m.

Site records showed that, at the time of the 24 July 2012 incident, there was no temporary drainage in the backyard of Bays 4 and 5. Water ponding in this area was observed shortly after the incident suggesting that it was a local low point (Plate 19). Similar to the 22 May 2013 incident, the upper end of the combined vertical/inclined drainage layer in the backyard of Bays 4 and 5 was exposed. Such arrangement could allow significant ingress of surface water into Wall R22 during rainstorms.

It was probable that ingress of surface water via the exposed drainage layer at the back of the wall was a key contributory factor of the distress. The Contractor's investigation (CSCE, 2012) also concluded that *"the failure was due to the flow of surface water towards the lowest point of the current backfilled level and flow through the back slope filter layer down to the surface of the mass concrete block which washed out the fill along its path"*.
