**REPORT ON THE 22 MAY 2013
LANDSLIDE ON A FILL SLOPE
AT A CONSTRUCTION SITE
ABOVE LEE ON ROAD,
SAU MAU PING**

*Fugro Scott Wilson Joint Venture
for
Geotechnical Engineering Office
Civil Engineering and
Development Department
The Government of The Hong Kong
Special Administrative Region*

December 2013
(minor amendments made in November 2020)

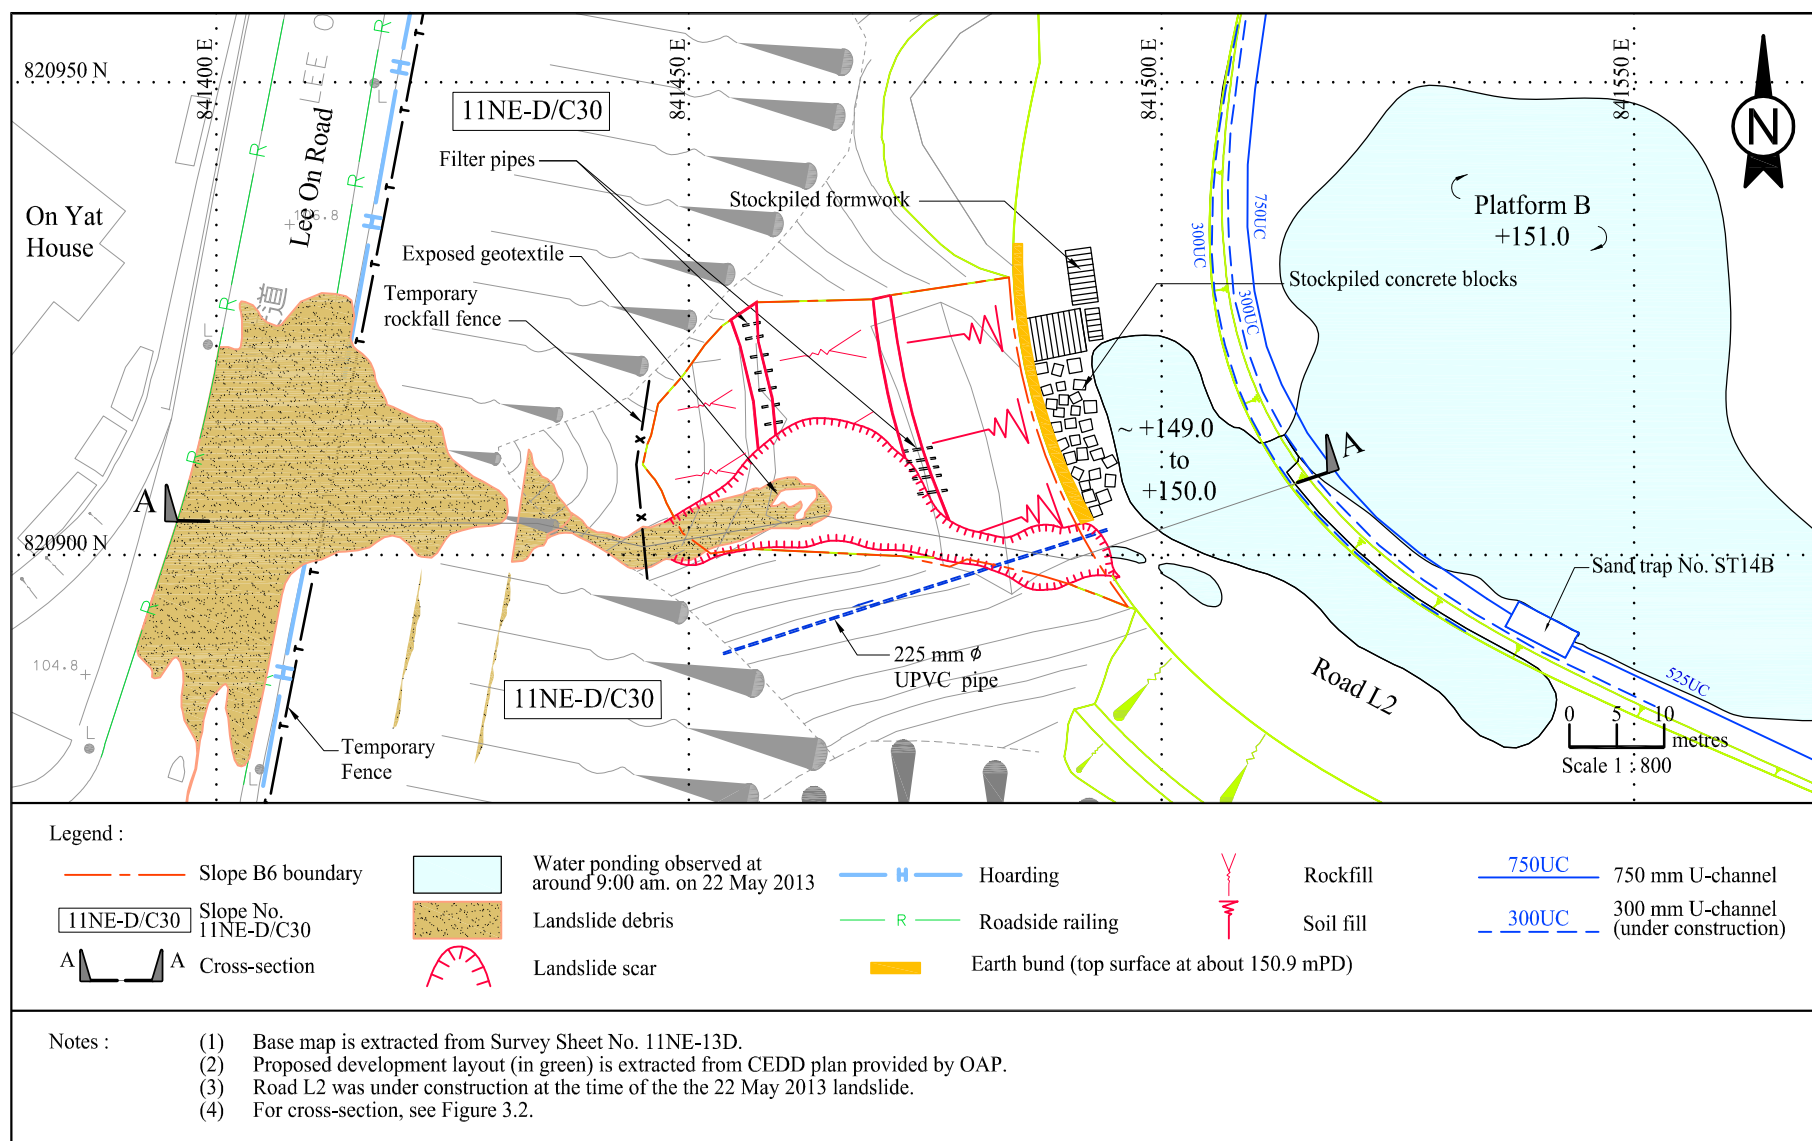
Figure 3.1 Plan of the 22 May 2013 Landslide at Slope B6

The landslide resulted in a curve-shaped scar on the southern side of Slope B6 (Plate 2). The scar was about 17 m high, about 2.5 m deep on average, with a maximum width of 14 m (Figure 3.1 and Plate 2). In-situ strata were exposed over the basal surface and the southern flank of the landslide scar (Plate 9). A geotextile layer was also observed at the base of the rockfill.

Post-failure inspection observed that a 5 m span of the earth bund at its southern end immediately above the landslide scar had been breached (Plate 10). A few hours after the landslide (at about 9:00 a.m. on 22 May 2013), ponding over an extensive area was observed at the crest area of Slope B6 (Plates 2 and 11, and Figure 3.1) with a significant amount of water running through the breach in the earth bund, discharging onto the landslide scar at Slope B6 below (Figure 3.1 and Plates 7, 10 and 12).

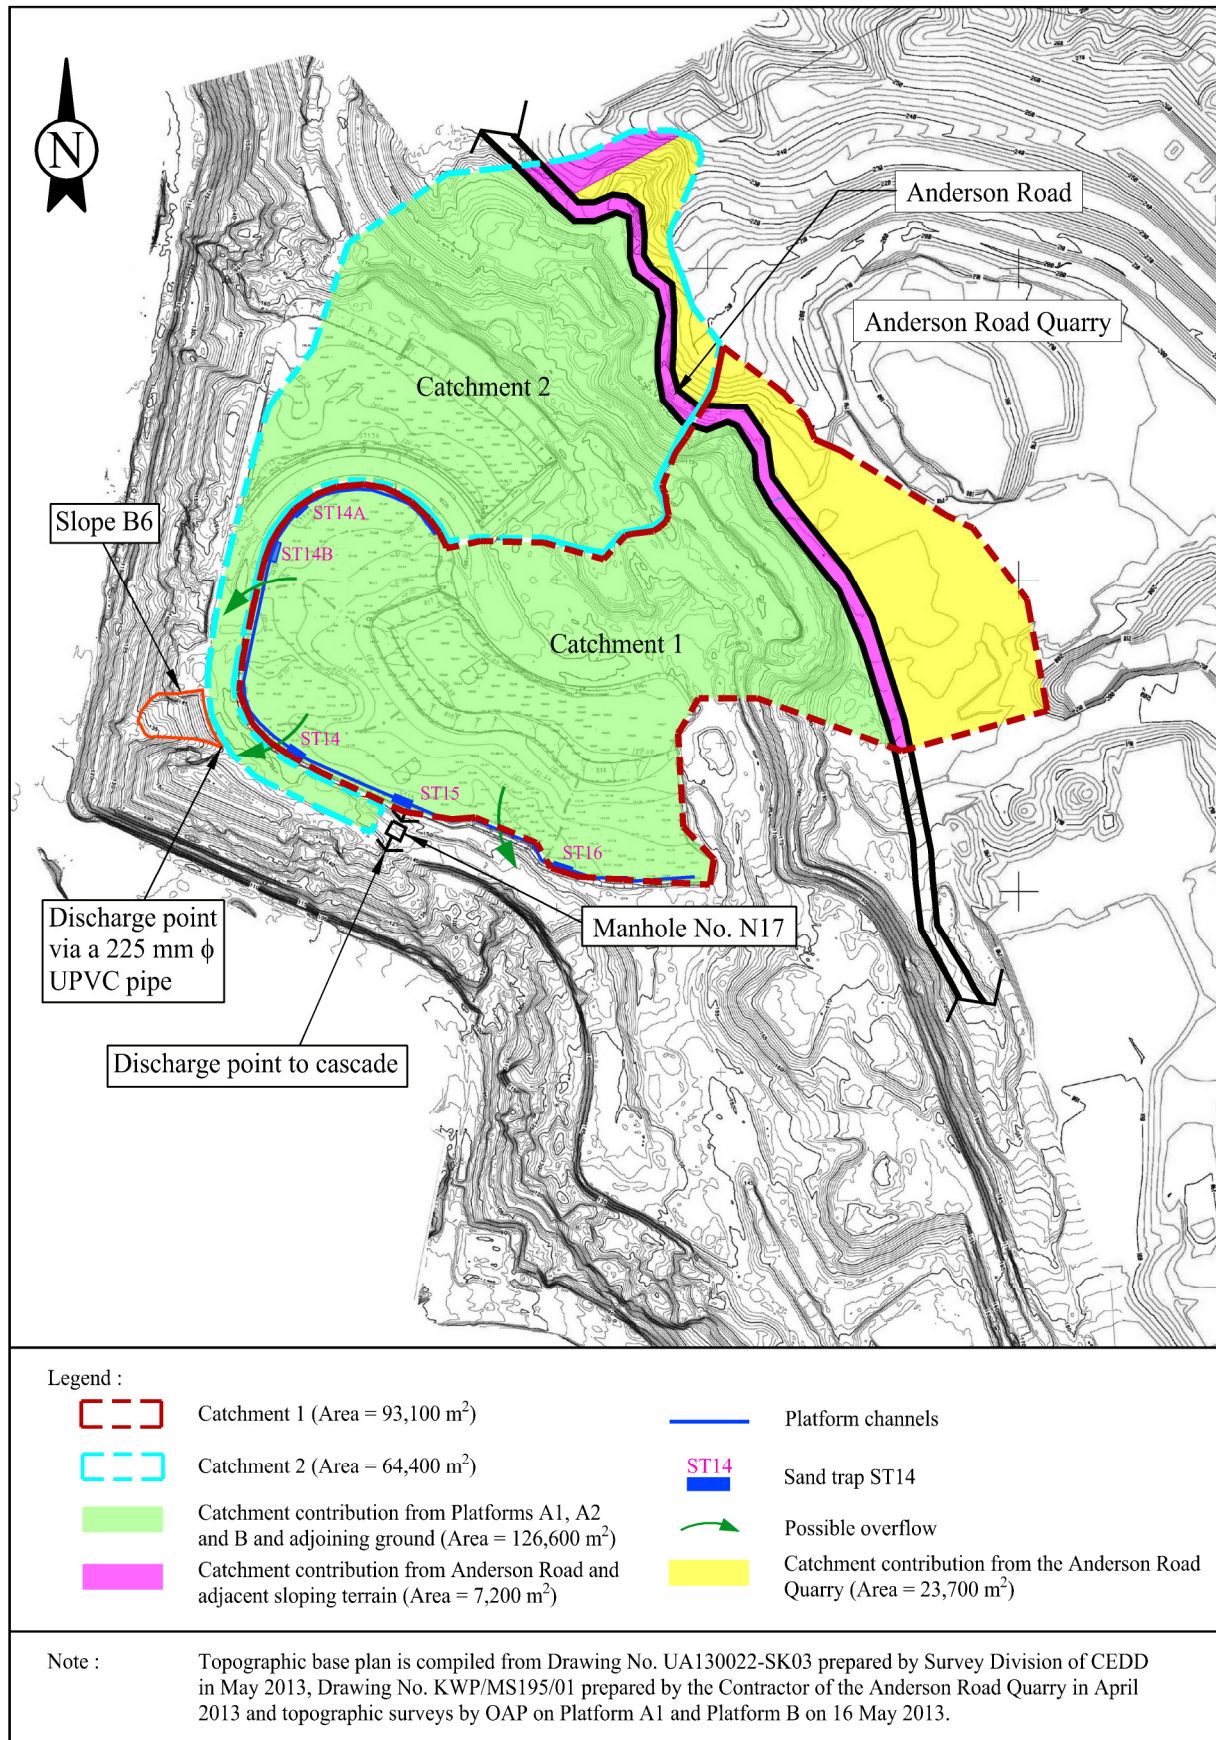
Figure 5.1 Catchment Boundary near Slope B6

Findings of a topographical assessment indicate that the surface runoff reaching the crest of Slope B6 largely came from the extensive catchment of Platforms A1, A2 and Platform B (Figure 5.1) within the DAR site, with a combined catchment area of about 157,500 m². Given the large catchment involved and the intense rainfall on 22 May 2013, the site drainage provisions in the area were unable to effectively discharge all the surface water and a large amount of surface water could have reached the crest area of Slope B6. The site drainage provisions at the time of the failure were not efficient in conveying surface runoff off site (Section 5.2).

The landslide involved a washout failure caused by the intense 22 May 2013 rainstorm. The site drainage provisions at the time of the failure were not efficient in conveying surface runoff off site and were overwhelmed by the large volume of surface runoff reaching Slope B6, which was at a topographic low spot. The majority of surface runoff probably came from the extensive catchment areas within the DAR site. The surface runoff contribution from Anderson Road and Anderson Road Quarry is considered relatively minor.

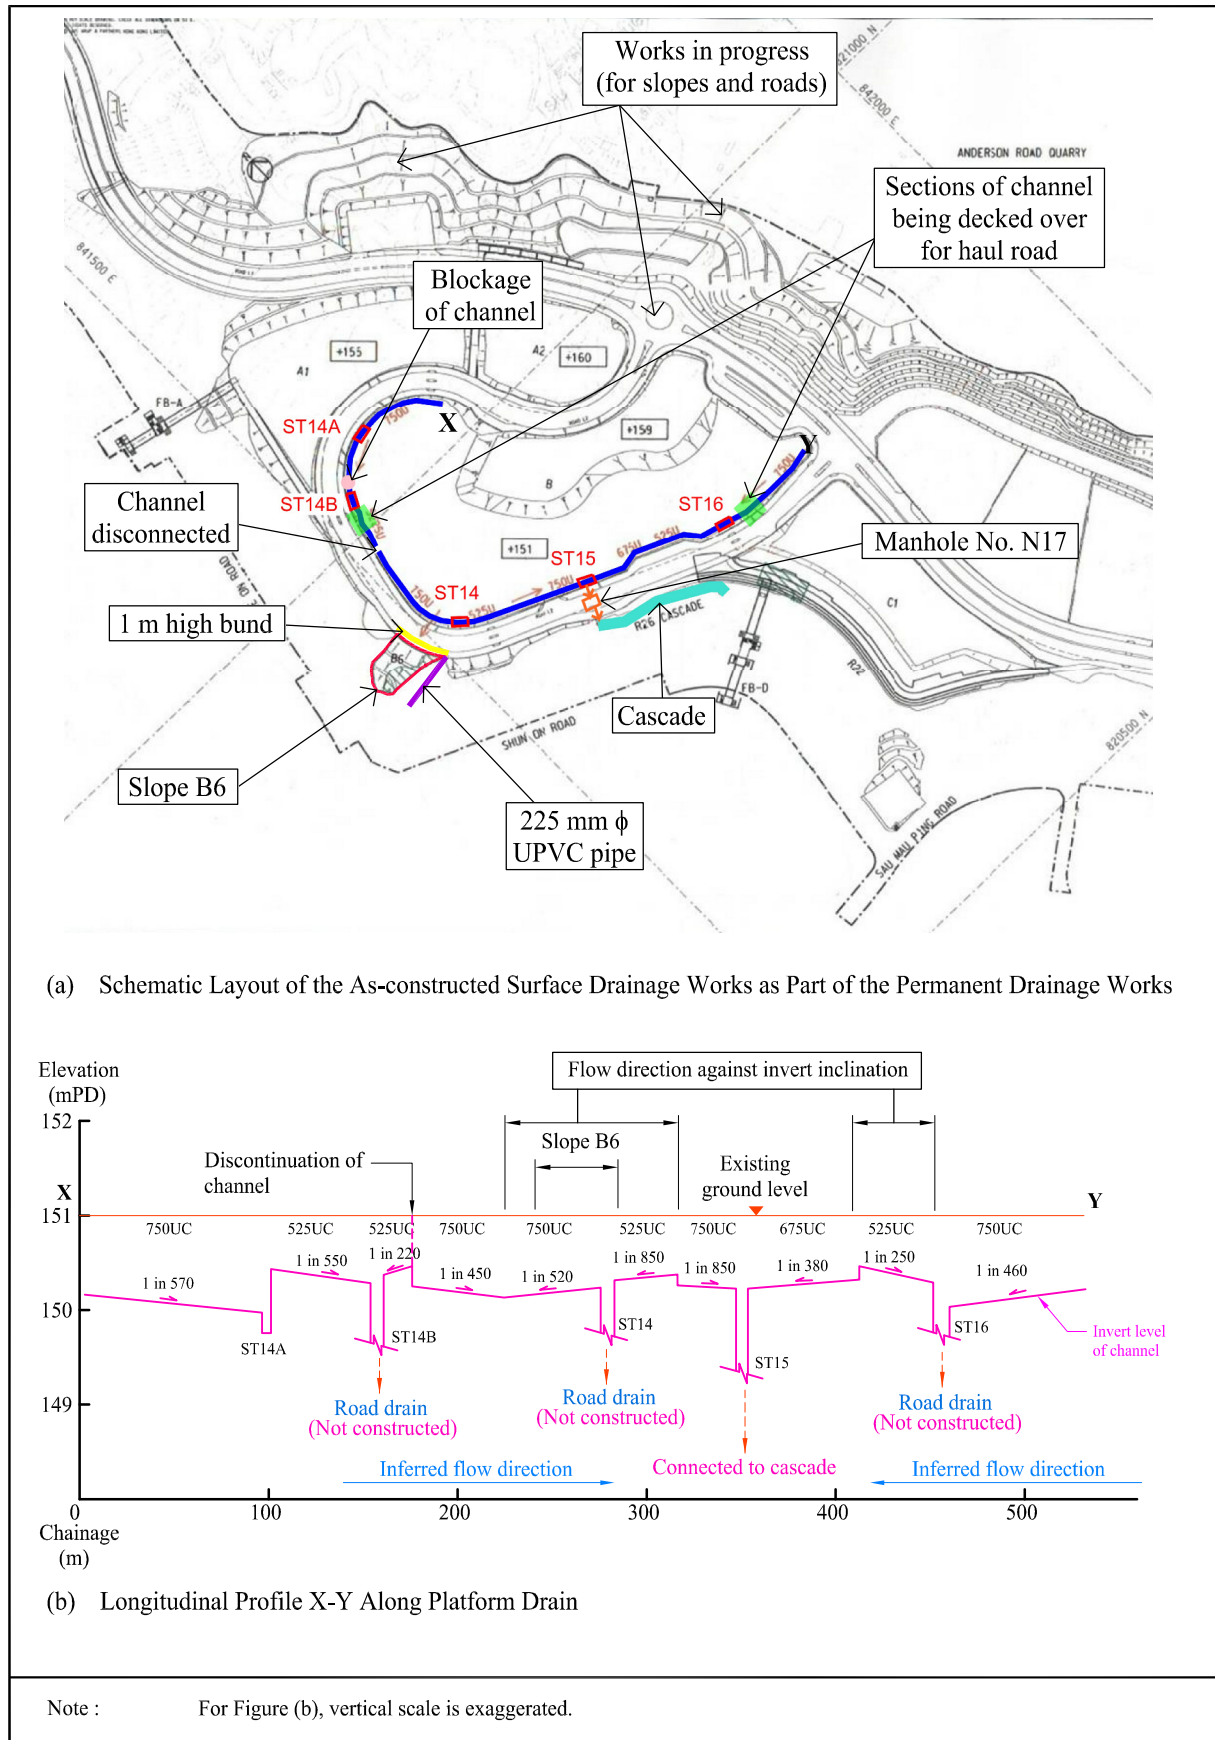
Figure 5.4 Schematic Layout of As-constructed Surface Drainage System at Platform B

Post-failure inspections and review of construction records revealed disconnection and signs of blockage with standing water at the U-channels at Platform B (Figure 5.4 and Plates 14 to 16), which could further hamper the flow efficiency and capacity of the U-channels. It is probable that a proportion of the surface runoff generated from Platform B could have overflowed from the U-channels onto the crest area of Slope B6, which was a low point of the DAR site. Signs of channel flooding were observed at the crest of Slope B6 (Plate 11) and overflow was also observed from the U-channel between sand traps ST15 and ST16 onto the toe of the haul road (Figure 5.1 and Plate 17).

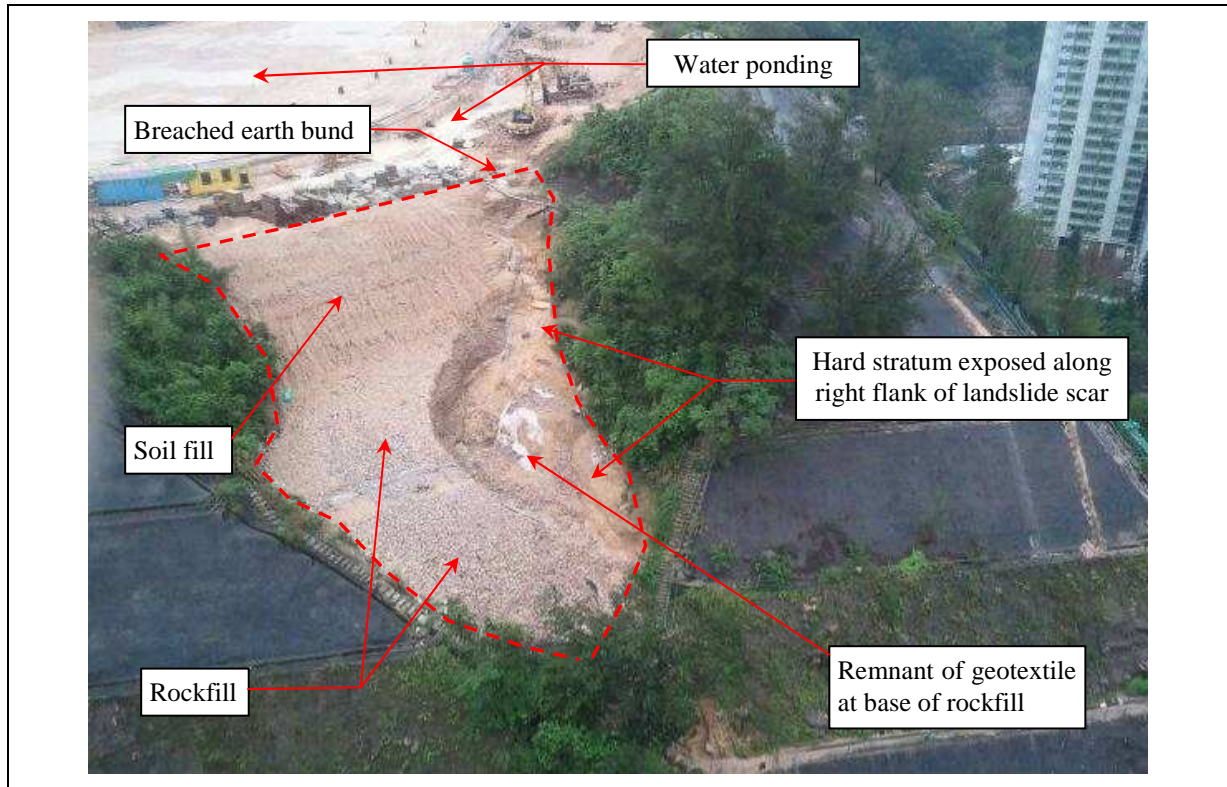
No significant signs of distress or instability were observed on the unfailed part of Slope B6. Only minor surface erosion gullies were noted on the upper soil fill batter of the slope (Plates 2 and 9).

Plate 2 Oblique Aerial View of the 22 May 2013 Landslide at Slope B6 (Photograph taken on 22 May 2013)

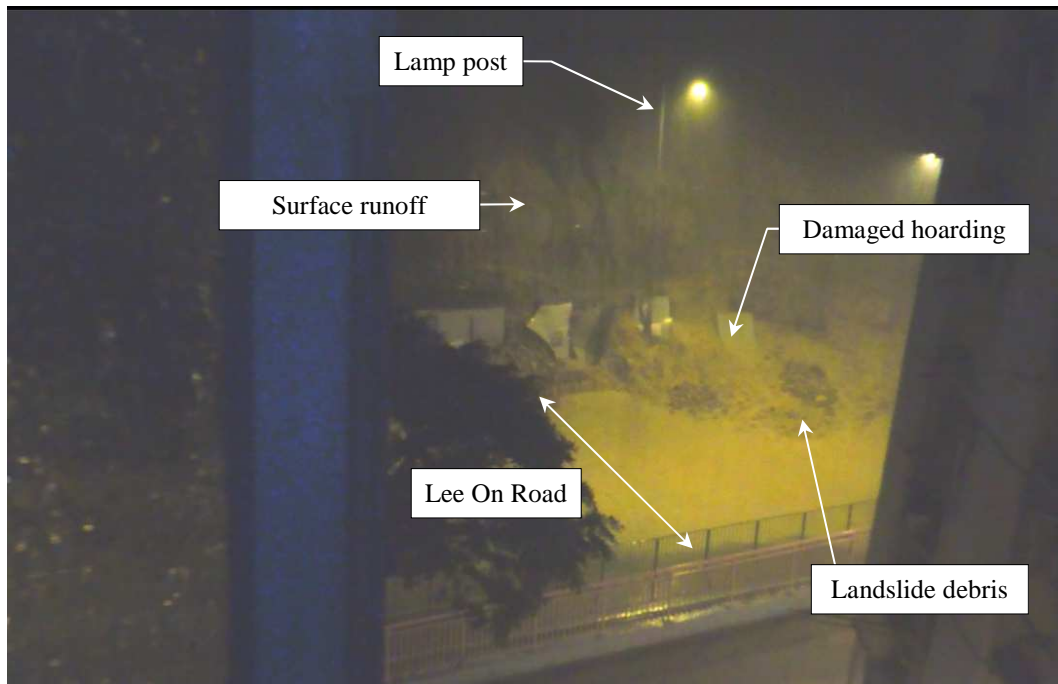
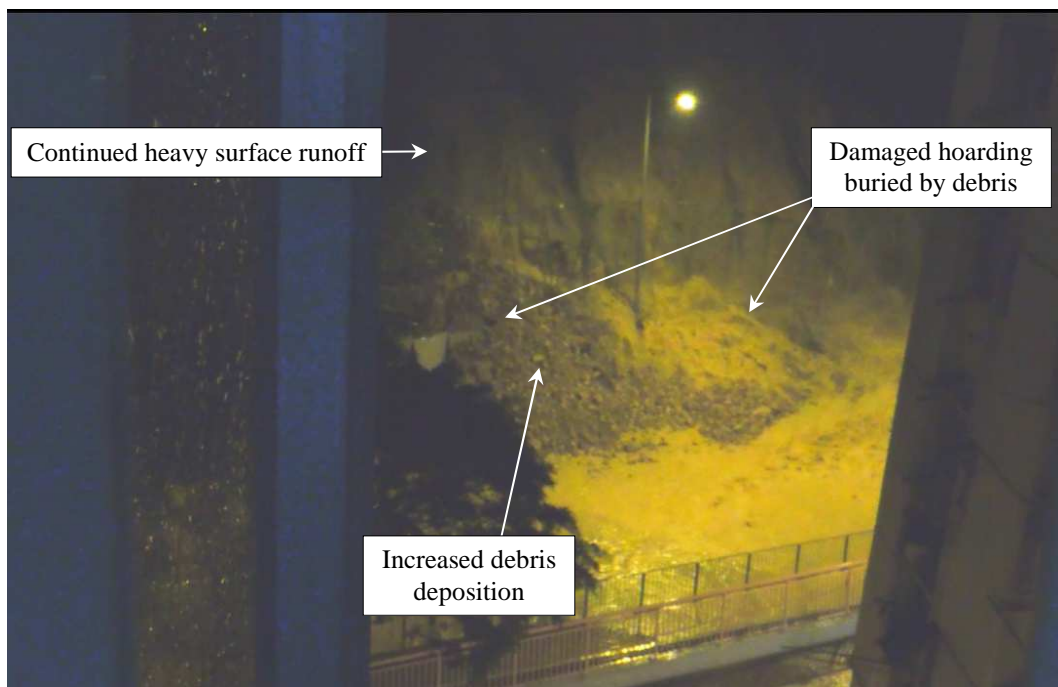
By about 4:30 a.m., the police officer attending the scene noted that some 2 m high landslide debris had already been deposited on Lee On Road and that no further landslide debris came down from the slope. He also reported much water coming down from the slope, "like a waterfall". A similar phenomenon was captured in a video footage taken by another eye-witness, which showed a torrent of water containing substantial rock pieces discharging down the slope onto Lee On Road shortly after the landslide. The 30-minute video footage showed that the debris was deposited on the road progressively (Plate 6).

(a) Initial Stage of Failure (Exact Time Unknown)

(b) Increased Debris Deposition 18 minutes after (a) (Exact Time Unknown)

**Plate 6 Surface Runoff and Progressive Landslide Debris Deposition on Lee On Road
(Captured from Witness Video Recording on 22 May 2013)**

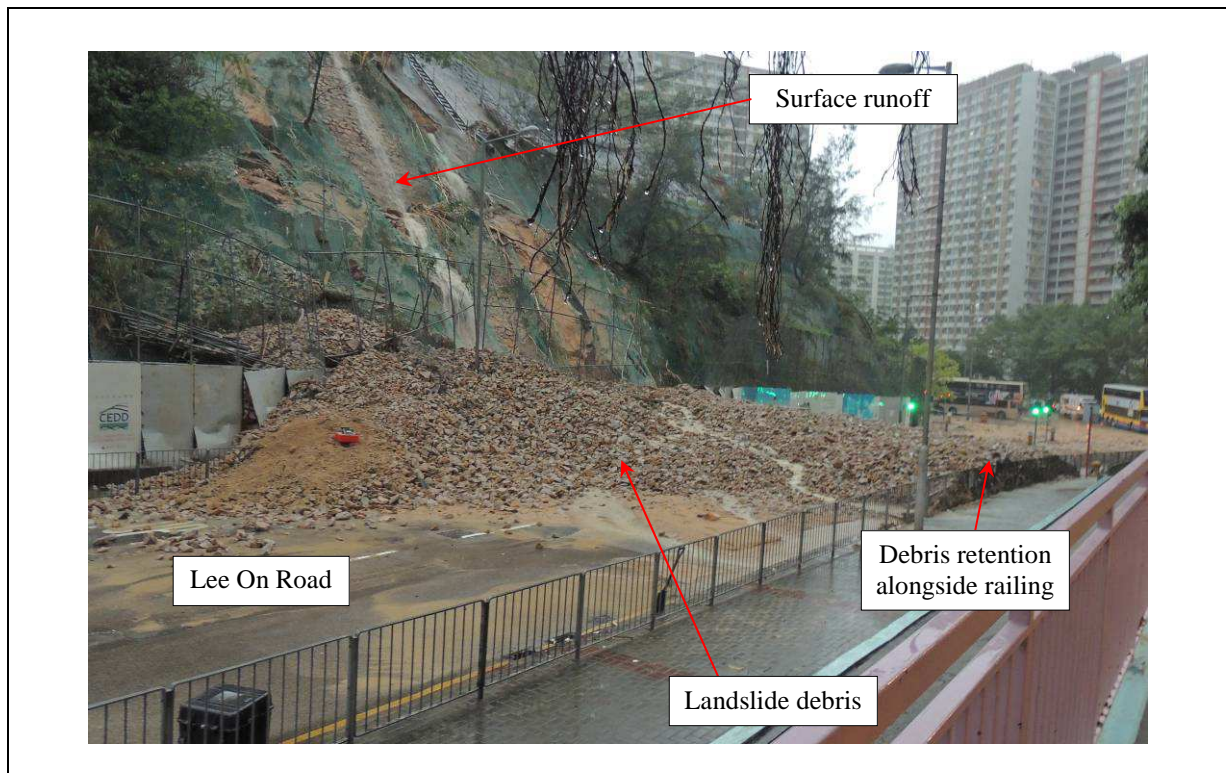
The landslide debris mainly comprised rockfill materials mixed with soil. Most of the landslide debris was deposited on Lee On Road and some travelled further to the junction of Lee On Road and Shun On Road (Figure 3.1 and Plate 7). Some debris was trapped by a temporary rockfall fence at the toe of Slope B6 (Figure 3.2 and Plate 8).

Plate 7 Debris on Lee On Road (Photograph taken on 22 May 2013)

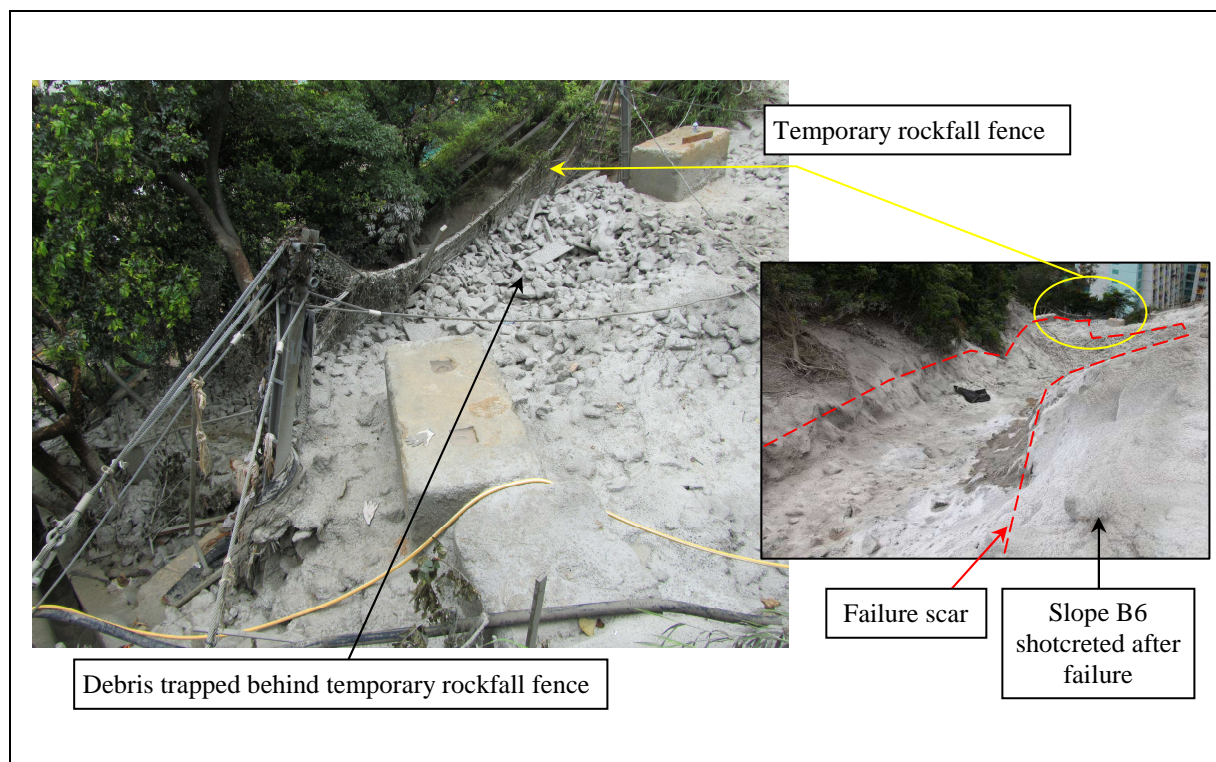
Plate 8 Debris Trapped by the Temporary Rockfall Fence (Photographs taken on 22 May 2013)

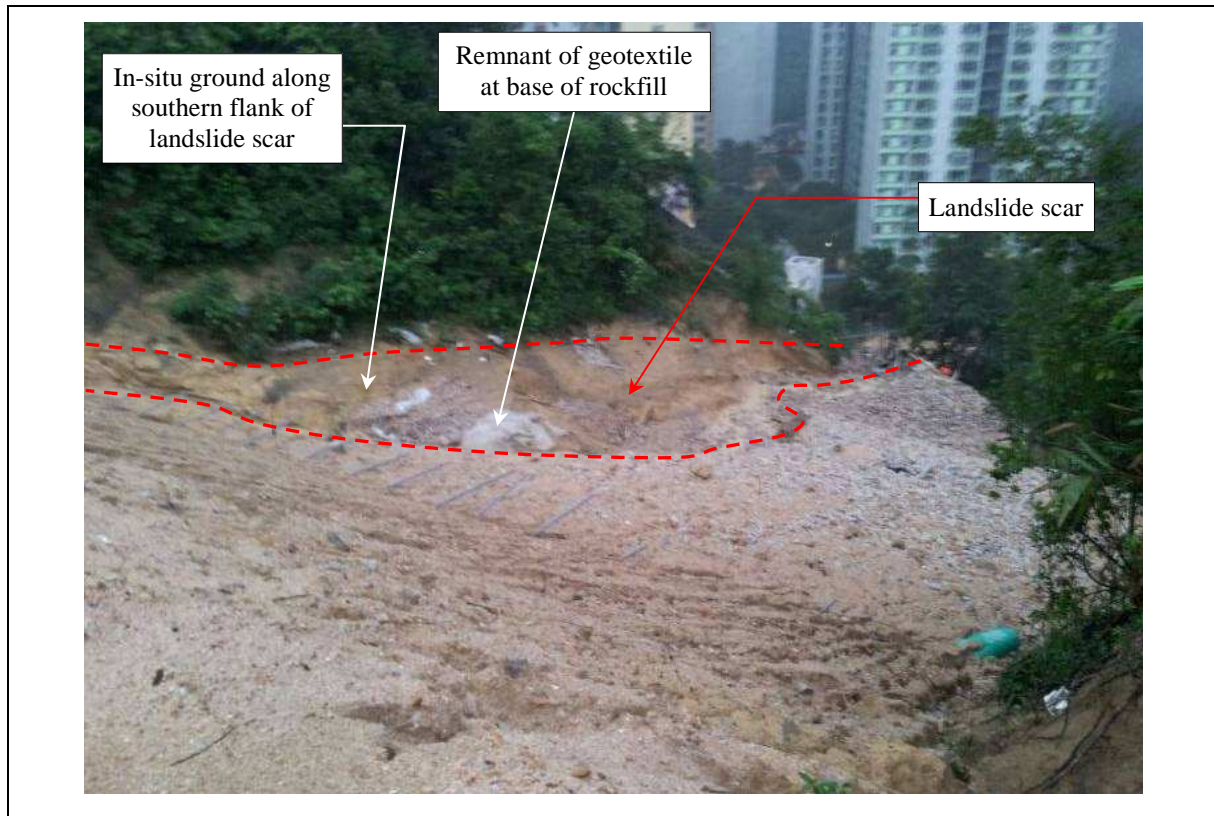
Plate 9 Landslide Scar at Slope B6 (Photograph taken on 22 May 2013)

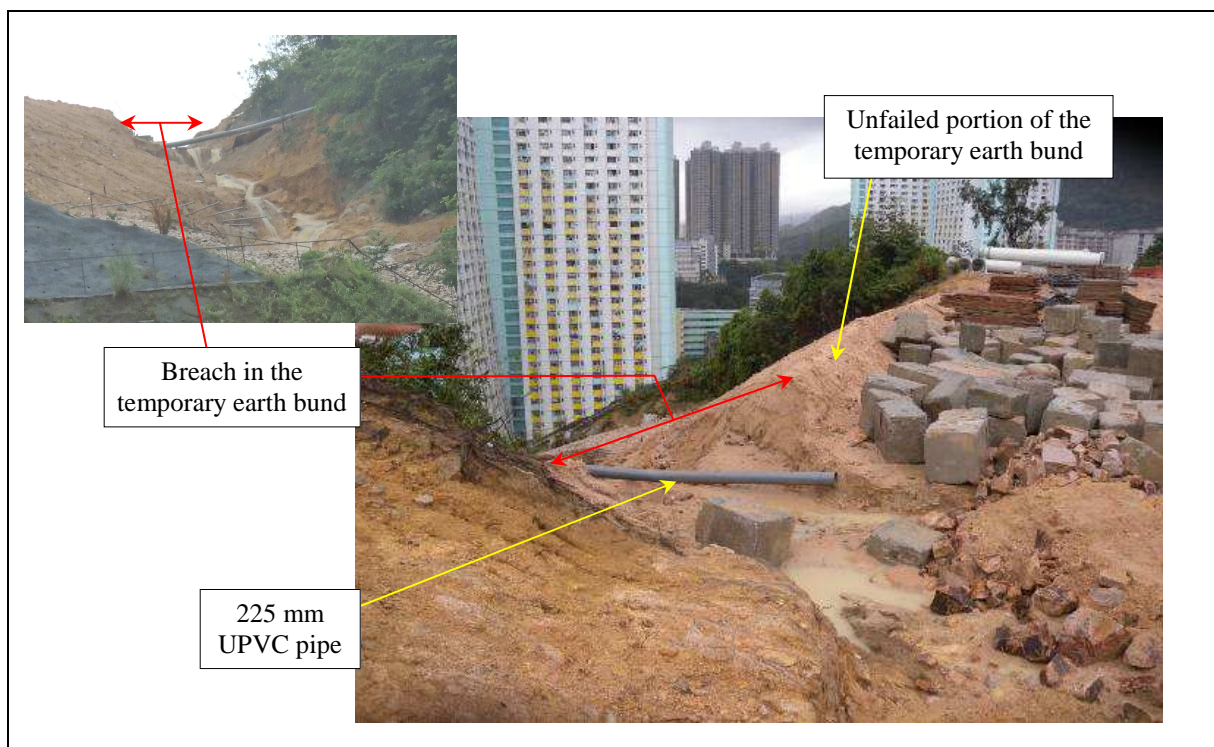
Plate 10 Breach in the Temporary Earth Bund at the Crest of Slope B6 (Photographs taken on 22 May 2013)

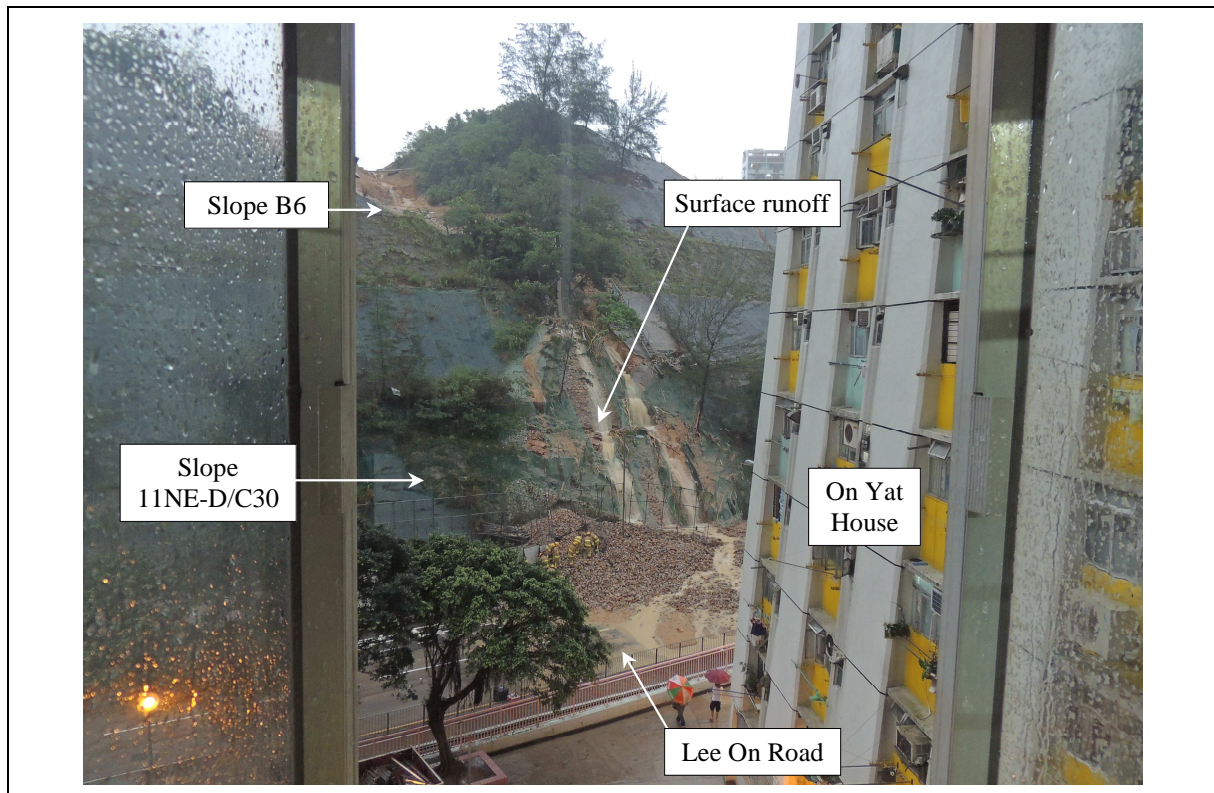
Plate 12 Continued Runoff over Slope B6 (Photograph taken by Witness around 6:20 a.m. on 22 May 2013)

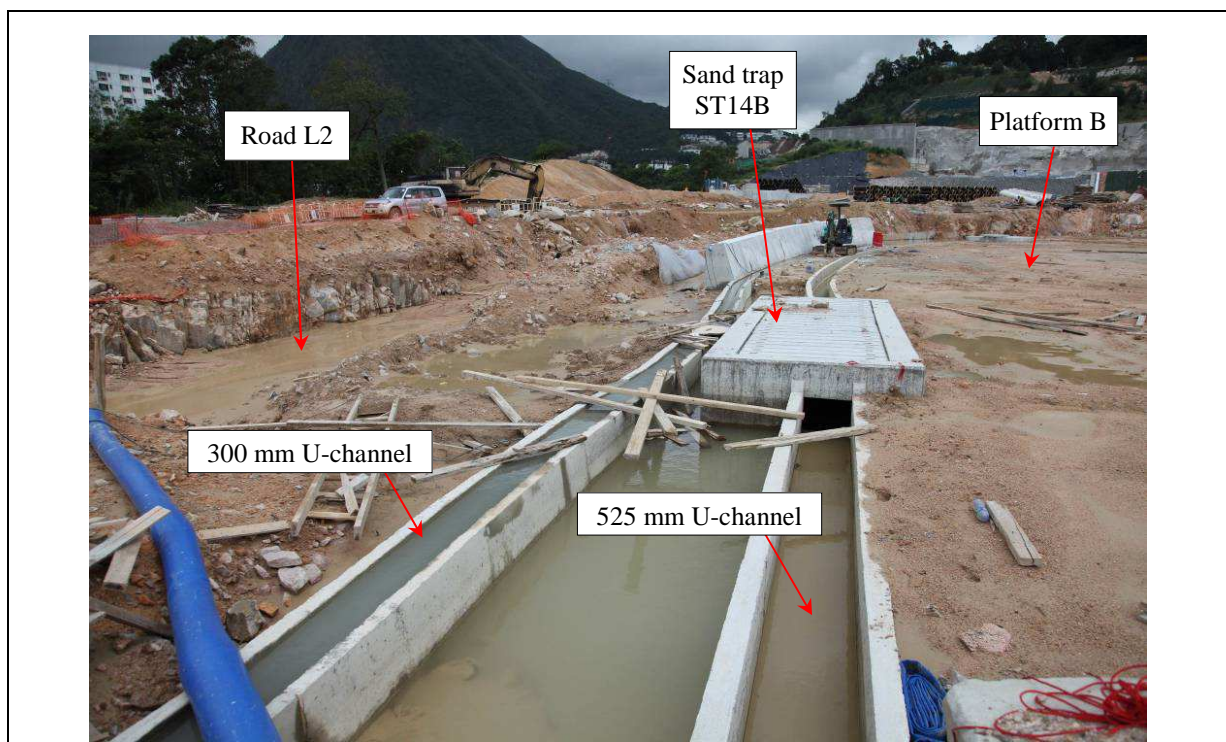
Plate 14 Signs of Blockage (with standing water) at 525 mm U-channel on the Downstream Side of Sand Trap ST14B (Photograph taken on 23 May 2013)

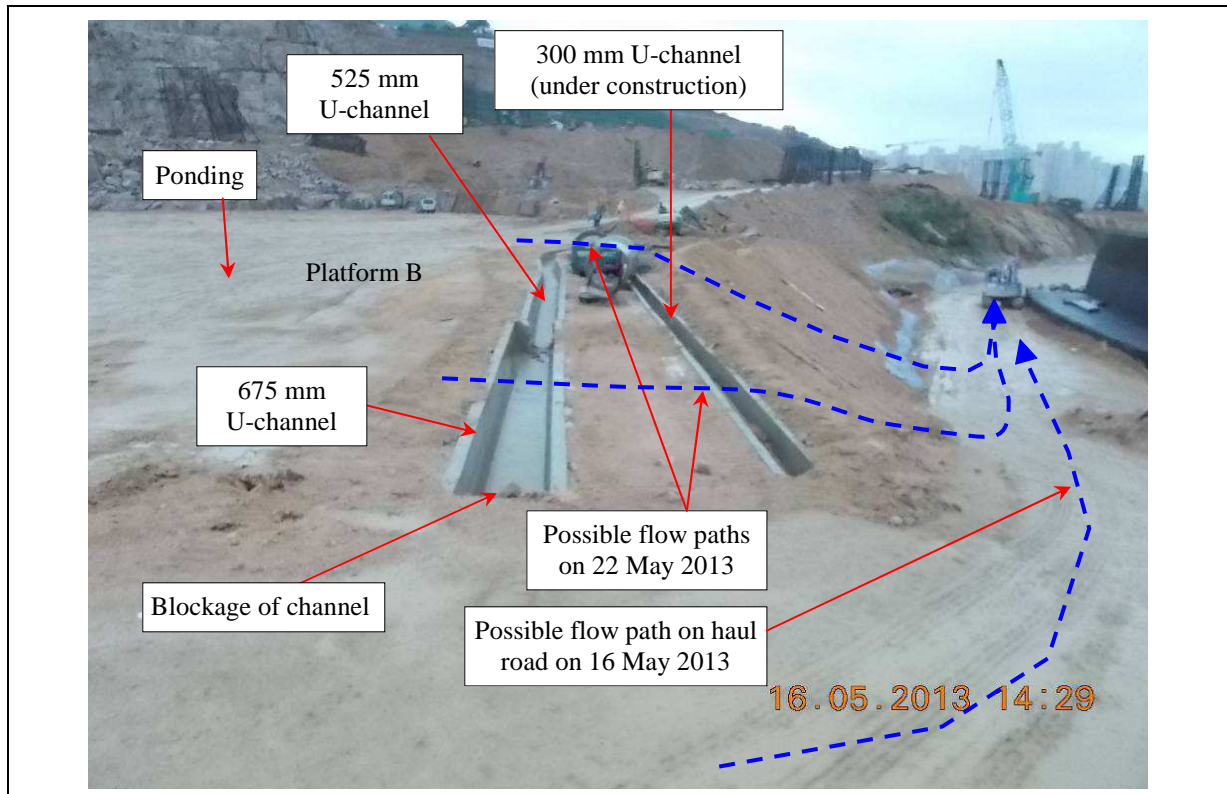
Plate 15 Temporary Haul Road over the 675 mm U-channel between Sand Traps ST15 and ST16 (Photograph taken on 16 May 2013)

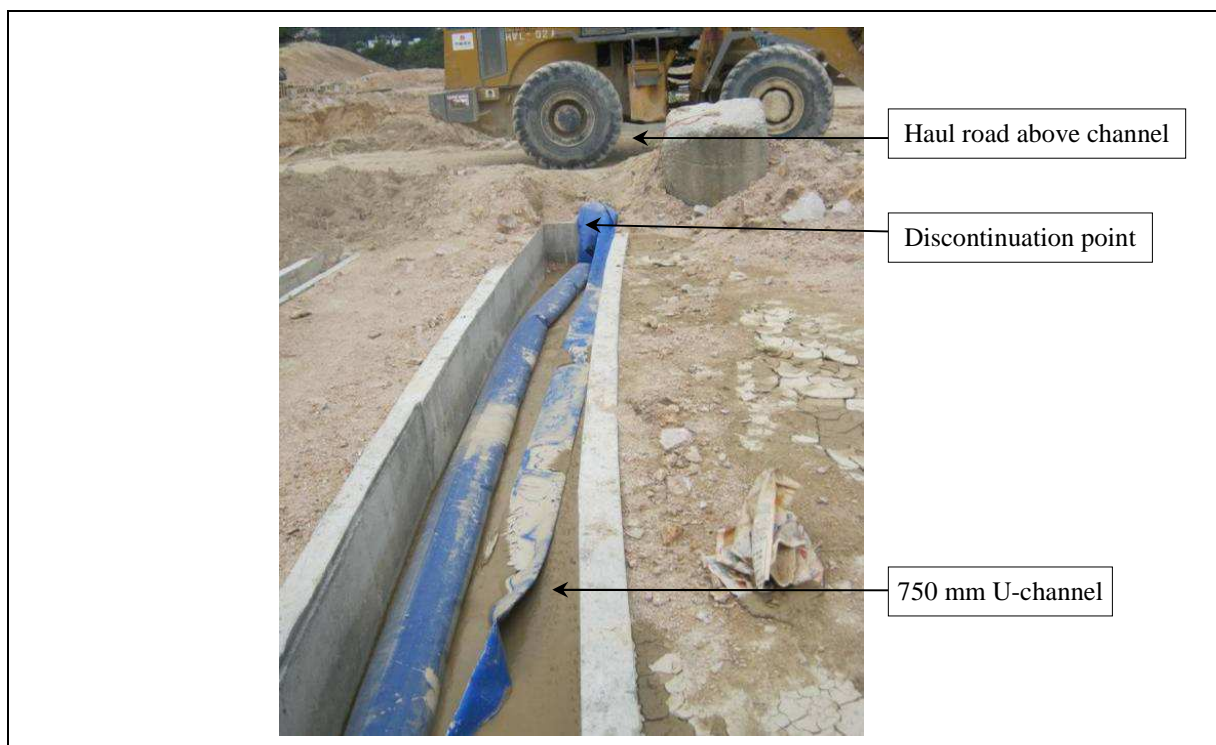
Plate 16 Discontinuation of Channel adjacent to Haul Road near Sand Trap ST14 (Photograph taken on 24 May 2013)

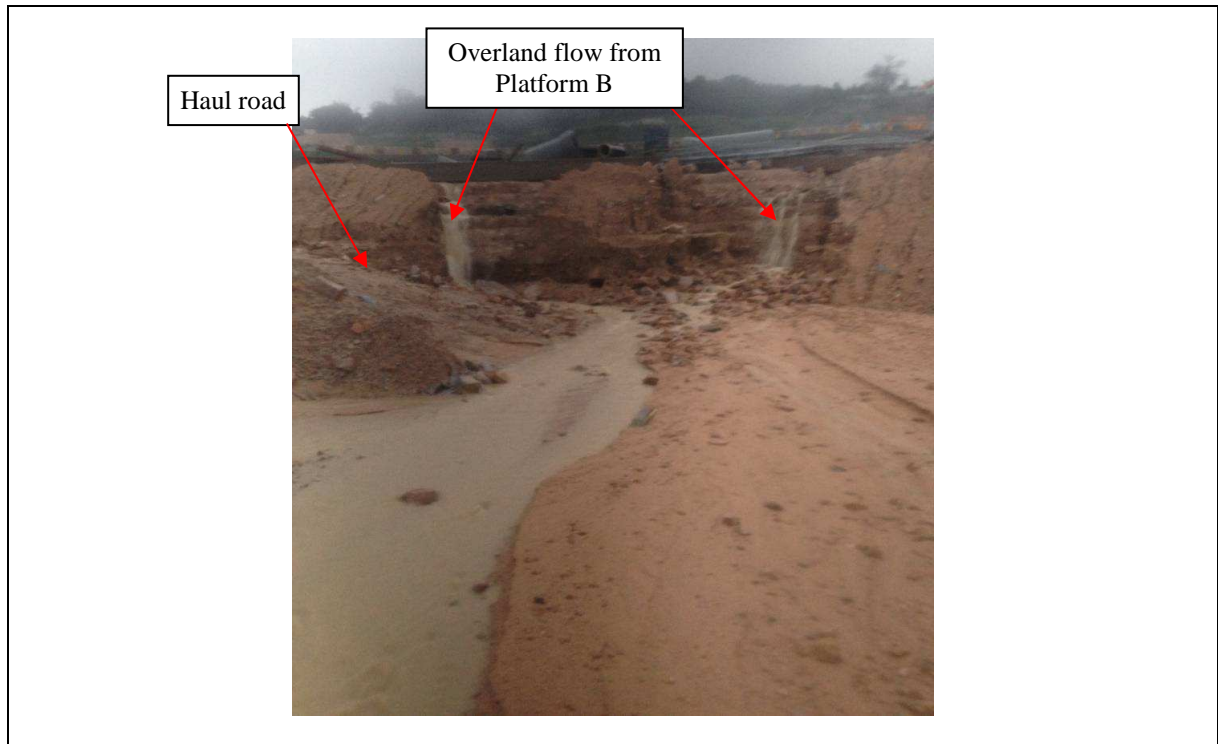
Plate 17 Significant Overland Flow from Platform B between Sand Traps ST15 and ST16 (Photograph taken around 9:00 a.m. on 22 May 2013)

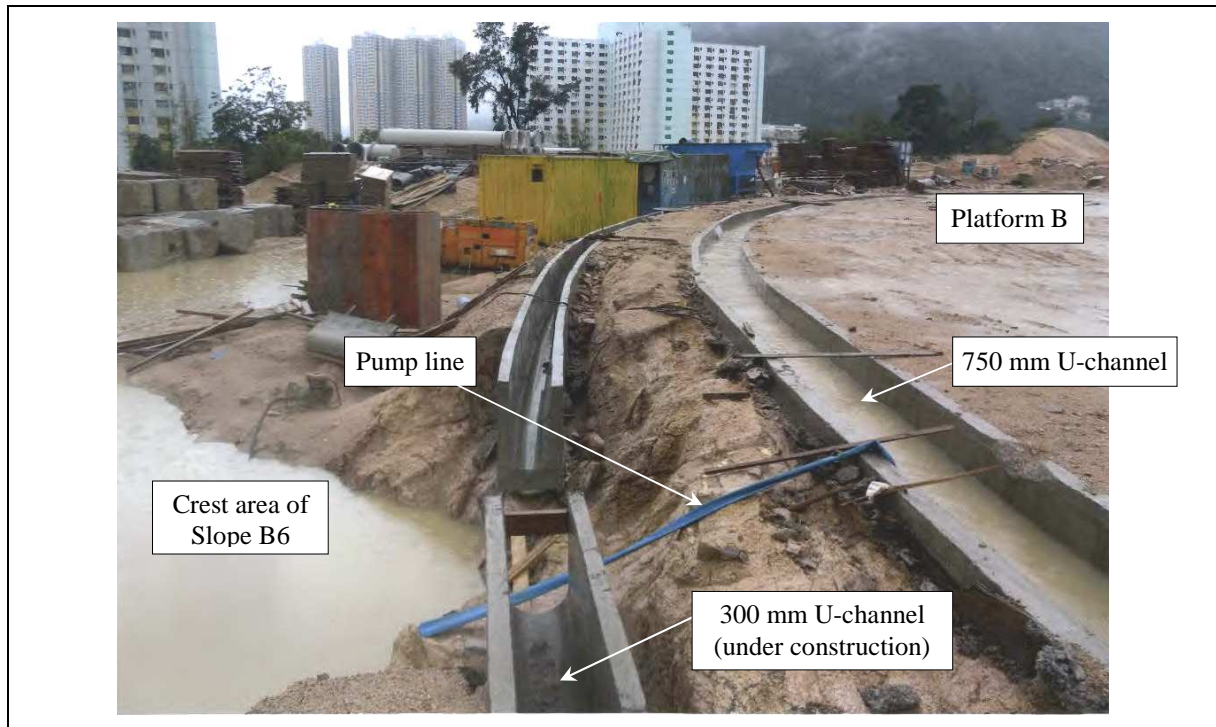
As discussed above, the crest area of Slope B6 was provided with a 1 m high temporary earth bund and a 225 mm diameter UPVC pipe connected to the surface drainage system of an adjacent slope (Plate 18). The standby electric pump was provided to pump out water accumulated at the crest area of Slope B6 back to the nearby periphery U-channels along Platform B (Plate 19). However, according to the Contractor, the pump was not in operation at the time of the landslide.

Plate 19 Standby Pump Provided at the Crest Area of Slope B6 (Photograph taken on 22 May 2013)
