REPORT ON THE FEI TSUI ROAD LANDSLIDE OF 13 AUGUST 1995

Volume 2

FINDINGS OF THE LANDSLIDE INVESTIGATION

*Geotechnical Engineering Office
Civil Engineering Department
Hong Kong Government*

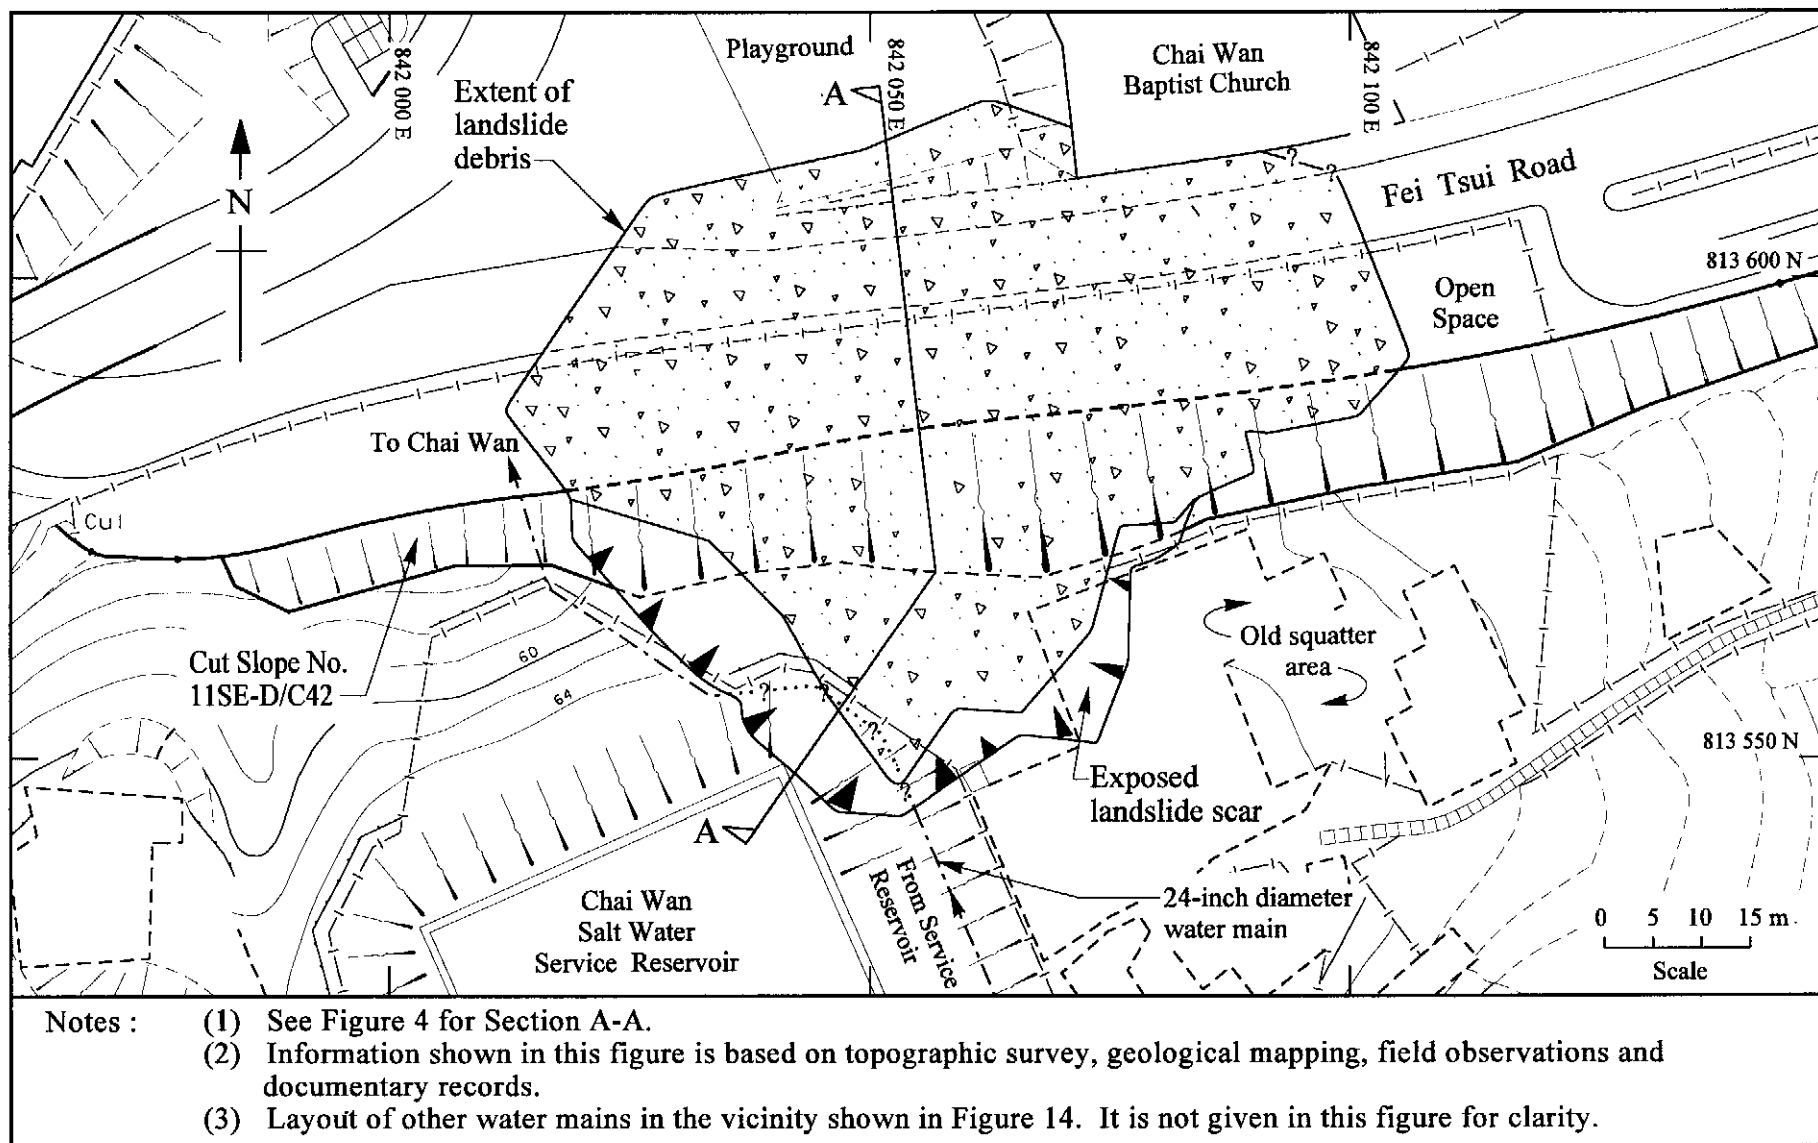
Figure 2 - Plan of the Landslide

A truncated 24-inch diameter underground salt water main was exposed near the crest of the landslide scar (Plate 1 & Figure 2). Another truncated underground water main, which is 6 inches in diameter, was also exposed near the crest of the back scarp at about 4 m to the east of the truncated 24-inch water main (Figure 5). Witnesses observed that water was discharging from the 24-inch water main onto the landslide area on the morning of 13 August after the failure. The witnesses interviewed by the GEO, however, did not report having noticed the presence of the truncated 6-inch water main.

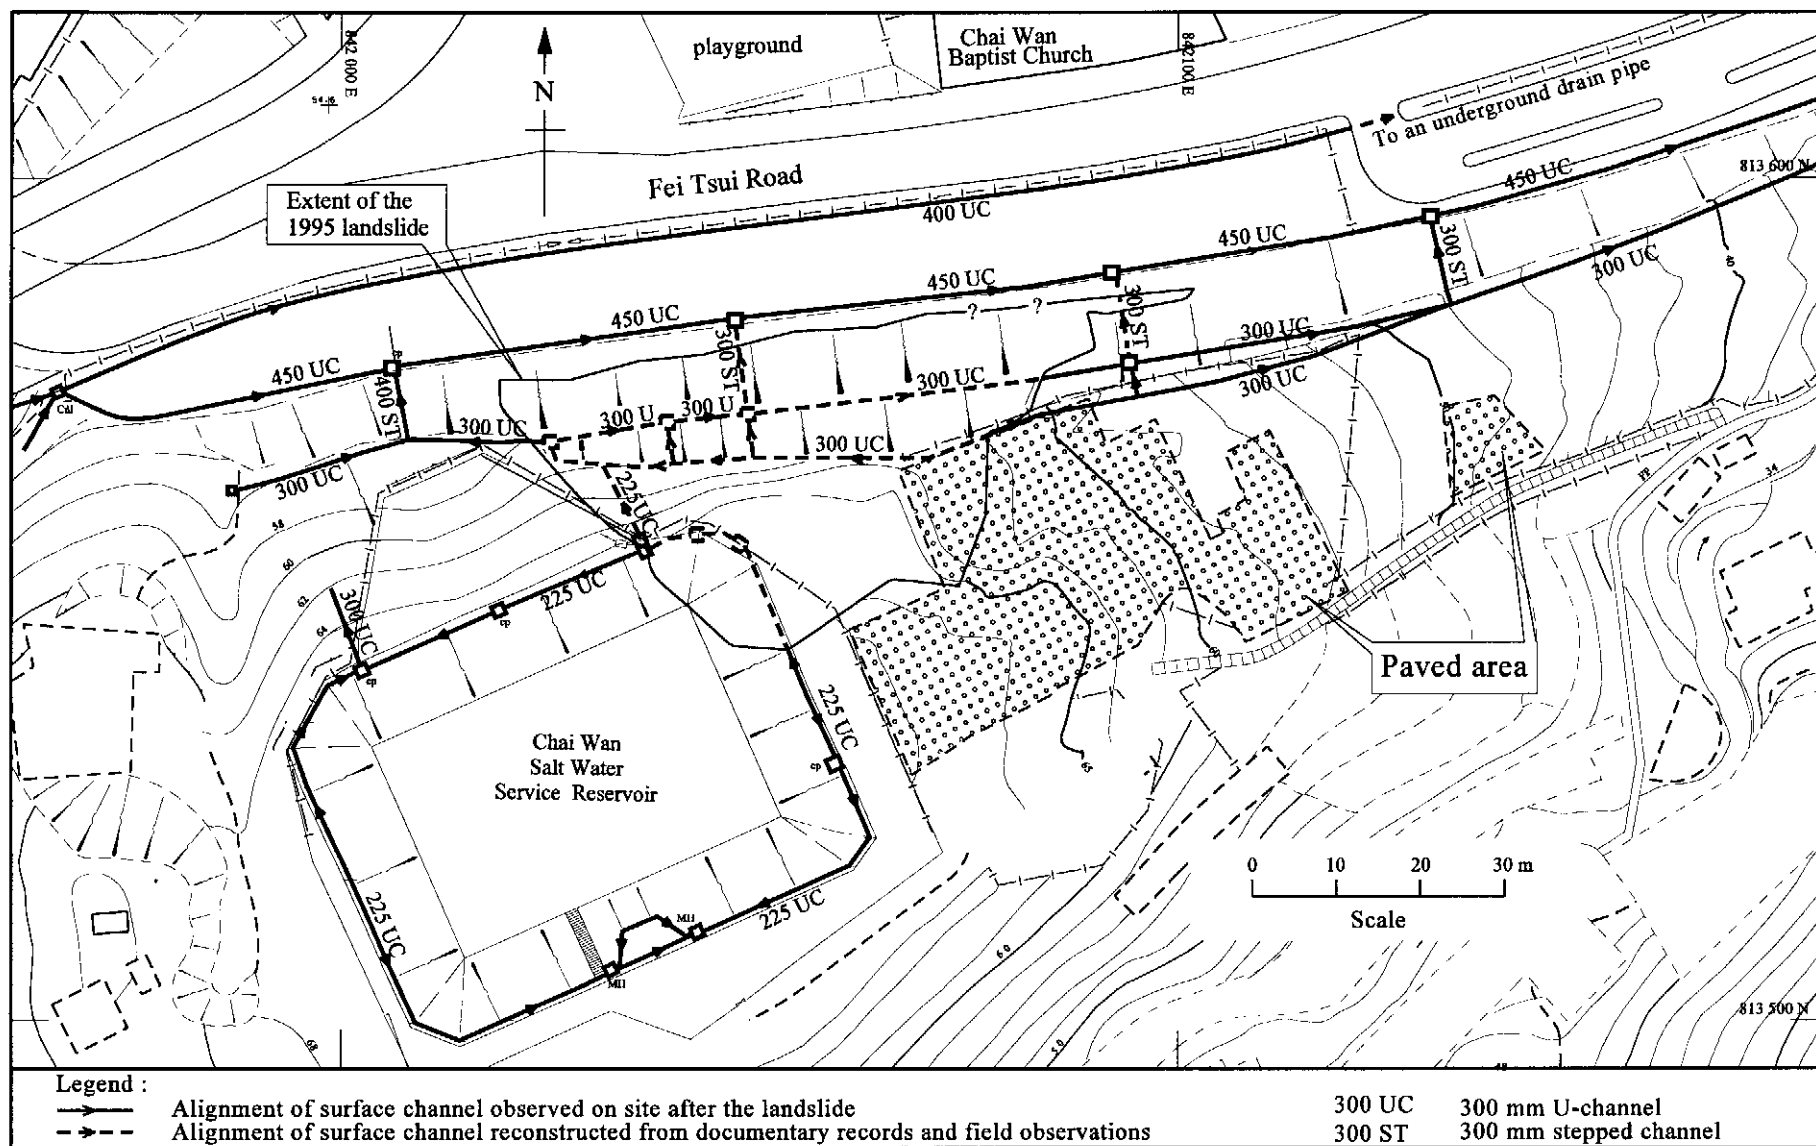
Figure 3 - Probable Drainage Layout of the Site

The probable layout of the surface drainage system of the site, as interpreted from the available documentary records and site observations after the landslide, is shown in Figure 3. It was found from inspections after the landslide that the surface drainage channels on the unfailed section of the cut slope to the east of the landslide were blocked by humus and black-stained silty soil (Plate 4). The crest channel on the cut slope to the west of the landslide was partly filled with fallen leaves and silty soil, to a depth of about 20 mm.

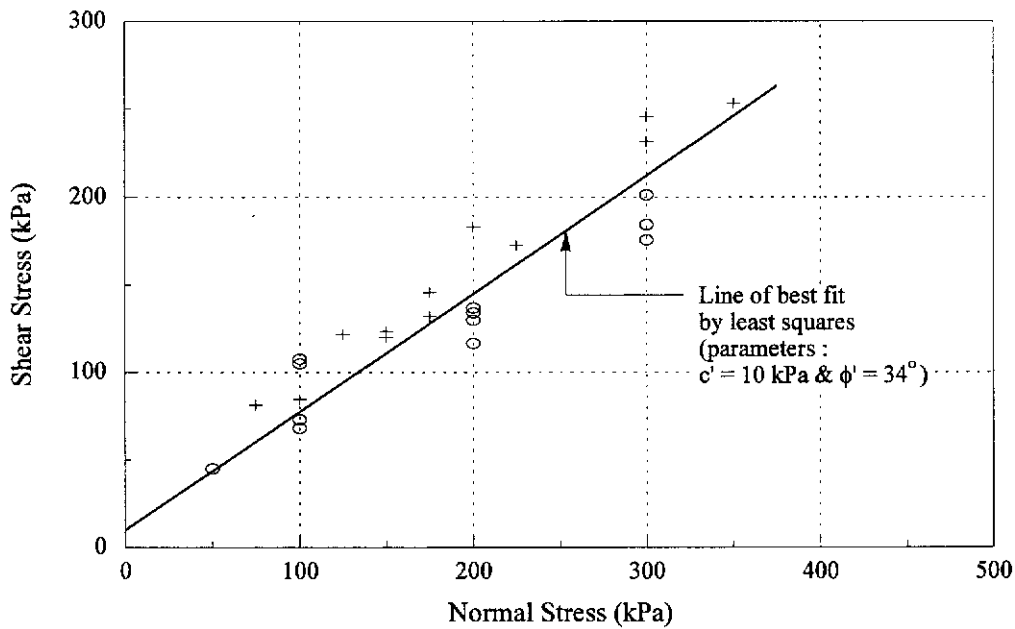
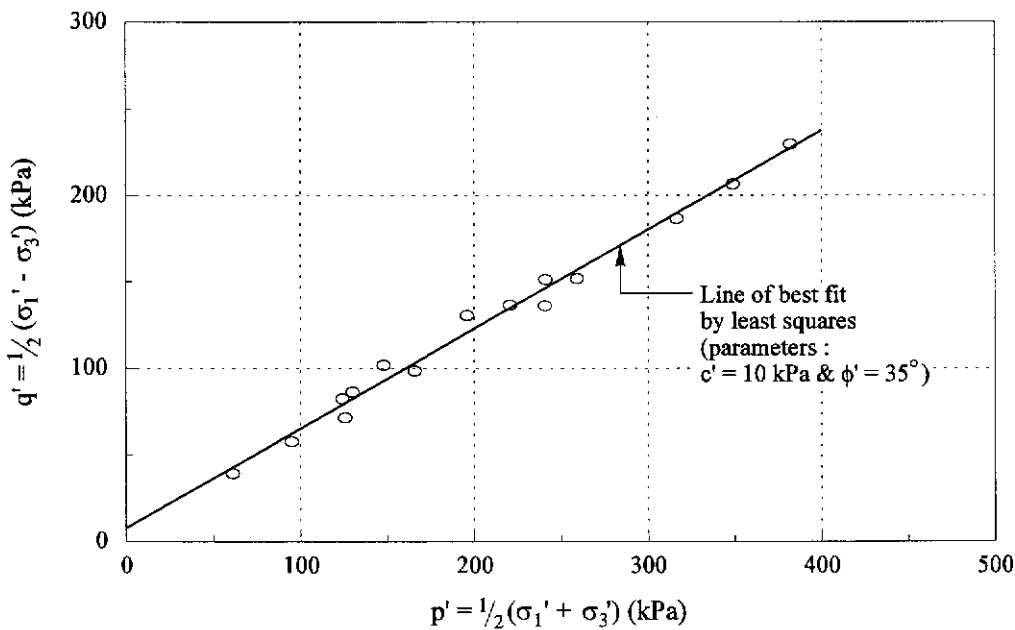
Figure 12 - Direct Shear and Triaxial Compression Test Results for Altered Tuff without Kaolinite Veins

For altered tuff samples without kaolinite veins, the angle of shearing resistance (ϕ') was found by direct shear tests to be 34° , with cohesion intercept (c') of 10 kPa. For altered tuff samples with kaolinite veins aligned to the direction of shearing in direct shear tests, the average ϕ' was 29° , with zero c' . The lower-bound ϕ' value was 22° , which corresponds to the situation for which the shearing was through soil with high clay content.

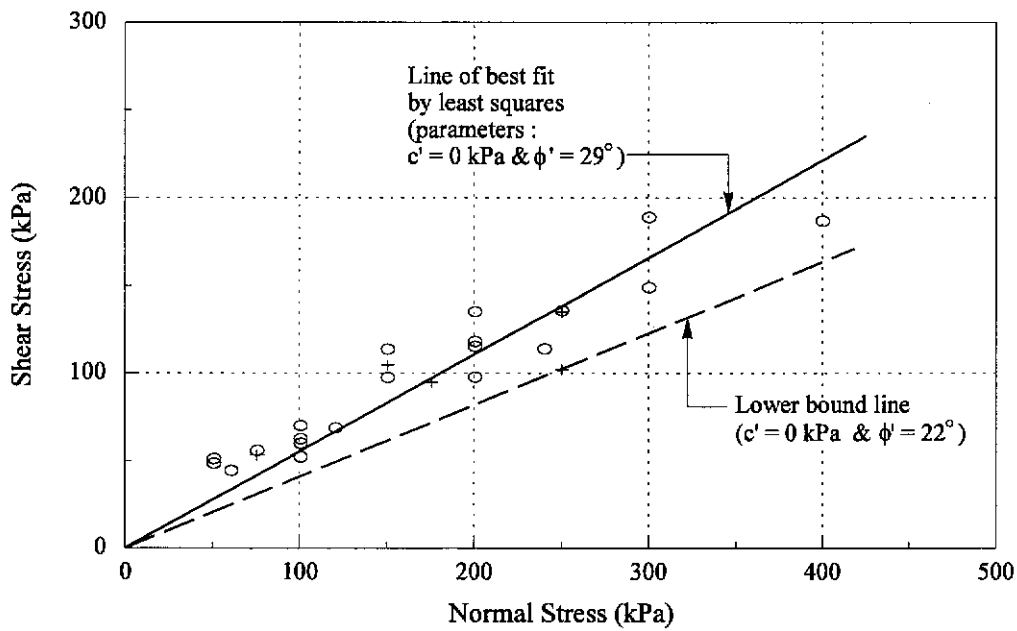
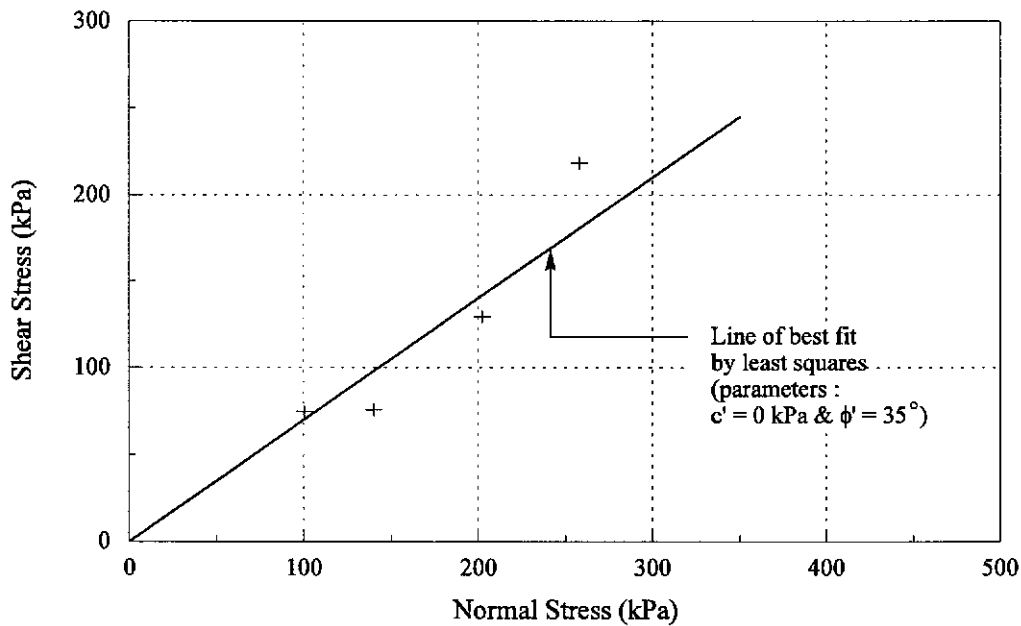
Figure 13 - Direct Shear Test Results for Altered Tuff with Kaolinite Veins and for Weathered Volcanic Joints

The average ϕ' for weathered volcanic joints was found by direct shear tests to be 35° , with zero c' . These parameters are considered representative for the persistent and rough and planar joints that formed the back scarp of the landslide.

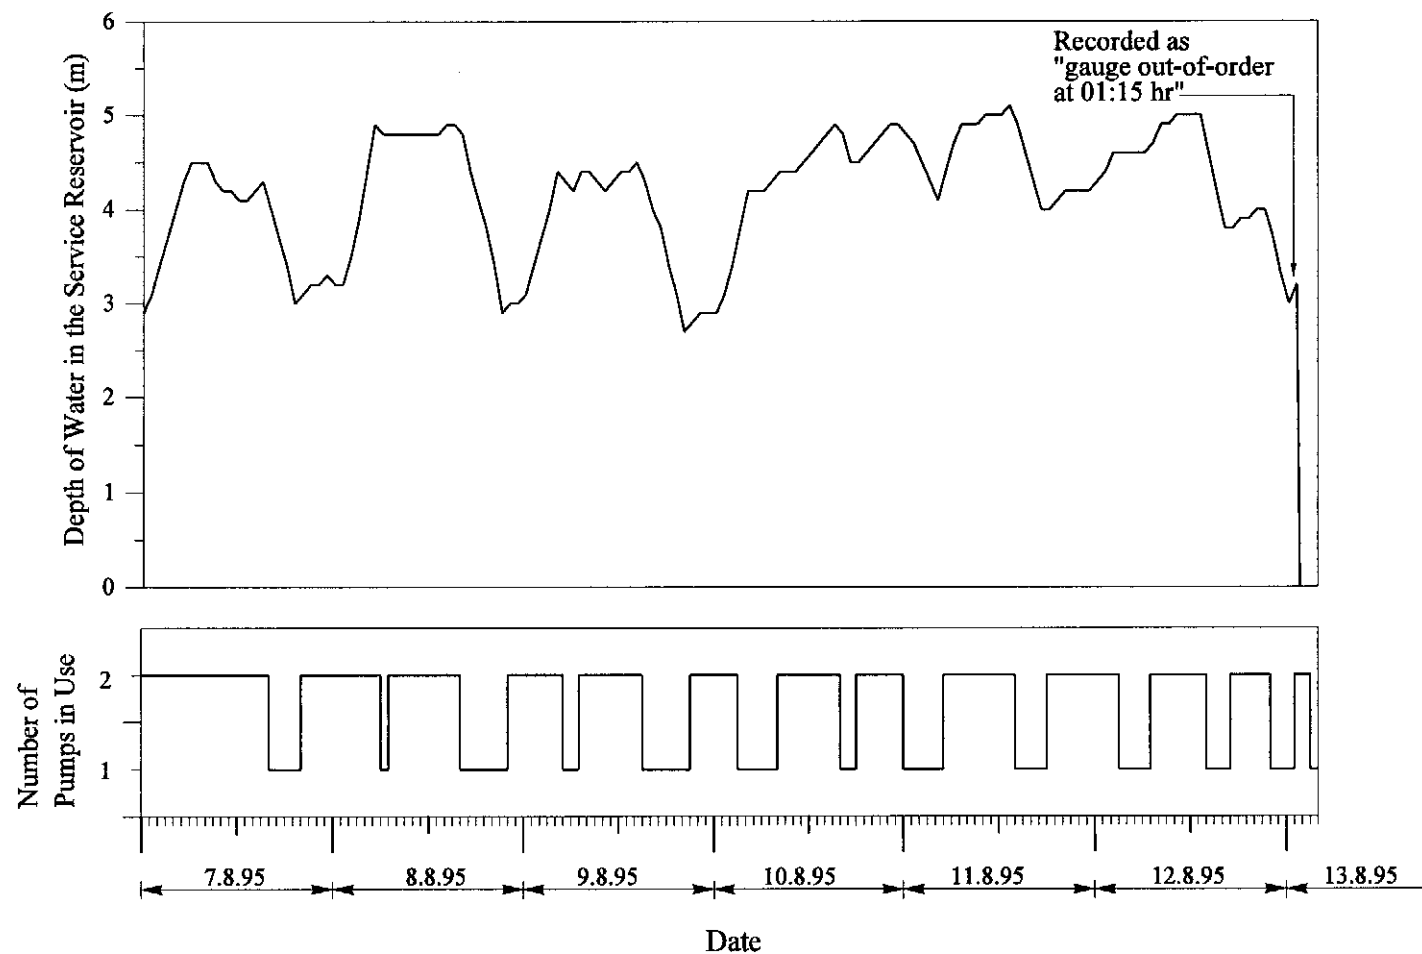
Figure 15 - Records of Water Levels in the Service Reservoir and Number of Pumps in Use

WSD's records of water levels in the reservoir before the landslide and the number of pumps in use for pumping water to the reservoir are shown in Figure 15. No signs of any abnormal operation or gross leakages indicated by a rapid drop in water level before the time of the main failure can be seen from the records. WSD (1995) stated that "Basing on the past inspection record and up to date operation record of the Chai Wan S.W. S/R, Chai Wan S.W. P/S and the supply and distribution network, it can be concluded that the service reservoir, the pumping station and the associated water mains were under normal operating conditions and were performing satisfactorily up to the time when the landslide occurred".

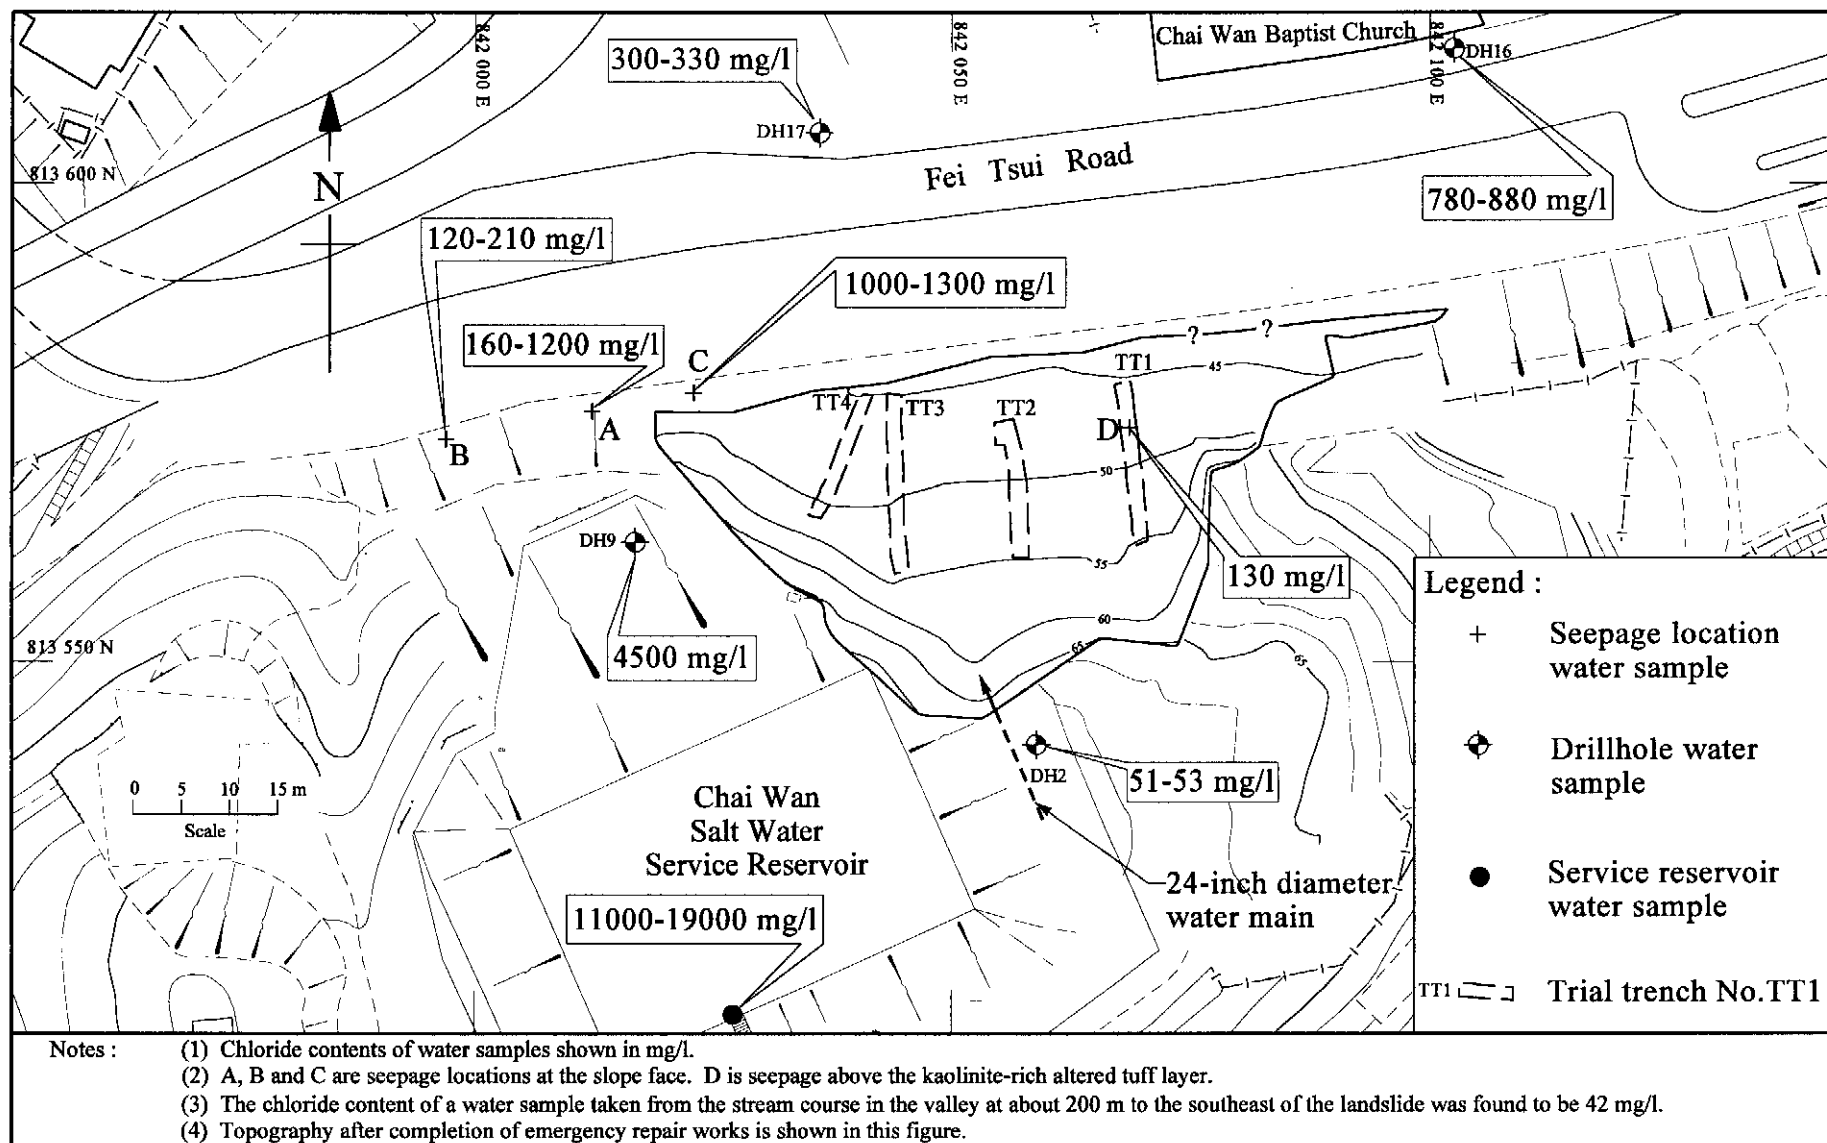
Figure 16 - Results of Chloride Content Tests on Water Samples

A high chloride content of 4 500 mg/l was found in two water samples collected from about 8 m and 11 m below the ground surface from a drillhole about 20 m to the north of the reservoir (Figure 16). This indicates probable seepage of salt water from the service reservoir. The chloride content of water samples collected from two drillholes across Fei Tsui Road and from seepage locations in the vicinity of the landslide area ranged from 120 mg/l to 1 300 mg/l, which is symptomatic of presence of salt water within about 10% by volume in the groundwater. This suggests that seepage from the reservoir was a probable source of water in the vicinity of the landslide. The salt water seepage might have contributed to the wetting of the altered tuff layer, though it was probably a less significant source of water in the build up of a high perched water table compared with water infiltration during heavy rain.

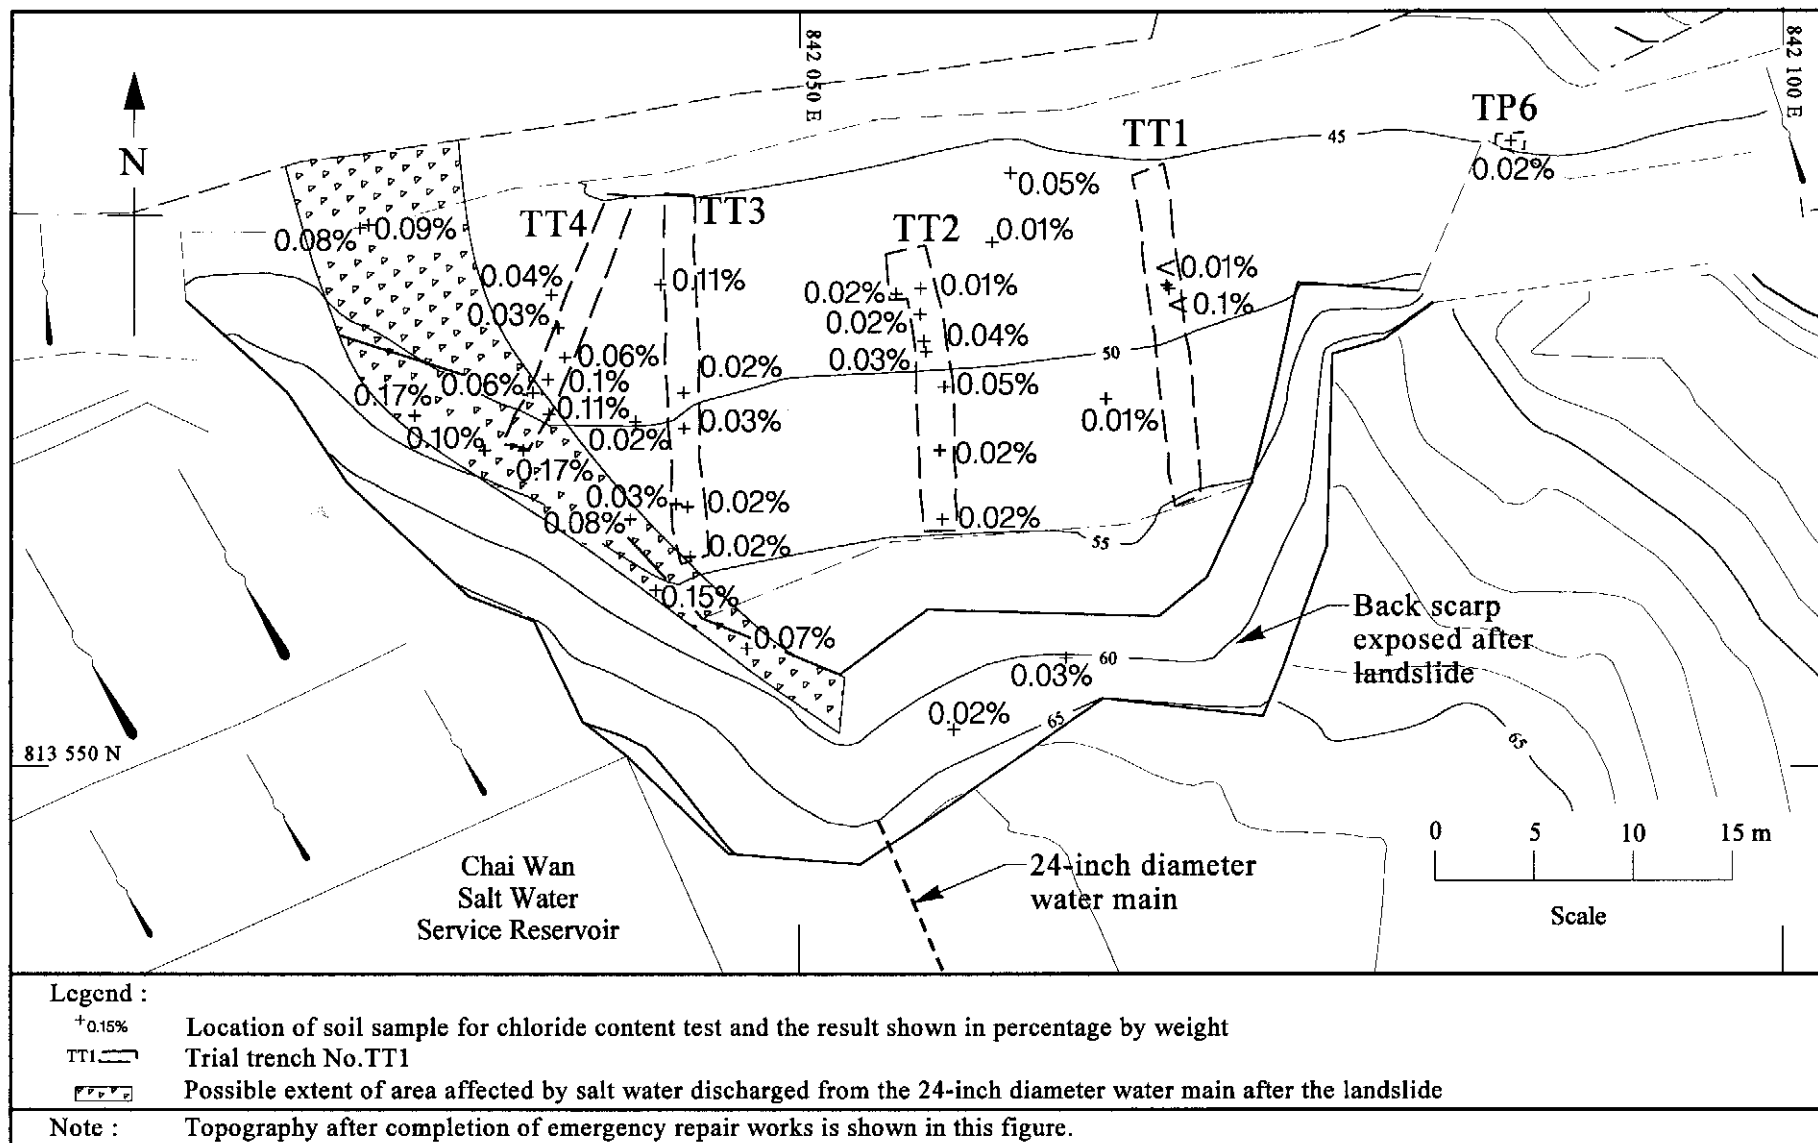
Figure 17 - Results of Chloride Content Tests on Soil Samples

The results of the soil chloride content tests are shown in Figure 17. High chloride contents ranging from 0.07% to 0.17% were found in soil samples recovered from the toe of the western part of the back scarp exposed after the landslide, along which salt water discharging from the reservoir through the truncated 24-inch water main would have flowed after the landslide. However, the chloride contents of soil samples taken from the back scarp and the debris at other locations in the landslide area were low, with an average chloride content of about 0.03%. Therefore, there are no indications that seepage from the reservoir was a significant source of groundwater in the vicinity of the landslide, which is consistent with the findings from chloride content tests on water samples.

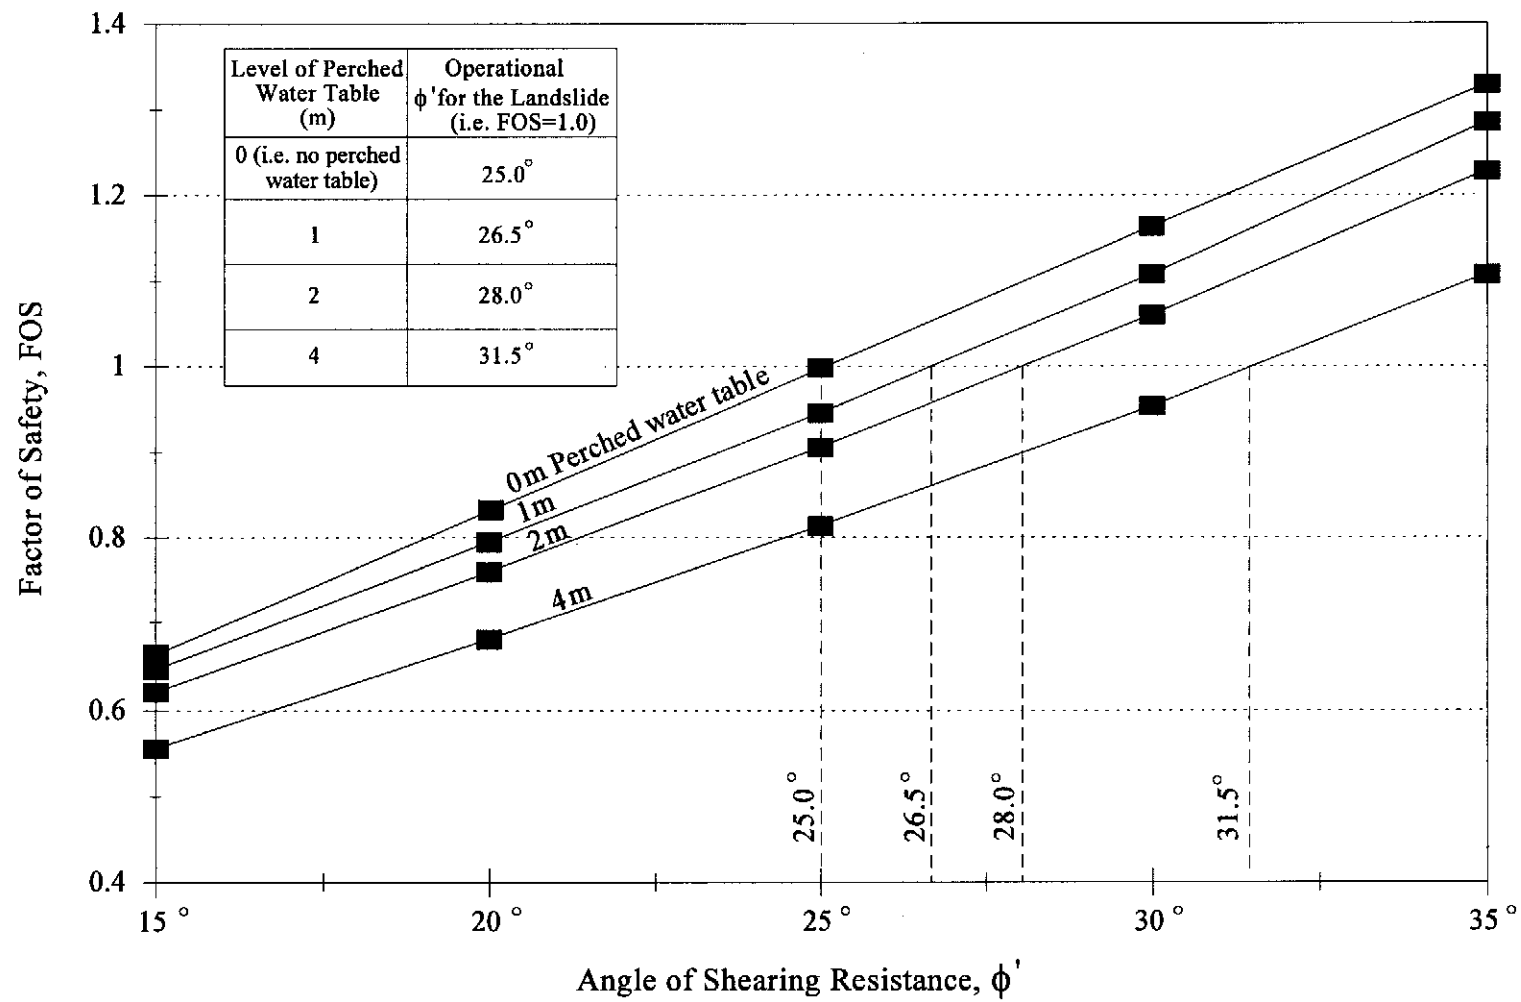
Figure 19 - Results of Theoretical Stability Analyses

The results of the analyses are summarised in Figure 19. For a factor of safety of 1.0, the angle of shearing resistance (i.e. ϕ') of the altered tuff layer was found to be 26.5°, 28° and 31.5°, for a perched water table of 1 m, 2 m and 4 m respectively. This range of ϕ' values agrees well with that determined from laboratory testing (Figure 13). Given the

development of a perched water table, the slope would theoretically become unstable, involving a translational failure through shearing along the altered tuff layer.

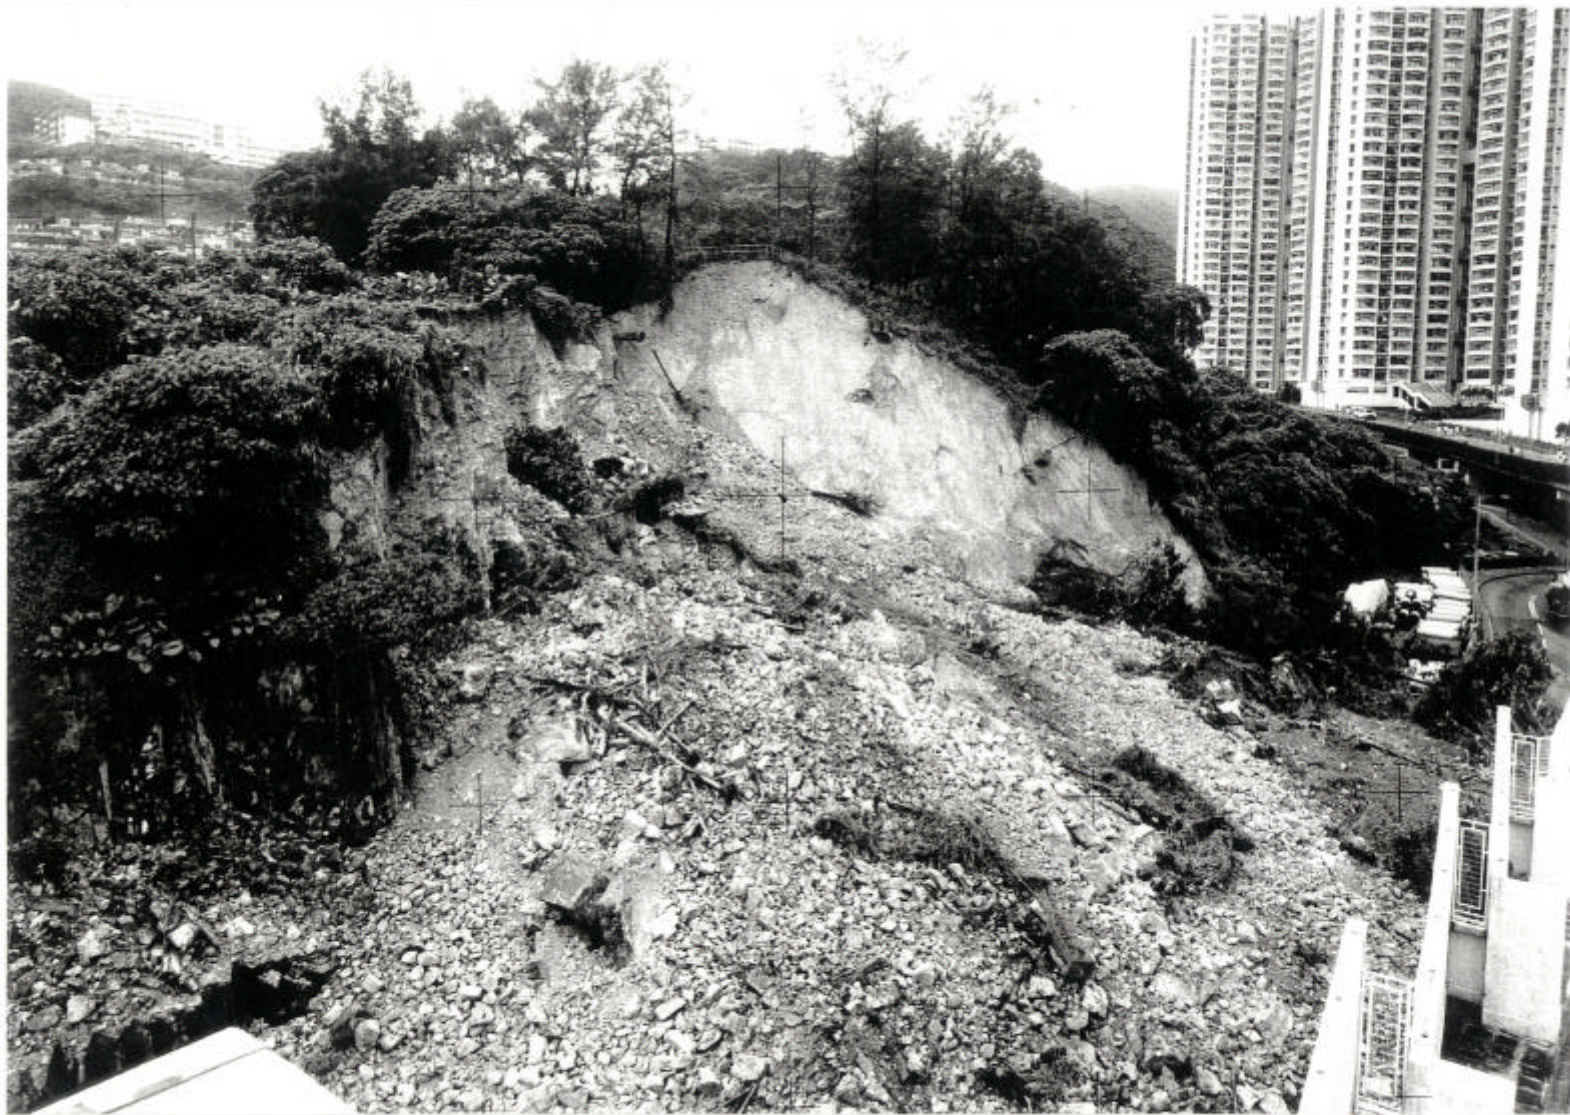
Plate 1 - Photograph of the Landslide Taken in the Morning of 13 August 1995 (See Figure 21 for Location)

According to the accounts of witnesses, the landslide involved two phases of failure. The main failure occurred at about 1:15 a.m. on 13 August 1995 and was preceded by a minor failure about 20 minutes earlier. The average depth of the landslide was about 15 m, which is deep compared with other rain-induced slope failures in Hong Kong. About 14 000 m³ of debris were released in the landslide. As shown in Figure 2, the landslide debris covered the lower part of the cut slope, the open space in front of the slope and Fei Tsui Road, with some deposited onto the playground across the road. Part of the debris piled up against the south-western corner of the Chai Wan Baptist Church to a maximum height of about 6 m. The maximum horizontal travel distance of the debris was about 70 m, as measured from the crest of the landslide. The maximum width of the debris mound was about 90 m.

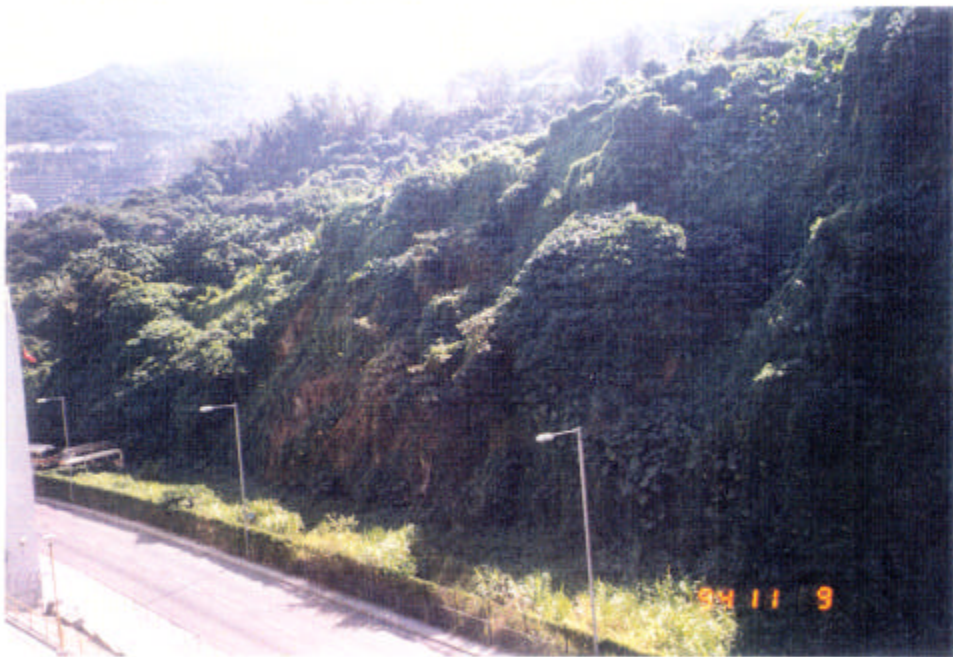
Plate 3 - Photograph of Cut Slope No. 11SE-D/C42 Taken on 9 November 1994
(See Figure 21 for Location)

inclined towards the north at an average angle of about 60° to the horizontal, with a maximum height of about 27 m. Rock was exposed at the lower part of the cut slope, and the upper portion was covered with chunam. A photograph of the cut slope taken after its formation in mid-1970s, which shows the condition of the rock face and the chunamed slope surface at the time, is shown in Plate 2. Photographs of the site taken in 1994 show that the cut face was covered extensively by unplanned vegetation (Plate 3).

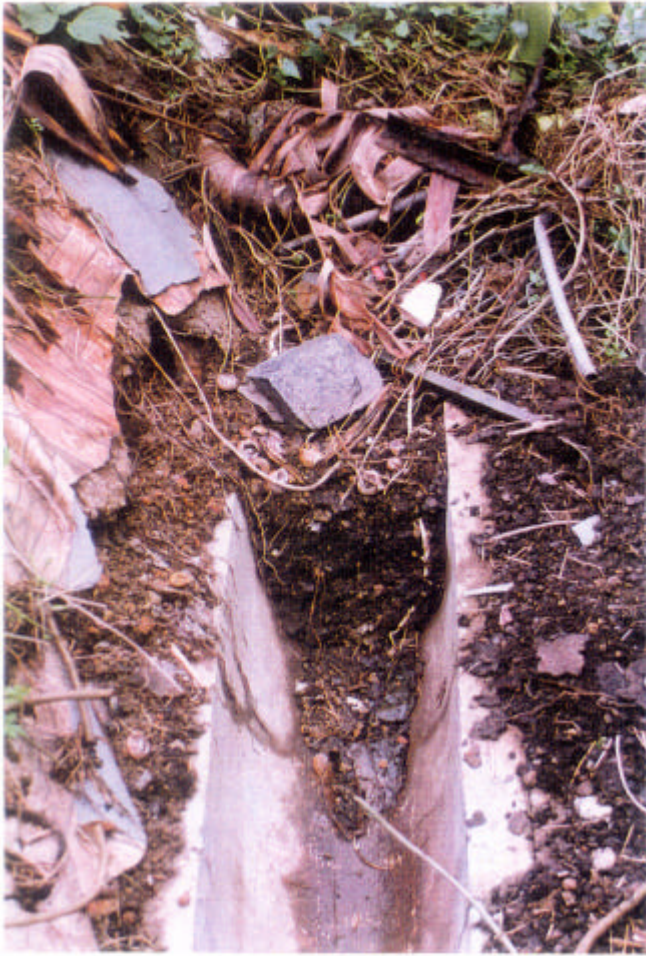
Plate 4 - Blocked Surface
Drainage Channel
on the Unfailed Section
of the Cut Slope
(Photograph Taken on
10 October 1995. See
Figure 21 for Location)

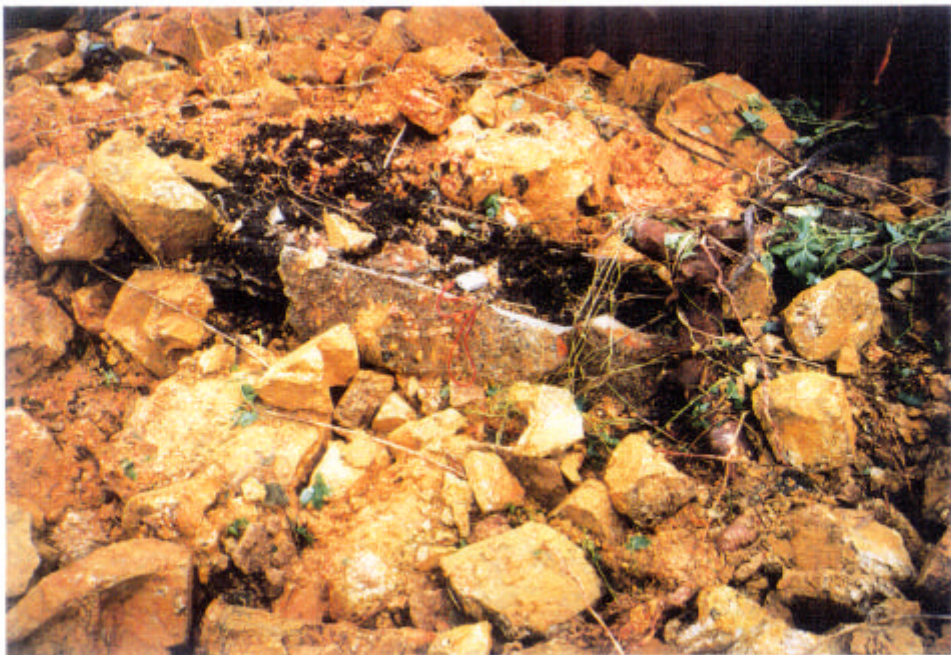
The landslide debris comprised predominantly coarse gravel-size to boulder-size joint-bound blocks of moderately and highly decomposed tuff in a matrix of clayey silty fine sand to sandy clayey silt, together with some man-made materials (Figure 5). The latter included sections of 24-inch and 6-inch diameter asbestos cement pipes, broken pieces of concrete surface channel, broken sections of a masonry wall, concrete blocks and catchpits, chain-link fencing, galvanized iron pipes, cables and damaged lamp posts. Many of the broken channels were filled with humus and black-stained soil (Plate 5), which indicates that they had been blocked for some time before the landslide.

Plate 5 - Blocked Surface Drainage Channel in the Landslide Debris (Photograph
Taken on 13 August 1995. See Figure 21 for Location)

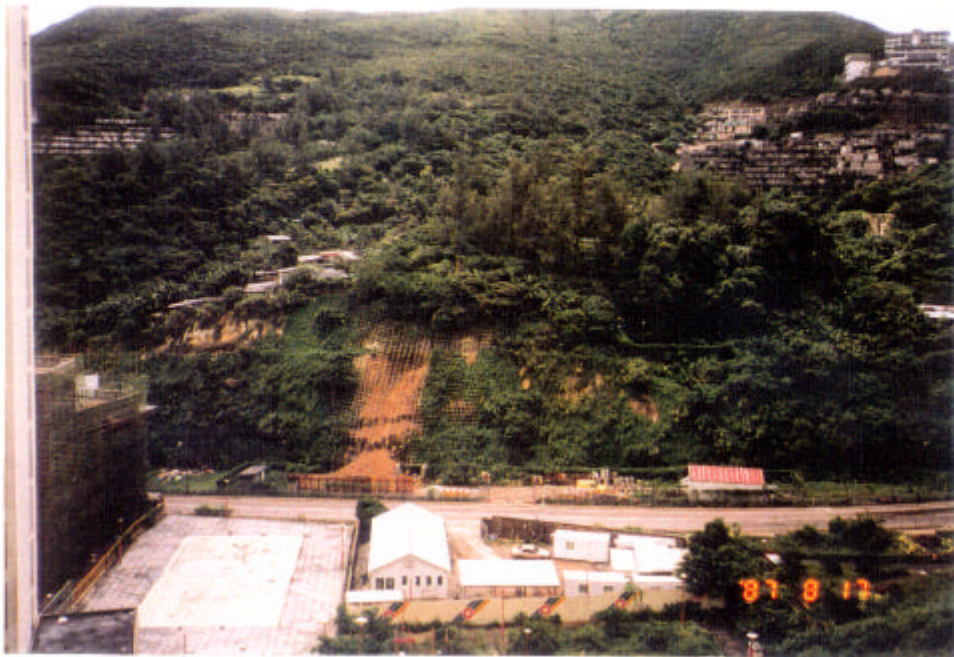
Two landslides, which occurred in 1987 (Plate 6) and in 1993 (Plate 7), with failure volumes of about 50 m³ and 30 m³ respectively, were reported to the Geotechnical Control Office (GCO) (renamed GEO in 1991). In each incident, the landslide occurred at the upper part of the cut slope, and the base of the failure daylighted at about 10 m above the level of Fei Tsui Road. The landslide debris came to rest in the flat open space in front of the slope, except that some windows of the Baptist Church were reported to have been damaged by small pieces of fly rock in the 1993 landslide.

Plate 6 - View of the 1987 Landslide (Photograph Taken on 17 August 1987.
See Figure 21 for Location)

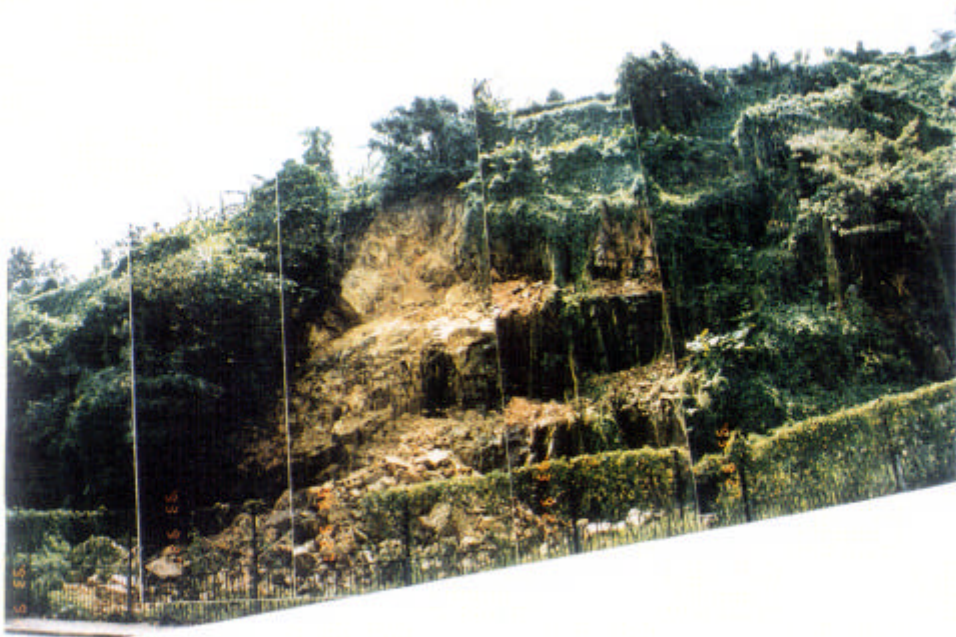
Plate 7 - View of the 1993 Landslide (Photograph Taken on 27 September 1993.
See Figure 21 for Location)

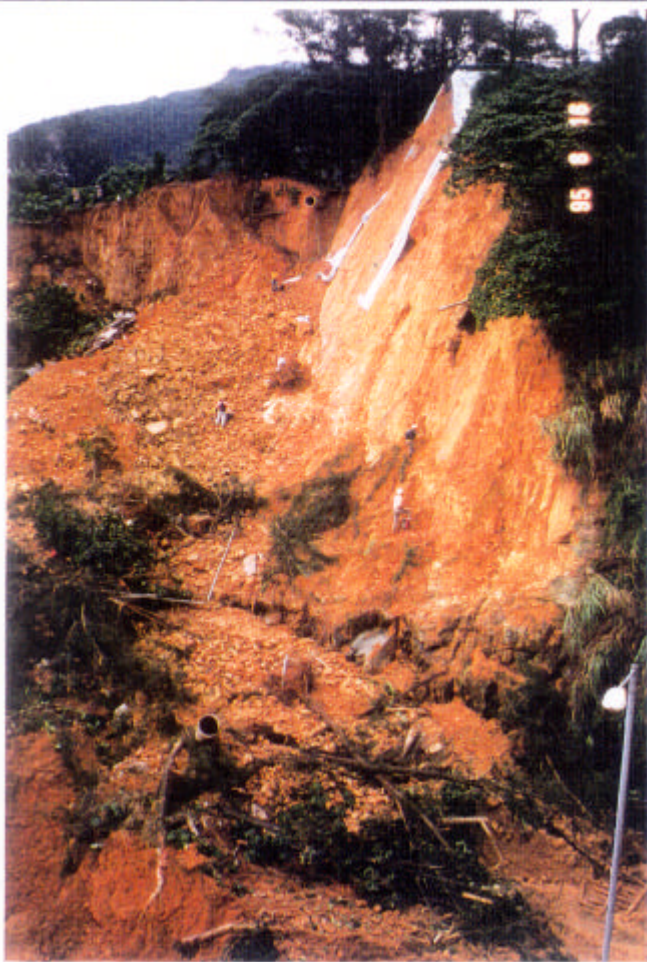
Plate 8 - Weathered Rock Joints
Forming the Back
Scarp of the Landslide
(Photograph Taken on
19 August 1995. See
Figure 21 for Location)

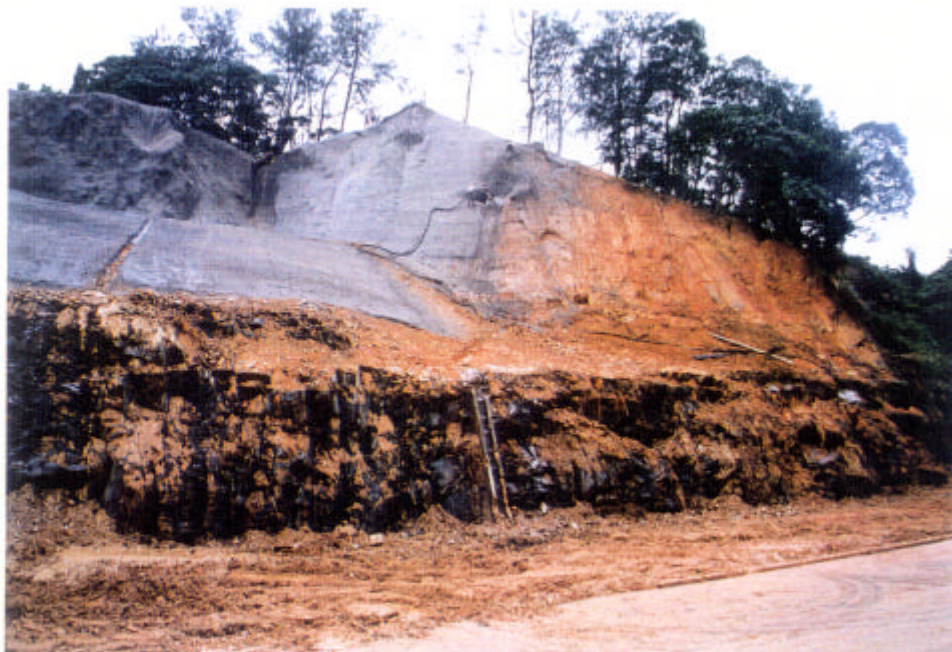
Plate 9 - Rock Face below the Base of the Landslide (Photograph Taken on
31 August 1995. See Figure 21 for Location)

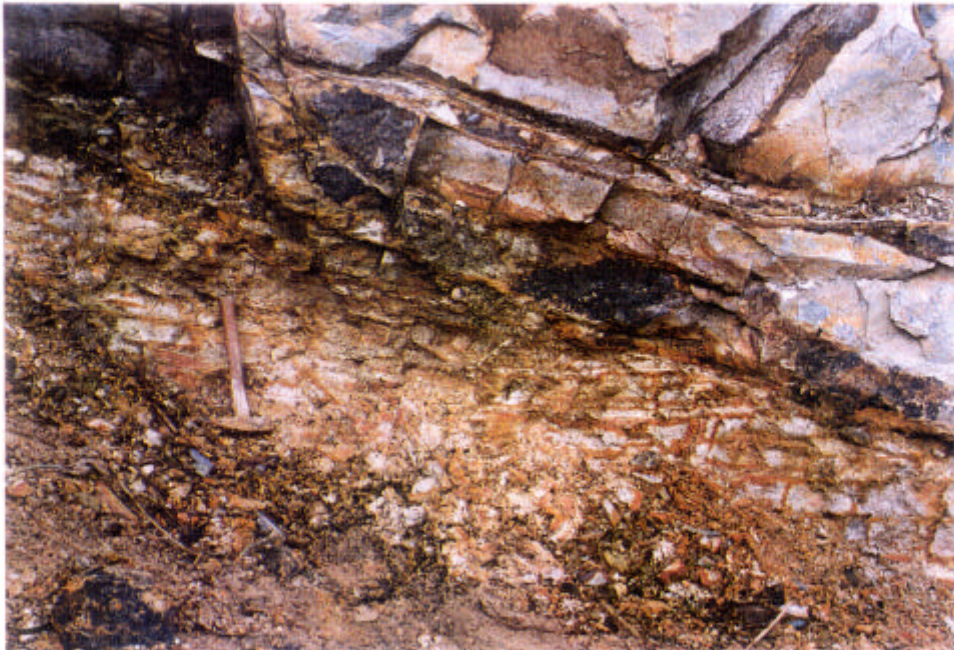
Plate 10 - Kaolinite-rich Altered Tuff at the Unfailed Portion of the Cut Slope to the East of the Landslide (Photograph Taken on 8 October 1995. See Figure 21 for Location)
