REPORT ON THE FEI TSUI ROAD LANDSLIDE OF 13 AUGUST 1995

Volume 2

FINDINGS OF THE LANDSLIDE INVESTIGATION

*Geotechnical Engineering Office
Civil Engineering Department
Hong Kong Government*

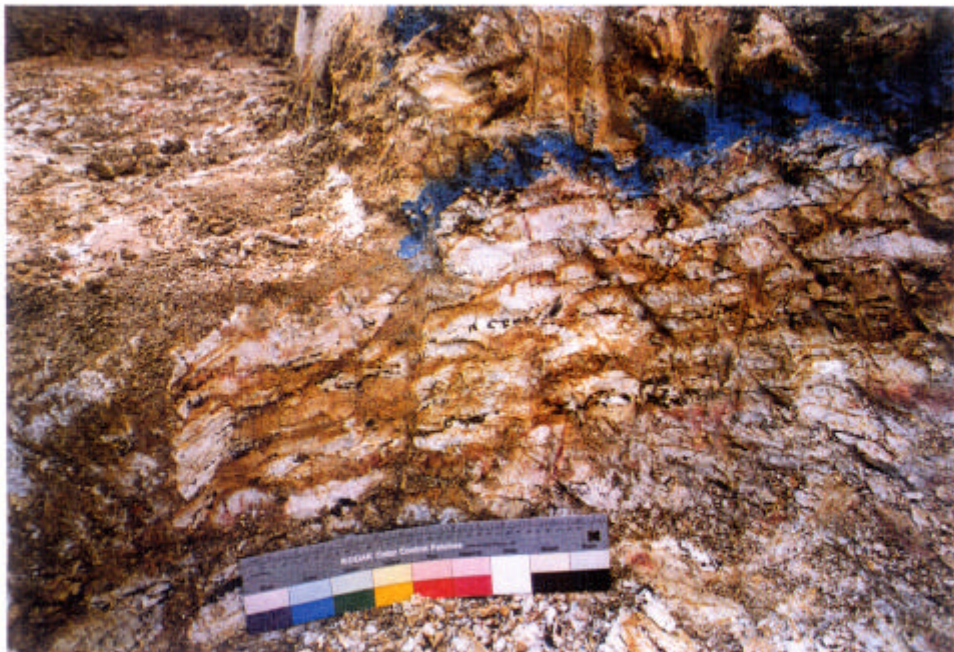
When the landslide debris was removed, similar altered tuff was found in the eastern and central part of the base of the landslide (Plate 11). The thickness of the layer in this area is up to about 0.6 m, although the upper part has been eroded in places by the landslide.

Plate 11 - Kaolinite-rich Altered Tuff at the Central Part of the Base of the Landslide (Photograph Taken on 20 October 1995. See Figure 21 for Location)

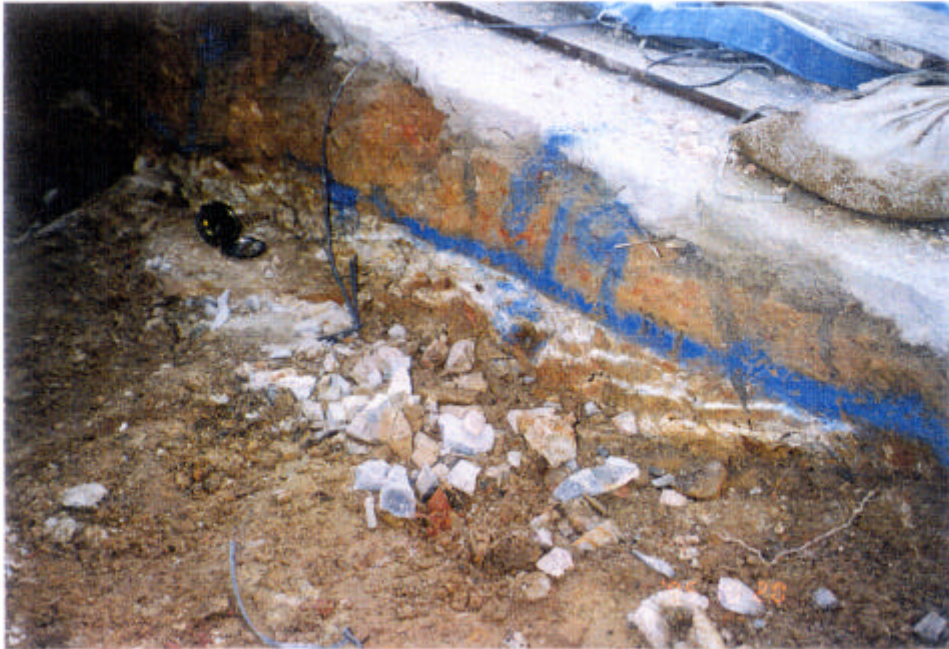
Plate 12 - Remnants of Kaolinite-rich Altered Tuff at the Western Toe of the Landslide (Photograph Taken on 20 October 1995. See Figure 21 for Location)

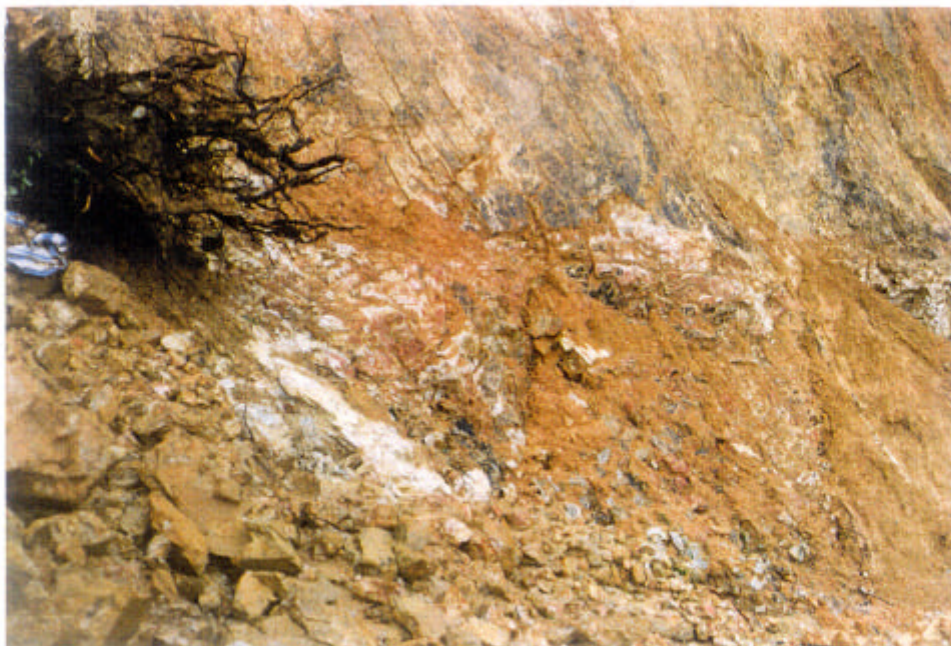
Plate 13 - The 'Diffuse' Layer at the Western Back Scarp (Photograph Taken on 14 August 1995. See Figure 21 for Location)
