REPORT ON THE SHUM WAN ROAD LANDSLIDE OF 13 AUGUST 1995

FINDINGS OF THE LANDSLIDE INVESTIGATION

*Geotechnical Engineering Office
Civil Engineering Department
Hong Kong Government*

April 1996

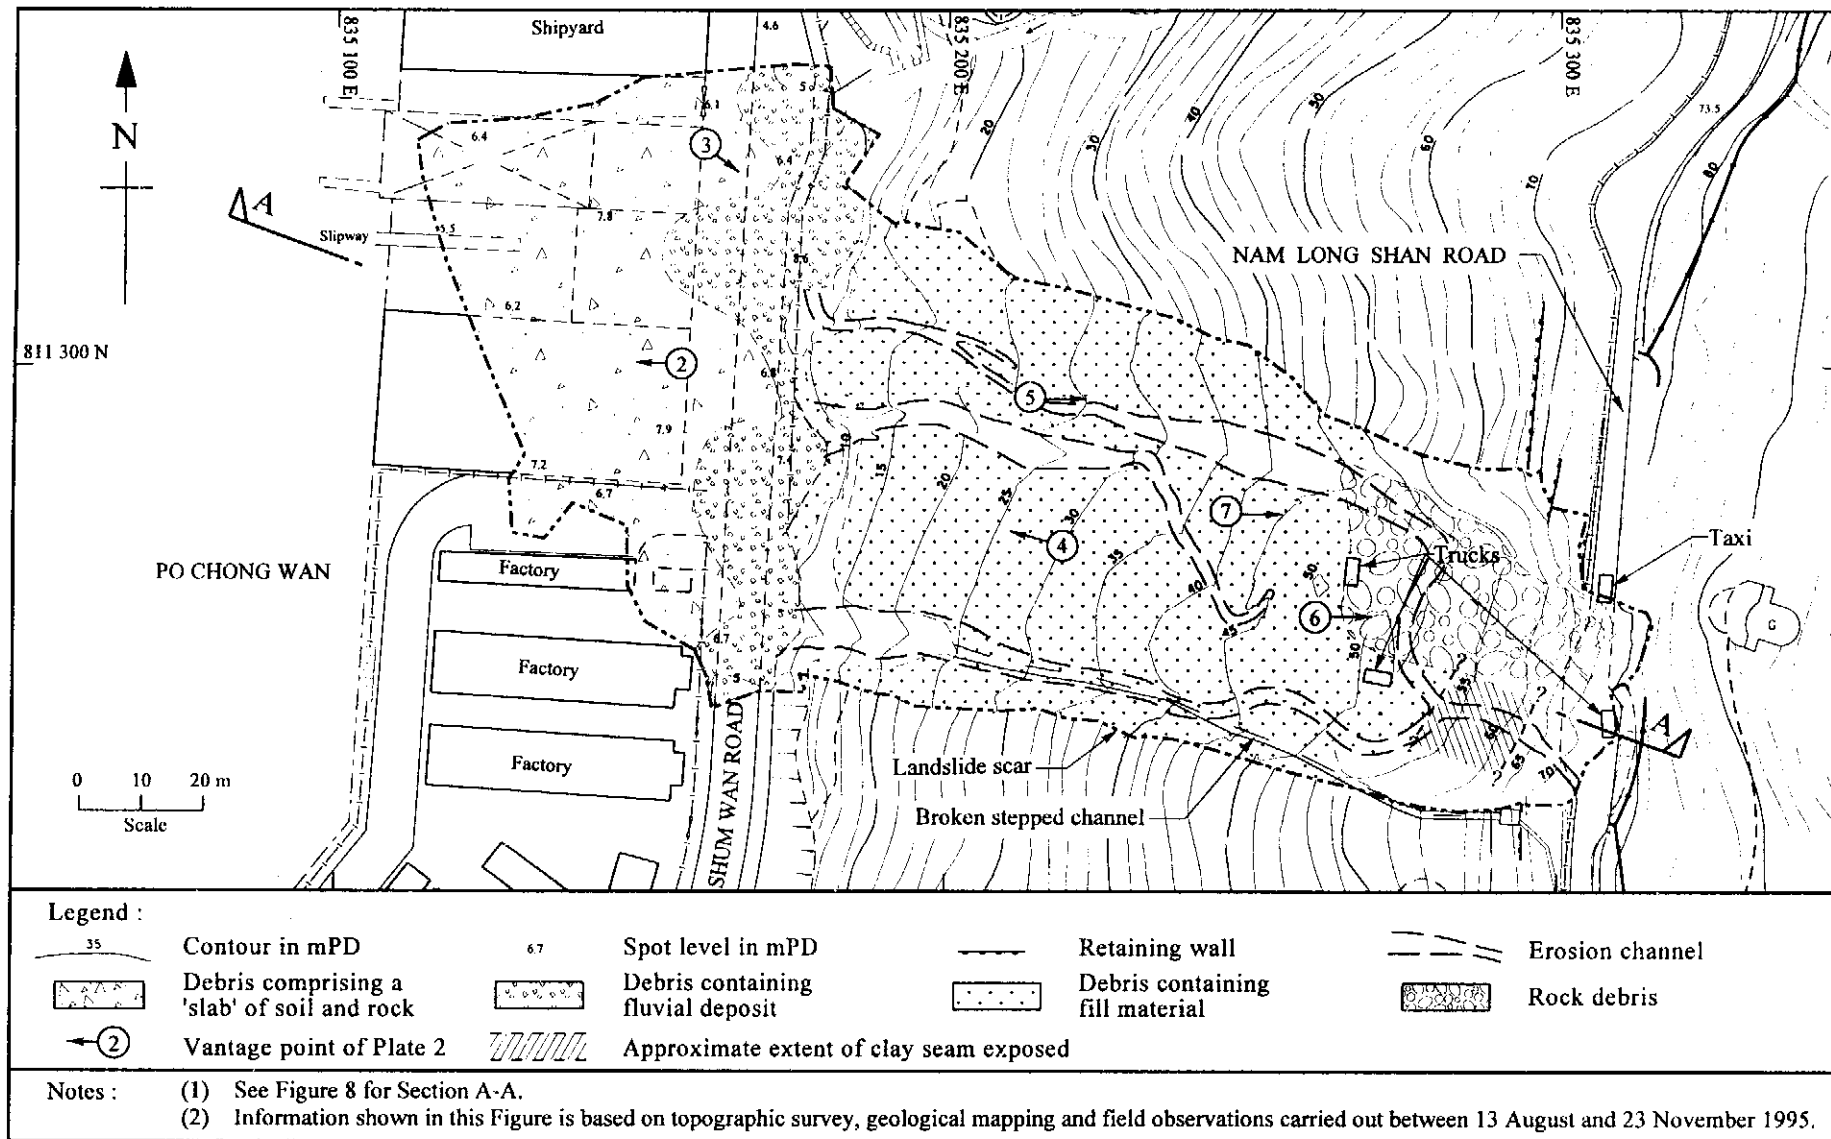
Figure 7 - Plan of the Landslide

The 1.2 m wide stepped-channel carrying water down the hillside between Nam Long Shan Road and Shum Wan Road was partly broken and buried by debris after the landslide (Figure 7). The condition of the broken portion of the stepped-channel before the landslide cannot be ascertained. However, a witness who walked part way up the stepped-channel one week before the landslide did not see any blockage of the channel. Some 20 m portion of the stepped-channel adjacent to the concave scar remained intact and clear after the landslide.

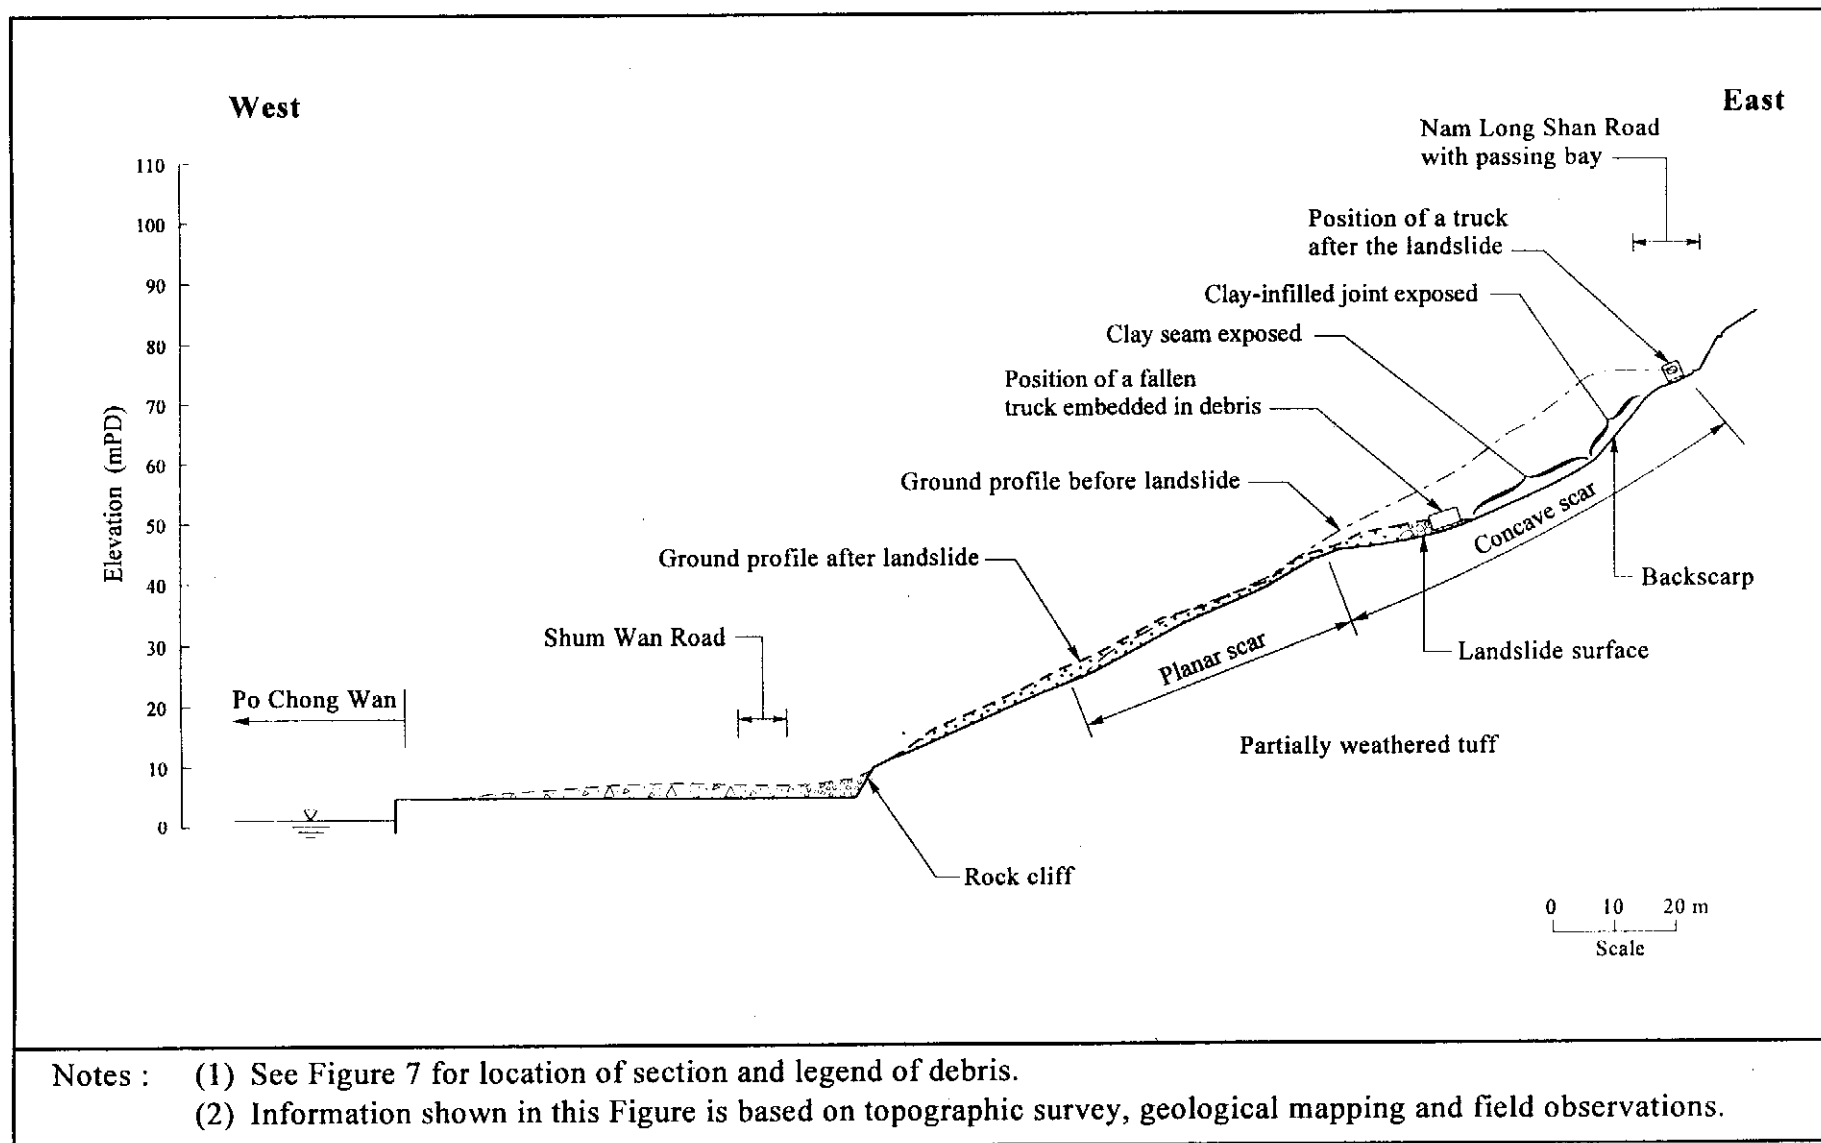
Figure 8 - Section A-A through the Landslide

The landslide resulted in a 70 m high scar, with a width varying from about 50 m just below Nam Long Shan Road to about 90 m above Shum Wan Road. The upper part of the landslide surface (Figure 8) was concave in shape and was up to about 12 m in depth below the pre-failure ground surface. The lower part of the landslide surface was planar and was 2 to 3 m below the pre-failure ground surface.

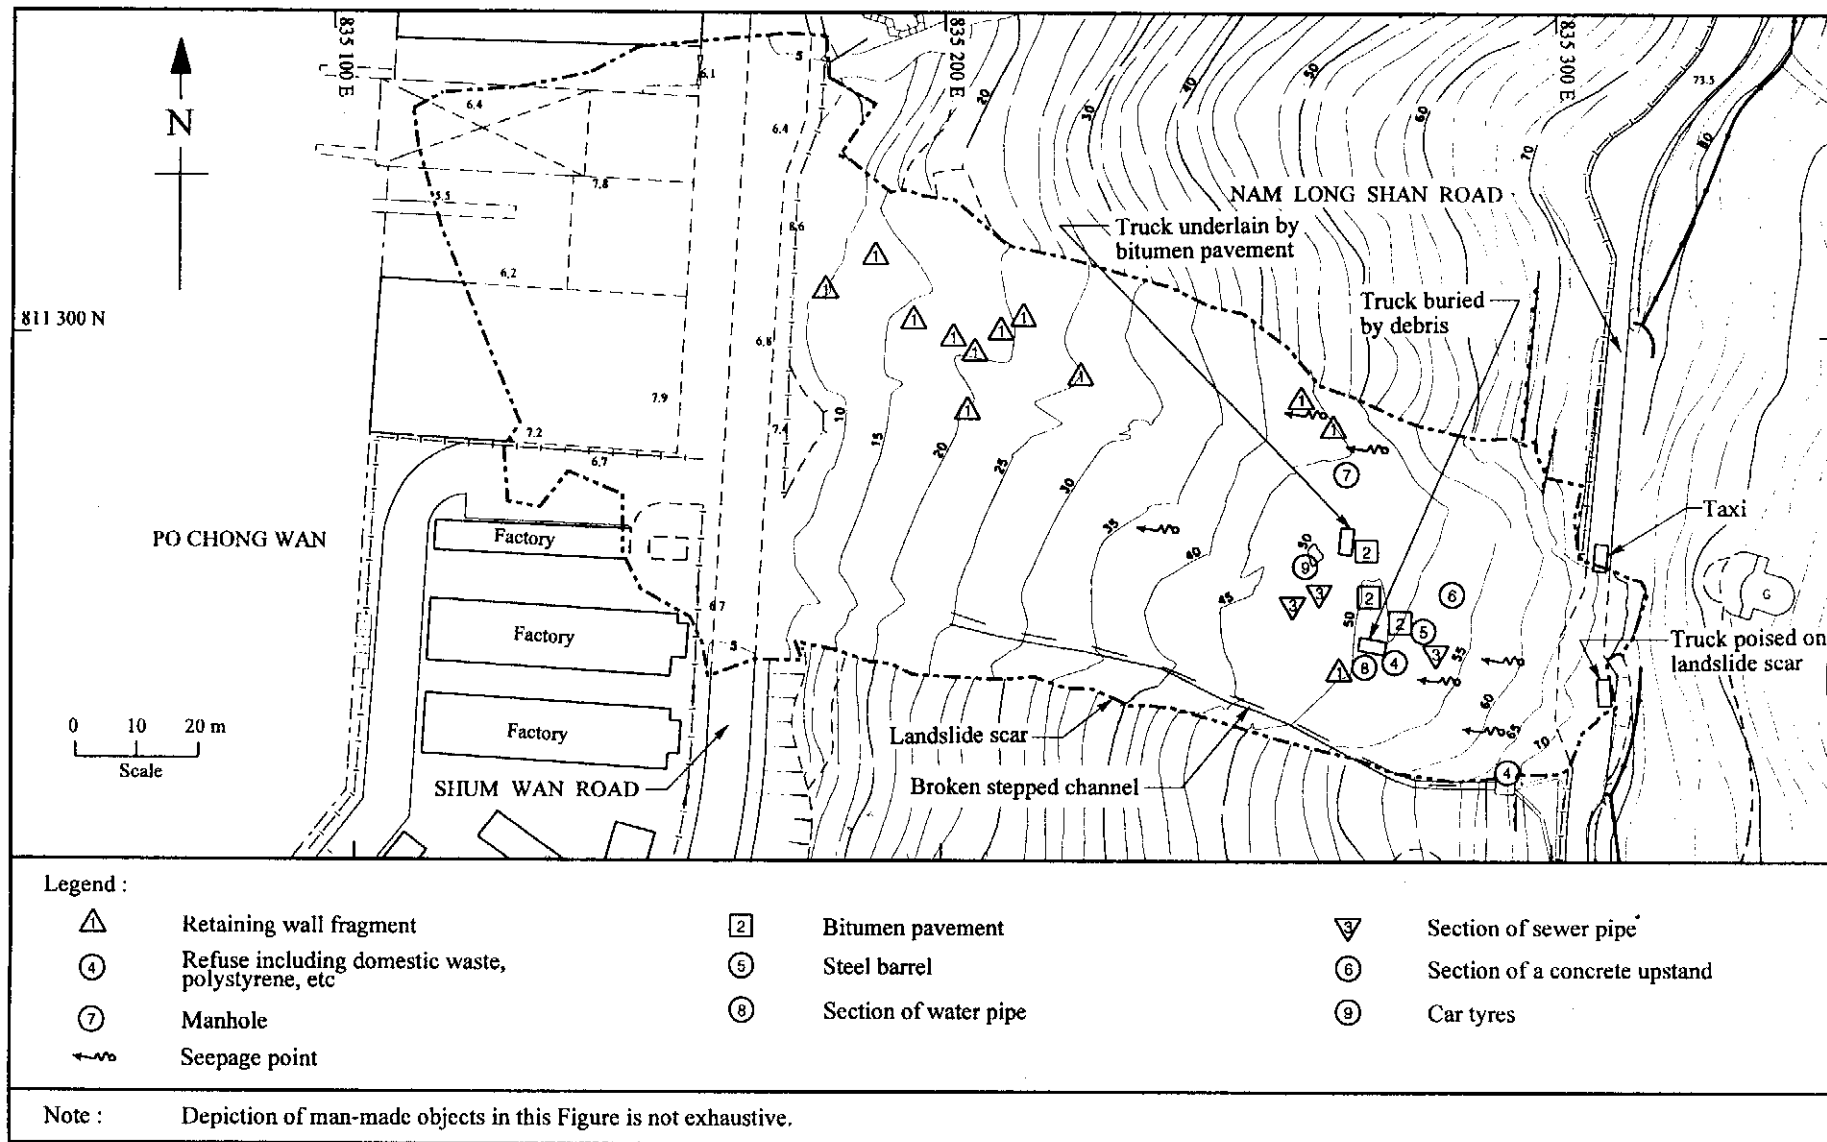
Figure 9 - Locations of Man-made Objects and Seepage Points

During the investigation of the landslide, persistent water seepage from the ground was observed at a number of points on the landslide scar (Figures 9 & 11). The elevations of the seepage points at mid-height of the failed hillside (35 to 50 m above Principal Datum) are compatible with the groundwater levels recorded in boreholes nearby and are considered to be a surface expression of the base groundwater level. The groundwater levels at these locations are about 1 to 3 m below the pre-failure ground surface.

from the ground in the concave scar just above the exposed clay seam (Figures 9 & 11). This seepage persisted for about one week after the landslide and reappeared after subsequent rainstorms. This suggests the presence of a transient perched water condition.

The segregation of concrete retaining wall fragments in the landslide debris from other man-made objects from Nam Long Shan Road, including the fallen trucks and pieces of bituminous pavement and sewer (Figure 9), is best explained by a minor failure of the fill embankment below the passing bay before the main landslide (Figure 13(a)). The minor failure could either have been a shallow slip in the fill or erosion of the fill surface. Although signs of such erosion can be seen on the surface of the fill embankment in aerial photographs taken in 1988 and 1991, a shallow slip might also have been possible. However, sufficient evidence could not be found to establish the nature of the failure. The intense rainfall from 11 p.m. on 12 August to 3 a.m. on 13 August triggered this first failure.

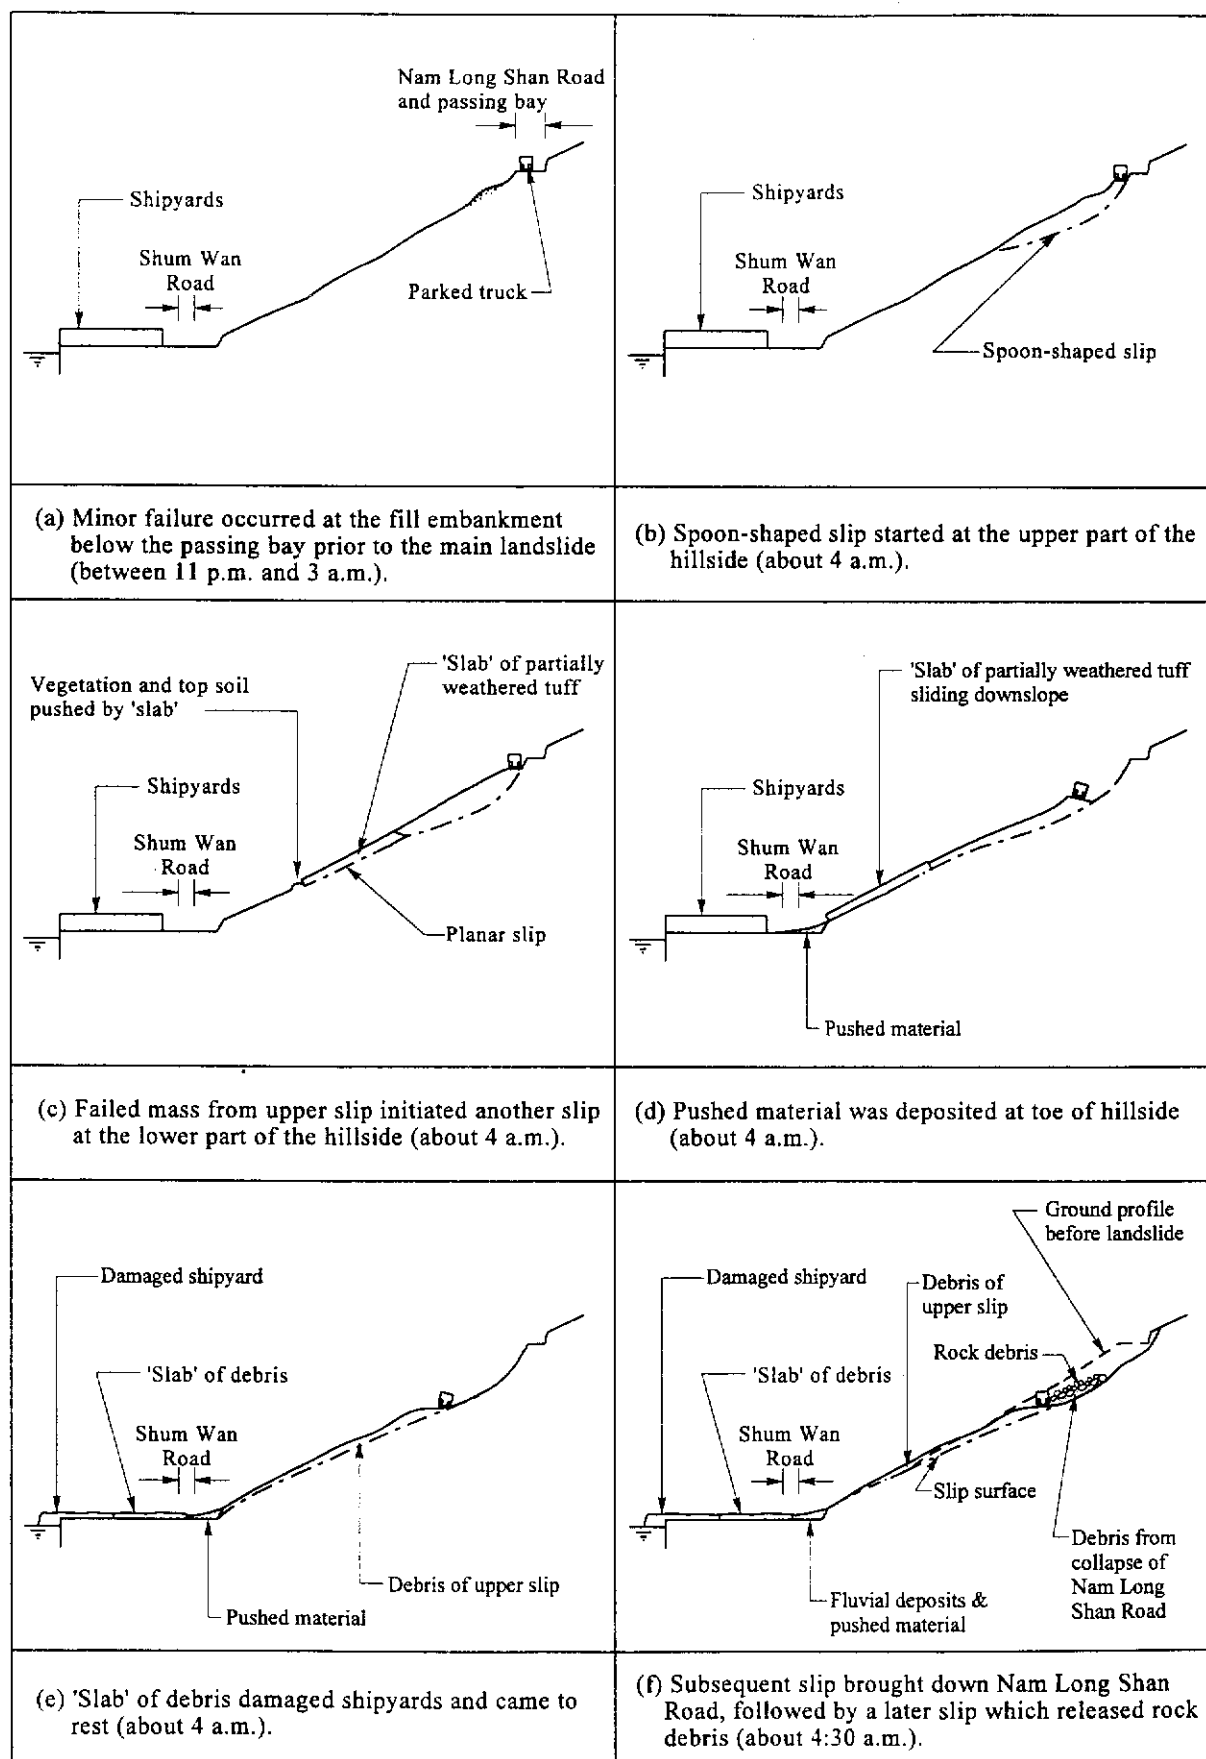
Figure 13 - Schematic Representation of Inferred Sequence of Events

The main landslide occurred at about 4 a.m. The upper part of the hillside slipped partly on a clay seam in the partially weathered tuff. This failure was approximately spoon-shaped and took with it the passing bay (Figure 13(b)). Movement of the ground associated with this failure was reported by an eye-witness to be not rapid but continuous. It resulted in the deposition of pieces of bituminous pavement and utility pipes on the concave scar. Fragments of the southern concrete retaining wall that were deposited earlier on the upper part of the hillside would have moved with the debris further downhill.

disturbed its equilibrium. The lower part of the hillside failed along a shallow planar surface sub-parallel to the ground surface (Figure 13(c)). This planar failure released a relatively thin layer of partially weathered tuff that slipped largely as an intact unit or 'slab' down the hill. The 'slab' pushed vegetation and top soil in front of it. Some of the pushed material and the front part of the 'slab' were deposited at the toe of the hillside (Figure 13(d)). The remaining portion of the 'slab' then overrode the deposited material and continued its journey towards the sea. The front of this 'slab' finally came to rest at a maximum distance of about 70 m from the toe of the hillside (Figure 13(e)).

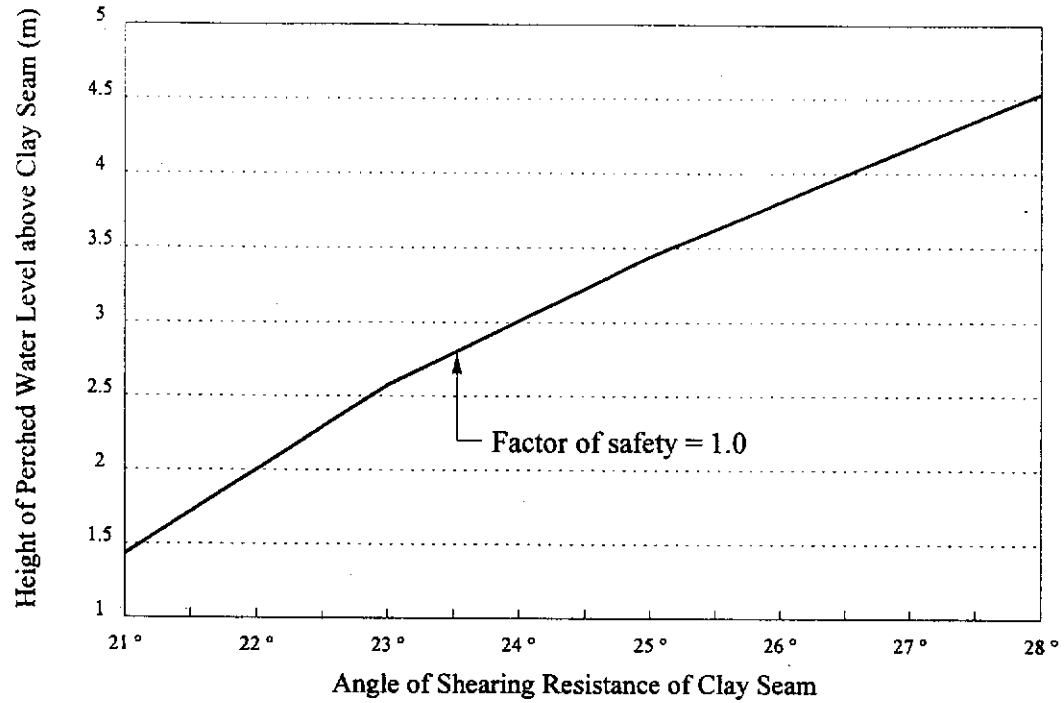
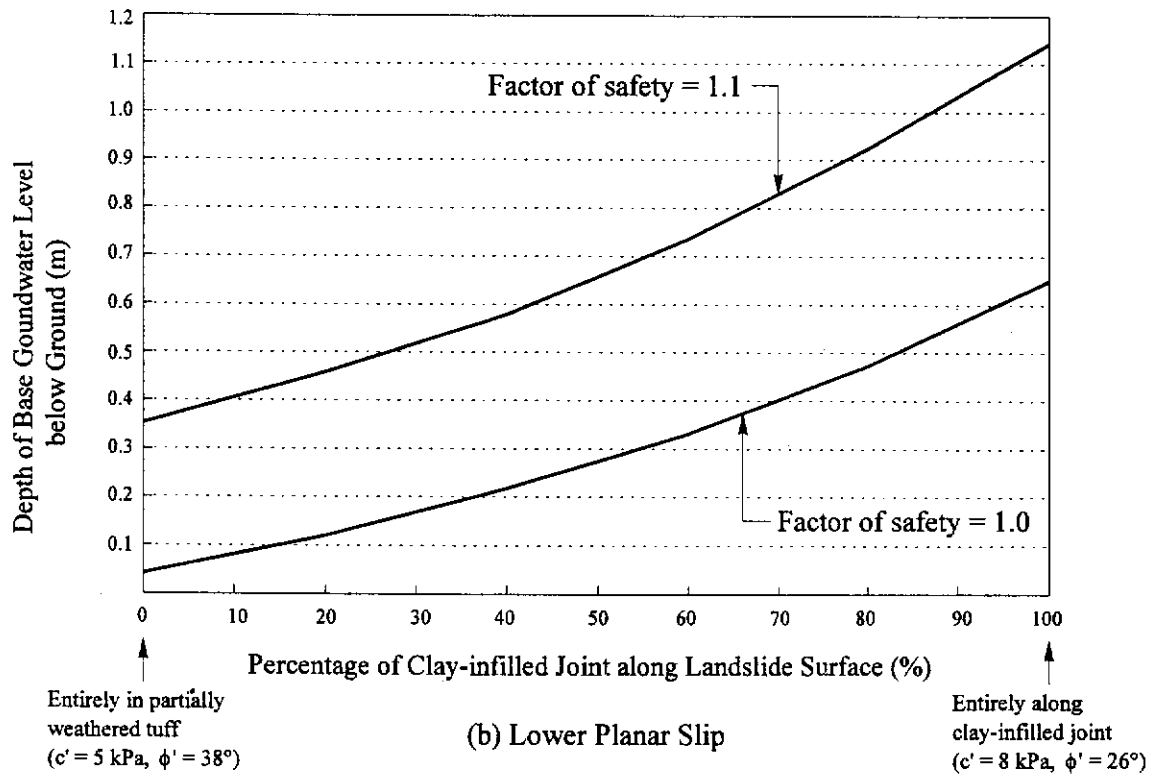
Figure 15 - Results of Slope Stability Analyses for Hillside

In the concave scar area, the post-failure base groundwater level was well below the landslide surface (Section 6.4). Theoretical analyses by the method of slices show that this part of the hillside would be stable under such a deep base groundwater condition. Perched water, however, was observed on the clay seam which formed part of the landslide surface of the concave scar (Section 6.2). The associated porewater pressure could have rendered the ground unstable. The theoretical perched water level needed for limit equilibrium depends on the shear strength of the clay seam. The ground could theoretically have failed under a high perched water level of 4 to 5 m coupled with the peak shear strength for the clay seam, or alternatively under a low perched water level of 1 to 2 m if the clay seam had a shear strength close to that of the clay with slickensiding (Figure 15(a)).

At the location of the planar scar, ground investigation showed that the base groundwater level was closer to the pre-failure ground surface than in the concave scar. Theoretical stability analyses by the limit equilibrium method, using the infinite slope solution, show that the ground could theoretically have become unstable under a range of base groundwater levels between zero and 1 m below ground, depending on the proportion of clay-infilled joints along the landslide surface (Figure 15(b)).

Note : For ease of comparison, $c' = 0$ is assumed for the analysis of the spoon-shaped slip. Taking peak strength of clay ($c' = 8$ kPa, $\phi' = 26^\circ$), the height of perched water level for factor of safety = 1.0 is 4.8 m.

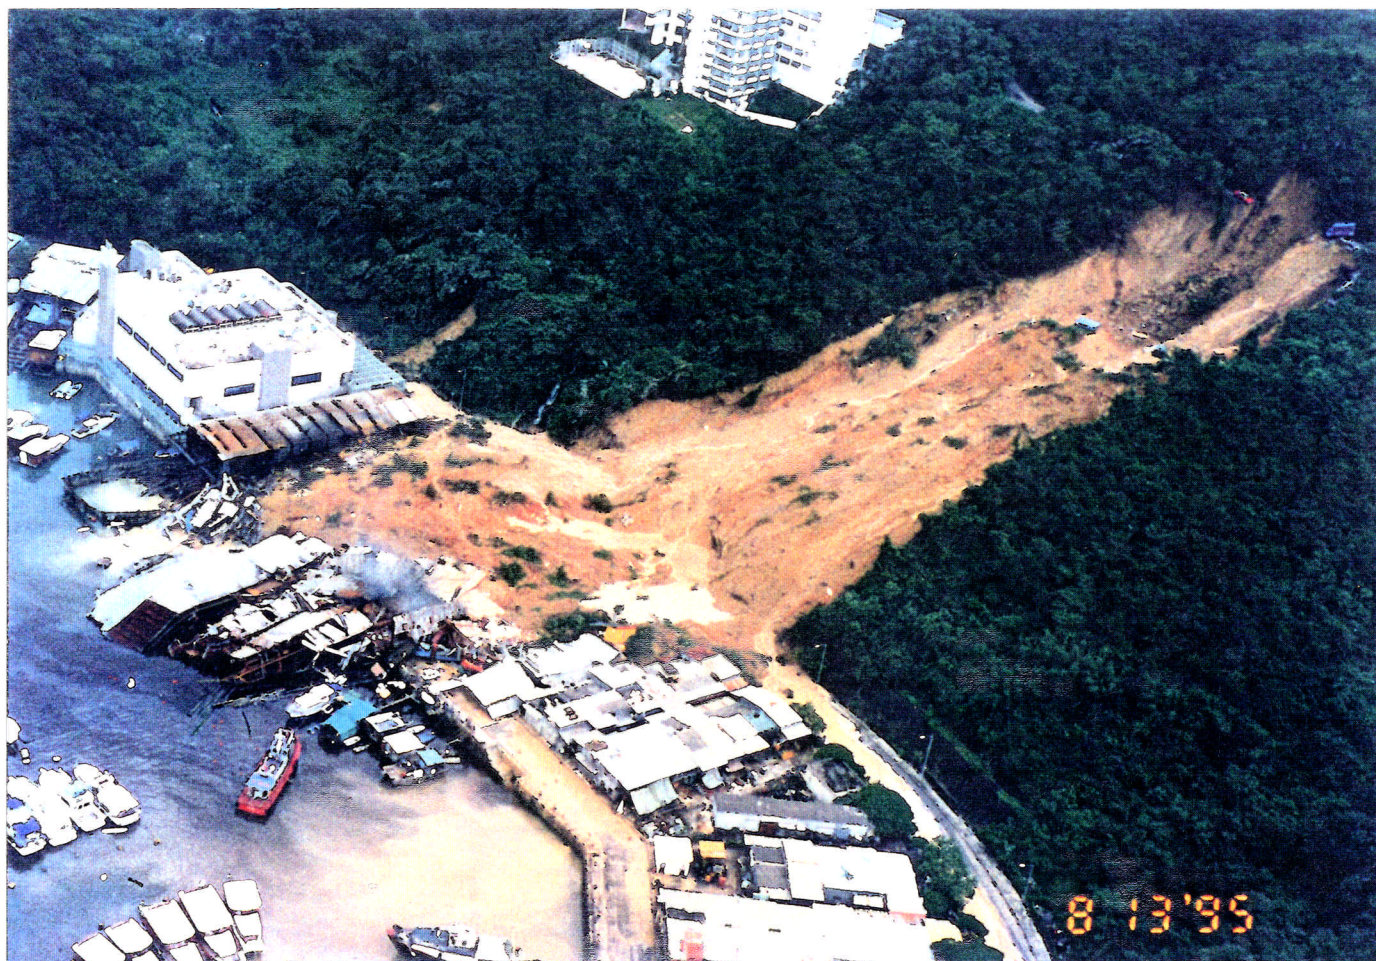
Plate 1 - The Landslide on 13 August 1995

At about 4:00 a.m. on 13 August 1995, a landslide took place at the hillside above Shum Wan Road, Aberdeen (Plate 1 & Figure 1), causing the collapse of a 30 m long section of Nam Long Shan Road. The landslide debris crossed Shum Wan Road and damaged three shipyards and a factory near the seafront. The landslide resulted in two fatalities, and five other people were injured.

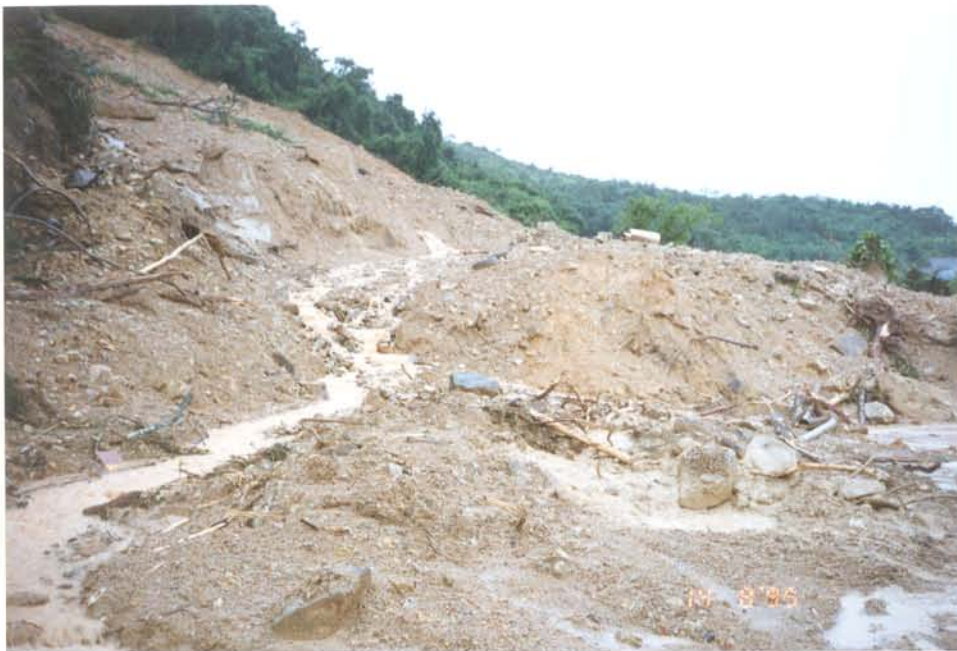
Plate 3 - Deposits at the Toe of the Failed Hillside

The debris in the space between the 'slab' debris and the hillside comprised mainly a very soft or loose fluvial deposit of clay, silt, sand, gravel and some cobbles and boulders (Plate 3). The debris was generally about 2 m thick.

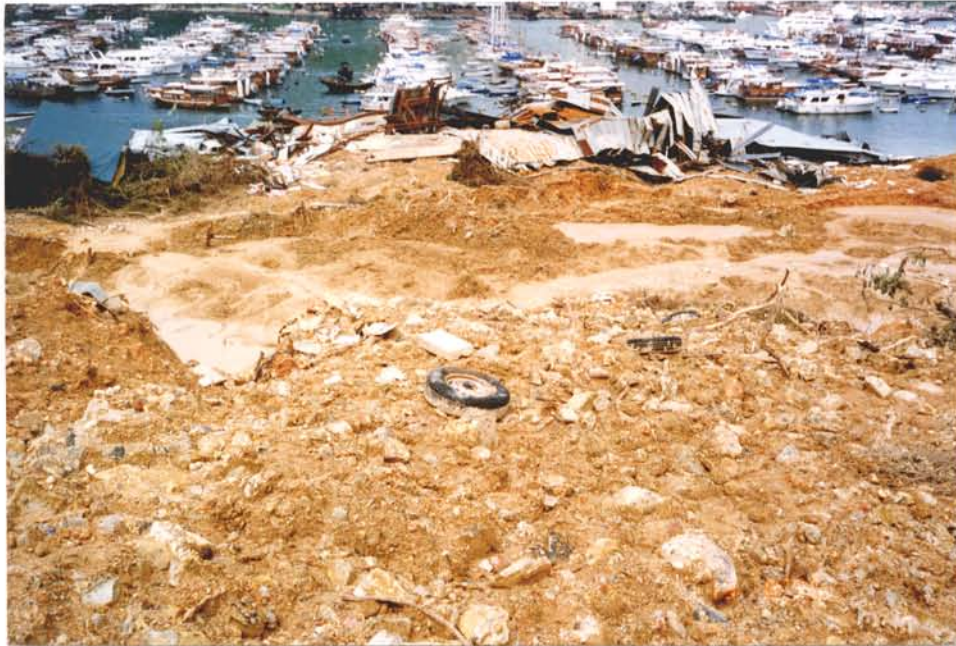
Plate 4 - Debris with Fill Material and Refuse on Landslide Scar

The planar part of the landslide surface was generally covered by soil debris up to about 3 m thick. The soil debris was up to about 5 m thick within the concave scar. The debris included fill material and refuse, such as bottles, polystyrene, car tyres and construction waste (Plate 4). Other man-made objects, including concrete retaining wall fragments, broken pieces of bituminous pavement, sections of 225 mm diameter earthenware pipes, 100 mm diameter galvanised iron water pipes and concrete slabs, were also found (Figure 9). It was noted that most of the concrete retaining wall fragments (Plate 5) were deposited in the lower planar scar, whereas the pieces of bituminous pavement (Plate 6) were all within the upper concave scar.

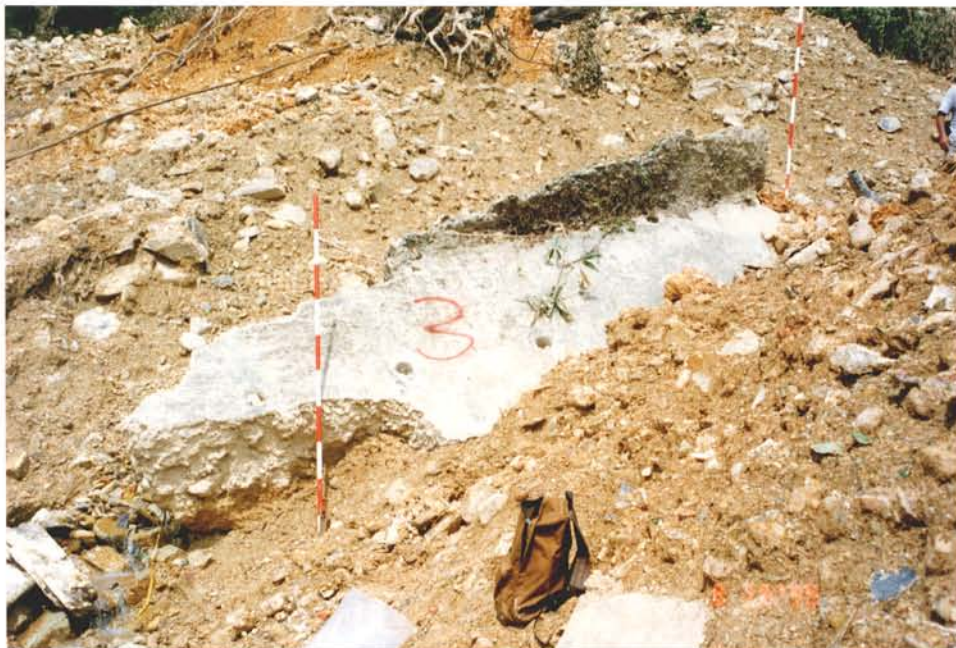
Plate 5 - Retaining Wall Fragment on Lower Part of Landslide Scar

A substantial part of the failed ground from the spoon-shaped slip in the upper part of the hillside was deposited on the planar scar in the lower part of the hillside. The southern concrete retaining wall fragments moved with the ground to rest on the planar scar some distance below the concave scar in the lower part of the hillside.
