**DETAILED STUDY OF
20 AUGUST 2005 LANDSLIDE
BEHIND NURSES' QUARTERS
BLOCK A, QUEEN MARY
HOSPITAL, POK FU LAM**

GEO REPORT No. 242

Fugro Scott Wilson Joint Venture

**GEOTECHNICAL ENGINEERING OFFICE
CIVIL ENGINEERING AND DEVELOPMENT DEPARTMENT
THE GOVERNMENT OF THE HONG KONG
SPECIAL ADMINISTRATIVE REGION**

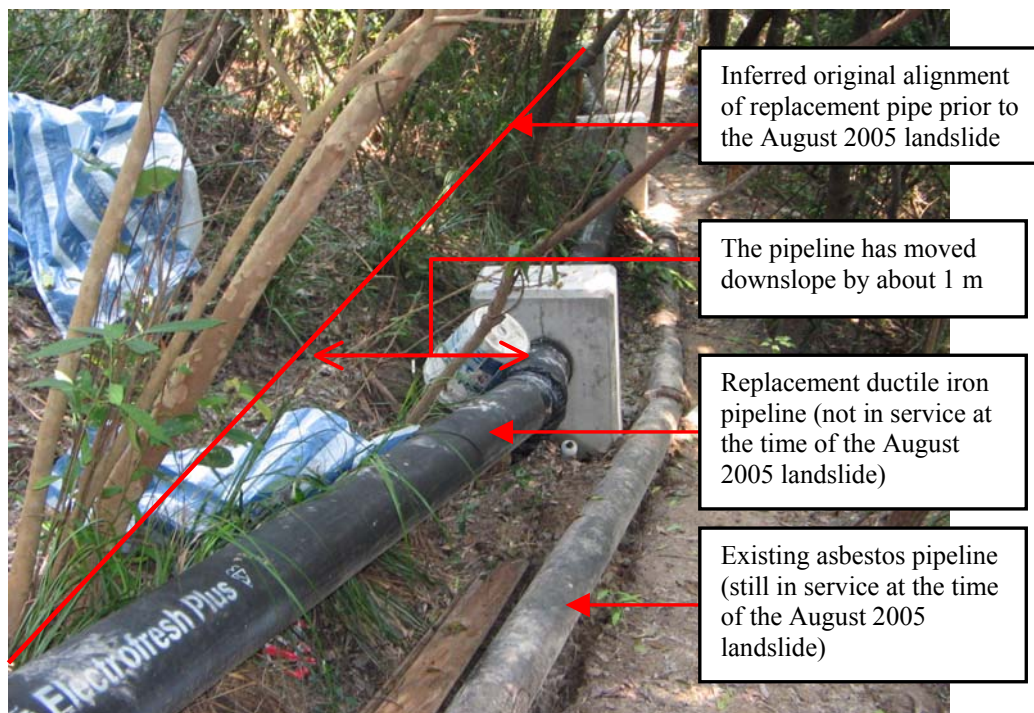
Plate 2 – General View of Displaced Section of New and Existing Pipelines
(Photograph taken by FSW on 24 August 2005)

A 15 m-long section of both the existing and replacement pipelines was severely deformed as a result of the August 2005 landslide (Figure 5 and Plates 2 and 3), following which works on the new pipeline were suspended. A section of plastic pipeline bridging the failed section of existing pipeline was installed by WSD as a temporary measure following the August 2005 landslide.

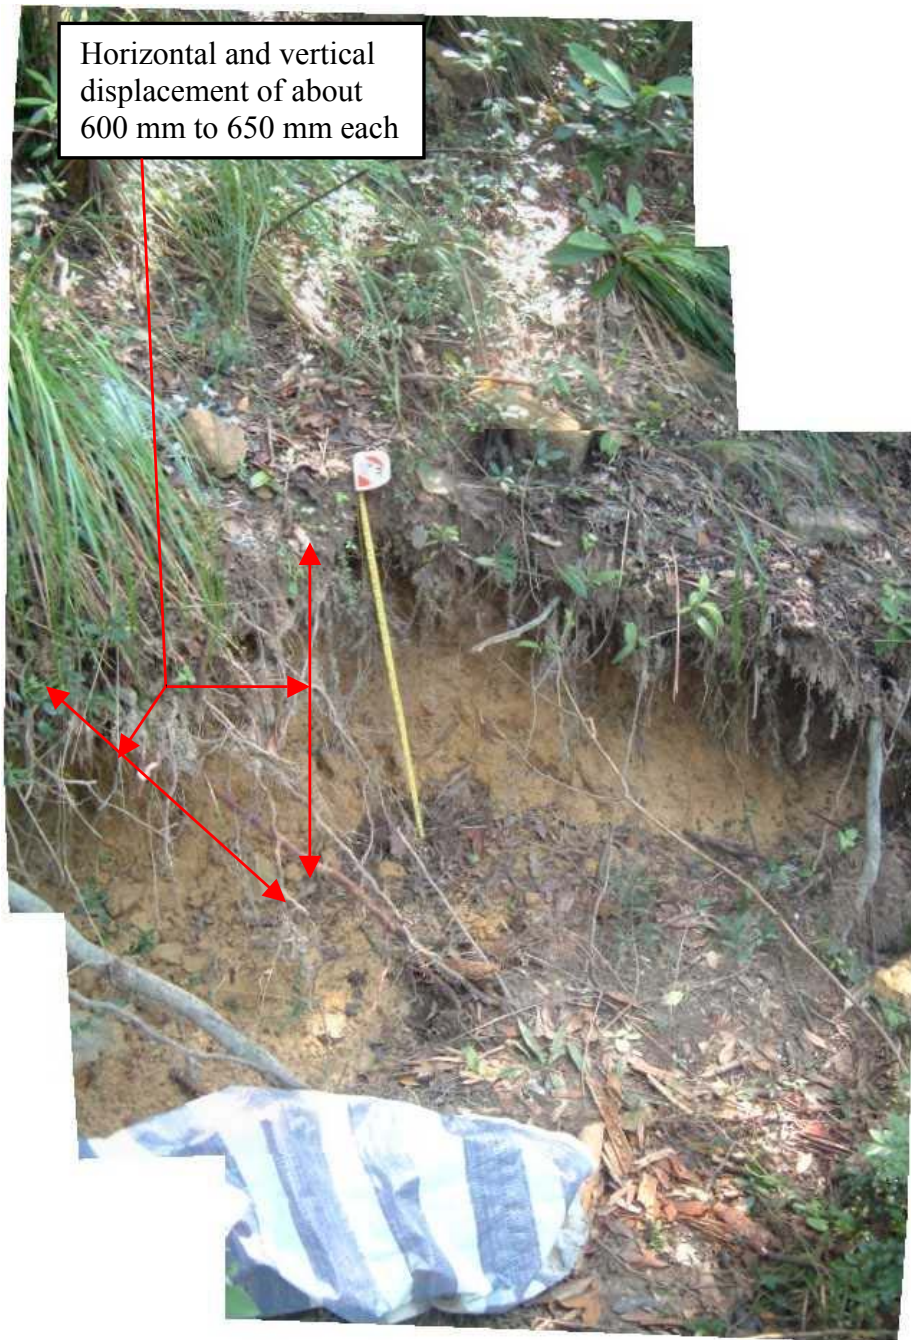
Plate 7 – View of Secondary Scarp in the Upper Southern Flank of the Landslide
(Photograph taken by FSW on 3 October 2005)

Horizontal and vertical displacement across scarp of about 500 mm and 600 mm respectively

An ephemeral drainage line passes through the secondary scarp

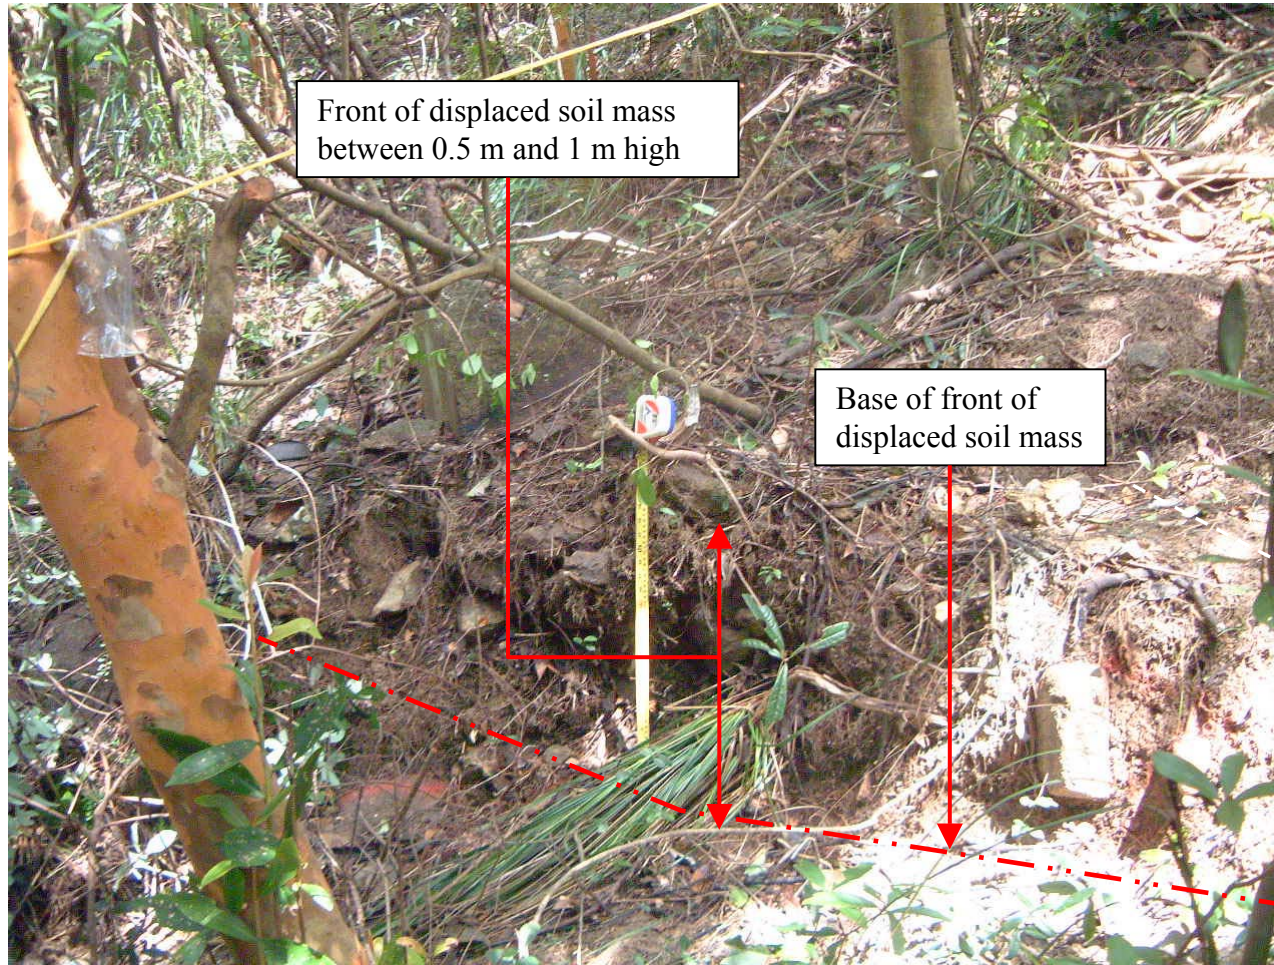
Plate 9 – View of Bulging in the Lower Southern Flank of the Landslide
(Photograph taken by FSW on 28 September 2005)

The landslide comprised a semi-circular area of distressed ground approximately 30 m wide by 40 m long that had moved downslope by about 1 m. The main scarp of the landslide was 17 m long and located about 20 m upslope of the pipeline (Figure 5 and Plates 4 to 6). The vertical displacement across the main scarp varied from 150 mm at the northern and southern ends to about 800 mm in the central portion. The horizontal displacement across the main scarp varied from 150 mm at the northern and southern ends to about 800 mm in the central portion. Several persistent tension cracks, 100 mm to 200 mm wide and up to 1 m deep, and secondary scarps with 500 mm to 600 mm horizontal and vertical displacement, were identified slightly above and downslope of the main scarp (Figure 5 and Plates 7 & 8). Below the pipeline, an area of hummocky ground indicative of possible ground bulging was identified (Figure 5 and Plates 9 & 10).

Front of displaced soil mass
between 0.5 m and 1 m high

Base of front of
displaced soil mass

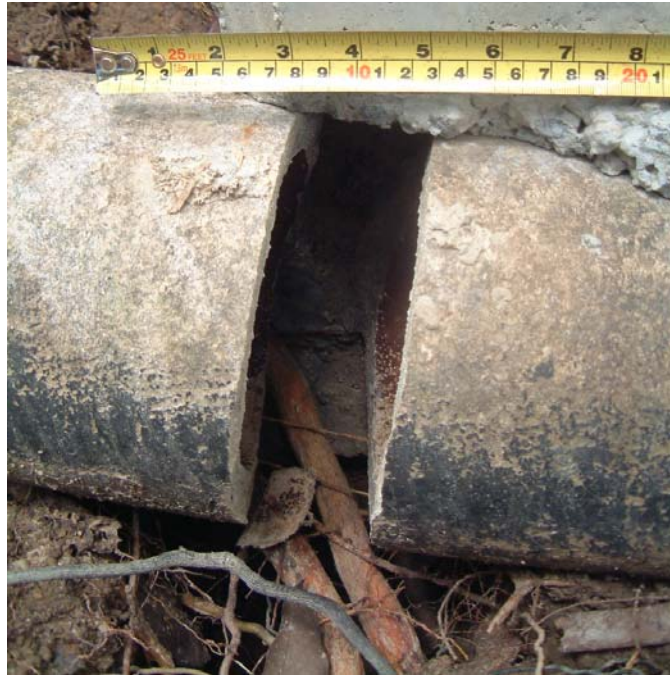
Plate 11 – View of Tensile Fracture in Existing Asbestos Pipeline
(Photograph taken by FSW on 12 September 2005)

Inspection of the pipelines further to the north of the severely deformed area revealed a 50 mm wide tensile fracture of the existing asbestos water main and hairline cracks (1 mm to 2 mm wide) at the base of one of the concrete plinth supports to the ductile iron pipeline (Figure 5 and Plates 11 and 12). On 8 December 2005, an additional hairline fracture developed in the existing asbestos pipeline about 8 m away from the 50 mm tensile fracture (Figure 5). The pipeline was also broken at the southern boundary of the August 2005 landslide and at about 5 m to the south of the landslide.

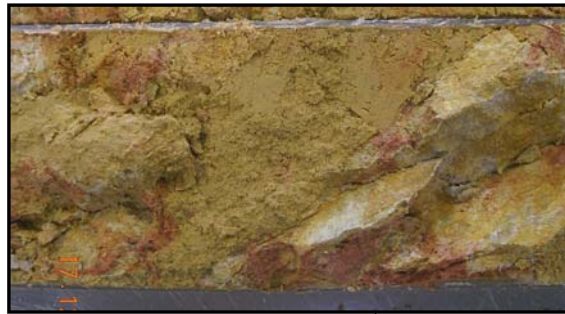
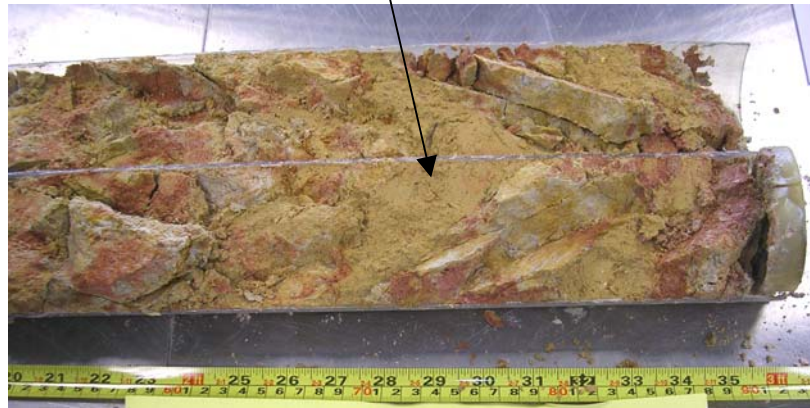
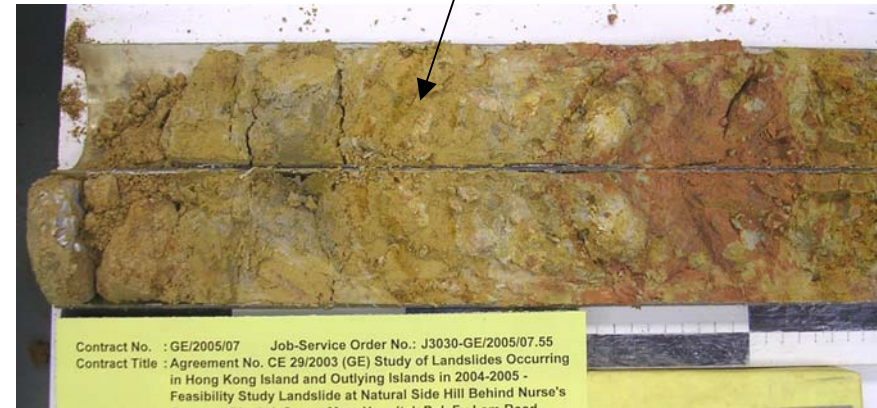
Plate 13 – View of Disturbed Zone in Drillhole BH2 at a Depth of 2.3 m to 2.8 m
(Photograph taken by FSW on 17 December 2005)

Yellowish brown,
slightly sandy silt infill
to fragmented Grade V
tuff – Disturbed zone

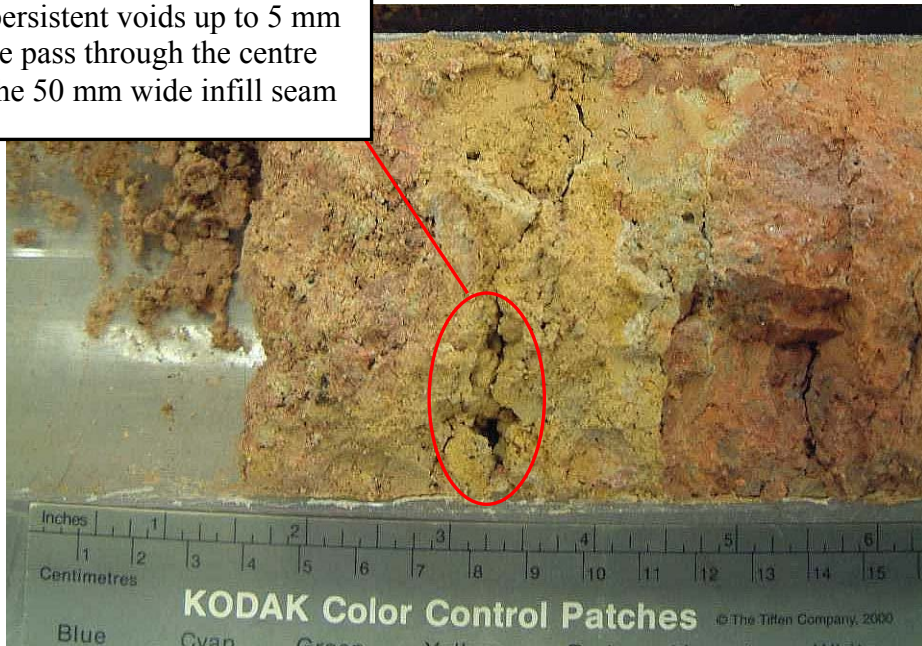
Plate 14 – View of 50 mm Infill Seam in Drillhole BH2 at a Depth of 3.7 m
(Photograph taken by FSW on 30 December 2005)

Impersistent voids up to 5 mm wide pass through the centre of the 50 mm wide infill seam

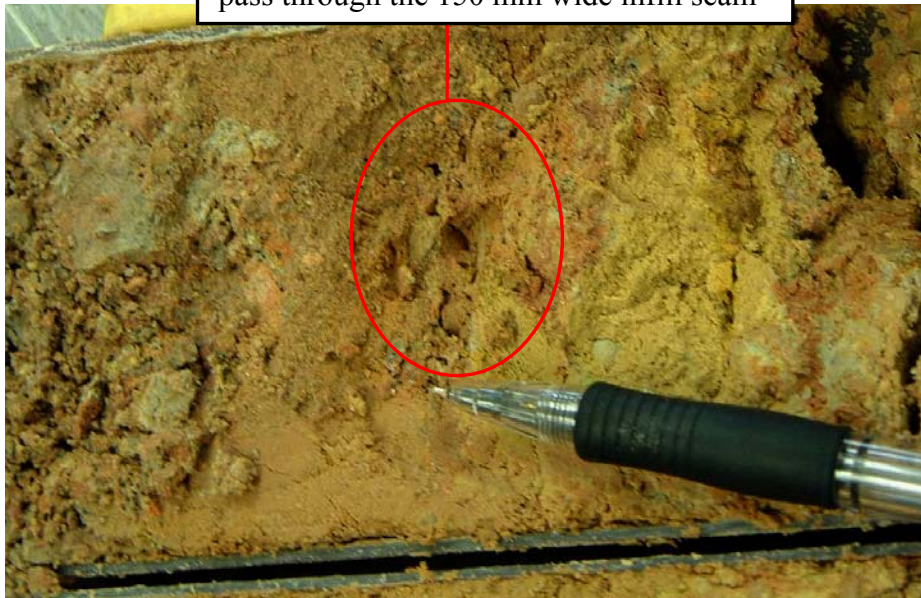
Plate 15 – View of 150 mm Infill Seam in Drillhole BH2 at a Depth of 5.9 m
(Photograph taken by FSW on 30 December 2005)

Impersistent voids 2 mm to 3 mm wide pass through the 150 mm wide infill seam

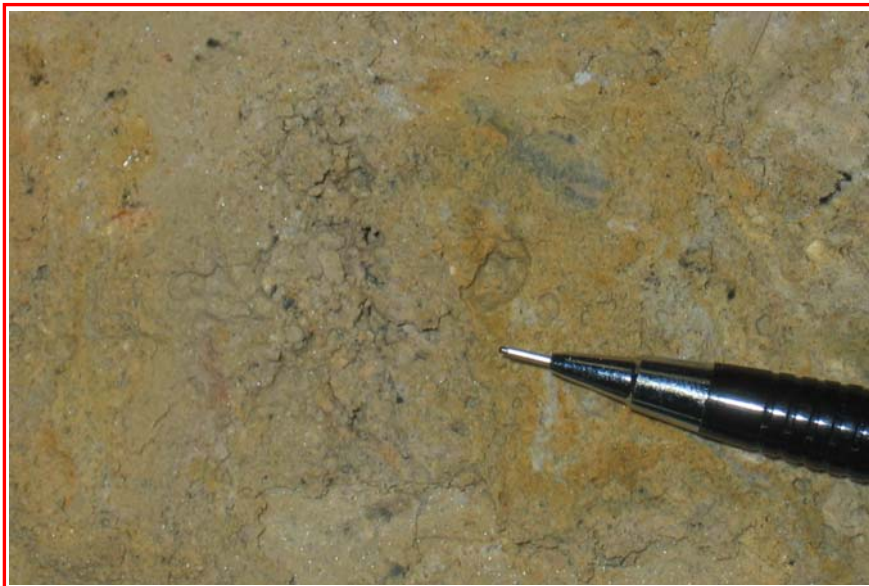
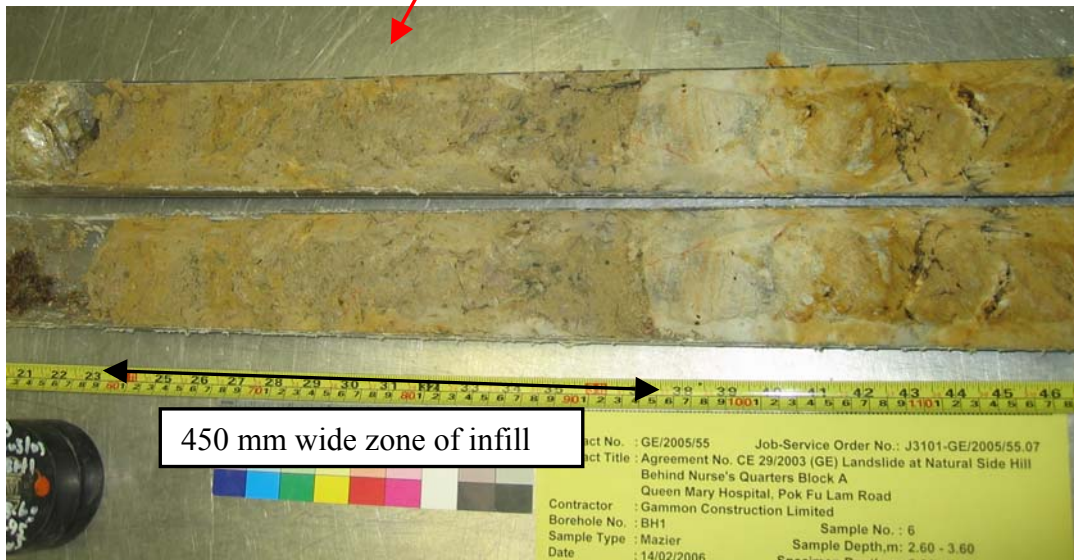
Plate 17 – View of Infill Material at Depth of 2.6 m in Drillhole BH1
(Photograph taken by FSW on 14 February 2006)

Grey and yellowish brown, slightly sandy silt infill with many small voids was present between a depth of 2.6 m and 3.1 m

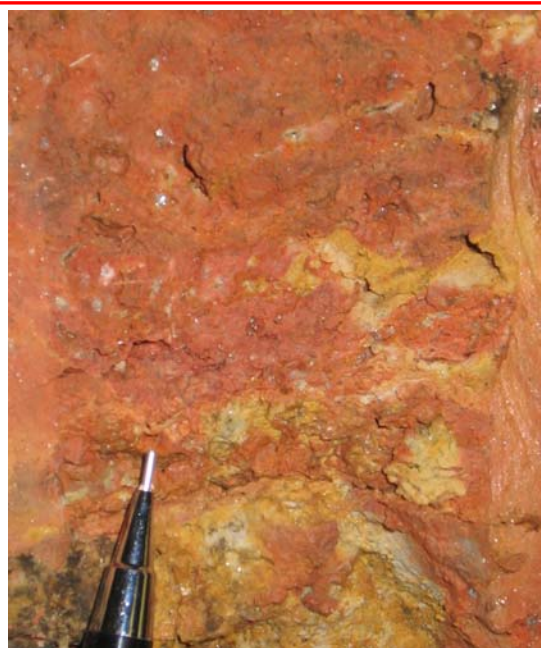
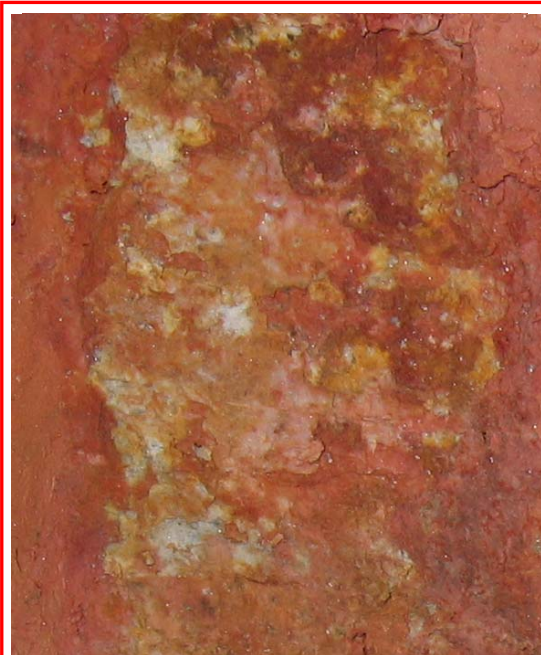
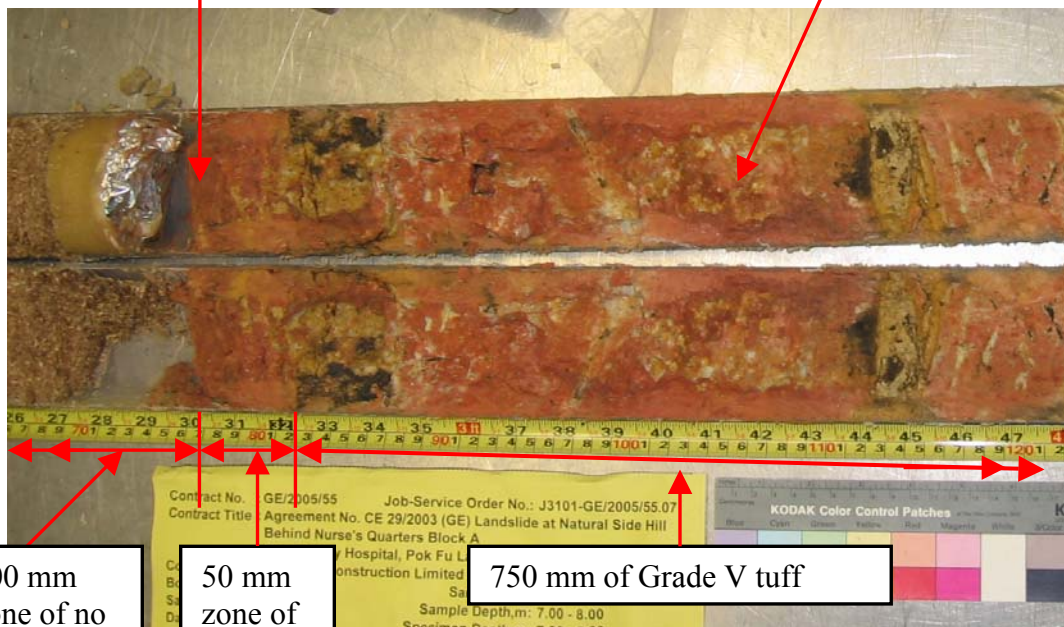
Plate 18 – View of Void and Infill Material at Depths of 7 m to 7.35 m in Drillhole BH1
(Photograph taken by FSW on 14 February 2006)

Infill material with many small voids was present at a depth of 7.3 m

No voiding was observed within intact Grade V tuff

300 mm
zone of no
recovery

50 mm
zone of
infill

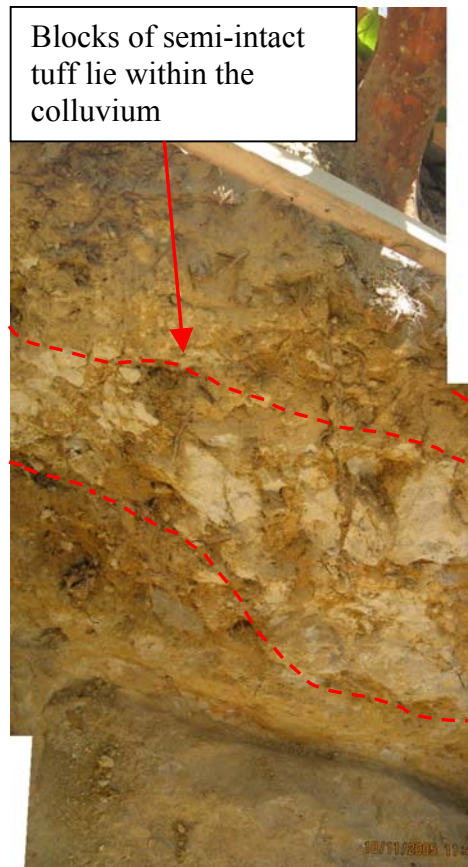
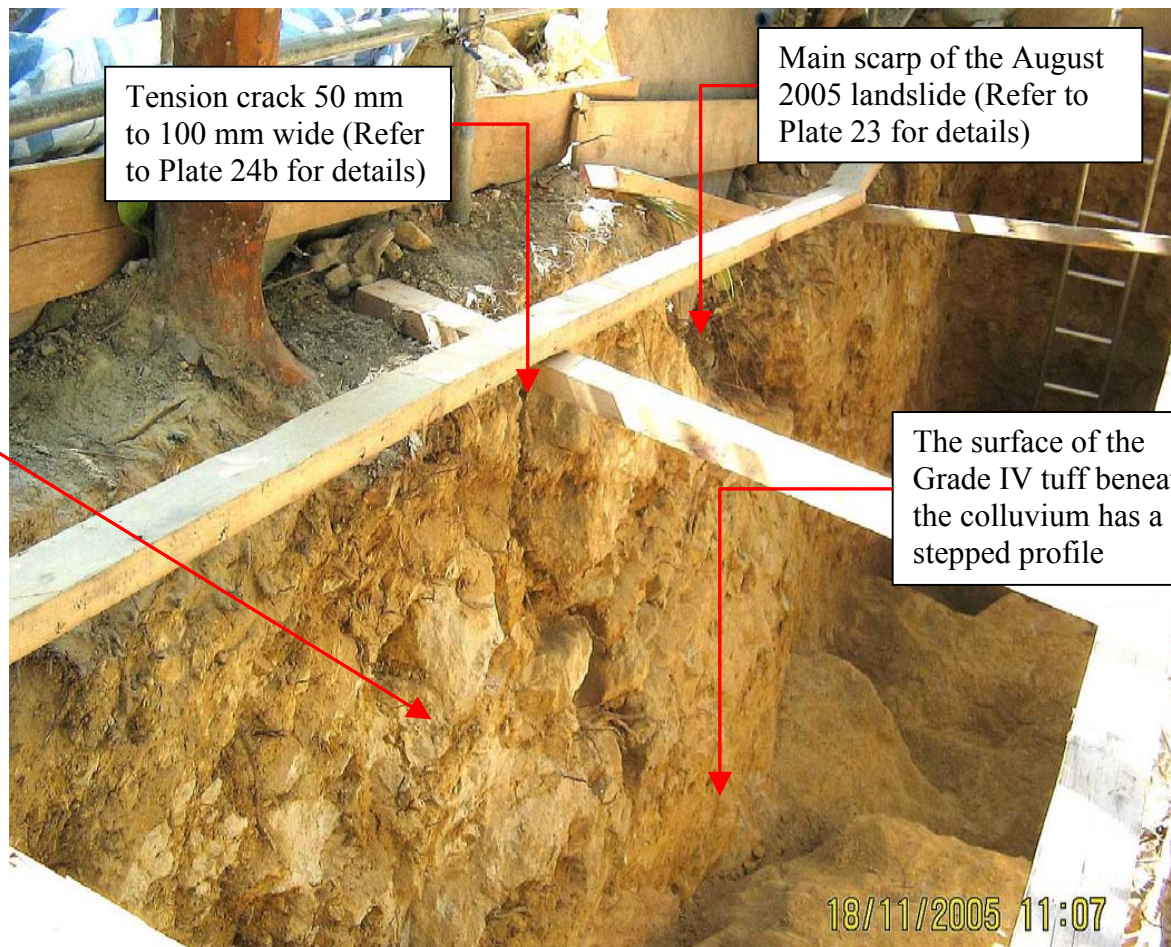
Plate 19 – View of Face B of Trial Trench TT1
(Photograph taken by FSW on 18 November 2005)

Trial trench TT1 positioned across the main scarp identified 1.5 m to 2.5 m thick colluvium overlying Grade IV tuff. The colluvium contained boulders and large, semi-intact blocks of Grades III/IV and IV/V tuff within a firm to stiff, yellowish and orangish brown, slightly sandy silt matrix (Figure 7 and Plate 19). The blocks of tuff within the finer colluvium matrix were very disturbed with open and infilled 2 mm to 15 mm-wide cracks.

Blocks of semi-intact tuff lie within the colluvium

Tension crack 50 mm to 100 mm wide (Refer to Plate 24b for details)

Main scarp of the August 2005 landslide (Refer to Plate 23 for details)

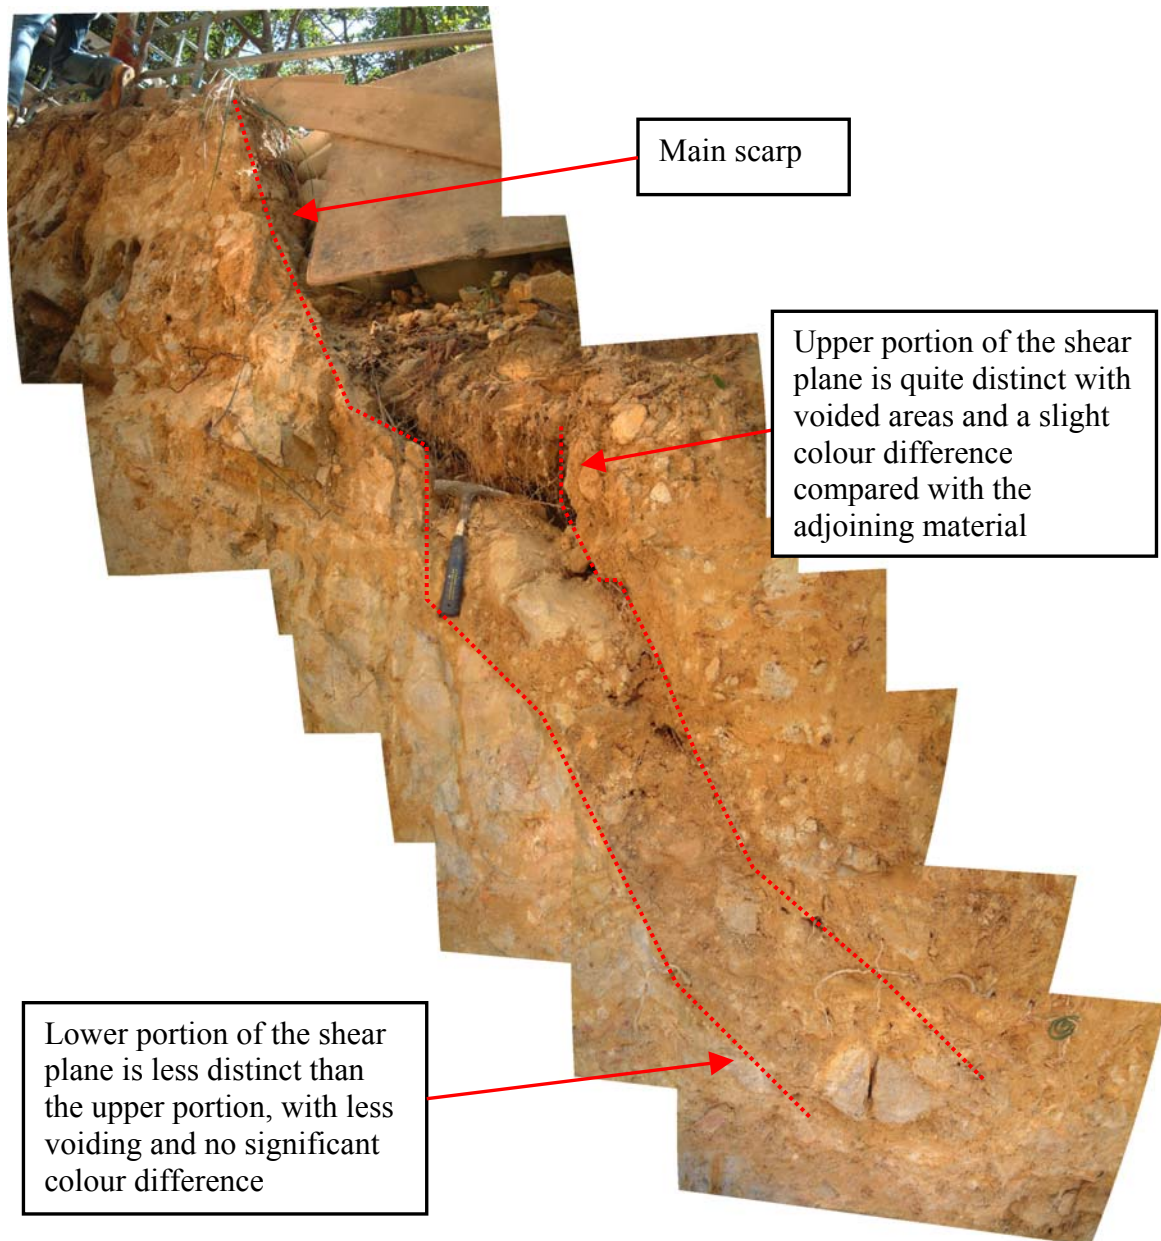
Plate 21 – View of Shear Plane Exposed in Face B of Trial Trench TT1
(Photograph taken by FSW on 18 November 2005)

A steeply inclined (60°), 300 mm wide shear plane was identified beneath the main scarp (Figure 7 and Plate 21). The shear plane consisted of brown, slightly sandy, silt with some sub-angular gravel and cobble fragments of Grade IV/V tuff. The material was loose in parts with some voids and had several roots passing through it that appeared to be aligned with the shear plane. The interface between the shear plane and the surrounding material was quite distinct in the upper portion, but became less distinct with depth and could not be identified reliably beyond a length of about 2 m (Plate 21). A steeply inclined 1 m drop in the Grade IV tuff was approximately coincidental with the main scarp and appeared to have influenced the location of the main scarp (Figure 7).

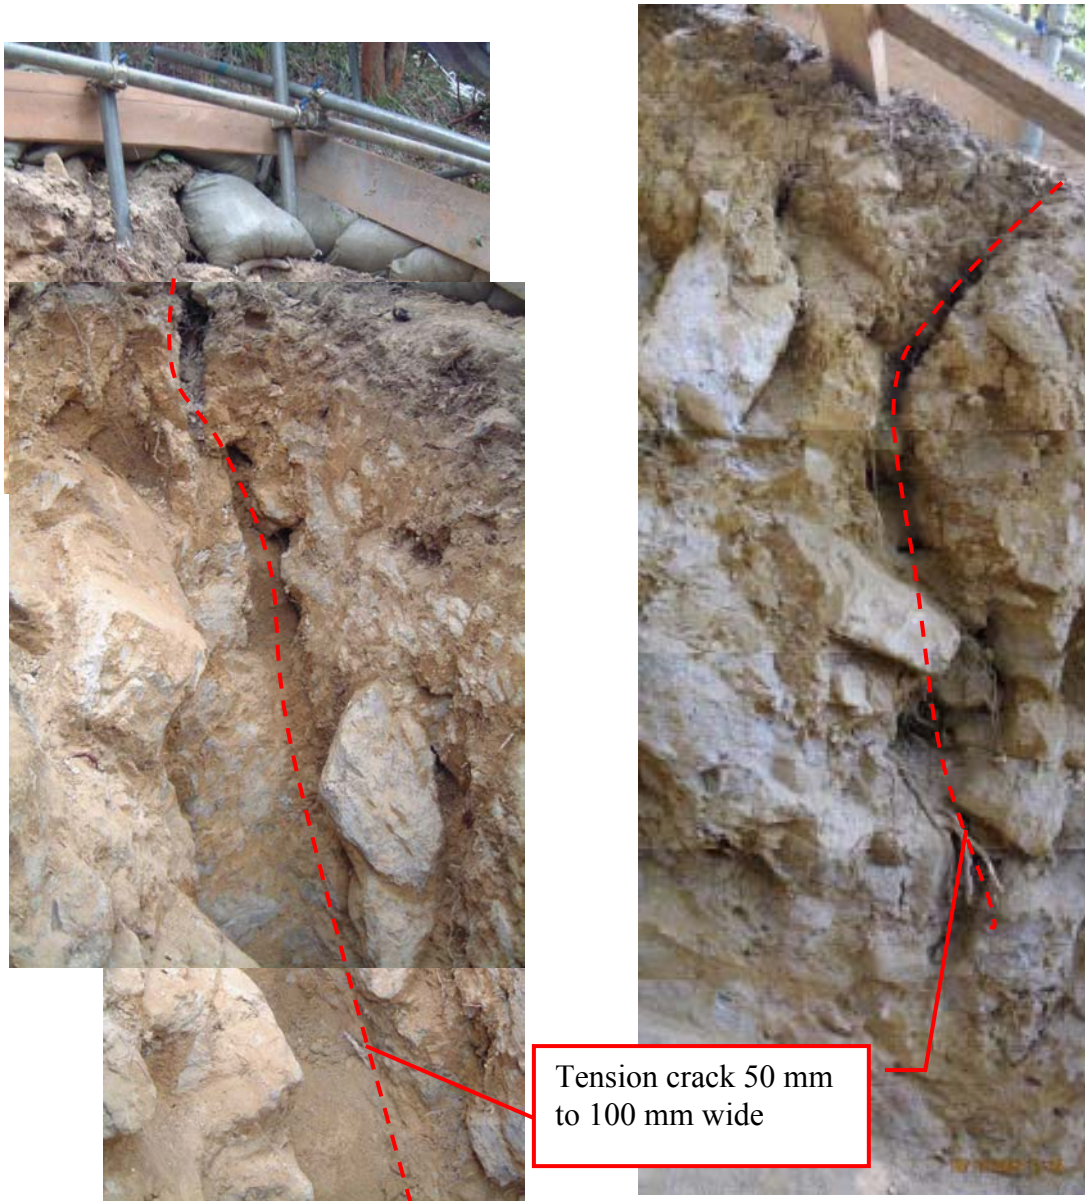
Plate 22 – View of Tension Cracks in Trial Trench TT1
(Photograph taken by FSW on 1 November 2005)

Two tension cracks (50 mm to 100 mm wide) were identified above the main scarp in Face B of the trial trench (Figure 7 and Plate 22), which converged into one larger tension crack (300 mm wide) in Face D of the trial trench.

a) Tension crack, 50 mm to 100 mm wide
at the upslope corner of trial trench TT1
between Face A and Face B

b) Tension crack, 50 mm to 100 mm wide,
in Face B of trial trench TT1 about 1 m
upslope of the main scarp

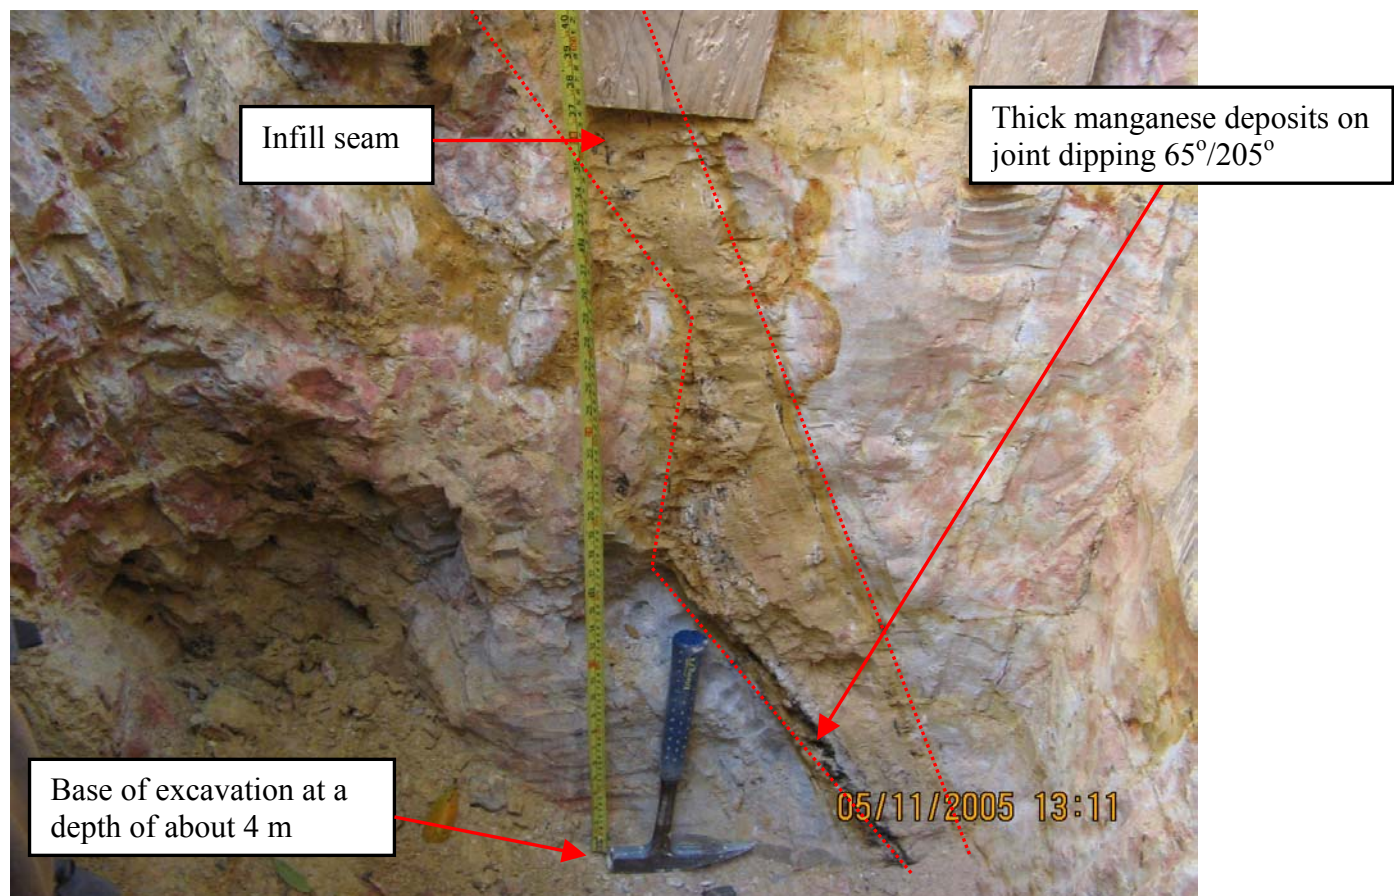
Plate 27 – Close-up of Infill Seam at the Base of Trial Trench TT6, Face B
(Photograph taken by FSW on 5 November 2005)

Infill seam at the
base of Face B
(refer to Plate 27)

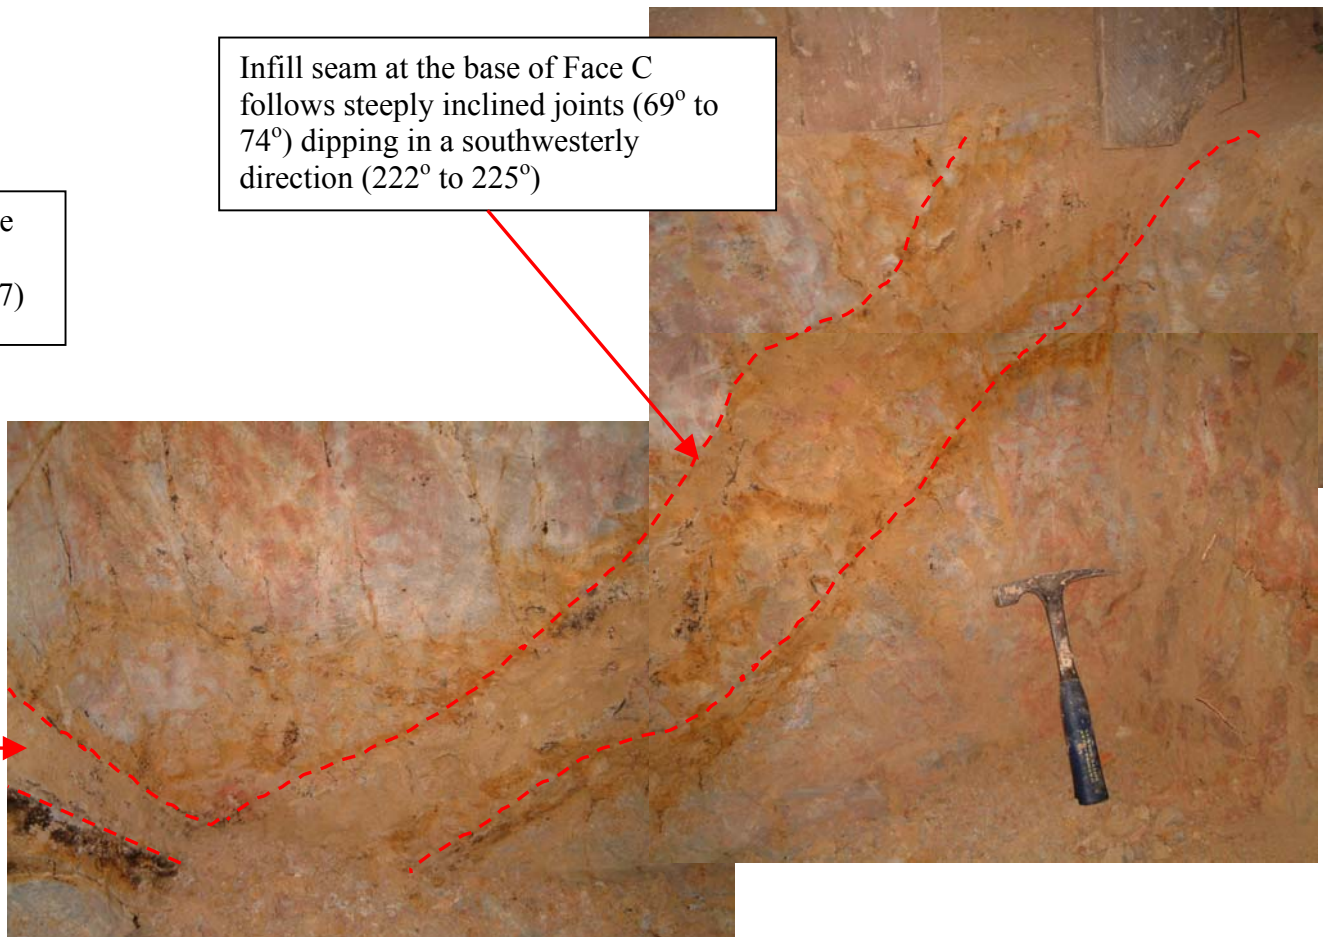
Plate 28 – View of the Infill Seam at the Base of Trial Trench TT6, Face C
(Photograph taken by FSW on 16 November 2005)

Infill seam at the base of Face C
follows steeply inclined joints (69° to
 74°) dipping in a southwesterly
direction (222° to 225°)

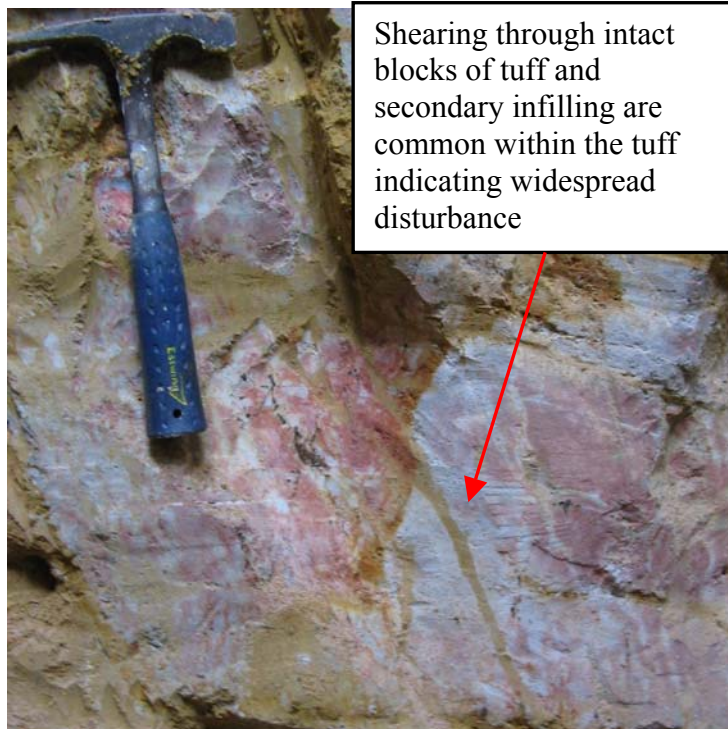
Plate 30 – View of Localised Shearing Through a Block of Tuff
(Photograph taken on 16 November 2005)

In addition to the primary zones of joint infill, evidence of secondary shearing and joint infill to smaller blocks of tuff were observed, which indicates the overall disturbed nature of the tuff (Plates 30 and 31).
