**REVIEW OF THE  
4 MAY 2007 ROCKFALL INCIDENT  
ON SLOPE NO. 11NE-C/C62  
AT HONG NING ROAD  
KWUN TONG**

**GEO REPORT No. 246**

**Halcrow China Limited**

**GEOTECHNICAL ENGINEERING OFFICE  
CIVIL ENGINEERING AND DEVELOPMENT DEPARTMENT  
THE GOVERNMENT OF THE HONG KONG  
SPECIAL ADMINISTRATIVE REGION**

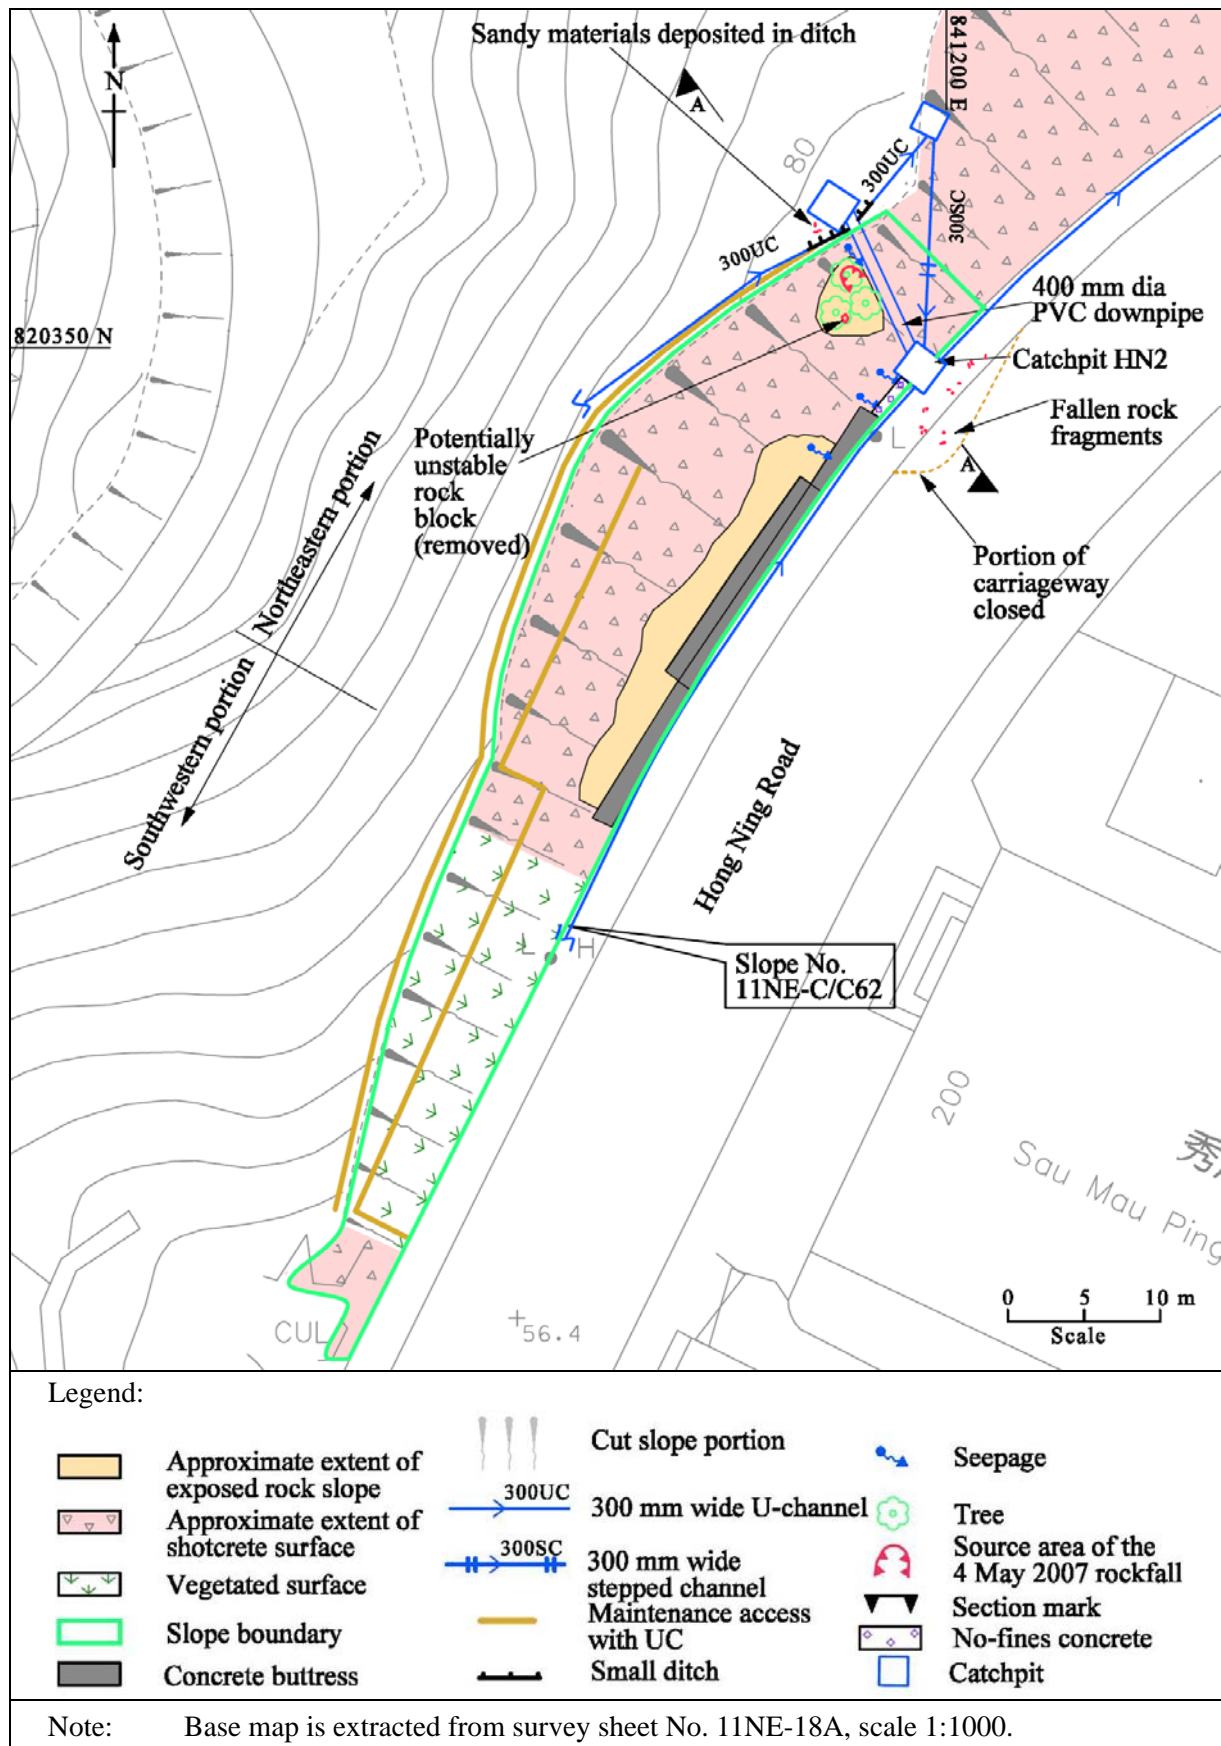
Figure 6 - Site Observations in the Vicinity of the 4 May 2007 Rockfall Location

identified at the scar (Plate 8). On these release planes, black and dark reddish brown stains were observed, which were possibly manganese and iron oxides (Plate 9). Such staining is indicative of water migration, weathering and possible opening of the rock joints prior to the detachment of the rock block in the 2007 incident. Tree roots of up to about 8 mm diameter were also observed on the side-release joint plane dipping at about  $68^{\circ}/037^{\circ}$  (Plate 9). A growth of moss on the shotcrete and rock surface was observed near the rockfall source. During the inspection on 12 June 2007, minor water seepage was noted at the bare rock/shotcrete interface at about 1 m to the northeast of the 2007 rockfall source area (Figure 8).

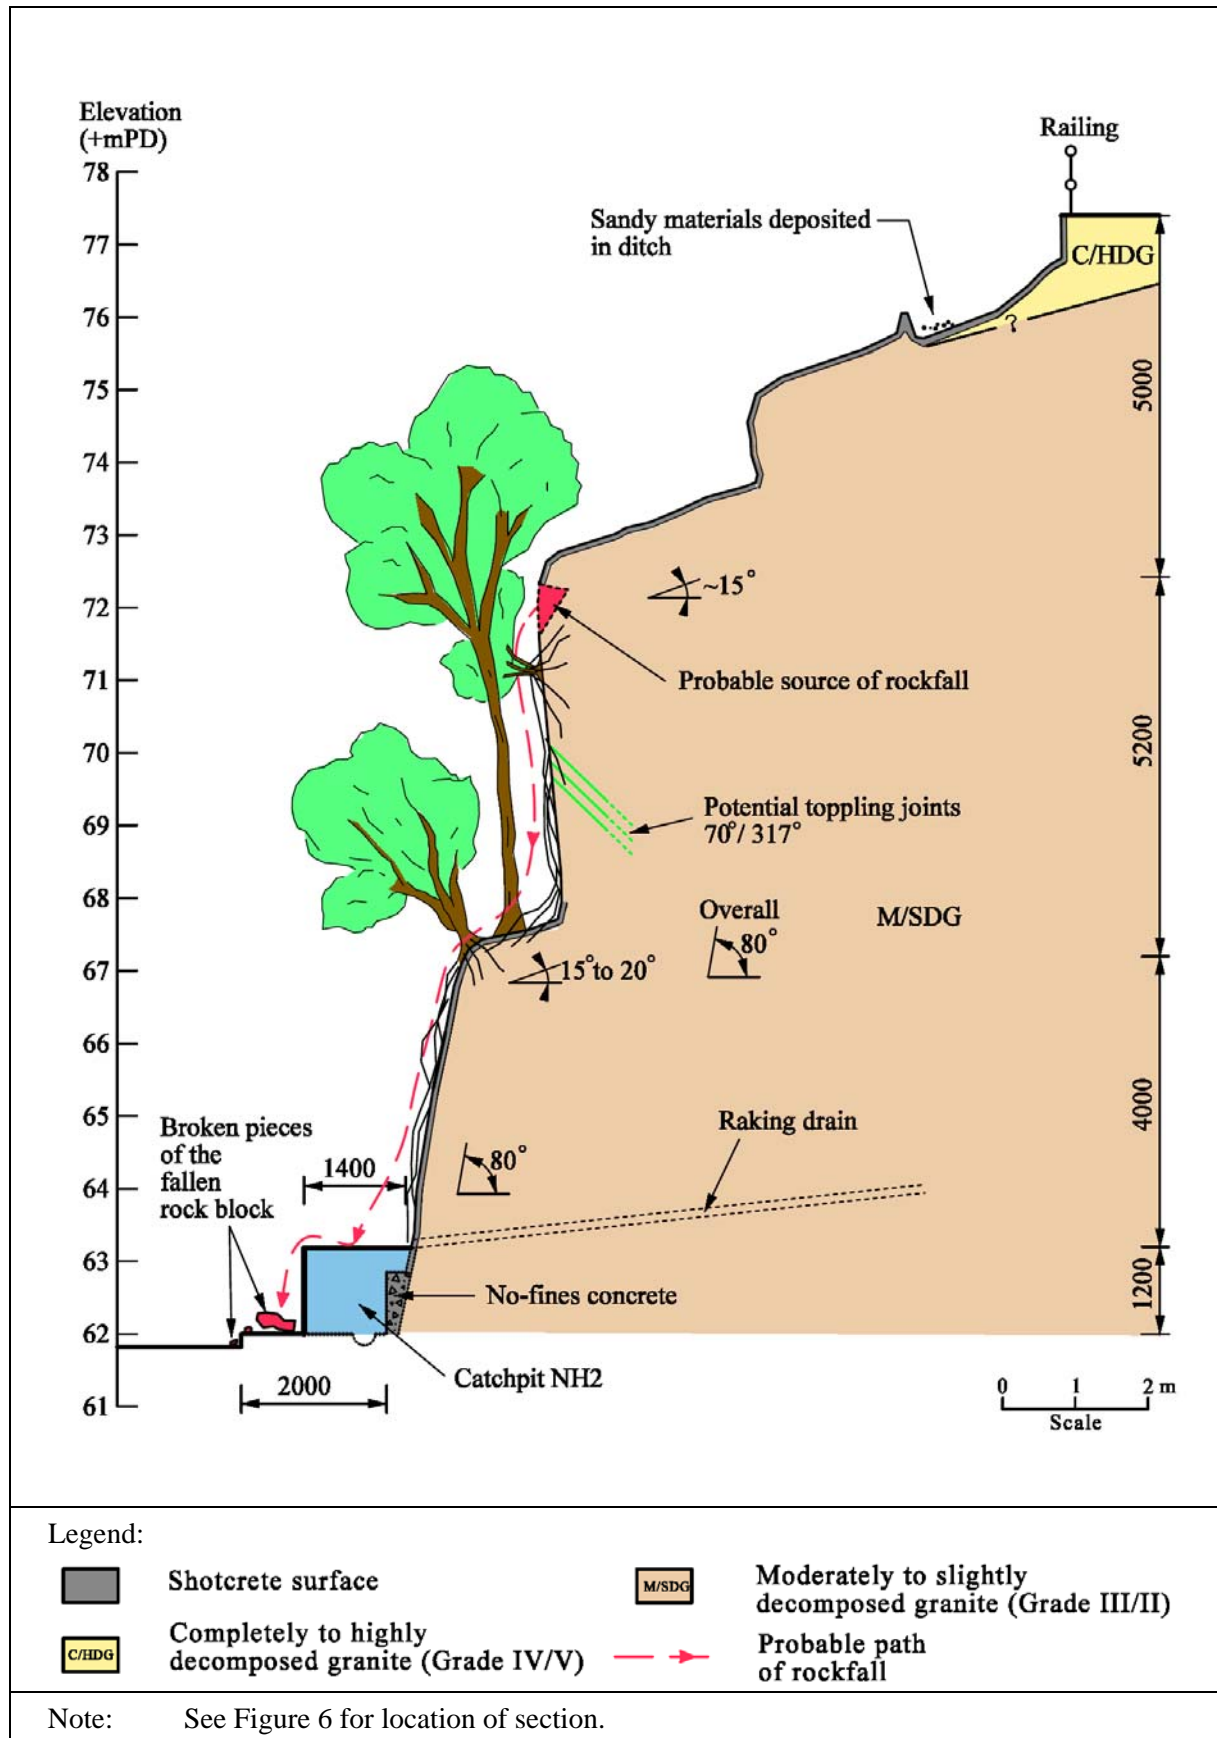
Figure 7 - Section A-A through the 4 May 2007 Rockfall Location

About 1 m below the rockfall source area, a tree with a main trunk of about 100 mm in diameter was growing on the bare rock surface (Figures 7 & 8 and Plate 10), with its roots covering much of the rock surface. Some scratch marks were observed on the tree roots (Plate 10), indicating the probable path of the rockfall. There were also scratch marks observed on the concrete covers and steel grating of Catchpit HN2 at the slope toe, below the rockfall source area (Plate 11). Two of the bars of the steel grating were observed to be severely deformed and rock fragments were found both on the grating and inside Catchpit HN2 during the inspection on 8 May 2007. The scratch marks on Catchpit HN2 suggest that it was probably the landing point of the detached rock block (Figure 8 and Plate 2).

At about 2 m below the rockfall source area, sub-vertical joint sets dipping at about  $80^{\circ}/110^{\circ}$  were observed on the bare rock face (Figure 7 and Plate 12). Some of the rock joints were found to have been jacked open (10 mm maximum) by tree roots, and a potentially unstable rock block (about 500 mm by 200 mm by 20 mm in size) was found to have detached from the rock surface (Plate 12). Another unstable rock block (about 300 mm by 200 mm by 20 mm in size) was also hanging on a tree root of about 5 mm in diameter, just below the detached rock block. These unstable rock blocks were subsequently removed and the rock face was covered with rock mesh netting by the HyD upon the advice of the GEO.

At about 4 m below the rockfall source area, a relatively flat area (dipping at about  $15^{\circ}$  to  $20^{\circ}$ ) was observed (Figure 7). This area was covered with 'old shotcrete' which appeared to be different in colour, as compared to the reinforced sprayed shotcrete applied as part of the LPM works in 1999. The uneven surface of this 'old shotcrete' indicated that wire mesh reinforcement was unlikely to have been incorporated. Two trees were growing on this flat area with their roots covering the slope surface in the vicinity. A crack (about 300 mm long by 3 mm wide) was noted in the shotcrete surface (Plate 12).

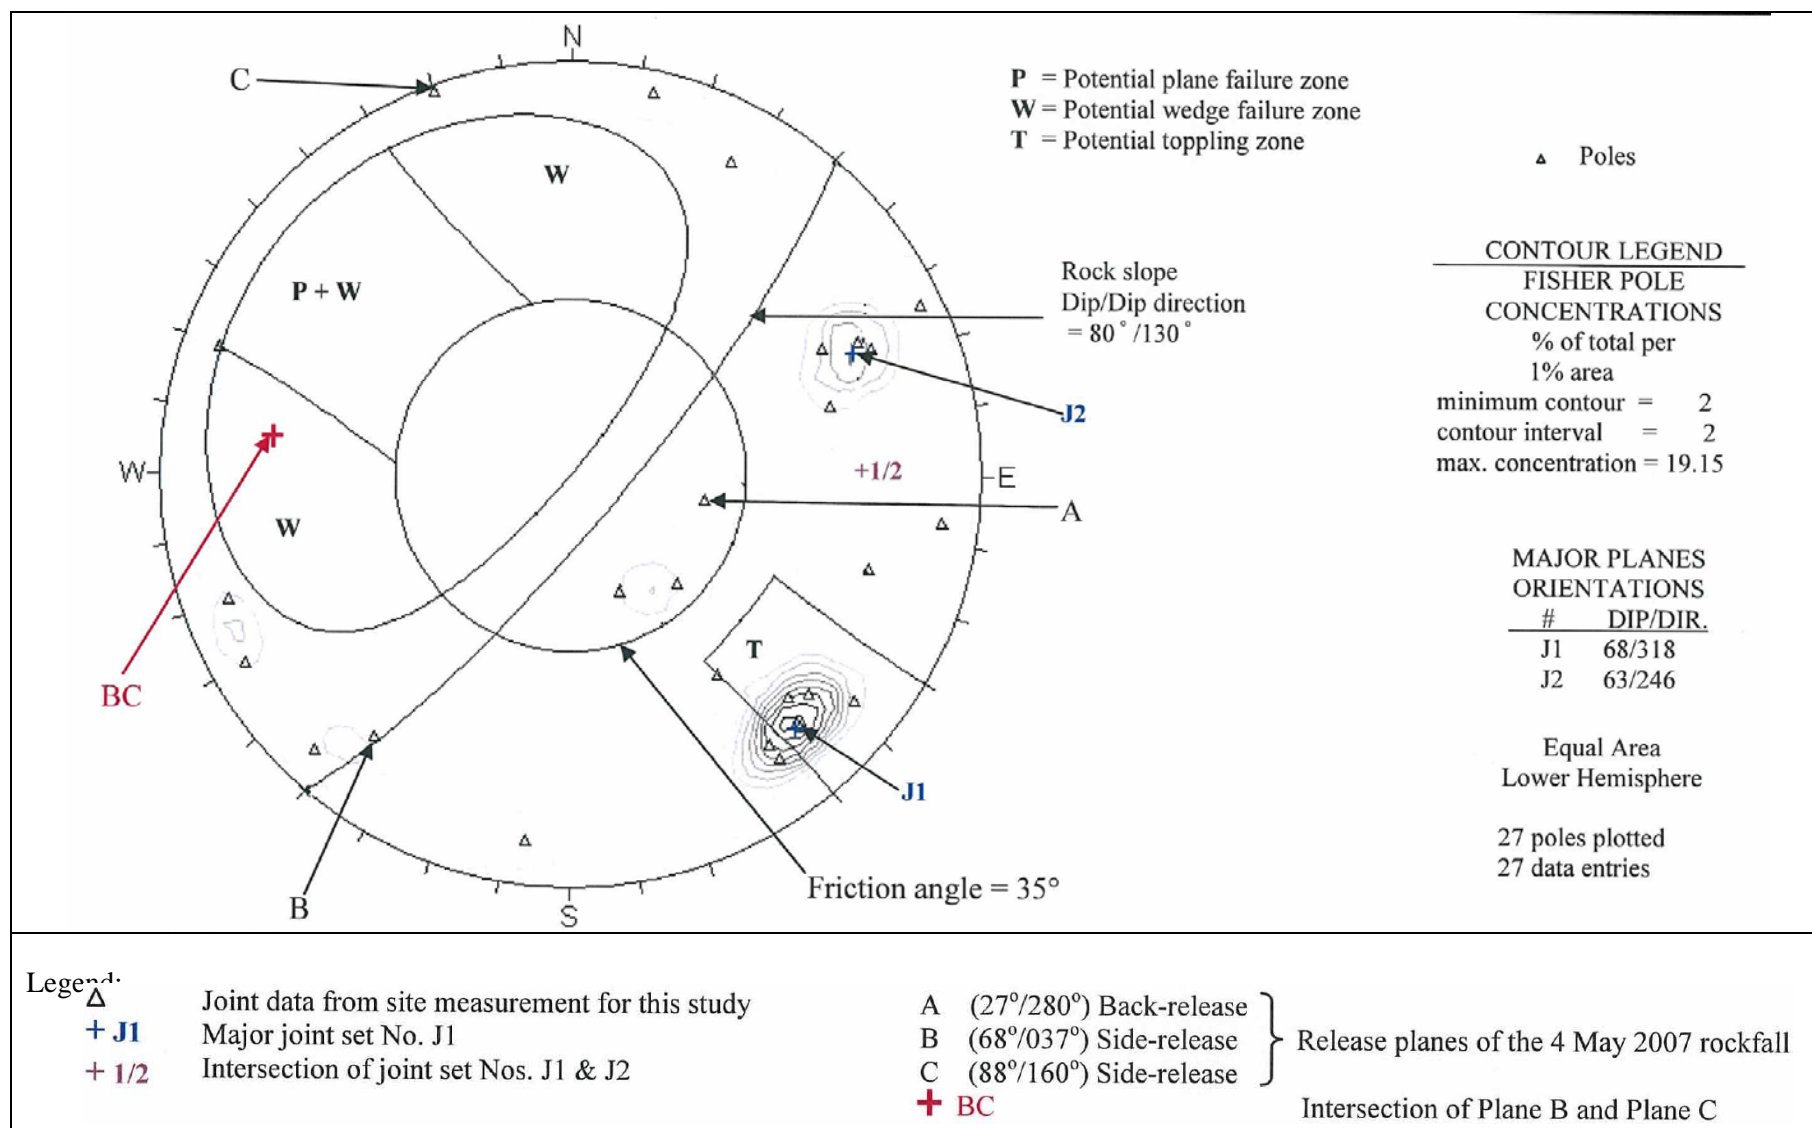
Figure 9 - Kinematic Analysis of Joint Orientations near the May 2007 Rockfall Location

the rockfall source area, are presented in a stereoplot (Figure 9). According to the stereoplot, the intersection of the two side-release planes (B and C) is kinematically unstable with respect to the rock slope face dipping at  $80^{\circ}/130^{\circ}$ , and potential wedge failure is indicated.

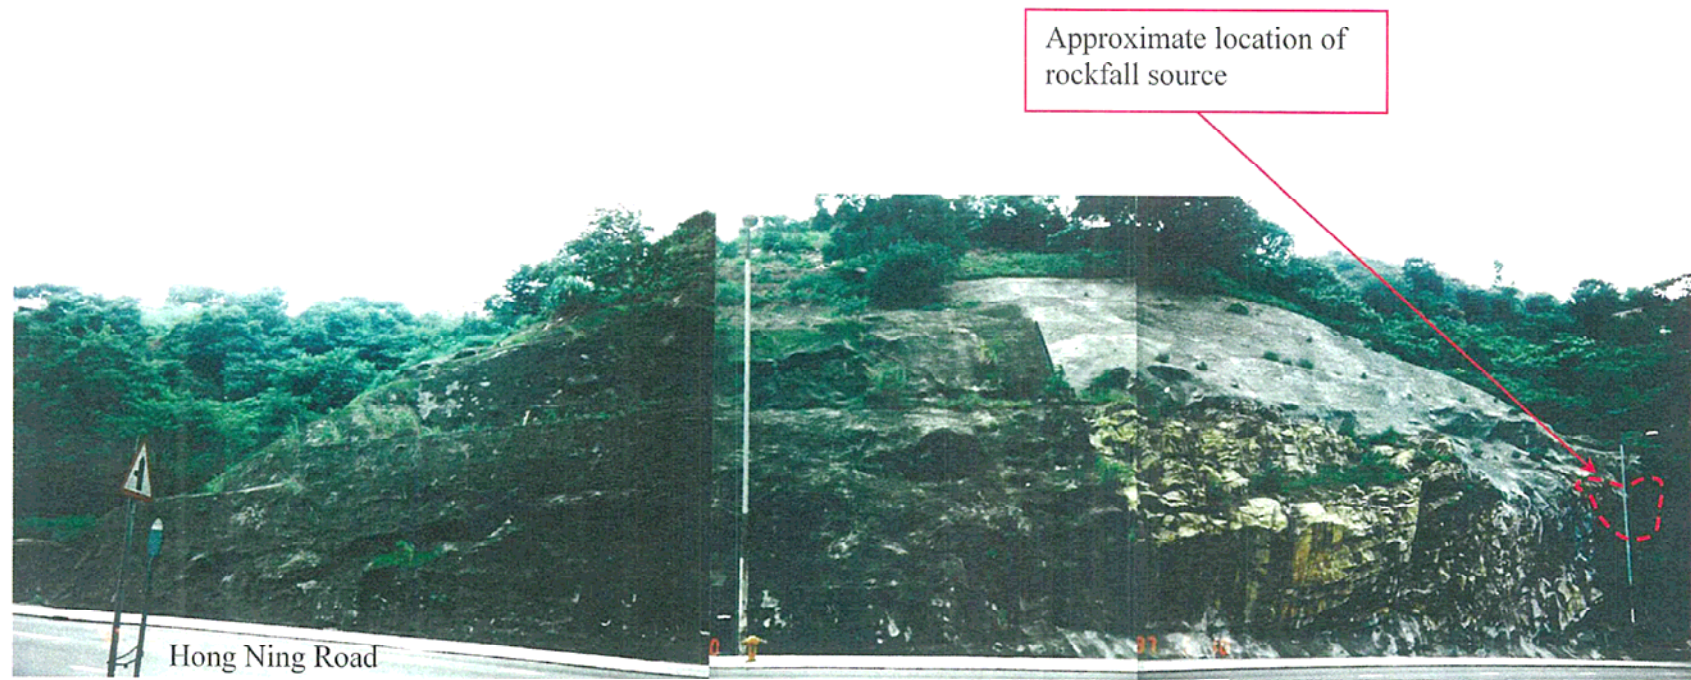
The subject slope was selected for upgrading under the LPM Programme as indicated in the 1997 RMI record, and therefore no maintenance works were recommended. A record photograph of the RMI (Plate 5) shows a general view of the subject slope in 1997, from which little change can be observed other than a general increase in vegetation density at the slope.

Plate 5 - General View of Slope No. 11NE-C/C62 in 1997 (Photograph taken on 10 May 1997)

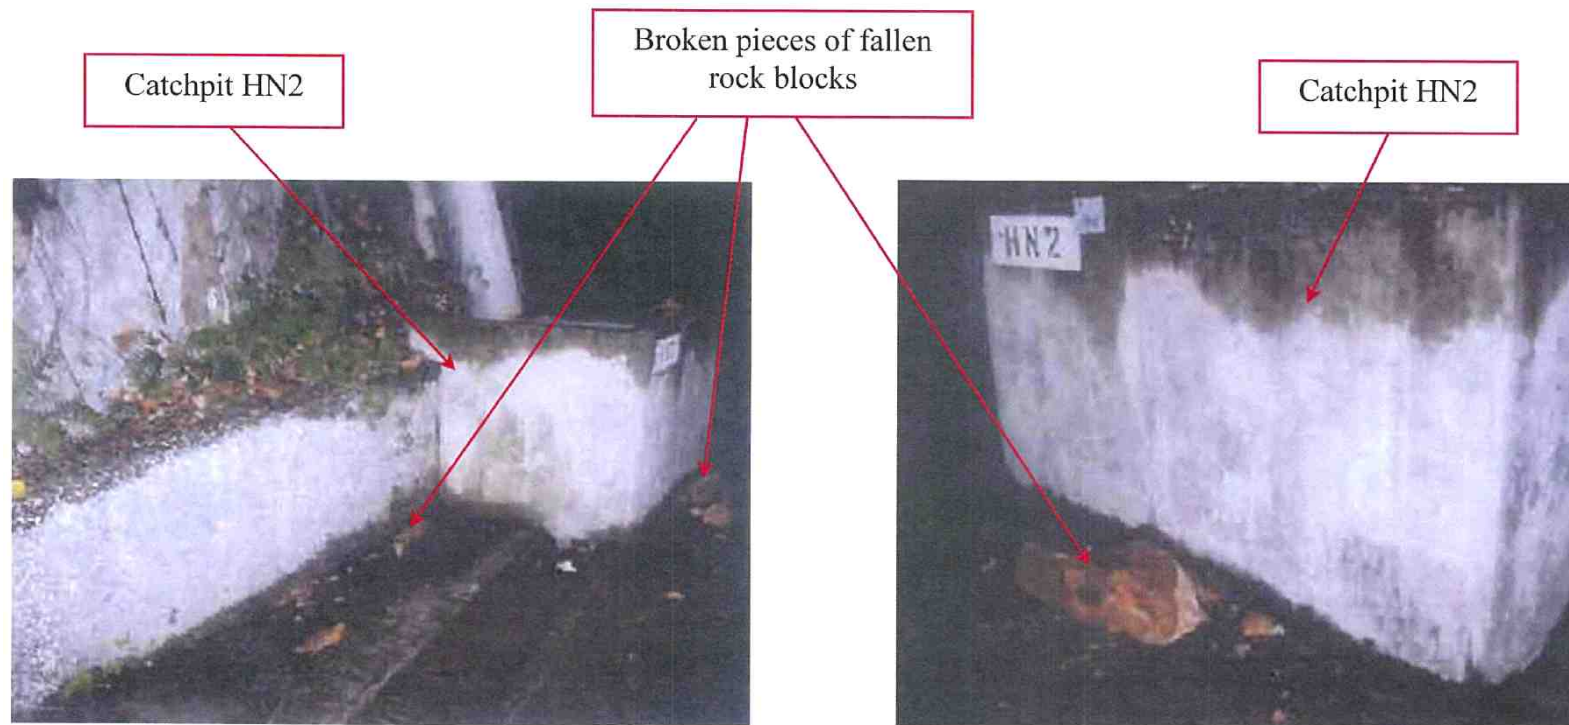
Plate 7 - Broken Pieces of Fallen Rock Block Deposited on Pedestrian Pavement  
(Photograph taken on 4 May 2007, extracted from incident report No. 2007/5/0008)

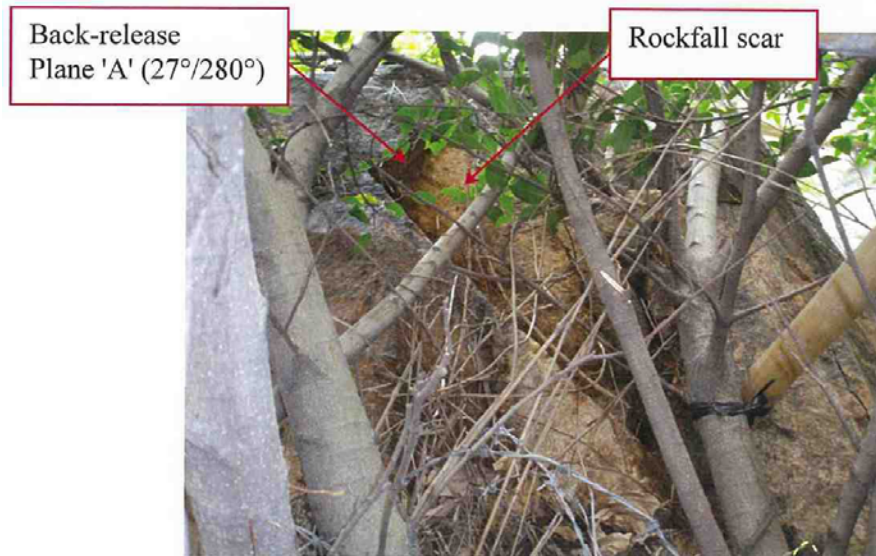
HCL subsequently made several visits to the rockfall site between 25 May and 12 June 2007. The source area of the rockfall was observed to be on a rock slope face generally dipping at about 80°/130° and comprising strong to moderately strong, pinkish grey, slightly to moderately decomposed, fine- to medium-grained granite, with generally closely to medium spaced joints (Plate 8). Two side-release joint planes (dipping at about 68°/037° and 88°/160° respectively) and a back-release joint plane (dipping at about 27°/280°) were

Plate 8 - General View of Rockfall Source Location (Photograph taken on 12 June 2007)

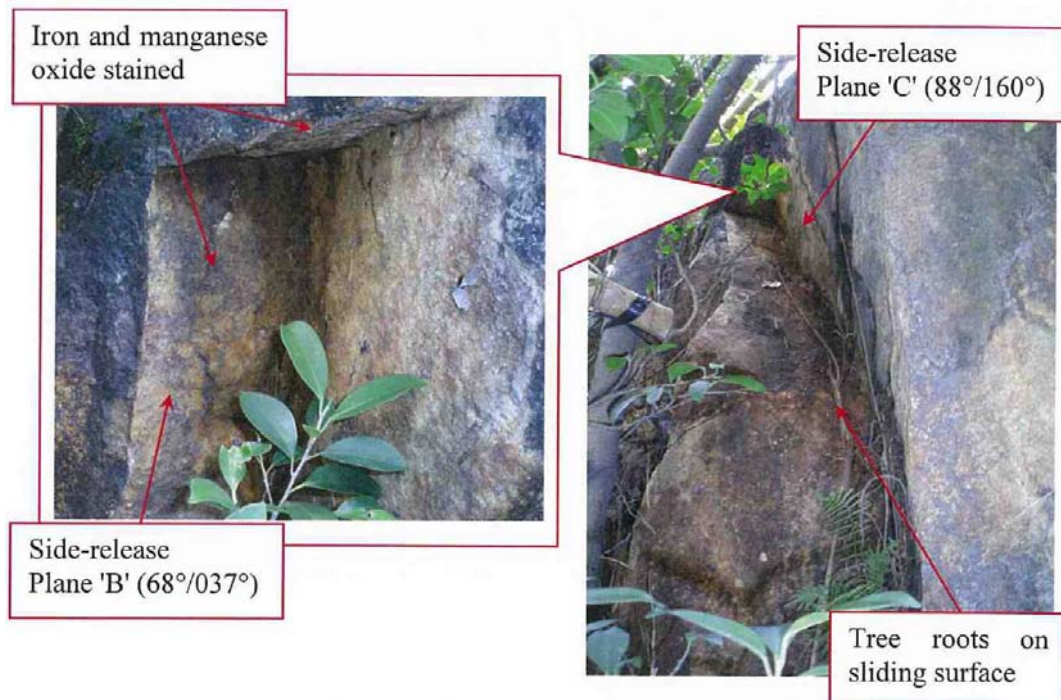
Plate 9 - Close-up View of Rockfall Source (Photograph taken on 12 June 2007)

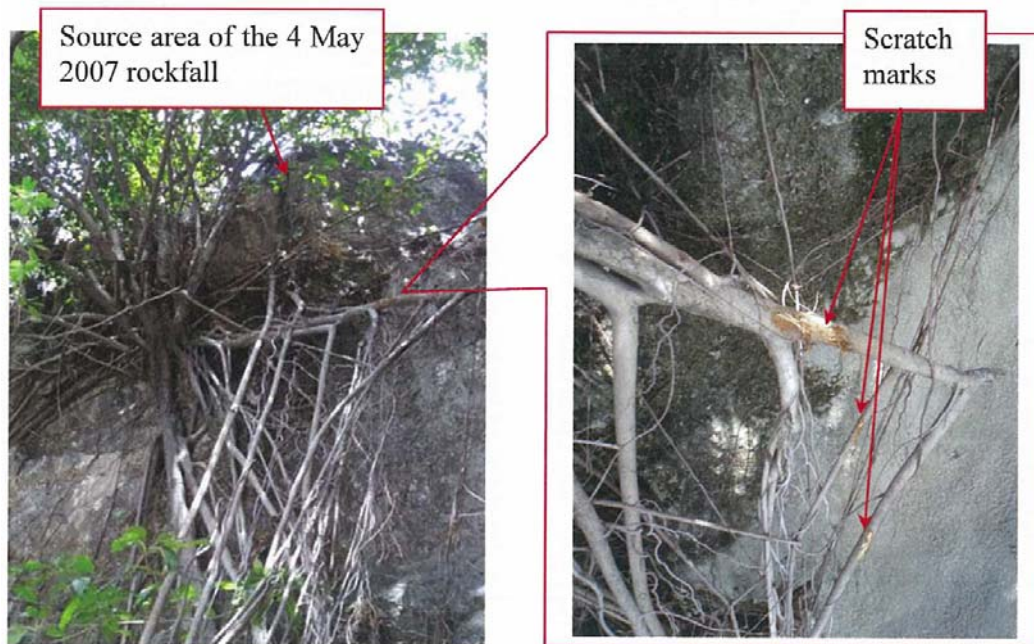
Plate 10 - Scratch Marks on Tree Roots below Rockfall Source Area  
(Photograph taken on 25 May 2007)

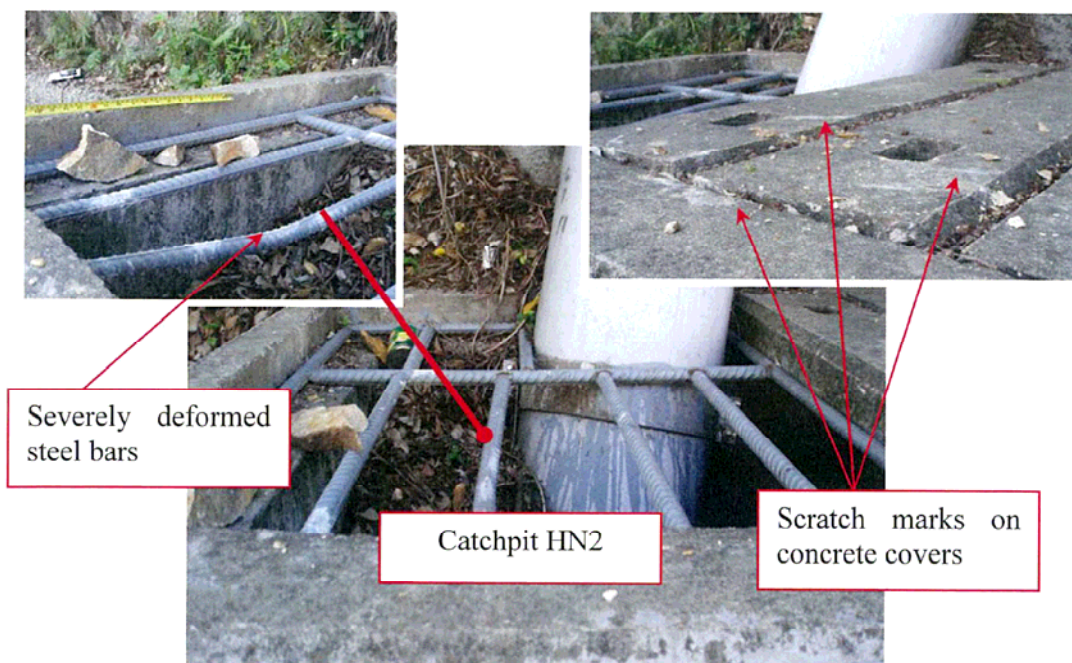
Plate 11 - Deformed Steel Bars and Scratch Marks at Catchpit HN2 below Rockfall Source  
(Photograph taken on 8 May 2007)

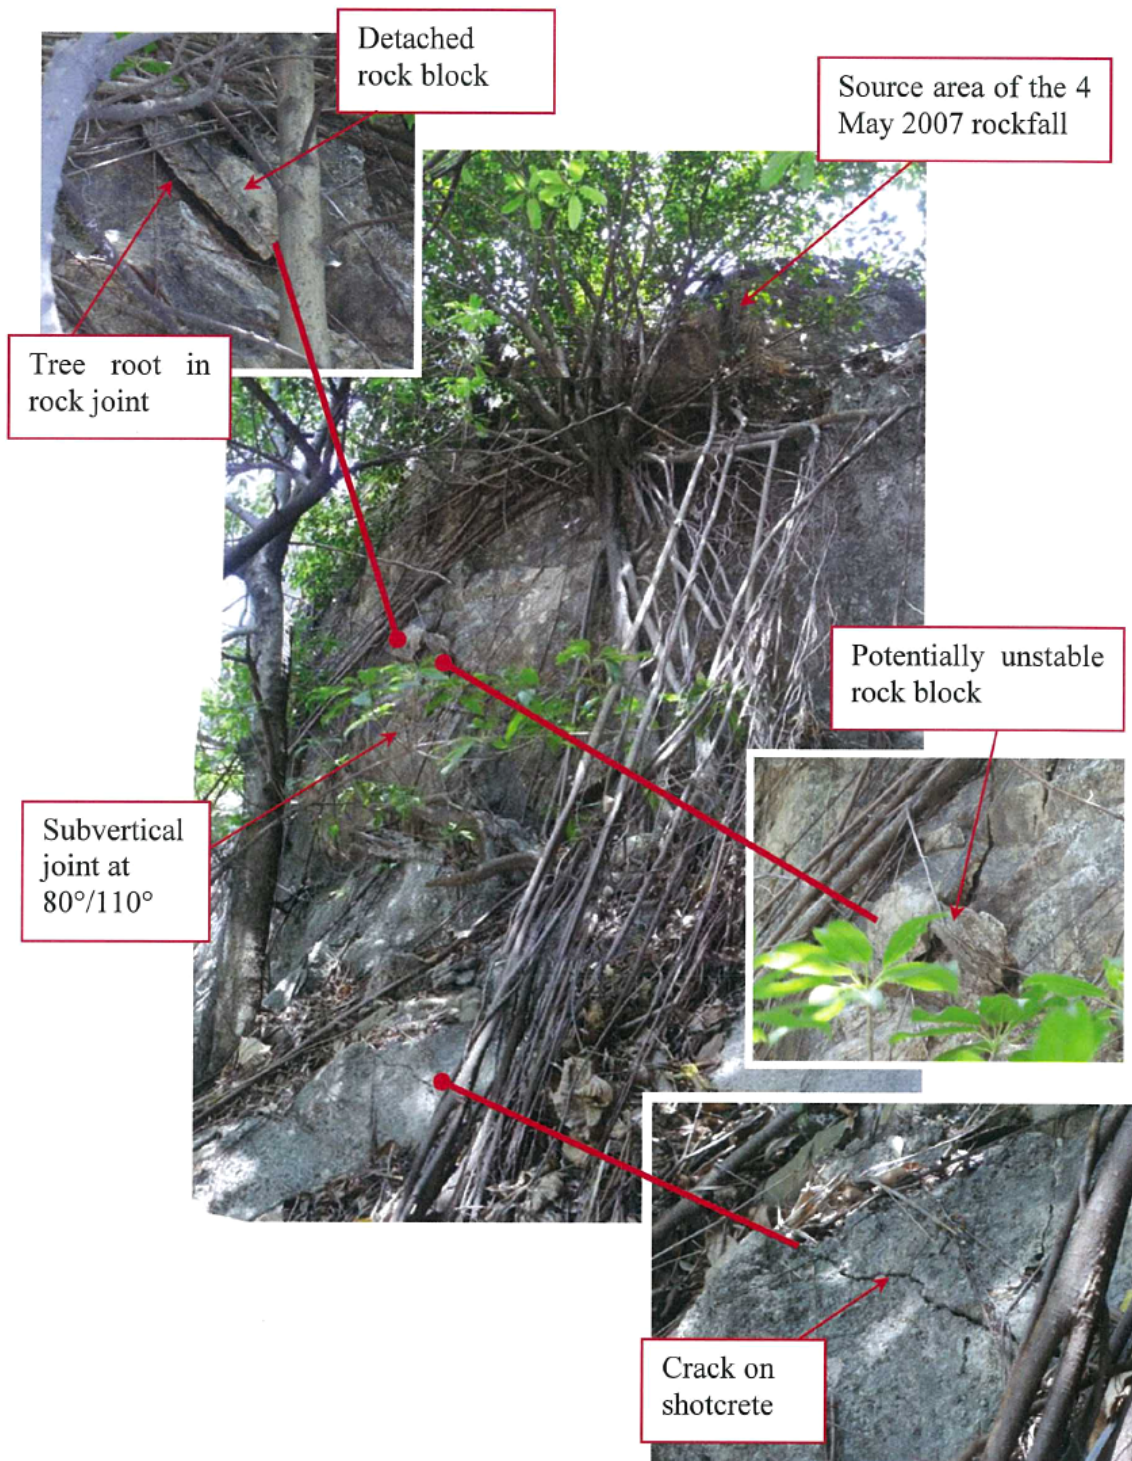
At the 2007 rockfall source area, much of the bare rock surface was covered with tree roots (Plate 12). Post-failure inspections indicated that the growing of these tree roots on the rock surface may have caused the rock mass to deteriorate progressively by way of joint dilation and fracture. Two small rock blocks were identified to have separated from the rock mass (Plate 12), and this appeared to be the result of the wedging action of the tree roots on the rock joints. At the rockfall source area, a small tree root of about 8 mm in diameter was present on the release plane (Plate 9). The effect of this tree root on the joint dilation leading to the 2007 rockfall was not certain, but it appeared to be one of the contributory factors for this particular minor rockfall incident. It is worth noting that the joint dilation and fracture of the rock mass can be exacerbated by unplanned vegetation, whereby failure can be triggered by relatively light rainfall, as the rock mass suffers progressive deterioration. In this particular incident, the rockfall from a height of 10 m could be hazardous to the public, although the detached rock block itself was small in size.

Plate 12 - Potentially Unstable Rock Blocks below Rockfall Source  
(Photograph taken on 9 May 2007)

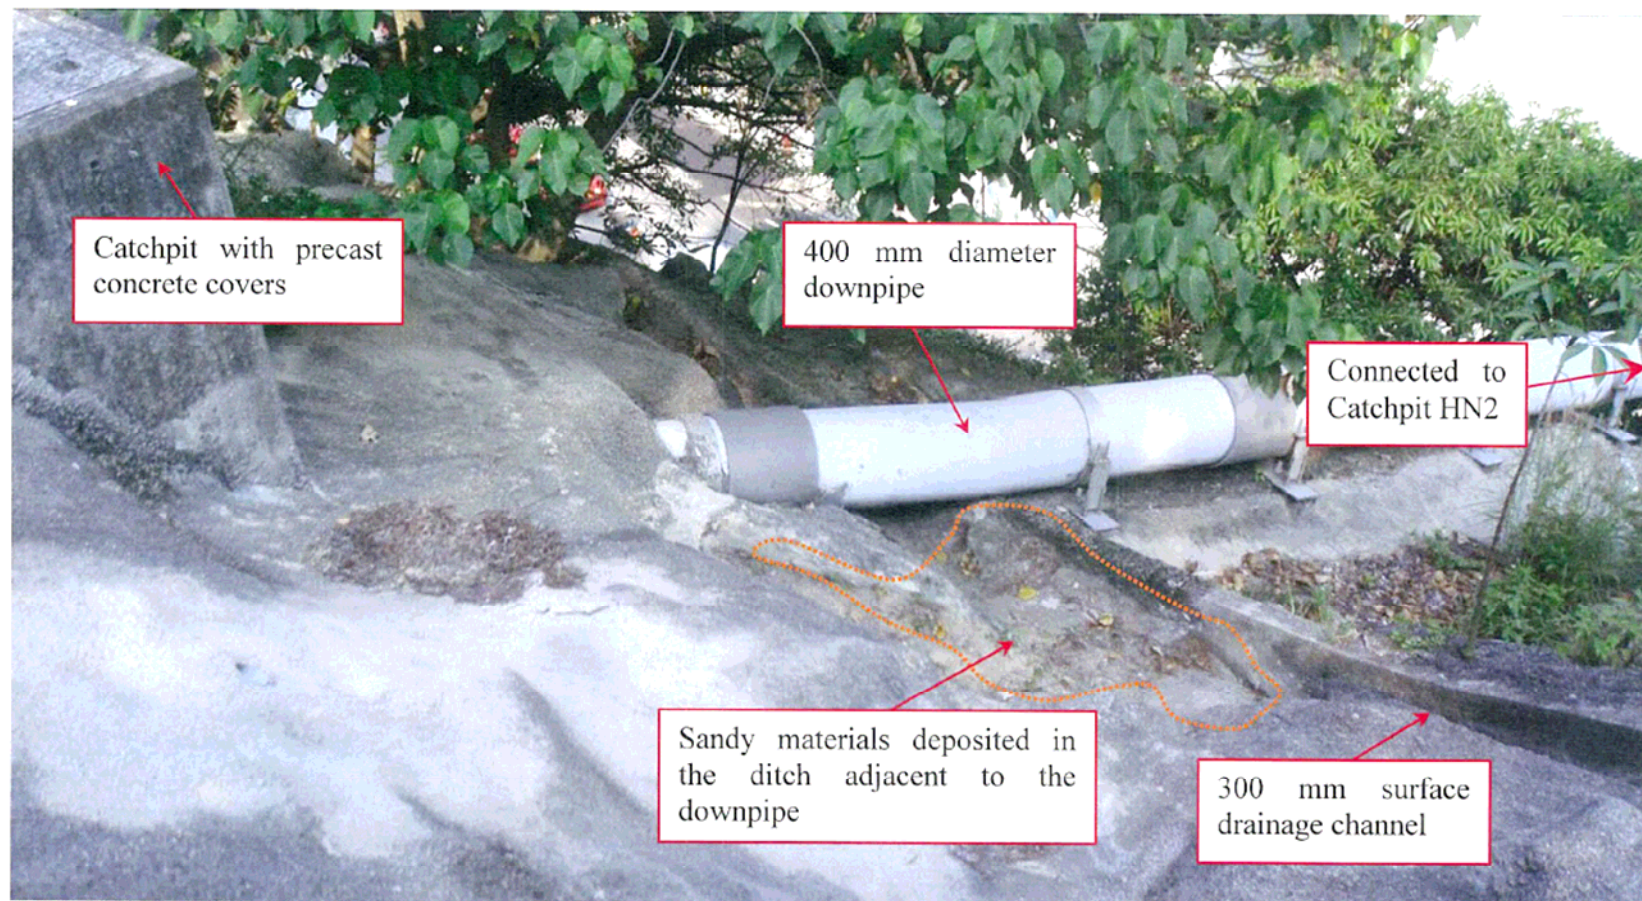
At the crest of the subject slope just above the rockfall source area, a ditch of about 300 mm in width was identified. Sandy materials were observed to have been deposited in the ditch during the inspection on 8 May 2007 (Plate 13).

Plate 13 - Surface Drainage Channel above Rockfall Source (Photograph taken on 8 May 2007)
