**REVIEW OF THE
20 AUGUST 2005 LANDSLIDE
ON SLOPE NO. 15NE-A/C152
AT MA HANG PRISON,
STANLEY**

GEO REPORT No. 247

Fugro Scott Wilson Joint Venture

**GEOTECHNICAL ENGINEERING OFFICE
CIVIL ENGINEERING AND DEVELOPMENT DEPARTMENT
THE GOVERNMENT OF THE HONG KONG
SPECIAL ADMINISTRATIVE REGION**

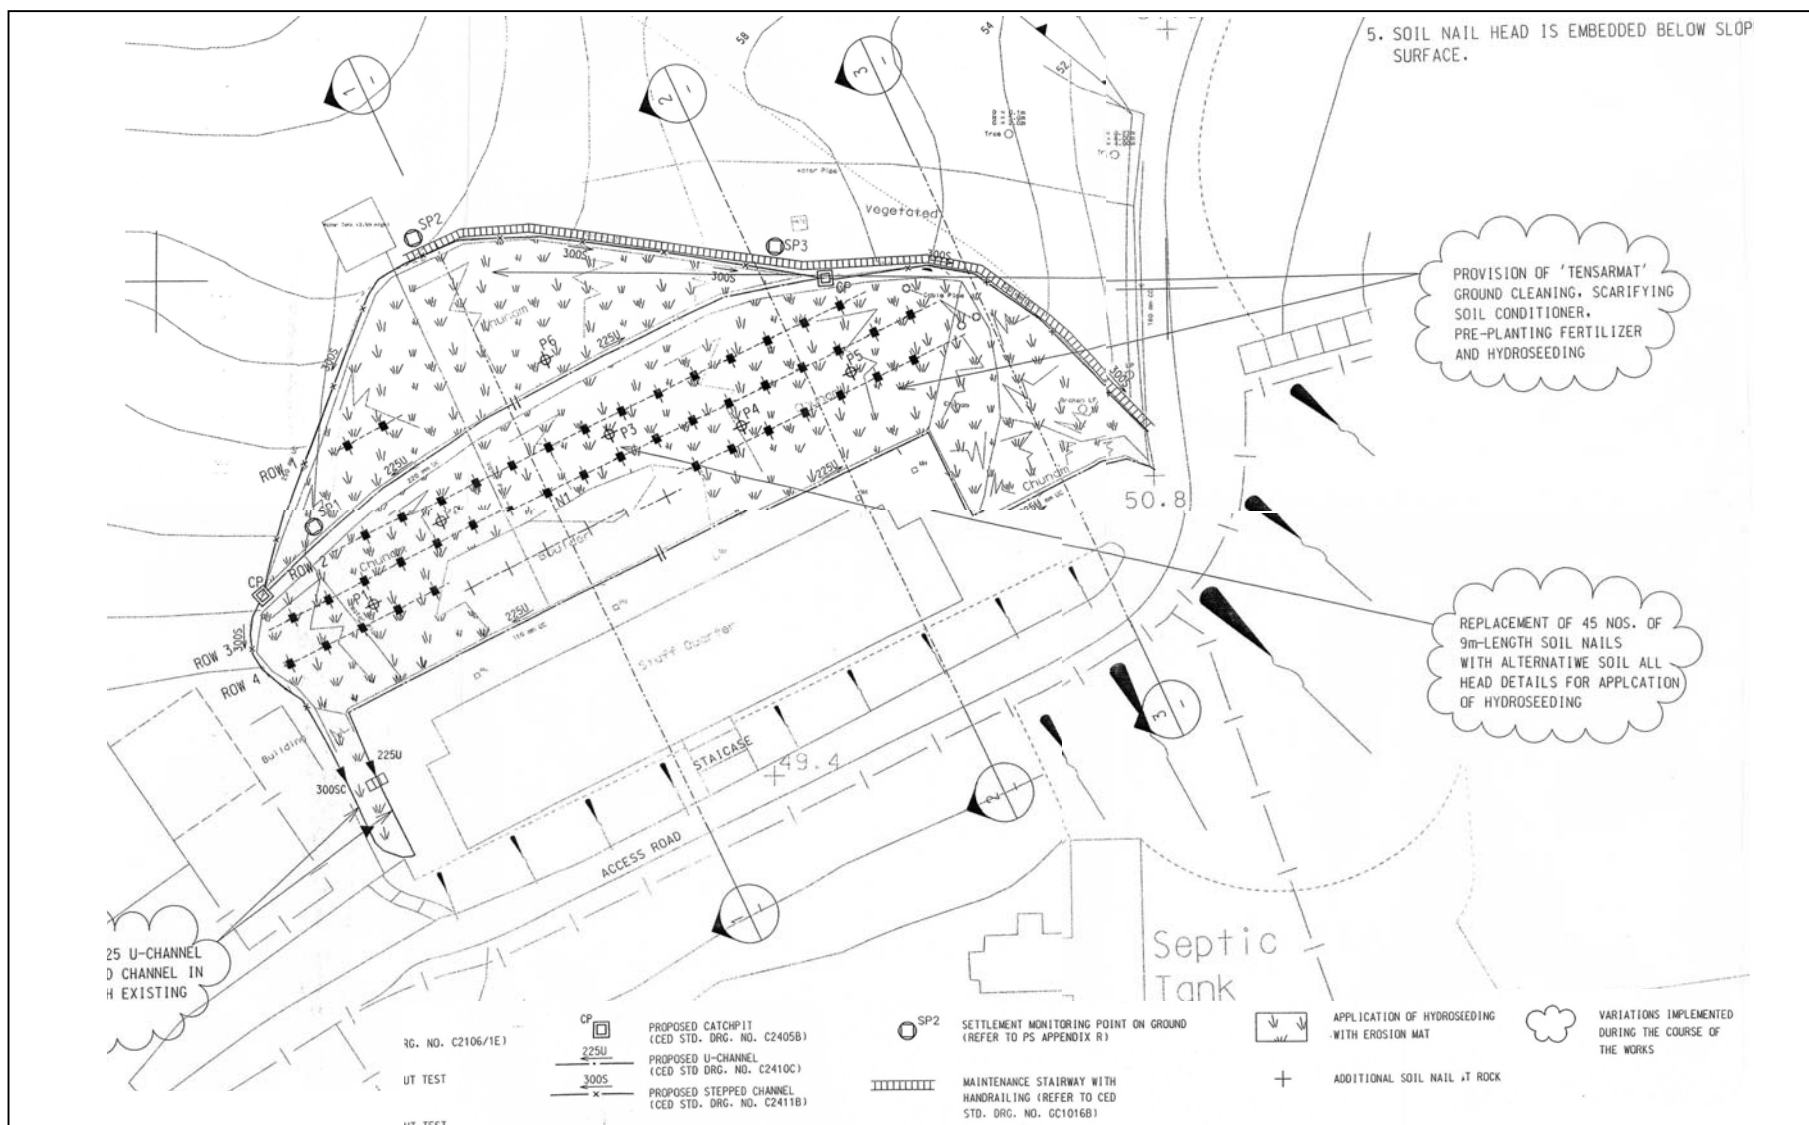
Figure 7 - As-built Arrangement of Soil Nails (Extracted from Drawing No. LPM9918/1622 (Revision A) of LPM Stage 3 Study Report No. S3R 107/99)

The landslide affected two soil nails from Row 2 (see Figure 7) installed in the lower batter of the slope. The two affected nails were exposed in the scar (see Figure 8). The surface of rupture daylighted at the toe of the scar and the main debris trail passed between two soil nails from Row 3 (see Figure 7) immediately below (see Figure 8), leaving these two lower nails unaffected.

Two soil nails from Row 2 within the lower batter (see Figure 7), with heads measuring about 400 mm and 500 mm square respectively and located about 3 m below the intermediate berm, were situated within the landslide scar (Figure 8, Plates 12 and 13). The exposed portions of these two soil nails were bent downward at about 30° to the horizontal, at approximately 0.5 m behind the slope face (Plate 14). The cement grout underneath the nail bars was found to have spalled and hence the nail reinforcement was exposed.

It did not appear that nails from Row 3 (see Figure 7), which were situated lower on the slope face immediately above the soil/rock interface, were affected by the failure, as the debris trail and the daylight of the surface of rupture passed between the locations of two soil nails in Row 3 (see Figure 8). A third soil nail head was observed within the debris trail on the rock outcrop below the scar, approximately 2.5 m above the slope toe (Plate 15). This nail head, which was one of the six additional soil nails installed across the rock outcrop (see Section 5.5), was noted to be intact and unaffected by the failure.

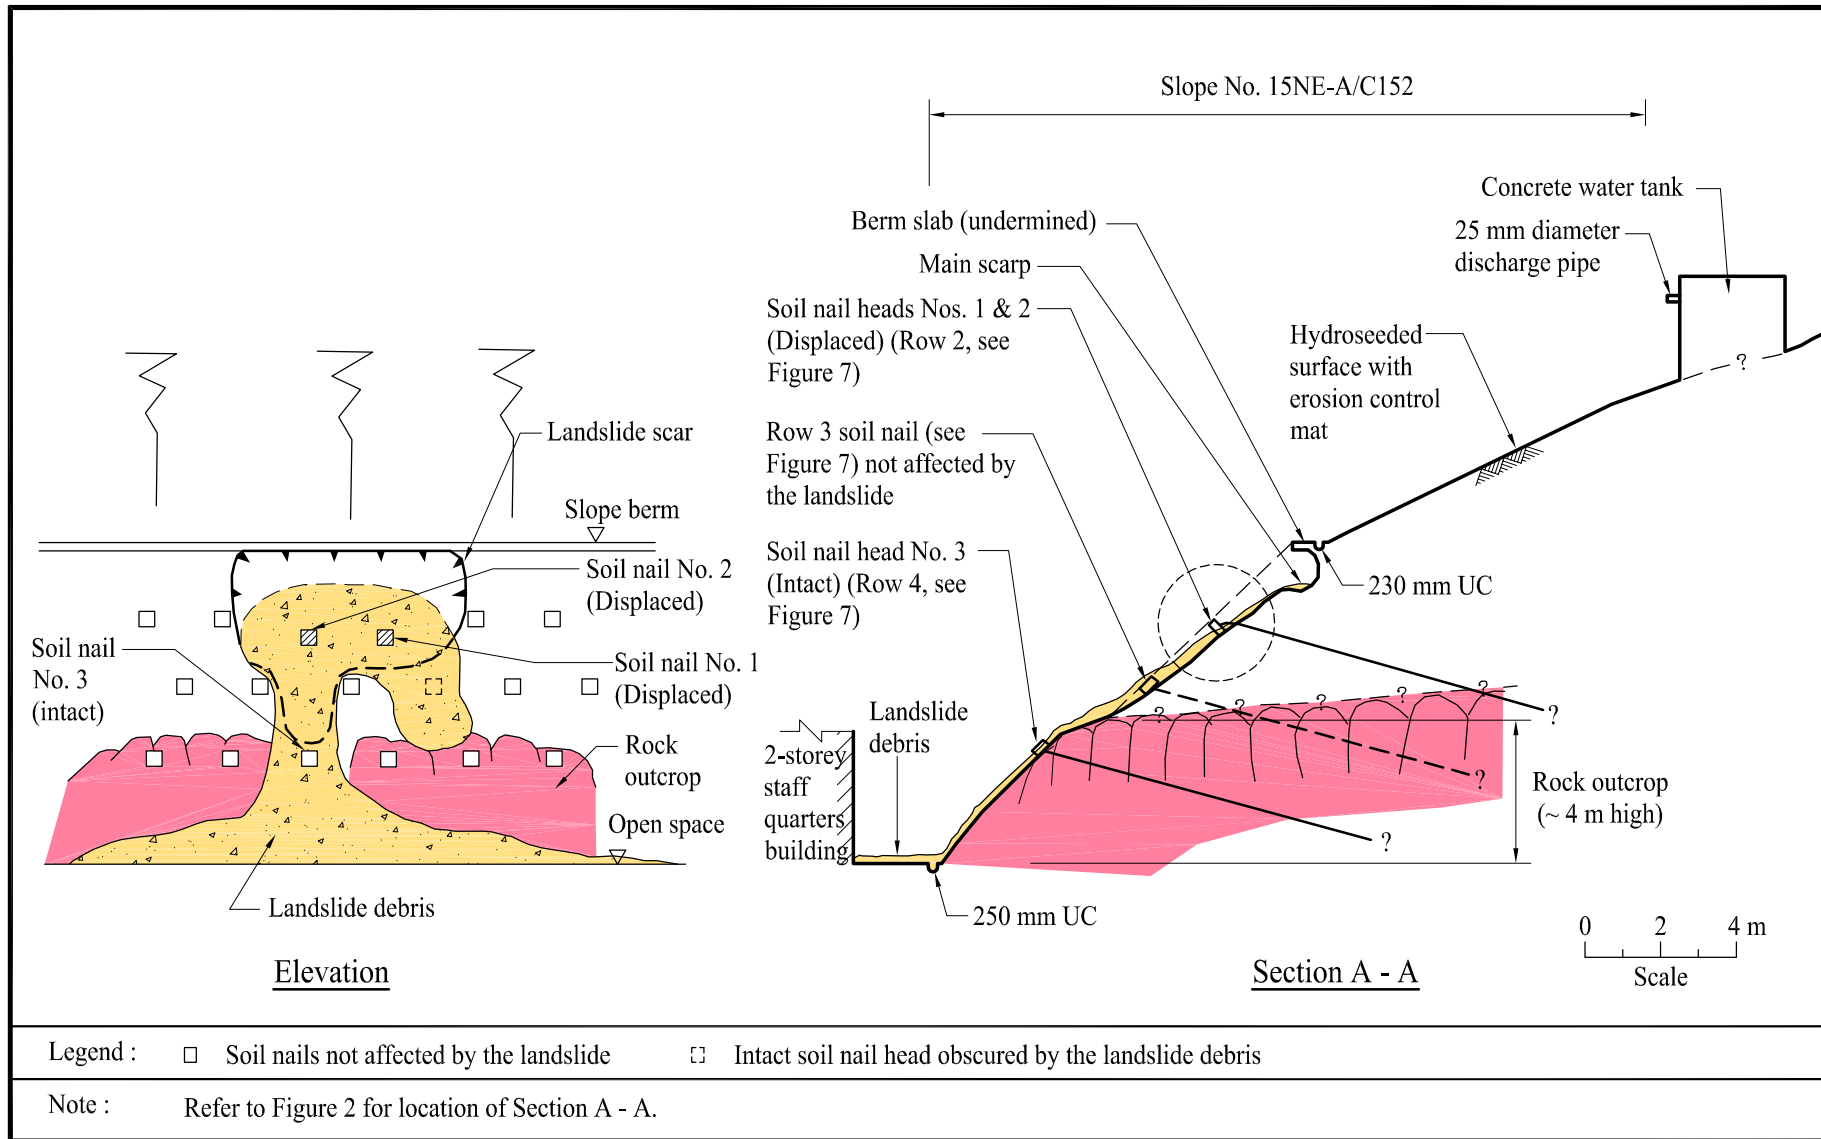
Figure 8 - Elevation of and Cross-section A - A through the 20 August 2005 Landslide Scar

The local failure occurred near the top of the lower slope batter, at a section through the location of a locally extensive moderately decomposed rock mass that measures 18 m across and 4 m high (see Figure 8). The ground investigation undertaken under the LPM Stage 3 Study comprised trial pits and surface strips, with no boreholes, and no groundwater monitoring was undertaken. In the LPM design, this rock mass was judged to be a "boulder". In the stability analysis of this section, the LPM design ground model assumed a soil profile, ignoring the large "boulder". The corresponding groundwater condition adopted in the LPM Study was generally commensurate with the above assumed ground model (see Figure 5).

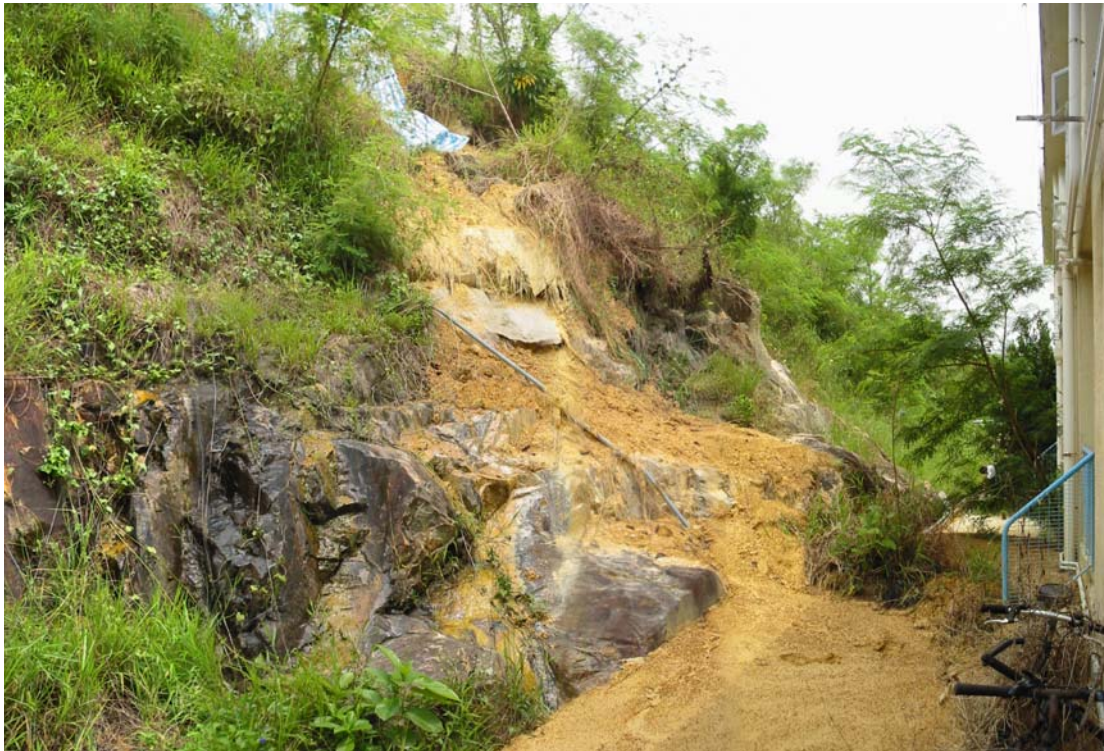
The landslide occurred on the lower batter of slope No. 15NE-A/C152. The exact timing of the failure is not known and is estimated to be around 10:00 a.m. on 20 August 2005, based on the account of a CSD staff stationed at Ma Hang Prison, who reported the incident to the GEO on 29 August 2005. At the time of the failure, the staff quarters building at the toe of the slope was vacant. No casualties were reported as a result of the landslide.

Plate 1 – General View of the 20 August 2005 Landslide (Photograph taken on 2 September 2005)

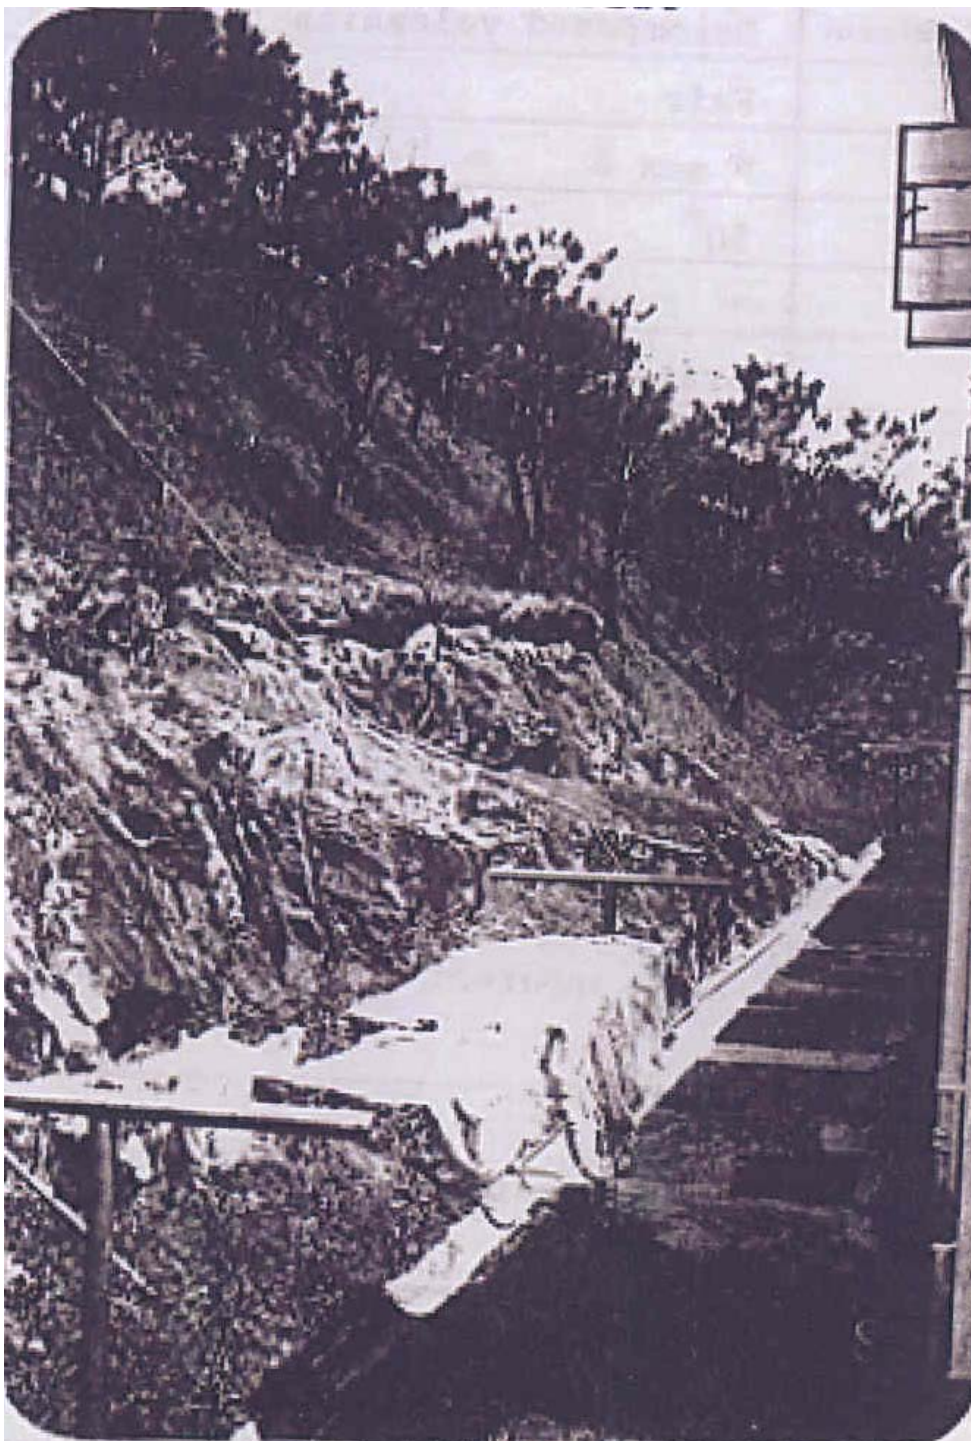
In April 1978, slope No. 15NE-A/C152 was inspected by Binnie & Partners (B&P) under the "Phase 1 Re-appraisal of Cut & Natural Slopes & Retaining Walls Study" and was subsequently registered in the 1977/78 Catalogue of Slopes (Plate 2). The field sheet for this feature reported the slope angle as 50° and recorded no signs of seepage or distress. B&P also recommended the clearance of U-channels, the clearance of vegetation and protection of the slope.

Plate 2 — Photographic Record of Slope No. 15NE-A/C152 in 1978 (Photograph taken by Binnie & Partners (HK) on 13 April 1978)

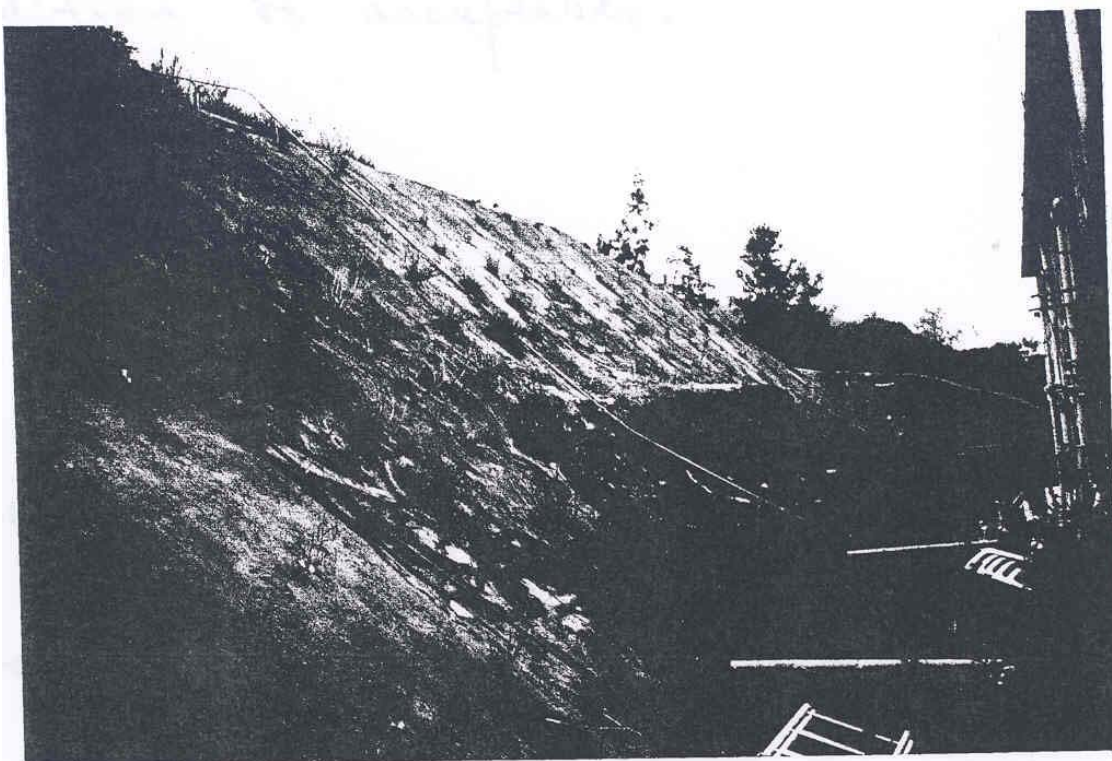
The February 1998 RMI recorded that the general condition of the slope was acceptable, and that no action was necessary. The previously recommended "remedial works" were reported as having been completed in 1997 (Plate 4). Subsequently, the April 1998 RMI made recommendations for the clearance and repair of drainage channels, the removal of surface vegetation and the clearance of weepholes. The December 1998 RMI records made similar recommendations, which were recorded as having been completed in February 1999.

Plate 4 – Photographic Record of Slope No. 15NE-A/C152 in 1998
(Photograph taken by ArchSD on 20 February 1998)

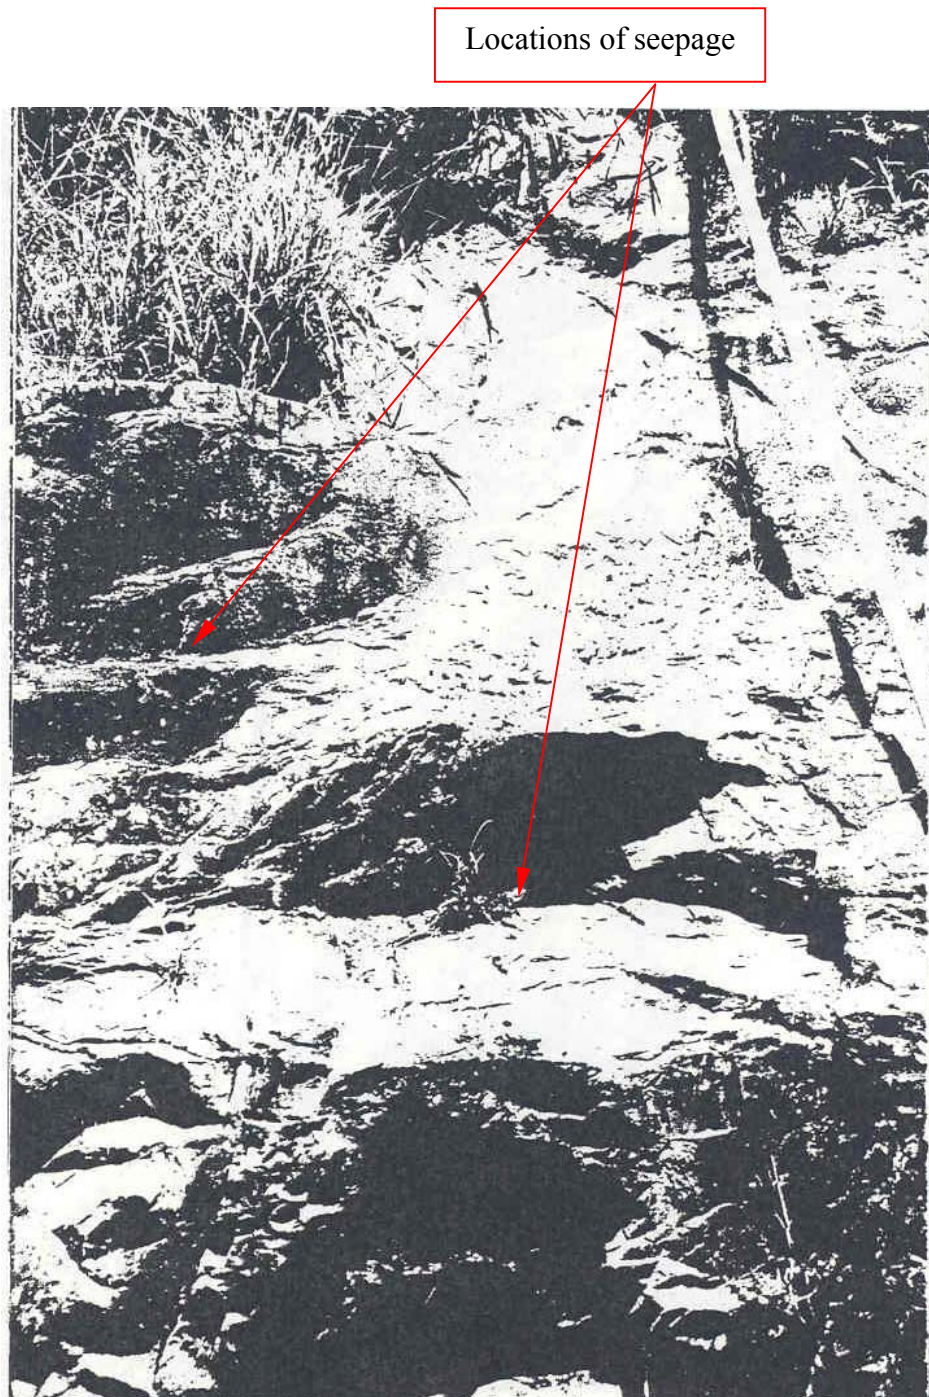
Past inspections during RMI and EI, and by the LPM consultants revealed persistent seepage from the soil/rock interface and from rock joints in the moderately decomposed rock mass below the failure. This suggests the possibility of a preferential flowpath and concentrated subsurface flow at this section, and the local hydrogeological setting may not be fully reflected by the surface topography, which has a relatively small catchment. Furthermore, the extensive moderately decomposed rock mass, which was judged to be a "boulder" by the LPM consultant, may actually be rock outcrop. The relative drilling rates of the nails installed through the moderately decomposed rock mass as well as in the overlying saprolite tend to support this postulation (see Section 5.5). If this were the case, then the site setting in this locality could be conducive to the build-up of transient seepage pressure or a local perched water table in the soil mass above, where the failure occurred. The shallow gradient of the upper slope batter (about 30°) directly above the location of the landslide is also favourable to enhance direct infiltration, thereby contributing to development of groundwater pressure in the soil mass.

Plate 5 – Photographic Record of Seepage from Joints in Rock Exposure at Slope Toe (Photograph taken by ArchSD on 30 June 2000)

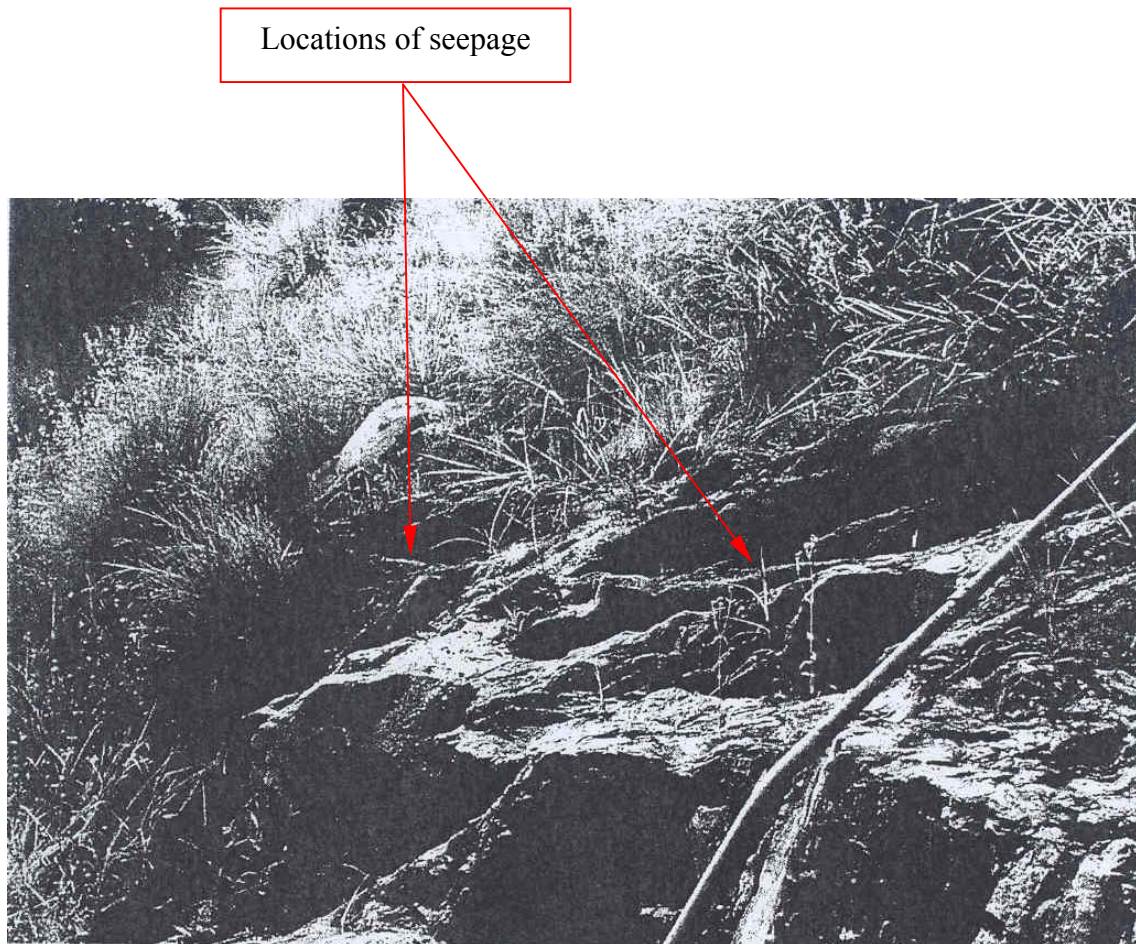
Plate 6 – Photographic Record of Seepage from Joints in Rock Exposure at Slope Toe (Photograph taken by Fugro (HK) Ltd. on 27 August 2002)

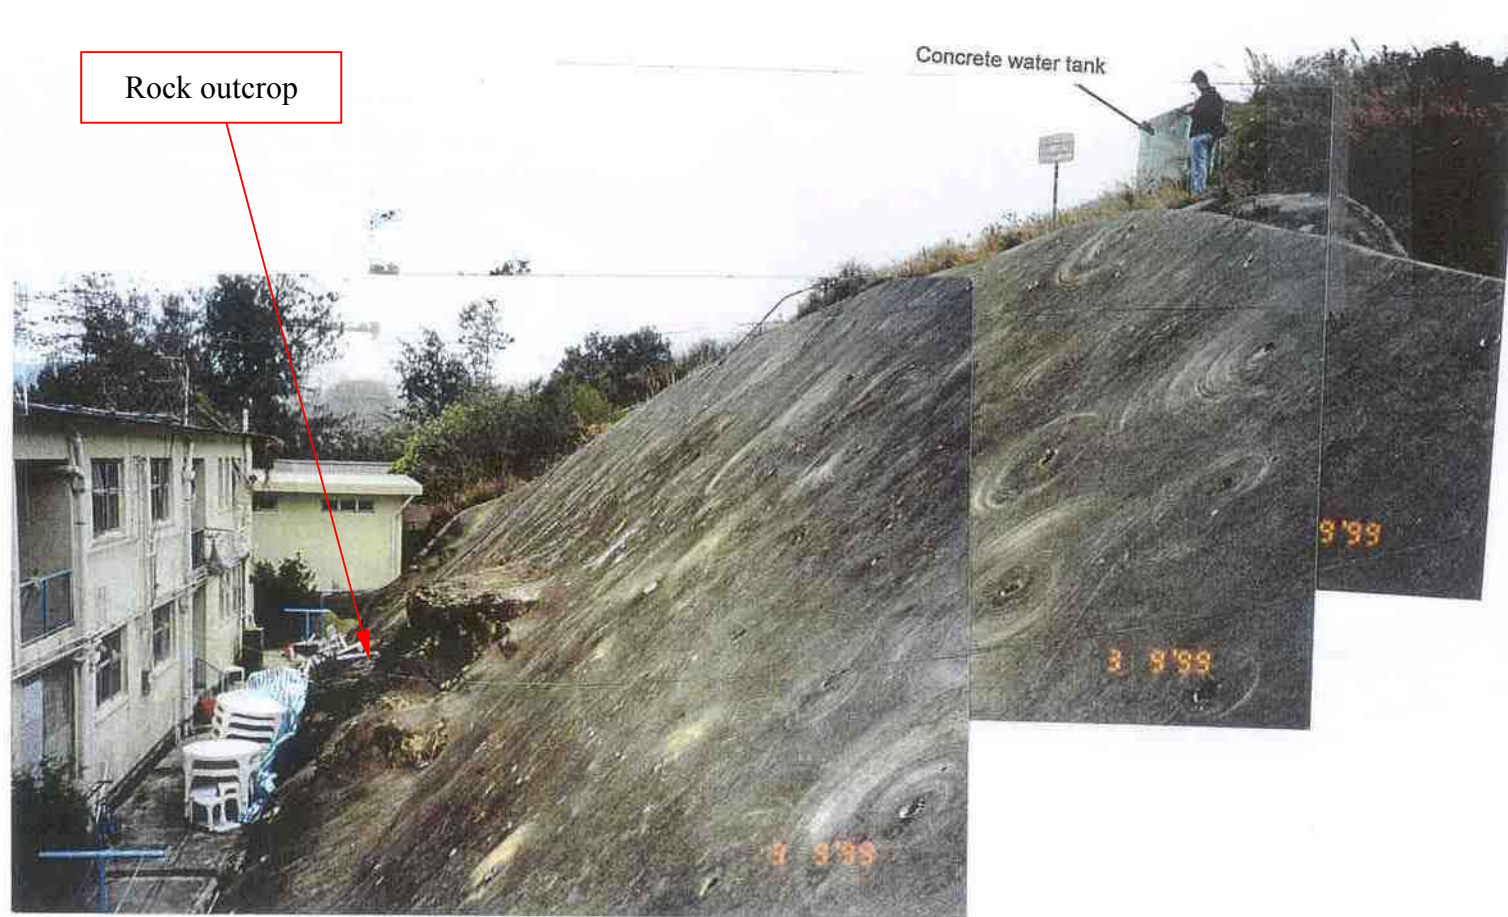
The rock exposure present in the lower central portion of the slope (Plate 7) was described as moderately to slightly decomposed tuff. No adversely orientated joints were identified by HAP. Slight seepage was observed to be issuing from the rock joints. The rockhead behind the slope face could not be determined from the available ground investigation data, and the extent of the exposed rock assumed for the LPM Stage 3 Study is shown in Figure 4. The overall slope angle was reported as "45°" in the LPM Stage 3 Report.

Plate 7 – General View West Across Slope No. 15NE-A/C152 (Photograph taken by HAP in 1999)

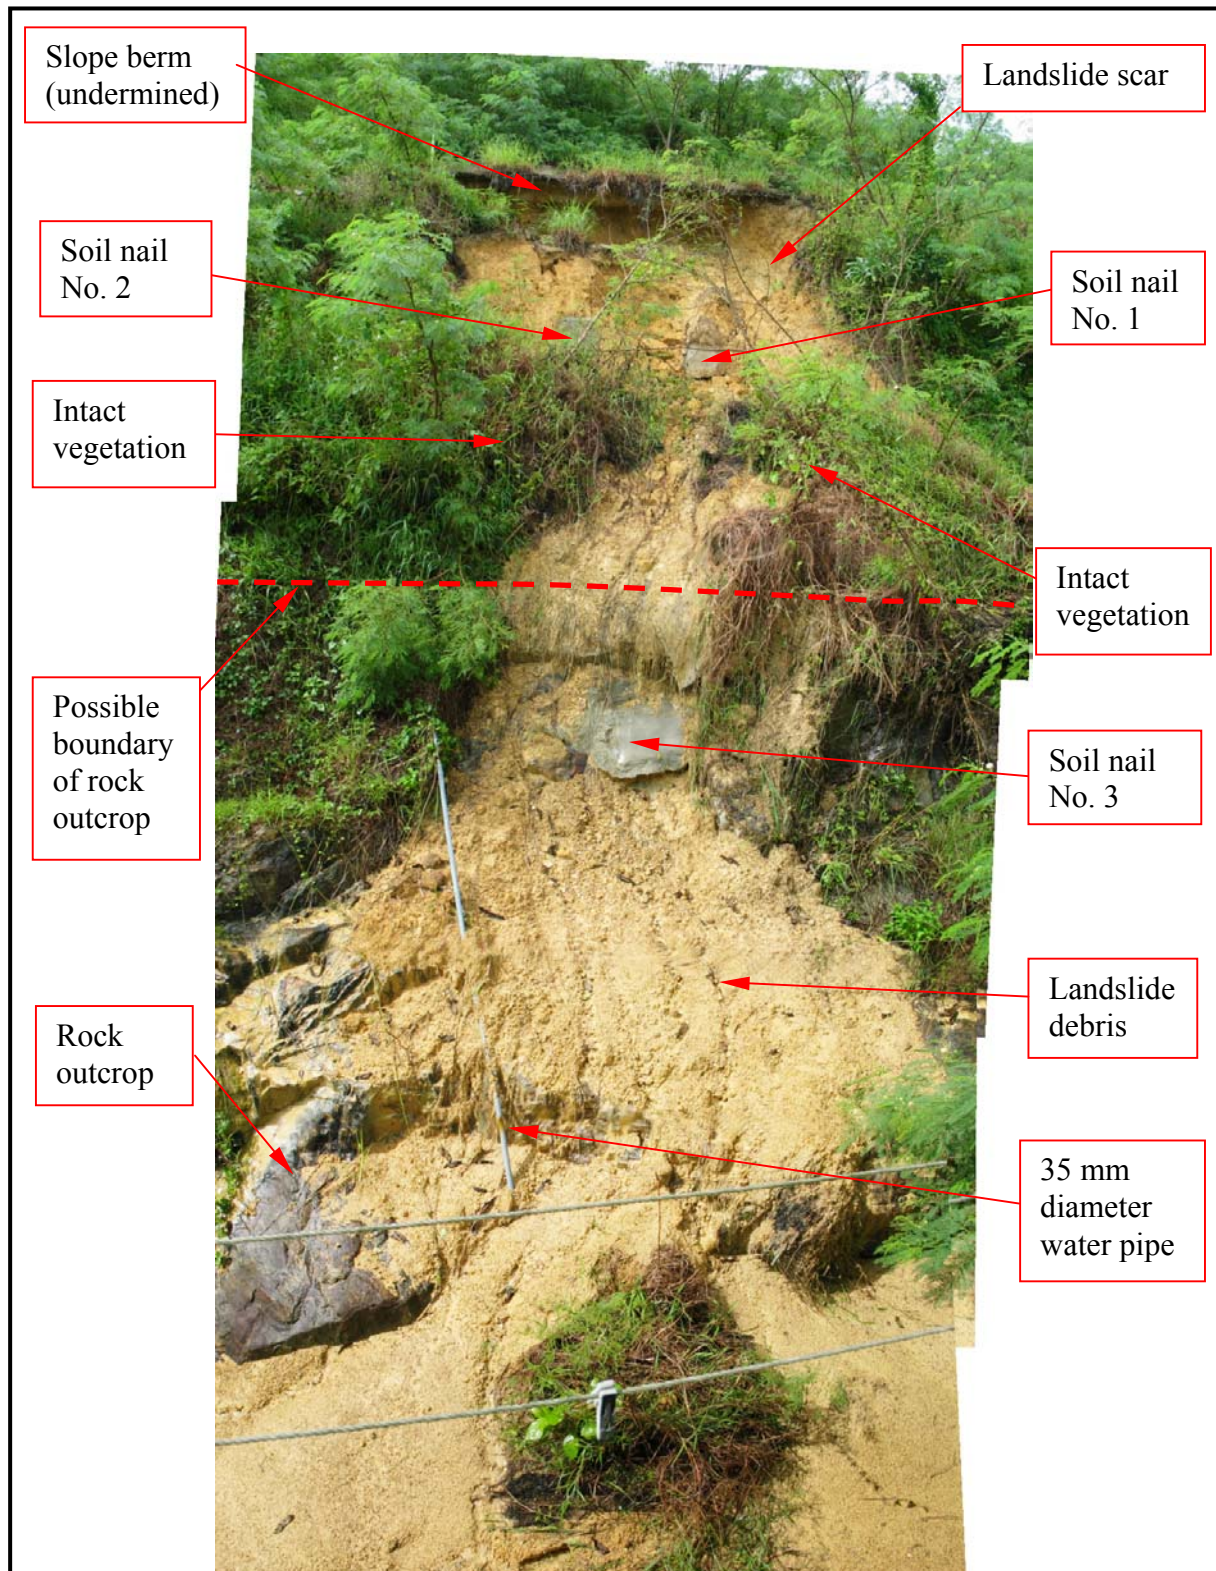
Plate 8 – View from Toe of Slope No. 15NE-A/C152 - Looking Northwest Towards the 20 August 2005 Landslide Scar (Photograph taken by GEO on 29 August 2005)

On 29 August 2005, GEO advised Arch SD to carry out urgent repair works to slope No. 15NE-A/C152, which comprised the trimming of the landslide scar and construction of a no-fines concrete buttress to match with the adjacent slope profile. The works were completed by the end of September 2005.

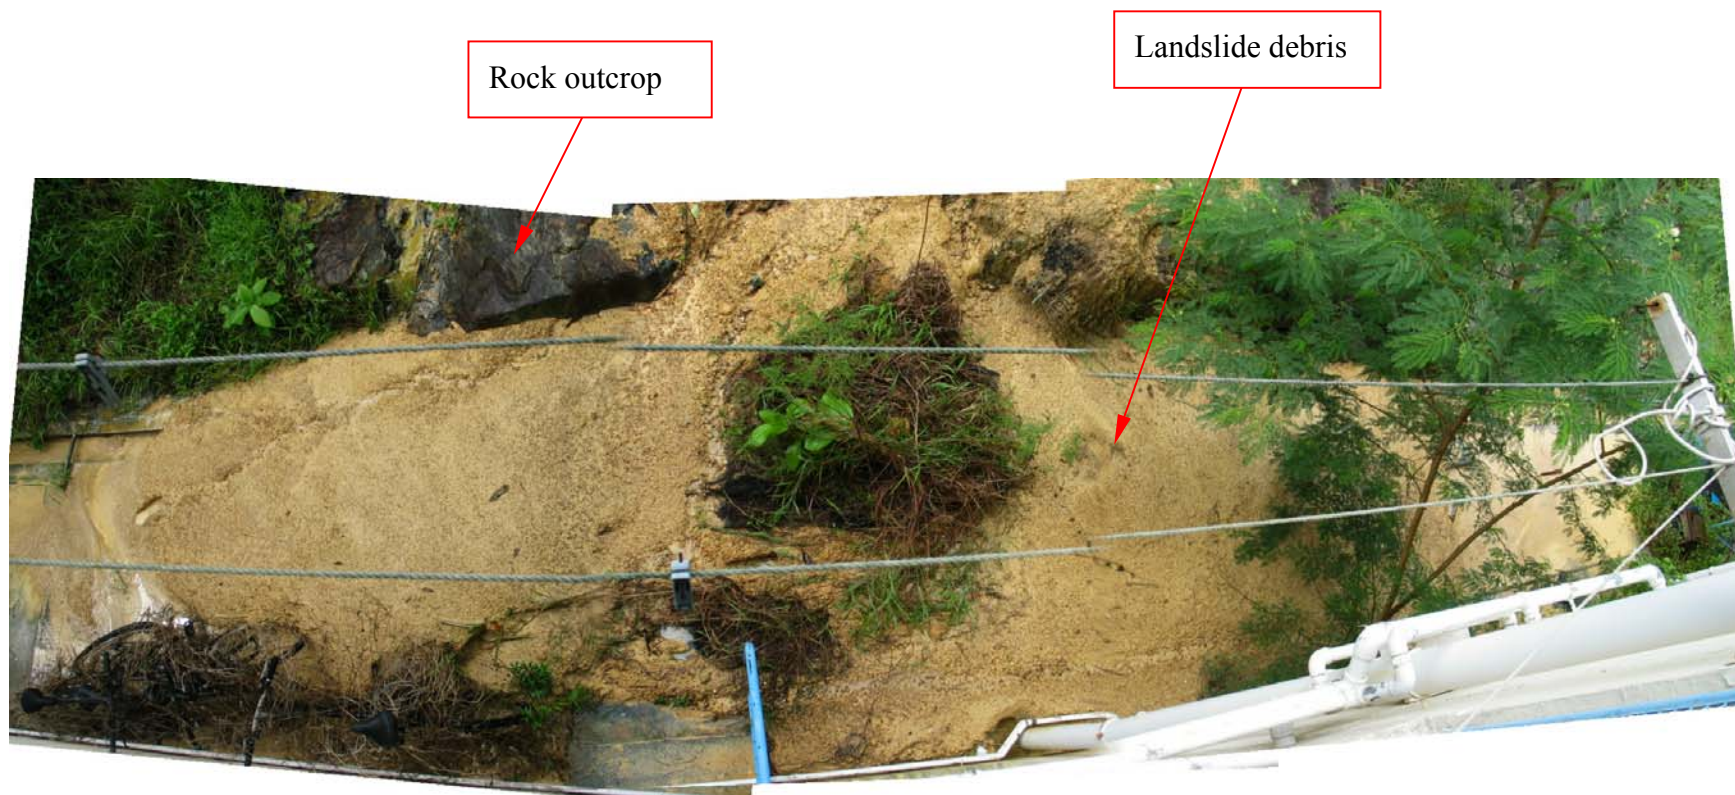
Debris from the landslide, with an estimated volume of about 35 m³ and comprising soil, vegetation and erosion control mat, was mostly deposited on the open space between the toe of slope No. 15NE-A/C152 and the adjacent staff quarters building, blocking the toe drainage provisions (Plate 10). A portion of the debris was deposited within the scar and on the slope face, obscuring the lower portion of the surface of rupture. The debris mound at slope toe was of about 0.6 m maximum depth, and spread laterally over a distance of about 18 m. The travel angle of the debris (Wong & Ho, 1996), as measured from the berm slab to the staff quarters building perpendicular to the strike of the slope face (i.e. not to the lateral extent of the debris mound), was about 38°.

Plate 10 – View of Landslide Debris from Roof of Staff Quarters Building (Photograph taken by GEO on 29 August 2005)

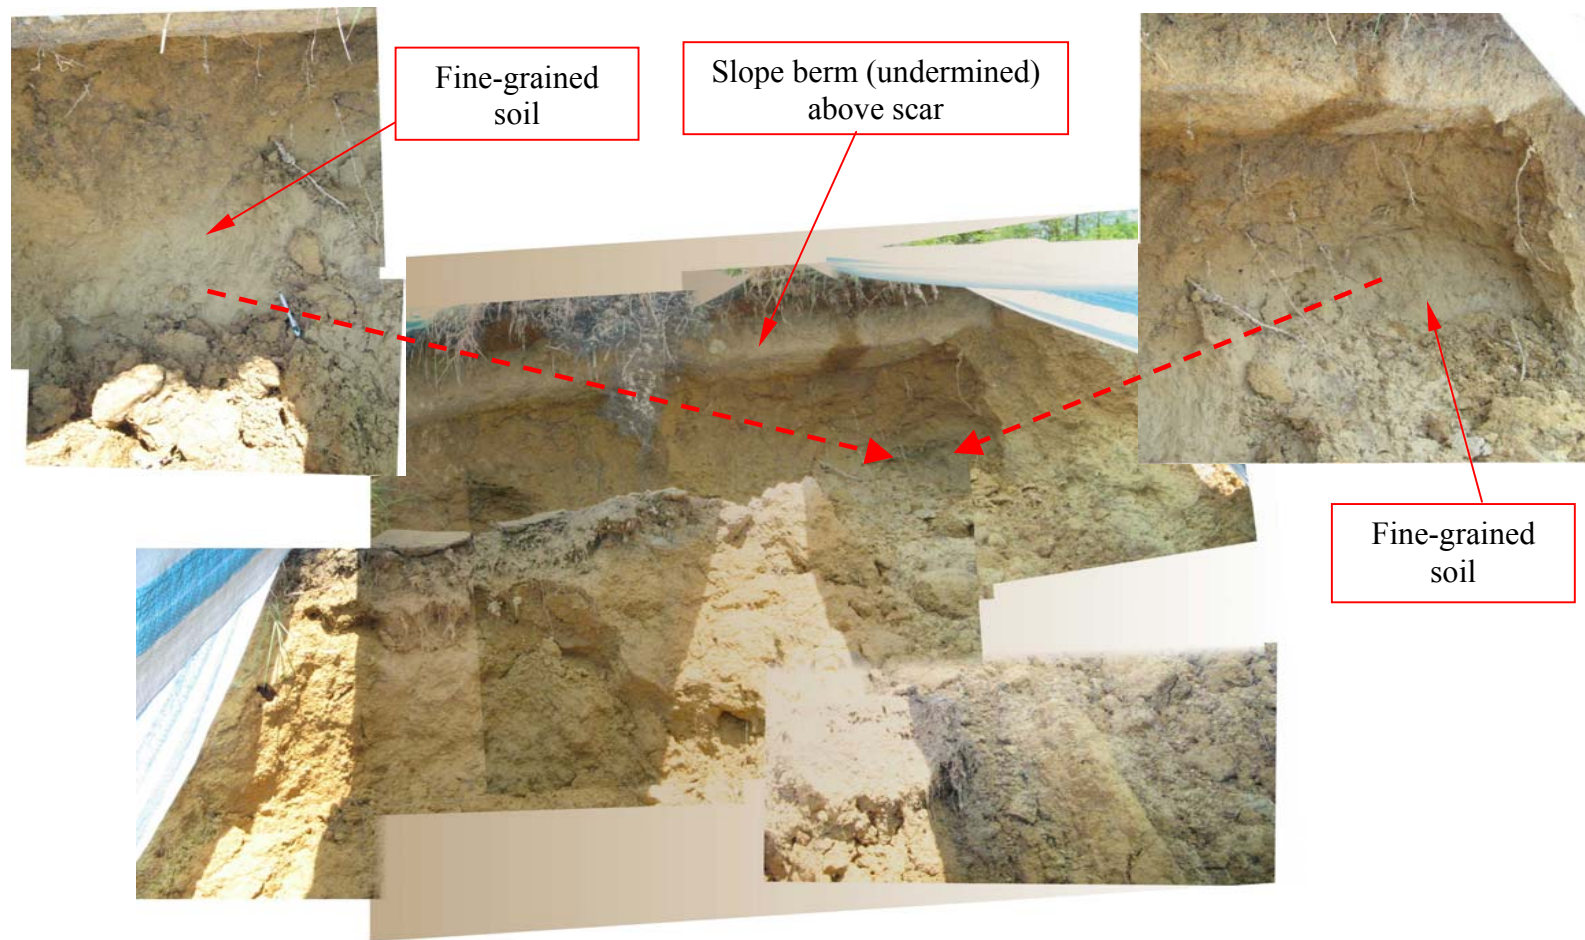
along the surface of rupture. Some fine-grained soils, comprising yellowish-brown silt, were also observed. No seepage was observed at the main scarp at the time of site inspection, and the exposed material was dry at the time of the inspections. Seepage was noted at the soil/rock interface immediately adjacent to both sides of the scar (Plate 9). No soil pipes could be observed at the main scarp. Adversely orientated joint sets, with dip/dip direction of $32^{\circ}/144^{\circ}$ (Joint Set 2) and $81^{\circ}/278^{\circ}$ (Joint Set 4), were noted on the rock exposed at slope toe (Figure 9). No obvious adverse relict joints were observed on the landslide scarp.

Plate 11 – Close View of the Main Scarp of the Landslide Scar (Photograph taken on 30 August 2005)

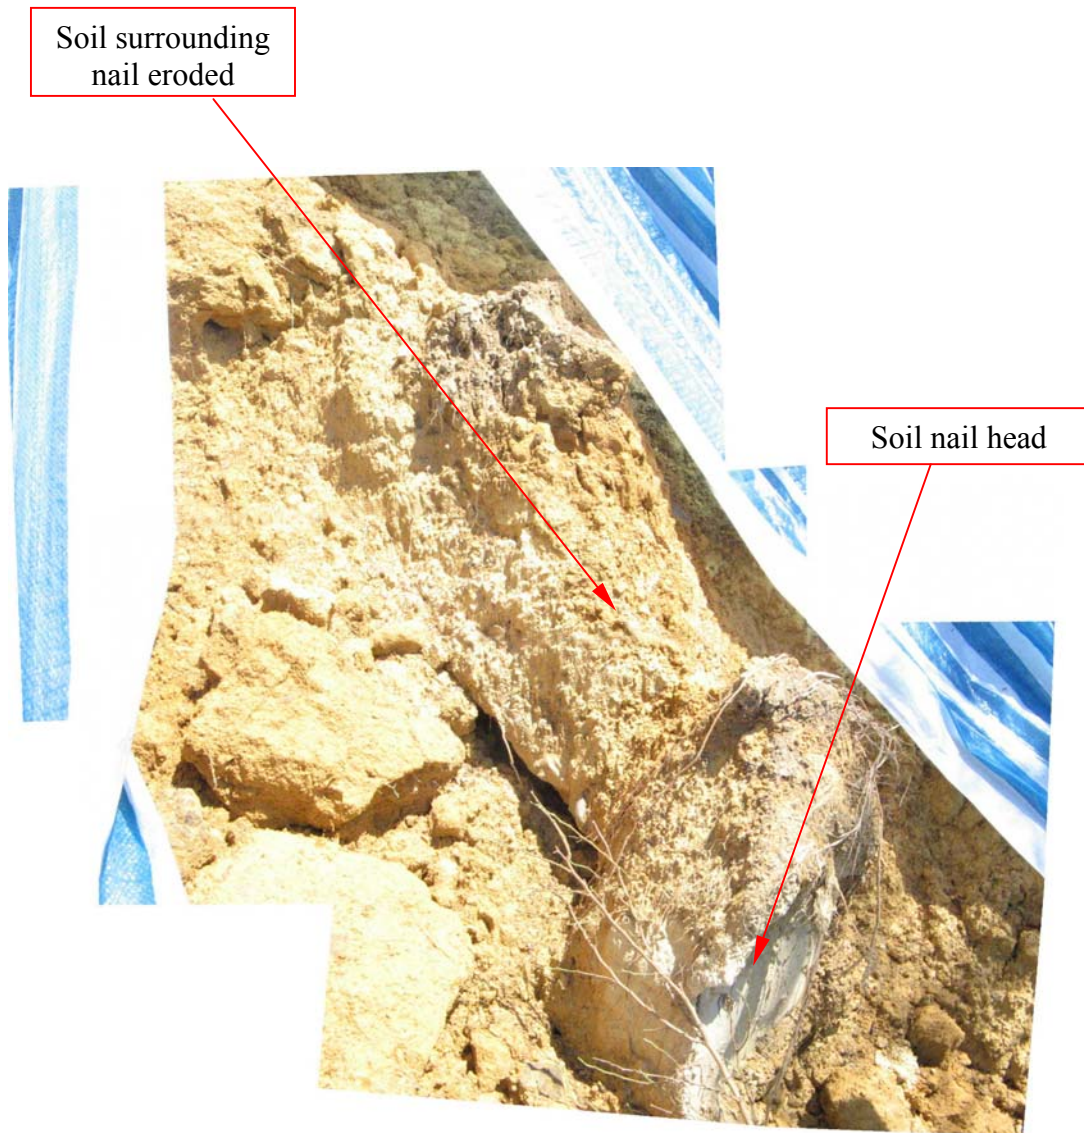
The landslide comprised an 'internal' failure of the soil-nailed system, with the detachment occurring within the active zone in CDT. The soil nails in the vicinity were evidently called into action and two of them were bent as a result of the instability. The lower end of the basal slip plane of the sliding failure was confined to the soil-rock interface. The detachment was not particularly mobile. It is not certain whether the soil nails, although they were unable to prevent the local failure, contributed to the ductility of the failure mode.

Plate 12 – Close View of Soil Nail No. 1 (Photograph taken on 30 August 2005)

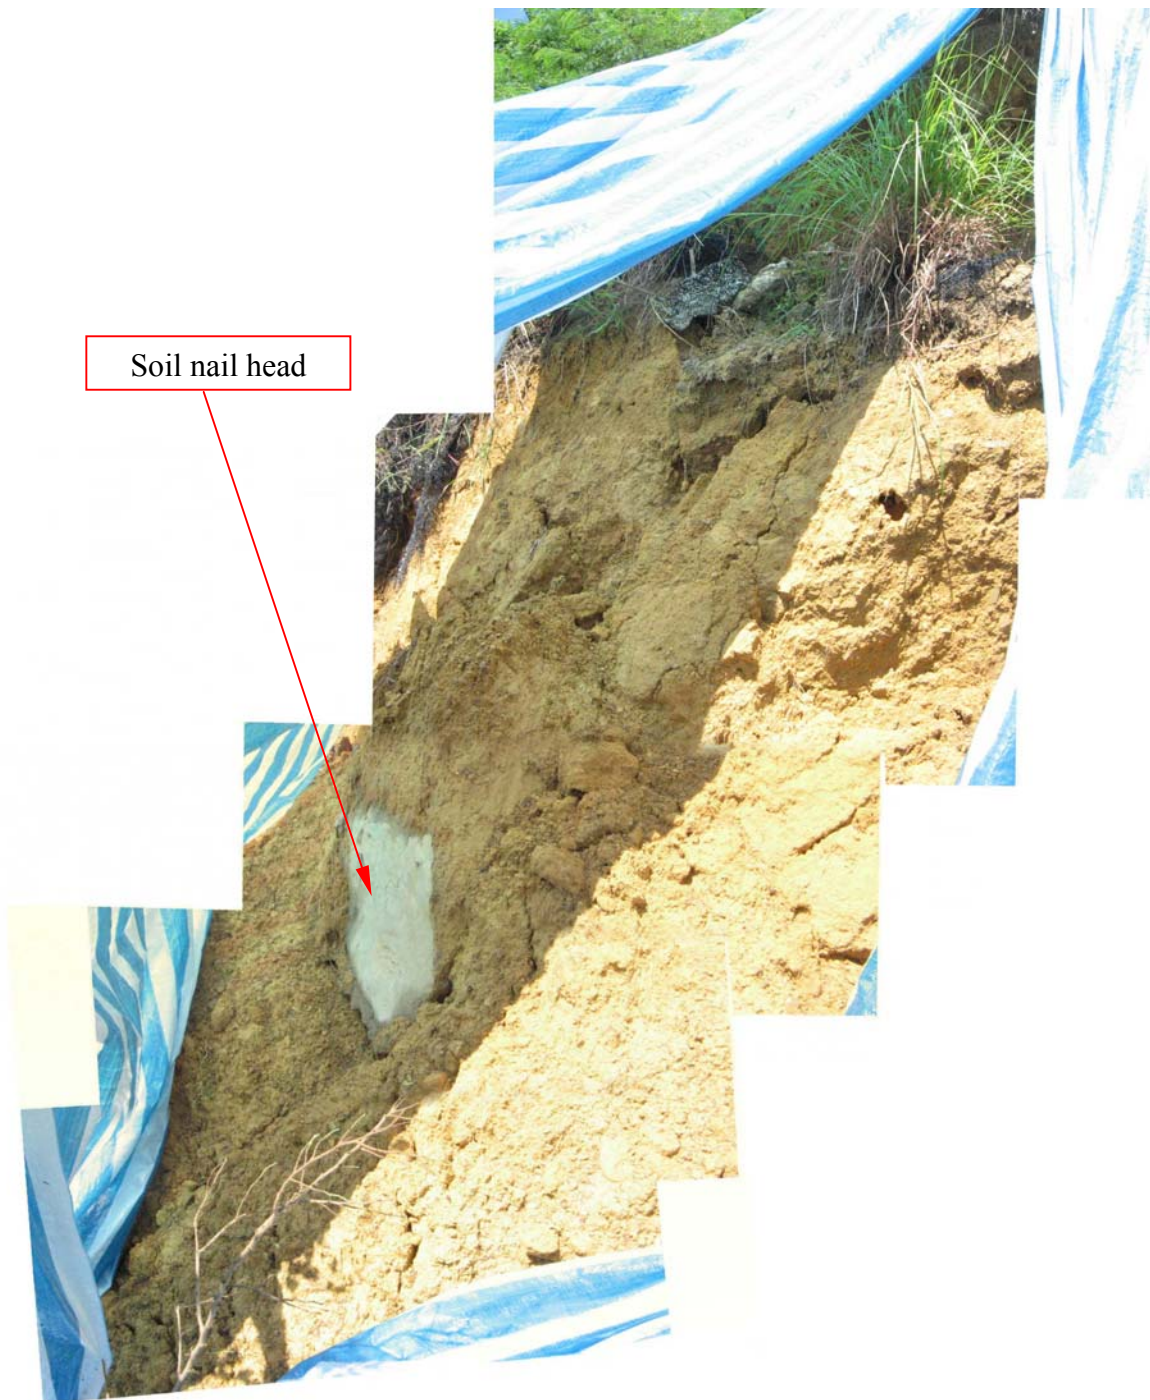
Plate 13 – Close View of Soil Nail No. 2 (Photograph taken on 30 August 2005)

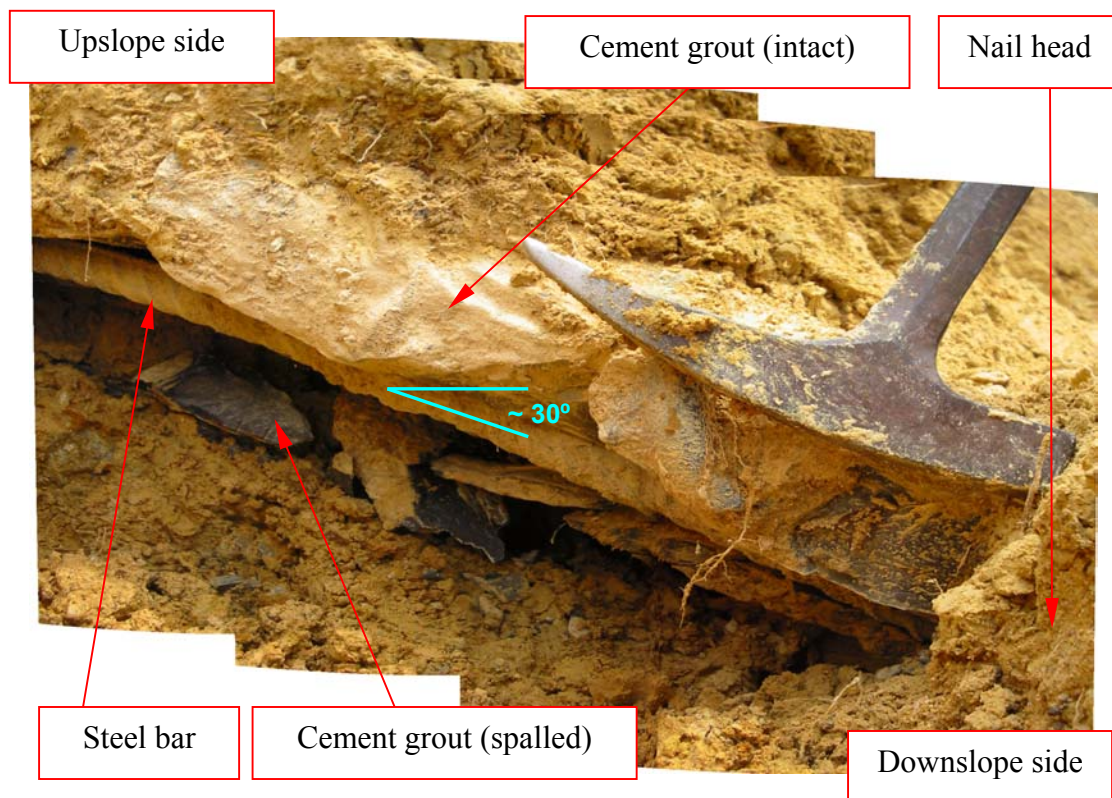
Plate 14 – Close View of Exposed Portion of Soil Nail No. 1 (Photograph taken on 2 September 2005)
