**REVIEW OF THE
20 AUGUST 2005 LANDSLIDE
ON SLOPE NO. 15NE-A/C152
AT MA HANG PRISON,
STANLEY**

GEO REPORT No. 247

Fugro Scott Wilson Joint Venture

**GEOTECHNICAL ENGINEERING OFFICE
CIVIL ENGINEERING AND DEVELOPMENT DEPARTMENT
THE GOVERNMENT OF THE HONG KONG
SPECIAL ADMINISTRATIVE REGION**

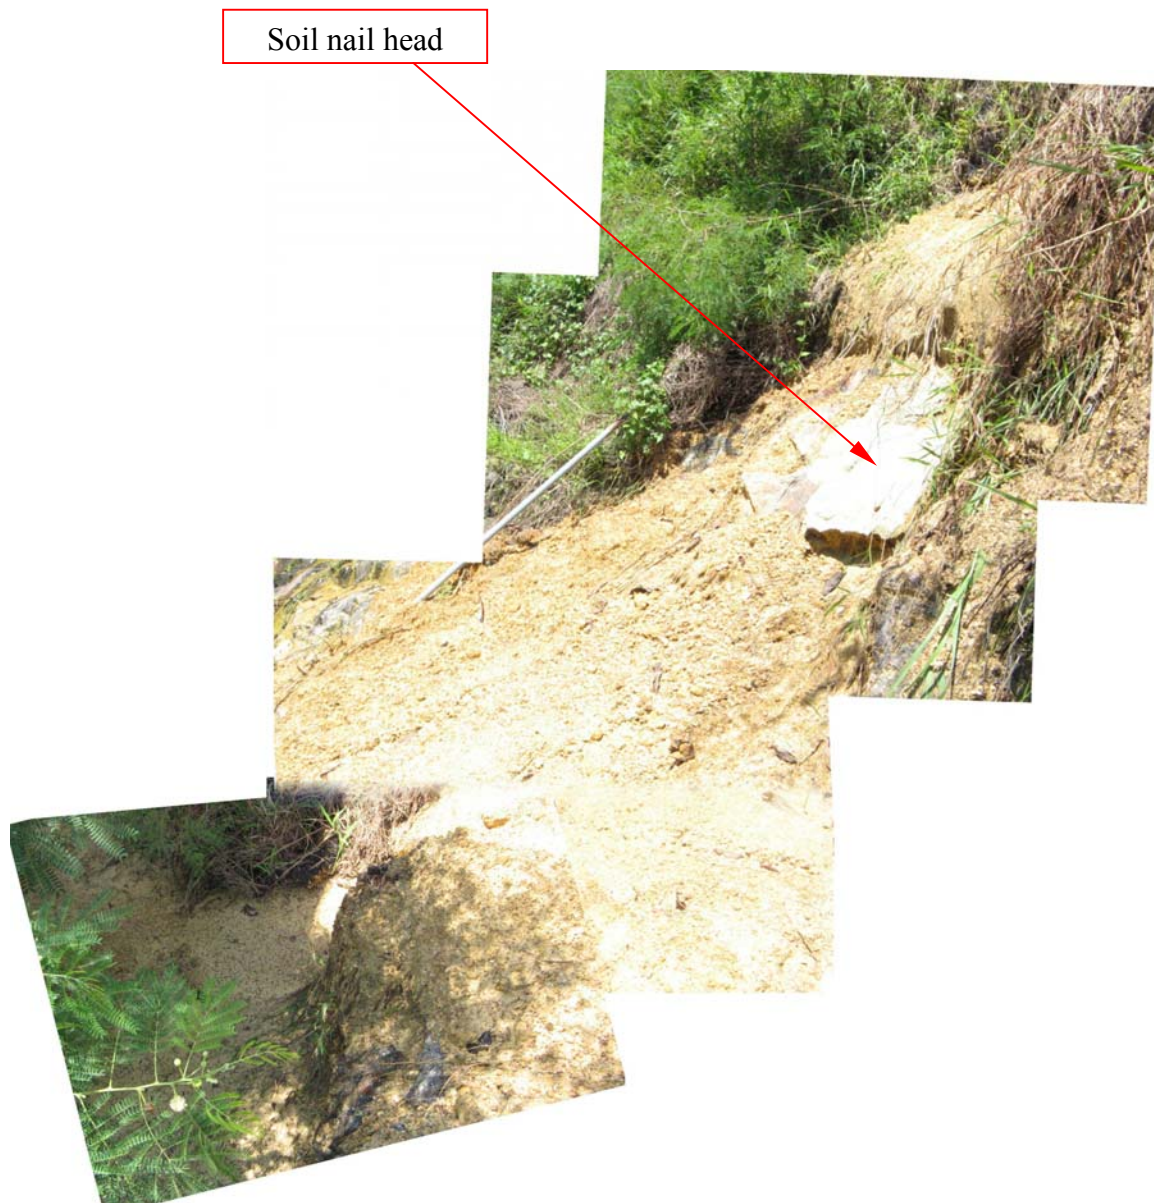
It did not appear that nails from Row 3 (see Figure 7), which were situated lower on the slope face immediately above the soil/rock interface, were affected by the failure, as the debris trail and the daylight of the surface of rupture passed between the locations of two soil nails in Row 3 (see Figure 8). A third soil nail head was observed within the debris trail on the rock outcrop below the scar, approximately 2.5 m above the slope toe (Plate 15). This nail head, which was one of the six additional soil nails installed across the rock outcrop (see Section 5.5), was noted to be intact and unaffected by the failure.

Plate 15 – Close View of Soil Nail No. 3 (Photograph taken on 30 August 2005)

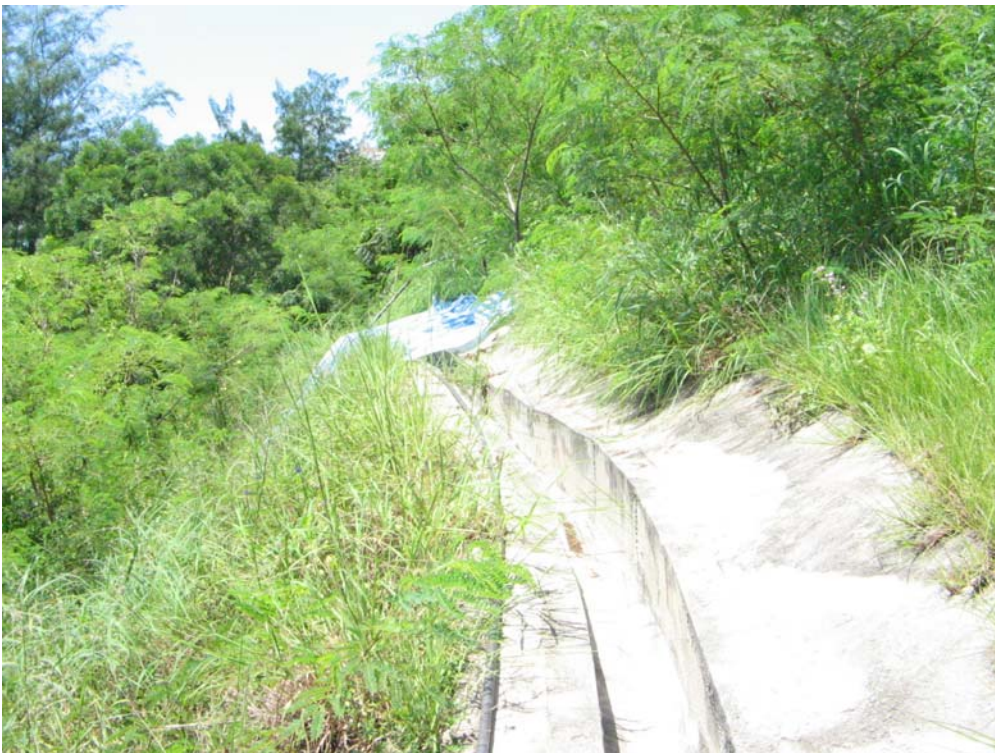
The 230 mm surface U-channel along the slope berm immediately above the landslide scar was clear at the time of the inspections and was in fair condition (Plate 16). No signs of overland flow were observed on the slope face above this channel.

Plate 16 – Surface Channel above Landslide Scar (Photograph taken on 30 August 2005)

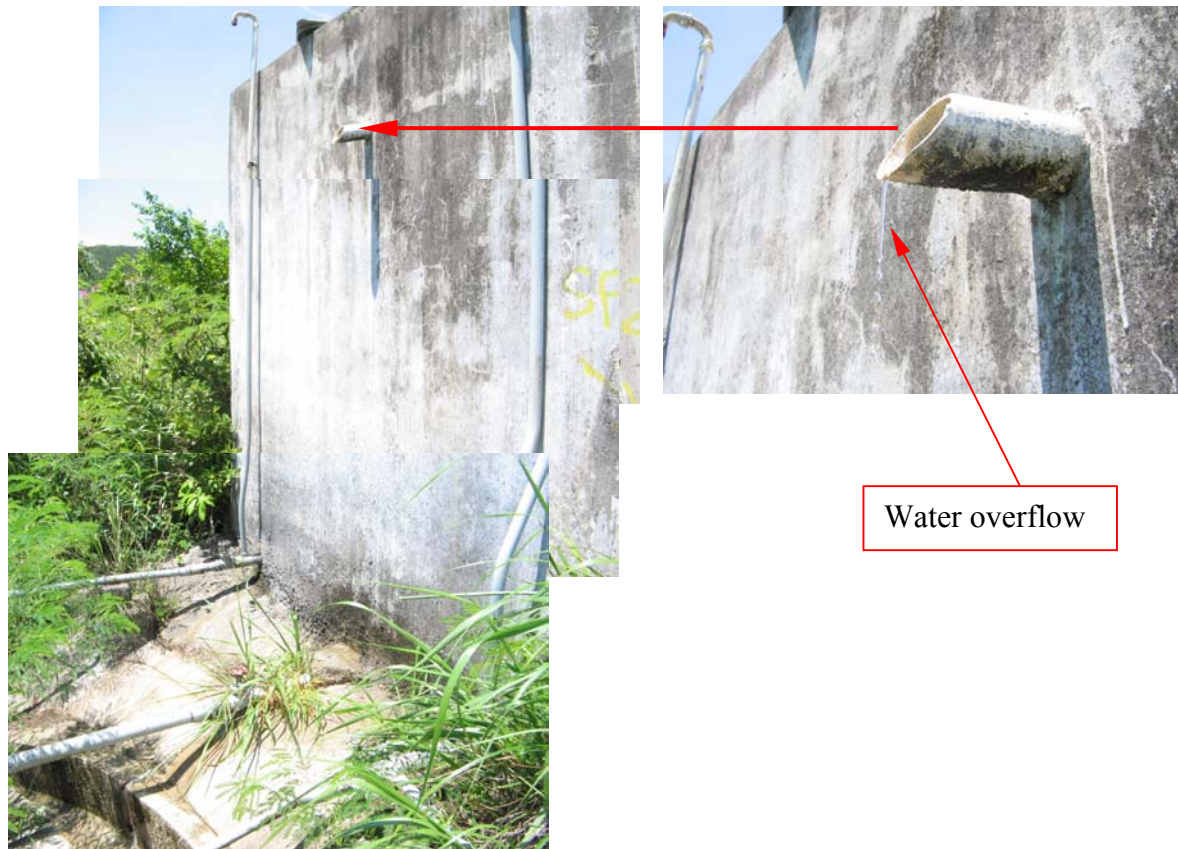
The mains-fed concrete water tank located at the slope crest was found to have an overflow pipe located about 2 m above ground level extending over the slope crest (Plate 17). A minor flow from the pipe was observed at the time of the inspections. The ground surrounding the tank, and extending to the slope crest channel, is concrete paved.

Plate 17 – Water Tank above Slope Crest (Photograph taken on 30 August 2005)
