**REVIEW OF THE  
3 JUNE 2007 FAILURE OF A  
MASONRY RETAINING WALL  
ON HILLSIDE ADJACENT TO  
NO. 84 PEAK ROAD**

**GEO REPORT No. 250**

**Fugro Scott Wilson Joint Venture**

**GEOTECHNICAL ENGINEERING OFFICE  
CIVIL ENGINEERING AND DEVELOPMENT DEPARTMENT  
THE GOVERNMENT OF THE HONG KONG  
SPECIAL ADMINISTRATIVE REGION**

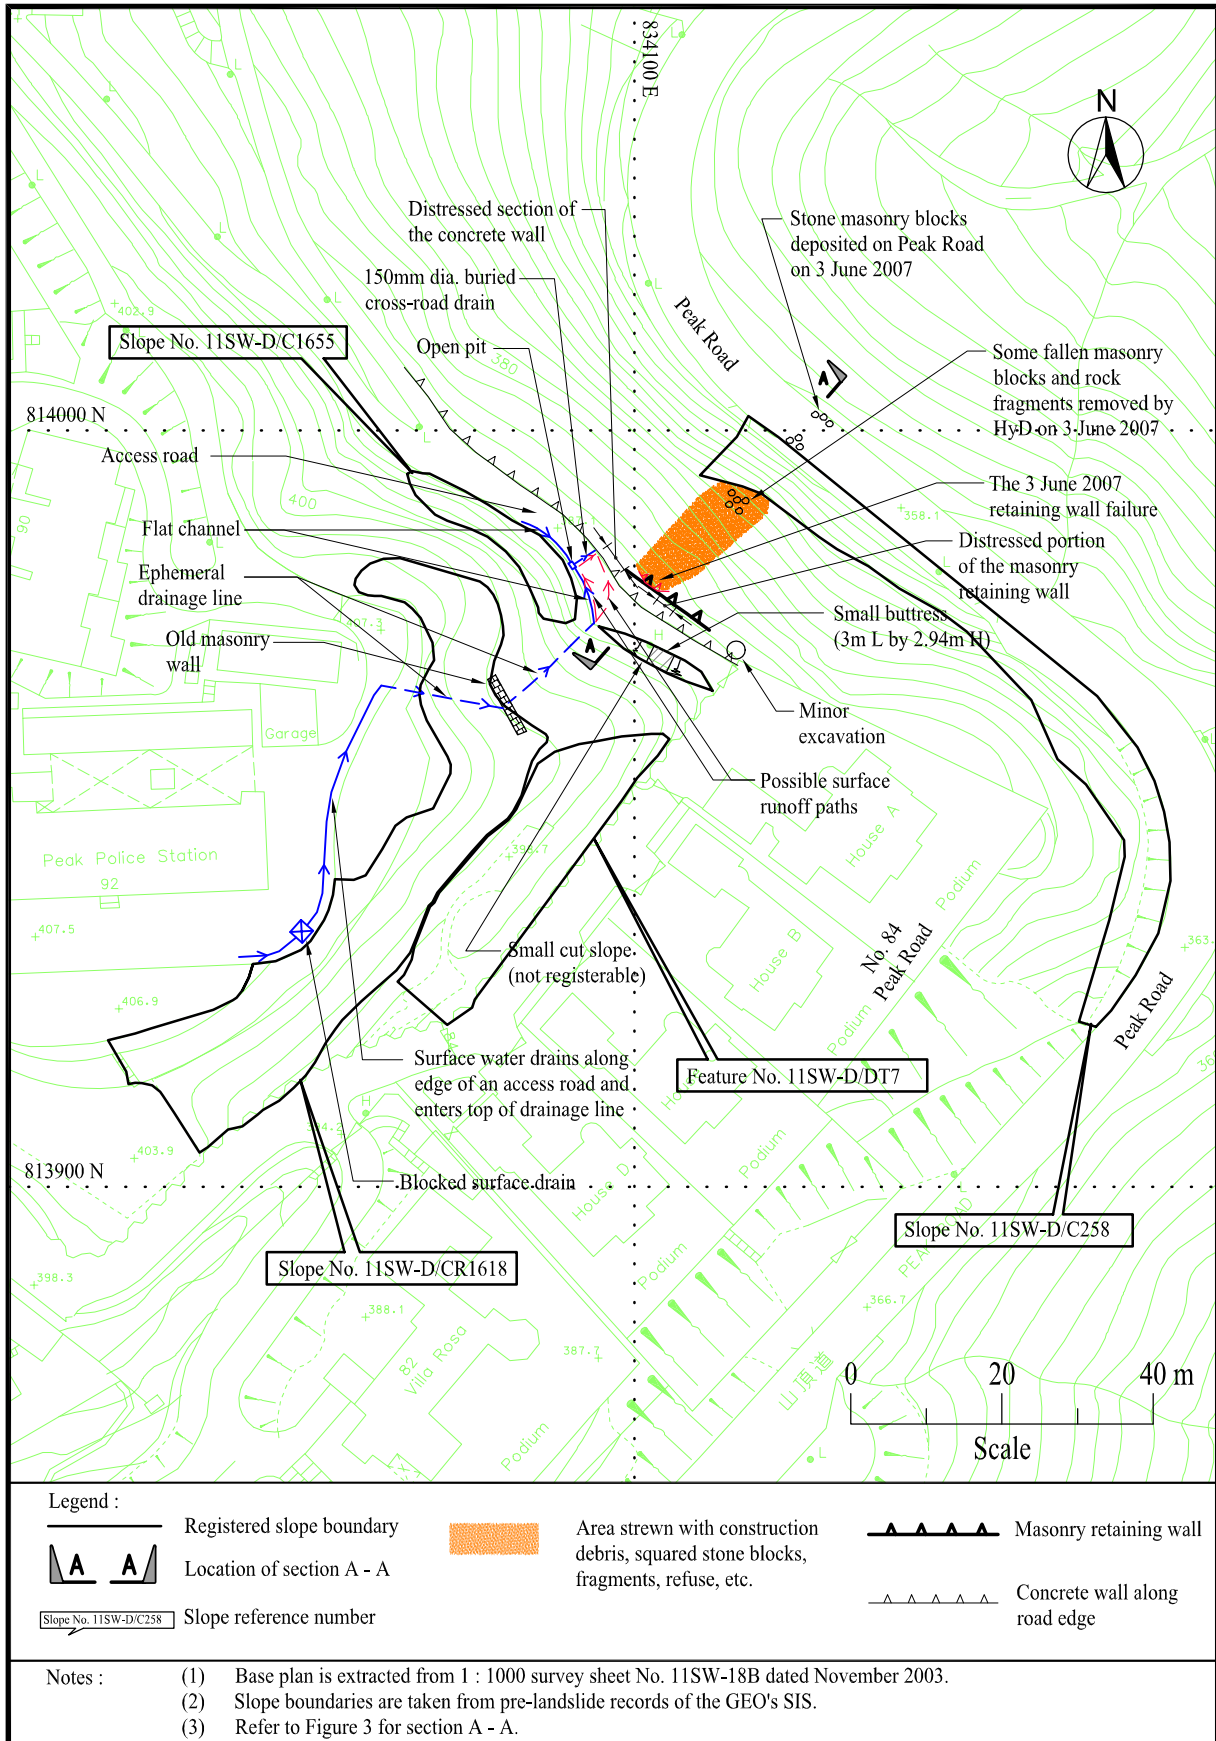
Figure 6 - Observations after the 3 June 2007 Failure

A 4.7 m wide section of the masonry retaining wall immediately to the southeast of the failure scar was found to be in an advanced state of severe distress (Figure 6 and Plate 10). A mature tree is present on this section of the wall with tree roots growing on the wall face and through the wall (Plate 10). Signs of bulging, together with major dislocation of stone blocks and numerous voids (e.g. a 1.2 m wide by 1.5 m high by 0.5 m deep void was located on the wall face), were observed near the wall toe.

No signs of settlement or significant cracking were observed on the pavement of the access road above the masonry wall. However, two linear cracks were observed across the road (Figure 6, and Plates 12 and 13) located on either side of the landslide site. Both cracks were about 1 mm to 3 mm wide. The crack at the northern part of the site extends to the concrete upstand on the downslope edge of the road (Plate 12), and connects to the side of a WSD manhole cover, which suggests that the crack may possibly be associated with previous construction work related to the water main. The crack to the south of the failure could be associated with cable laying activities related to an old street lamp on the upslope edge of the road (Plate 13). The cracks did not exhibit any obvious vertical displacement.

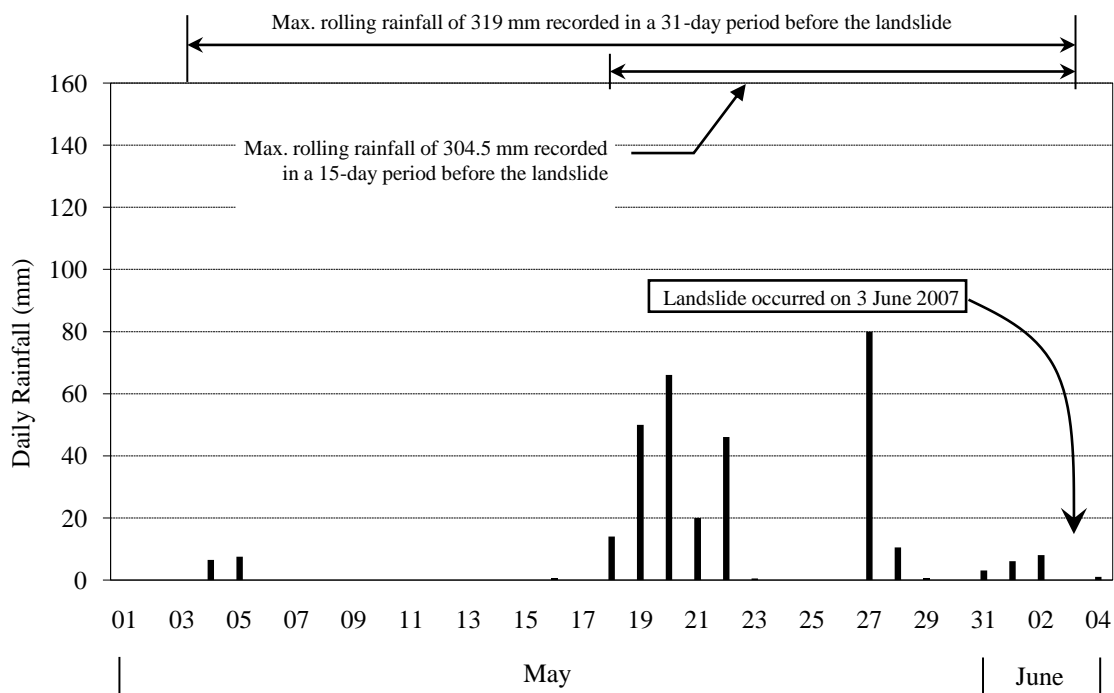
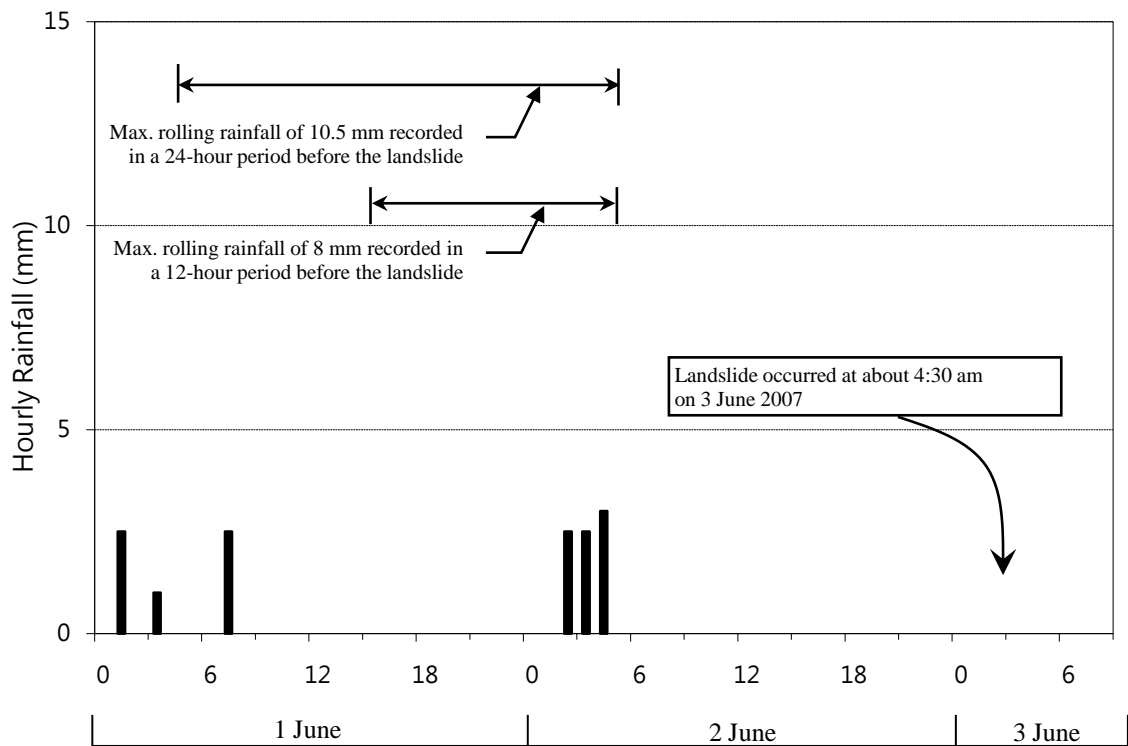
Figure 7 - Daily and Hourly Rainfall Recorded at GEO Raingauge No. H16

According to the incident report prepared by the GEO, the failure occurred at 4:30 a.m. on 3 June 2007. The daily rainfall recorded by raingauge No. H16 over the month preceding and one day following the incident, together with the hourly rainfall readings for the period between 1 June 2007 and 3 June 2007, are presented in Figure 7. The rainfall before the

failure of the masonry wall was not heavy. It is noted that there was no rainfall within the 24-hour period preceding the landslide incident.

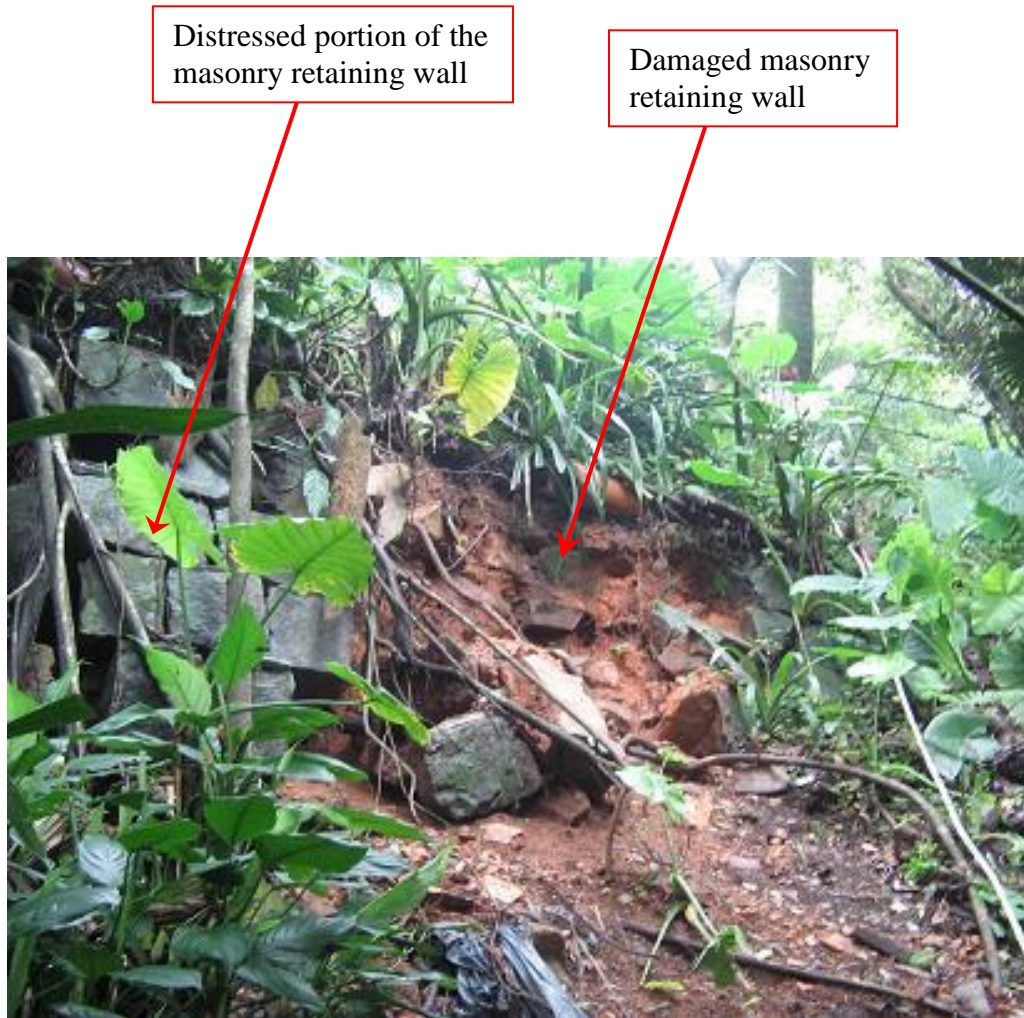
Plate 1 - The 3 June 2007 Retaining Wall Failure  
(Photograph taken on 11 June 2007)

At about 4:30 a.m. on 3 June 2007, a failure (Incident No. 2007/06/0020) occurred at a masonry retaining wall<sup>1</sup>, which is located on the hillside adjacent to No. 84 Peak Road (Figure 1, and Plates 1 and 2). The failure involved the detachment of six large stone masonry blocks (with maximum dimensions of 0.47 m by 0.3 m by 0.3 m), and about ten smaller stone masonry blocks (with dimensions of <0.1 m by 0.1 m by 0.1 m) from the northwest portion of the wall. Some of the detached stone masonry blocks were deposited on the hillside and some came to rest on Peak Road. One lane of Peak Road was closed temporarily and no casualties were reported as a result of the failure.

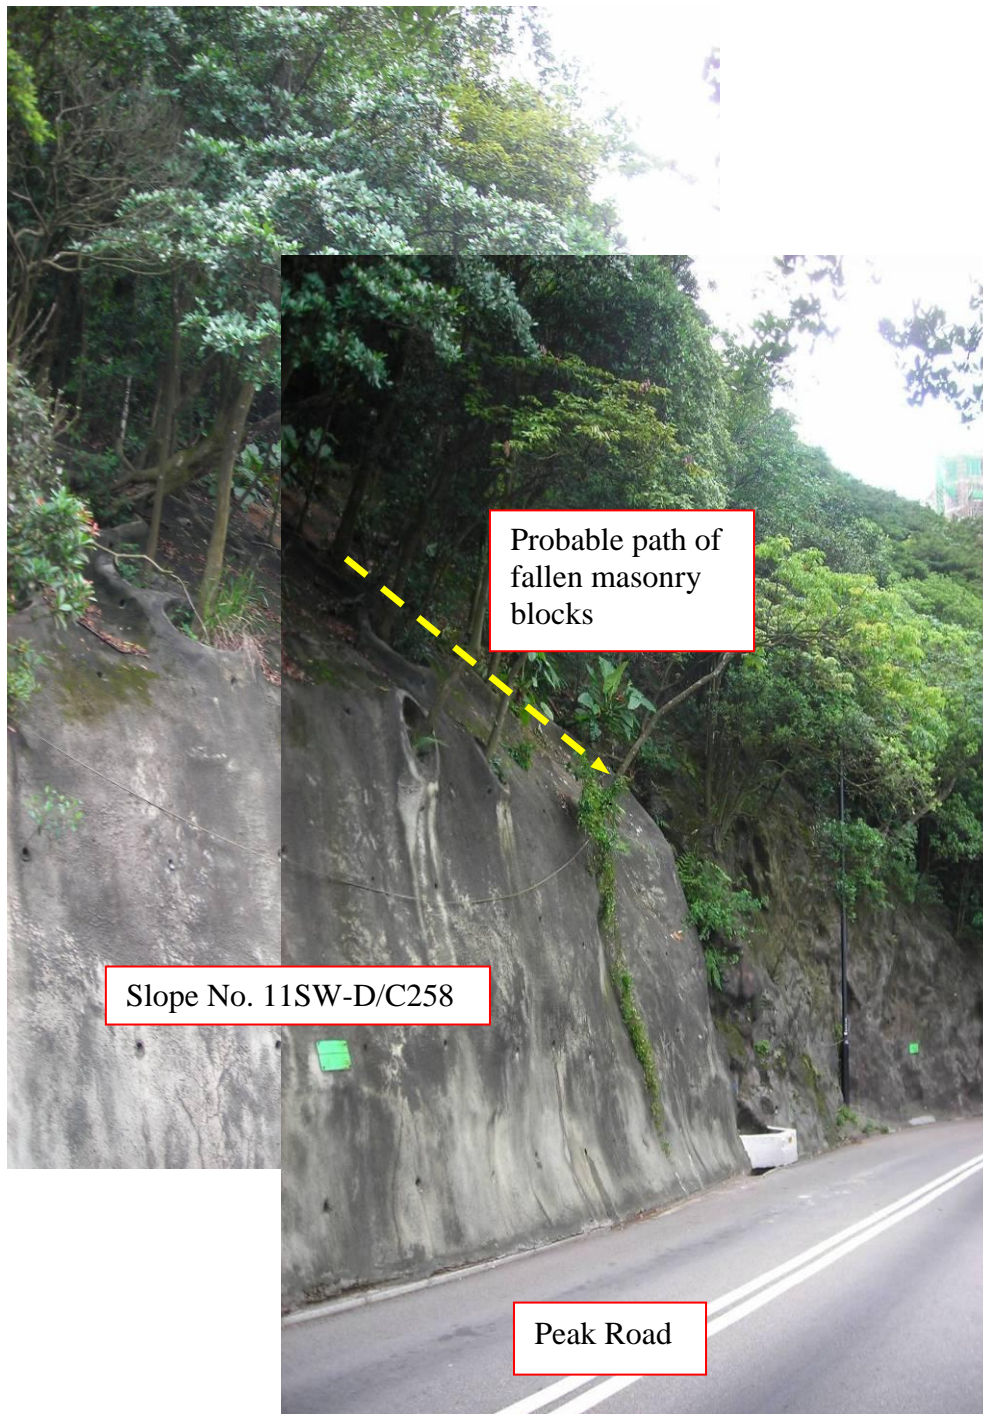
Plate 2 - Slope No. 11SW-D/C258 and the Hillside above  
(Photograph taken on 4 June 2007)

Slope No. 11SW-D/C258 is a northeast- and east-facing cut slope above Peak Road (Figures 1 and 2, and Plate 2), and is located below the failed masonry retaining wall. It is about 104 m long, up to 14 m high and 65° (on average) steep (Figure 3). Overlying slope No. 11SW-D/C258 is an 18 m high, 35° steep hillside, which is covered with dense vegetation comprising grass, shrubs and mature trees (Plate 2). The toe of the failed masonry retaining wall is located at about 18 m horizontal distance and 12 m height above the crest of slope No. 11SW-D/C258. Peak Road is a single two-lane carriageway with a minimum width of 6 m.

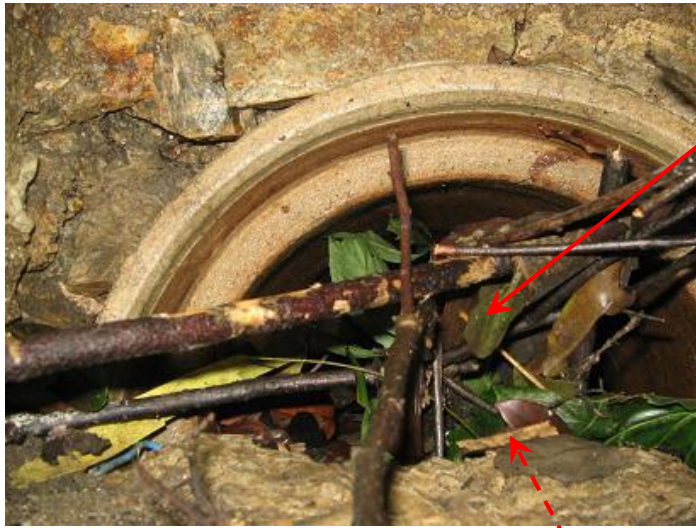
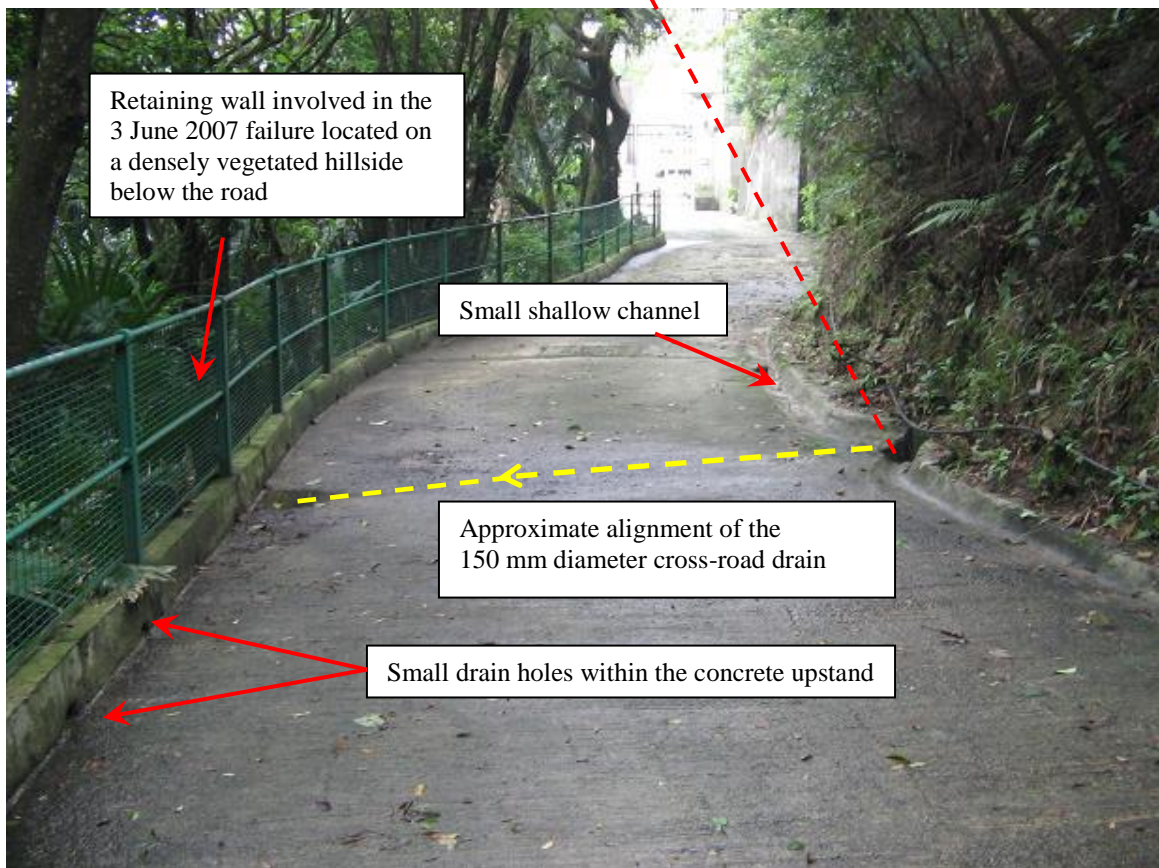
Plate 3 - Access Road above the Hillside on which the 3 June 2007 Retaining Wall Failure Occurred (Photograph taken on 11 June 2007)

A 200 mm high concrete upstand, with approximately 95 mm wide by 50 mm high drainage outlets at about 1.1 m spacing, is present along the downslope edge of the access road (Plate 3). A small, flat channel runs along the upslope edge of the access road (Plate 3), and is connected to a 150 mm diameter cross-road drain (Plate 3) through a 460 mm by 310 mm open catchpit, which discharges directly onto the hillside below the access road.

Blocked 150 mm diameter cross-road drain (viewed from inside the open catch pit)

Retaining wall involved in the 3 June 2007 failure located on a densely vegetated hillside below the road

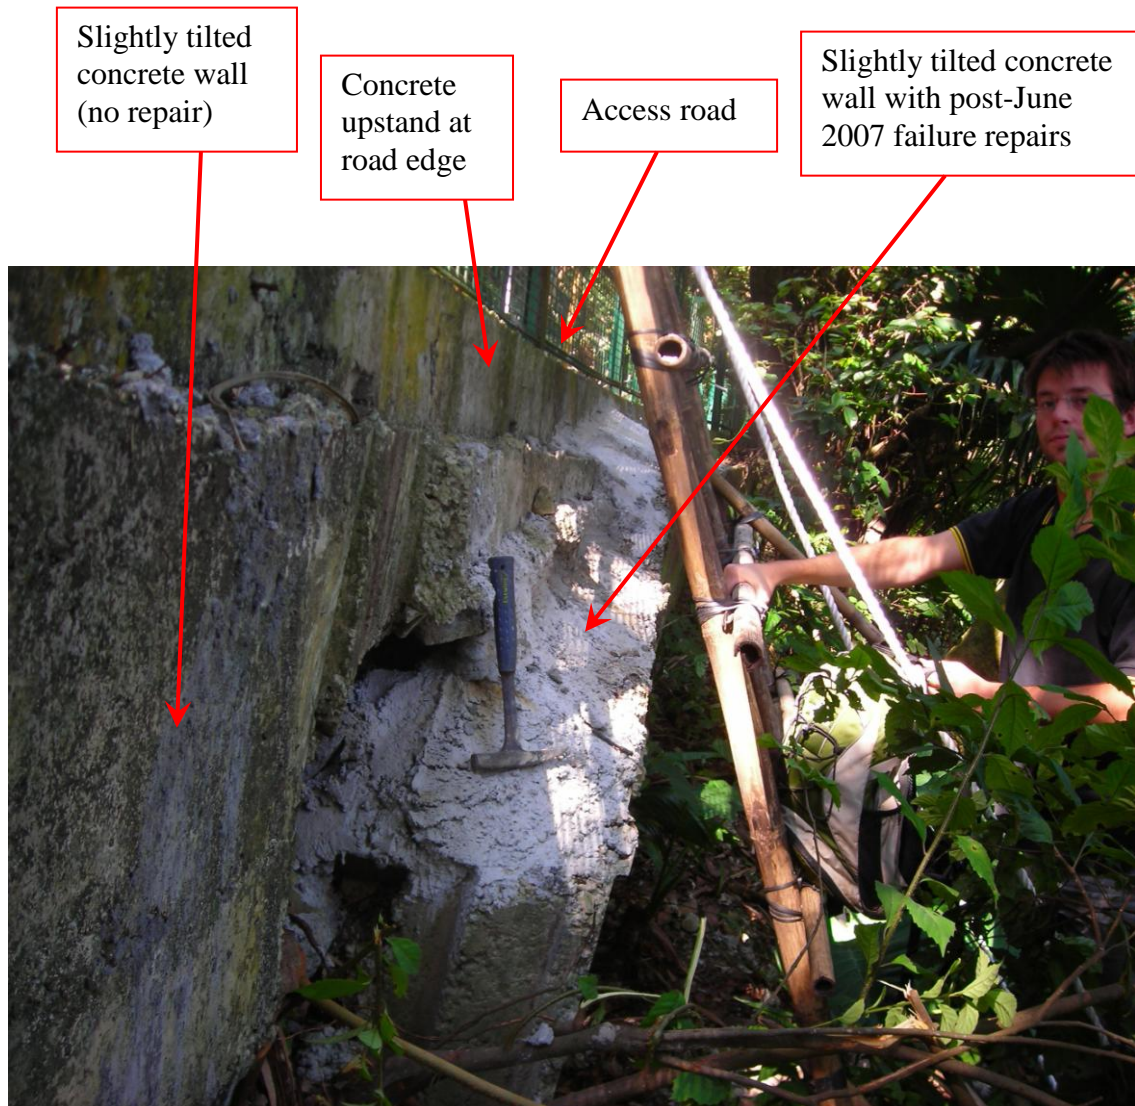
Plate 4 - Concrete Wall between the Access Road and Hillside below  
(Photograph taken on 7 November 2007)

The concrete wall located directly below the access road and above the northwestern portion of the masonry retaining wall (close to the failed portion of the wall) shows signs of distress in the form of tilting. It is not clear if this distress is associated with, or related to, the June 2007 incident. The tilting of the concrete wall is indicative of overturning wall movements. This could be caused by settlement of the ground below the concrete wall. Again, this wall was probably formed across the same ephemeral drainage line where the masonry wall below was built. Minor filling up of the drainage line (in a loose state) for the construction of this concrete wall is a possibility, where ground settlement is plausible.

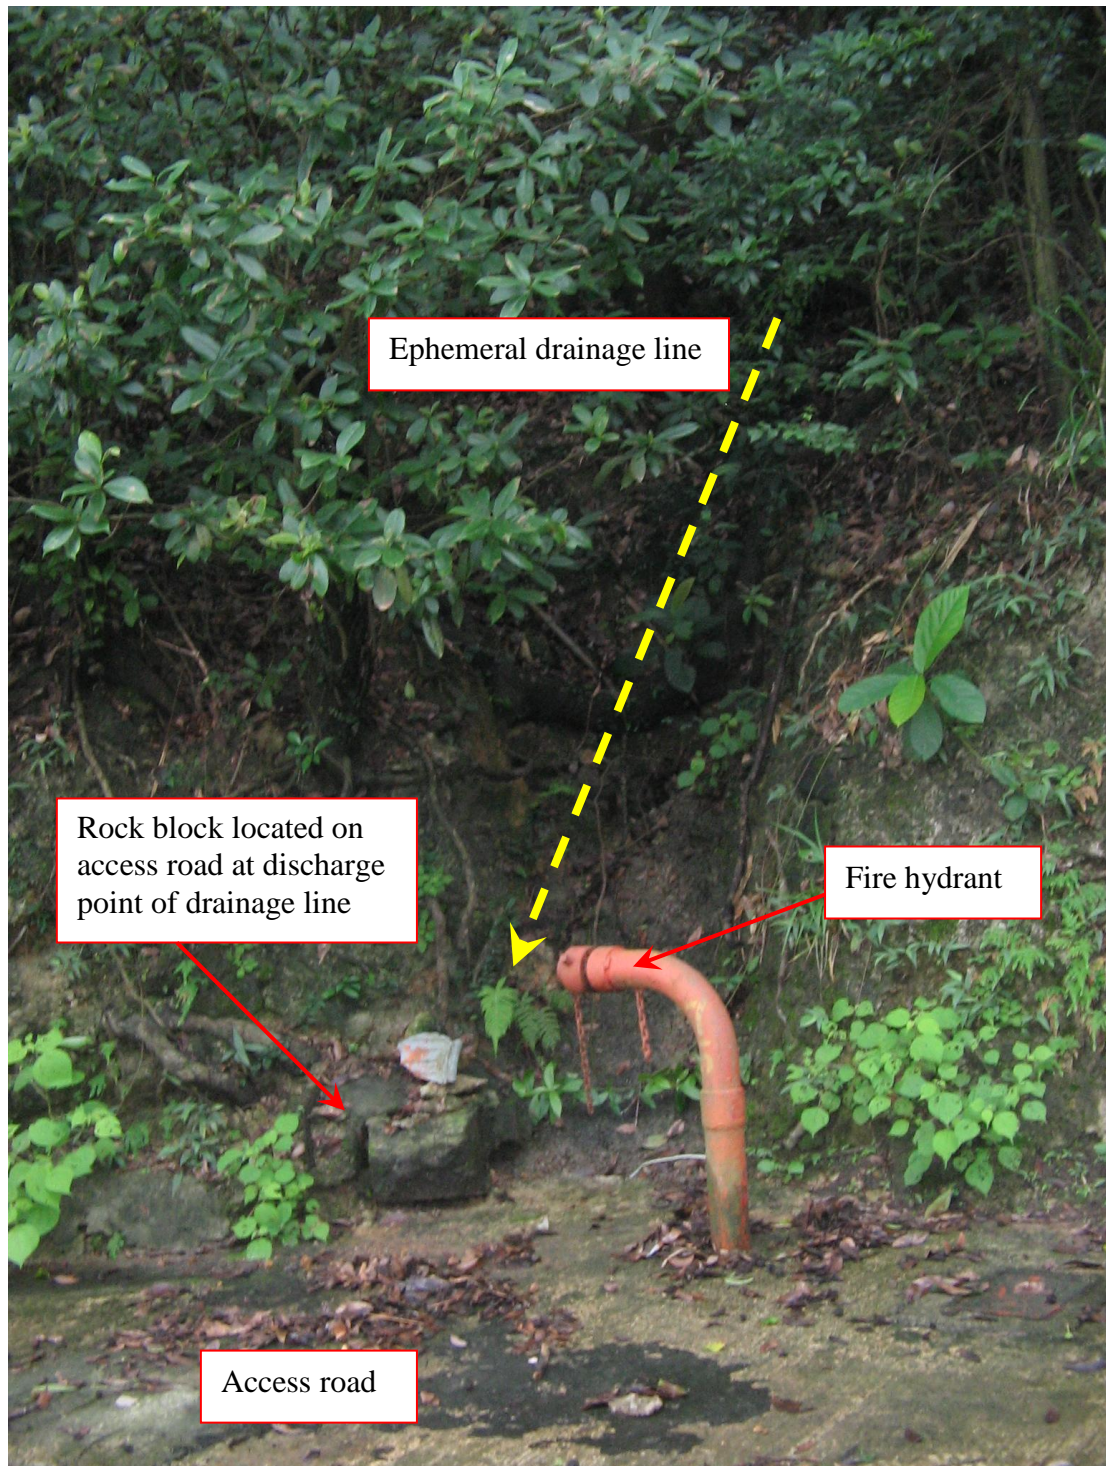
Plate 5 - Ephemeral Drainage Line which Discharges Directly onto the Access Road (Photograph taken on 11 June 2007)

An ephemeral drainage line, about 1 m wide by 0.6 m deep, is located on the upslope side of the access road (Plates 5 and 6). The drainage line discharges directly onto the access road at a location approximately opposite the masonry retaining wall that failed in the June 2007 incident (Figure 2). Surface water then appears to flow along the access road and onto Craigmin Road towards the northwest. Two cut slopes are located above the access road to No. 84 Peak Road on either side of the ephemeral drainage line (Plate 6). Slope No. 11SW-D/C1655 is a soil cut slope located to the north of the drainage line. The slope to the south of the drainage line is a 2.9 m high cut slope (i.e. does not satisfy the slope registration criteria), which is supported by a 2.94 m high and 3 m long concrete buttress in front. (Figure 2). Surface runoff enters the drainage line from the access road of the Peak Police Station at No. 92 Peak Road, which is situated at the top of a small hill above the June 2007 landslide site (Figure 2 and Plate 7). The drainage line is located on a hillside covered with trees and shrubs. At the upper part of the hillside, the surface is covered with loose fill materials, some scattered refuse and a small (about 1m high and 4 m long) masonry wall. The catchment area for the drainage line above the access road is about 1,200 m<sup>2</sup>.

The existing surface drainage provisions on the access road above the subject masonry retaining wall was probably inadequate at the time of the incident, in that the ephemeral drainage line located on the upslope of the access road discharged directly onto the access road. However, given the presence of a 200 mm high concrete upstand at the downslope side of the access road and the light antecedent rainfall at the time, it is highly unlikely that significant surface water could have overtopped from the access road onto the hillside below, thus contributing to the masonry wall failure. However there is a slight chance that overtopping could have occurred during periods of heavy rainfall in the past.

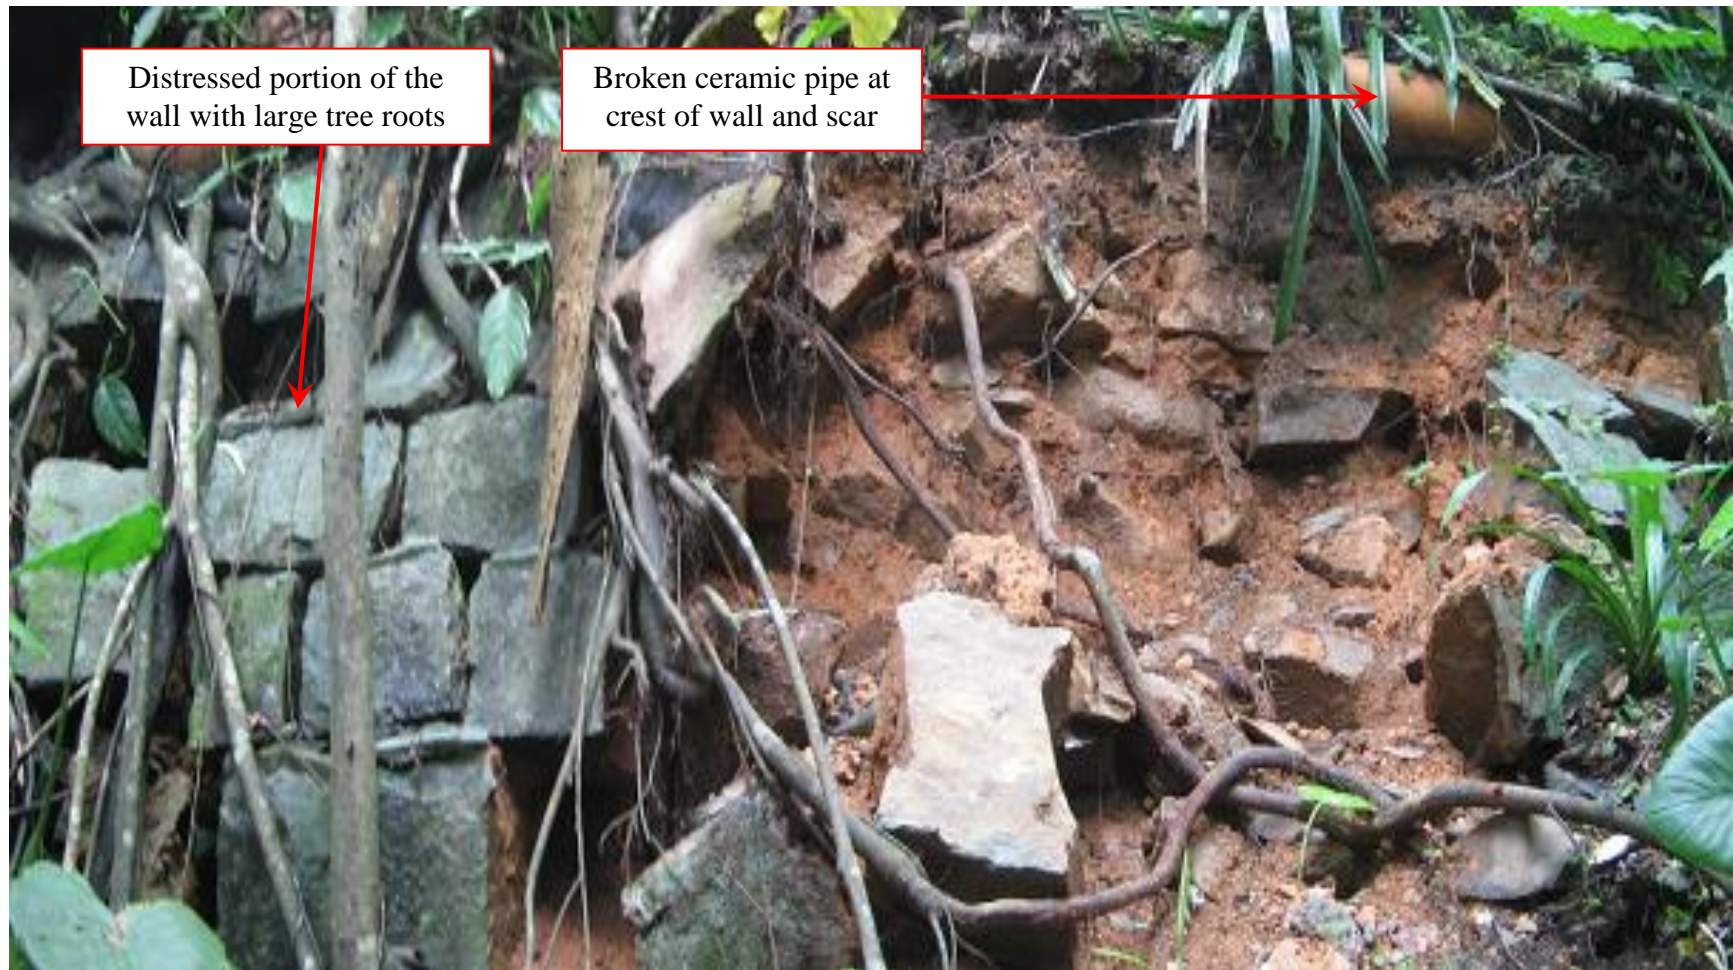
Plate 8 - Failure Scar on the Squared Masonry Retaining Wall  
(Photograph taken on 11 June 2007)

A section of a 150 mm diameter broken ceramic pipe is partly exposed along the crest of the masonry retaining wall (Plate 8). The function of the pipe is not clear. The pipe was dry at the time of FSW's inspections, suggesting that it had been abandoned.

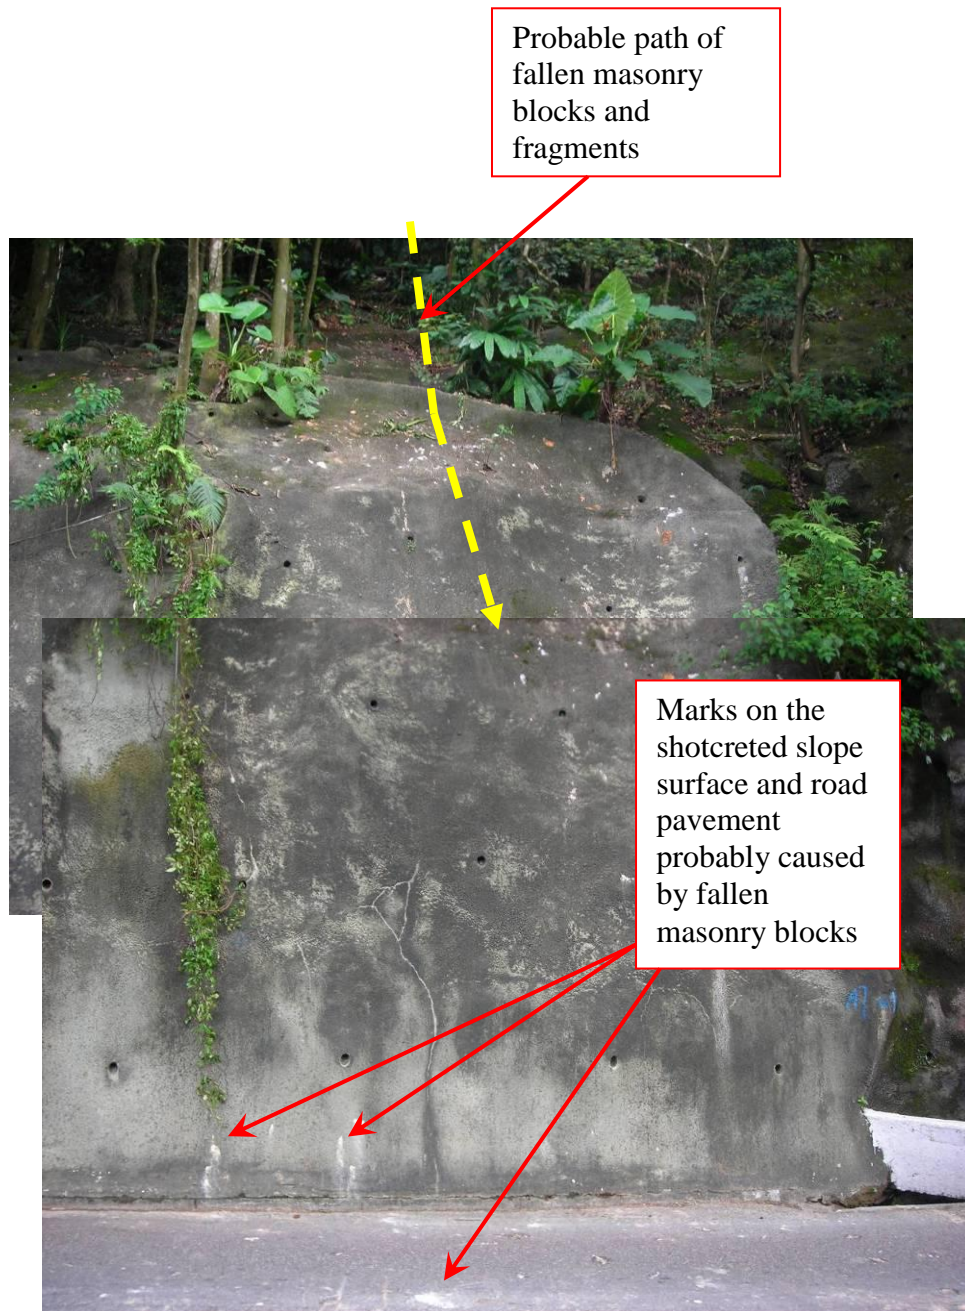
Plate 9 - View of the Marks on the Slope Surface and Road Pavement Probably Caused by the Impact of Fallen Masonry Blocks and Fragments  
(Photograph taken on 4 June 2007)

The landslide debris deposited on Peak Road had been removed by the HyD before the site was first visited by FSW on 4 June 2007. Imprints resulting from the impacts by the fallen blocks were observed on the sprayed concrete surface of slope No. 11SW-D/C258 and on the road pavement (Plate 9).

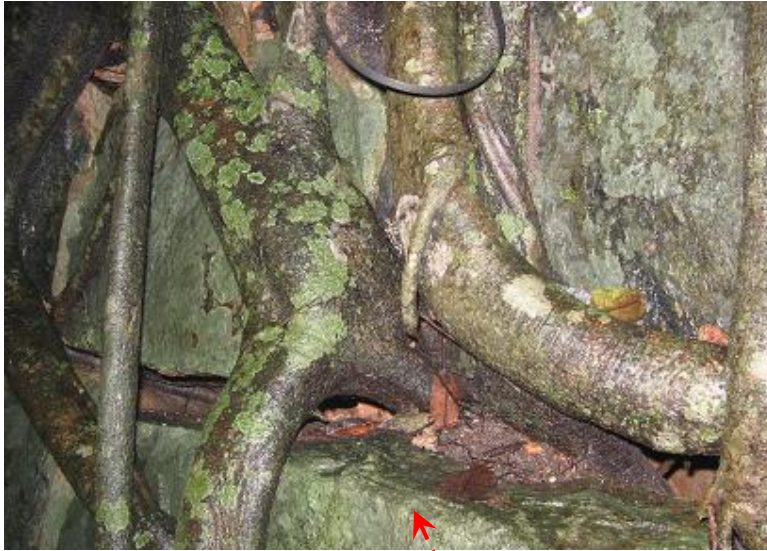
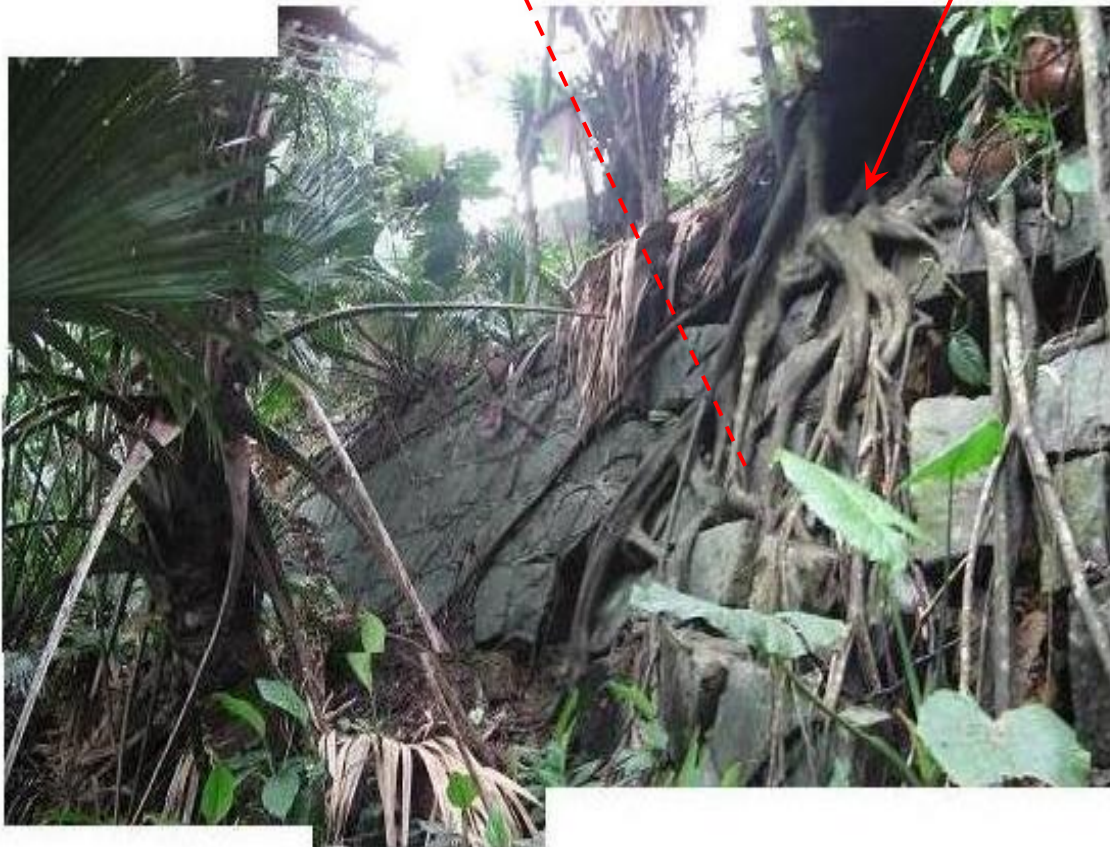
Plate 10 - Portion of the Masonry Retaining Wall  
in an Advanced State of Distress  
(Photograph taken on 13 June 2007)

Part of the unfailed portion of the retaining wall shows significant signs of distress in the form of bulging of the wall face, and there are numerous tree roots covering parts of the wall and in between some of the masonry blocks. In addition, some of the masonry blocks are absent from the wall face along the unfailed portion. The missing blocks could have been dislodged by previous wall movements. Some roots have penetrated behind the front face and between the masonry blocks, probably giving rise to wedging actions from the roots.

Large tree and  
extensive tree  
roots at crest and  
draped over the  
face of the wall

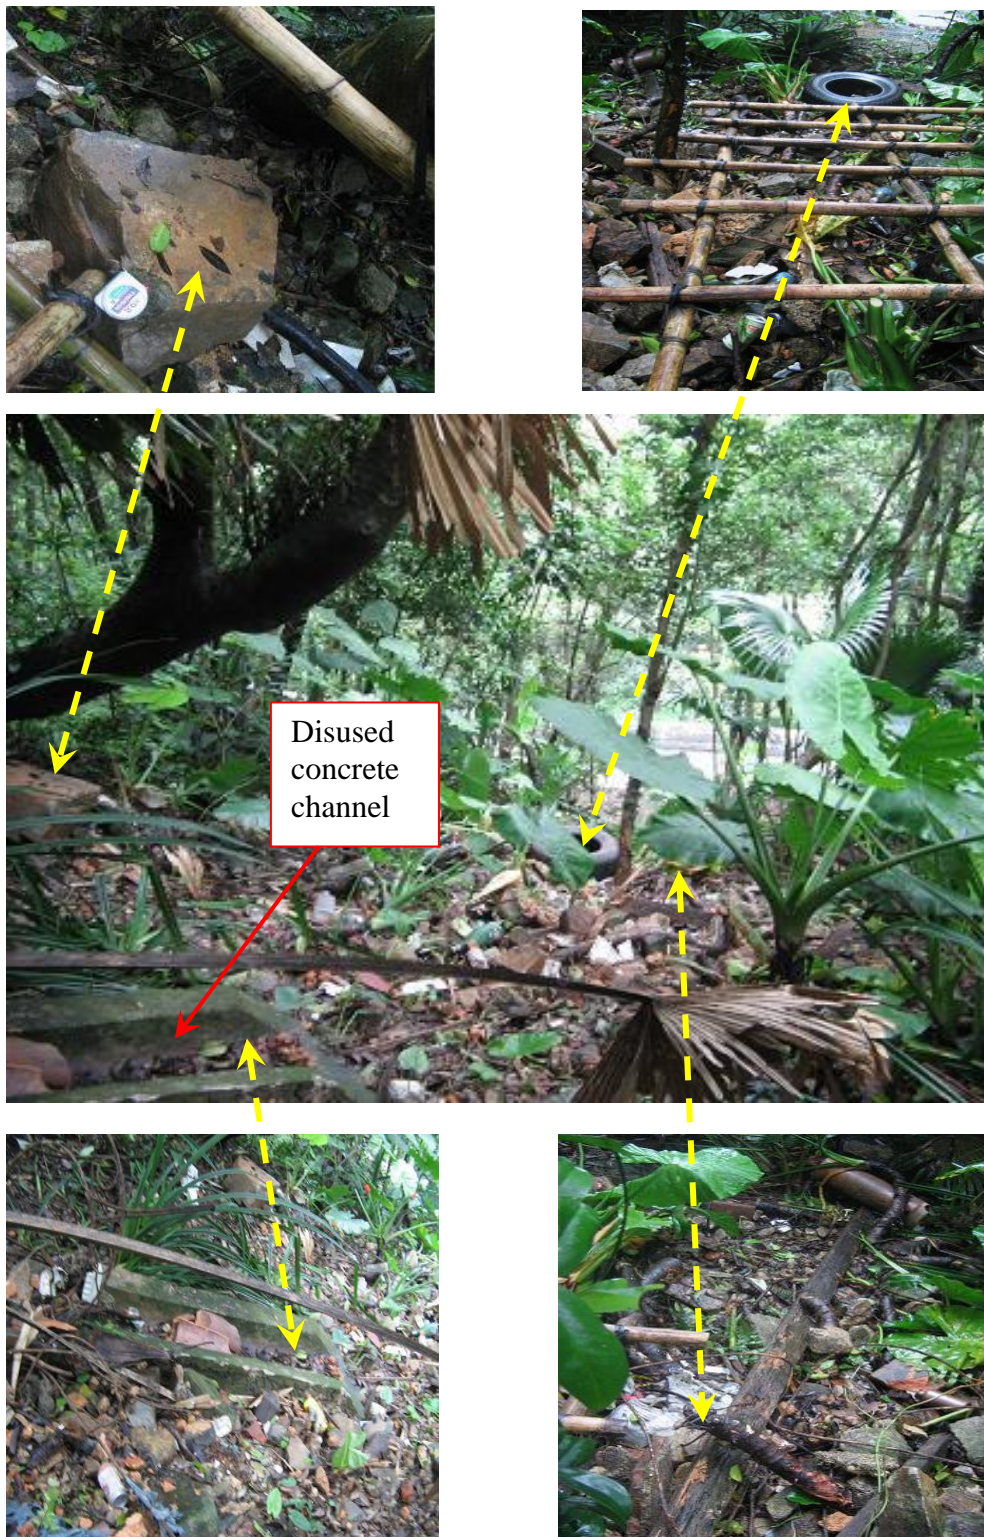
Plate 11 - Hillside below the Failure Scar Strewn with Construction Debris, Refuse and Rock Blocks  
(Photograph taken on 4 and 11 June 2007)

The overall setting comprising an old, 2.2 m high substandard masonry wall, together with an old 1.4 m high concrete wall which exhibit signs of distress, with sloping ground probably comprising fill in between the walls, on a steep hillside at some distance above a 14 m high steep cutting is liable to pose a hazard to the road users below. The presence of loose construction debris and refuse on the steep hillside is also a potential hazard to the road users below.

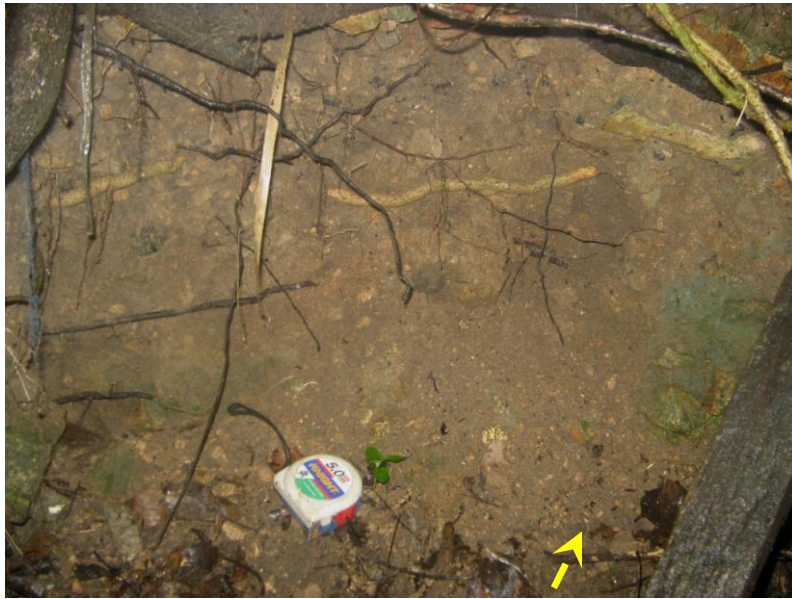
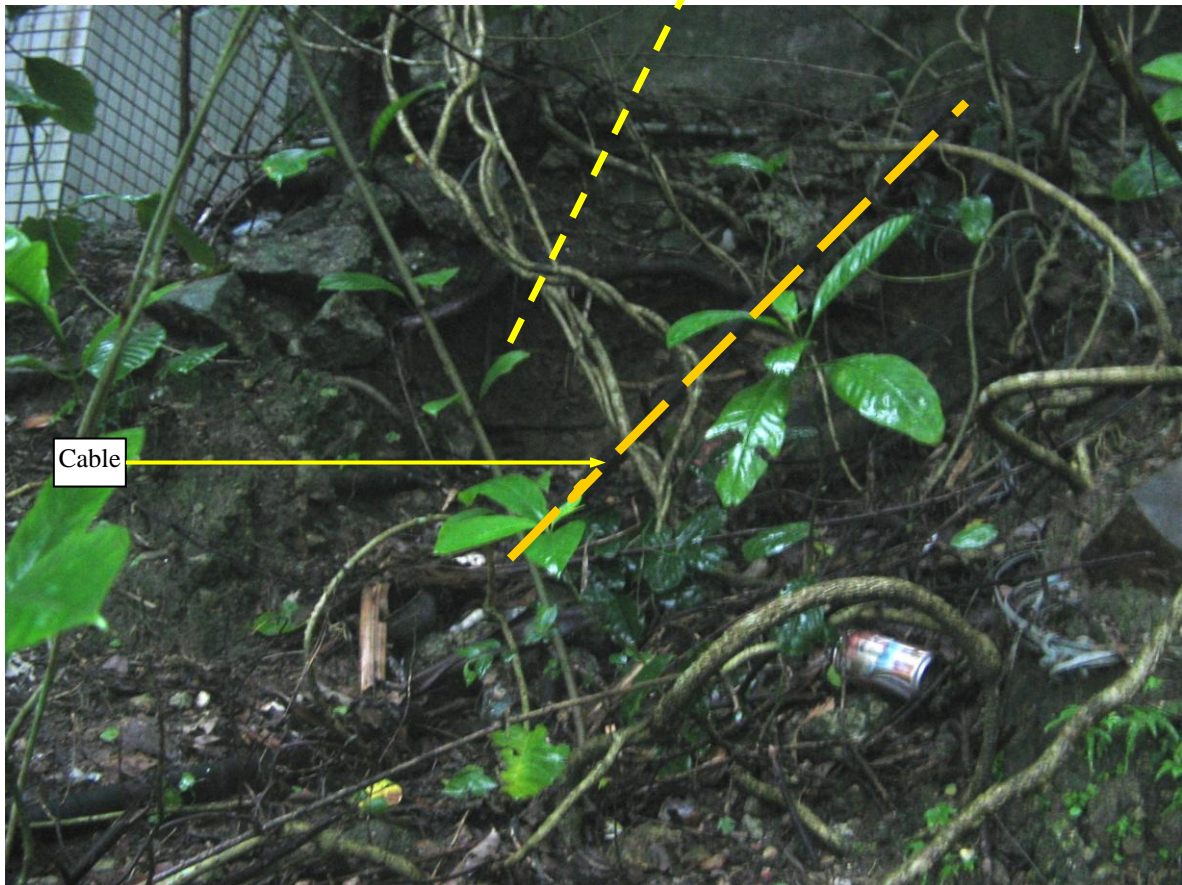
Plate 15 - Small Excavation at the Crest of the Hillside below the Entrance to House A of No. 84 Peak Road  
(Photograph taken on 13 June 2007)

A small excavation pit, with dimensions of about 1.3 m wide by 0.6 m long by 0.5 m deep, was observed at the crest of the hillside below the entrance to No. 84 Peak Road (Figure 6 and Plate 15). A cable was located through the middle of the pit, which suggests that it was man-made.
