# **REVIEW OF LANDSLIDES IN 2007**

**GEO REPORT No. 253**

**A.F.H. Ng, J.W.C. Lau & T.M.F. Lau**

**GEOTECHNICAL ENGINEERING OFFICE  
CIVIL ENGINEERING AND DEVELOPMENT DEPARTMENT  
THE GOVERNMENT OF THE HONG KONG  
SPECIAL ADMINISTRATIVE REGION**

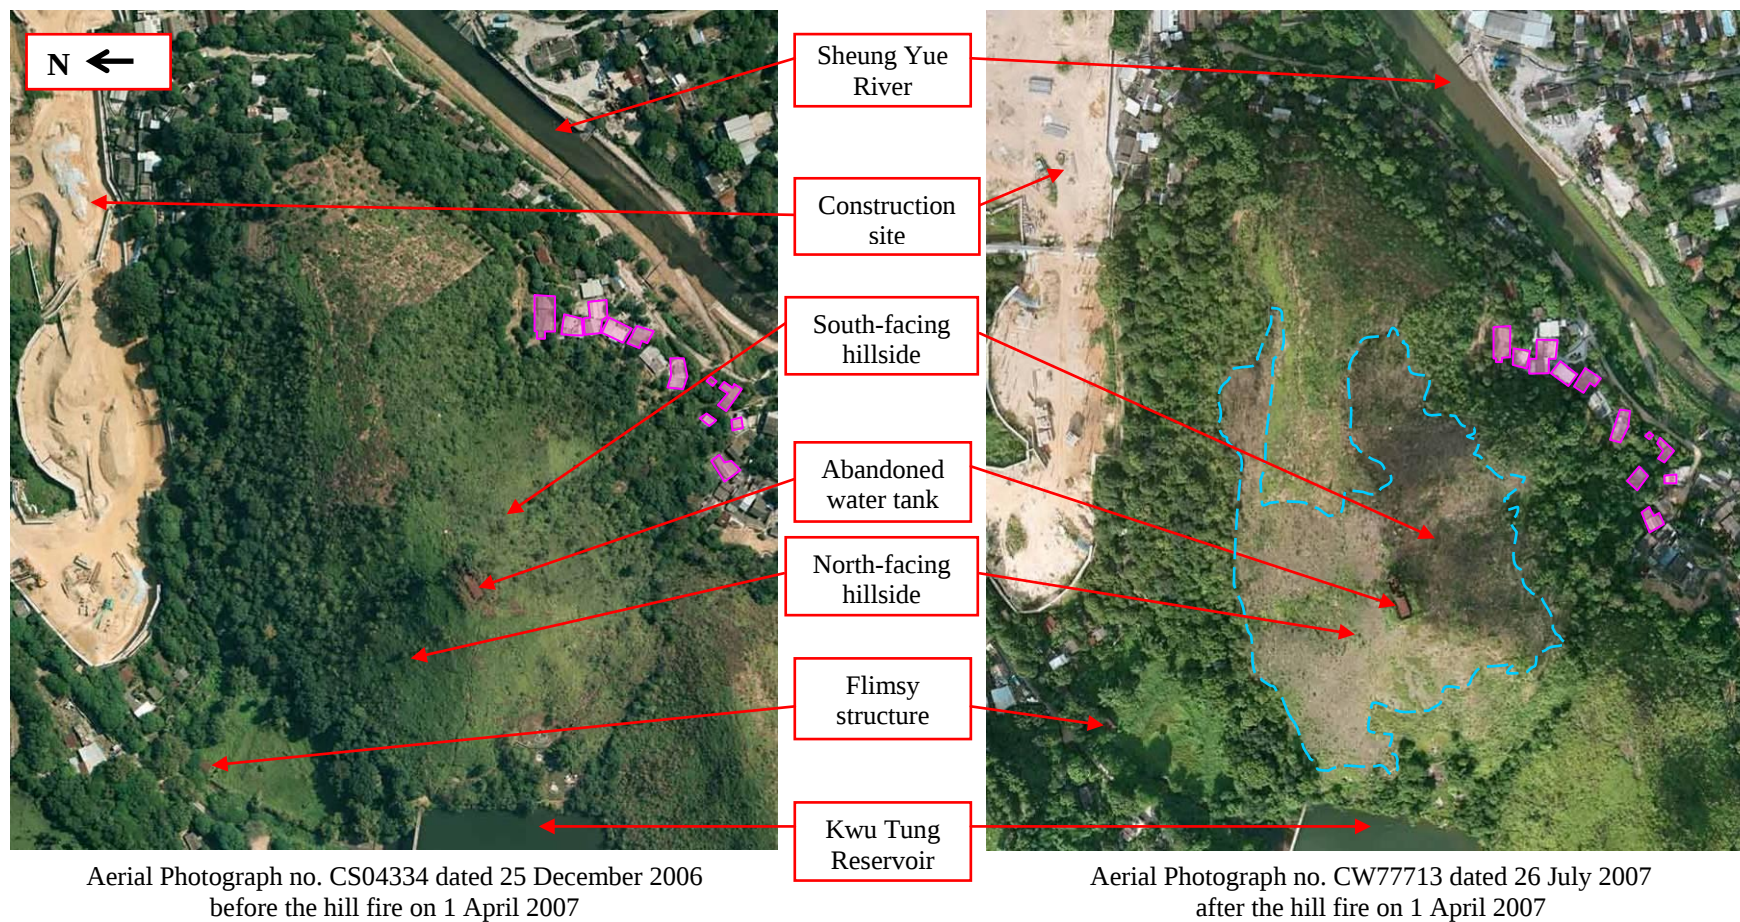
Plate 1 - Aerial View of the Distressed Natural Hillsides at East of Kwu Tung Reservoir

Major tension cracks were identified by a consultant working on a nearby development site after the dense vegetation on the north-facing and south-facing hillsides was removed by a hill fire in April 2007. A cluster of occupied squatter dwellings is located at the toe of the south-facing hillside (which is a historical landslide catchment (HLC)), whilst an abandoned farmland is located at the toe of the north-facing hillside.

The tension cracks were up to about 35 m long, 0.8 m deep with a horizontal separation of about 0.3 m. Field evidence suggests that the cracks have probably existed for quite some time before they were exposed following the hill fire. It is noteworthy that the distress on the south-facing hillside was located above a number of relict landslide scars.

Five relict landslides on the south-facing hillside are included in GEO's Enhanced Natural Terrain Landslide Inventory (ENTLI). The tension cracks are near 4 of these relict scars. Nine occupied squatter dwellings located at the toe were subjected to previous inspections by the GEO under the Non Development Clearance (NDC) Programme, 4 of which were subjected to Category 2 NDC recommendations in 1993. In light of the distress observed on the hillside, the remaining 5 squatter dwellings at the toe, together with 3 other

squatter dwellings in the vicinity of a drainage line that were similarly subjected to previous NDC inspections (also with no NDC recommendations), were recommended for Category 2 clearance in late 2007. At the recommendation of the GEO, the tension cracks were sealed up by the Highways Department as emergency works.

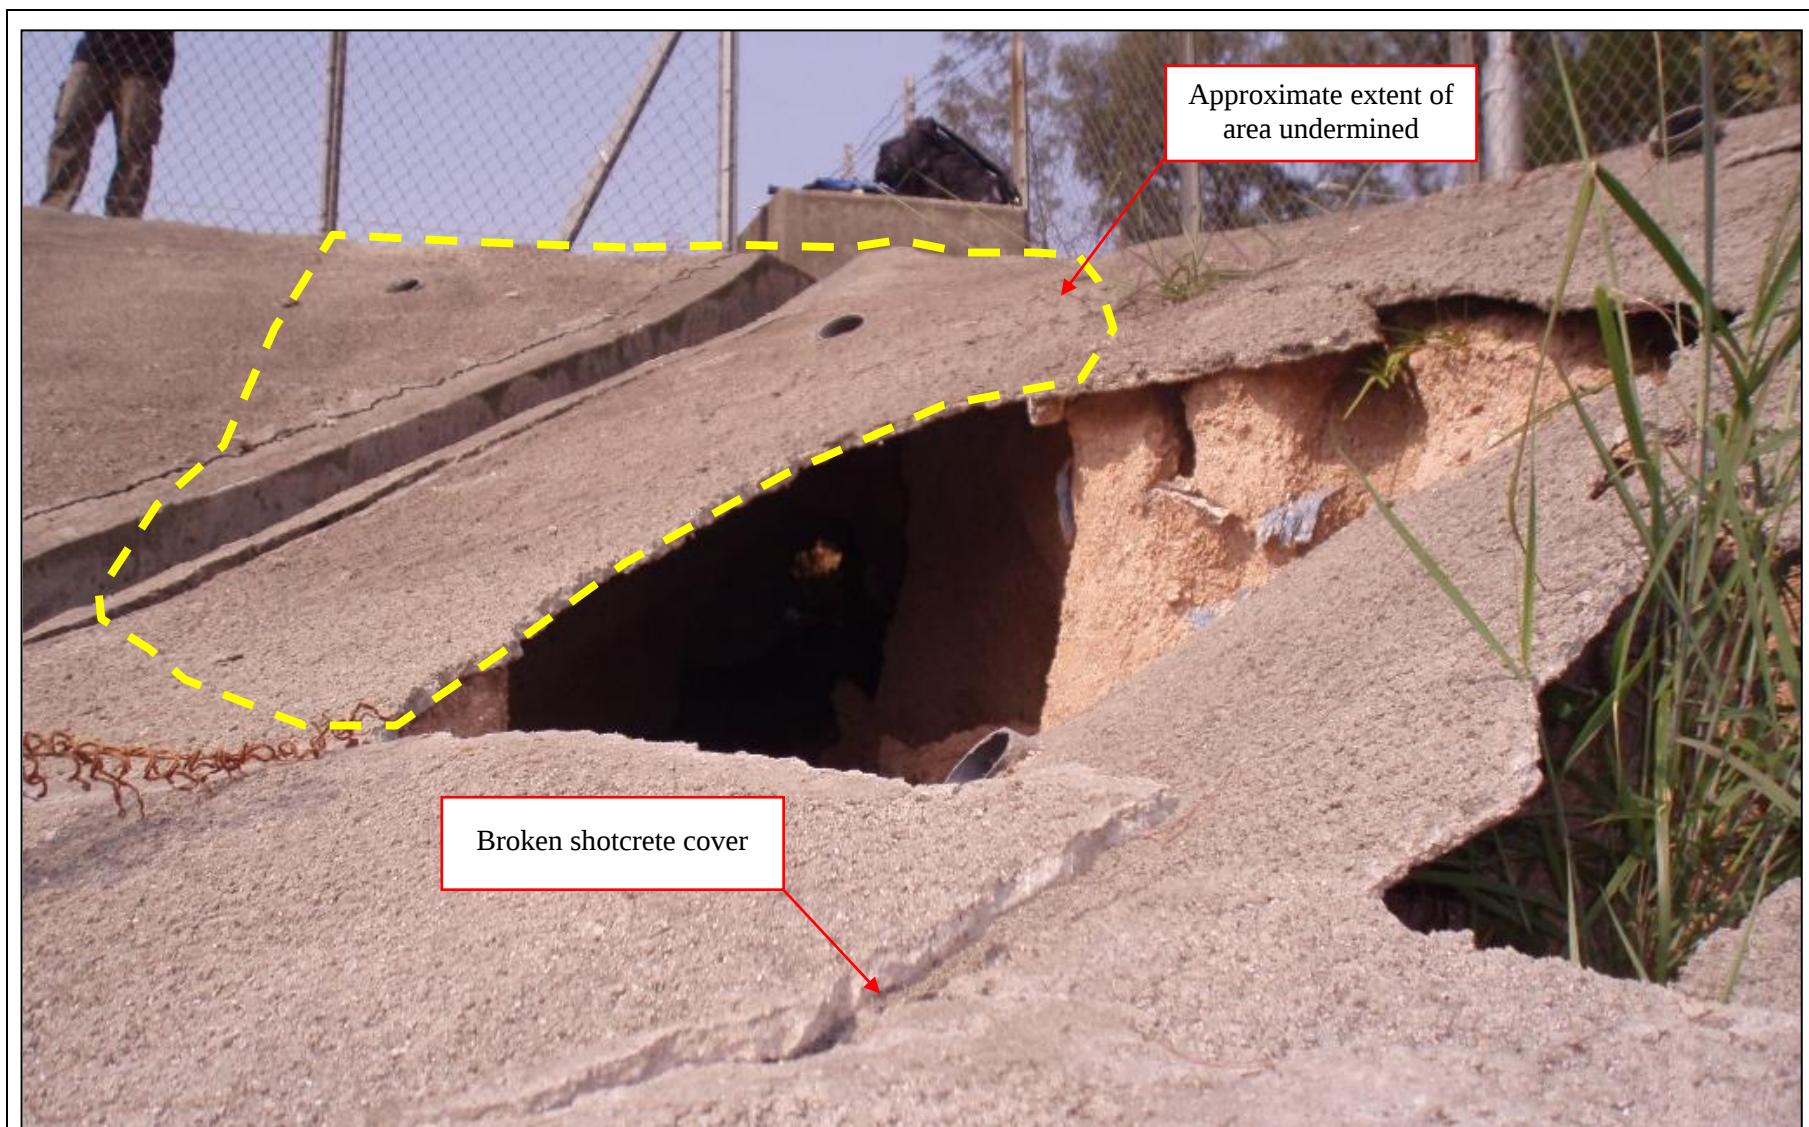
Plate 3 - The 14 November 2007 Landslide Incident at Pui Man Street

| Slope No. | Incident No. | Location | Volume (m <sup>3</sup> ) | Type of Slope | Remarks |
|---|---|---|---|---|---|
| 11NE-A/F444 | 2007/11/0070<br>(see Plate 3) | Pui Man Street,<br>Kowloon | 2<br>(erosion) | Fill | Geotechnical design, undertaken by the Housing Department, was checked and accepted by the GEO in 1999. The failure was possibly associated with uncontrolled overflow of surface water from blocked drains (severe blockage of drain, together with erosion damage to the crest platform cover, was observed in March 2007 by the maintenance department). For the incident that was reported in November 2007, uncontrolled concentrated surface water flow probably eroded part of the crest platform at a low point (at about the same location of the damaged area observed in March 2007), leading to the formation of erosion gullies on the fill slope below. |
