STUDY ON MASONRY WALLS WITH TREES

GEO REPORT No. 257

C.M. Wong & Associates Limited & C.Y. Jim

**This report was prepared by C.M. Wong & Associates Limited and C.Y. Jim in
November 2005 under Consultancy Agreement No. CE 11/2004(GE)
for the sole and specific use of the Government of the
Hong Kong Special Administrative Region**

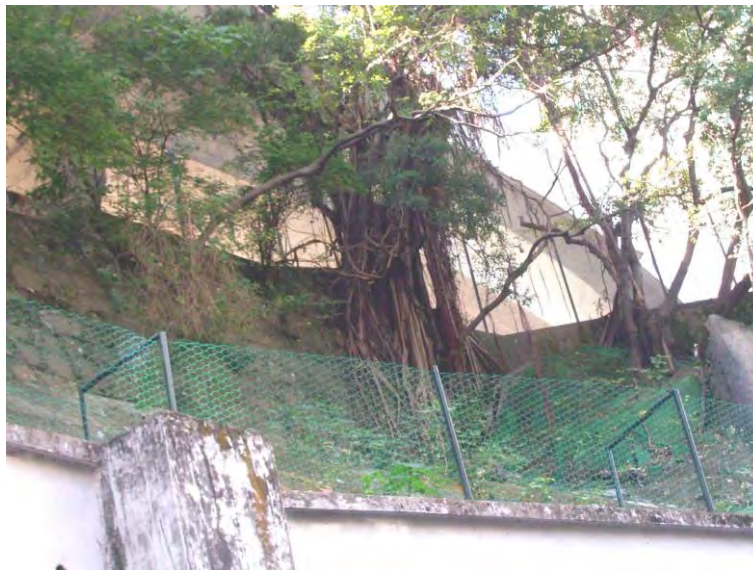
Figure 4 - Feature No. 11SW-A/FR24

Based on the landslide incident report (HK97/5/2), Feature No. 11SW-A/FR24 was a dry-packed random rubble wall. A tree was located on the wall face near the crest of the feature. The incident recorded was a non landslip case. (See Appendix B, Pages B2-B12) A tree fell down and caused localized damage to the masonry wall (two masonry blocks fell down). No signs of past instability could be found on the feature during the site inspection carried out in Nov 2004.

The incidents in Feature Nos. 11SW-A/FR24 and 11SW-A/R120, although involved or might involve falling down of masonry blocks caused by wall trees, the failures were localized and the scales were small. They were caused by failure of a tree due to its own weight or wind load, not related to the growth of tree roots.

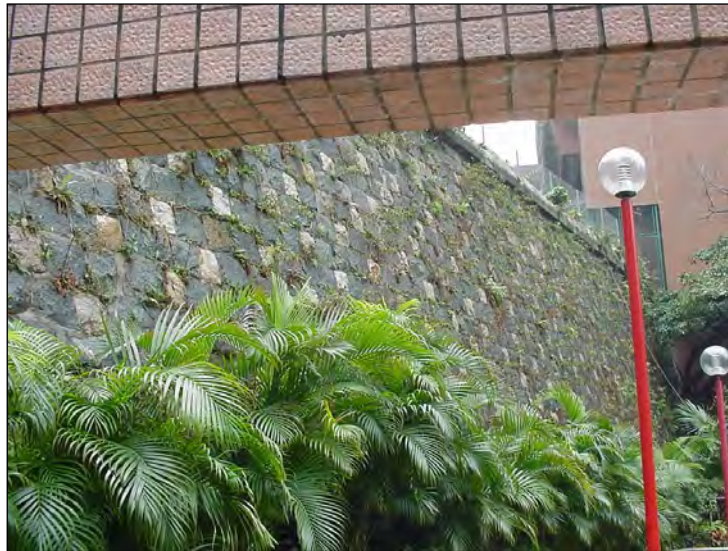
Figure 5 - Feature No. 11SW-A/R120

Photographs about the incident in Ka Wai Man Road Garden on Sep 2003 were received from LCSD. (See Appendix B, Pages B13-B29) From site inspection in Feb 2005, the fallen tree was located at Feature No. 11SW-A/R120. Minor repair works were noted on the wall. The joints between masonry blocks at the location of the fallen tree were repaired by cement mortar.

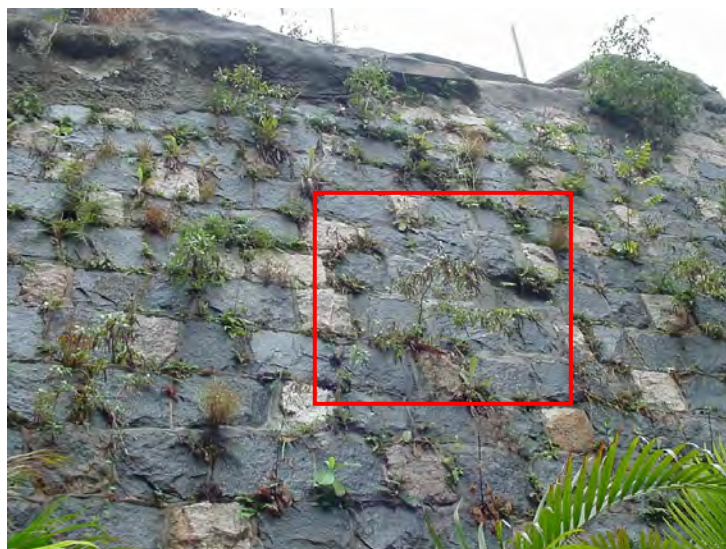
Figure 6 - Joints between Masonry Blocks at the Location of Fallen Tree were Repaired

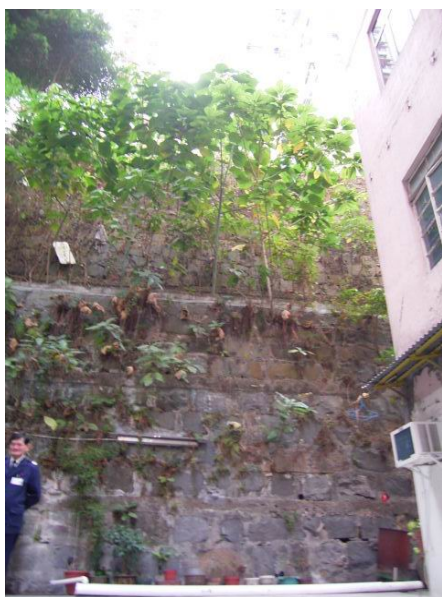
Figure 7 - Feature No. 11SW-A/R751

Based on the landslide incident report (HK1999/8/4) of Feature No. 11SW-A/R751, the incident recorded involved a fallen tree only. (See Appendix B, Pages B30-B38) The masonry retaining wall was not failed. Although trees were found on the wall face of the feature, the incident report indicated that the tree fallen was located behind the crest of the feature. Therefore, this incident did not involve any wall trees. No signs of past instability could be found on the feature during the site inspection carried out in Nov 2004 and Feb 2005.

Photographs about the incident in Clarence Terrace Children's Playground were received from LCSD. (See Appendix B, Pages B39-B40) From the photos and site inspection carried on Feb 2005, the fallen tree was likely to be located at the children's playground behind the crest of Feature No. 11SW-A/R751, not on the wall. No incident records in 1999 at Feature No. 11SW-A/R751 could be found in GEO. As the photographs did not indicate any wall failure and no landslide incident report of the wall were found in GEO, it appears that this incident involved fallen tree only. The masonry wall did not fail.

The failure of the wall tree on Feature No. 11SW-B/R735 did not cause any wall failure. The trees that failed near Feature No. 11SW-A/R751 were not actually wall trees per se. The incidents in Feature Nos. 11SE-A/C897 and 11NW-B/C321 did not involve masonry walls and thus are not related to this study.

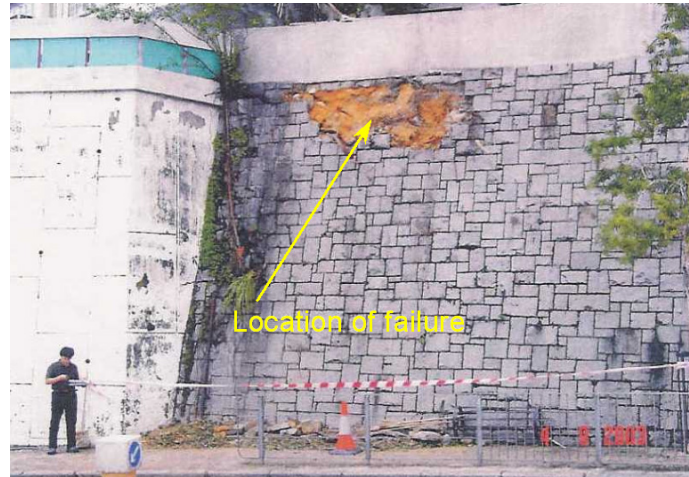
Based on the landslide incident report (HK2003/9/0180) of Feature No. 11SE-A/C897, stone pitching blocks near the crest of wall were pulled down by a tree uprooted by strong wind. However, the tree causing the failure was located behind the crest of the feature (See Appendix B, Pages B41-B50) and the feature was a cut slope, not a retaining wall. The

stone pitching blocks were a facing only. Therefore, this incident did not involve any wall trees and wall failures. The stone blocks were pulled down by a tree uprooted by strong wind not associated with the growth of the tree roots.

Figure 9 - Photo Extracted from Landslide Incident Report (HK2003/9/0180)

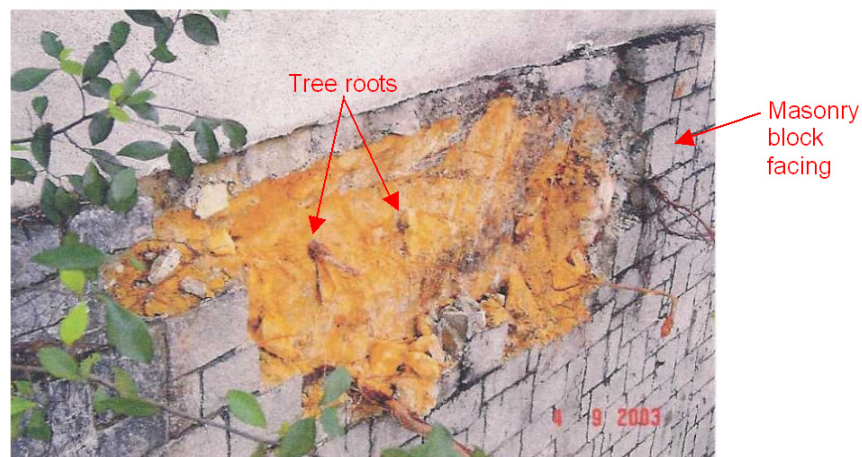
Figure 10 - Photo Extracted from Landslide Incident Report (HK2003/9/0180)

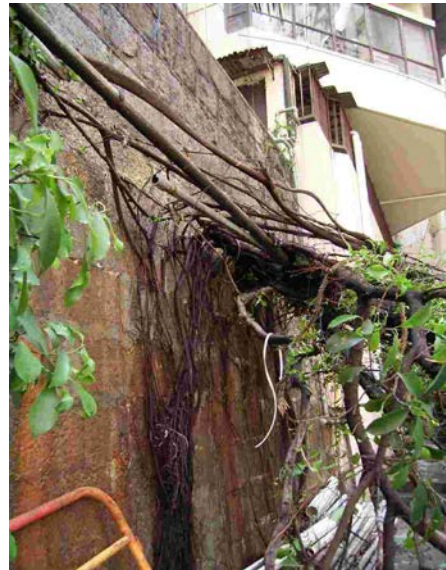
Based on the newspapers, a wall tree on Feature No. 11SW-B/R735 failed on 9 Aug 2005. Site inspection was carried out on 10 Aug 2005. The masonry wall was not damaged.

Figure 11 - Tree failure on Feature No. 11SW-B/R735

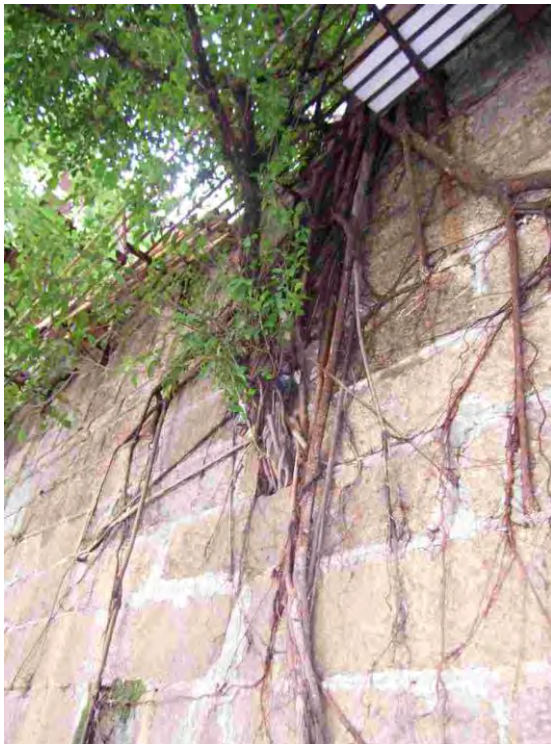
Figure 12 - Wall Tree with Weak Anchorage between Roots and Wall

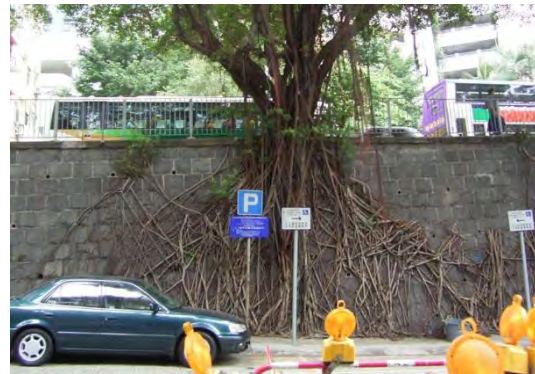
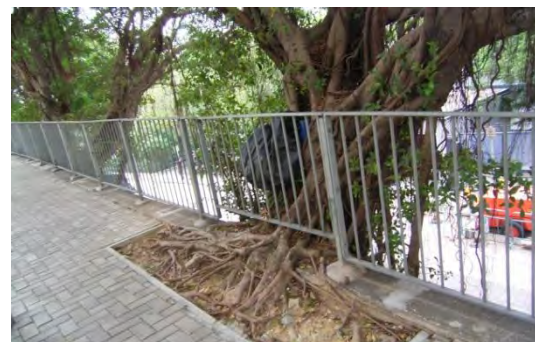
Figure 13 - Wall Tree with Strong Anchorage between Roots and Wall

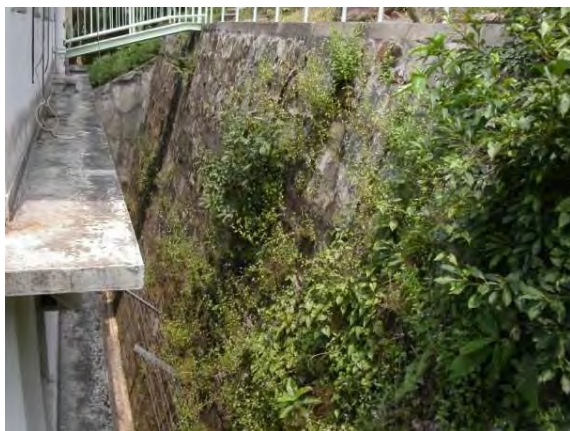
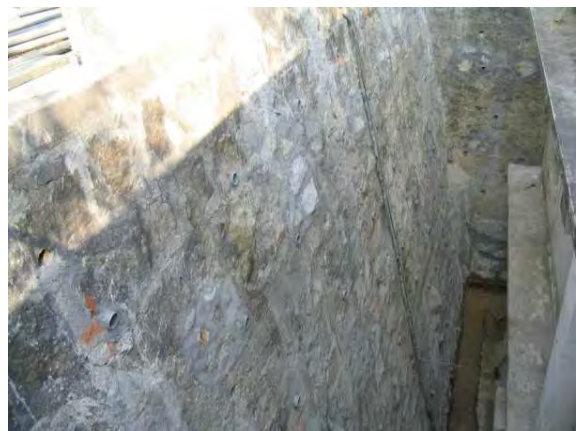
Figure 15 - Feature No. 11SW-A/R1086 before and after Upgrading Works Using Soil Nails

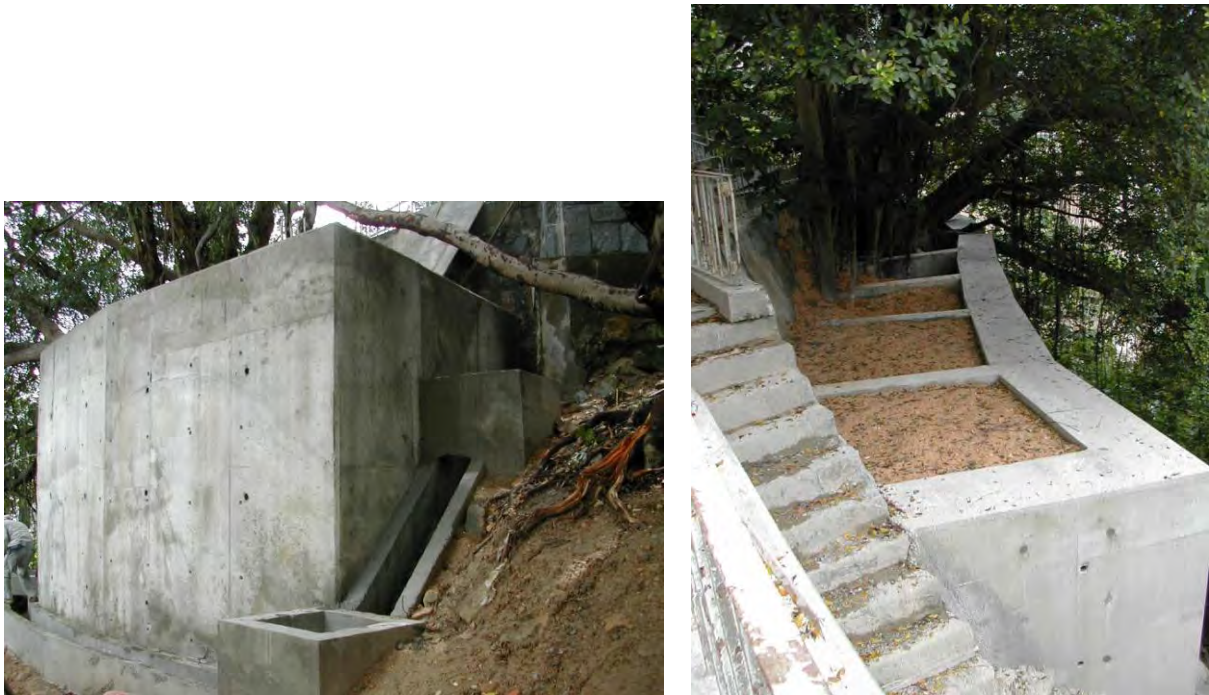
Figure 16 - Feature No. 11SW-C/R476 Upgraded Using Soil Nails, L-shaped Wall and Planter

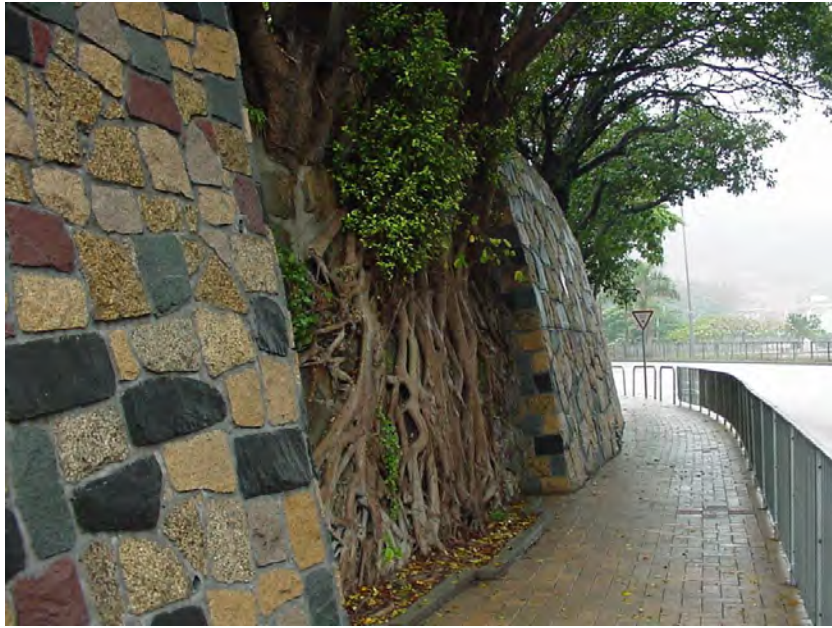
Figure 17 - Feature No. 11SW-C/R38 Upgraded Using Mass Concrete Wall and Finished with the Old Granite Blocks

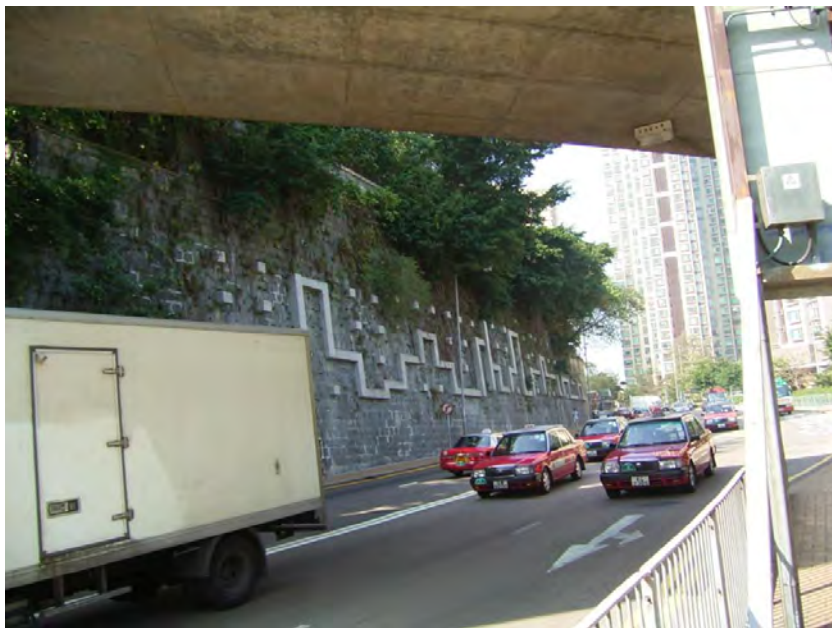
Figure 18 - Feature No. 11SW-A/R346 Upgraded Using Soil Nails

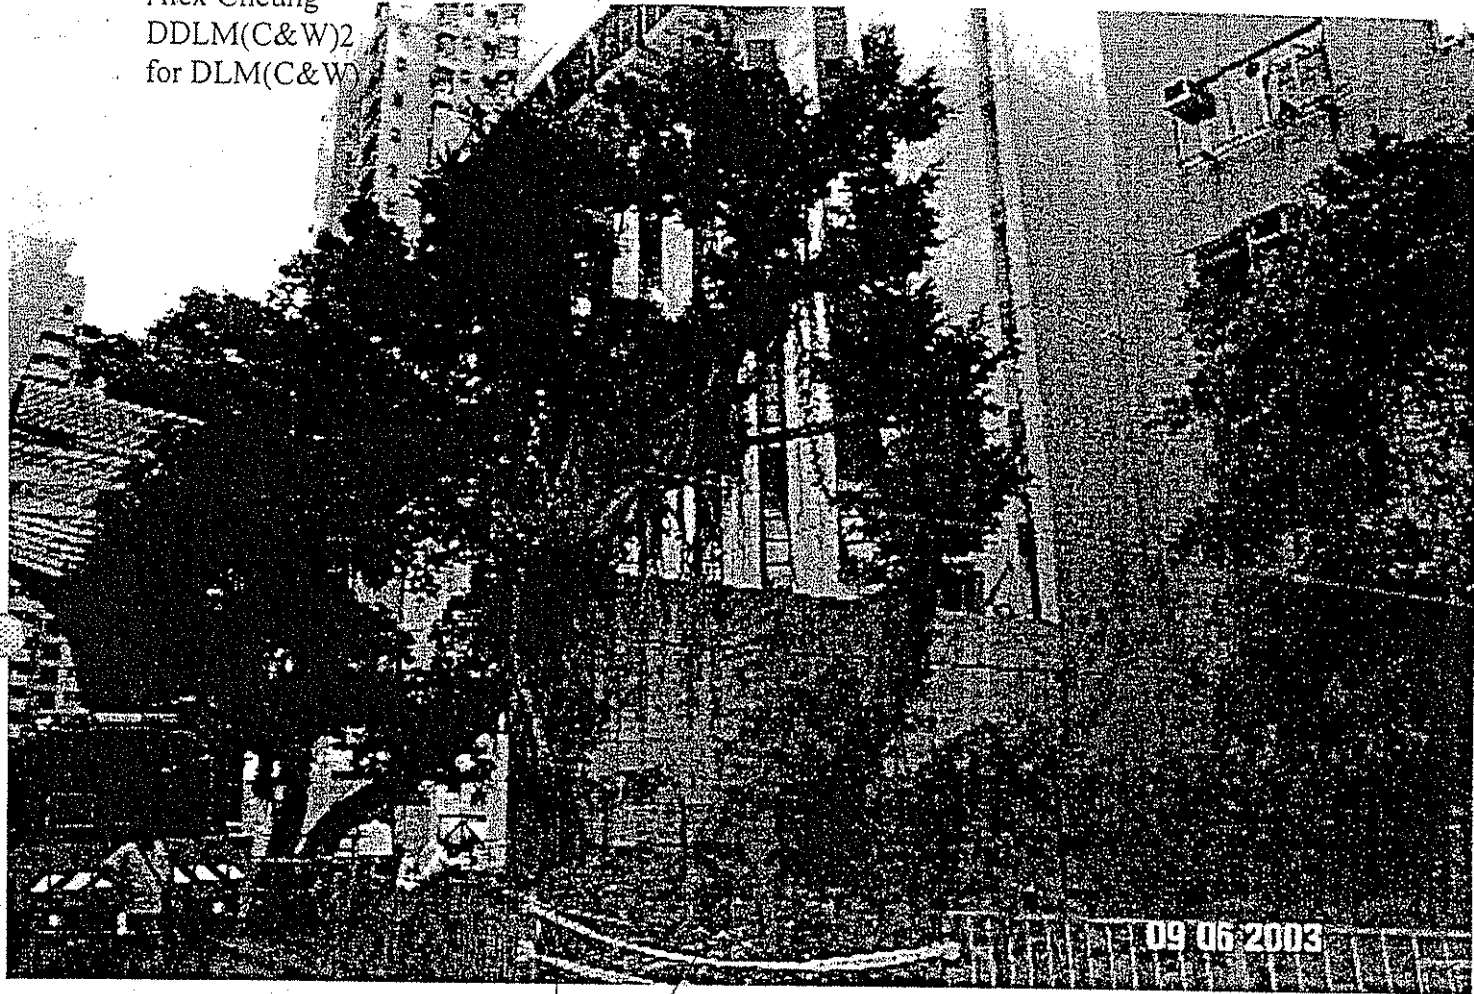
The trees immediately adjacent to the collapsed tree are in danger of falling.
