Review of the 12 September 2007 Rockfall Incident on Slope No. 7SW-C/C67 at Kwai Shing Circuit Kwai Chung

GEO Report No. 263

Halcrow China Limited

**Geotechnical Engineering Office
Civil Engineering and Development Department
The Government of the Hong Kong
Special Administrative Region**

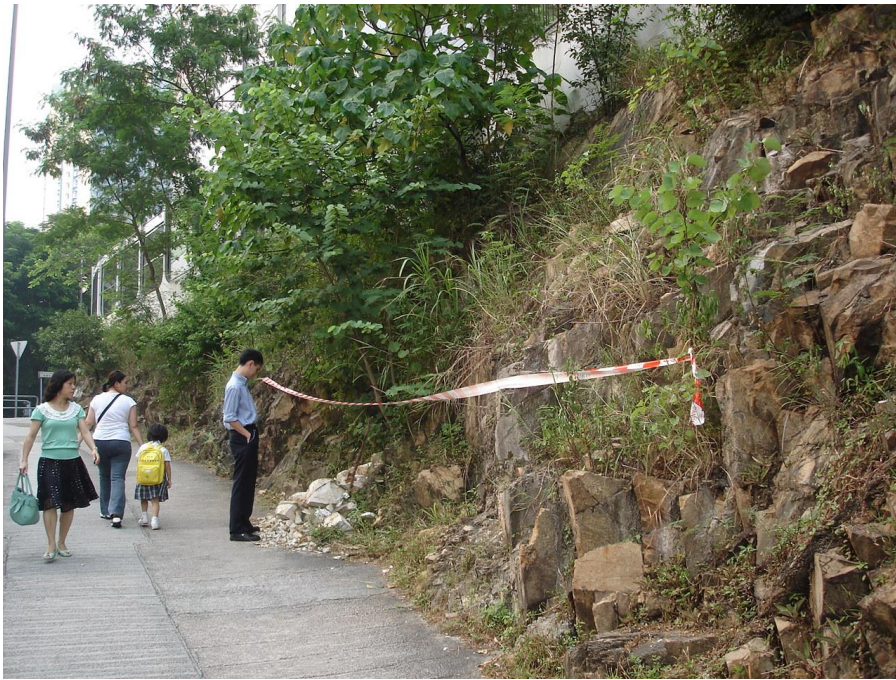
**Figure 2.3 General View of the Northern Portion of Slope No. 7SW-C/C67
(Photograph Taken by ArchSD on 17 September 2007)**

At the 2007 rockfall source area, much of the bare rock surface was covered with vegetation and tree roots (Figure 2.3). Several small rock blocks were identified to have separated from the rock mass (Figure 5.6), and these appeared to be the result of the wedging action of the tree roots on the rock joints. At the rockfall source area, a tree root of about 40 mm in diameter was present on the sliding joint plane (Figures 5.2 & 5.4). The wedging effects of tree roots might have opened up existing joints in the rock, resulting in progressive deterioration of the rock mass. Moreover, the kinematic analysis carried out as part of this review indicates that the release planes in the area of the 2007 rockfall are adversely orientated. The wedging effect of tree roots, coupled with the presence of adverse joints, might be a key contributory factor towards the rockfall. In addition, the possible build-up of transient water pressure due to the rainfall on 12 September 2007 within the joint planes might have triggered the incident.

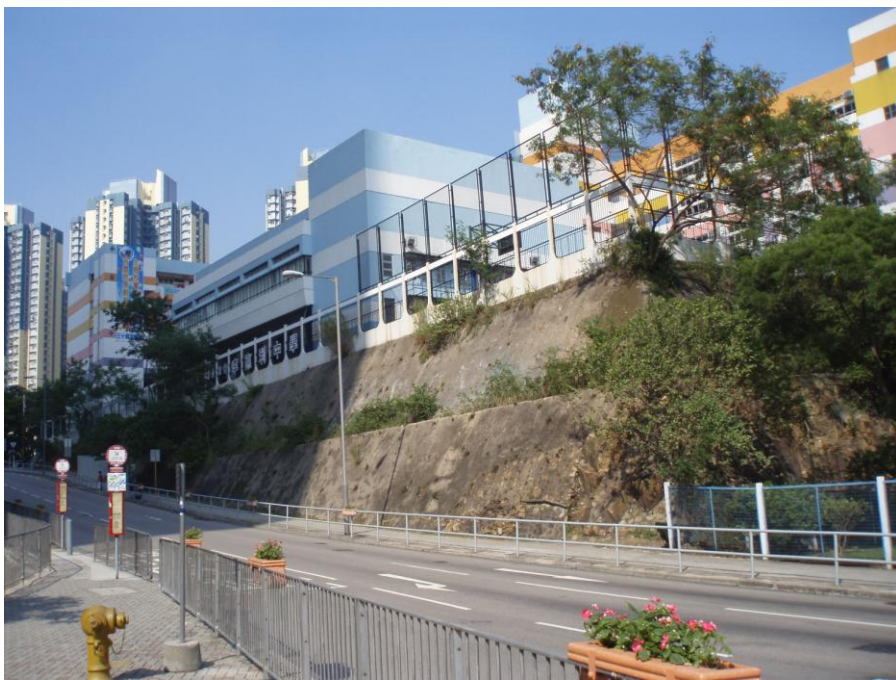
The southern portion of the subject slope is approximately 50 m long, comprising a 5 m high upper batter and a 6 m high lower batter with an intervening berm of 1 m in width. This portion comprises predominantly a soil slope covered with chunam and is inclined at about 55° . Rock outcrops are present in the lower batter at the southern end.

**Figure 2.4 General View of the Southern Portion of Slope No. 7SW-C/C67
(Photograph Taken by HCL on 9 November 2007)**

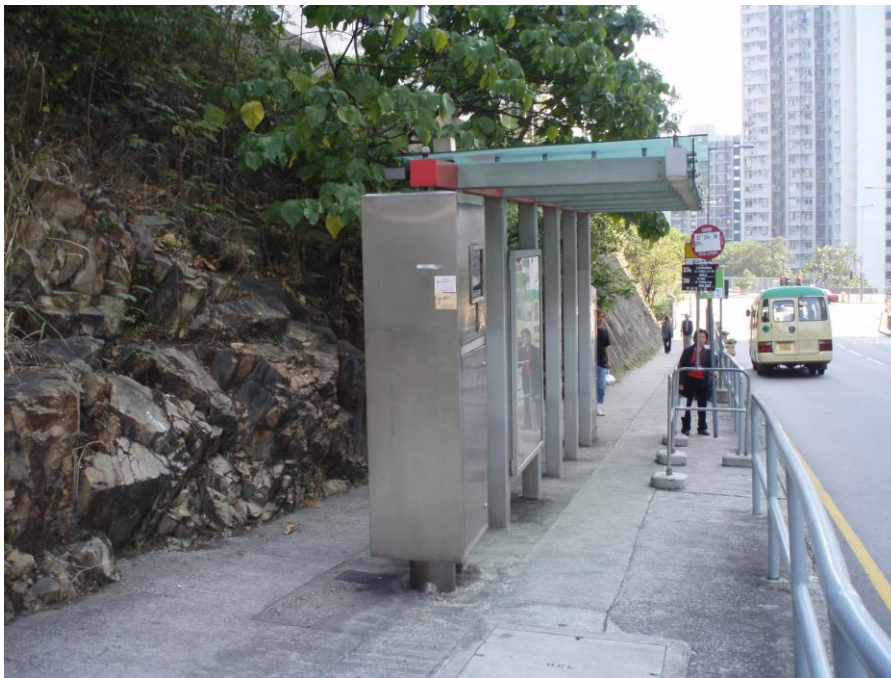
**Figure 2.5 View of the Sheltered Bus Stop at the Toe of Slope No. 7SW-C/C67
(Photograph Taken by HCL on 9 November 2007)**

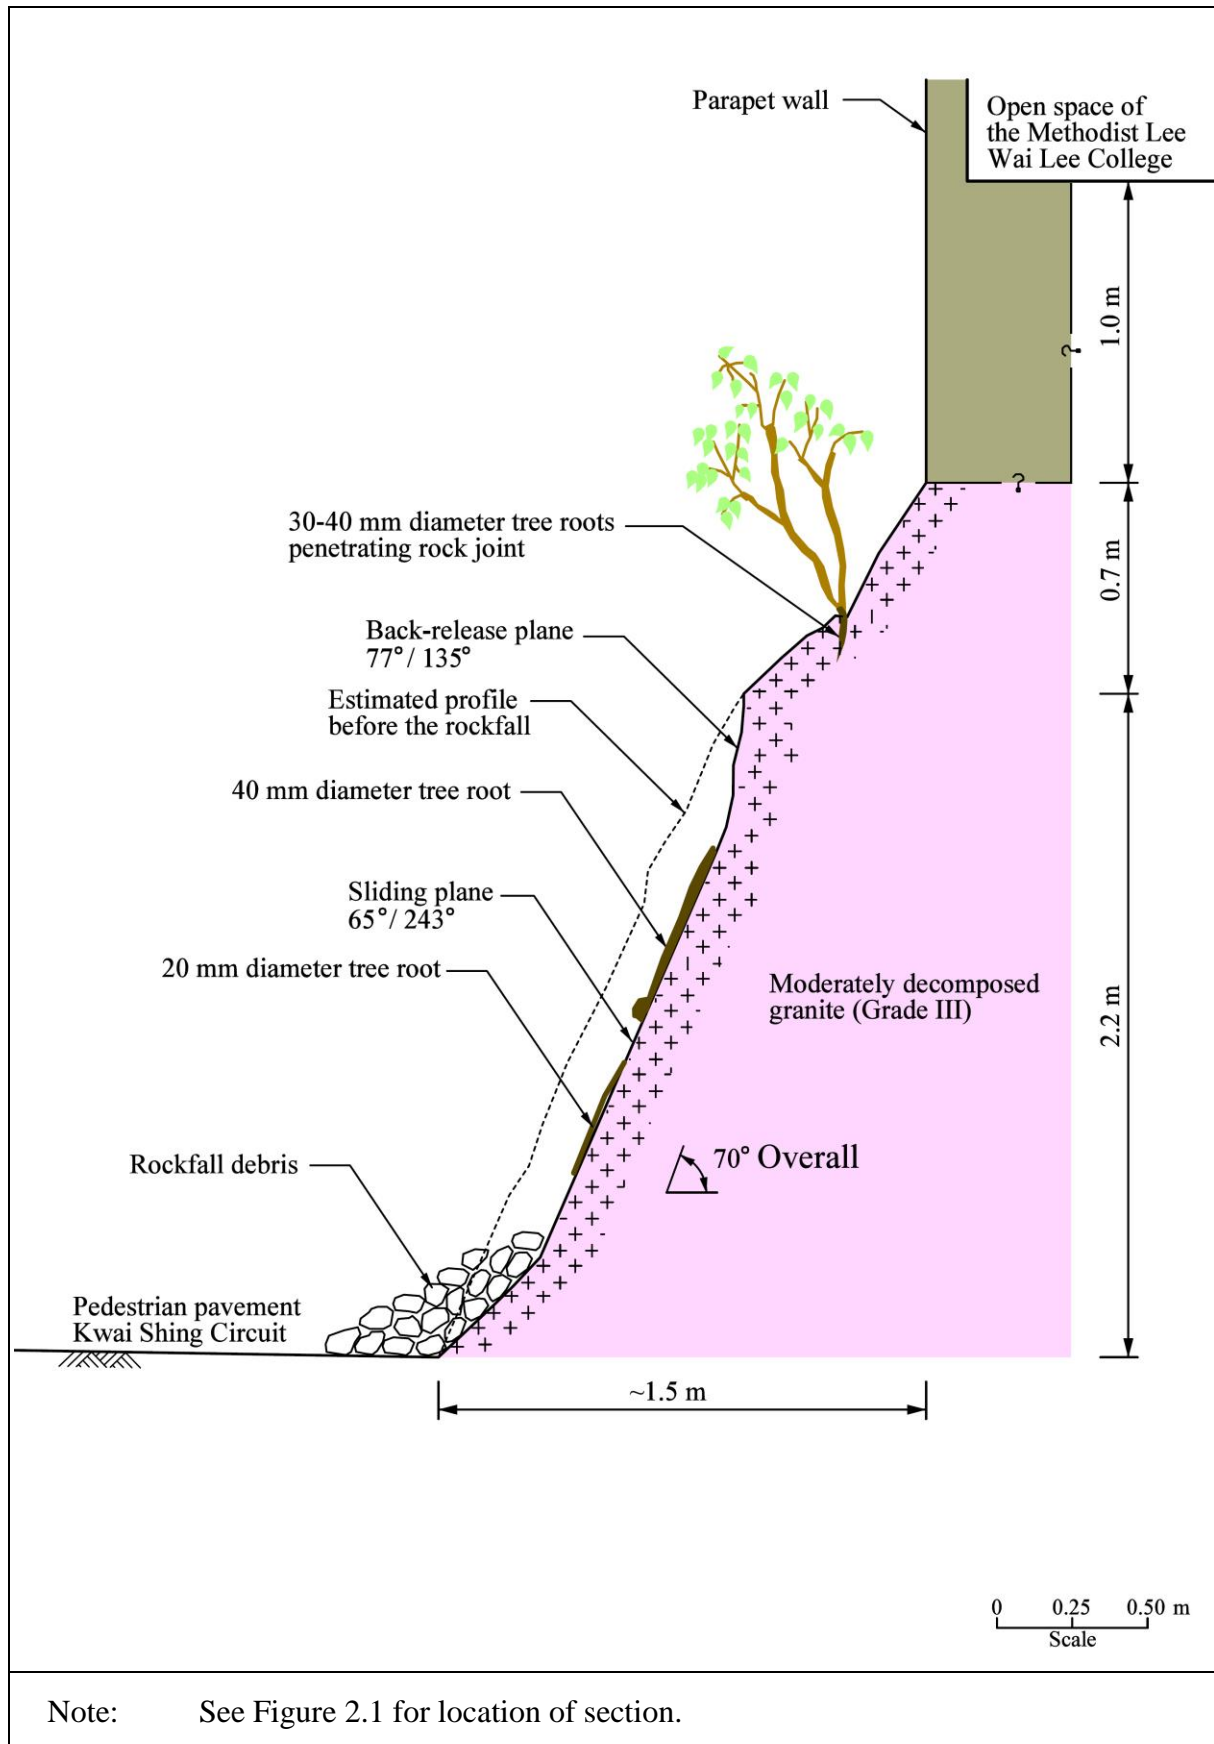
Figure 5.1 Section A-A Through the 12 September 2007 Rockfall Location

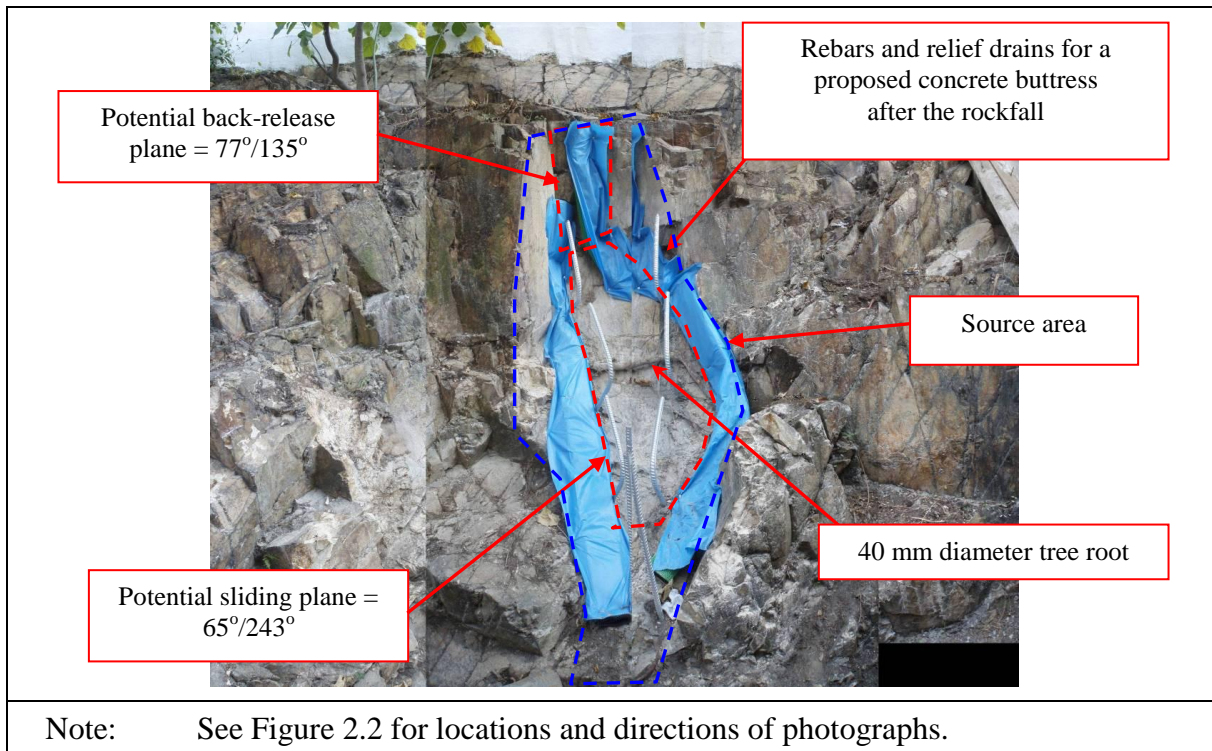
The incident involved the detachment of rock blocks (approximately 0.5 m³ in volume) from the subject slope. The source area was about 2.3 m by 1.8 m of 0.1 m in depth as measured on site and was located in the northern middle portion of the slope and 2.2 m above the toe (Figures 5.1 & 5.2). The rockfall debris was deposited on the edge of the pedestrian pavement at the slope toe (Figure 5.3). No casualties were reported and no closure of the pedestrian pavement was implemented as a result of the incident.

HCL subsequently visited the site several times between 9 November 2007 and 30 April 2008. The source area of the rockfall was observed to be on a rock slope face generally dipping at about 65°/250°. It comprises pinkish grey, moderately strong, moderately decomposed, fine- to medium-grained granite, with closely to medium spaced joints (Figure 5.2). A sliding joint plane (dipping at about 65°/243°) and a back-release joint plane (dipping at about 77°/135°) were identified at the scar. On these release planes, black and dark reddish brown stains were observed, which were possibly manganese and iron oxides. Such staining indicates water migration, weathering and possible opening of the rock joints prior to the detachment of the rock block in the 2007 incident. Tree roots of up to about 40 mm diameter were also observed growing on the sliding joint plane (Figures 5.2, 5.3 & 5.4). During the inspections, no water seepage was noted at the exposed rockfall source area.

Figure 5.2 View of the Source Area of the 12 September 2007 Rockfall (Photograph Taken by HCL on 9 November 2007)

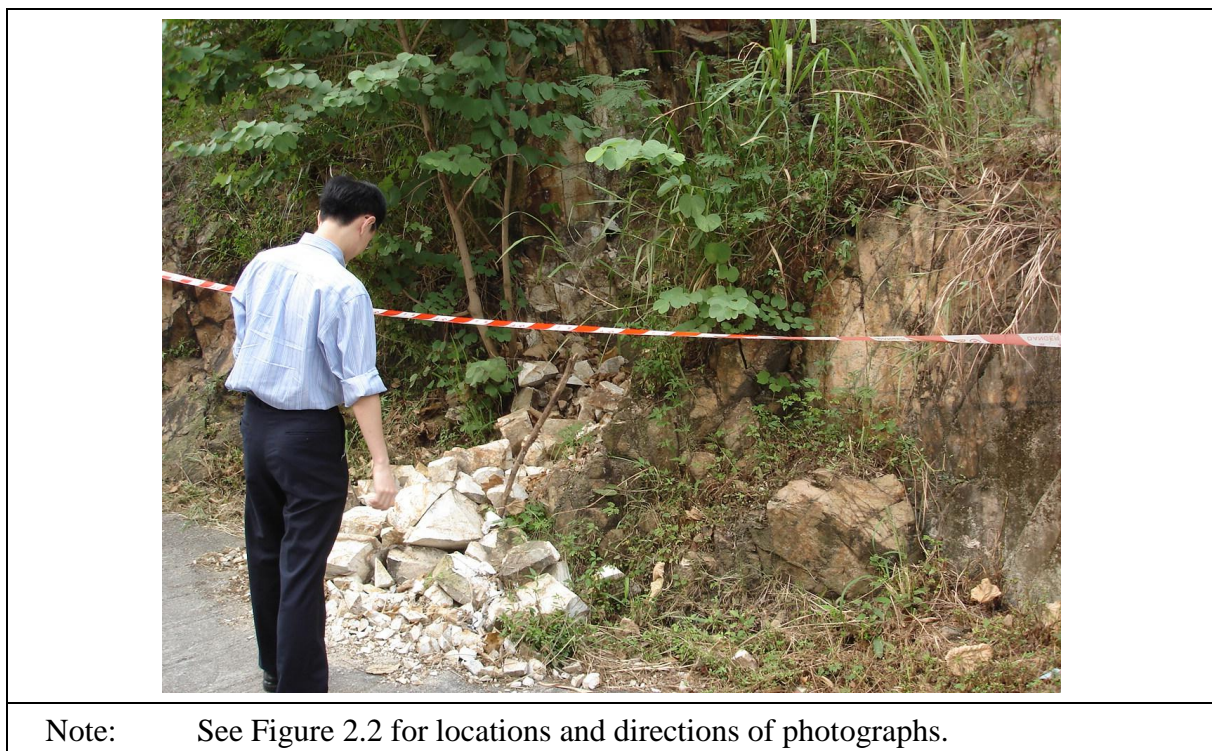
Figure 5.3 View of the Detached Rock Blocks from the 12 September 2007 Rockfall (Photograph Taken by ArchSD on 17 September 2007)

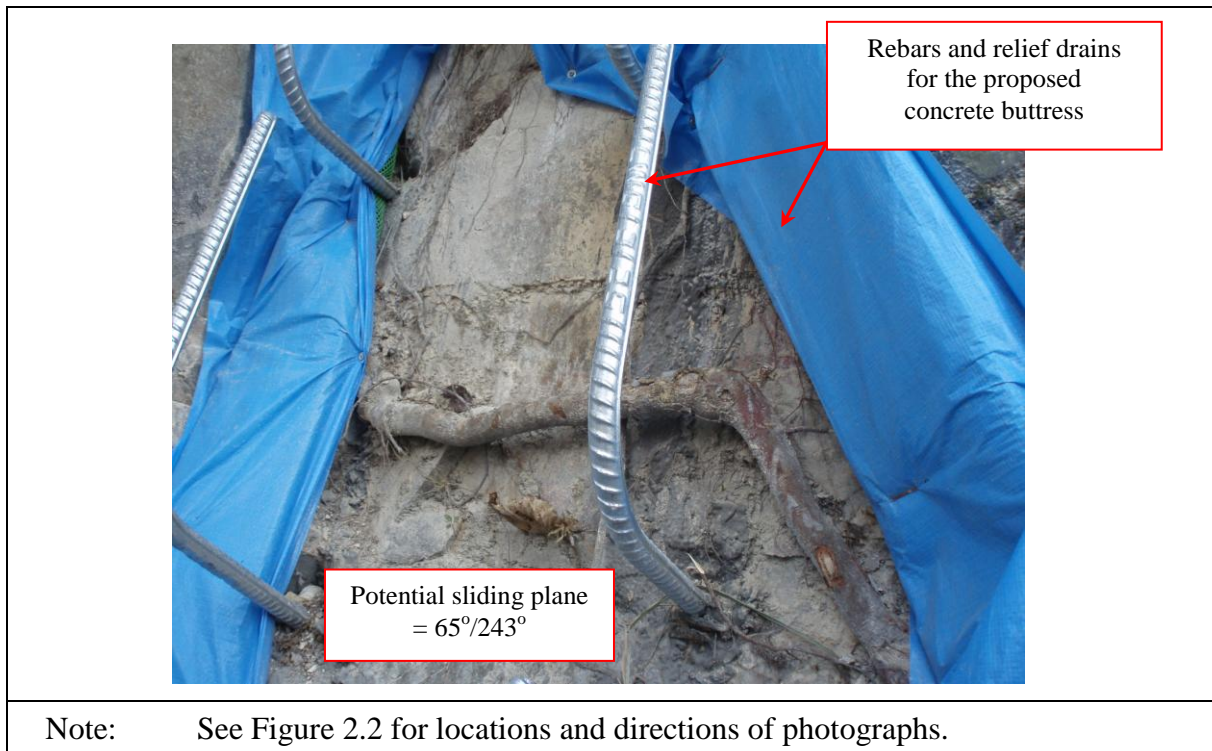
**Figure 5.4 Close-up View of the Source Area of the 12 September 2007 Rockfall
(Photograph Taken by HCL on 9 November 2007)**

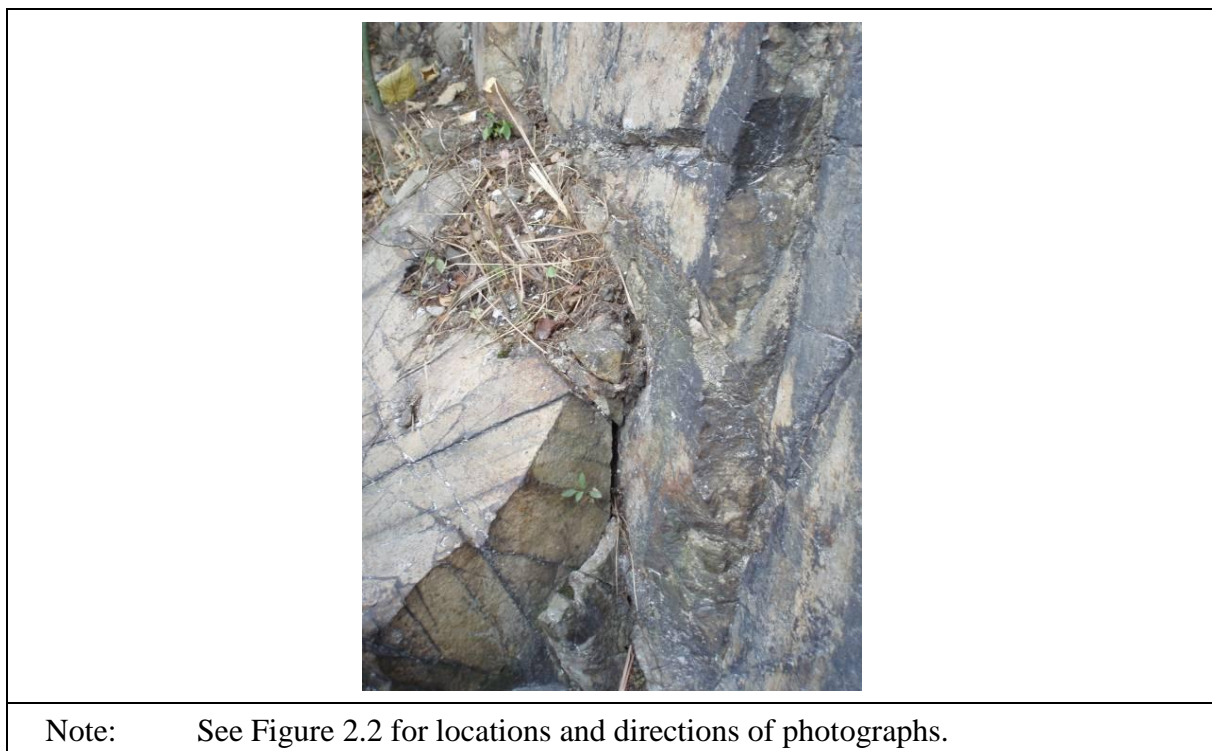
About 0.7 m to the north just above the rockfall source area, a tree with a main trunk of about 100 mm in diameter was growing on the rock surface (Figure 5.5). Its roots of about

**Figure 5.5 Tree Root Penetrating Rock Joint above Failure Scar
(Photograph Taken by HCL on 9 November 2007)**

30 mm to 40 mm in diameter penetrated and opened the rock joint up to 30 mm.

This incident highlights the importance of regular maintenance of rock slopes, especially removal of undesirable vegetation and potentially loose rock blocks that are prone to

deterioration and undue movement caused by tree root growth. The maintenance works may include fixing of wire mesh on the rock face, especially where the rock is highly fractured, to prevent loose rock blocks from falling directly towards critical facilities in close proximity.

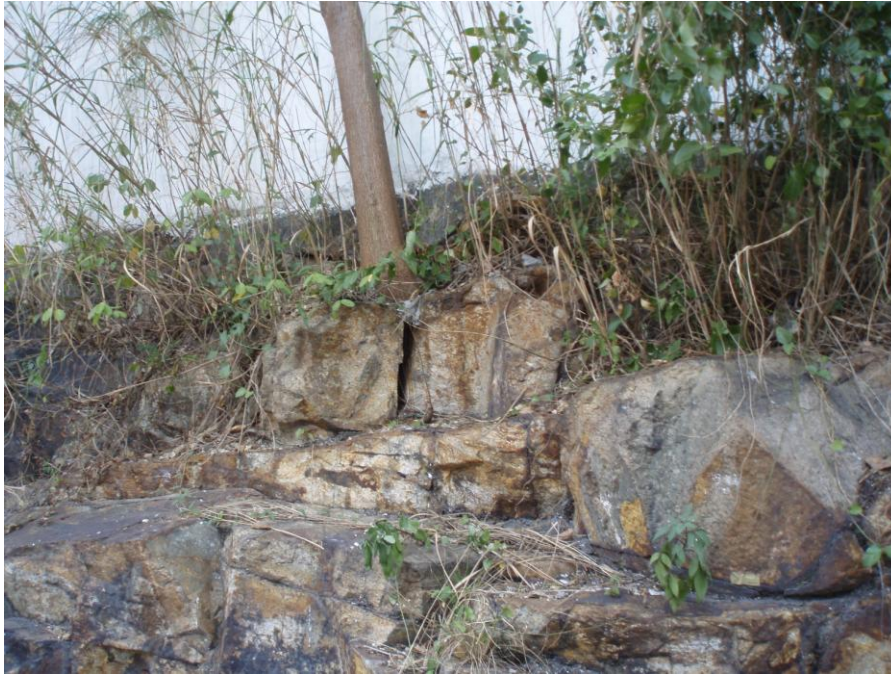
Overgrown vegetation including shrubs and trees up to several meters high covered the rock surface at northern portion of the subject slope. At about 20 m to the northeast of the rockfall location, some of the rock joints were found to have been opened up by 50 mm maximum due to the tree roots, resulting in displacement of rock blocks (about 300 mm by 300 mm by 100 mm in size) from the rock surface (Figure 5.6).

Figure 5.6 Slightly Separated Rock Blocks
(Photograph Taken by HCL on 9 November 2007)

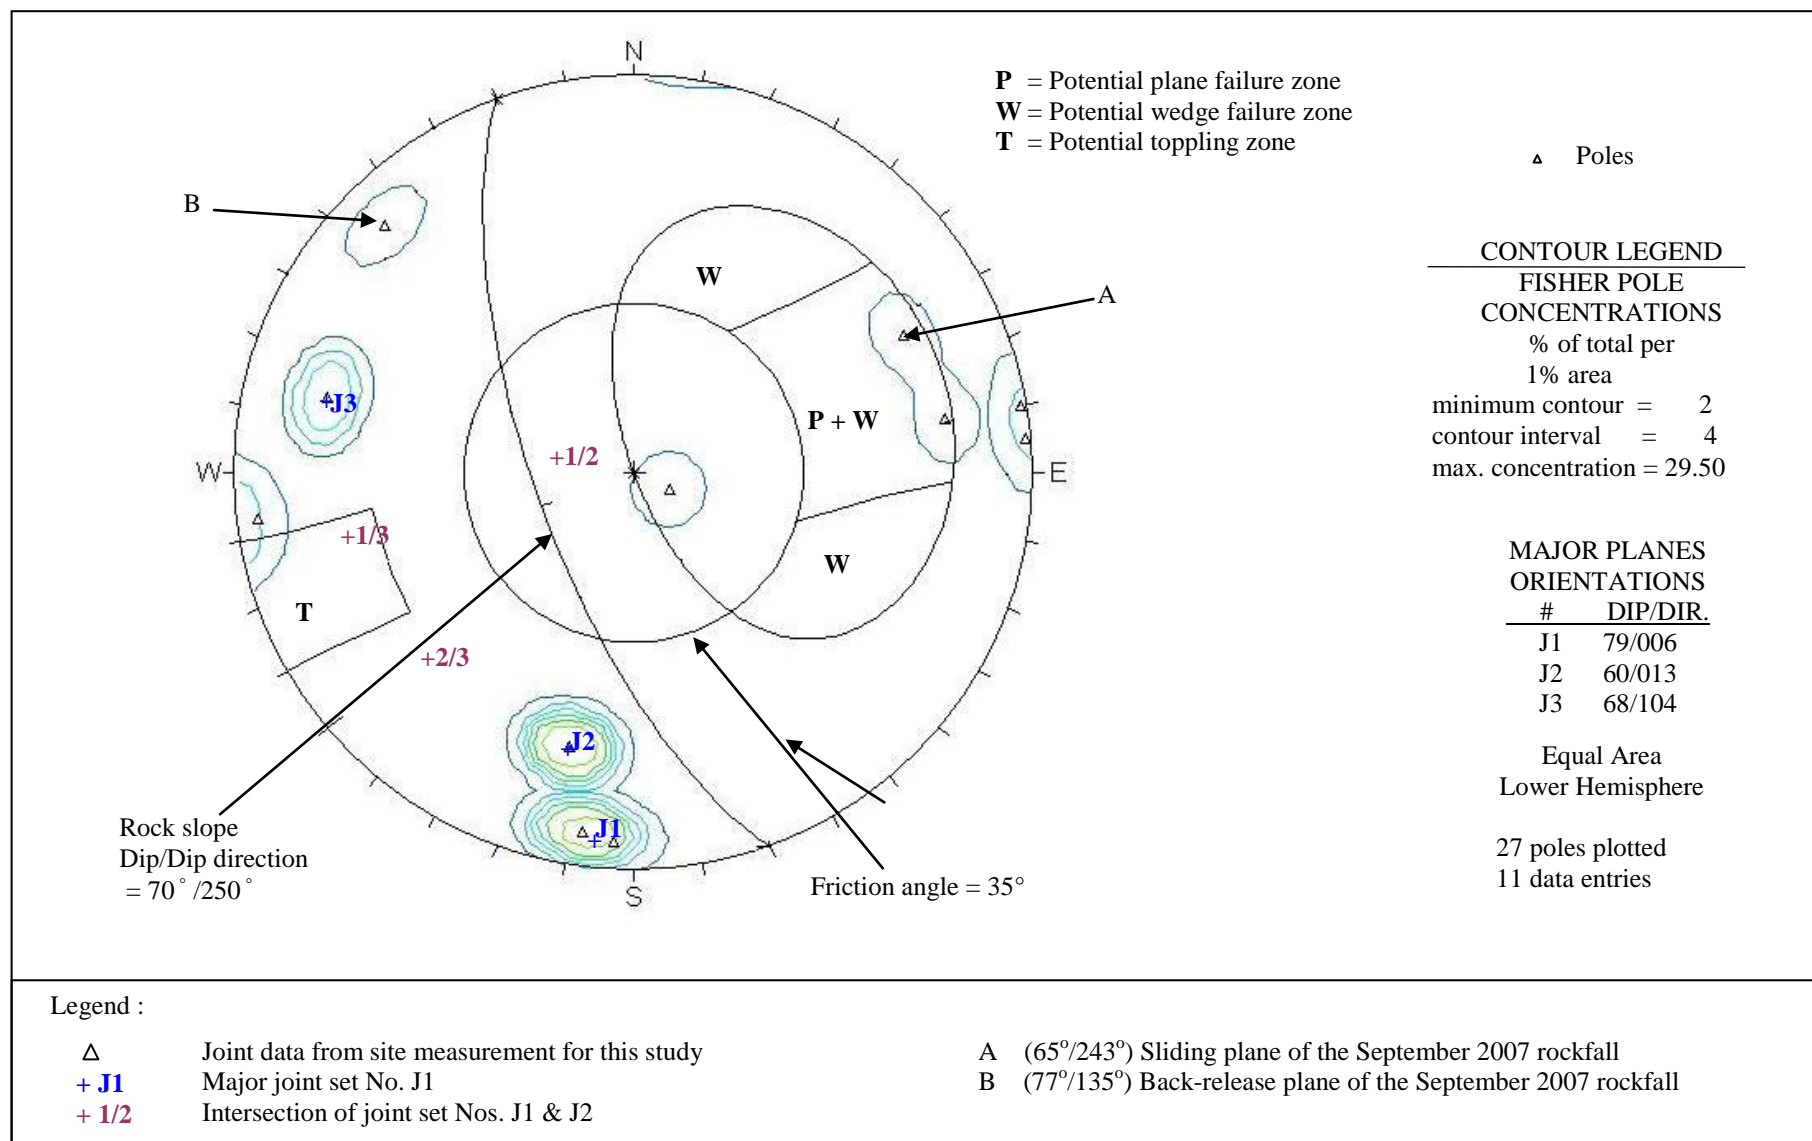
The rock joint data collected, including sliding plane and back-release plane of the rockfall source area, are presented in a stereoplot (Figure 5.7). According to the stereoplot, the joint plane $65^{\circ}/243^{\circ}$ falls within the unstable zone for sliding with respect to the rock slope face dipping at $70^{\circ}/250^{\circ}$ and is kinematically unstable.

Figure 5.7 Kinematic Analysis of Joint Orientations for the 12 September 2007 Rockfall Location
