**REVIEW OF THE  
24 JUNE 2005 LANDSLIDE  
ON SLOPE NO. 7SW-C/CR564  
TO THE NORTH OF  
TZE CHUK LAM  
FU YUNG SHAN, TSUEN WAN**

**GEO REPORT No. 266**

**Halcrow China Limited**

This report presents the findings of a review of a landslide (Incident No. 2005/06/0181) which occurred on slope No. 7SW-C/CR564 and an adjoining sloping ground to the north of Tze Chuk Lam, Fu Yung Shan, Tsuen Wan on 24 June 2005. The incident involved the failure of an approximately 5.5 m high slope portion and a 2 m high masonry toe wall, with a total failure volume of about 100 m<sup>3</sup>. The failed mass hit a squatter structure at the slope toe, broke two columns of the structure and piled up against the rear wall which was severely damaged. A portion of a flimsy squatter structure at the crest of the sloping ground in the western end was undermined. Both the squatter structures were evacuated as a result of the incident. No casualties were involved.

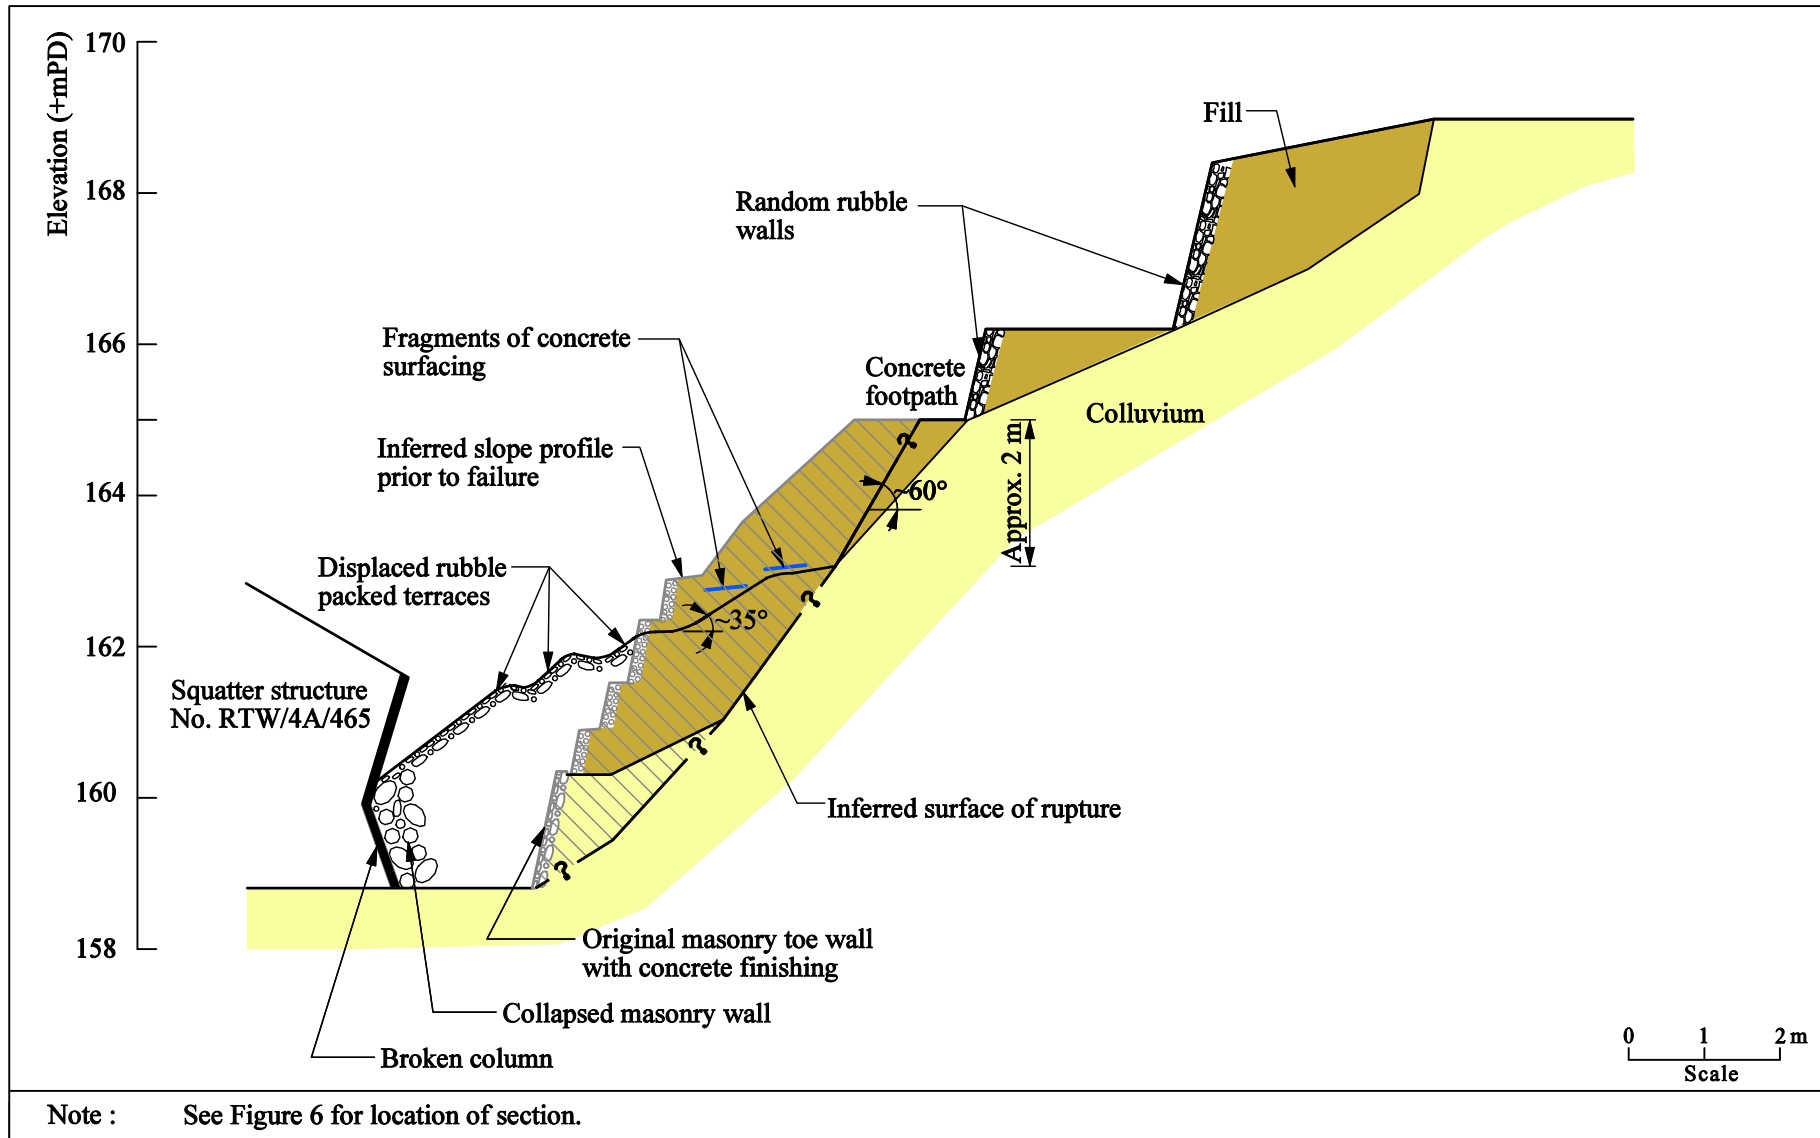
Figure 7 - Section A - A through the Landslide Site

The debris from the landslide scar of about 18.6 m (W) by 13.4 m (L) by 2.3 m (D) hit the squatter structure at about 2 m from the slope toe, broke two columns of the structure and piled up against the rear wall with a corresponding travel angle of about 35° (Figure 7 and Plate 3). The debris was observed to be largely saturated and comprised loose, yellowish brown, slightly silty, fine to coarse sand with many angular to sub-angular fine to coarse gravel, cobble and some boulder sized rock fragments, fragments of concrete surfacing and sections of the collapsed masonry wall (Plate 1 and Plate 4). The debris buried the toe portion of the masonry wall and the basal surface of rupture could not be determined on site. It was inferred that the surface of rupture was possibly along the interface of fill and underlying colluvium/in-situ soil (Figure 7).

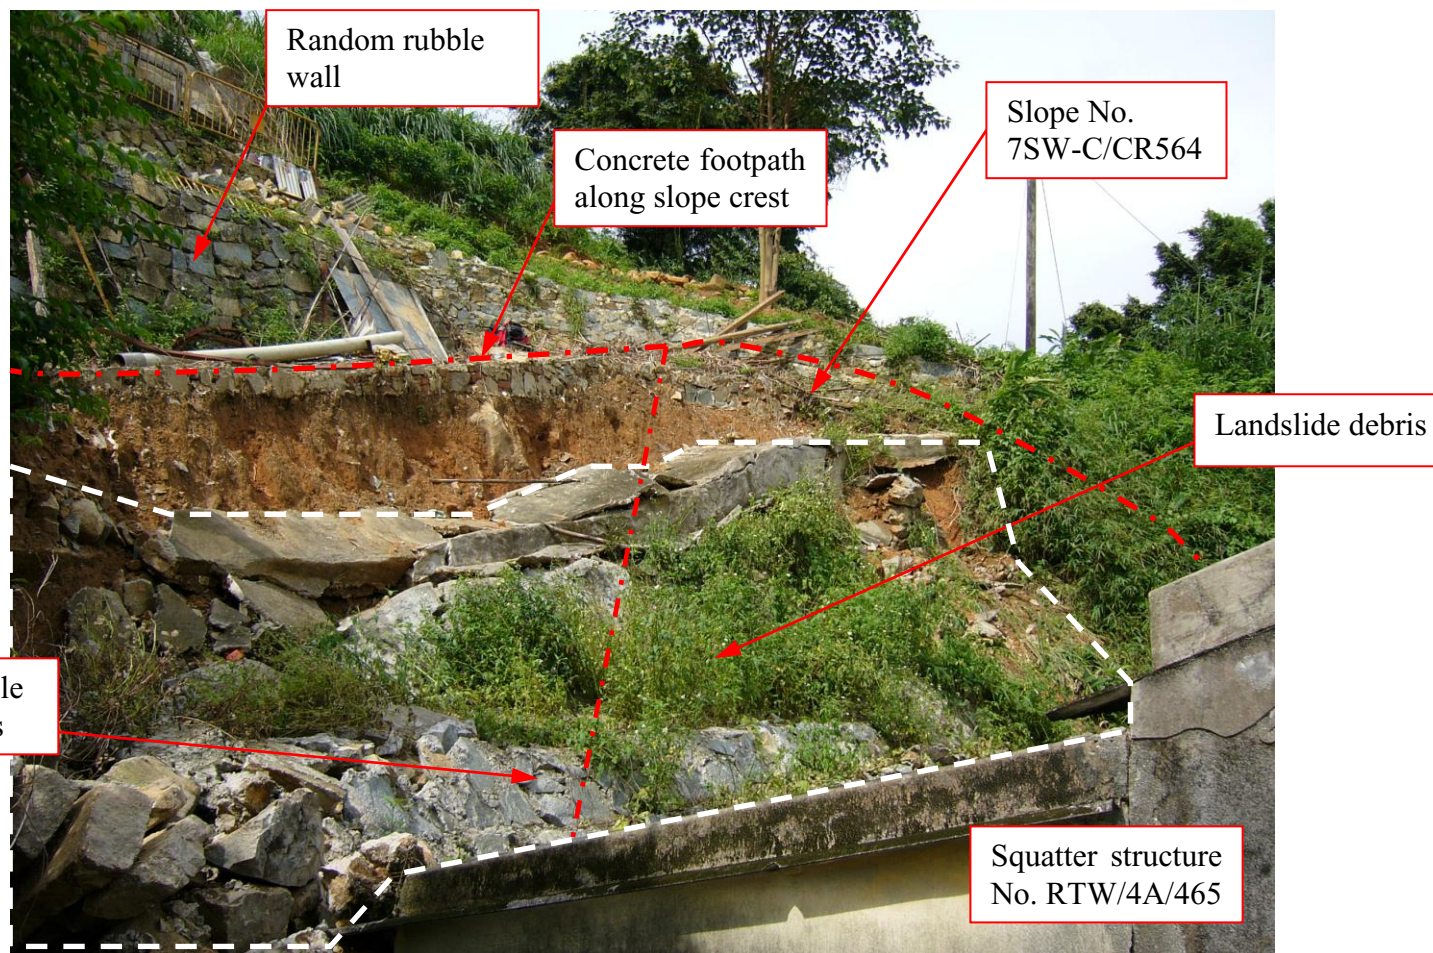
Plate 1 - General View of the Landslide from Slope Toe  
(Photograph taken on 29 June 2005 by MGSL)

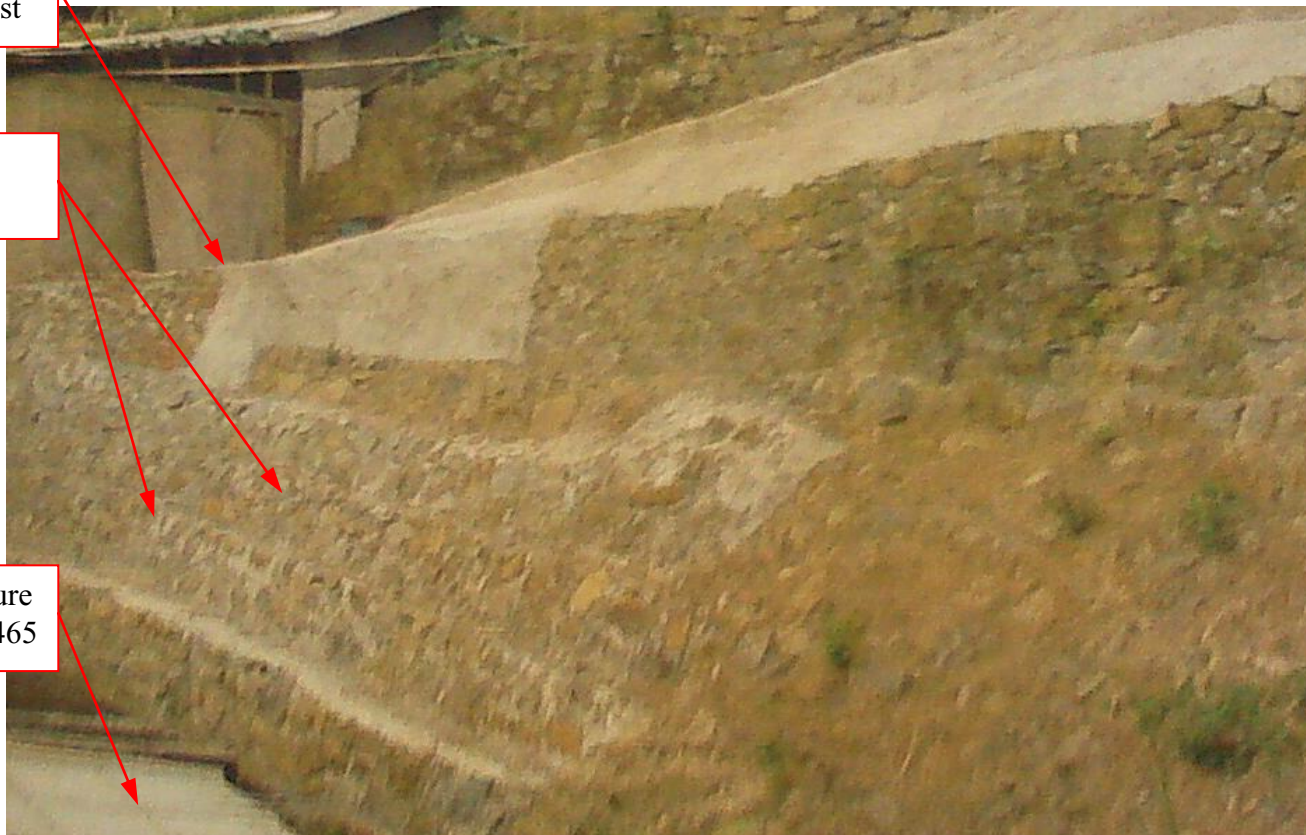
In early March 2004, GWAL inspected the site, including slope No. 7SW-C/CR564. It was observed that concrete surfacing had been applied to slope No. 7SW-C/CR564, and a rubble facing retaining wall and the soil portion of the adjoining sloping ground (Figure 4 and Plate 2). Some minor site formation works, including hard surfacing and slope re-profiling, had taken place at two other unregistered slopes to the northwest of the location of the 24 June 2005 landslide (Figure 4). According to GWAL, the above works were carried out probably between December 2003 and January 2004 by an occupant of the squatter structures on the lot. Following the inspection, GWAL recommended that weepholes be provided for the newly applied concrete surfacing of slope No. 7SW-C/CR564 and the adjoining sloping ground, as well as provision of proper surface protection and conducting an investigation for the above two unregistered slopes. However, there is no record available to indicate that the recommended works had been completed. According to the file records of the BD, GWAL continued to undertake site monitoring until December 2004.

Plate 2 - General View of Slope No. 7SW-C/CR564 in 2004  
(Photograph taken in early March 2004 by GWAL)

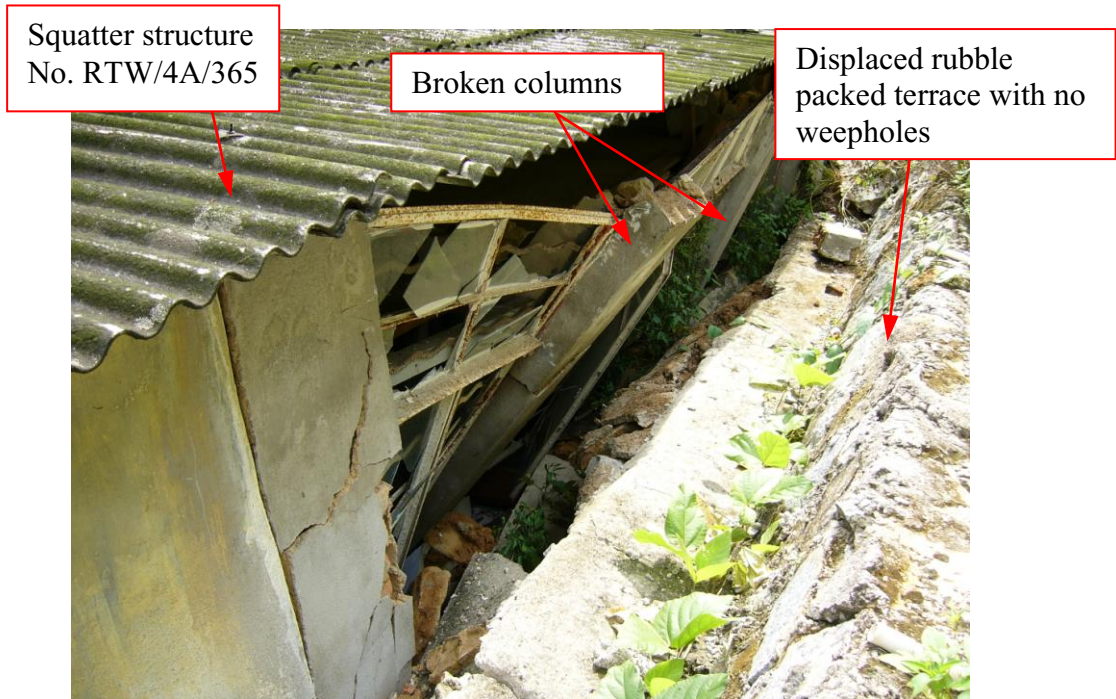
As a result of the displacement of the failed groundmass, a portion of a flimsy squatter structure at the western end of the backscarp had been undermined, and construction waste comprising broken bricks, rock fragments and pieces of plastic bags, was observed at the underside of the structure (Plate 10). At the toe of the landslide, the rear wall of the squatter structure was severely damaged, two columns of the wall were broken and steel window frames were distorted (Plate 3).

Plate 3 - Debris Piled Up against Rear Wall of Squatter Structure at Toe  
(Photograph taken on 29 June 2005 by MGSL)

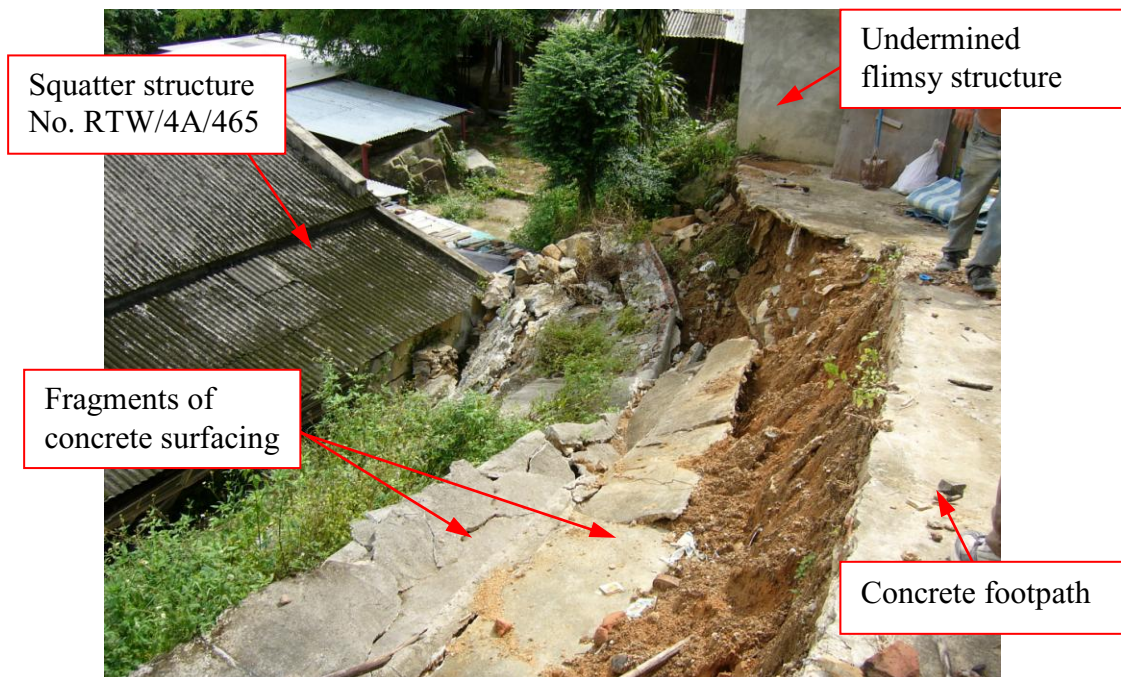
Plate 4 - General View of the Landslide from Slope Crest  
(Photograph taken on 29 June 2005 by MGSL)

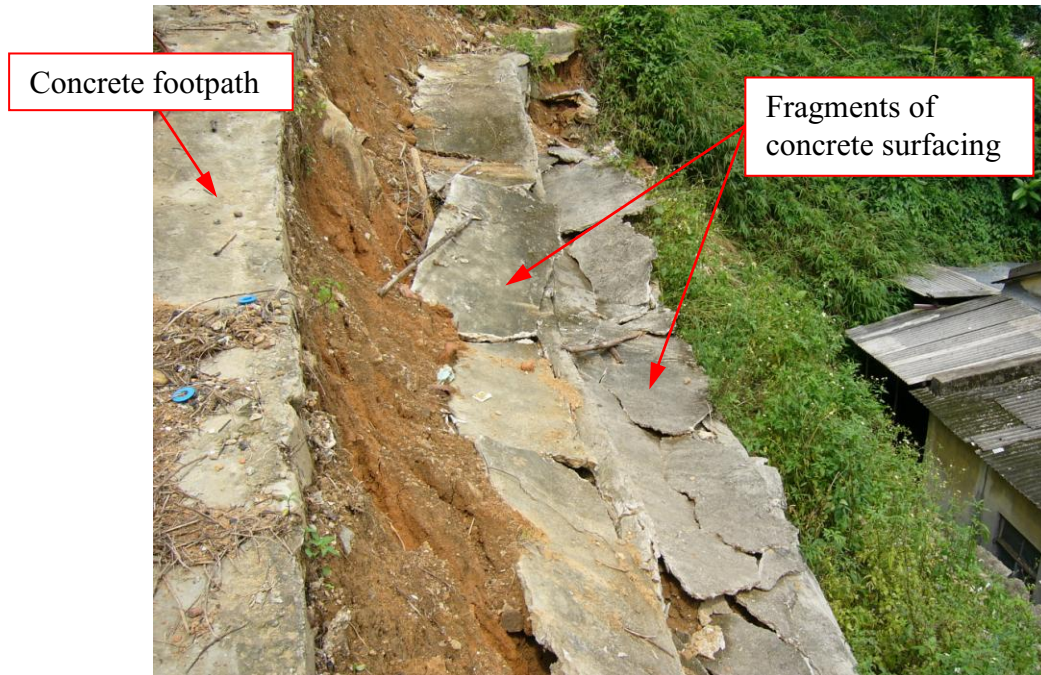
The main scarp of the landslide was about 2 m high and was inclined at about 60° to the horizontal below a concrete footpath along the crest of the landslide site (Plate 5). Part of the concrete footpath collapsed and a 'smooth' surface was observed at the remaining concrete above the scarp (Plate 6). This 'smooth' surface appeared to be a joint of the concrete footpath. The materials exposed at the scarp comprised mostly fill and localised colluvium (Plate 6). The fill had been placed onto the slope crest for the construction of the footpath, as observed in the 2004 aerial photographs, on which no surface drainage provisions could be observed. The pre-existing ground profile of the landslide site was inferred at about 50° with reference to the previous topographical survey records (Figure 5 and Plate 2). Broken pieces of concrete surfacing were observed below the main scarp, suggesting the original slope surface had been covered with concrete. There were no weepholes identified on the broken pieces of the surfacing (Plates 3, 5 and 8). The remaining portion of the masonry toe wall was observed to be about 1.7 m to 2 m high and less than 0.5 m thick. Concrete finishing was observed to have detached from the wall surface and no weepholes were seen (Plate 7). Two rows of rubble packed terraces (each about 600 mm high) were observed to have displaced above the failed toe wall (Plate 8). These terraces were probably constructed between December 2003 and January 2004 (Section 4.5).

Plate 5 - View of the Main Scarp  
(Photograph taken on 29 June 2005 by MGSL)

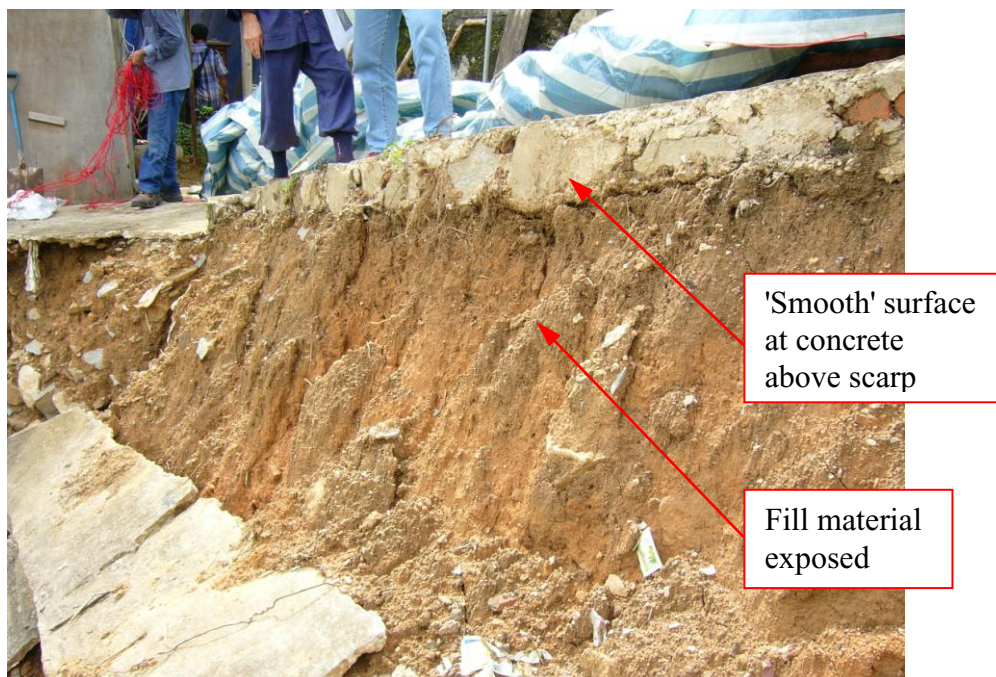
substandard and slope upgrading works were necessary to ensure its stability. The stability condition of slope No. 7SW-C/CR564 and the adjoining sloping ground was exacerbated by the unauthorized works carried out in late 2003 to early 2004. These unauthorized works, comprising the construction of a series of rubble packed terraces and placement of fill materials overlying the slope and adjoining ground at an angle of about 60° to the horizontal, were not constructed to the required safety standards. This was probably a key contributory factor to the failure as evidenced by the landslide which mainly involved the newly placed fill materials.

Plate 6 - Fill Materials at the Main Scarp  
(Photograph taken on 29 June 2005 by MGSL)

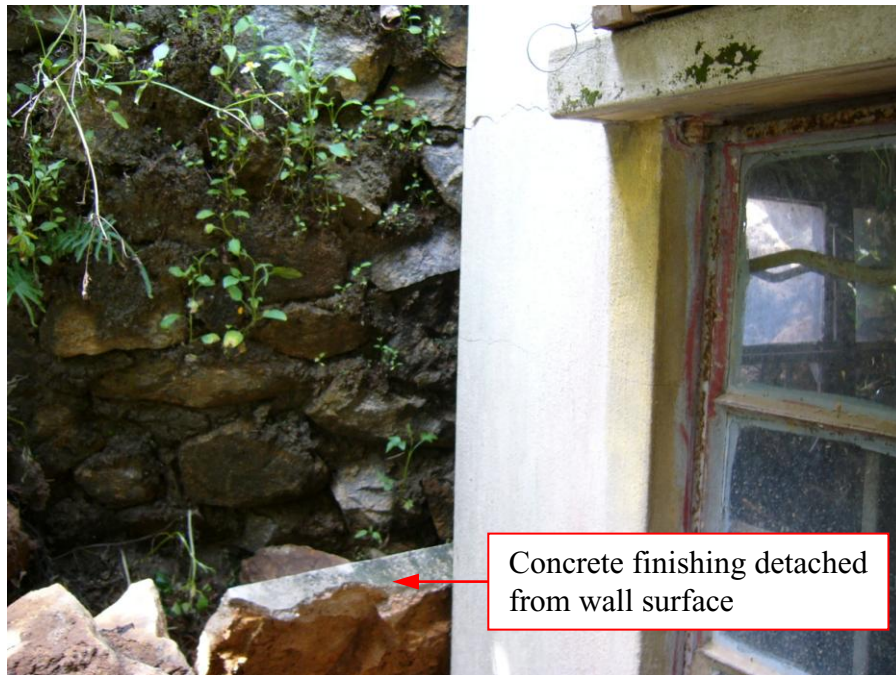
Plate 7 - Concrete Finishing of Toe Wall  
(Photograph taken on 29 June 2005 by MGSL)

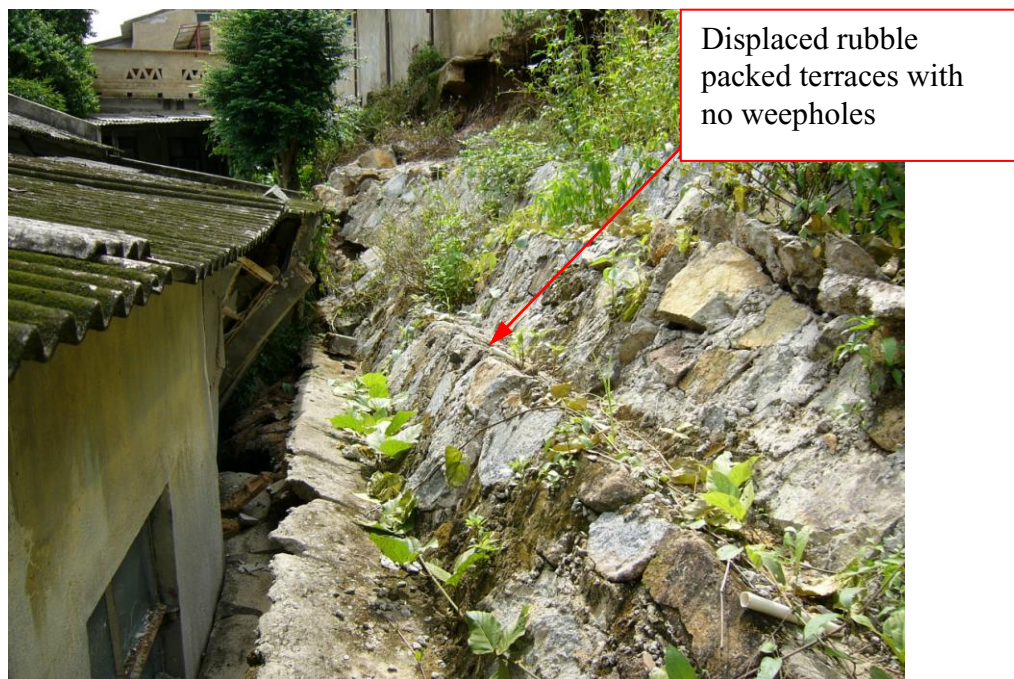
Plate 8 - Displaced Rubble Packed Terraces above Failed Toe Wall  
(Photograph taken on 29 June 2005 by MGSL)

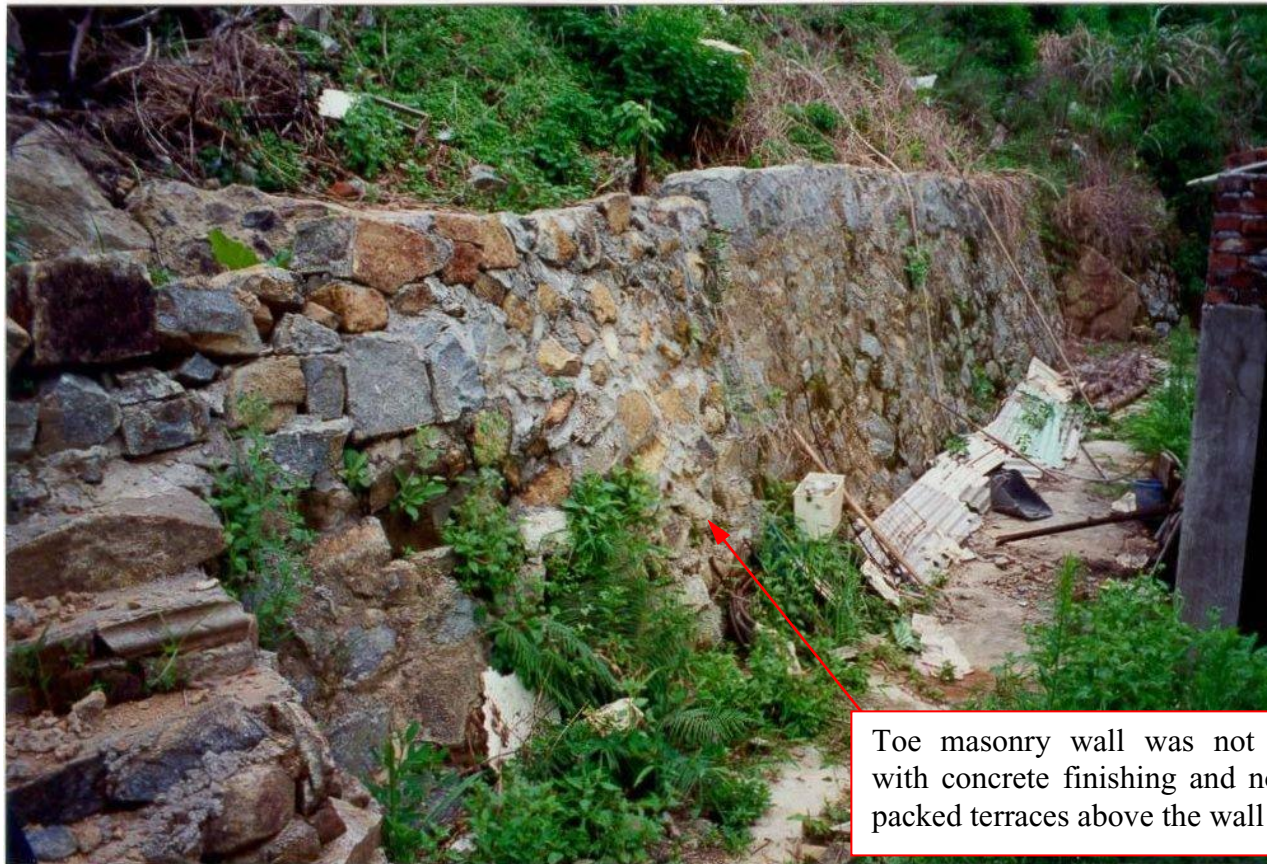
Plate 9 - View of Slope No. 7SW-C/CR564 in 1996  
(Photograph taken on 23 August 1996 and extracted from GEO's Slope Information System)

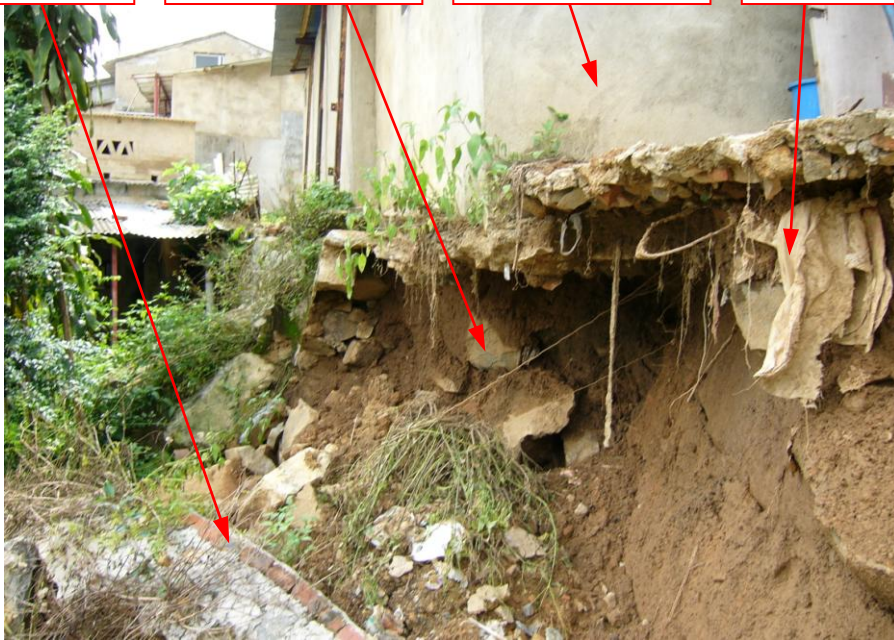
Plate 10 - Undermined Flimsy Squatter Structure  
(Photograph taken on 29 June 2005 by MGSL)

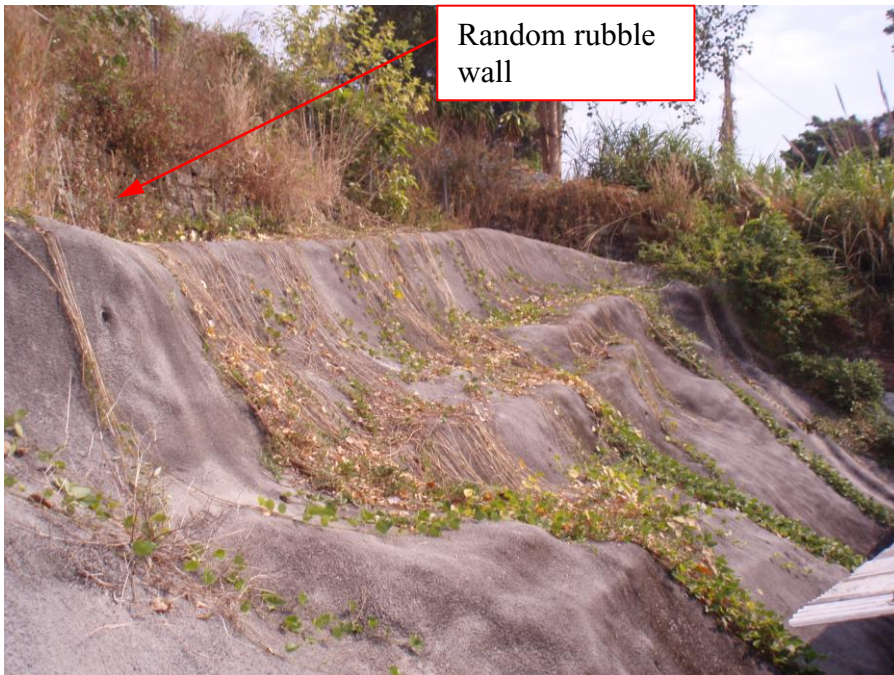
HCL inspected the landslide site on 3 December 2007 and in late 2008. At the time of inspection, slope No. 7SW-C/CR564 and the adjoining sloping ground were covered with sprayed concrete with weepholes at about 1.5 m centres. It appeared that the sprayed concrete was applied as an urgent repair measure to the 24 June 2005 landslide (Plate 11 and Plate 12). Based on the field measurements, there have not been any significant changes to the ground profile of the slopes since the 24 June 2005 incident (Plates 1 & 11 and Plates 4 & 12), except for the slope toe, where a more gentle profile was observed (probably resulting

Plate 11 - Eastern Portion of Slope No. 7SW-C/CR564 in 2007  
(Photograph taken on 3 December 2007 by HCL)

Urgent repair works, comprising trimming of the failure surface and provision of hard surface protection with weepholes, had been implemented to remove the immediate and obvious danger. In mid July 2005, the two squatter structures affected by the landslide were permanently evacuated at the recommendation of the GEO.

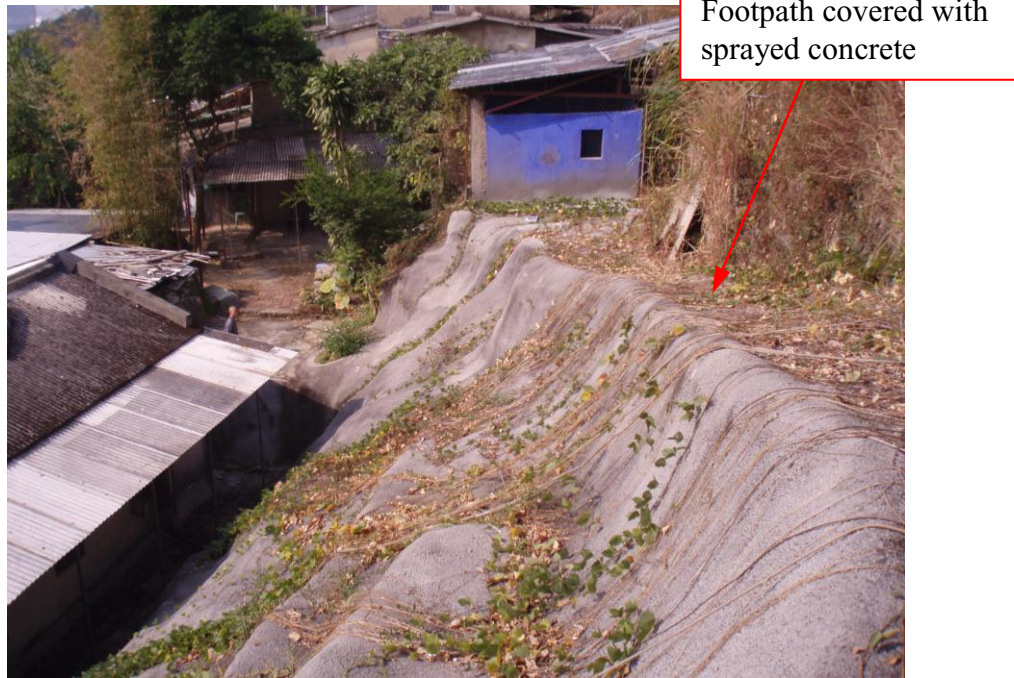
Plate 12 - Western Portion of Slope No. 7SW-C/CR564 in 2007  
(Photograph taken on 3 December 2007 by HCL)

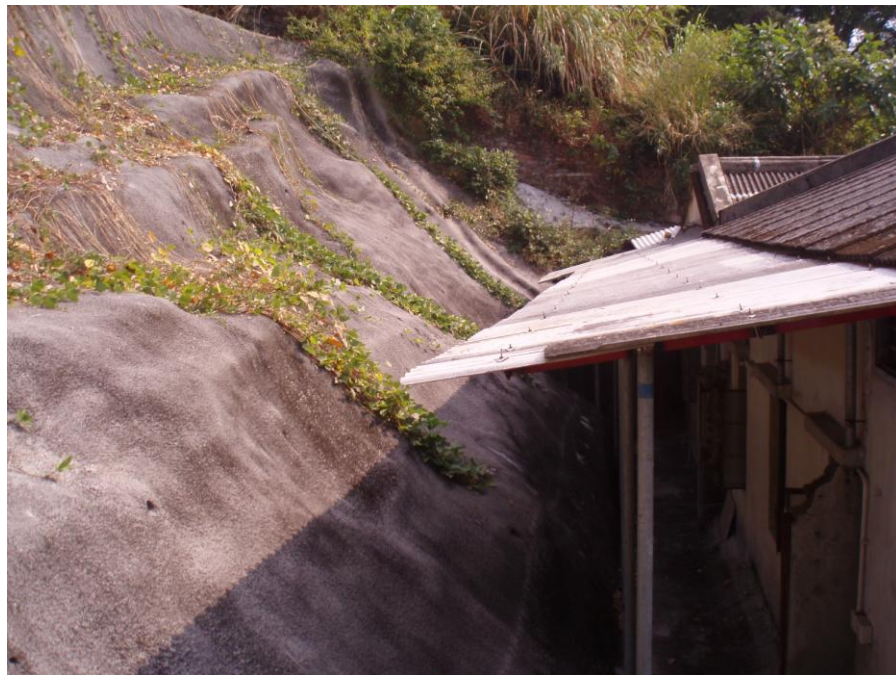
from the removal of the collapsed toe wall). The collapsed rear wall of the squatter structure at the slope toe was also observed to have been removed and replaced with a canopy comprising steel corrugated cladding supported by steel tubular vertical posts (Plate 13). During the inspections, no signs of seepage or distress were observed on the slopes.

Plate 13 - Toe of Slope No. 7SW-C/CR564 in 2007  
(Photograph taken on 3 December 2007 by HCL)

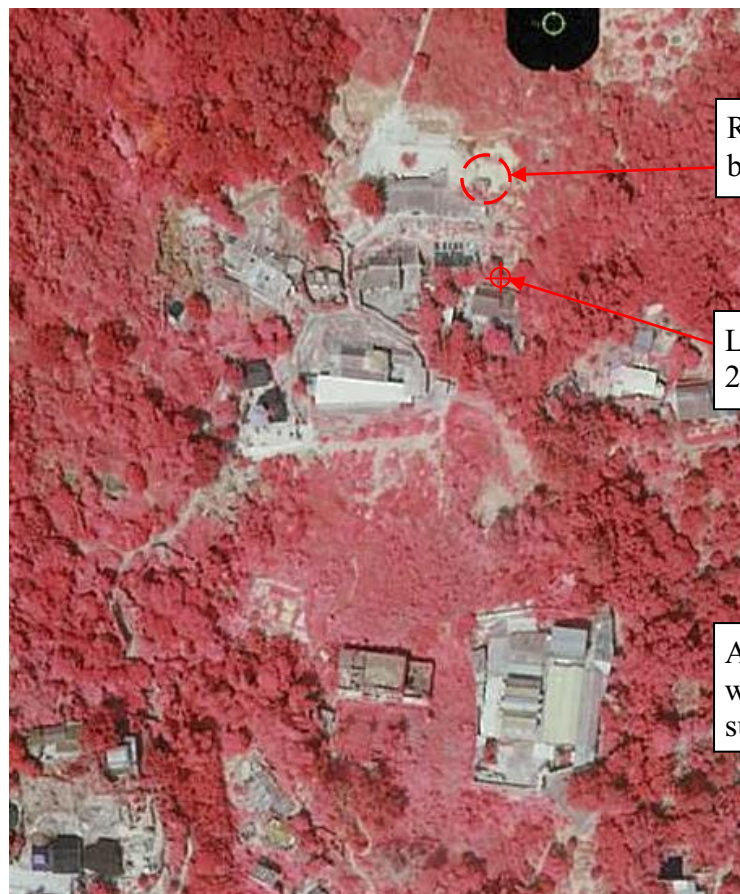
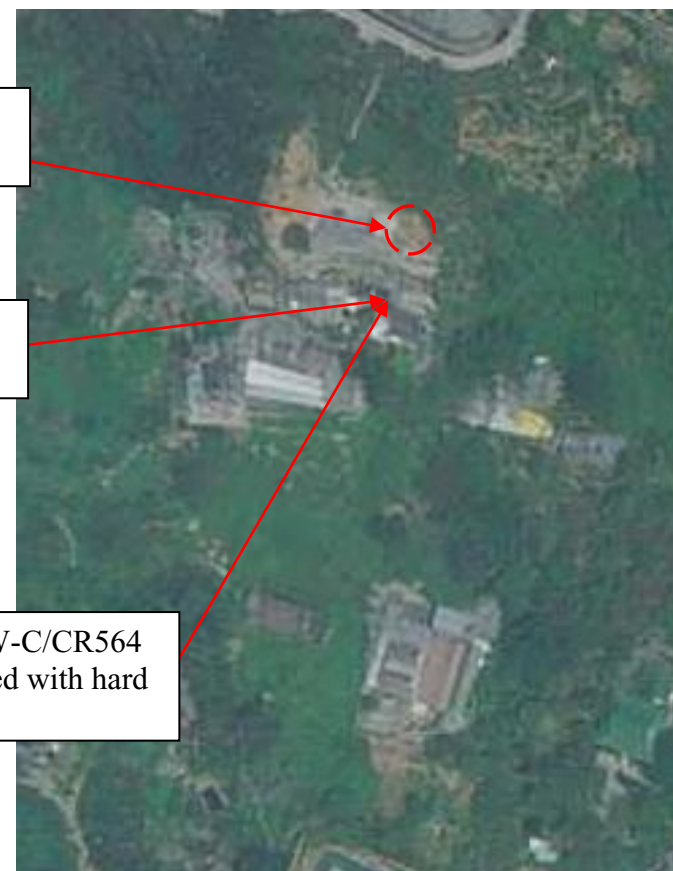
Plate A6 - Extract from 2003 and 2004 Aerial Photographs

Removal of boulders  
between 2003 and 2004

Area above slope No. 7SW-C/CR564  
was re-profiled and covered with hard  
surface

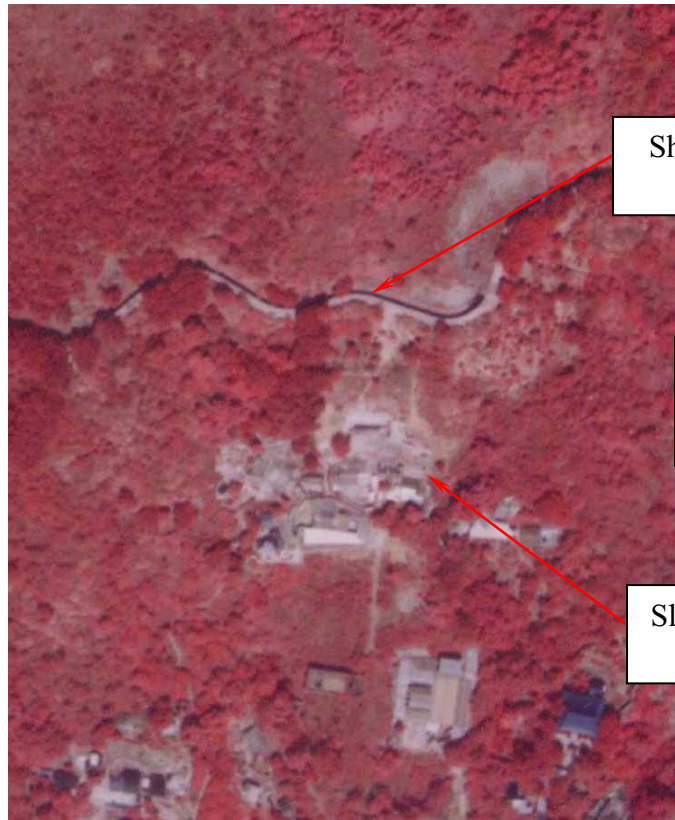
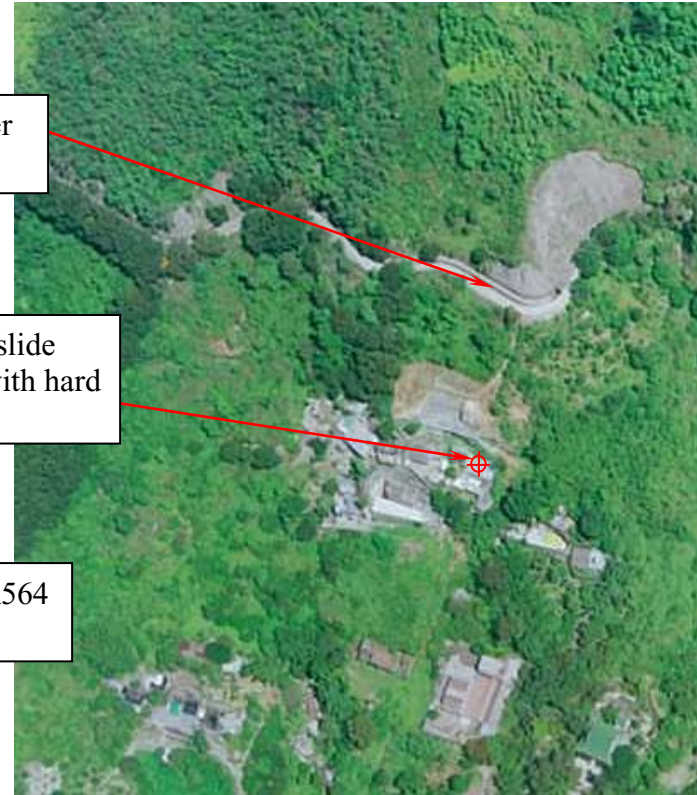
Plate A7 - Extract from 2005 and 2006 Aerial Photographs

Surface of the landslide scar was covered with hard surface
