REVIEW OF THE DISTRESSED HILLSIDE NEAR KWU TUNG RESERVOIR

GEO REPORT No. 267

Halcrow China Limited

**This report was originally produced in August 2009
as GEO Landslide Study Report No. LSR 5/2009**

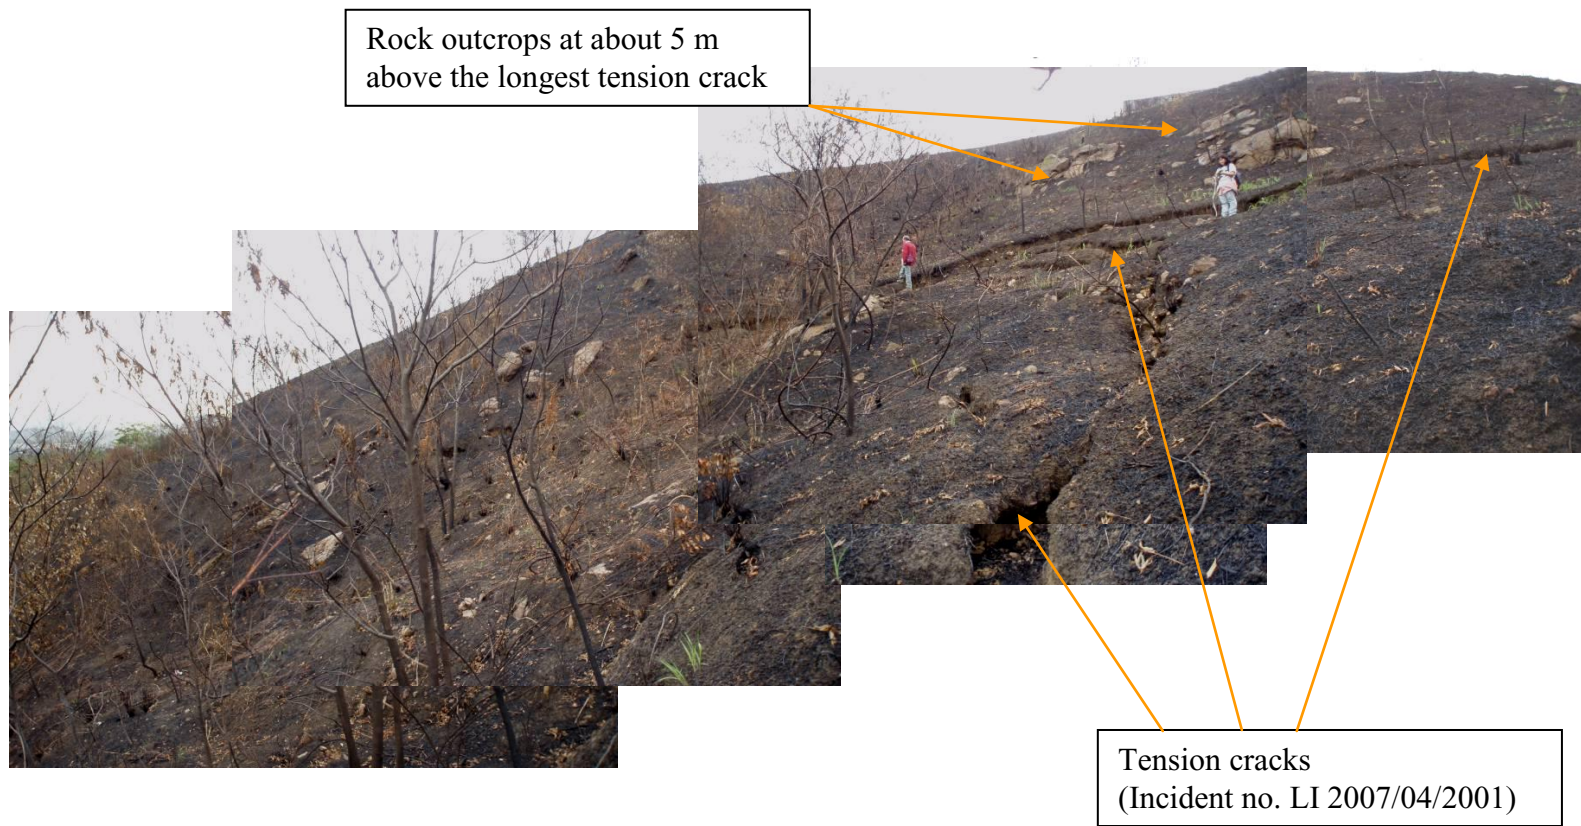
Several tension cracks were exposed after the hillfire on the north-facing hillside at an elevation of approximately 40 – 60 mPD i.e. 20 – 40 m above the toe of the hillside (Plate 1 and Plates 5 to 6). The distressed area bounded by the tension cracks is located at the head of a slightly concave break in slope, which forms a shallow linear depression (an ephemeral drainage line) at the upper portion of the hillside where the gradient is up to 45° locally (Figure 3). The longest tension crack was approximately 35 m in length and was located below a slightly concave break of slope with rock outcrops above. A soil pipe was exposed in the main scarp of the tension crack within the ephemeral drainage line (Figure 9, Plate 7). The width of the tension cracks ranged from 150 mm to 250 mm and the depth from 600 mm

to 800 mm. The cracks were infilled by rootlets, burnt vegetation and organic materials, indicating that they were probably at least a few years old. Only colluvial material was observed in the walls of the tension cracks.

Plate 1 - General View of the Tension Cracks on the North-facing Hillside (Photograph taken on 23 April 2007)

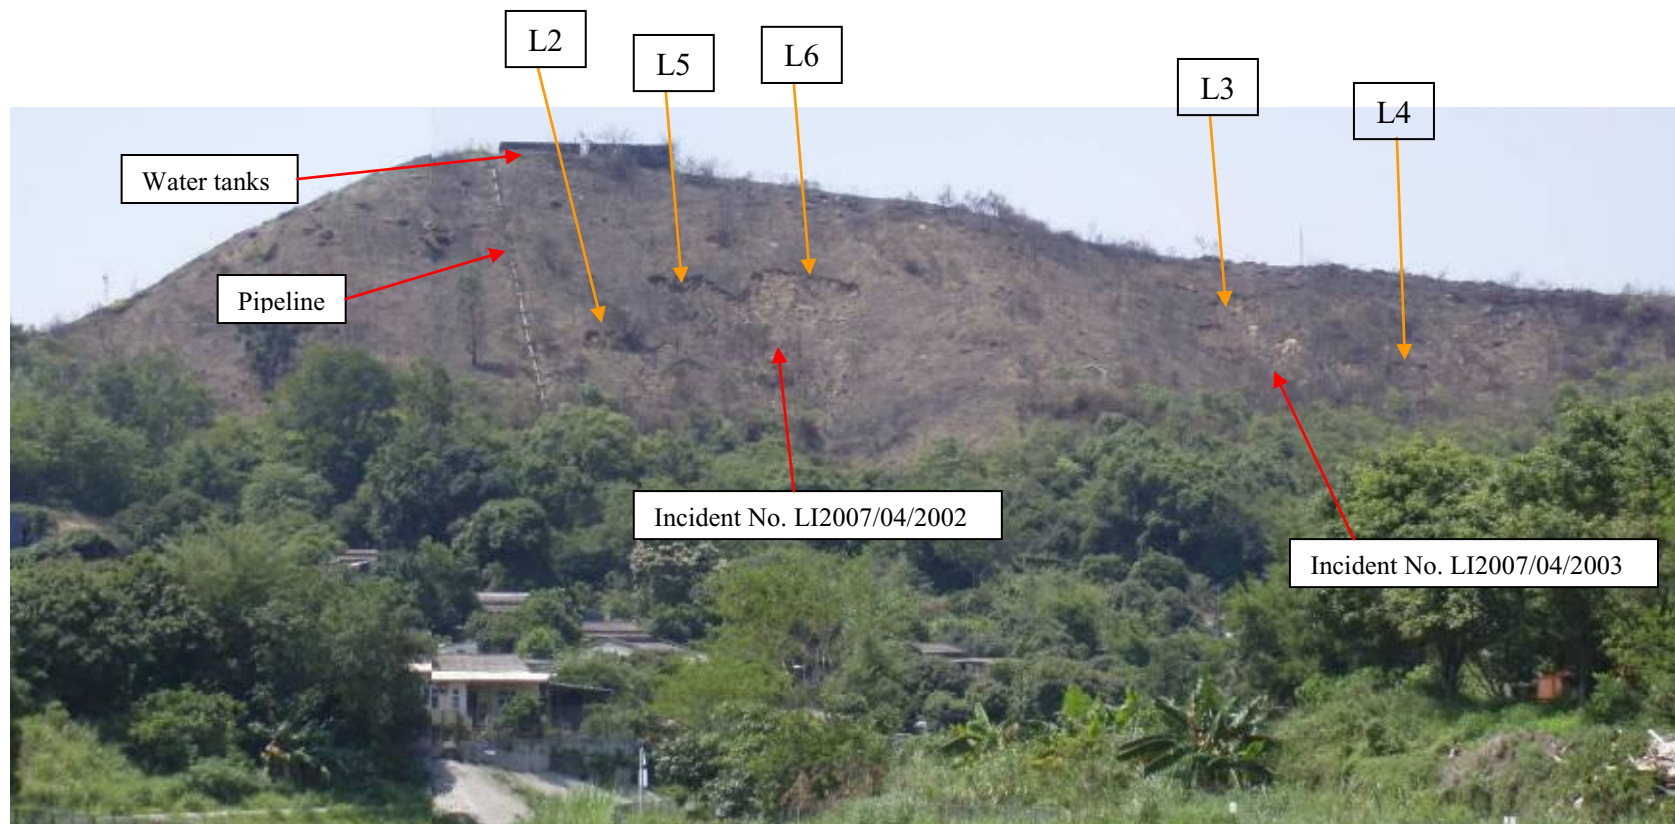
The south-facing hillside is approximately 80 m in height and is inclined at about 25° to 40° (Figures 4 and 5). Two shallow depressions are present in the central and eastern portions of the south-facing hillside. In the vicinity of these depressions are a number of relict and recent landslide scars, distressed ground and tension cracks (Plate 3).

Plate 3 - Signs of Distress on the South-facing Hillside (Photograph taken on 7 May 2007)

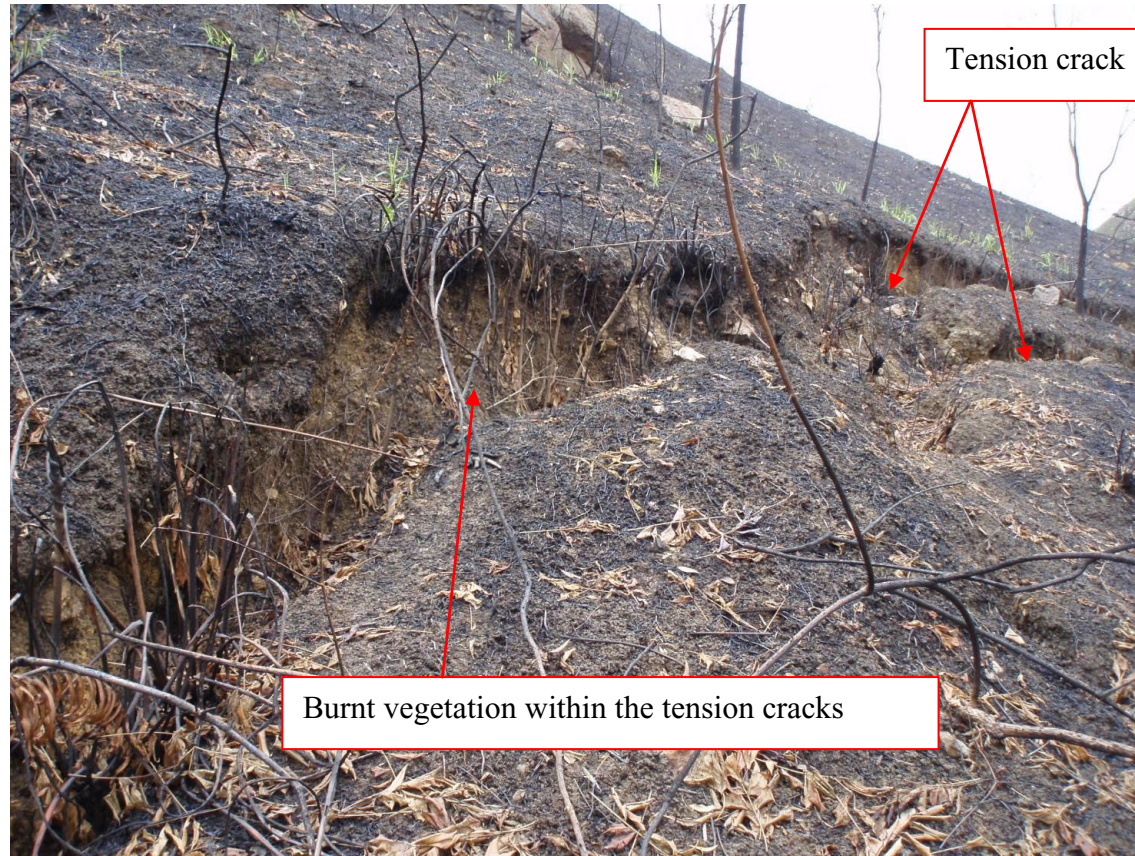
Plate 5 - View of the Central Portion of the Tension Cracks at the North-facing Hillside (Photograph taken on 23 April 2007)

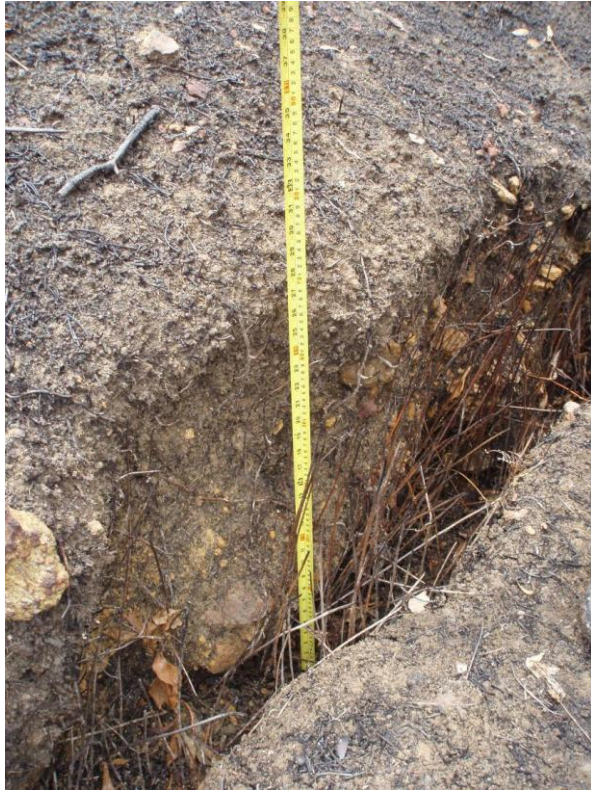
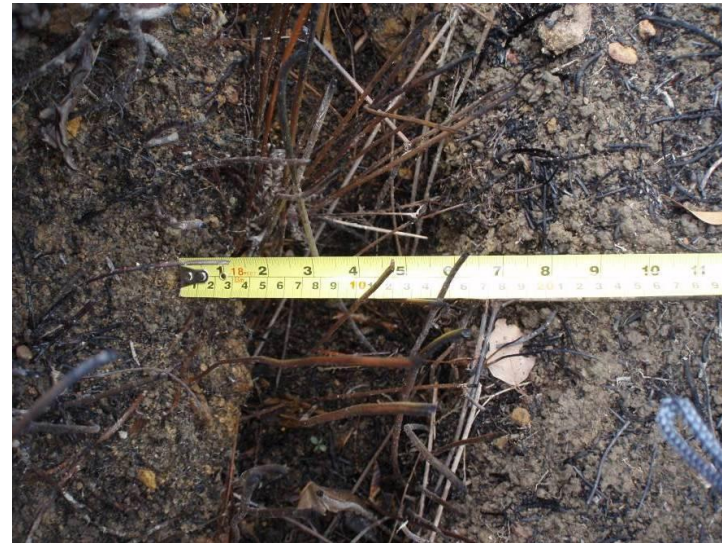
Plate 6 - Close-up of the Main Tension Crack at the North-facing Hillside (Photograph taken on 23 April 2007)

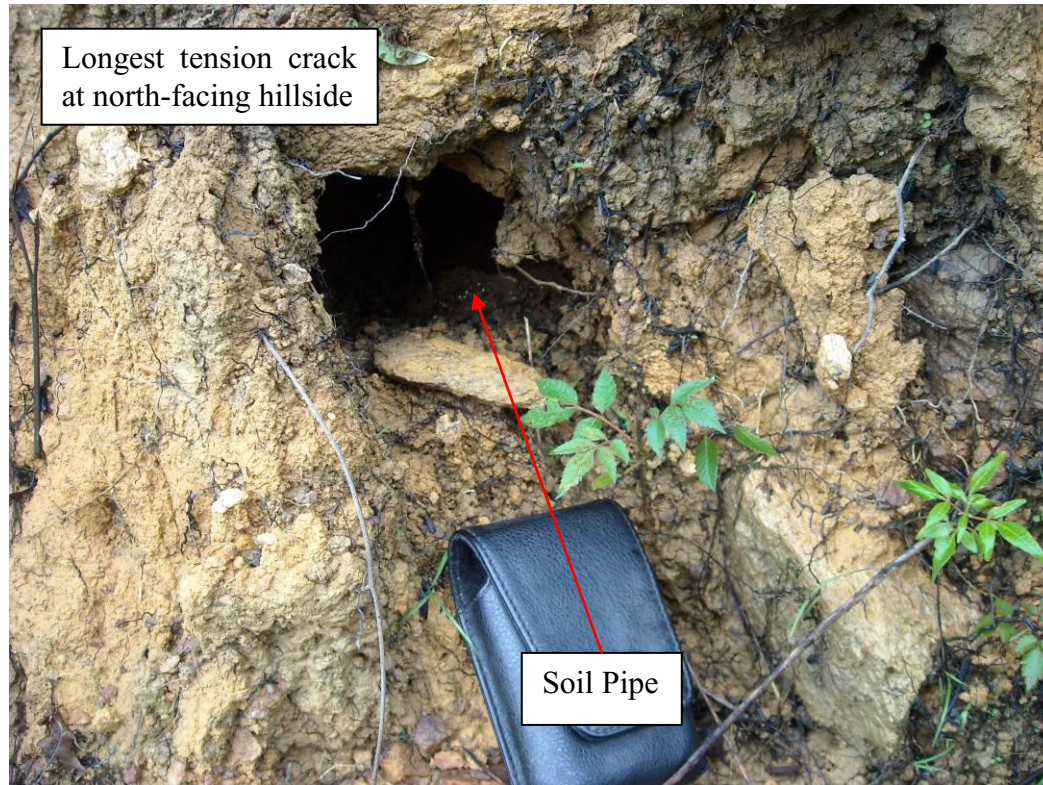
Plate 7 - Soil Pipe at Main Tension Crack on the North-facing Hillside (Photograph taken on 30 June 2008)

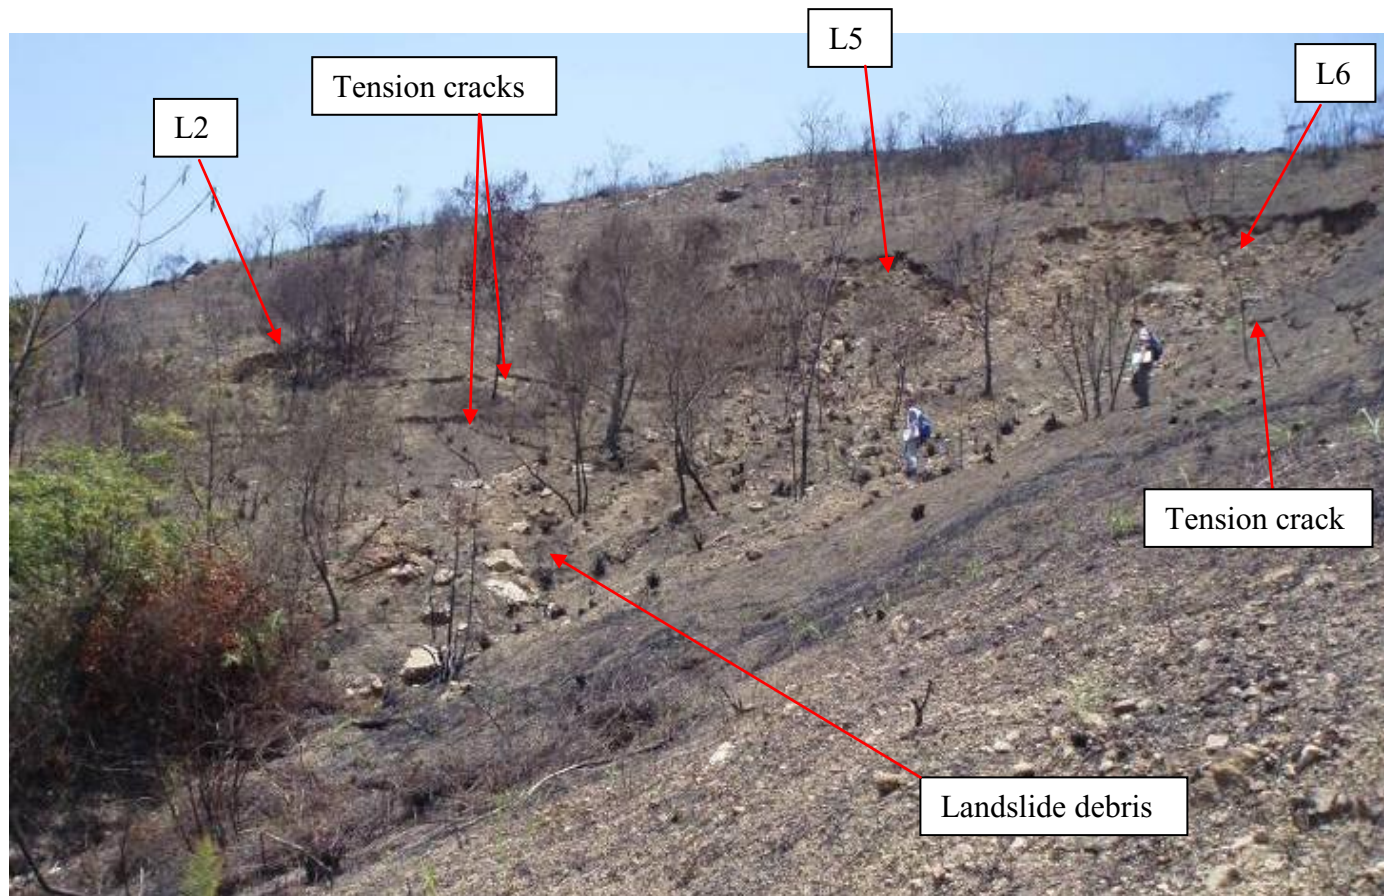
All of the landslides identified were shallow open hill slope failures. The depths of the landslide scarps were less than 1 m and the estimated landslide volumes ranged between <5 m³ and 150 m³. The lengths of the debris trails ranged between <5 m and 50 m long and the estimated travel angles were between 20° and 30°.

Plate 8 - General View of the Landslide Scars and Tension Cracks of Incident No. LI2007/04/2002 on the South-facing Hillside(Photograph taken on 7 May 2007)

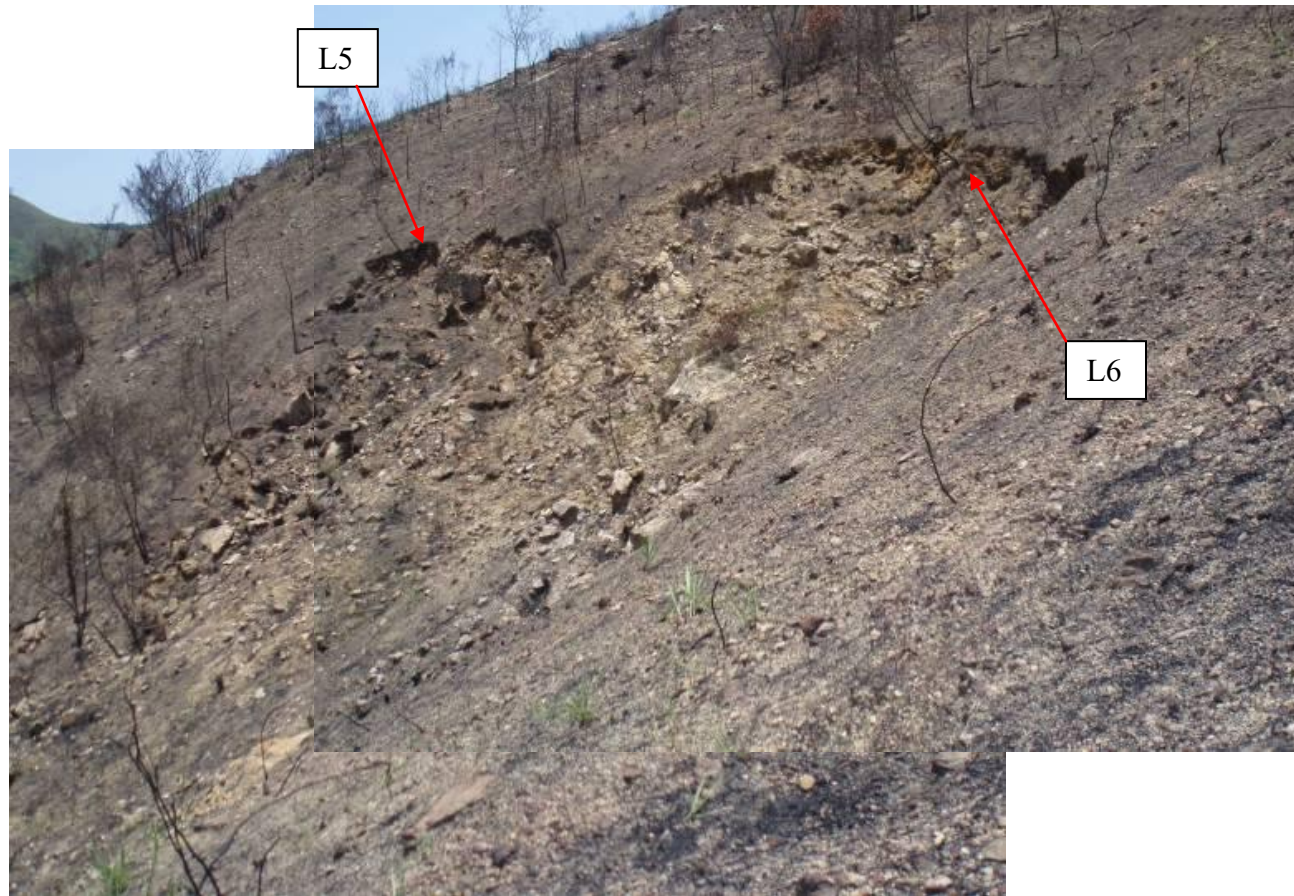
Plate 9 - Close-up of Main Scarps of the Landslide Scars of Incident No. LI2007/04/2002 on the South-facing Hillside (Photograph taken on 7 May 2007)

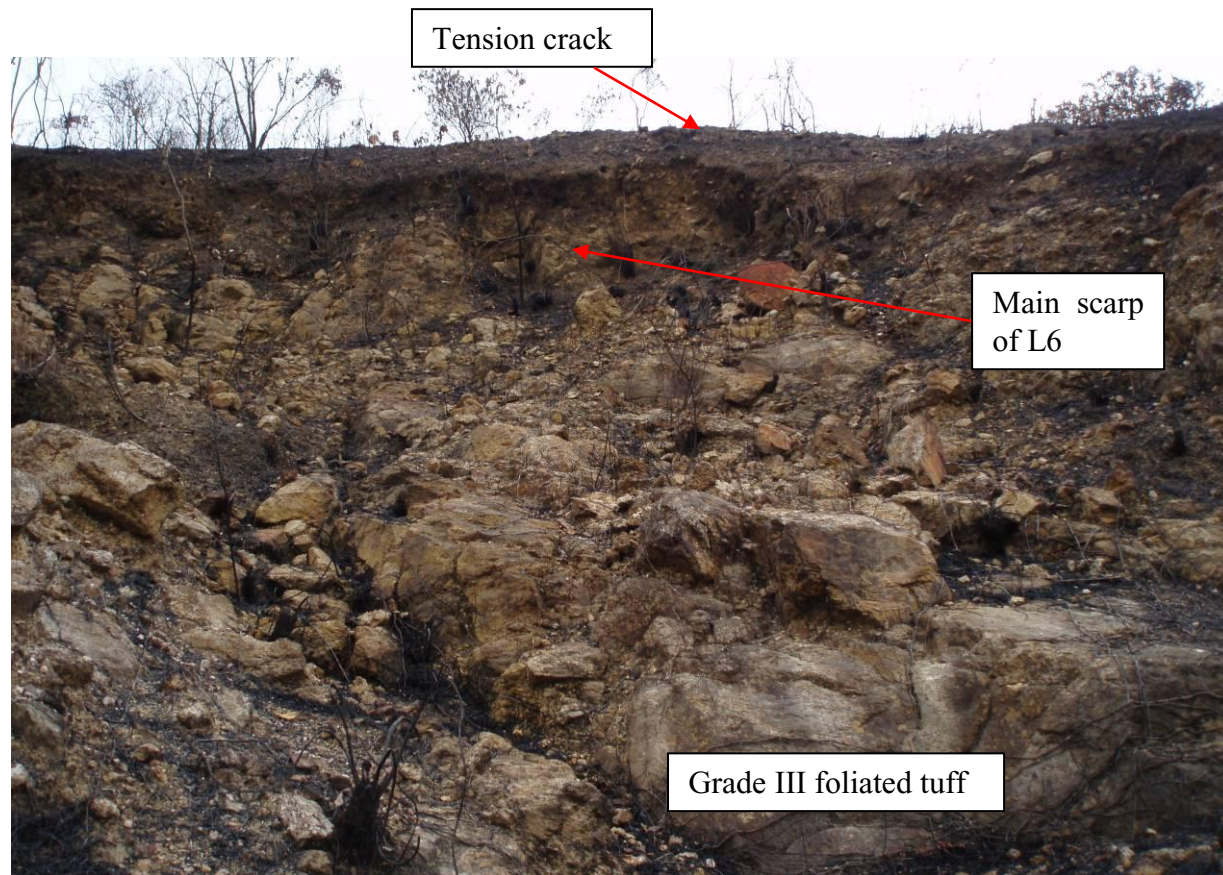
Plate 10 - Close-up of the Main Scarp of Landslide Scar L6 on the South-facing Hillside
(Photograph taken on 23 April 2007)

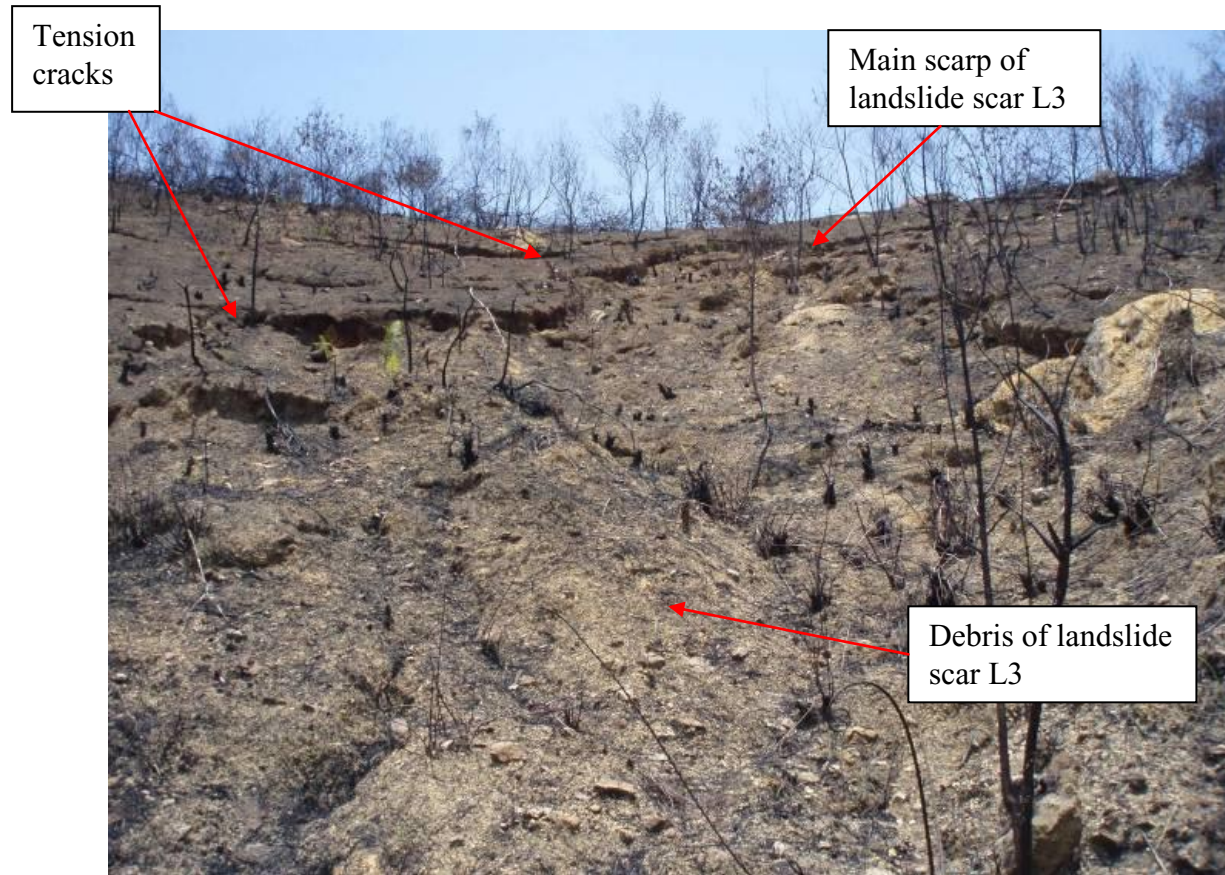
Plate 11 - General View of the Landslide Scar and Tension Cracks of Incident No. LI2007/04/2003 on the South-facing Hillside (Photograph taken on 7 May 2007)

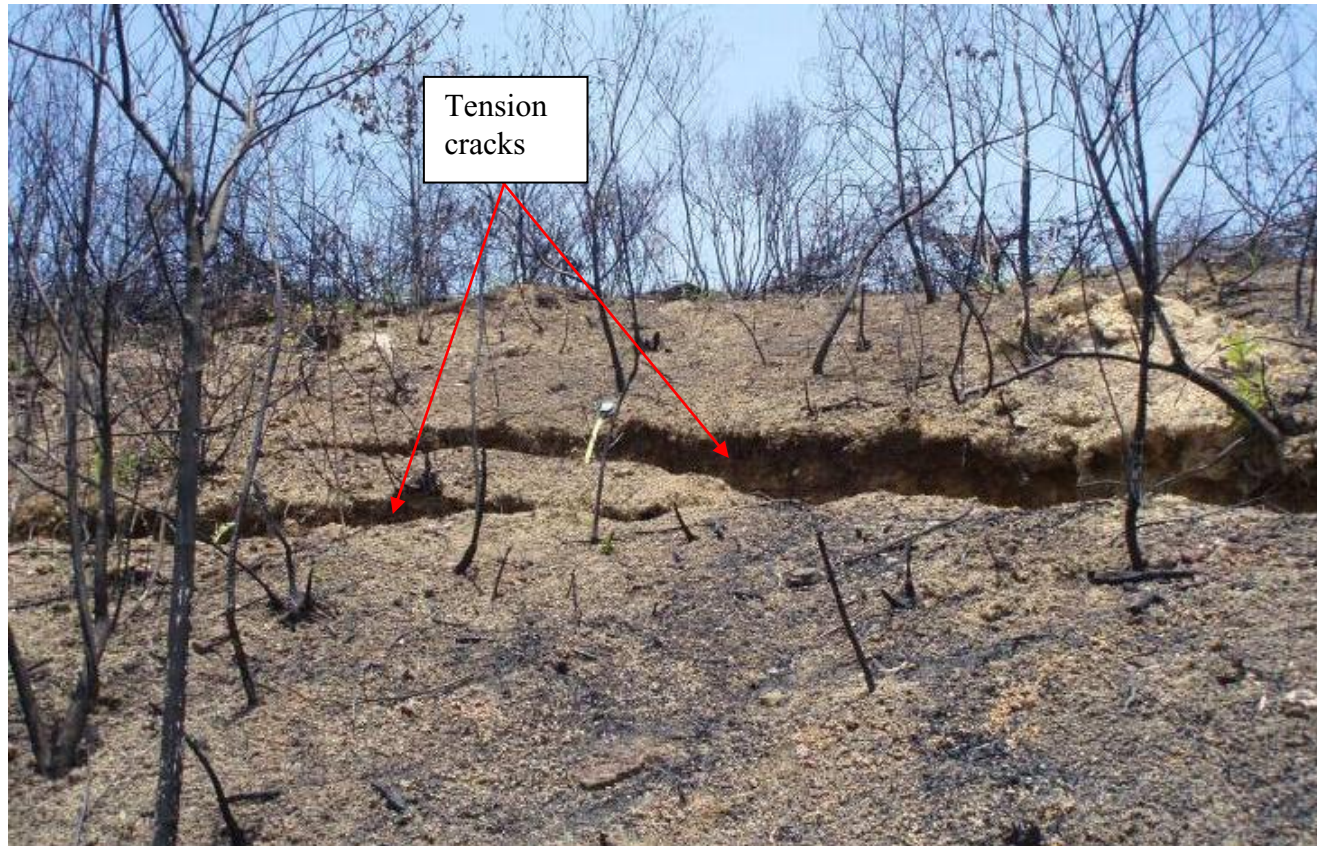
Several tension cracks were also identified at an elevation of approximately 55 mPD and 75 mPD in the vicinity of the landslide scars (Plate 12). The longest tension crack, approximately 8 m long, was located above the largest recent landslide scar (L3). The width and depth of the tension cracks ranged from 100 mm to 300 mm and from 400 mm to 500 mm respectively. Only colluvial material was observed in the walls of the tension cracks.

Plate 12 - Close-up of Tension Crack above Landslide Scar L3 of Incident No. LI2007/04/2003
on the South-facing Hillside (Photograph taken on 7 May 2007)

At the time of HCL's inspection in November 2007 the tension cracks above L3 and the main scarp of L3 had been sealed with cement soil mortar by HyD's term contractor, following the reporting of the incidents to HyD on 17 August 2007.

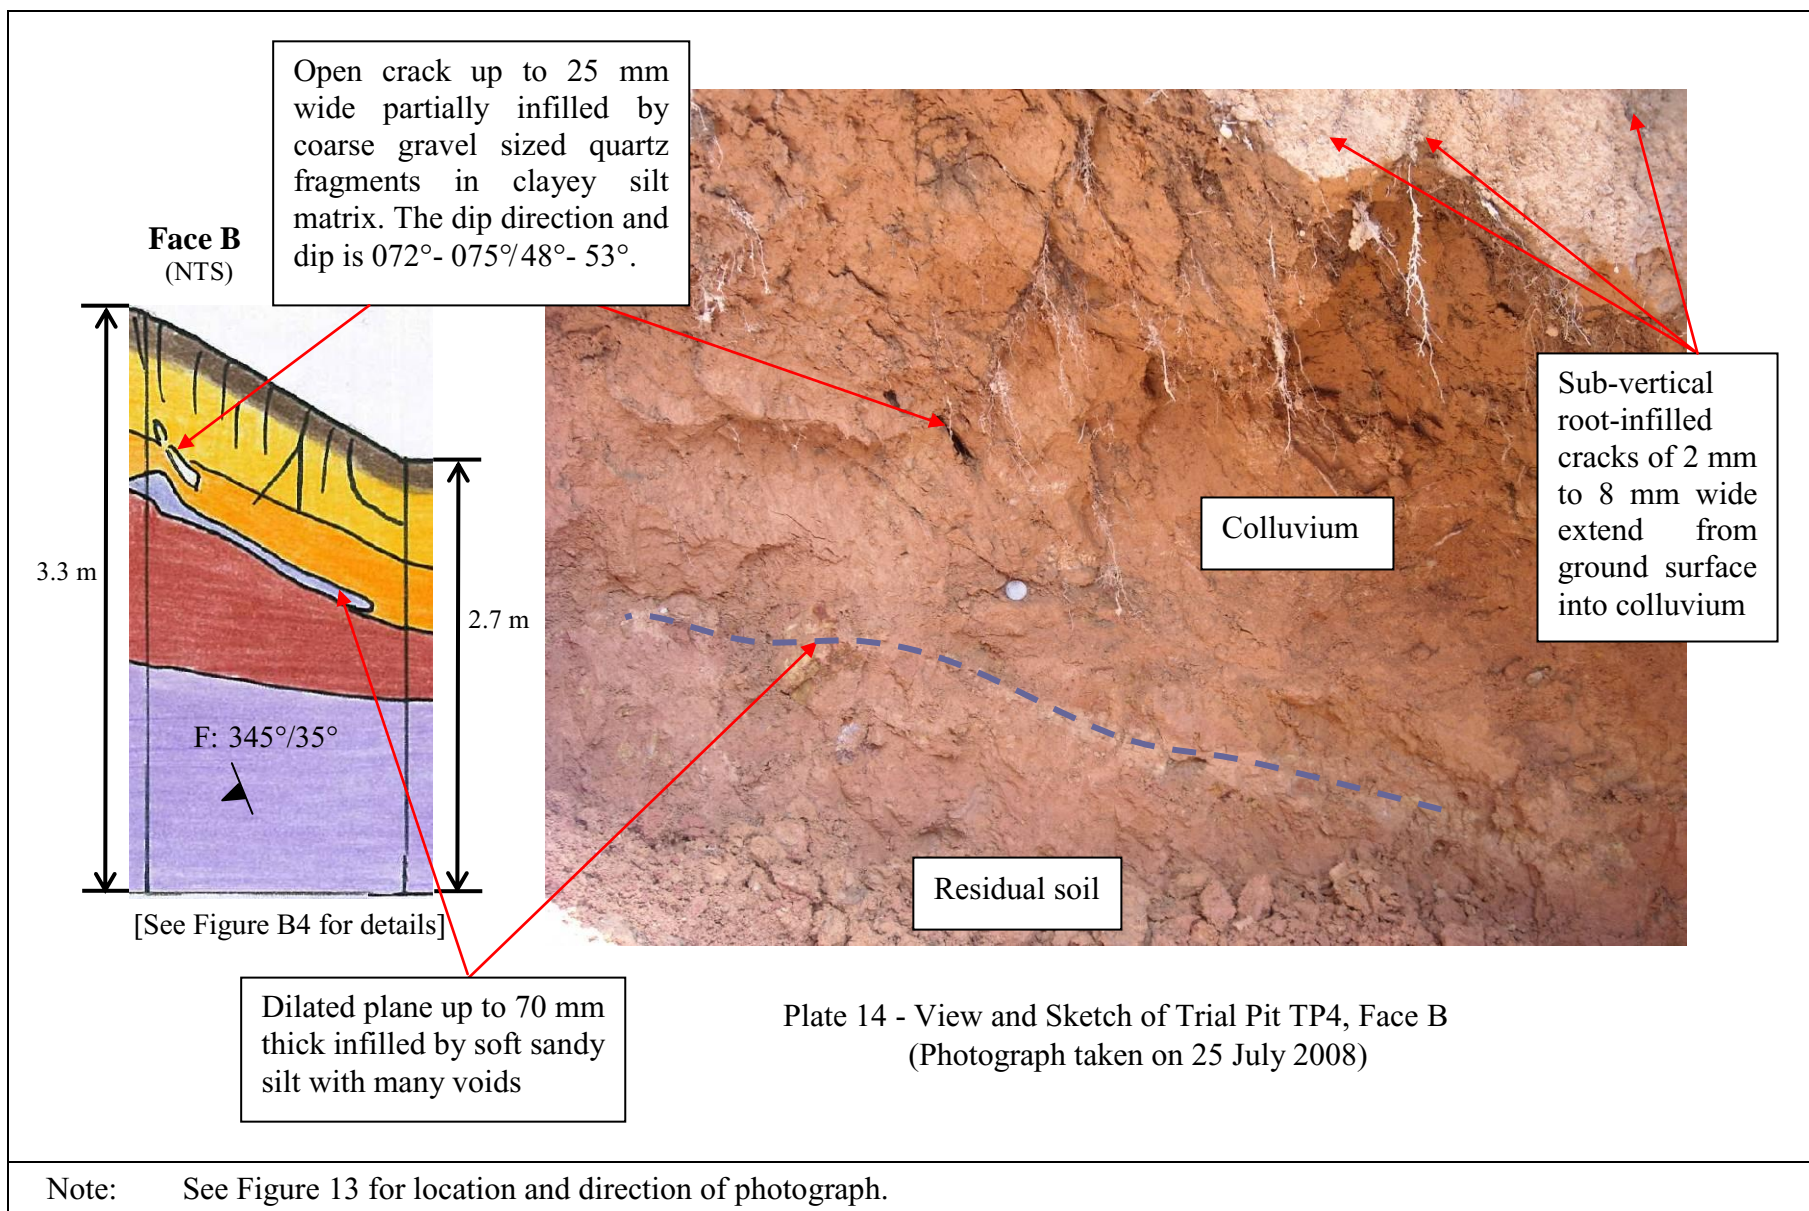
Trial pit TP4, positioned outside the western flank of landslide scar L3 on the south-facing hillside, encountered two layers of colluvium up to 1.0 m thick overlying residual soil. The upper colluvium layer was up to 0.7 m thick and comprised sandy clayey silt with occasional medium to coarse gravel. Many sub-vertical root-infilled cracks were identified in the upper colluvium layer. The lower colluvium layer was up to 0.3 m thick and comprised clayey silt with some medium to coarse gravel and occasional cobble sized rock fragments. The layer of residual soil was up to 1m thick and comprised firm brownish red slightly sandy clayey silt overlying Grade V tuff. At the interface between the colluvium

and residual soil at Face B of the trial pit, a dilated crack, about 70 mm wide and 1.35 m long, infilled by sandy silt with many small voids was identified. Numerous tension cracks about 0.05 m to 0.3 m wide were observed extending upslope. The cracks were infilled by rootlets and organic materials indicating that they were probably at least a few years old.

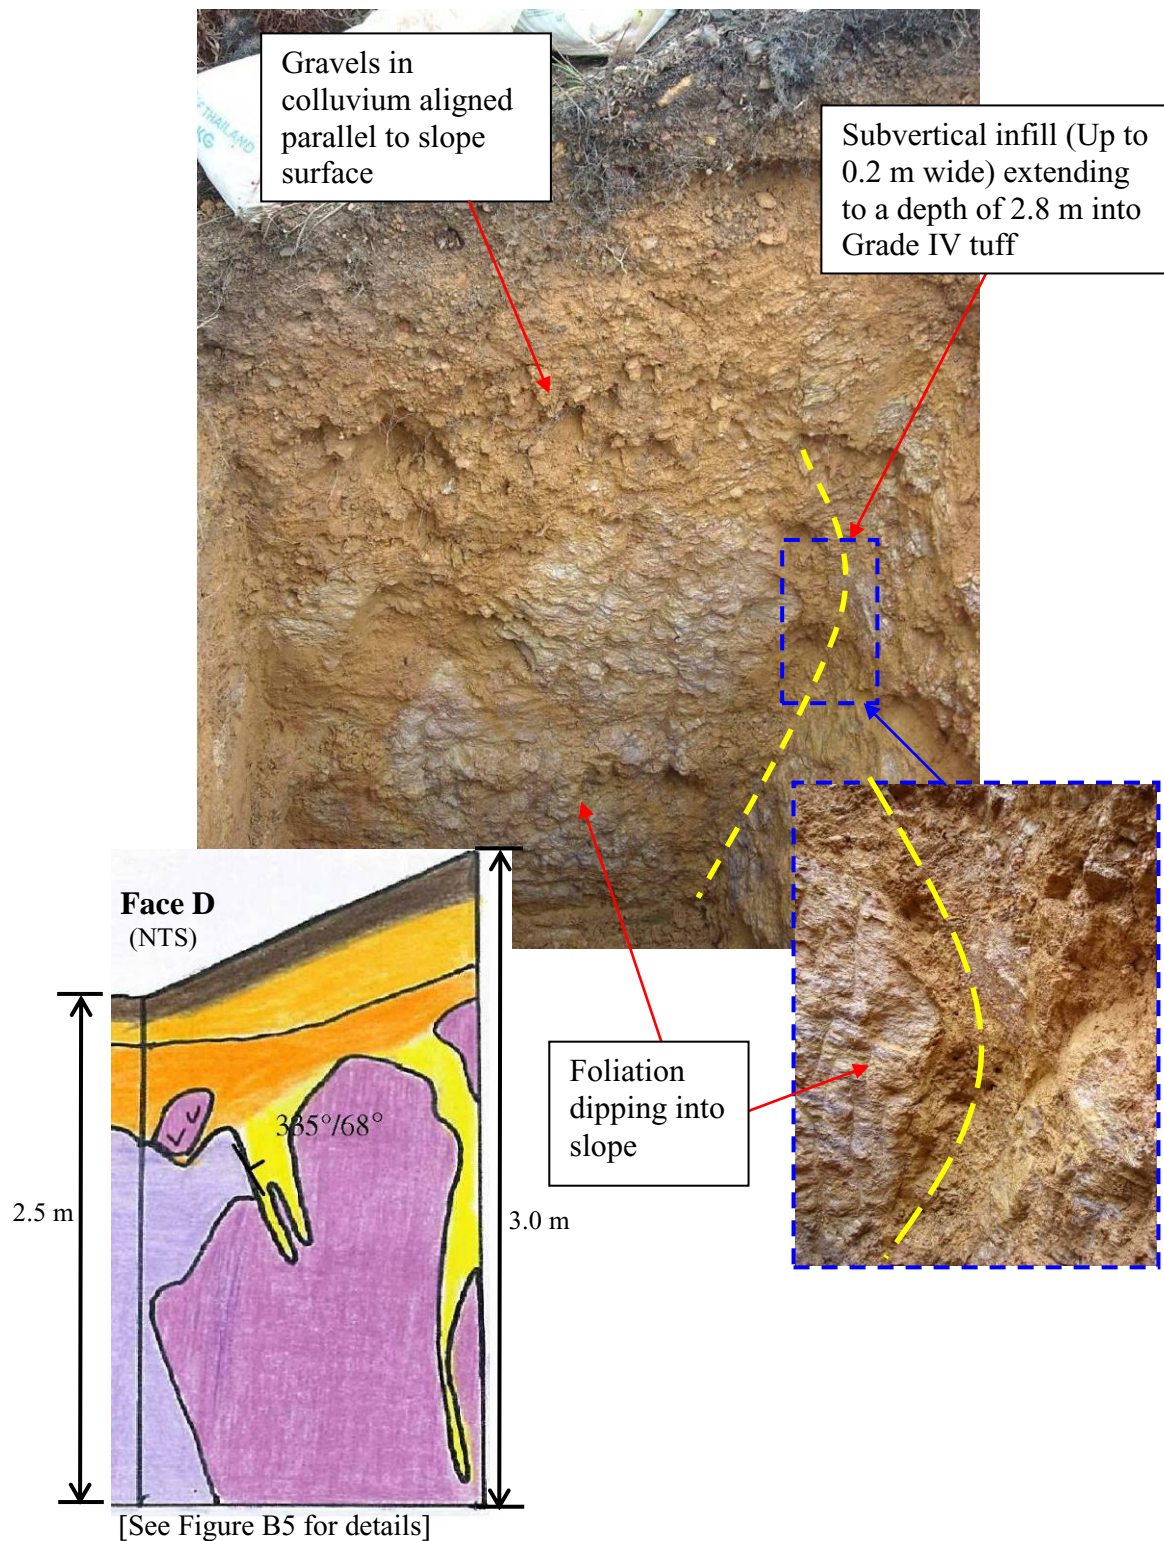
Plate 15 - View and Sketch of Trial Pit TP5, Face D (Photograph taken on 11 Aug 2008)

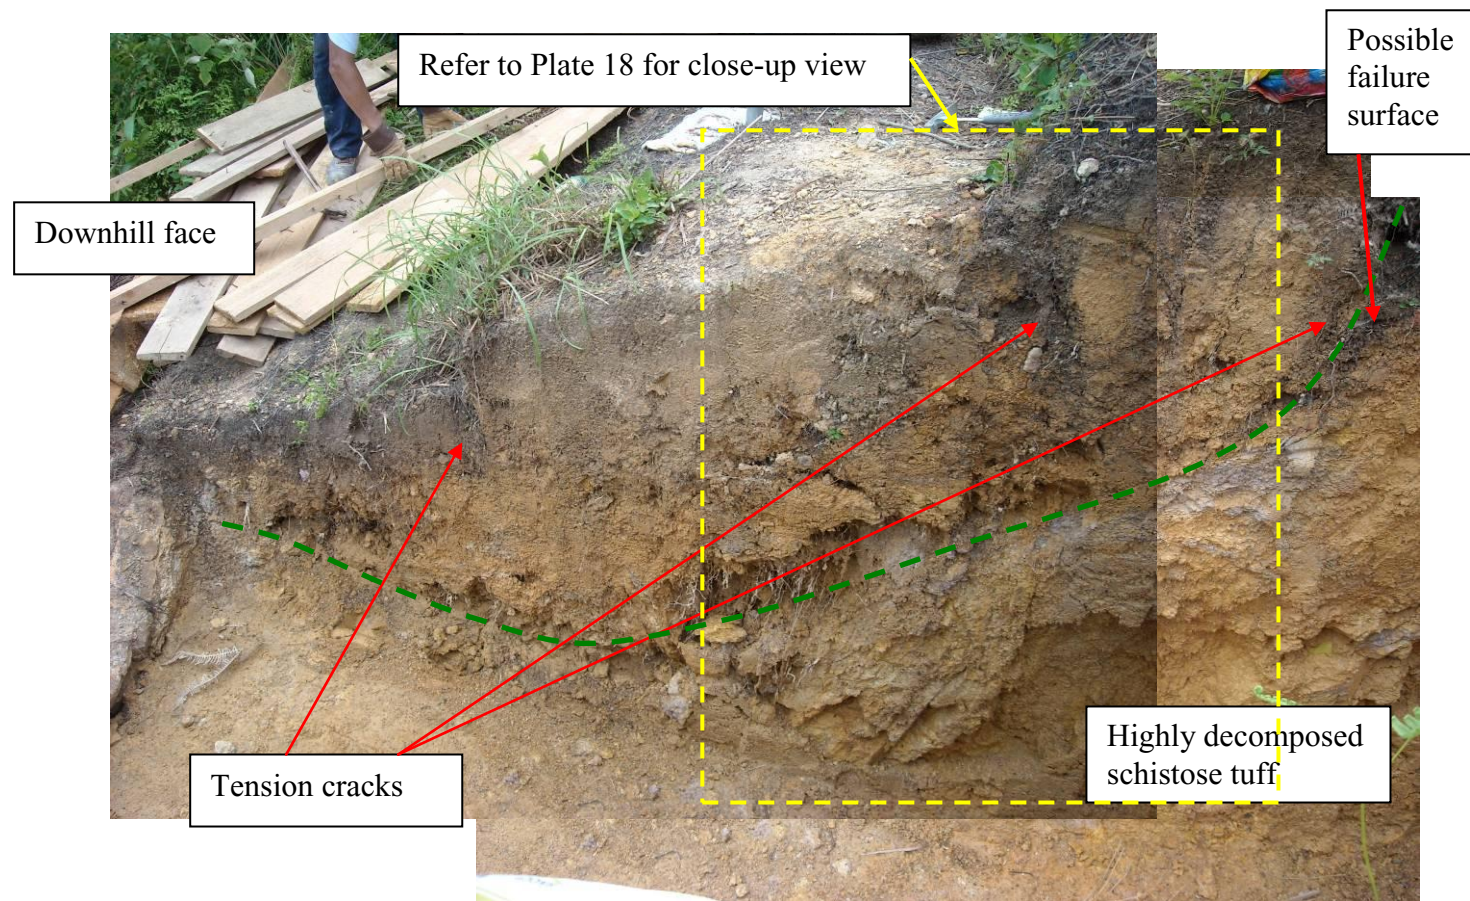
Trial Trench TT1 was positioned across three tension cracks at the north-facing hillside and encountered colluvium up to 0.8 m thick comprising firm, yellowish brown sandy silt with some gravel and occasional cobble sized rock fragments, overlying Grade V/IV tuff. Several root-filled sub-vertical cracks were identified within the colluvium layer. At Face B of the excavation, tension cracks of between 8 mm and 300 mm in width converged to a shear plane at about 0.6 m below ground level at the interface between the colluvium and Grade IV tuff. A disturbed zone was identified beneath the shear plane in which blocks of decomposed tuff had apparently rotated within the rock mass, suggesting that movement has extended into the upper zone of the tuff (Plate 16). The tension cracks and the shear plane were infilled by dark grey, loose silty sand and organic materials with many rootlets. Evidence of past movement in the form of infilling materials up to 300 mm thick, comprising coarse gravel and cobble sized rock fragments in a firm, brownish yellow clayey silt matrix was also identified within the Grade IV tuff. Grade III foliated tuff with iron oxide stained joints parallel to the foliation was encountered at a depth of 1.25 m below ground level at the corner of Face A and Face B of the excavation. At Face D, tension cracks of between 5 mm and 220 mm in width converged to a shear plane at about 0.5 m to 0.7 m below ground level, at the interface between the colluvium and Grade IV/V tuff. The shear plane was up to about 250 mm wide and partially infilled by loose yellowish brown silty sand with many rootlets (Plates 17 and 18).

Plate 17 - View of Trial Trench TT1, Face D (Photograph taken on 29 July 2008)

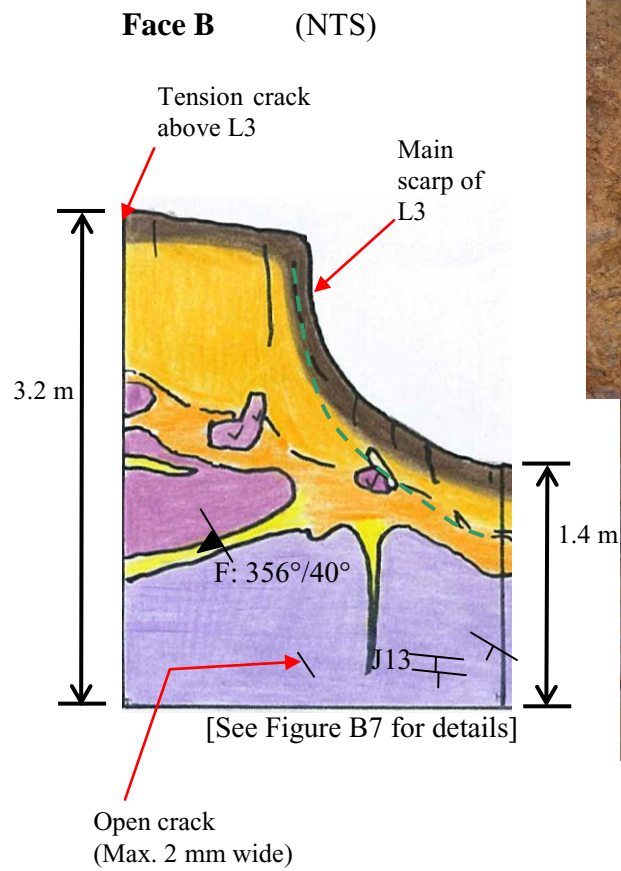
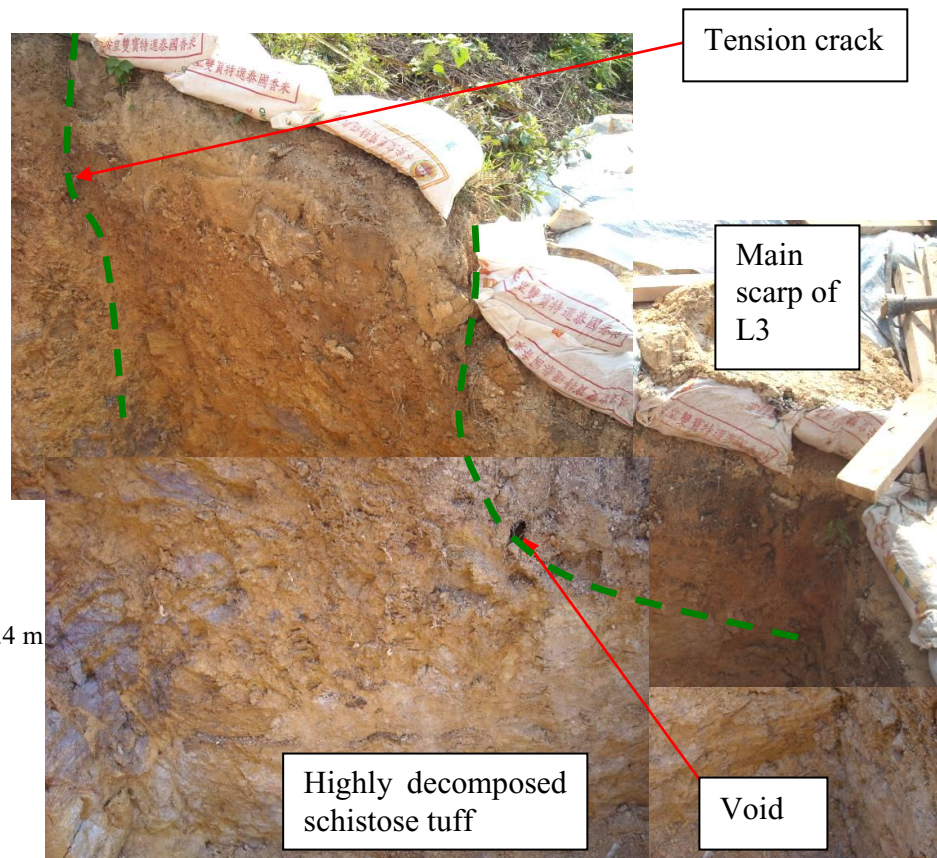
Trial trench TT2 was positioned across the tension cracks and main scarp of landslide scar L3 on the south-facing hillside and encountered two layers of colluvium up to 1.3 m thick overlying Grade V/IV tuff (Plate 19). The upper colluvium layer was up to 1.0 m thick and comprised sandy silt with some coarse gravel and cobble sized Grade V/IV tuff fragments and with several root-filled sub-vertical cracks. The lower colluvium was up to 0.8 m thick and comprised sandy silt with many gravel, cobble and occasional boulder sized Grade V/IV tuff fragments. At Face C, recent movement in the form of discontinuous open cracks with maximum aperture of 25 mm was identified at the interface between the upper and lower colluvium, at about 0.35 m below the ground surface. Evidence of past movement in the form of infilling materials up to 200 mm wide, partially infilled and open cracks between 50 mm and 150 mm wide and voids was identified extending from the base of the lower

Plate 19 - View and Sketch of Trial Trench TT2, Face B (Photograph taken on 27 July 2008)
