**REVIEW OF THE 27 MAY 2007  
BOULDER FALL INCIDENT  
ON THE SLOPING GROUND  
ABOVE RETAINING WALL  
NO. 11SW-A/R677,  
PO SHAN ROAD**

**GEO REPORT No. 268**

**Fugro Scott Wilson Joint Venture**

**GEOTECHNICAL ENGINEERING OFFICE  
CIVIL ENGINEERING AND DEVELOPMENT DEPARTMENT  
THE GOVERNMENT OF THE HONG KONG  
SPECIAL ADMINISTRATIVE REGION**

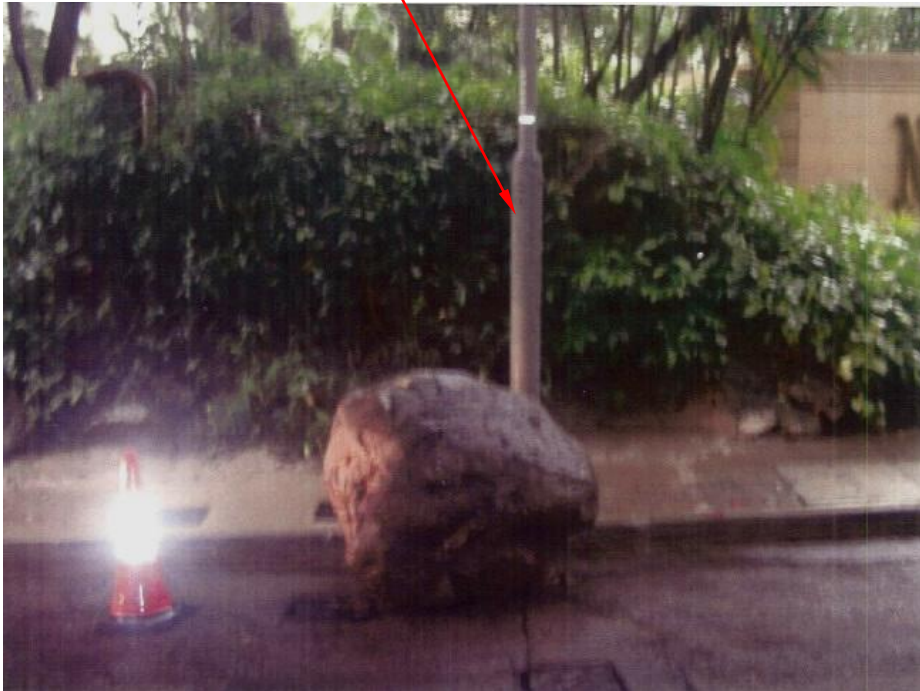
Plate 1 - Close View of Boulder Involved in the 27 May 2007 Incident  
(Photograph taken by GEO on 27 May 2007)

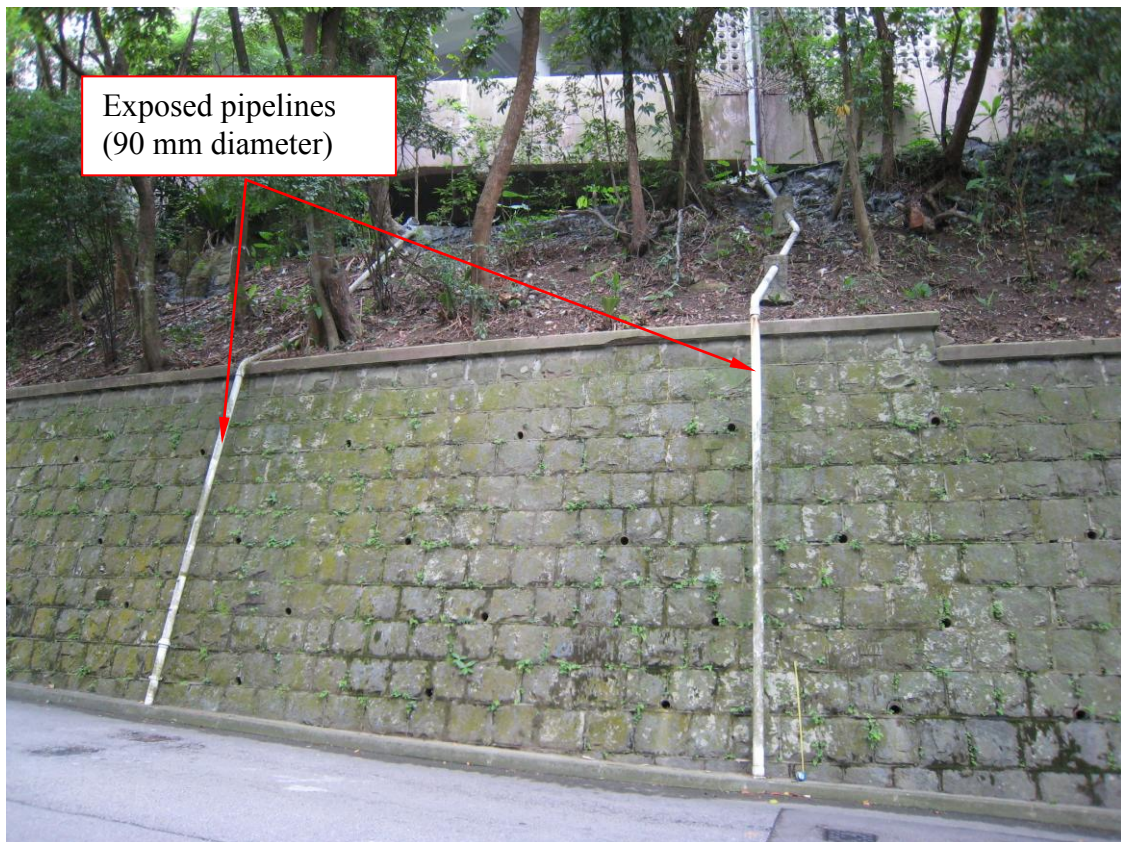
Exposed pipelines  
(90 mm diameter)

Plate 4 – Exposed Pipelines on Retaining Wall No. 11SW-A/R677 (Photograph taken on 25 July 2007)

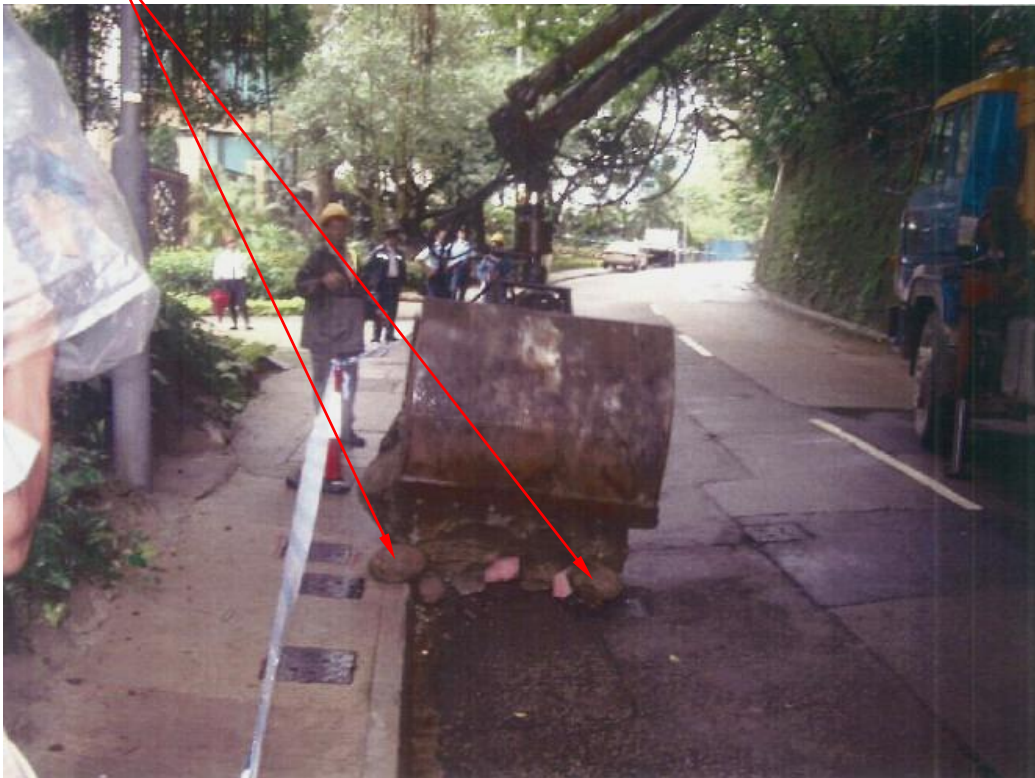
Cobble-sized rock  
fragments

Plate 7 - Cobble-sized Rock Fragments Brought down with the Main Boulder  
(Photograph taken by HyD on 27 May 2007)

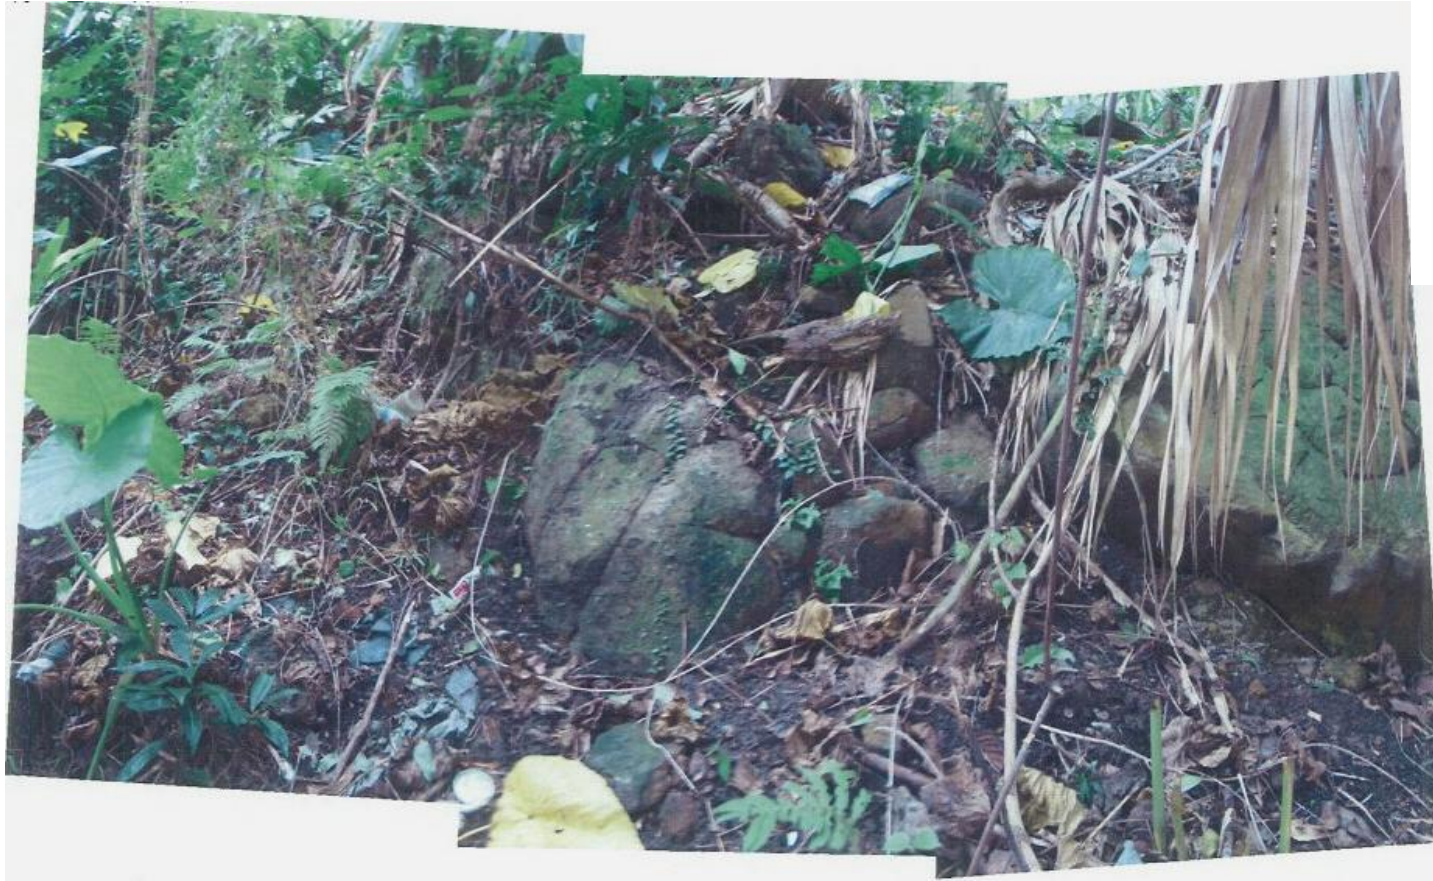
Plate 8 - Cluster of Loose Boulders Identified on Sloping Ground above Retaining Wall No. 11SW-A/R677  
(Photograph taken by GEO on 4 June 2007)

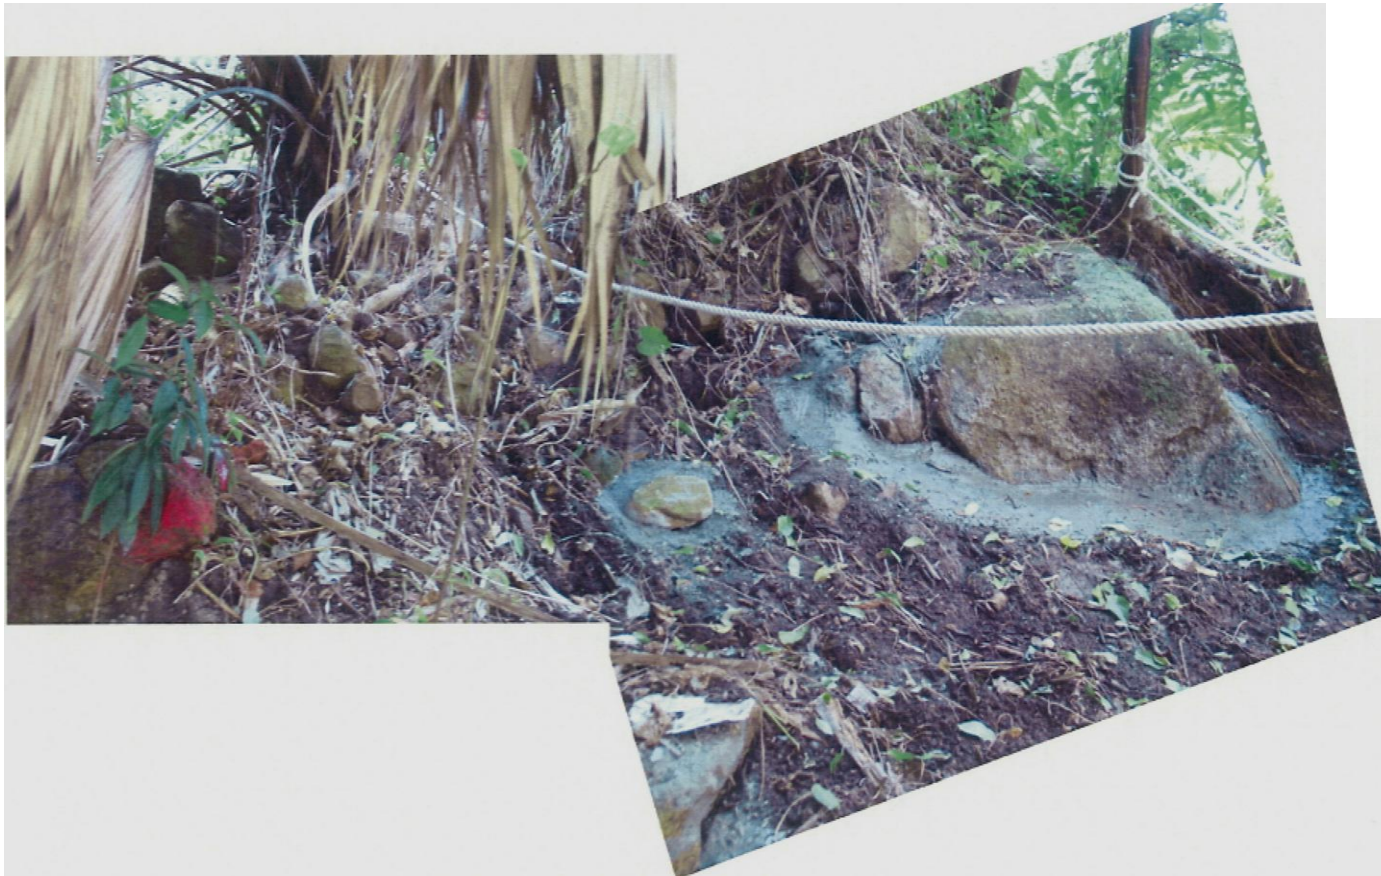
Plate 9 - Boulder Stabilisation Works Completed by HyD following the 27 May 2007 Boulder Fall  
(Photograph taken by GEO on 4 June 2007)

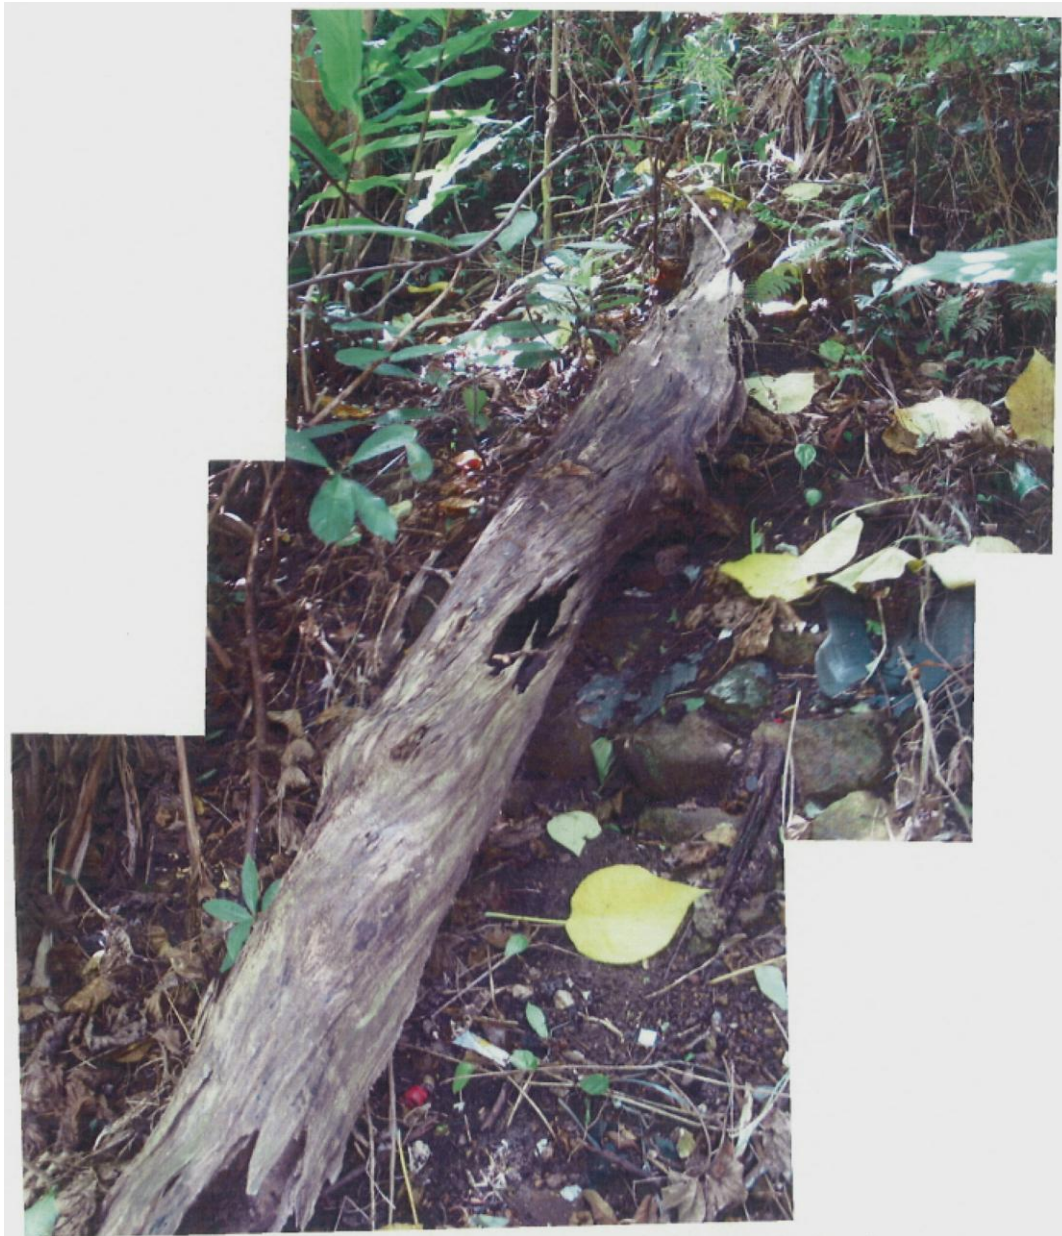
Plate 10 – Fallen Tree on Sloping Ground above Retaining Wall No. 11SW-A/FR677  
(Photograph taken by GEO on 4 June 2007)

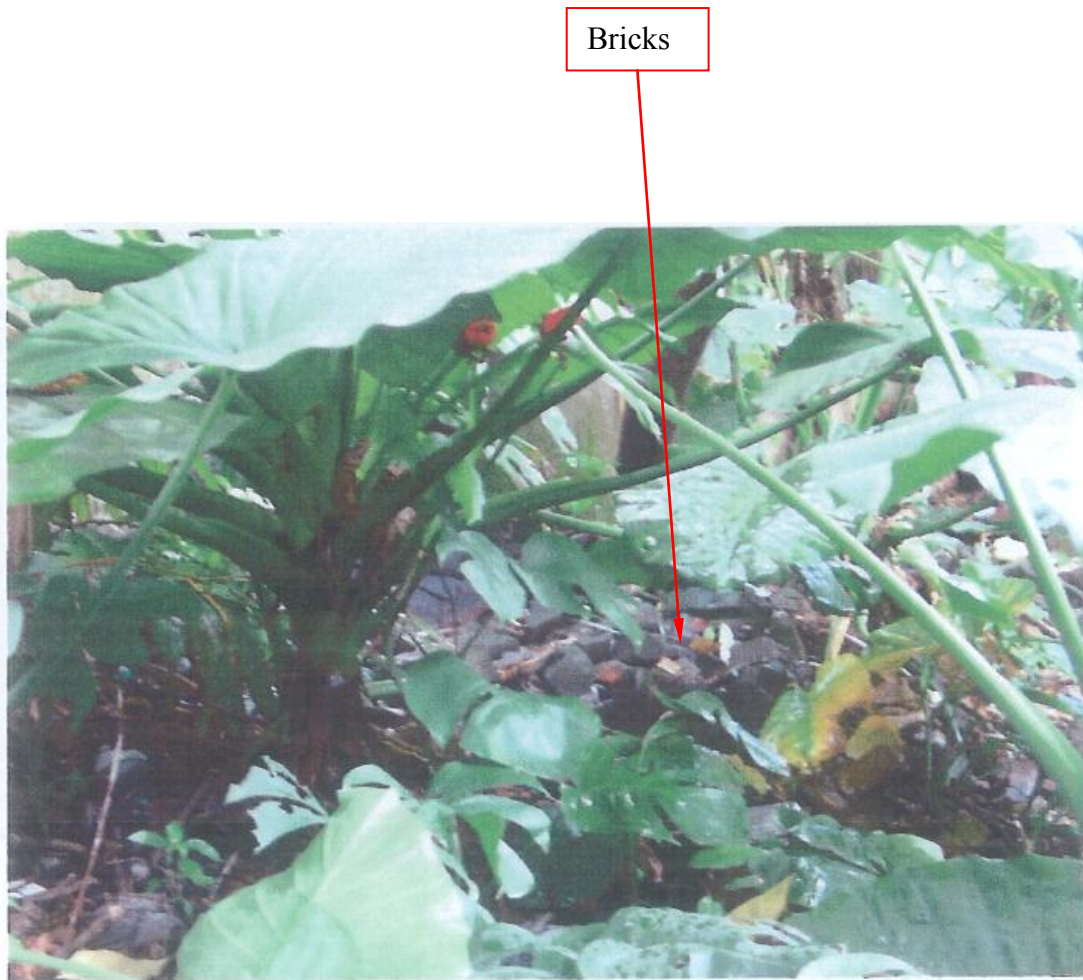
Plate 11 – Construction Debris on Sloping Ground above Retaining Wall  
No. 11SW-A/R677 (Photograph taken by GEO on 1 June 2007)

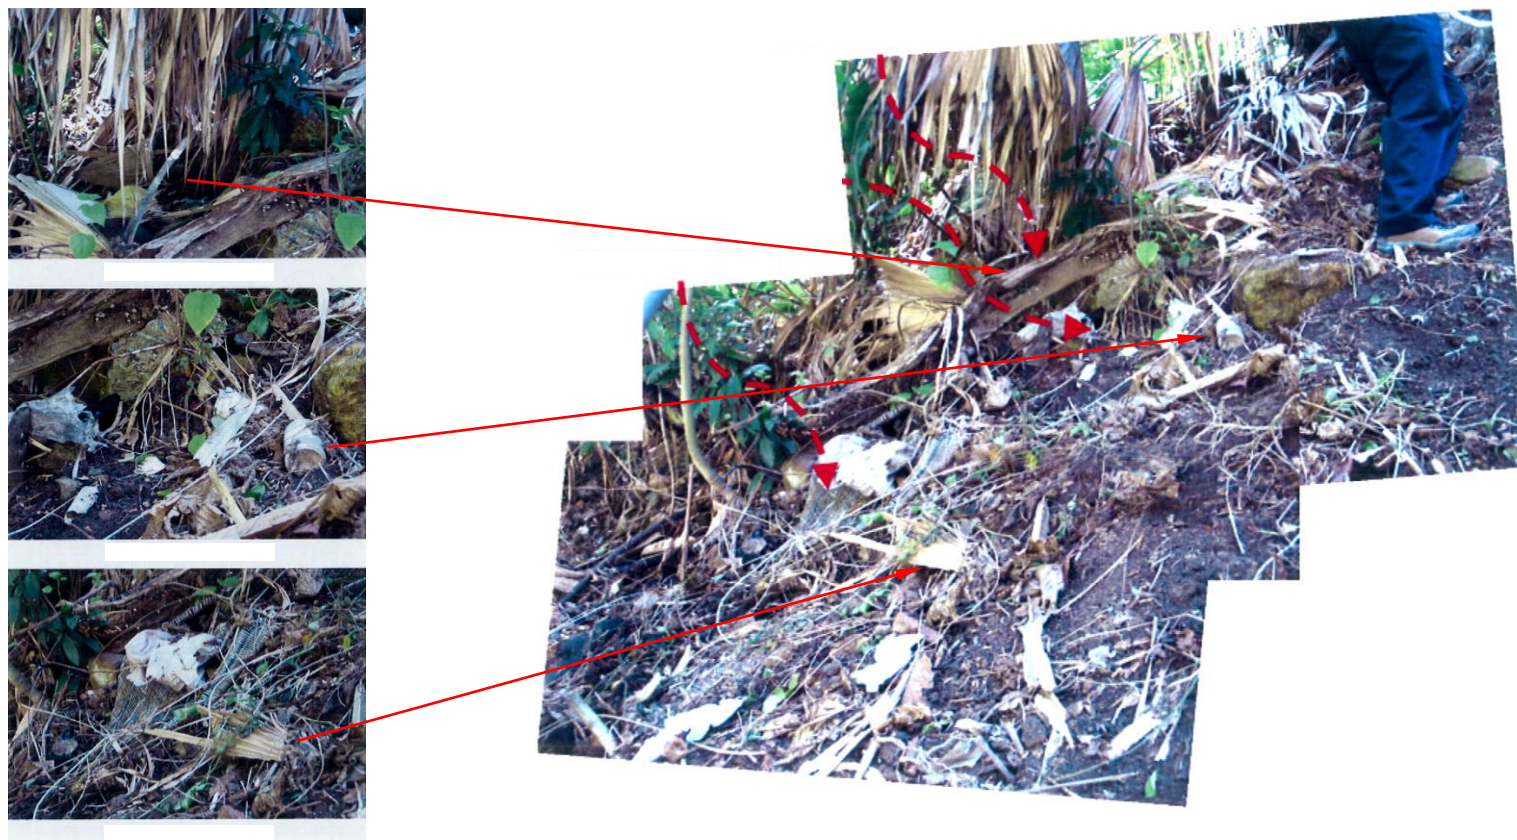
Plate 12 - General Rubbish on Sloping Ground above Retaining Wall No. 11SW-A/R677  
(Photograph taken by GEO on 1 June 2007)

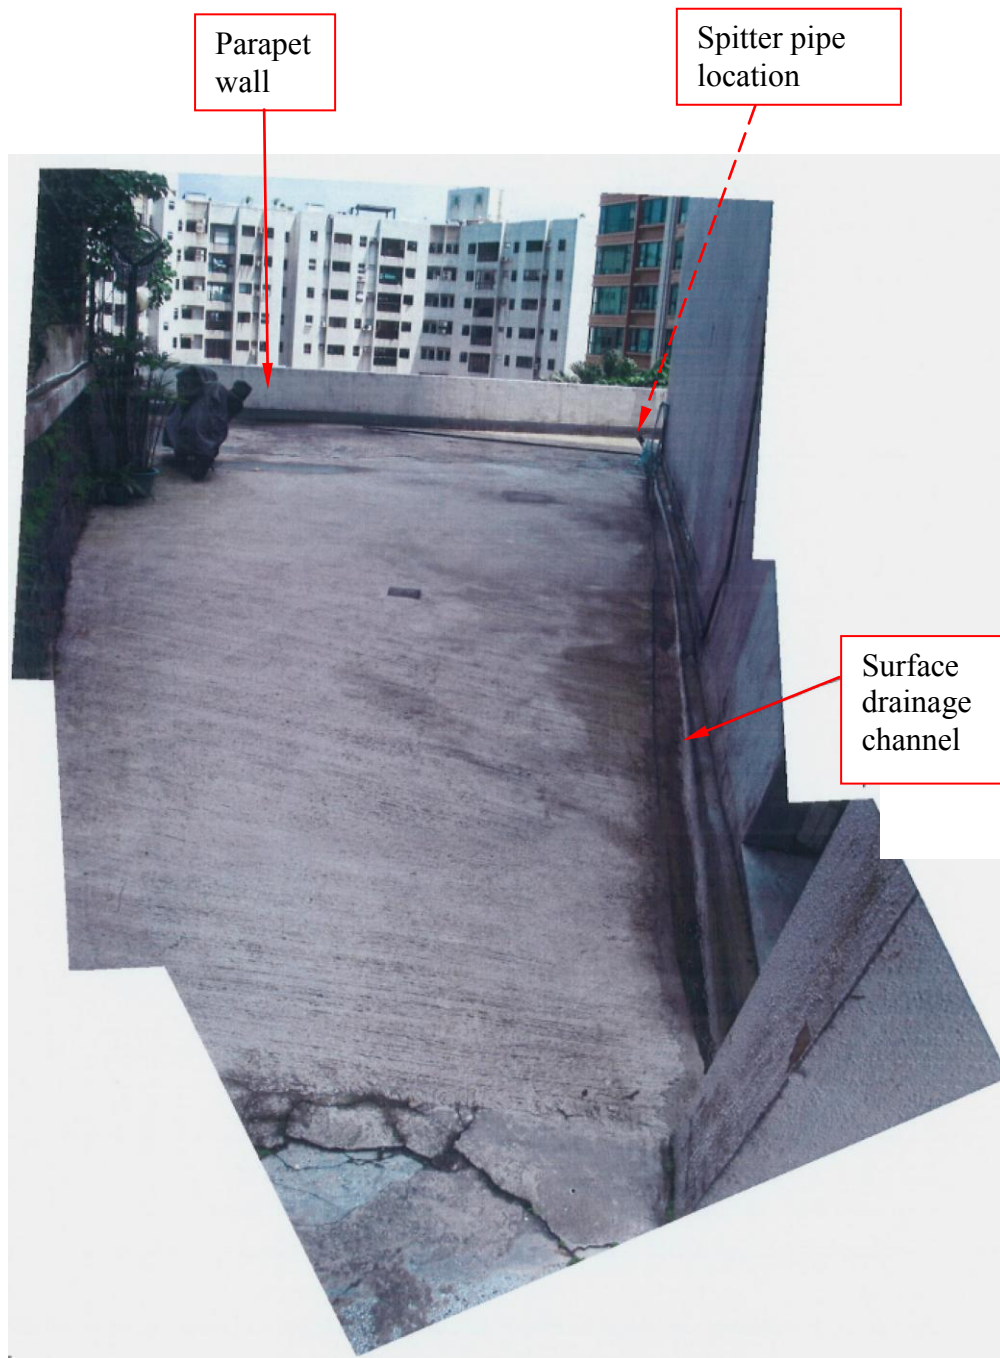
Inspection of the Hamilton Court podium by the GEO identified a 220 mm surface drainage channel that collects stormwater from the Hamilton Court apartment building as well as the podium area (Figure 2 and Plate 13), and extends to the northern edge of the podium. The channel was observed to discharge surface water through a 140 mm diameter 'spitter' pipe (Plate 14) directly onto the sloping ground behind retaining wall No. 11SW-A/R677 above the source area of the May 2007 boulder fall. In a joint site meeting attended by GEO, HyD and the management office of Hamilton Court on 1 June 2007, the GEO advised the management office of Hamilton Court to divert the flow from the surface drainage channel to a suitable discharge point. The diversion work had been completed at the time of a site inspection by FSW in mid-July 2007 (Plate 15).

Plate 13 – Surface Drainage Channel on Hamilton Court Podium Discharging Collected Runoff to Spitter Pipe above the 27 May 2007 Boulder Fall Source Location (Photograph taken by GEO on 1 June 2007)

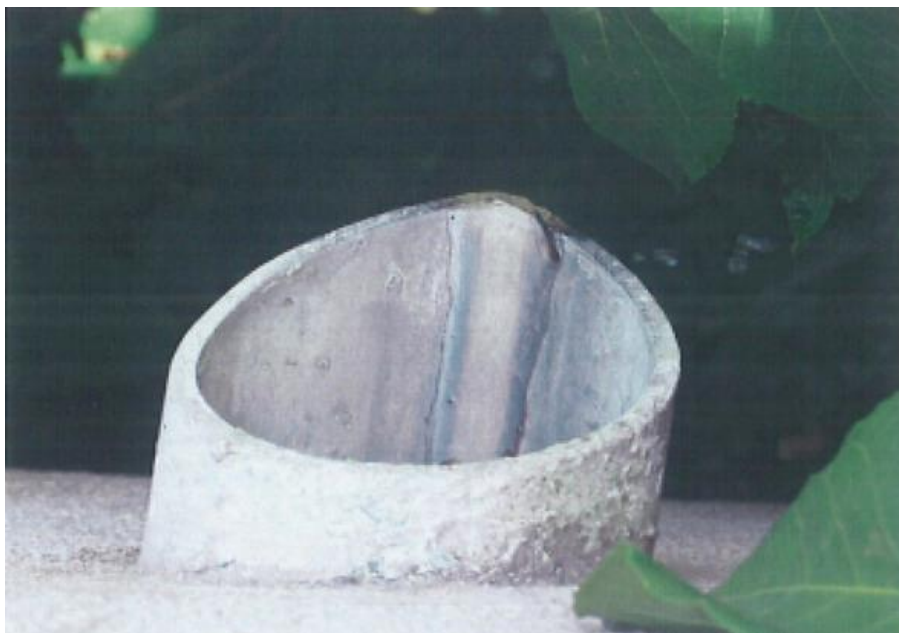
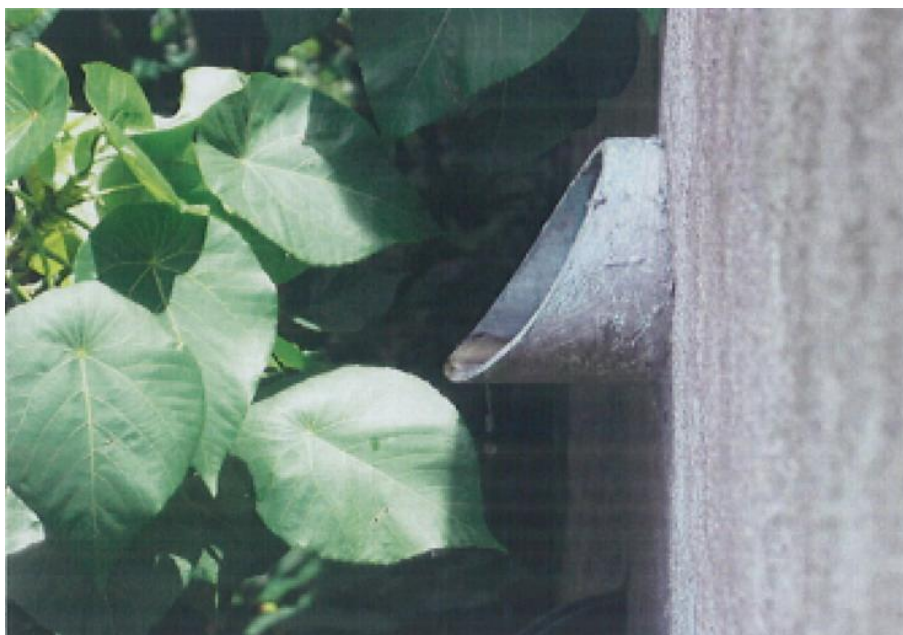
Plate 14 – Spitter Pipe on Hamilton Court Podium above the 27 May 2007 Boulder  
Fall Source Location (Photograph taken by GEO on 1 June 2007)

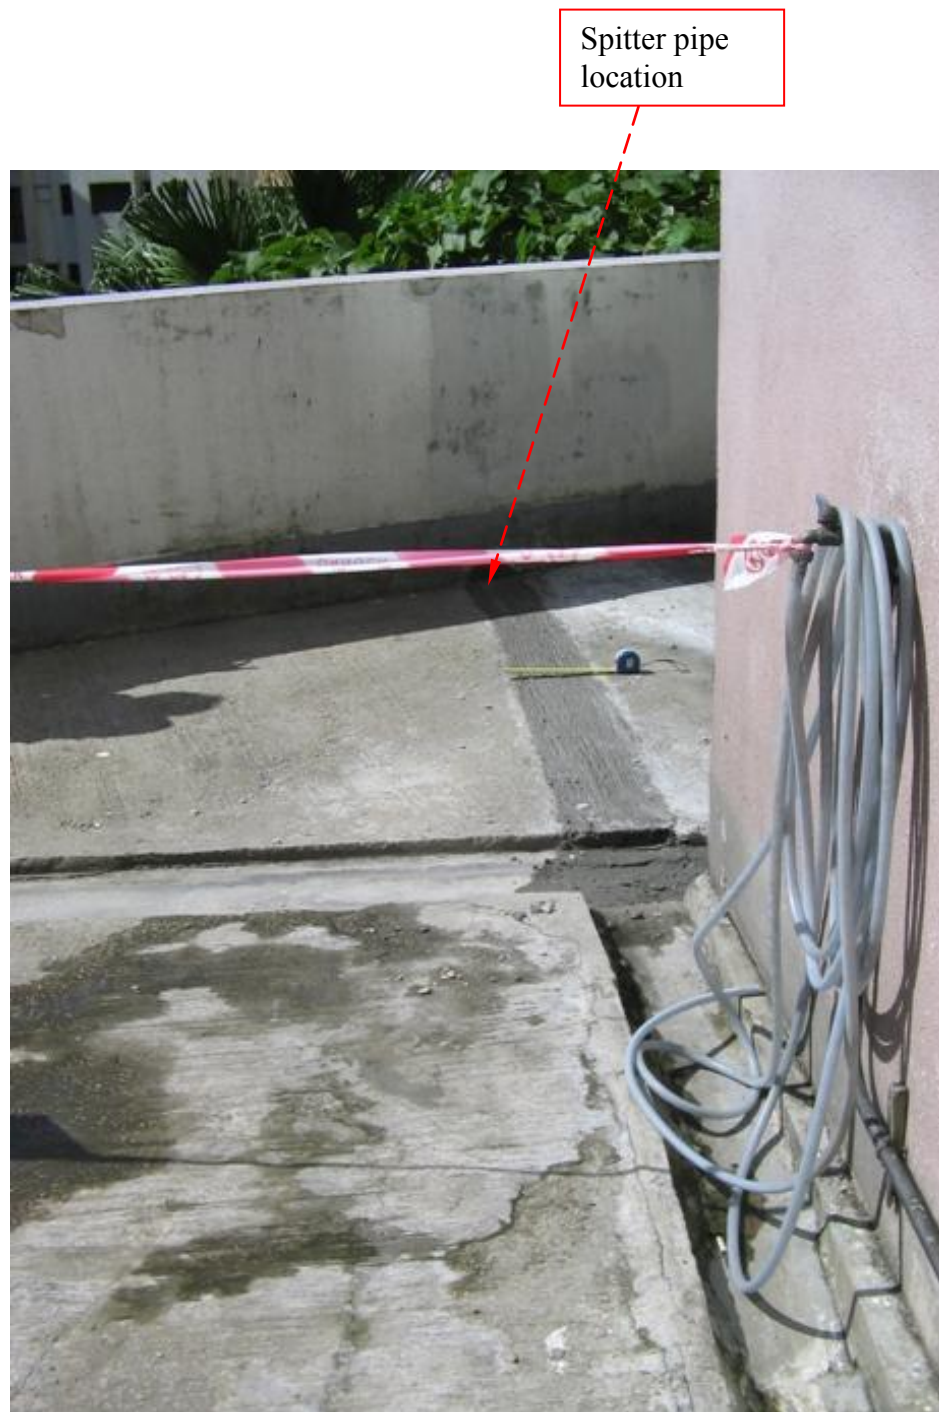
Plate 15 – Completed Diversion Works to Hamilton Court Podium Surface Drainage System (Photograph taken on 19 July 2007)

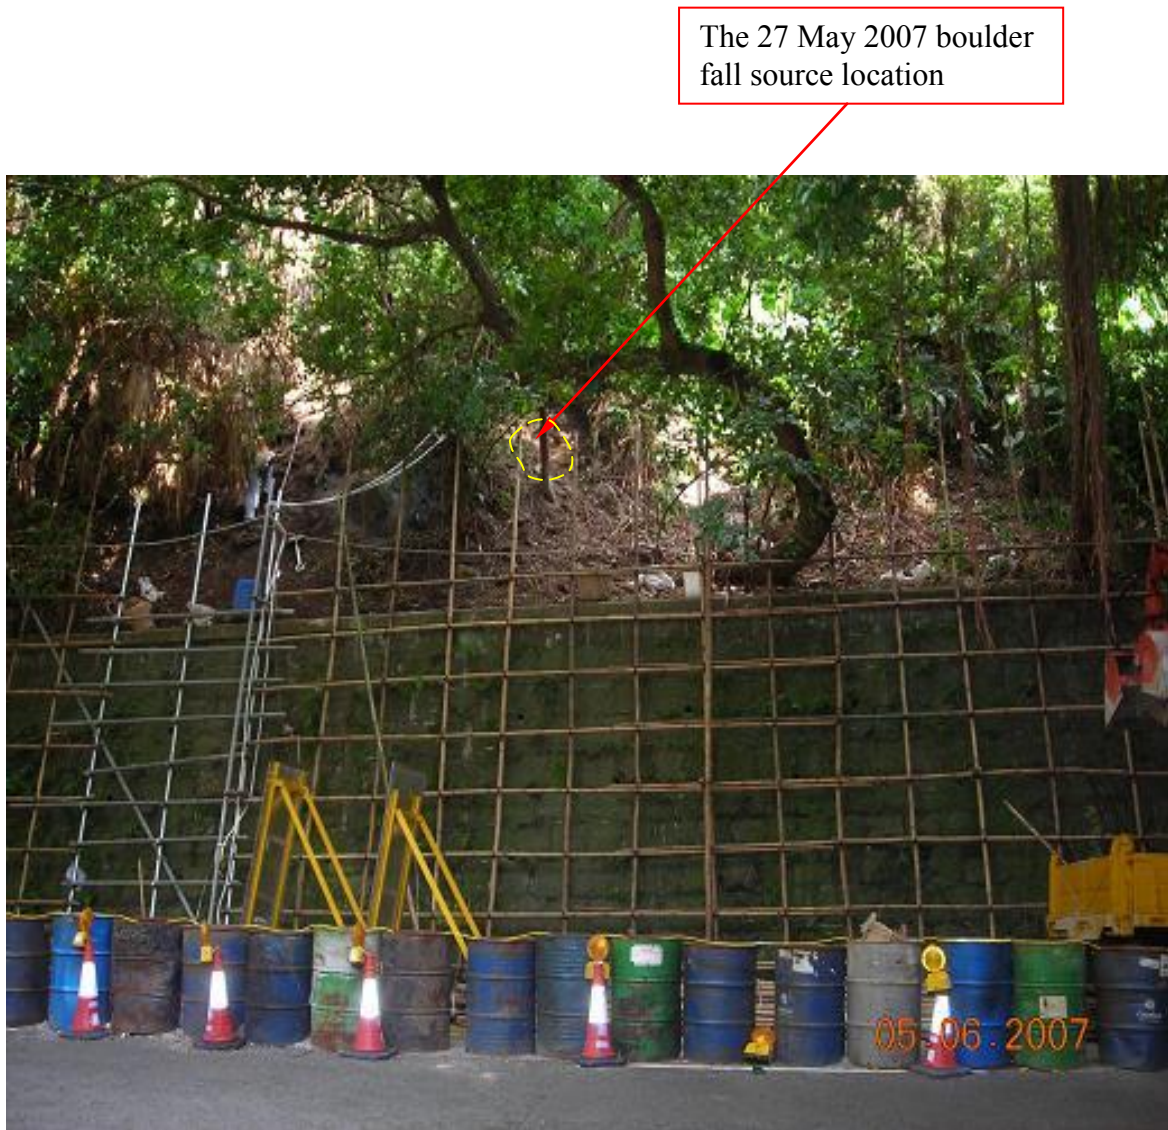
The source area exposed slightly silty sand with many sub-angular to sub-rounded, gravel- and cobble-sized, moderately decomposed rock fragments and a number of tree roots of about 10 mm in diameter, with the largest one being of about 40 mm. No signs of groundwater seepage were observed within the source area at the time of the inspection.

Plate 16 – Source Location of the 27 May 2007 Boulder Fall (Photograph taken on 5 June 2007)

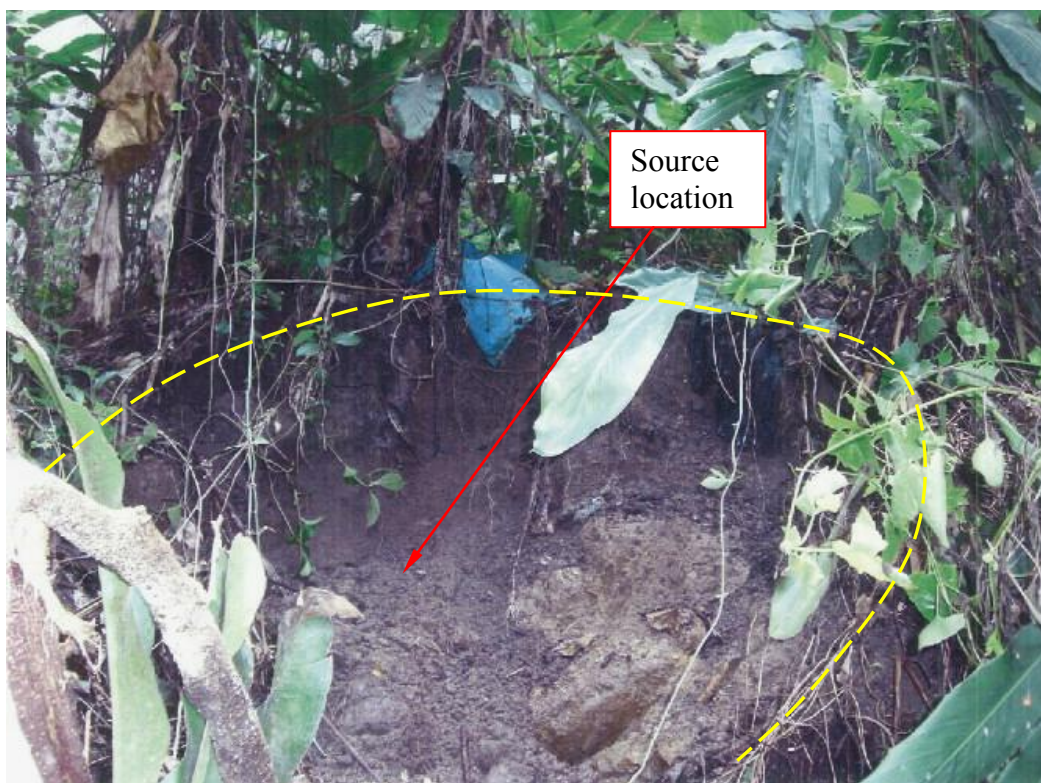
Plate 17 - Close View of Source Location of 27 May 2007 Boulder Fall (Photograph taken by HyD on 8 June 2007)

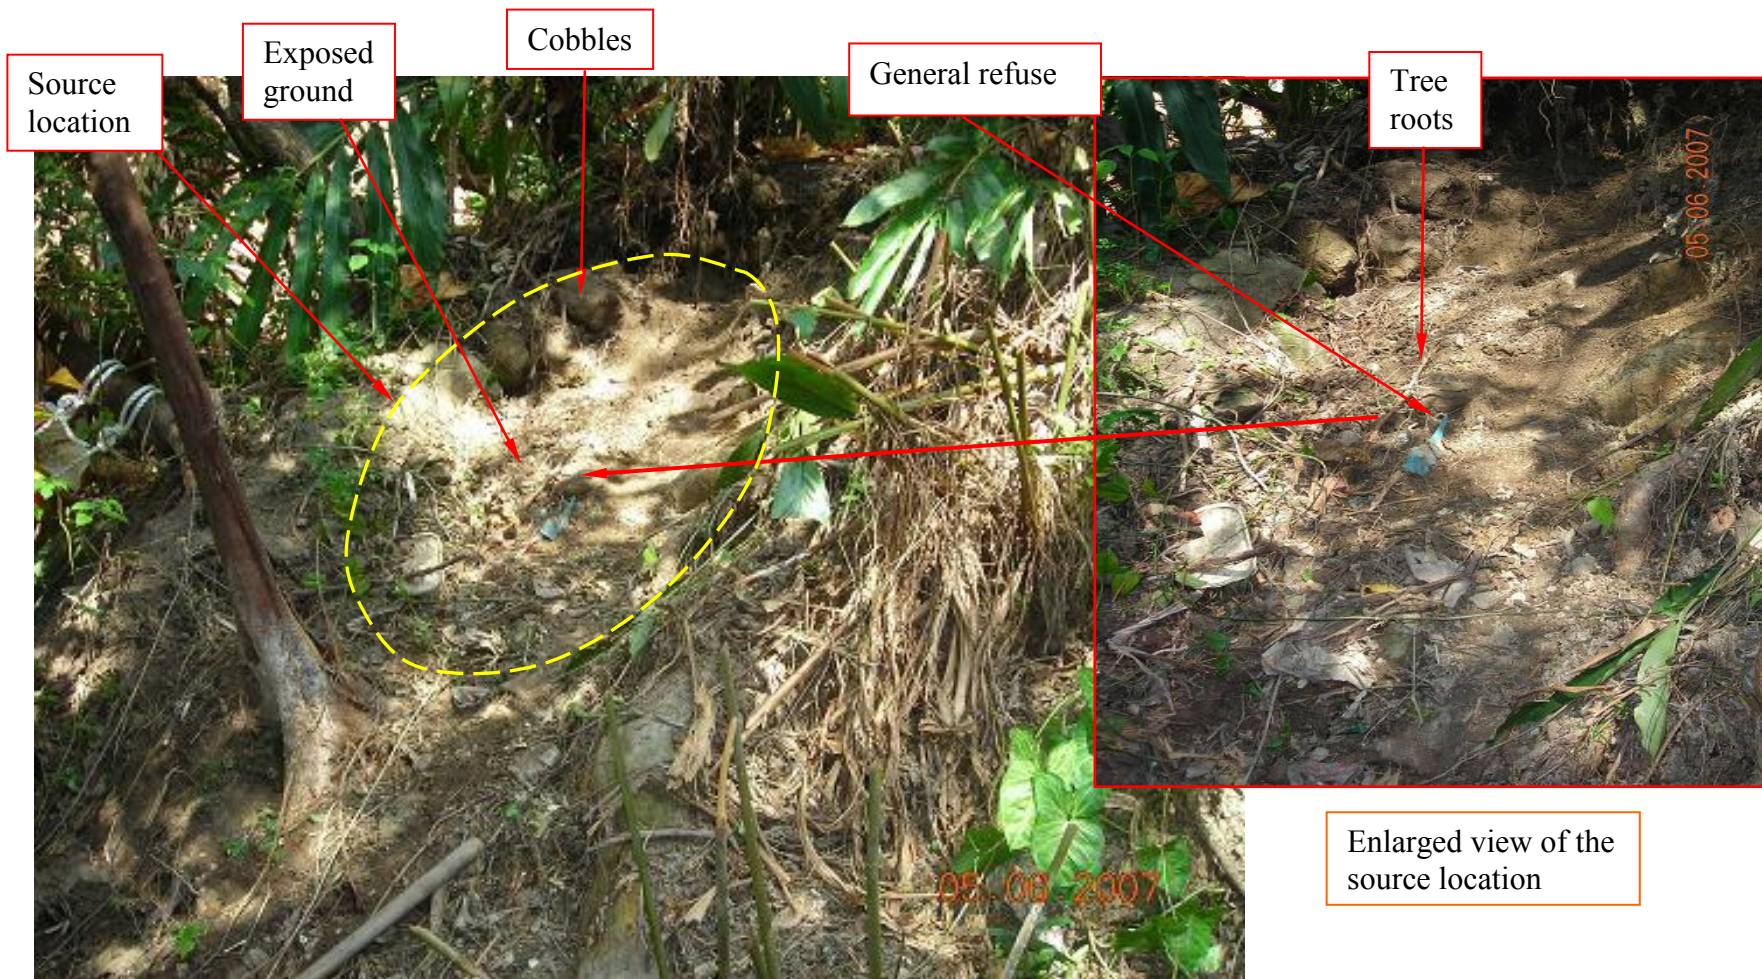
Plate 18 – Condition of the Area in the Vicinity of the Source Location of the 27 May 2007 Boulder Fall Incident  
(Photograph taken on 5 June 2007)

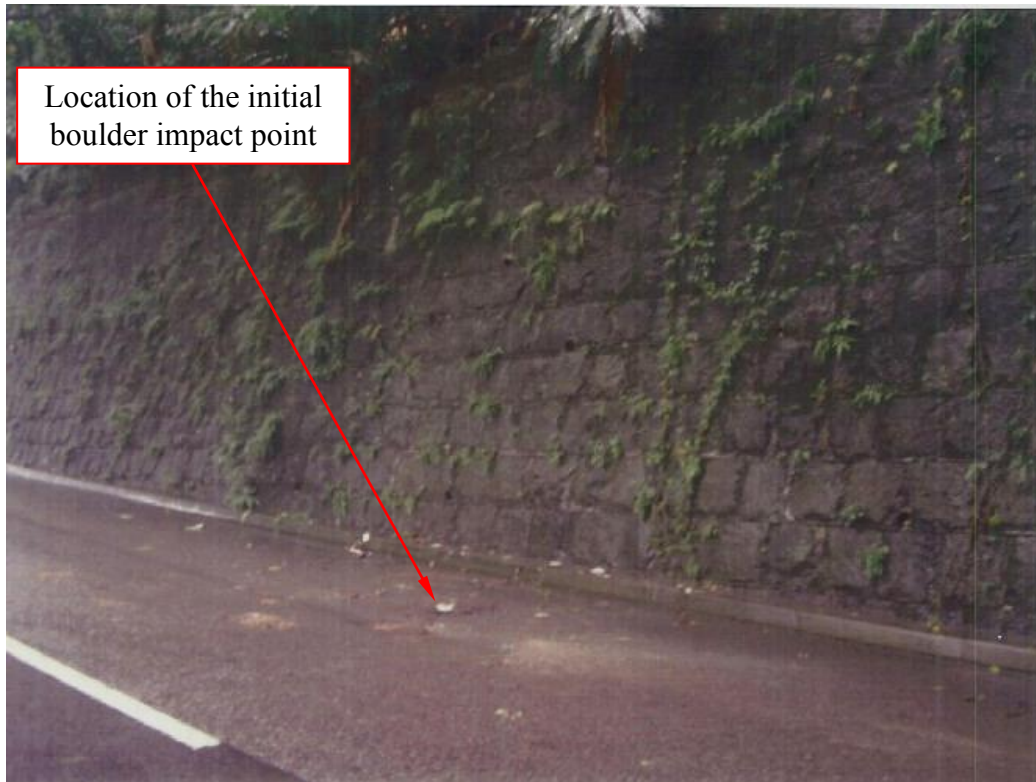
Plate 19 - Location of the Initial Boulder Impact Point on Po Shan Road  
(Photograph taken by HyD on 27 May 2007)

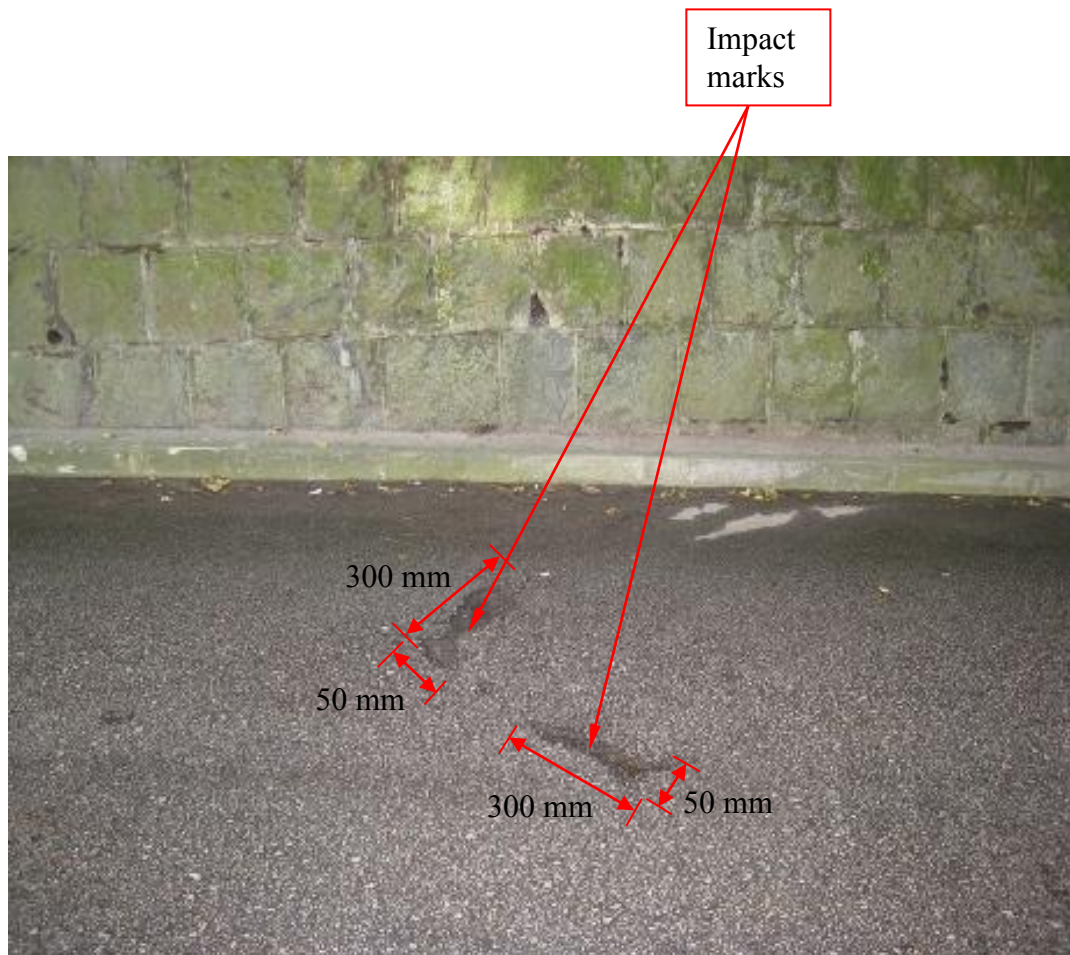
Plate 20 – Impact Marks on Pavement of Po Shan Road (Photograph taken on 25 July 2007)

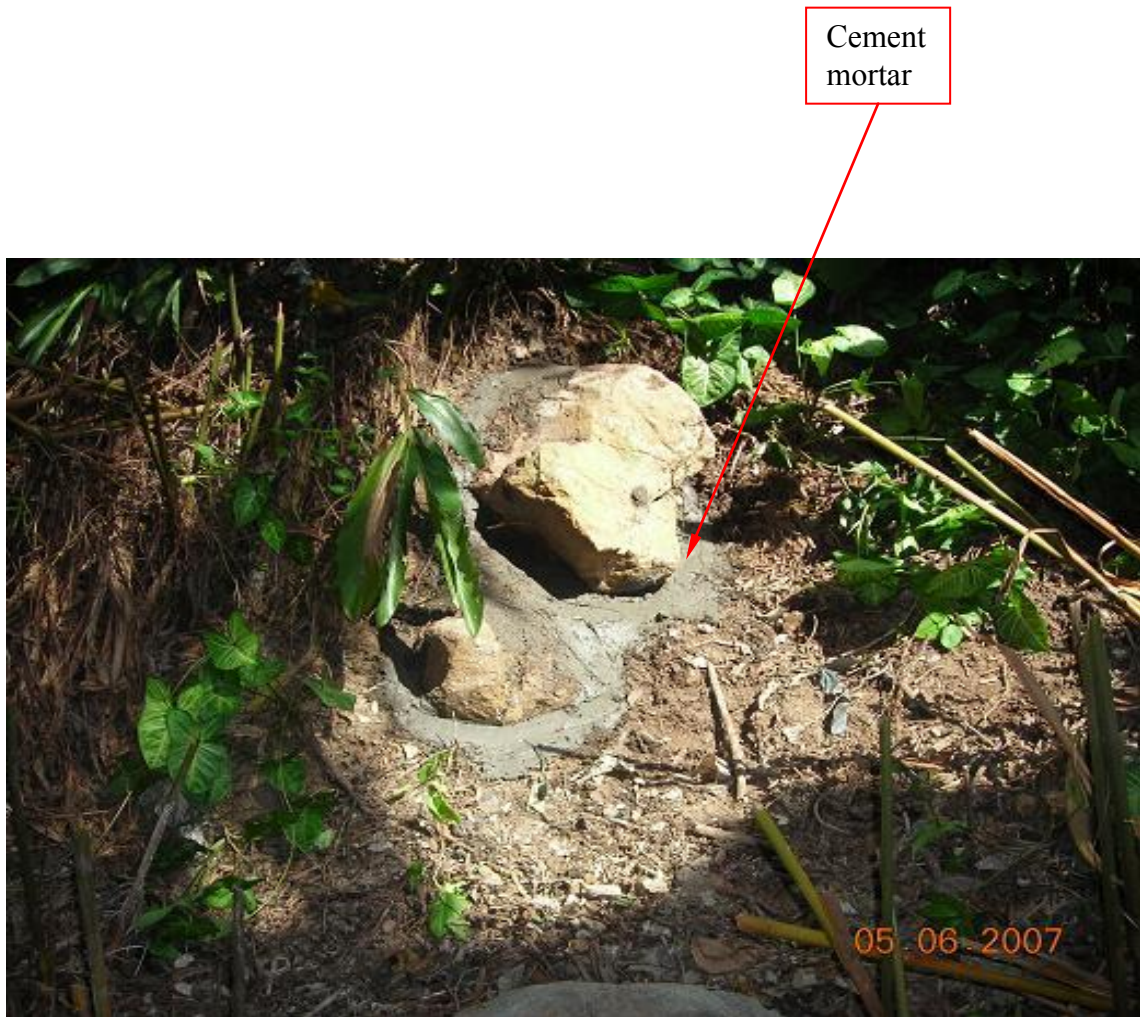
May 2007 incident (Figure 8). At the time of inspection, the term contractor of HyD was in the process of applying cement mortar around the base of a number of these boulders, which formed part of the urgent repair works recommended by the GEO (Plate 21).

Plate 21 – Boulder Stabilisation Works Completed by HyD following the 27 May 2007 Boulder Fall (Photograph taken on 5 June 2007)

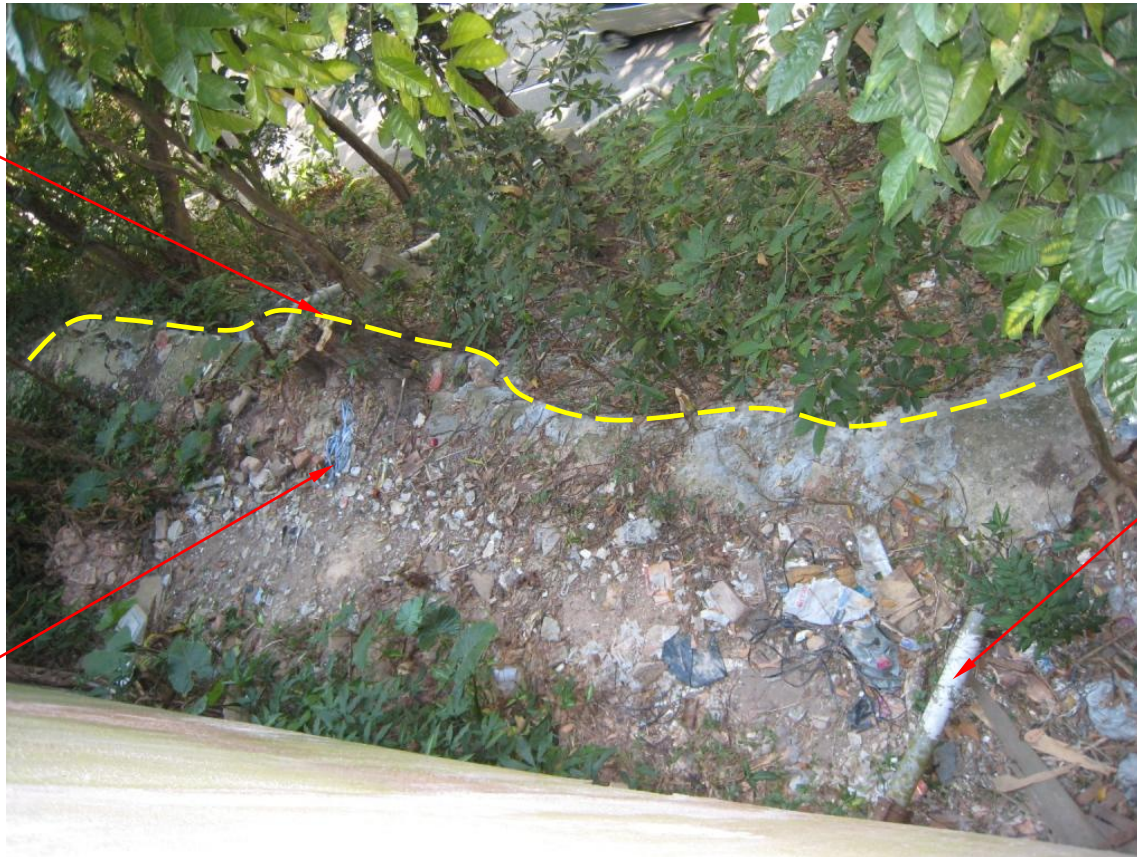
Extent of chunam  
surfacing

General refuse

Construction  
debris

Plate 22 - Condition of Chunam Surfacing (Photograph taken on 13 November 2007)

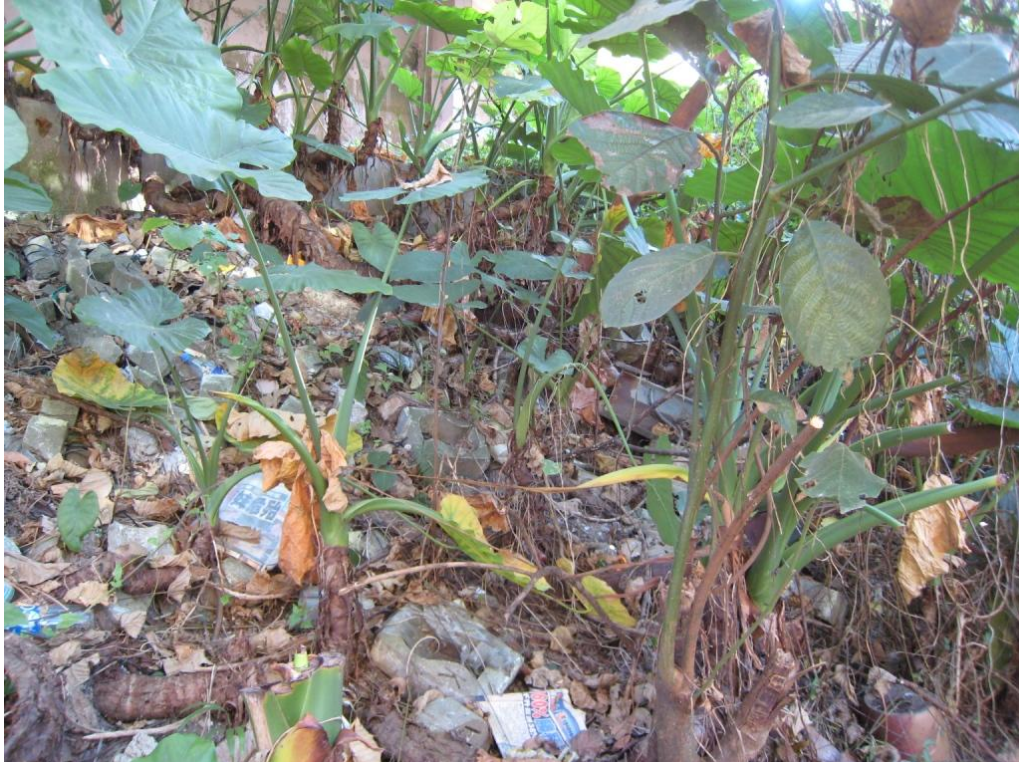
Plate 23 - Construction Debris and General Refuse on Sloping Ground above Retaining Wall No. 11SW-A/R677 (Photograph taken on 13 November 2007)
