**REVIEW OF THE 27 MAY 2007  
BOULDER FALL INCIDENT  
ON THE SLOPING GROUND  
ABOVE RETAINING WALL  
NO. 11SW-A/R677,  
PO SHAN ROAD**

**GEO REPORT No. 268**

**Fugro Scott Wilson Joint Venture**

**GEOTECHNICAL ENGINEERING OFFICE  
CIVIL ENGINEERING AND DEVELOPMENT DEPARTMENT  
THE GOVERNMENT OF THE HONG KONG  
SPECIAL ADMINISTRATIVE REGION**

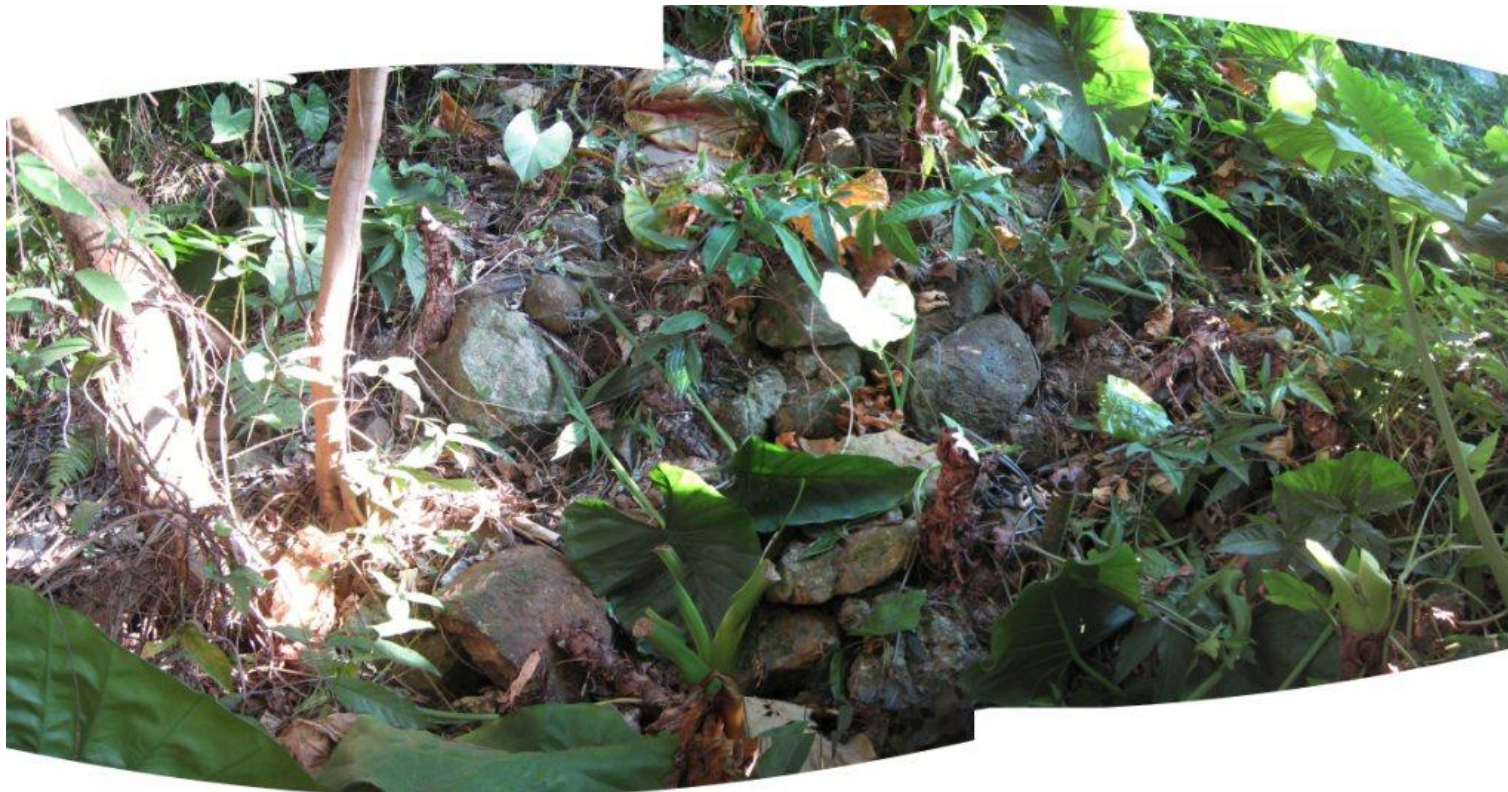
Plate 24 - Bouldery Fill on Sloping Ground above Retaining Wall No. 11SW-A/R677 (Photograph taken on 13 November 2007)

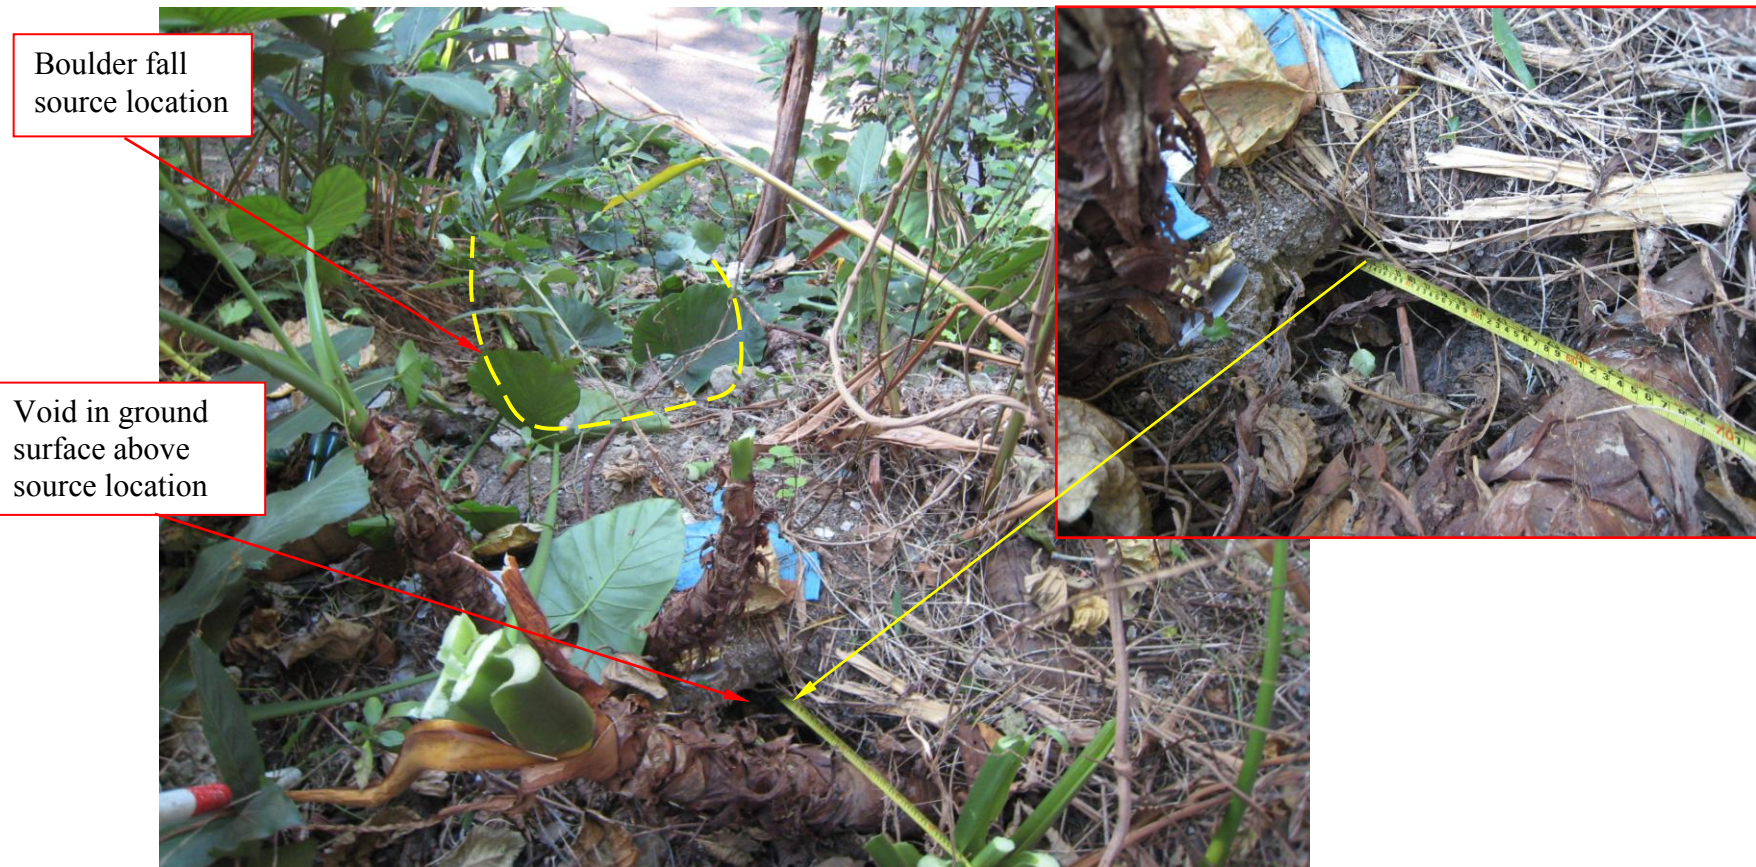
Plate 25 - Void in Ground Surface above 27 May 2007 Boulder Fall Source Location (Photograph taken on 25 October 2007)

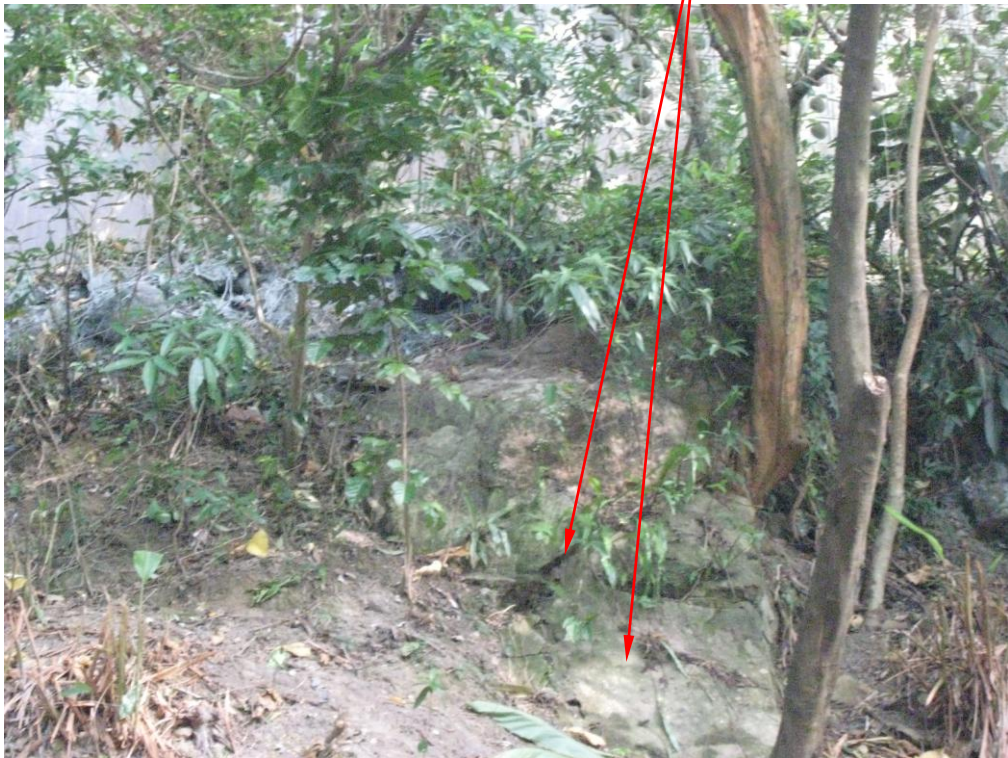
Rock outcrops/corestones comprising light brownish grey, moderately decomposed fine ash vitric tuff were observed to be protruding from the ground surface to the east of the May 2007 boulder fall source area (Figure 8). Steeply inclined joints stained with black manganese oxide were observed in the rock outcrops/corestones (Plate 26). The residual soil surrounding the rock outcrops/corestones comprised dense to very dense fine-grained silty sand with some gravel.

Joint planes of the rock  
outcrops/corestones

Plate 26 - Rock Outcrops/Corestones Exposed on Ground Surface above Crest of Retaining Wall No. 11SW-A/R677 (Photograph taken on 25 July 2007)

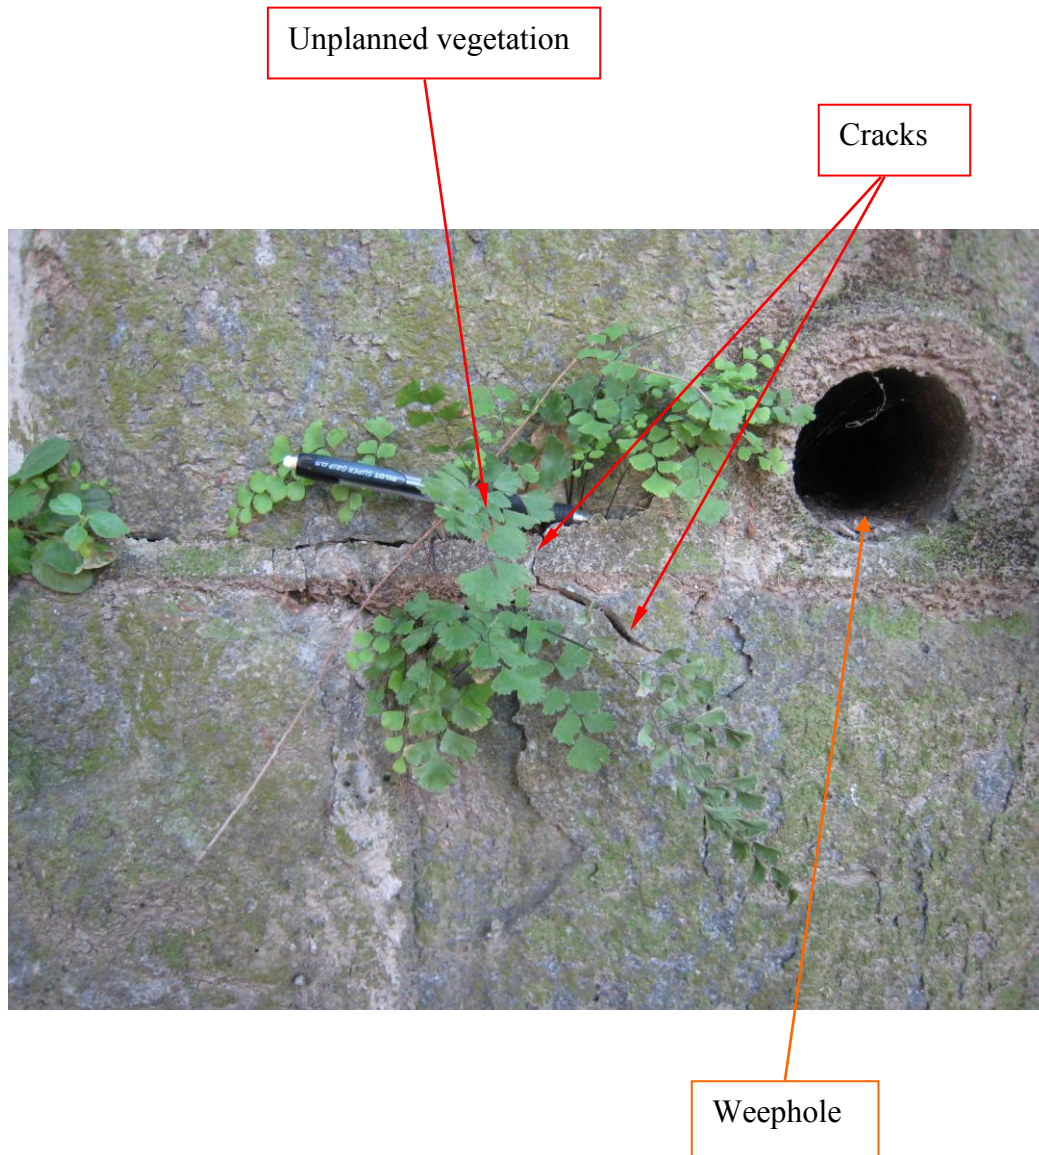
Inspection of retaining wall No. 11SW-A/R677 indicated that the masonry wall was in fair condition, with signs of minor cracking through the mortar pointing and masonry blocks, possibly caused by unplanned vegetation (Plate 27), but there were no signs of significant recent movement. Probing of the weepholes achieved penetrations ranging between 0.2 m near the crest and 1.9 m towards the toe.

Plate 27 - Cracking Through Mortar Joint and Masonry Block of Retaining Wall No. 11SW-A/R677 (Photograph taken on 14 November 2007)
