**DETAILED STUDY OF THE
7 JUNE 2008 LANDSLIDES
ON THE HILLSIDE
ABOVE YU TUNG ROAD,
TUNG CHUNG**

GEO REPORT No. 271

AECOM Asia Company Limited

**GEOTECHNICAL ENGINEERING OFFICE
CIVIL ENGINEERING AND DEVELOPMENT DEPARTMENT
THE GOVERNMENT OF THE HONG KONG
SPECIAL ADMINISTRATIVE REGION**

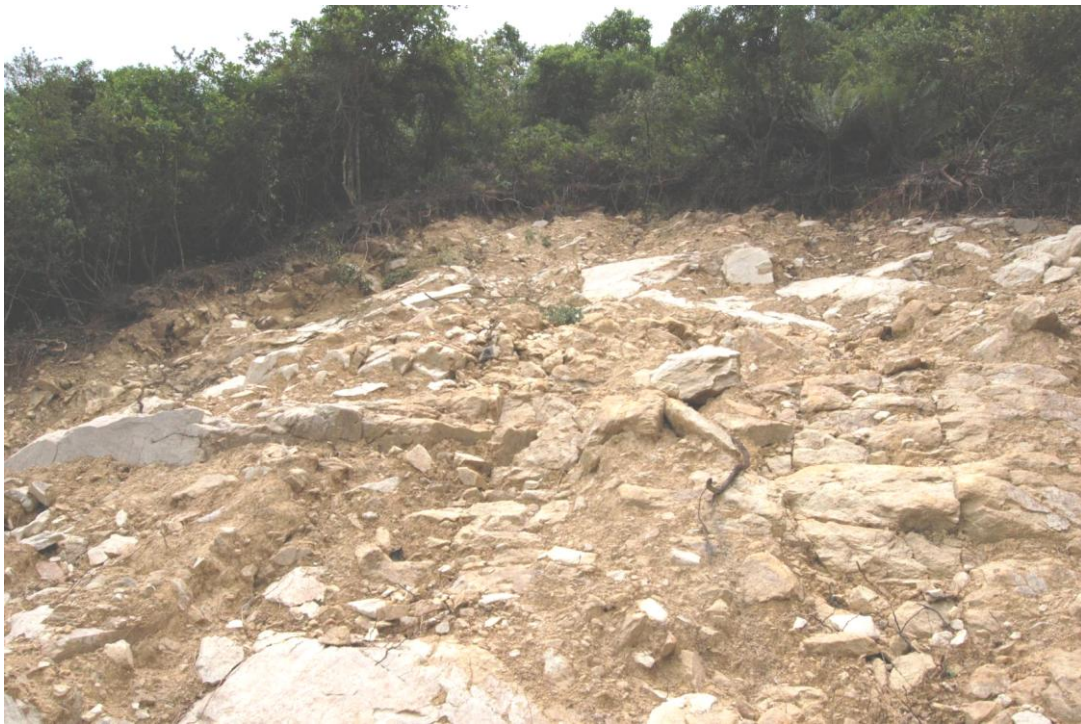
Plate 8 - Source of Landslide No. L3 in Catchment No. 24
(Photograph taken on 15 June 2008)

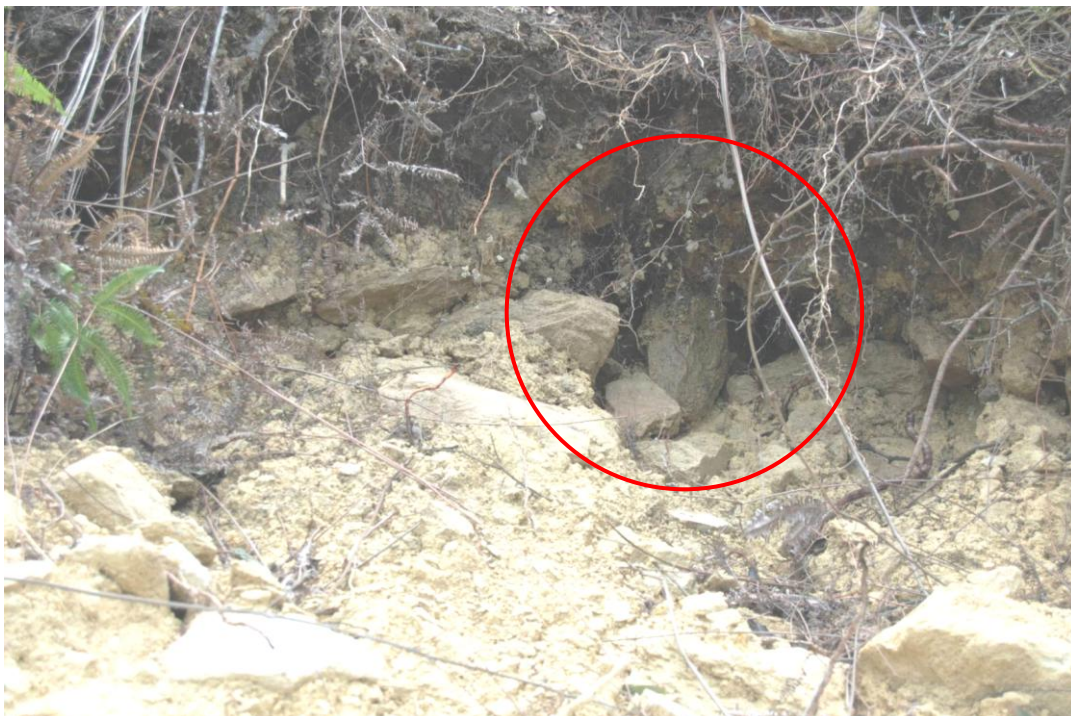
The landslide source area involved a displaced volume of about 150 m³ of colluvium, which comprised angular to subrounded cobbles with much gravel and occasional boulders in a silty sandy matrix. The failure scar measured about 15 m wide, 15 m long and about 1 m deep. The surface of rupture was inclined between 35° and 50° and ran primarily along the interface between the colluvium and underlying moderately to slightly decomposed tuff (Plate 8). Soil pipes and voids were observed in the backscarp (Plate 9) at the colluvium/rock interface.

Plate 9 - Voids in Colluvium at Landslide No. L3 in Catchment
No. 24 (Photograph taken on 15 June 2008)

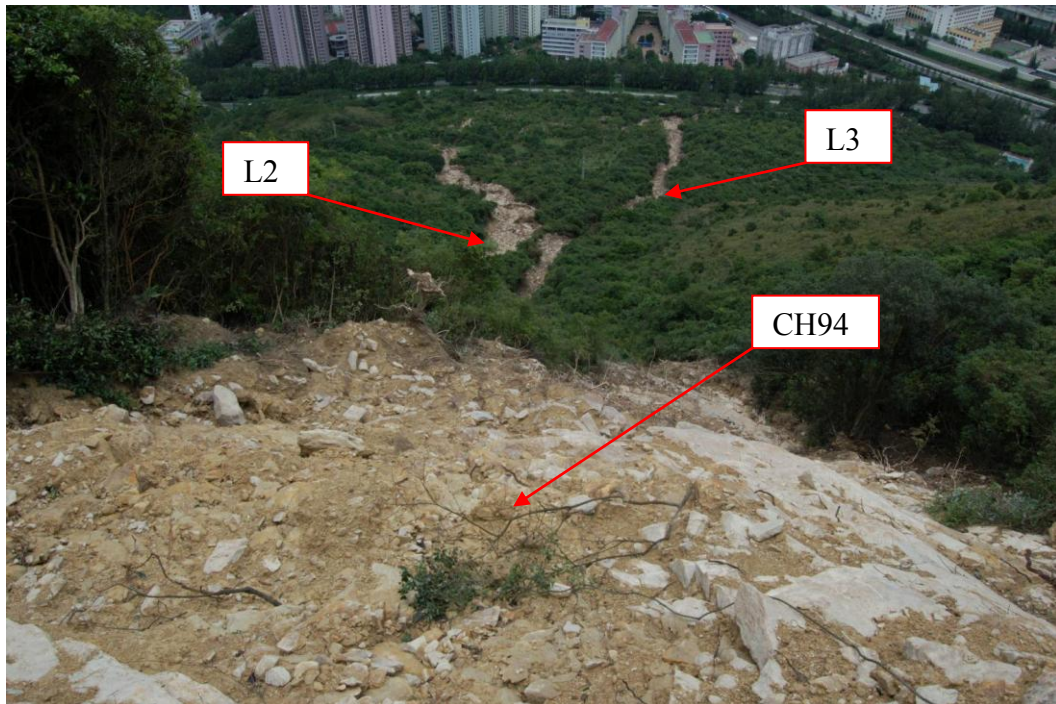
Landslide debris from the failure source area travelled as an avalanche over a steep rockface, inclined between 40° and 45°. Owing to a slight transverse dip of the rockface towards the east, the debris movement entrained about 230 m³ of colluvial material locally from the eastern flank between chainage CH15 and CH94. The debris active volume increased to about 400 m³ at CH94 before the debris entered into the drainage line (Plate 10) and developed into a CDF.

Plate 10 – View of the Landslide Occurred in Catchment No. 24 at CH94 before the Debris Entered the Drainage Line (Photograph taken on 15 June 2008)

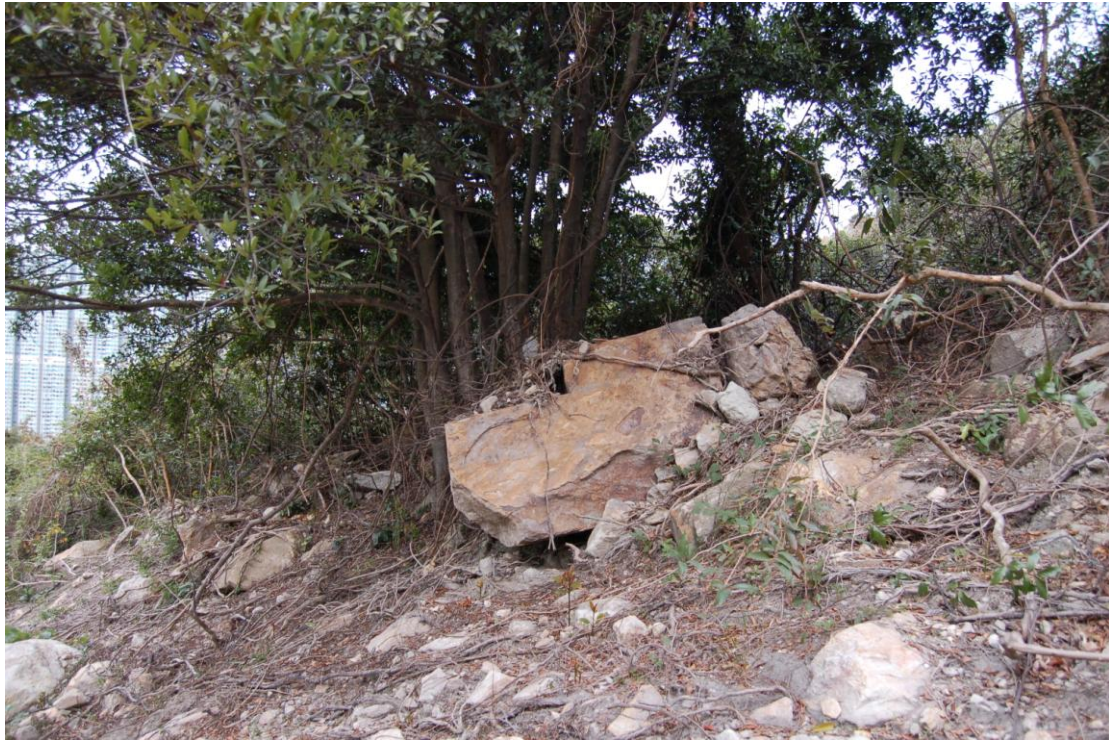
0.5 m³/m) of material were entrained and 90 m³ of material were deposited, resulting in a maximum active volume about 450 m³ near the toe of the transport zone. Debris levees were observed along the side of the debris trails at CH240 and CH343, which contained large boulders of up to 2 m diameter (Plate 12).

Plate 12 – Debris Levees with Large Boulders of up to 2 m Diameter along the Side of the Debris Trail at about CH255 in Catchment No. 24 (Photograph taken on 7 June 2008)

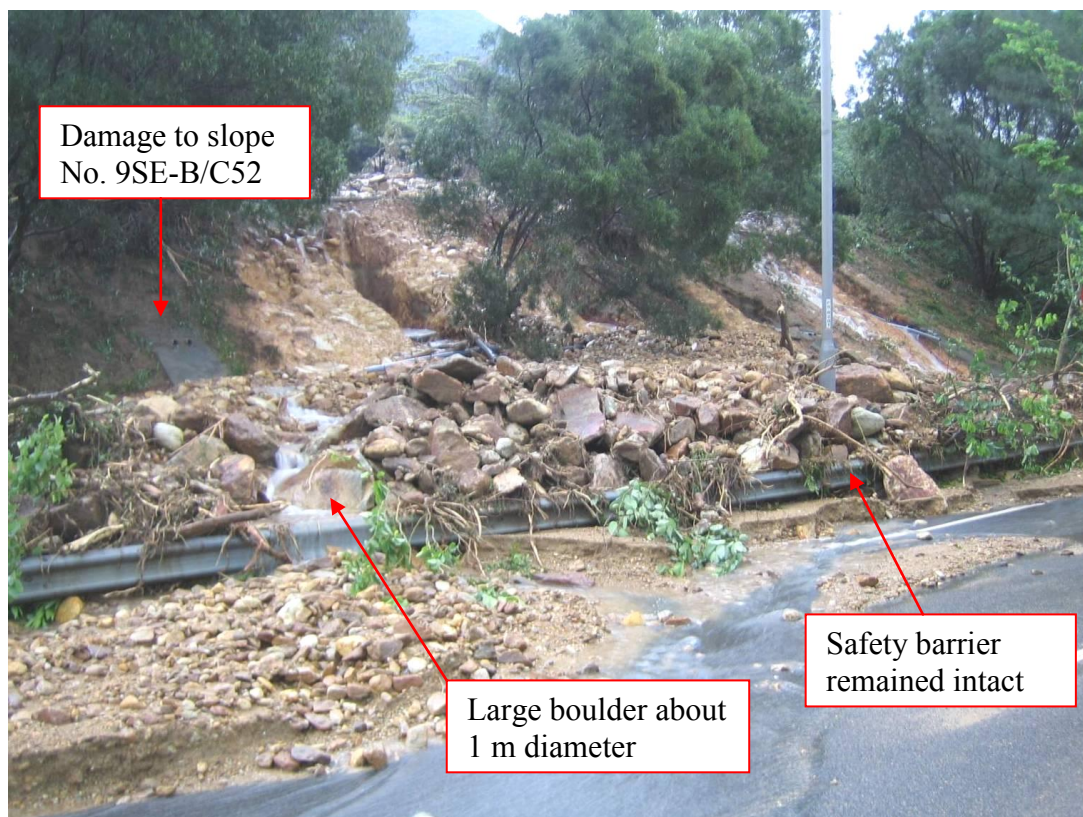
Plate 14 – Bouldery Debris from Landslide No. L3 in Catchment No. 24
(Photograph taken on 7 June 2008)

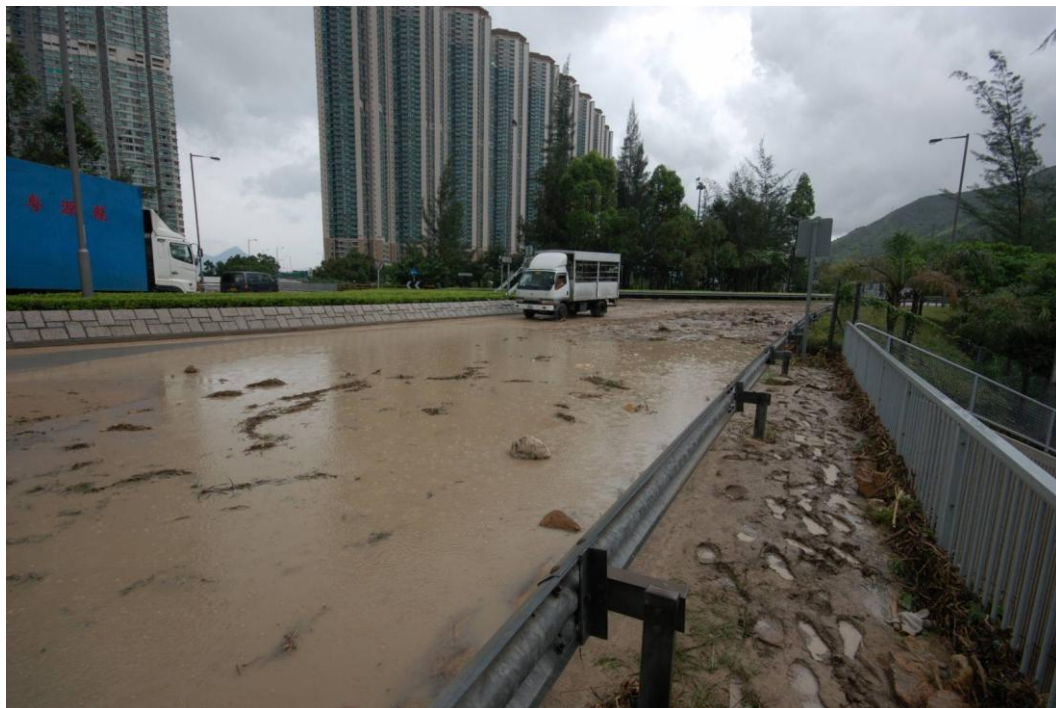
Subsequent flow of surface water caused further erosion of the debris deposits and washed out about 50 m³ of fines onto Yu Tung Road (Plate 15). Some outwash debris continued along Yu Tung Road, and reached the Tung Chung Eastern Interchange some 300 m away as well as part of the Cheung Tung Road below. This resulted in severe flooding along the affected road sections (Plates 3 and 16).

Plate 15 – Outwash from Landslide No. L3 in Catchment No. 24 on Yu Tung
Road and Tung Chung Eastern Interchange (Photograph taken on
7 June 2008)

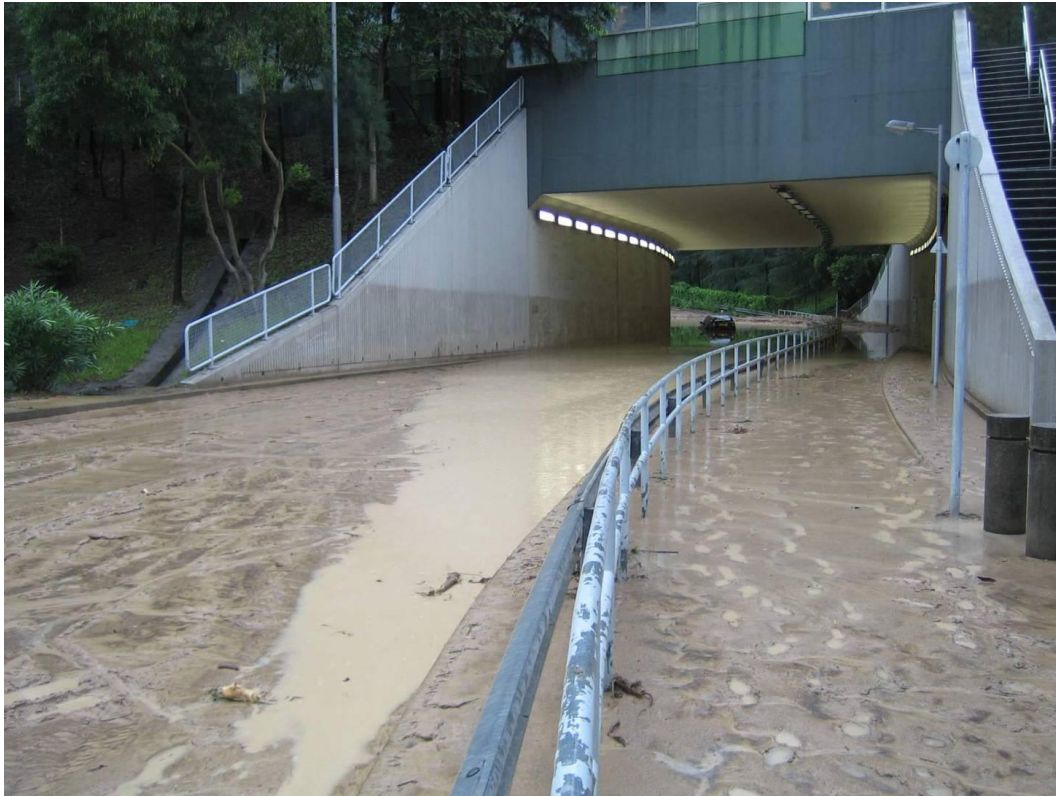
Plate 16 – Flooding of Cheung Tung Road below Yu Ting Road and Tung Chung Eastern Interchange (Photograph taken on 7 June 2008)

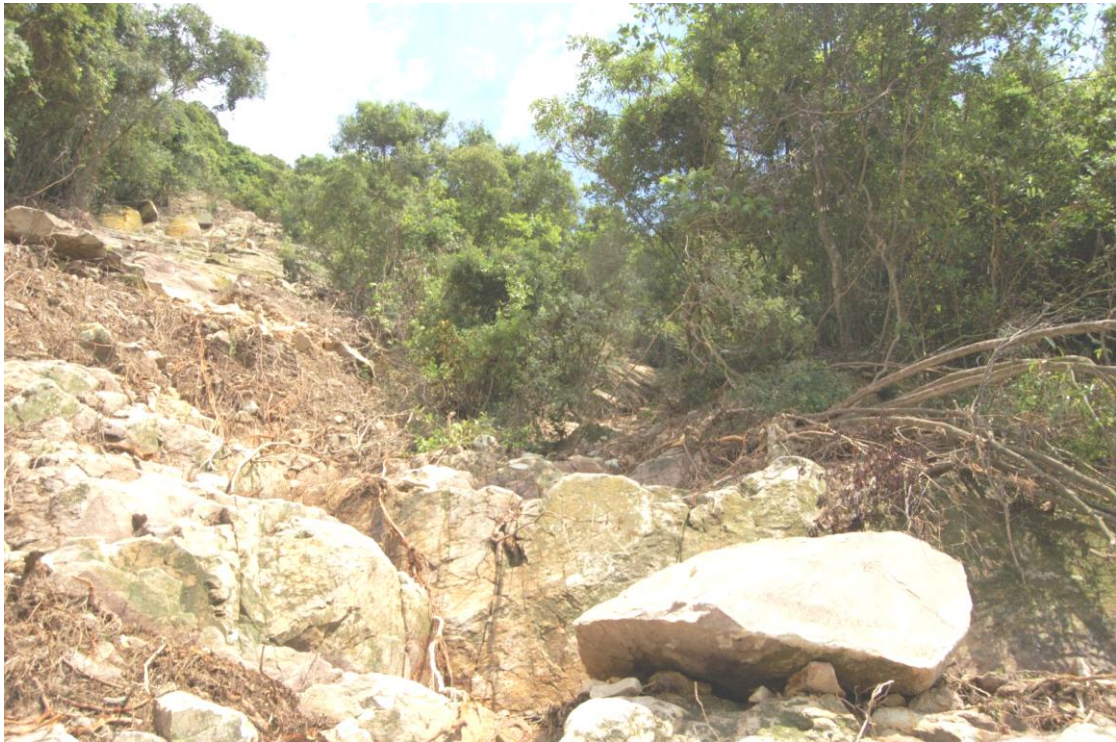
Plate 19 – Vegetation Partially Blocking Outlet of Drainage Line Affected by Landslide No. L1 in Catchment No. 25 (See Plate 17 for Location) (Photograph taken on 15 June 2008)

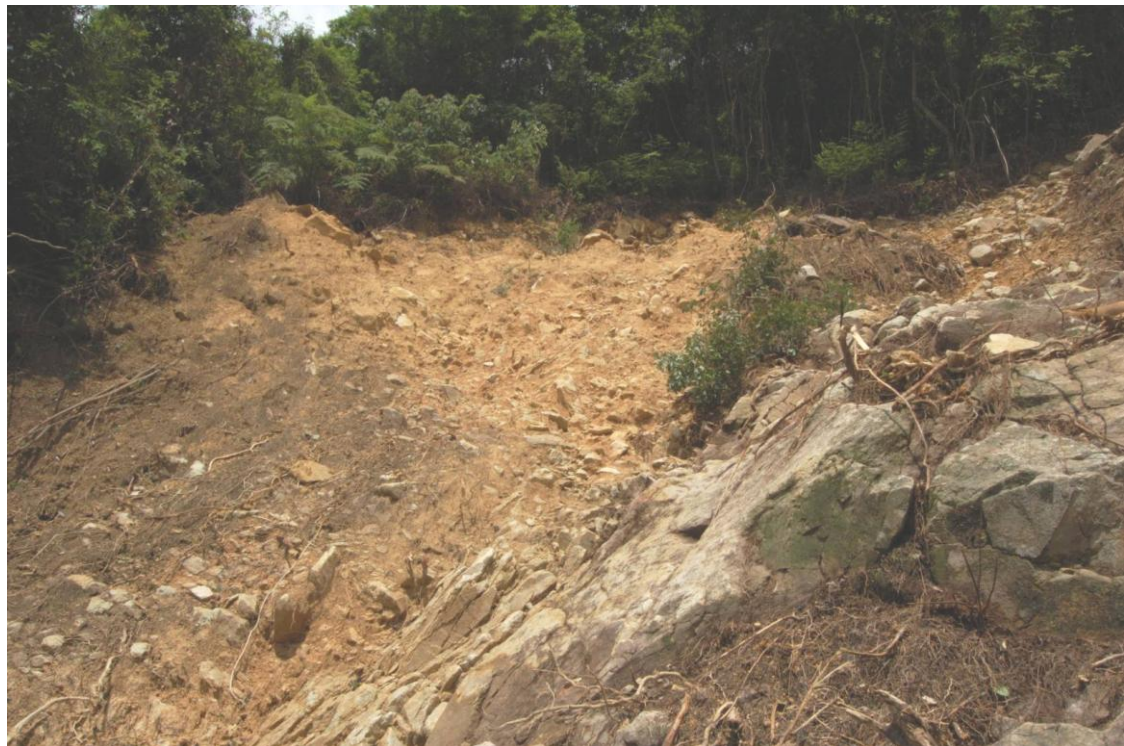
landslide No. L2 tributary failed and released about 290 m³ of debris (Plate 20). The side slope may have failed as a result of impact or undermining action from the debris arising from landslide source No. L2. The slight transverse dip in the rocky stream bed might have directed the passage of debris towards the side slope causing direct impact or undermining of the colluvial material, and resulting in the failure (Plate 20). This gave rise to a total active volume of about 460 m³ at the confluence point. The debris then entered into the drainage line at CH176 and developed into a CDF.

Plate 20 – Failed Side-slope at the Confluence of Landslides Nos. L1 and L2 in Catchment No. 25 (See Plate 17 for Location) (Photograph taken on 15 June 2008)

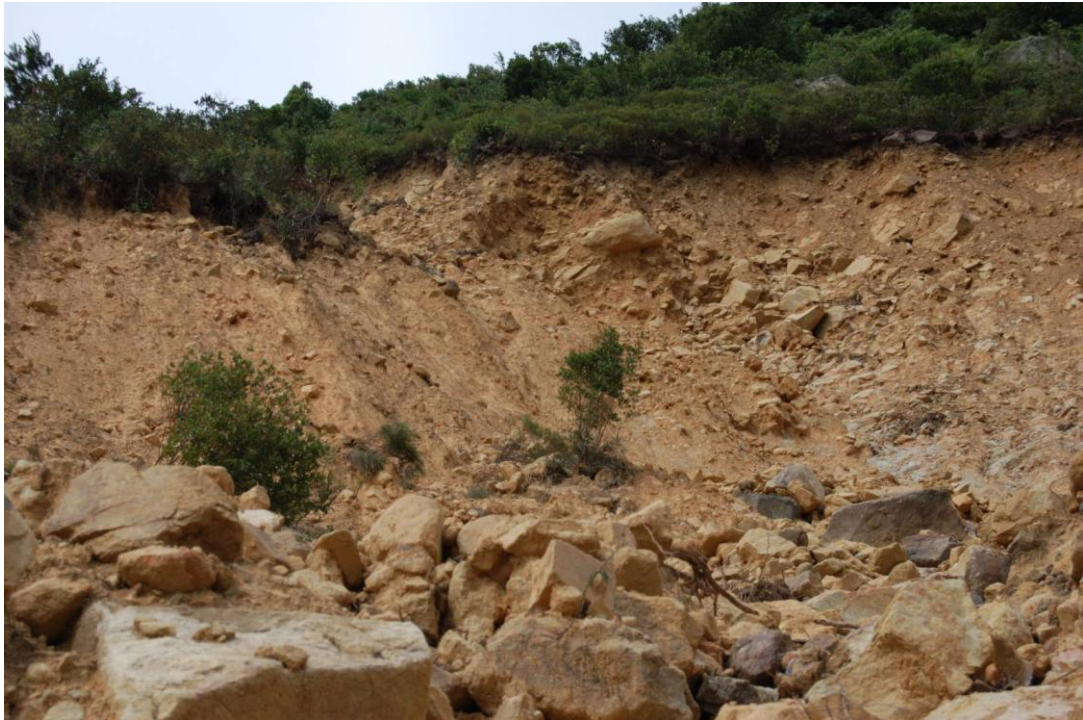
boulder rich colluvium, Plates 29 and 30), which comprised subangular to subrounded cobbles with many gravels and occasional boulders in a silty/clayey sandy matrix. The failure scar measured about 32 m by 50 m long with a maximum thickness of about 3 m. The gradient of the rupture surface varies between 35° and 50° at the backscarp and down to about 30° near the toe. Part of the rupture surface appears to have been through the upper portion of the underlying completely and highly decomposed fine ash tuff. A planar adversely orientated joint surface (30/258) in moderately decomposed tuff was exposed in the base of the landslide near the northeastern portion of the landslide source area (Plate 31). Landslide debris from the source travelled over a short section of open hillside into the drainage line below at about CH65 and developed into a CDF.

Plate 29 – Talluvium Exposed in Backscarp of Source of Landslide No. L25
in Catchment No. 30 (Photograph taken on 14 June 2008)

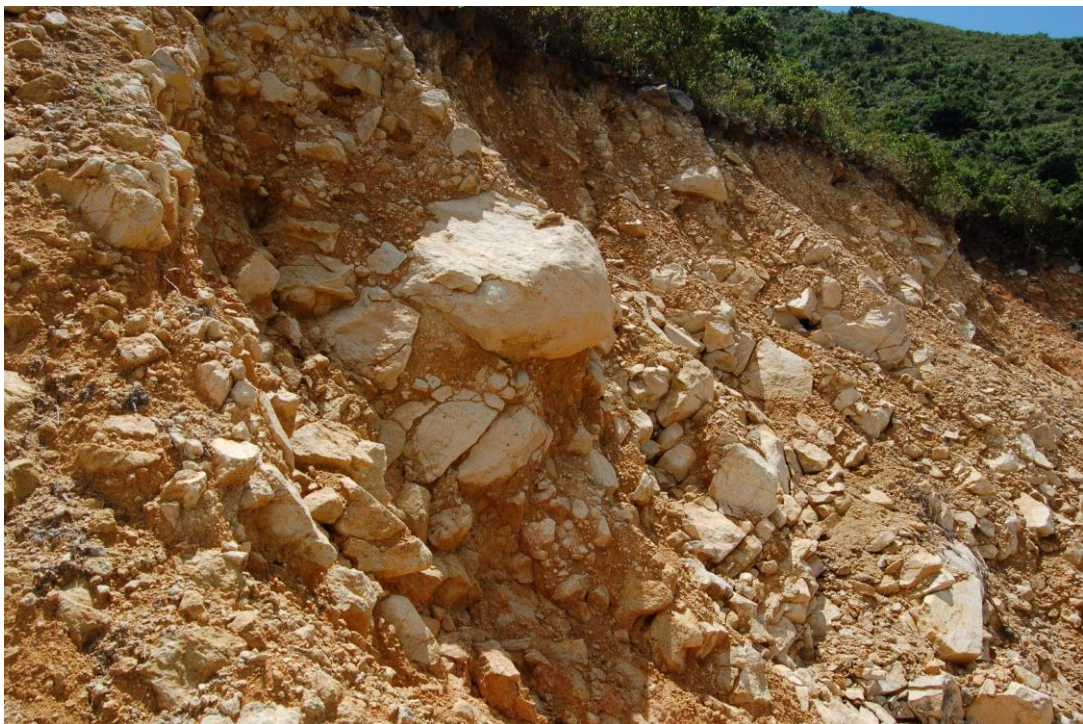
Plate 30 – Close-up of Talluvium in Backscarp of Landslide No. L25
in Catchment No. 30 (Photograph taken on 21 July 2008)

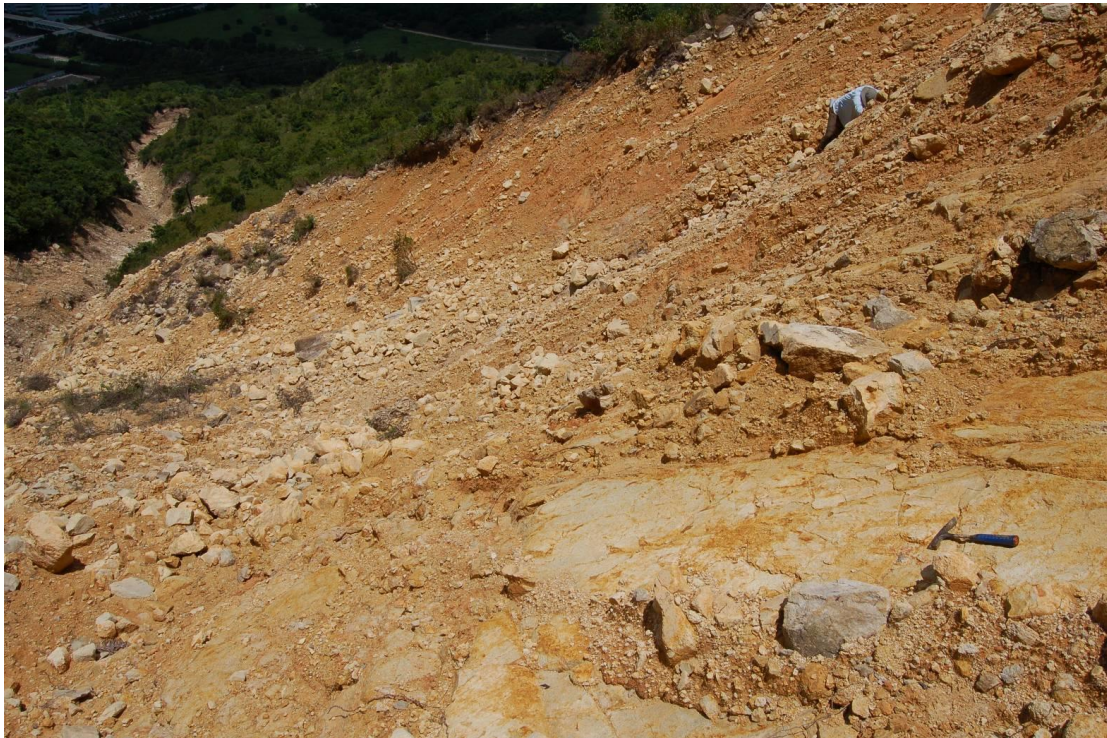
Plate 31 – Planar Joint Moderately Decomposed Tuff in Base of Landslide Scar at Landslide No. L25 in Catchment No. 30 (Photograph taken on 21 July 2008)

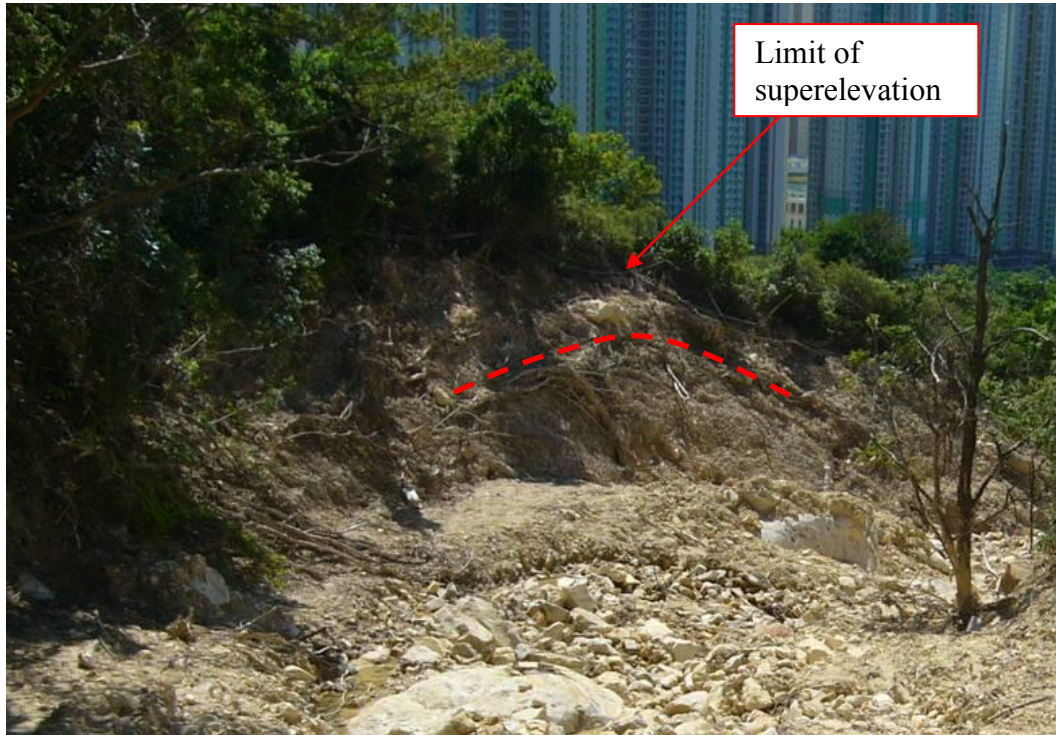
Plate 35 – View of Western Flank of Drainage Line at CH413 Showing Superelevated Debris (Photograph taken on 25 July 2008)

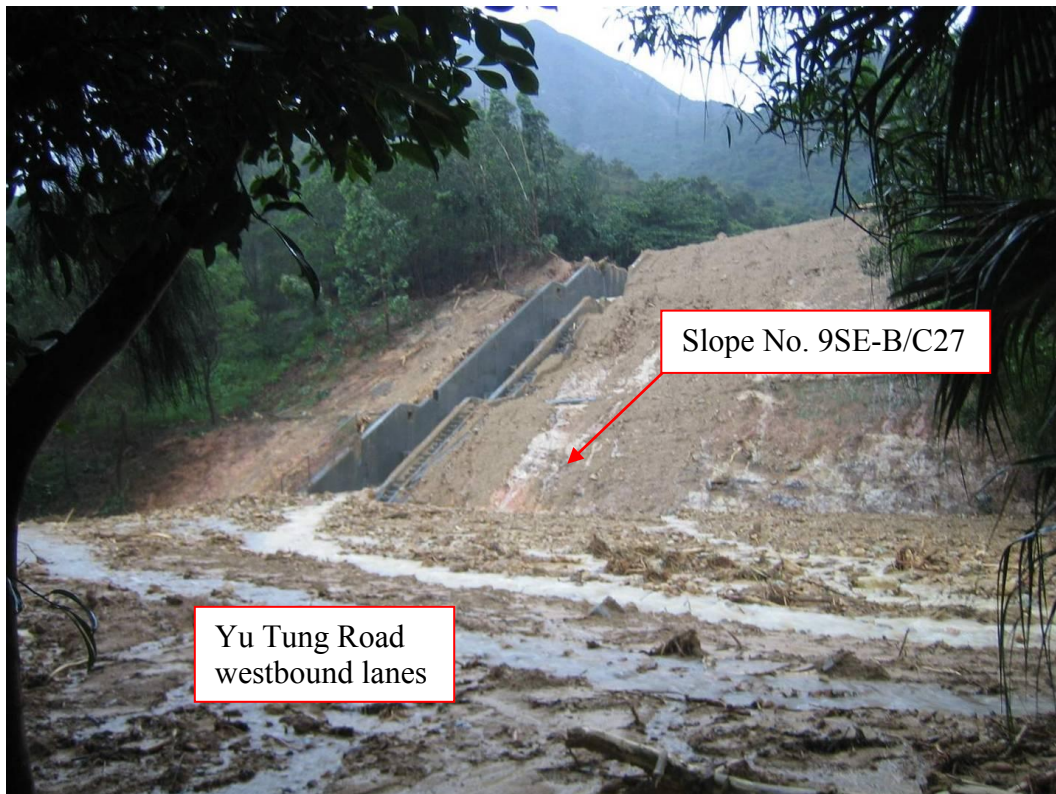
The high mobility of the CDF in catchment No. 30 may be related to the increased water content of debris. The relatively large area of catchment No. 30 (about 100,000 m²), compared with catchments Nos. 24 (32,000 m²) and 25 (62,000 m²), together with the presence of streamcourse tributaries, could have brought additional water into the main drainage line in catchment No. 30. This would increase significantly the bulked volume of the debris and its water content, turning the material into “watery” debris as observed in the “You Tube” video. Consequently the main pulse of the CDF in catchment No. 30 may have been able to maintain a high velocity up to and beyond the drainage outlet, where the debris was discharged over a 9 m high cut slope before landing on Yu Tung Road.

Plate 36 – View of Debris Running over Slope No. 9SE-B/C27 and Deposited onto Yu Tung Road (Photograph taken on 7 June 2008)

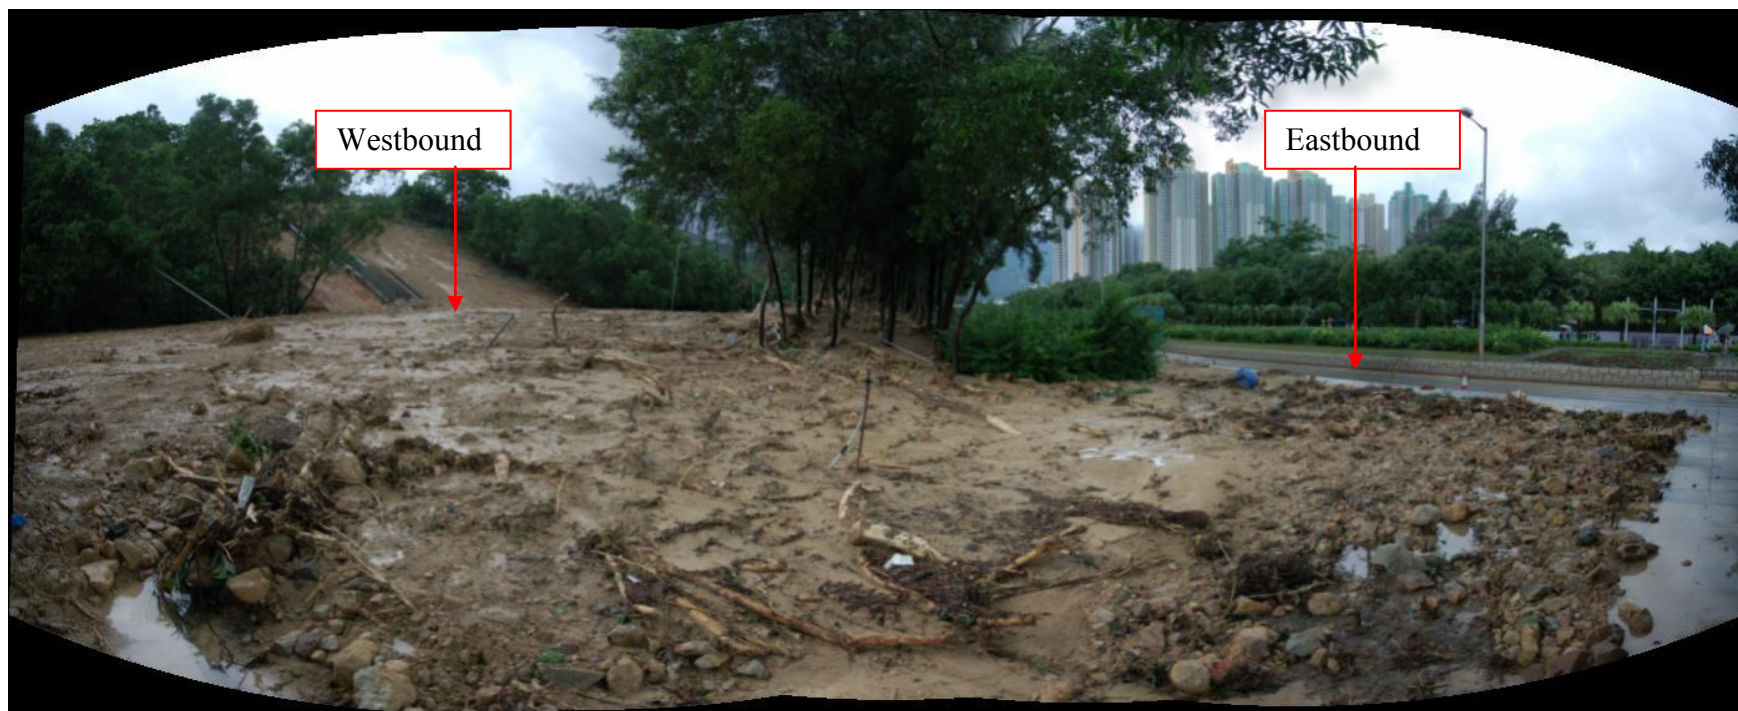
Plate 37 – View of Debris on Yu Tung Road Extending onto Eastbound Carriageway (Photograph taken on 7 June 2008)

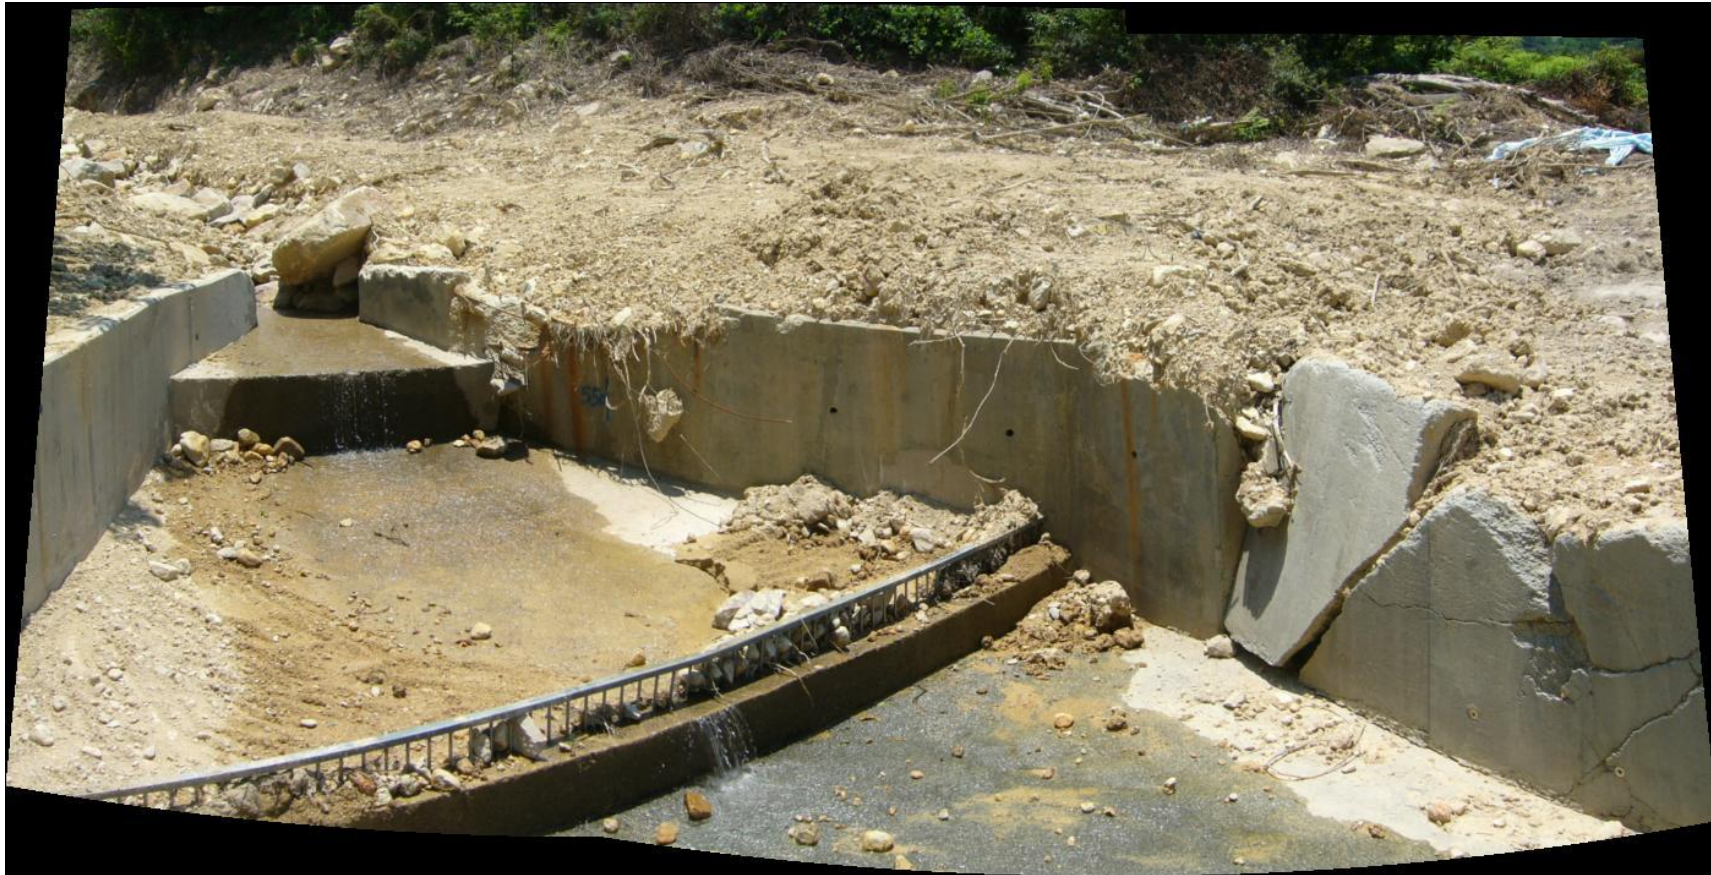
Plate 40 – Damage to Concrete Drainage Channel at West of Slope No. 9SE-B/C27 in Catchment No. 30
(Photograph taken on 25 July 2008)

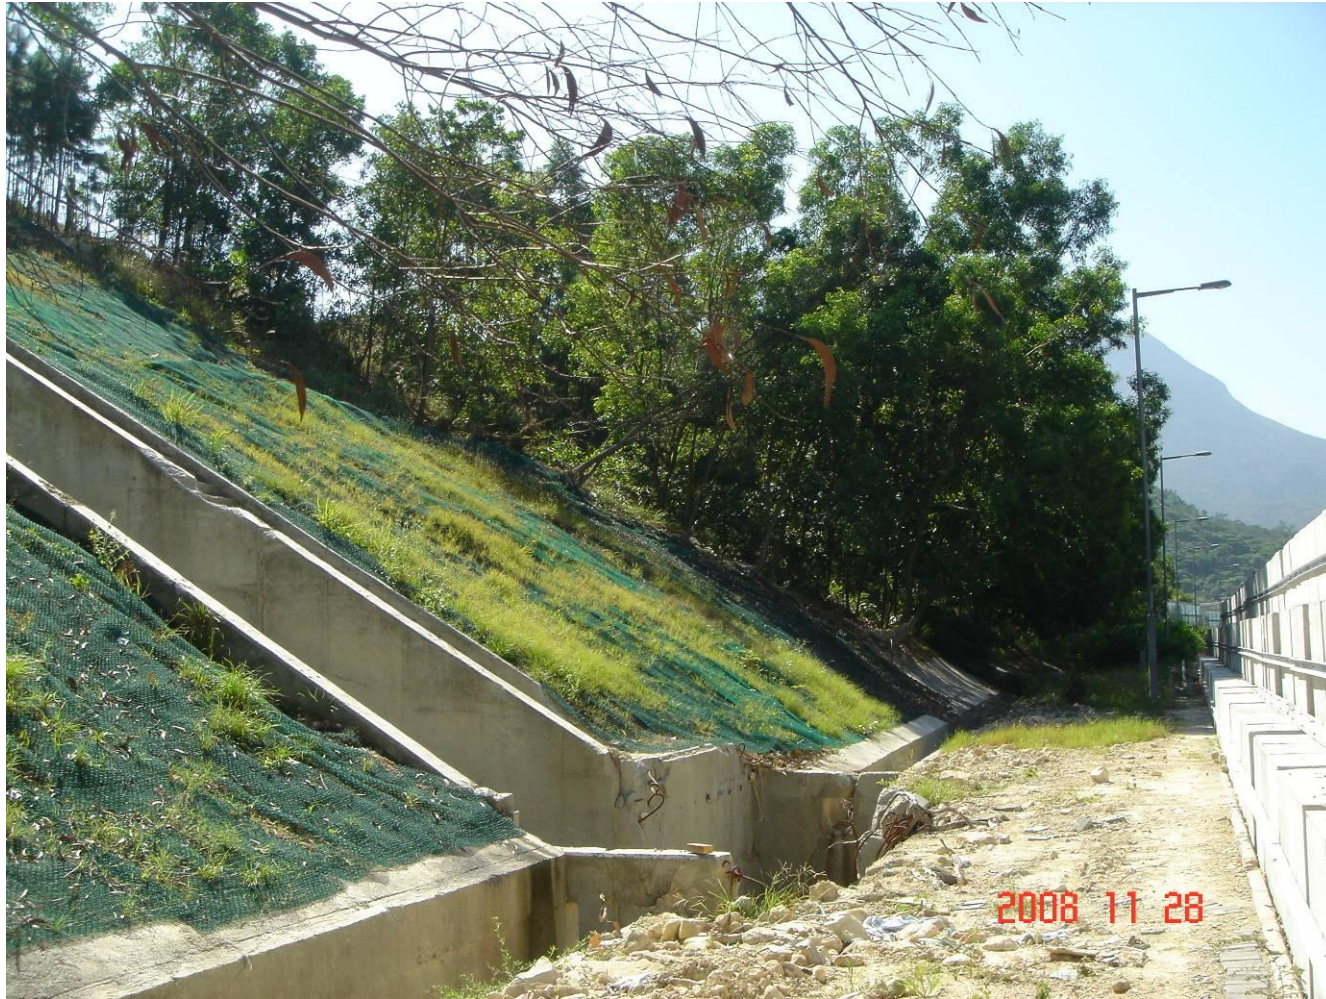
Plate 41 – Damage to Concrete Channel at Toe of Slope No. 9SE-B/C27 in Catchment No. 30
(Photograph taken on 11 November 2008)
