**DETAILED STUDY OF THE  
7 JUNE 2008 LANDSLIDES ON  
THE HILLSIDE ABOVE THE  
NORTH LANTAU HIGHWAY AND  
CHEUNG TUNG ROAD,  
NORTH LANTAU**

**GEO REPORT No. 272**

**AECOM Asia Company Limited**

**GEOTECHNICAL ENGINEERING OFFICE  
CIVIL ENGINEERING AND DEVELOPMENT DEPARTMENT  
THE GOVERNMENT OF THE HONG KONG  
SPECIAL ADMINISTRATIVE REGION**

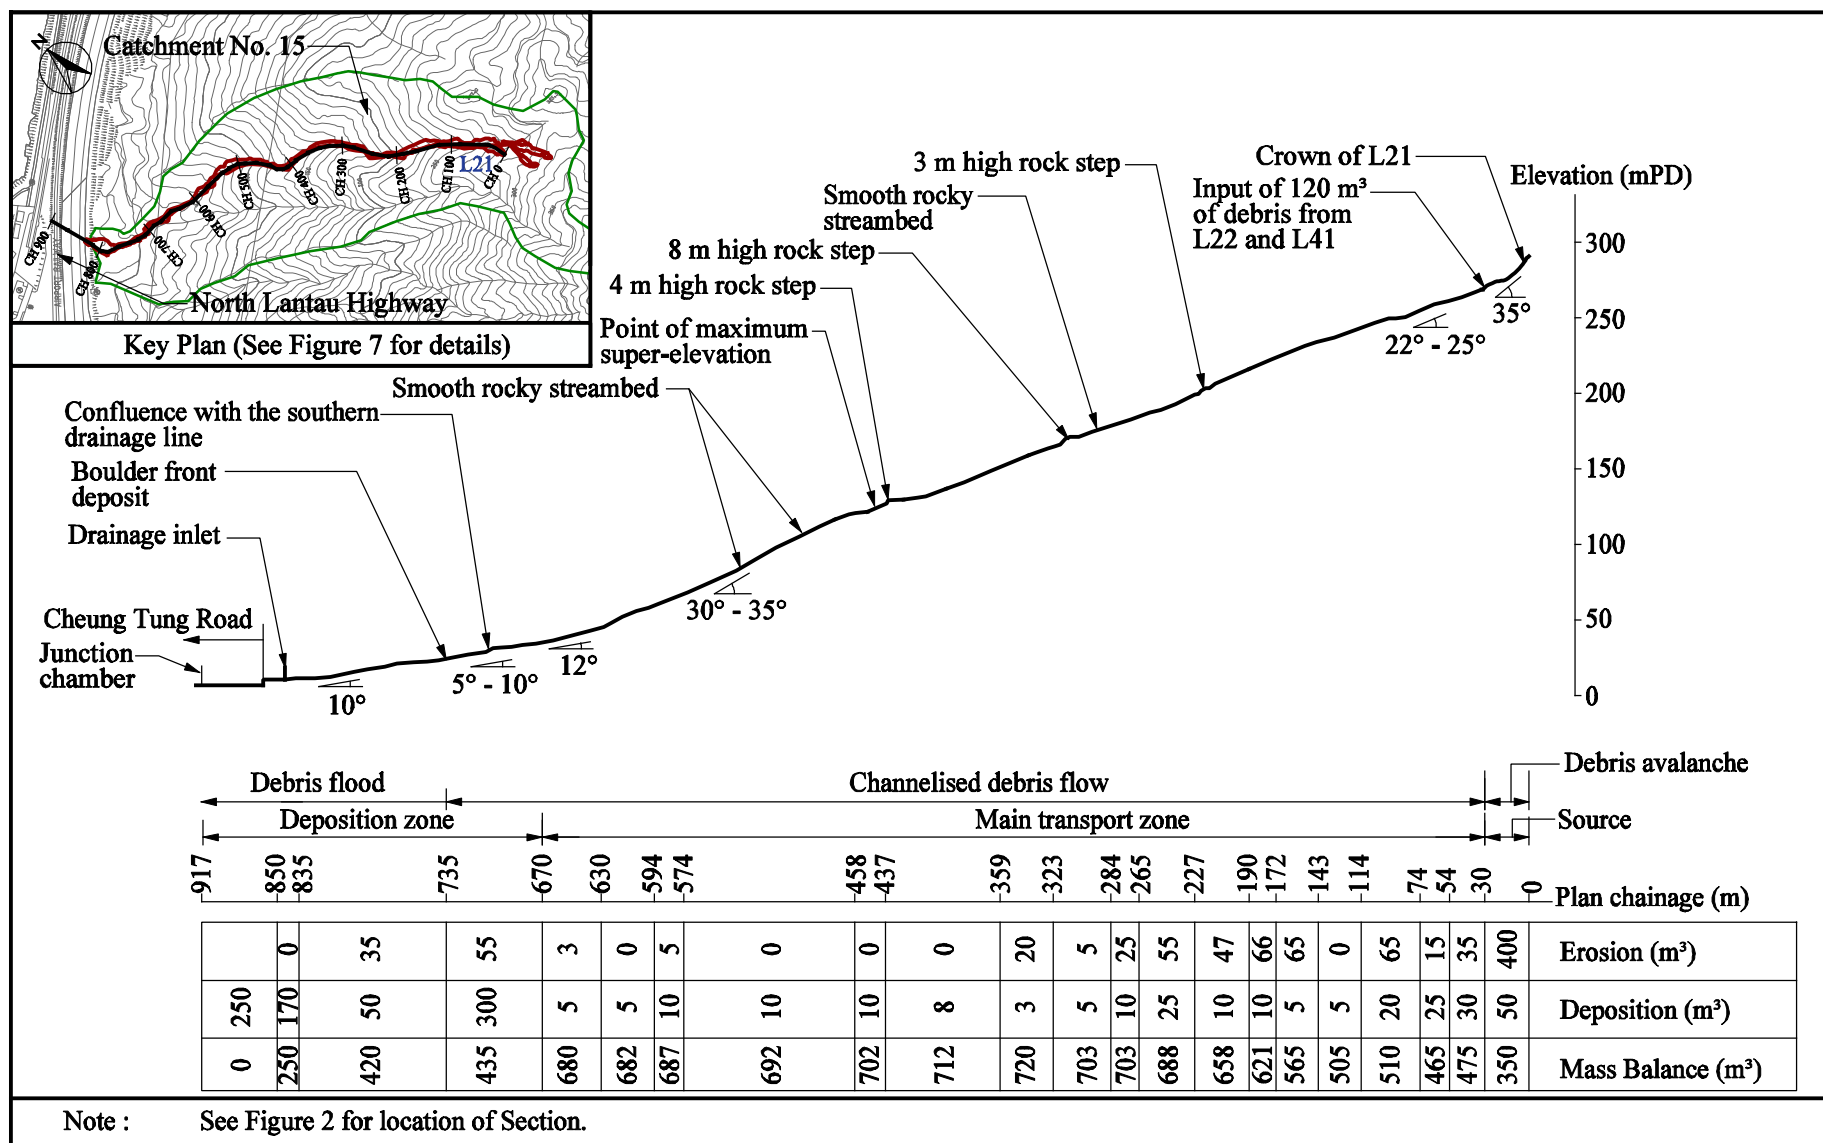
Figure 6 - Section A-A through Landslide No. L21 in Catchment No. 15

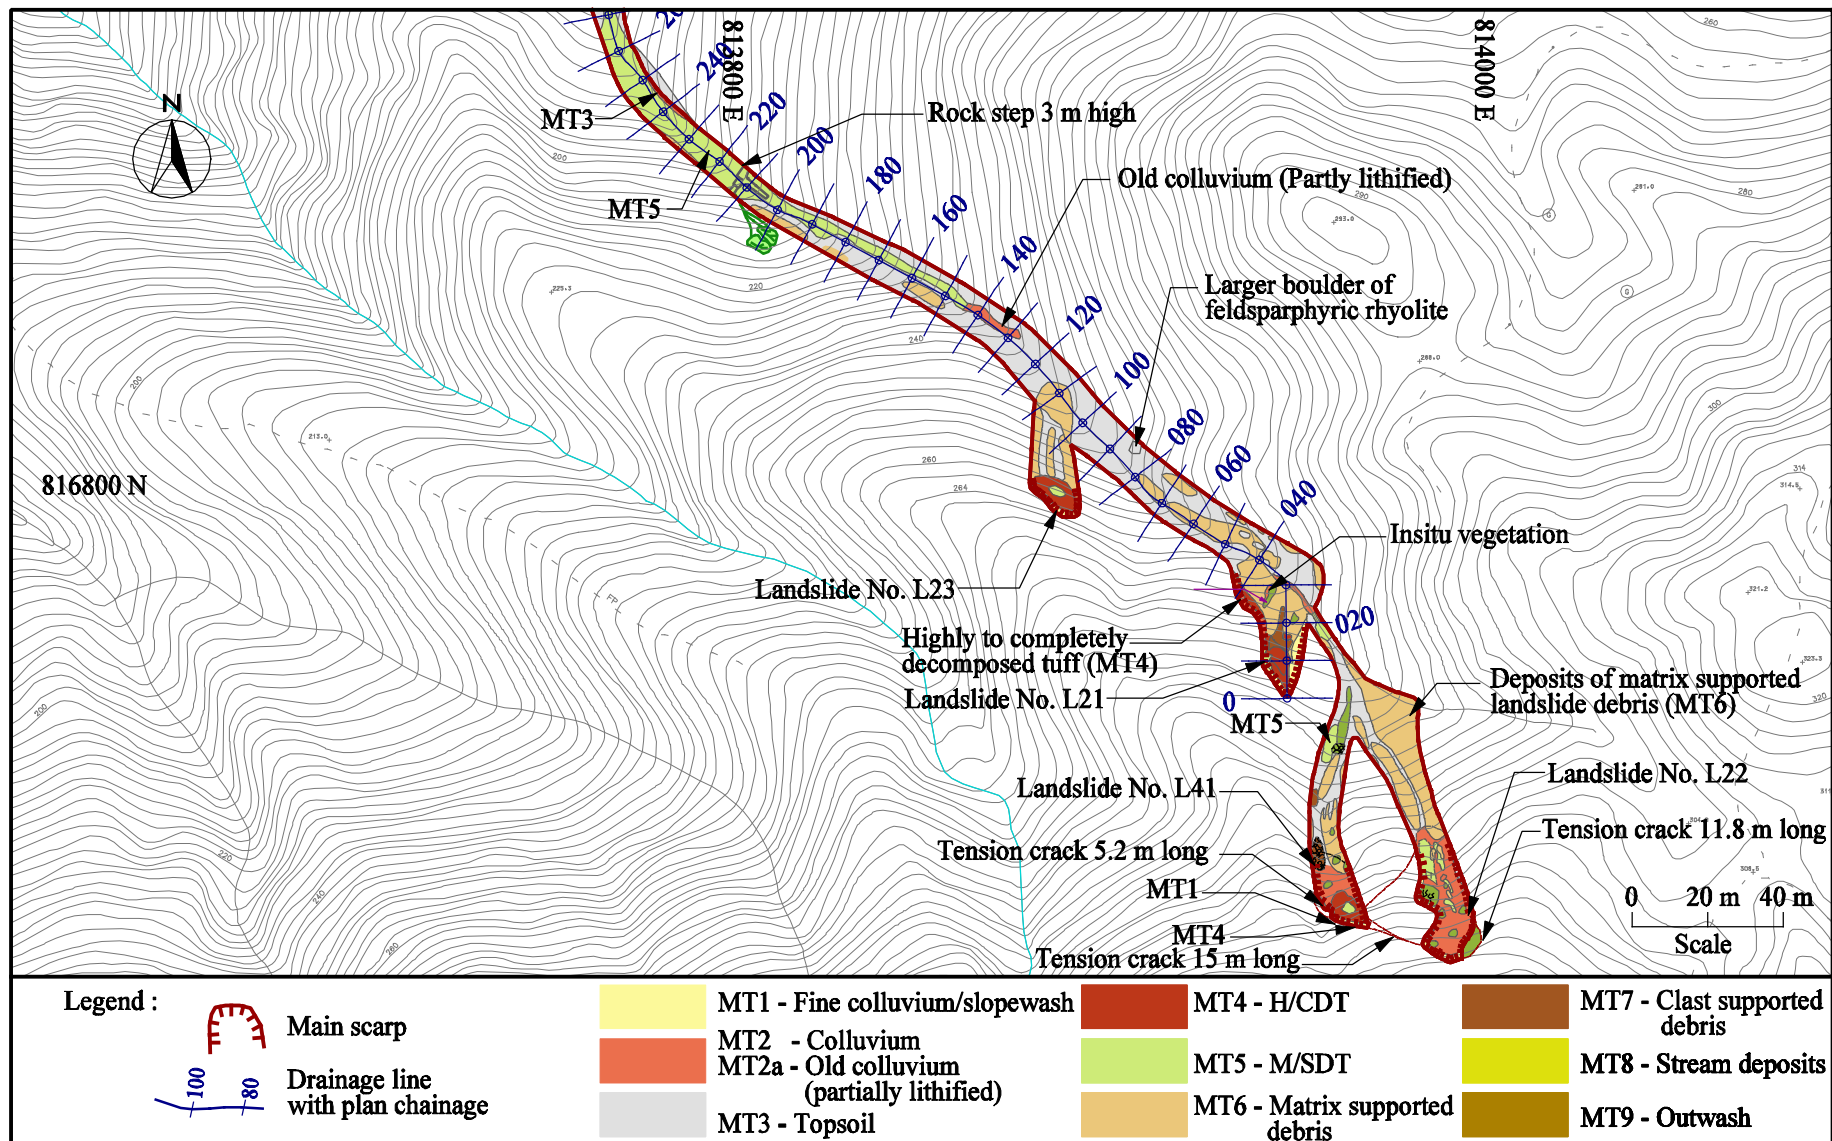
Between CH30 and CH670 was the main transport zone (Figure 6), in which the channel bed was generally rocky. Throughout the runout path, erosion was mainly observed between CH140 to CH285 at the central portion of the drainage line, where the width is about 2 m to 3 m (Plate 16), exposing rock and in places partially lithified old colluvium (Plate 17). From CH285 onwards, erosion of the channel bed or side slopes was minimal. Based on field evidence, there was no significant amount of perched material in the channel prior to the June 2008 event (Plate 18). This was also later confirmed by API (Section 4.4). The maximum active volume of the CDF was about 720 m<sup>3</sup> at about CH330. Deposits of super-elevated debris were observed at about CH440 (Plate 19), and measured super-elevation indicates that the debris velocity was about 7 m/s at this location (Hung et al, 1984). In general, the channel gradient in the transport zone is over 20° with occasional rock steps up to 8 m high (Figure 6 and Plate 20). The channel is not particularly incised (with a channelization ratio<sup>6</sup> (CR) of 6 to 7) throughout the transport zone (Plate 21), but is very smooth and rocky (Plates 22 and 23).

Figure 7a - Detailed Layout Plan of the Longer Channelised Debris Flow in Catchment No. 15 (Sheet 1 of 2)

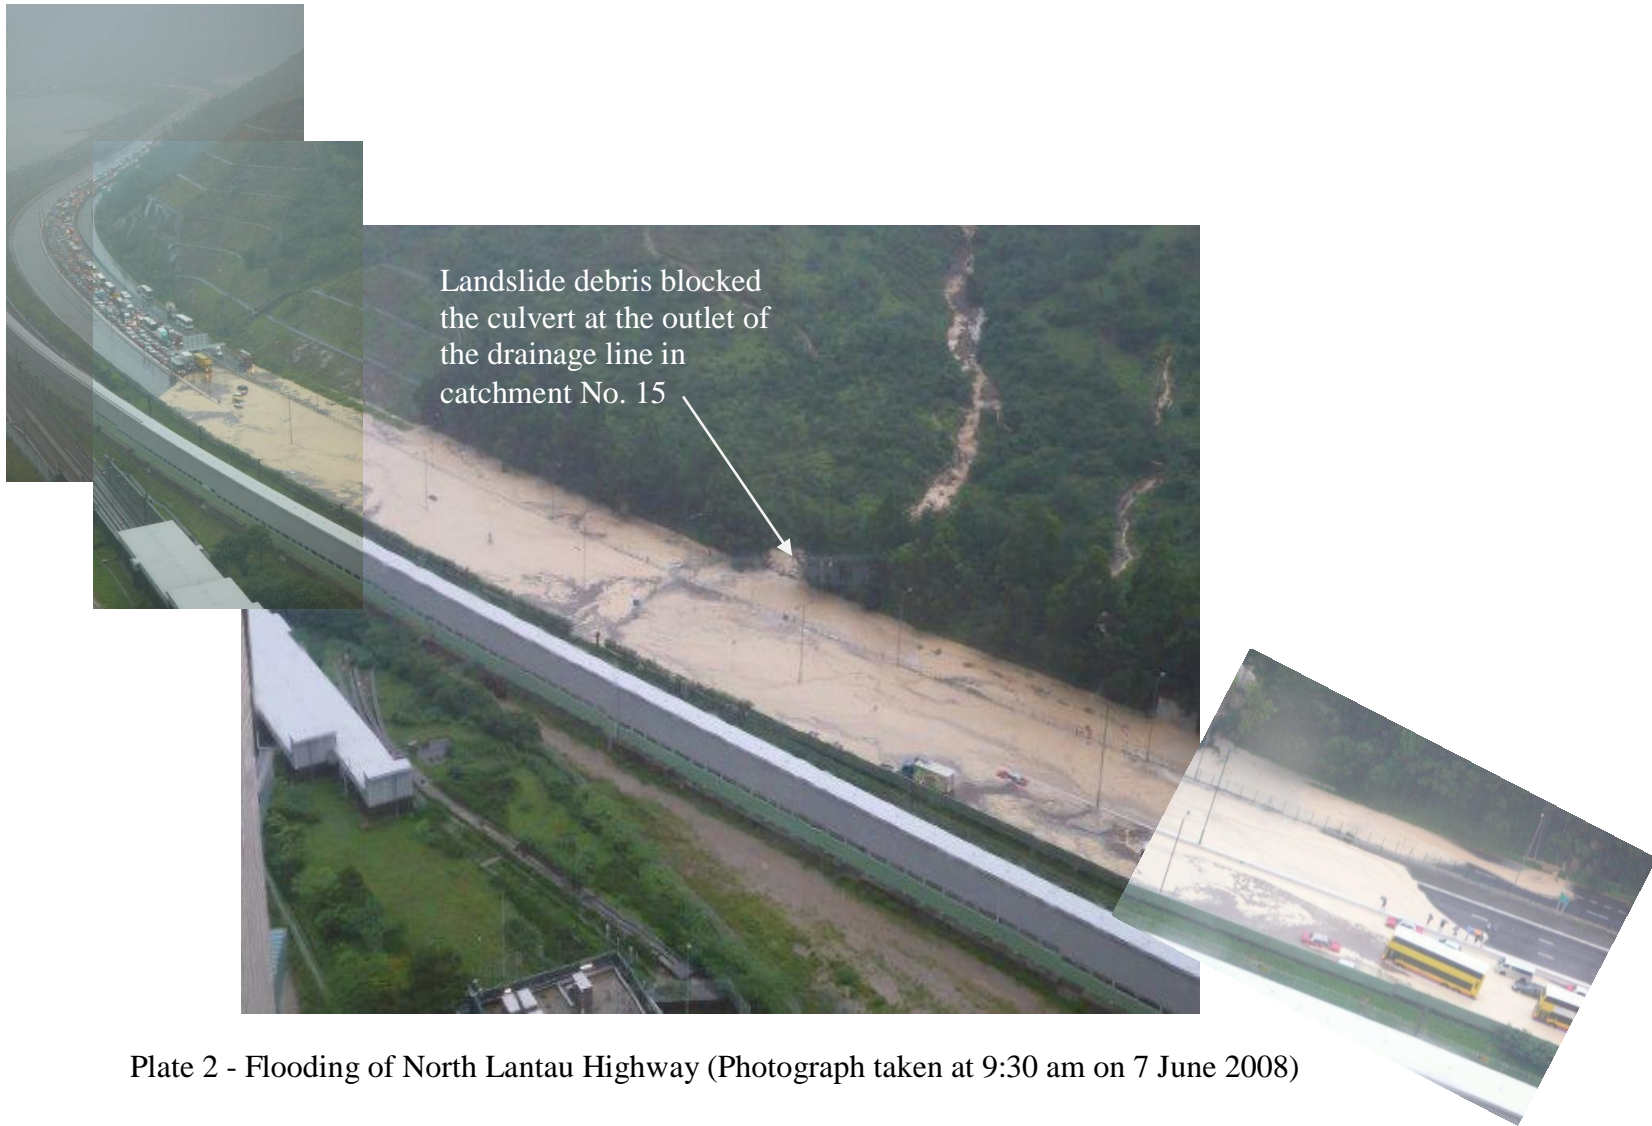
Plate 2 - Flooding of North Lantau Highway (Photograph taken at 9:30 am on 7 June 2008)

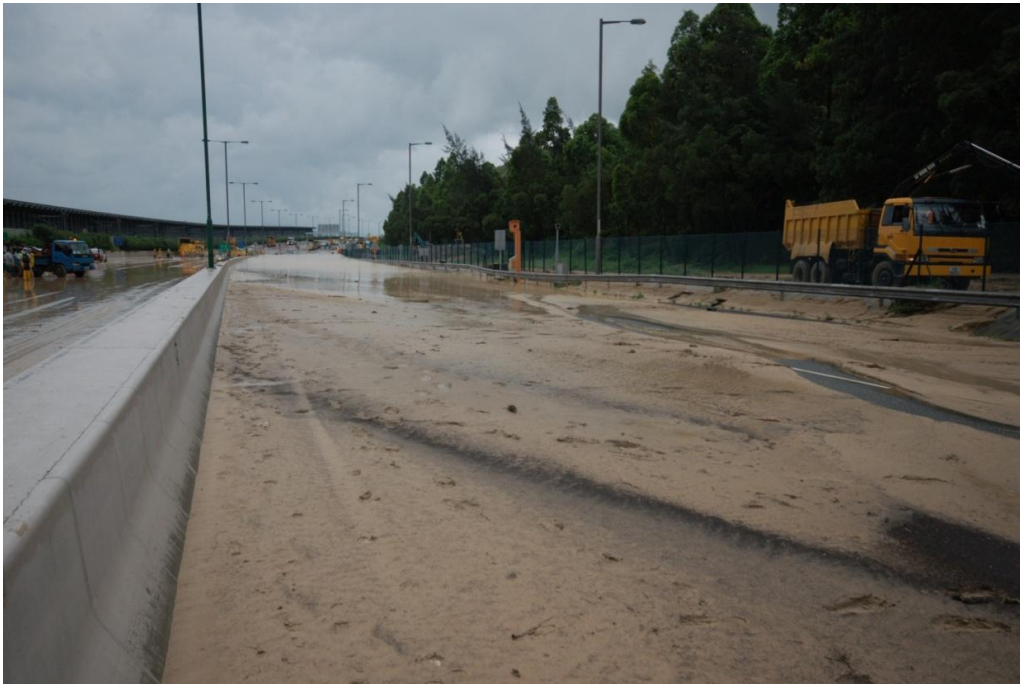
Plate 4 - Fines Observed on North Lantau Highway (Photograph taken at 2 pm on 7 June 2008)

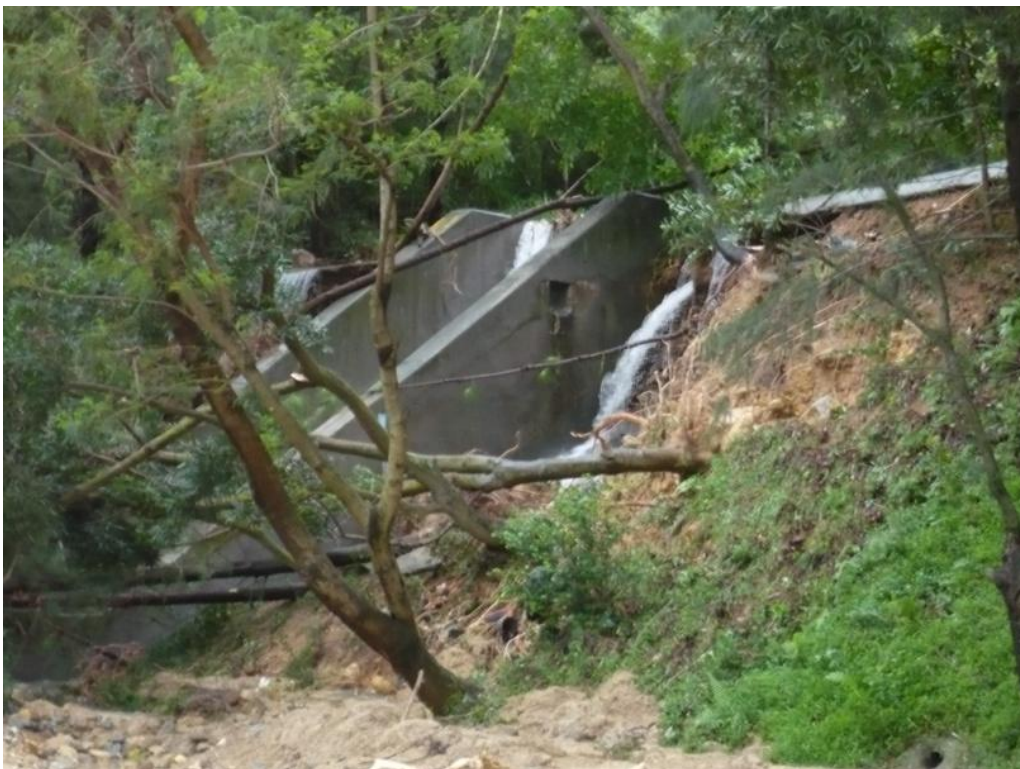
Plate 5 - Erosion at the Side of Drainage Channel at the Toe of Catchment No. 16 (Photograph taken at 2-3 pm on 7 June 2008)

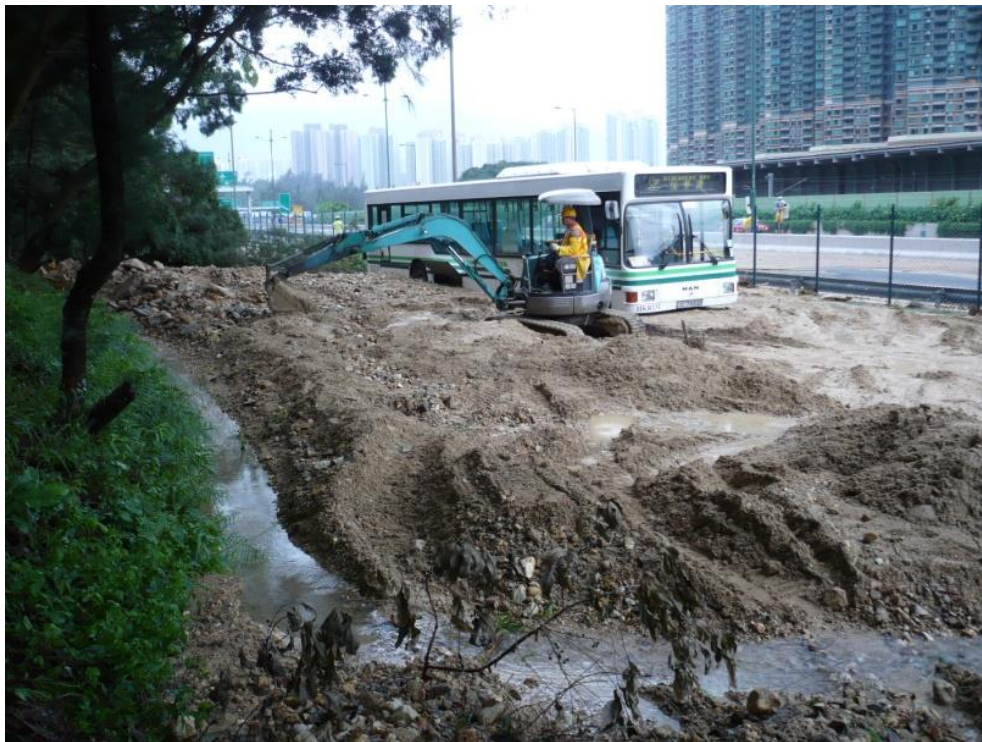
Plate 6 - Up to 0.5 m thick Sandy/Gravelly Deposit on Cheung Tung Road below Catchment No. 16 (Photograph taken at 2 pm on 7 June 2008)

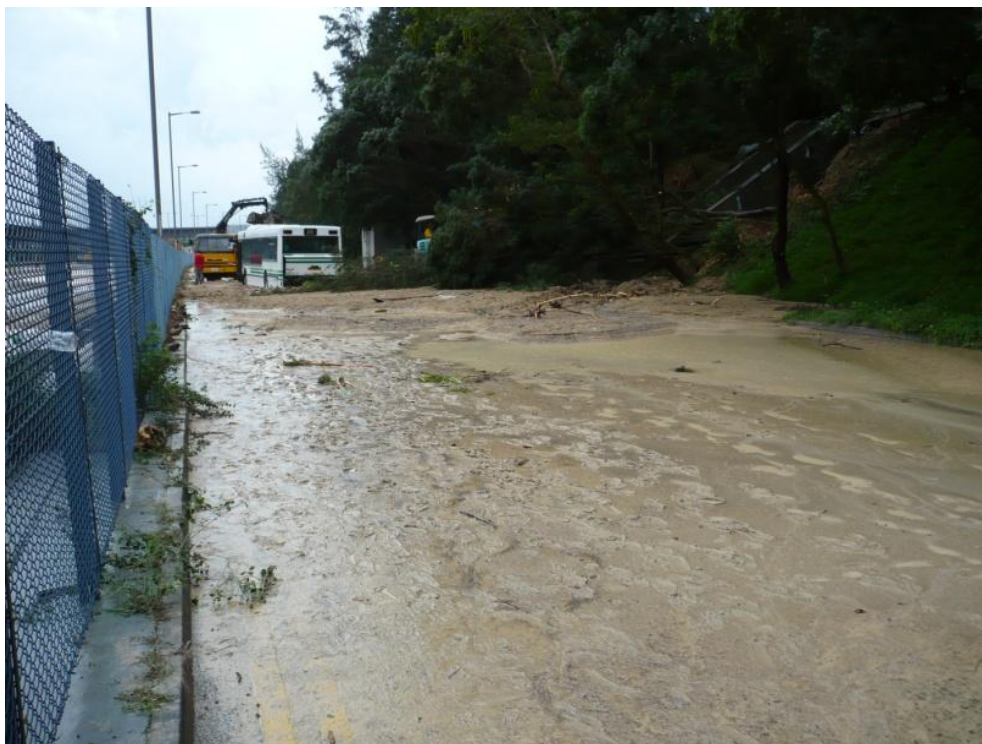
Plate 7 - Outwash Debris on Cheung Tung Road from Catchment No. 16 (Photograph taken at 2 pm on 7 June 2008)

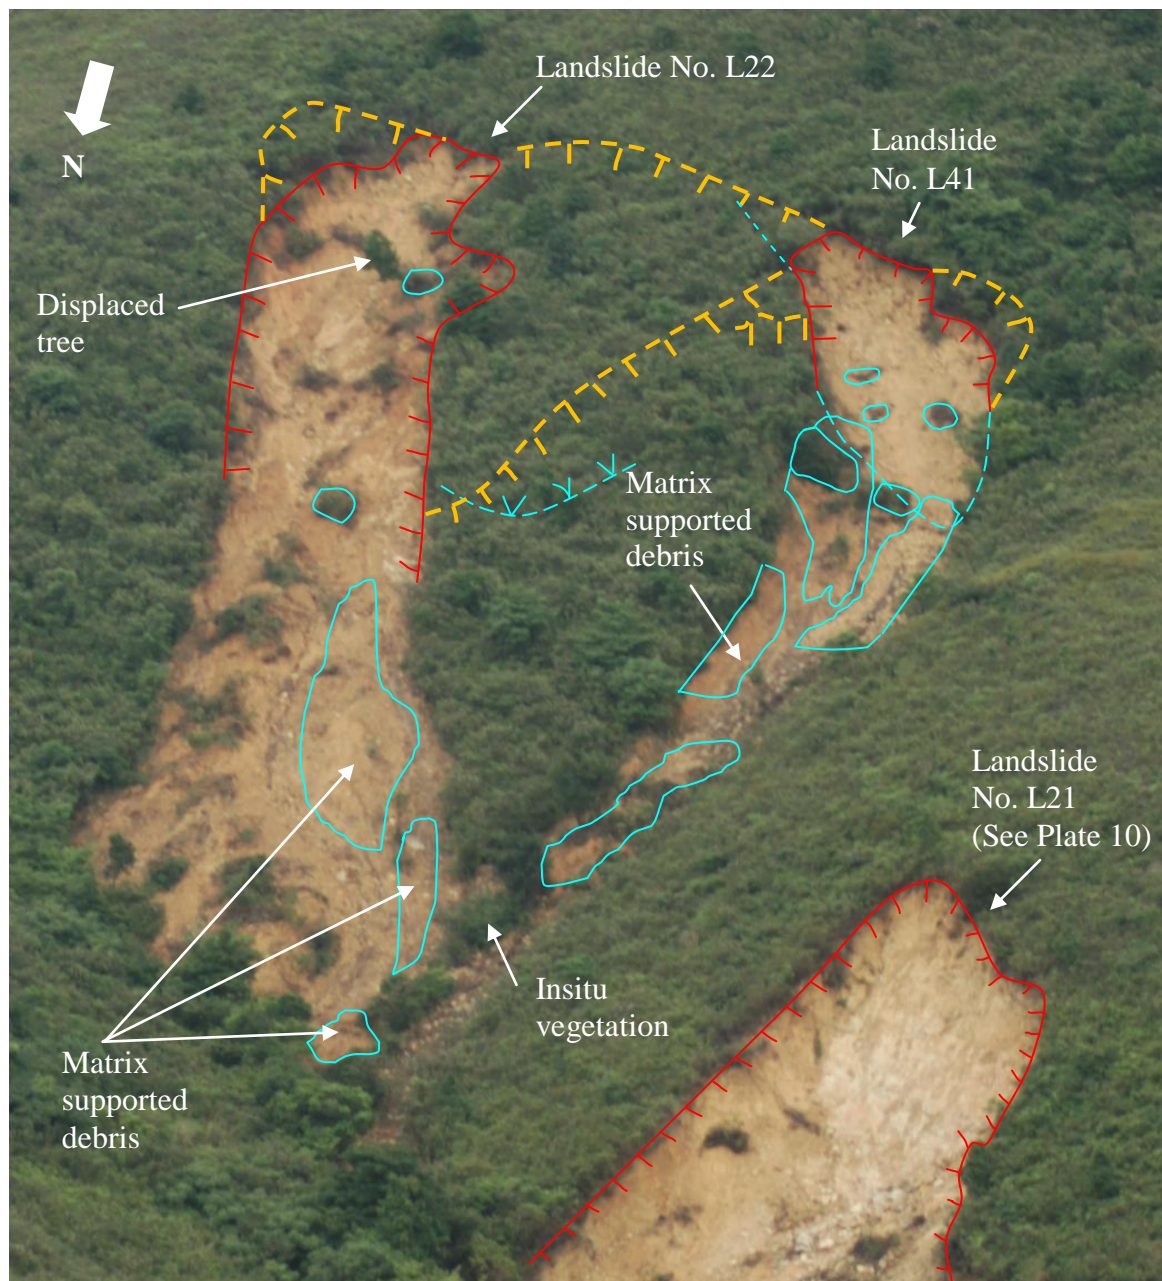
At landslides Nos. L22 and L41 (in catchment No. 15), a number of fresh tension cracks were observed at and around the crowns of the two landslides and on the hillside area

in-between (Plates 9 and 11). The tension cracks were up to 20 m long and 1 m deep, and were probably caused by the 7 June 2008 rainstorm. No other fresh tension cracks were observed within the study area.

Plate 9 - Oblique Aerial Photograph of Landslides Nos. L22 and L41  
Showing Tension Cracks and Distressed Hillside (Photograph  
taken on 16 June 2008)

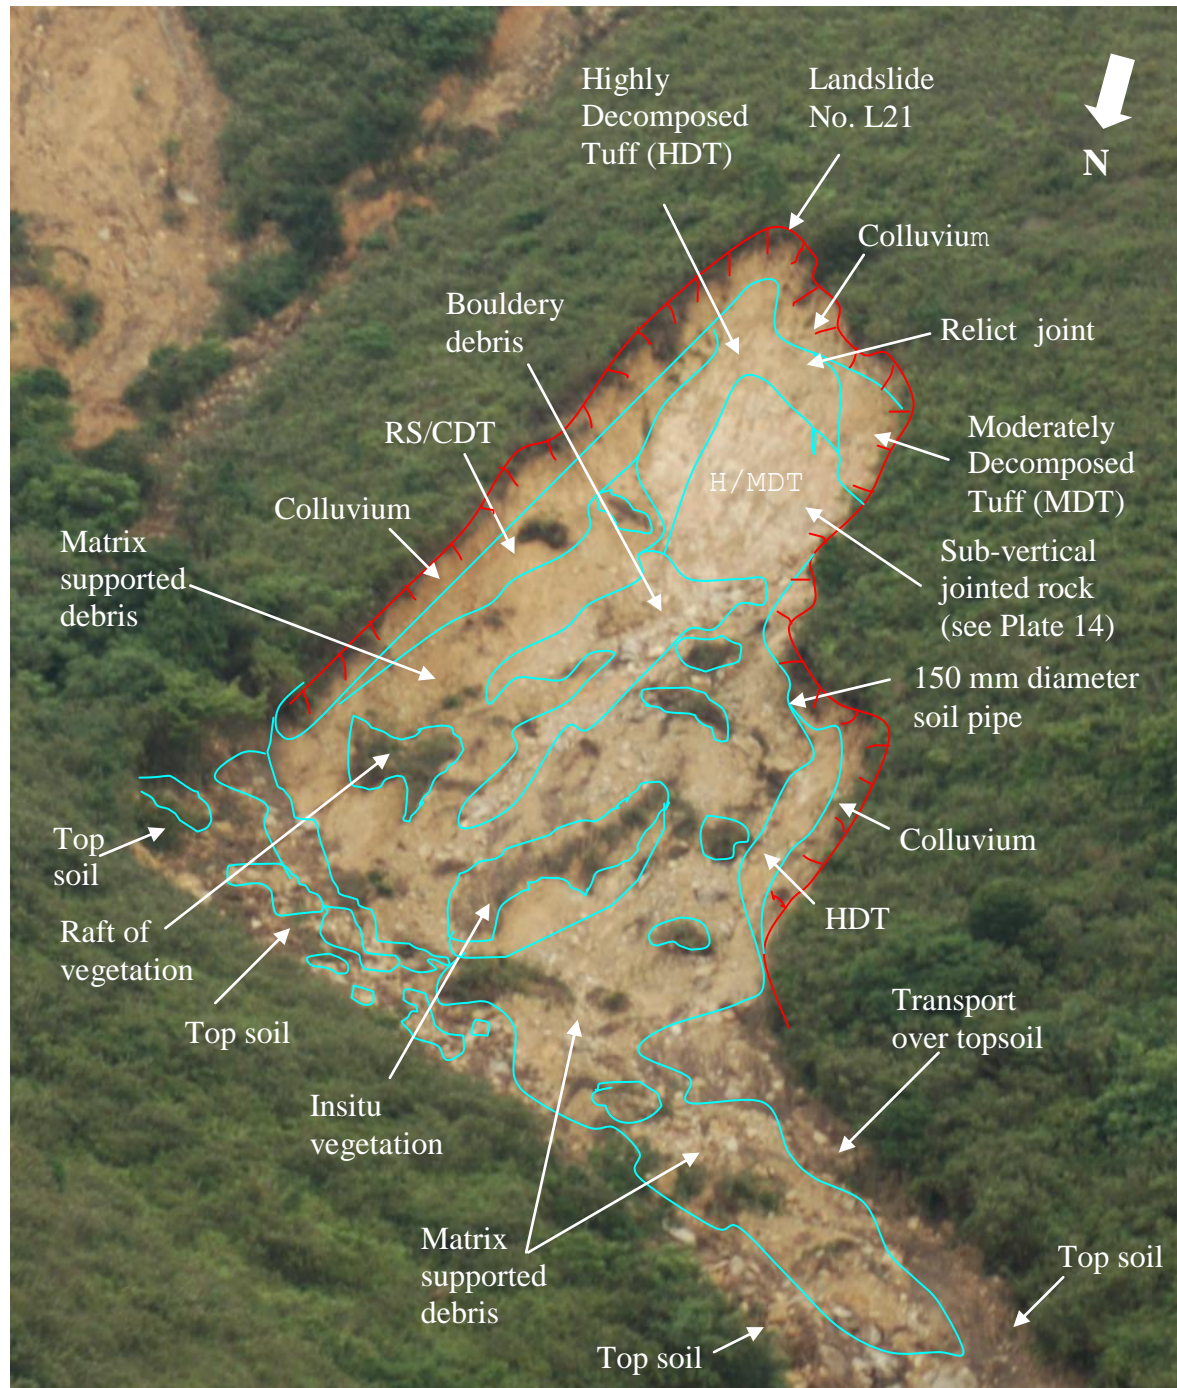
The failure appeared to have mainly involved a thin layer of fine colluvium, with the rupture surface running along the interface between the colluvium and underlying insitu completely to highly decomposed tuff (Plate 10). At the western flank of the landslide, the rupture surface extended to the underlying moderately decomposed tuff where the failure depth increased to about 3 m, exposing surface release planes including an adversely oriented (70/340) relict joint dipping out of hillside (Plates 10 and 14). A large soil pipe (150 mm diameter) was observed at the lower portion of the landslide (Plate 10).

Plate 10 - Oblique Aerial Photograph of Landslide No. L21 (Photograph taken on 16 June 2008)

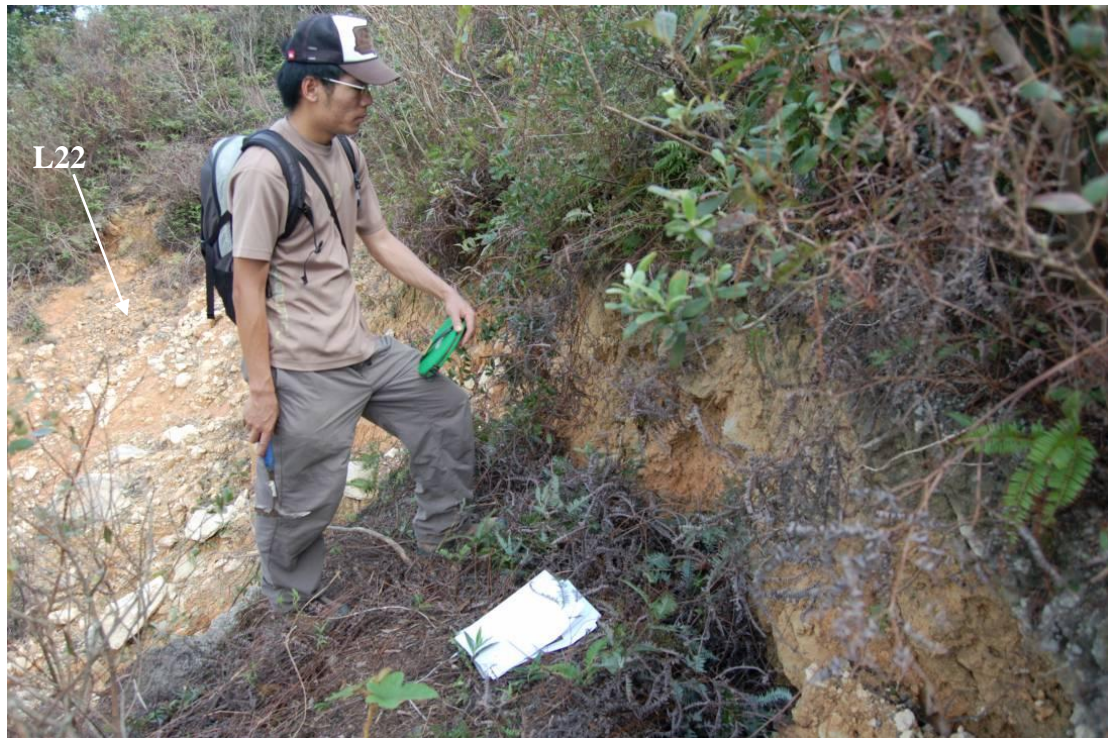
Plate 11 - View of Tension Crack between Landslides Nos. L22 and L41  
(Photograph taken on 10 October 2008)

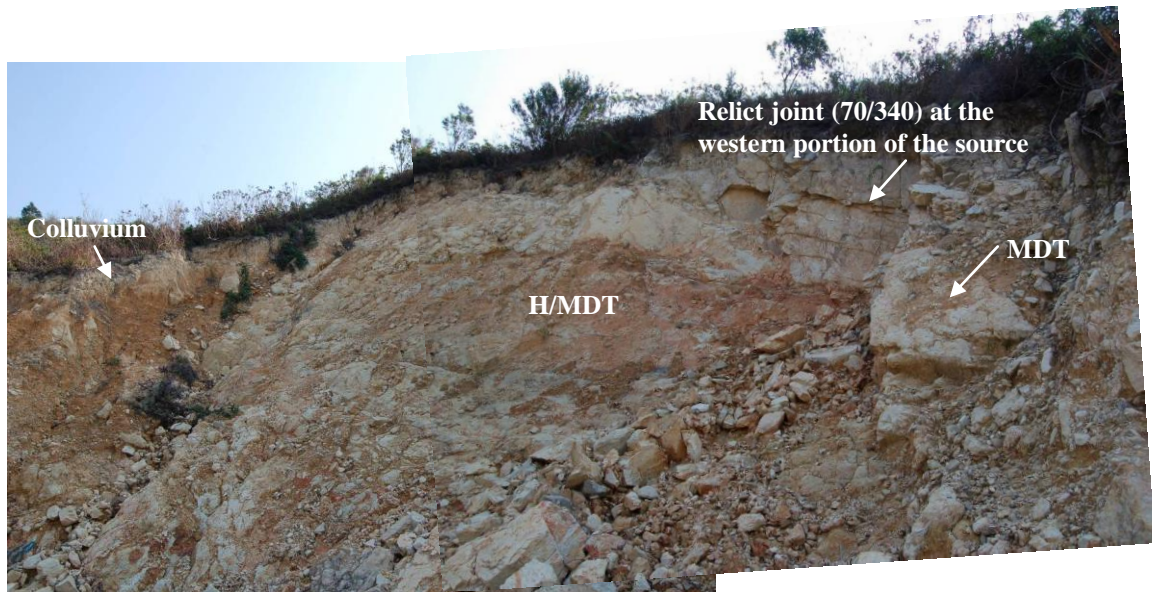
Plate 14 - Source of Landslide No. L21 in Catchment No. 15  
(Photograph taken on 26 November 2008)

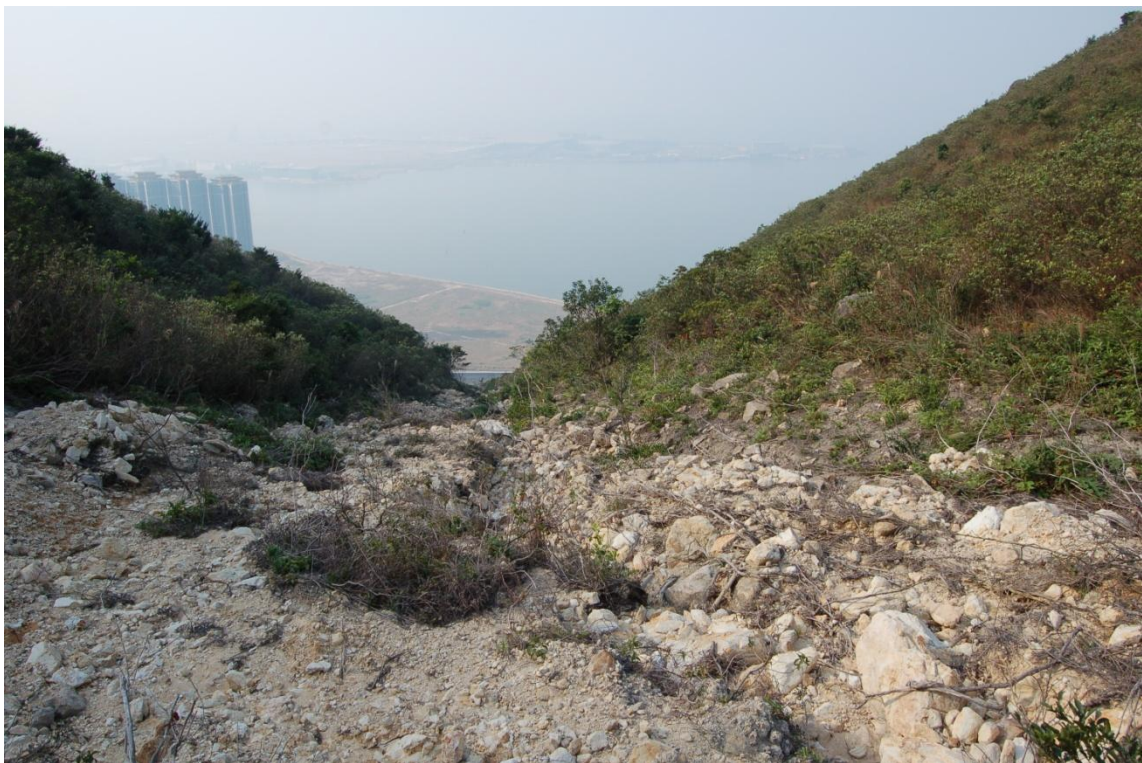
Plate 15 - Debris Avalanche for Landslide No. L21 in Catchment No. 15 at about CH30  
(Photograph taken on 26 November 2008)

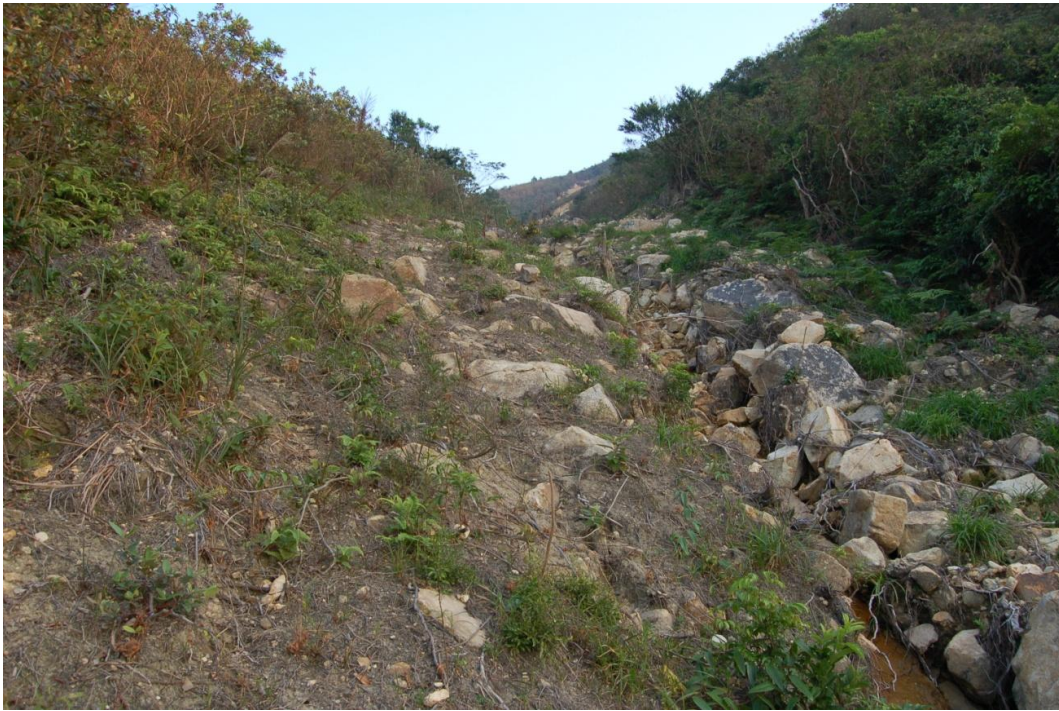
Plate 16 - View at CH140 (Looking up) Exposing Post Landslide Erosion at Central Portion of the Northern Drainage Line in Catchment No. 15  
(Photograph taken on 26 November 2008)

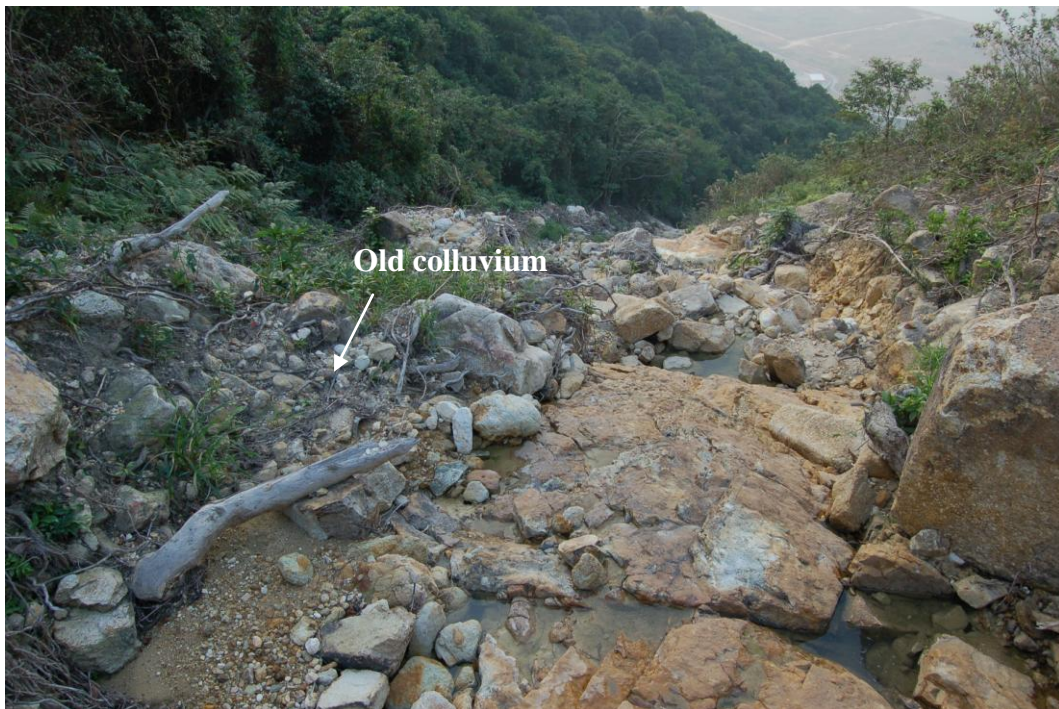
Plate 17 - View at CH140 (Looking Down) in the Northern Drainage Line in Catchment No. 15 Exposing Rock and Partially Lithified Old Colluvium  
(Photograph taken on 26 November 2008)

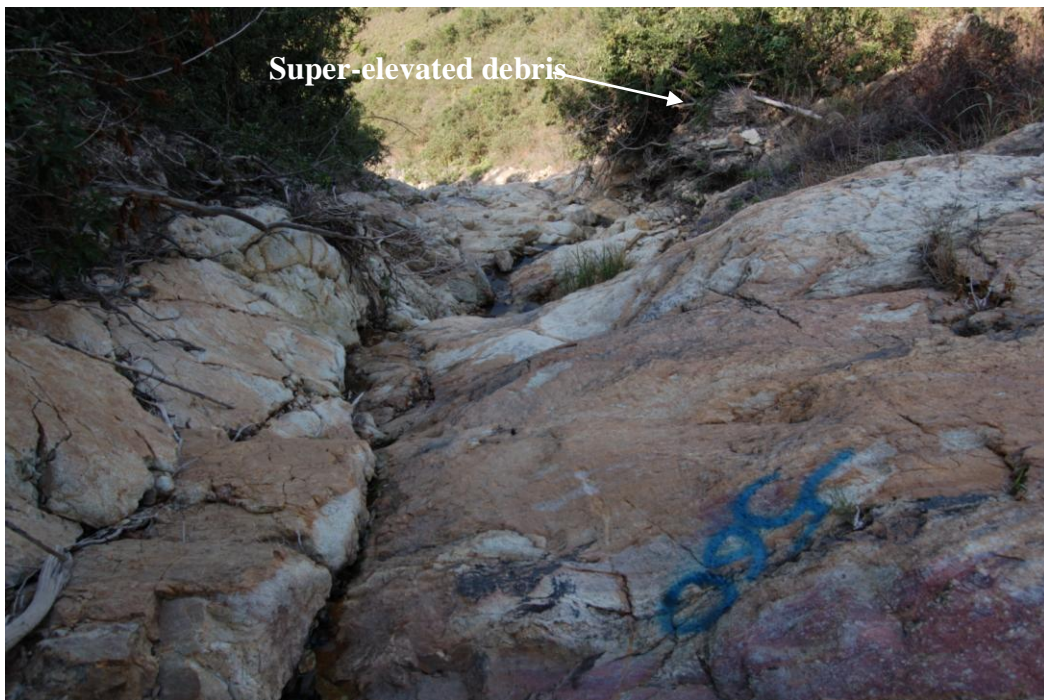
Plate 19 - View at CH460 (Looking Up) Revealing Deposition of Super-elevated Debris at about CH440 in the Northern Drainage Line in Catchment No. 15 (Photograph taken on 27 November 2008)

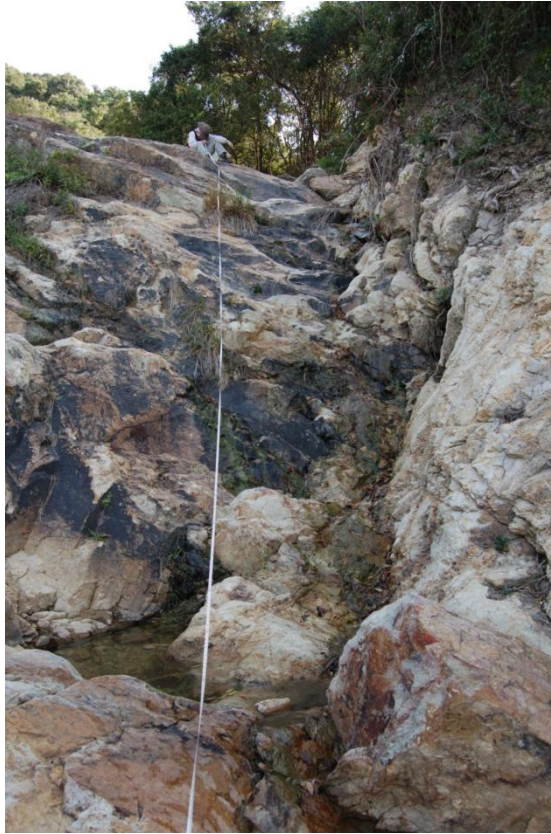
Plate 20 - View at CH310 Showing 8 m High Rock Step in the Northern Drainage Line in Catchment No. 15 (Photograph taken on 27 November 2008)

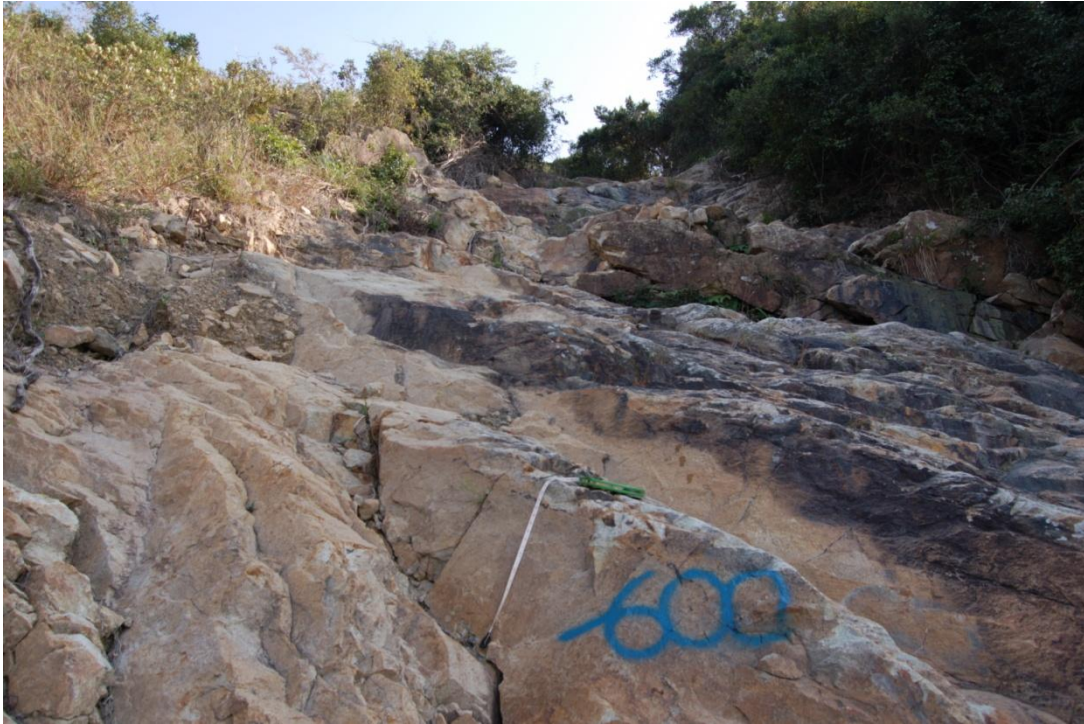
Plate 22 - View at CH520 (Looking Up) Revealing Smooth Rocky Streambed in the Northern Drainage Line in Catchment No. 15 (Photograph taken on 27 November 2008)

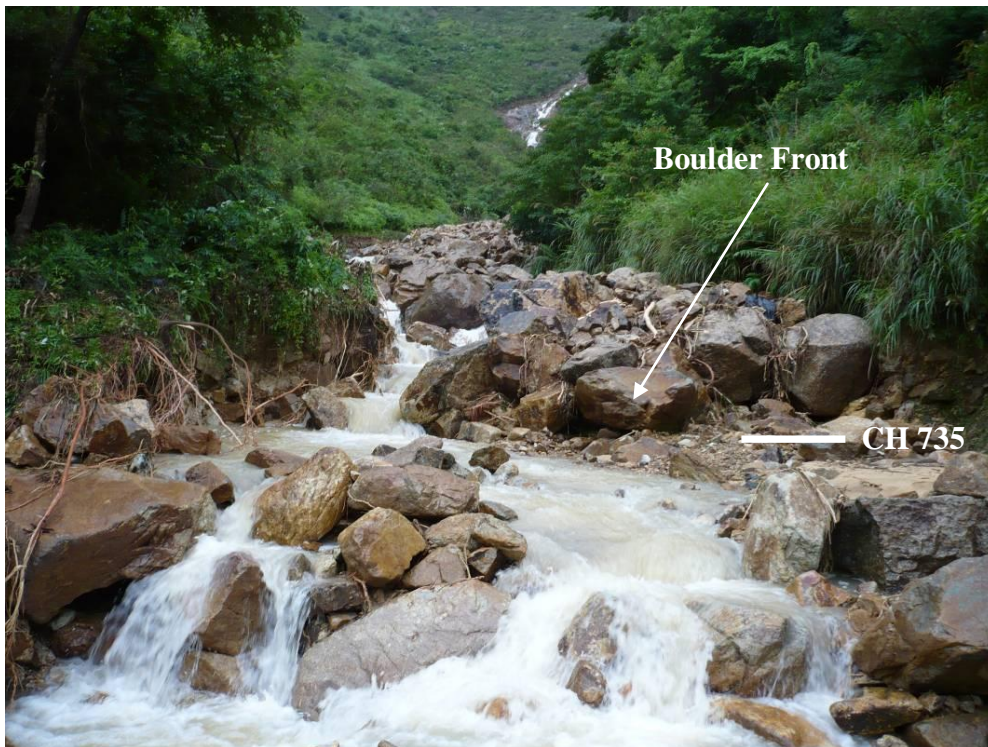
As the coarse material deposited as a boulder front at CH735, the more dilute sediment charged flow probably continued as a debris flood, transporting some 400 m<sup>3</sup> of sediment/debris further downstream. The debris flood deposits spreaded out between CH735 and CH850 with no levees. The deposits comprised sorted, clast-supported fine debris (i.e. sediment) with occasional matrix-supported bouldery debris (Plate 26). Approximately 170 m<sup>3</sup> of the sediment/debris containing small boulders up to 0.5 m in diameter was observed blocking the culvert inlet at CH850 along Cheung Tung Road (Plates 27 and 28). The sediment/debris did not cause any impact marks or significant damage on the concrete head wall connecting the culvert (Plate 29), indicating that the debris flood was not fast moving. According to Drainage Services Department (DSD), approximately 250 m<sup>3</sup> sediment/debris almost fully filled up the 2 m x 2 m culvert (Plate 31) and reached a junction chamber located at 67 m downstream of the inlet (Plate 32). The debris at the junction chamber comprised vegetation and coarse material (Plate 32). As a result, Chung Tung Road and the adjoining NLH were severely flooded.

Plate 25 - About 300 m<sup>3</sup> of Matrix-Supported Bouldery Debris Observed at CH735, along the Northern Drainage Channel with a Gradient of 5° to 10° in Catchment No. 15 (Photograph taken at about 1 pm on 7 June 2008)

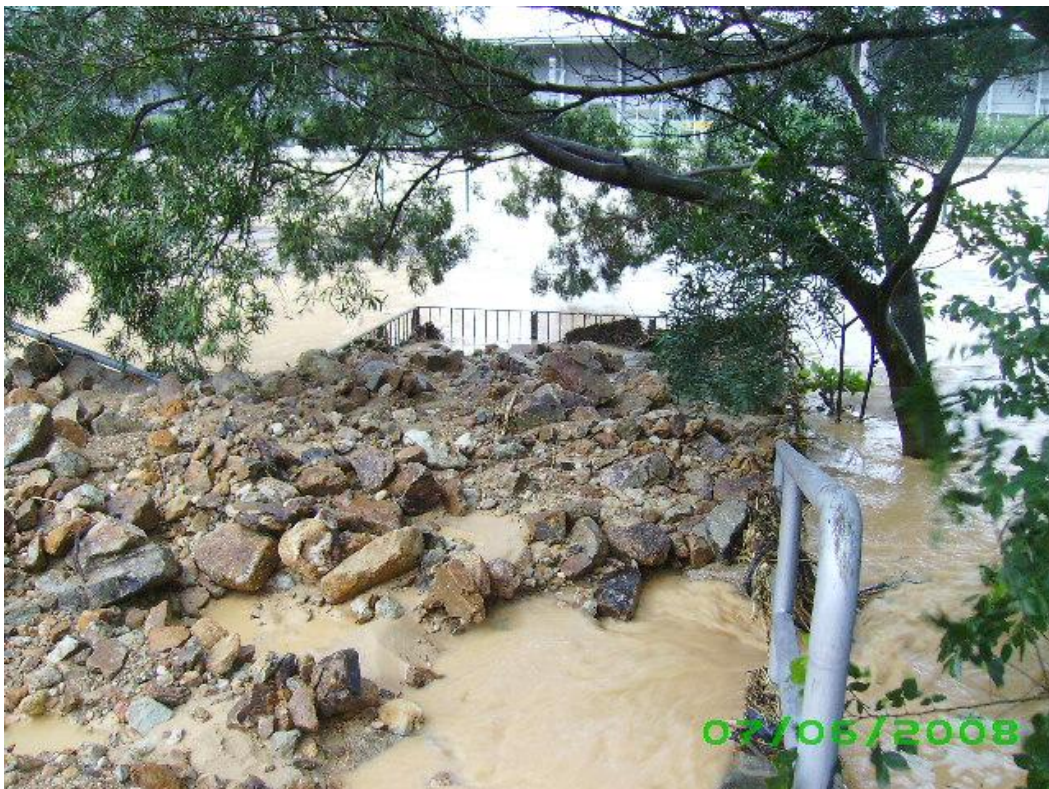
Plate 27 - Drainage Inlet Blocked with Clast-Supported Bouldery Debris at CH850  
(Photograph taken at 11:30 am on 7 June 2008)

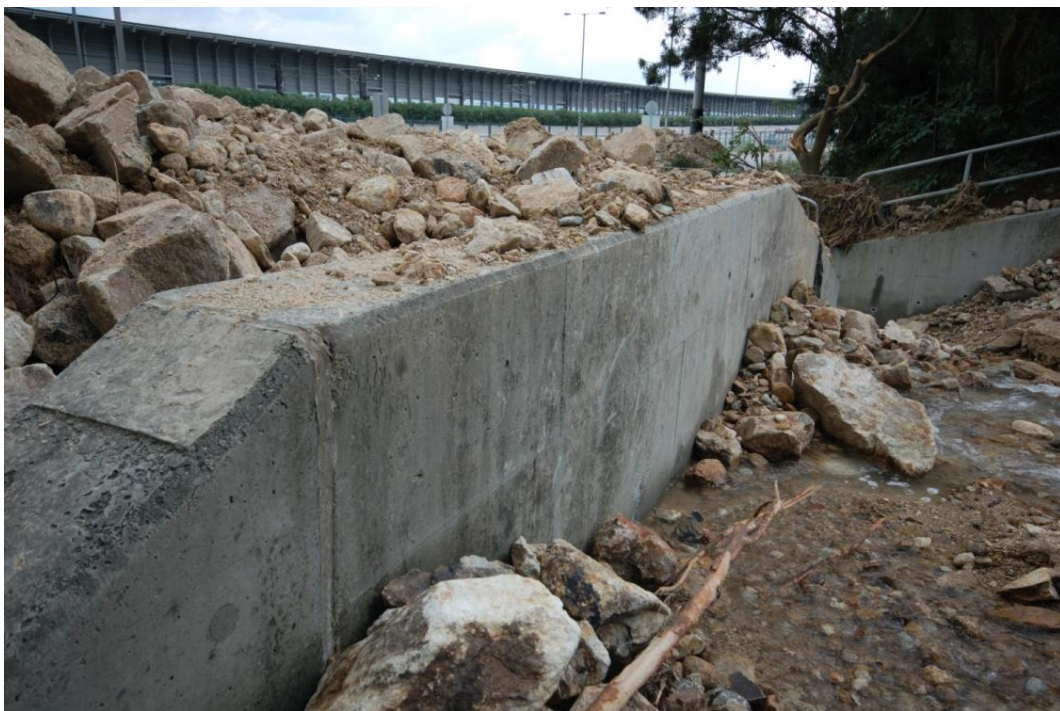
A debris flood may have occurred as a longitudinal extension of the debris flow, as the coarse material deposited at CH735, whilst the more dilute, sediment charged flood continued further downstream. About 420 m<sup>3</sup> of sediment/debris, comprising sorted, clast-supported sediment with occasional matrix-supported bouldery debris (Plate 26) were transported downstream from CH735. The observed debris flood deposits spreaded out between CH735 and CH850 with no levees. About 170 m<sup>3</sup> of the sediment/debris containing boulders up to 0.5 m in diameter was observed blocking the culvert inlet at CH850 along Cheung Tung Road (Plates 27 and 28) and another 250 m<sup>3</sup> of sediment/debris, continued along the 2 m x 2 m culvert and reached the junction chamber 67 m downstream (Plates 31 and 32). The sediment/debris blocked the drainage culvert and inlet, resulting in severe flooding of Cheung Tung Road and the adjoining NLH. No signs of damage were observed at the drainage inlet structure at CH850 (Plate 29), indicating that the debris flood was not fast moving.

Plate 29 - No Impact Marks on the Concrete Head Wall Connected to the Drainage Inlet in Catchment No. 15 (Photograph taken on 8 June 2008)

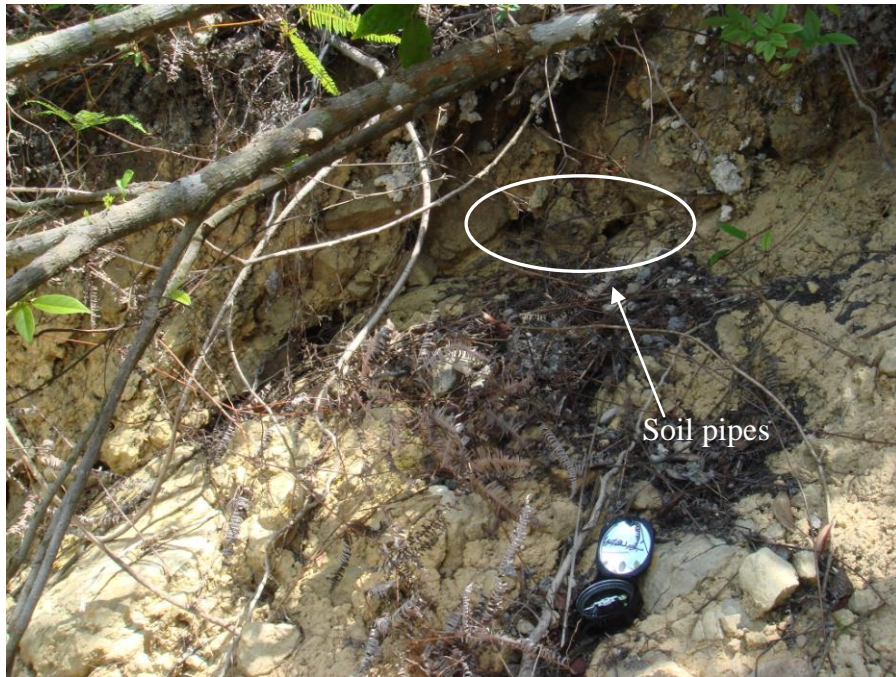
Plate B2 - Observed Soil Pipes at Source Area of Landslide No. L40 in Catchment No. 15 (Photograph taken on 18 August 2008)
