**DETAILED STUDY OF THE  
7 JUNE 2008 LANDSLIDES ON  
THE HILLSIDE ABOVE THE  
NORTH LANTAU HIGHWAY AND  
CHEUNG TUNG ROAD,  
NORTH LANTAU**

**GEO REPORT No. 272**

**AECOM Asia Company Limited**

**GEOTECHNICAL ENGINEERING OFFICE  
CIVIL ENGINEERING AND DEVELOPMENT DEPARTMENT  
THE GOVERNMENT OF THE HONG KONG  
SPECIAL ADMINISTRATIVE REGION**

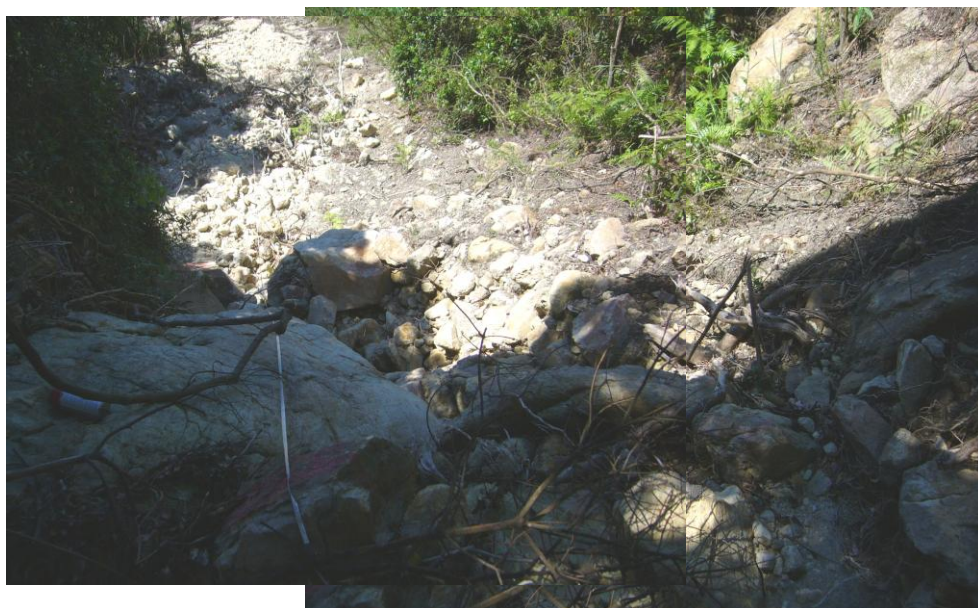
Plate B5 - 10 m High Vertical Step on a Rock Outcrop at CH220 in the Southern Drainage Line in Catchment No. 15 (Photograph taken on 18 August 2008)

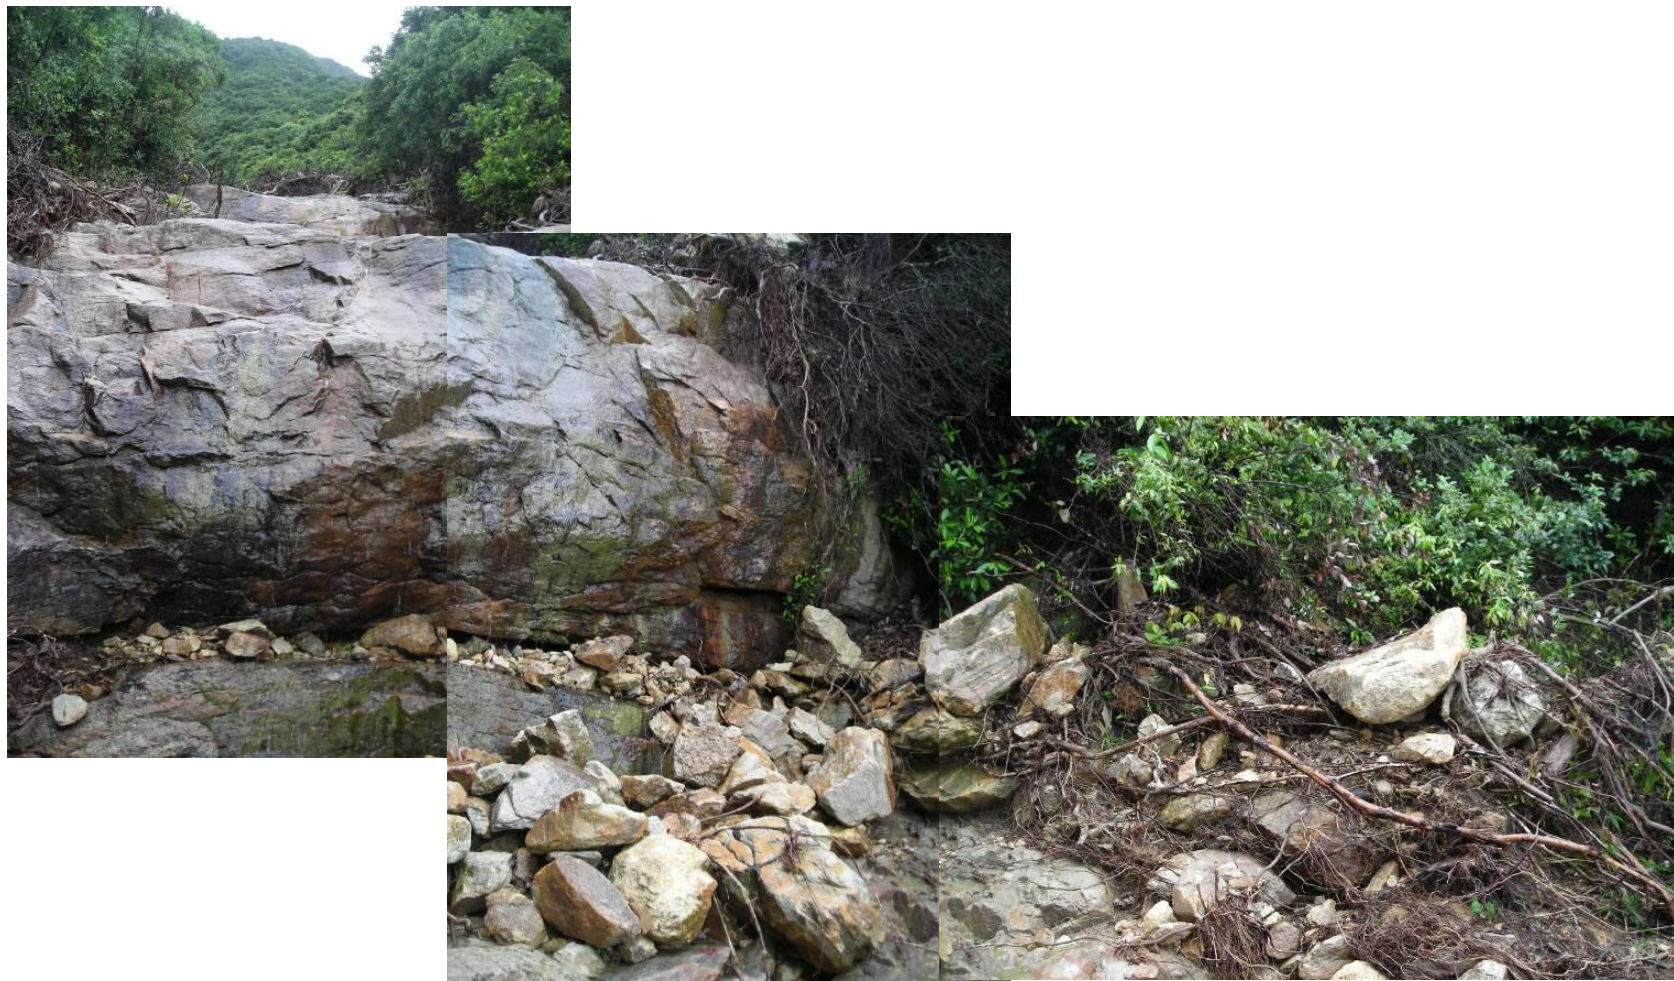
Plate B9 - Debris Deposited below a Steep Rock Step at CH170 in Catchment No. 21 (Photograph taken on 14 August 2008)

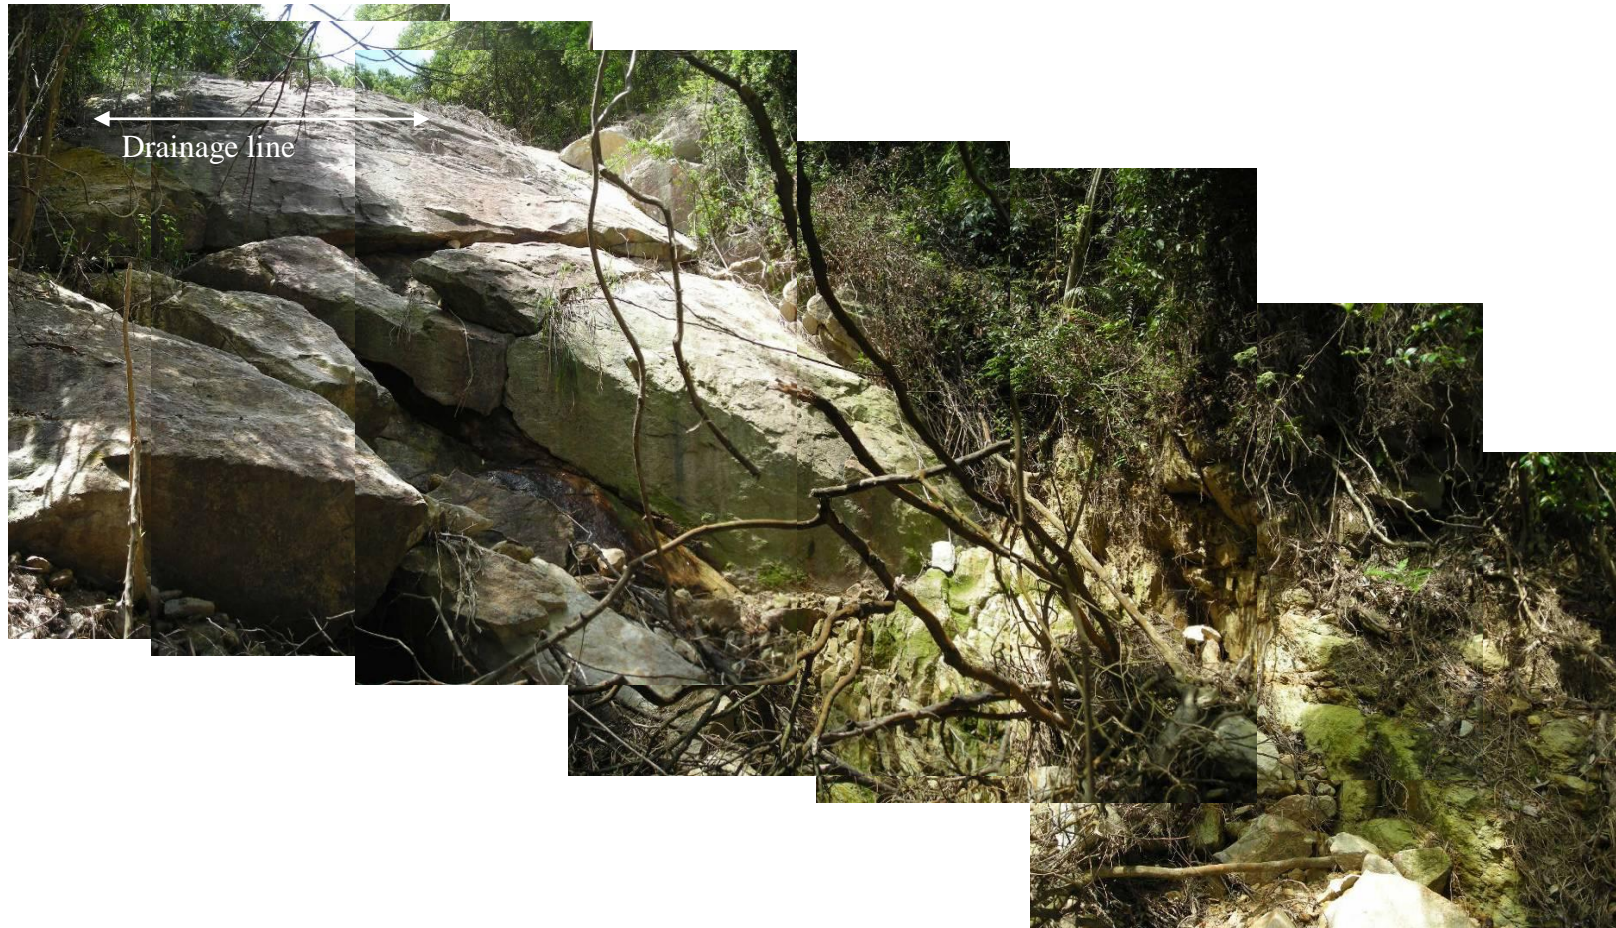
Plate B10 - Debris Deposited below a Rock Outcrop at CH250 in Catchment No. 21 (Photograph taken on 14 August 2008)
