Review of Landslides in 2008

GEO Report No. 274

**Geotechnical Engineering Office
Civil Engineering and Development Department
The Government of the Hong Kong
Special Administrative Region**

**This report was originally produced in December 2009
as GEO Landslide Study Report No. LSR 15/2009**

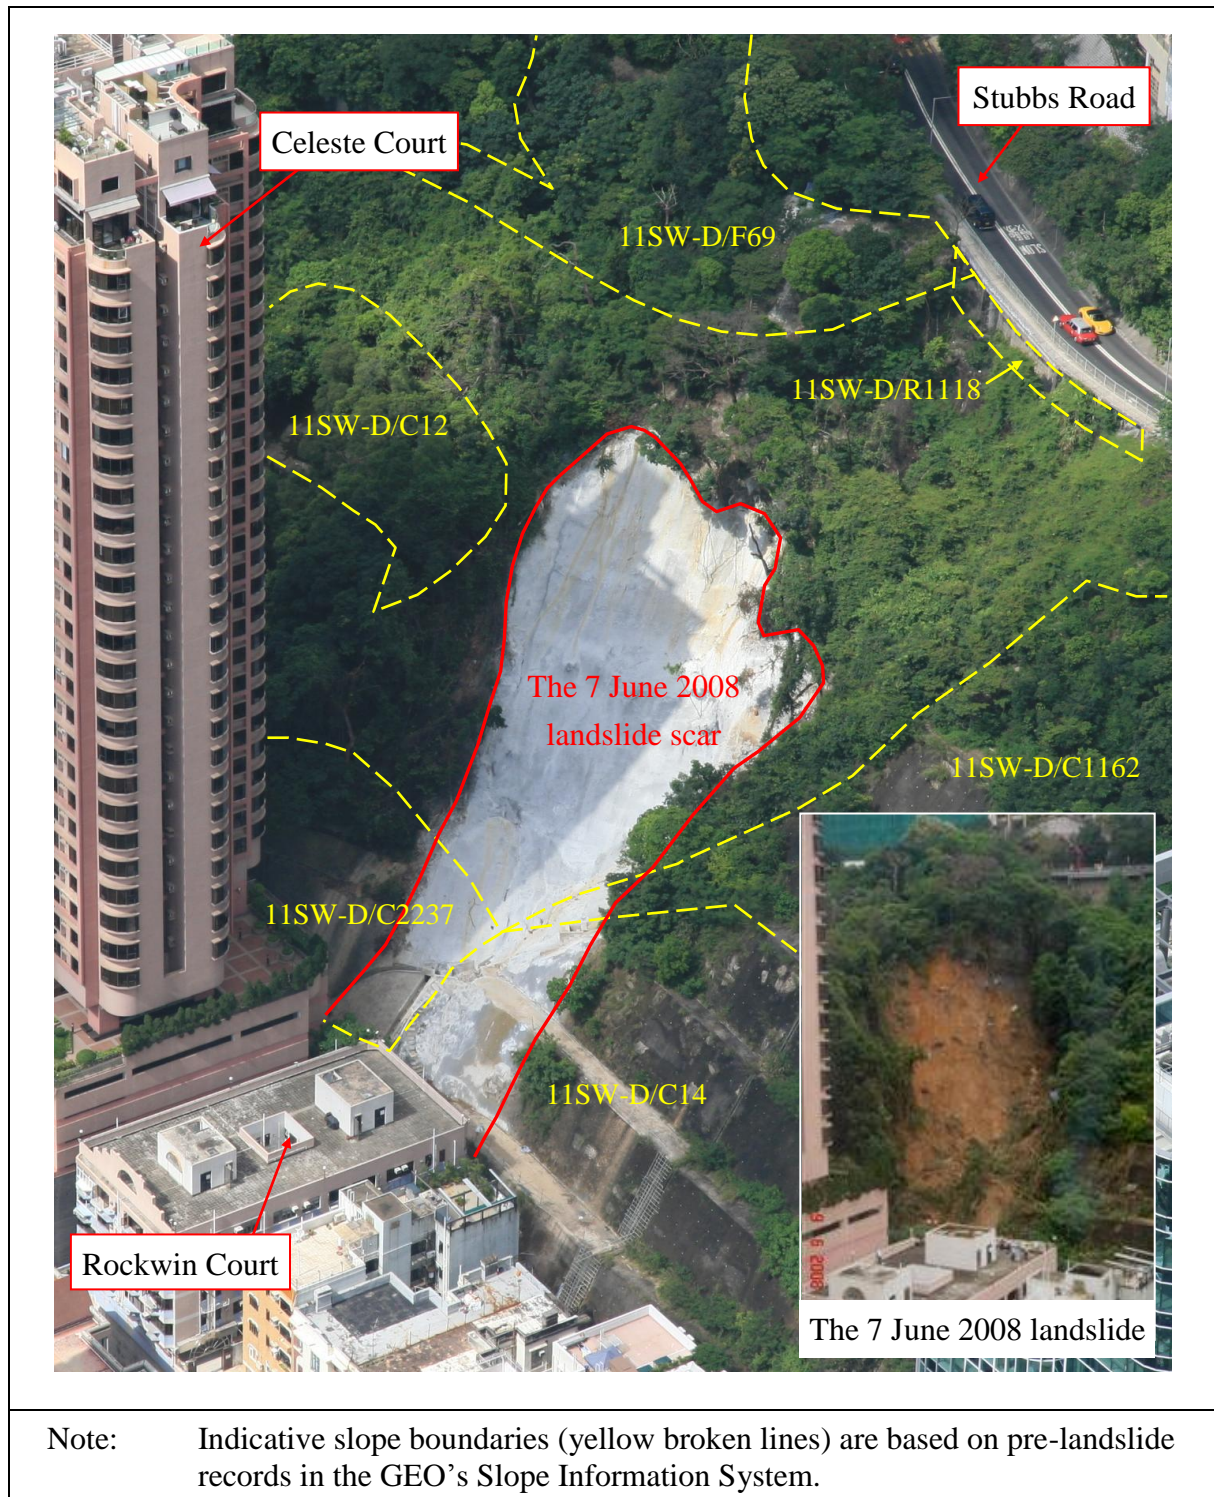
Figure 4.10 Overall Setting of the Hillside behind Rockwin Court, Fung Fai Terrace

Rockwin Court were temporarily evacuated. The incident did not result in any casualties. The concerned hillside, which is situated below Stubbs Road overlooking Rockwin Court (Figure 4.10), is steeply inclined at about 40° and densely vegetated. The hillside catchment is a relatively small catchment with a plan area of about $1,100 \text{ m}^2$ and measures about 35 m wide and 30 m long. According to the GEO's Landslide Database and Enhanced Natural Terrain Landslide Inventory (ENTLI), there are no records of previous landslides on the concerned hillside.
