**Review of the  
7 June 2008 Landslide Cluster  
on the Natural Hillside  
above Tai O San Tsuen,  
Tai O, Lantau Island**

**GEO Report No. 275**

**AECOM Asia Company Limited**

Agreement No. CE 41/2007 (GE)  
Study of Landslides Occurring in Kowloon  
and the New Territories in 2008 – 2009

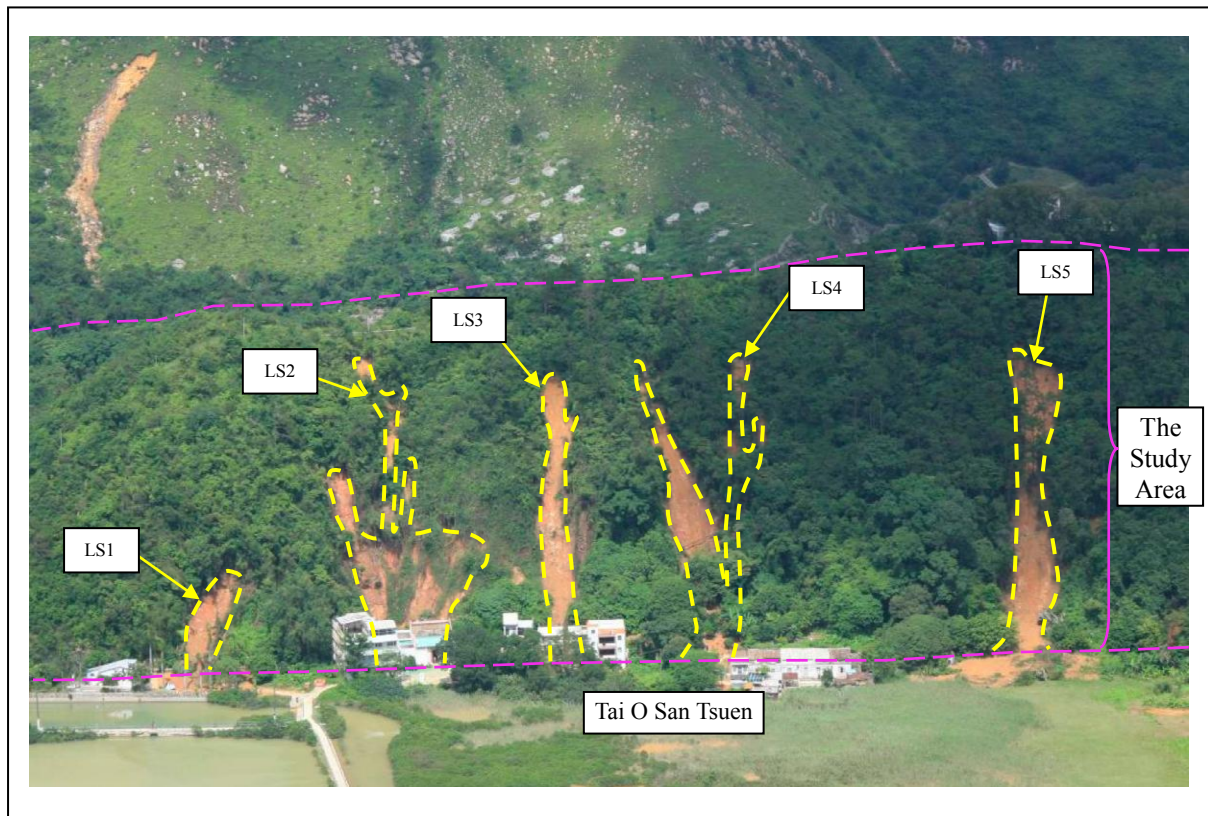
The 7 June 2008 landslides occurred on the west-facing hillside overlooking Tai O San Tsuen (Figure 2.1). The hillside is about 70 m high and 300 m long, and covered with dense bushes and mature trees. The hillside is relatively steep with an average slope angle of about 45° and increasing locally to over 75°, where rock outcrops are present, and decreases to about 30° in the upper hillside. There are no observable drainage lines in the hillside within the study area.

**Figure 2.1 General View of the 7 June 2008 Landslides from Helifight  
(Photograph Taken in June 2008)**

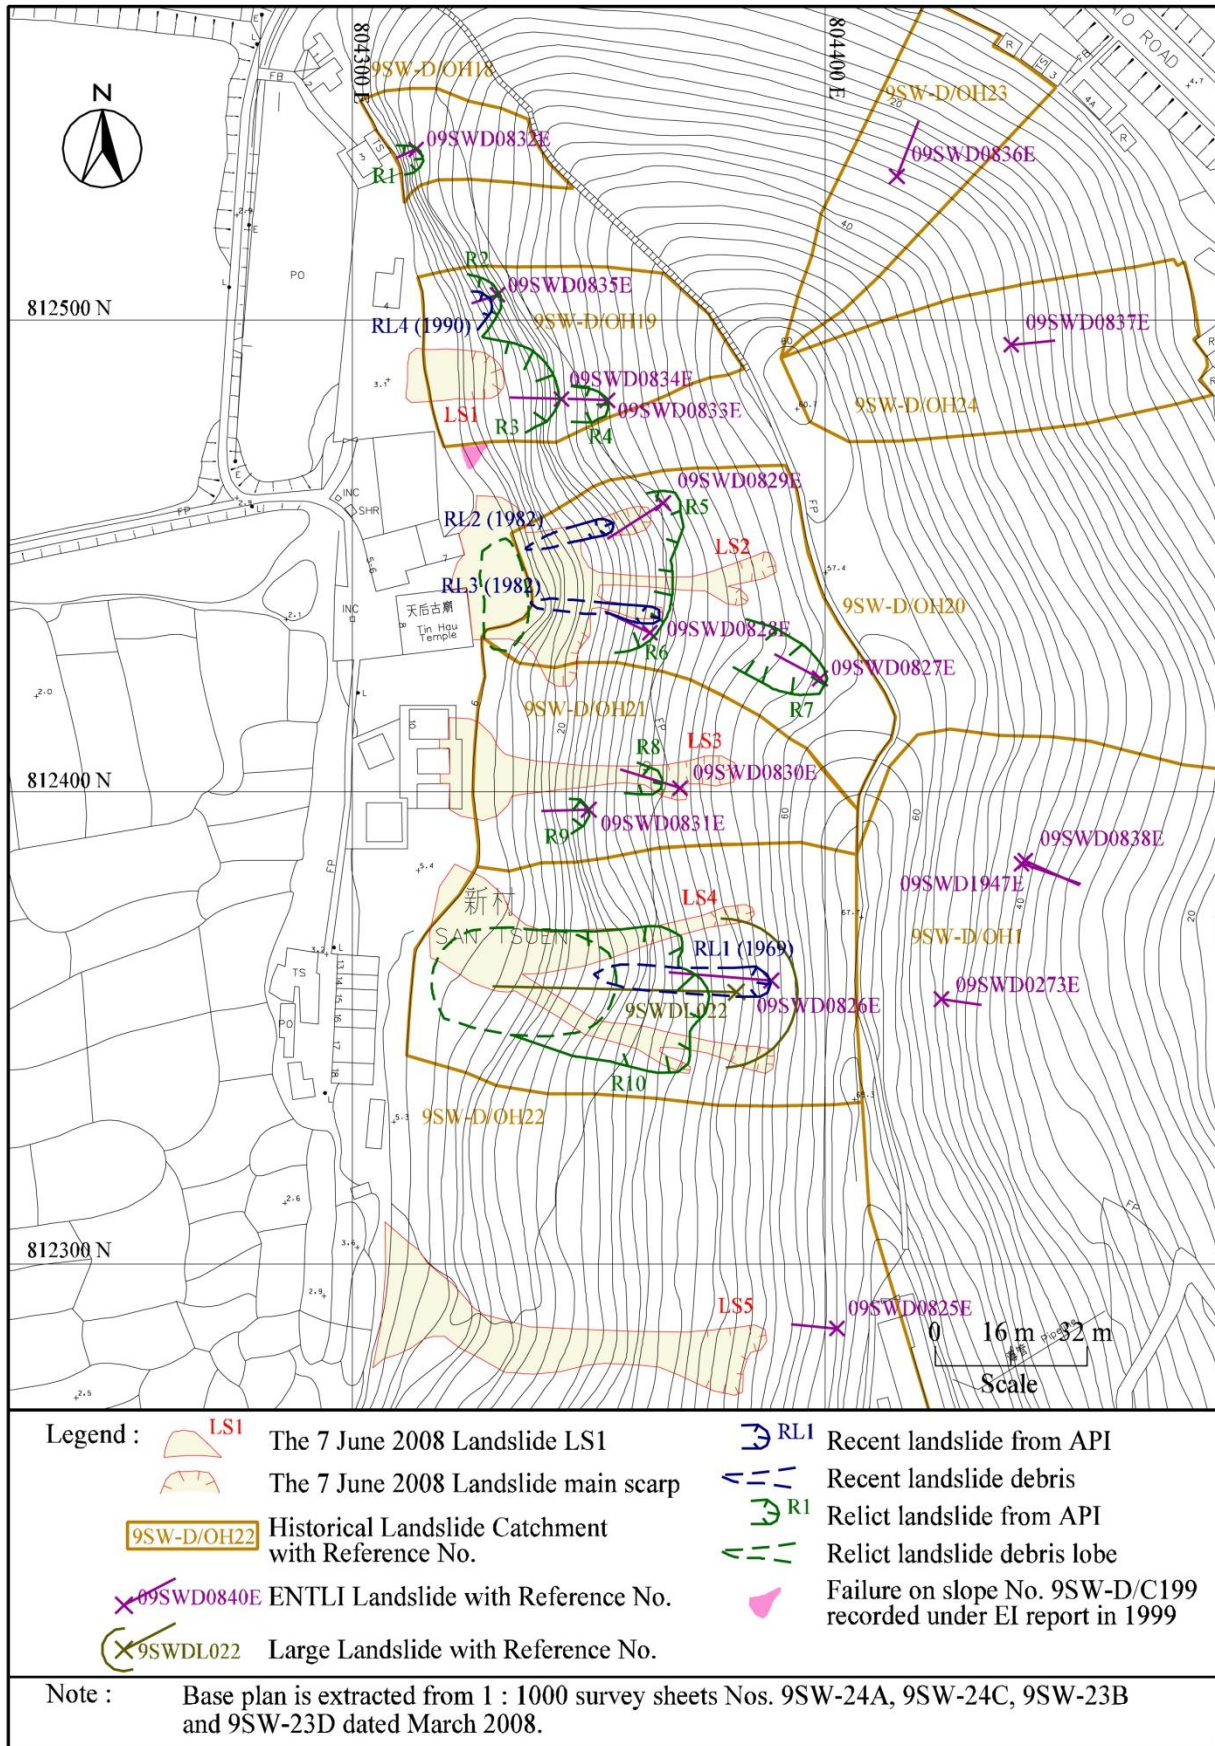
### Figure 4.2 Past Instabilities

The study area has a history of landslides. In the 1963 aerial photographs, ten relict landslides (namely R1 to R10) are identified (Figure 4.2). Between 1963 and 1969, a possible area of local instability or an excavation was observed near the toe of landslide LS2 (Figure 4.1). Between 1969 and 1990, four recent landslides (namely RL1 to RL4) are visible within the study area (Figure 4.2). According to the GEO's Large Landslide database (Scott Wilson, 1999), there is one large landslide in the vicinity of landslide No. LS4 (Figure 4.2).

The previous landslides recorded within the study area are predominantly open hillslope landslides, many of which are located at or close to the 7 June 2008 landslides (Figure 4.2). The scale of previous landslides is similar to that of the 7 June 2008 landslides, typically at about 50 m<sup>3</sup> to 150 m<sup>3</sup>.

In 1999, Engineer Inspection identified a minor failure with an estimated failure volume less than 50 m<sup>3</sup> at slope No. 9SW-D/C199 (Figure 4.2 & Appendix B). The failure was probably due to erosion, and was located about 10 m south to landslide No. LS1.

Except for landslide No. LS5, the June 2008 failures are all located within Historical Landslide Catchments (Figure 4.2).

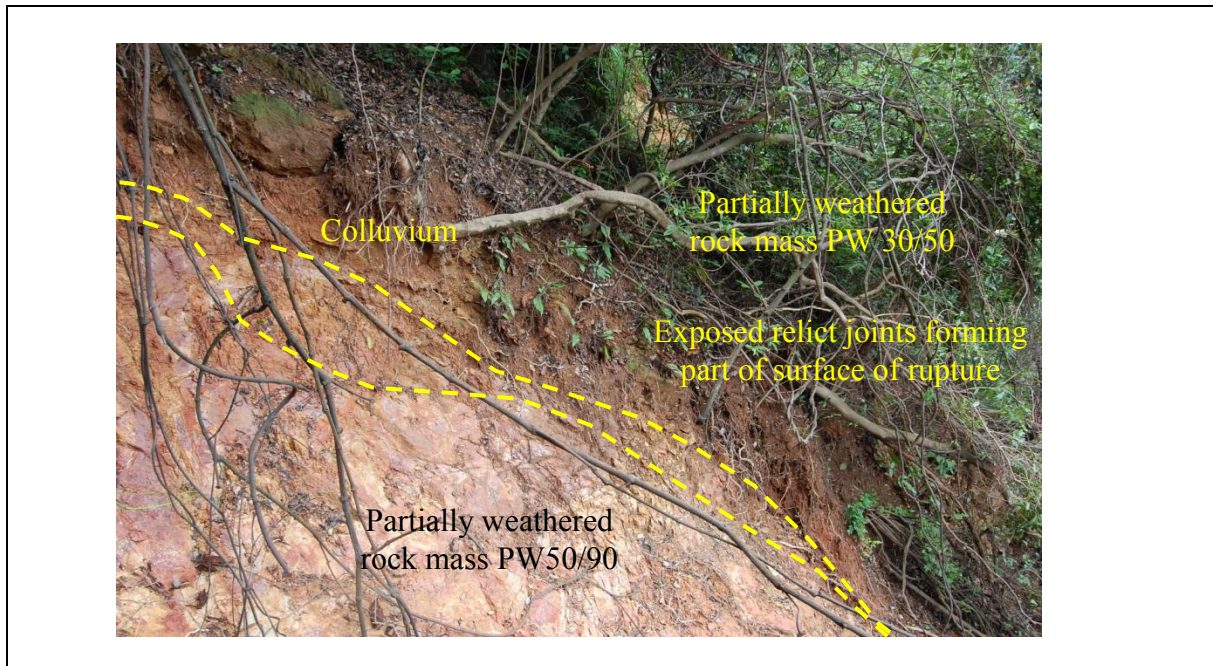
The material exposed on the surface of rupture typically comprised partially weathered rock mass (PW30/50 to 90/100) with a thin layer of colluvium (Figures 5.3, 5.4 & 5.5). The weathered rock mass is generally dilated with some open and sediment infilled joints as observed at some source areas (Figure 6.2). The orientation of the joints was generally not adverse. However, a joint set striking sub-parallel out of the slope was observed at the basal rupture surface of landslide No. LS3 (Figure 5.6).

**Figure 5.3 View of the Southern Flank at Source Area LS2e (Colluvium Overlying Partially Weathered Rock Mass) (Photograph Taken on 19 June 2008)**

The basal rupture surface at source area LS2e comprised patches of moderately decomposed tuff with the remainder being completely decomposed tuff (partially weathered rock mass PW 30/50 and 50/90). The flanks and main scarp consisted of approximately 0.5 m of PW 30/50 and about 1 m of colluvium.

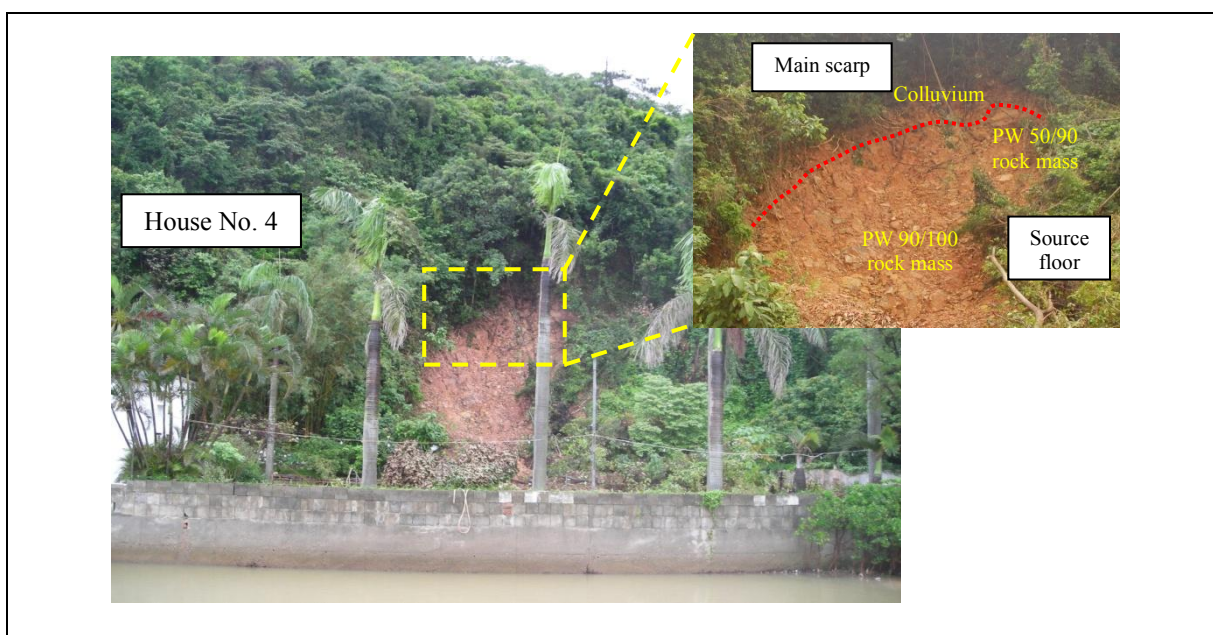
**Figure 5.4 View of Landslide No. LS1 (Photograph Taken on 13 June 2008)**

No distress was observed in the flanks or above the main scarp of the landslide, although access was limited above the main scarp due to the very steep terrain. With a travel distance of 21 m, debris was confined to the garden and open area around one of the village houses at the toe of the hillside (Figure 5.4).

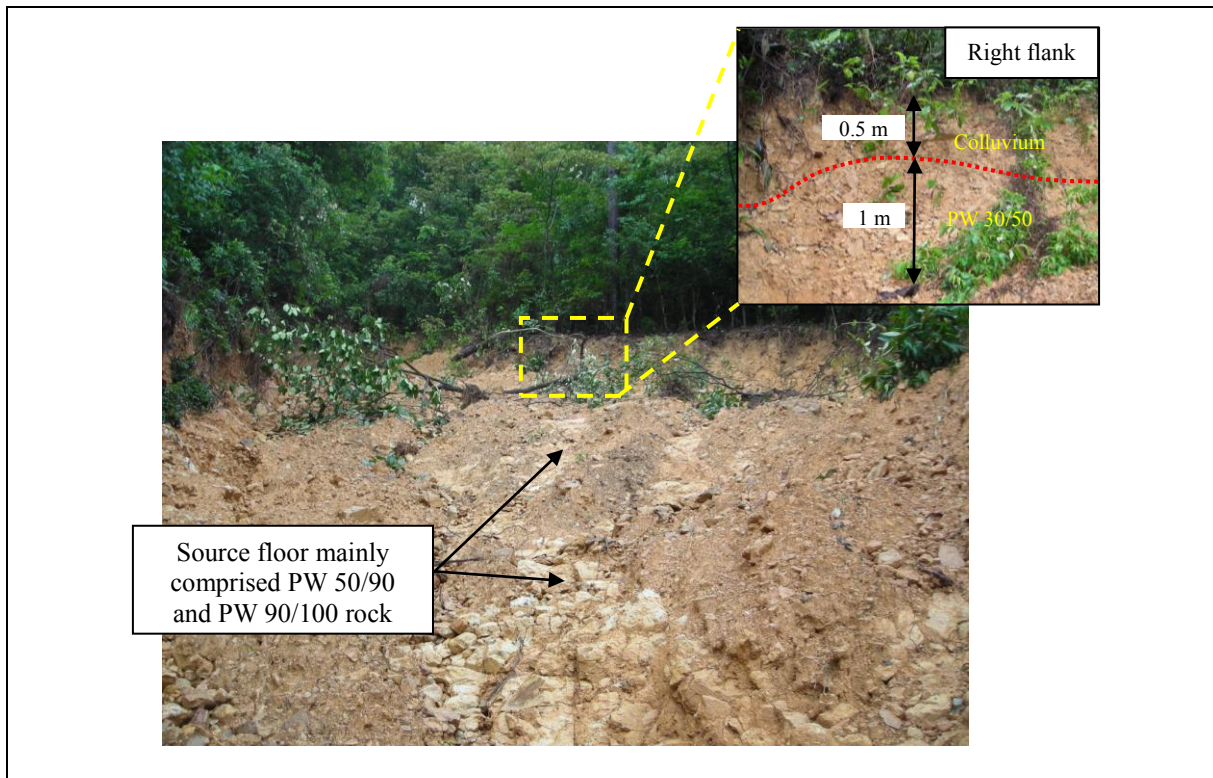
**Figure 5.5 View of the Source Area of Landslide No. LS5 (Photograph Taken on 13 June 2008)**

This landslide is an open hillside failure and at an elevation of about 16 mPD, is the lowest landslide inspected (Figure 5.5). The dimensions of the landslide source are about 12 m long, 10 m wide and 1.5 m deep. The rupture surface is steep (approximately 50°) and is mostly within partially weathered rock mass (PW 90/100). The main scarp consists of some partially weathered rock mass (PW 50/90) with a thin layer of colluvium. Rock was exposed above the main scarp for a distance of between 5 m and 10 m uphill (Figure 5.1). The rock is typically closely jointed and dilated due to stress relief.

The basal rupture surface comprised partially weathered rock mass (PW 30/50 and PW 50/90) with some highly decomposed tuff patches and local debris deposits. The main scarp and flanks comprised PW 30/50 and colluvium of about 0.5 m thickness respectively (Figure 5.5).

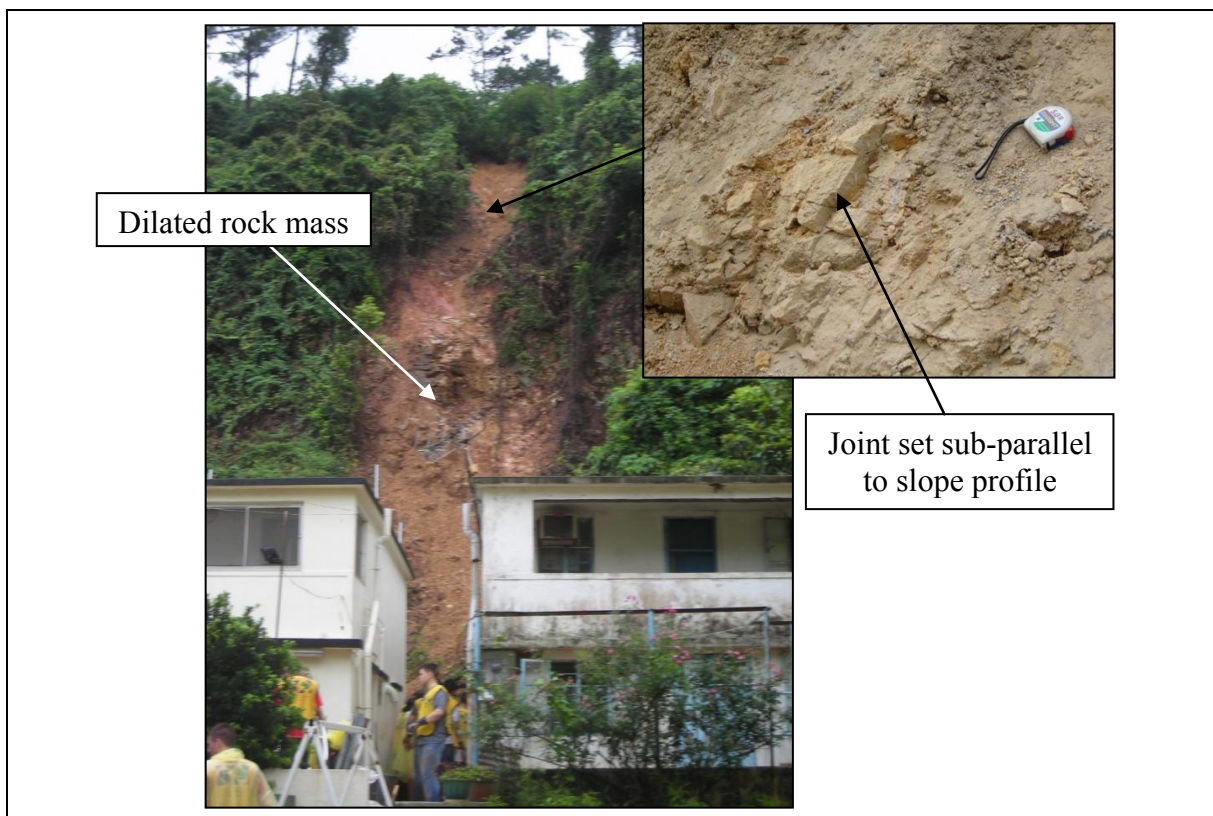
**Figure 5.6 General View of Landslide No. LS3 (Photograph Taken on 13 June 2008)**

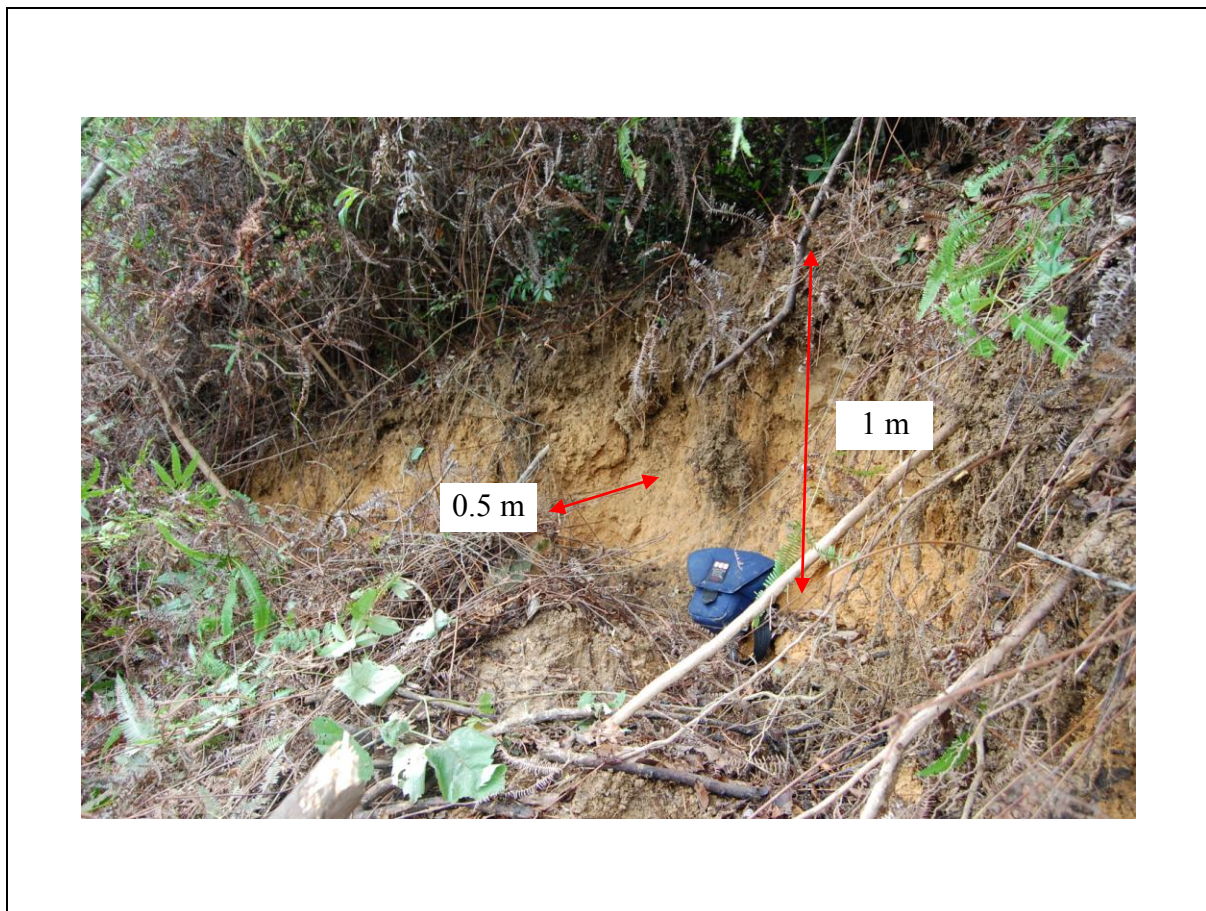
Several tension cracks were observed adjacent to the source areas of landslides Nos. LS2 to LS5 (Figures 2.2, 5.7, 5.8 & 5.9). These cracks were up to about 5 m long with a vertical displacement of 0.5 m and probably extended into the weathered rock mass. The presence of tension cracks, together with the open joints in weathered rock mass, suggests that the hillside may have been undergoing deterioration.

**Figure 5.7 Tension Crack on North Flank of Main Scarp of Source Area LS2a  
(Photograph Taken on 19 June 2008)**

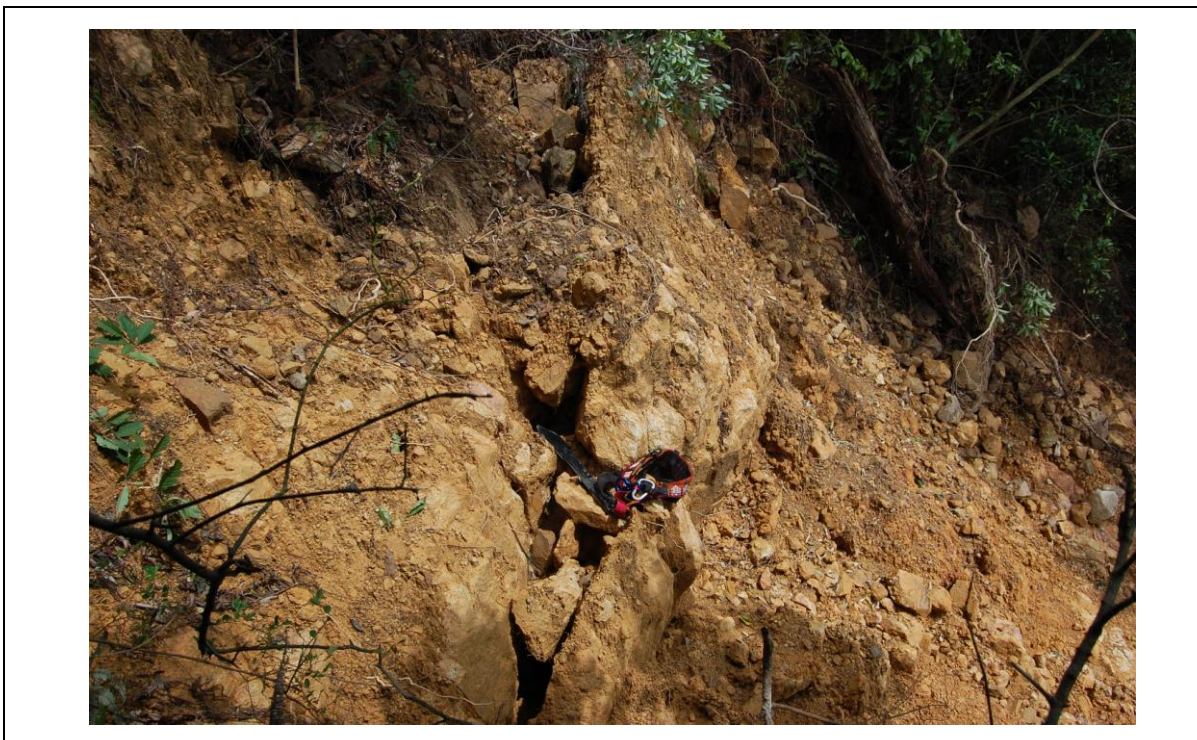
**Figure 5.8** Tension Crack within Source Area LS4b (Photograph Taken on 19 June 2008)

The basal rupture surface comprised partially weathered rock mass (PW 30/50 to 50/90), highly decomposed tuff and patches of debris. The main scarp and flanks comprised PW 30/50 material and colluvium about 0.5 m thick (Figures 5.8 & 6.5).

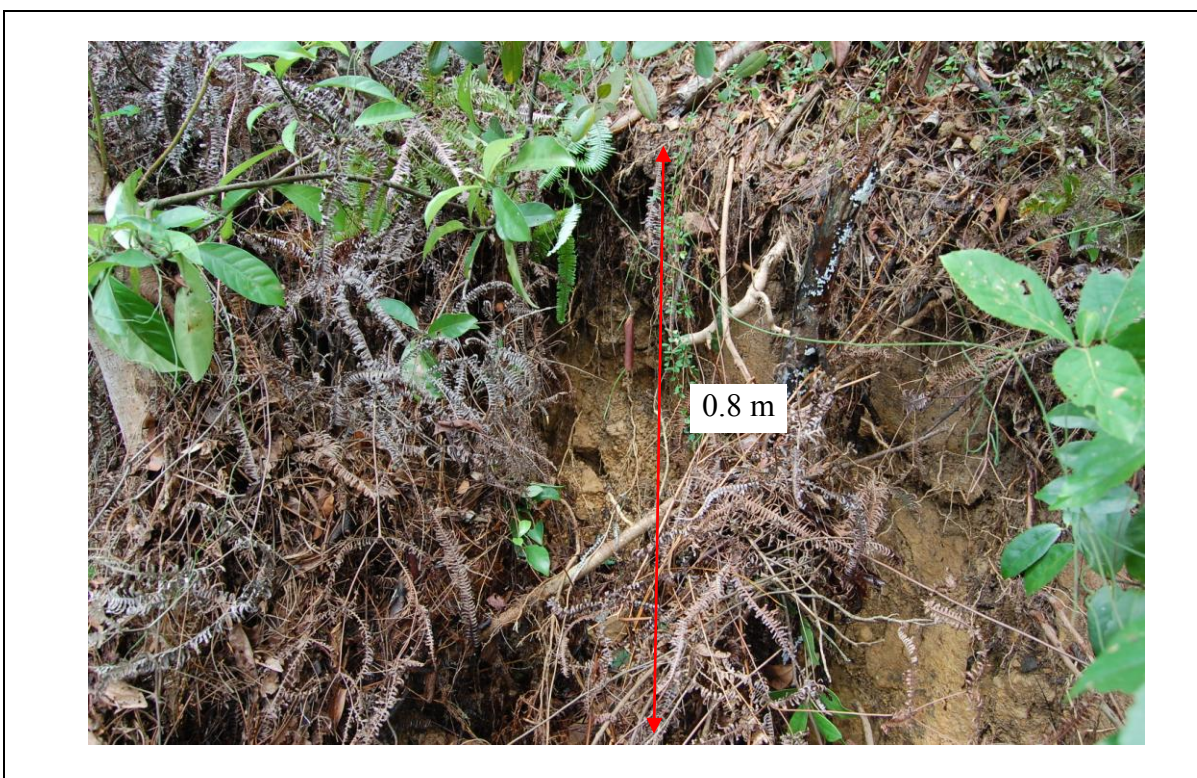
**Figure 5.9** Tension Crack above Main Scarp at Source Area LS4b (Photograph Taken on 19 June 2008)

The basal rupture surface at source area LS4a comprised highly decomposed tuff, partially weathered rock mass (PW 30/50), with patches of deposited remoulded and intact debris. The main scarp and flanks comprised some partially weathered rock mass (PW 30/50) but mainly (75%) colluvium of about 1 to 1.5 m thickness. No significant distress was seen above or adjacent to the source area. A small tension crack approximately 1 m long was observed adjacent to the main scarp. Occasional over-steepened flanks that could detach a significant volume ( $> 10 \text{ m}^3$ ) of material were observed (Figure 5.9).

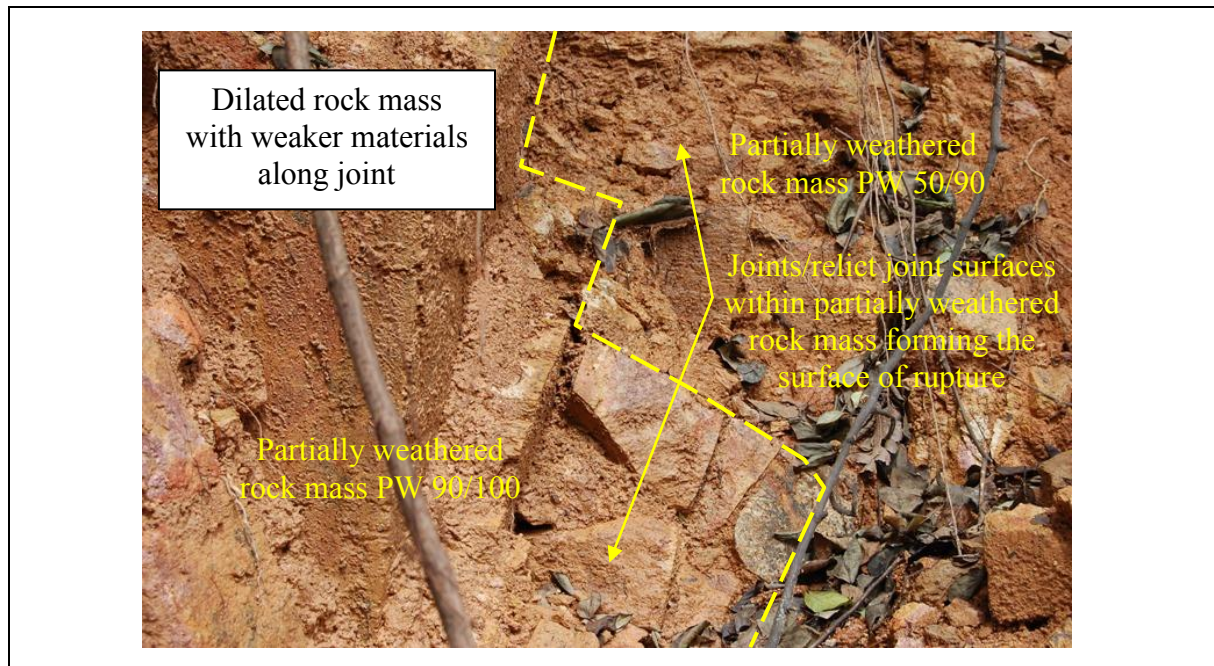
**Figure 6.2 Moderately Decomposed Tuff showing Dilation and Infills along Joint within the Source Area LS2c (Photograph Taken on 15 June 2008)**

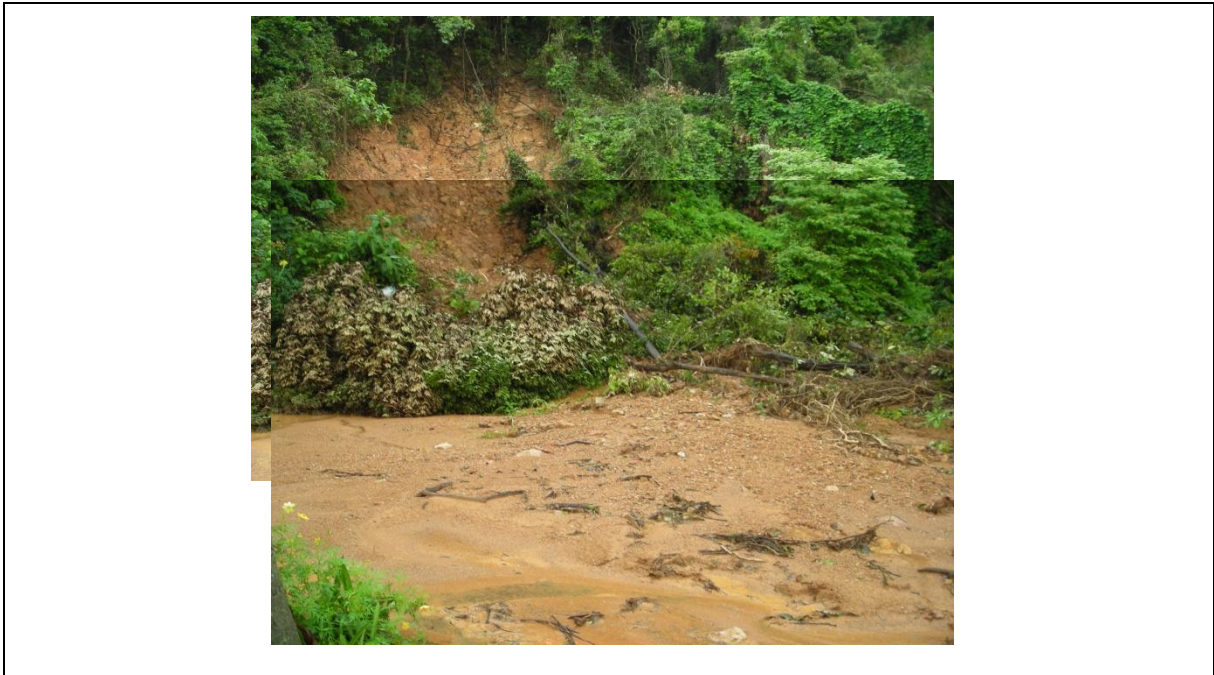
**Figure C1 View of the Debris of Landslide No. LS1 Confined to the Open Area/Garden adjacent to House No. 4 (Photograph Taken on 13 June 2008)**

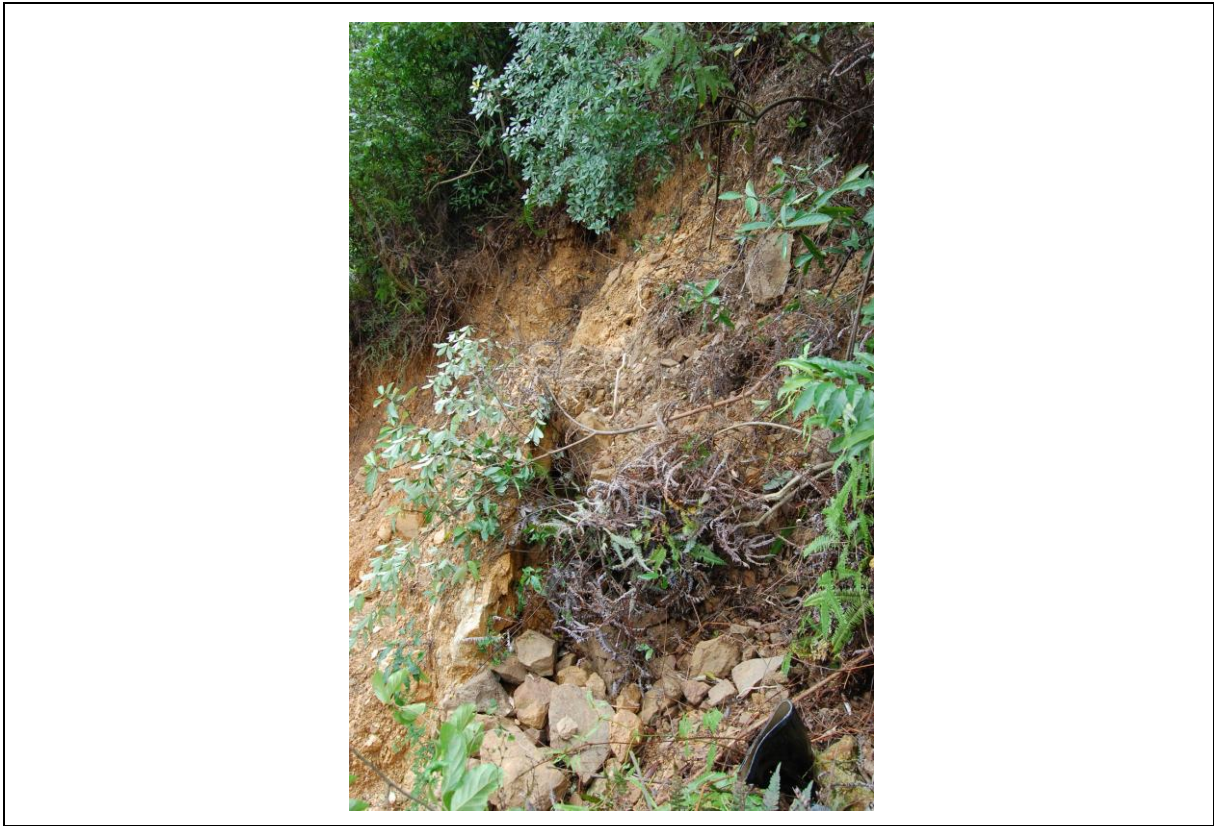
**Figure C2 Over-steepened Flank at Source Area LS4a (Photograph Taken on 19 June 2008)**
