**DETAILED STUDY OF THE  
7 JUNE 2008 LANDSLIDE ON  
THE NATURAL HILLSIDE  
BEHIND CHOW YEI CHING  
BUILDING AT THE  
UNIVERSITY OF HONG KONG,  
POK FU LAM**

**GEO REPORT No. 276**

**Maunsell Geotechnical Services Limited**

**GEOTECHNICAL ENGINEERING OFFICE  
CIVIL ENGINEERING AND DEVELOPMENT DEPARTMENT  
THE GOVERNMENT OF THE HONG KONG  
SPECIAL ADMINISTRATIVE REGION**

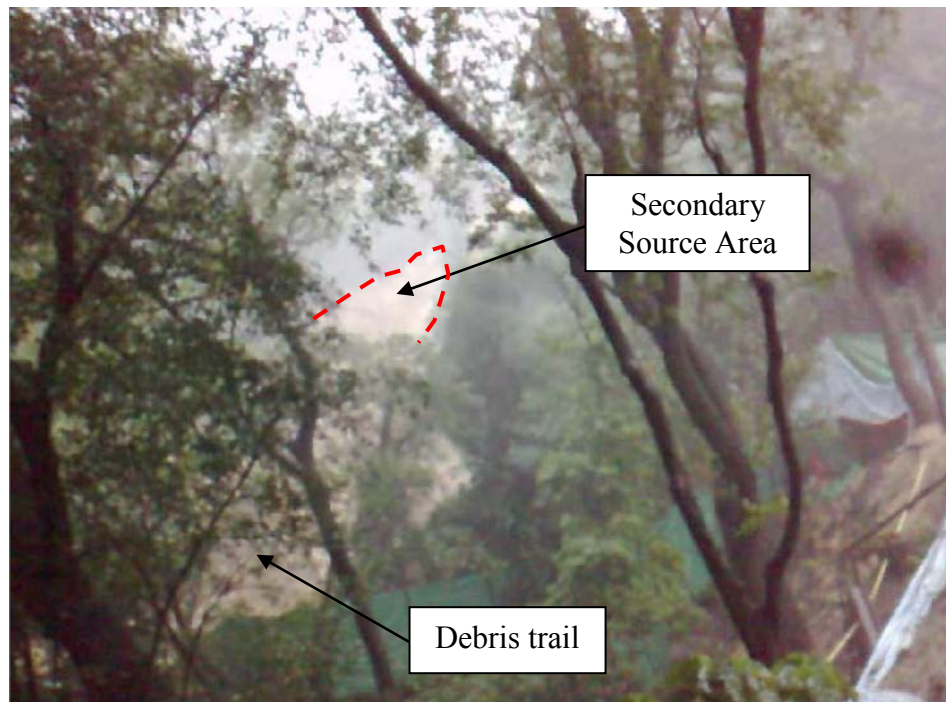
Plate 3 - View of the Secondary Source Area at about 8.42 a.m. on 7 June 2008  
(Image captured from video taken by a plant operator)

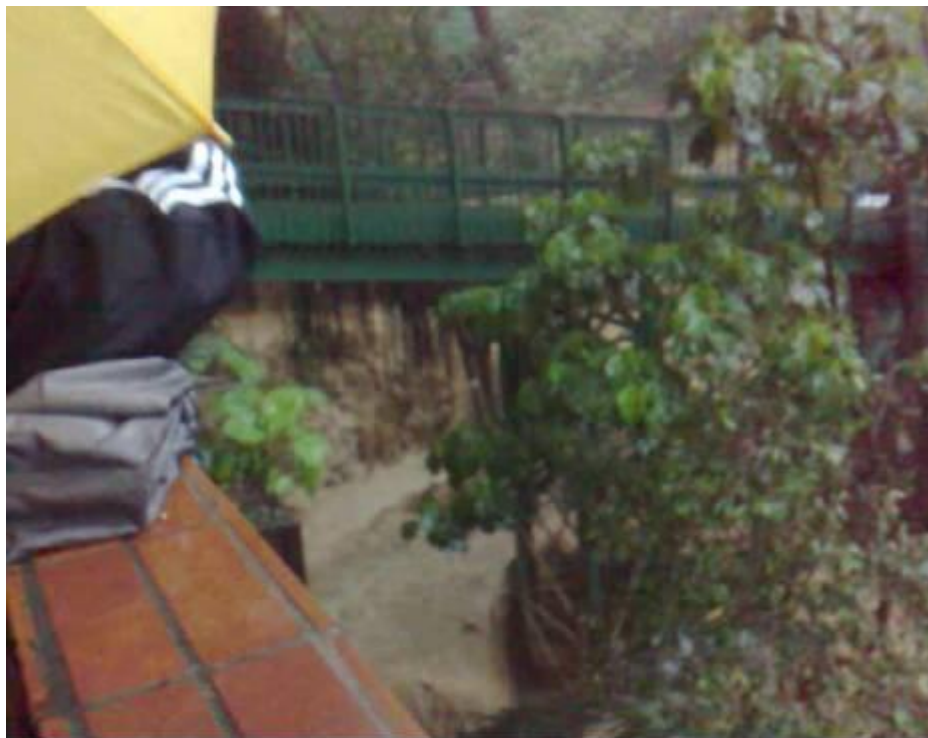
Plate 4 - View of the Temporary Steel Footbridge with Significant Muddy Water  
Running through it and Some Debris Piled behind it at about 8.42 a.m. on  
7 June 2008  
(Image captured from video taken by a plant operator)

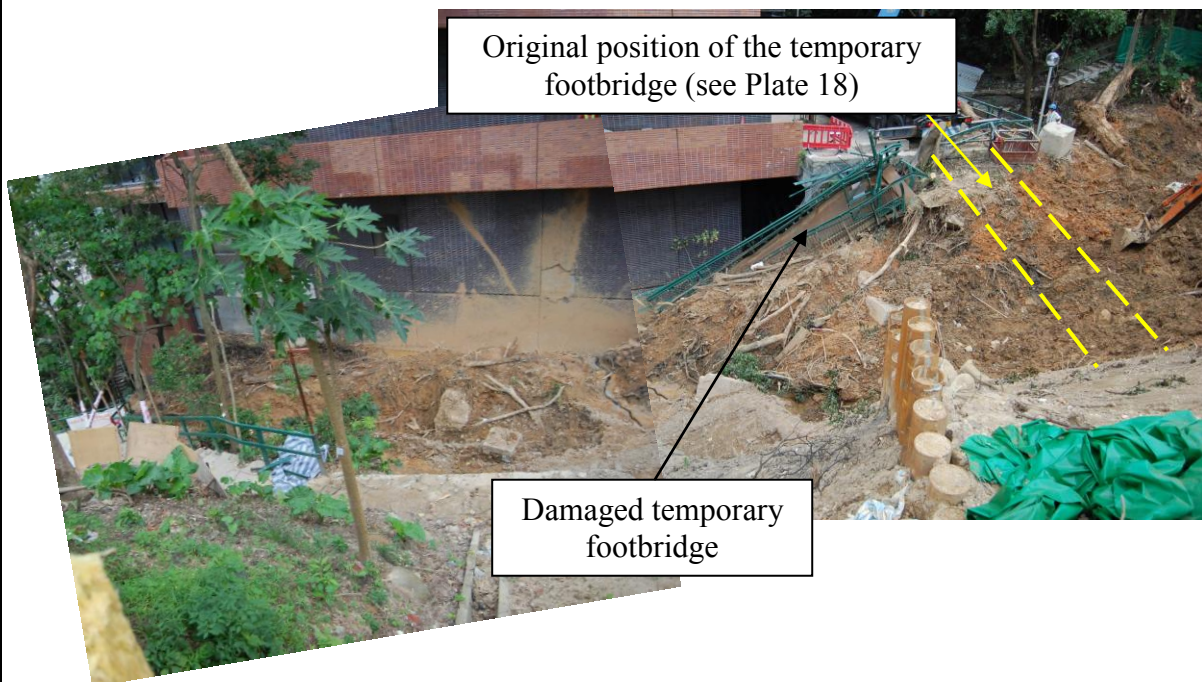
Plate 10 - Debris Accumulation at the Toe Area next to CYC Building  
(Photograph taken on 24 June 2008)

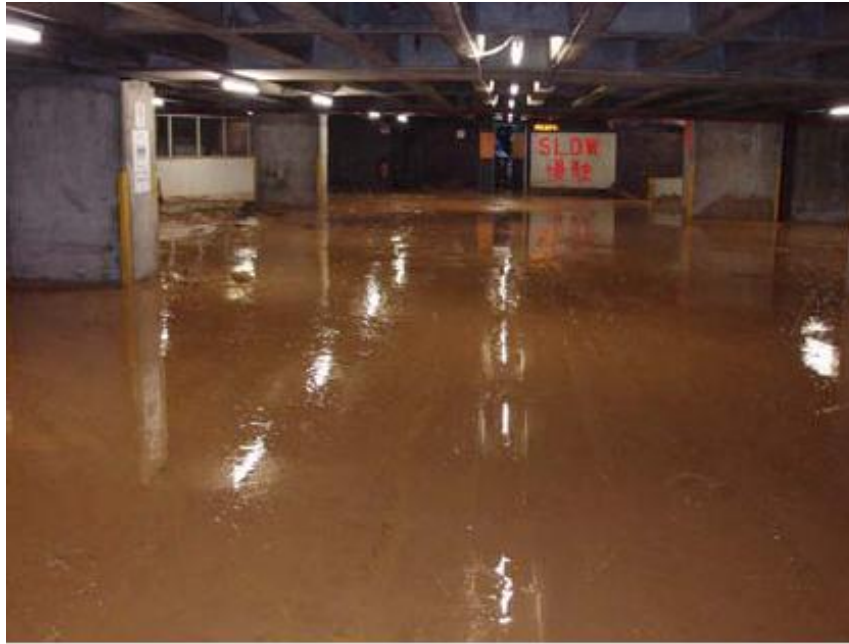
Plate 11 - Flooding of the Upper and Lower Carpark CP1 Level in CYC Building  
(Photograph taken on 8 June 2008 by HKU Estates Officer)

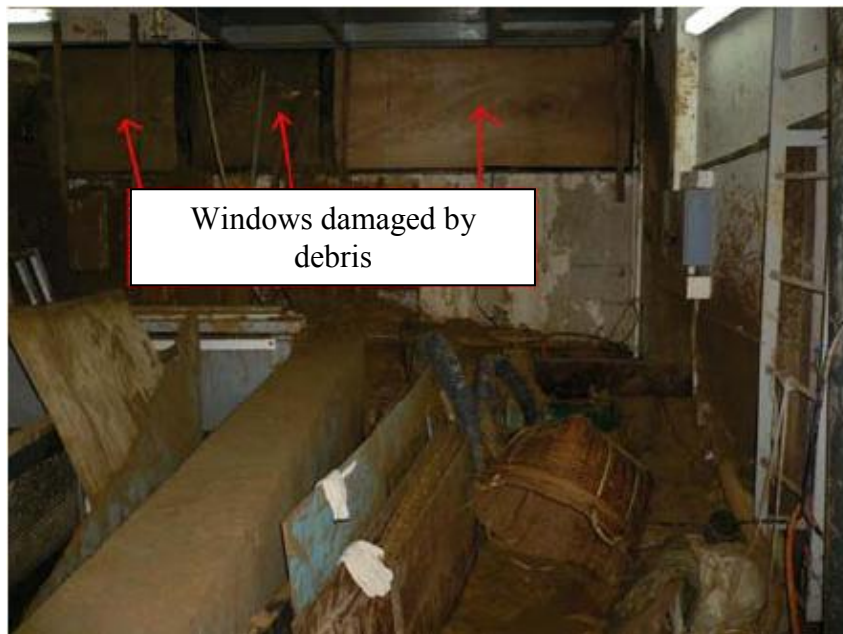
Plate 12 - Debris Flowed into LG3 of a Hydraulics Laboratory in CYC Building  
(Photograph taken on 8 June 2008 by HKU Estates Officer)

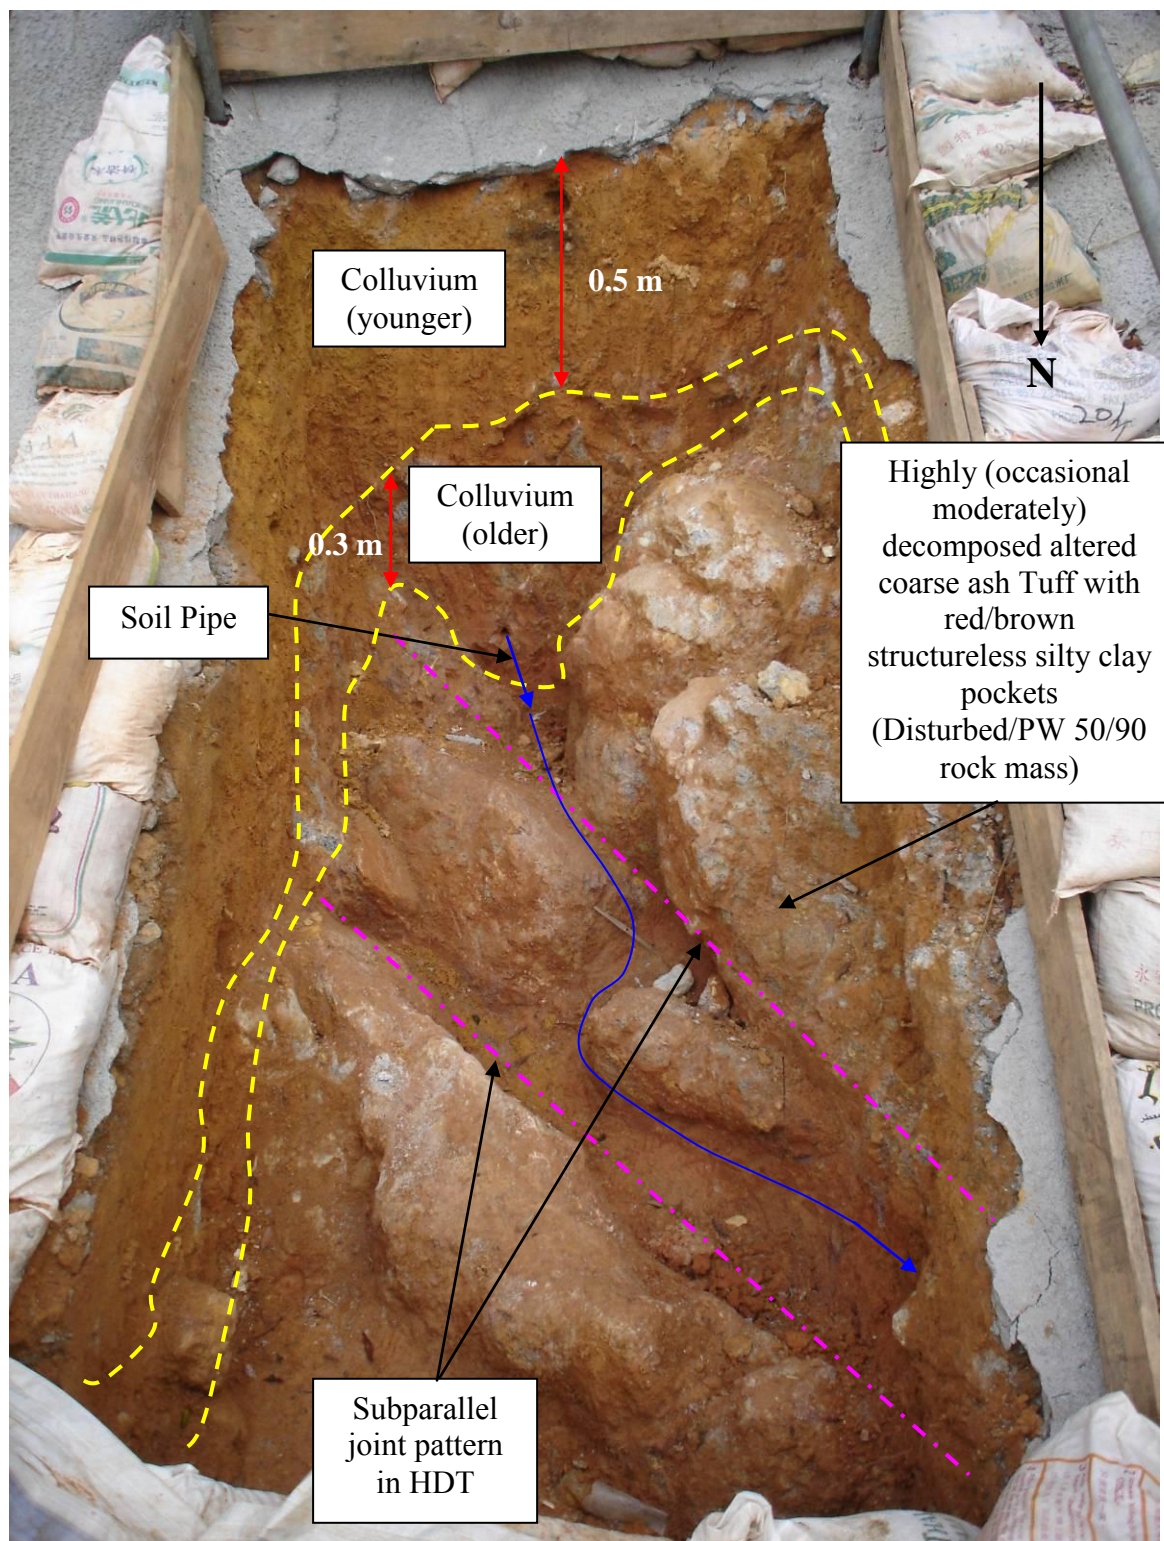
The observations made from the trial pits and trenches indicate that the surface of rupture was at or near to the interface of old colluvium and residual soil (RS) derived from tuff. The colluvium could be divided into at least two distinct layers representing differing ages and processes of deposition (Plate 13). The insitu weathered tuff varied from residual soil (with no relict structure or fabric) to partially weathered and rock mass with variable portions of highly to moderately decomposed cobble-sized tuff fragment (Plate 14).

Plate 14 - Trial Trench TTH1 Showing Two Layers of Colluvium Overlying HDT  
(Photograph taken on 10 October 2008)

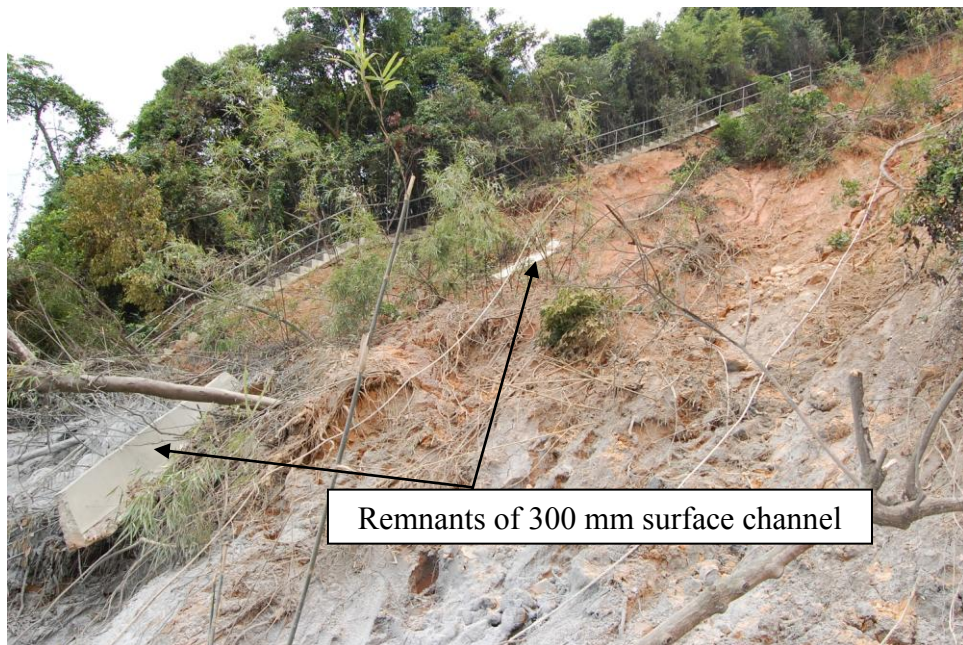
On the eastern flank of the debris trail, about 100 m<sup>3</sup> of remoulded debris has accumulated, straddling the footpath to over 2 m in height. In this vicinity, the remnants of a 300 mm surface channel (Figure 10 and Plate 15), which traversed part of the source area prior to failure, can be seen. A broken section of the 200 mm water main can be seen approximately 5 m below Pik Shan Path. A downhill gully has formed, possibly due to several hours of water discharge following the failure (Plate 16). Further down from the eastern part of the debris trail, where there is debris deposition adjacent to CYC Building, 3 erosion gullies (about 10 m wide and 1.5 m deep in total) were observed, exposing highly decomposed granite in the narrow base of the drainage line.

Plate 15 - Remnants of the 300 mm Surface Channel within the Lower Portion of the Primary Source Area  
(Photograph taken on 24 June 2008)

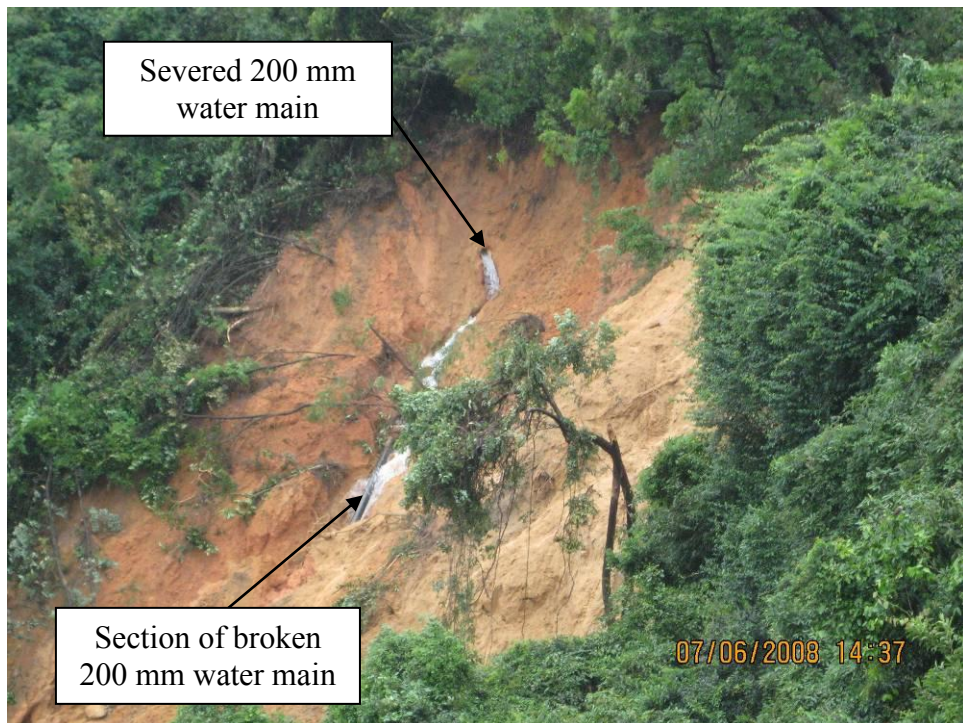
The severed fresh water pipe was discharging water onto the eastern part of the debris trail area just below Pik Shan Path for approximately 7 hours following the failure, enlarging a local scarp within the detached material which had accumulated from the primary source area (Section 4.4). Post-event erosion is apparent downhill due to the water discharge (Plates 8 & 9). An adjacent ductile iron 300 mm pressurised salt water main adjoining Pik Shan Path was not damaged.

Plate 16 - Close-up View of the Damaged 200 mm dia. Fresh Water Pipe below Pik Shan Path which was Displaced Downslope by Landslide Debris  
(Photograph taken on 7 June 2008 by BV)

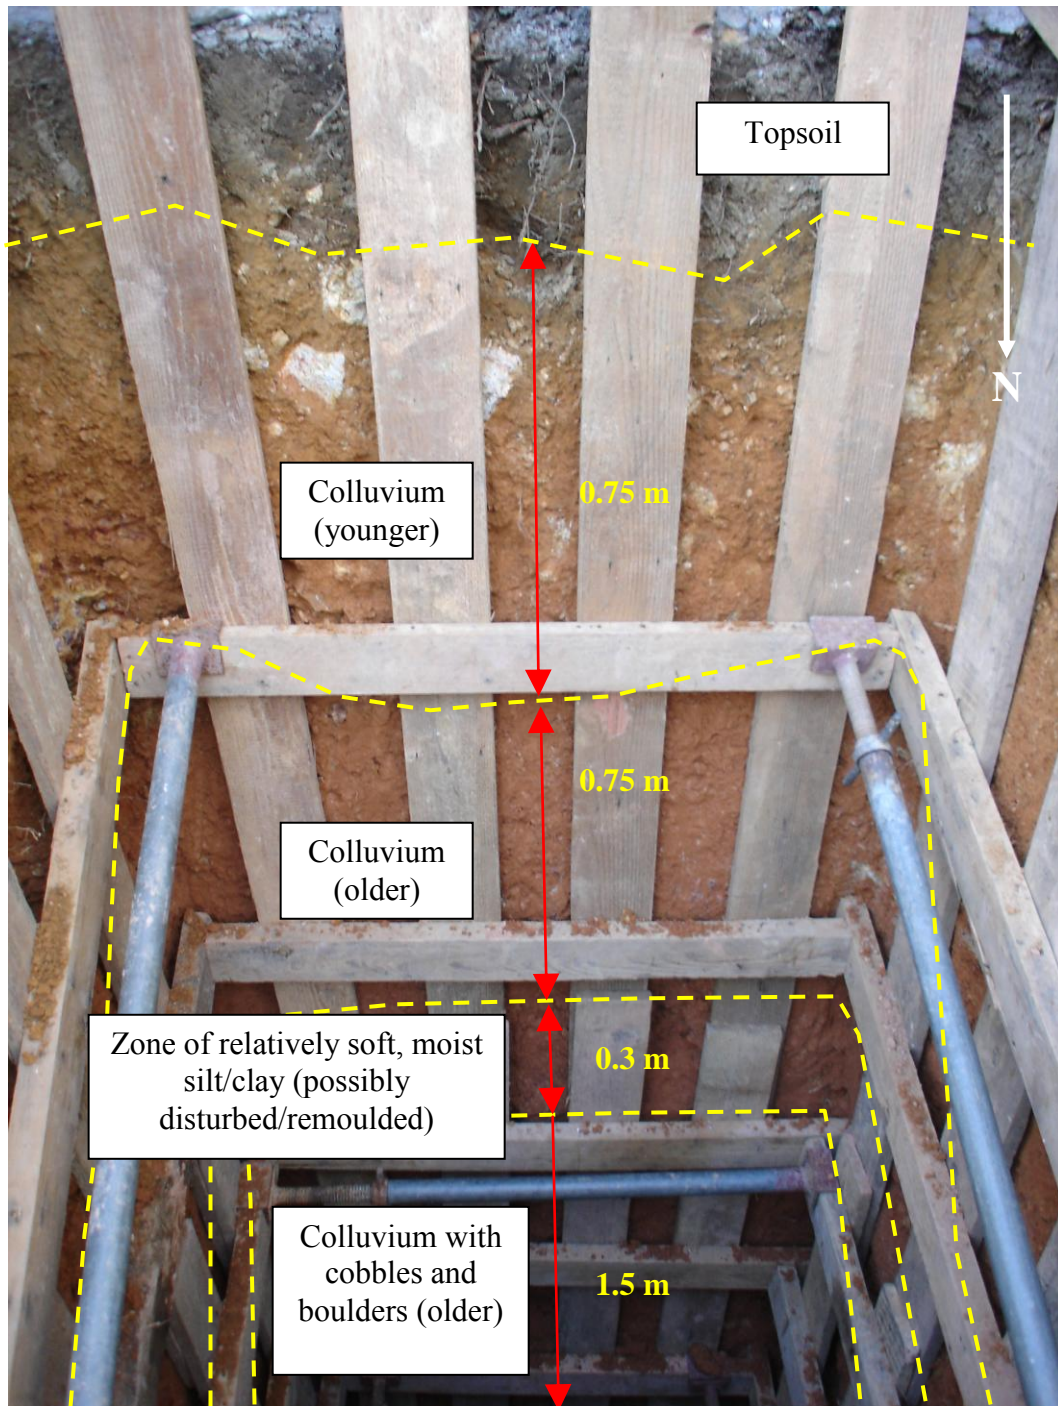
No discrete shear surfaces can be found from the GI. There are zones of wetted, clayey material at about 2 m depth within the old colluvium at some locations including trial pit Nos. TPH5 (Plate 19) and TPH7. The material in these zones appears 'remoulded' and may be associated with local deformation movement of the material above. Although apparently disturbed, no evidence of relative movement such as slickensides or smearing were observed in these zones. Further evidence of local progressive deformation of the old colluvium is given by the presence of relict tension cracks observed in trial pit TPH5 (Plate 20).

Plate 19 - Trial Pit TPH5 Showing a Zone of Softened, Silt/Clay within the Older Colluvium Layer  
(Photograph taken on 18 November 2008)

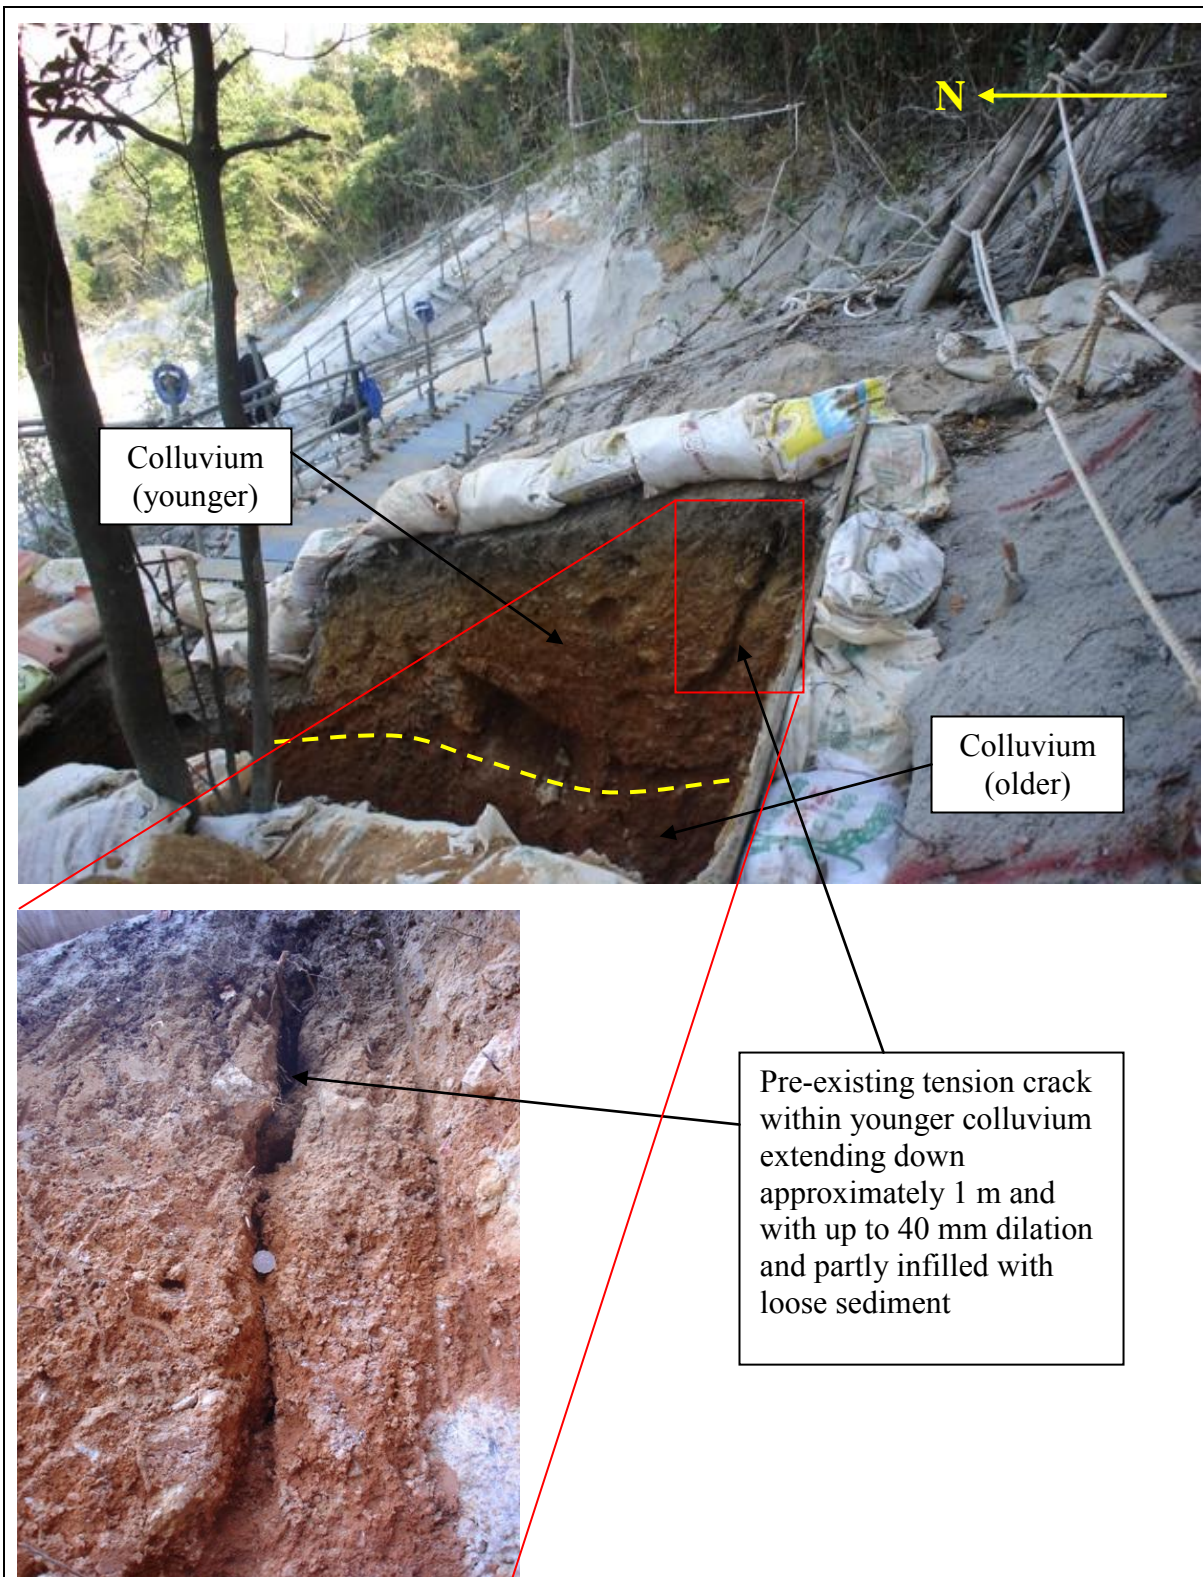
Plate 20 - Trial Pit TPH5 Just to the West of the Main Scarp, Looking East Showing a Tension Crack Exposed within Colluvium (Photograph taken on 3 December 2008)
