**DETAILED STUDY OF
THE 7 JUNE 2008
LANDSLIDE BEHIND
EWAN COURT,
KENNEDY ROAD,
WANCHAI**

GEO REPORT No. 278

Fugro Scott Wilson Joint Venture

**This report is largely based on GEO Landslide Study Report
No. LSR 8/2009 produced in September 2009**

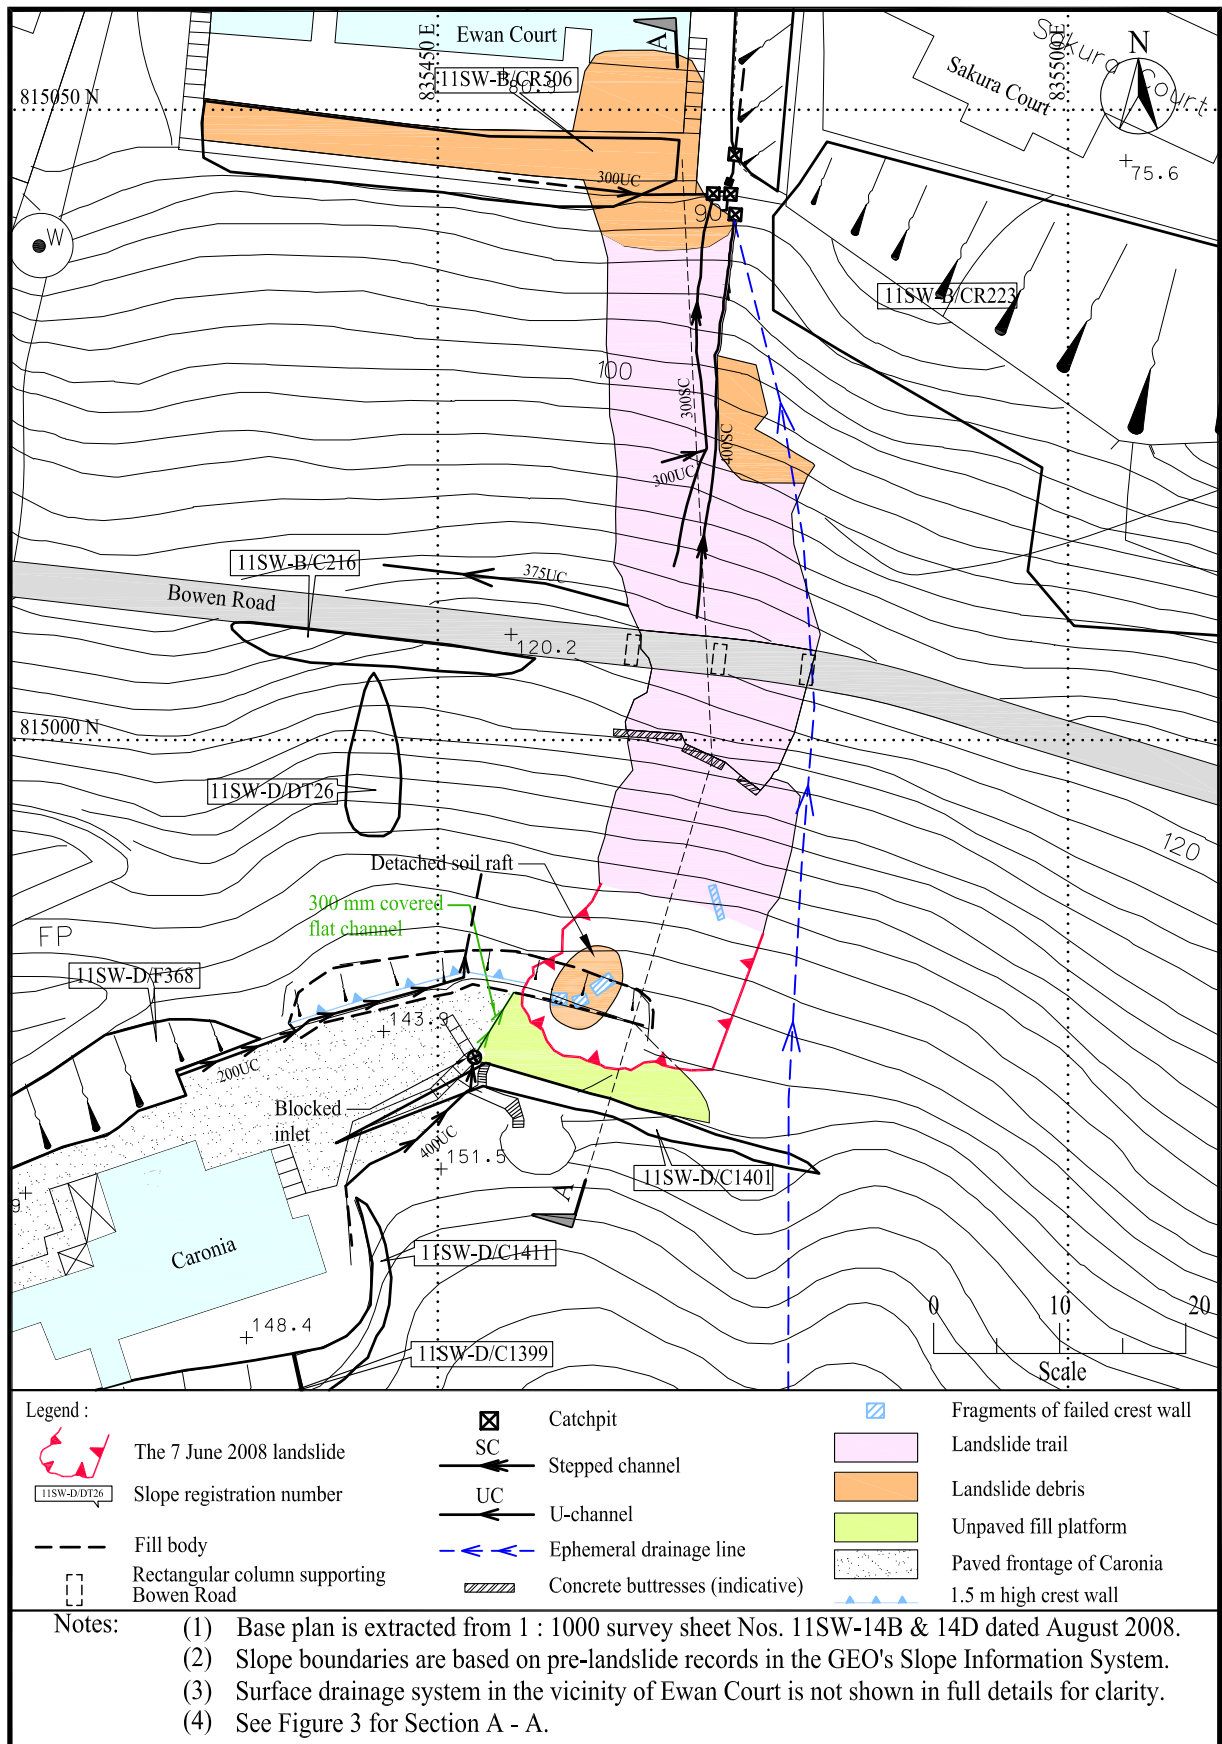
Figure 2 - Site Layout Plan and Field Observations

The landslide, with a failure volume of about 200 m³ occurred between 7:00 a.m. and 7:30 a.m. on 7 June 2008. The source area of the landslide measured about 15 m wide by 20 m long, with an average depth of about 1.5 m. The landslide mainly involved the natural hillside above Bowen Road and a portion of an unpaved fill platform at its crest (Figure 2).

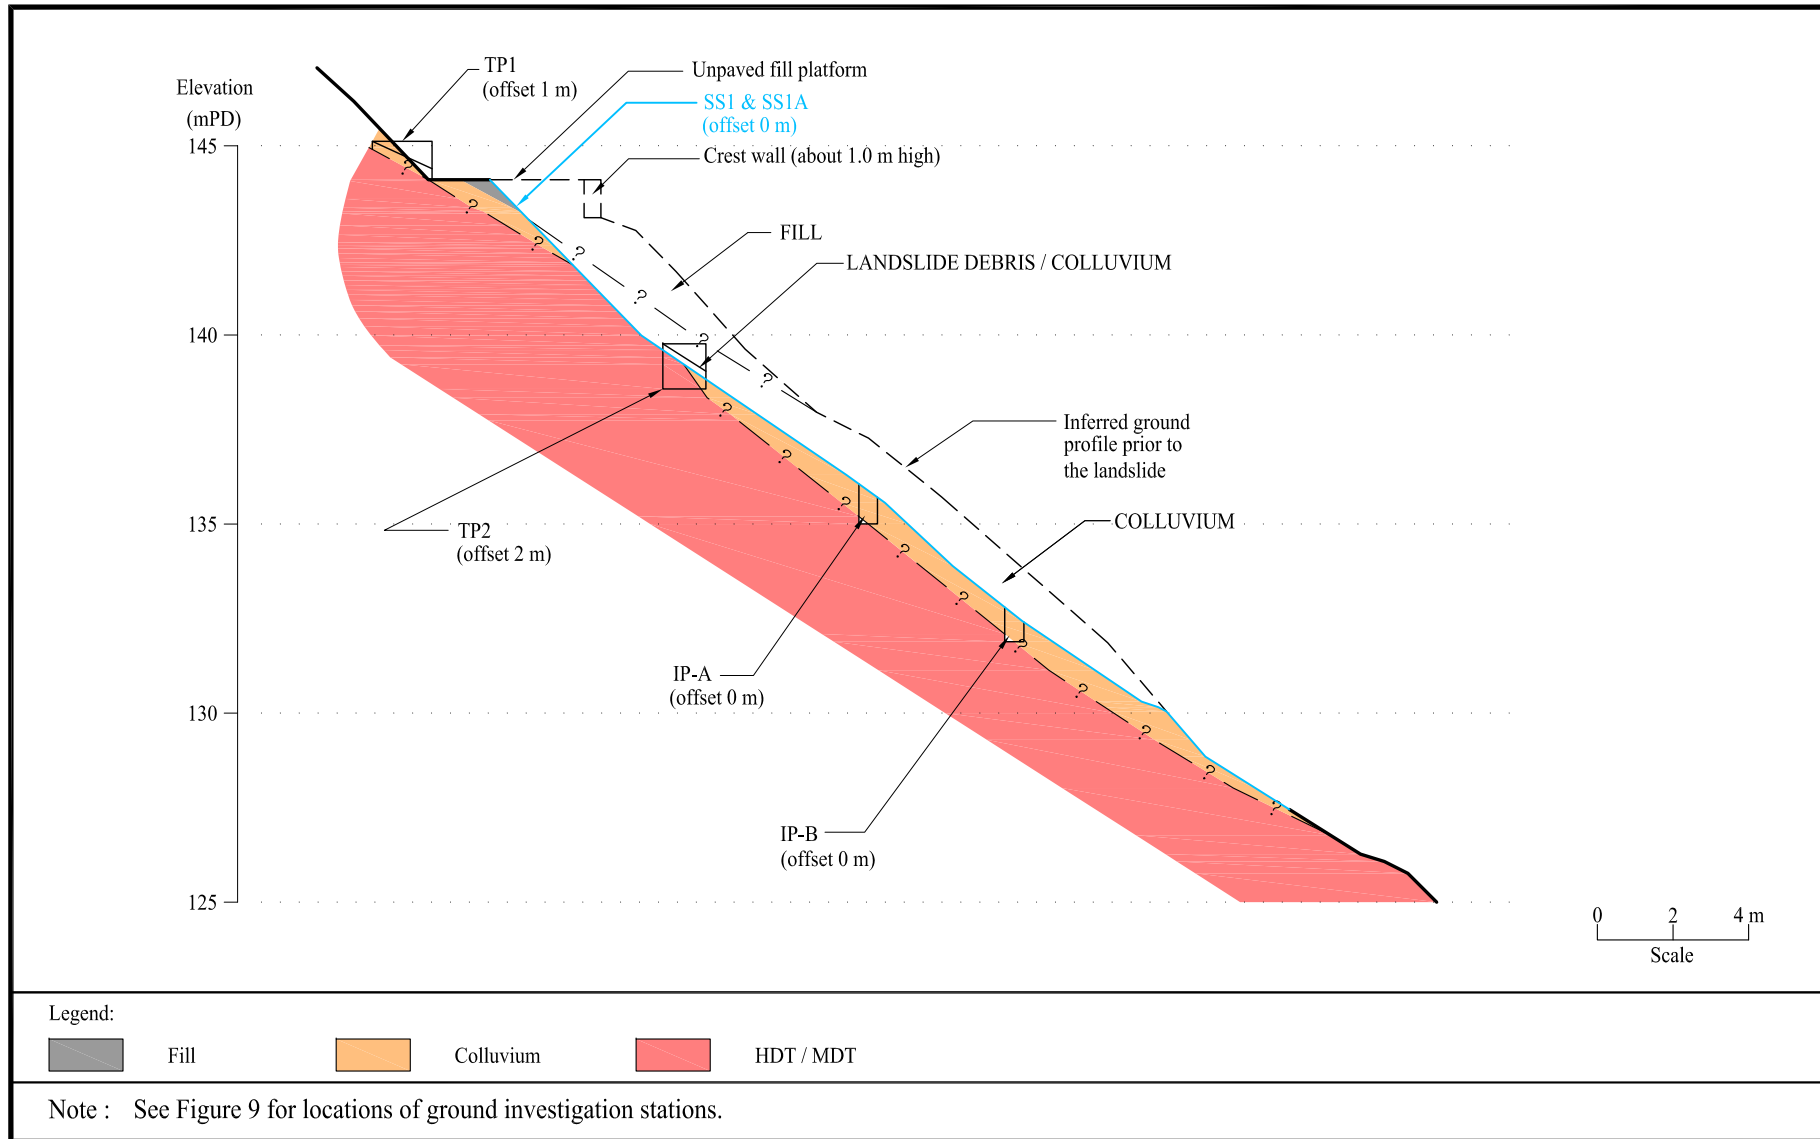
Figure 4 - Geological Section of the Source Area of the Landslide

Within the landslide scar, trial pits and surface strips revealed that the rupture surface of the 7 June 2008 landslide was largely within the colluvium or HDT, with the upper 2 m of the rupture surface through the fill body of the unpaved platform (Figure 4). The post-failure GI did not encounter any adverse relict joints in H/MDT, nor any weak geological features in the near-surface groundmass. No seepage was observed on the landslide scar.

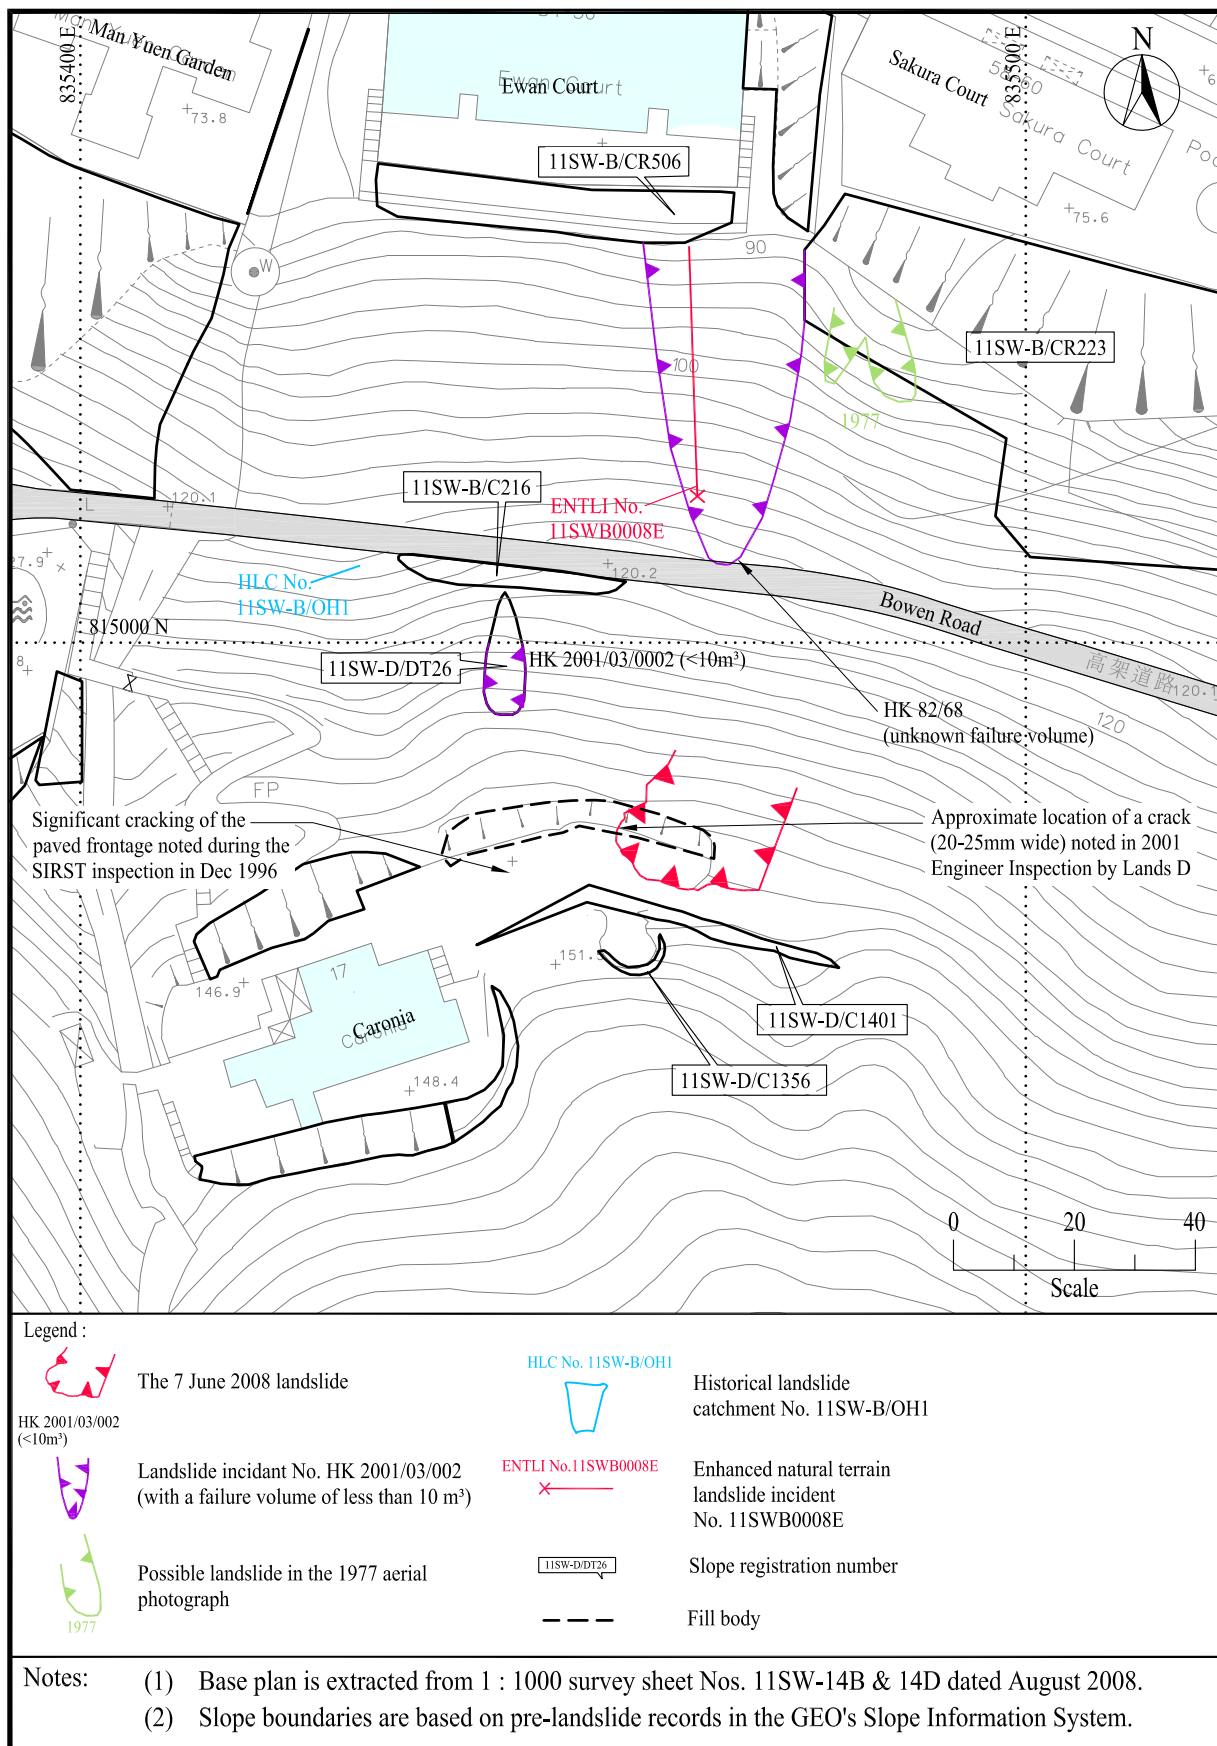
Figure 6 - Past Instability and Signs of Distress

On 29 May 1982, a landslide (Incident No. HK82/68), with no record on the failure volume, occurred on the natural hillside below Bowen Road (Figure 6). The landslide debris had a runout distance of about 40 m, reaching the rear alleyway of Ewan Court and blocking the access ramp to the carpark area. The 1982 landslide is also registered in the Enhanced Natural Terrain Landslide Inventory as landslide No. 11SWB0008E and the concerned hillside catchment is classified in the Historical Landslide Catchment Inventory as catchment No. 11SW-B/OH1 (Figure 6).

On 28 March 2001, a minor landslide (Incident No. HK2001/03/0002), with a failure volume of about 10 m³, occurred on the natural hillside above slope No. 11SW-B/C216 about 30 m to the northwest of the 7 June 2008 landslide (Figure 6). By May 2001, urgent repair works, comprising the removal of landslide debris, trimming of overhanging surface, application of slope surface protection and provision of surface drainage channels, were completed by Highways Department.

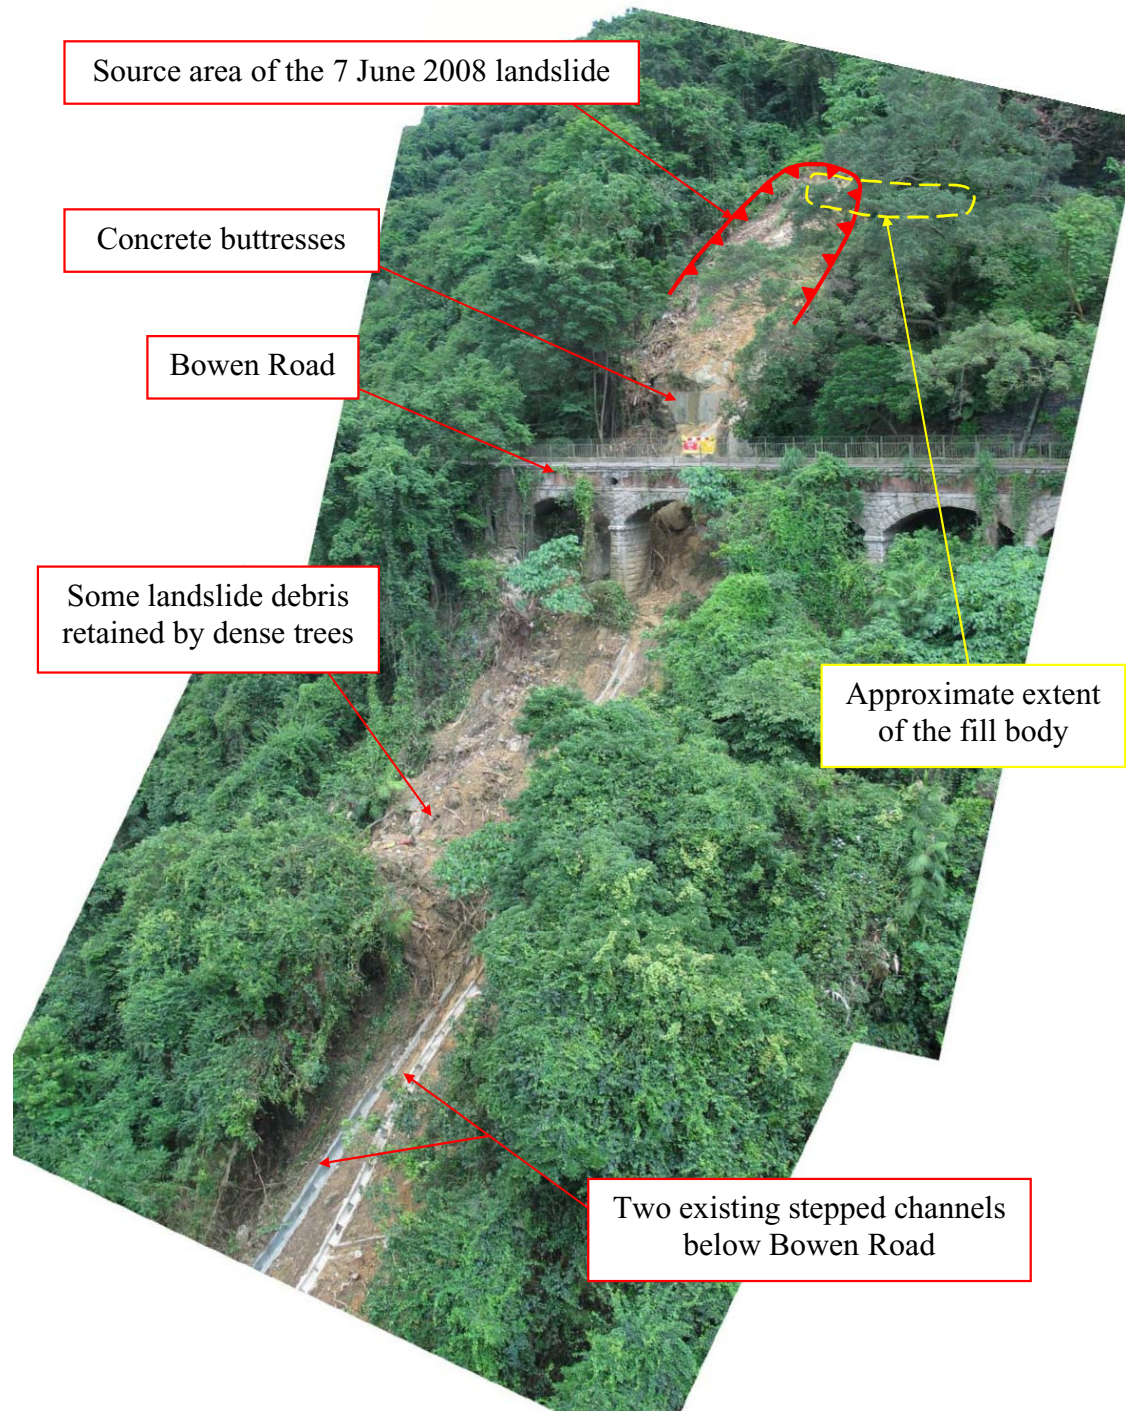
Between 7:00 a.m. and 7:30 a.m. on 7 June 2008, when both Landslip Warning and Black Rainstorm Warning were in effect, a major landslide (Incident No. 2008/06/0182) occurred on the north-facing hillside above Bowen Road overlooking the residential blocks of Ewan Court at Nos. 54-56 Kennedy Road, Wanchai (Figure 1 & Plate 1).

Plate 1 - General View of the 7 June 2008 Landslide
(Photograph taken on 10 June 2008)

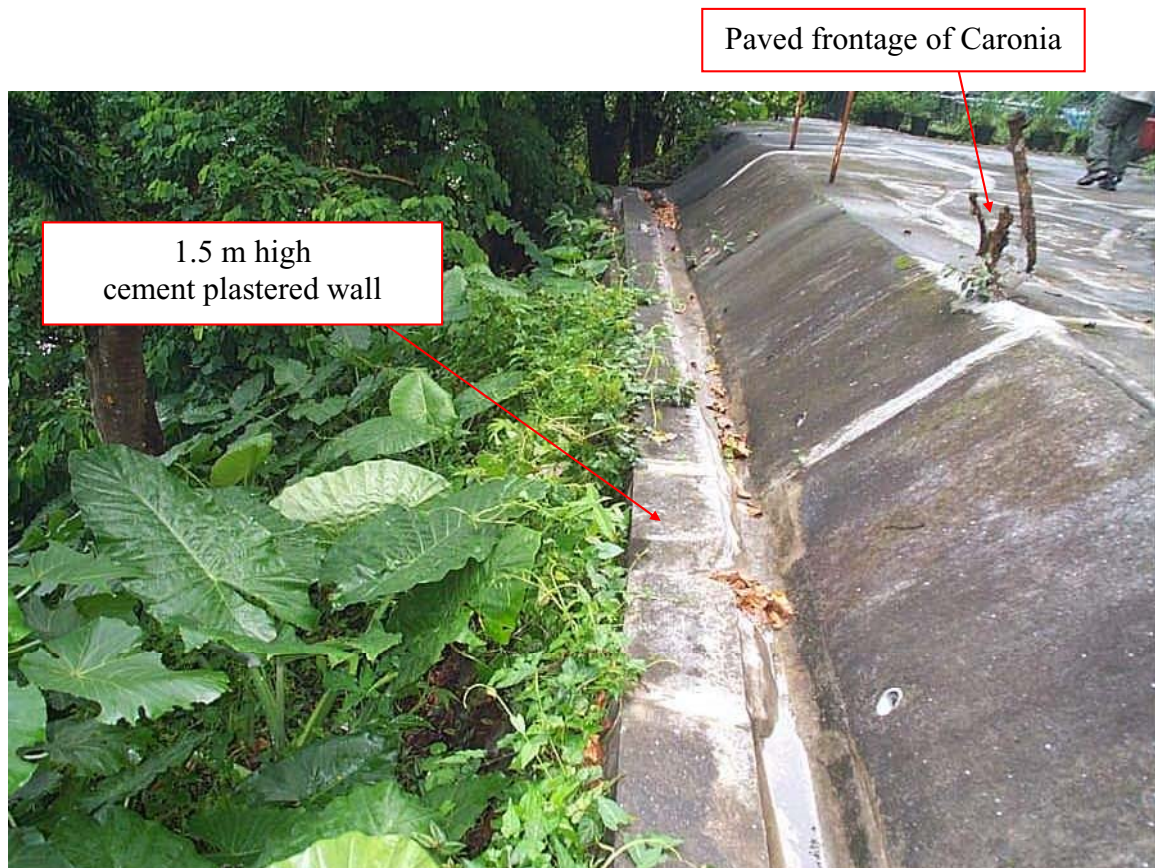
The ground at the crest of the landslide is an unpaved fill platform, which is about 6.5 m wide by 15 m long and was previously used as horticultural ground. The unpaved fill platform comprised a fill body, which was about 45 m long. Only the eastern portion of the fill body, about 15 m long, failed on 7 June 2008 (Figure 2). The unfailed portion of the fill body is about 4.2 m high, comprising a 0.7 m high, 40° steep fill batter at the crest and a 1.5 m high subvertical cement plastered wall at mid-slope as well as a 2 m high fill batter with a slope angle of about 40° at the toe (Plate 2). The ground to the west of the unpaved fill platform is a paved frontage of a two-storey house, viz. Caronia, at No. 17 Bowen Road (Figure 2 & Plate 2).

Plate 2 - General View of the Unfailed Portion of the Fill Body
(Photograph taken on 24 July 2001)

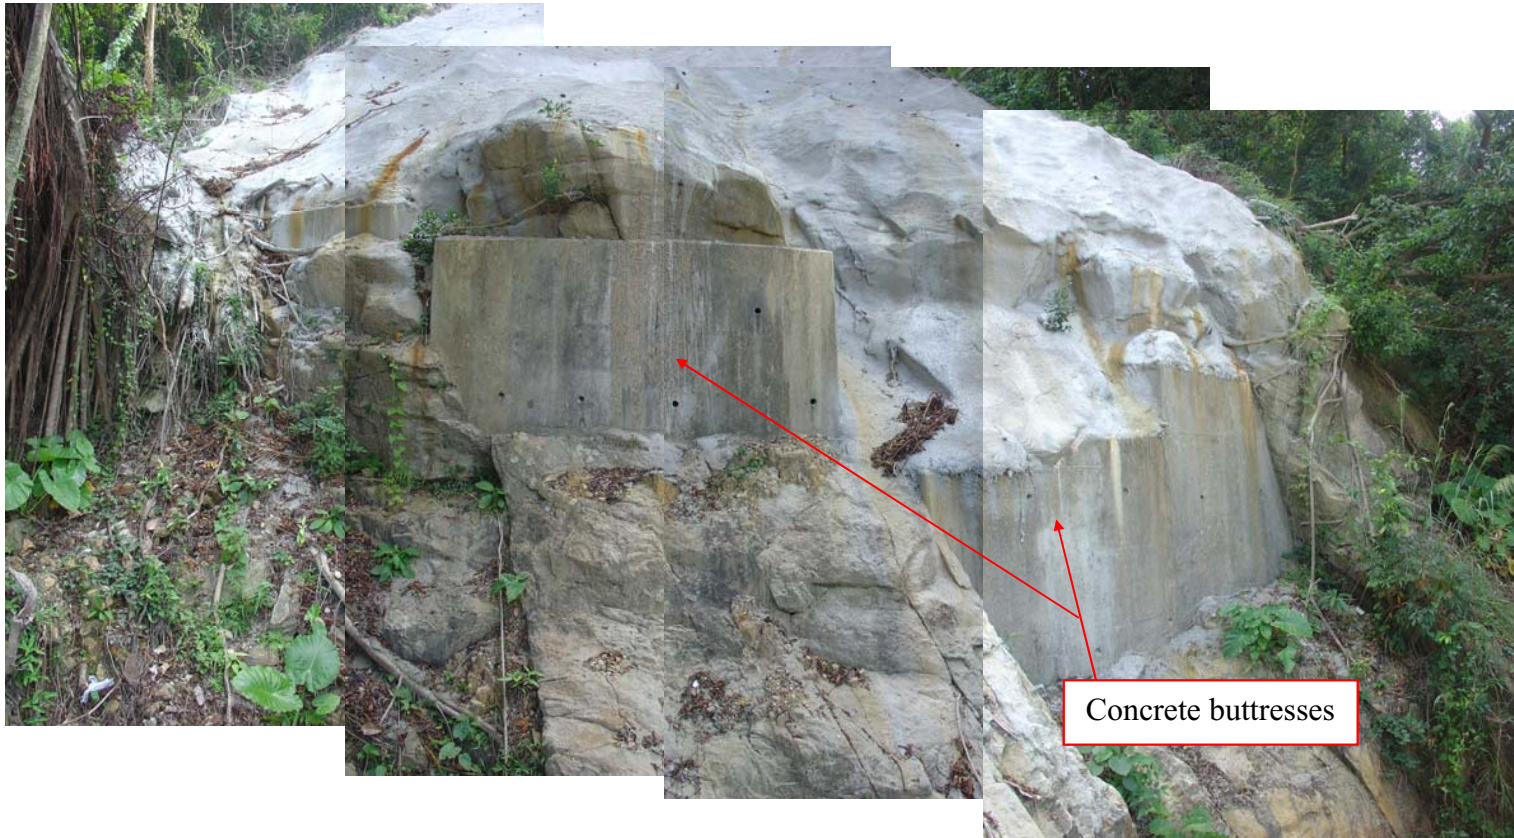
Between 1983 and 1984, concrete buttresses (Figure 2 & Plate 3) were constructed to provide support to rock overhangs exposed on the natural hillside near Bowen Road as part of the upgrading works for slope No. 11SW-B/C216 under the 1982/83 Landslip Preventive Measures Programme of the Government.

Plate 3 - Concrete Buttresses Supporting Rock Overhangs above Bowen Road
(Photograph taken on 30 October 2008)

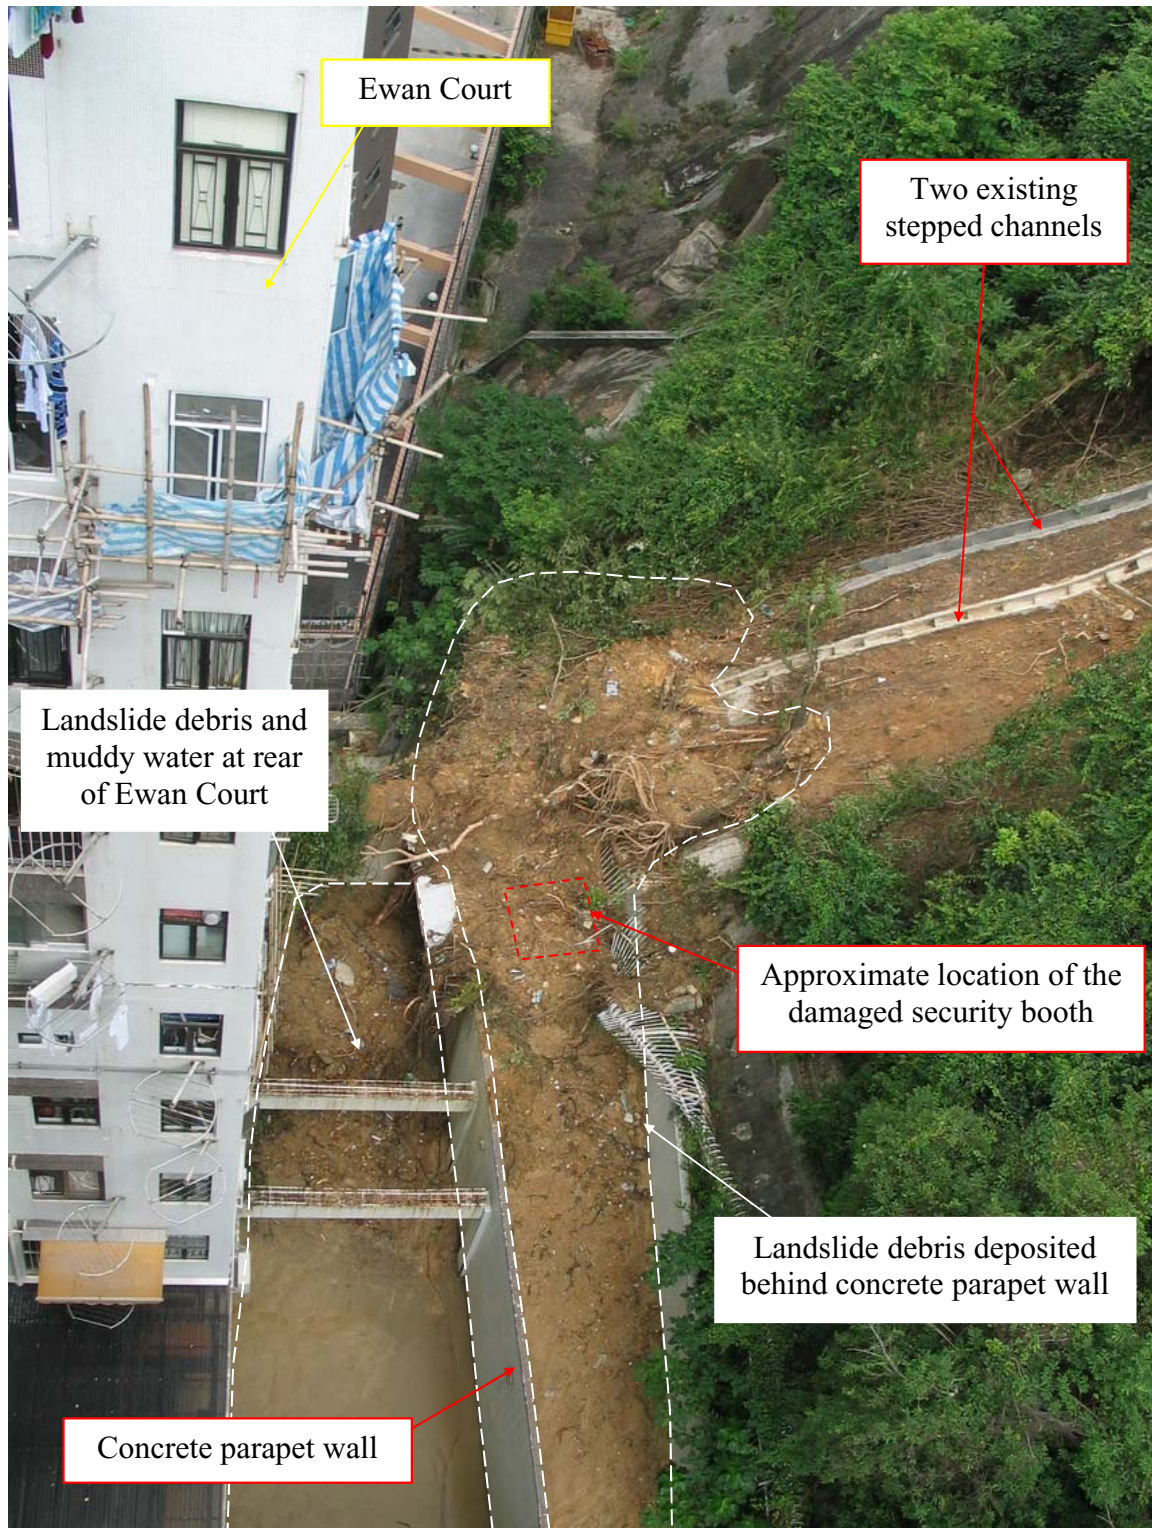
of Ewan Court (Plates 4 to 6). As a result of the landslide, a security booth, which was unoccupied at the time of the failure, and a section of the concrete parapet wall at the rear of Ewan Court were severely damaged (Plates 4 & 5). A section of the fence at the crest of the toe wall of slope No. 11SW-B/CR506 was also damaged by the landslide debris (Plate 7).

Plate 4 - Landslide Debris Deposited at the Rear of Ewan Court
(Photograph taken on 10 June 2008)

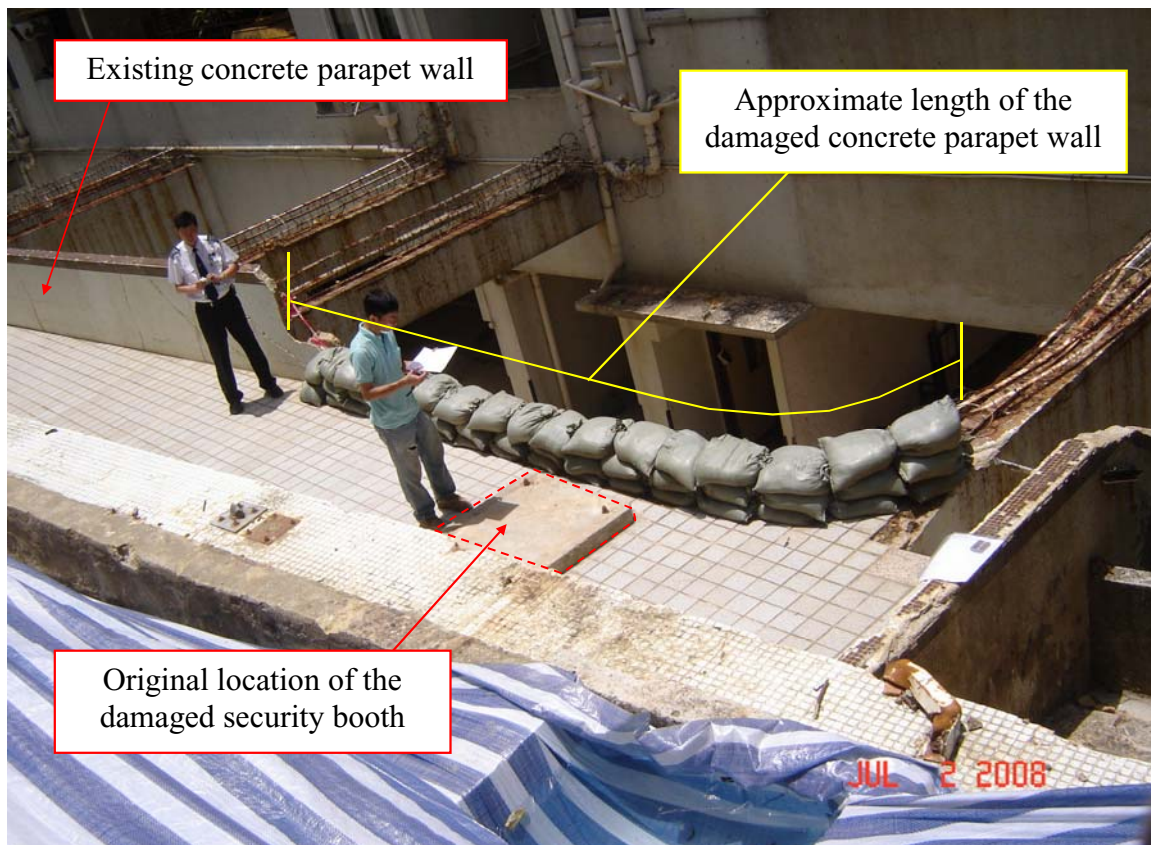
Plate 5 - Damaged Security Booth and Concrete Parapet Wall at the Rear of Ewan Court
(Photograph taken on 2 July 2008)

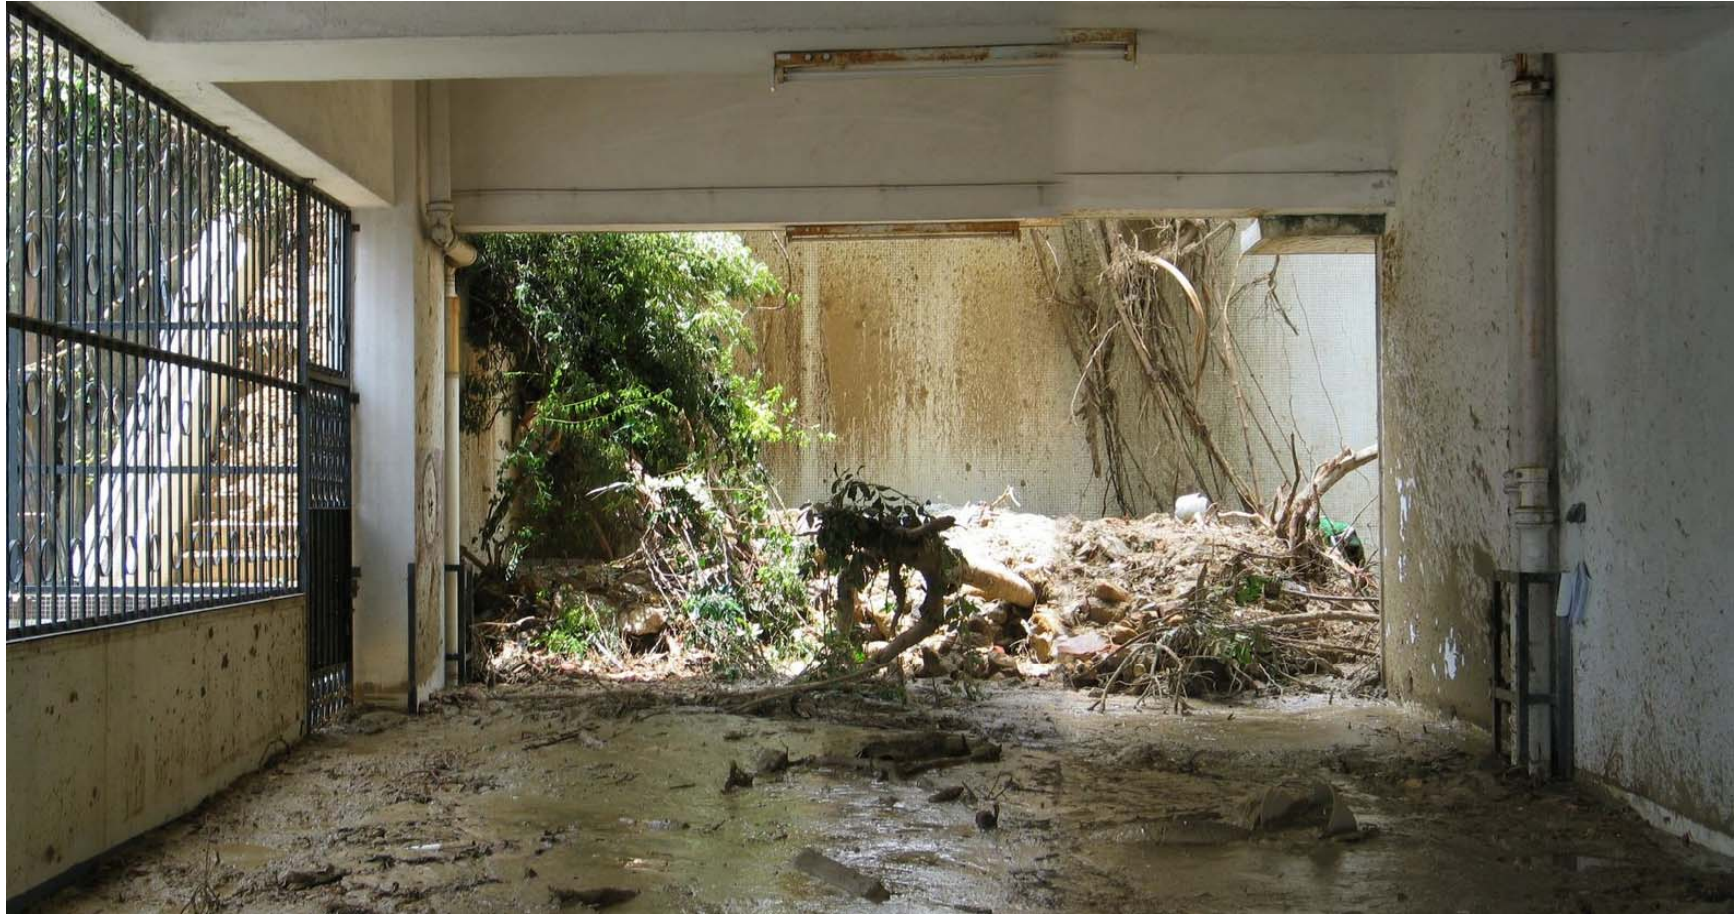
The landslide site was inspected by GEO on 10 June 2008. It was observed that most of the landslide debris mixed with vegetation was deposited at the rear alleyway of Ewan Court (Figure 2 & Plate 6). Some landslide debris was retained by dense trees at the mid-slope below Bowen Road (Plate 11). Fragments of the crest walls and planter pots, as well as a 5 m by 5 m large raft of landslide debris, were found on the western flank of the landslide, about 3 m below the original position of the unpaved fill platform (Plate 12). The remaining unfailed portion of the platform above the landslide was unpaved with a number of abandoned planter pots (Plate 13).

Plate 6 - Landslide Debris Deposited at the Rear Alleyway of Ewan Court
(Photograph taken on 10 June 2008)

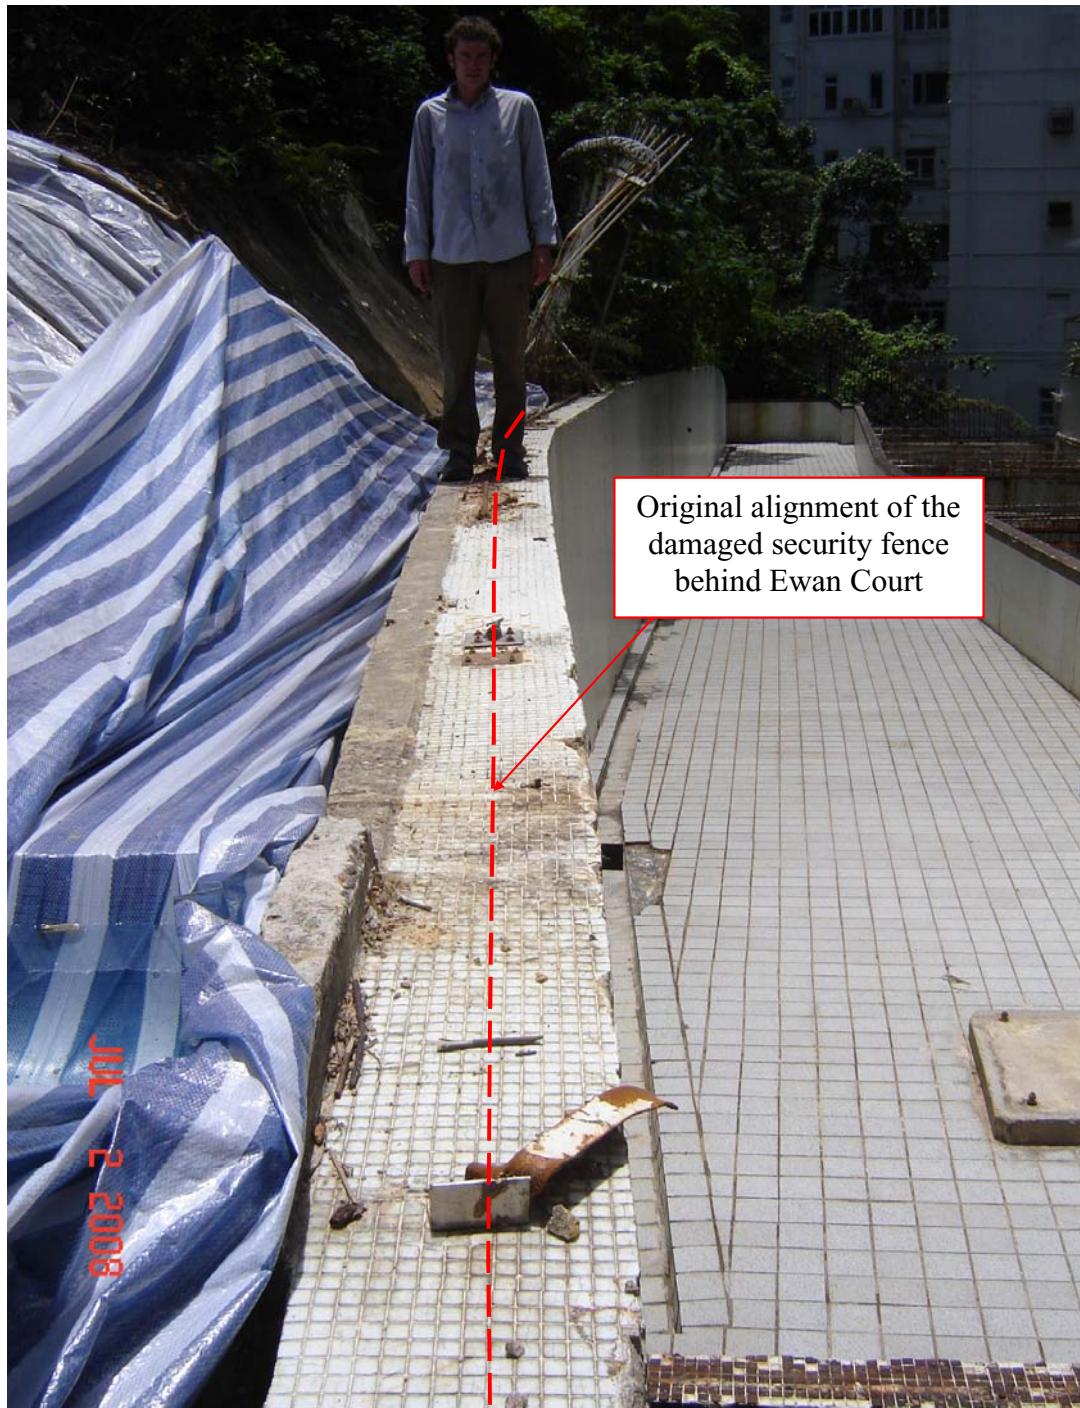
Plate 7 - Damaged Security Fence at the Crest of Retaining Wall of
Feature No. 11SW-B/CR506 behind Ewan Court
(Photograph taken on 2 July 2008)

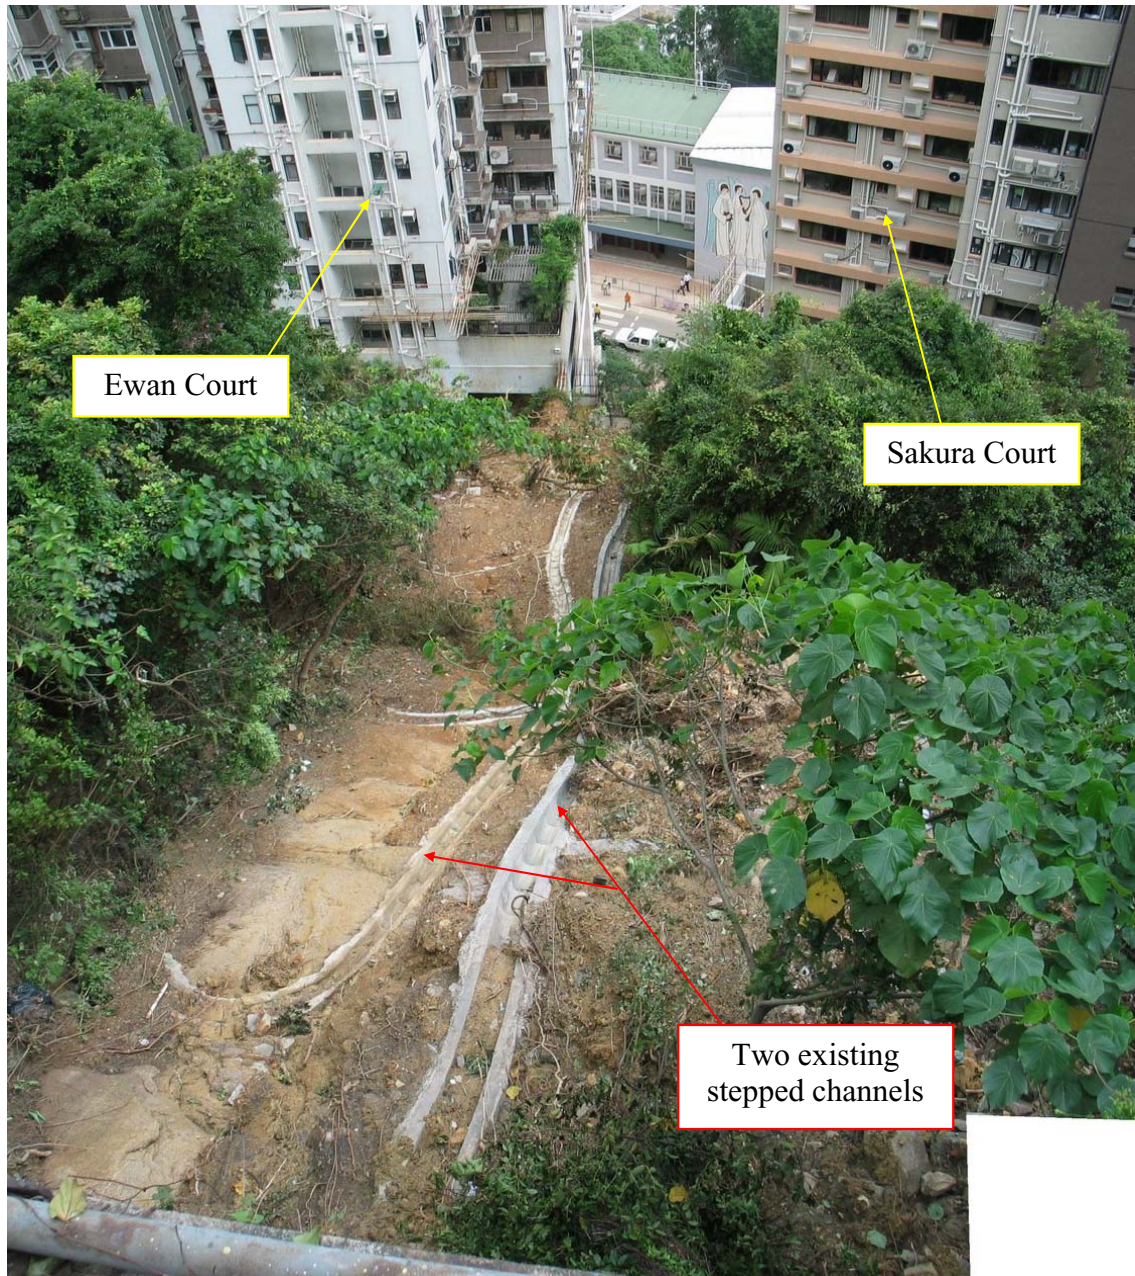
Two stepped channels (300 mm & 400 mm wide respectively), generally in good condition, are present below Bowen Road, connecting to the surface drainage system to the east of Ewan Court (Plate 8). No significant signs of erosion were observed in the area along the two channels.

Plate 8 - Landslide Trail below Bowen Road
(Photograph taken on 10 June 2008)

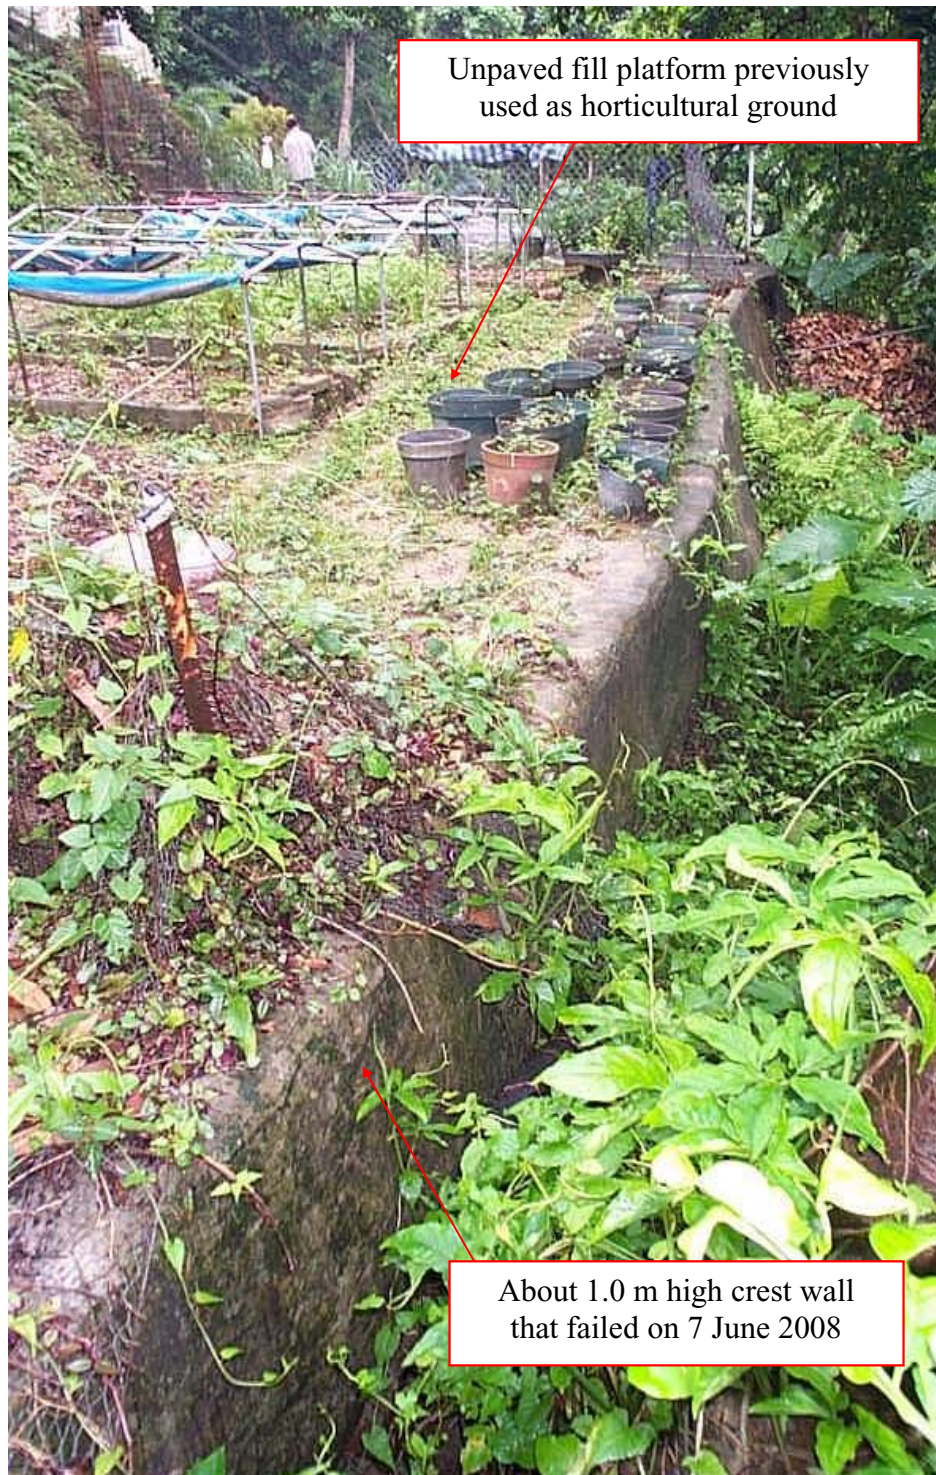
Plate 9 - General View of the Unpaved Fill Platform at the Crest of the
7 June 2008 Landslide
(Photograph taken on 24 July 2001)

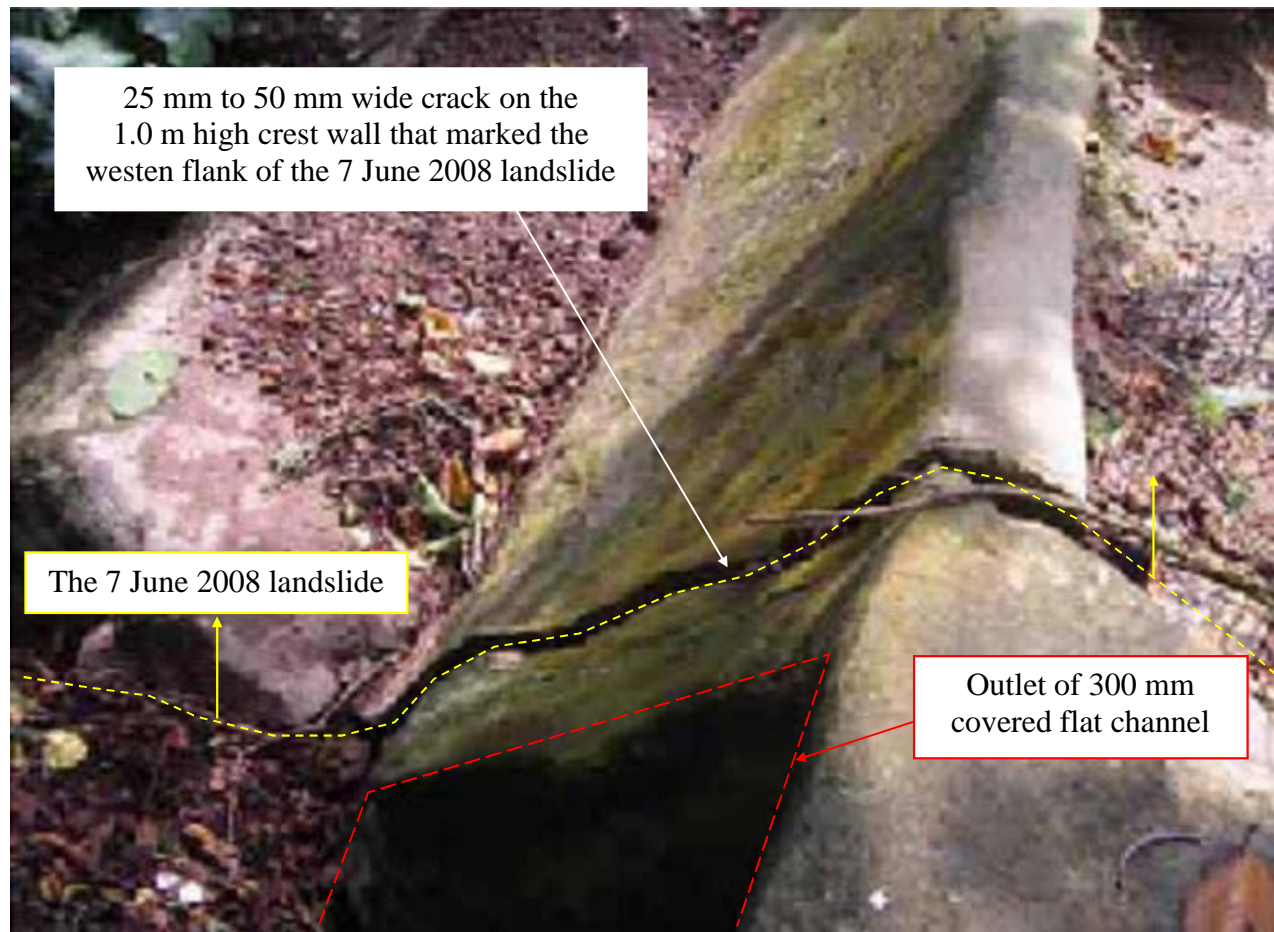
In August 2005, a Routine Maintenance Inspection (RMI) of slope No. 11SW-D/F525 was carried out by Lands D. The RMI record noted a severe crack (estimated to be about 25 mm to 50 mm wide) on the 1 m high crest wall at the eastern portion of the slope (Figure 6 & Plate 10), which marked the western flank of the 7 June 2008 landslide. The recommended RMW, including sealing of the crack, were completed in April 2006.

Plate 10 - Crack Identified in Routine Maintenance Inspection in 2005
(Photograph taken on 11 August 2005)

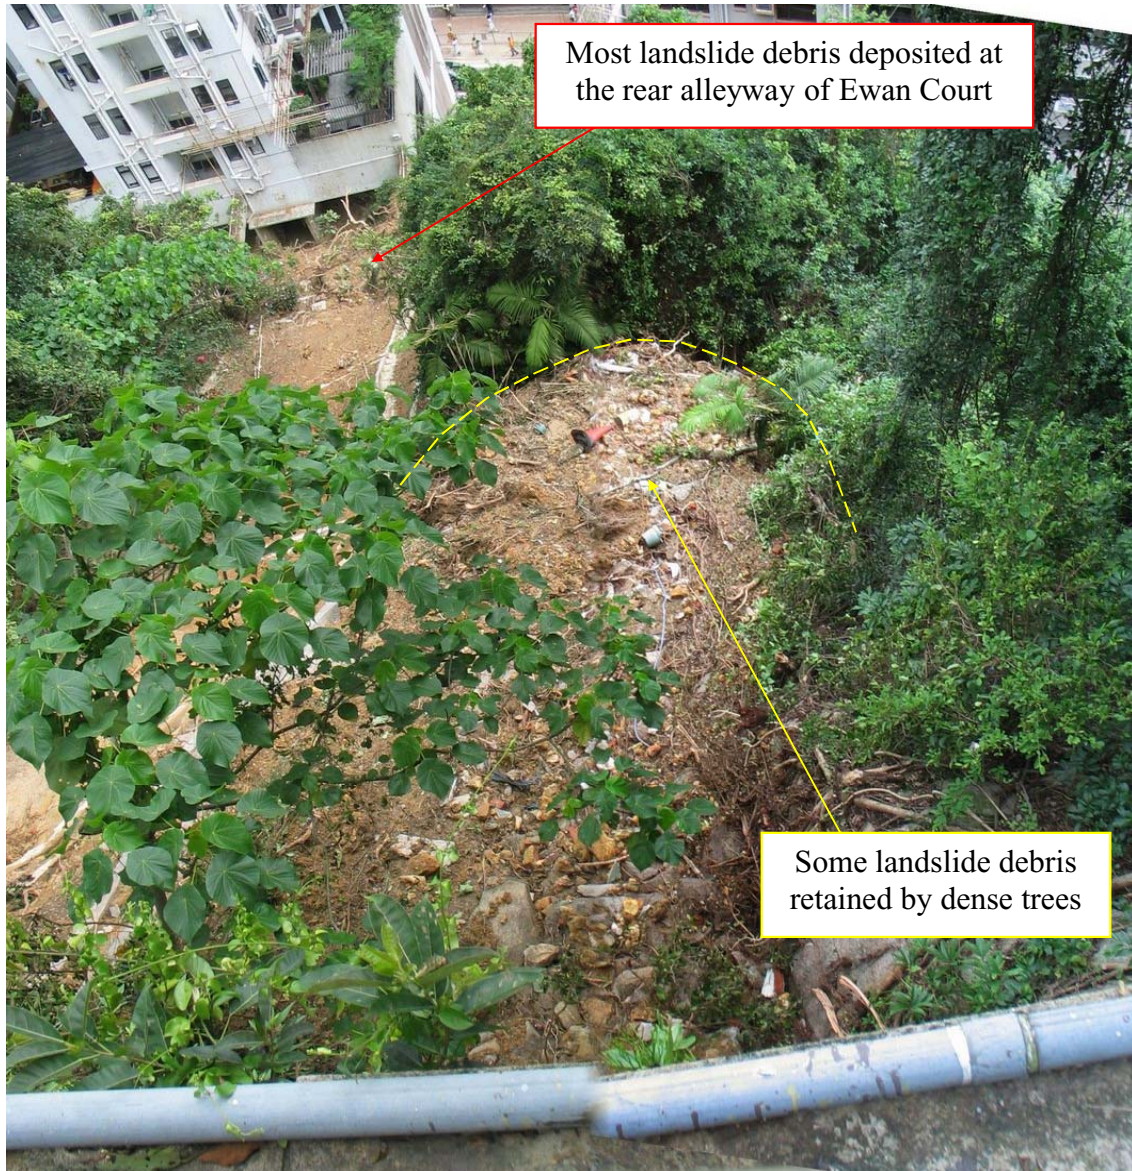
Plate 11 - Landslide Debris Retained by Dense Trees on the Hillside below Bowen Road
(Photograph taken on 10 June 2008)
