**DETAILED STUDY OF
THE 7 JUNE 2008
LANDSLIDE BEHIND
EWAN COURT,
KENNEDY ROAD,
WANCHAI**

GEO REPORT No. 278

Fugro Scott Wilson Joint Venture

**This report is largely based on GEO Landslide Study Report
No. LSR 8/2009 produced in September 2009**

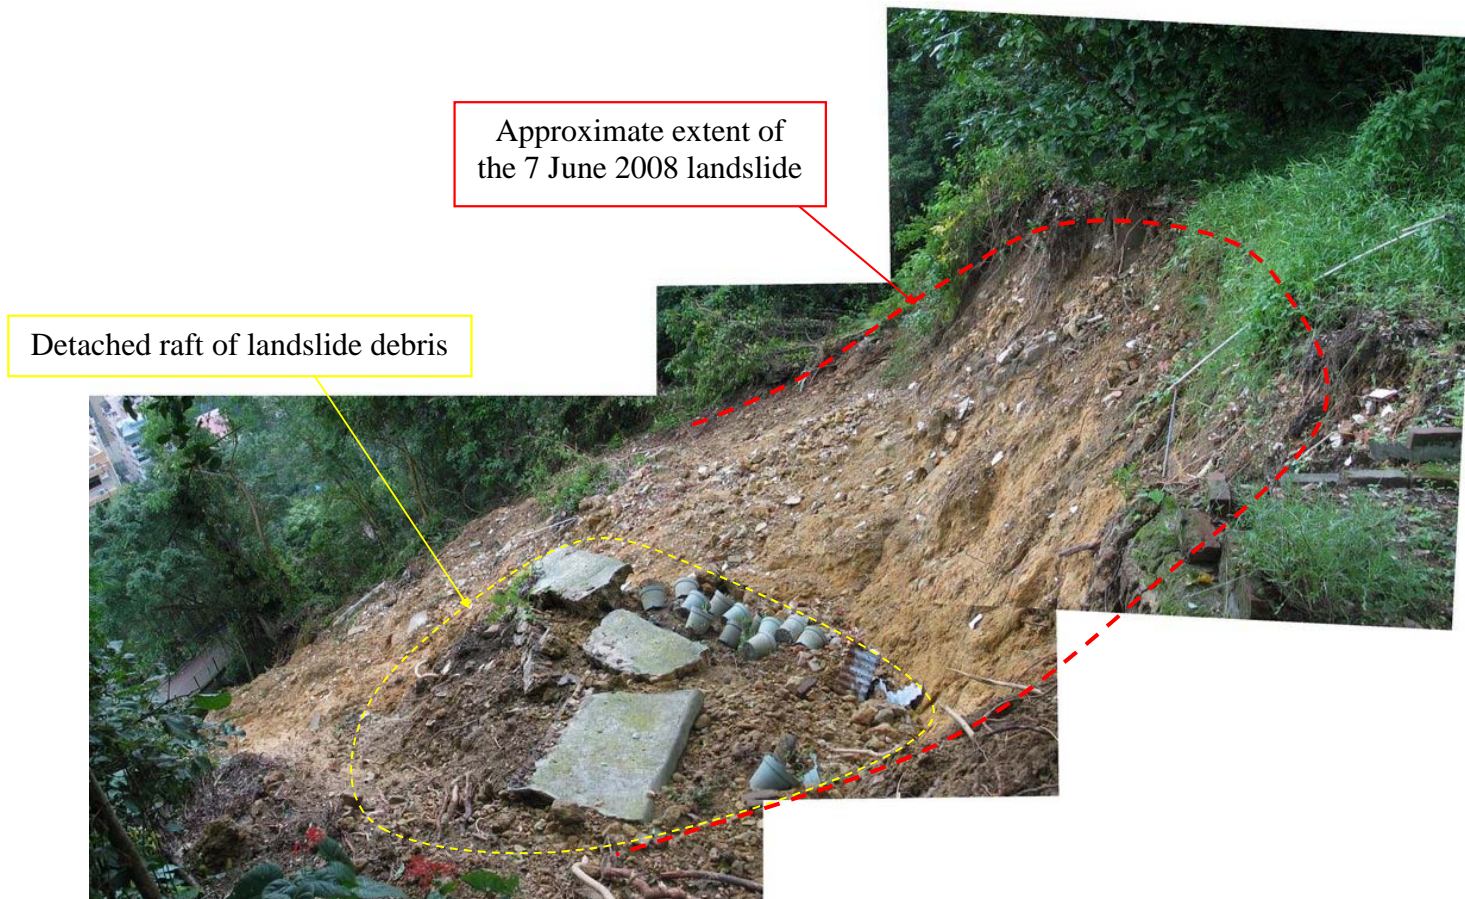
Plate 12 - Source Area of the 7 June 2008 Landslide and the Detached Raft of Landslide Debris at the Western Flank of the Landslide
(Photograph taken on 10 June 2008)

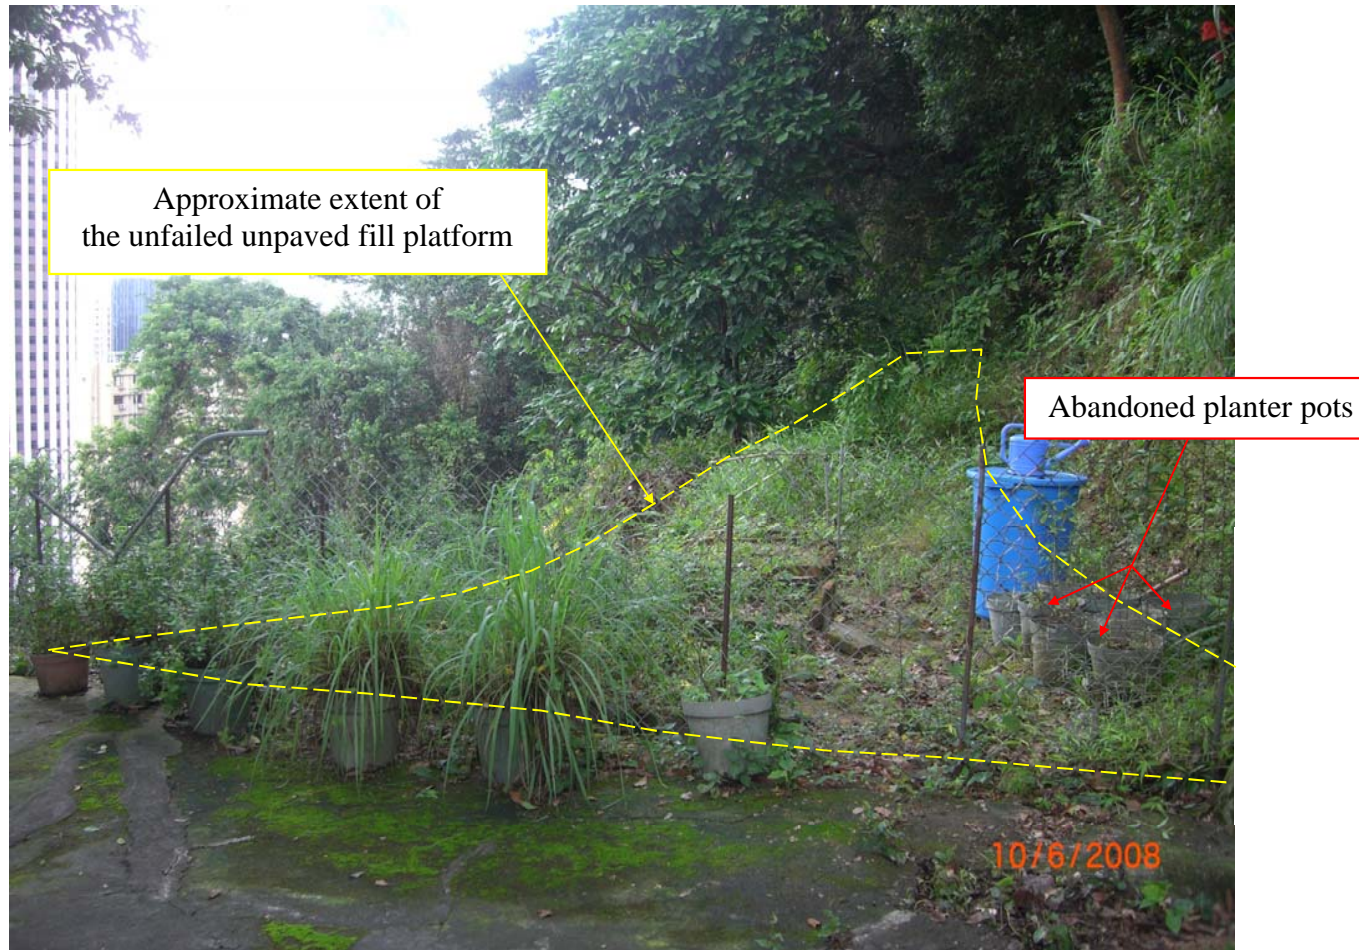
The landslide site was inspected by GEO on 10 June 2008. It was observed that most of the landslide debris mixed with vegetation was deposited at the rear alleyway of Ewan Court (Figure 2 & Plate 6). Some landslide debris was retained by dense trees at the mid-slope below Bowen Road (Plate 11). Fragments of the crest walls and planter pots, as well as a 5 m by 5 m large raft of landslide debris, were found on the western flank of the landslide, about 3 m below the original position of the unpaved fill platform (Plate 12). The remaining unfailed portion of the platform above the landslide was unpaved with a number of abandoned planter pots (Plate 13).

Plate 13 - General View of the Unfailed Unpaved Fill Platform at the Crest of the 7 June 2008 Landslide
(Photograph taken on 10 June 2008)

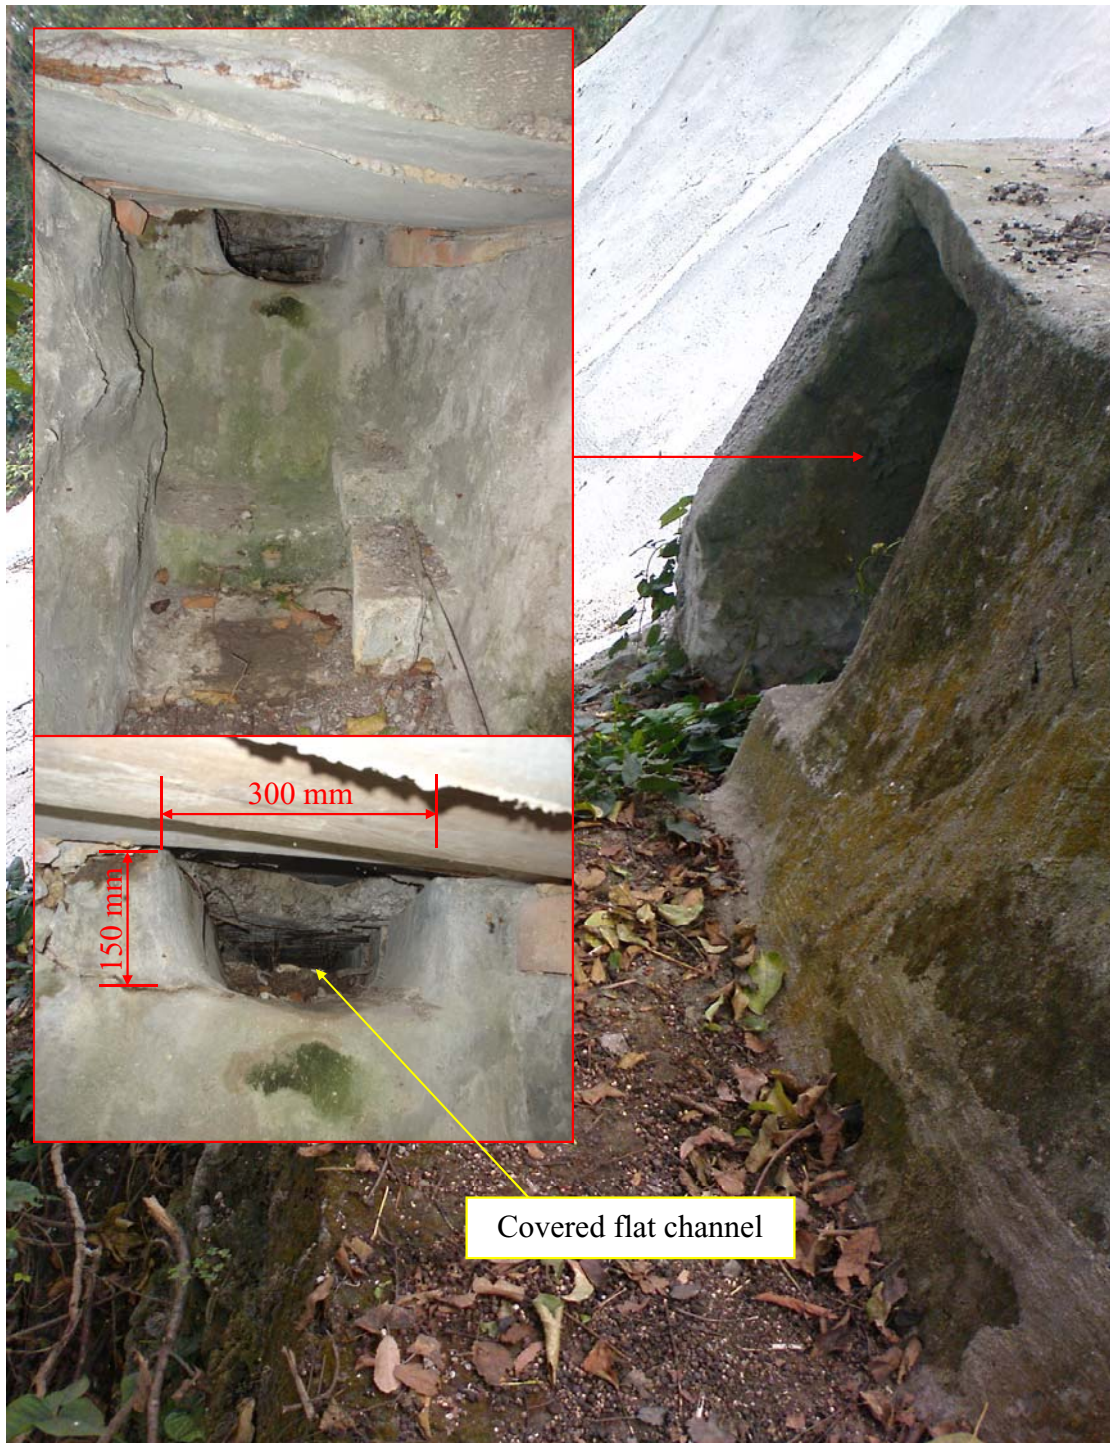
At the western flank of the unpaved fill platform, a covered flat channel (about 150 mm deep by 300 mm wide) is present, which collects surface water from a 400 mm crest U-channel of slope No. 11SW-D/C1401 (Figure 2, Plates 14 & 15). The 400 mm crest U-channel also connects with and collects surface water from the surface drainage systems of two adjacent slopes Nos. 11SW-D/C1399 and 11SW-D/C1411. It was observed that the inlet to the flat channel was completely blocked by leaf debris during an inspection in September 2008 (Plate 15). The covered flat channel was in a reasonably good condition.

Plate 14 - Condition of the 300 mm Covered Flat Channel
(Photograph taken on 23 April 2009)

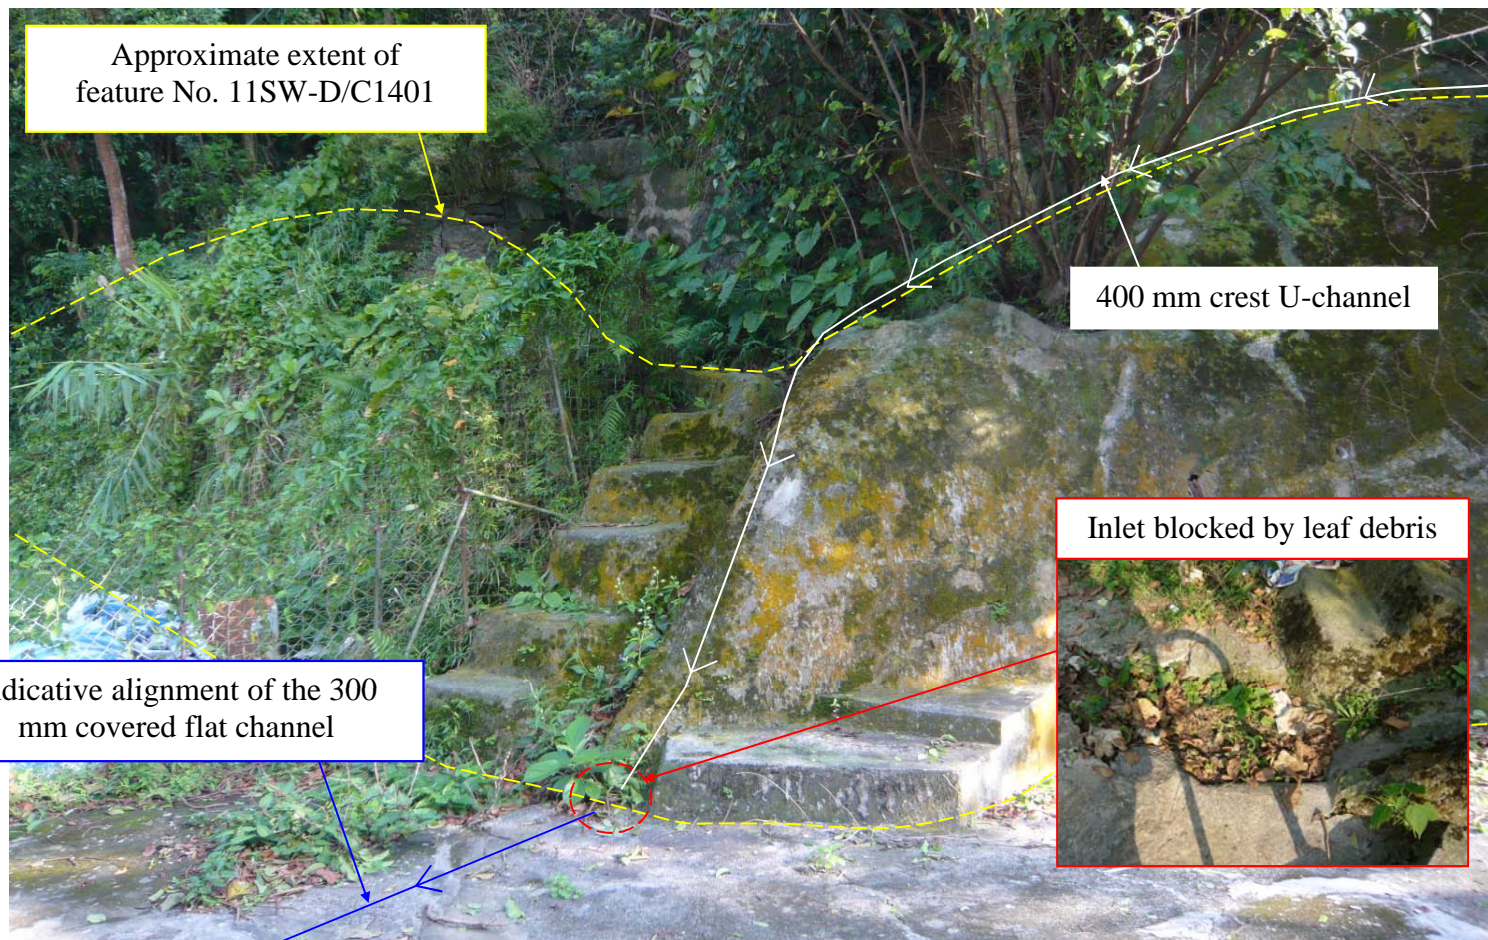
The situation could have been aggravated by additional water ingress into the groundmass, resulting from the blockage of the inlet to the 300 mm flat channel at the western flank of the landslide (Plate 15), which collects surface water from the nearby slopes. Blockage of the channel inlet would have led to uncontrolled over-spilling of surface water onto the adjoining unpaved fill platform and additional water ingress into the groundmass at the location of the landslide. In addition, the unpaved fill platform might have been subject to deterioration and possibly movement, as evidenced by the pre-existing crack of up to 50 mm wide on the crest wall in August 2005, which was subsequently sealed, and the significant cracking on the adjoining frontage of Caronia in December 1996 (Section 6). Should continual deterioration occur, the pre-existing crack could have opened up and new cracks might have been developed, leading to additional water ingress into the groundmass.

Plate 15 - Blocked Inlet to the 300 mm Covered Flat Channel at the Toe of Feature No. 11SW-D/C1401
(Photograph taken on 26 September 2008)
