**REVIEW OF THE
3 AUGUST 2006
LANDSLIDE INCIDENT ON
SLOPE NO. 11SW-C/FR319,
NO. 131 POK FU LAM ROAD**

GEO REPORT No. 279

Fugro Scott Wilson Joint Venture

**This report is largely based on GEO Landslide Study Report
No. LSR 2/2008 produced in March 2008**

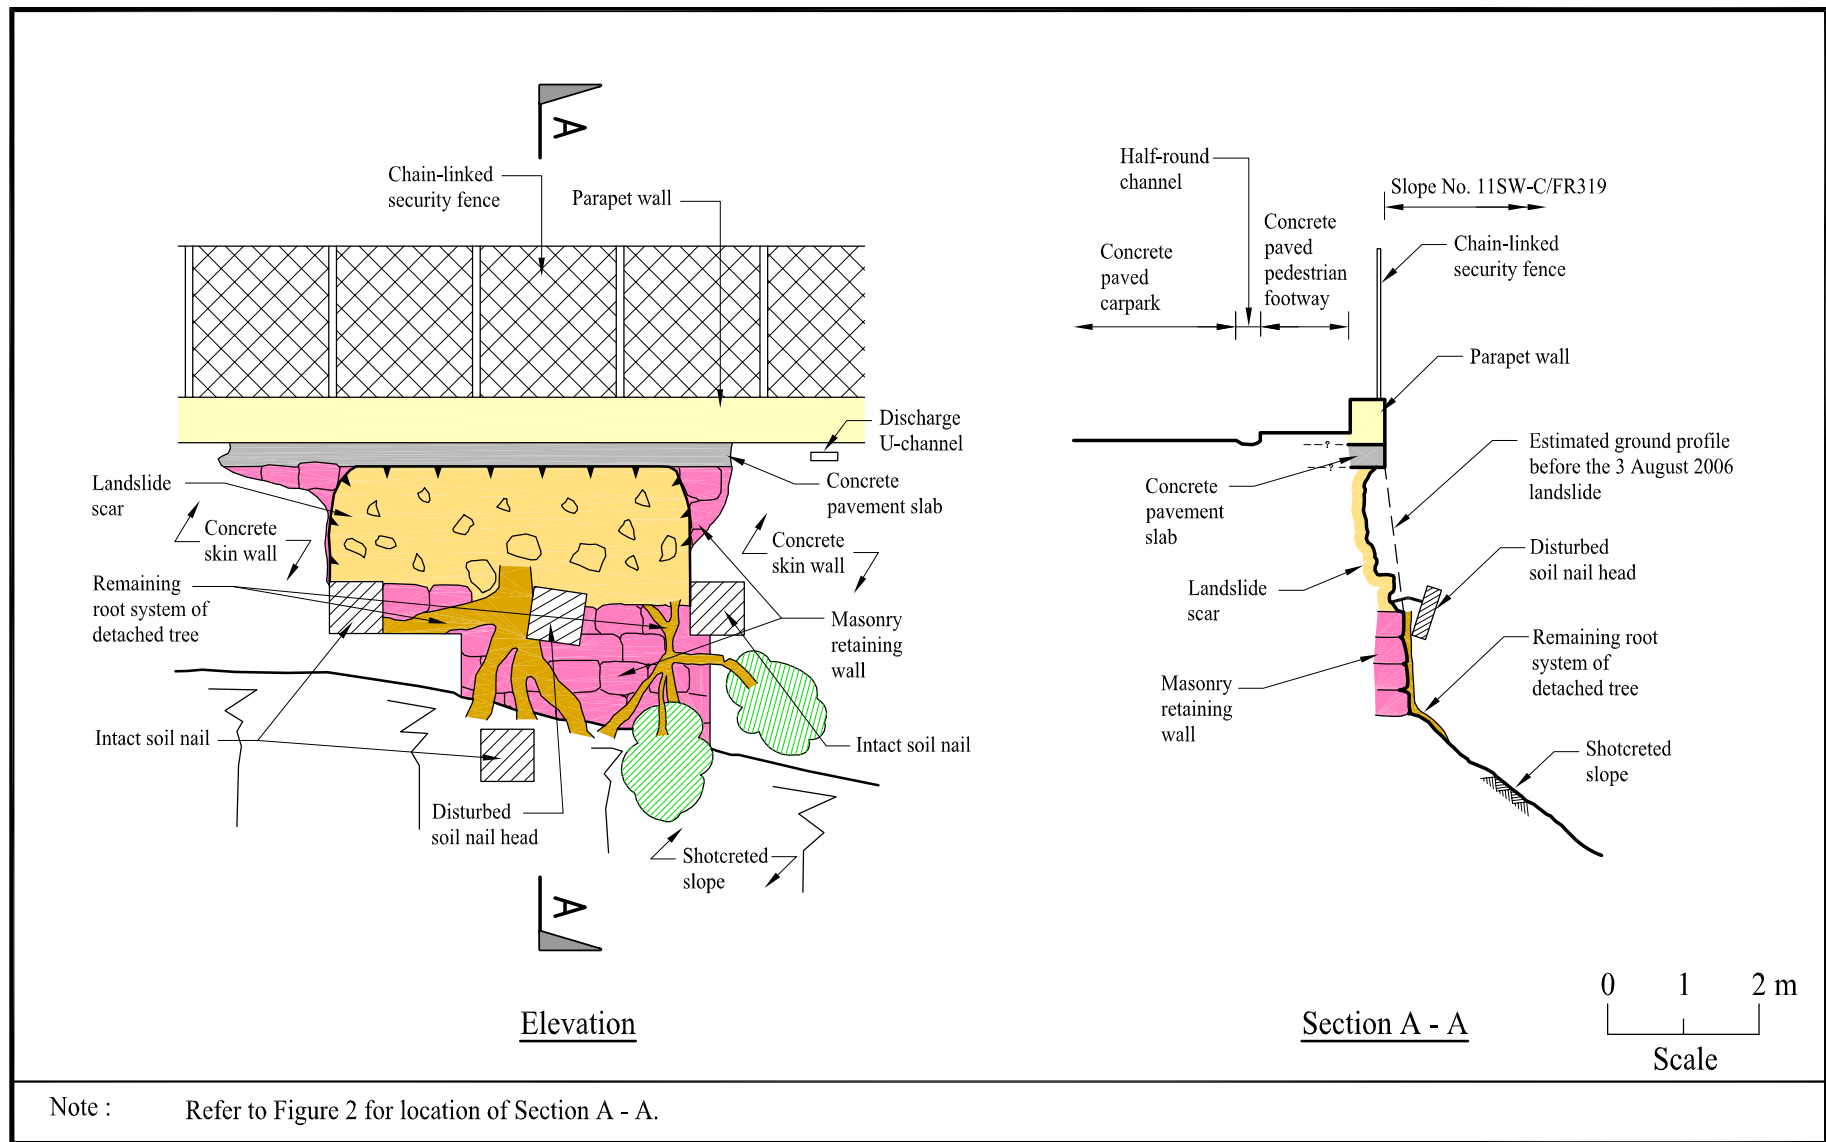
Figure 9 - Elevation View and Cross-section A - A Through the 3 August 2006 Landslide

A plan view of the failure is presented in Figure 2. An elevation and a section are presented in Figure 9.

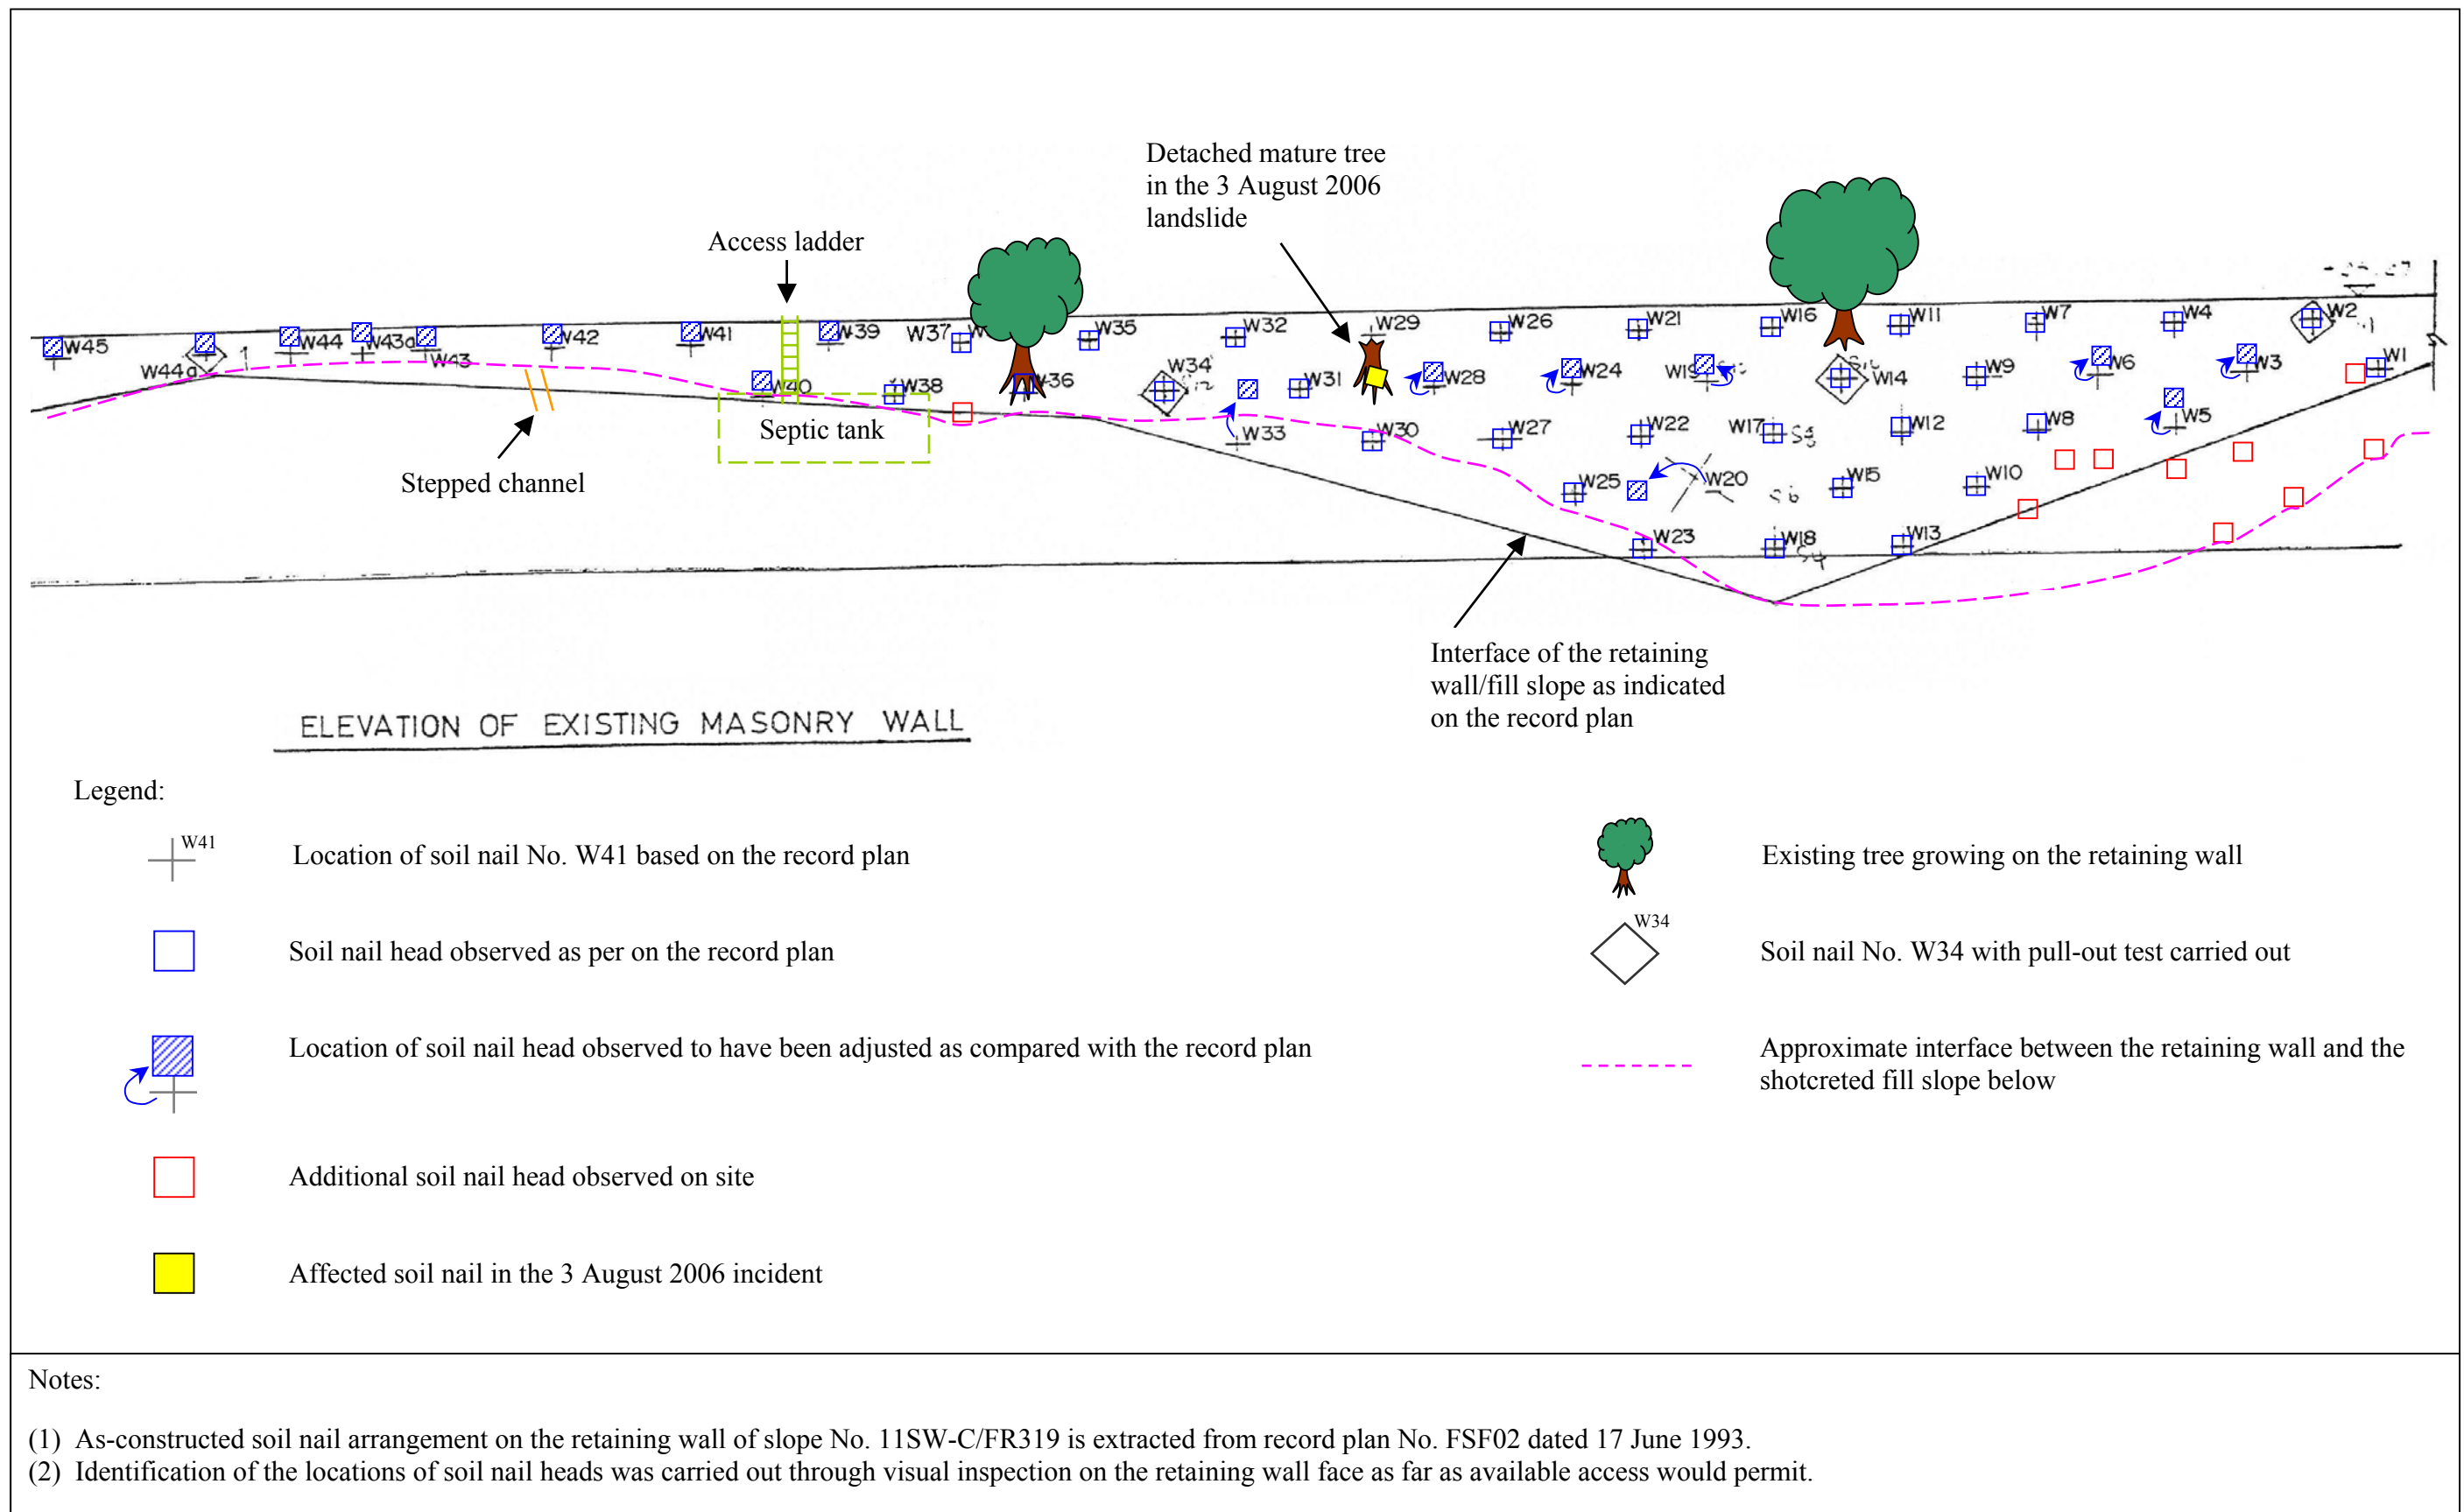
Figure 10 – Locations of Soil Nail Heads Observed on Site

The location of the affected soil nail as observed on site is not consistent with the record plan, on which no soil nail is shown to have been installed at that location. According to the record plan, the nearest soil nail to the affected soil nail is the one with reference No. 'W29', which is approximately 2 m above the affected soil nail. It is noted that the mature tree that was involved in the 3 August 2006 incident was located at the recorded location of soil nail No. 'W29' on the record plan. It is postulated that the affected soil nail is the one with reference No. 'W29', which was likely to have been relocated due to the presence of the mature tree at the originally proposed nail location. The drilled length of the soil nail hole for soil nail No. 'W29', as recorded on the record plan, is 6.4 m, including a rock socket length of 1.5 m.

Identification of the locations of the other soil nail heads (i.e. soil nails Nos. 'W1' to 'W28', 'W30' to 'W43', 'W43a', 'W44', 'W44a' and 'W45' as shown on the record plan) was carried out through visual inspection on the retaining wall face as far as available access would permit. A total of 56 nail heads on the retaining wall face have been identified (see Figure 10). A number of the nail heads were noted to be out of position by a small distance (mostly less than 1 m except soil nail No. 'W20' which is out of position by approximately 2 m) from the standard pattern. As compared with the approved drawing dated 24 March 1993 (see Figure 5) and the record plan (Drawing No. FSF02) submitted by the AP to BD on 17 June 1993 (see Figure 6), ten additional nail heads were also found. Nine of the additional nail heads are located at the southern end of the wall (about 35 m to the south of the August 2006 incident) where the actual interface between the retaining wall and the shotcreted fill slope below is lower (about 5 m) than the elevation shown on the record plan. The other additional nail head is located between soil nail Nos. 'W36' and 'W38' at the base of the retaining wall (about 15 m to the north of the August 2006 incident).

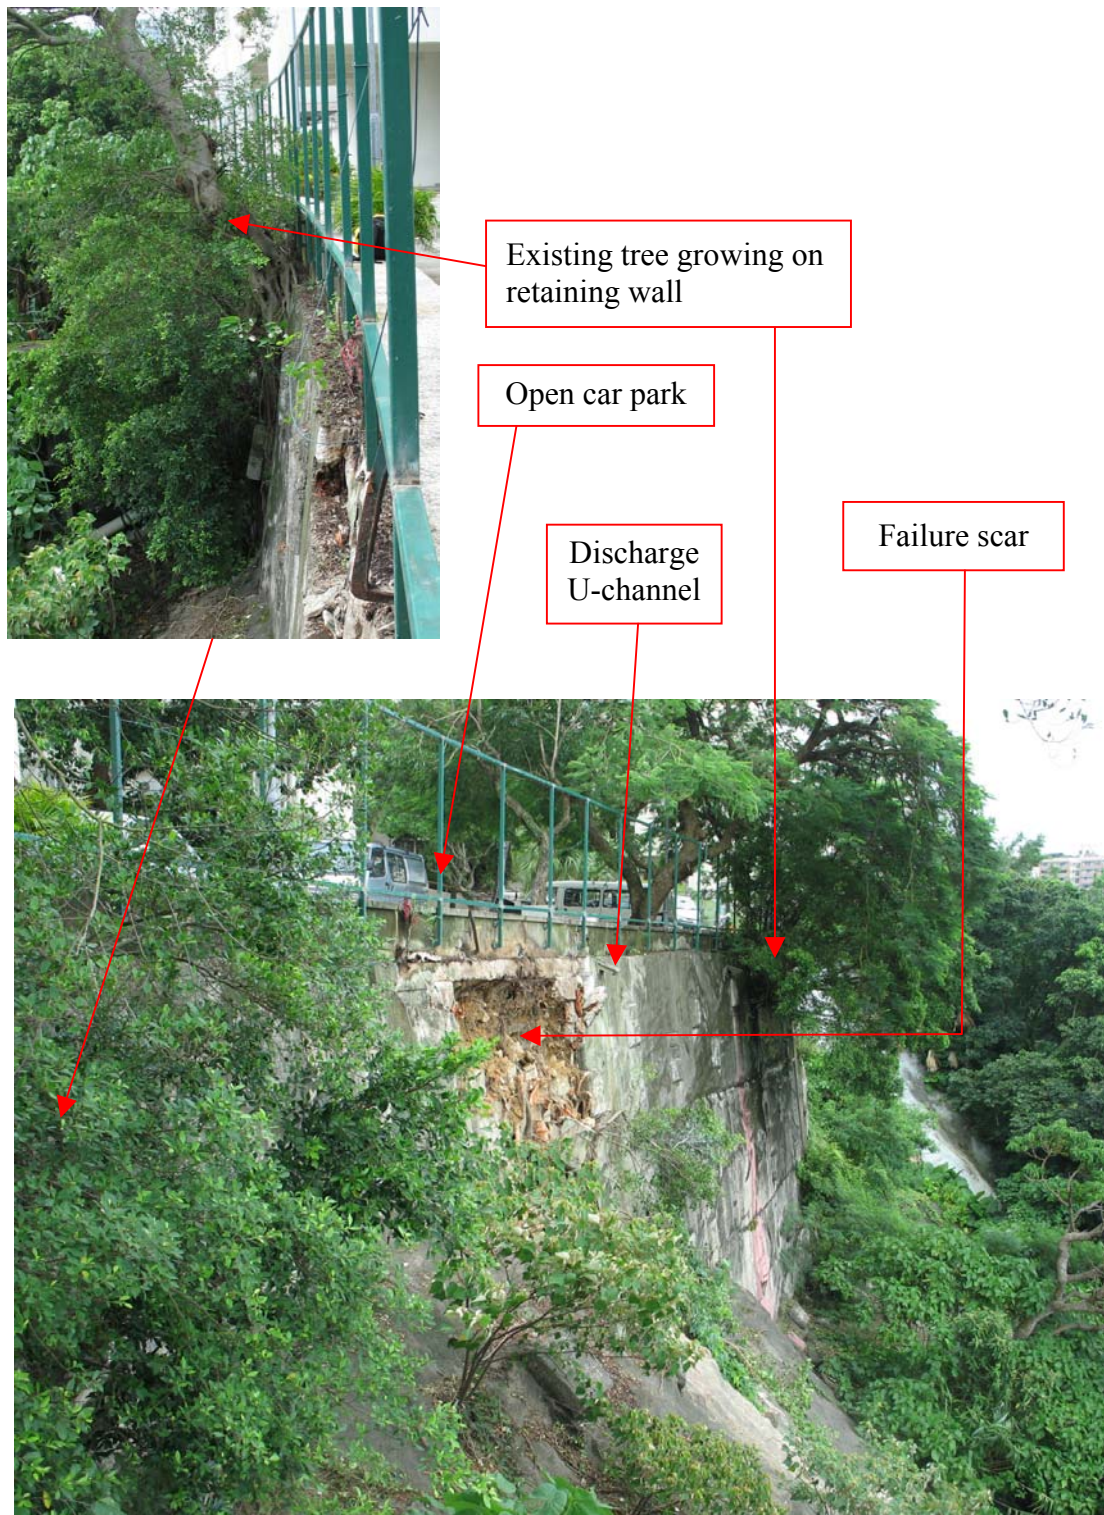
The source area of the failure (Plate 5) was located about 38 m from the southeastern end of the feature. The failure involved the detachment of a mature tree protruding from the

Plate 1 – General View of Retaining Wall Portion of Slope No. 11SW-C/FR319 Showing the 3 August 2006 Landslide Incident (Photographs taken by GEO on 4 August 2006)

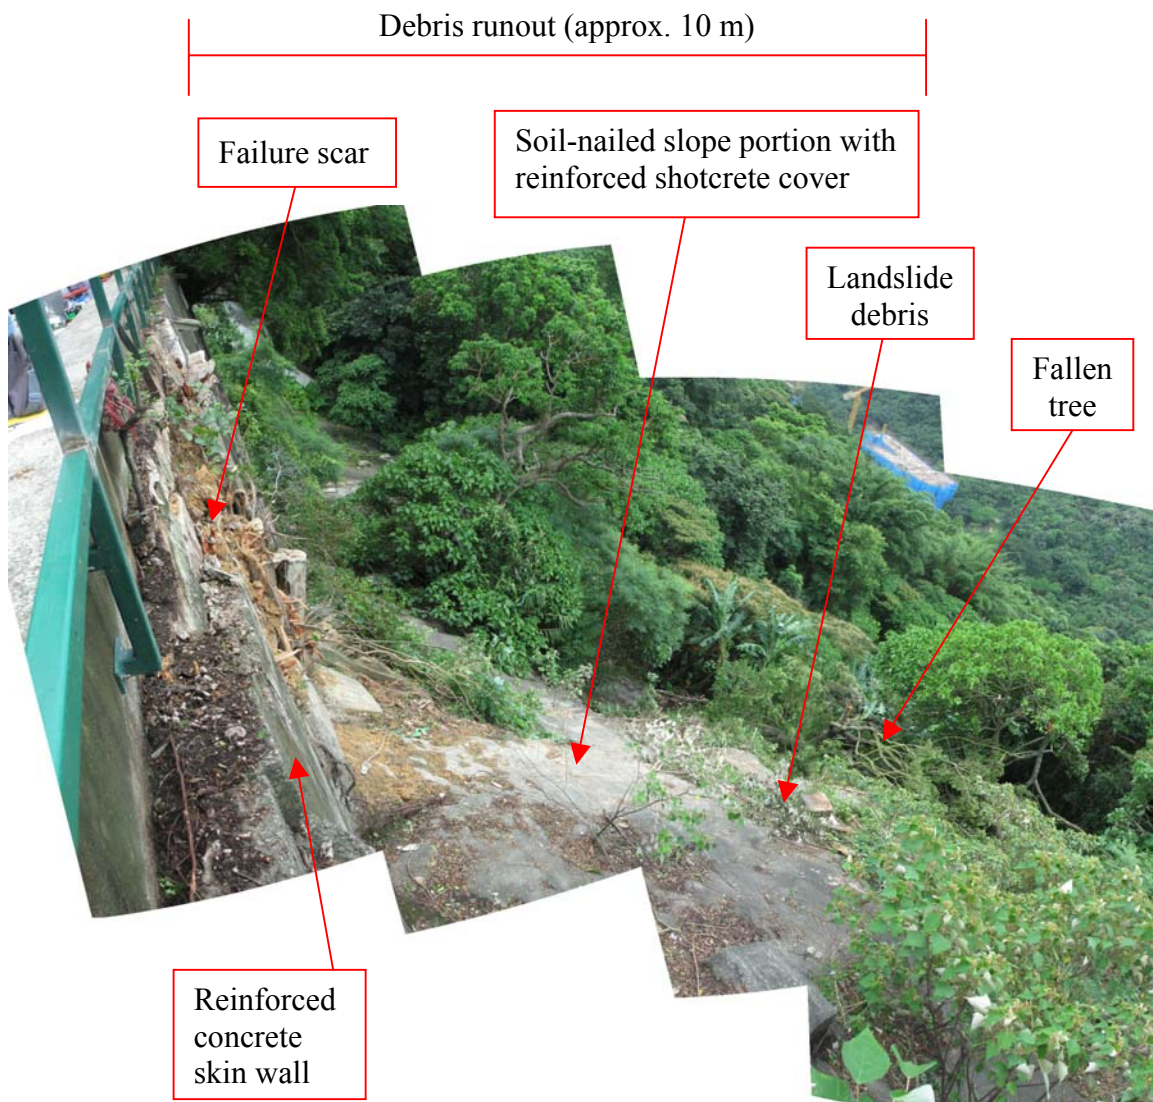
Debris from the failure, with an estimated volume of about 4 m³ and comprising the detached tree and portions of the root system, small sections of concrete skin wall, masonry blocks and soil and rubble backfill, was mostly deposited on the shotcreted sloping ground at the toe of the retaining wall, travelling a maximum distance of about 10 m on plan downslope (Plate 2).

Plate 2 – General View of Slope Portion of Slope No. 11SW-C/FR319 Showing Debris Runout (Photograph taken by GEO on 4 August 2006)

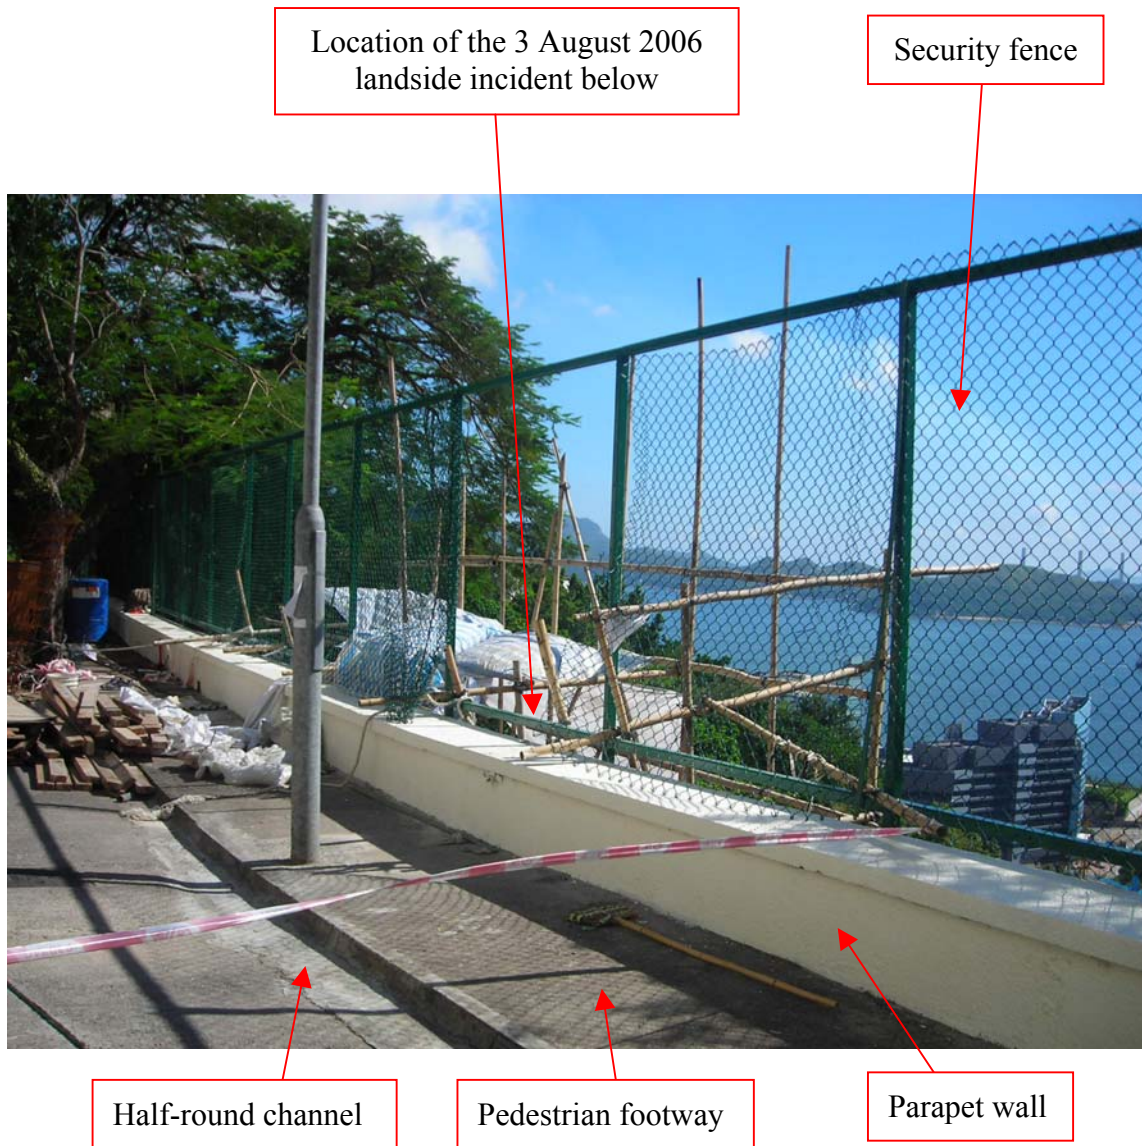
A 0.45 m high parapet wall and a 2 m high chain-linked security fence run along the crest of the masonry wall (Plate 3), and two mature trees, excluding the one involved in the August 2006 incident, are established high on the wall face at roughly 22 m and 48 m from

Plate 3 – General View of Crest Area of Slope No. 11SW-C/FR319 above Location of the 3 August 2006 Landslide Incident (Photograph taken on 30 August 2006)

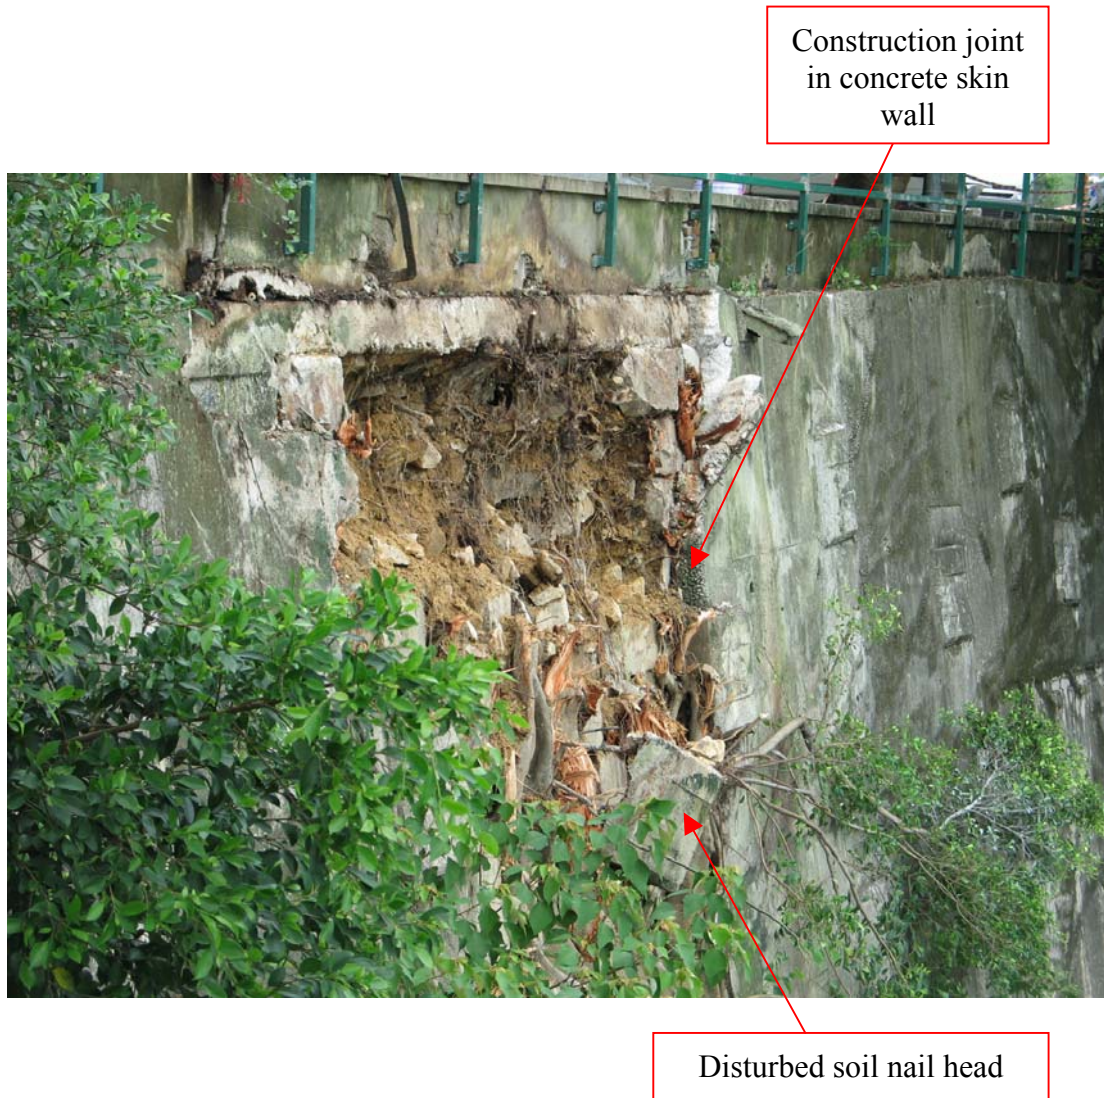
Inspection of trees growing on the wall face to the northwest and southeast of the failure scar revealed that the concrete skin wall constructed over the original masonry facing between 1992 and 1995 at these locations had been curtailed locally around the extensive exposed root systems. The extent of the concrete skin wall within the failure scar prior to the failure could not be determined. Based on the observations at the adjacent trees, it is probable that it was similarly curtailed. This is supported by the small proportion of skin wall fragments observed in the debris and the presence of construction joints in the skin wall at the edge of the failure scar (Plate 5). The curtailment details are not shown on the record plan.

Plate 5 – Close View of Scar Associated with the 3 August 2006 Landslide Incident (Photograph taken by GEO on 4 August 2006)

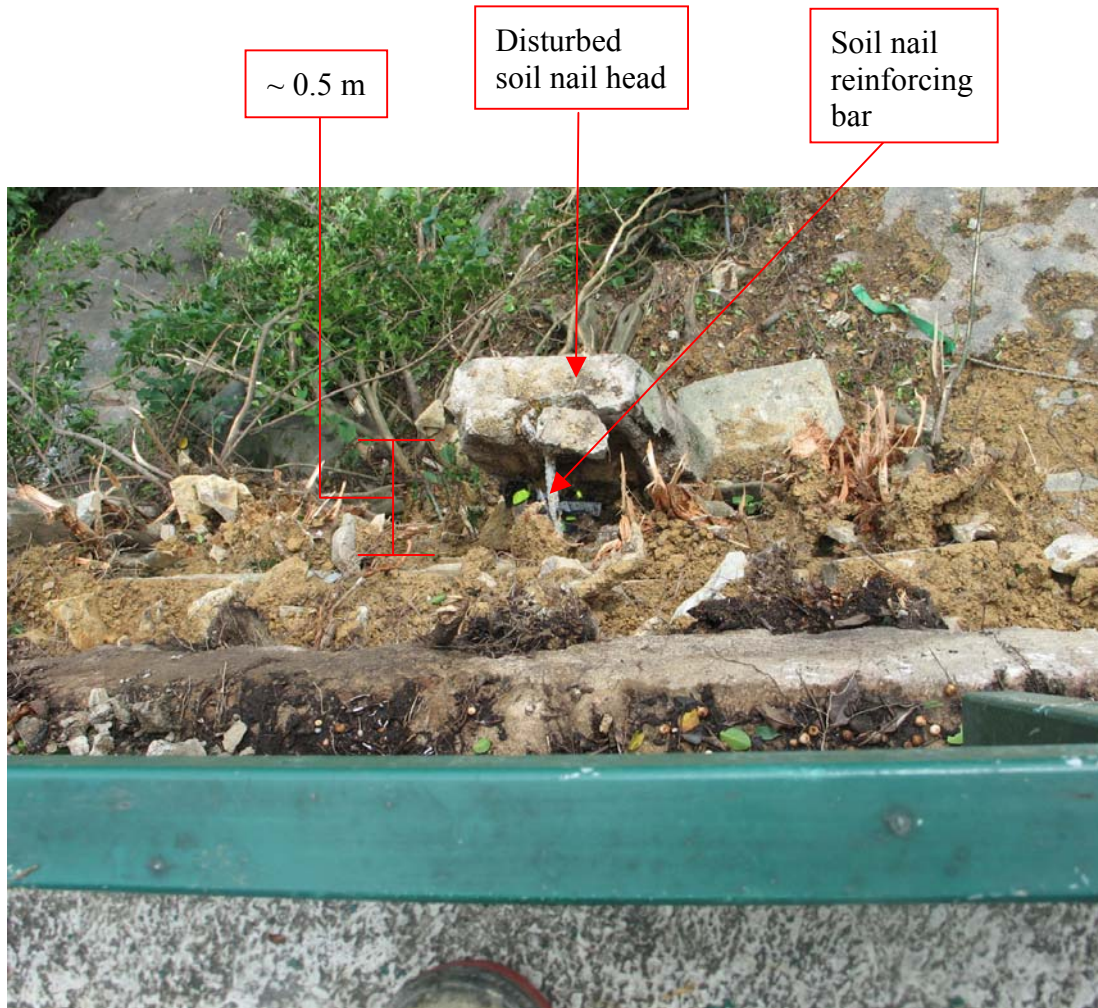
Plate 6 – Soil Nail Head Disturbed by Landslide Incident (View from Top of Retaining Wall) (Photograph taken by GEO on 4 August 2006)

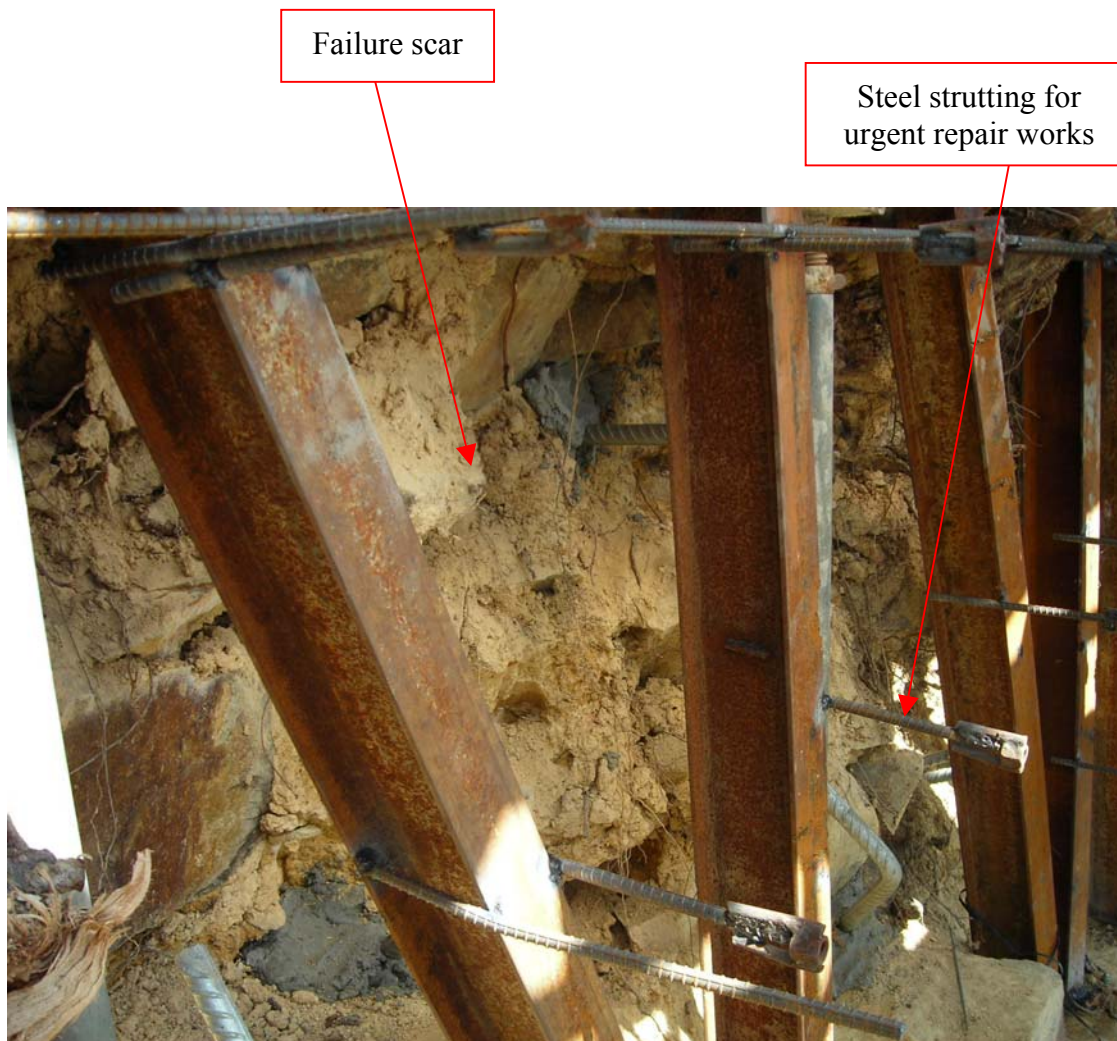
FSW inspected the site on 30 August and 4 September 2006, during which time the urgent repair works were underway. The failure scar (Plate 7) exposed light brown clayey silty sand fill containing gravel- and cobble-sized rock fragments in the upper portion and masonry blocks in the lower portion. Many tree rootlets were also exposed in the fill (Plate 8), as well as the more developed portions of the tree root system growing in the interstices between the masonry blocks. The masonry blocks disturbed by the failure had been removed to provide a stable base for the repair works on the undisturbed blocks below. No signs of seepage were observed on the scar, based on the GEO incident report and during the post-failure inspection by FSW.

Plate 7 – Close View of Failure Scar (Photograph taken on 30 August 2006)

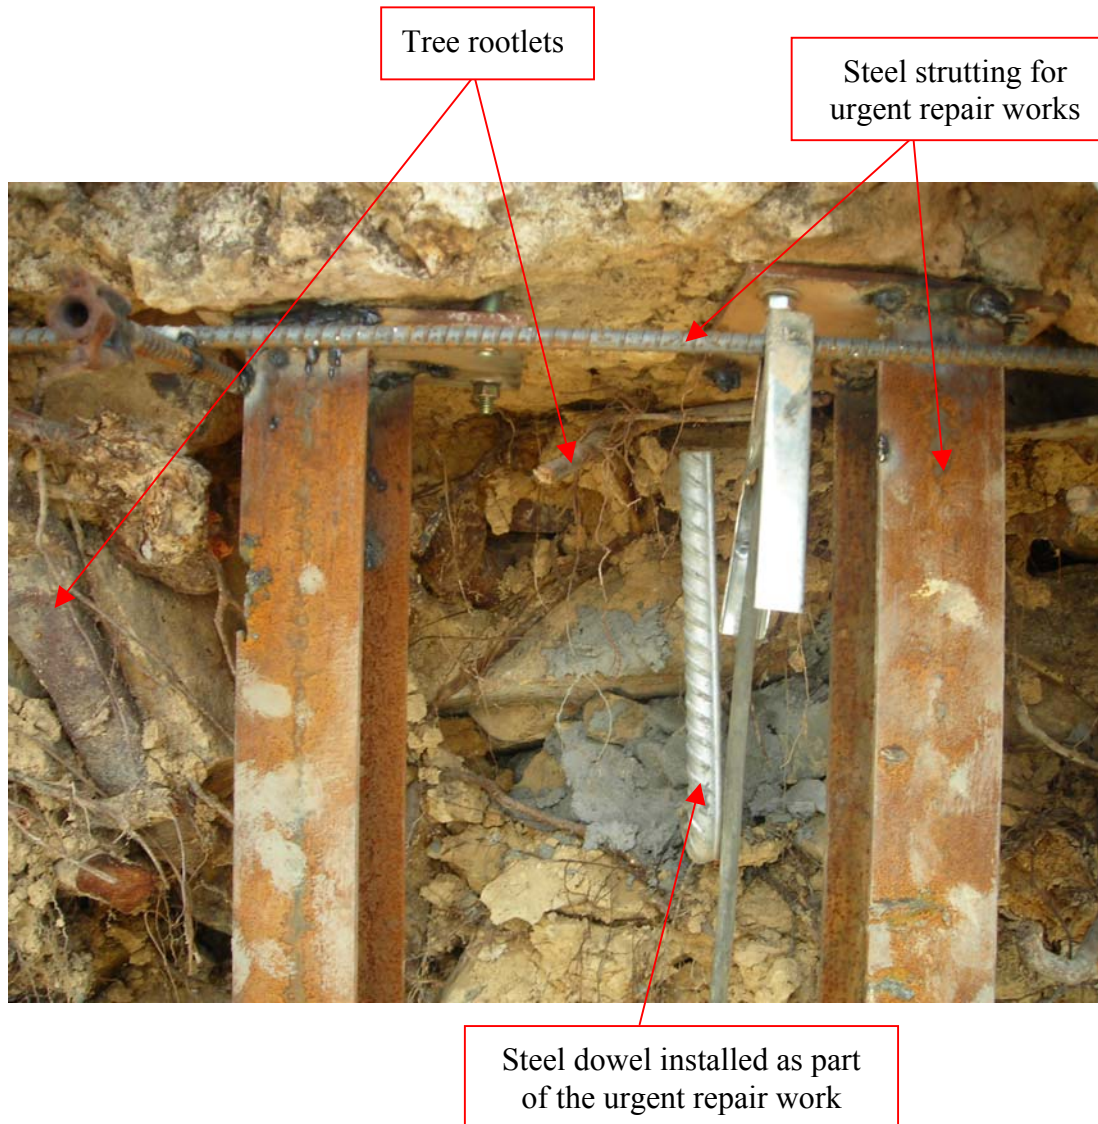
Plate 8 – Tree Rootlets Exposed in Failure Scar (Photograph taken on 30 August 2006)

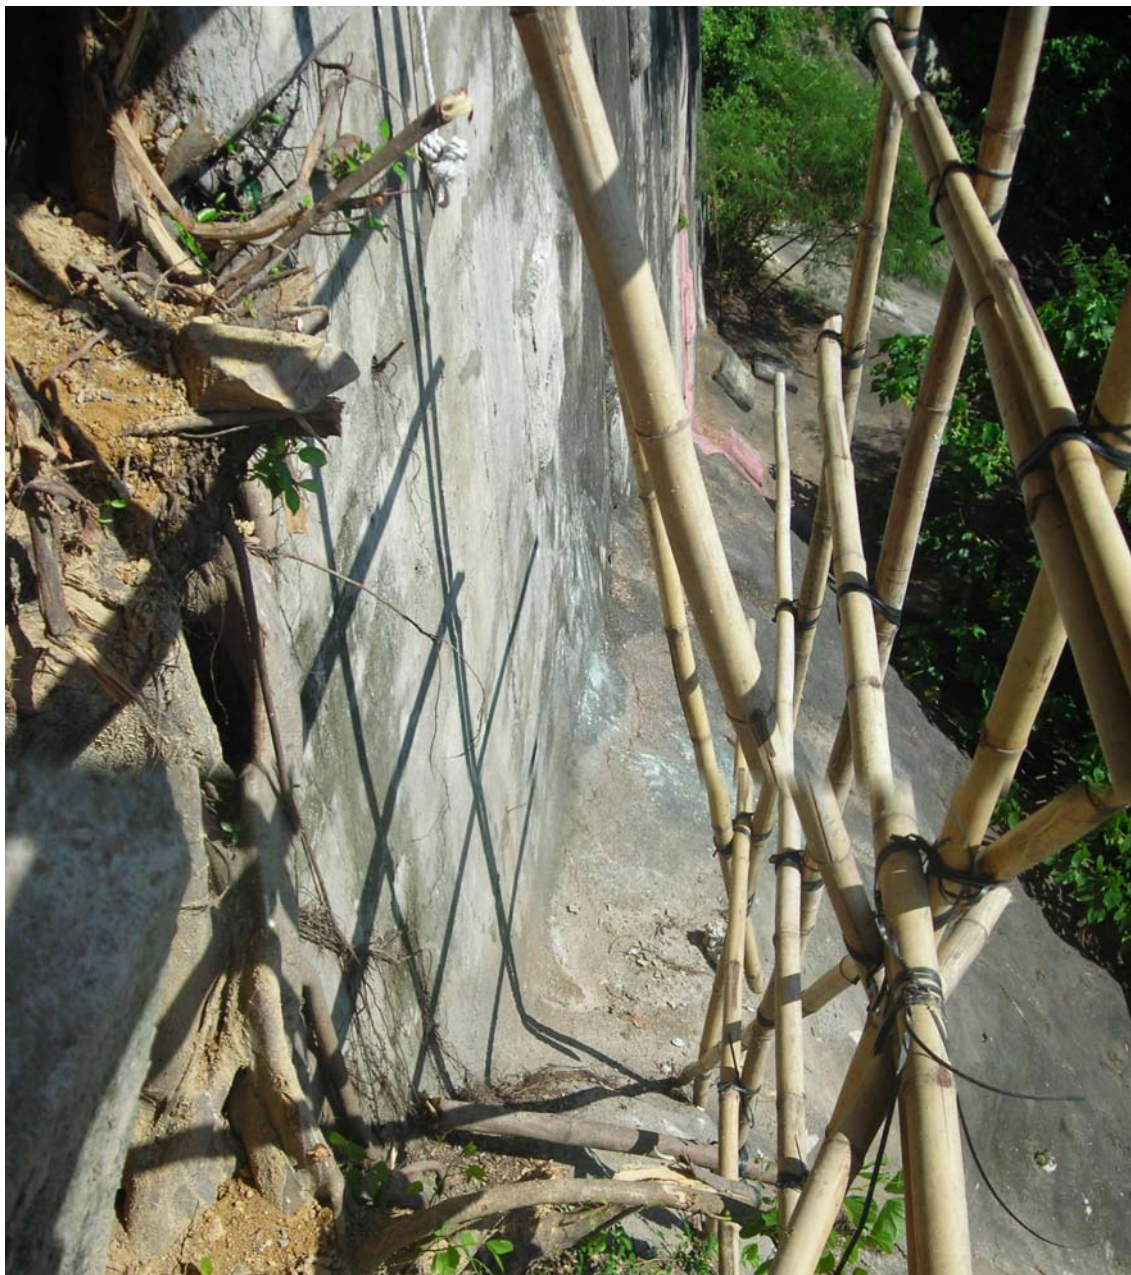
Inspection of the adjacent portions of the retaining wall face and sloping ground at the toe of the wall (Plate 9) identified no obvious signs of distress. Similarly, inspection of the concrete paved driveway and carpark area behind the failure location as well as the parapet wall indicated no obvious signs of distress attributable to the failure.

Plate 9 – General View Across Retaining Wall Portion of Slope No. 11SW-C/FR319
(Photograph taken on 30 August 2006)

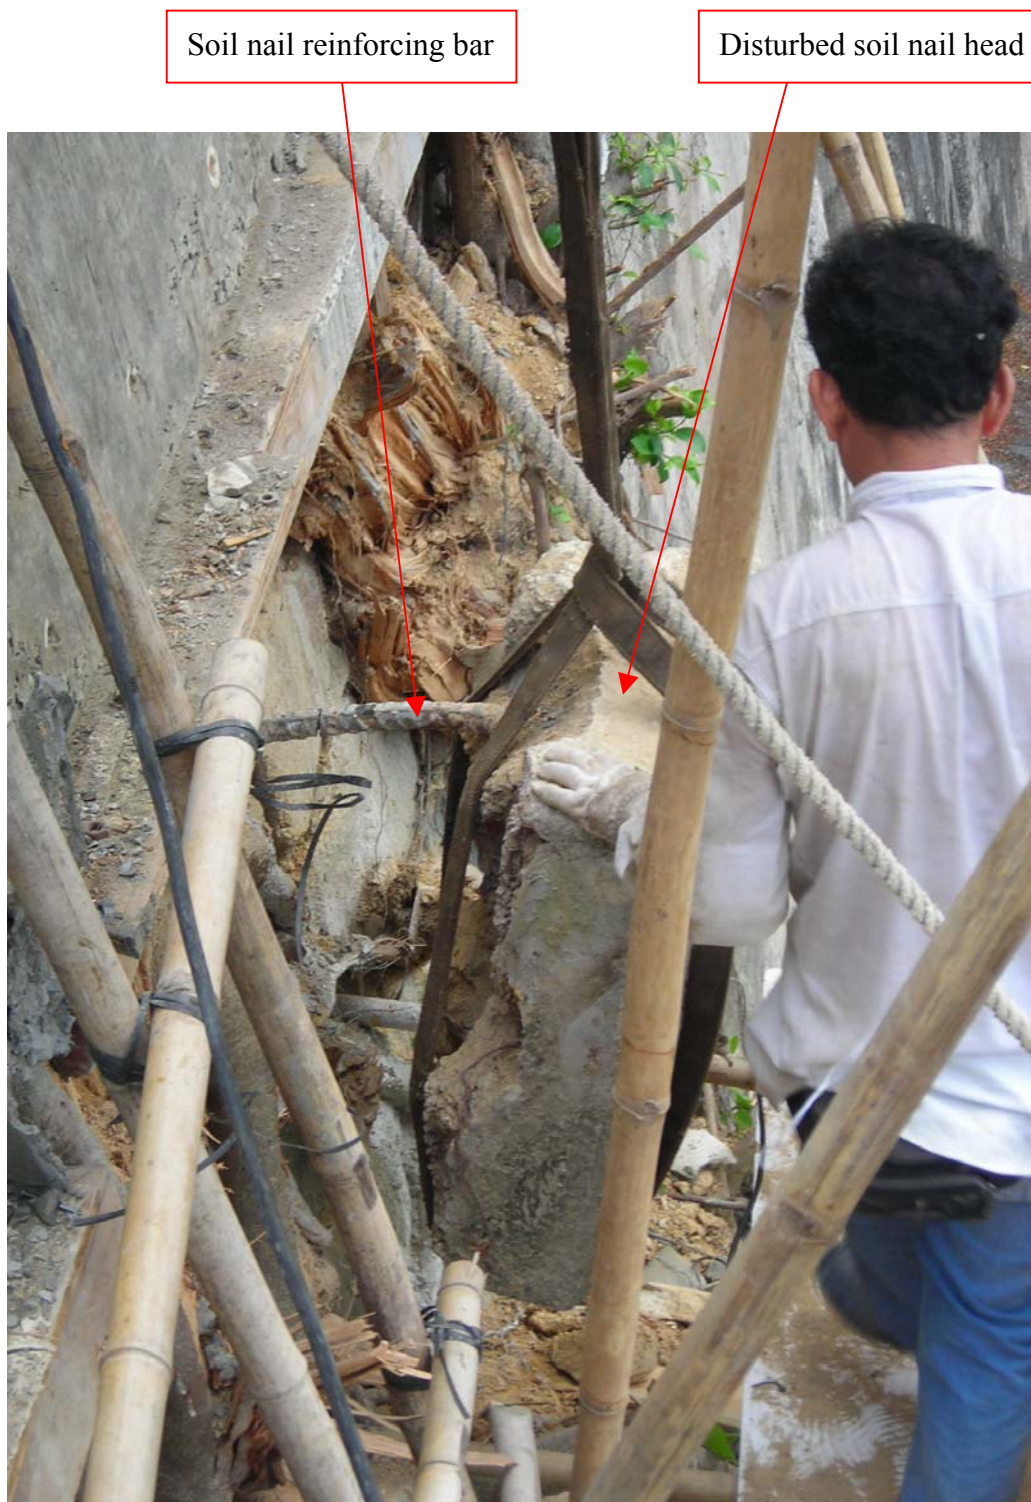
The dimensions of the displaced soil nail head (Plate 10) measured about 0.7 m by 0.7 m by 0.2 m. The corresponding exposed soil nail reinforcing bar, which was inclined at an angle of about 10° below horizontal into the retaining wall face, had been bent downwards locally to an angle of about 15° at about 250 mm behind the soil nail head. The connection between the reinforcing bar and the soil nail head appeared to be intact. No signs of grout surrounding the reinforcing bar were observed over the exposed length or in the soil nail

drillhole. Inspection of the soil nail head and skin wall construction in the general vicinity of the failure scar indicated that the heads had been constructed separately to the skin wall, i.e. a cold joint was present between the perimeter of the nail head and the skin wall.

Plate 10 – Close View of Disturbed Soil Nail Head (Photograph taken on 4 September 2006)

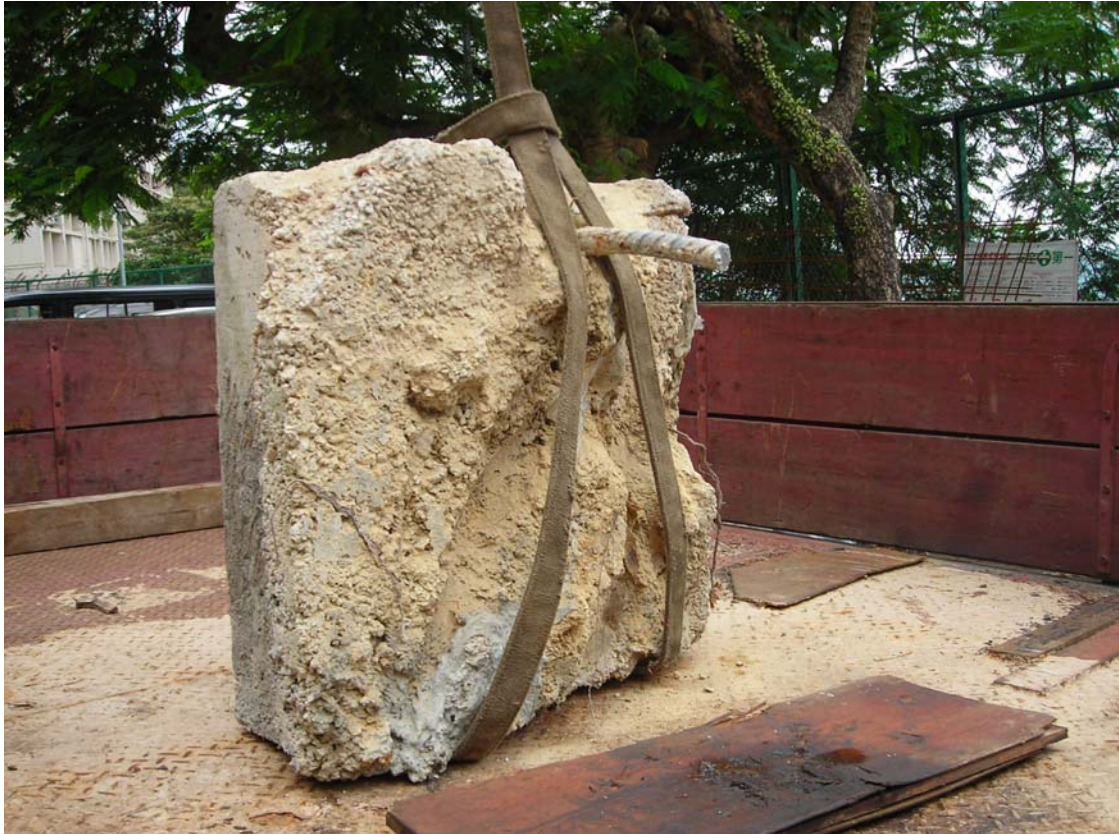
Plate 11 – Soil Nail Head Following Detachment from Reinforcing Bar
(Photograph taken on 4 September 2006)

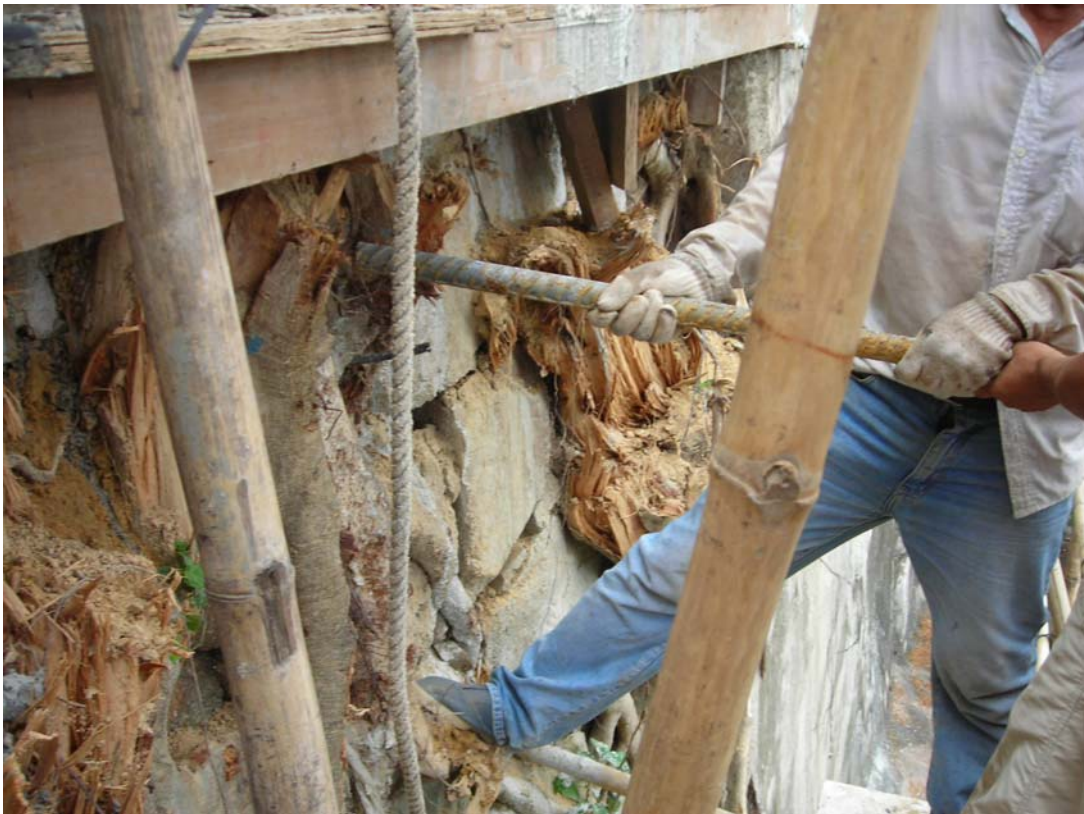
Plate 12 – Manual Removal of Soil Nail Reinforcing Bar (Photograph taken on 4 September 2006)

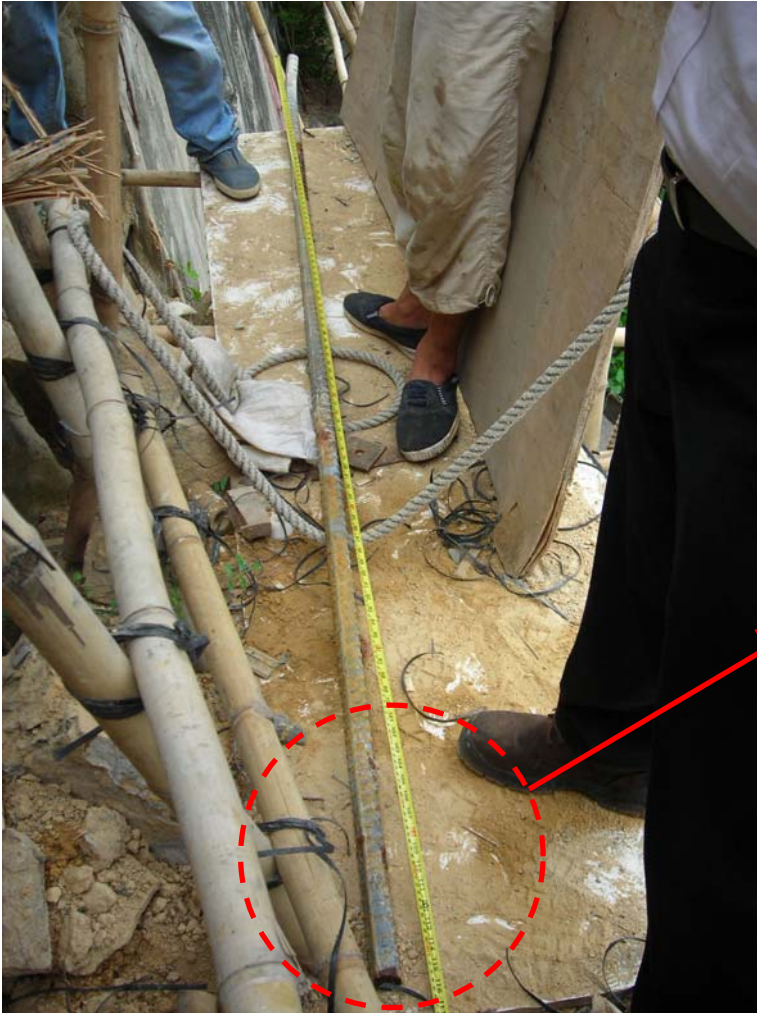
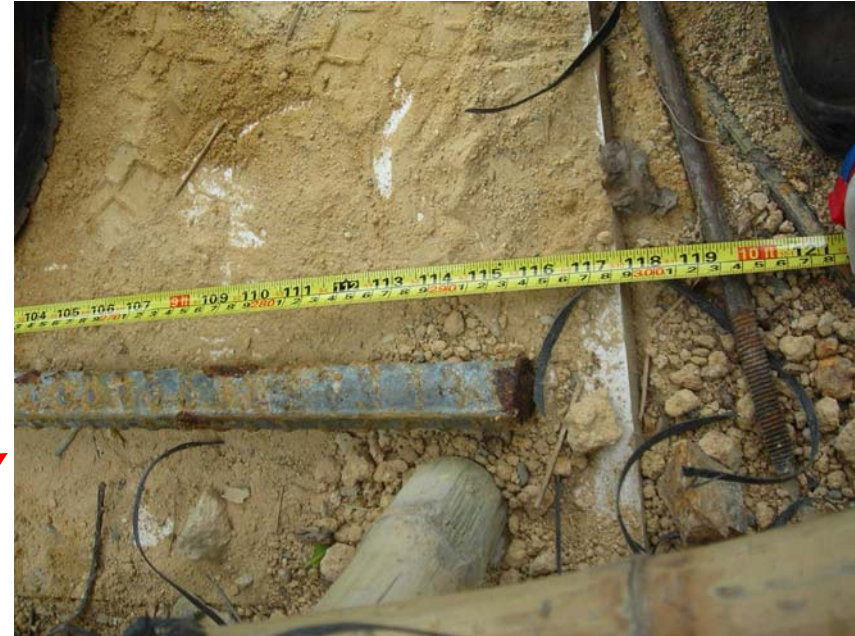
Plate 13 – Exhumed Soil Nail Reinforcing Bar (Photograph taken on 4 September 2006)
