**REVIEW OF THE
3 AUGUST 2006
LANDSLIDE INCIDENT ON
SLOPE NO. 11SW-C/FR319,
NO. 131 POK FU LAM ROAD**

GEO REPORT No. 279

Fugro Scott Wilson Joint Venture

**This report is largely based on GEO Landslide Study Report
No. LSR 2/2008 produced in March 2008**

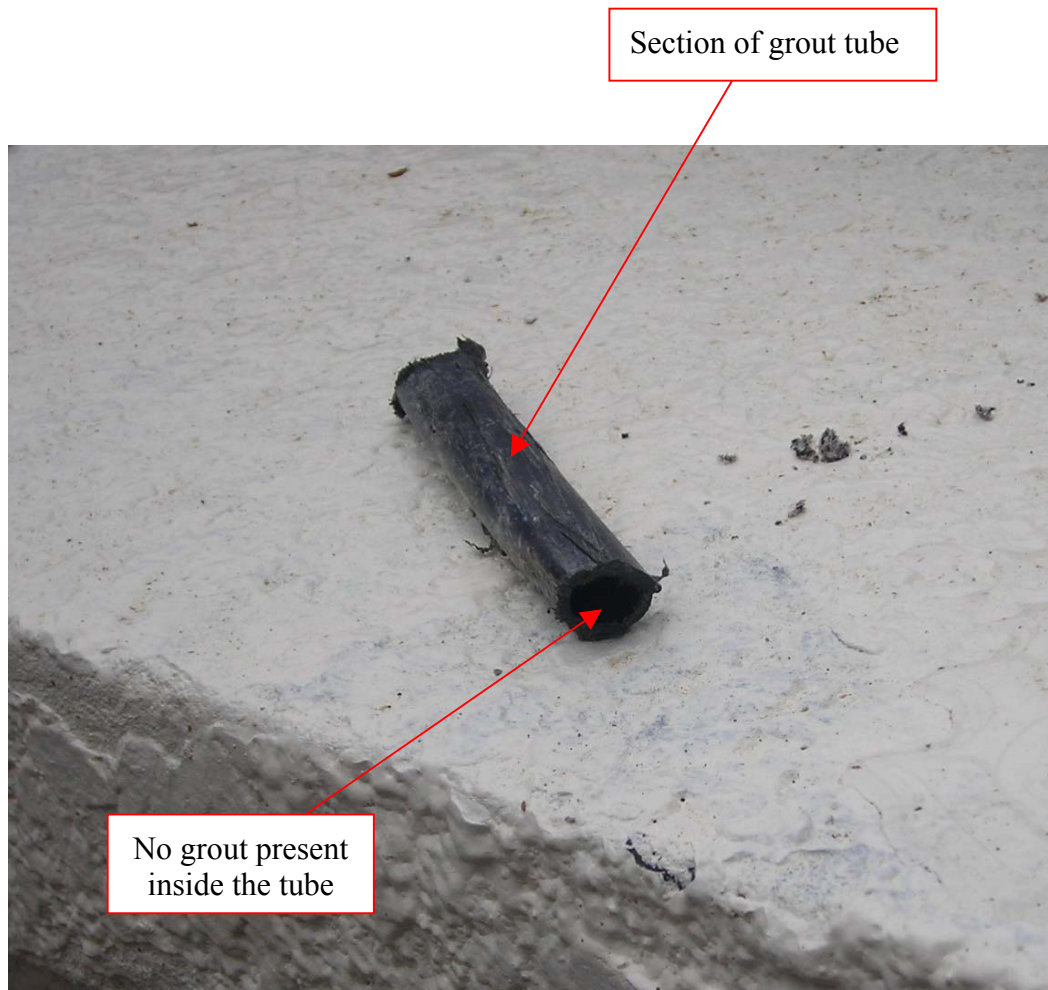
Plate 14 – Section of Grout Tube Recovered from Soil Nail Drillhole (Photograph taken on 4 September 2006)
