**REVIEW OF THE
LANDSLIDE AT SLOPE NO.
2NE-D/C112 AND THE
NATURAL HILLSIDE ABOVE
NEAR TAK YUET LAU
LO WU**

GEO REPORT No. 280

Halcrow China Limited

**This report is largely based on GEO Landslide Study Report
No. LSR 10/2009 produced in November 2009**

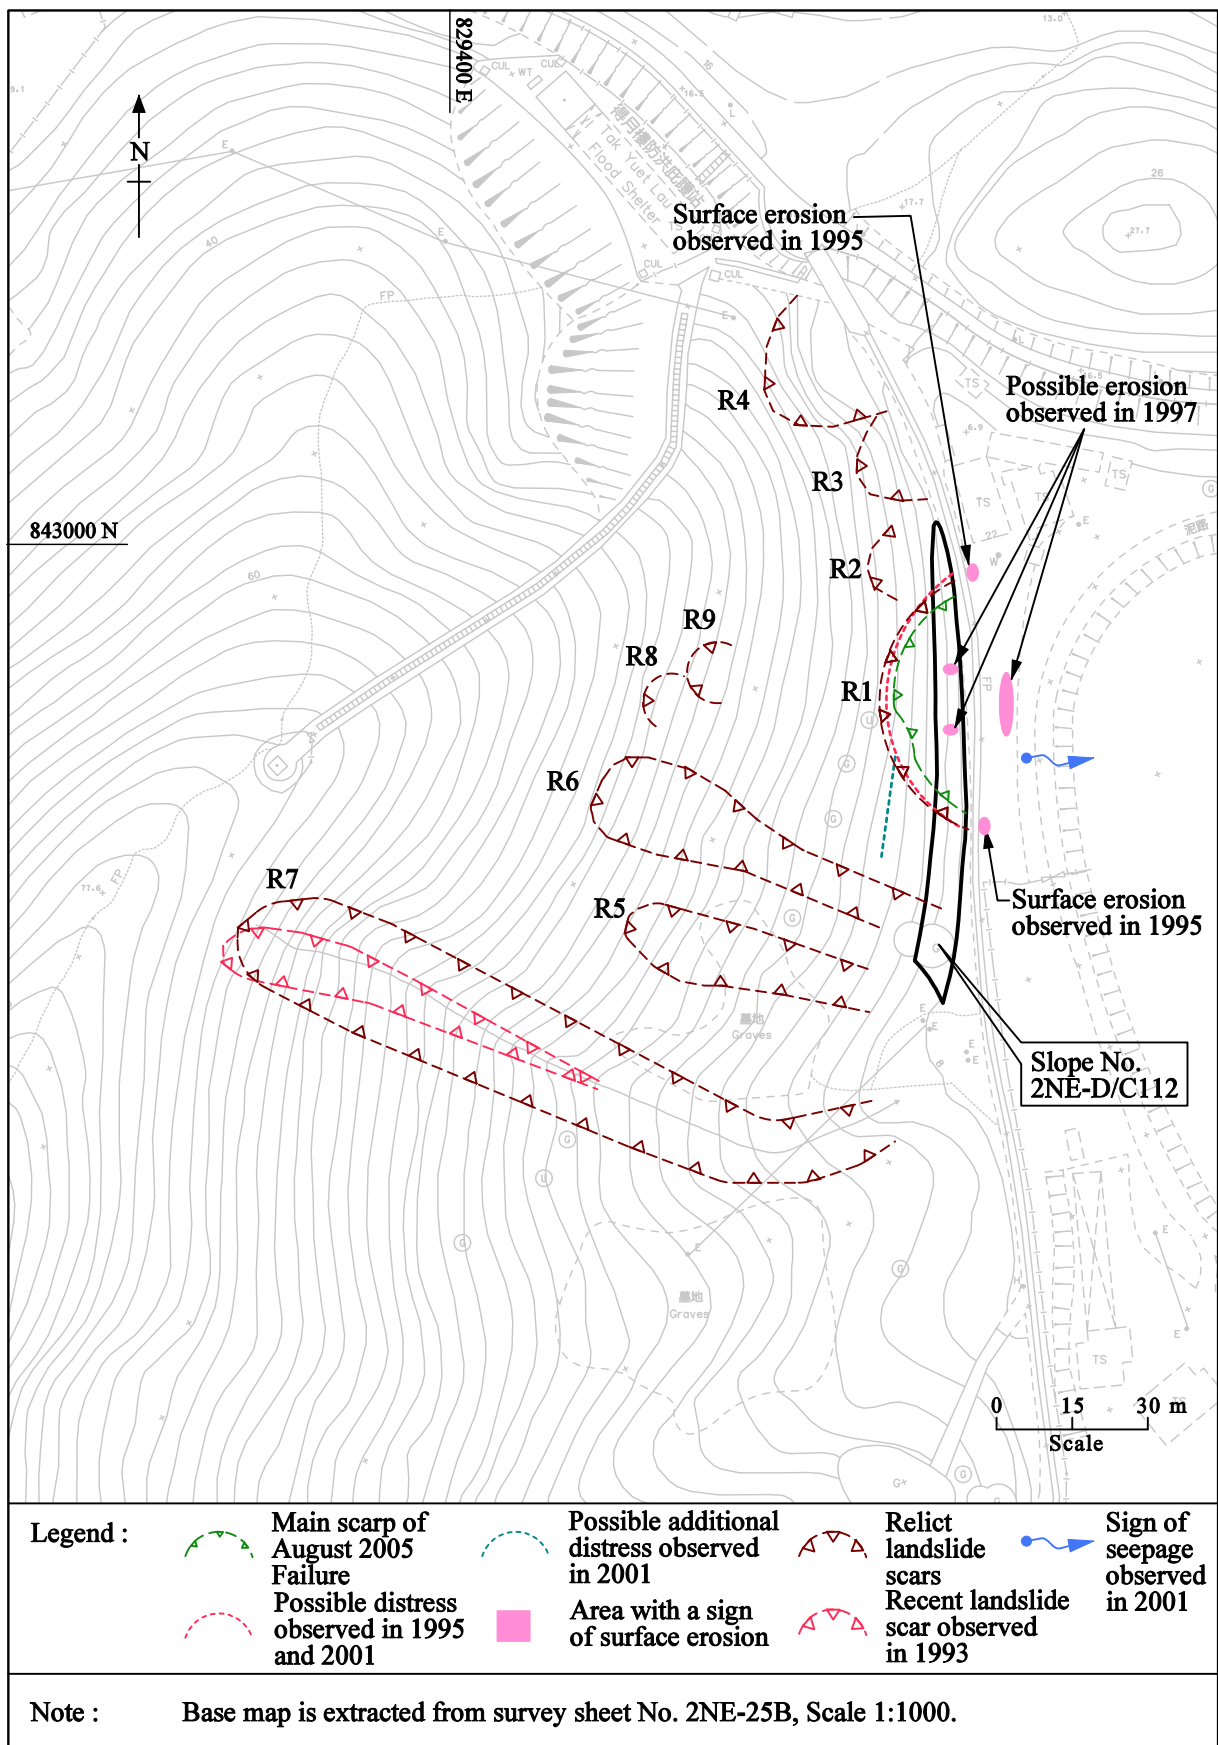
Figure 4 - Past Instabilities

In the 1964 aerial photographs, a number of relict landslides scars (Figure 4 - R1 to R6) were seen within the subject catchment. These relict landslides scars were degraded features evidenced by subtle convex break-in-slope and probably existed prior to 1924. Relict landslide scars R1 to R4 were located at the foothill of the catchment, where more recent colluvium is expected to be accumulated. The other two landslide scars R5 and R6 were located at mid catchment and were close to the head of two preferential drainage paths.

It appears that the location of relict landslide scar R1 was approximately at the same location as the subsequent landslide in August 2005. However, it was noted that the scar was no longer observable in later aerial photographs due to vegetation growth. This may suggest that the landslide scar was relatively shallow. A subtle concave break-in-slope could be observed at the toe of the subject slope, which could be traced further down to the footpath and may represent the downhill limit of movement associated with the relict landslide R1.

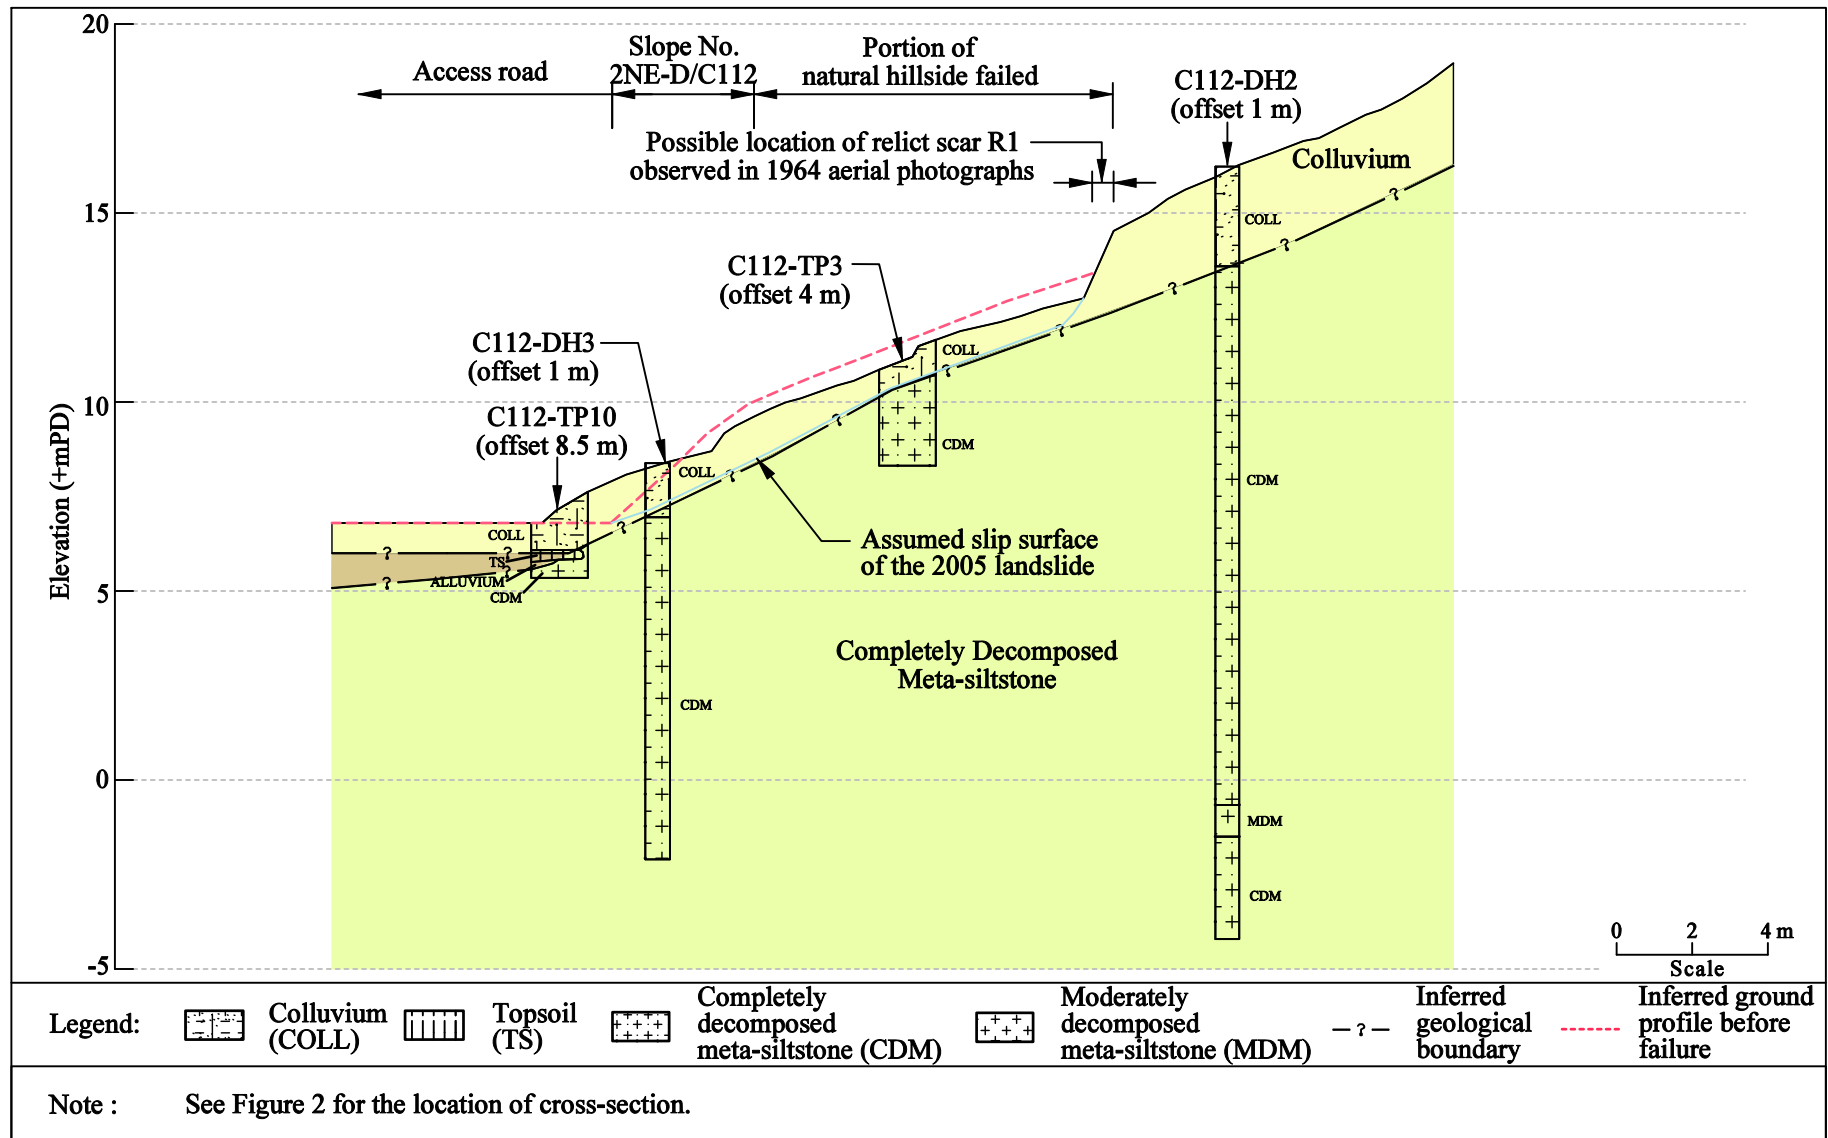
Figure 6 - Section A-A through the 2005 Landslide

No GI works were carried out for the present landslide study. Nevertheless, site-specific GI works were carried out as part of the Stage 3 Study, as noted in Section 4.4 above. A geological model based on the available information was prepared in this study as shown in Figure 6.

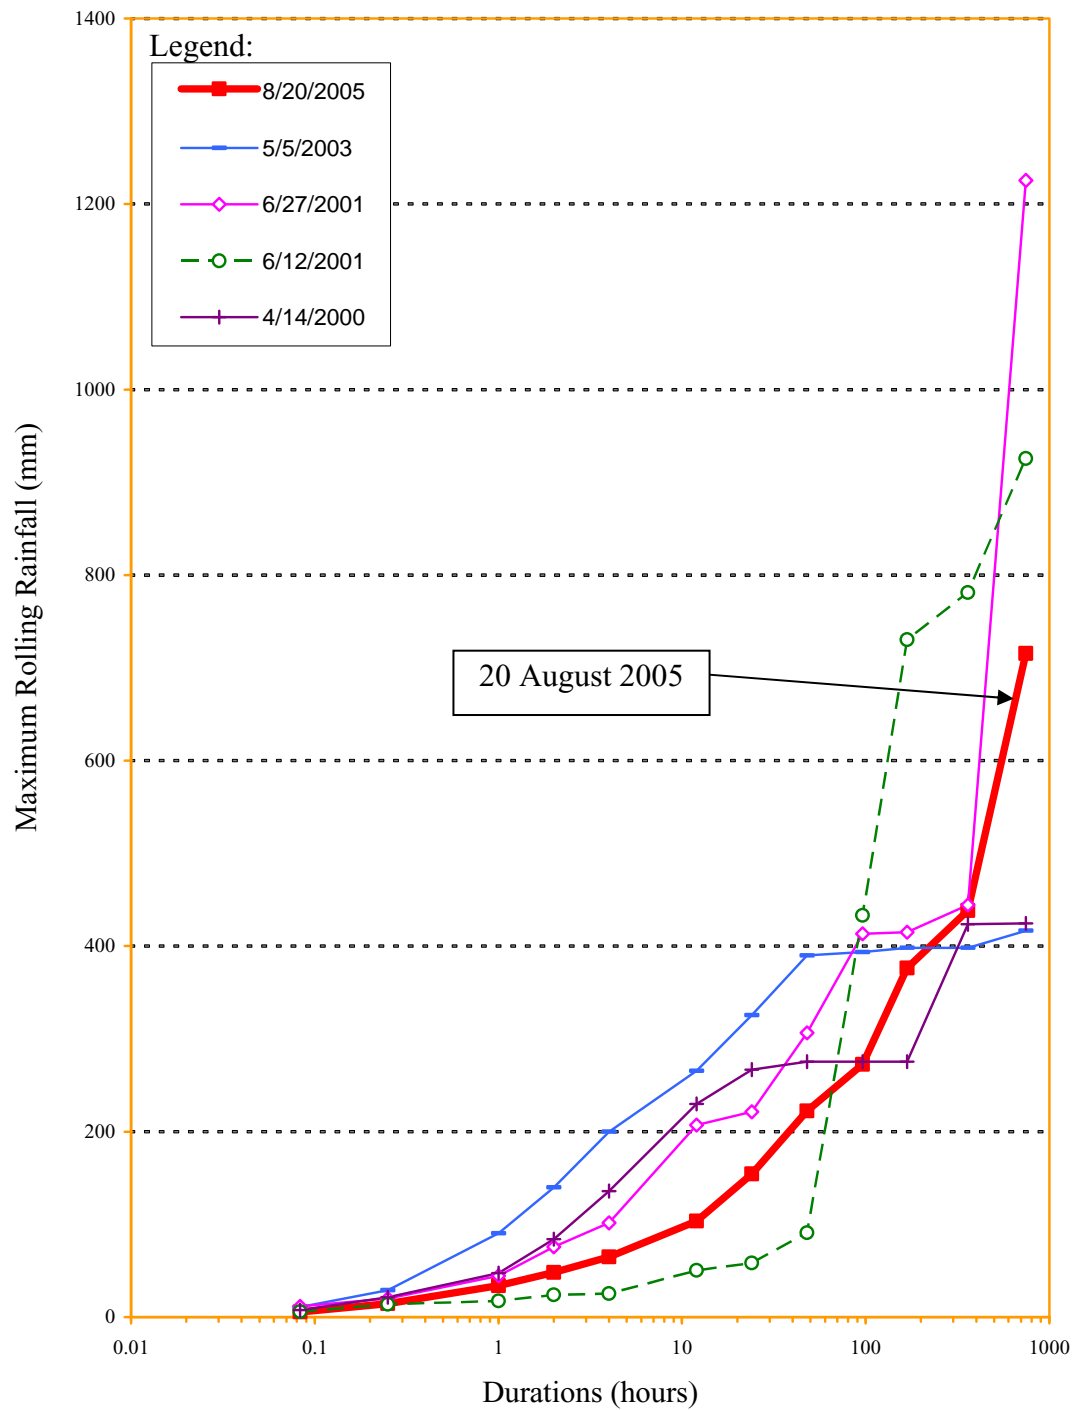
Figure 9 – Maximum Rolling Rainfall for Previous Major Rainstorms at GEO Raingauge No. N34 between 2000 and 2005

A comparison of the maximum rolling rainfall of the 20 August 2005 rainstorm with those of the past major rainstorms between 2000 and 2005 recorded by raingauge No. N34 is presented in Figure 9. It is noted that the rainfall on 20 August 2005 is less severe than the previous major rainstorm.

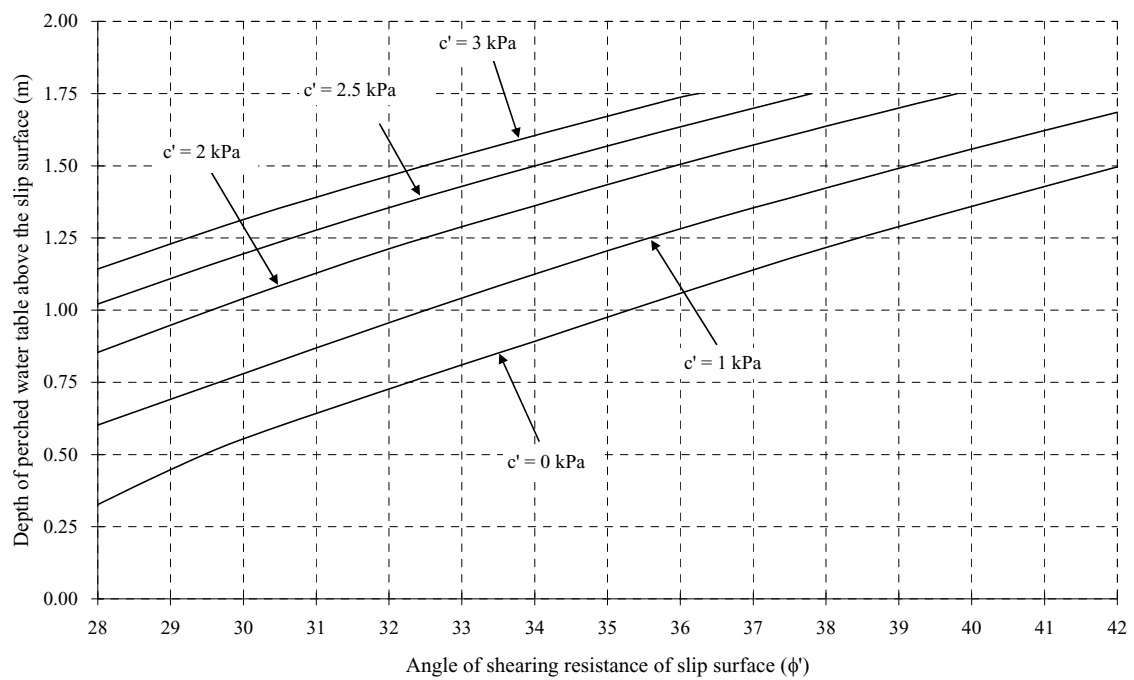
Figure 11 - Results of Theoretical Stability Analyses

The results of the back analyses are summarised in Figure 11. The results indicate that with the “best fit” shear strength parameters derived from the triaxial tests (i.e. $c' = 2.5$ kPa and $\phi' = 37^\circ$) for the colluvium, together with a perched water level of 1.7 m above the slip surface (close to ground surface), failure could occur. However, if the shear strength parameters of the colluvium are reduced to the lower bound value of $c' = 0$ kPa and $\phi' = 33^\circ$, which are close to the shear strength parameters of the remoulded samples ($c' = 0$ kPa and $\phi' = 32^\circ$) taken from the distressed material (FHK, 2007), a perched water table of 0.8 m (i.e. about 0.9 m below the ground surface) would be sufficient to initiate failure.

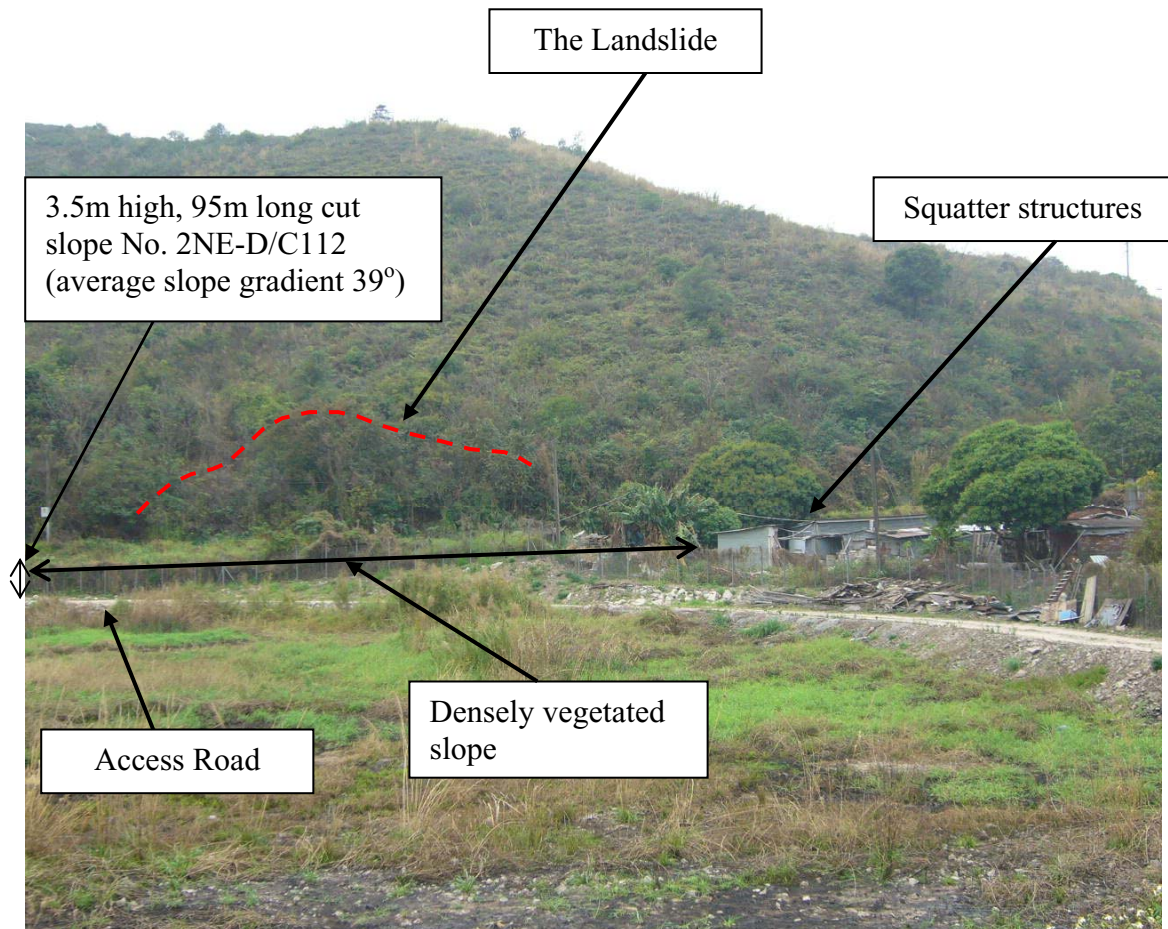
Plate 1 – General View of the Landslide Site

A major landslide (Incident No. 2006/01/0570), which occurred at slope No. 2NE-D/C112 and the natural terrain above, near Tak Yuet Lau, Lo Wu (Figure 1 and Plate 1), was reported by the District Office (DO) on 19 January 2006. According to the GEO Incident Report, the failure occurred in August 2005 but the exact date and time of failure was unknown. The landslide involved a failure volume of about 550 m³. The majority of the debris remained within the landslide area, and some debris came to rest within a 500 mm wide trench adjoining a footpath at the toe of the slope. No casualties or closure of the footpath were reported as a result of the incident.

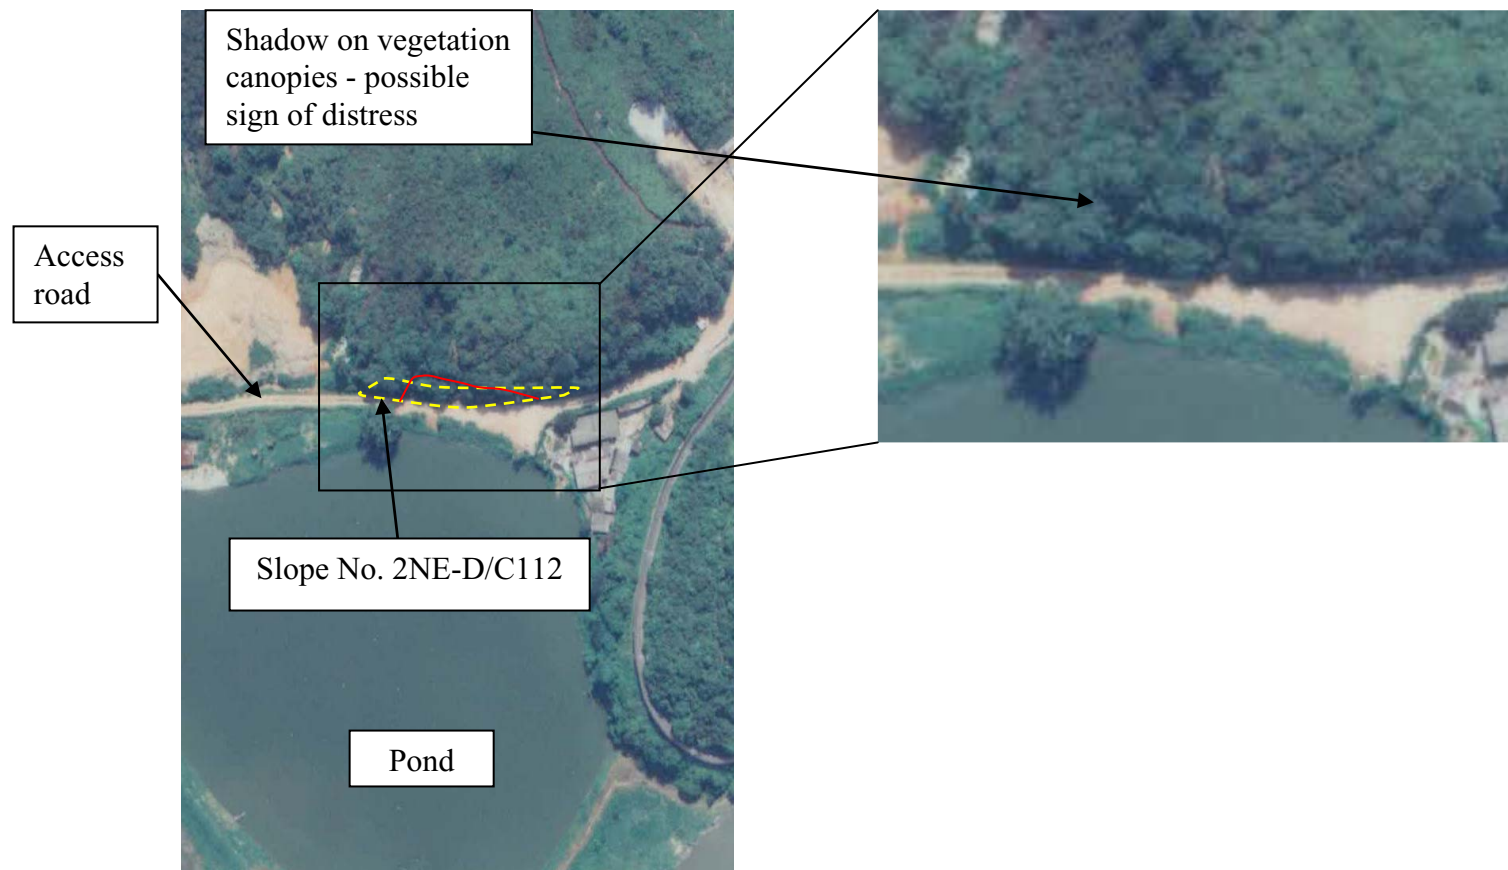
Plate 4 – Distress Observed in 1995 Aerial Photograph

In 1995, a curvilinear shadow in the tree canopy was observed at the subject slope, extending 10-20 m above the slope crest (Plate 4). This shadow may be associated with the tilting of trees, steps on the ground created by distress or could be the presence of a footpath. Two patches of bare soil were visible on the slope below the access path immediately in front of the subject slope, which may be associated with erosion or instabilities.

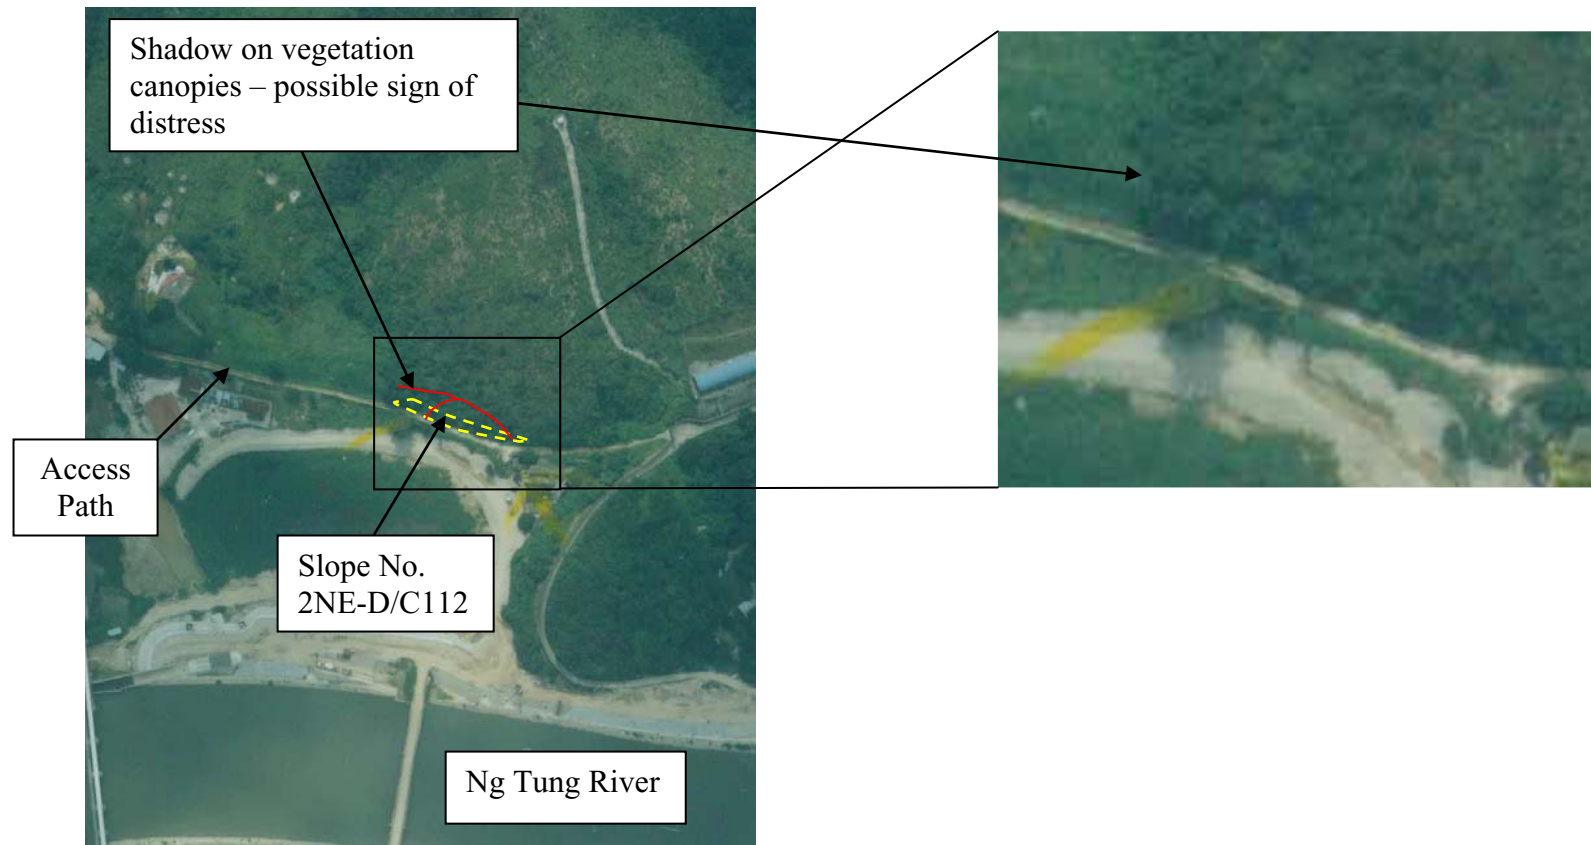
Plate 5 – Distress Observed in 2001 Aerial Photograph

No significant sign of erosion or instability were visible since 1997 except that in 2001 the curvilinear shadow in the tree canopy, as previously observed in 1995, was again visible but with an additional linear shadow extending further to the south (Plate 5).

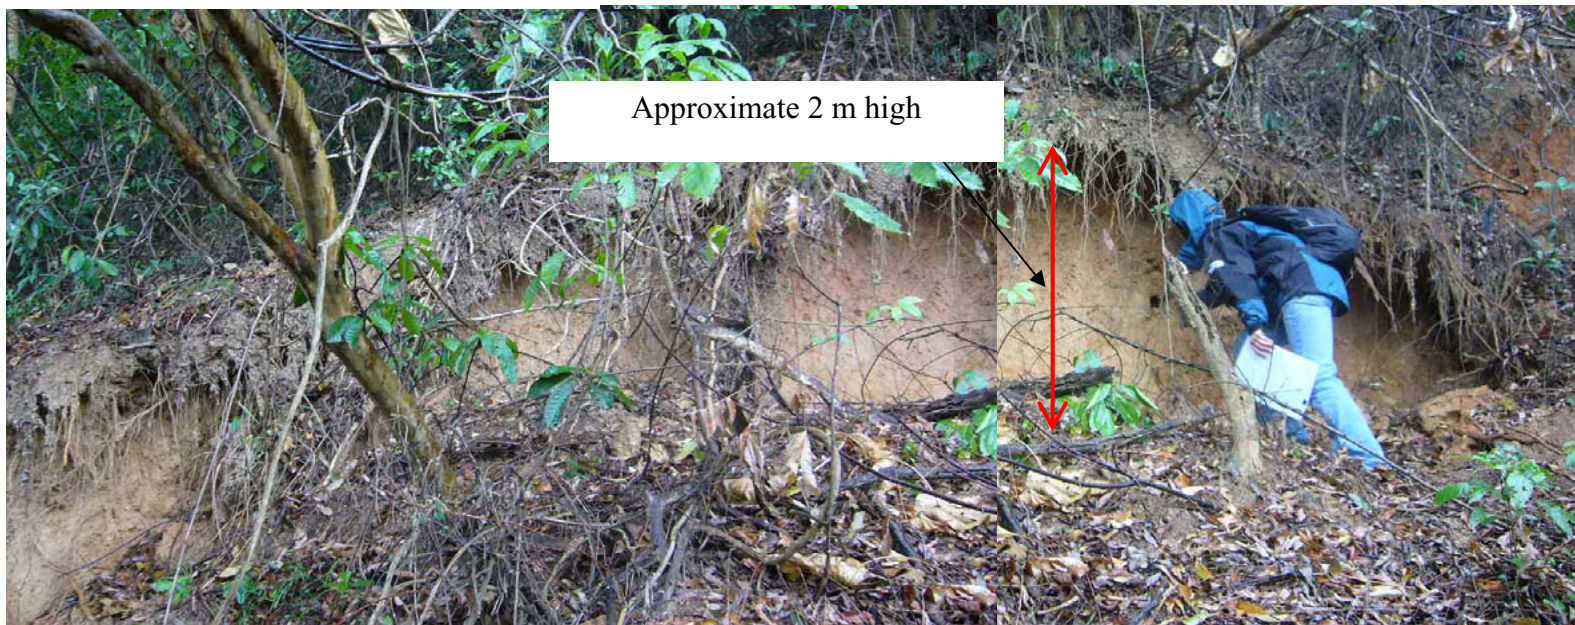
Plate 6 – View of the Soil Portion at the Main Scarp

Based on MGSL's inspection record, the main scarp was about 2 m high where mainly colluvium was exposed (Plate 6). The central and southern portions of the main scarp comprised mainly dense, yellowish brown slightly silty fine to coarse sand with some gravels and cobbles, whereas many cobble sized rock fragments were exposed at the northern main scarp. The central portion of the upper part of the main scarp (Figure 6) possibly is the location of relict landslide scar R1 observed in 1964 aerial photographs.

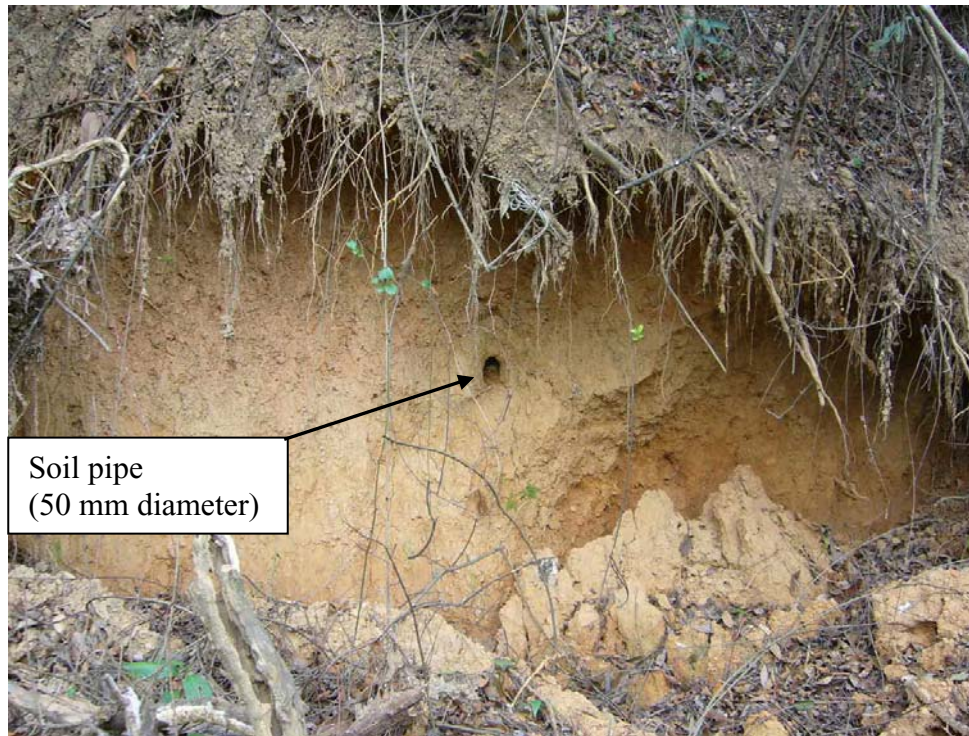
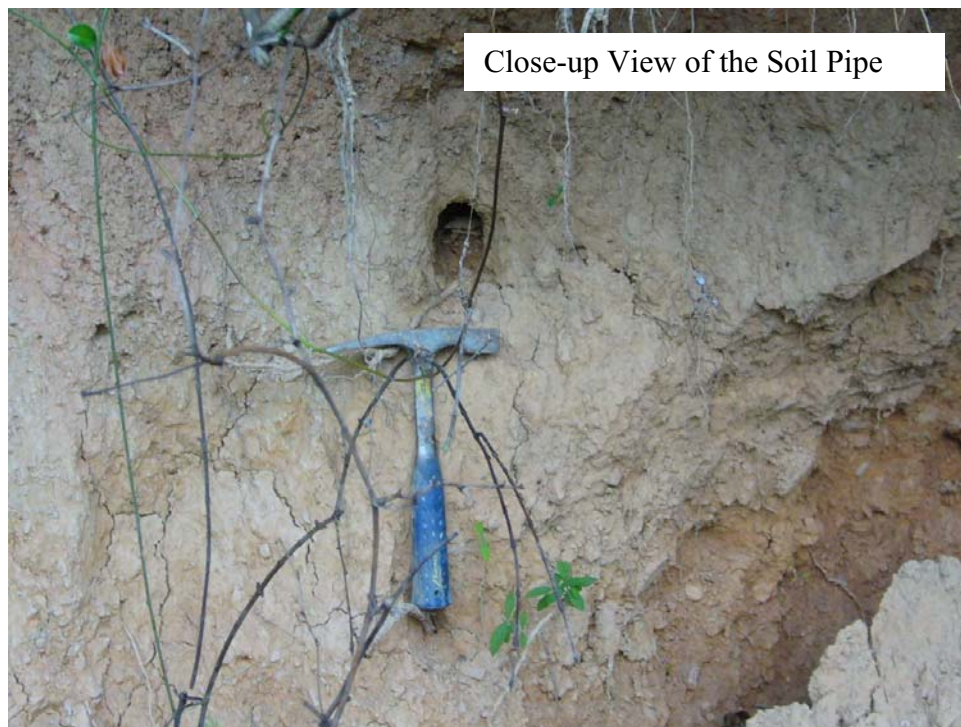
Plate 7 – View of Soil Pipe in Scarp within Colluvium

The Stage 3 Report noted that, considering the relative permeability of the colluvium and CDM beneath and the presence of soil pipes within the layer of colluvium in the landslide scar (see Section 5.2 below), the 2005 landslide might be caused by the build-up of a perched water table in the colluvium layer. A sensitivity analysis showed that the factor of safety against failure is less than one when a 1.5 m of groundwater is perched on the top of the CDM within the colluvium layer. The report concluded that the landslide occurred mainly in the colluvium layer.

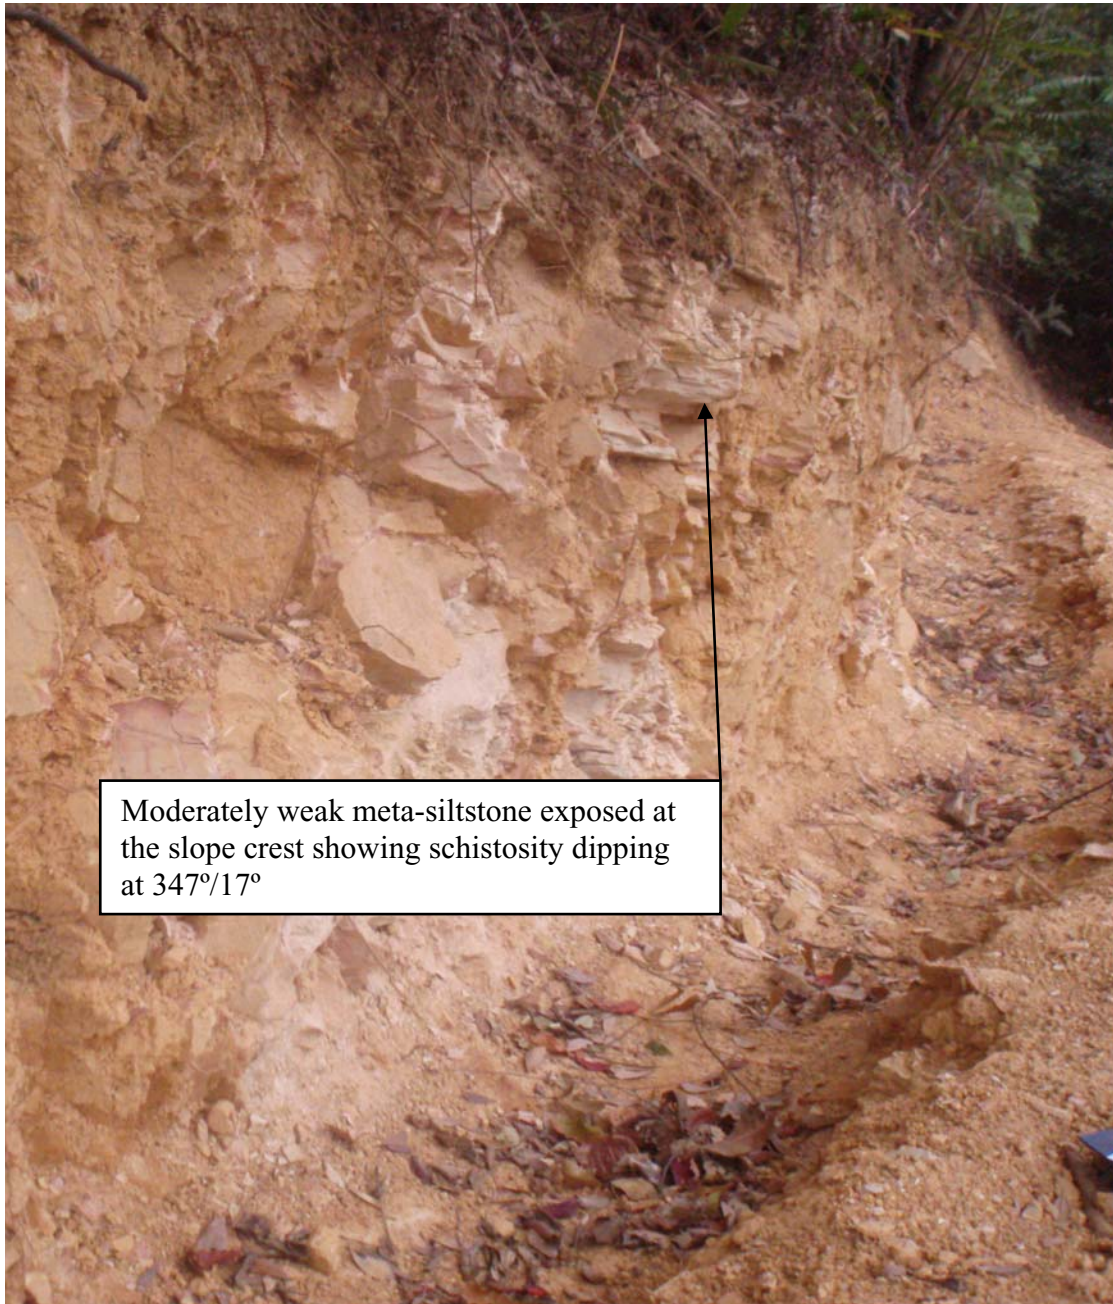
Plate 9 – Schistosity Observed at Slope Crest during Site Visit on 7 November 2007

scars, i.e. the tension cracks and the break in slope, had already been removed and the slope surface was generally covered with a thin veneer of loosened soil. At the crest of the newly trimmed slope, a small ditch had been excavated for the construction of a crest channel. Inspection of the temporary cut face alongside this ditch revealed the presence of colluvial soil. A soil pipe was observed in the cut face, which was 100 mm in diameter with a measured depth of 470 mm (Plate 8). This soil pipe appeared similar to the other soil pipes recorded in MGSL's inspection record. An exposure of in-situ material, comprising moderately weak to weak, light yellowish brown, slightly metamorphosed siltstone (metasiltstone), was observed in the cut face of the ditch. Extremely closely spaced jointing appeared to run parallel to the foliation of the in-situ material and was measured as having an orientation of $347^{\circ}/17^{\circ}$ (Plate 9).

Moderately weak meta-siltstone exposed at the slope crest showing schistosity dipping at 347°/17°

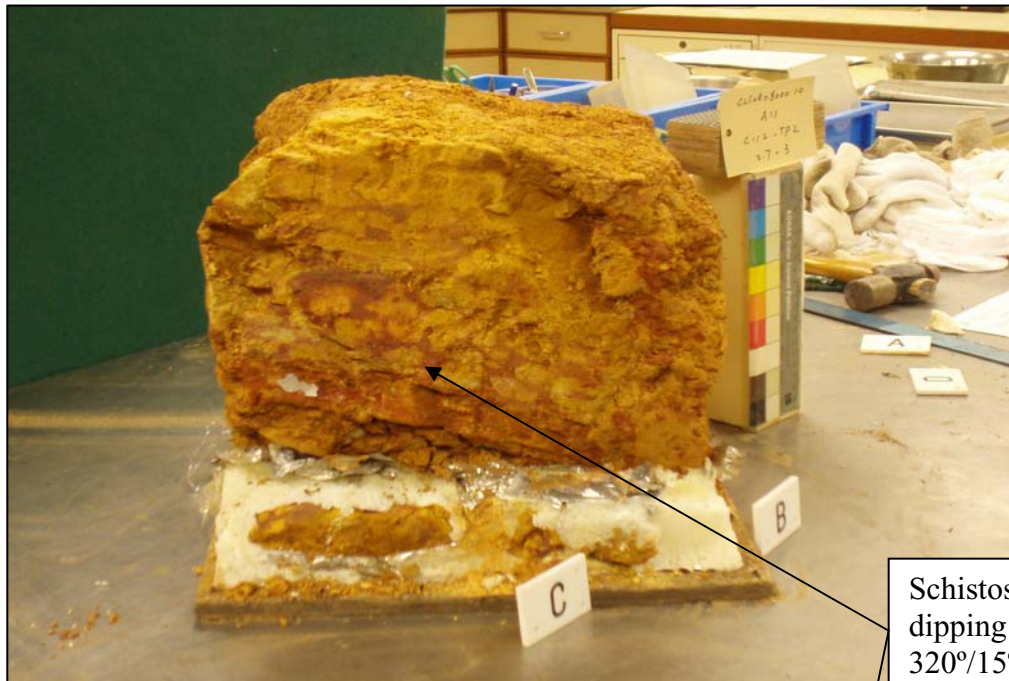
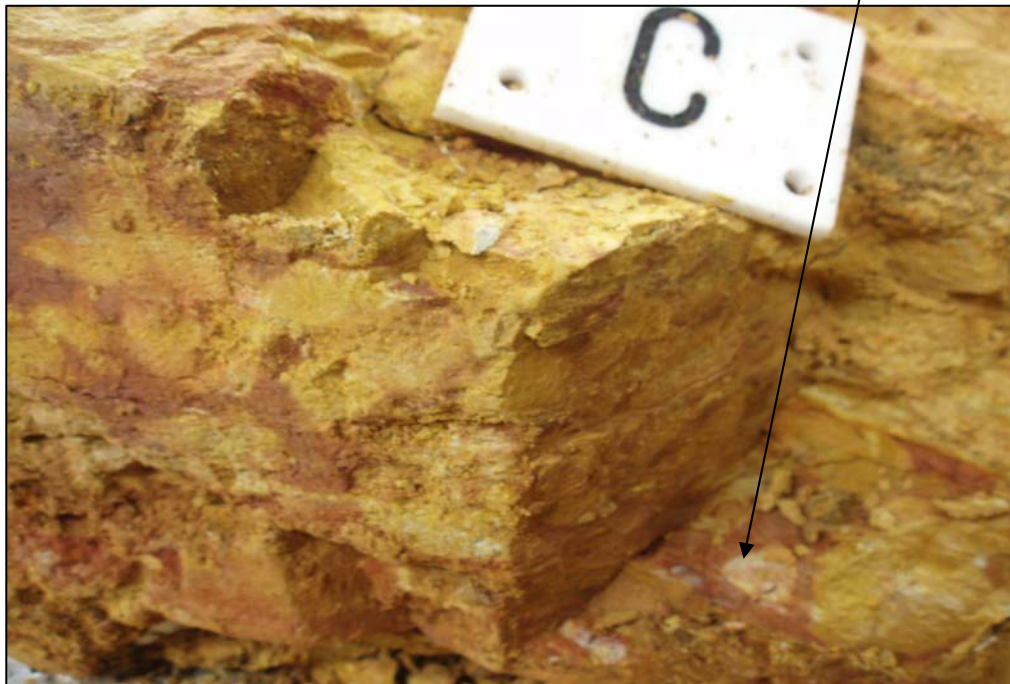
Plate 10 - Schistosity Identified in Block Sample Taken in TP2 at Depth 2.7 m to 3.0 m
(Sample Taken by Vibro (HK) Ltd. during LPM Study in 2006)

The foliation appeared to be low-persistence relict discontinuities with an orientation of $320^{\circ}/15^{\circ}$ (Plate 10). Sub-vertical and slightly inclined joints commonly infilled with firm silt were also observed in the decomposed metasiltstone. The dip direction and dip angle of the sub-vertical relict joints was typically about $125^{\circ}/80^{\circ}$. None of the discontinuities were adversely orientated.

Schistosity
dipping at
320°/15°
