# **TSING SHAN DEBRIS FLOW AND DEBRIS FLOOD**

**GEO REPORT No. 281**

This GEO Report consists of two Landslide Study Reports on the “Tsing Shan Debris Flow and Debris Flood” (LSR 2/2001) and “The 2000 Tsing Shan Debris Flow” (LSR 3/2001).

# **SECTION 1: THE 1990 TSING SHAN DEBRIS FLOW**

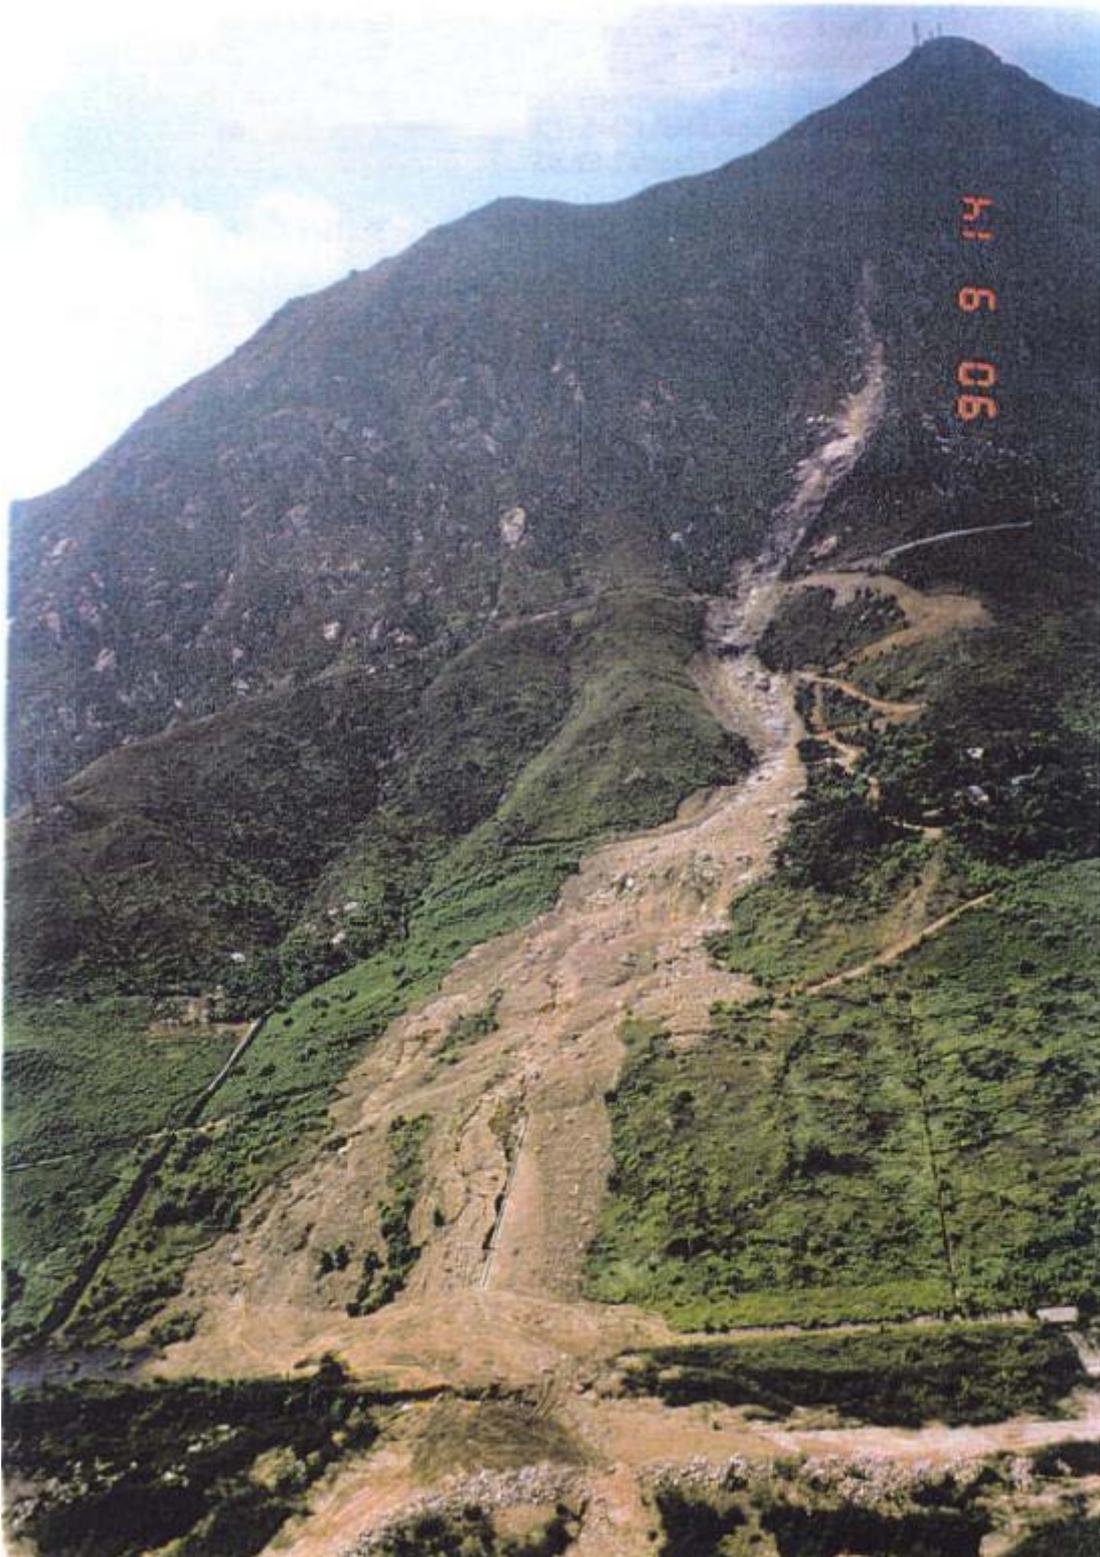
MW 90191C-12

Plate 1 - Overall View of Tsing Shan Debris Flow 14.9.90

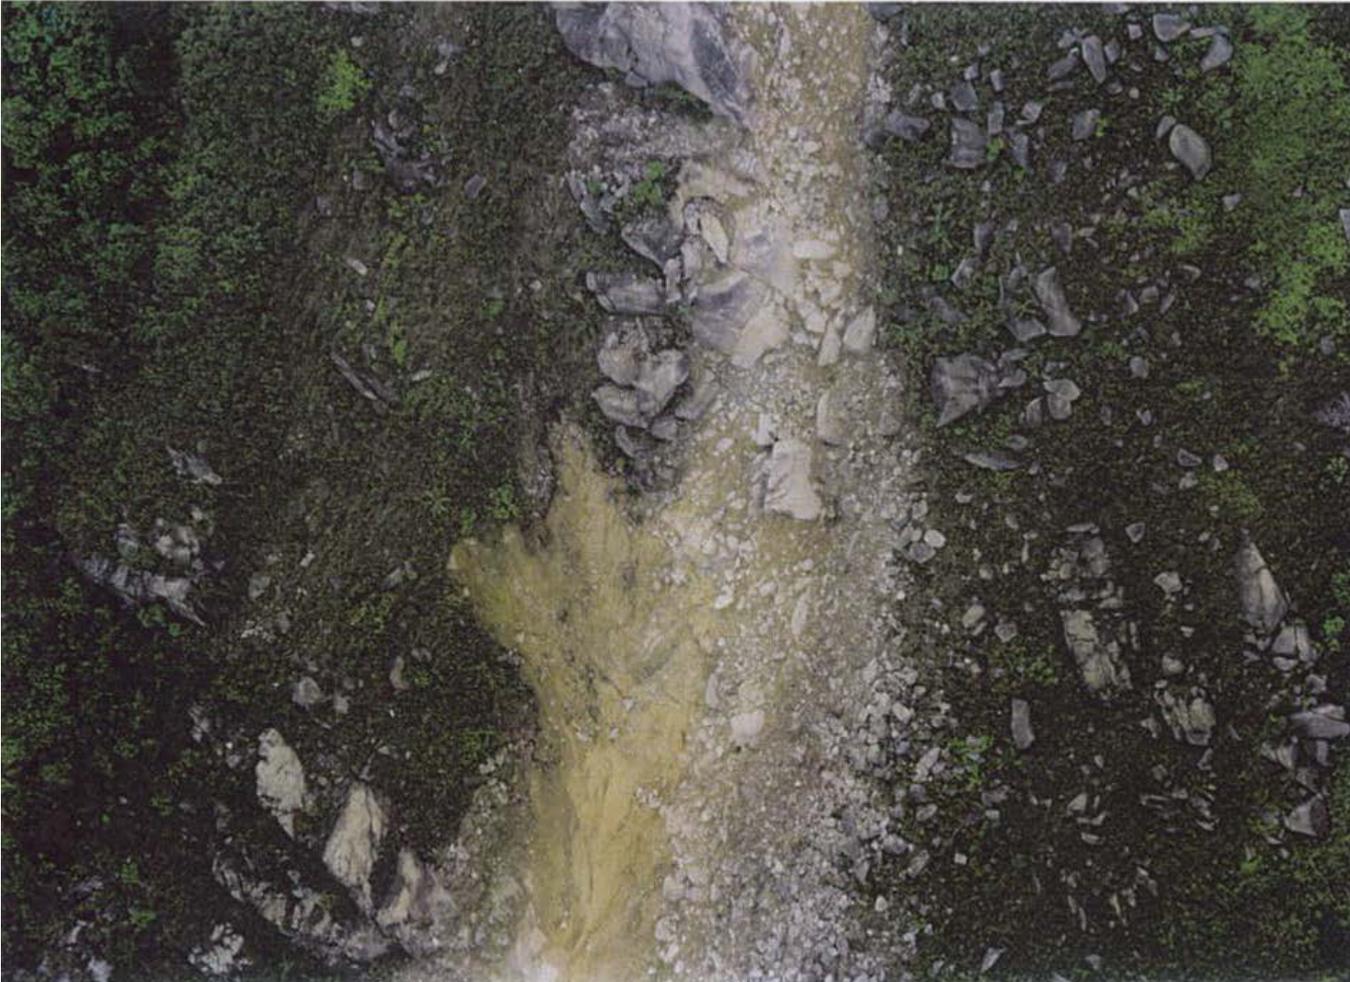
PS 688-5

Plate 5 - Parent Landslide. Note CDG and Loose Bouldery Deposits

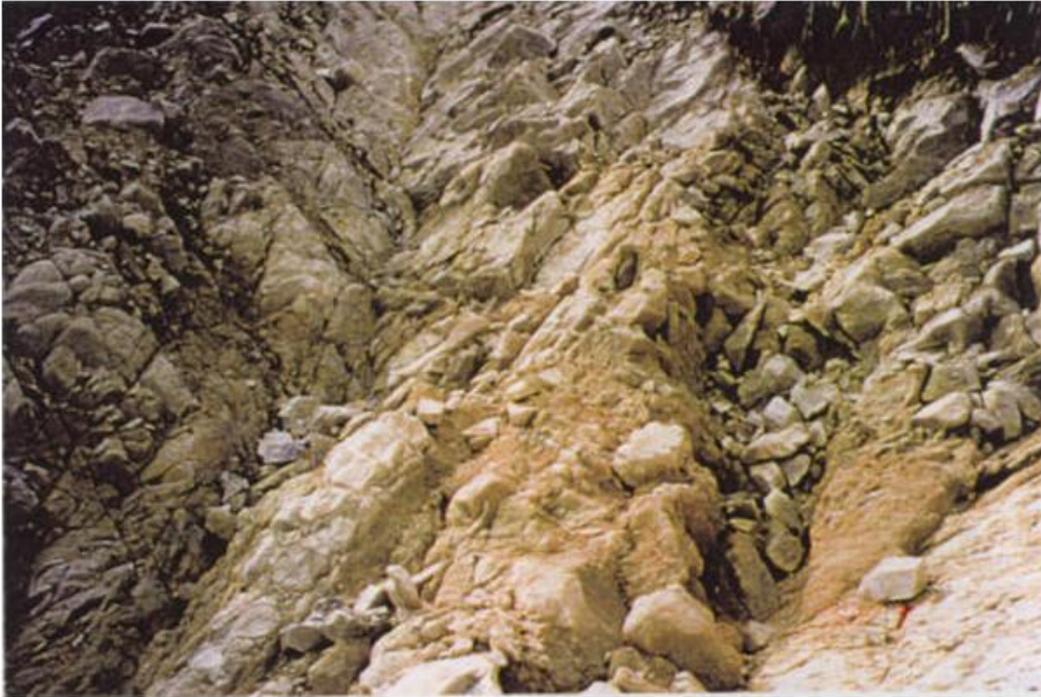
MW 90185-22

Plate 22 - Decomposed Granite at Toe of V-shaped Gully (Ch 38). Similar Material Could Have Filled the Gully Prior to Failure

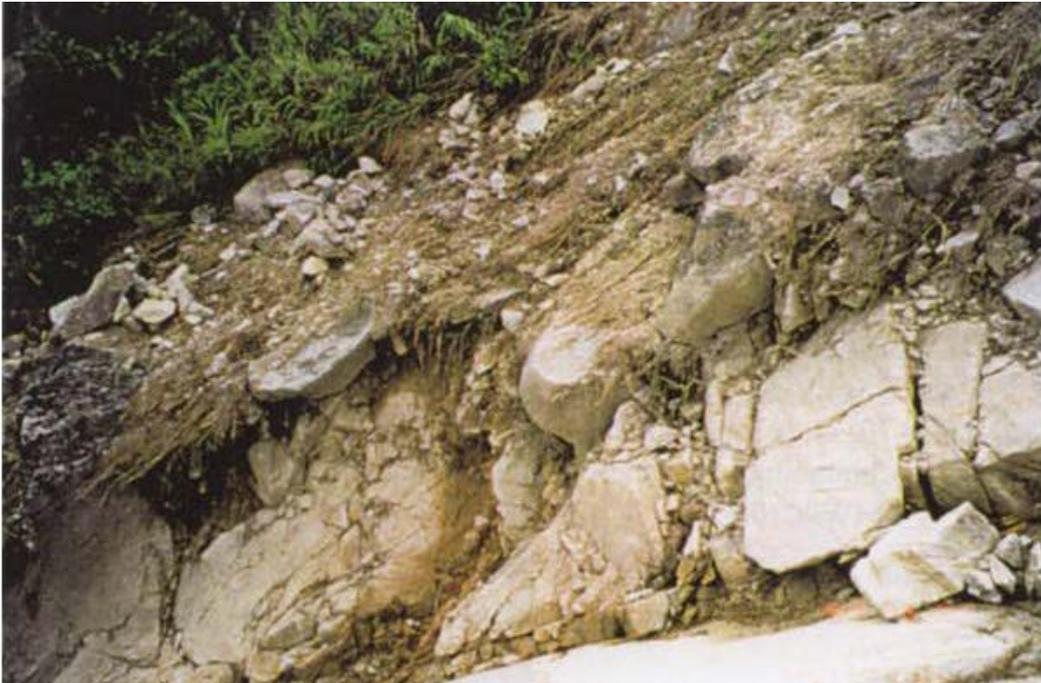
MW 90185-21

Plate 23 - Trail of Clasts and Remoulded Debris at Ch 40

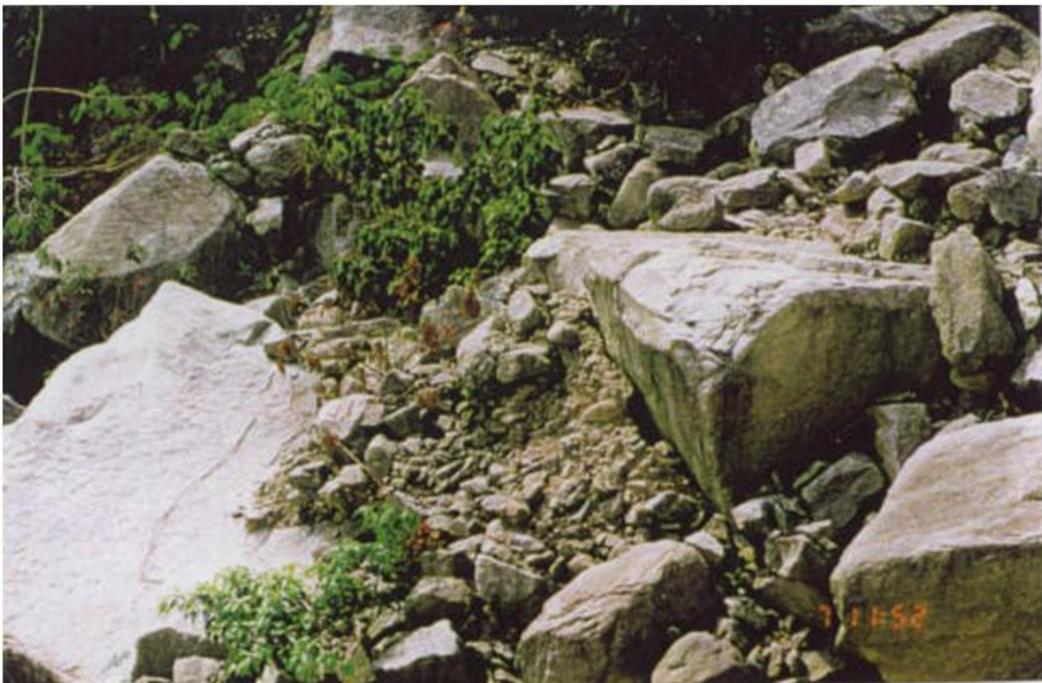
TP 160-8

Plate 43 - Remoulded Debris Accumulation Downslope from an Insitu Boulder (1993)

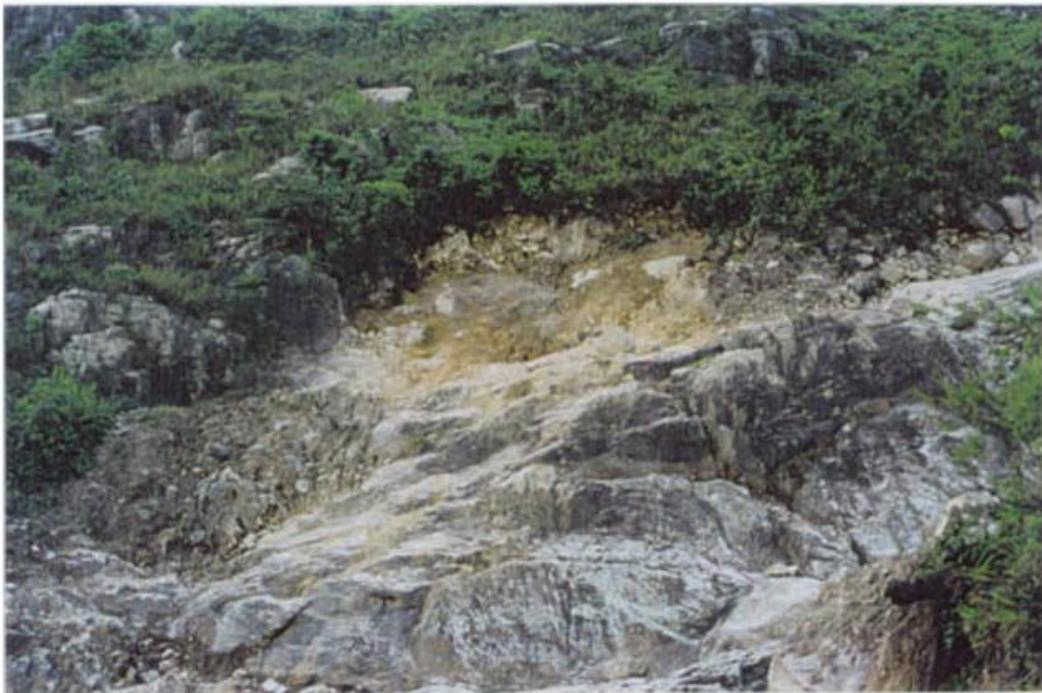
TP 109-3

Plate 45 - Secondary Failure at Ch 265. Note Trail Downslope from Scar on LHS

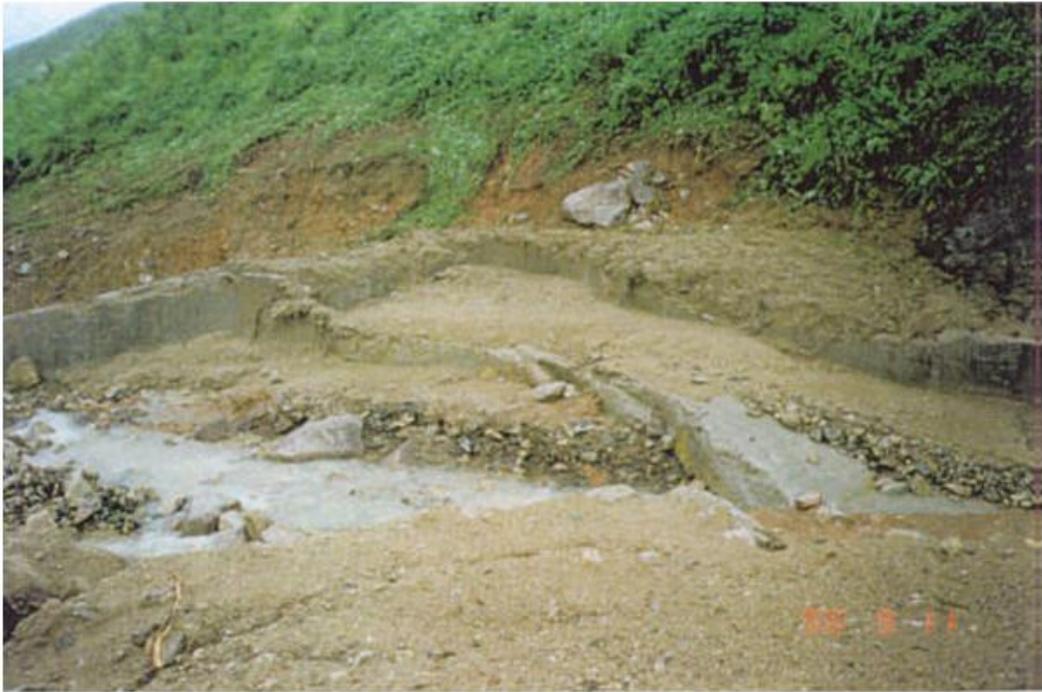
TE 95146-26

Plate 54 - Water Eroded Residual Soil Adjacent to the Damaged Intake

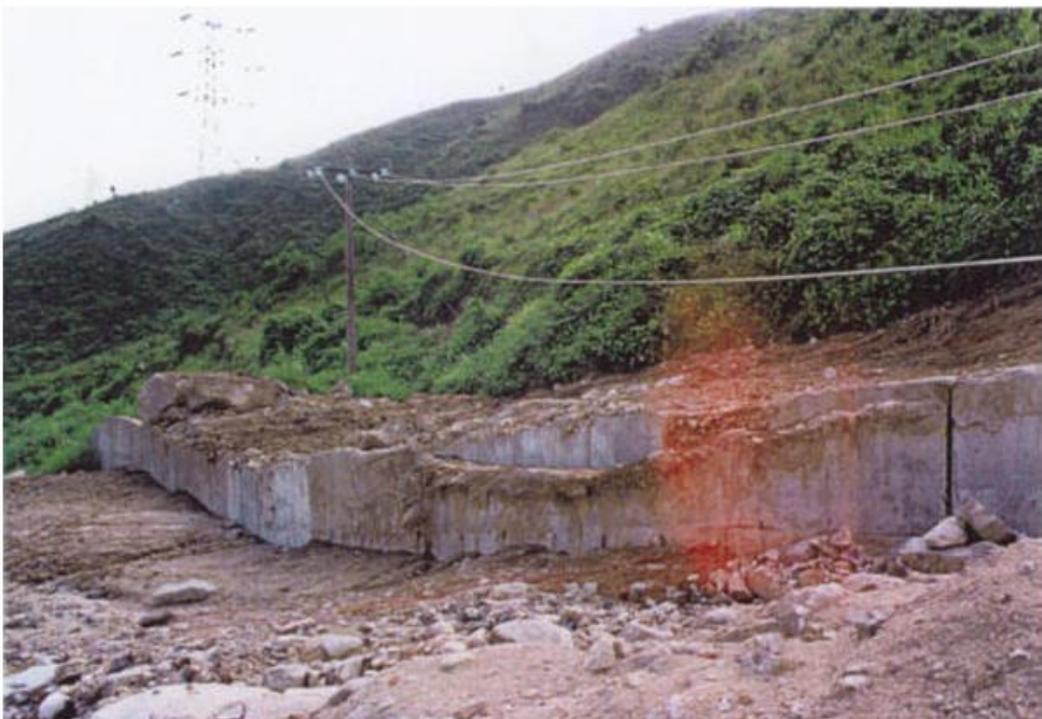
MW 90178-00

Plate 55 - Remains of Concrete Channel

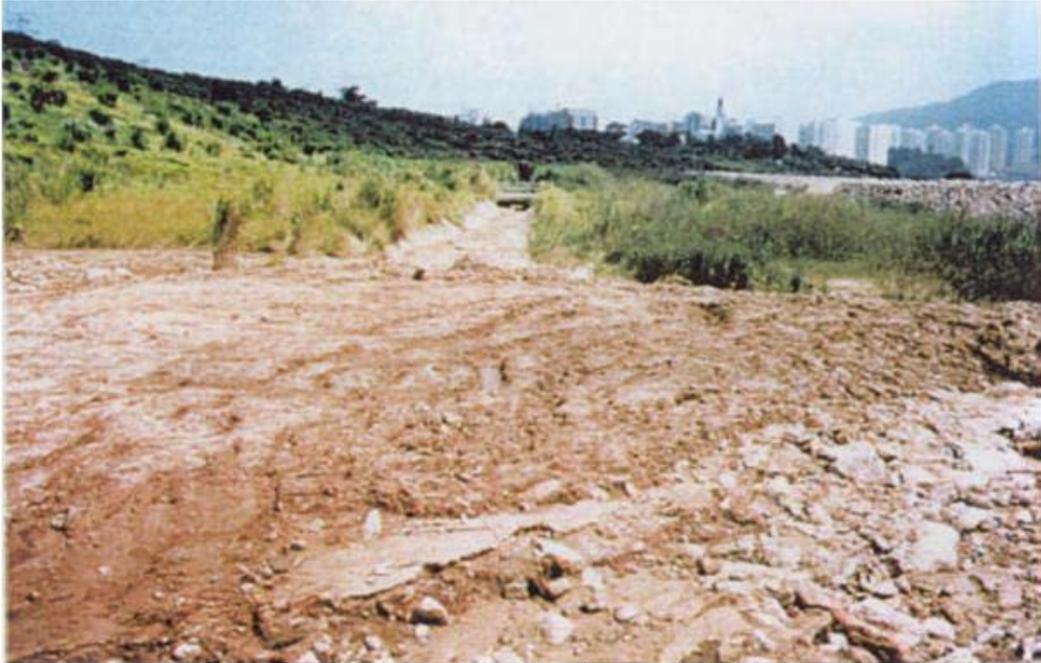
TP 134B-17

Plate 78 - Channel Eroded onto Matrix Rich Debris at Slope Toe. Note Linear Cracks Where Debris Has Slumped towards the Eroded Gully

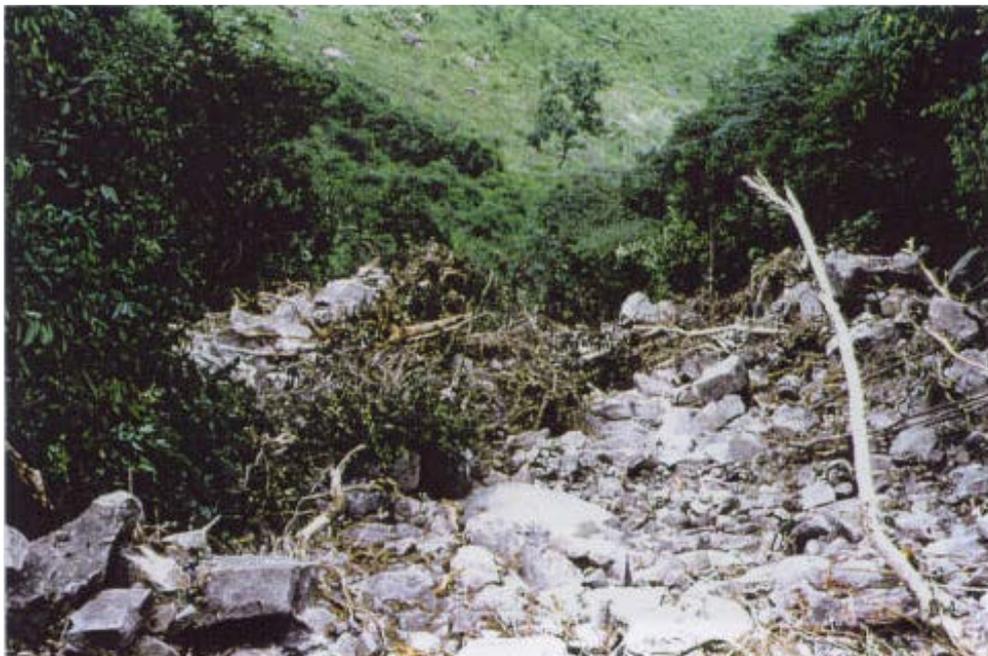
TP 135-9

Plate 22 - Blockage in the Upper Valley at Ch 180

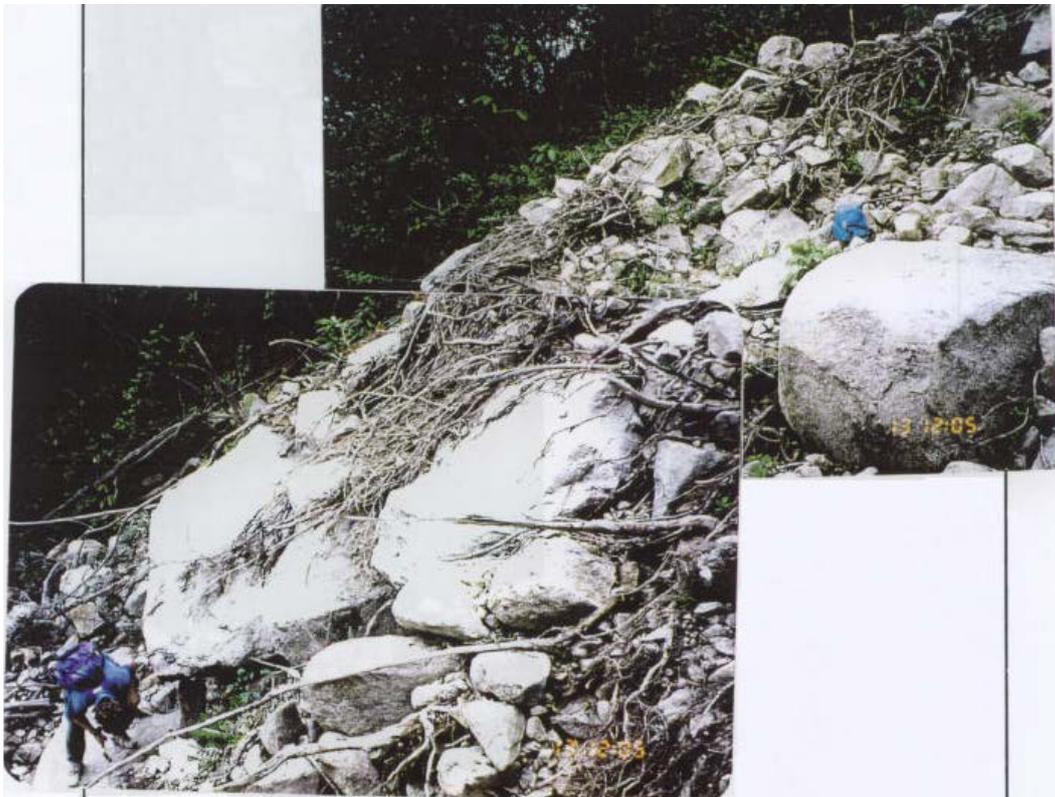
TP 181-25A & 26A

Plate 26 - Loose Propped Boulder, Ch 220 Remains of Blockage

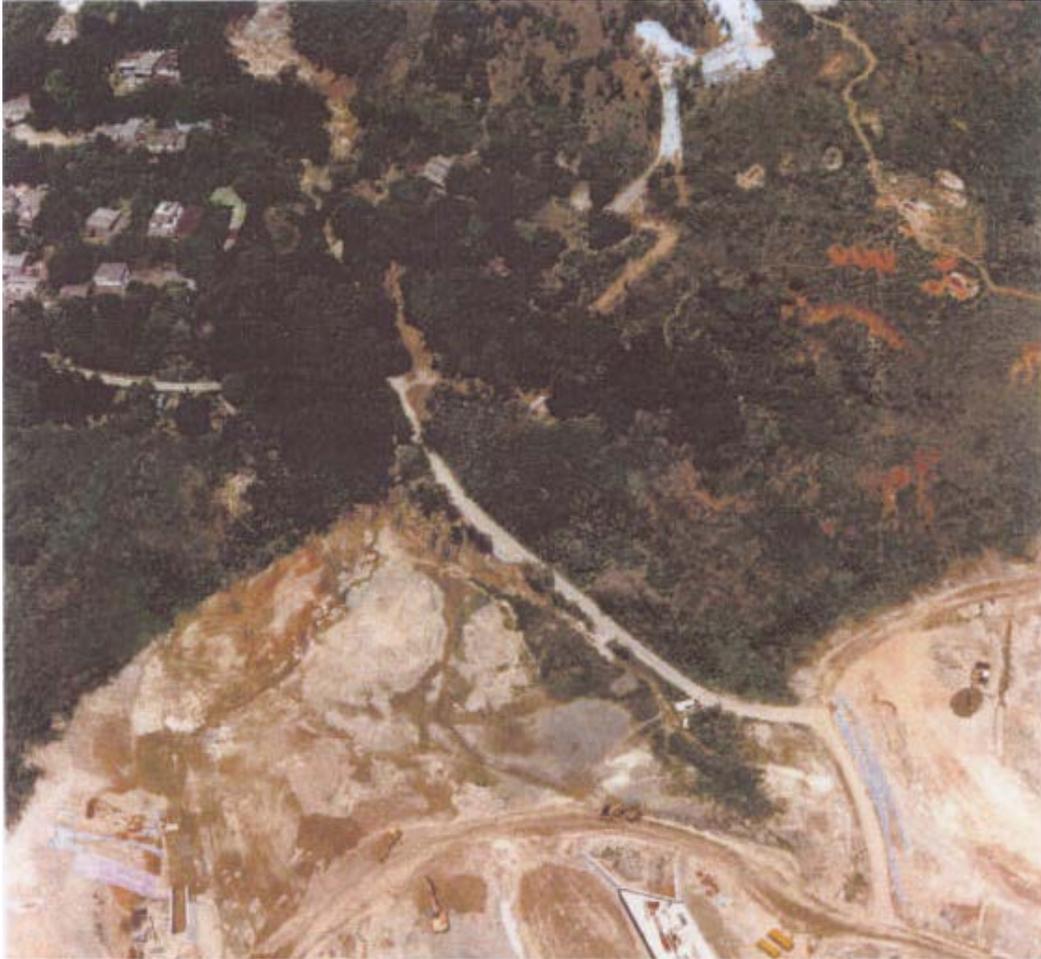
PS 1110/10

Plate 7 - The Blocked Culvert at Ch S650 and Southern Branch Deposition  
at the Foothills Bypass Site (to Ch S800)  
(20 April 2000 after Cleanup, Plate 33 Shows Same Area on 17 April)

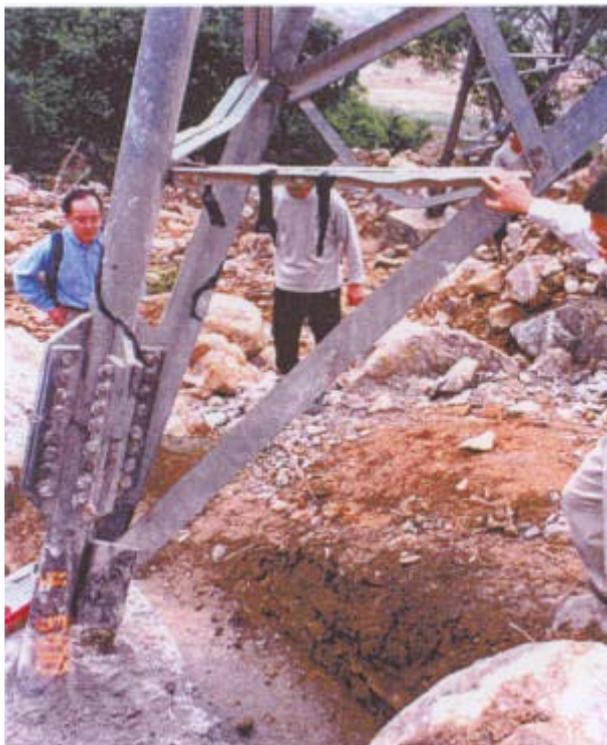
TE 2000/033/7

Plate 21 - Damage to the Same Pylon Leg Shown in Plate 18, 4 May 2000

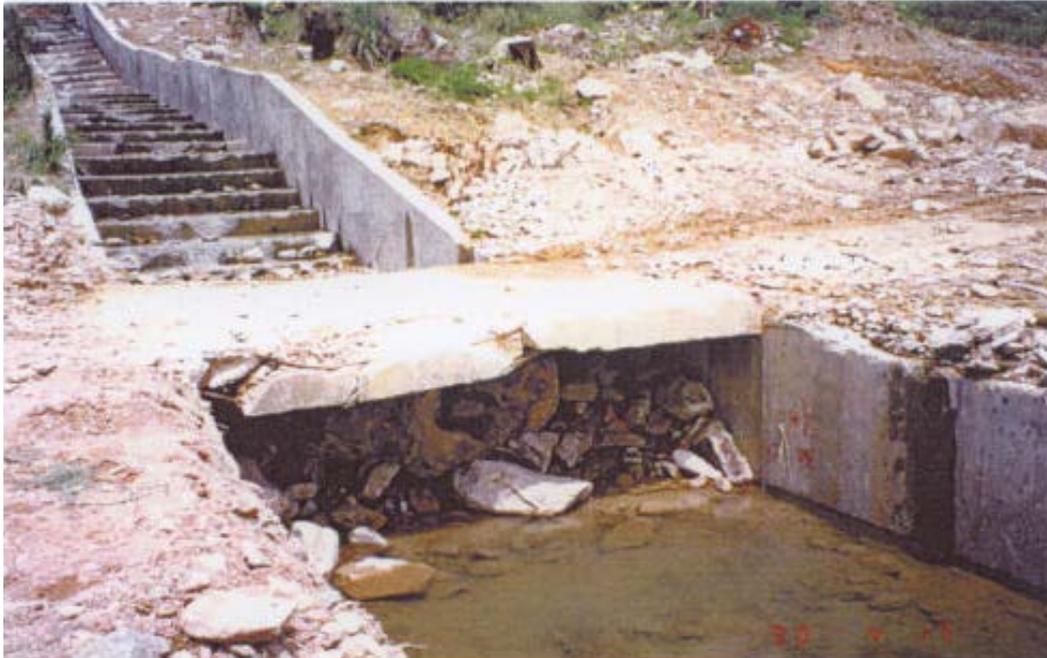
TE 2000/014/7

Plate 24 - Damage to a Reinforced Concrete Bridge at Ch S620

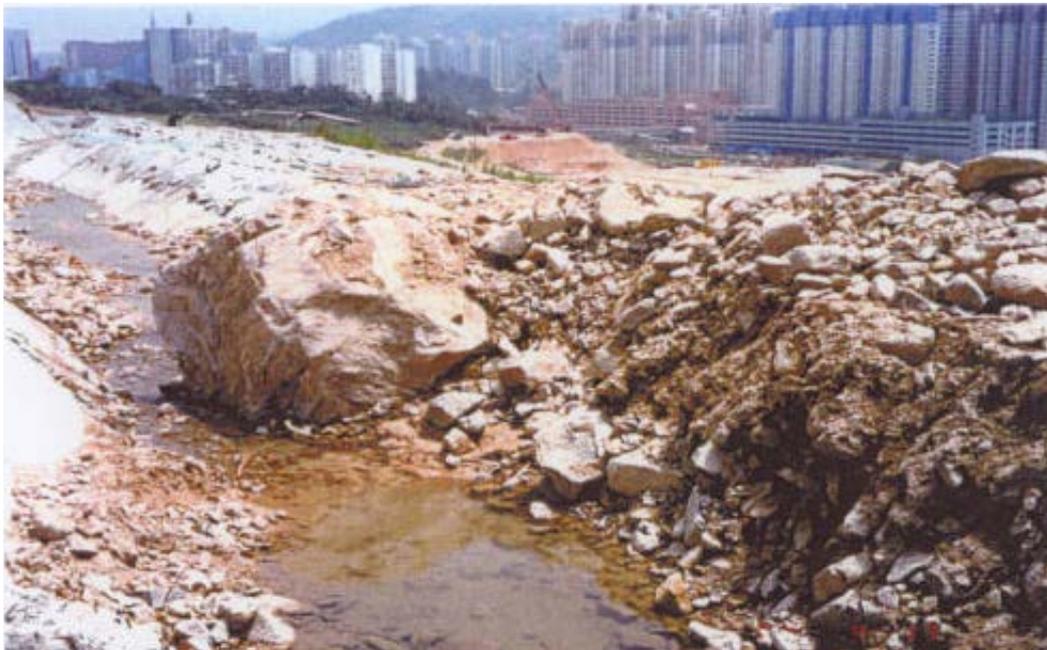
TE 2000/014/6

Plate 25 - Deposition at the Diversion Channel at Ch S620, 17 April 2000
