**REVIEW OF THE  
20 AUGUST 2005 LANDSLIDE  
ON SLOPE NO. 11NW-D/C144  
BEHIND NOS. 12 AND 14  
WYLIE ROAD  
KING'S PARK**

**GEO REPORT No. 283**

**Halcrow China Limited**

**This report is largely based on GEO Landslide Study Report  
No. LSR 9/2009 produced in September 2009**

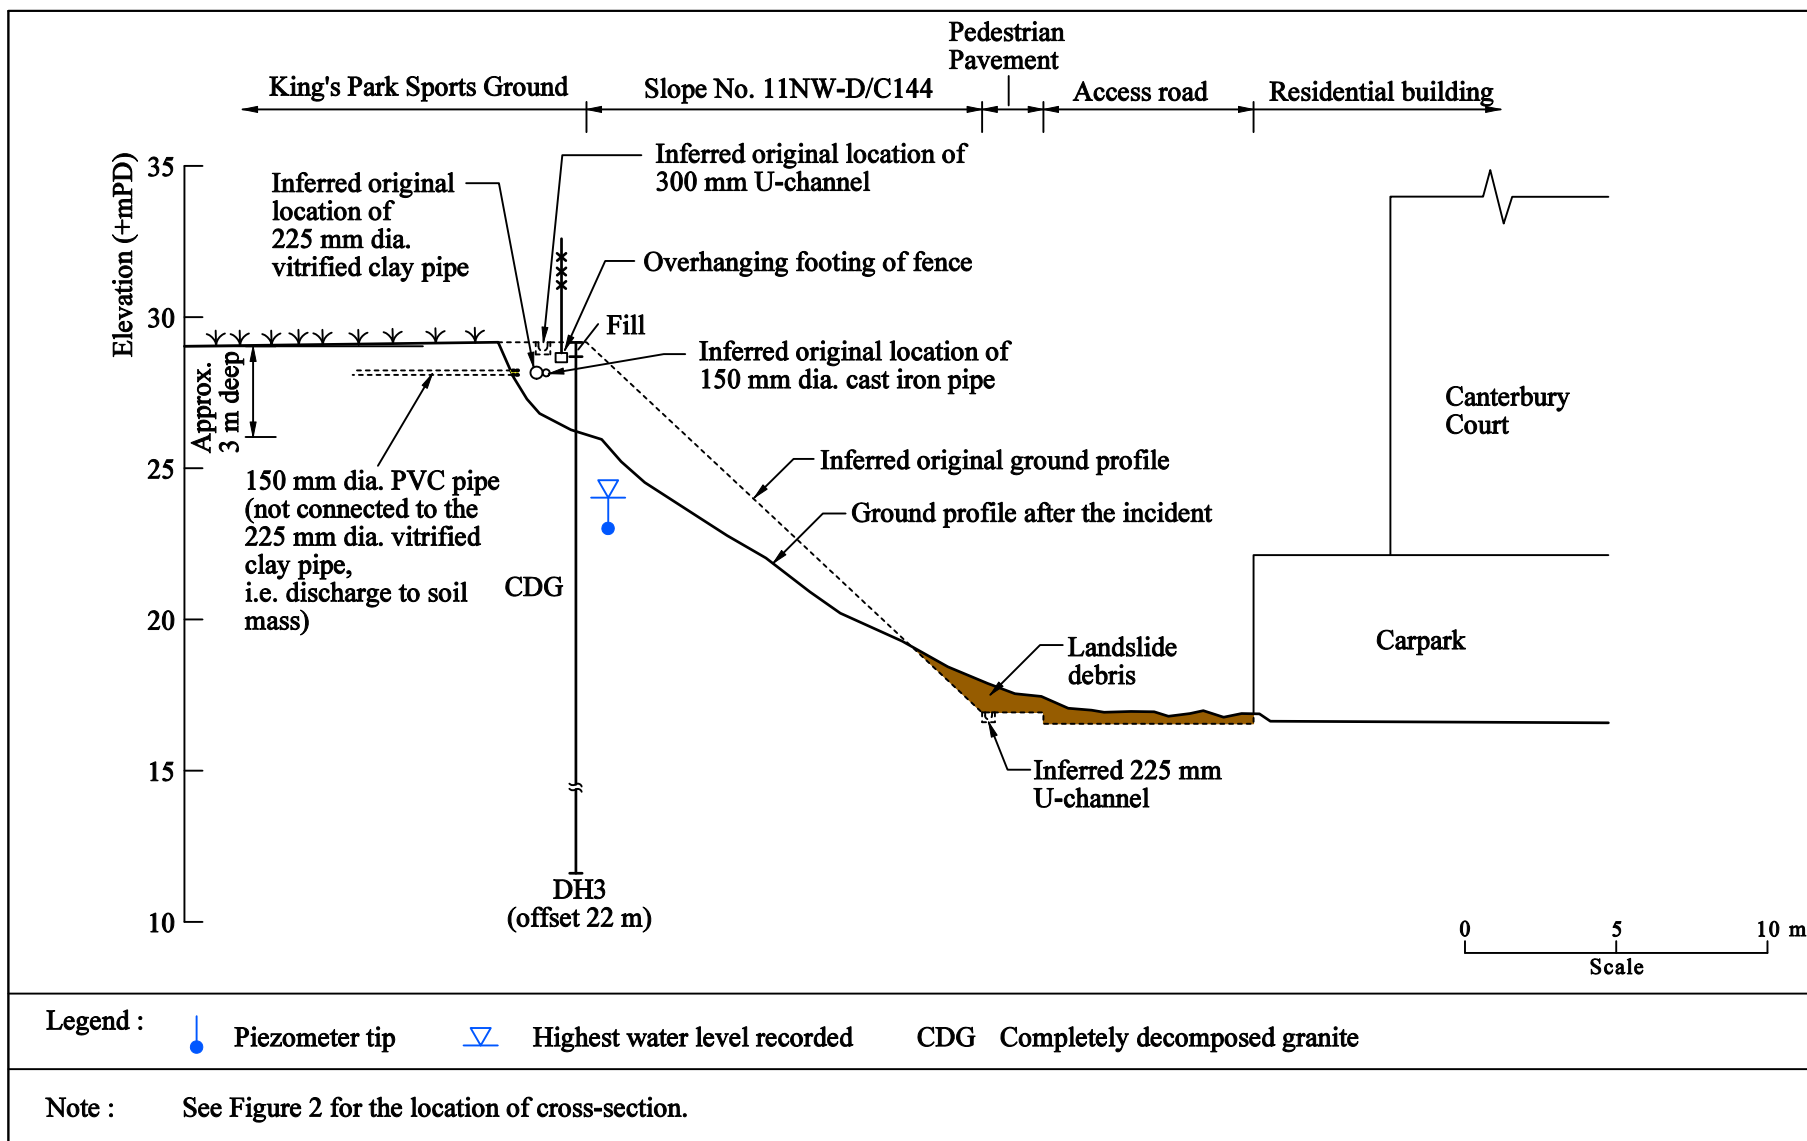
Figure 3 - Section A-A through the 20 August 2005 Landslide

According to the information provided by MGSL, the dimensions of the failure scar was about 12 m high by 15 m long by 3 m deep, with an estimated failure volume of about 200 m<sup>3</sup>. At the time of inspection, three buried water-carrying pipes were found broken and exposed at the crest of the scar and were still discharging water onto the failed area, resulting in significant erosion and subsequent washout. Several footings of a steel fence, which separated the grassed sports ground and the subject slope, were found overhanging at the crest of the landslide scar. MGSL stated that close inspection was not carried out for safety reasons and the observations on the crest of the failed slope were made from a distance.

The landslide site was originally covered with chunam with 50 mm diameter weepholes. The failed material mainly comprised completely decomposed granite in the form of reddish brown silty sand. A 300 mm wide U-channel was found running along the crest of the subject slope. Another 375 mm diameter buried water pipe was exposed near the southern flank of the landslide scar. MGSL also recorded that, according to their in-house information and site interview with the Electrical and Mechanical Services Department (EMSD) staff (i.e. the maintenance agent to Arch SD), no record of all the buried water-carrying pipes exposed in the landslide was available.

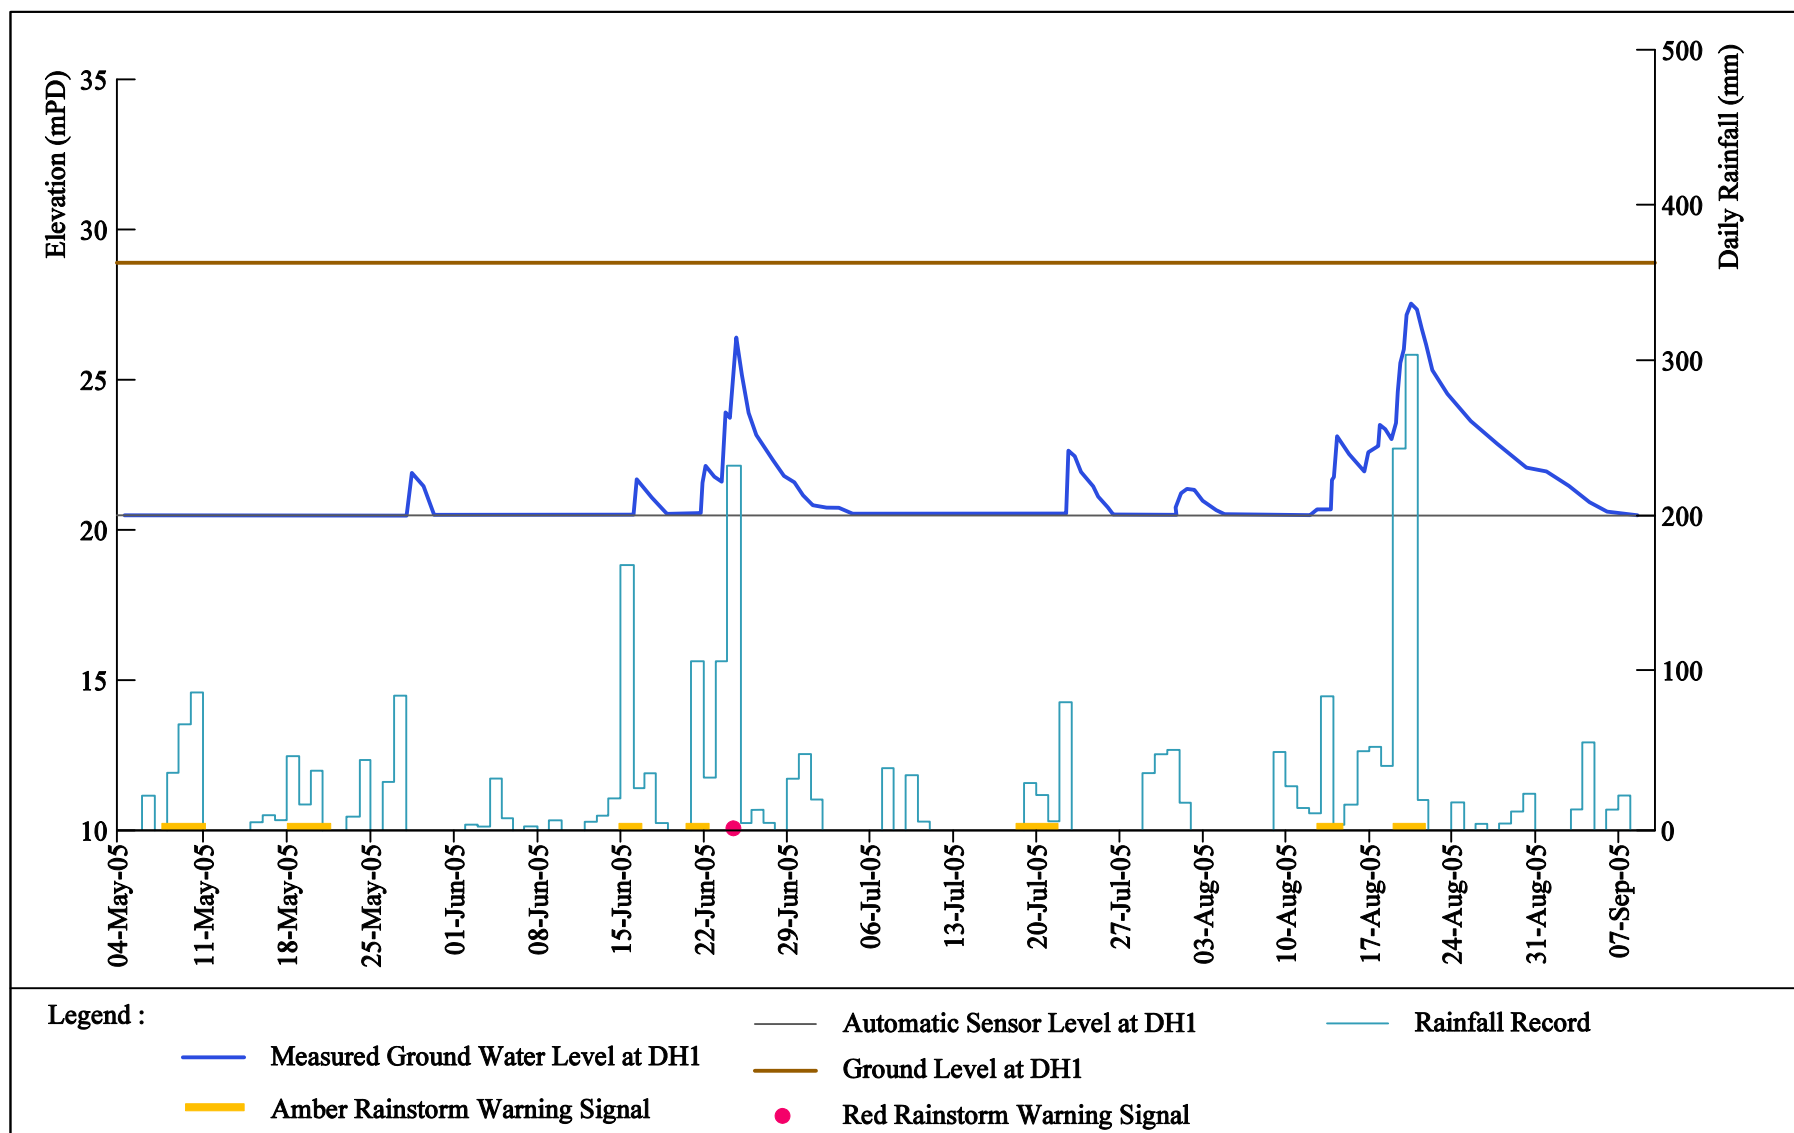
Figure 9 - Ground Water Monitoring Results and Daily Rainfall Records (DH1)

The Stage 3 Study Report indicated that the highest groundwater level recorded in drillhole No. DH 1 was about 3.5 m higher than that measured in drillhole Nos. DH 2 and DH 3, even though the three drillholes were located along the crest of the slope at similar ground levels and with similar ground conditions. The report suggested that probable leakage of buried drainage pipes at concentrated locations near drillhole No. DH 1 could be the explanation for the difference in the recorded groundwater levels.

According to the Stage 3 Study Report, the high groundwater levels recorded in the wet season of 2005 were attributed to the infiltration of rainfall into the large area of the grassed sports ground behind the crest of the subject slope. Leakage of buried drainage pipes at certain locations behind the crest of the slope could also be a contributory factor to the high groundwater level.

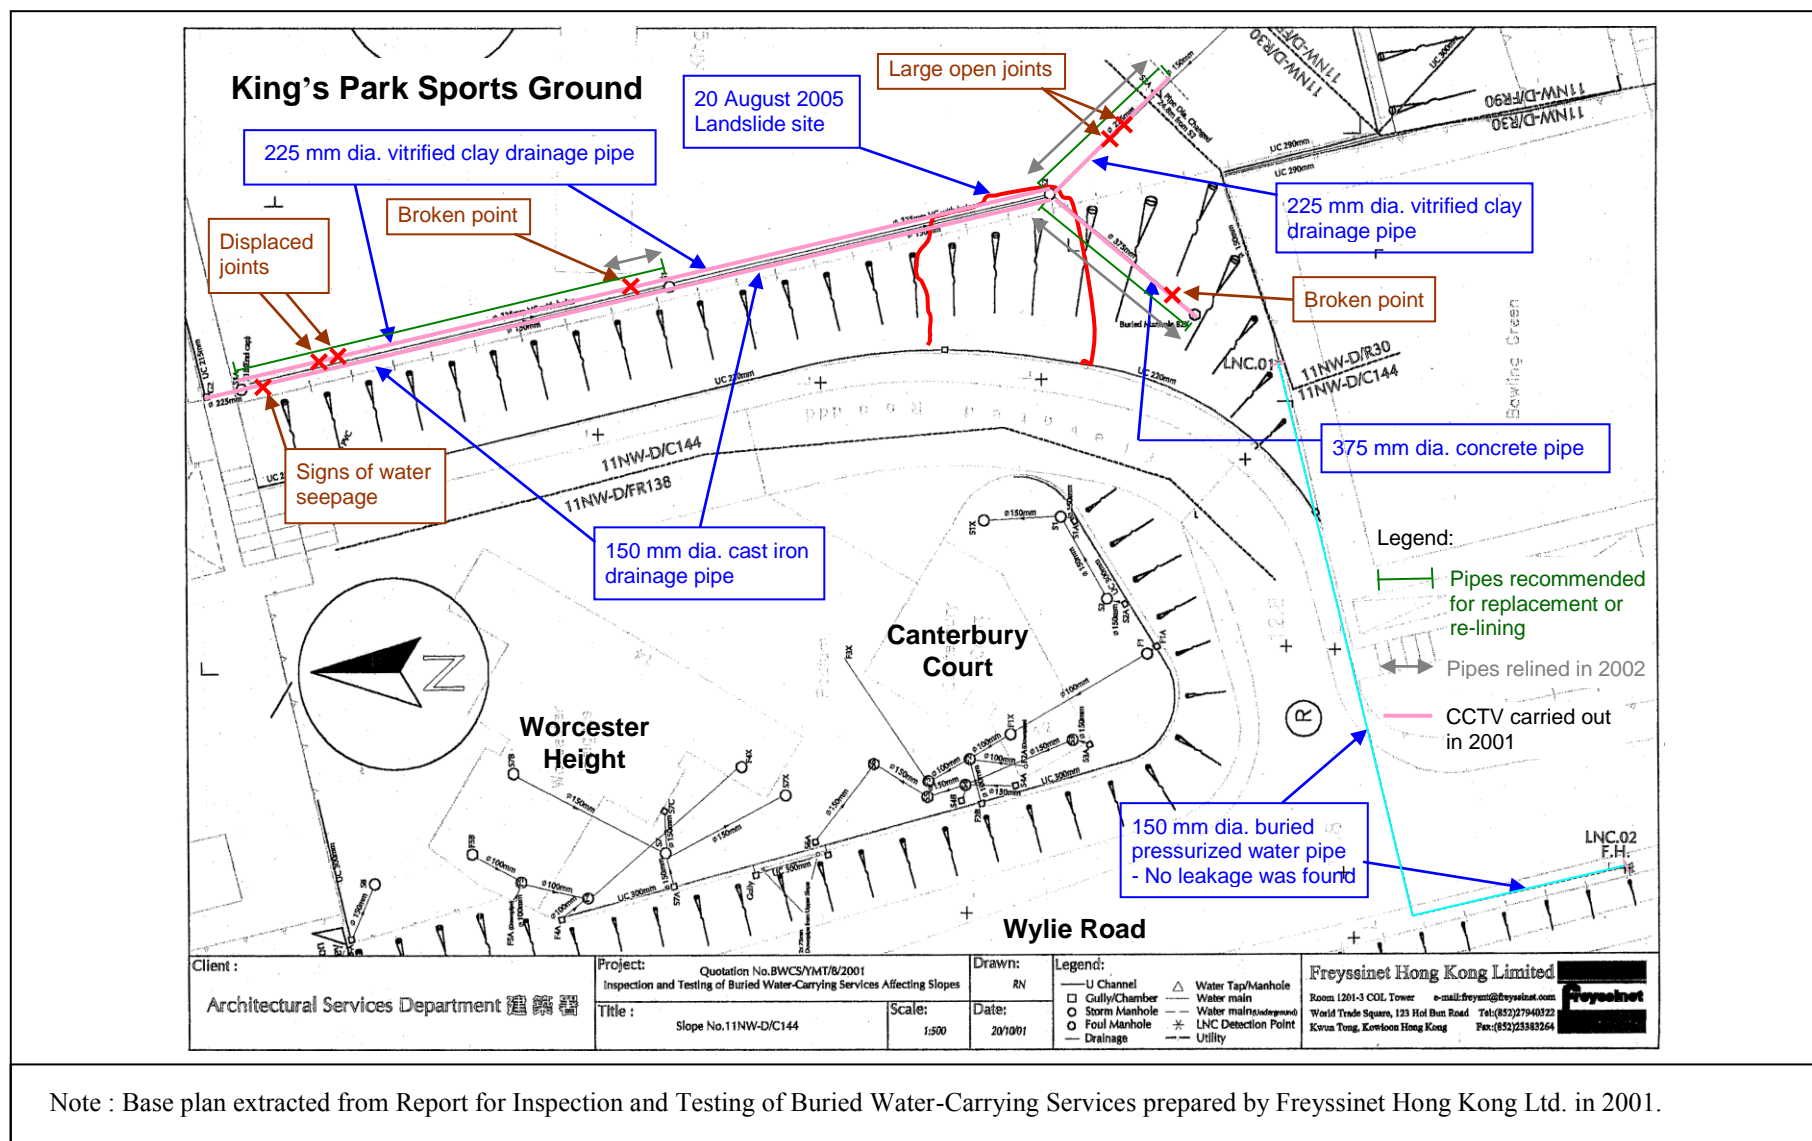
Figure 14 – Inspection Records of Buried Water-carrying Services at Slope No. 11NW-D/C144 in 2001

The survey results showed that some displaced/open joints were present along the two 225 mm diameter VC drainage pipes at several locations and “infiltration (seeper)” (signs of water seepage) were found at the northern section of the 150 mm diameter CI drainage pipe. No defect was found inside the drainage pipes along the section immediately above the August 2005 landslide area after clearance of debris/obstructions using high pressure water jetting. Broken sections were found inside the 375 mm diameter concrete pipe near the mid-height of the slope and at the middle portion of the 225 mm diameter VC drainage pipe at the slope crest. However, the sizes of the broken sections were not given in the survey report. The locations of defects recorded in the report are shown in Figure 14.

The report also recorded that a 150 mm diameter water main running along the southern boundary of the subject slope was tested by Leak Noise Correlator (LNC) methods and no leakage was detected (Figure 14). The three manholes located at the crest of the slope were also inspected and found to be in fairly good condition.

The report recommended that the 375 mm diameter concrete drainage pipe near the mid-height of the slope, the 225 mm diameter VC drainage pipe running from the southeast of the slope to a manhole near the southern end of the slope and the northern section of the 225 mm diameter VC drainage pipe at the slope crest be replaced or re-lined in order to prevent any leakage from the pipes into the slope. However, no remedial works to the northern section of the 150 mm CI pipe were recommended in the report.

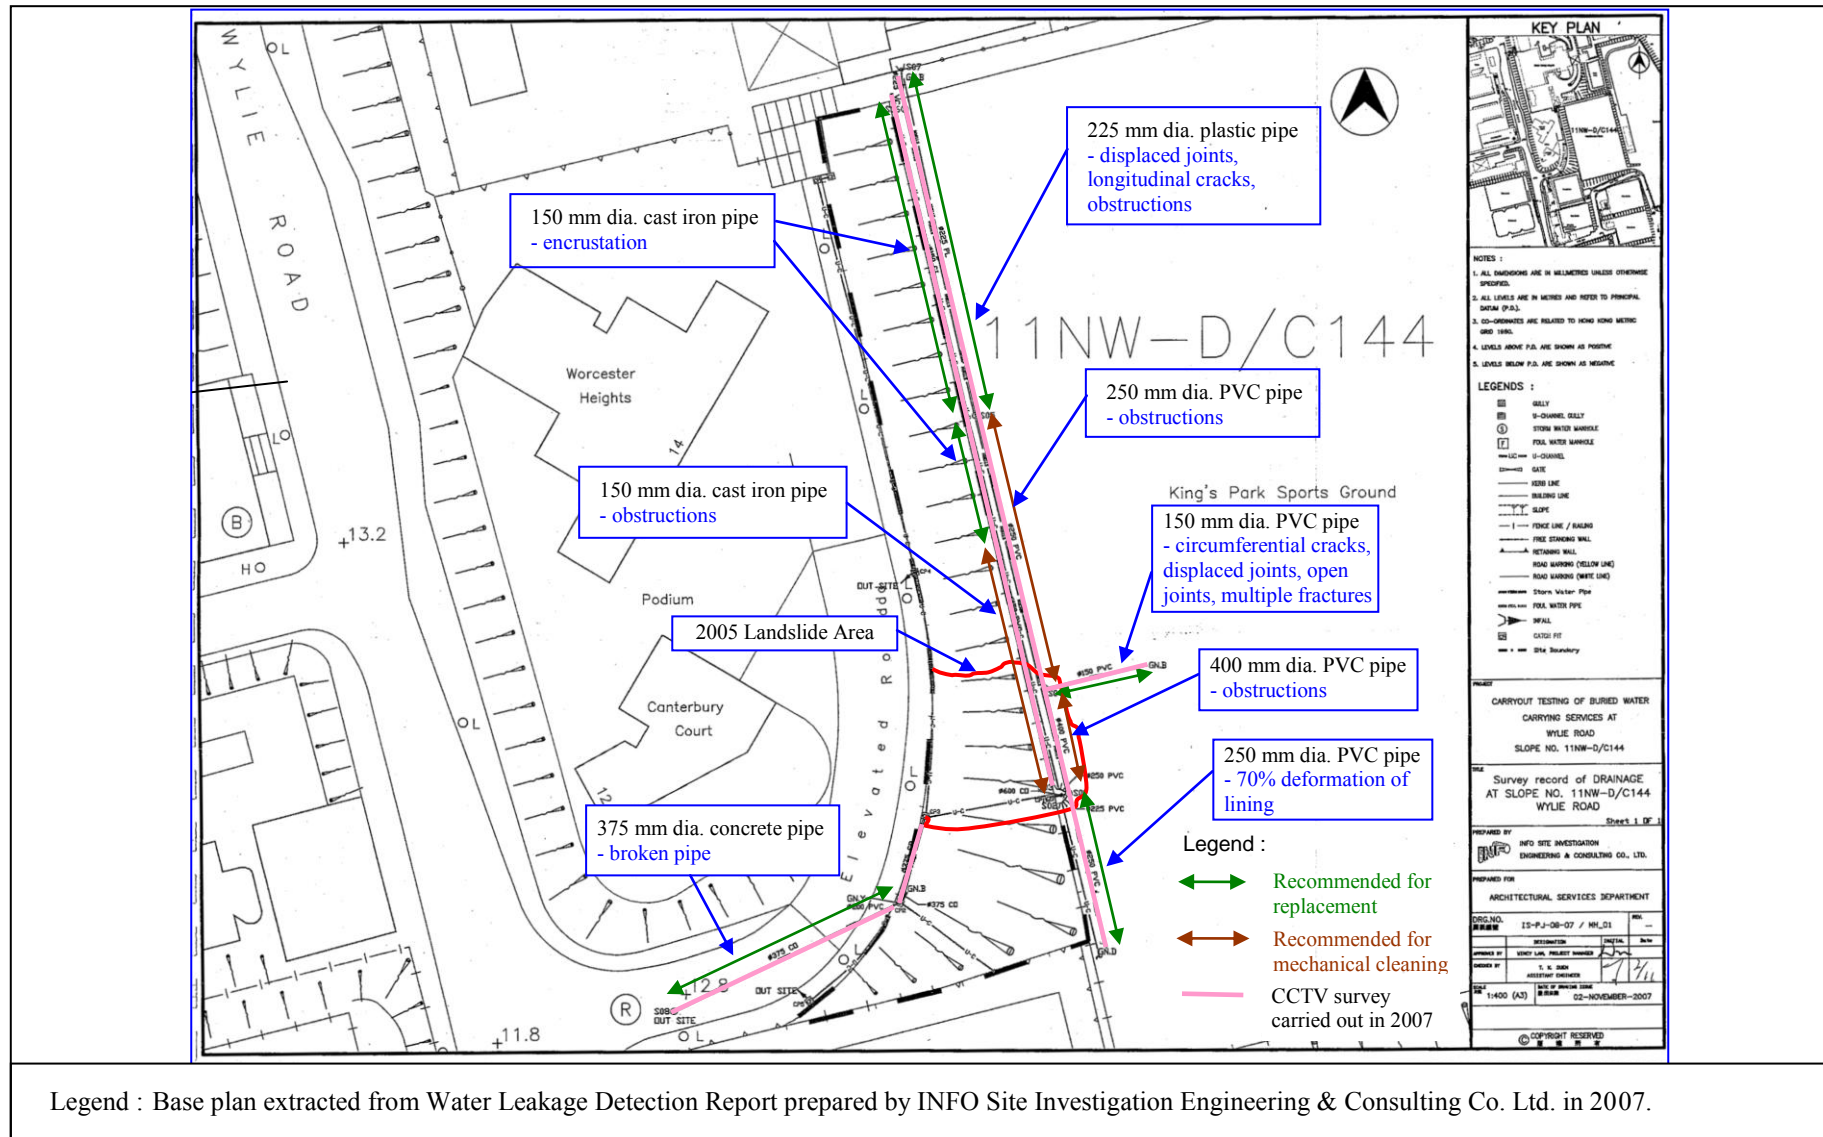
Figure 15 – Survey Records of Drainage at Slope No. 11NW-D/C144 in 2007

After the completion of LPM works in November 2006, Arch SD took over the maintenance responsibility of the subject slope with effect from 30 October 2007. INFO Site Investigation Engineering and Consulting Company Limited (INFO) prepared a CCTV survey report entitled "Inspection and Testing of Buried Water-Carrying Services Affecting Slope" in November 2007 for Arch SD after examining the internal conditions of the buried water pipes in the vicinity of the subject slope. CCTV Survey, Manhole Survey, Leak Noise Correlation (LNC) Survey and High Pressure Water Jetting were carried out. The 2007 survey report shows a 150 mm diameter PVC drainage pipe passing across the sports ground discharging to a 250 mm diameter PVC drainage pipe running along the crest of slope No. 11NW-D/C144. This 150 mm diameter PVC drainage pipe was not identified in the 2001, 2002 and 2005 CCTV surveys. The 150 mm diameter PVC drainage pipe was found to contain cracks, displaced joints, open joints, multiple fractures and circumferential cracks and it was recommended for replacement. The video of the 2007 CCTV survey showed branches of buried drains present alternatively along both sides of the 150 mm diameter PVC drainage pipe. Obstructions were found in the 250 mm diameter drainage pipe running along the slope crest and in the 400 mm diameter PVC drainage pipe at the crest of the slope within the landslide scar. Displaced joints,

longitudinal cracks and obstructions were also found in the 225 mm diameter PVC pipe running along the crest of the slope. The defects recorded and recommendations made in the report are summarised and presented in Figure 15.

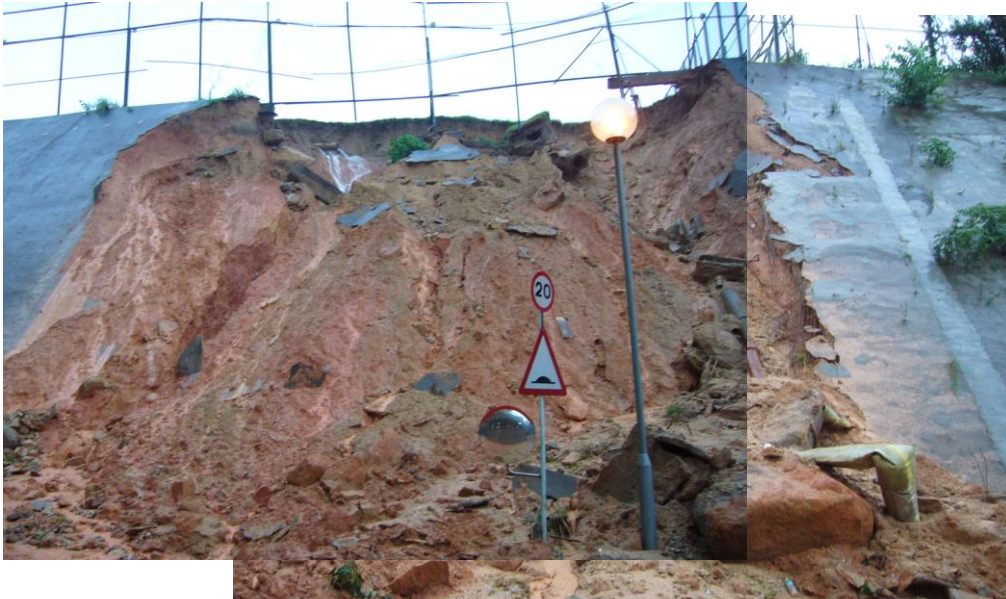
Plate 1 – General View of the August 2005 Landslide Area  
(Photograph taken by MGS� on 20 August 2005)

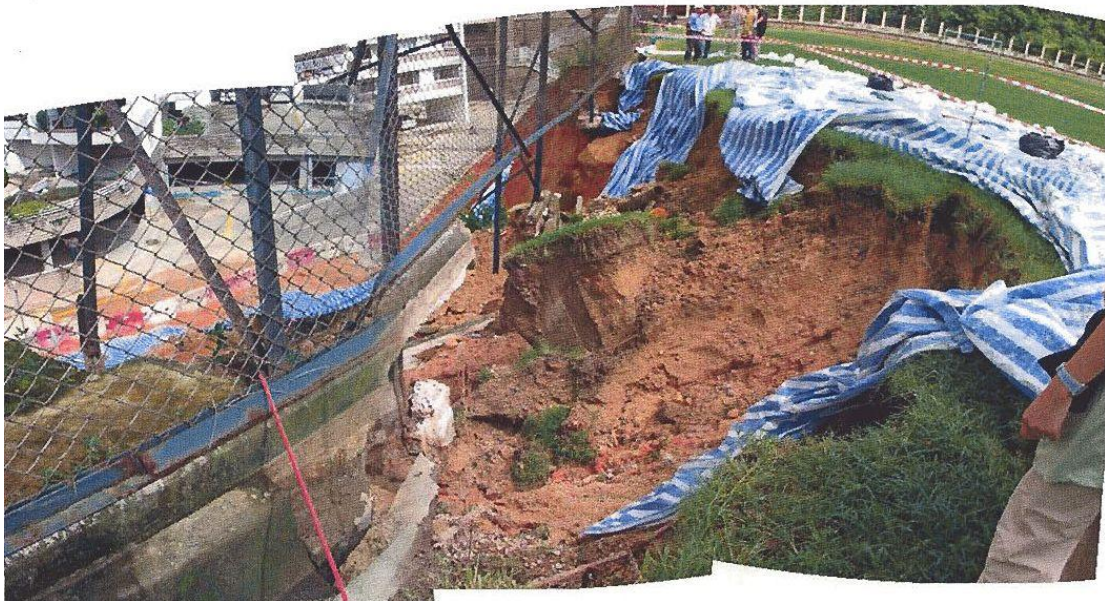
Plate 2 – View of the Landslide Scar Extending into the Grassed Sports Ground  
above Slope No. 11NW-D/C144  
(Photograph taken by GEO on 22 August 2005)

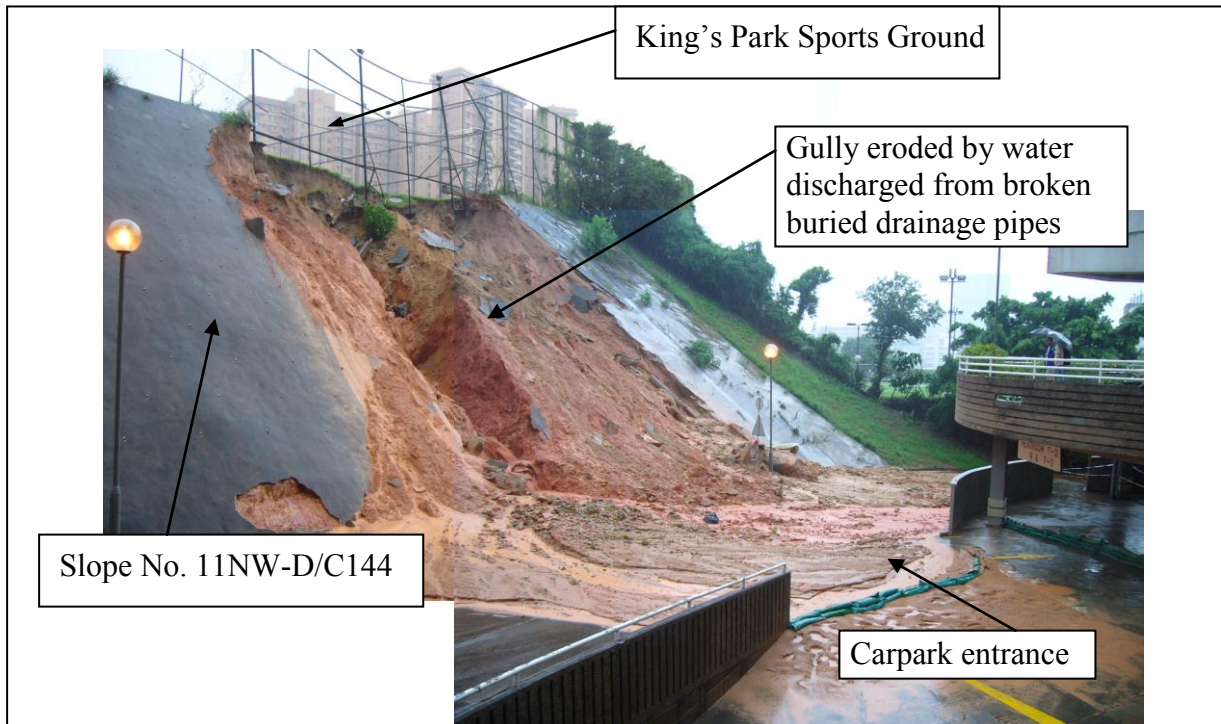
Plate 3 – Landslide Debris Deposited on the Carpark Entrance of Canterbury Court  
(Photograph taken by MGSL on 20 August 2005)

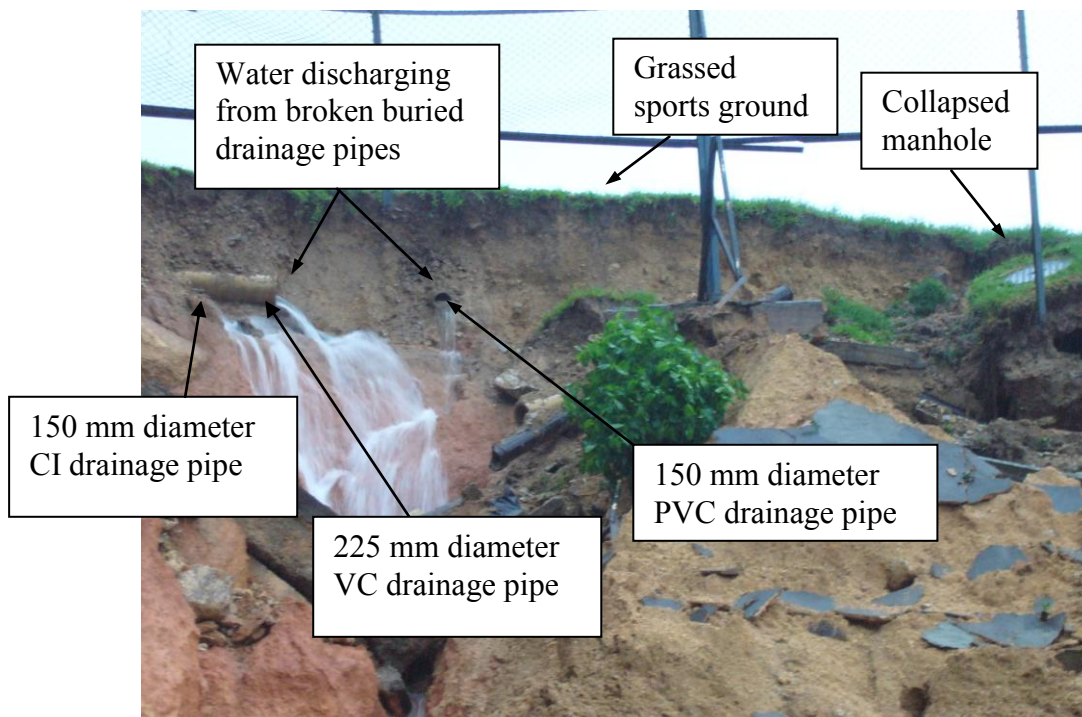
Plate 4 – Close-up View of the Crest of the Failure Scar  
(Photograph taken by MGSL on 20 August 2005)

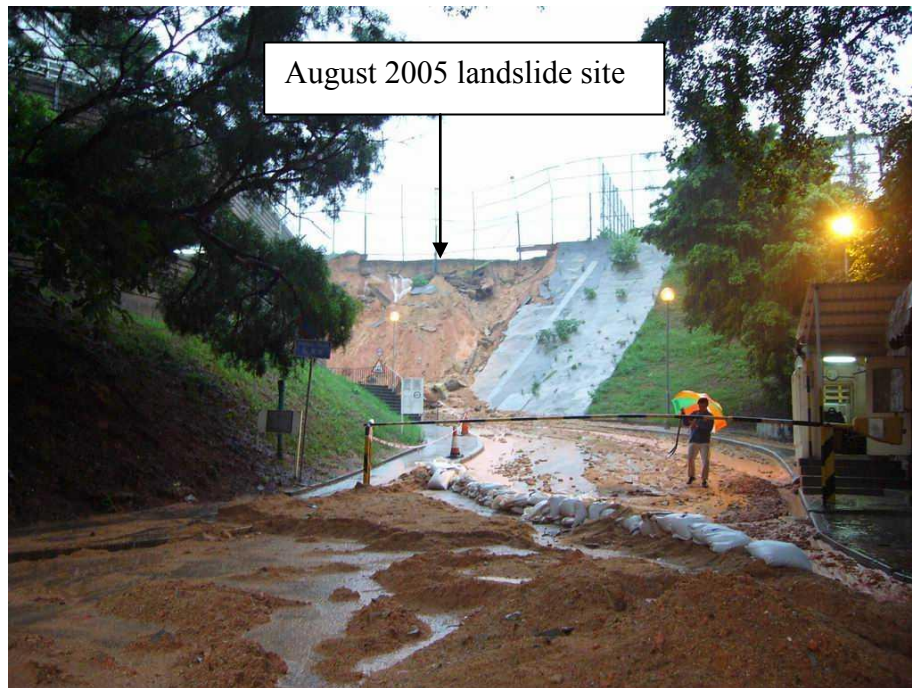
Plate 5 – Landslide Debris with Muddy Water on the Inclined Access Road  
(Photograph taken by MGSL on 20 August 2005)

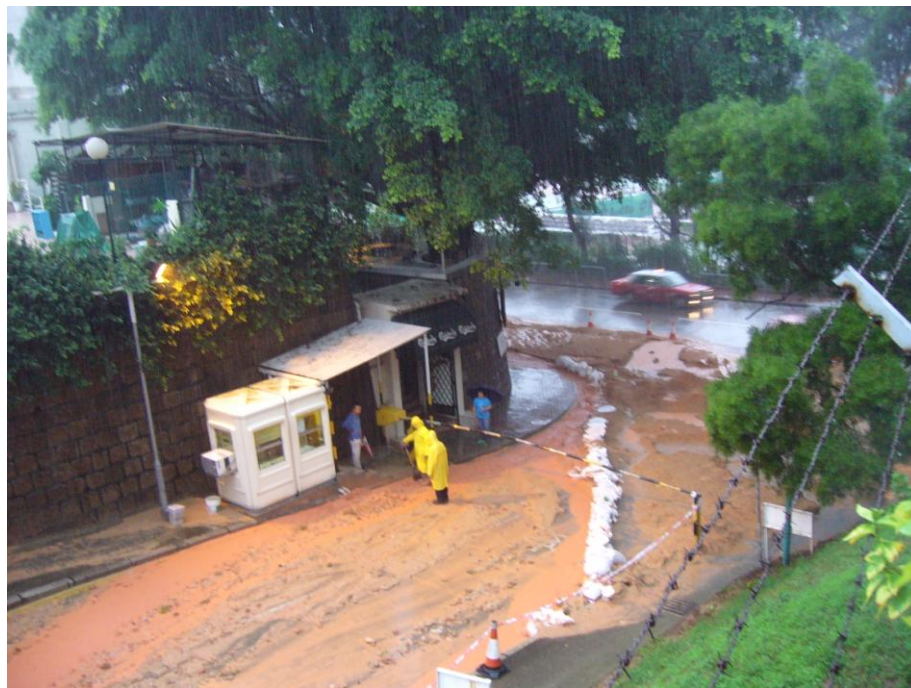
Plate 6 – Landslide Debris Deposited on the Entrance of the Access Road at Wylie Road  
(Photograph taken by MGSL on 20 August 2005)

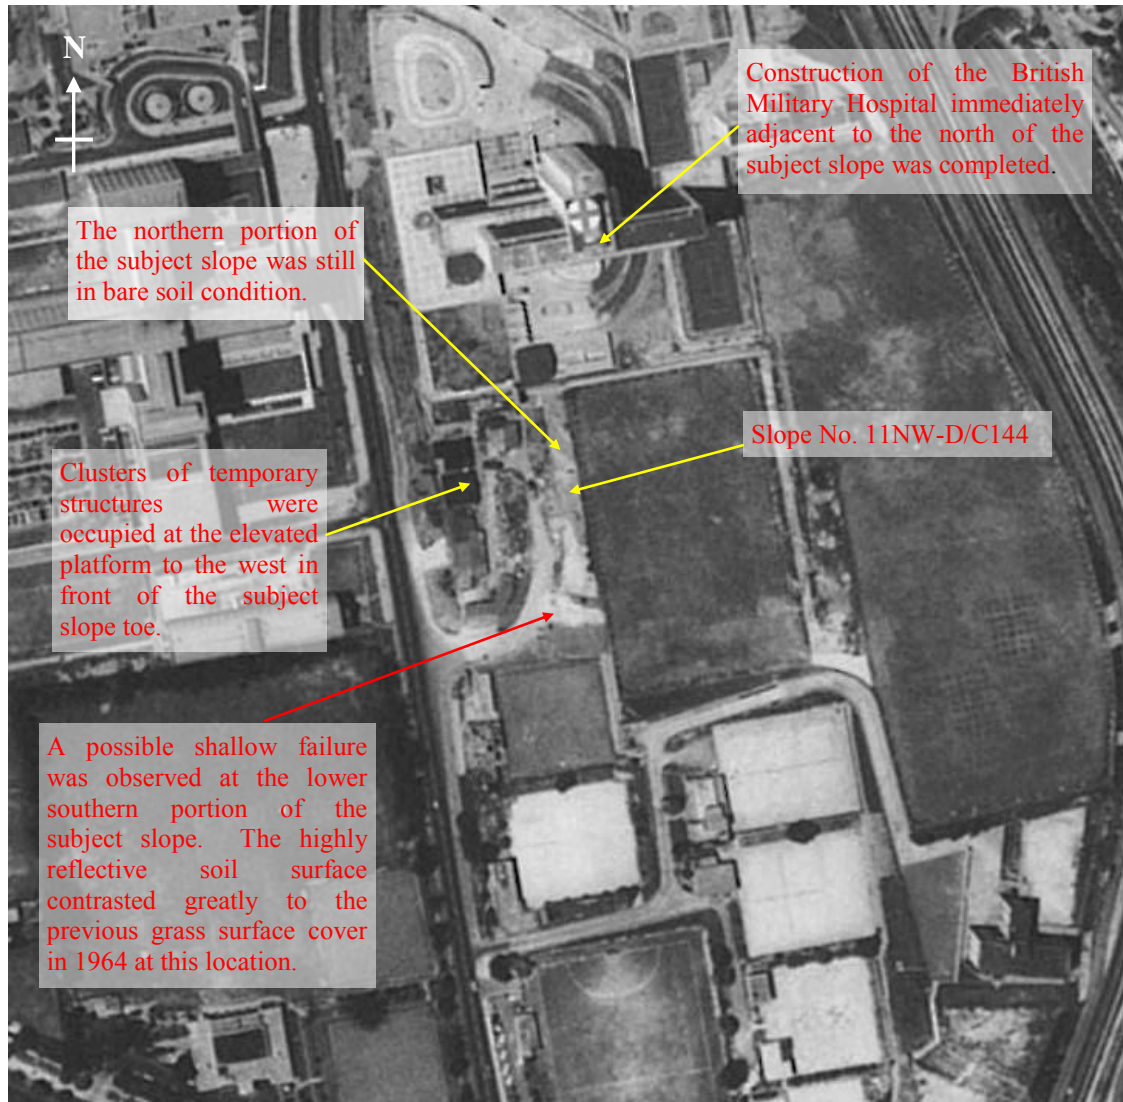
Plate A4 – Interpretation of 1967 Aerial Photograph

By 1967, a highly reflective soil surface, which was possibly a shallow failure, is apparent in the aerial photographs at the lower southern portion of slope No. 11NW-D/C144, while the northern portion of the subject slope appears to be a bare soil surface. A cluster of temporary structures is present on the elevated platform in front of the subject slope. Construction of the British Military Hospital adjacent to the northern end of the subject slope had been completed.

According to the API, a shallow failure is evident at the lower southern portion of the subject slope in 1967.

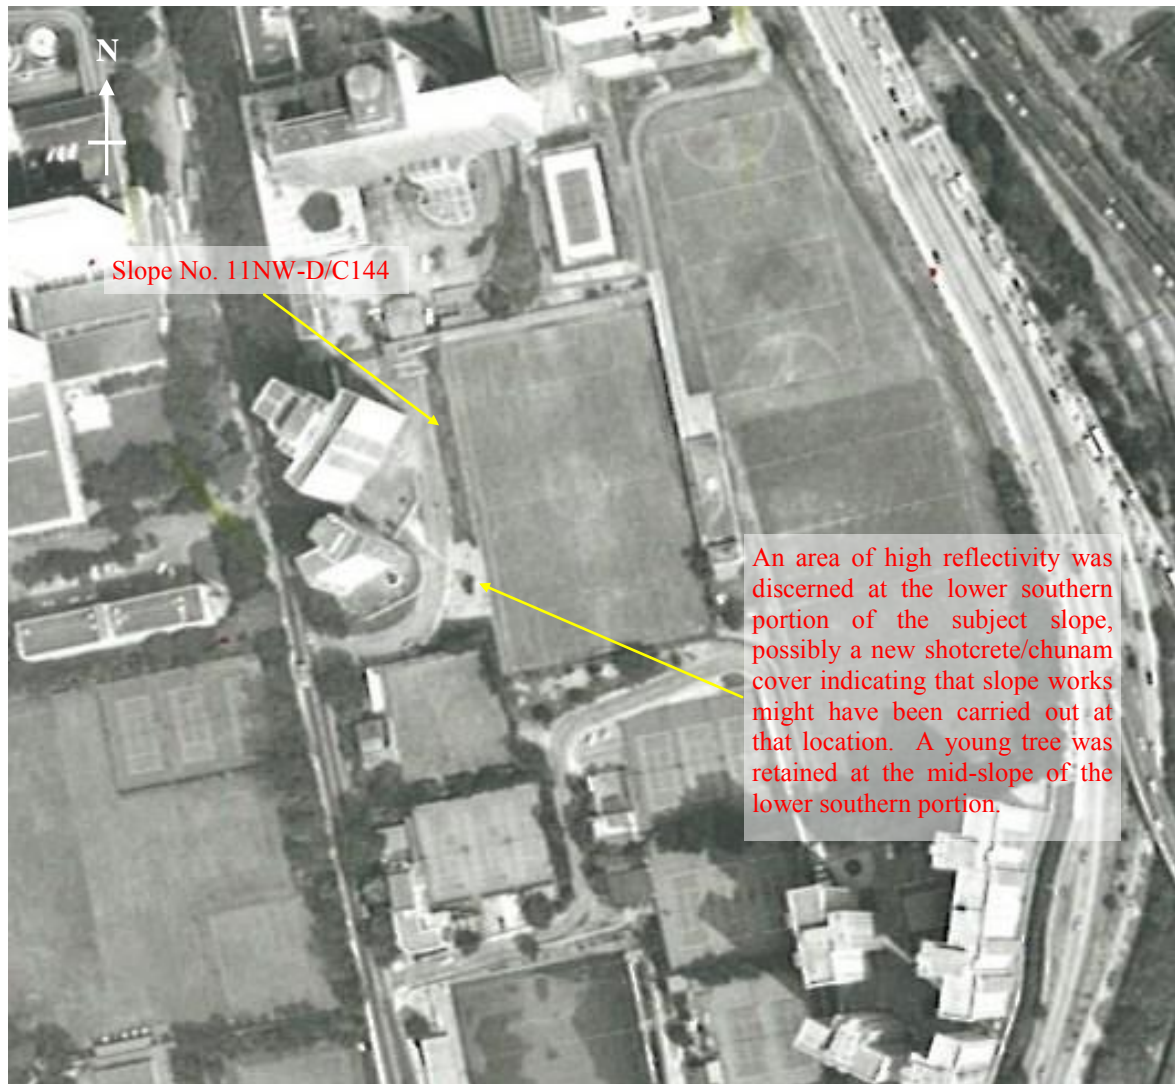
Plate A9 – Interpretation of 1988 Aerial Photograph

In the 1988 aerial photographs, an area of high reflectivity, possibly a new hard surface cover, is apparent at the lower southern portion of slope No. 11NW-D/C144. In 1991, linear grey tone features are observed on the new hard surface cover identified in 1988, which might be indicative of water seepage in that area.
