**DETAILED STUDY OF THE  
7 JUNE 2008 LANDSLIDE  
BEHIND ROCKWIN COURT,  
FUNG FAI TERRACE,  
HAPPY VALLEY**

**GEO REPORT No. 285**

**Fugro Scott Wilson Joint Venture**

**GEOTECHNICAL ENGINEERING OFFICE  
CIVIL ENGINEERING AND DEVELOPMENT DEPARTMENT  
THE GOVERNMENT OF THE HONG KONG  
SPECIAL ADMINISTRATIVE REGION**

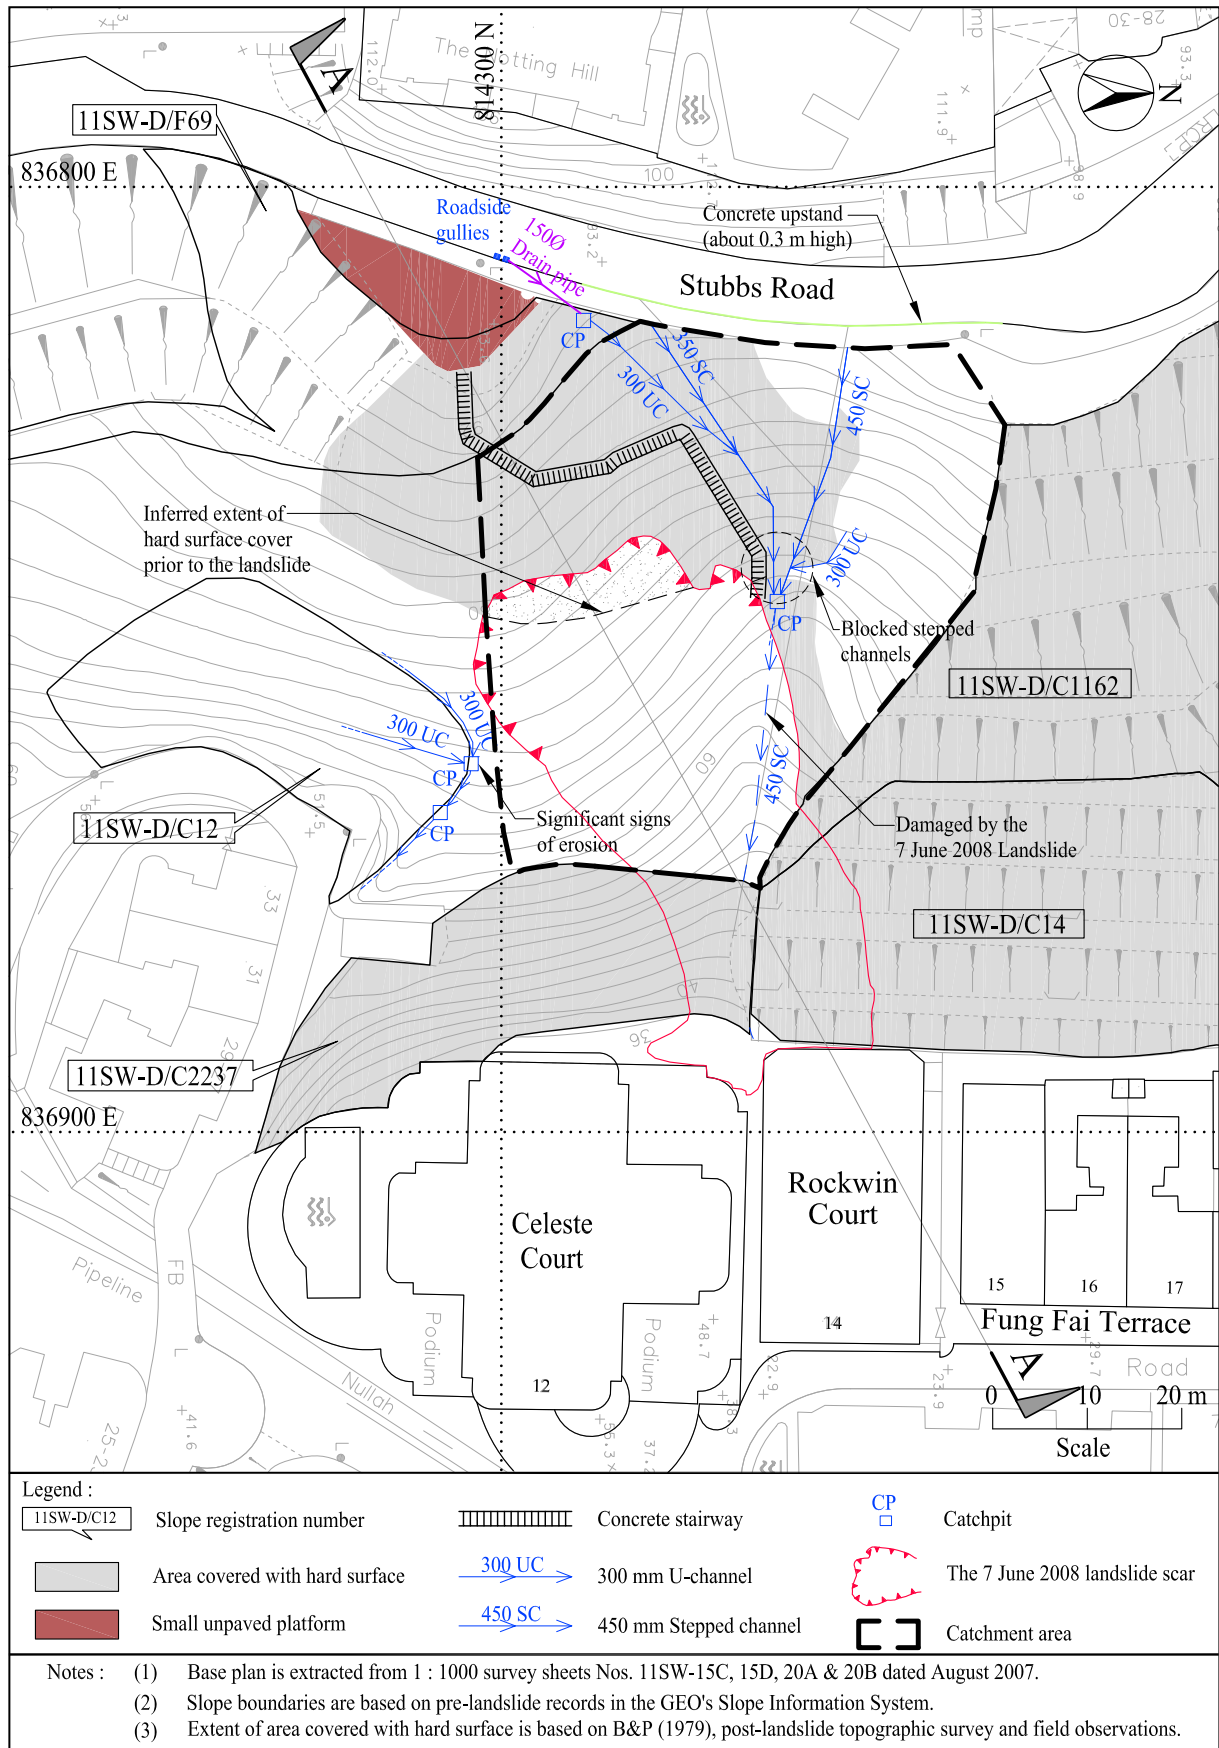
Figure 2 - Site Layout Plan and Field Observations

The landslide source area was about 30 m wide by 20 m long on plan, and was relatively shallow with a maximum depth of about 1.5 m (Plate 5). The volume of the landslide was about 500 m<sup>3</sup>. The failure surface comprised a steeply inclined main scarp and an undulating basal slip surface (Figure 3). No obvious signs of subsurface seepage and concentrated surface runoff were observed on the landslide scar. There was no significant entrainment of material along the landslide trail, as the lower part of the hillside is largely covered with hard surface (Figure 2).

Above the landslide scar is a 40° steep sloping ground, which was sparsely vegetated with some mature trees and generally covered with a hard surface (Figure 2). The pre-existing hard surface cover that is in a reasonably good condition marked the main scarp of the 7 June 2008 landslide (Plate 2). No topographic depressions or drainage features and no signs of distress in the form of tension cracks were observed on the area above the 7 June 2008 landslide.

Site inspection carried out on 10 June 2008 observed that the stepped channels connected to a catchpit at the northern flank of the 7 June 2008 landslide were blocked by leaf debris (Figure 2 and Plate 11). During subsequent inspections, fairly significant surface erosion was also noted at the sides of catchpit and surface drainage channels of cut slope No. 11SW-D/C12 to the south of the landslide scar (Figure 2 and Plate 12).

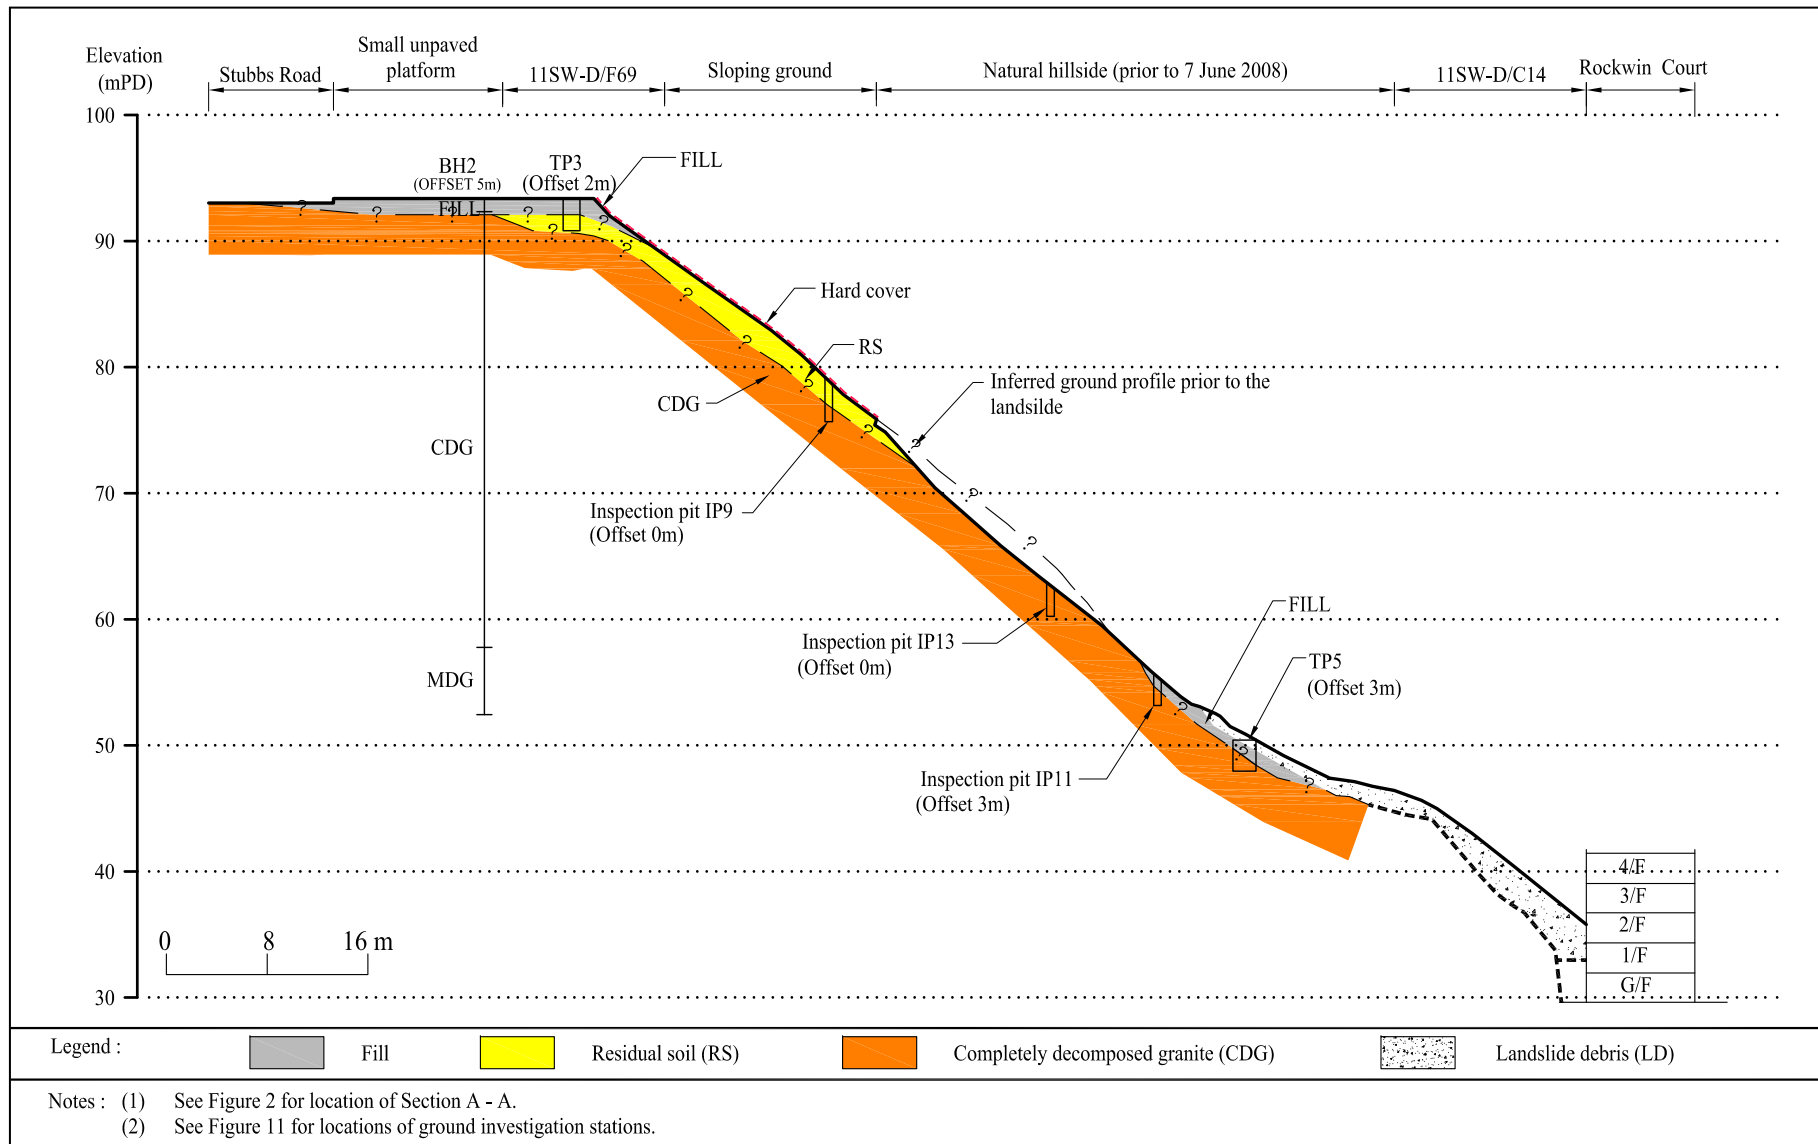
Figure 3 - Section A-A through the landslide

An interpreted geological section through the 7 June 2008 landslide is shown in Figure 3, which indicates that the site comprises a mantle of residual soil of up to about 1.8 m thick, overlying completely decomposed granite (CDG) and bedrock comprising slightly to moderately decomposed granite (S/MDG). The post-failure GI revealed that the 7 June 2008 landslide appeared to have taken place within the residual soil or CDG. No adversely orientated relict joints in the residual soil and CDG were noted in the post-failure GI stations. Other pertinent observations from individual GI stations are summarised as follows.

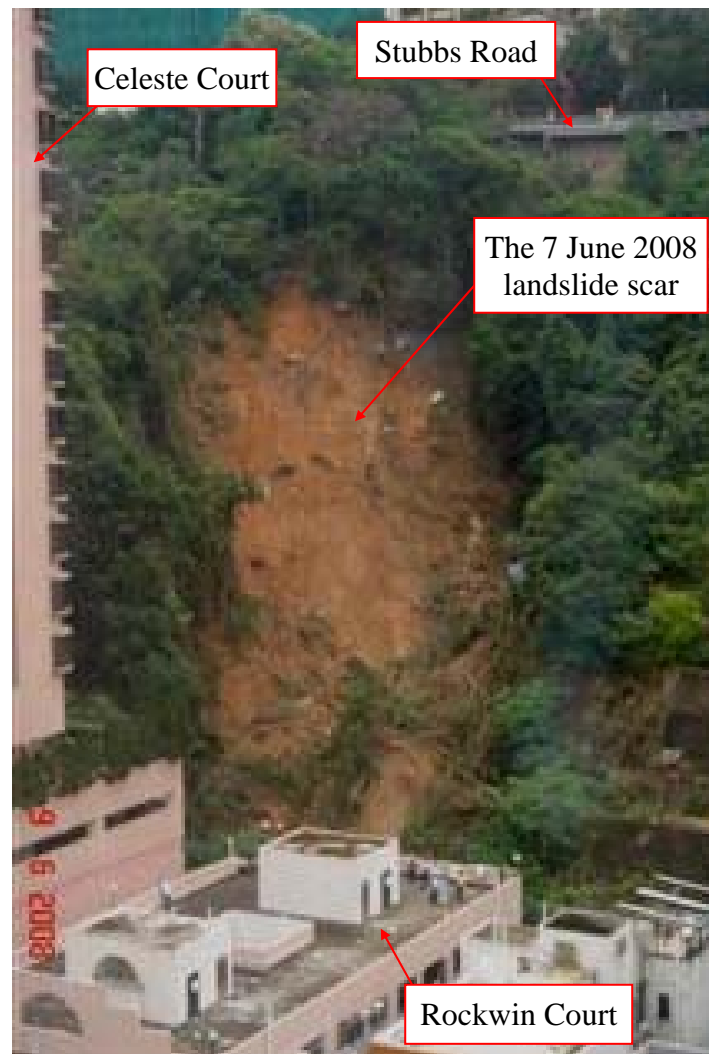
Plate 1 - General View of the 7 June 2008 Landslide  
(Photograph taken by a resident of Rockwin  
Court on 9 June 2008)

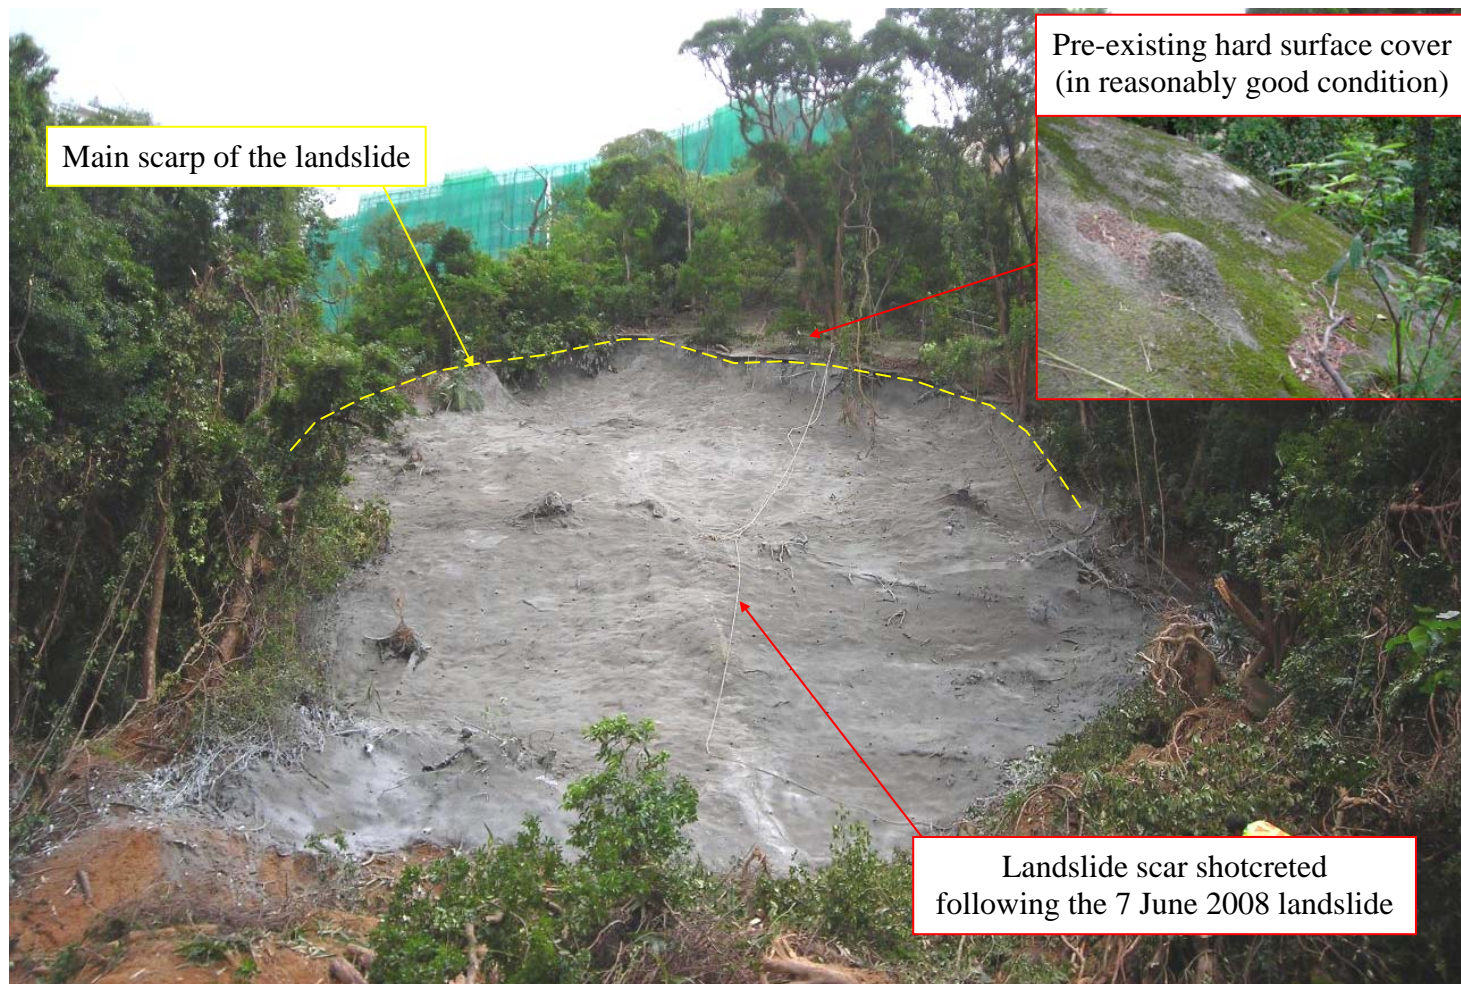
Plate 2 - Pre-existing Hard Surface Cover Marked the Main Scarp of the 7 June 2008 Landslide  
(Photograph taken on 10 June 2008)

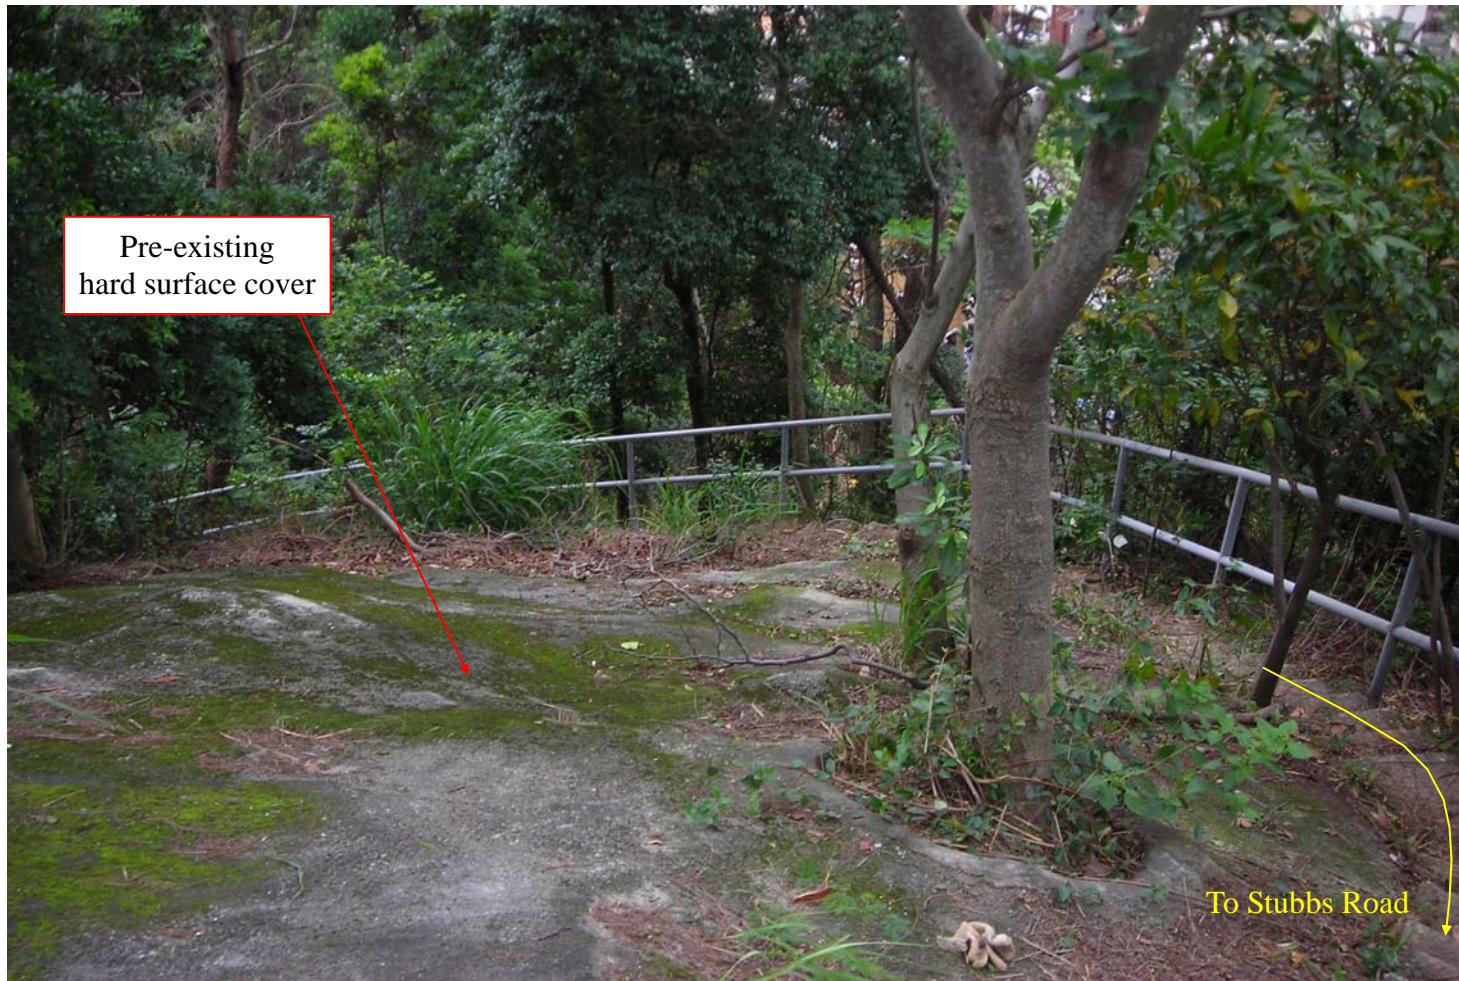
Plate 3 – Concrete Stairway above the 7 June 2008 Landslide Scar  
(Photograph taken on 10 June 2008)

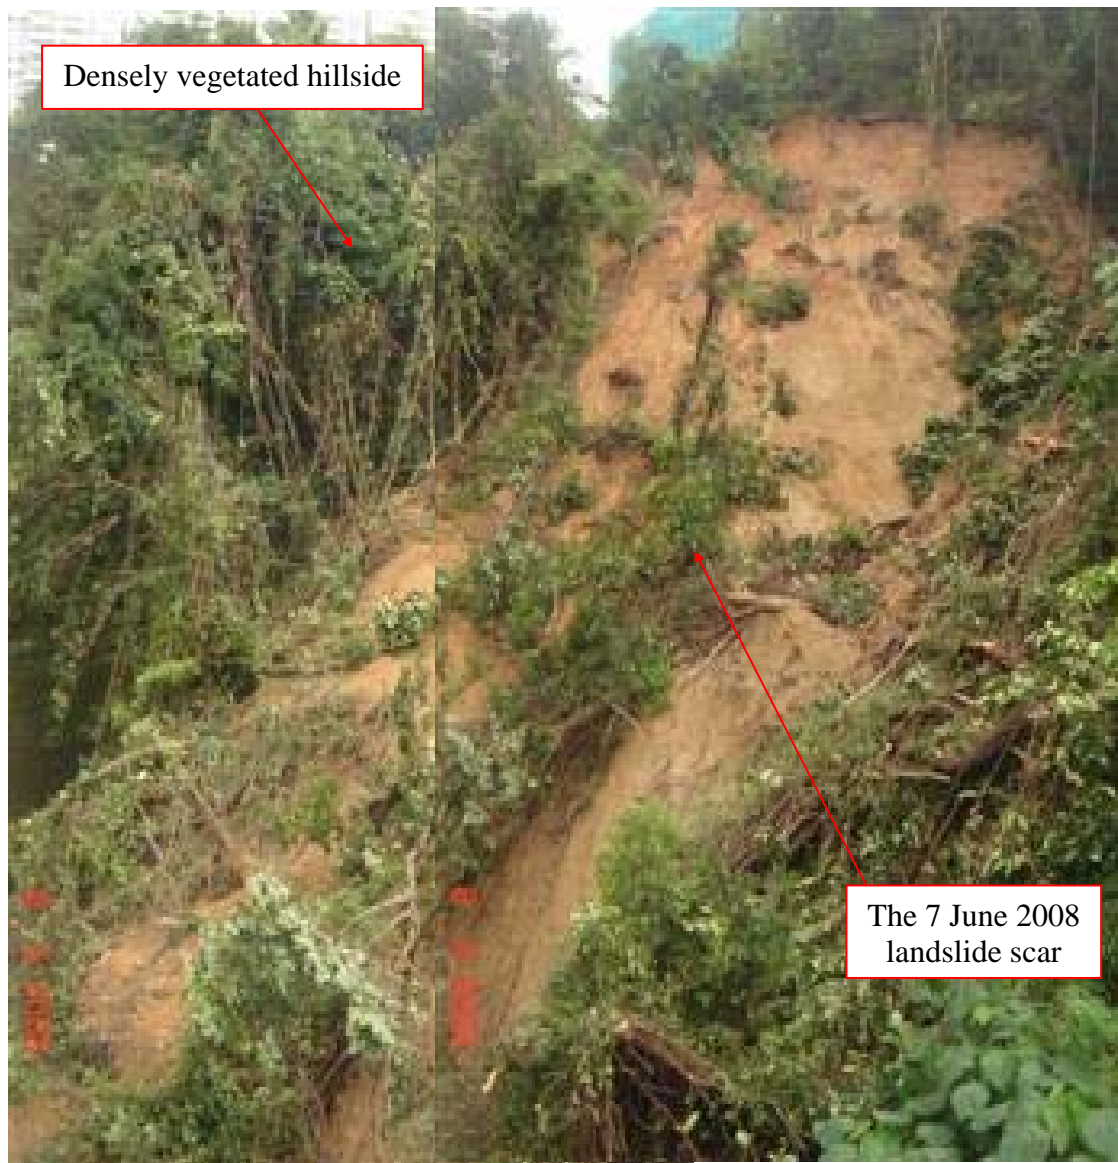
Plate 5 - Source Area of the 7 June 2008 Landslide  
(Photograph taken by a resident of Rockwin  
Court on 8 June 2008)

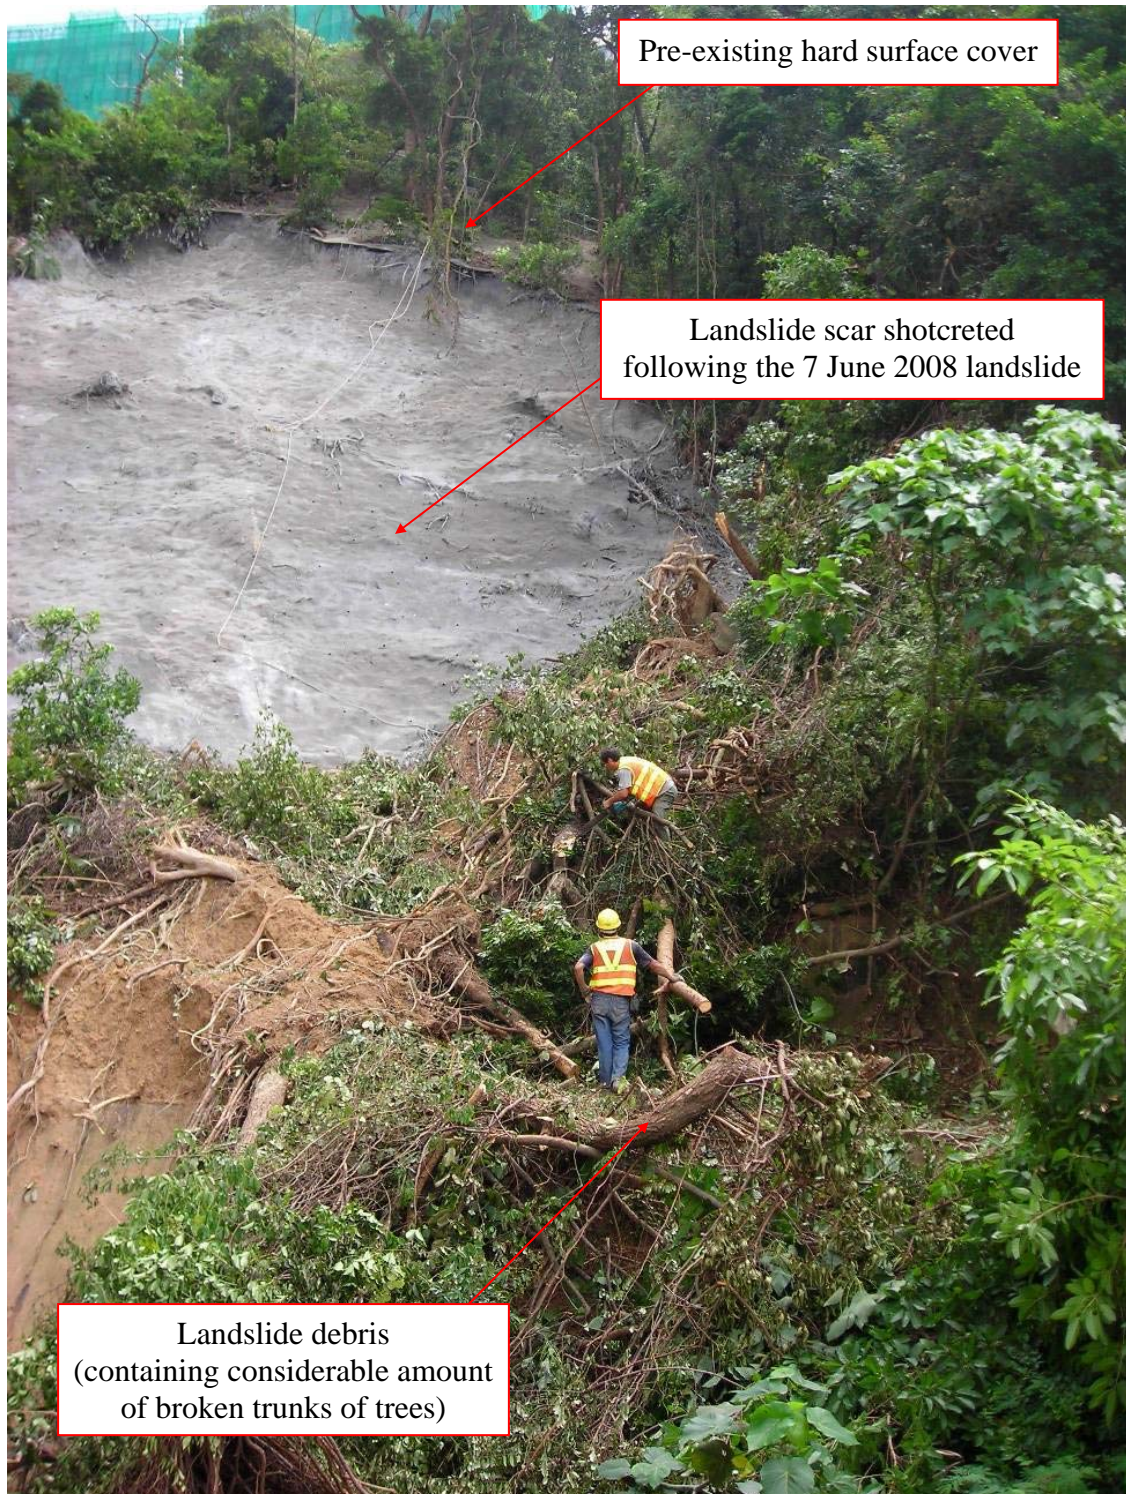
The landslide debris deposited at the rear of Rockwin Court and at the rear alleyway of Celeste Court was about 4 m and 0.5 m thick respectively, which comprised mainly a soil matrix of light reddish brown mottled yellow clayey sandy silt with some gravel- or cobble-sized and occasional boulder-sized rock fragments. The debris contained considerable amount of vegetation including many broken tree trunks (Plates 6, 7 and 10).

Plate 6 - Landslide Debris Deposited on the Cut Slopes at the Toe of Hillside  
(Photograph taken on 10 June 2008)

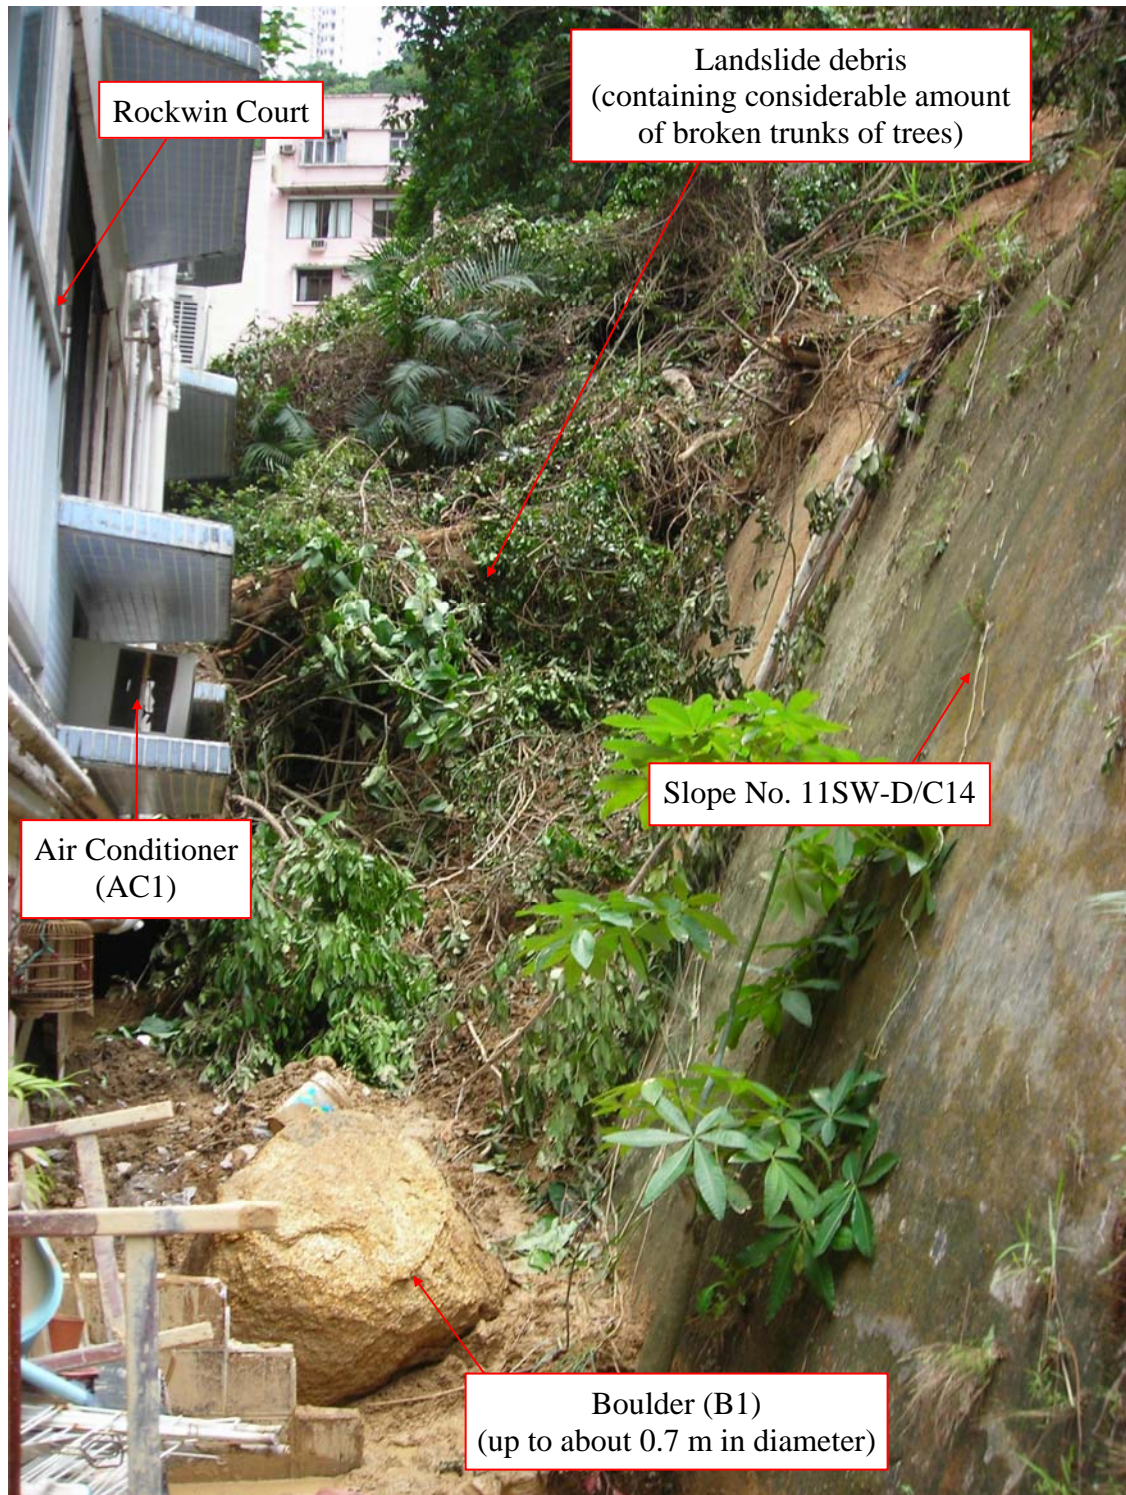
Plate 7 - Landslide Debris Deposited at the Rear of Rockwin Court  
(Photograph taken on 10 June 2008)

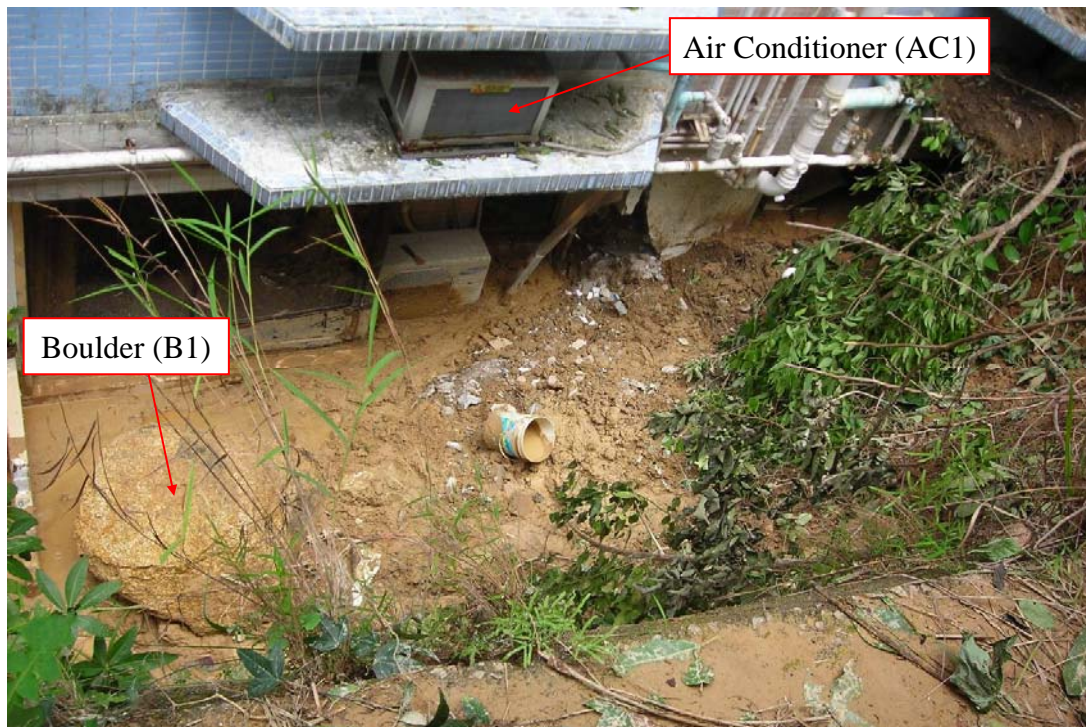
Plate 8 - Landslide Debris Piled against Rockwin Court  
(Photograph taken on 10 June 2008)

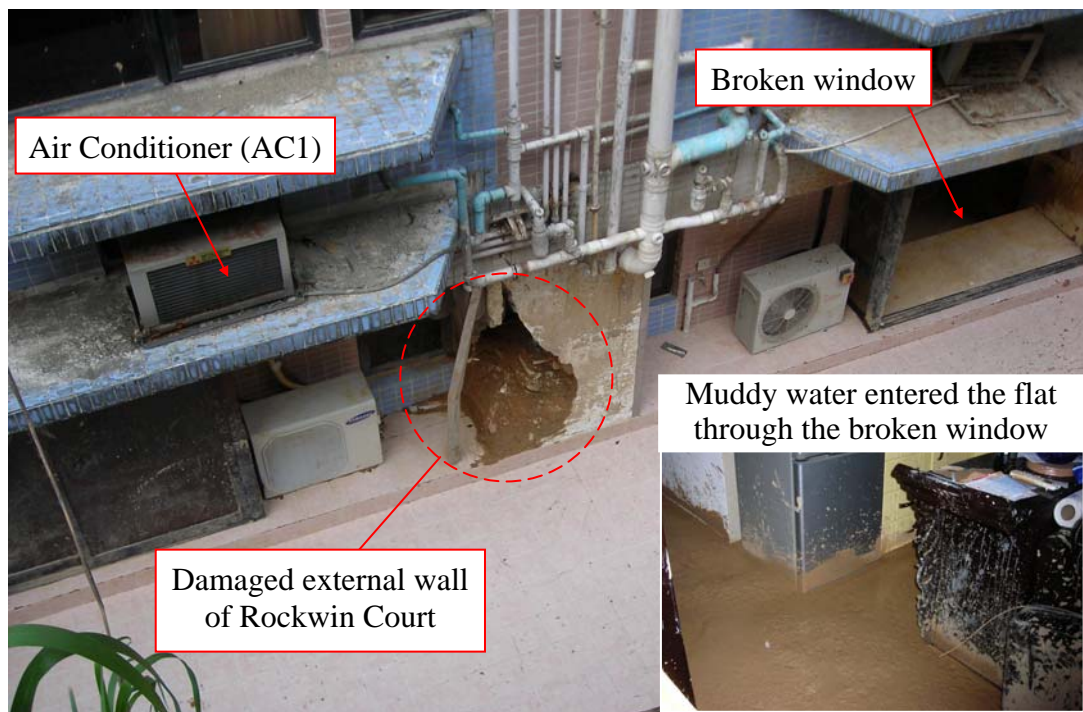
Plate 9 - Damage to Rockwin Court as a Result of the 7 June 2008 Landslide  
(Photograph taken on 14 July 2008 after removal of landslide debris)

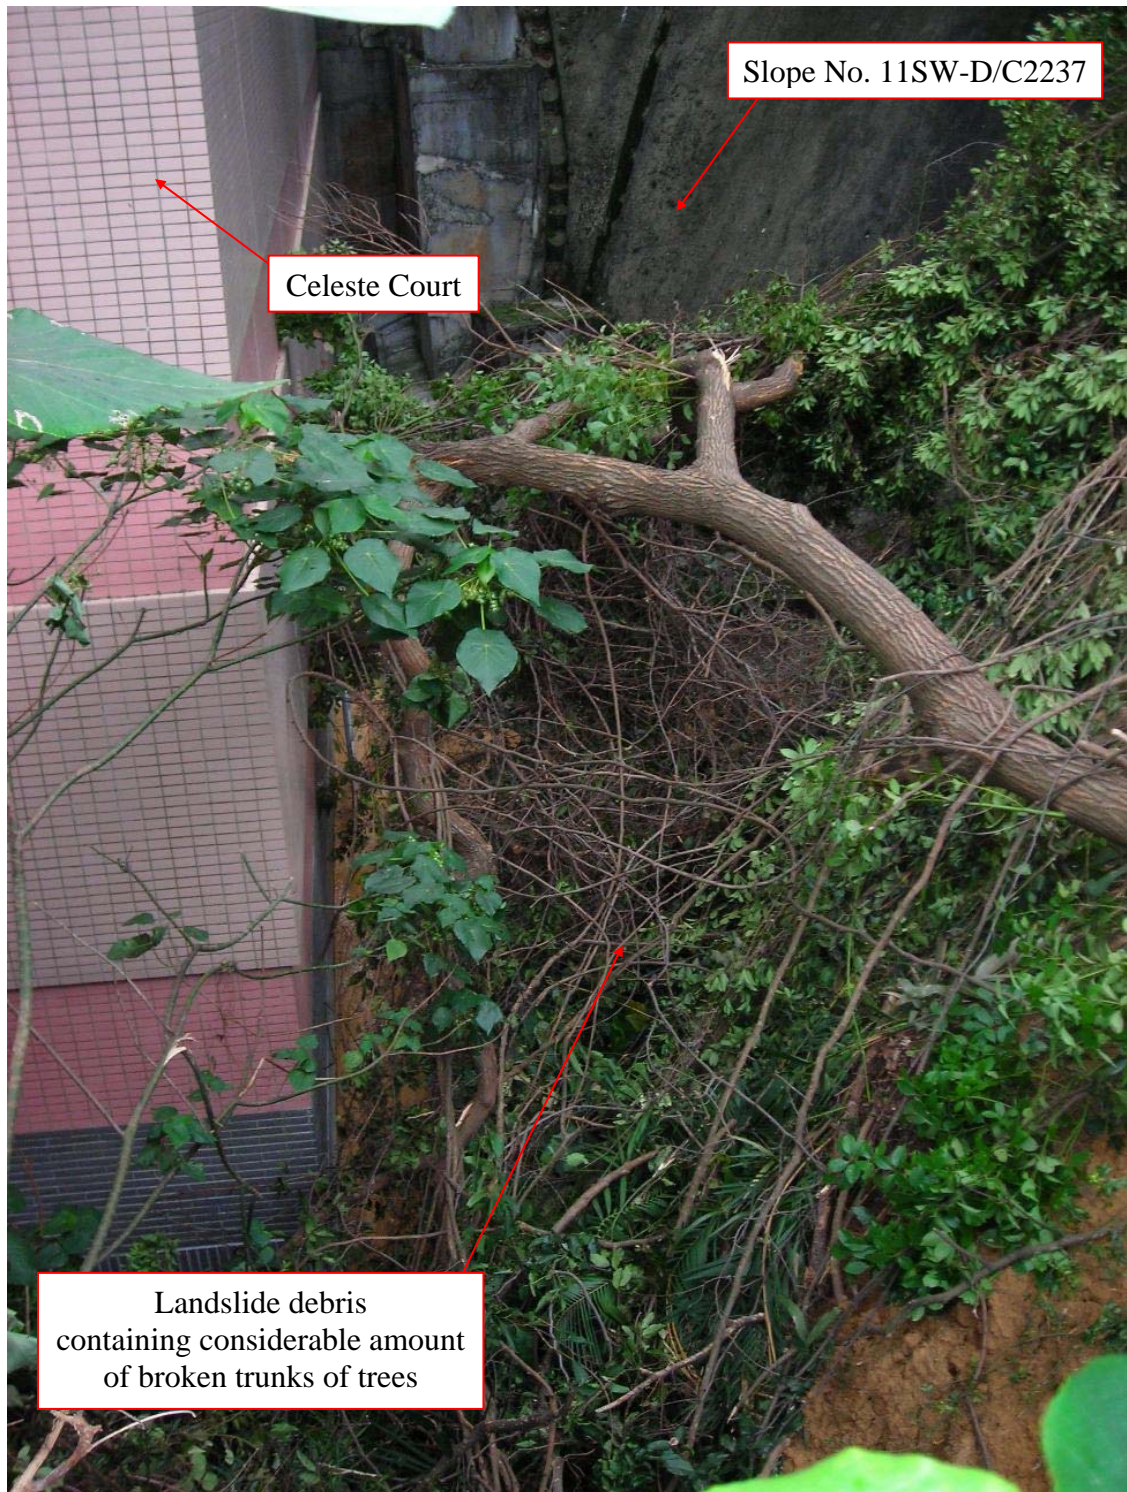
Plate 10 - Landslide Debris Deposited at the Rear Alleyway of Celeste Court  
(Photograph taken on 10 June 2008)

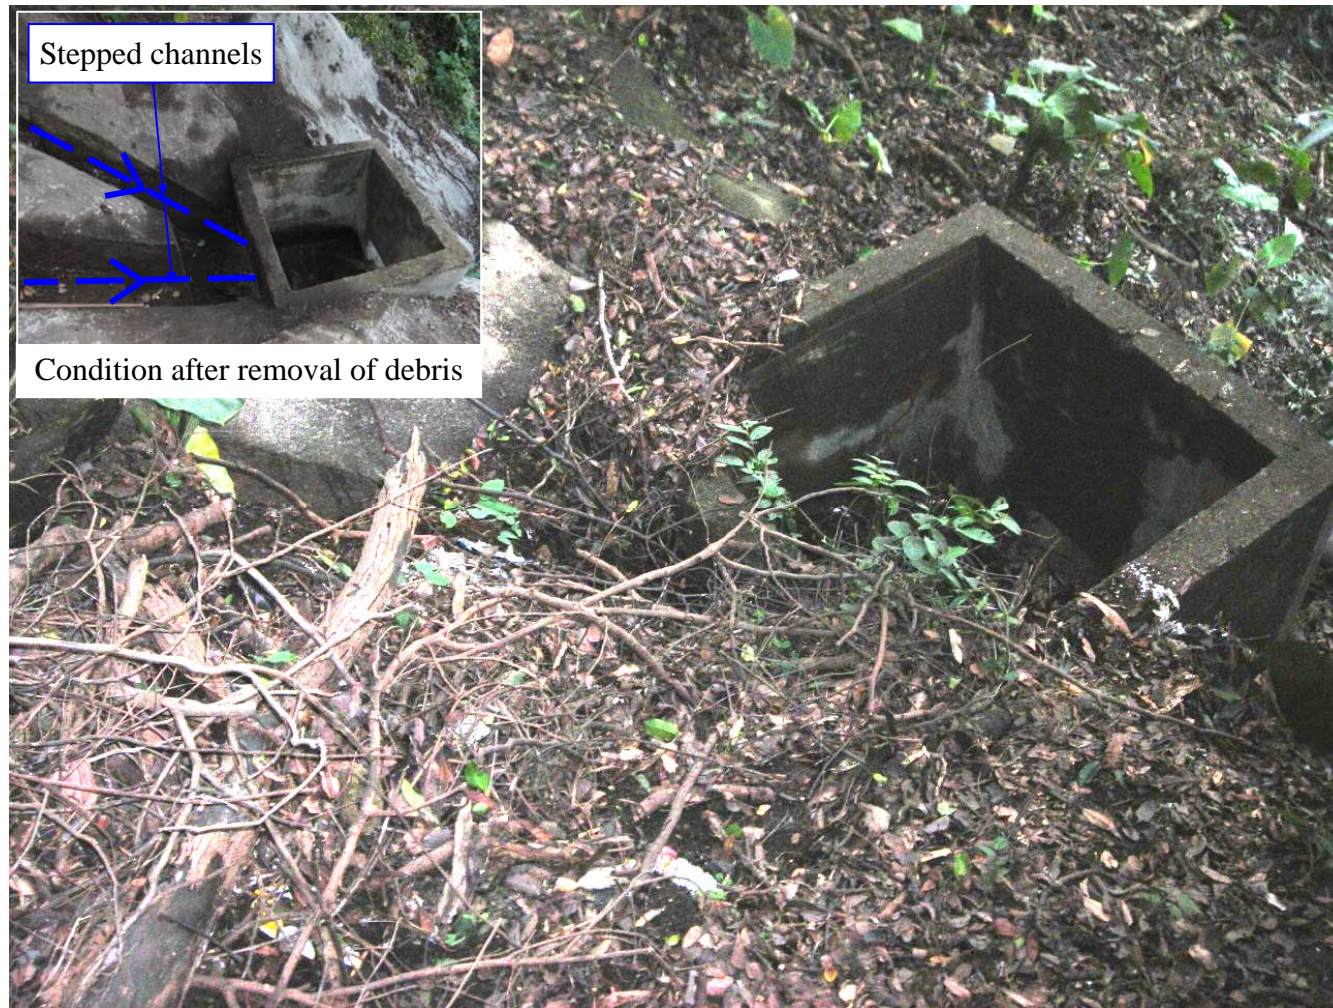
Another factor that might have contributed to the failure could be the blocked stepped channels (Figure 2 and Plate 11), which were located immediately above the northern flank of the 7 June 2008 landslide. The channels collect surface water from the hillside above and any blockage would have resulted in overspilling onto the northern flank of the hillside that failed on 7 June 2008. This is, however, considered to have a relatively minor contribution to the failure, as the extent of the area affected by the overspilling would likely have been limited.

Plate 11 - Blocked Stepped Channels at the Northern Flank of the 7 June 2008 Landslide  
(Photograph taken on 10 June 2008)

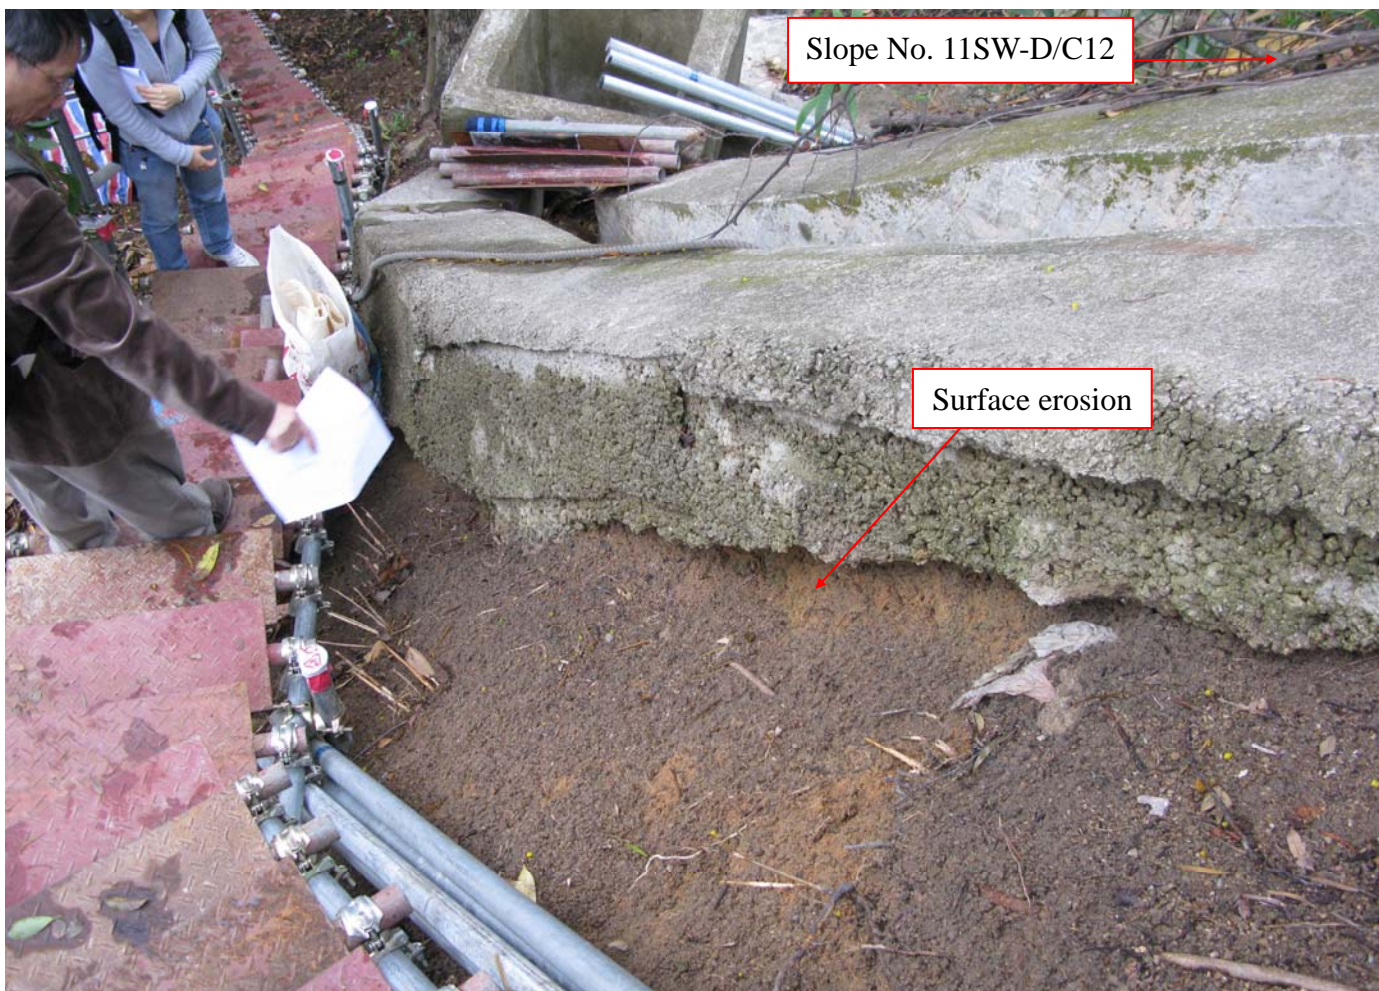
Plate 12 - Sign of Surface Erosion at the Sides of the Surface Drainage System of Slope No. 11SW-D/C12  
(Photograph taken on 24 March 2009)

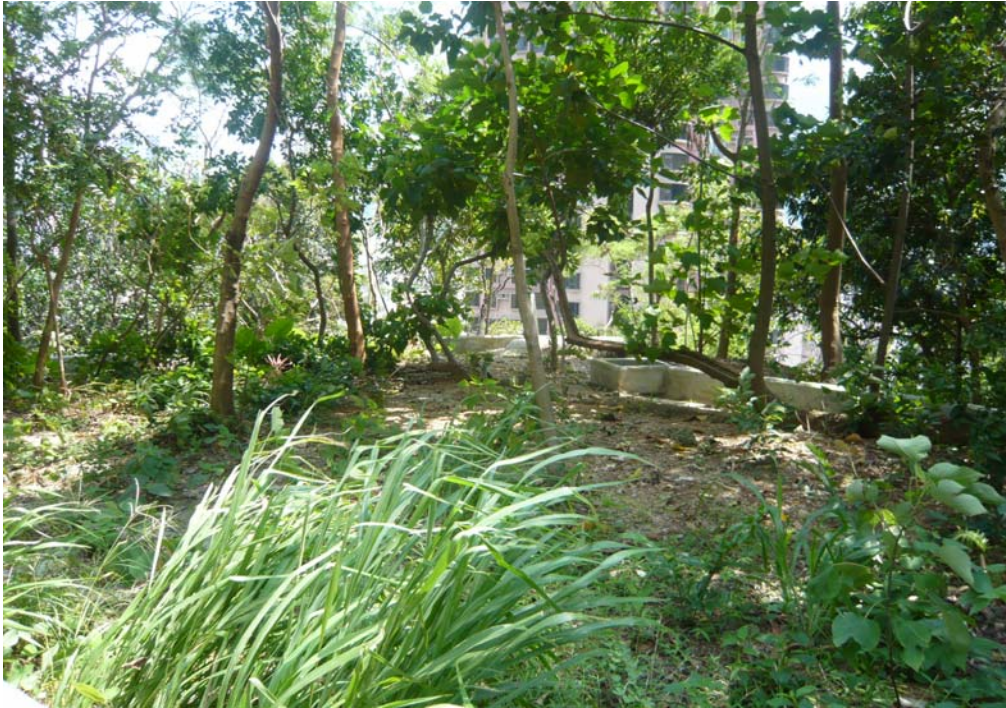
A small unpaved platform with a plan area of about 130 m<sup>2</sup> is present at the crest of fill slope No. 11SW-D/F69 alongside the uphill lane of Stubbs Road (Plate 13), at about 25 m to the southwest of the subject landslide site. An approximately 38 m long, 0.3 m high concrete upstand is provided along the elevated section of Stubbs Road above the concerned hillside (Figure 2 and Plate 14). Moreover, two roadside gullies along the uphill lane of Stubbs Road (Figure 2), which collect surface runoff from a portion of Stubbs Road, are connected to the surface drainage system at the northern end of slope No. 11SW-D/F69 through a 150 mm diameter drain pipe.

Plate 13 - Small Unpaved Platform at Crest of Slope No. 11SW-D/F69  
(Photograph taken on 23 September 2009)

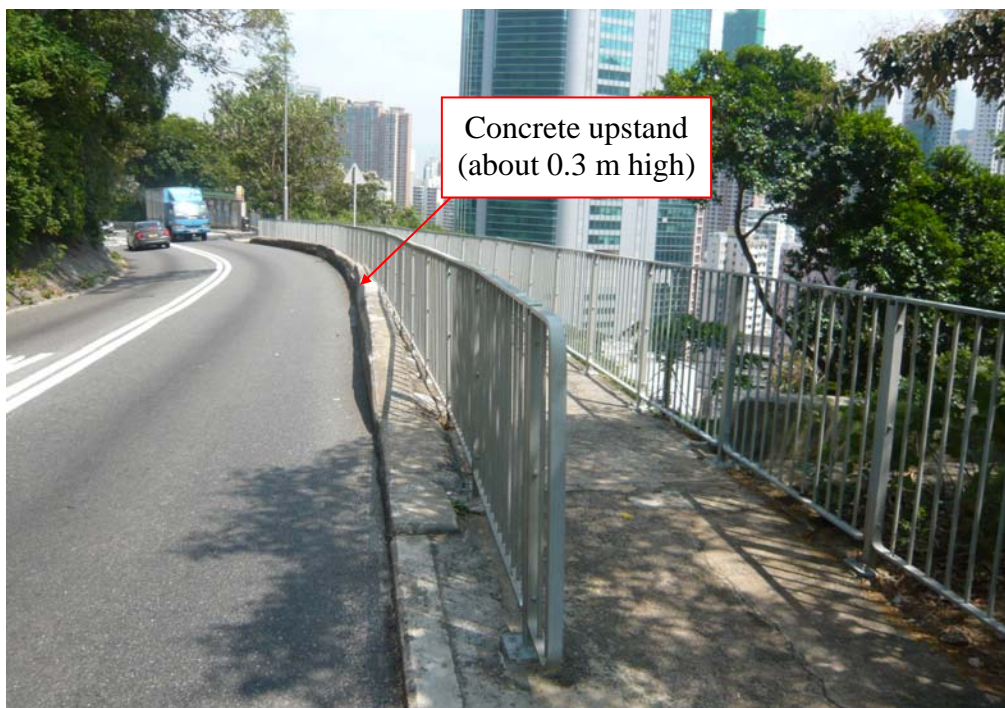
Plate 14 - Concrete Upstand along Stubbs Road above the 7 June 2008 Landslide  
(Photograph taken on 23 September 2009)
