**REVIEW OF THE  
21 AUGUST 2005 LANDSLIDE  
ON SLOPE NO. 3SW-C/C234 AT  
POLICE TACTICAL UNIT DEPOT  
FANLING**

**GEO REPORT No. 286**

**Halcrow China Limited**

**GEOTECHNICAL ENGINEERING OFFICE  
CIVIL ENGINEERING AND DEVELOPMENT DEPARTMENT  
THE GOVERNMENT OF THE HONG KONG  
SPECIAL ADMINISTRATIVE REGION**

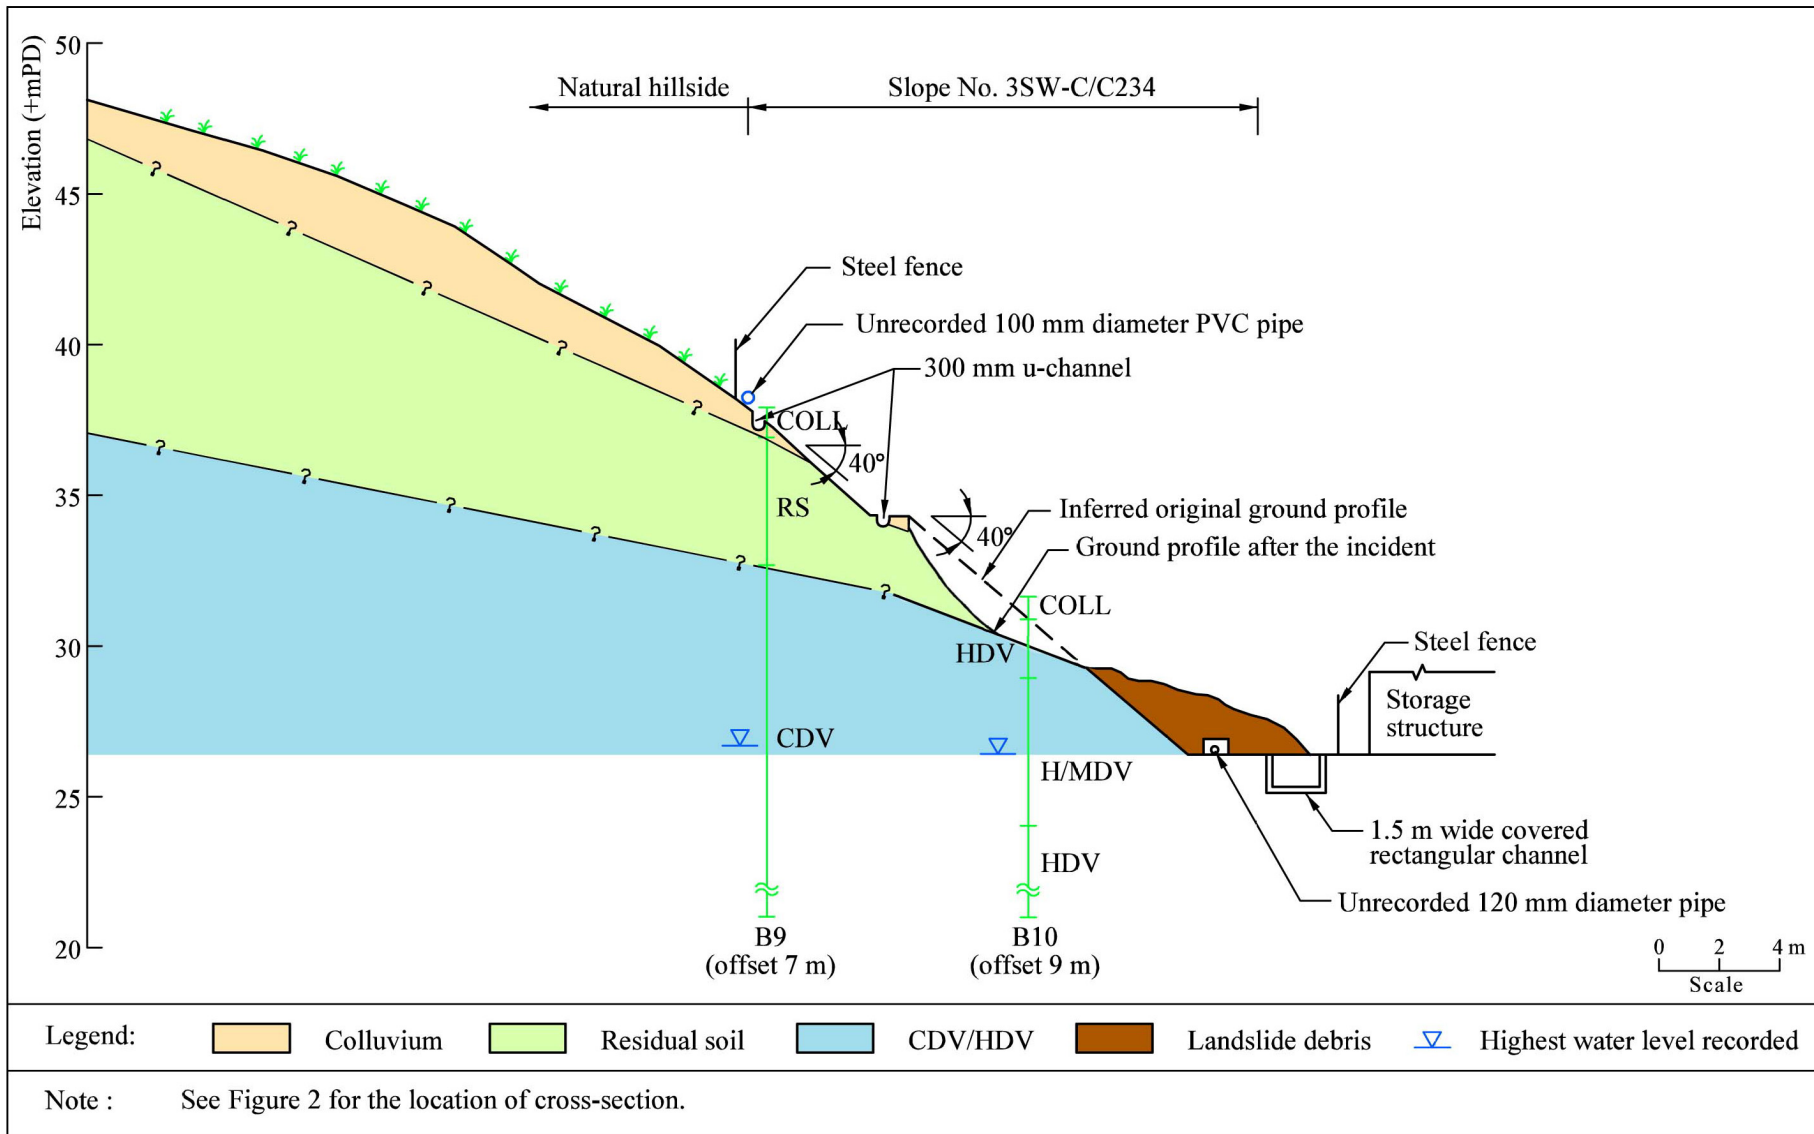
Figure 8 - Section A-A through the 21 August 2005 Landslide

An inspection of the landslide site was undertaken by MGSL, another Landslide Investigation Consultants, on 14 November 2005 (Plates 3 to 6). According to the MGSL inspection records, the landslide scar measured about 8.6 m wide by 7.5 m high with a depth of about 1.5 m. The failure volume was about 40 m<sup>3</sup>. MGSL recorded that the back scarp of the landslide site was near sub-vertical, and the debris deposited at slope toe had an average angle of 30° (Plates 3 and 4). The slope was covered with trees, shrubs and grass at the time of failure. The failed material mainly comprised residual soil with some stones and cobbles and some completely decomposed tuff (Plate 9). MGSL did not observe tension crack or water seepage on the slope during their inspection. A cross-section through the landslide site is presented in Figure 8.

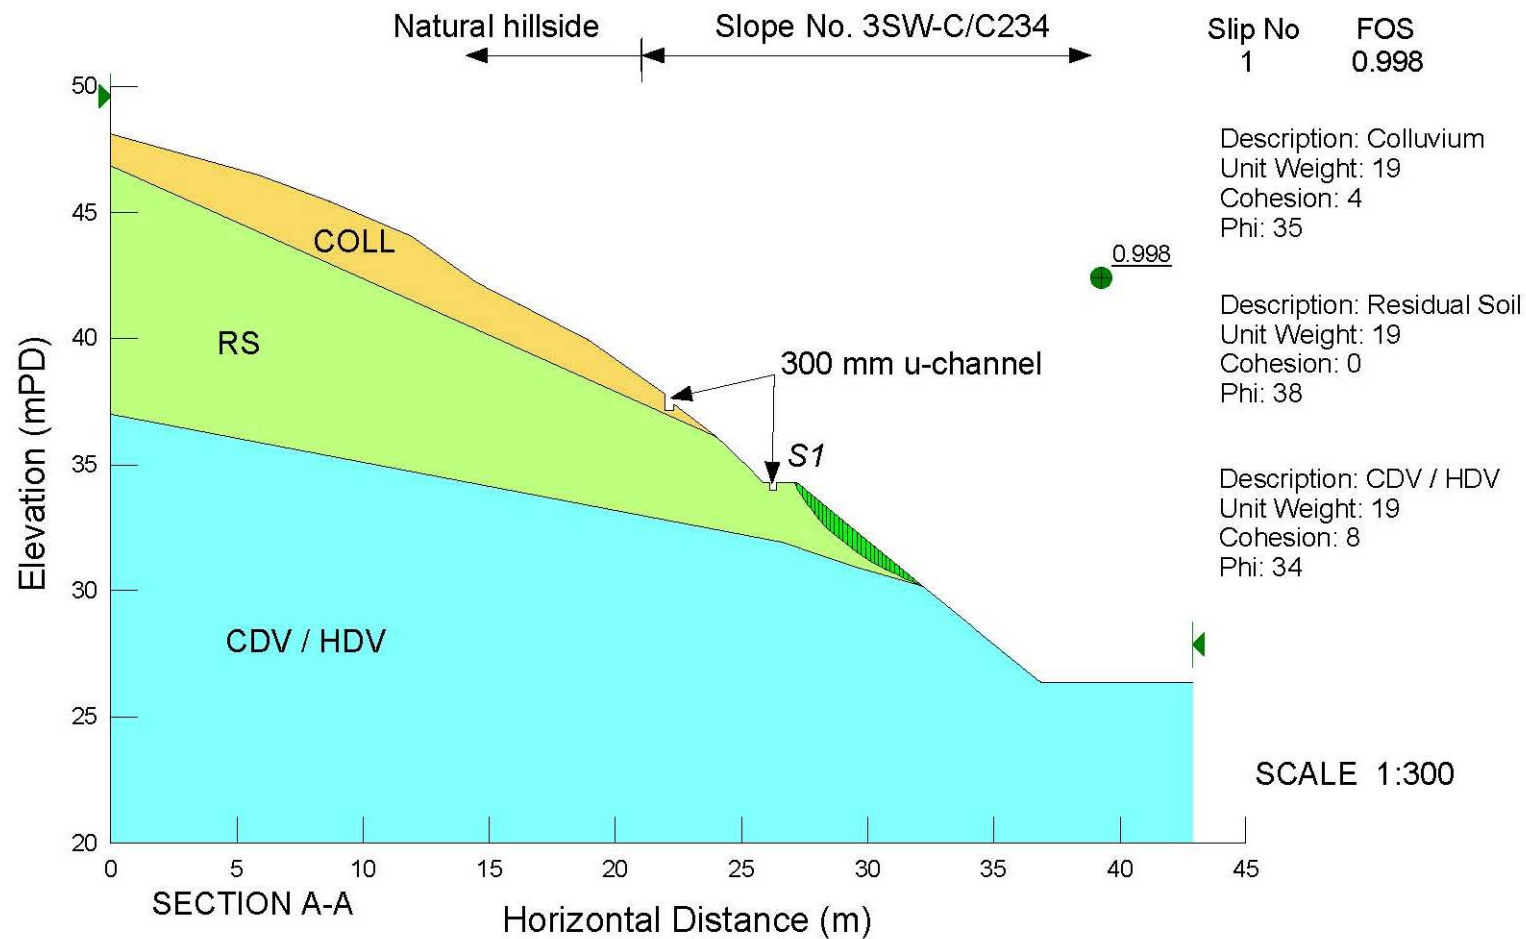
Figure 12 - Summary of Theoretical Stability Analysis of the August 2005 Slip Surface

Based on these shear strength parameters, stability analysis indicates that the FOS of the slope is about unity even if no pore water pressure is assumed. This shows that the slope could fail upon loss of suction. The incident is thus theoretically admissible (Figure 12).

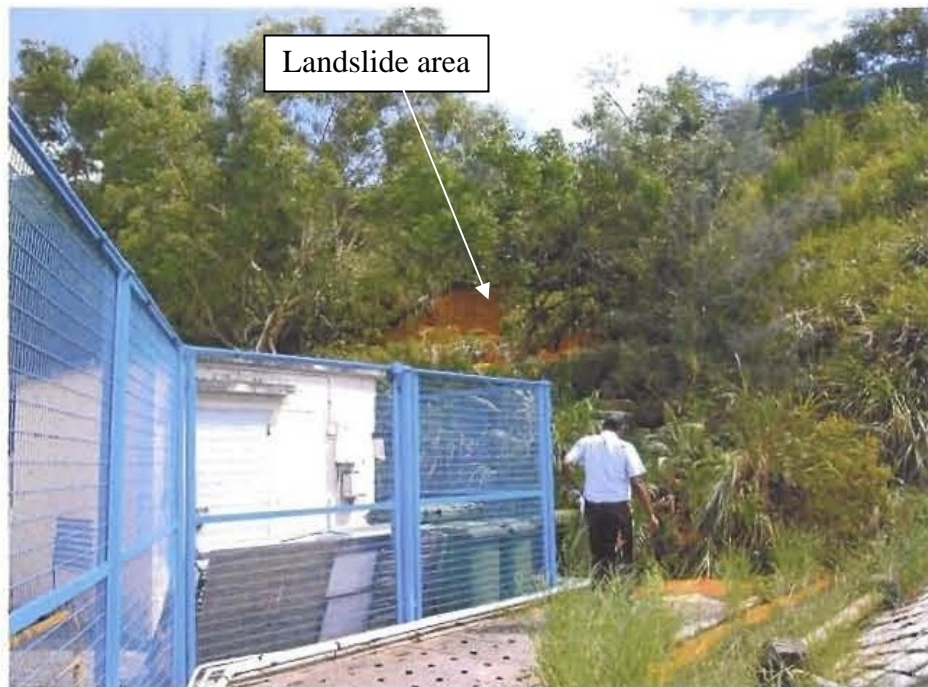
In response to a report from the PTU Depot, an initial inspection of the landslide site was carried out by the GEO at 2:40 p.m. on 22 August 2005. The landslide debris, with a failure volume of about 40 m<sup>3</sup>, was deposited at the slope toe (Plate 3). A 120 mm diameter cast iron water pipe running along the slope toe was damaged by the landslide debris. No casualties were reported as a result of the incident.

Plate 1 - General View of the Landslide Site  
(Photograph taken by GEO on 22 August 2005)

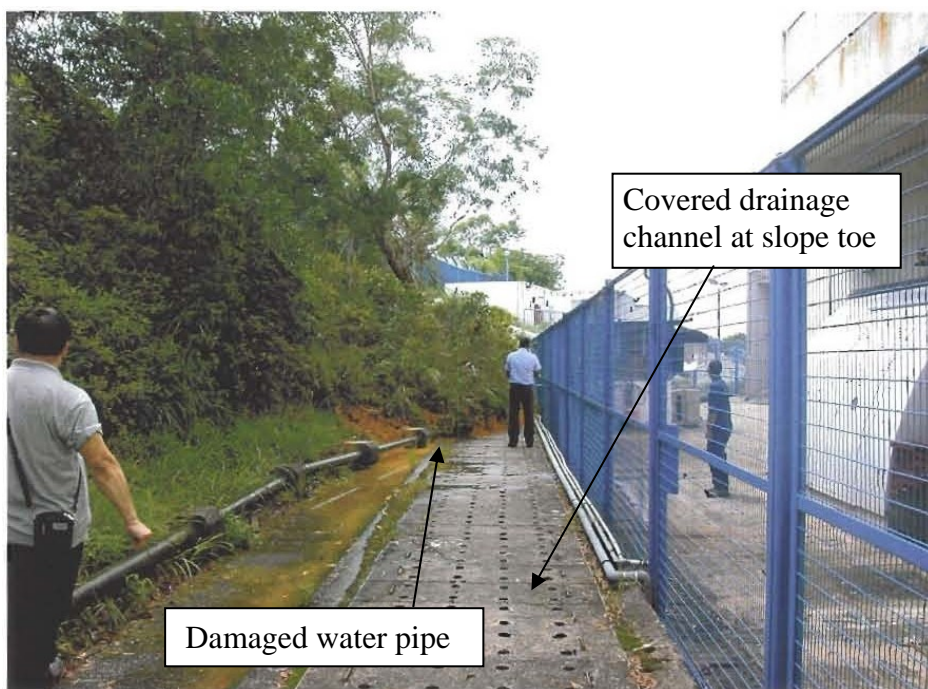
Plate 2 - Landslide Debris Damaged a Water Pipe along the Slope Toe  
(Photograph taken by GEO on 22 August 2005)

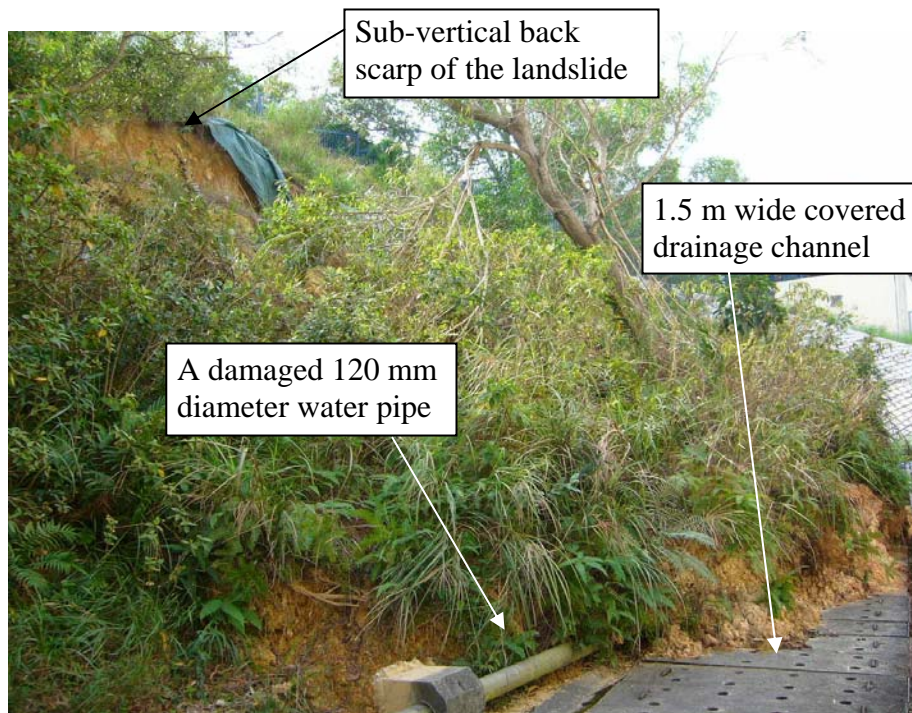
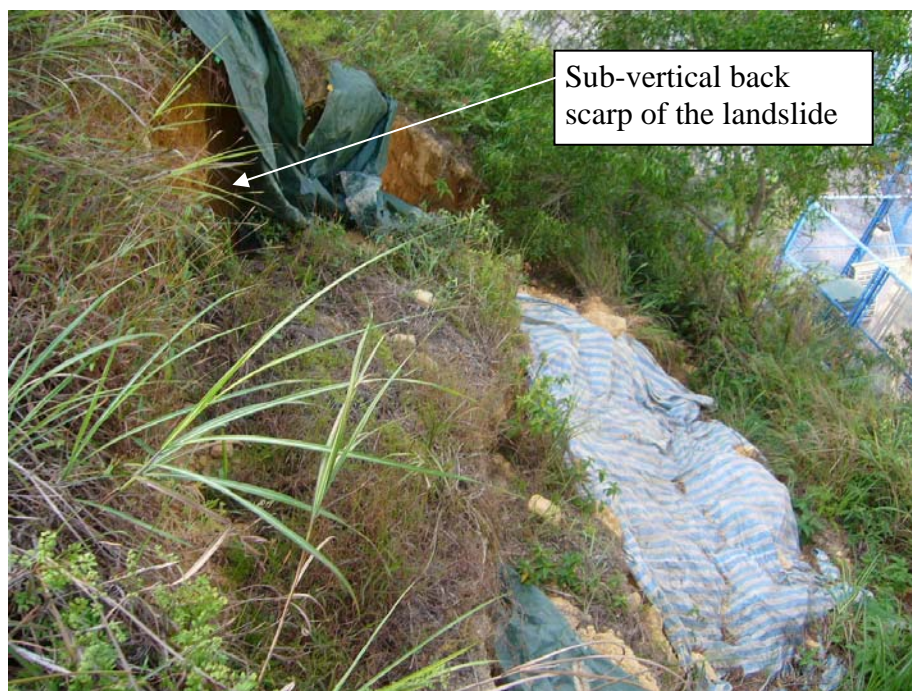
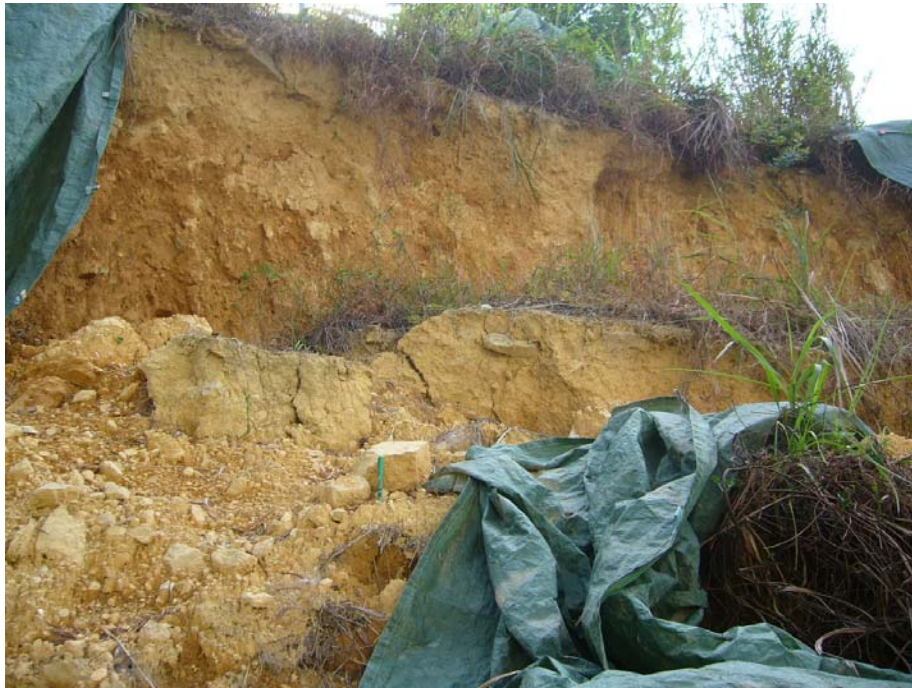
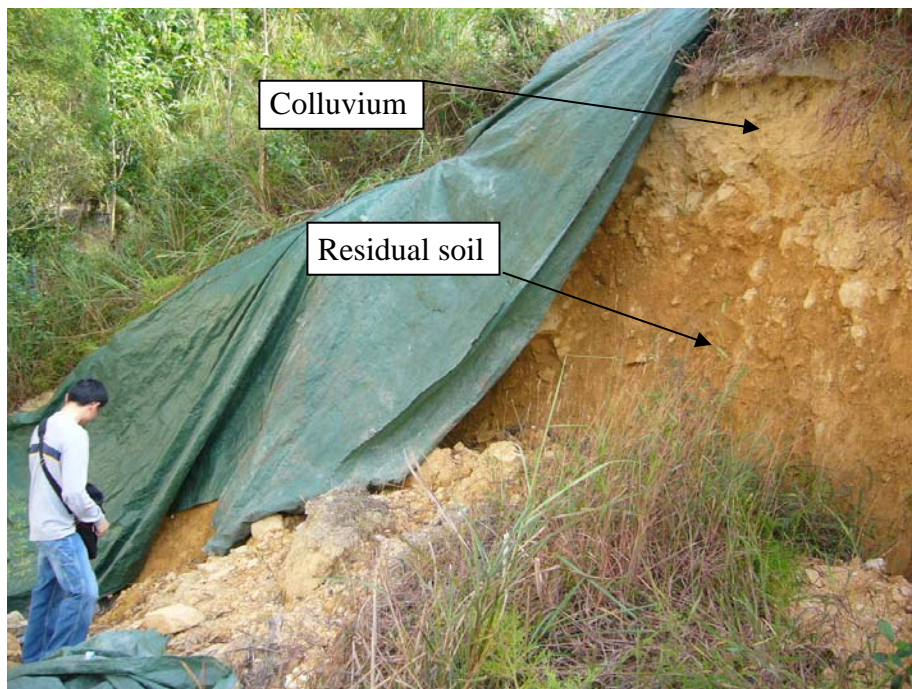
Plate 3 - Side View of the Landslide Site  
(Photograph taken by MGSL on 14 November 2005)

Plate 4 - General View of the Crest of the Landslide Site  
(Photograph taken by MGSL on 14 November 2005)

Plate 5 - General View of the Back Scarp of the Landslide Site  
(Photograph taken by MGSL on 14 November 2005)

Plate 6 - Soil Materials Exposed on the Back Scarp of the Landslide Site  
(Photograph taken by MGSL on 14 November 2005)

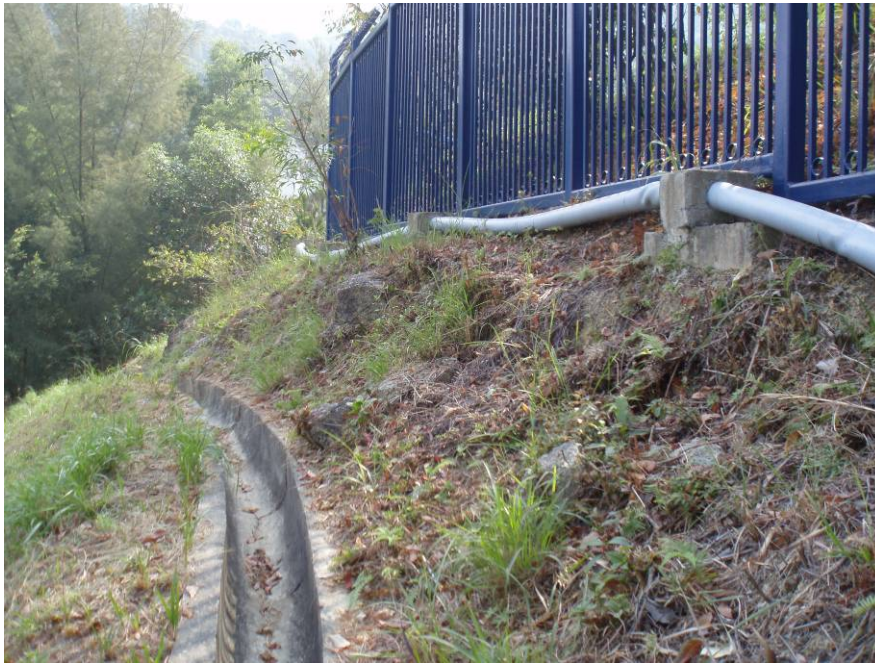
However, a water pipe (120 mm in diameter) was found emerging from the lower batter of the slope at its eastern end and running along the toe of slope No. 3SW-C/C234, and another water pipe (100 mm in diameter) was found along the crest of the subject slope (Figure 2 and Plates 7 and 8). No sign of leakage was observed during the site inspections after the August 2005 landslide.

Plate 7 - A 100 mm Diameter PVC Pipe Running along the Crest of Slope No. 3SW-C/C234  
(Photograph taken by HCL on 18 December 2007)

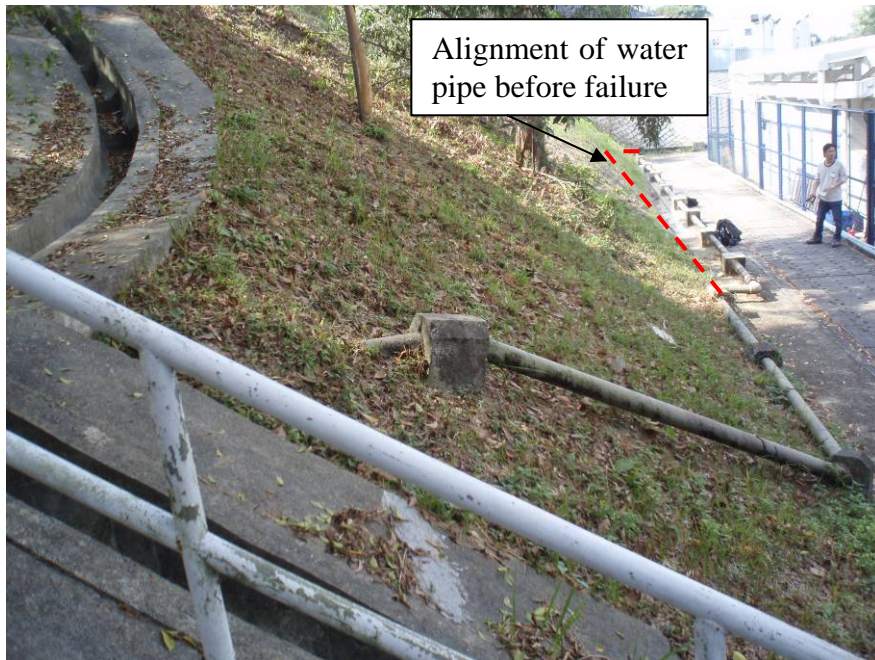
Plate 8 - A 120 mm Diameter Pipe Emerging from the Lower Batter of Slope No. 3SW-C/C234  
(Photograph taken by HCL on 18 December 2007)

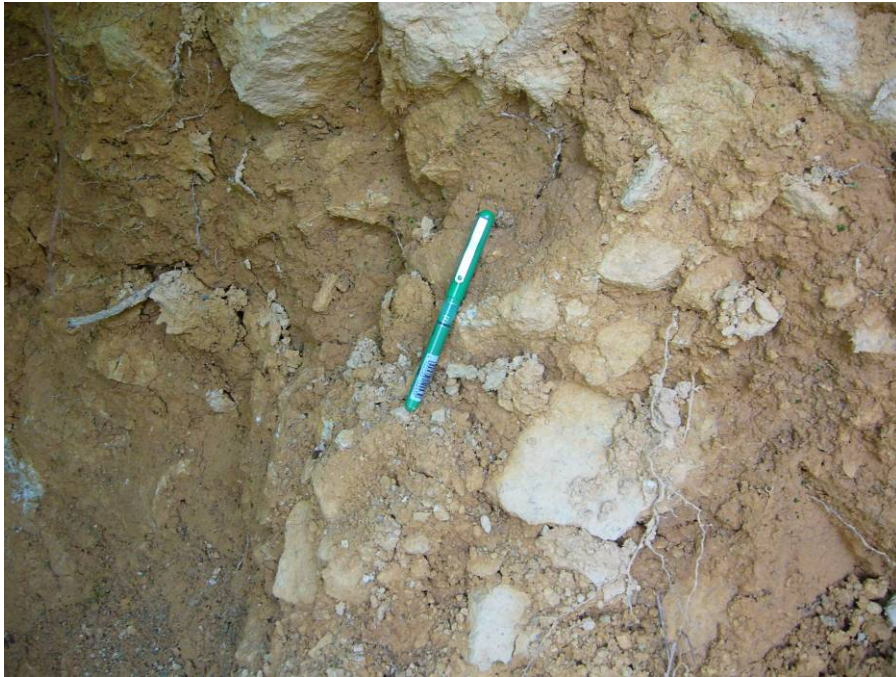
Plate 9 - Completely Decomposed Tuff Exposed on the Landslide Debris  
(Photograph taken by MGSL on 14 November 2005)

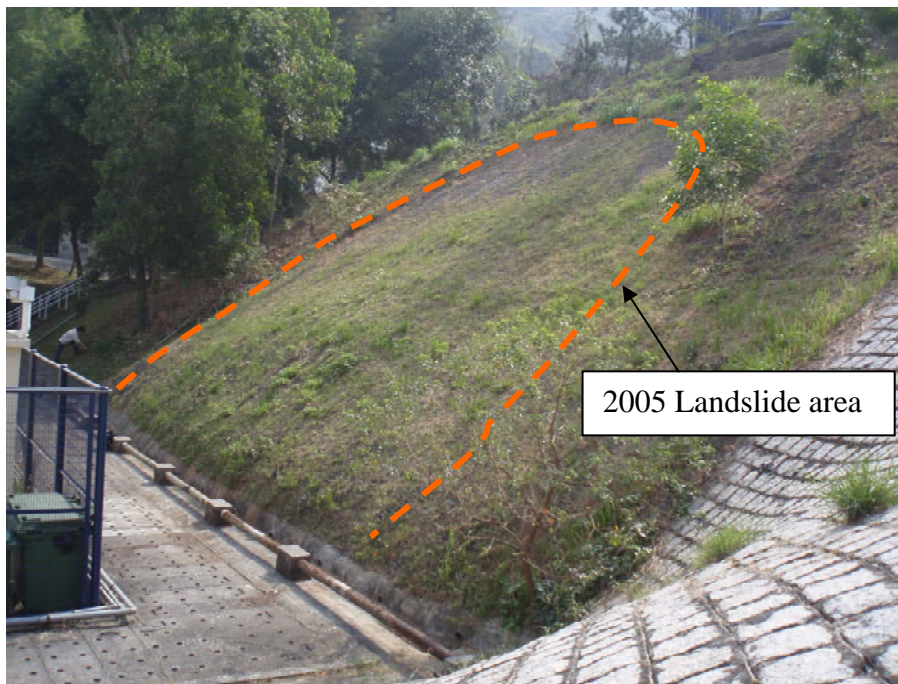
HCL subsequently inspected the landslide site on 18 December 2007, by which time the urgent repair works had already been completed. The landslide area had been backfilled with compacted cement soil and covered with vegetation (Plate 10). The affected water pipe along the slope toe had been re-aligned (Plate 8). A patch of bare surface was observed at the upper portion of the backfilled area (Plate 11), where the growth of vegetation may have been hindered by the cement soil.

Plate 10 - General View of Slope No. 3SW-C/C234 after  
Completion of Urgent Repair Works  
(Photograph taken by HCL on 18 December 2007)

Following the 2005 landslide, urgent repair works including benching of the failed area to facilitate the subsequent filling with compacted cement soil, provision of 75 mm diameter perforated PVC pipes and hydroseeding with provision of wire mesh. The works were completed in February 2006. A 150 mm U-channel was also constructed at the toe of the repaired portion, which discharges water into an adjacent 1.5 m wide covered rectangular drainage channel (Plate 17).

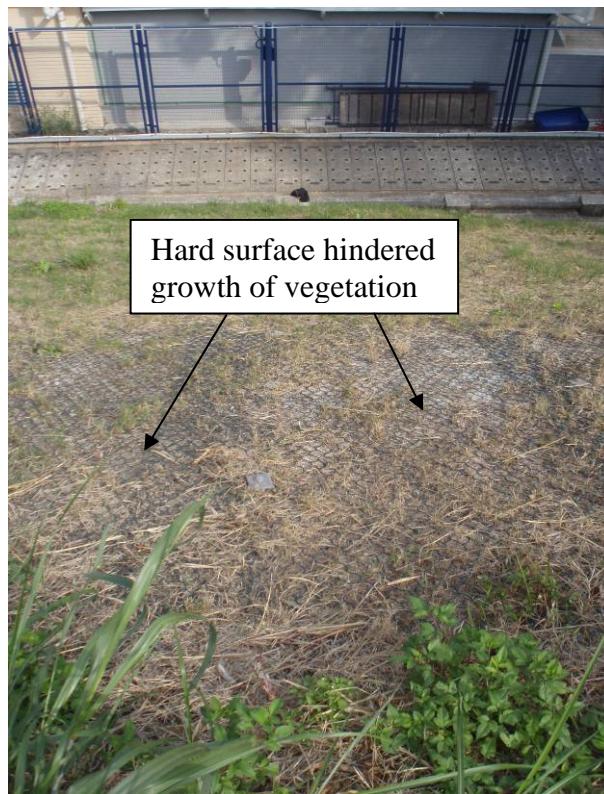
Plate 11 - Close-up View of Bare Surface from Slope Berm  
(Photograph taken by HCL on 18 December 2007)

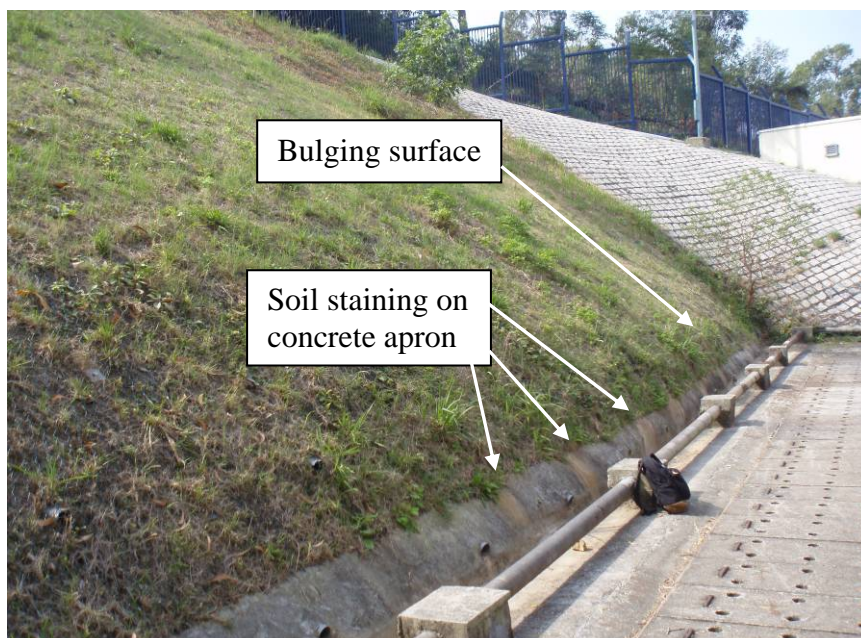
Some soil staining was observed on the hard surface apron at the slope toe. This possibly indicated minor surface erosion or washout at the slope (Plate 12). Minor bulging was also visible at the slope toe (Plate 12). The bulging could have been a result of overfilling of the cement soil during the slope repair works following the August 2005 landslide. No other signs of distress or movement, or signs of seepage were noted at the subject slope at the time of inspection.

Plate 12 - Soil Staining and Bulging Observed at the Toe of Slope No. 3SW-C/C234  
(Photograph taken by HCL on 18 December 2007)

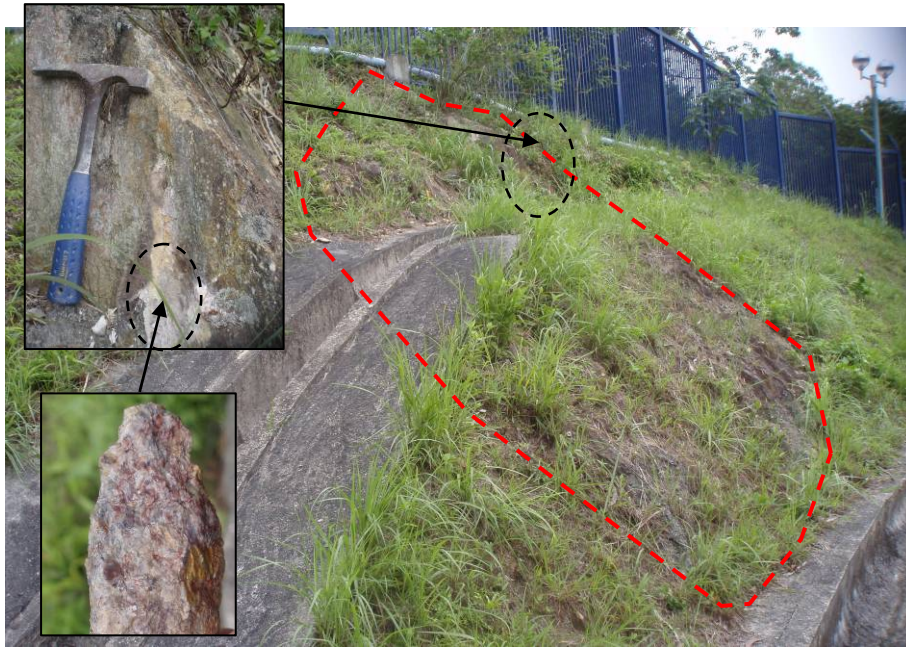
Plate 13 - Rock Outcrop Exposed on the Upper Batter of the Slope No. 3SW-C/C234  
(Photograph taken by HCL on 18 December 2007)

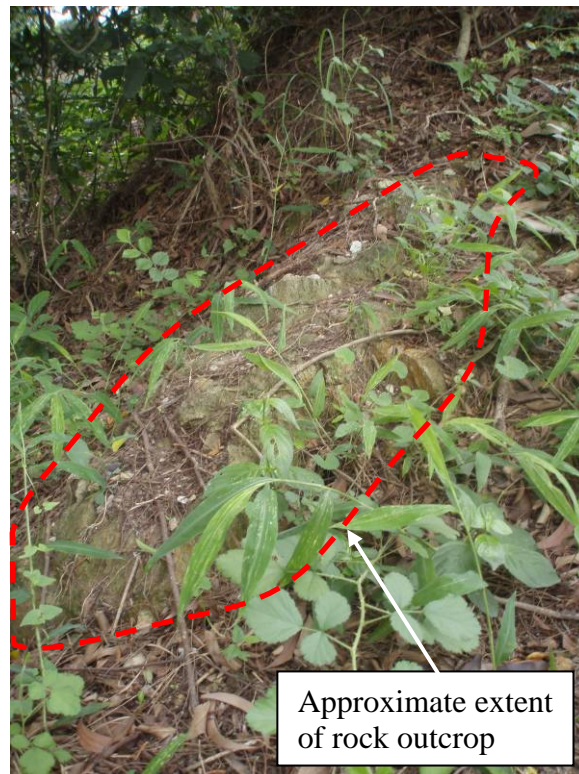
A small rock outcrop was seen in the upper batter of the eastern portion of the slope and comprised moderately strong to strong, light grey to yellowish brown, moderately decomposed, coarse ash crystal TUFF. Close examination of the rock material revealed some schistosity and that the matrix of the tuff appeared to have a very high quartz content and silicified (Plate 13). Immediately to the east of the subject slope was another smaller isolated rock outcrop (Plate 14) with similar schistosity and silicification. Some small rock outcrops were also found on both sides of a paved footpath leading to the southwest of the subject slope (Plates 15 and 16), but these were limited in extent.

Plate 14 - Rock Outcrop Exposed Immediately to the East of Slope No. 3SW-C/C234  
(Photograph taken by HCL on 18 December 2007)

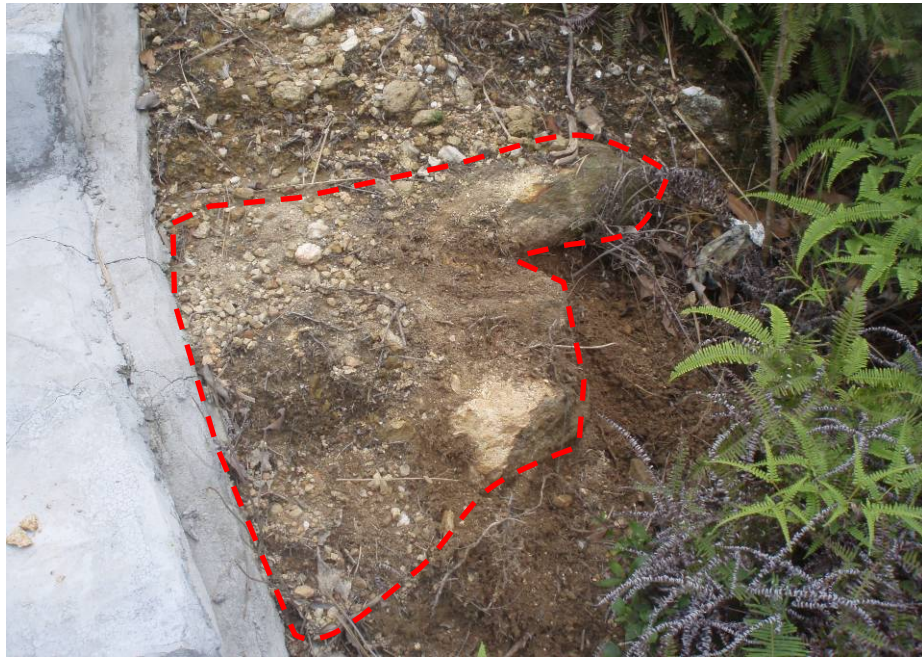
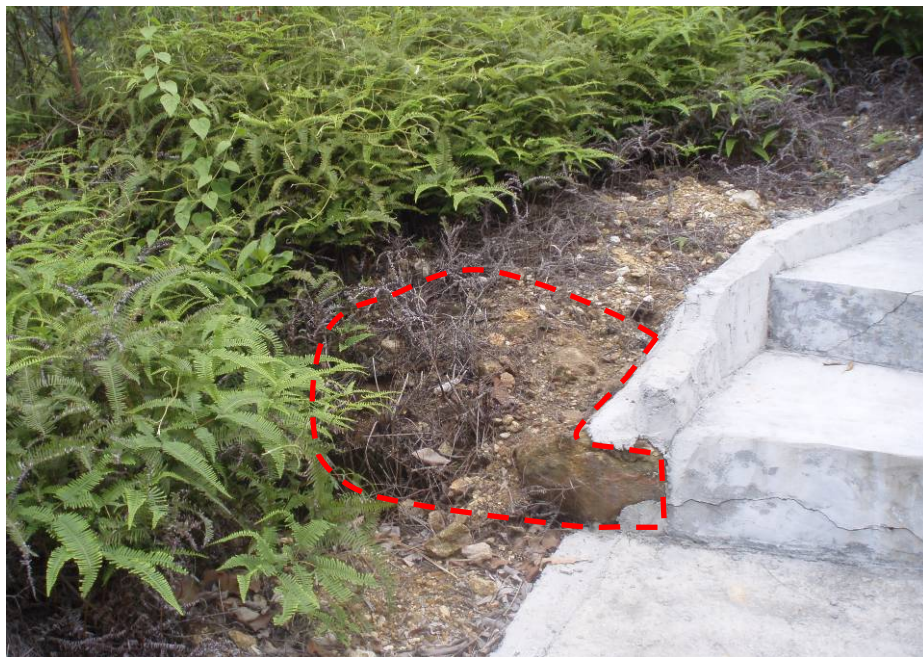
Plate 15 - Possible Rock Outcrop Exposed at the Right Hand Side of the Paved Footpath to the Southwest of Slope No. 3SW-C/C234  
(Photograph taken by HCL on 30 April 2008)

Plate 16 - Possible Rock Outcrop Exposed at the Left Hand Side of the Paved Footpath to the Southwest of Slope No. 3SW-C/C234  
(Photograph taken by HCL on 30 April 2008)

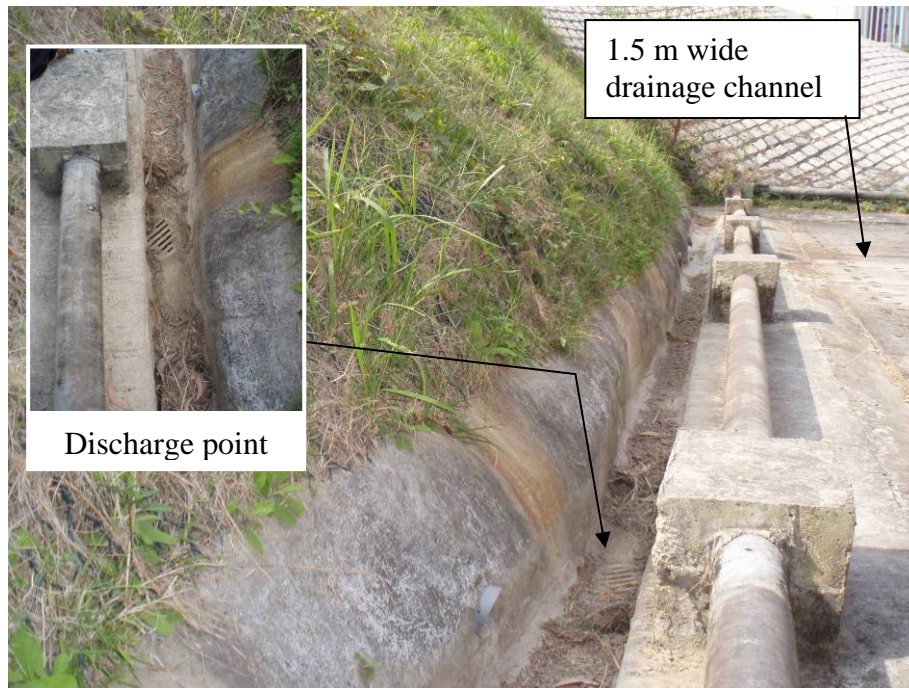
Plate 17 - The 100 mm U-channel at the Toe of Slope No. 3SW-C/C234 Discharges Water to the Adjacent 1.5 m Wide Covered Drainage Channel  
(Photograph taken by HCL on 18 December 2007)
