**DETAILED STUDY OF
THE 30 JUNE 2007 LANDSLIDE
ON WALL NO. 11SE-C/R7 AND
THE ADJOINING HILLSIDE
AT REPULSE BAY ROAD**

GEO REPORT No. 287

Fugro Scott Wilson Joint Venture

**GEOTECHNICAL ENGINEERING OFFICE
CIVIL ENGINEERING AND DEVELOPMENT DEPARTMENT
THE GOVERNMENT OF THE HONG KONG
SPECIAL ADMINISTRATIVE REGION**

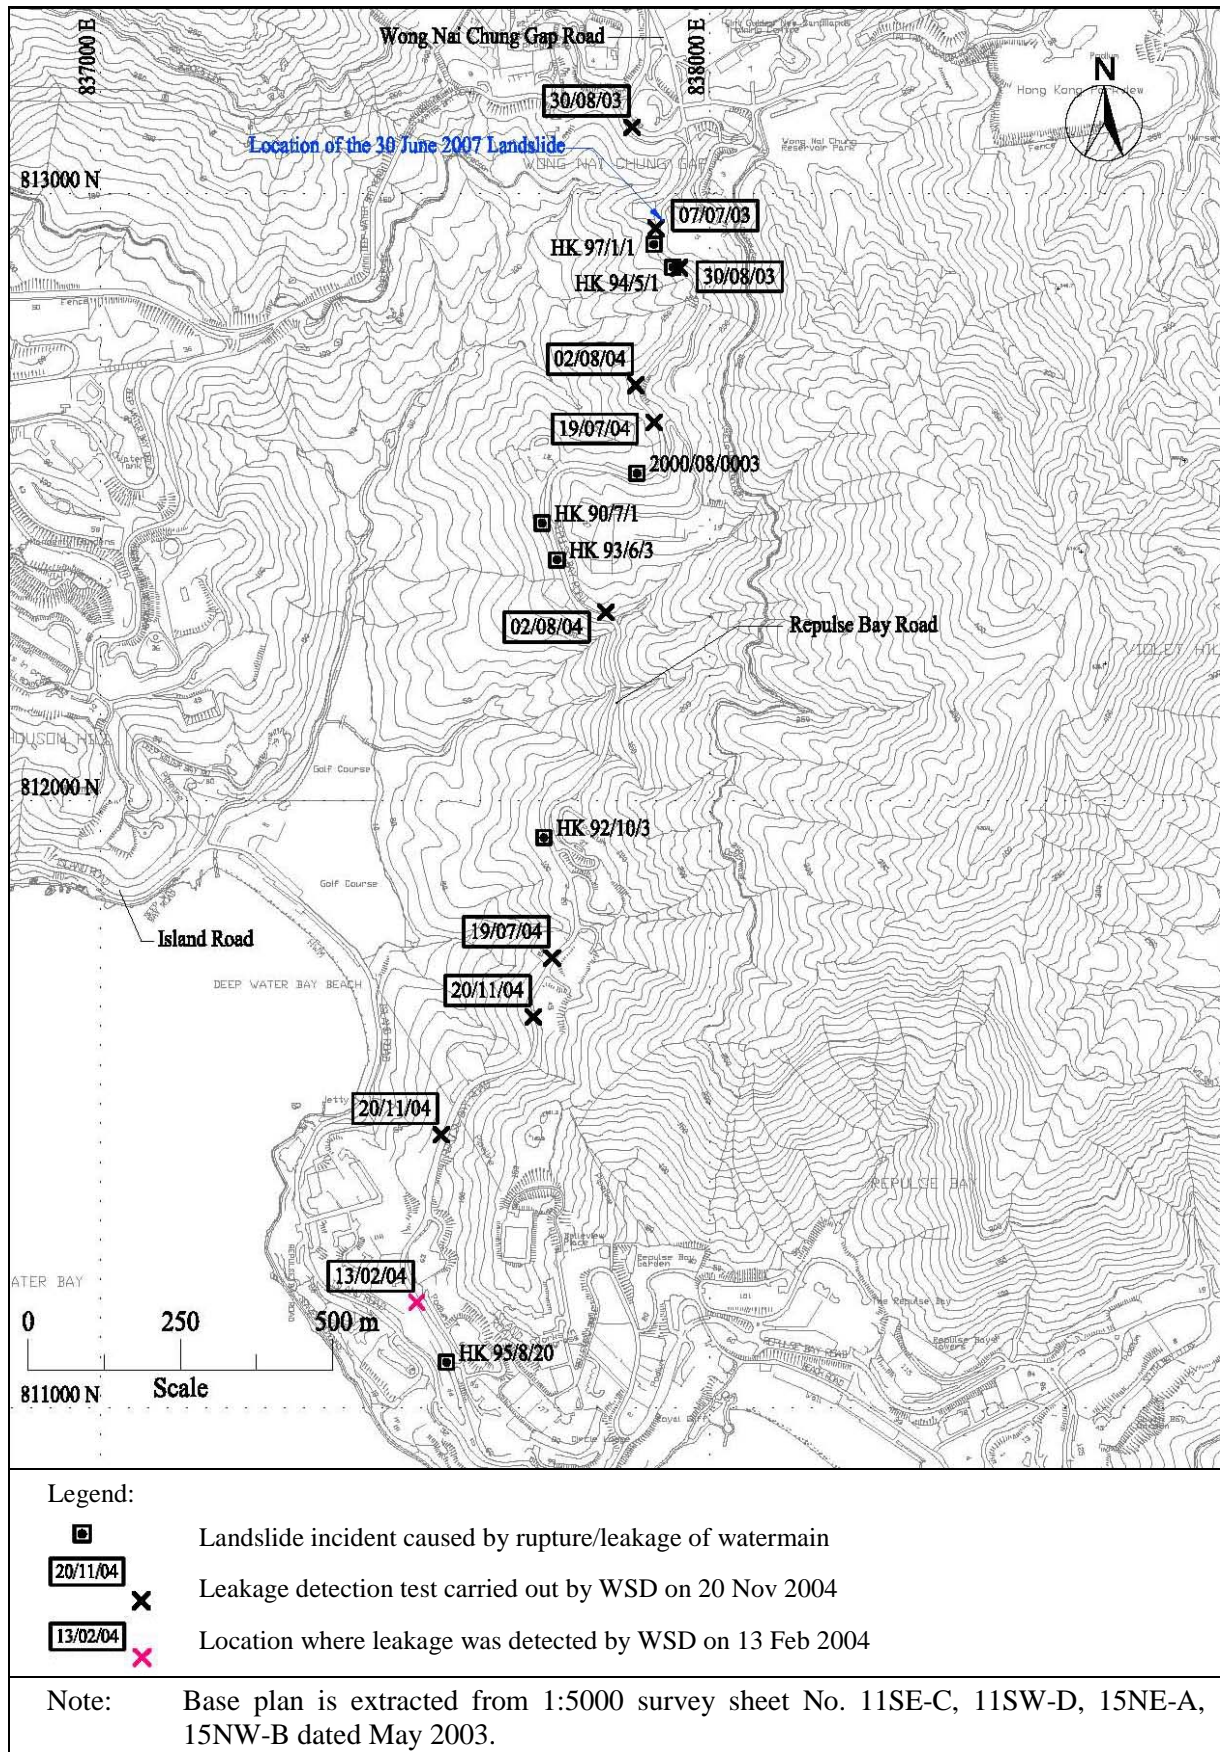
Figure 8 - Past Slope Instability Induced by Bursting of Watermains along Repulse Bay Road

According to WSD, ten leakage detection tests were carried out between July 2003 and November 2004 on the watermains along the section of Repulse Bay Road between Wong Nai Chung Gap Road and Island Road (Figure 8). The tests were carried out by Dragages

et-Travaux Publics (HK) Limited, under Contract No. 20/WSD/02 entitled “Leakage Detection of Buried Water Mains Affecting Slopes - Second Five-year Cycle”. One of the tests was carried out in the vicinity of the June 2007 landslide site and no leakage was detected. Of the ten leakage detection tests, only the one conducted on 13 February 2004 on a 50 mm diameter gate valve, which is about 1.8 km to the south of the June 2007 landslide site, detected leakage (see Figure 8).

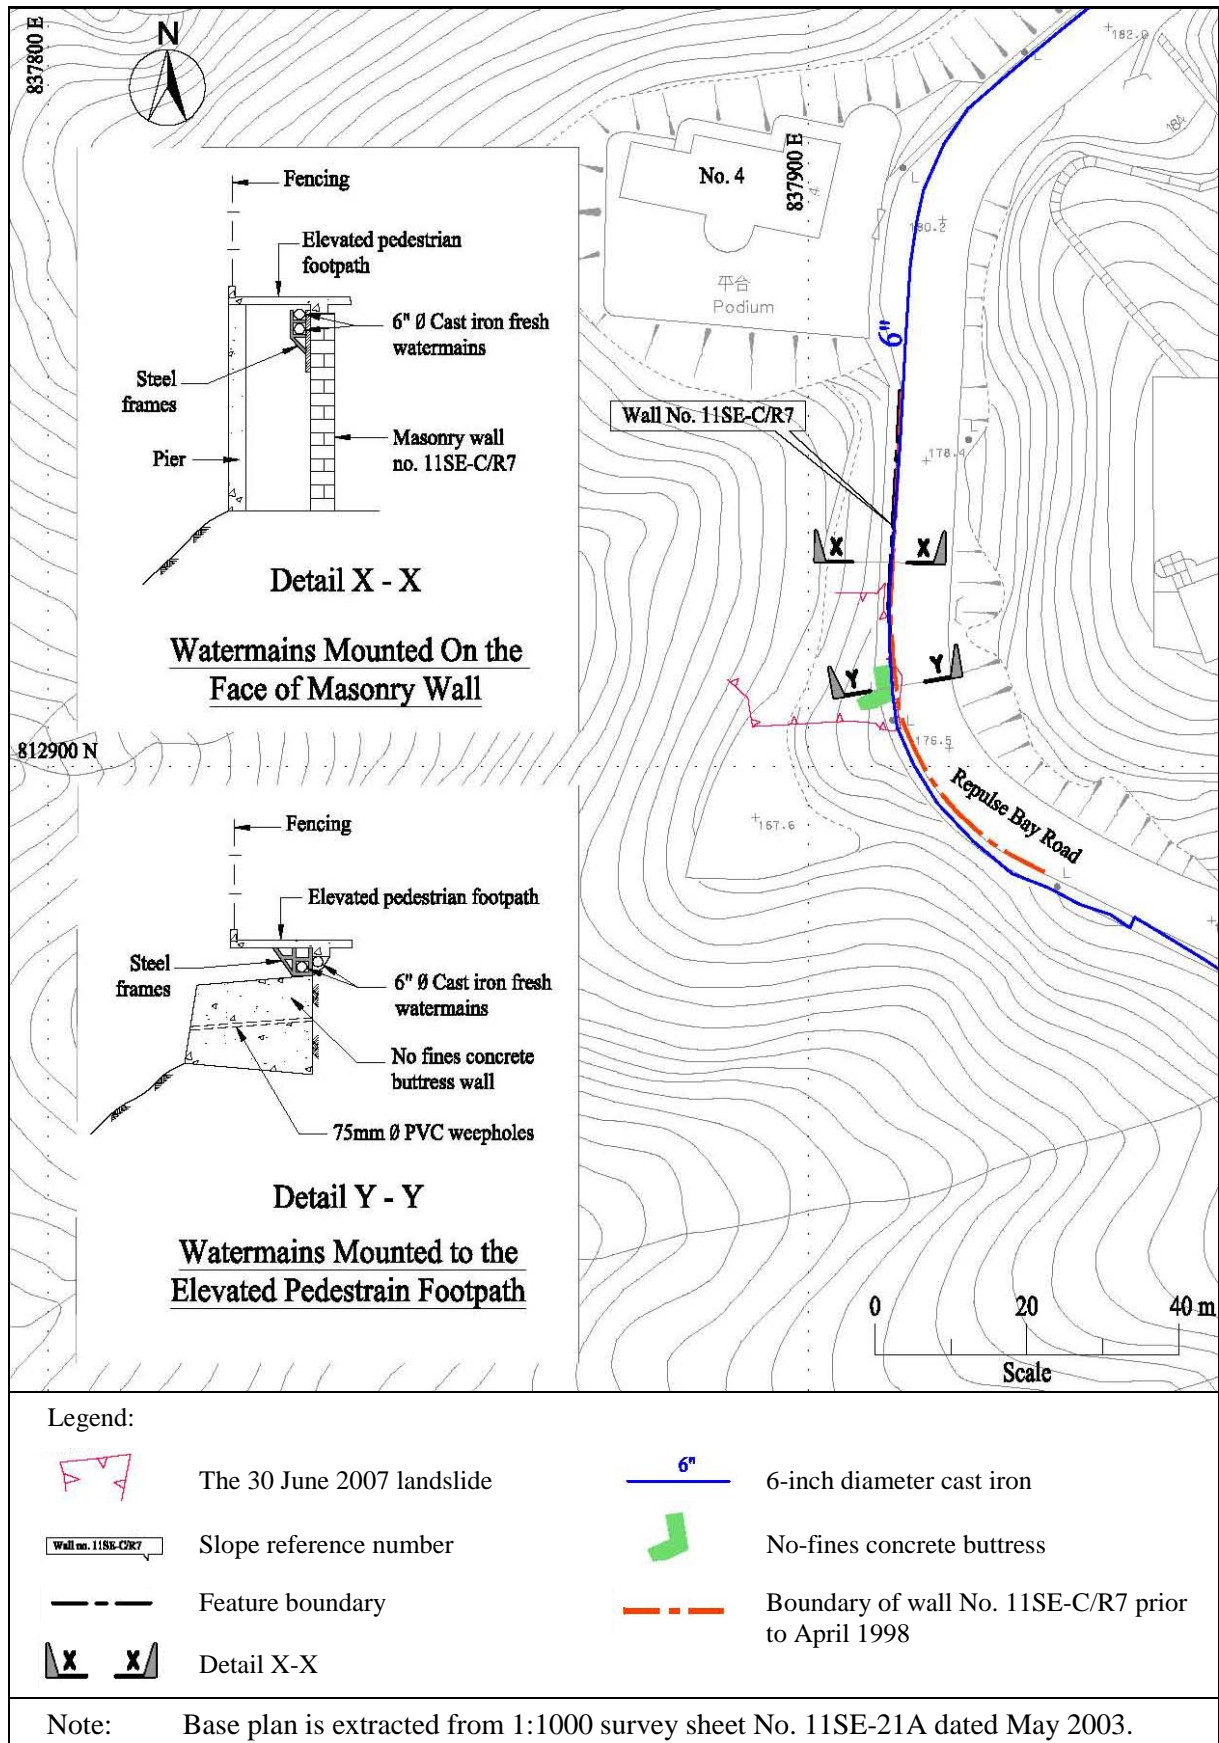
Figure 9 - Schematic Plan Showing Mounting Details of Watermains on Wall No. 11SE-C/R7

There is strong evidence to suggest that the landslide was probably triggered by the bursting of either one or both of the old 6-inch diameter watermain mounted on wall No. 11SE-C/R7. There has been a history of landslides in 1994 and 1997 due to rupture of the watermain at or in the vicinity of the landslide site. According to WSD, there is no record indicating that the section of the ruptured watermain was replaced after the January 1997 incident which occurred within the area of the 2007 landslide. Highly pressurised water jets were seen to be spraying sub-horizontally in a wide-spreading manner onto the failed hillside at 9:17 a.m. on 30 June 2007, about 5 hours after the failure. The large quantity of pressurised water ejected from either one or both of the watermain could have played a key role in triggering the extensive failure. This postulation is considered plausible as the old watermain were in a dilapidated condition (e.g. with severe rusting) prior to the June 2007 landslide.

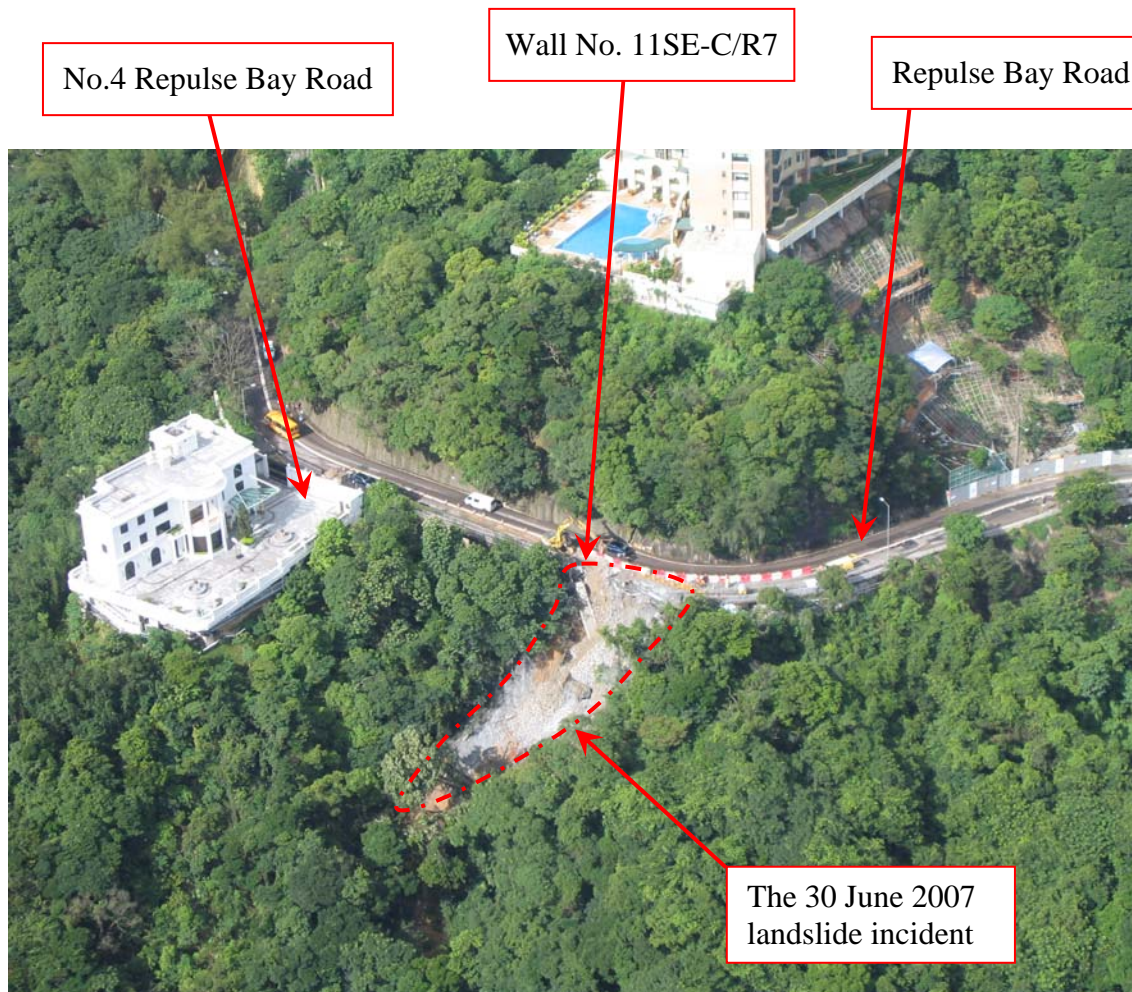
The landslide involved a failure volume of about 600 m³. The failure scar was about 15 m wide by 30 m long by 4 m deep and encroached about 1 m onto the road pavement, undermining the downhill edge of the northbound lane of the road and causing some of the concrete piers supporting the elevated pedestrian footway to detach from the footway. The main scarp was about 3 m high and almost sub-vertical (Plate 4).

Plate 1 - Oblique Aerial View of the 30 June 2007 Landslide
(Photograph taken on 7 July 2007)

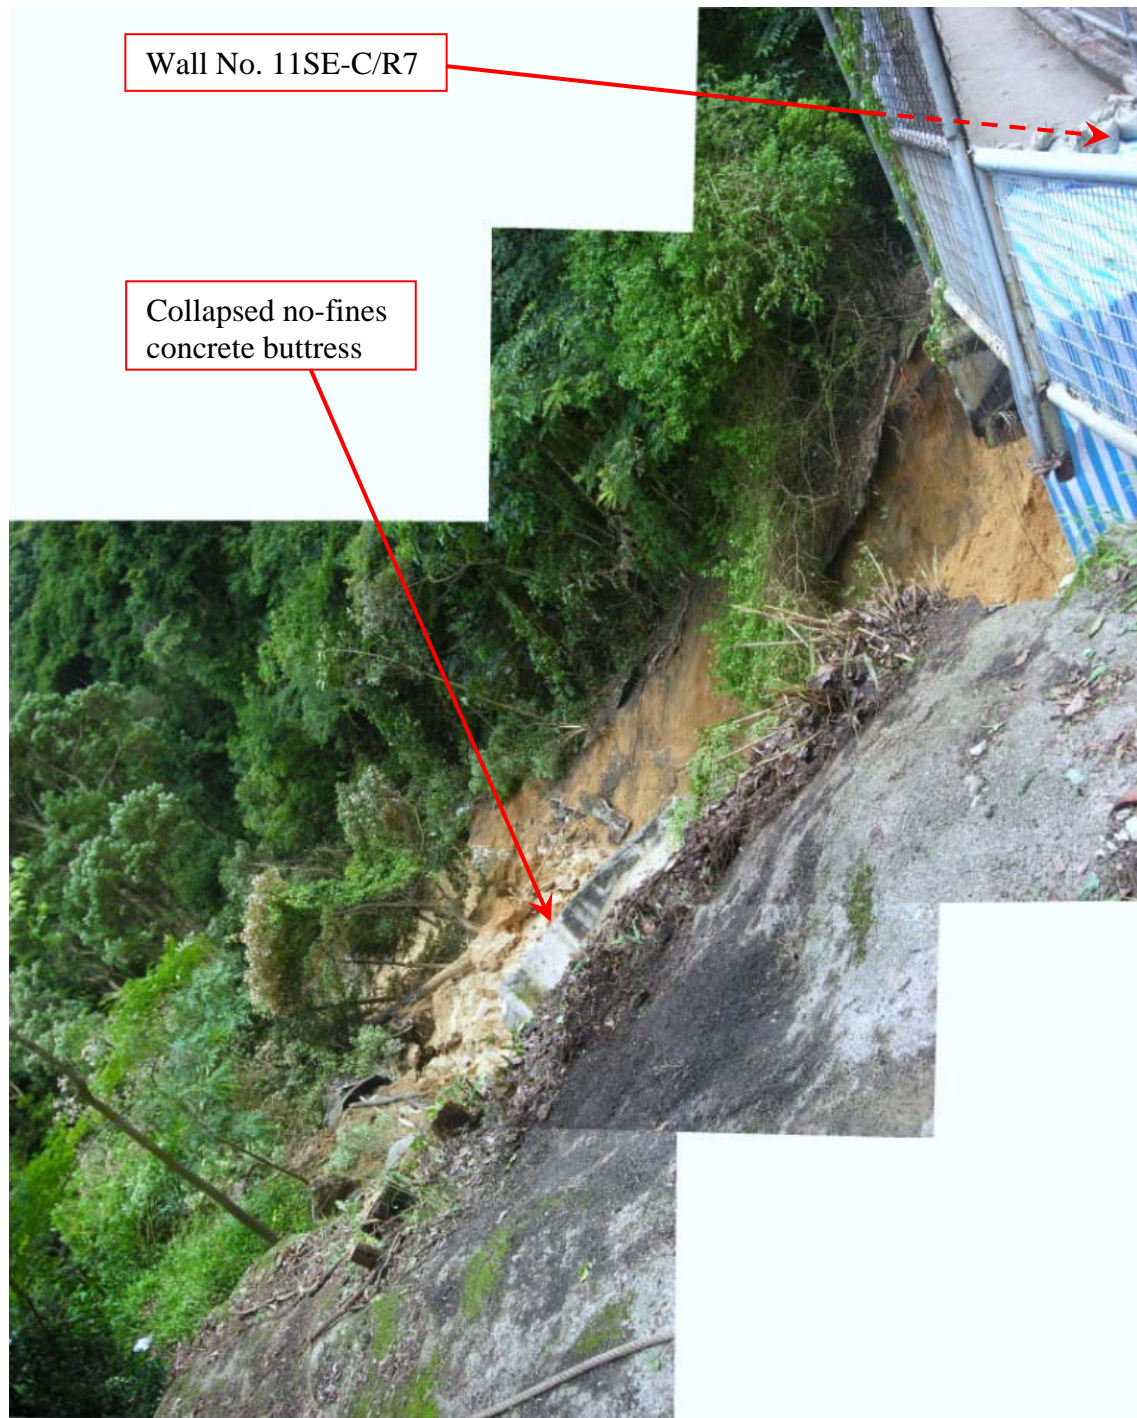
Most of the landslide debris was deposited on the hillside immediately below the failure scar (Plates 4 & 5), and some travelled further downhill to reach a 1.2 m wide by 0.6 m deep ephemeral drainage line, along which the debris travelled another 10 m downstream before coming to rest (Figure 2 and Plate 2). The travel angle of the debris from the source to the ephemeral drainage line was about 34° (Wong & Ho, 1996). The debris deposited on the ephemeral drainage line was about 5 m wide and up to 2.5 m high and comprised mainly orange, light brown, mottled yellow sandy, gravelly, CLAY/SILT with cobble- and boulder-sized fragments of rock, sprayed-concrete cover and reinforced concrete (Plate 2).

Plate 2 - Side View of the 30 June 2007 Landslide (Looking North)
(Photograph taken on 30 June 2007)

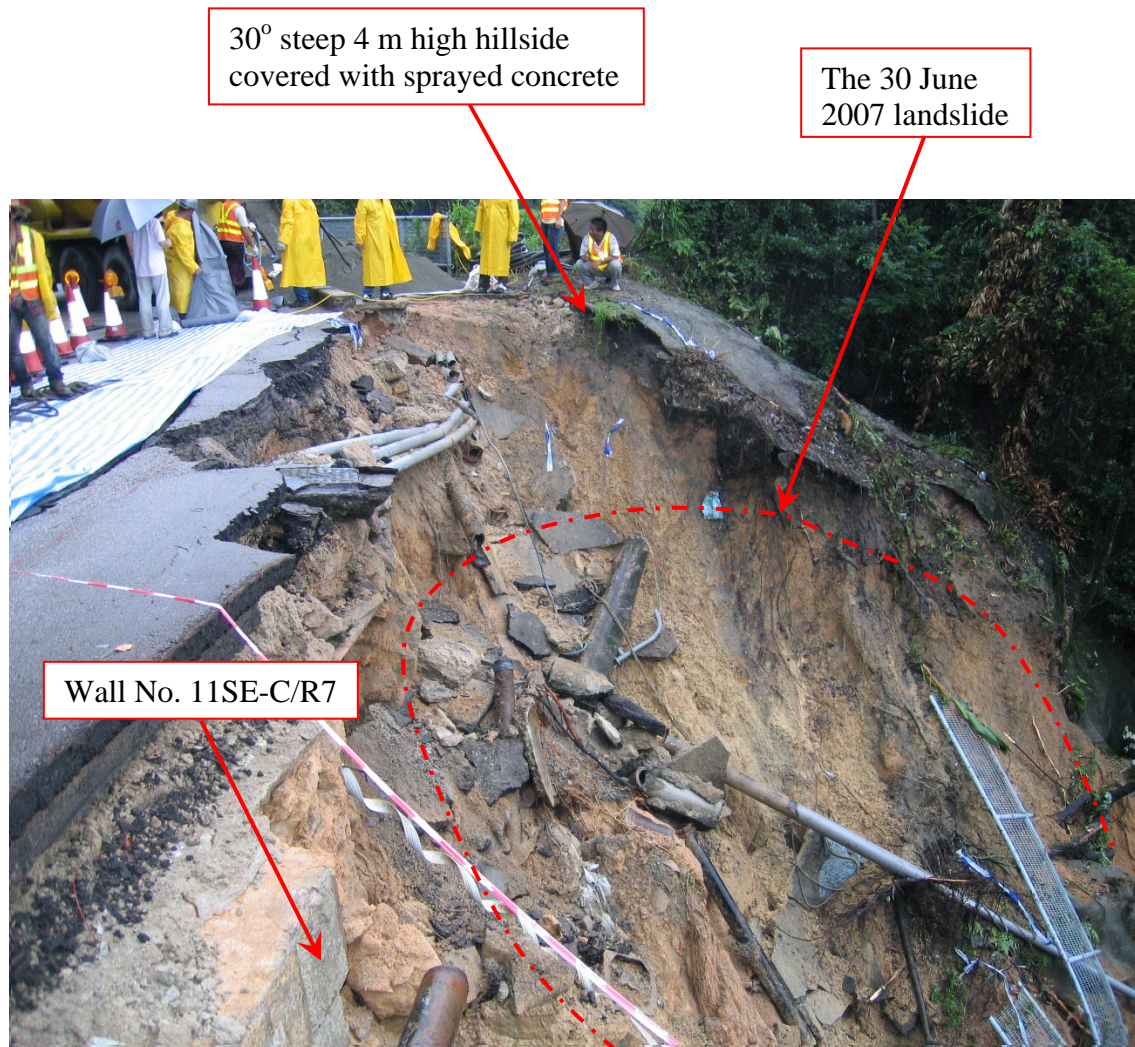
Plate 4 - Side View of the Upper Portion of the 30 June 2007 Landslide after Demolition of Elevated Pedestrian Pathway under HyD's Urgent Repair Works (Looking South) (Photograph taken by GEO on 30 June 2007)

Following the landslide incident, the undermined portion of the northbound carriageway, the unsupported section of the elevated pedestrian walkway and a DSD sewer manhole were demolished by HyD to facilitate the urgent repair works. Sprayed concrete was applied to the failure scar by HyD on 1 and 2 July 2007 respectively and rockfill was placed in the following few days to support the failure scar as part of the urgent repair works recommended by GEO.

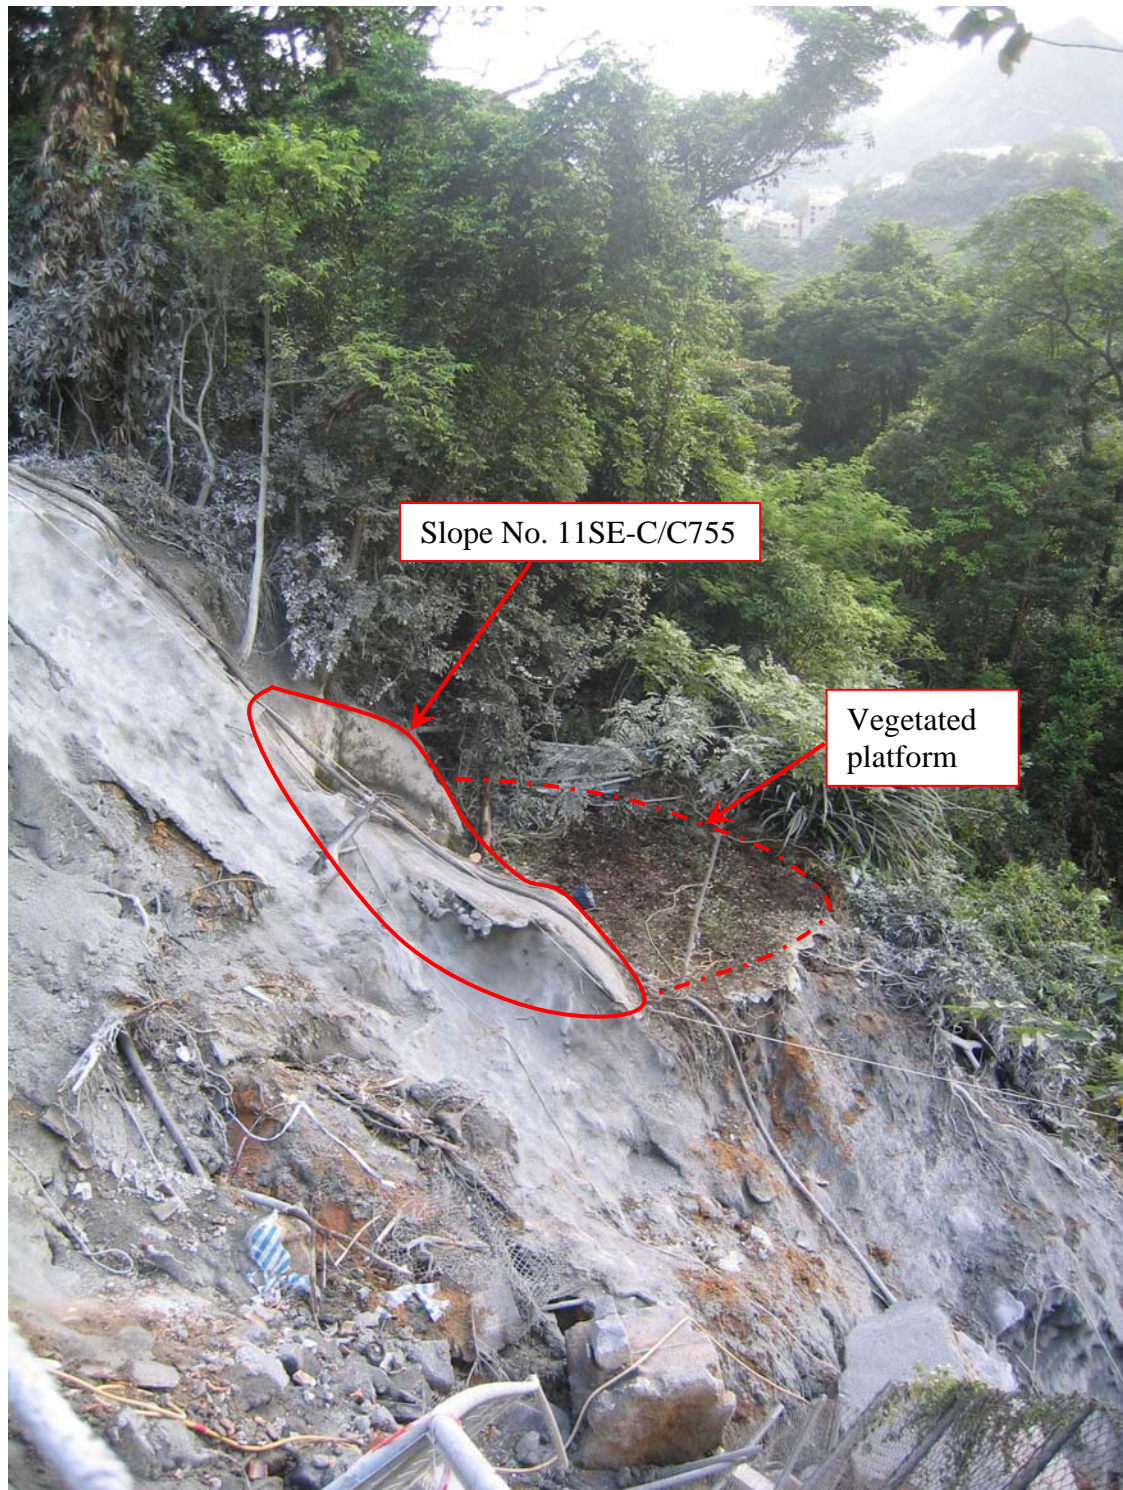
Plate 5 - Side View of the Middle Portion of the 30 June 2007 Landslide
(Looking South) (Photograph taken on 3 July 2007)

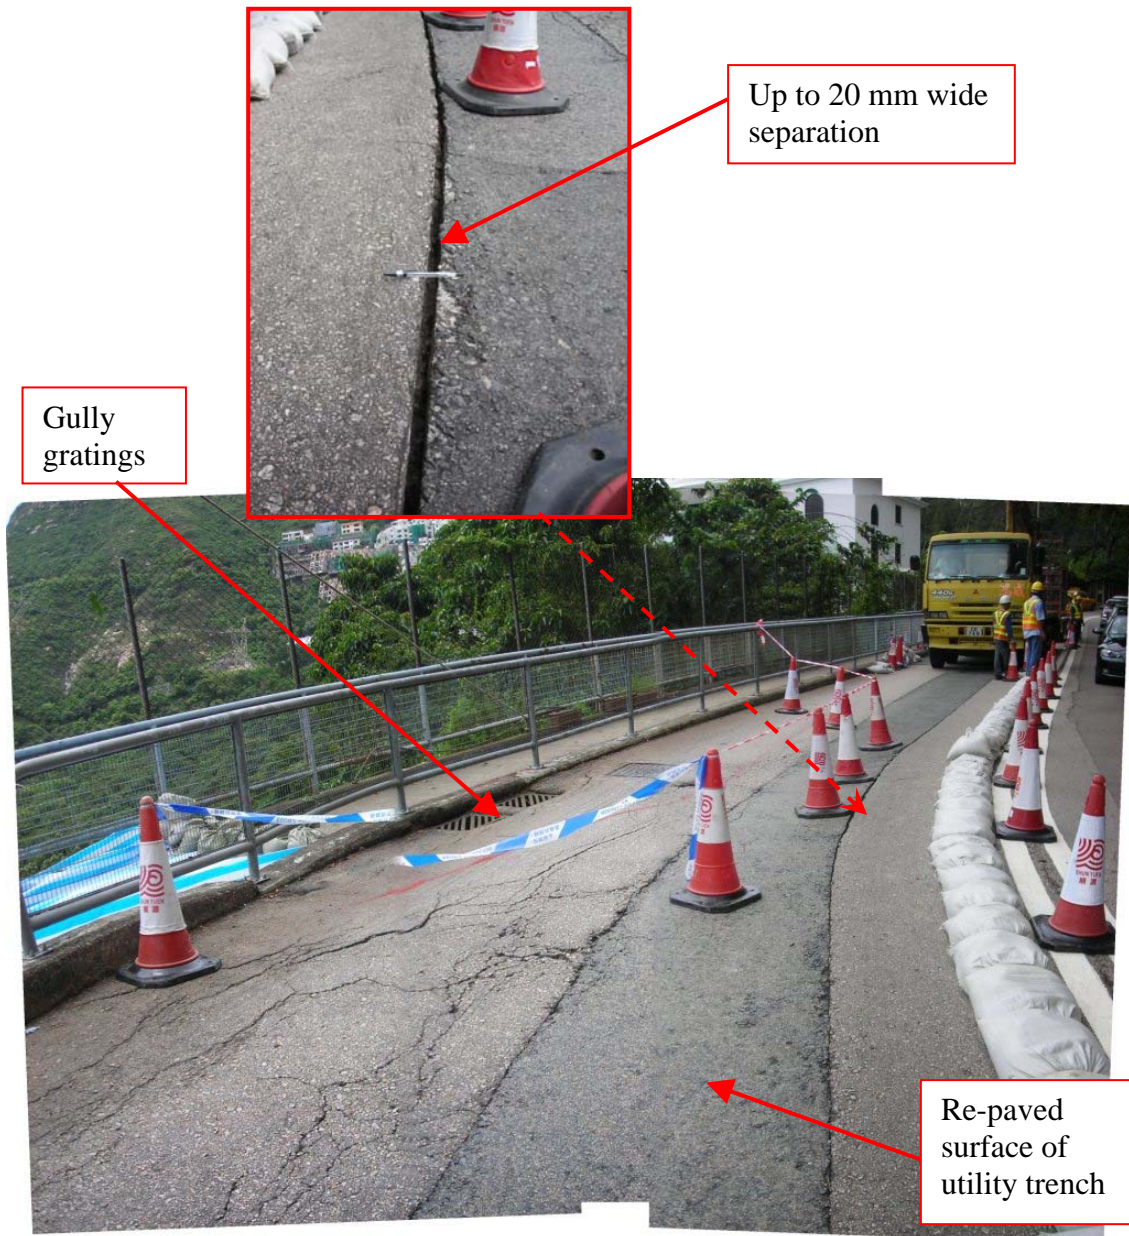
Cracking (up to 20 mm wide) and settlement (about 10 mm to 20 mm) were observed at the road pavement of the section of Repulse Bay Road above wall No. 11SE-C/R7. In

particular, a persistent crack of up to about 20 mm wide and some signs of settlement were observed along the uphill edge of the reinstated pavement to a utility trench located on the northbound lane of the road (Plate 7).

Plate 7 - Condition of the Road Pavement above the 30 June 2007 Landslide Site before HyD's Urgent Repair Works (Photograph taken on 30 June 2007)

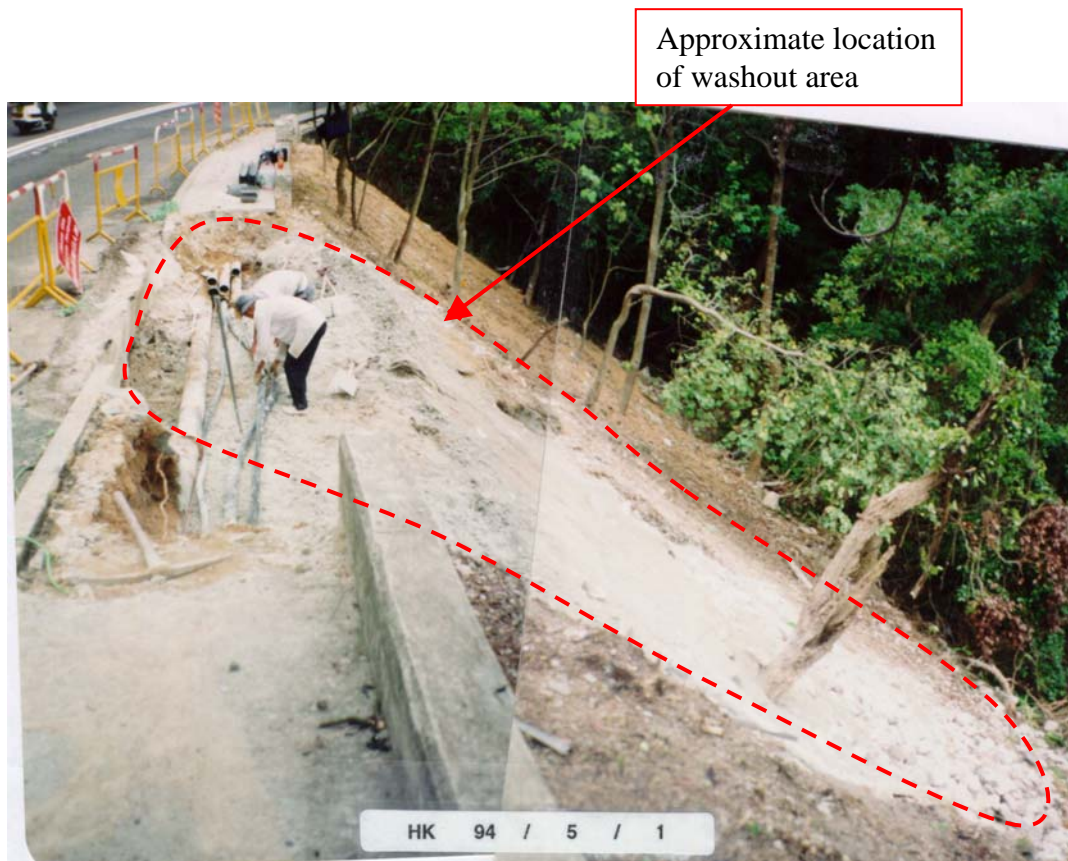
On 19 May 1994, when no rainfall was recorded within the day, a washout incident (No. HK 94/5/1), with a failure volume of about 45 m³, involving mostly fill and some residual soils, occurred on a slope below Repulse Bay Road (currently known as slope No. 11SE-C/FR154, see Figure 7), about 45 m to the southeast of wall No. 11SE-C/R7. Most of the landslide debris was deposited on the hillside immediately below and some of the debris was deposited on the floor of a streamcourse, about 50 m downstream. The pedestrian footway was collapsed in the incident (Plate 8). No casualties were reported as a result of the incident. According to the incident report prepared by the GEO, the failure was attributed to a "broken water main".

Plate 8 - Record Photo of the May 1994 Washout Incident
(Photograph taken by GEO on 20 May 1994)

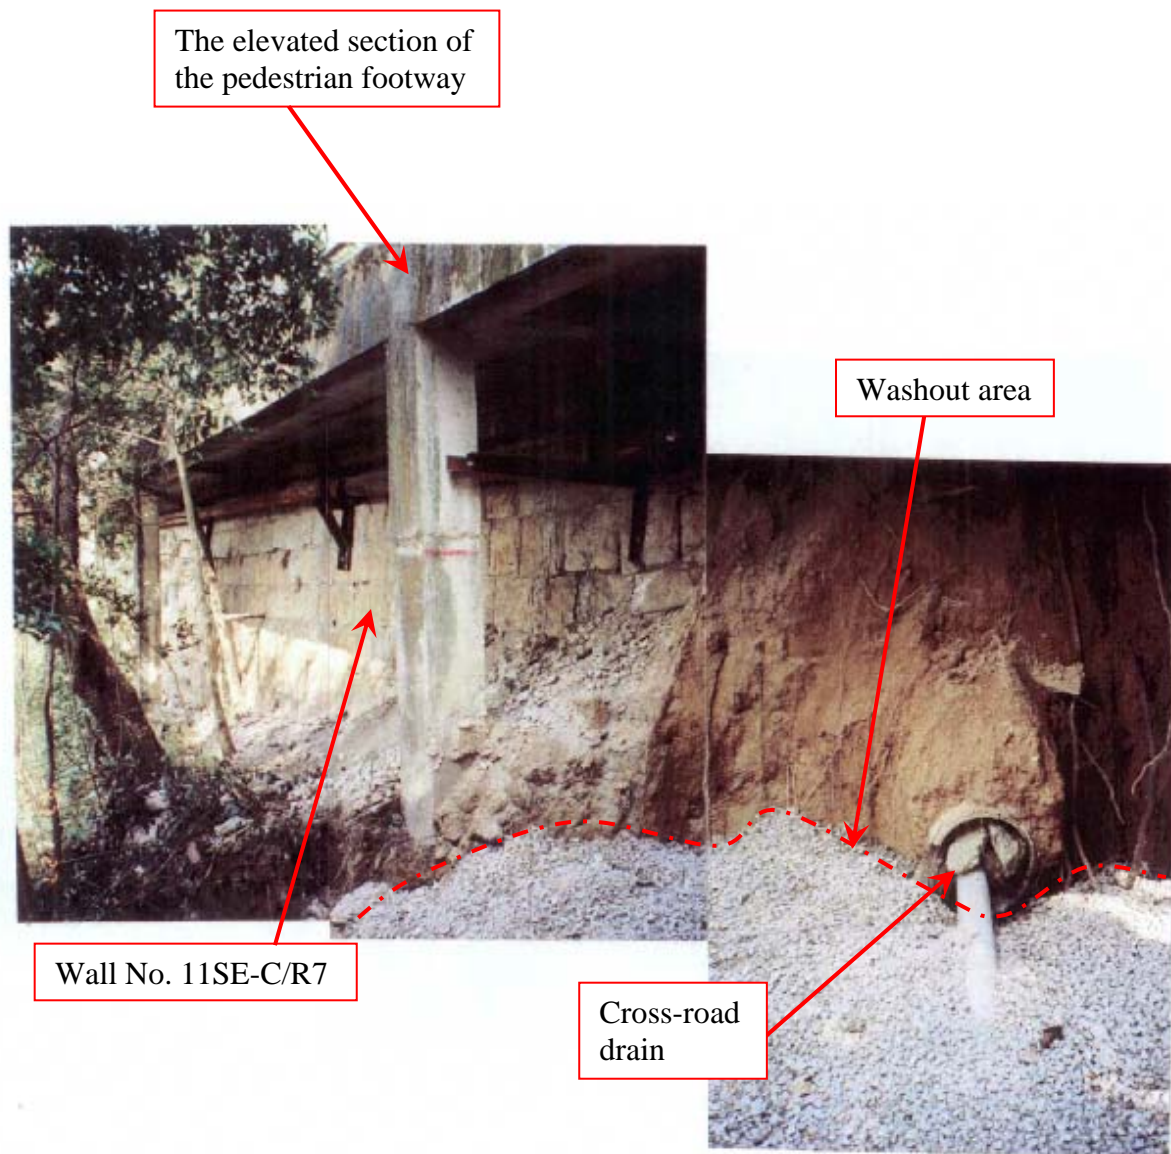
On 22 January 1997, with light rainfall of 5mm recorded within the day, a washout incident (No. HK 97/1/1), involving a failure volume of about 7 m³, occurred on the hillside adjacent to the southern portion of wall No. 11SE-C/R7 (Figure 7 and Plate 9), which was located within the area of the 2007 landslide. The pedestrian footway of the northbound lane of Repulse Bay Road was undermined by the 1997 incident. The incident also caused damage to a "375 mm" diameter cross-road drain (which is the 300 mm diameter cross-road drain now connected to roadside catchpit No. RB5, see Figure 4 and Plate 9). No casualties

were reported as a result of the washout. According to a memorandum (file ref. GCI 2/E2/1997(1)) dated 28 May 1998 from the Island Division to Landslide Investigation Division (renamed LPM Division 1 in July 2004) of the GEO, “the failure was triggered by the rupture of the WSD’s 150 mm diameter water main hanging below the existing footbridge and buried at the crest of the fill slope [located to the south of wall No. 11SE-C/R7]”. Most of the damages were due to local erosion of the slope at shallow depths and there were no signs of any slippage of soil mass based on site observations at that time. No field evidence of past instability at or adjoining the failure location of the 1997 incident was observed by the Island Division during the post-failure inspection.

Plate 9 - Record Photo of the January 1997 Washout Incident
(Photograph taken by GEO on 27 January 1997)

Urgent repair works were recommended by the GEO to the HyD in January 1997. These comprised the removal of loose materials, replacement of the damaged section of the cross-road drain with the provision of 150 mm thick concrete surround and connecting the new drain “to the existing surface drain”, construction of a 2 m high by 6 m long no-fines concrete buttress to support the failed section of the slope and re-construction of the 450 mm wide drainage channel at the toe of the slope, trimming of local over-steepened area, filling up of the local depressions and the failure scar with no-fines concrete and provision of sprayed concrete cover (with weepholes) to the failed area. According to HyD, the recommended slope remedial works were completed by early February 1997.

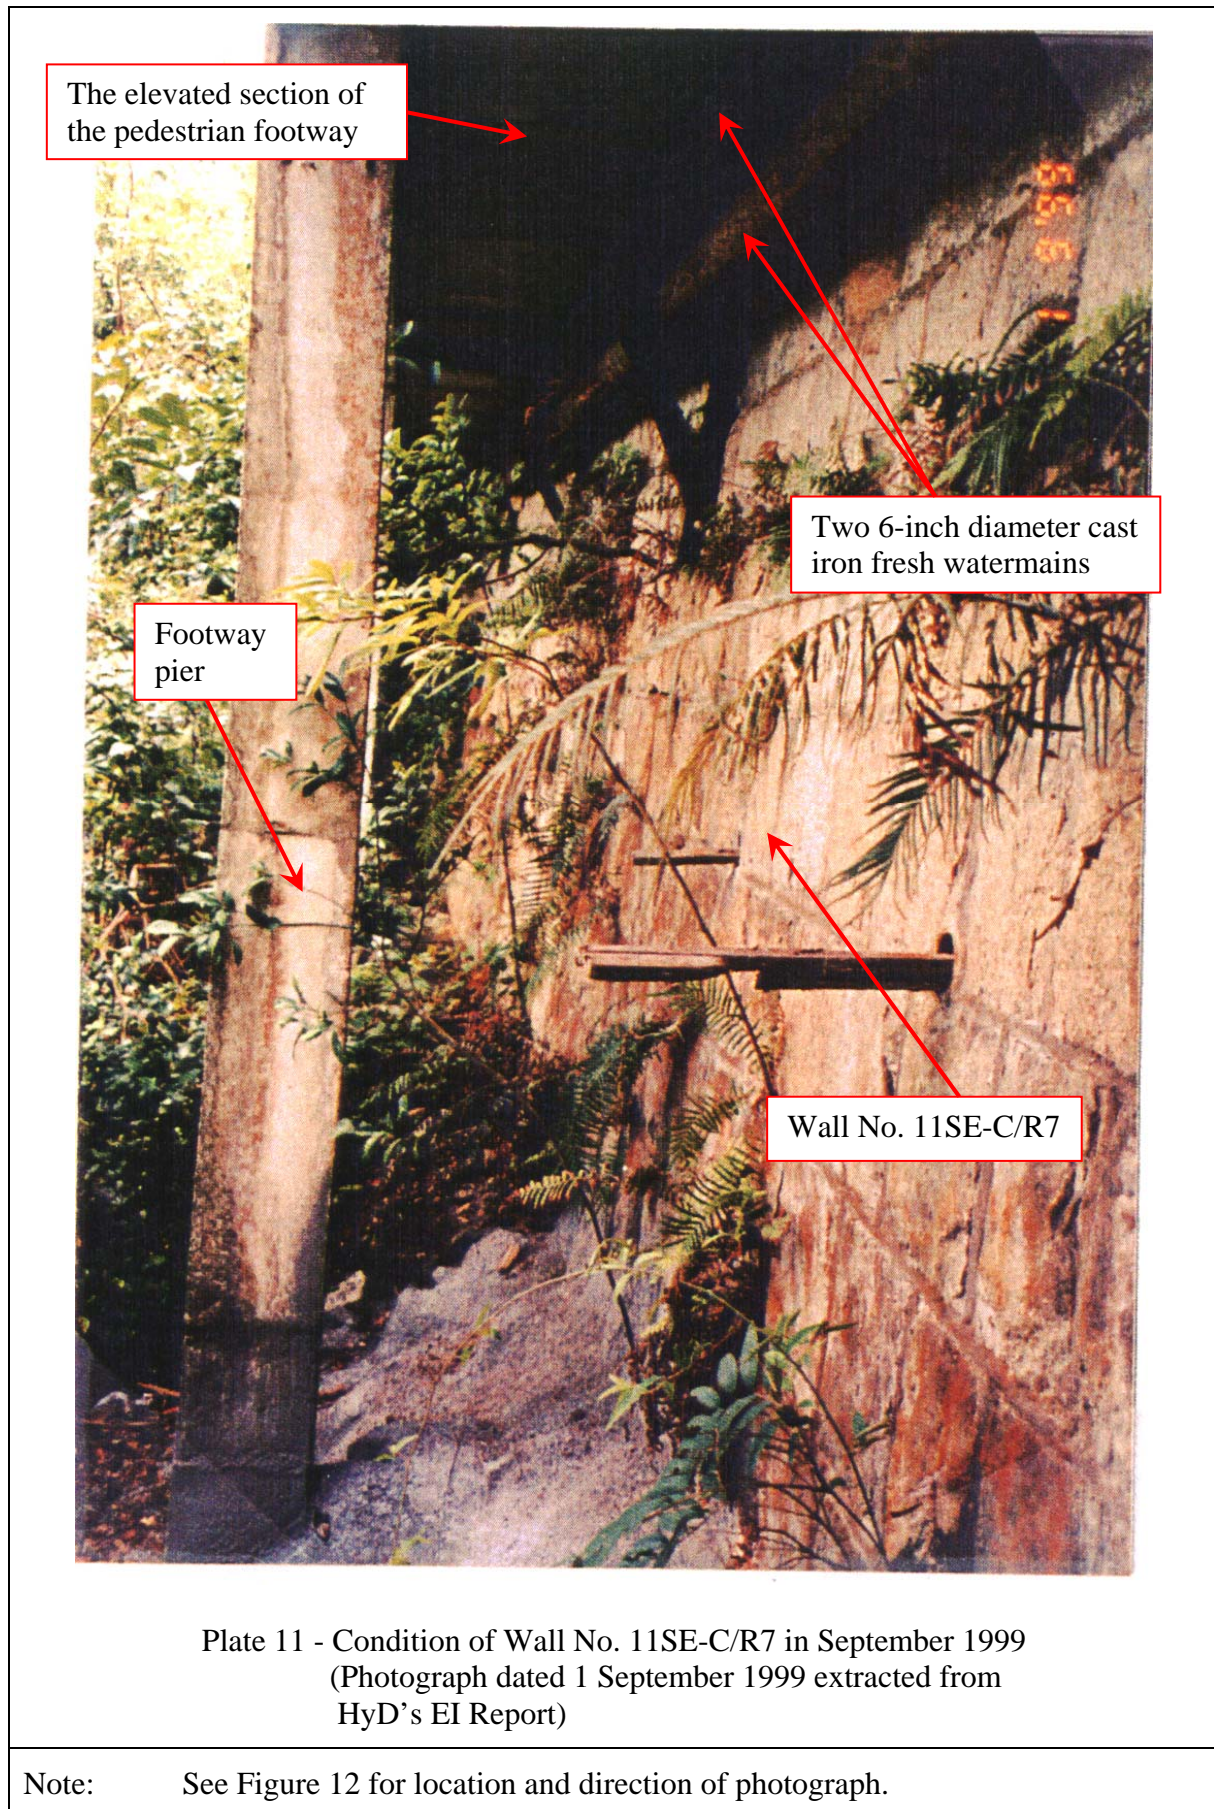
In September 1999, Maunsell Geotechnical Services Limited (MGSL), the consultant to HyD, carried out an Engineer Inspection (EI) for wall No. 11SE-C/R7 (Plate 11). The EI report considered that the consequence-to-life category of the wall was “low” and the overall state of maintenance was “Fair”. The EI report did not identify any signs of distress on the wall or signs of leakage from the water-carrying services, and recommended Routine Maintenance Works (RMW) including unblocking weepholes, removing unplanned vegetation from the wall surface and re-pointing the deteriorated cement-mortared joints on the masonry face of the wall. “Low Priority Stability Assessment” was also recommended in the EI report. The record photograph (Plate 11) shows that the 6-inch watermains mounted on the surface of the retaining wall were probably rusted.

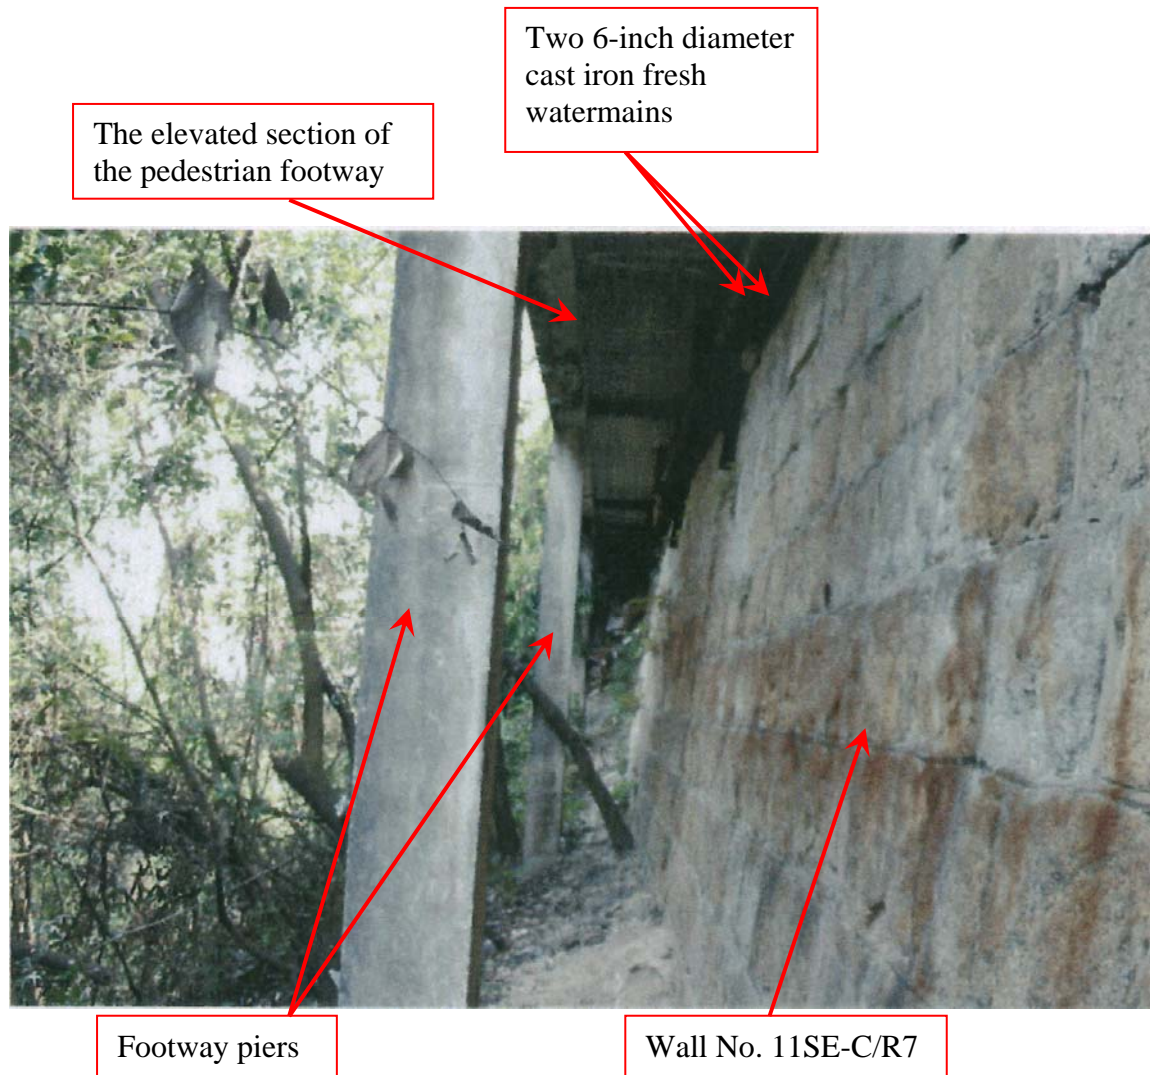
In March 2004, a further EI for wall No. 11SE-C/R7 was carried out for HyD by MGSL (Plate 12). The EI report considered the overall state of maintenance to be satisfactory. The EI did not identify any signs of seepage on the wall or signs of leakage from the watermains. Signs of deterioration in the form of “mortar missing or minor dislocation of isolated blocks” were recorded in the EI report. RMW recommended in the EI report included removal of undesirable vegetation from the wall surface and re-pointing of joints with missing cement-mortar on the masonry face of the wall. The March 2004 EI report also recommended a Stability Assessment of the wall to be carried out. According to HyD, “there is no such [Stability Assessment] record found” in their files subsequent to the EI. There are records indicating that minor slopes works were completed in November 2004, including removal of vegetation causing severe cracking of slope surface cover and drainage channels.

Plate 12 - Condition of Wall No. 11SE-C/R7 in March 2004
(Photograph dated 1 March 2004 extracted from
HyD's EI Report)

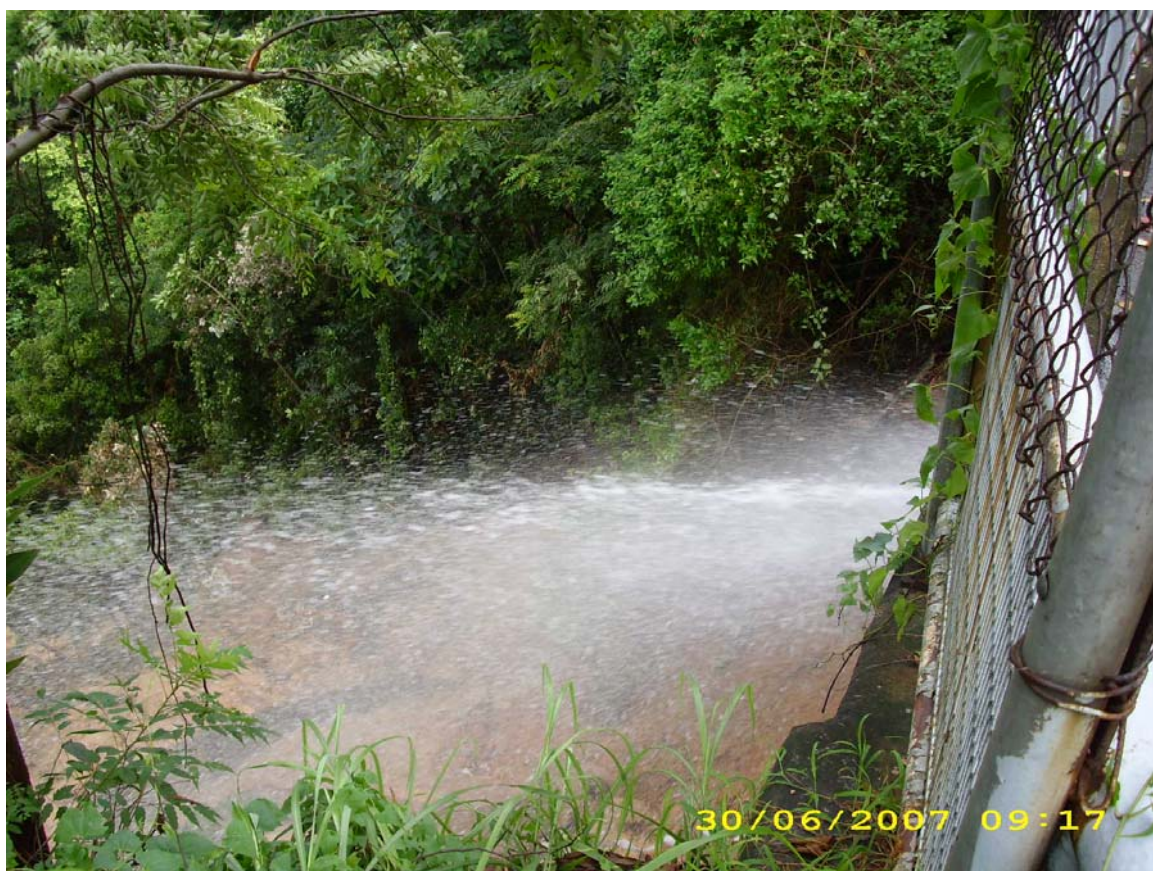
The two 6-inch diameter watermains mounted on the face of wall No. 11SE-C/R7 were severed. Streams of high pressurised water were still jetting outward and sub-horizontally from the watermains at 9:17 a.m. on 30 June 2007 (i.e. about 5 hours after the failure, assuming that the failure occurred when the loud noise was heard by the security guard at No. 4 Repulse Bay Road), as recorded by a photograph taken by a resident site staff of a nearby GEO’s Landslip Preventive Measures (LPM) site (Plate 16). According to WSD, they were notified of the watermains burst incident at 8:51 a.m. on 30 June 2007 by HKPF via telephone. After a burst watermain was substantially isolated by WSD, bursting of the other

watermain on the wall face was noted by WSD at 9:35 a.m. Both watermains were completely isolated at 12:30 p.m. on the same day.

Plate 16 - Water Jet from the Burst Watermains
(Photograph taken by Ove Arup & Partners Hong
Kong Ltd.on 30 June 2007)

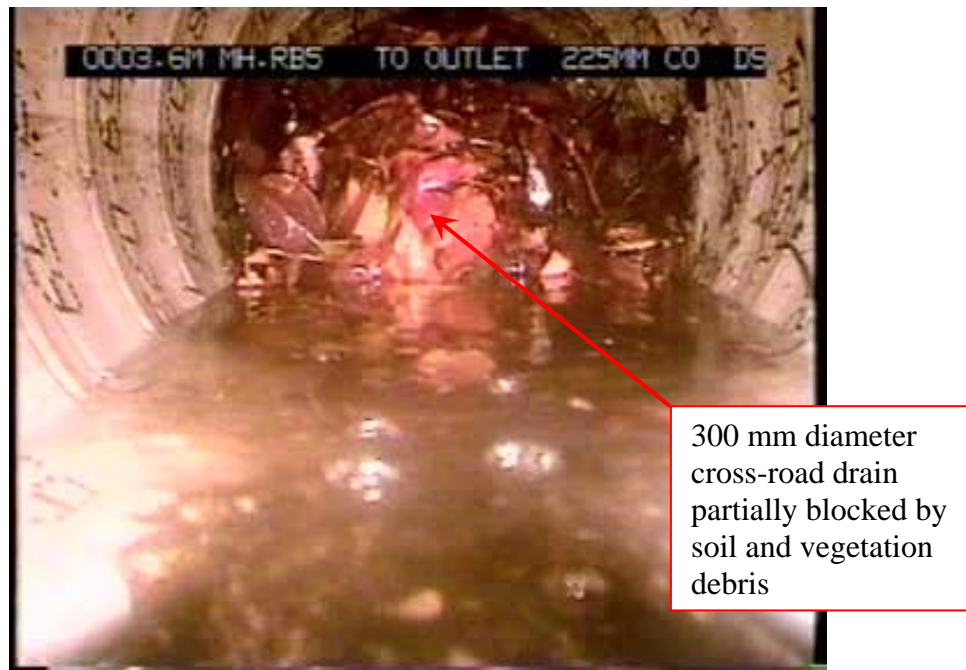
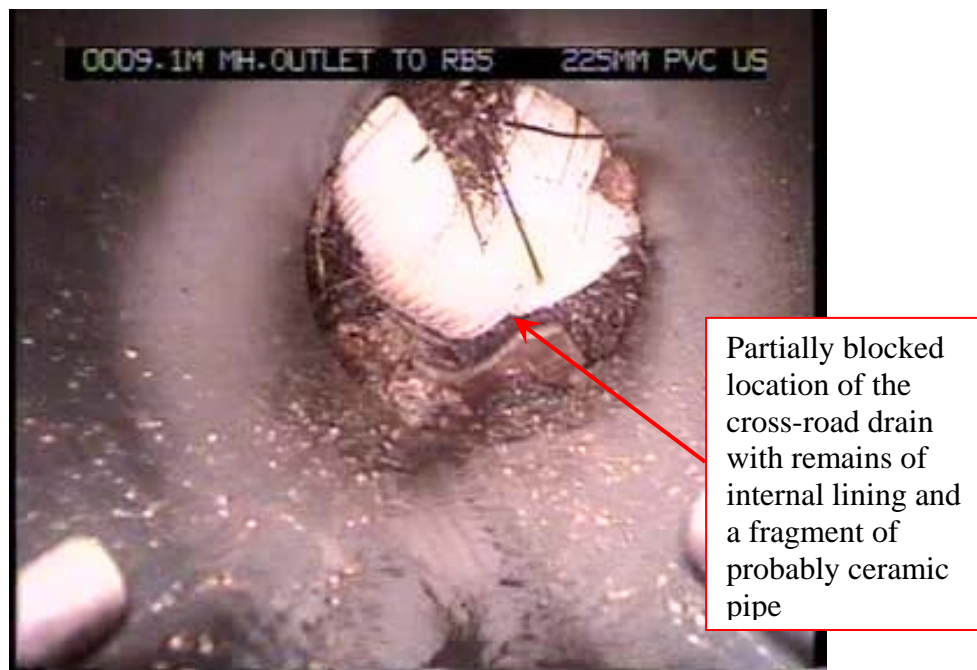
The cross-road drain was noted to have been partially blocked by soil and vegetation debris at a location about 3.6 m from the upstream end of the drain (i.e. as measured from catchpit No. RB5) (Figure 4 and Plate 17a). This section of the drain was previously lined. A small flow (depth of water about 10 mm) was observed within the drain during the CCTV survey and water accumulated to a level of about 75 mm above the invert level immediately upstream of the collapsed location.

At the downstream side of the partially blocked location (i.e. between the partially blocked location and the cross-road drain outlet), remnants of internal lining to the drain and a fragment of ceramic pipe in a matrix of sand and gravels were present (Plate 17b). This section was not lined. No other defects of the cross-road drain were identified by the CCTV survey.

Plate 17 - Condition of the Cross-road Drain Connected to Roadside Catchpit No. RB5 (from CCTV Survey Carried out in September 2007)
