**DETAILED STUDY OF
THE 30 JUNE 2007 LANDSLIDE
ON WALL NO. 11SE-C/R7 AND
THE ADJOINING HILLSIDE
AT REPULSE BAY ROAD**

GEO REPORT No. 287

Fugro Scott Wilson Joint Venture

**GEOTECHNICAL ENGINEERING OFFICE
CIVIL ENGINEERING AND DEVELOPMENT DEPARTMENT
THE GOVERNMENT OF THE HONG KONG
SPECIAL ADMINISTRATIVE REGION**

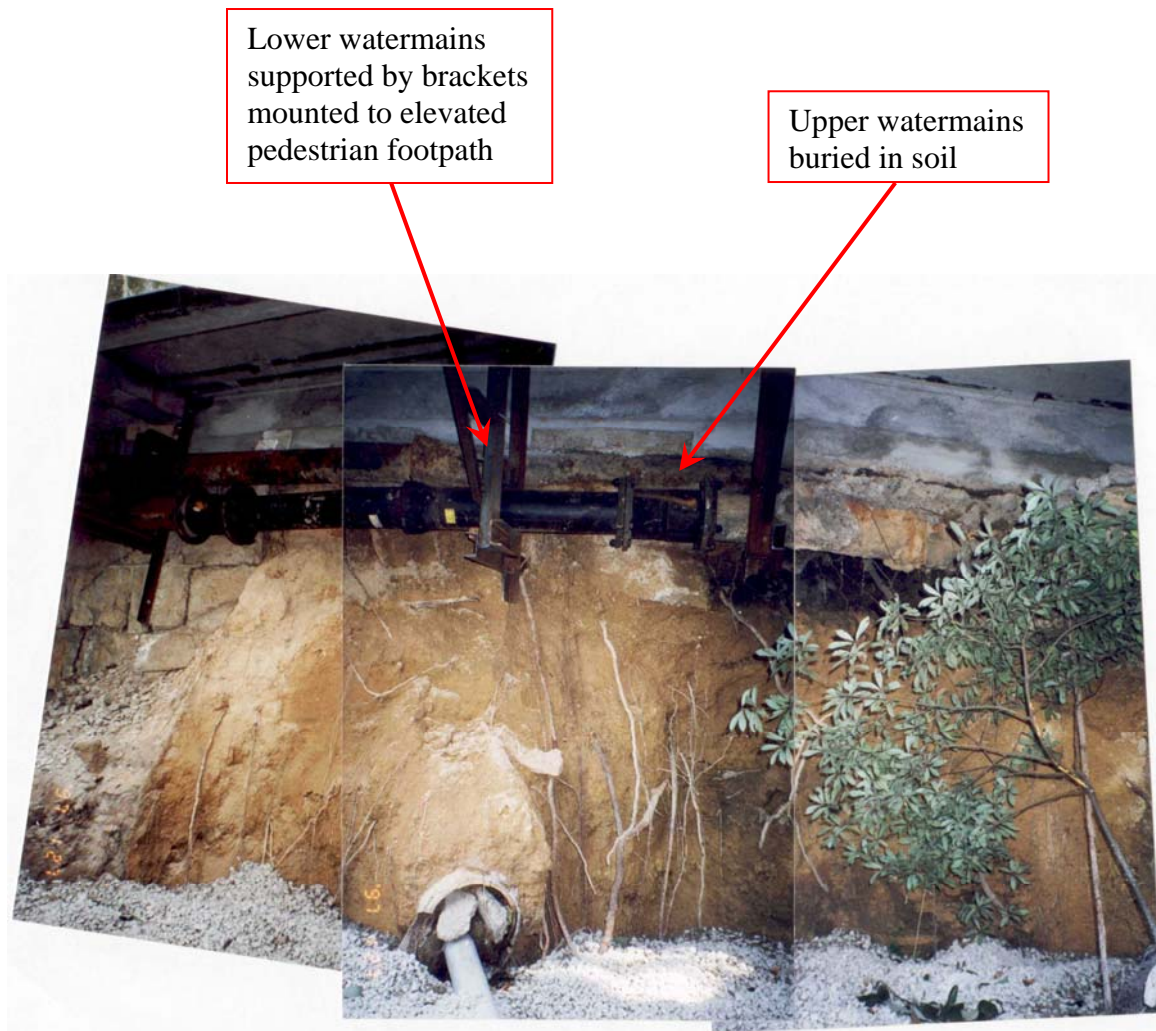
Plate 18 - Condition of Watermain in January 1997
(Photograph dated 27 January 1997 extracted from
Landslide Incident Report HK97/1/1)
