**REVIEW OF THE
7 JUNE 2008 ROCK SLOPE
FAILURE ON SLOPE
NO. 10NE-B/C56
BELOW TSING YI ROAD**

GEO REPORT No. 288

C.L.H. Lam & H.W.K. Lam

**GEOTECHNICAL ENGINEERING OFFICE
CIVIL ENGINEERING AND DEVELOPMENT DEPARTMENT
THE GOVERNMENT OF THE HONG KONG
SPECIAL ADMINISTRATIVE REGION**

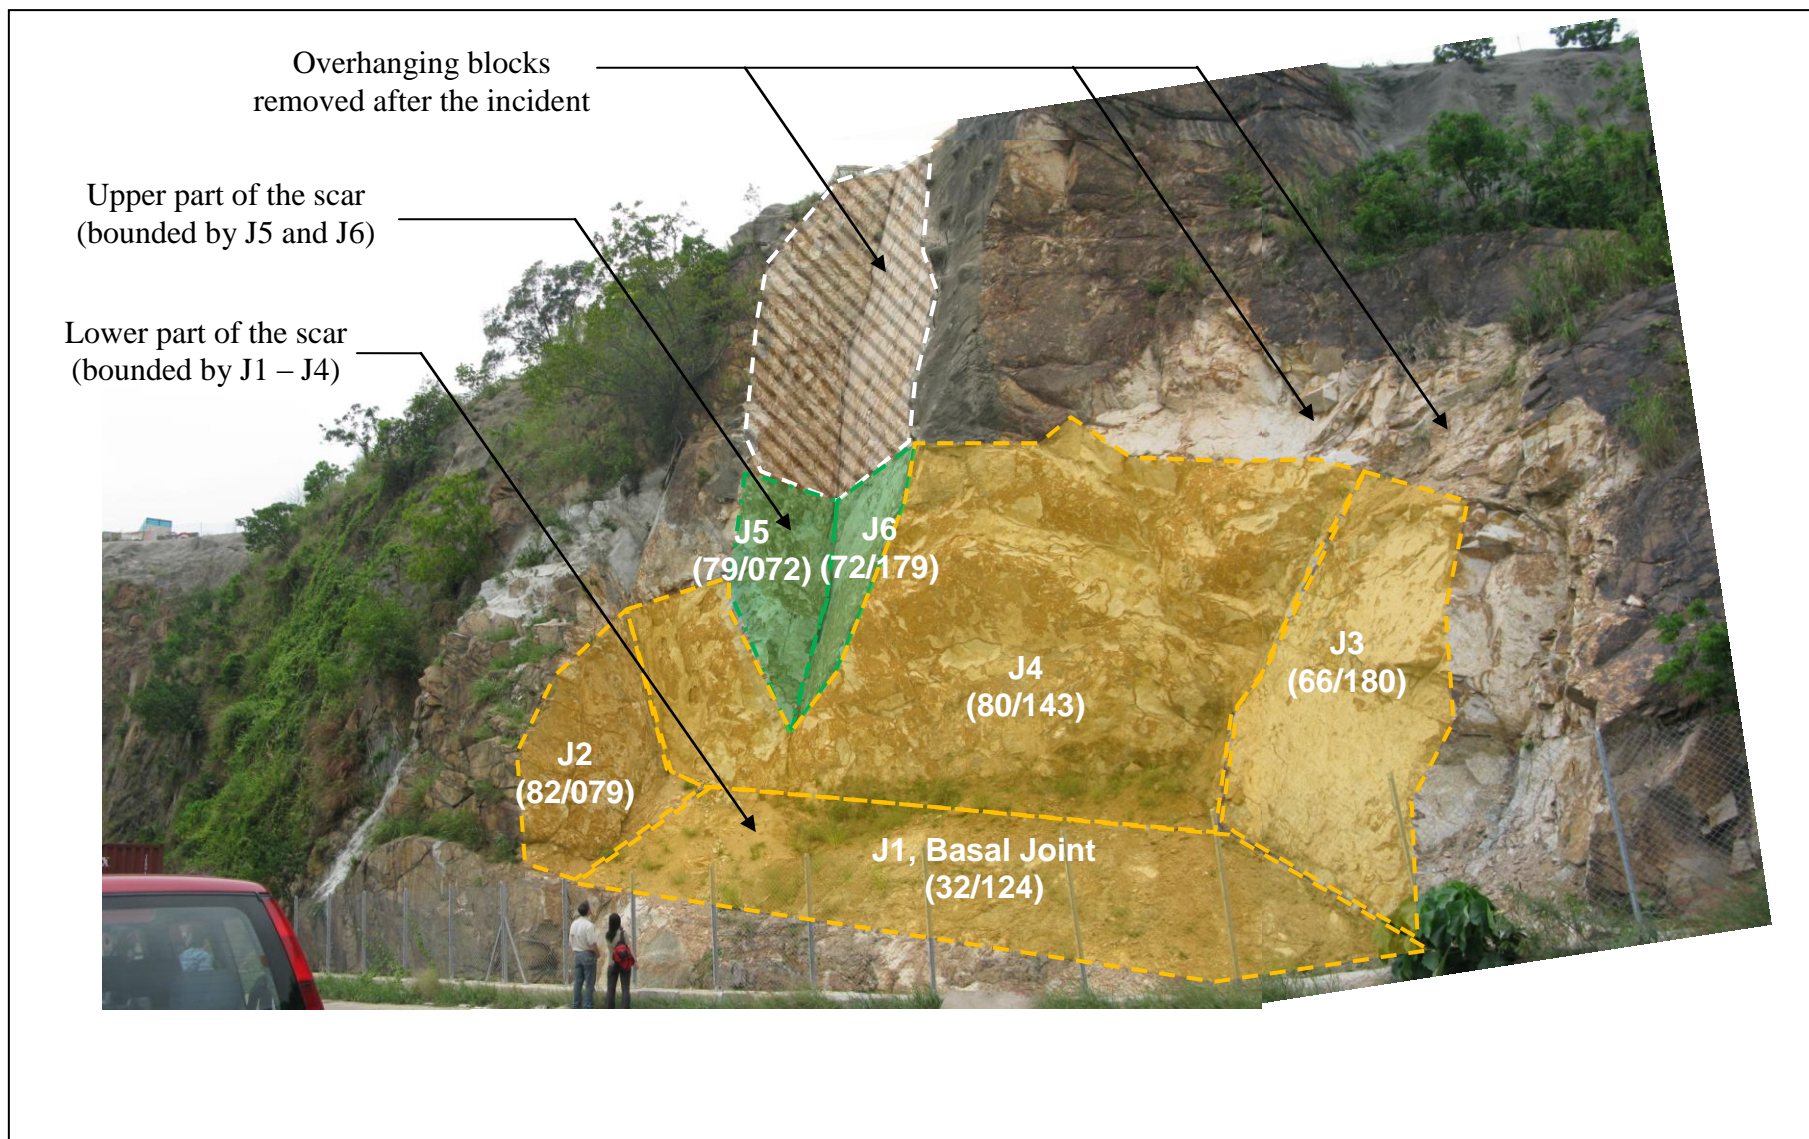
Figure 6 - Post-Incident Site Observations

The landslide comprised a main scar, and a minor scar at the crest of the northwest corner of the main scar (Figure 6). The main scar was defined by 3 major joint sets (Figure 6), viz the two side-release planes (namely J2 (82/079) and J3 (66/180)) and backscarp (namely J4 (80/143)). The three joint sets are in general subvertical. Brown staining was also observed along these joint sets. The basal slip surface which was defined by a distinct joint (namely J1 (32/124)) was planar and laterally-persistent (> 10 m wide) with black staining; and it undulates, having a southerly dip of about 32°. No infill was observed on the basal slip surface.

The minor scar measured about 4 m wide, 4 m high and 2 m deep, in the form of a wedge. The failure volume was about 15 m³ (Figure 6). This scar is defined by two joint sets (namely J5 (79/072) and J6 (72/179)), with the line of intersection plunging out of J4 (Figure 8). Above this scar, the overhanging rock blocks were removed as part of the emergency remedial works following the landslide (Figure 6).

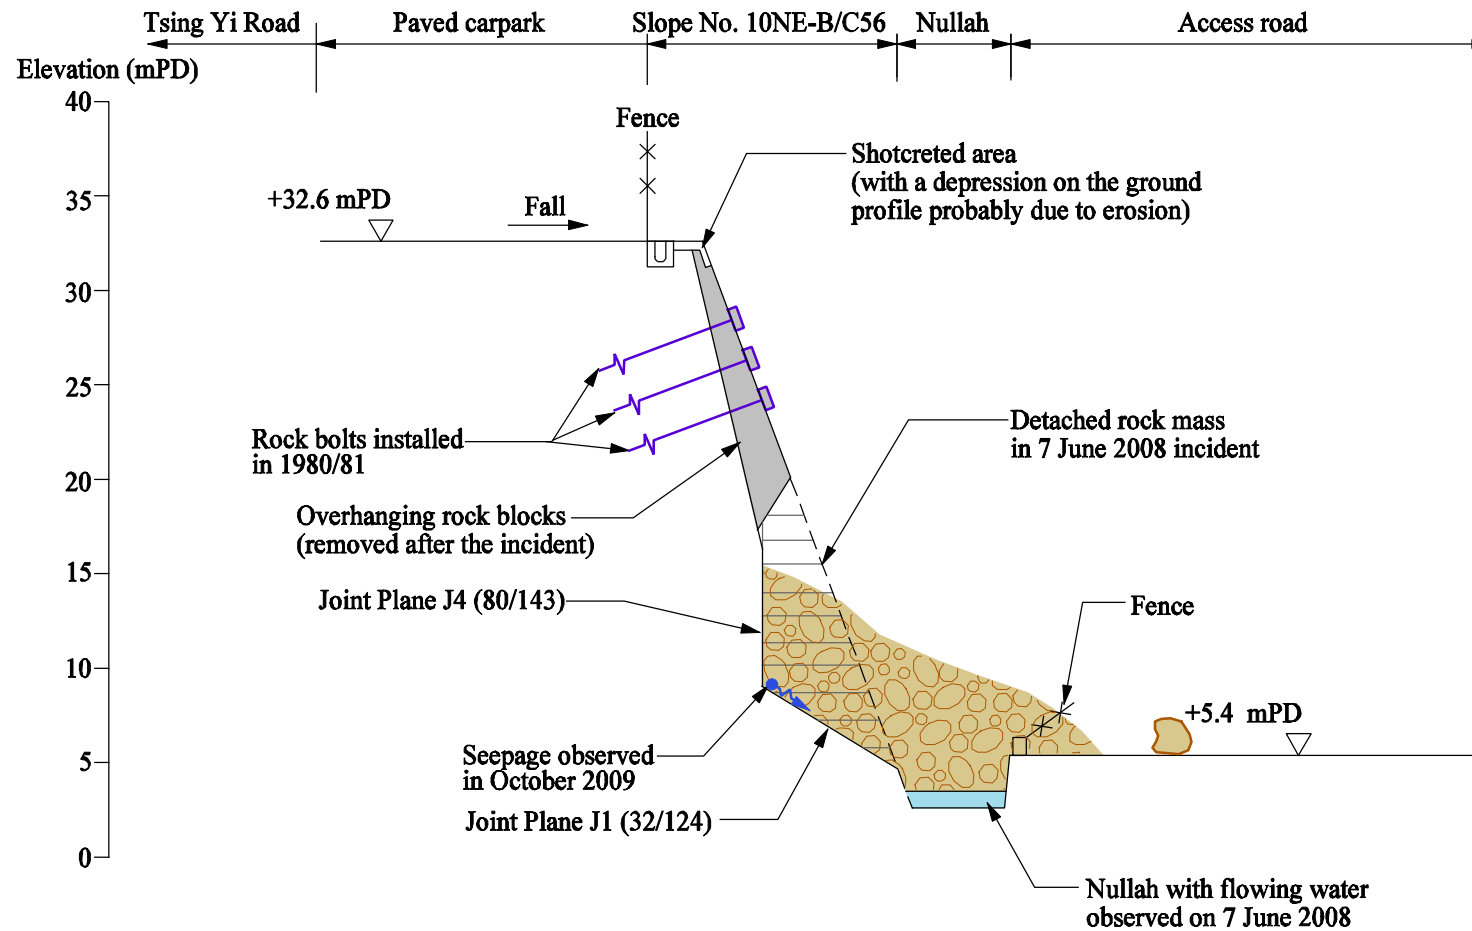
Figure 7 - Section A-A

The landslide was up to about 20 m wide, 13 m high and 4 m deep. The landslide scar exposed slightly to moderately decomposed fine-grained to medium-grained granite. The main body of debris comprised rock blocks up to about 3 m in size, mixed with remnant of vegetation. Brown and black staining was observed at the scar and rock blocks in the debris. The staining may have been associated with seepage flow through discontinuities in the rock mass over a long period of time (Plates 6 and 10). Continuous seepage emerging from the basal slip surface of the scar was also observed during the inspection in October 2009 (Plate 9 and Figure 7).

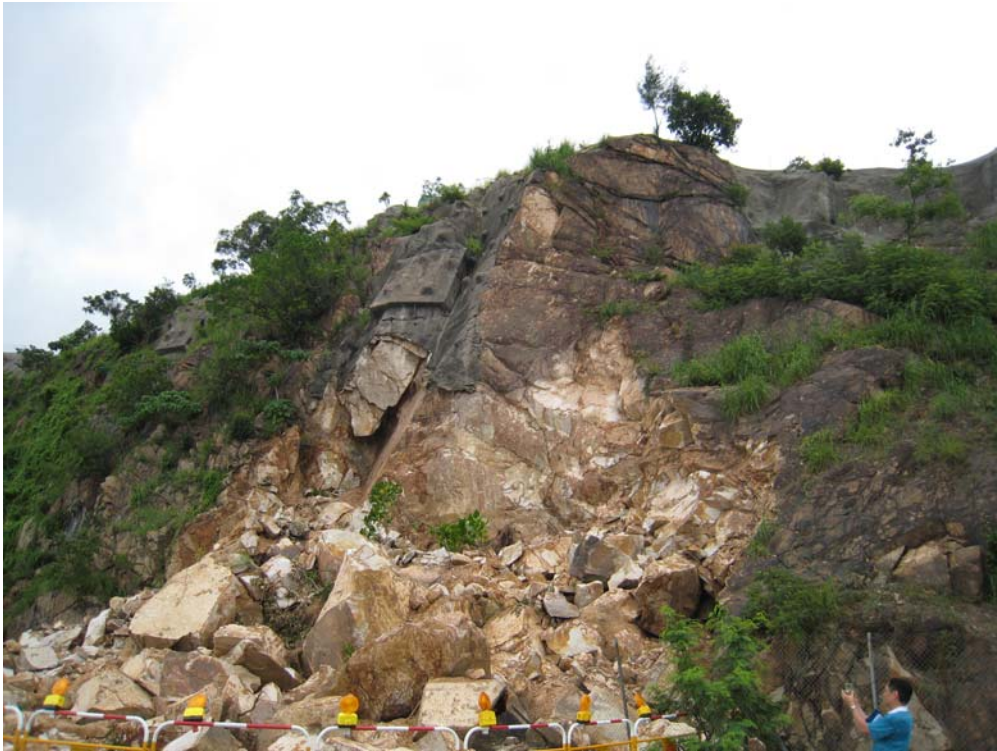
The slope was subject to stabilisation in 1981 and stability assessment in 1999. The rock 'bolts' installed in 1981 were proved to be effective in stabilising the portion of the rock slope above the failure location (Plate 1). However, the critical joint (i.e. the basal slip surface) leading to the 7 June 2008 failure was not identified in the previous assessments. Hence, no stabilization works were applied to the portion that failed.

Plate 1 - General View of the 7 June 2008 Failure on Slope No. 10NE-B/C56 (Photograph taken on 12 June 2008)

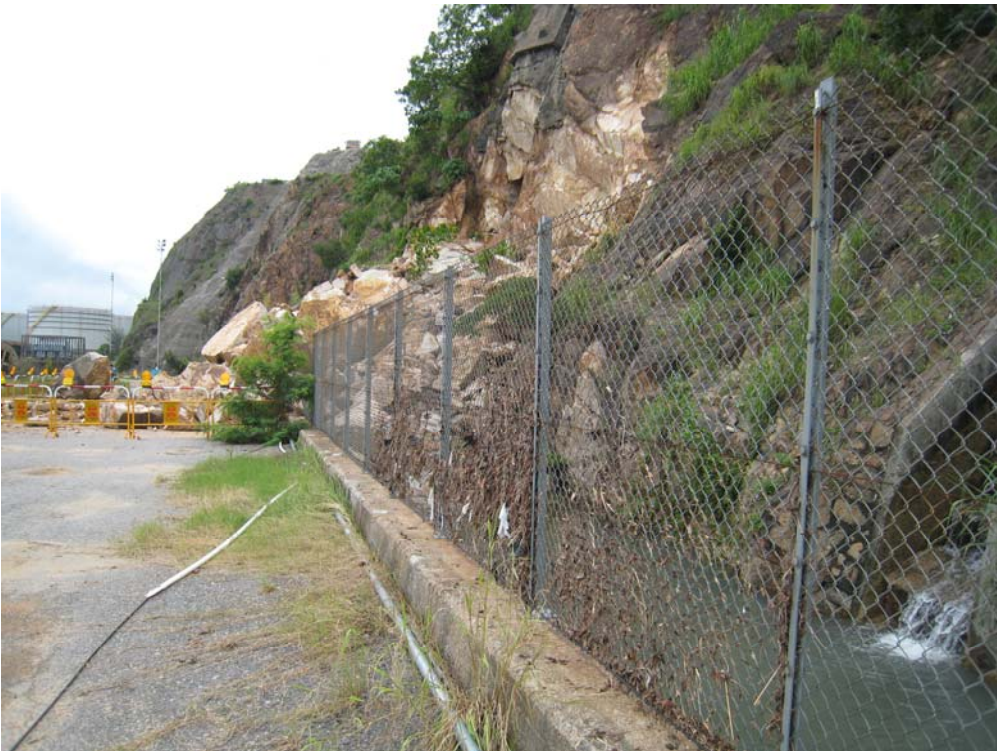
The incident was reported by HyD at 15:10 on 7 June 2008, and the exact time of the failure was unknown. The failure occurred at the eastern rock cut portion of slope No. 10NE-B/C56, with a failure volume of about 250 m³ (Plates 1 to 4). Most of the debris was deposited within the drainage nullah at the toe of the slope and some was scattered further away on the access road adjoining to the nullah. The debris also severed part of the road-side fencing below the slope toe (Plate 2).

A sizeable rock block of about 2 to 3 m in diameter was deposited at the distal end further to the front of the main debris mound (Plate 2), about 10 m away from the slope toe.

Plate 2 - Side View of the Rock Slope Failure towards the West and the Drainage Channel of Slope No. 10NE-B/C56 (Photograph taken on 12 June 2008)

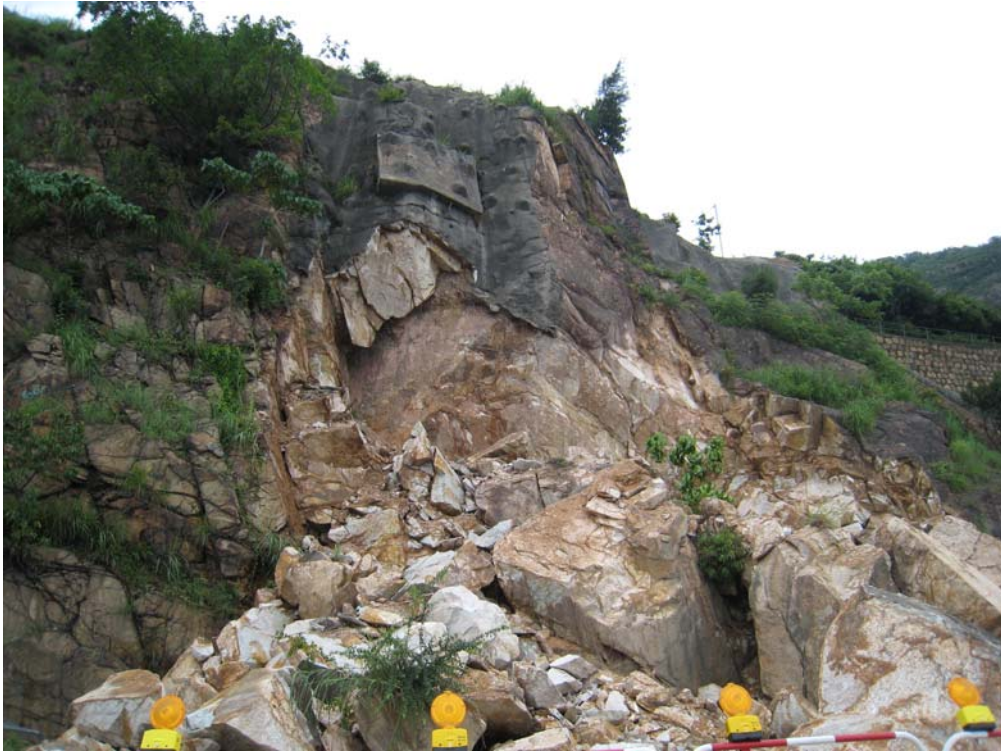
Plate 3 - Side View of the Rock Slope Failure towards the East
(Photograph taken on 12 June 2008)

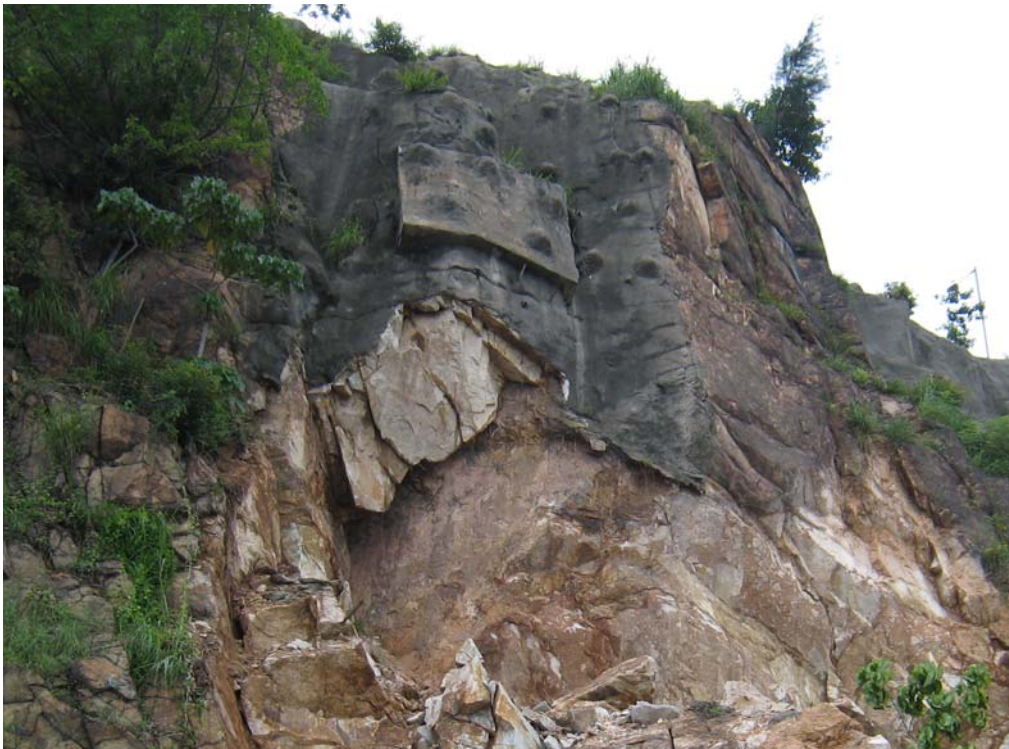
Plate 4 - Close View of Overhanging Blocks and the Rock Stabilisation
Measures Installed in the 1980s above the Scar (Photograph
taken on 12 June 2008)

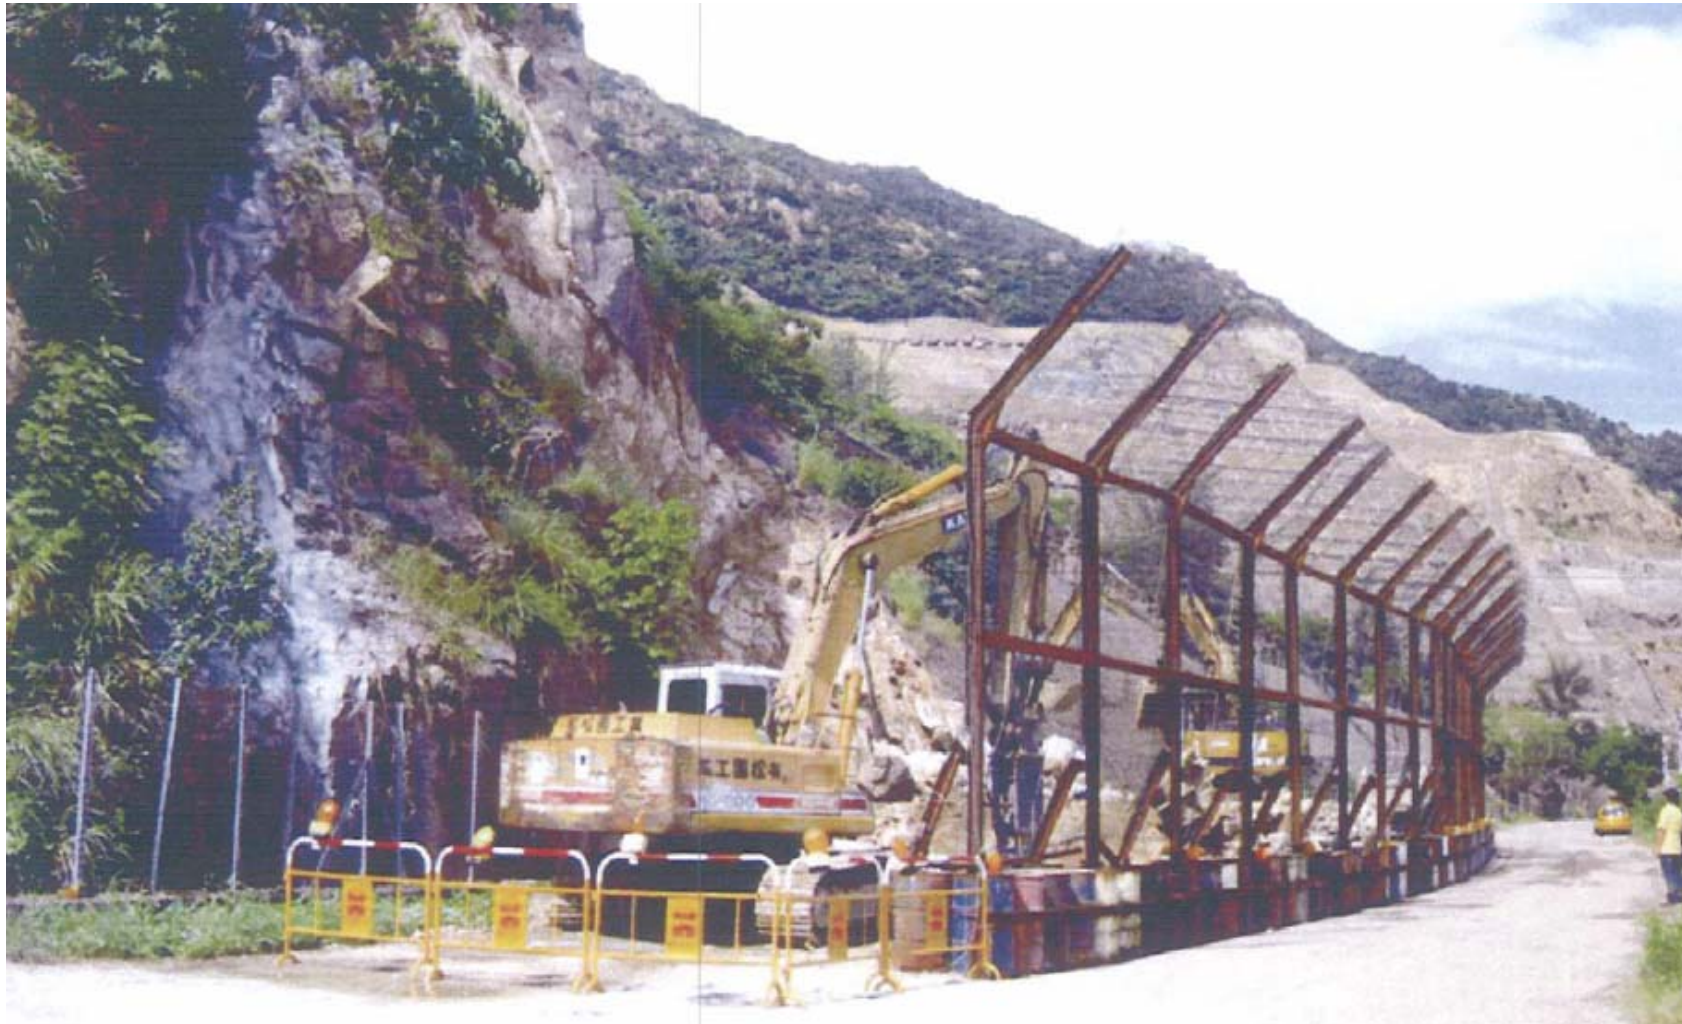
Plate 5 - Urgent Repair Works by the Highways Department after the 7 June 2008 Landslide

Subsequent to the incident, HyD carried out urgent repair works (Plate 5) which comprised removal of landslide debris and overhanging rock blocks, and provision of shotcrete to the rock mass near the scar. The works were completed on 9 September 2008.

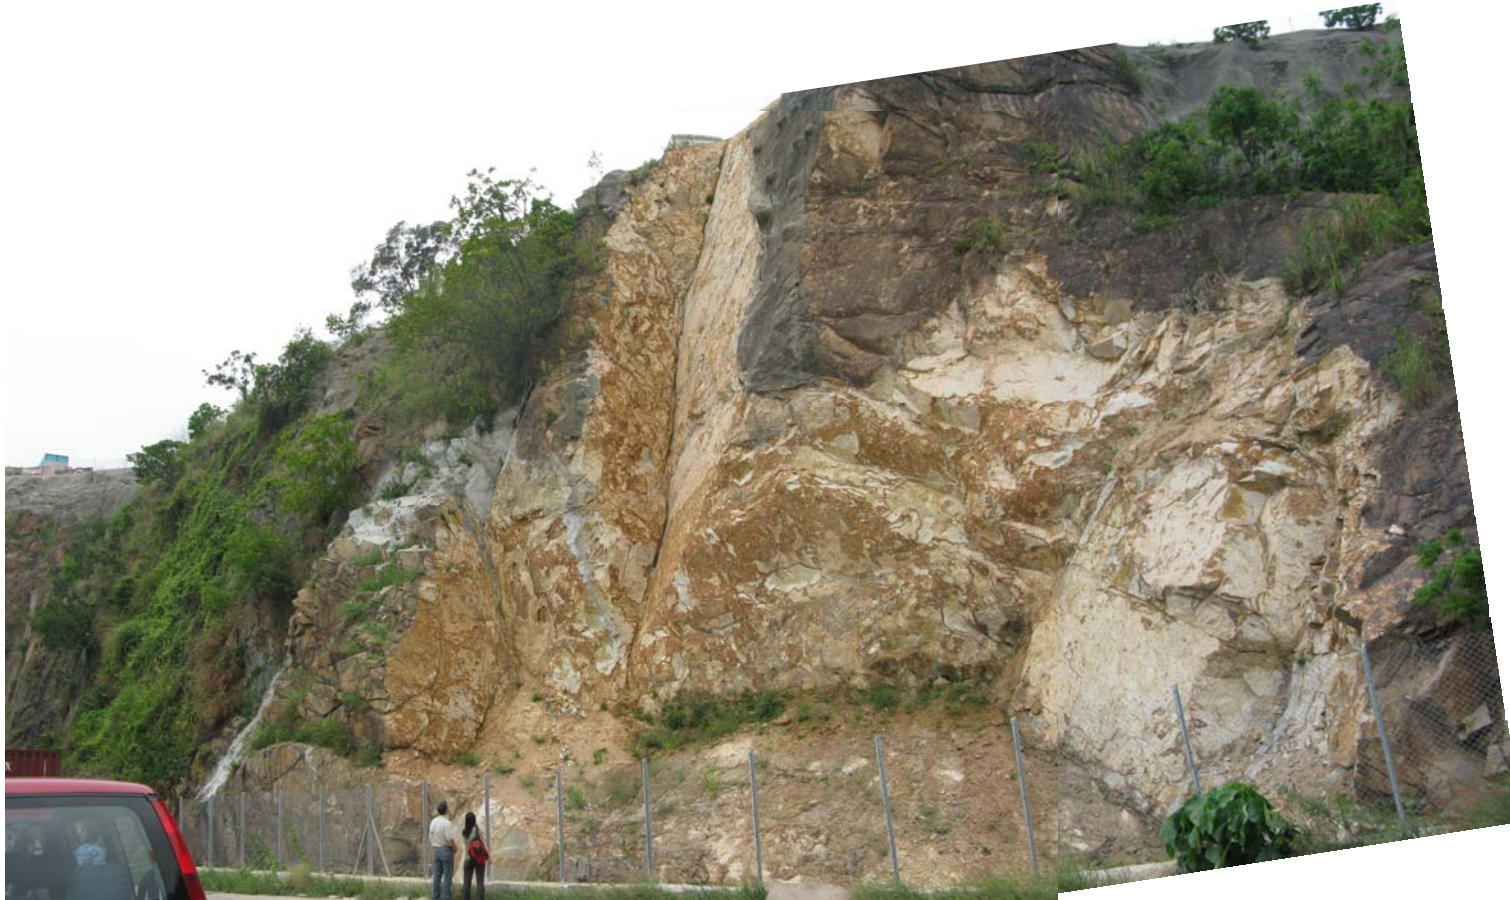
Plate 6 - General View of the Scar after Removal of Debris and Overhanging Rock Blocks
(Photograph taken on 23 April 2009)

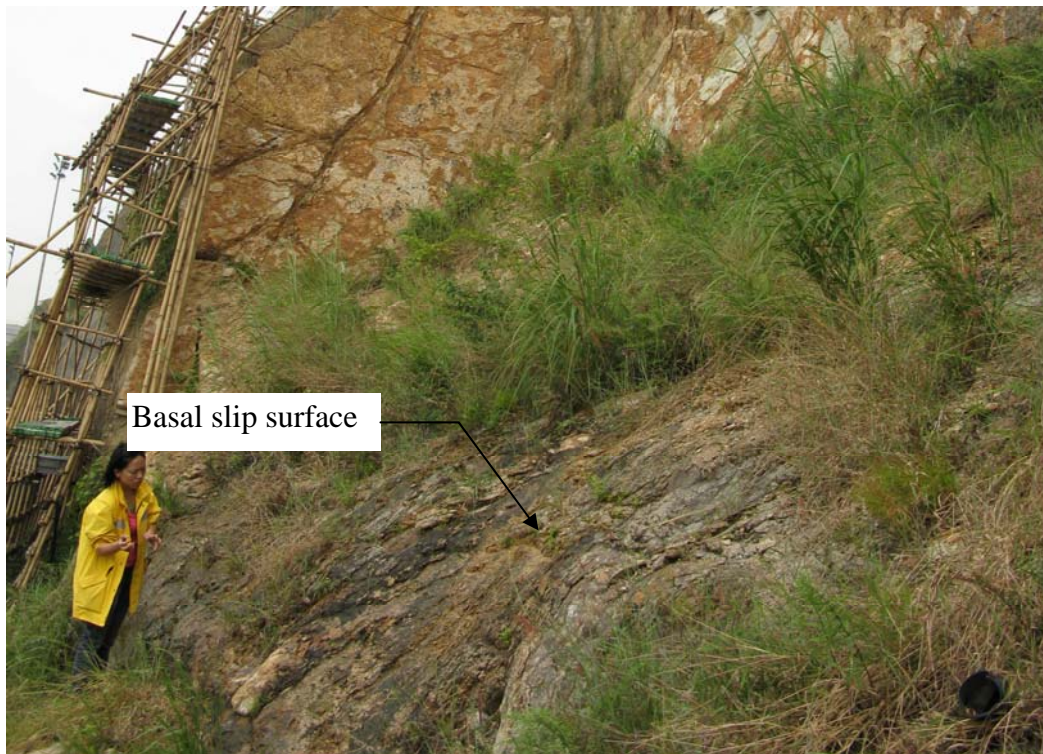
Plate 7 - General View of the Basal Slip Surface (Photograph taken on 20 October 2009)

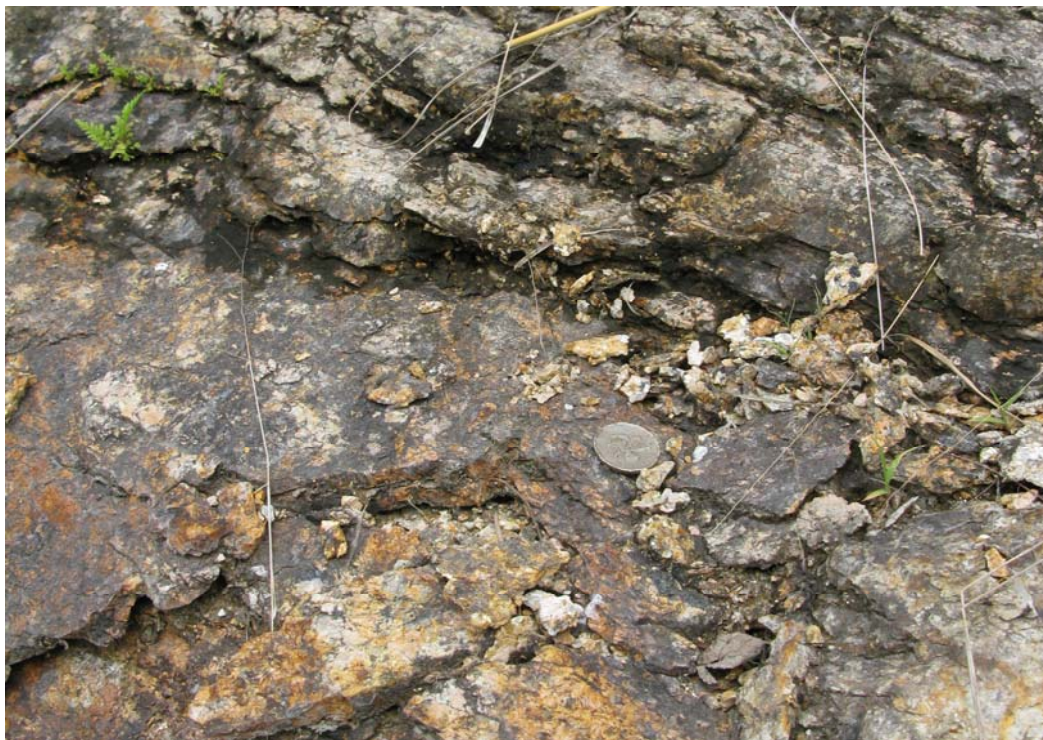
Plate 8 - Close View of the Basal Slip Surface
(Photograph taken on 20 October 2009)

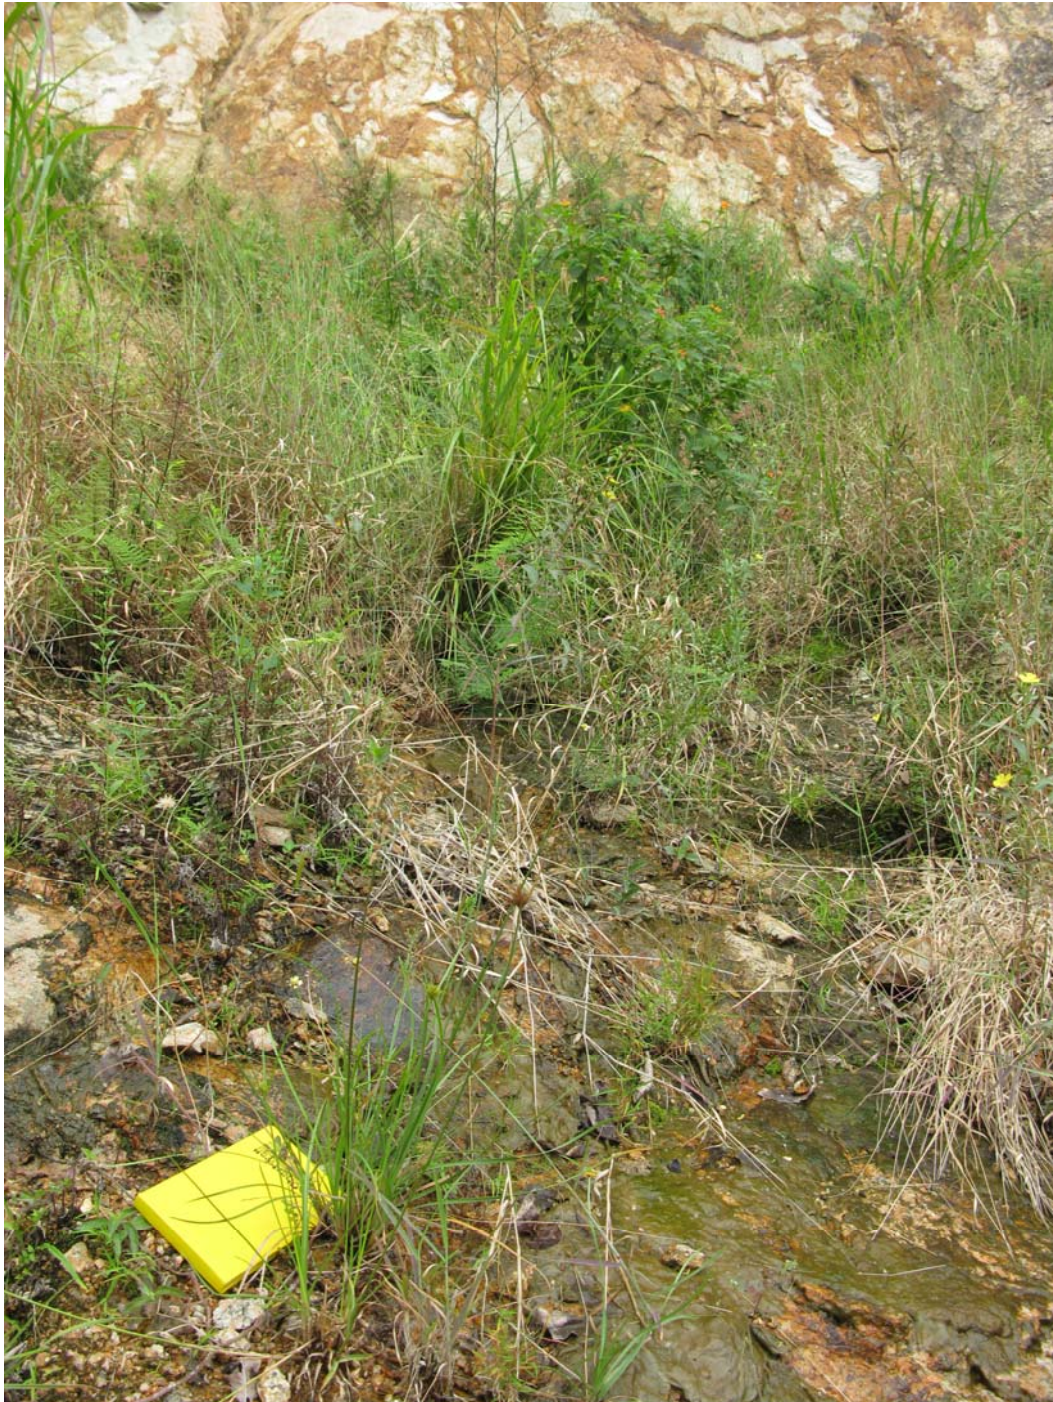
Plate 9 - Seepage with Growth of Algae Observed at the Basal Slip Surface
(Photograph taken on 20 October 2009)

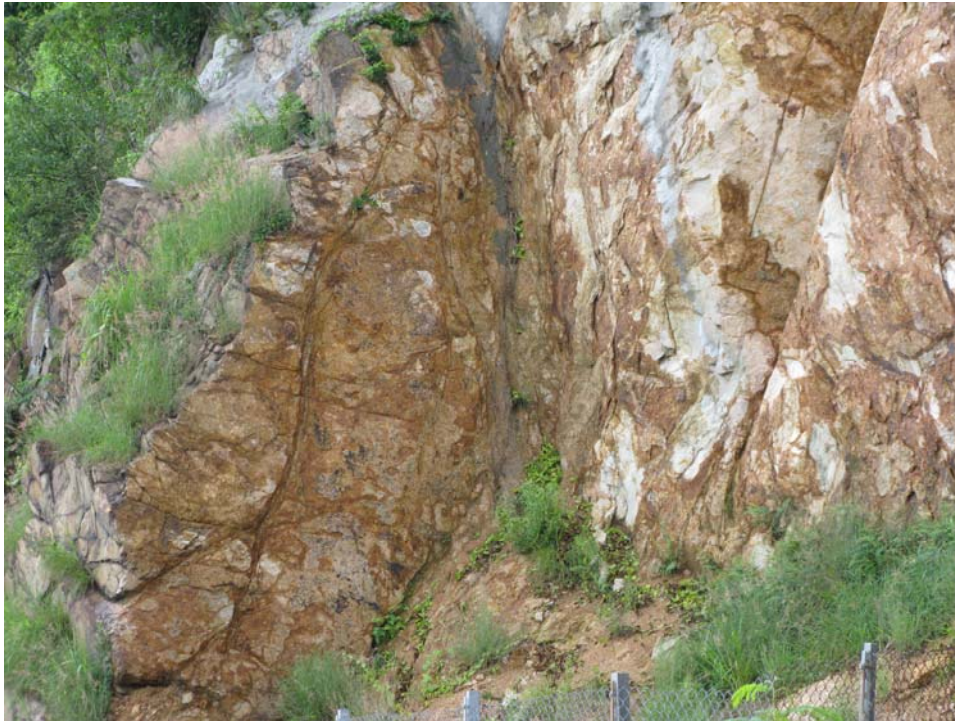
Plate 10 - Signs of Degradations and Heavy Staining at Release Joints
(Photograph taken on 25 June 2009)

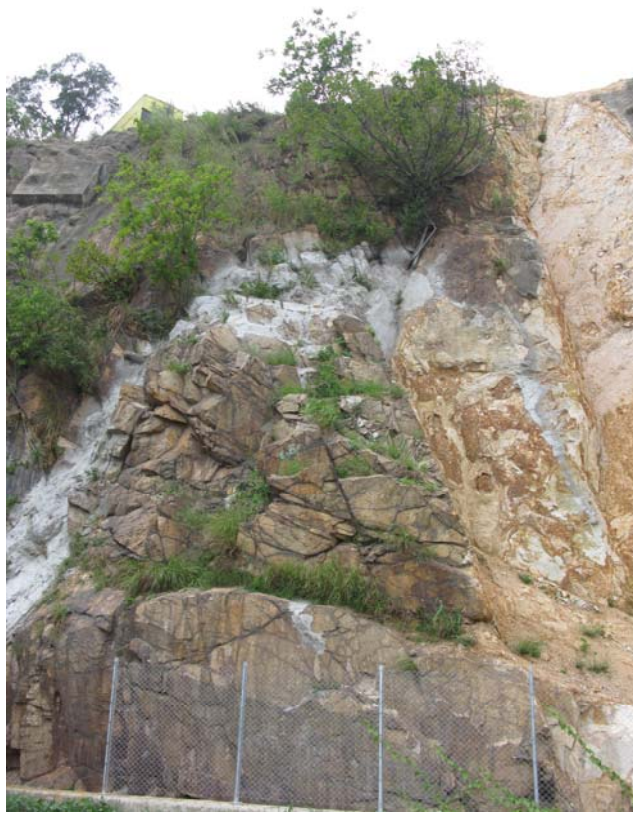
Plate 11 - Unplanned Vegetation on Rock Mass Adjoining the
Scar (Photograph taken on 23 April 2009)

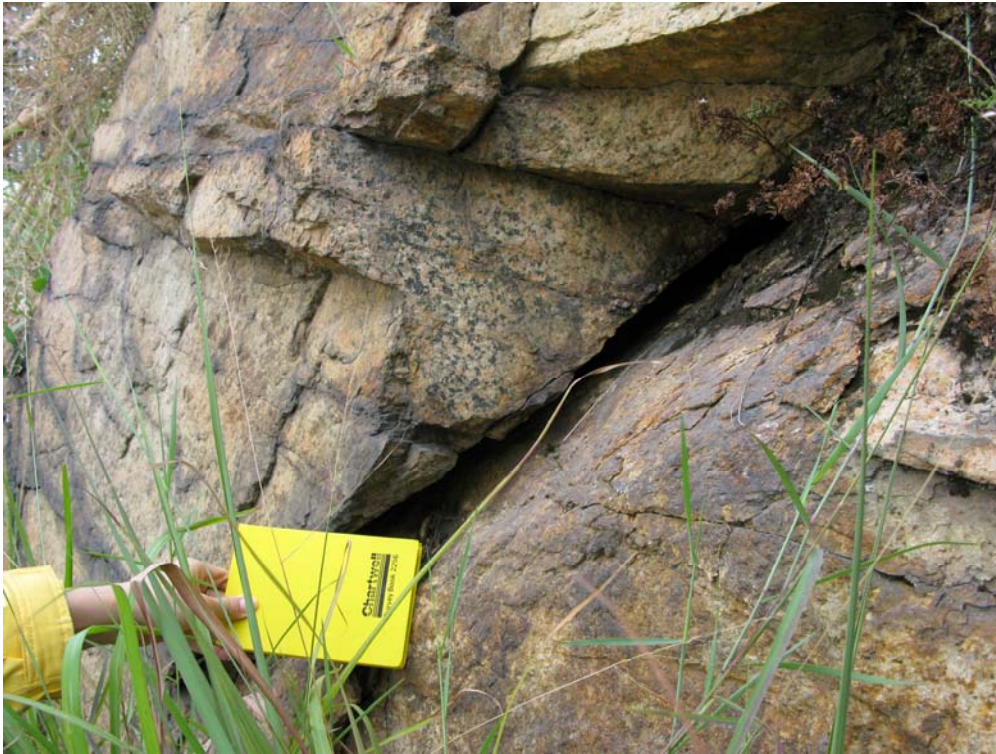
On the unfailed parts of the slope, the rock mass is characterised by closely to medium-spaced open joints with a width in the order of centimetres (Plate 12). The sprayed shotcrete proposed in the design drawing in 1999 could not be found (Section 6.2). Displaced rock blocks probably due to root-wedging effect were observed (Plates 11 and 13). Minor rock fall ($< 0.1 \text{ m}^3$) (Plate 14) was also noted depositing on the nullah at the slope toe.

Plate 12 - Opening-up of Rock Joint Observed Close to the Scar
(Photograph taken by 20 October 2009)

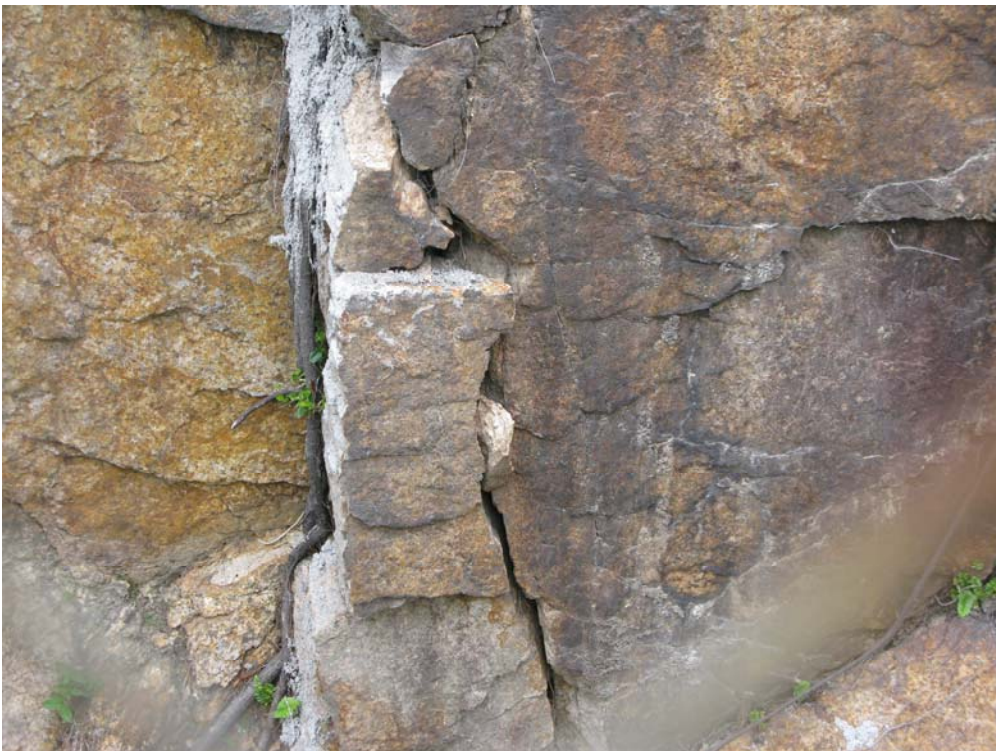
Plate 13 - Signs of Root-wedging and Dislodged Rock Blocks Near the Scar
(Photograph taken by 23 April 2009)

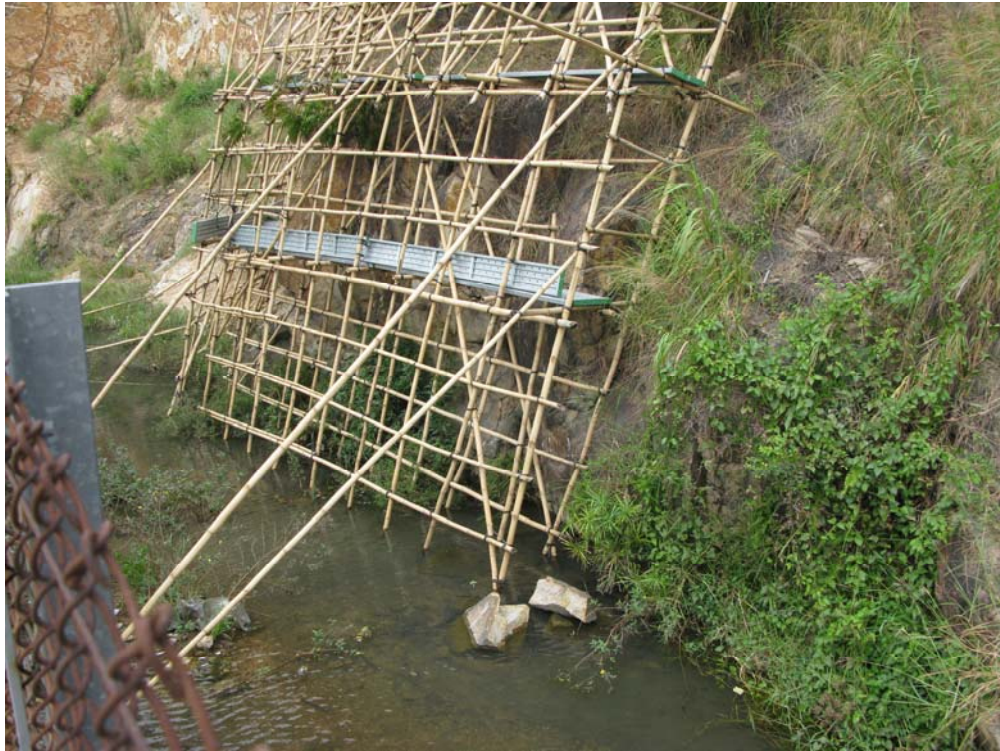
Plate 14 - Fallen Rock Fragments Noted after the 7 June 2008 Failure
(Photograph taken on 20 October 2009)

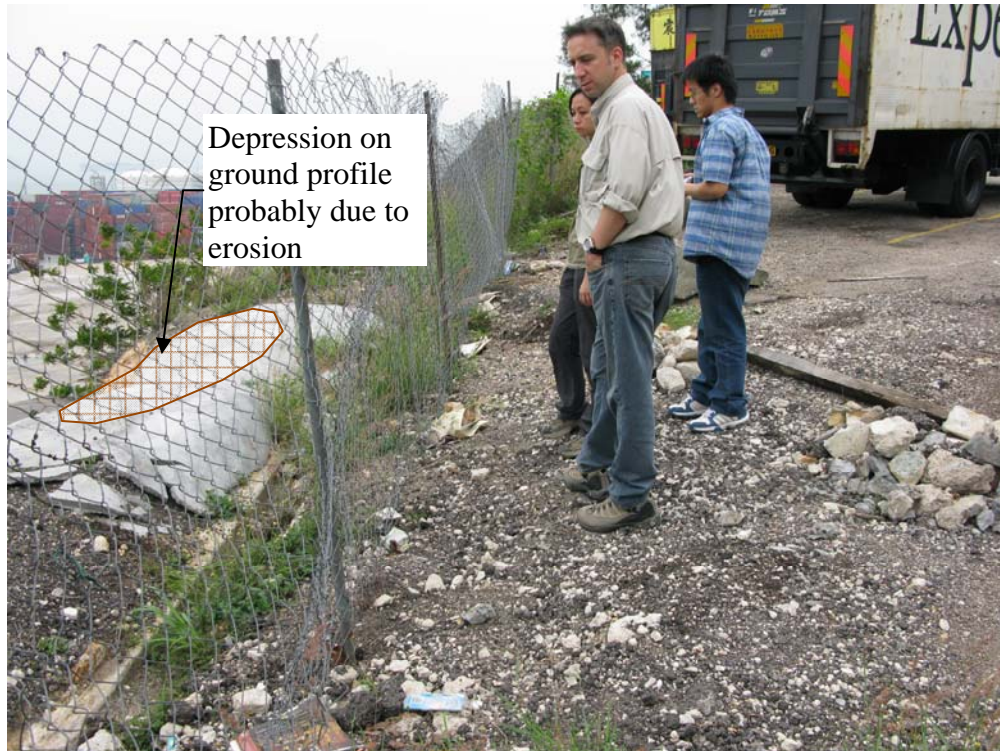
A 300 mm surface channel was present along the crest of the cut slope, 15 m above the 7 June 2008 failure. The channel was fenced-off by a chain link fence and might not be readily accessible for maintenance (Plate 15). The channel collects runoff from a 4,500 m² paved carpark on the crest platform, and discharges the water, via some stepped channels, to the nullah at the slope toe. The crest channel was relatively shallow, and was found partly blocked by vegetation and debris during the inspection on 23 April 2009 (Plate 15). The channel runs in northeast direction and bends at a location immediately above the 7 June 2008 failure (Figure 2). At this location, a slight depression was observed on the ground profile downslope of the channel. The ground depression was probably associated with surface erosion due to overspilling from the channel, and the area had been covered by cement (Plate 15). The API indicated that the cement was probably placed in 2002.

The slope crest channel above the 7 June 2008 failure location was blocked by vegetation and debris, probably due to lack of maintenance. This would have resulted in overspillage and additional water ingress into the slope. Signs of deterioration including minor rock falls, displaced rock blocks and opening of rock joints were also observed on the unfailed portions of the slope.

Plate 15 - Conditions of the Crest Channel above the Incident and Signs of
Surface Repair (Photograph taken on 23 April 2009)
