**DETAILED STUDY OF THE  
7 JUNE 2008 LANDSLIDE  
ON SLOPE NO. 11SE-A/C502  
AT PAK FUK ROAD,  
NORTH POINT**

**GEO REPORT No. 289**

**Fugro Scott Wilson Joint Venture**

**GEOTECHNICAL ENGINEERING OFFICE  
CIVIL ENGINEERING AND DEVELOPMENT DEPARTMENT  
THE GOVERNMENT OF THE HONG KONG  
SPECIAL ADMINISTRATIVE REGION**

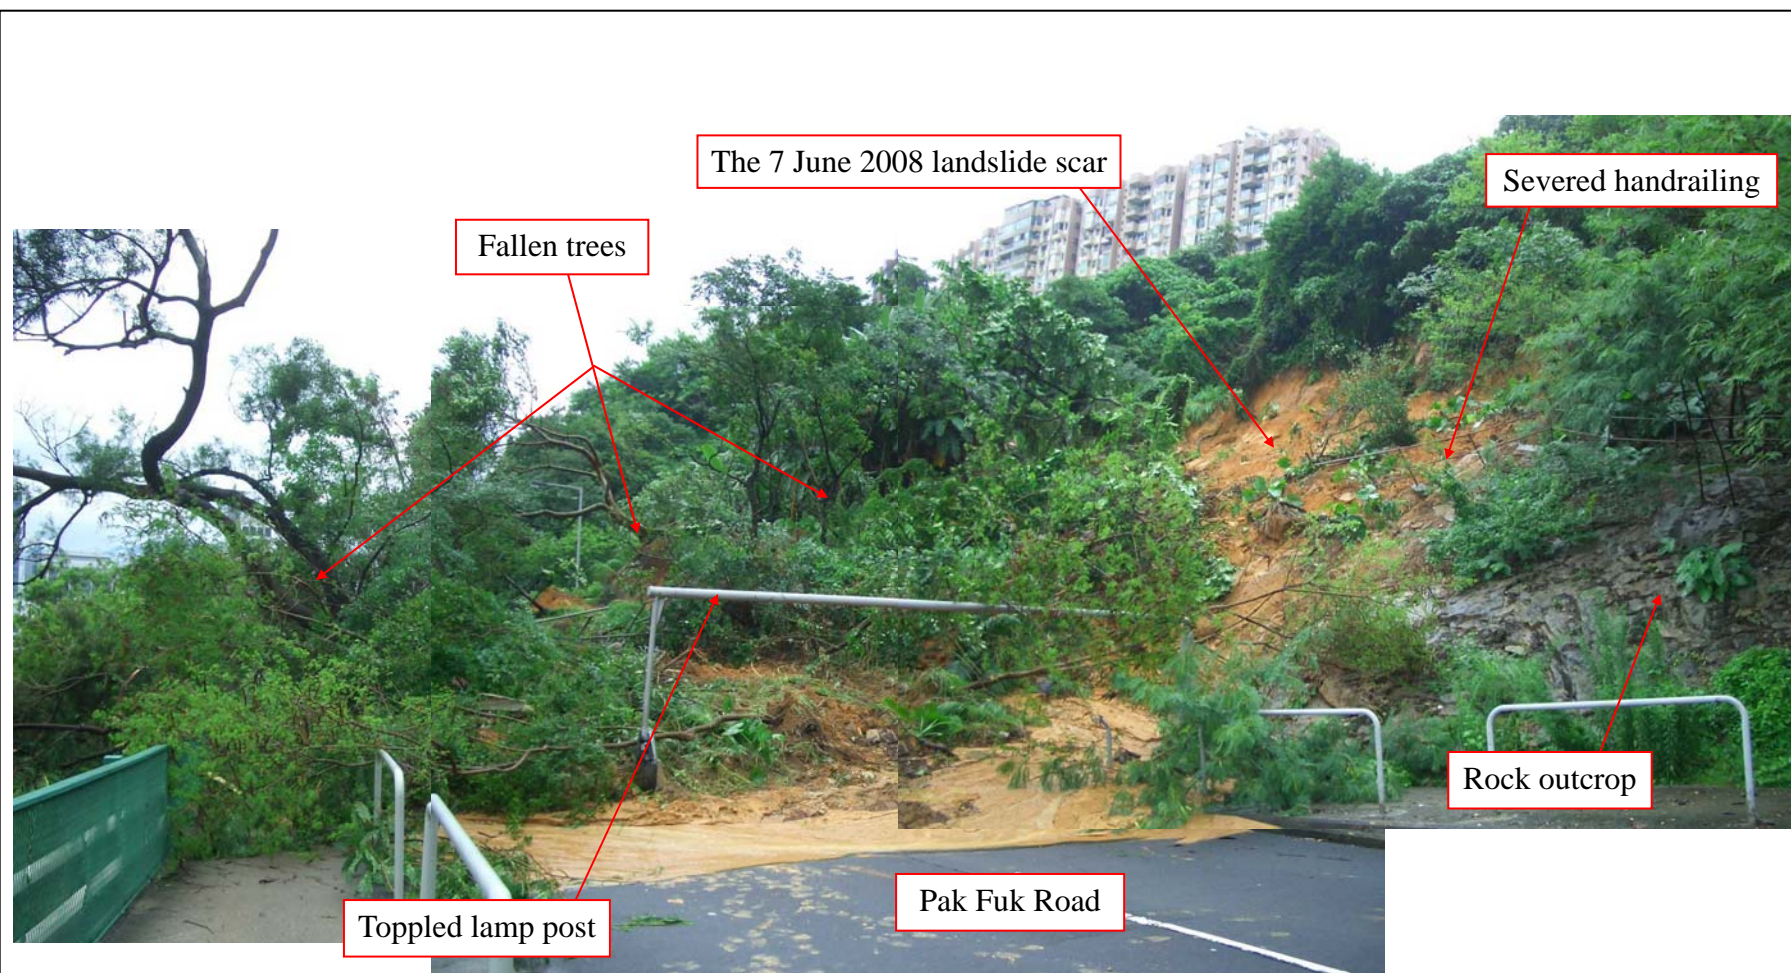
At about 8:40 a.m. on 7 June 2008, a major landslide occurred above Pak Fuk Road, North Point on an unsupported soil and rock cut slope No. 11SE-A/C502 (Figure 2). The landslide involved a failure volume of about 1,270 m<sup>3</sup> and resulted in the closure of all two lanes of Pak Fuk Road for 16 days from 7 to 23 June 2008. The impact of the landslide debris toppled a lamp post and damaged the roadside parapet (Plate 1).

Plate 1 - General View of the 7 June 2008 Landslide (Looking East)  
(Photograph taken on 7 June 2008)

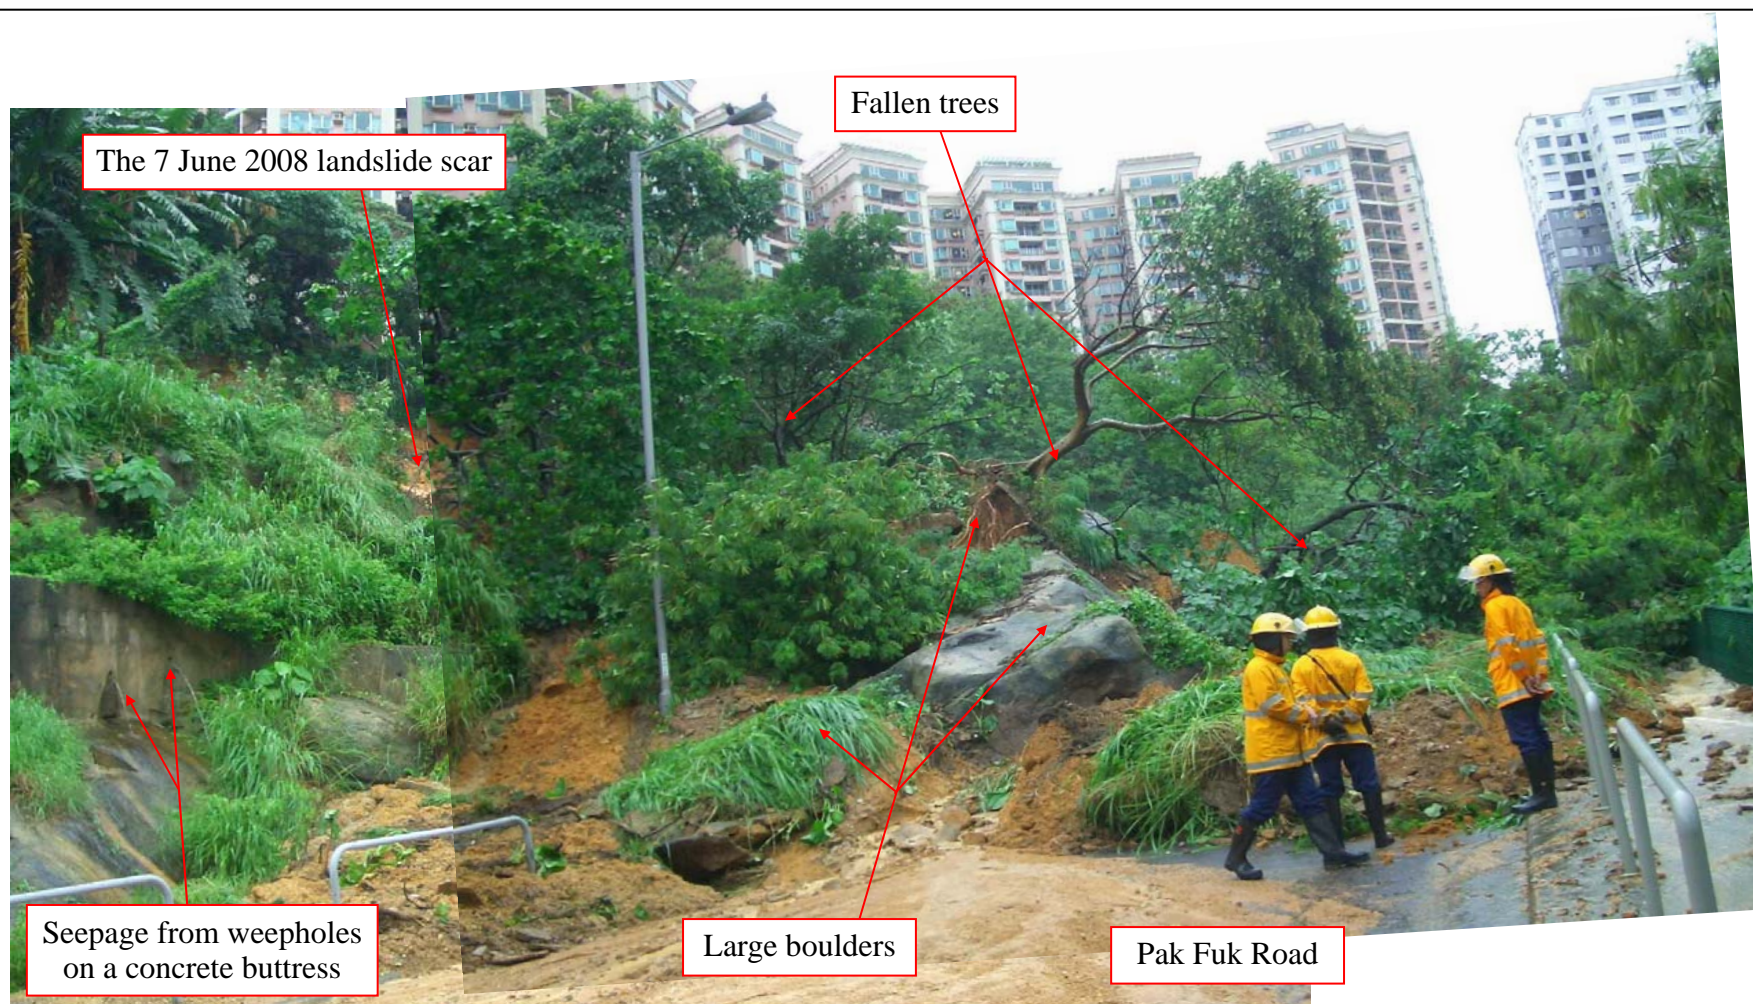
deep, with a debris volume of about 1,270 m<sup>3</sup> (Plates 1 and 2). The surface of rupture, in particular the basal slip plane, was irregular in nature (Plate 16), which was likely related to the corestone-bearing groundmass as evidenced by the record photograph of the slope (Plate 11) and the presence of large corestones/boulders in the debris (Plate 2).

- (a) On 7 June 2008, heavy seepage was noted flowing from two weepholes on a concrete buttress located immediately to the east of the landslide (Figure 2 and Plate 2), as well as from rock joints adjoining the landslide scar (Plates 27 and 28);
- (b) On 18 June 2008 prior to the provision of the shotcrete cover to the landslide scar, seepage above the colluvium/CDG interface was noted at the western flank of the main scarp (Plate 29) although no soil pipes could be observed;

Plate 2 - General View of the 7 June 2008 Landslide (Looking West)  
(Photograph taken on 7 June 2008)

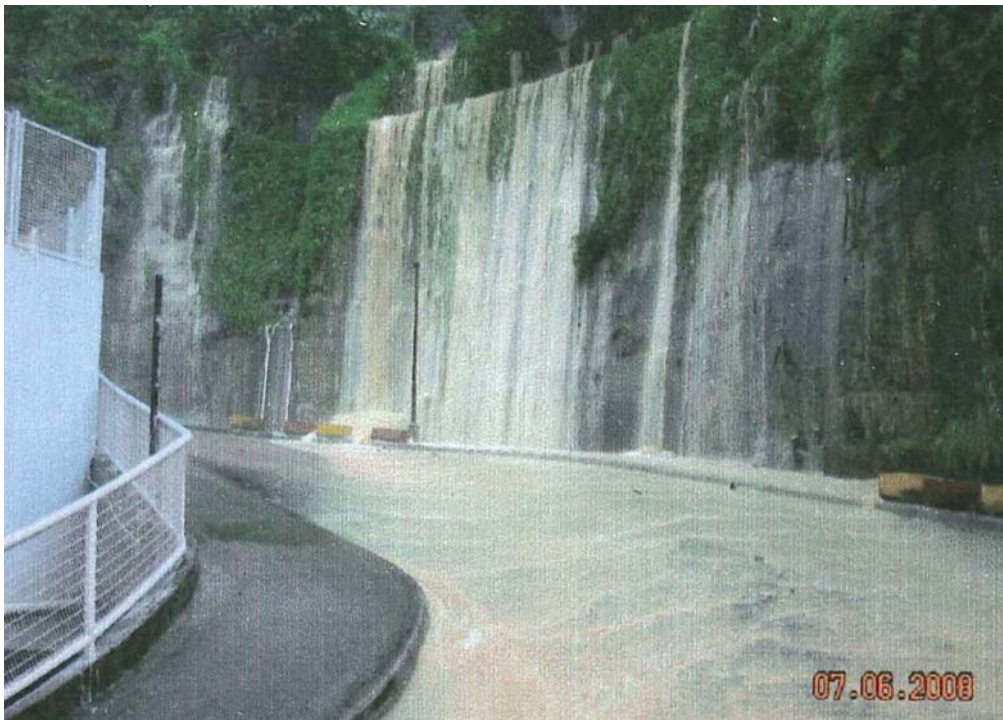
Plate 3 - Muddy Surface Runoff Travelling Down to Bedford Gardens  
(Photograph taken on 7 June 2008)

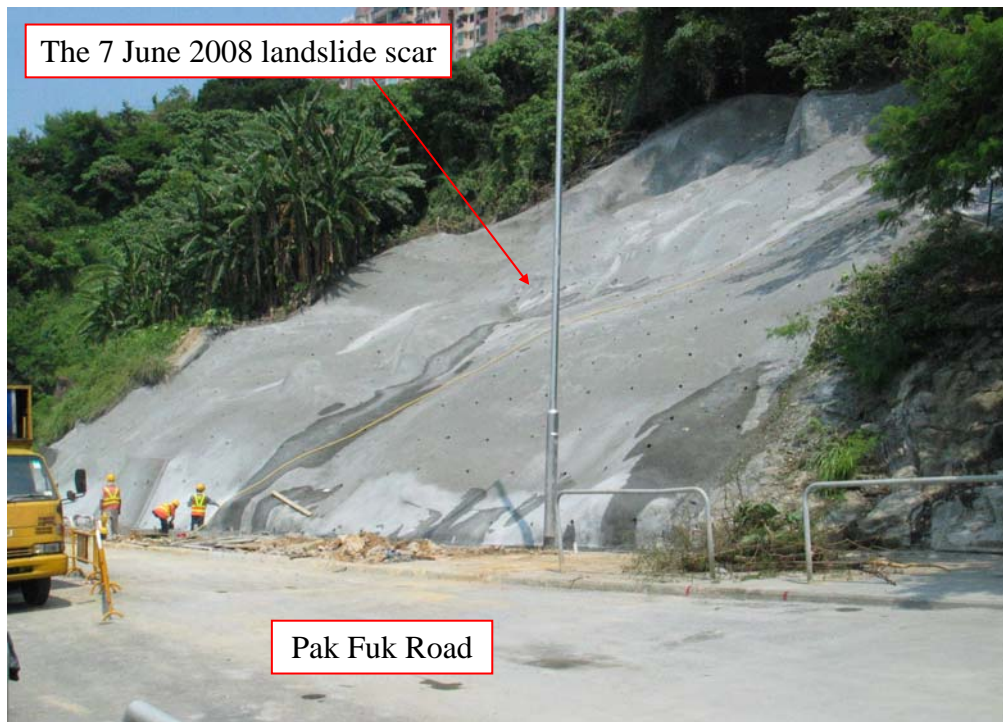
Plate 8 - The 2008 Landslide Scar after Completion of Emergency Repair Works  
(Photograph taken on 23 June 2008)

Emergency repair works, mainly comprising the removal of landslide debris, provision of a shotcrete cover to the landslide scar and the re-construction of the slope surface drainage channels, were carried out by the HyD between 7 and 23 June 2008 (Plate 8).

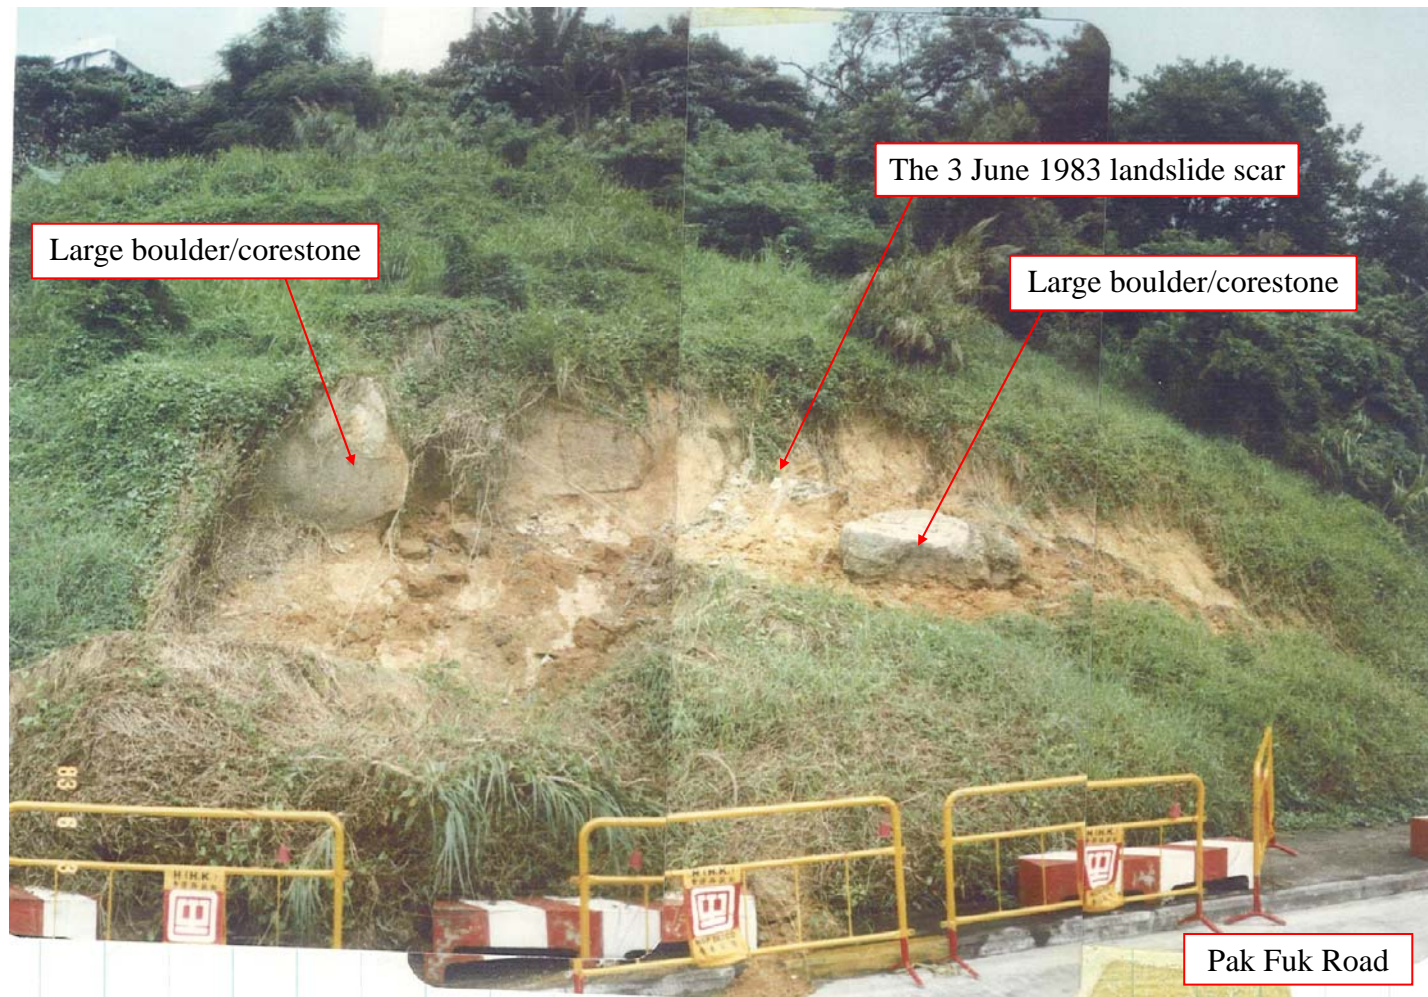
On 3 June 1983, a landslide (Incident No. HK83/6/1), with a failure volume of about 50 m<sup>3</sup>, was reported to have occurred on the lower eastern portion of slope No. 11SE-A/C502 (Figure 4, Plates 10 and 11). The landslide scar measured about 7 m high and 10 m wide. The landslide debris with boulders came to rest on the pedestrian pavement and did not affect Pak Fuk Road. The landslide was probably caused by saturation of the near-surface groundmass as a result of infiltration during heavy rainfall.

Plate 10 - General View of the 3 June 1983 Landslide  
(Photograph taken on 3 June 1983)

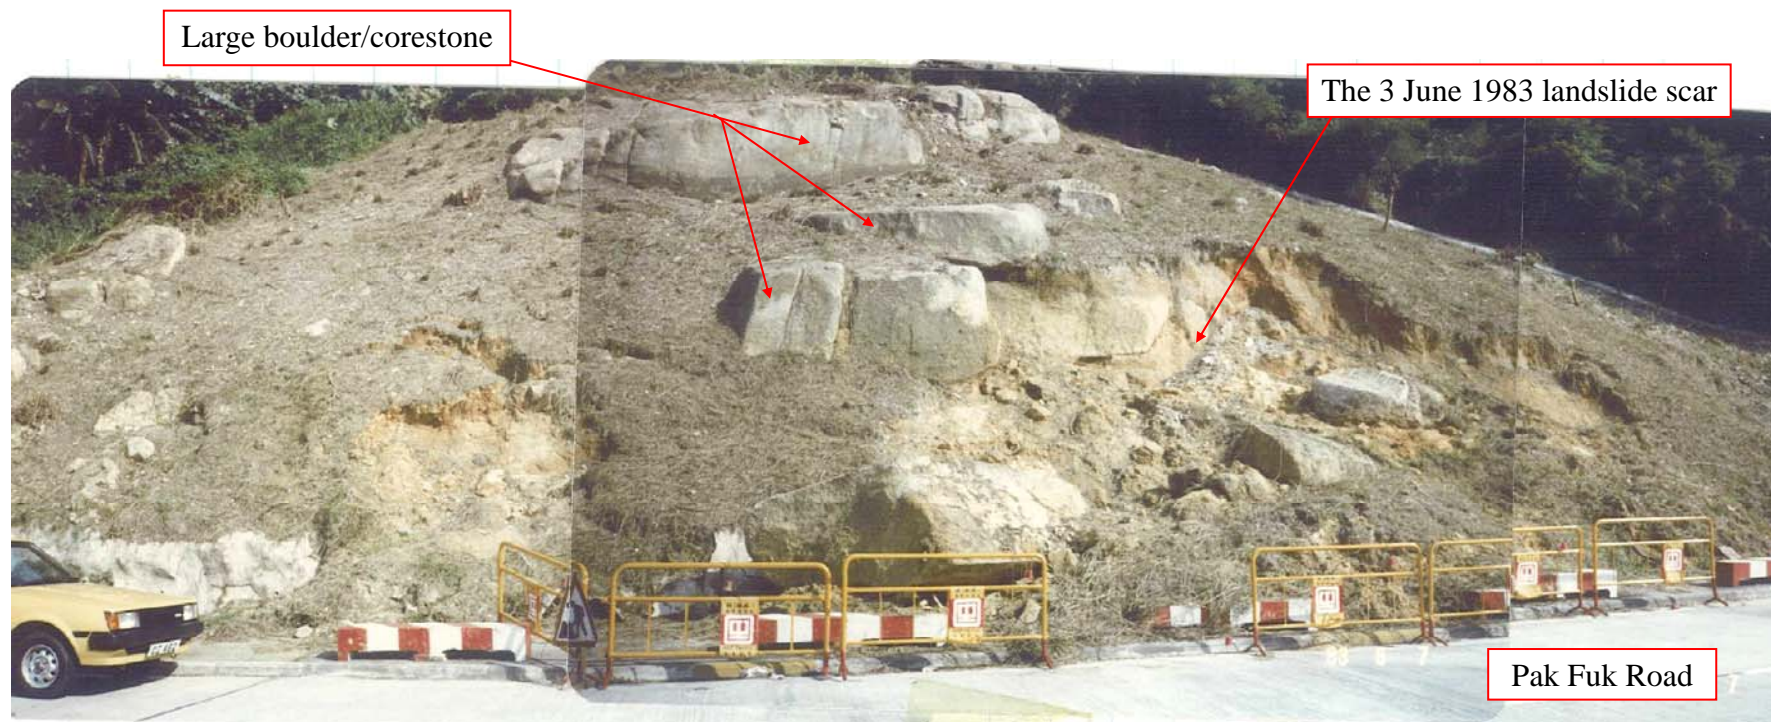
Plate 11 - General View of the 3 June 1983 Landslide Scar after Vegetation Clearance  
(Photograph taken on 7 June 1983)

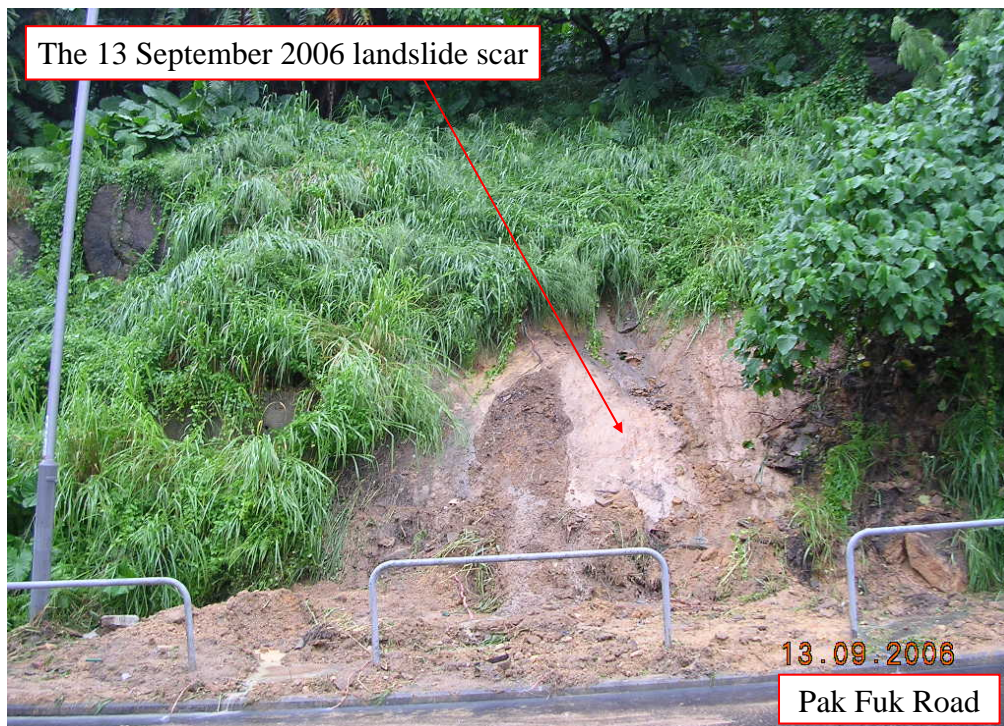
In the morning of 13 September 2006, a minor landslide (Incident No. 2006/09/0713) occurred on the eastern end of slope No. 11SE-A/C502 adjacent to the 1983 concrete buttress. The landslide debris affected the pedestrian pavement and blocked one lane of Pak Fuk Road (Figure 4 and Plate 12). The landslide scar was about 3 m high and 5 m wide, with a failure volume of 3 m<sup>3</sup>. During the follow-up inspection by the GEO on 13 September 2006 at which time the weather was rainy, seepage was observed at the failure location. Infiltration and unfavourable groundwater conditions were possible contributory factors to the landslide. Following the 2006 landslide, urgent repair works, comprising the removal of loose materials and provision of a sprayed concrete cover to the landslide scar, were arranged by the HyD and completed on 28 September 2006 (Plate 13).

Plate 12 - General View of the 13 September 2006 Landslide  
(Photograph taken on 13 September 2006)

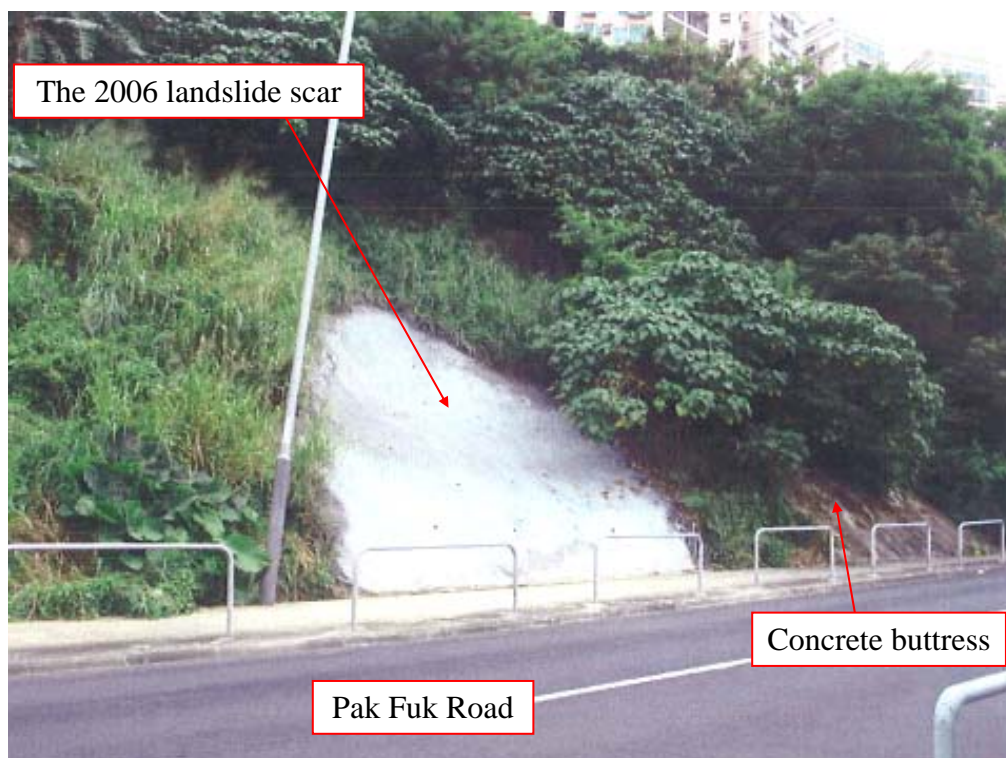
Plate 13 - The 2006 Landslide Scar after Completion of Emergency Repair Works  
(Photograph taken on 9 October 2006)

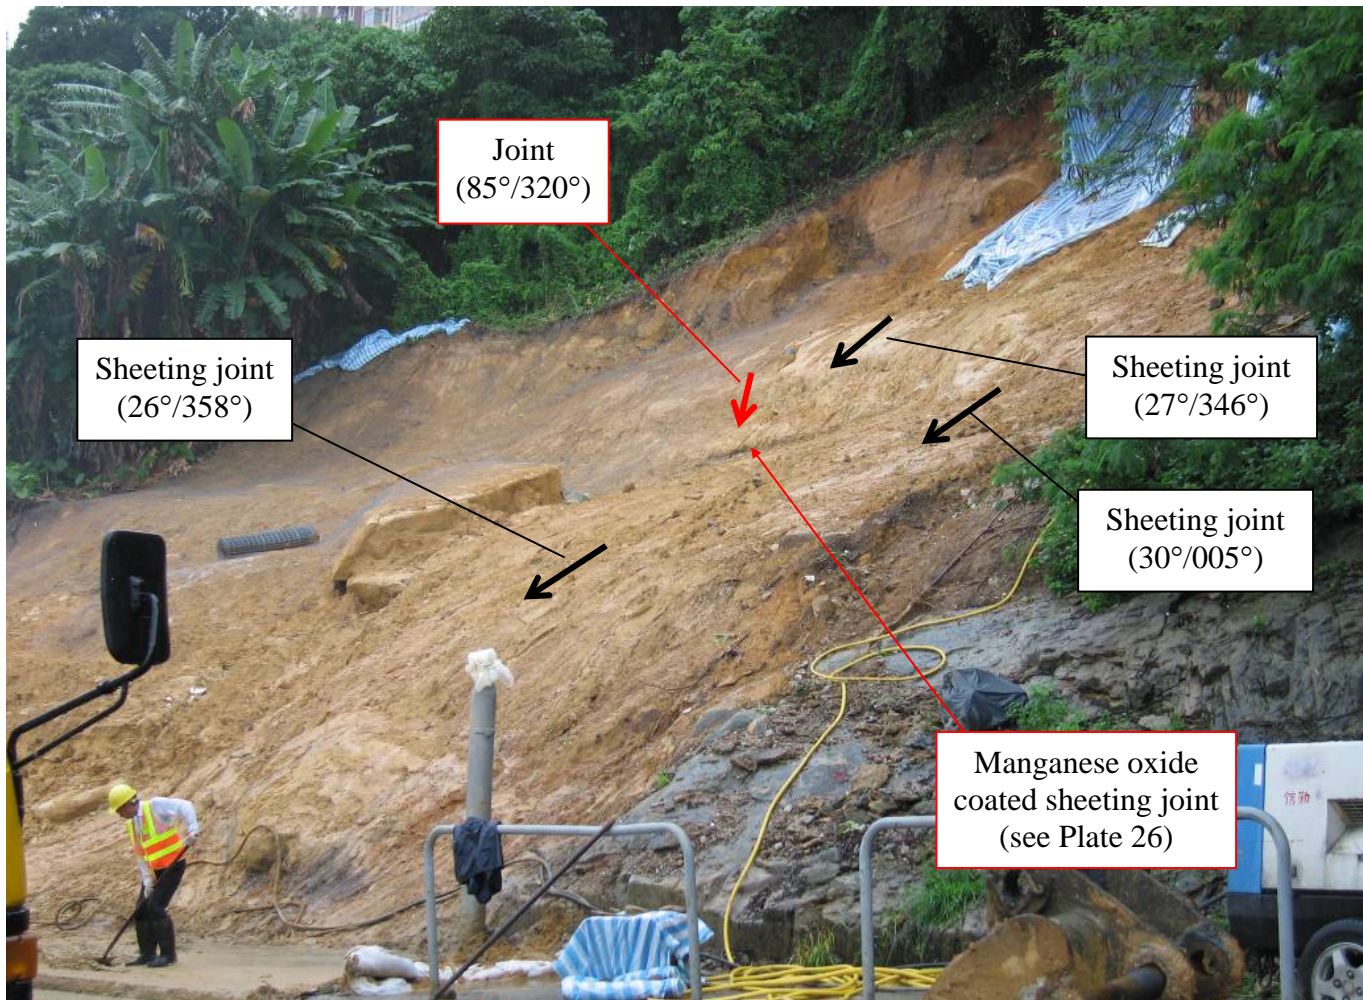
Plate 16 - Rupture Surface of the 7 June 2008 Landslide  
(Photograph taken on 18 June 2008)

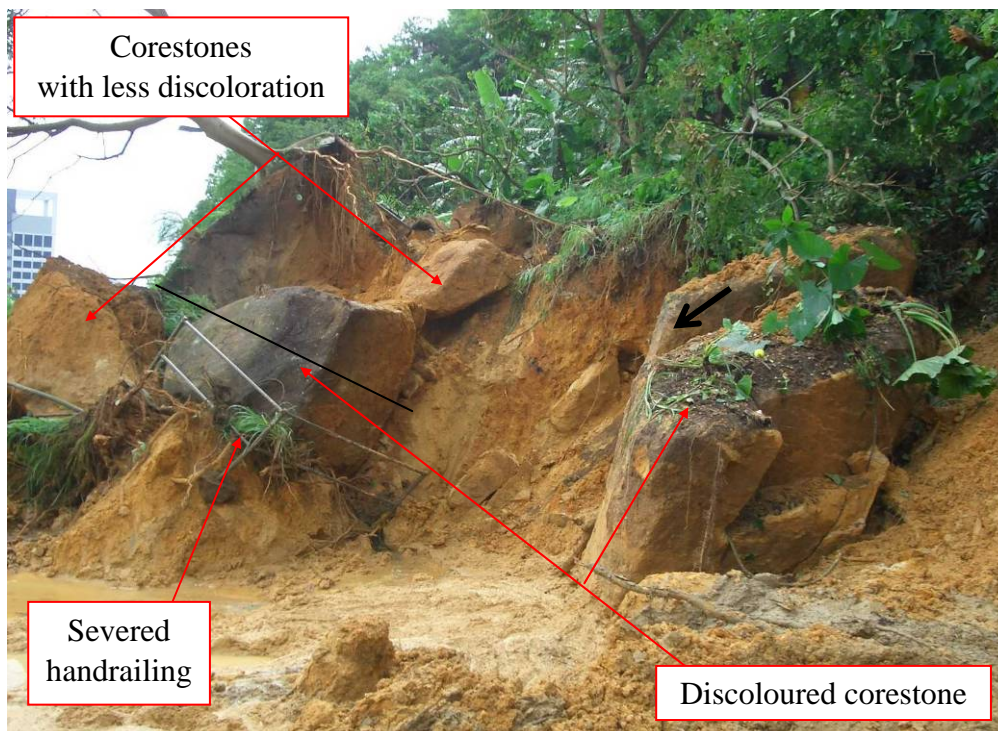
The landslide debris was wet and predominantly comprised residual soil and fine- to medium-grained completely decomposed granite (CDG) with many boulders of less than 1.2 m in diameter and considerable amount of mature trees and vegetation. Several large boulders were evident within the debris mass (Figure 2, Plates 17 and 18), some of which appeared to have been exposed prior to the landslide and others appeared to be corestones within the failed groundmass based on the relative discoloration (Plate 18). One of these large boulders measured about 8.4 m by 4.0 m by 1.4 m (i.e. Boulder A in Plate 17).

Plate 18 - Large Boulders in the Landslide Debris  
(Photograph taken on 8 June 2008)

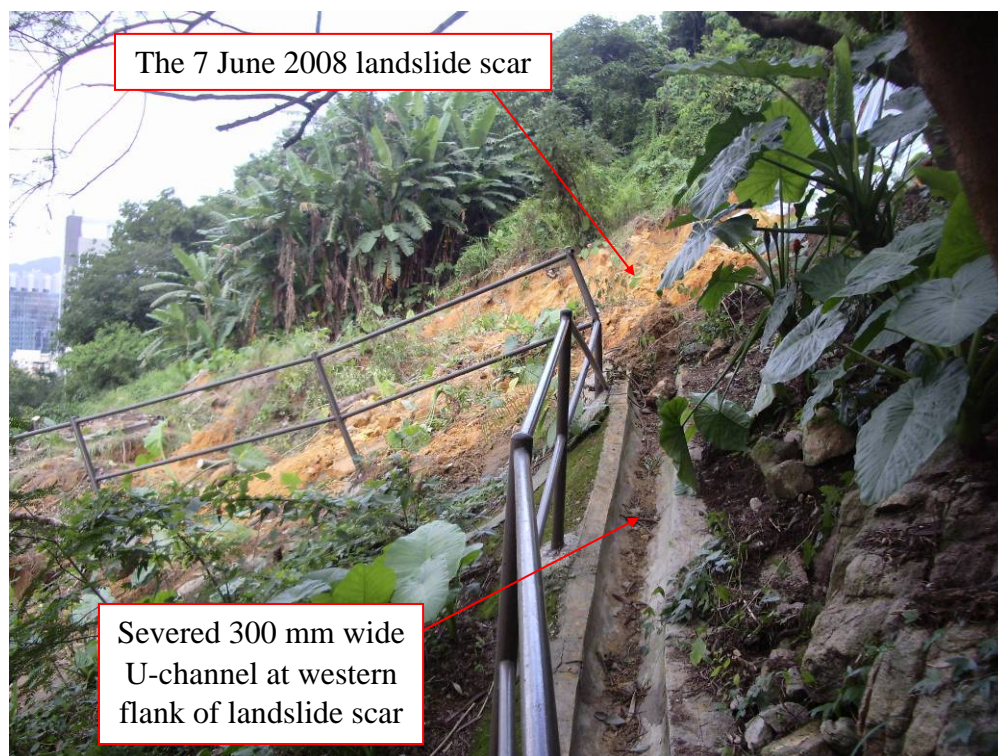
A block of concrete approximately 1 m by 1 m in section and 4 m in length was also noted (Figure 2 and Plate 17) within the debris mass, possibly from the 1983 concrete buttress (Plate 4). Moreover, a 300 mm surface drainage channel at the mid-height of slope No. 11SE-A/C502 was severed by the landslide (Plate 19). Parts of the broken drainage channel were found in the landslide debris (Figure 2 and Plate 20). The remaining section of the drainage channel at the western flank of the landslide scar was generally clear of debris and in reasonably good condition (Plate 19).

Plate 19 - Severed Drainage Channel at Mid-height of the Slope  
(Photograph taken on 10 June 2008)

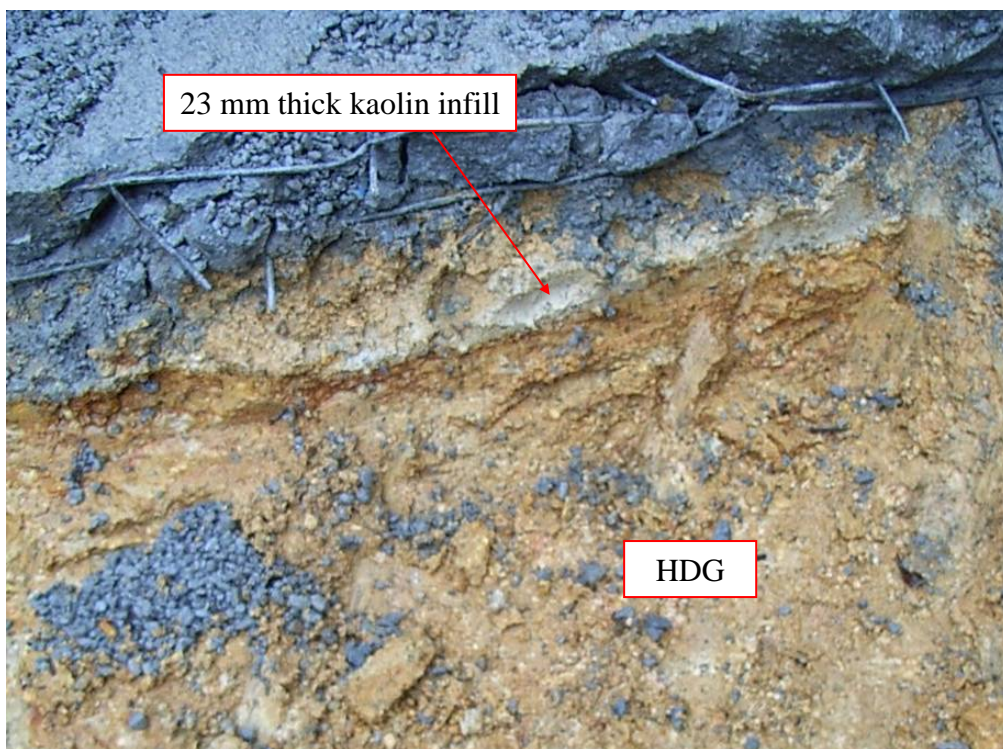
Plate 21 - Kaolin Infill Observed in Trial Pit No. TP6  
(Photograph taken on 26 May 2009)

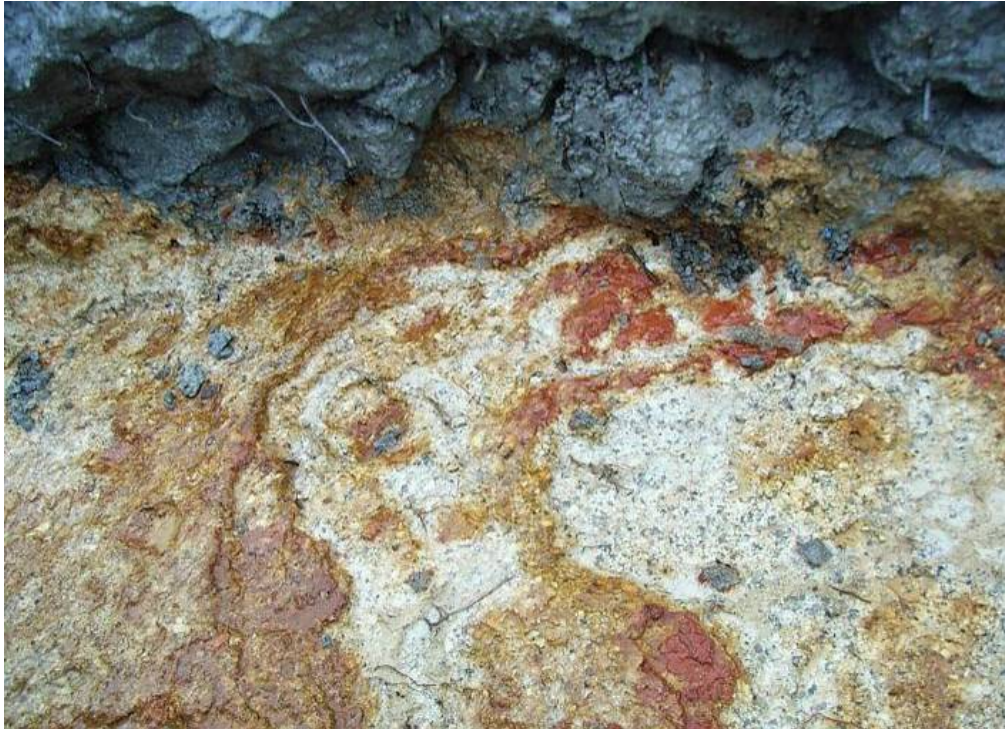
Plate 22 - Kaolin Infill Observed in Slope Surface Strip No. SS1  
(Photograph taken on 26 May 2009)

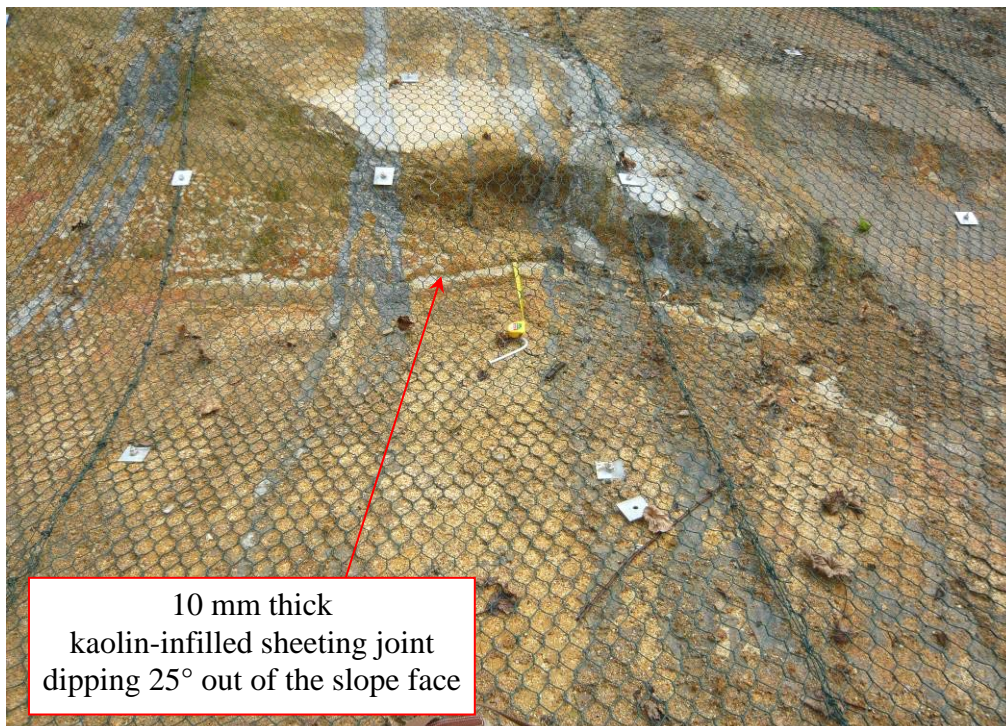
Plate 23 - Kaolin-infilled Sheeting Joint Exposed during LPM Works  
(Photograph taken on 4 June 2010)

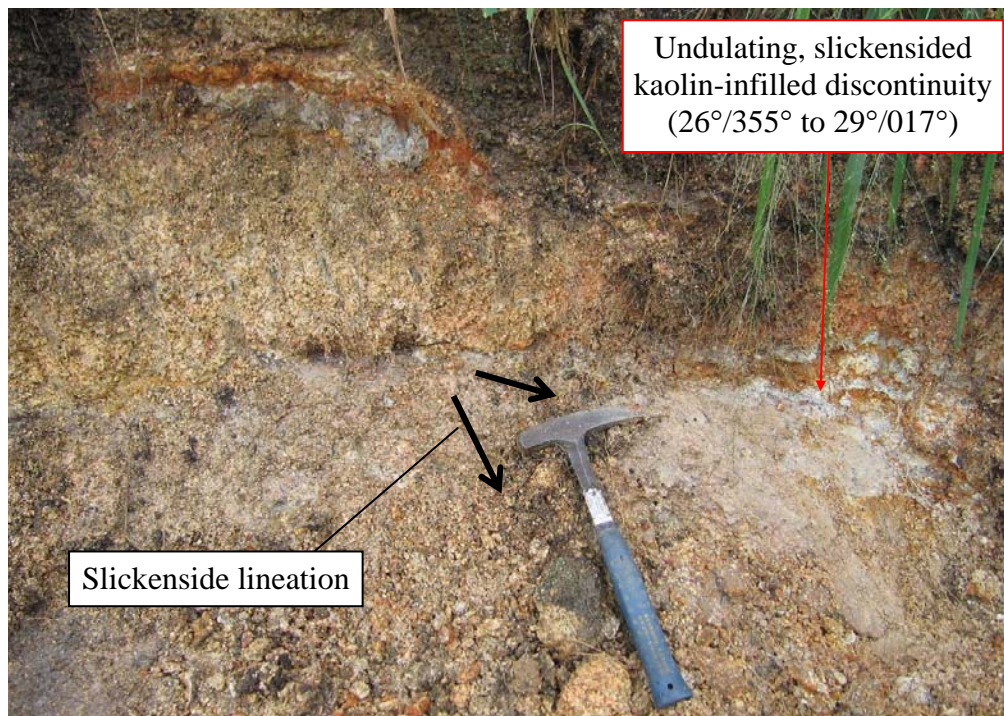
Immediately to the east of the landslide scar, an undulating discontinuity dipping at 26°/355° to 29°/017° with up to 2 mm thick kaolin infill and slickensides was observed (Plate 24). The observed slickensides were not in the direction of the 7 June 2008 landslide.

Plate 24 - Slickensided Kaolin-infilled Discontinuity  
(Photograph taken on 18 June 2008)

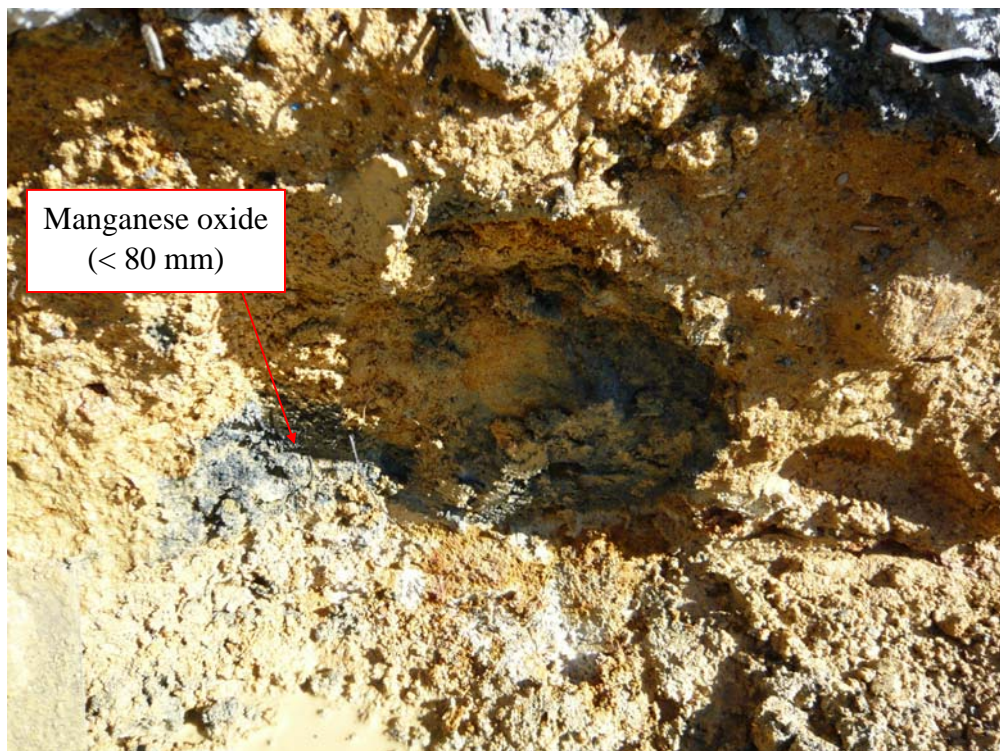
Soft, bluish grey, manganese oxide infill was also present locally on the relict sheeting joints forming the basal slip plane. The infill was about 80 mm to 100 mm thick as observed in slope surface strip No. SS2 on the landslide scar (Plate 25). The manganese oxide infill was rich in rootlets, indicating a possible preferential seepage flowpath that favoured the growth of vegetation (Plate 26).

Plate 25 - Manganese Oxide Observed in Slope Surface Strip No. SS2  
(Photograph taken on 26 May 2009)

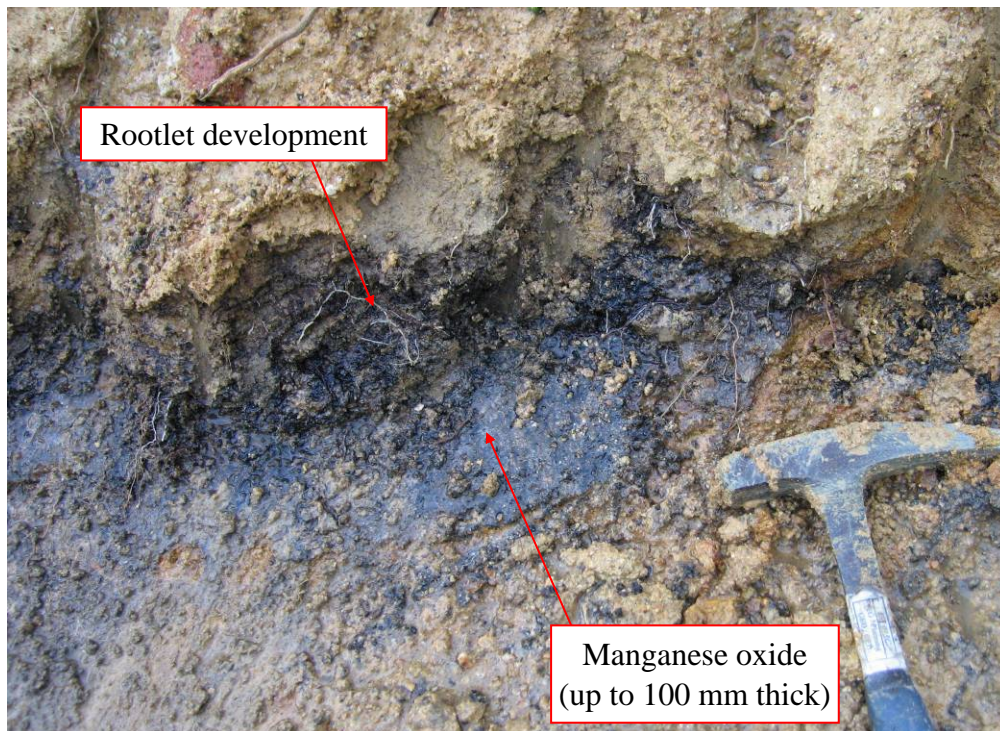
Plate 26 - Manganese Oxide Coated Sheeting Joint  
(Photograph taken on 18 June 2008)

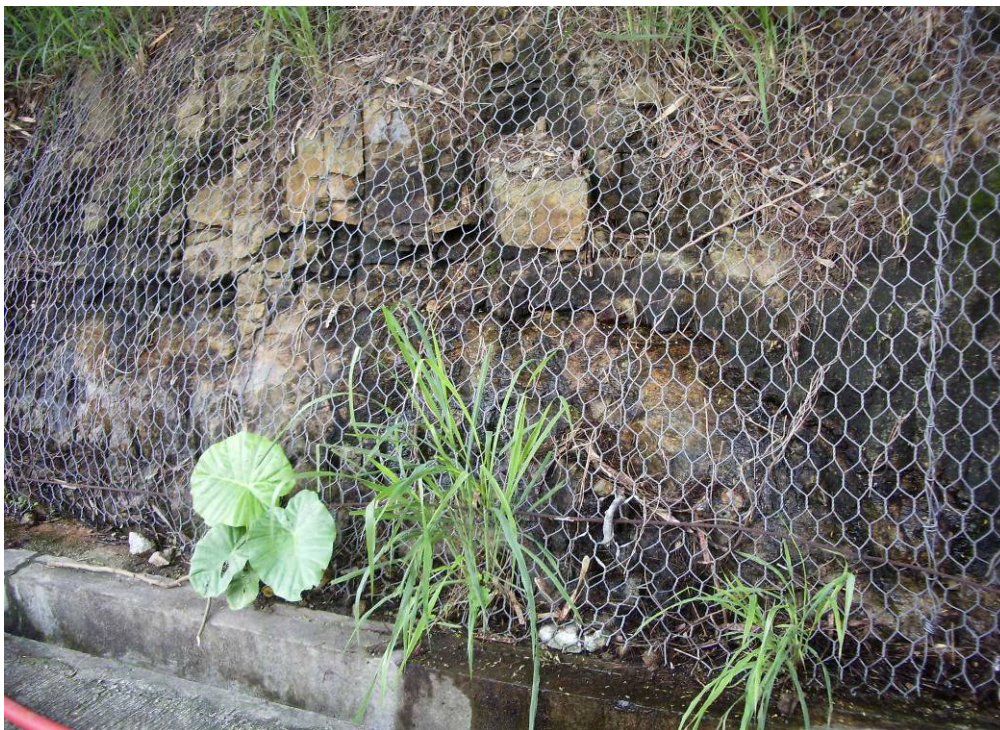
Plate 27 - Seepage from Toe of Western Portion of Slope No. 11SE-A/C502  
(Photograph taken on 10 June 2008)

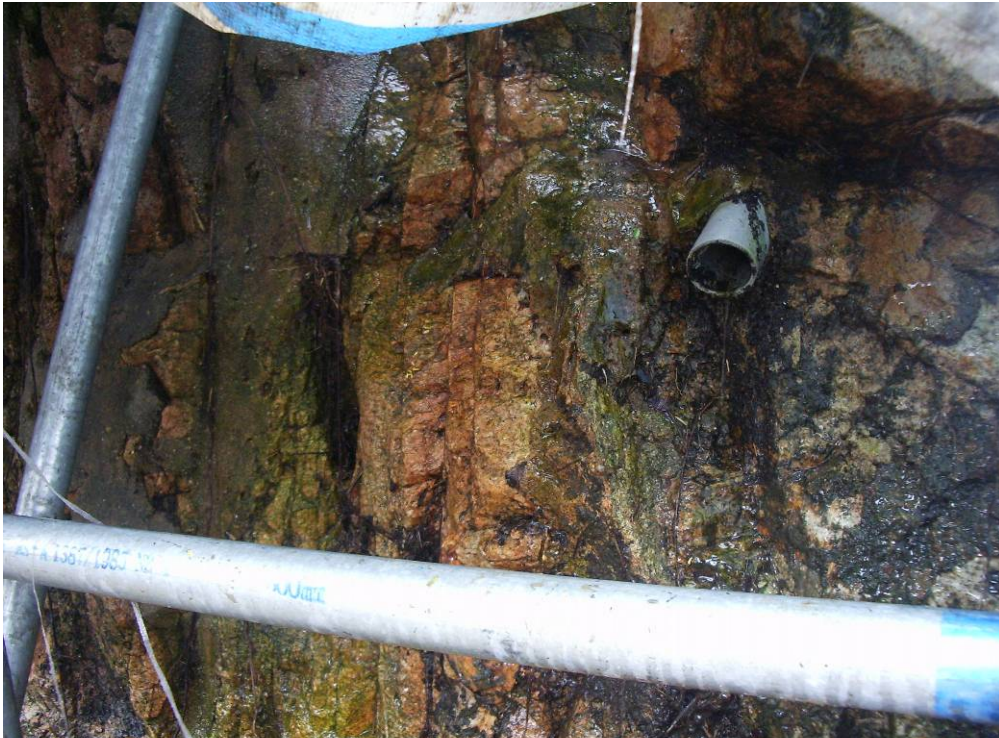
Plate 28 - Seepage at the Lower Portion of Slope No. 11SE-A/C710  
(Photograph taken on 10 June 2008)

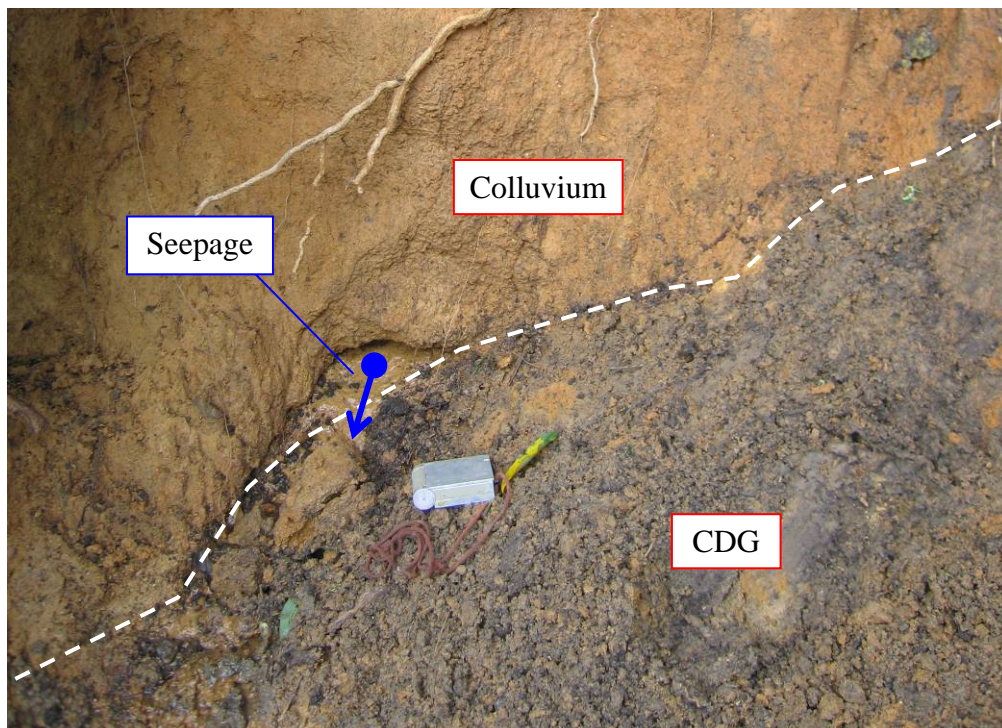
Plate 29 - Seepage at the Base of Colluvium in the Landslide Scarp  
(Photograph taken on 18 June 2008)

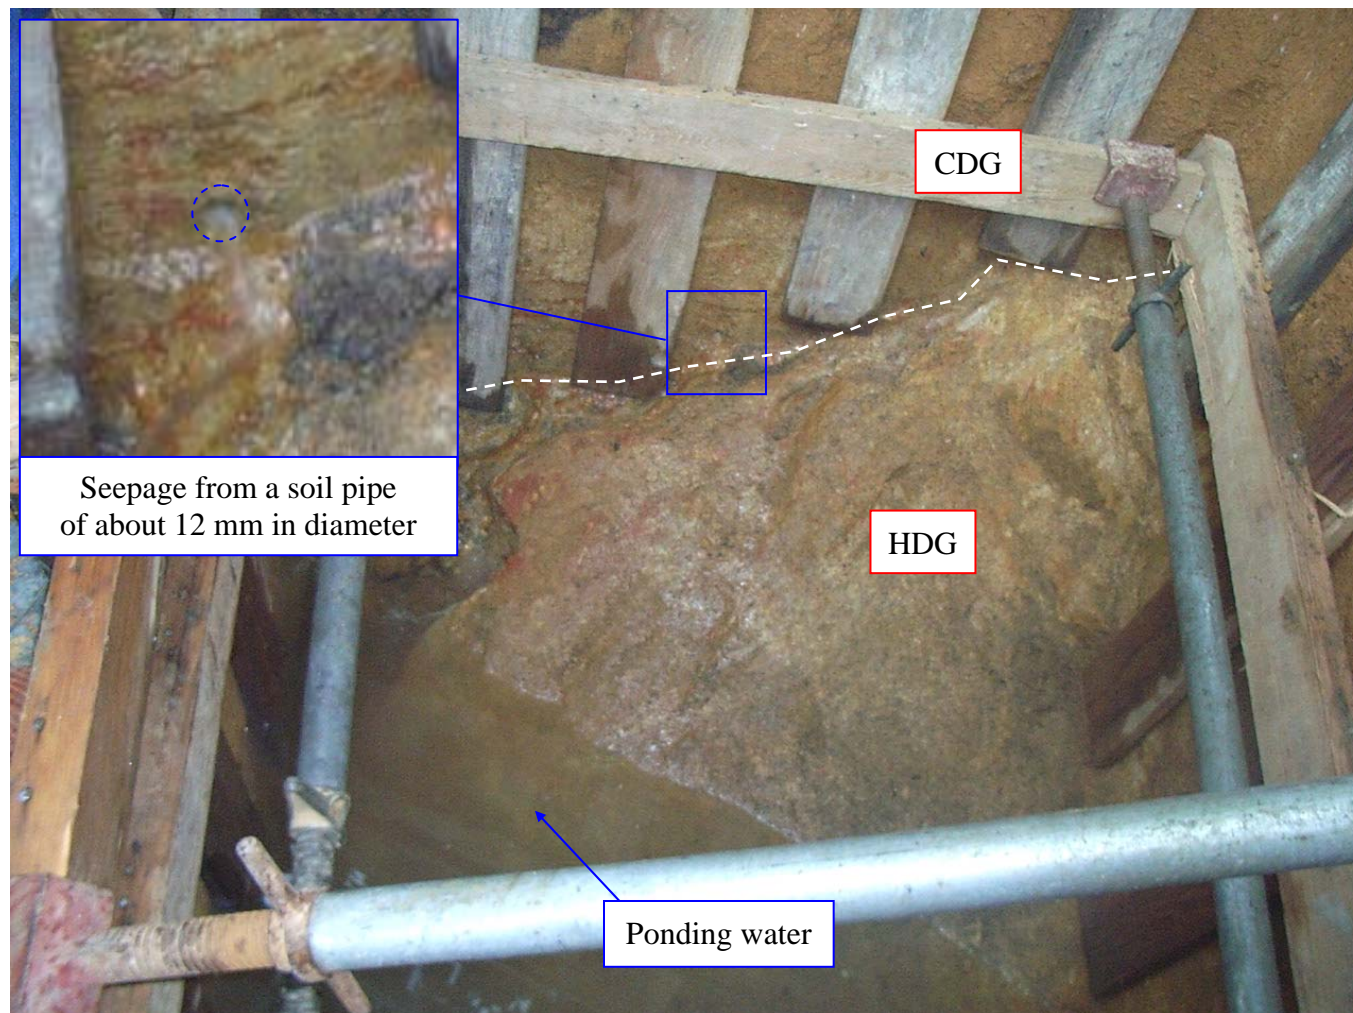
- (c) On 25 May 2009 following 157.5 mm of rainfall over the previous two days, heavy seepage from a soil pipe of approximately 12 mm in diameter at the CDG/HDG interface was observed in trial pit No. TP5 (Figure 14 and Plate 30); and
- (d) On 26 May 2009, light to moderate seepage was noted at the kaolin-rich zone within the mottled weathering zone of decomposed granite at slope surface strip No. SS1 (Figure 14).

Plate 30 - Seepage from a Soil Pipe in Trial Pit No. TP5  
(Photograph taken on 25 May 2009)
